**U.S. Department
of Transportation**

**Pipeline and
Hazardous Materials
Safety Administration**

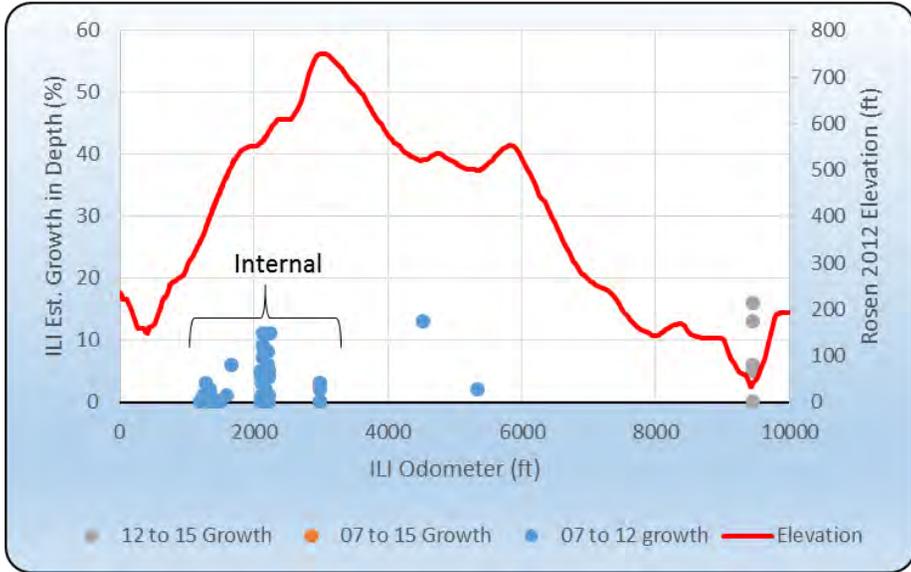
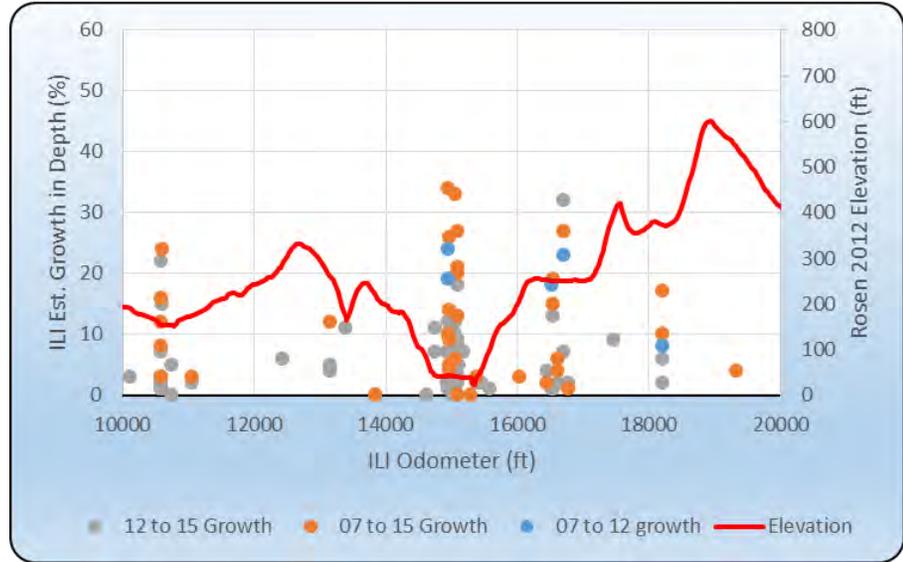
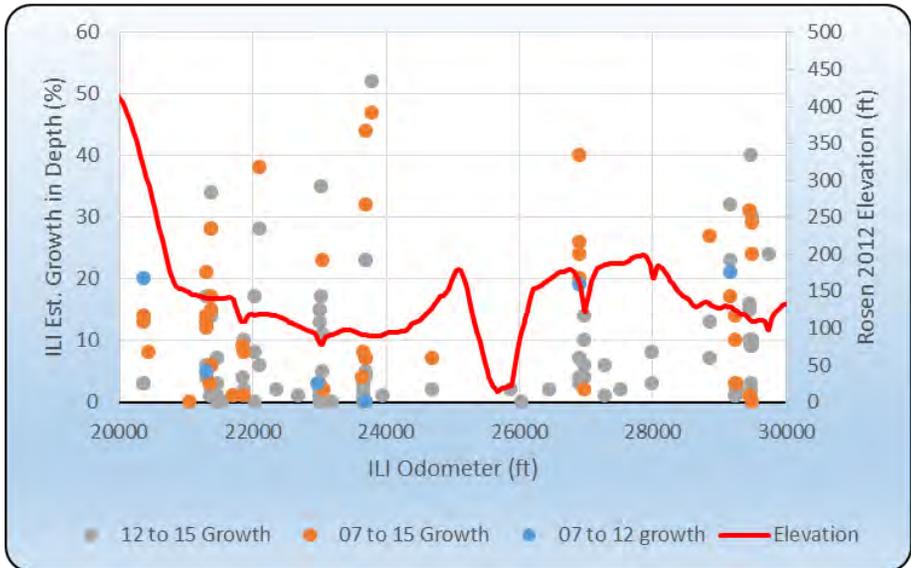
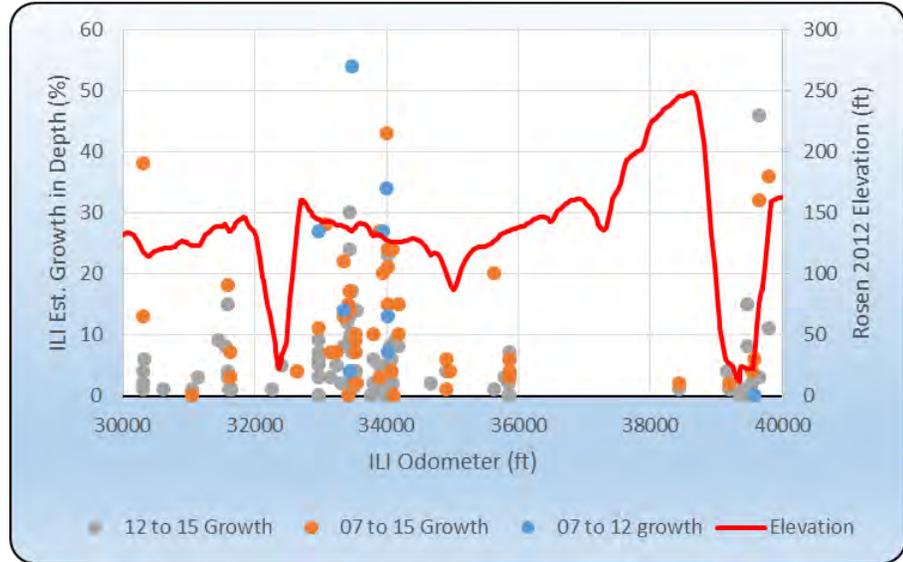
Appendix A – ILI growth variance in depth between all inspections

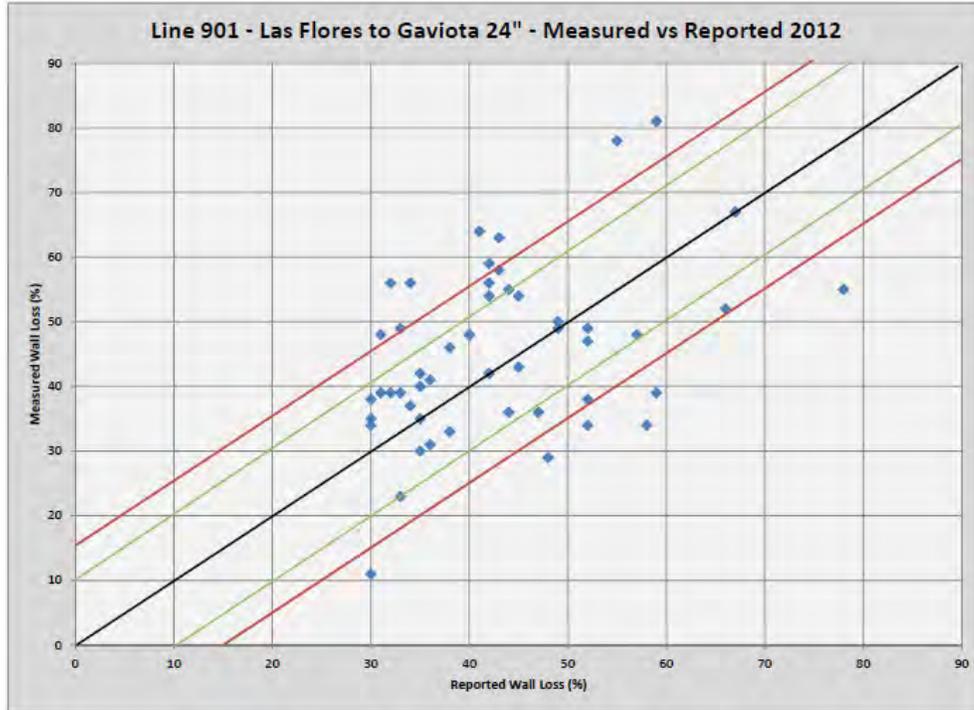
The black line is the one to one line where any “as-called equal as-found” anomalies would be plotted. The green lines are +/- 10% lines and the red lines are +/- 15% lines. ~57% of the plotted anomalies are within the +/- 10% lines. Reported tool accuracy is +/- 10% 80% of the time. There is no documentation regarding any further analysis or discussion which may have ensued after the creation of this Unity Plot for wall loss (depth).

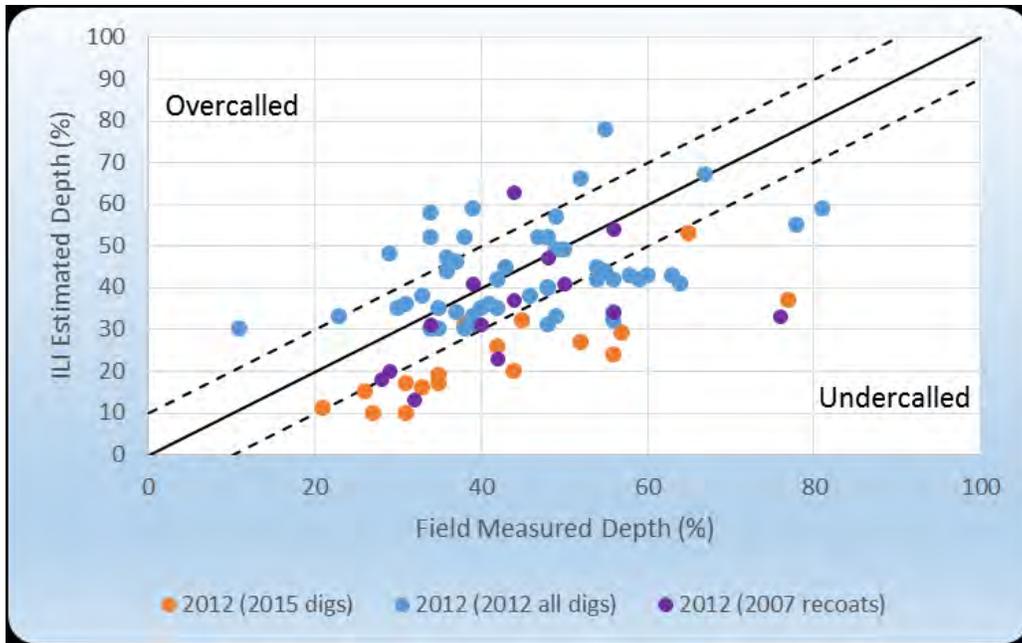
“The 2015 ILI estimated depths are compared to field measured depths either from the 4 excavations following the failure or the areas recoated after the 2007 and 2012 inspections. The unity plot shows that the 2015 Rosen inspection is within $\pm 10\%$, 57% of the time. It may be seen that the failure location has an uncharacteristically high deviation from the ILI estimate.”

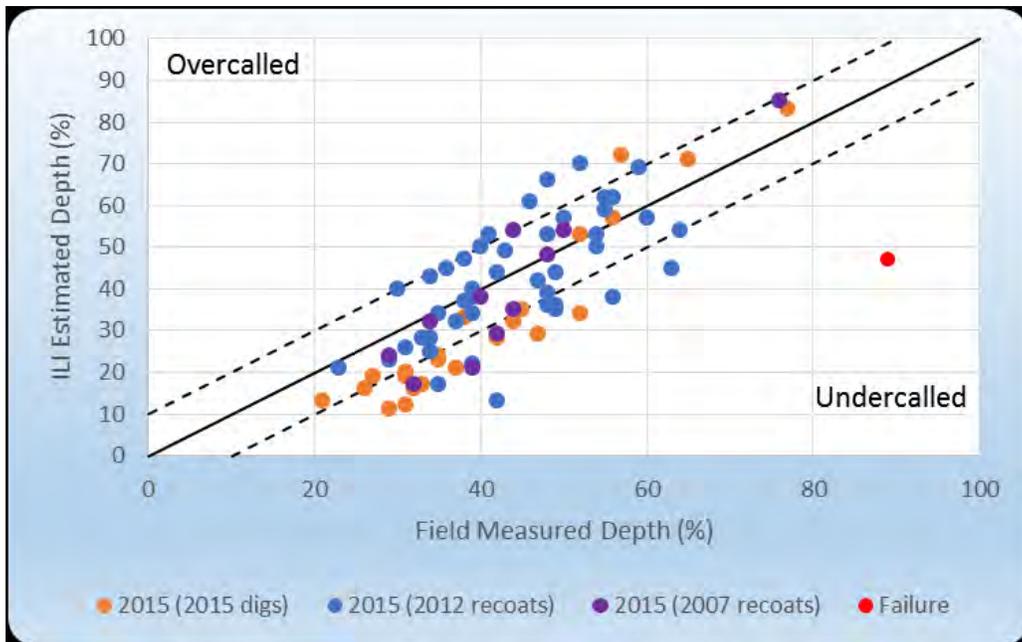
The ILI-SME describes the process for calculating the remaining strength of a pipe based on the length, width and depth of an anomaly. He also describes the manner in which ILI vendors’ interact individual pits into boxes and then how the boxes interact to form clusters and how clusters can be grouped. Suffice it to say that there is a defined process for

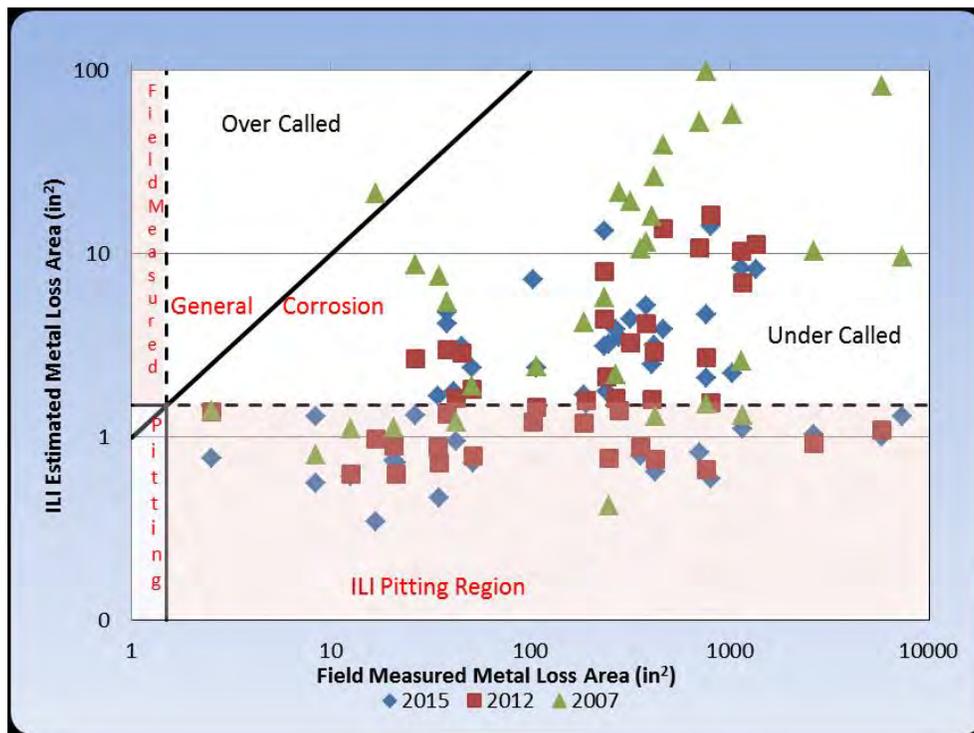
Figure 16. Metal loss area; ILI vs field measurement.

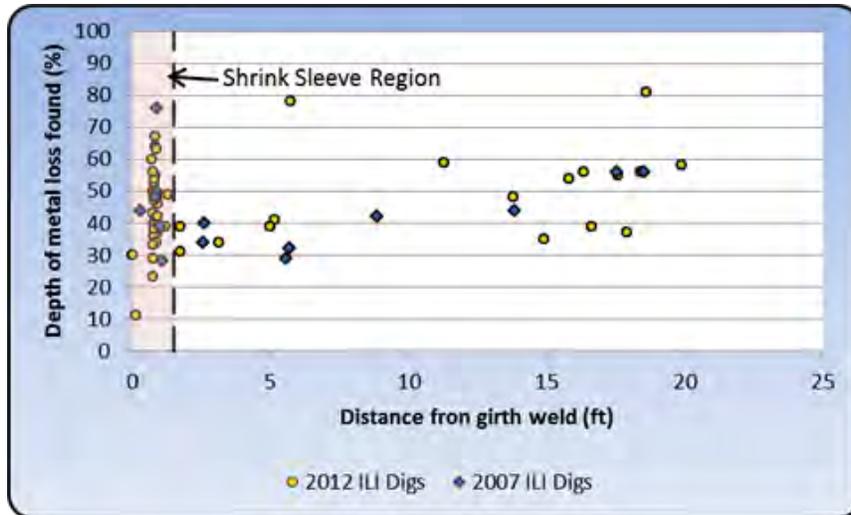
The second analysis had to do with the estimated cubic yards of dirt excavated during each anomaly dig. Plains’ personnel explained to PHMSA that they were required to keep their excavations below 100 cubic feet. This is important because PHMSA was told by the Plains’ IMP Group that Santa Barbara County has strict requirements for excavators and that obtaining a permit for larger excavations would take from six months or more to obtain a permit. However, Plains’ IMP Group reported that there is an exception for excavations made that are less than 100 cubic yards of dirt. Below is an excerpt from the “Santa Barbara County, Planning and Development, Building and Safety Division Grading Plan Submittal Requirements for Projects (Other than Subdivisions)” delineating exception #4.

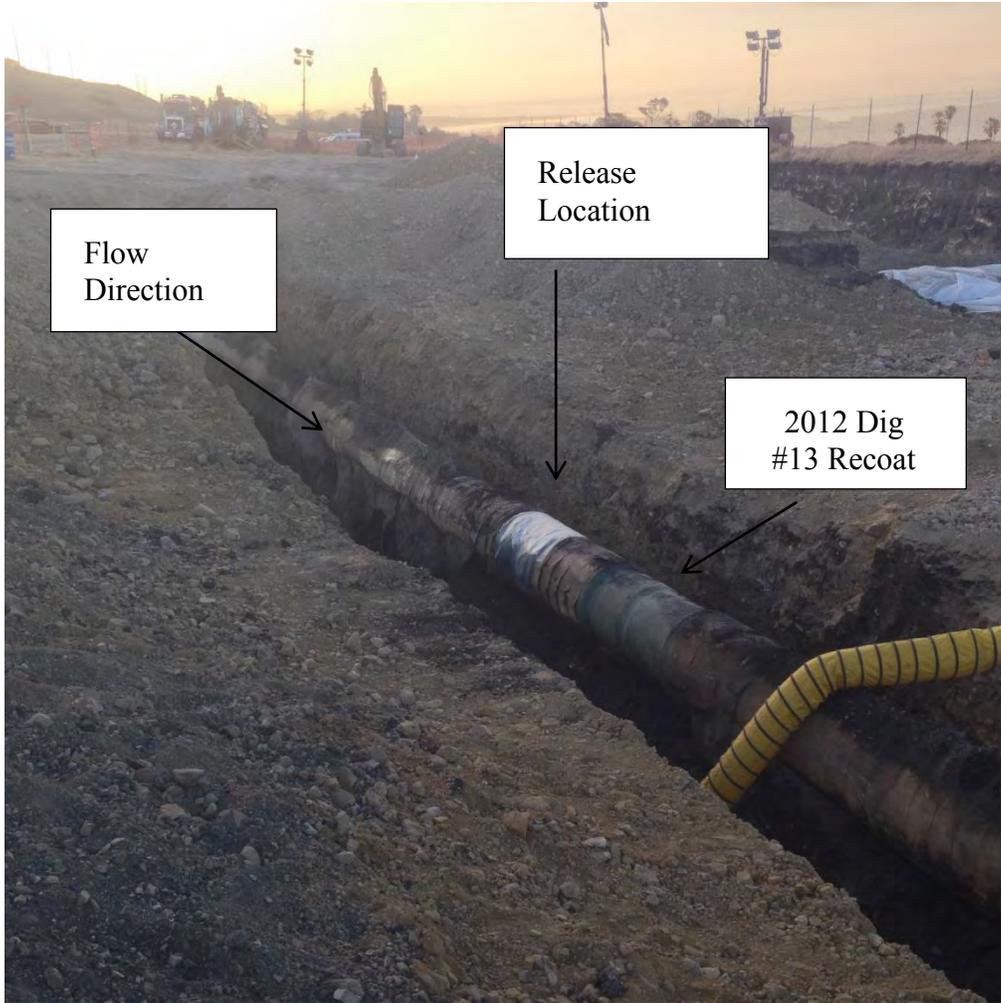
This picture shows the release site wrapped in plastic 6 feet upstream from girth weld 5940 where the coating repair is visible. The repair was identified as Dig #13 from the Post 2012 ILI Survey Anomaly Digs.

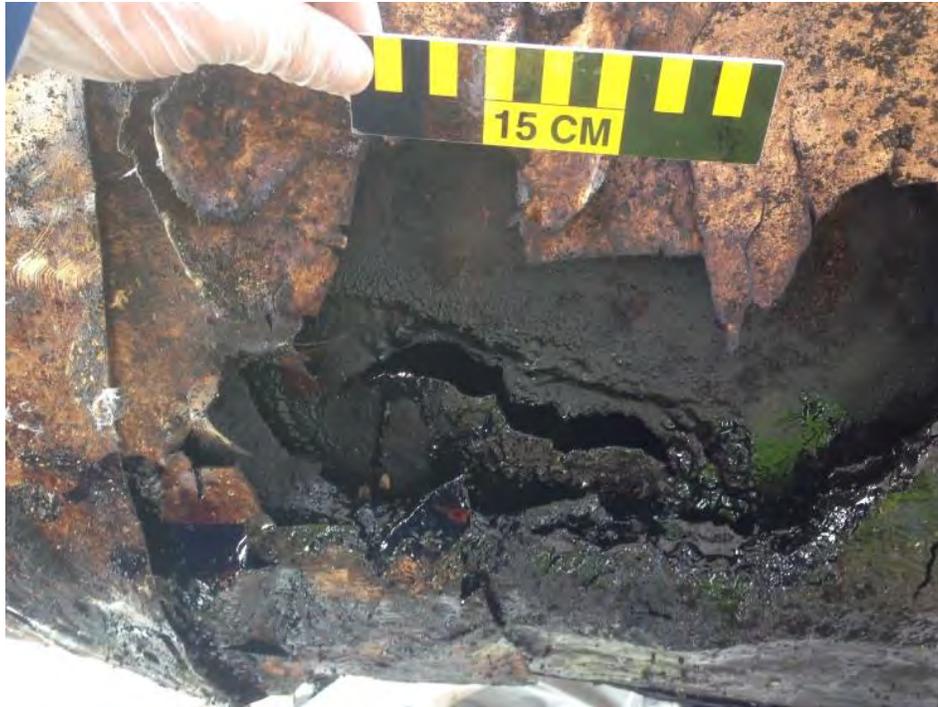
This is one of the first pictures of the release location after removal from the ditch.

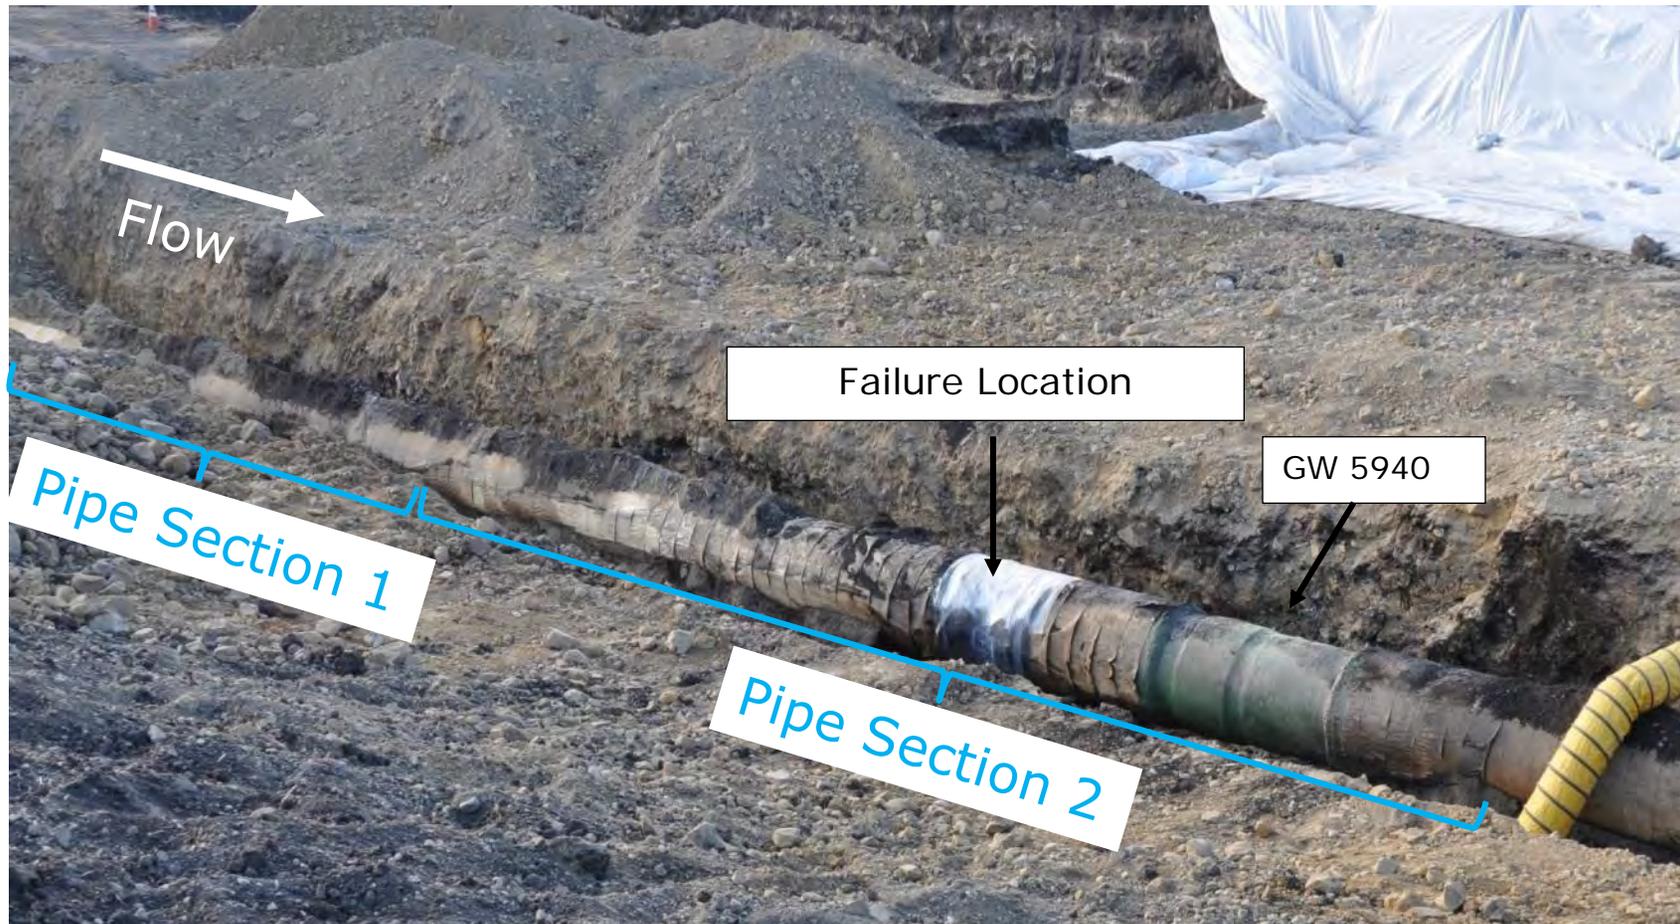
Figure 1. Photograph showing the failure location and the locations of the two pipe sections, during excavation.

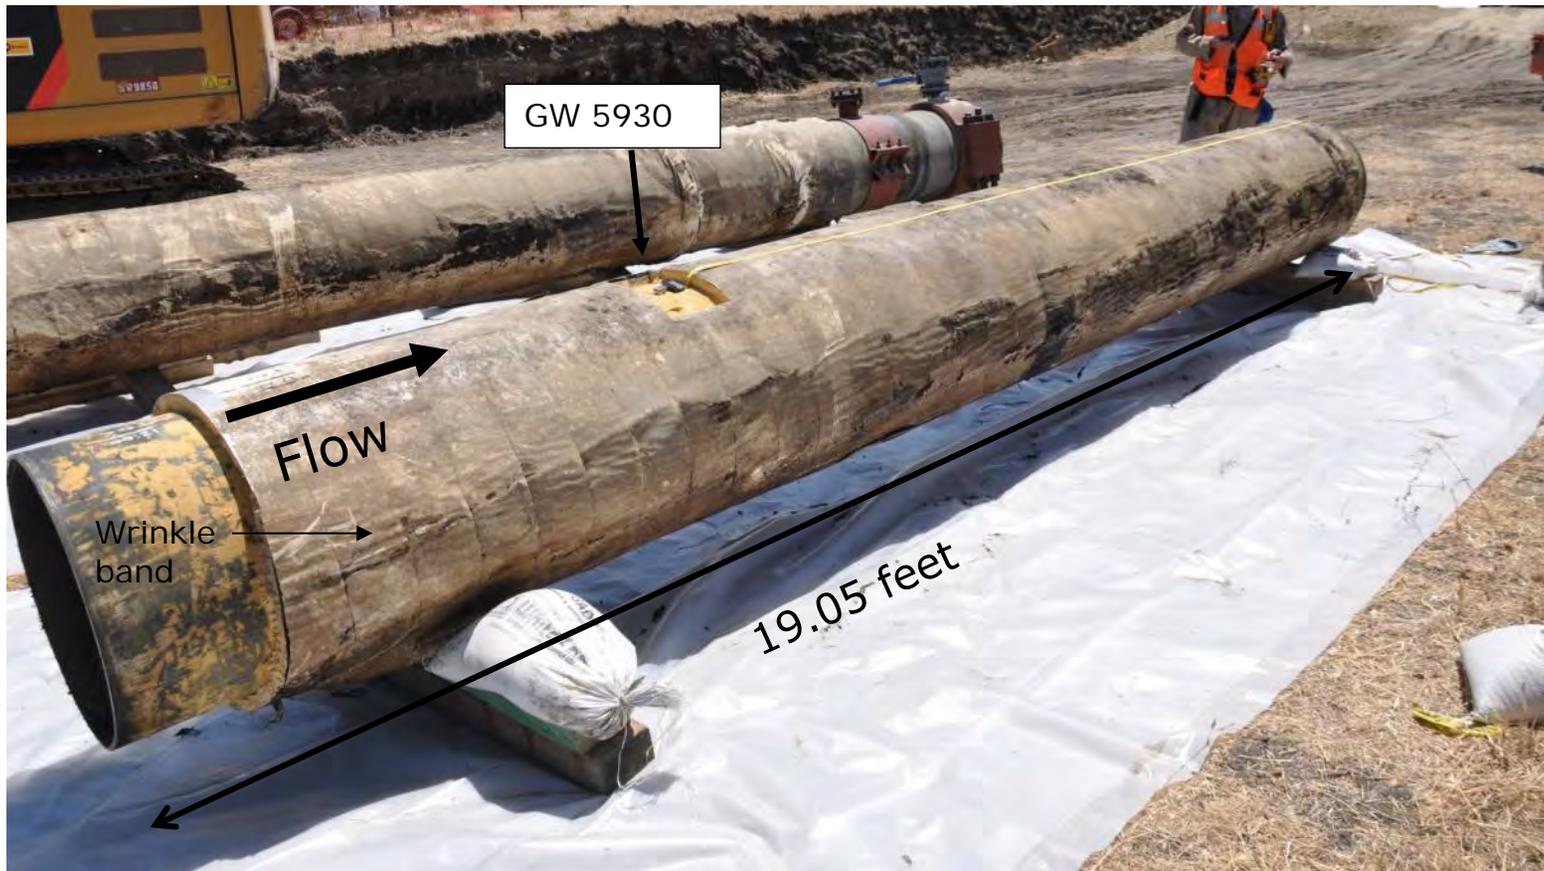
Figure 2. Photograph showing Pipe Section 1 following removal from the ditch.

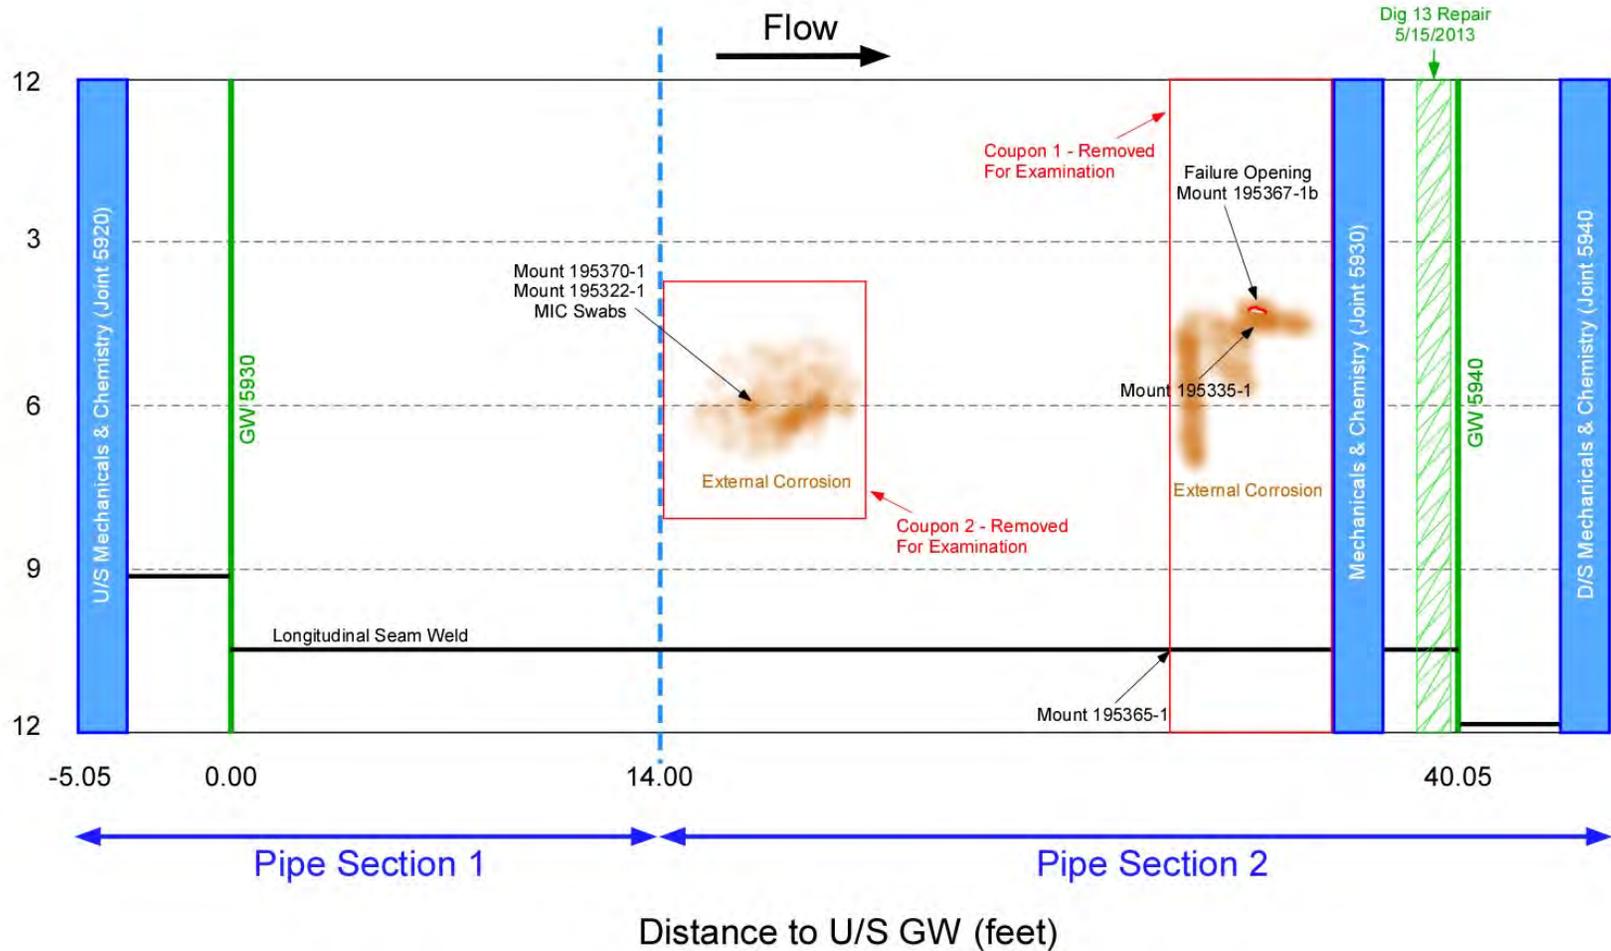
Figure 4. Schematic showing the location of the failure and where samples were removed for various analyses.

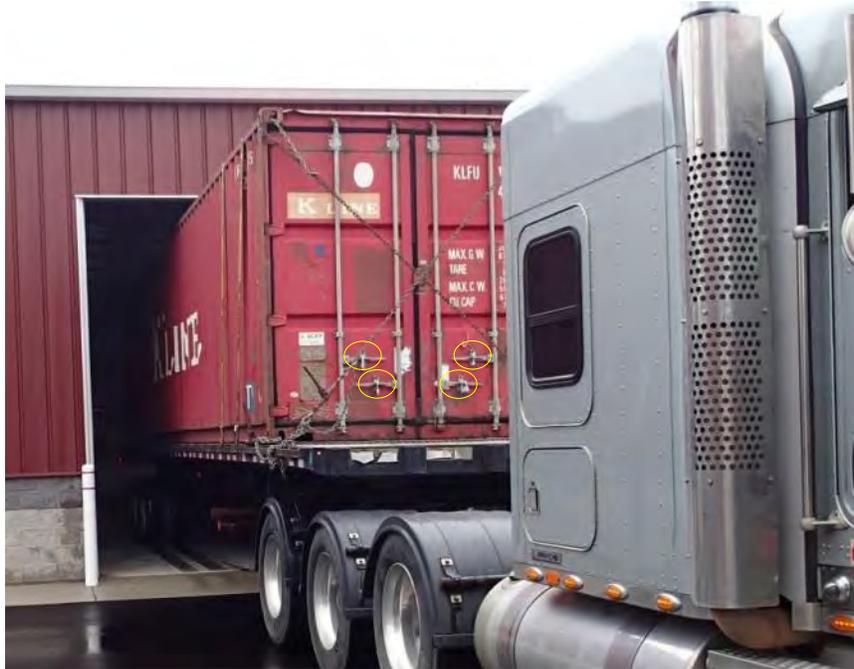
Figure 5. Photograph showing the cargo container in the as-received condition.

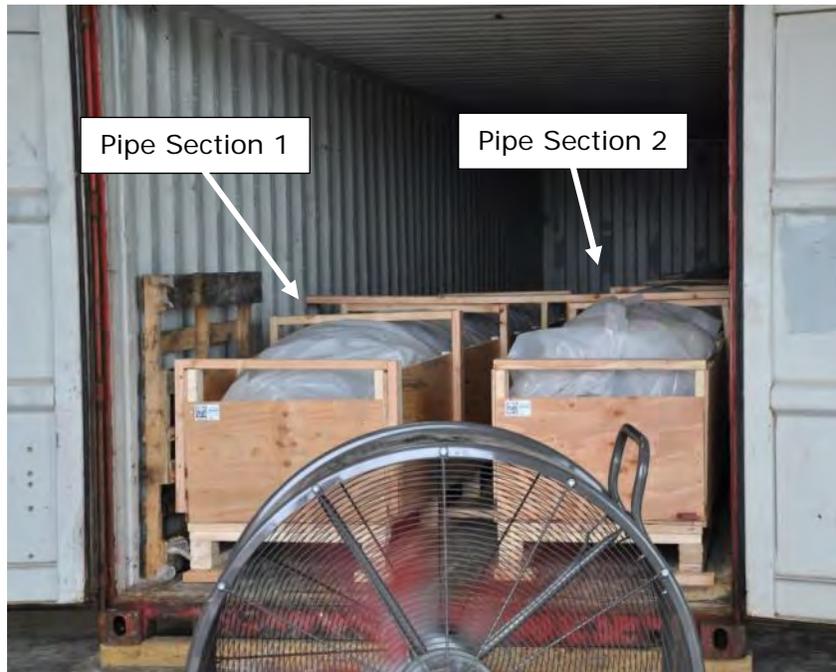
Figure 6. Photographs showing the pipe sections in the as-received condition, within the cargo container.

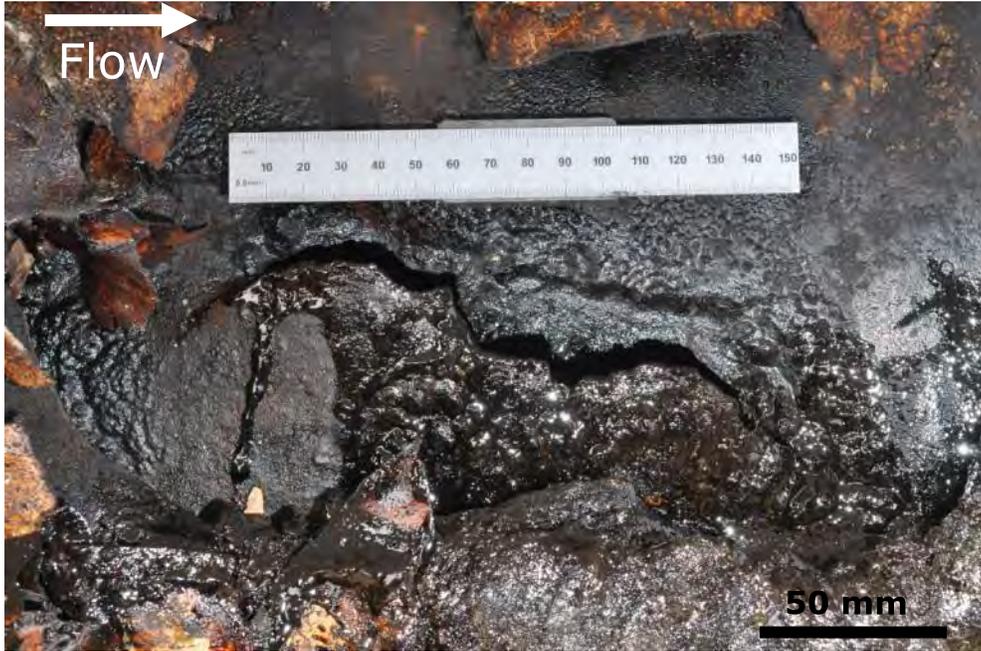
Figure 7. Photographs showing failure location on PS 2 a) before and b) after evidence tape and a clear protective wrapping was removed.

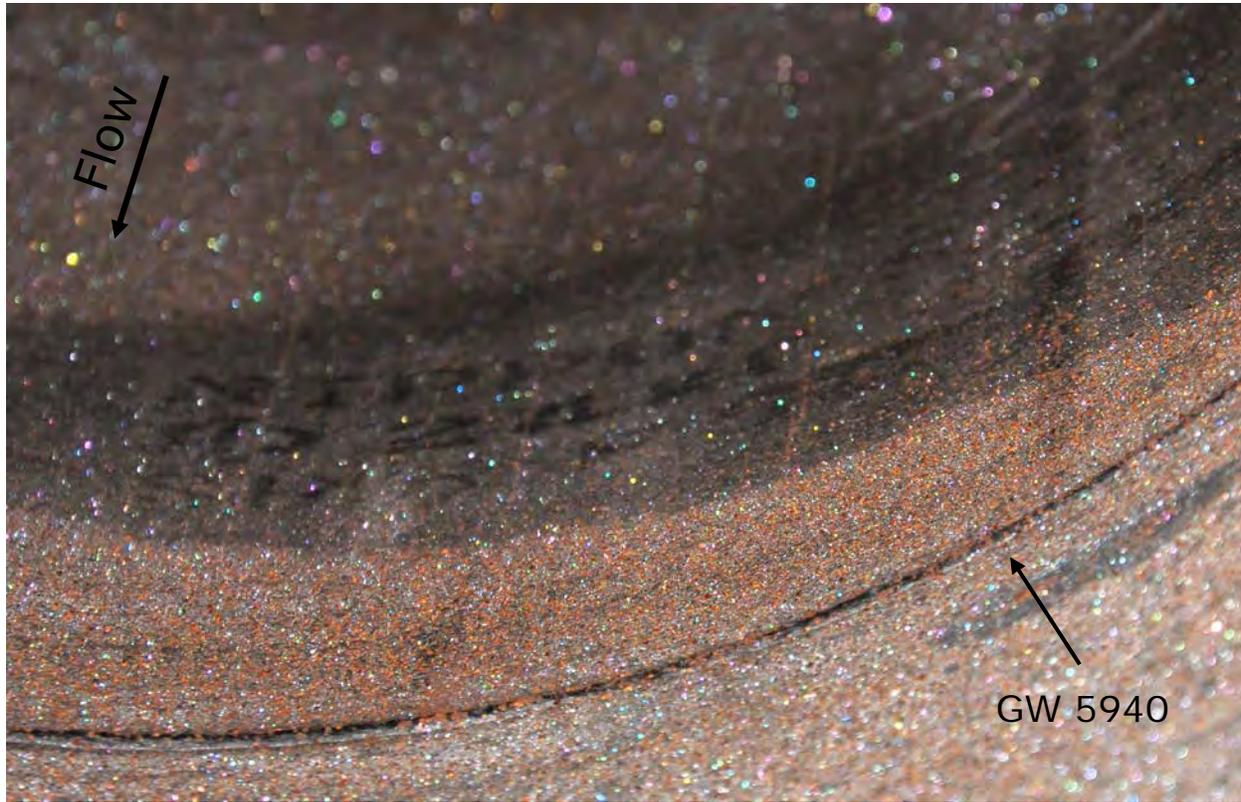
Figure 9. Photograph showing a stamp on the internal surface of the failure joint, near the D/S GW (GW 5940). "NIPPON" and "24" are legible.

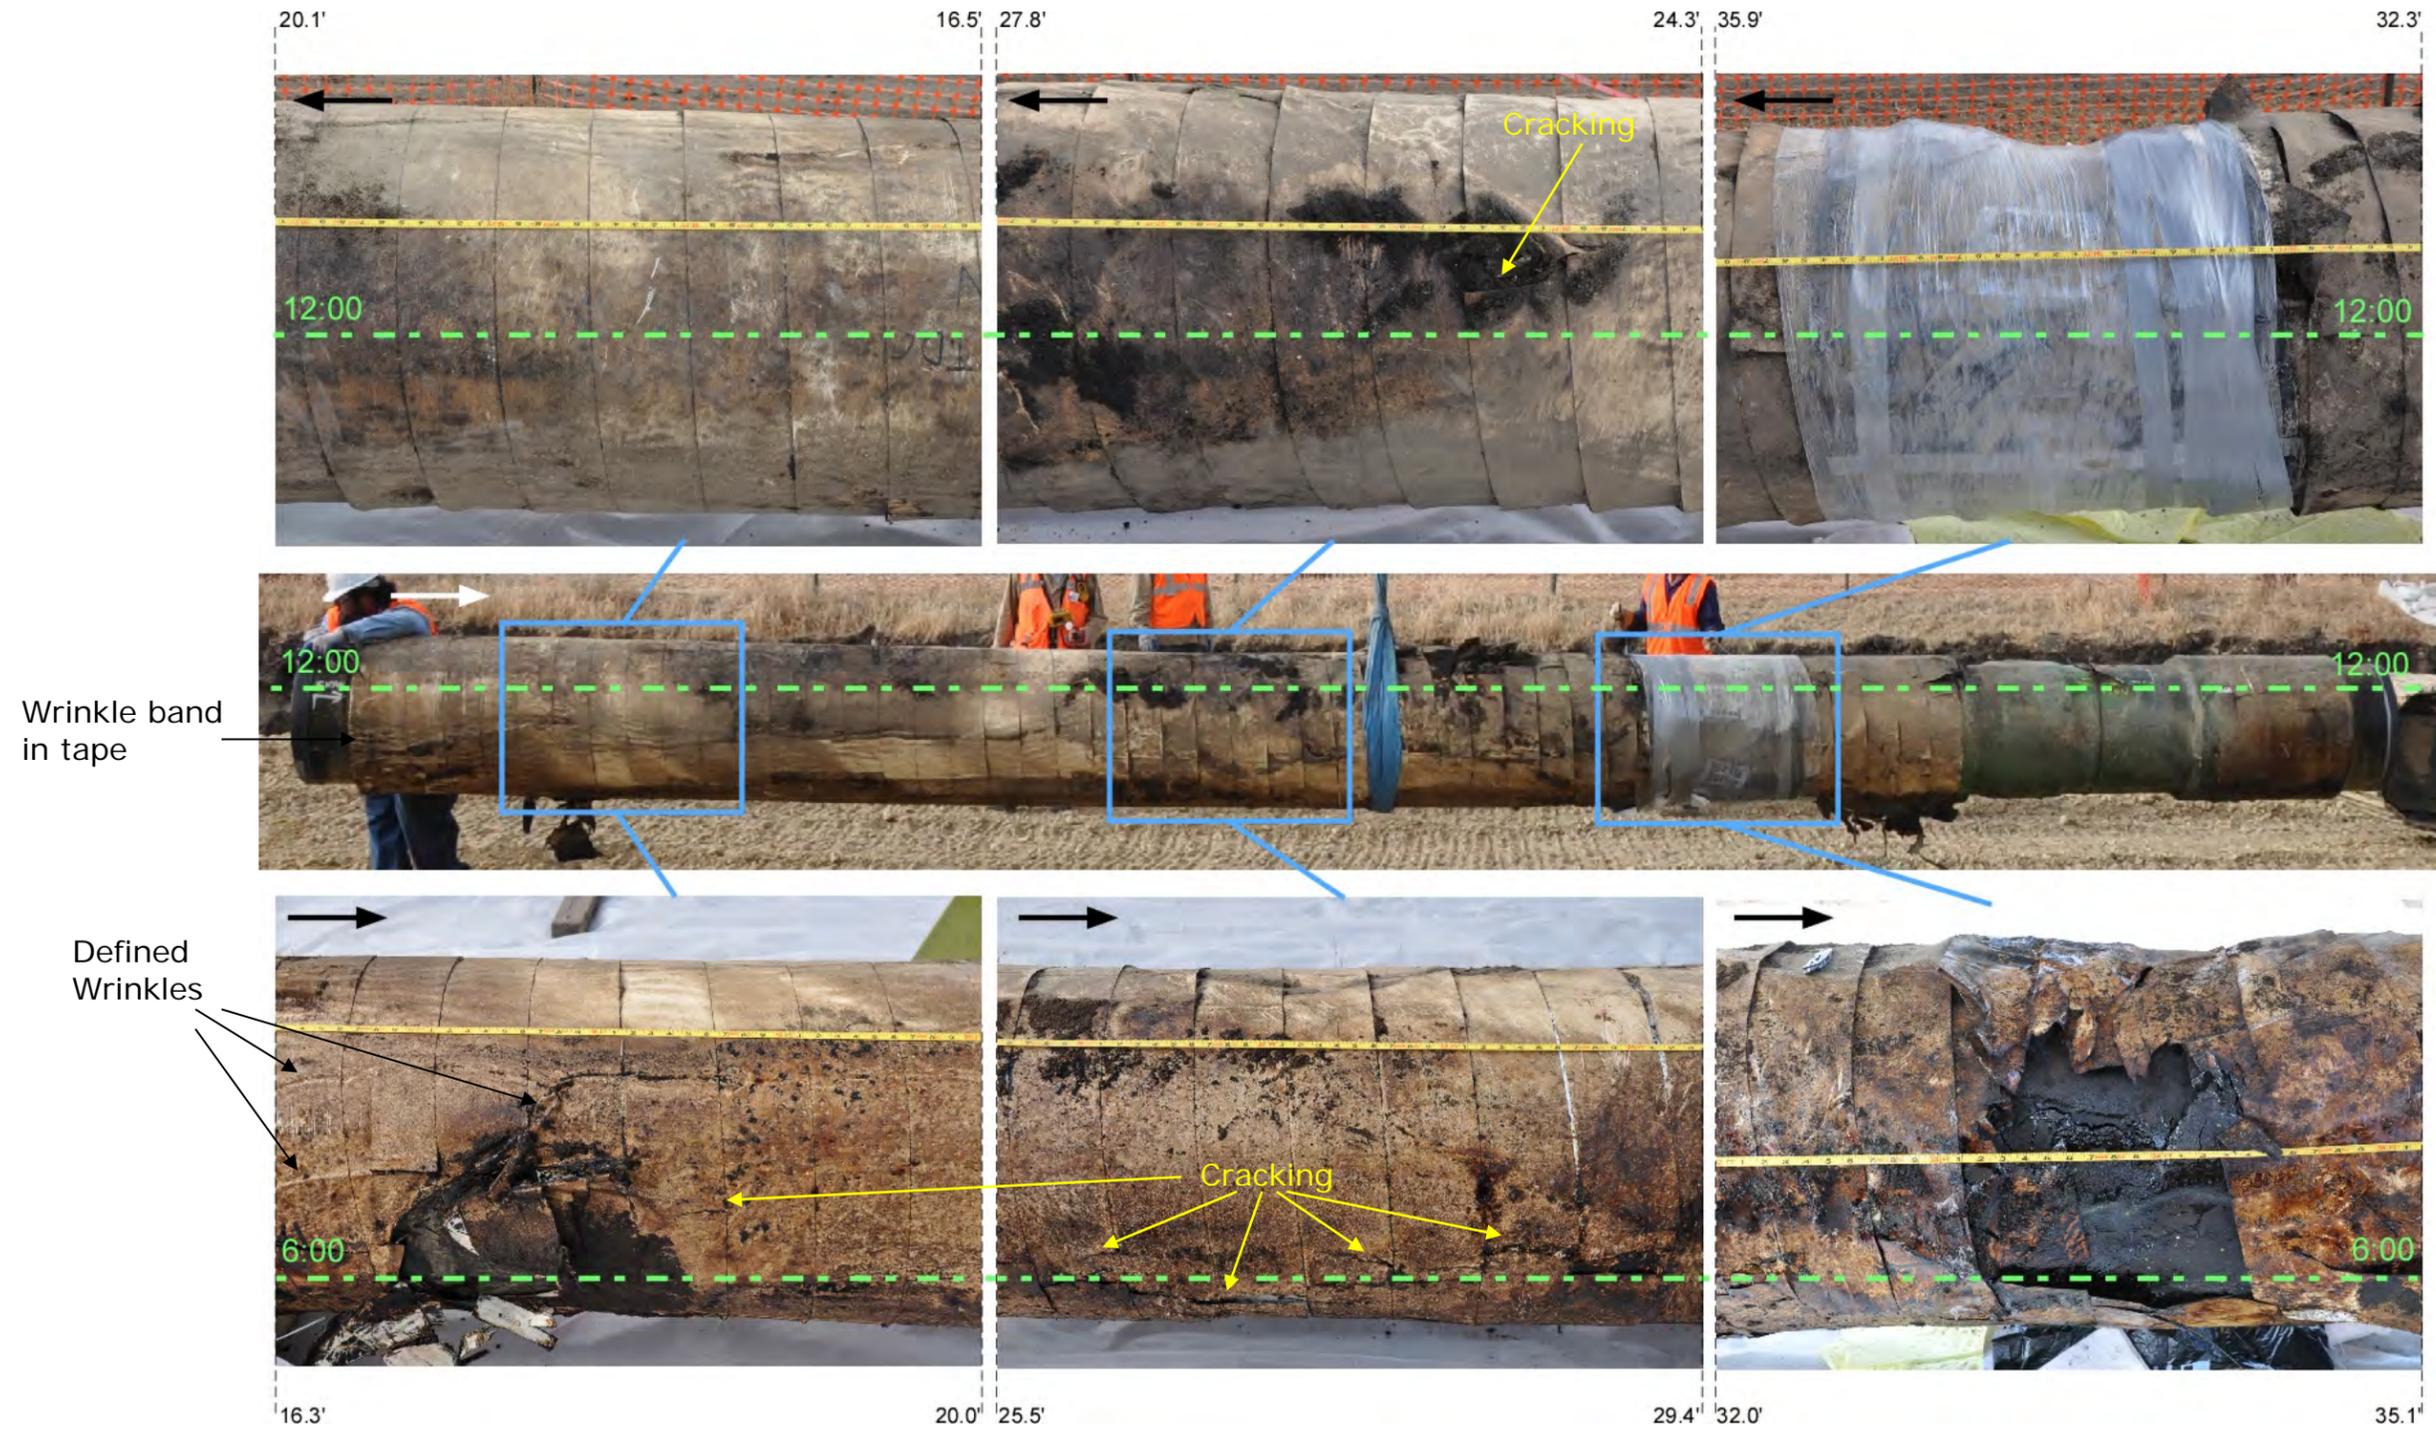
Figure 10. Photographs showing the condition of the external tape on the failure joint. Tape measure indicates distance to upstream girth weld.

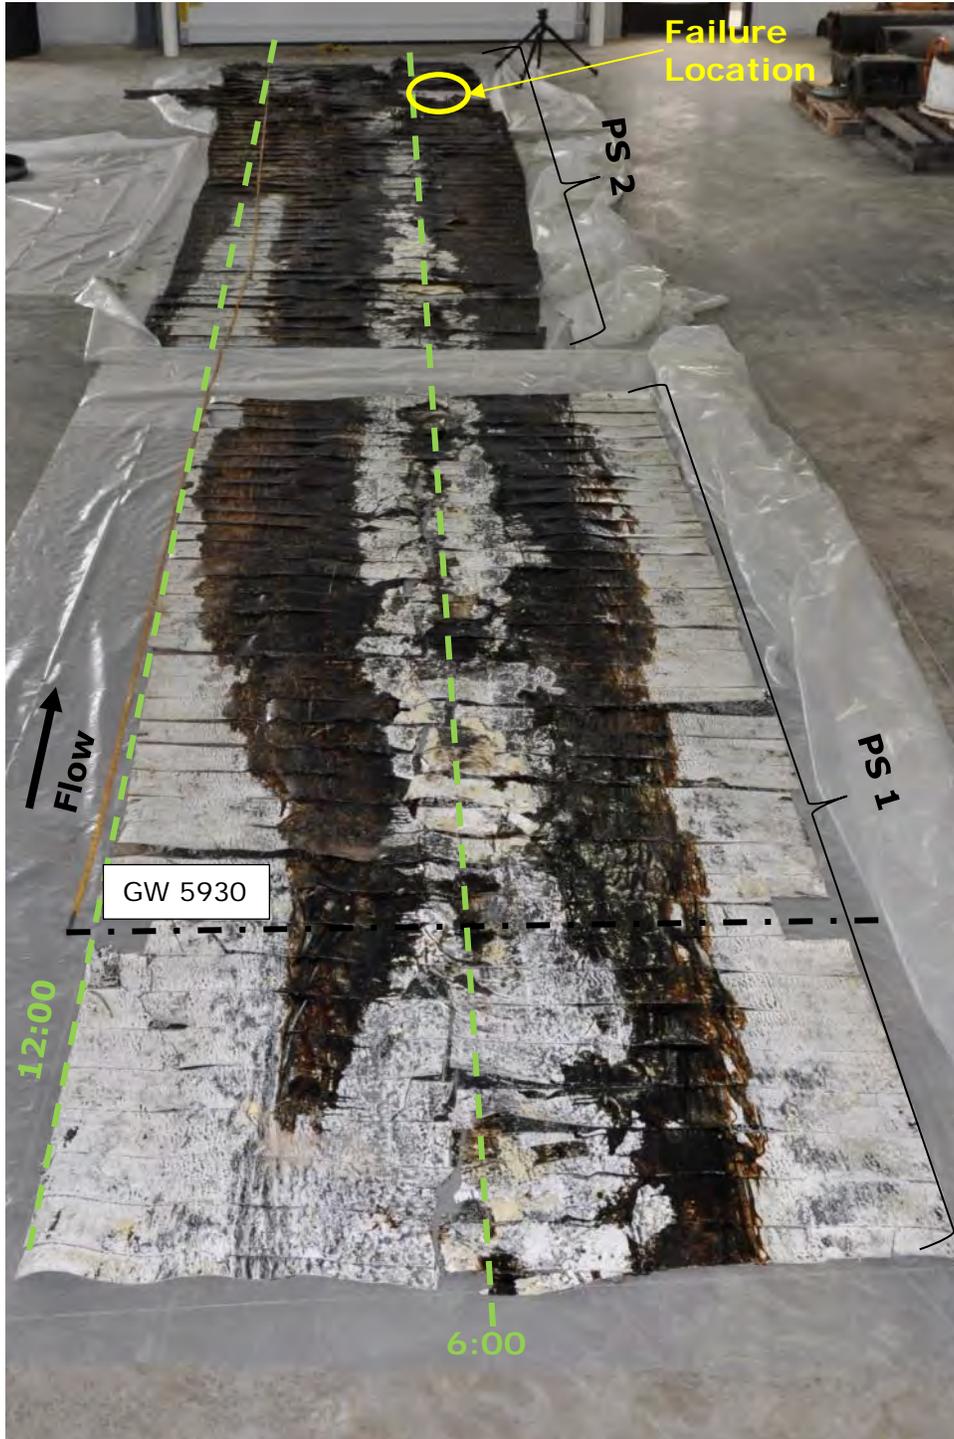
Figure 11. Photograph showing the internal surface of the external tape from the failure joint.

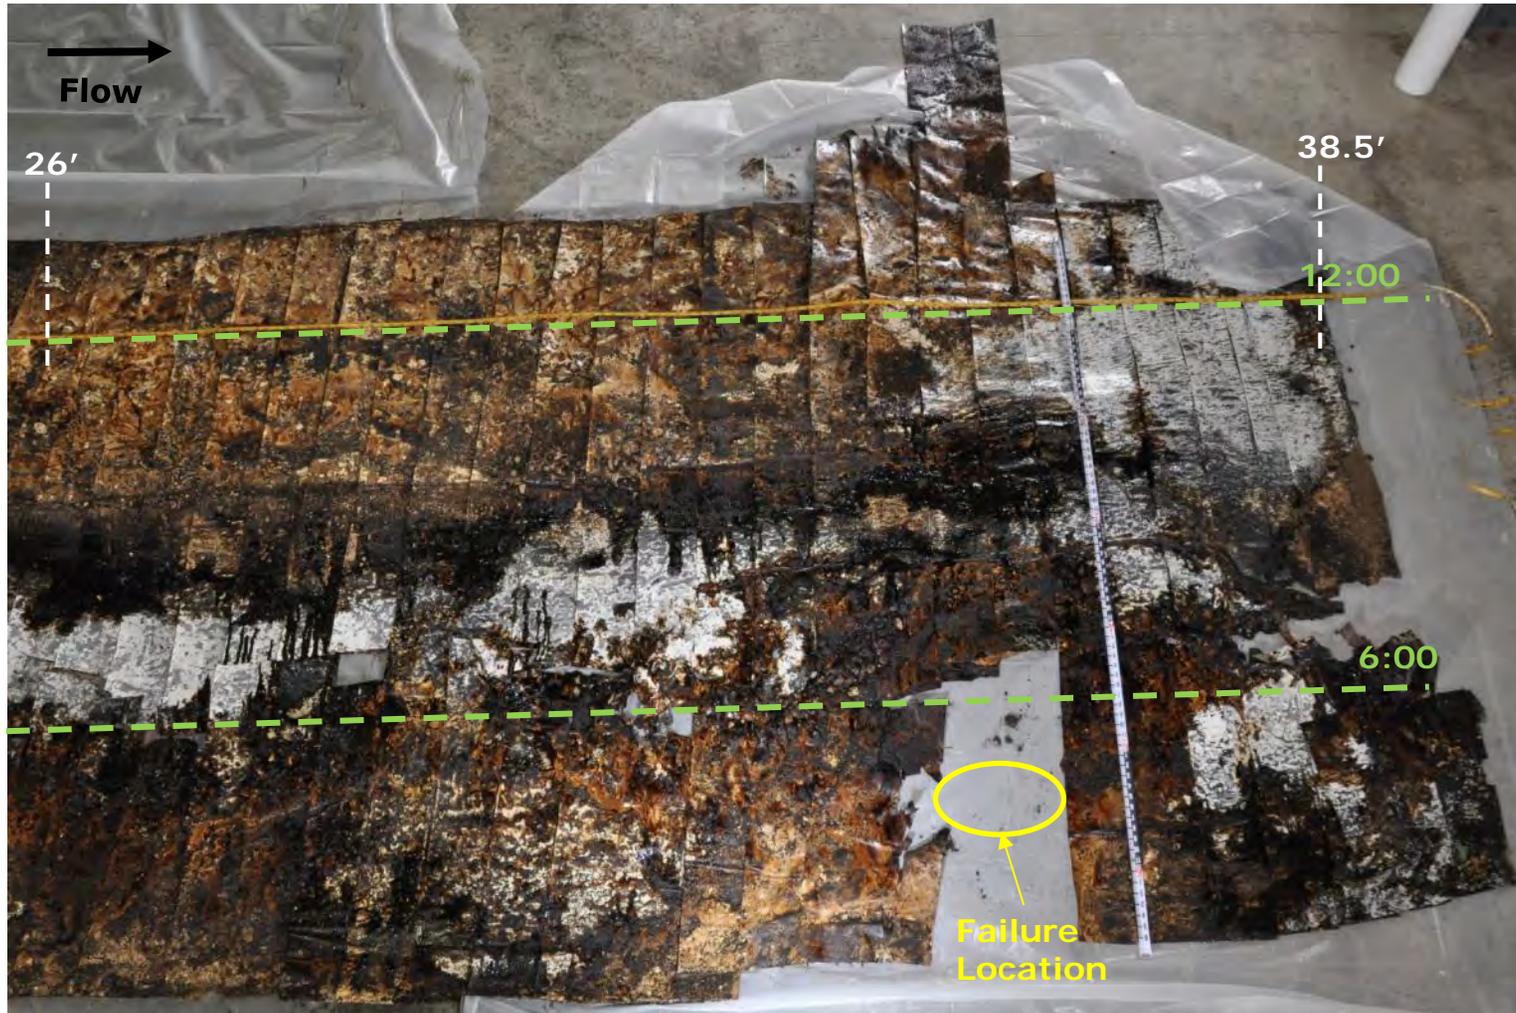
Figure 12. Photograph showing the internal surface of the external tape at the failure location. Tape measure indicates distance to upstream girth weld.

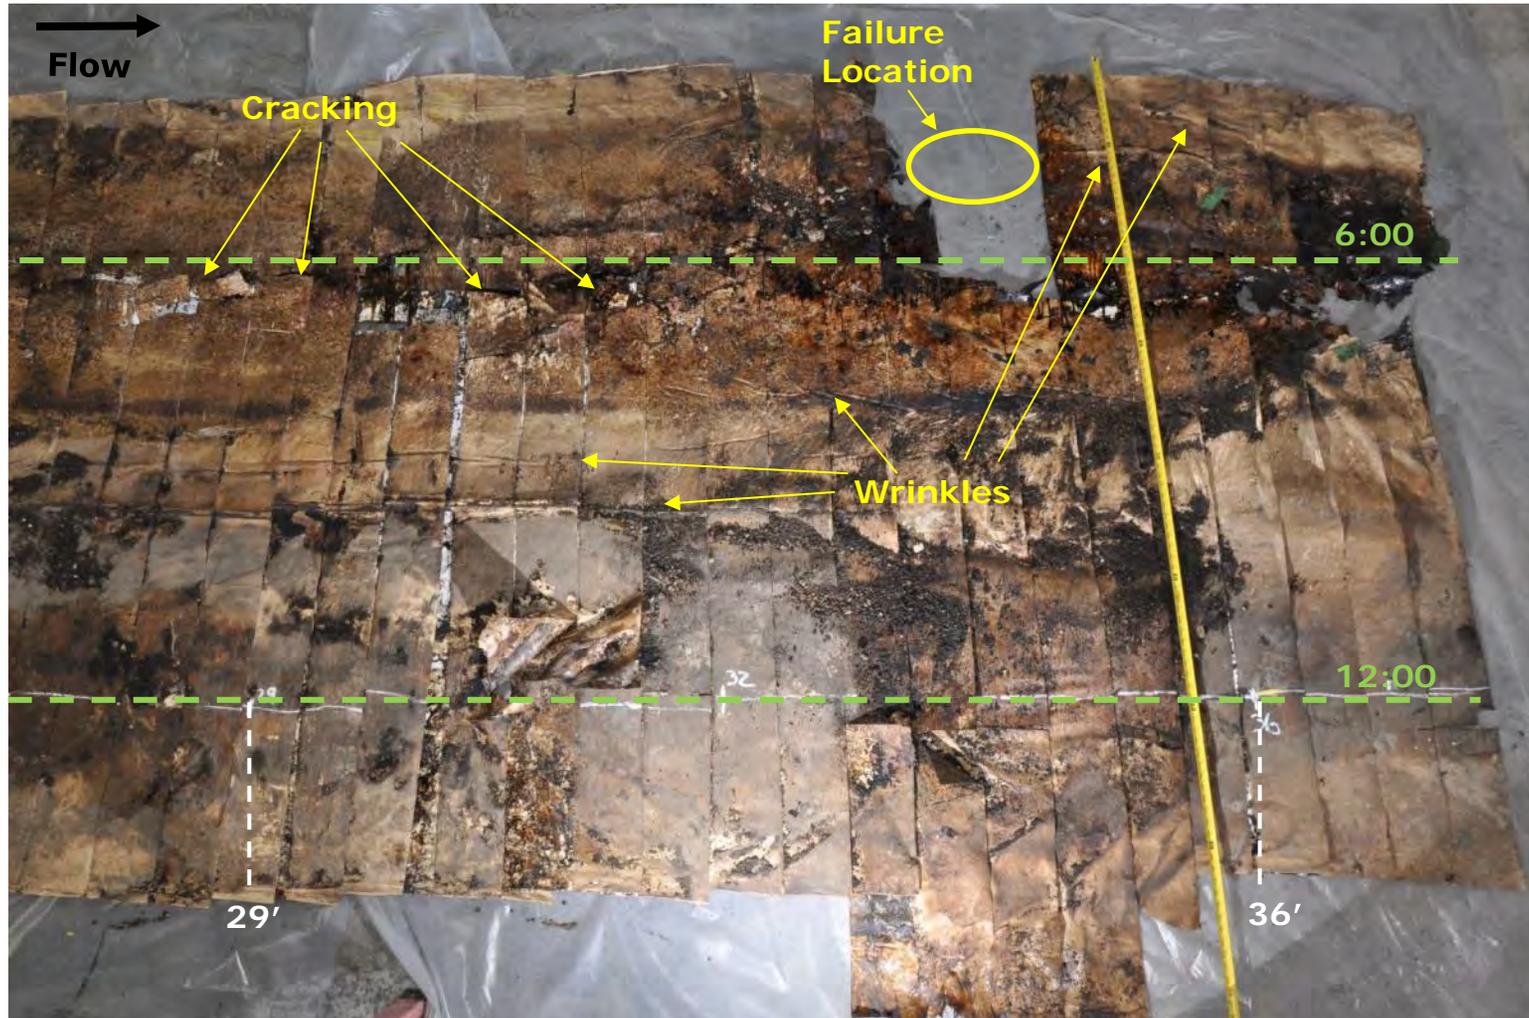
Figure 13. Photograph showing the external surface of the external tape at the failure location.
