**U.S. Department
of Transportation**

**Pipeline and
Hazardous Materials
Safety Administration**

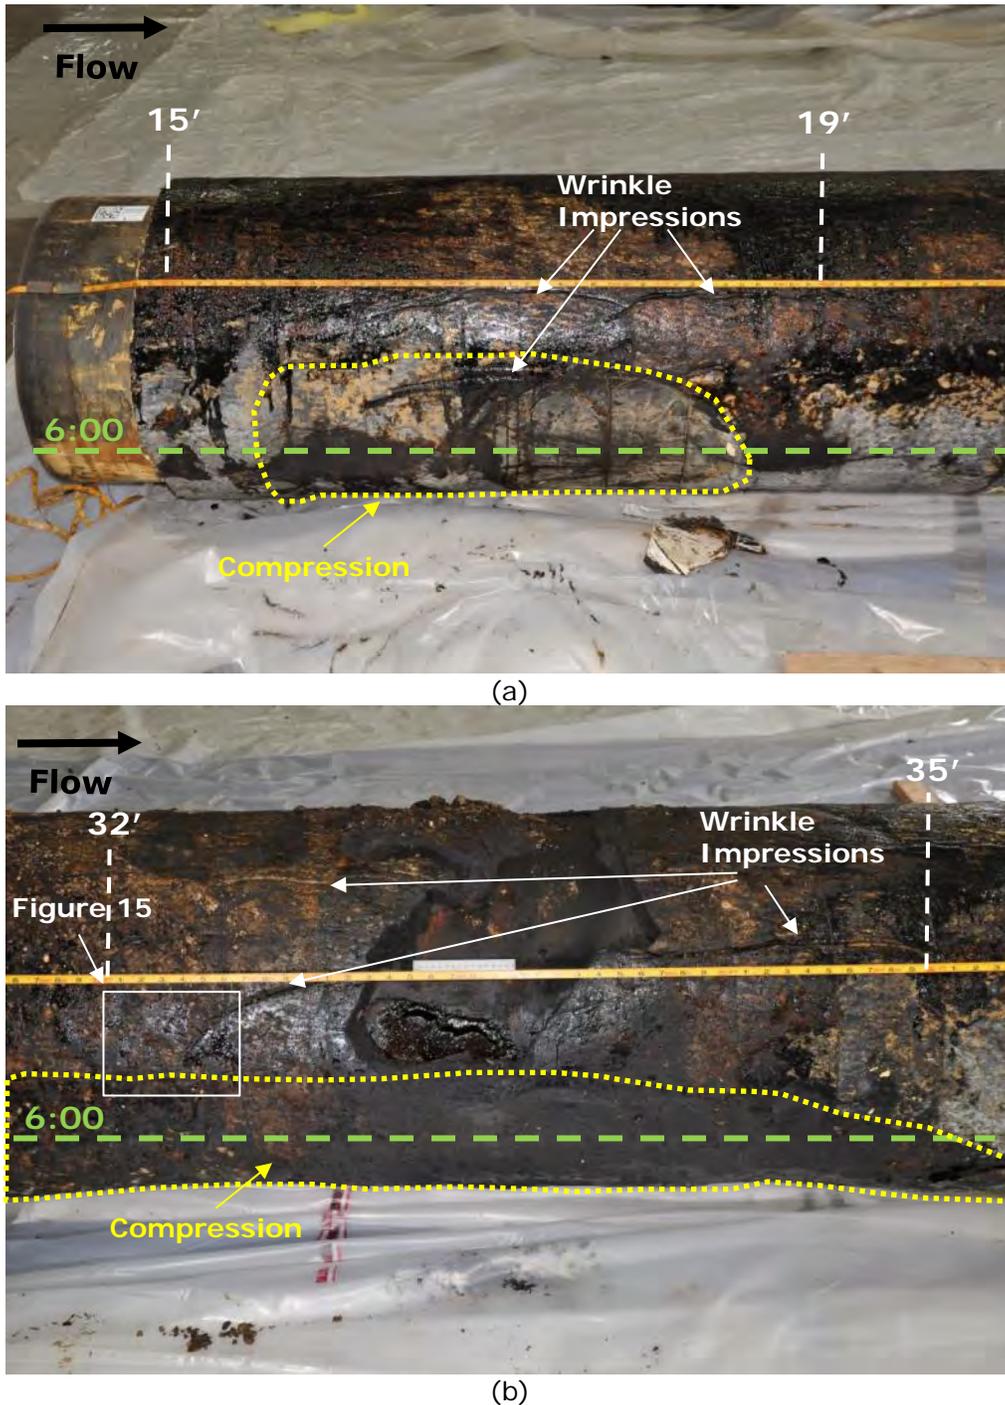
Figure 14. Photographs showing the external surface of the PU insulation at a) the U/S end of PS 2 (14' to 20' from U/S GW) and b) the failure location (31.5' to 36.4' from U/S GW). Tape measure indicates distance to upstream girth weld.

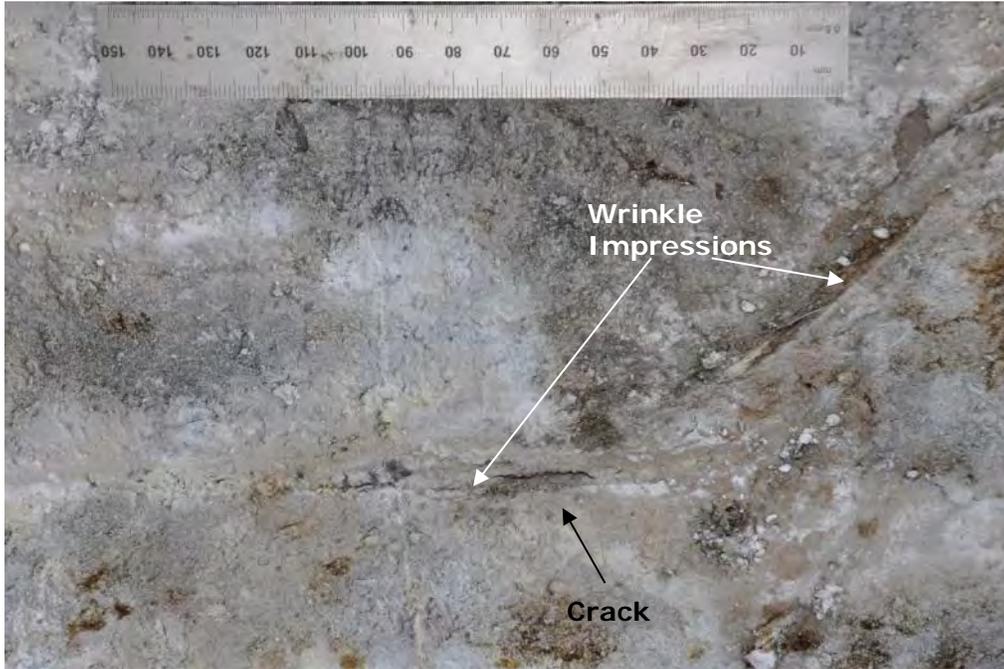
Figure 15. Photograph showing a crack in the PU insulation within a wrinkle. White contrast paint was applied to the surface to facilitate laser scanning and visual inspection. Area shown in Figure 14; scale in mm.

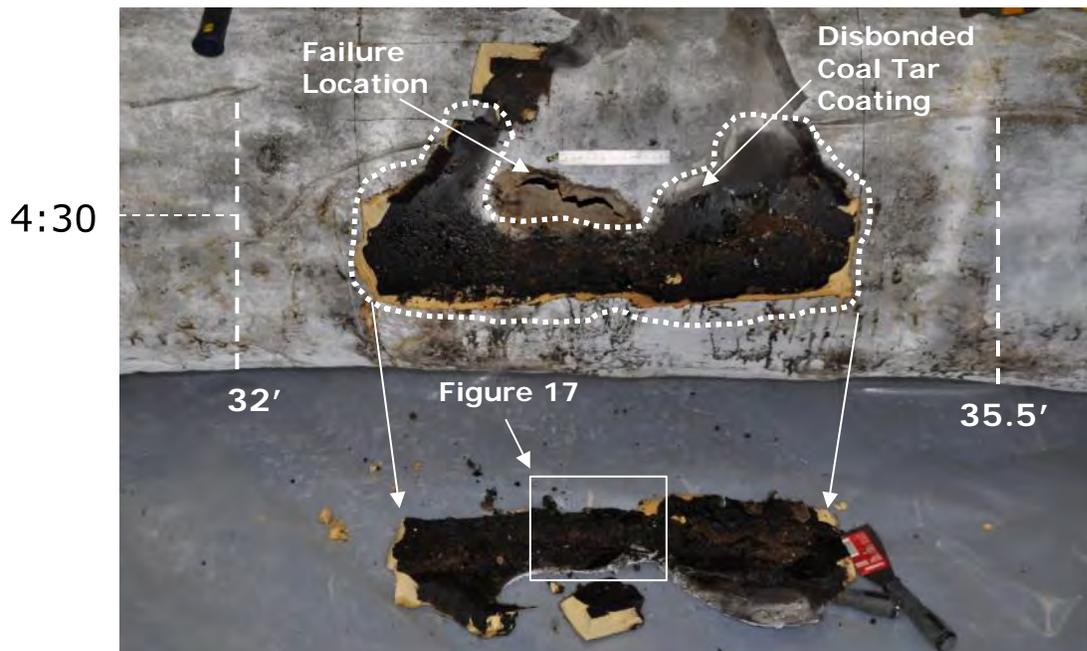
Figure 16. Photograph showing a piece of insulation removed from adjacent to the failure location; near 4:30 orientation.

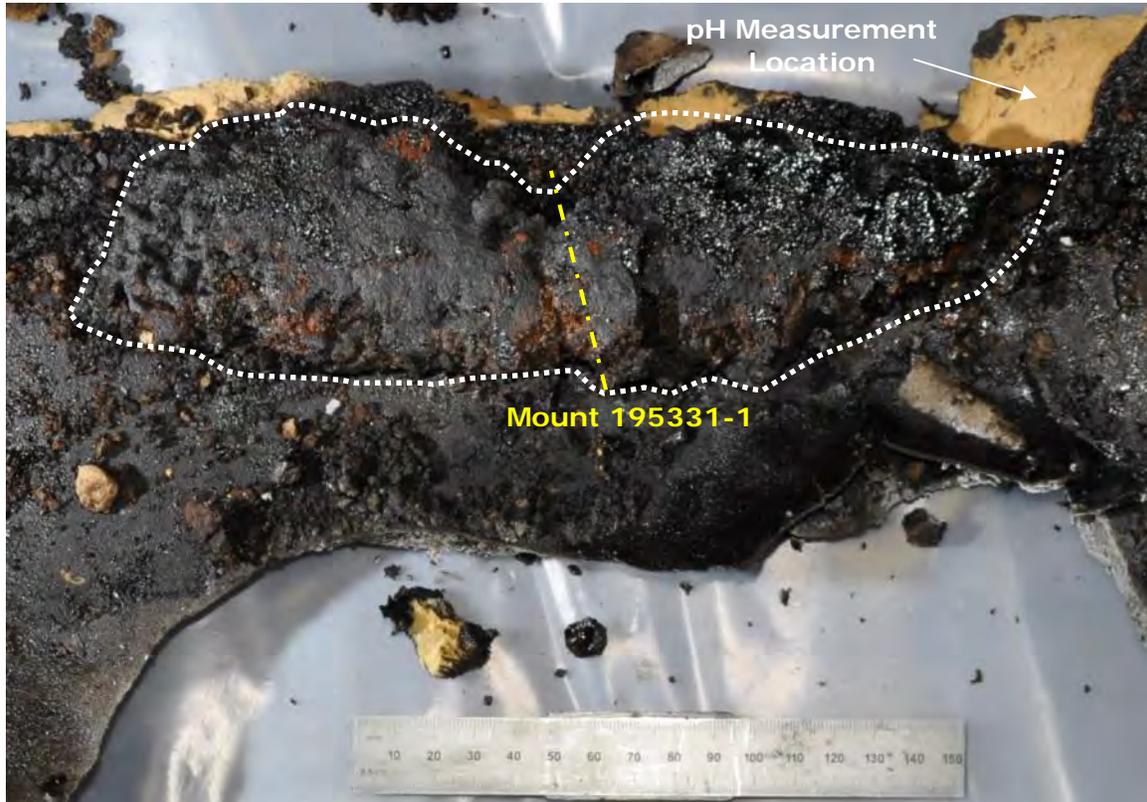
Figure 17. Photograph showing corrosion product that was wedged between the pipe surface and polyurethane insulation. Location indicated in Figure 16; scale in mm.

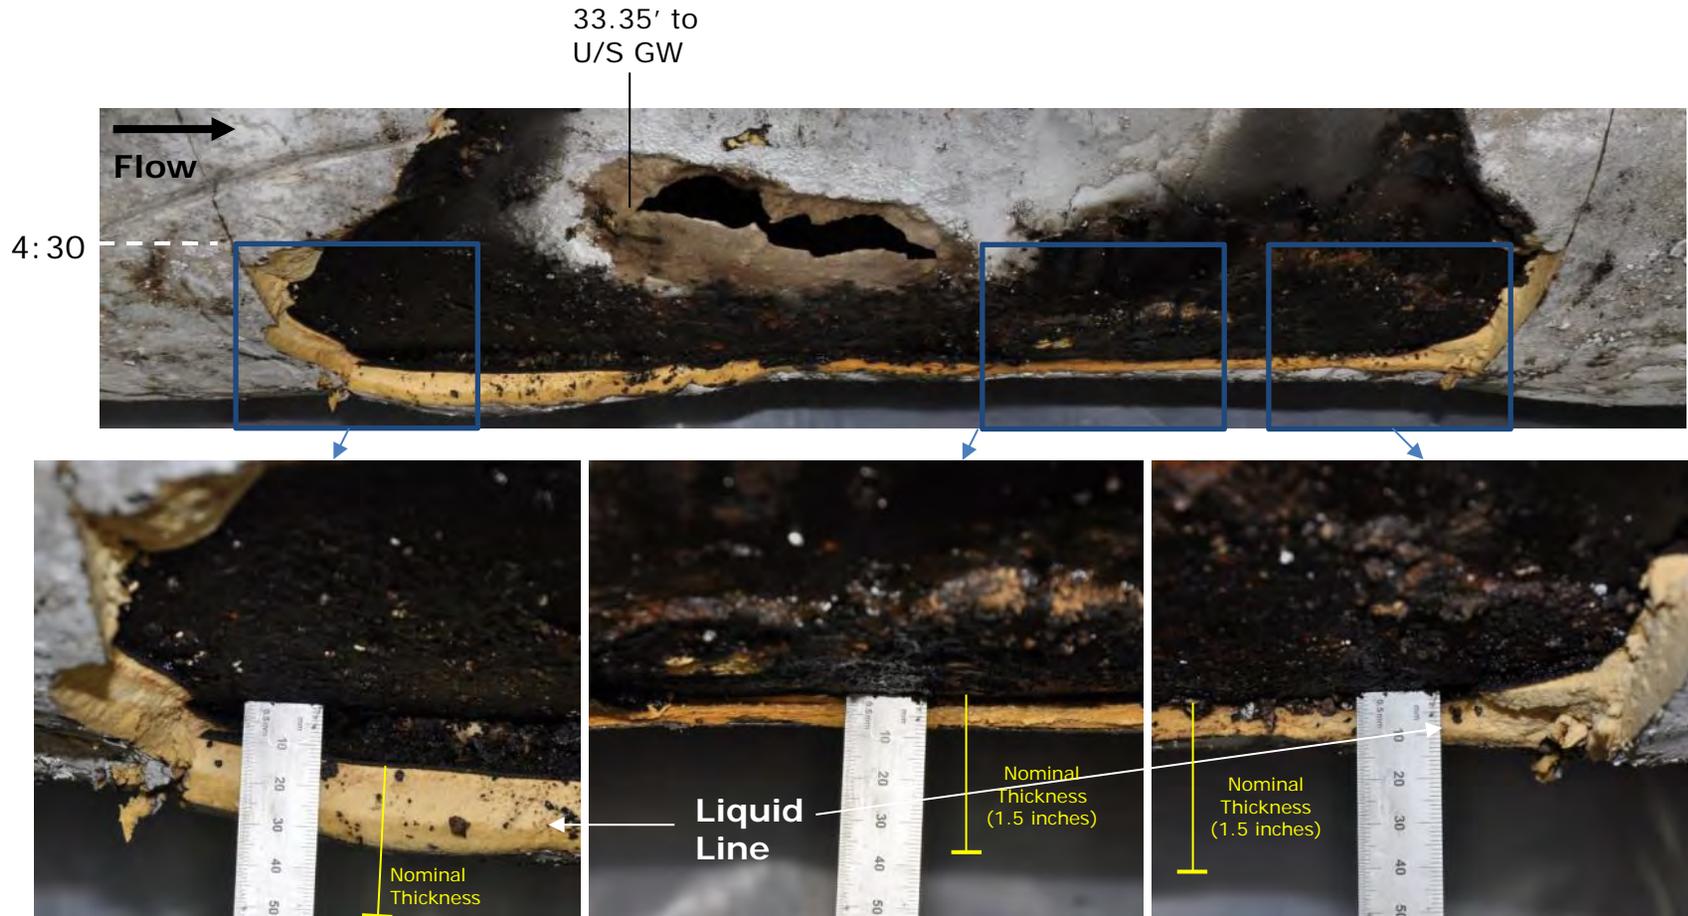
Figure 18. Photographs showing the amount of compression in the insulation adjacent to the failure location; near 6:00 orientation. Scale in mm.

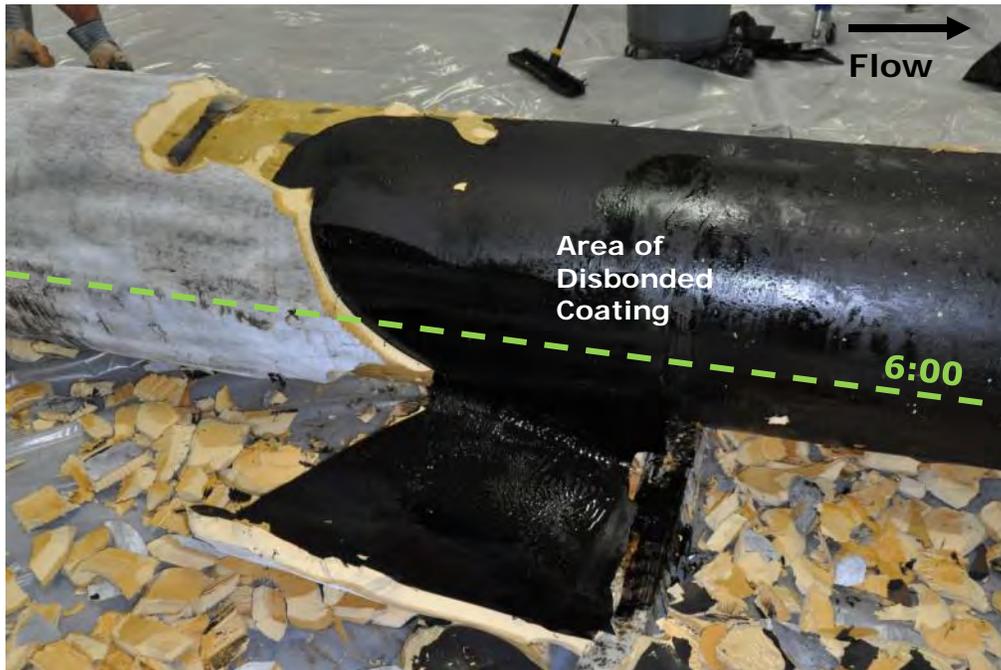
Figure 19. Photograph showing the insulation and coal tar coating separating from the pipe in large sheets on the underside of the pipe; approximately 29' from U/S GW.

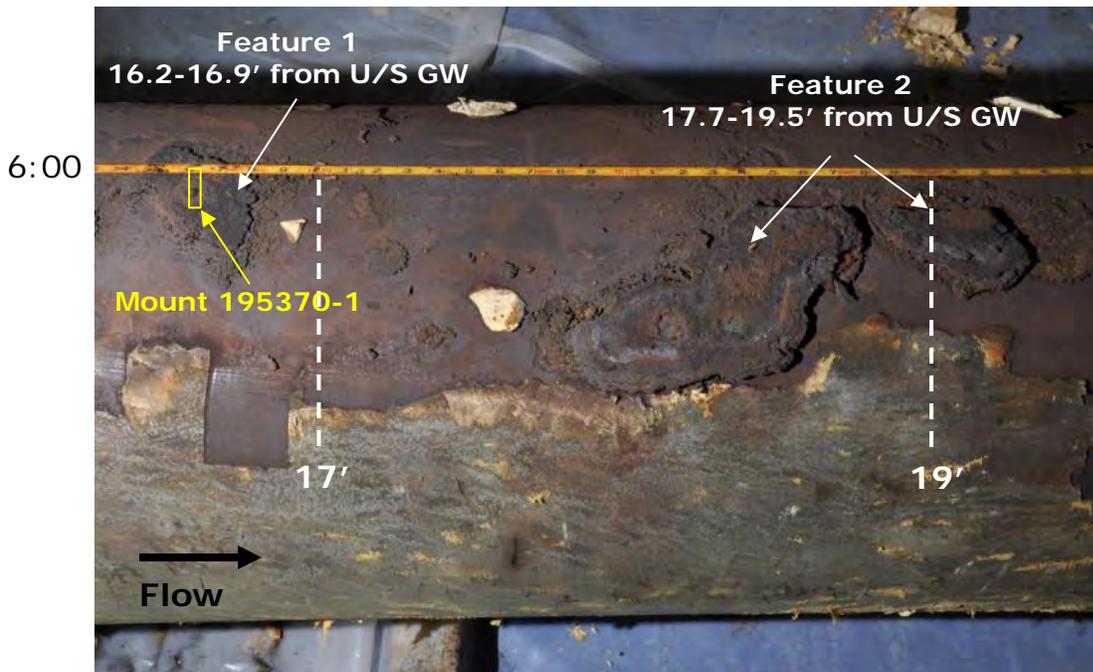
Figure 22. Photograph showing external corrosion features on PS 2; Feature 1 and Feature 2. Tape measure indicates distance to upstream girthing weld.

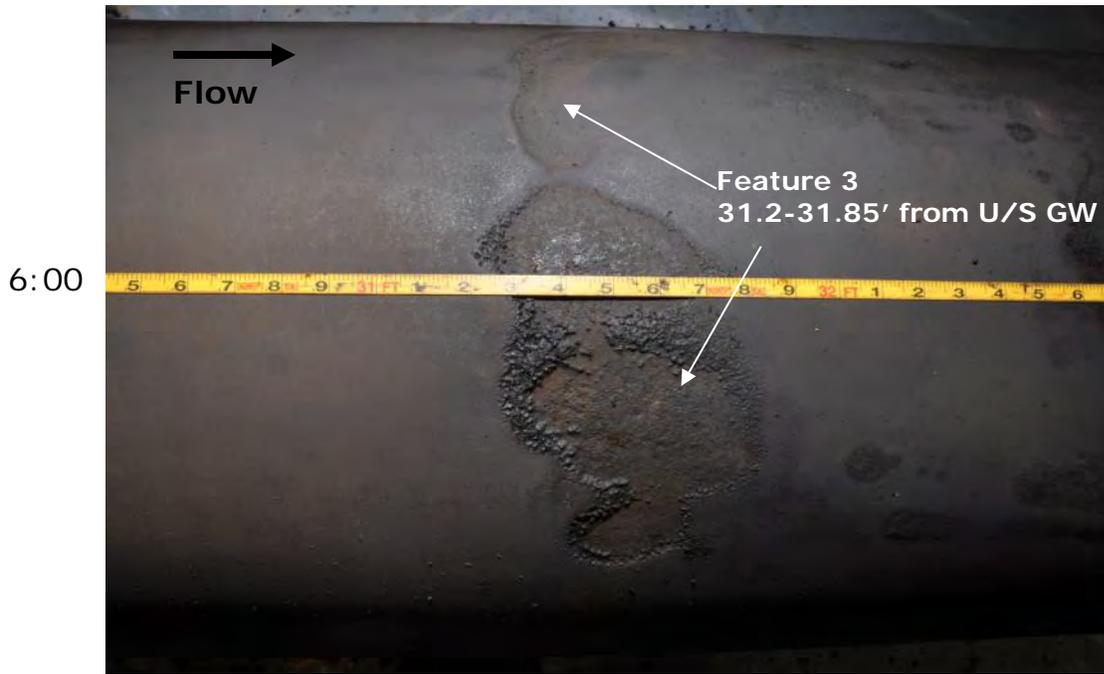
Figure 23. Photograph showing an external corrosion feature on PS 2; Feature 3. Tape measure indicates distance to U/S GW.

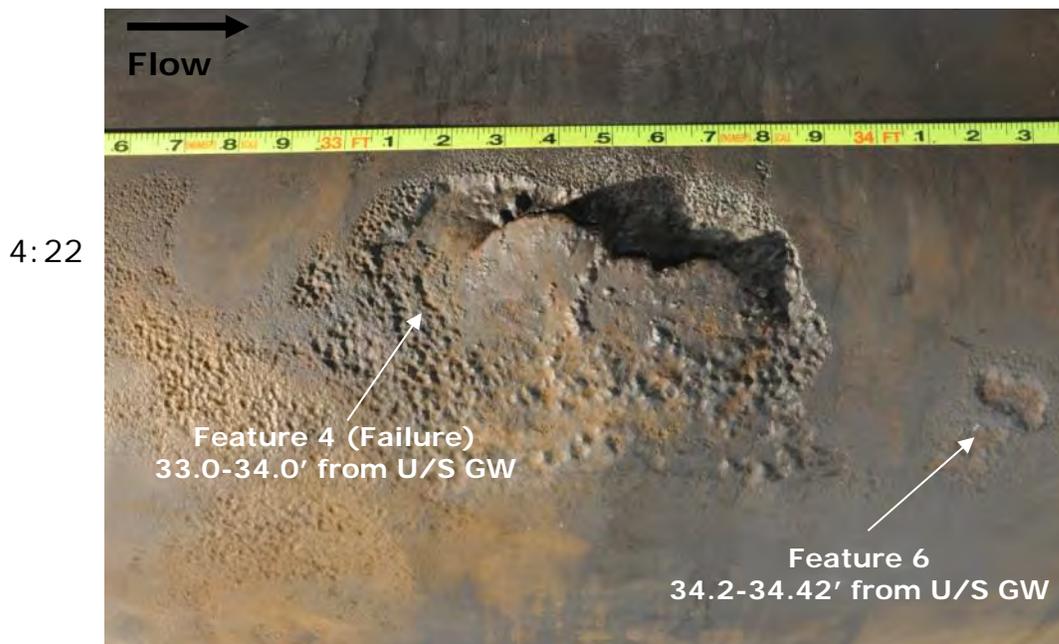
Figure 24. Photograph showing external corrosion features on PS 2; Feature 4 and Feature 6. Tape measure indicates distance to U/S GW (Note: tape slipped 0.1' to the right).

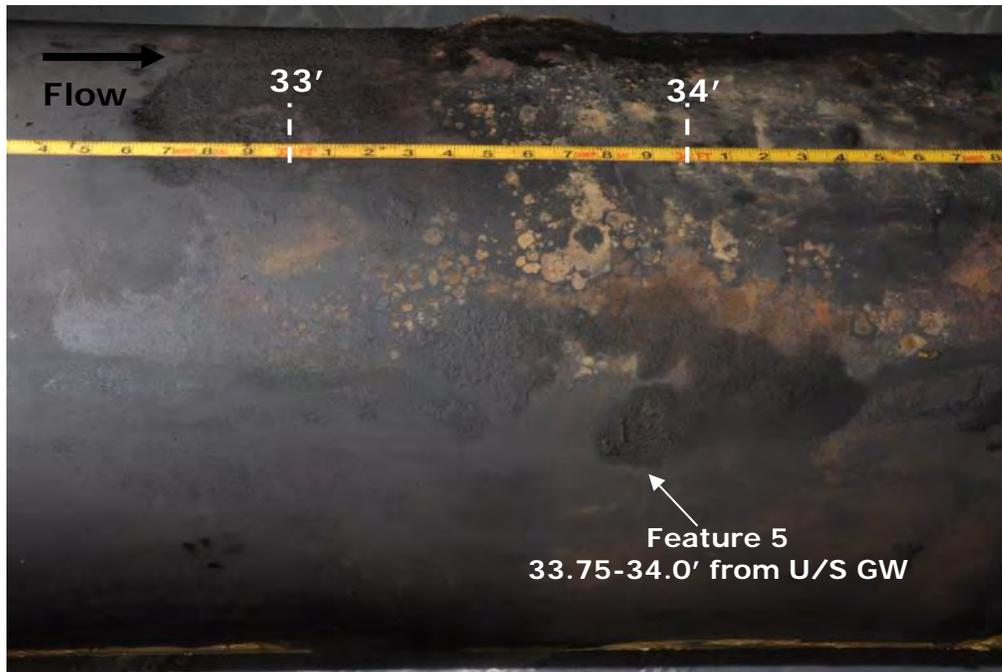
Figure 25. Photograph showing an external corrosion feature on PS 2; Feature 5. Tape measure indicates distance to U/S GW.

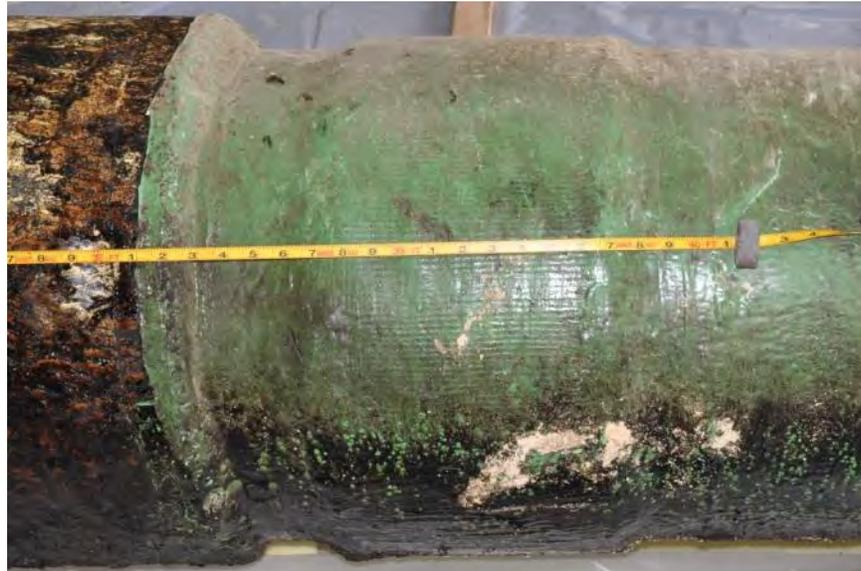
Figure 26. Photographs showing the a) external and b) internal surfaces of the pipe section at the failure location (Coupon 1).

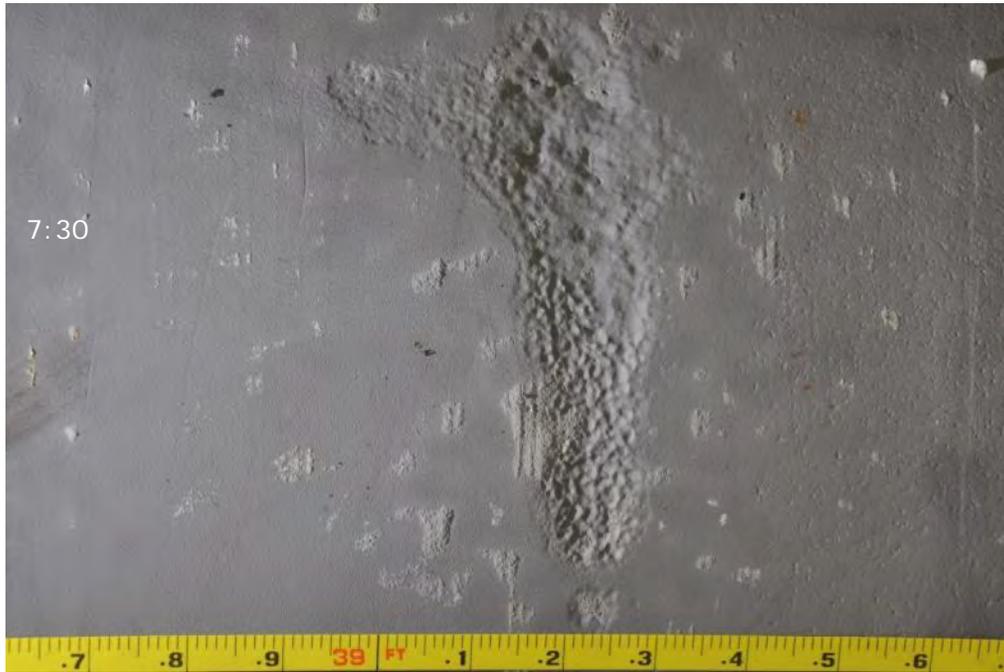
Figure 28. Photograph the primary feature repaired on May 13, 2013. Area shown in Figure 27. Tape measure indicates distance to U/S GW.

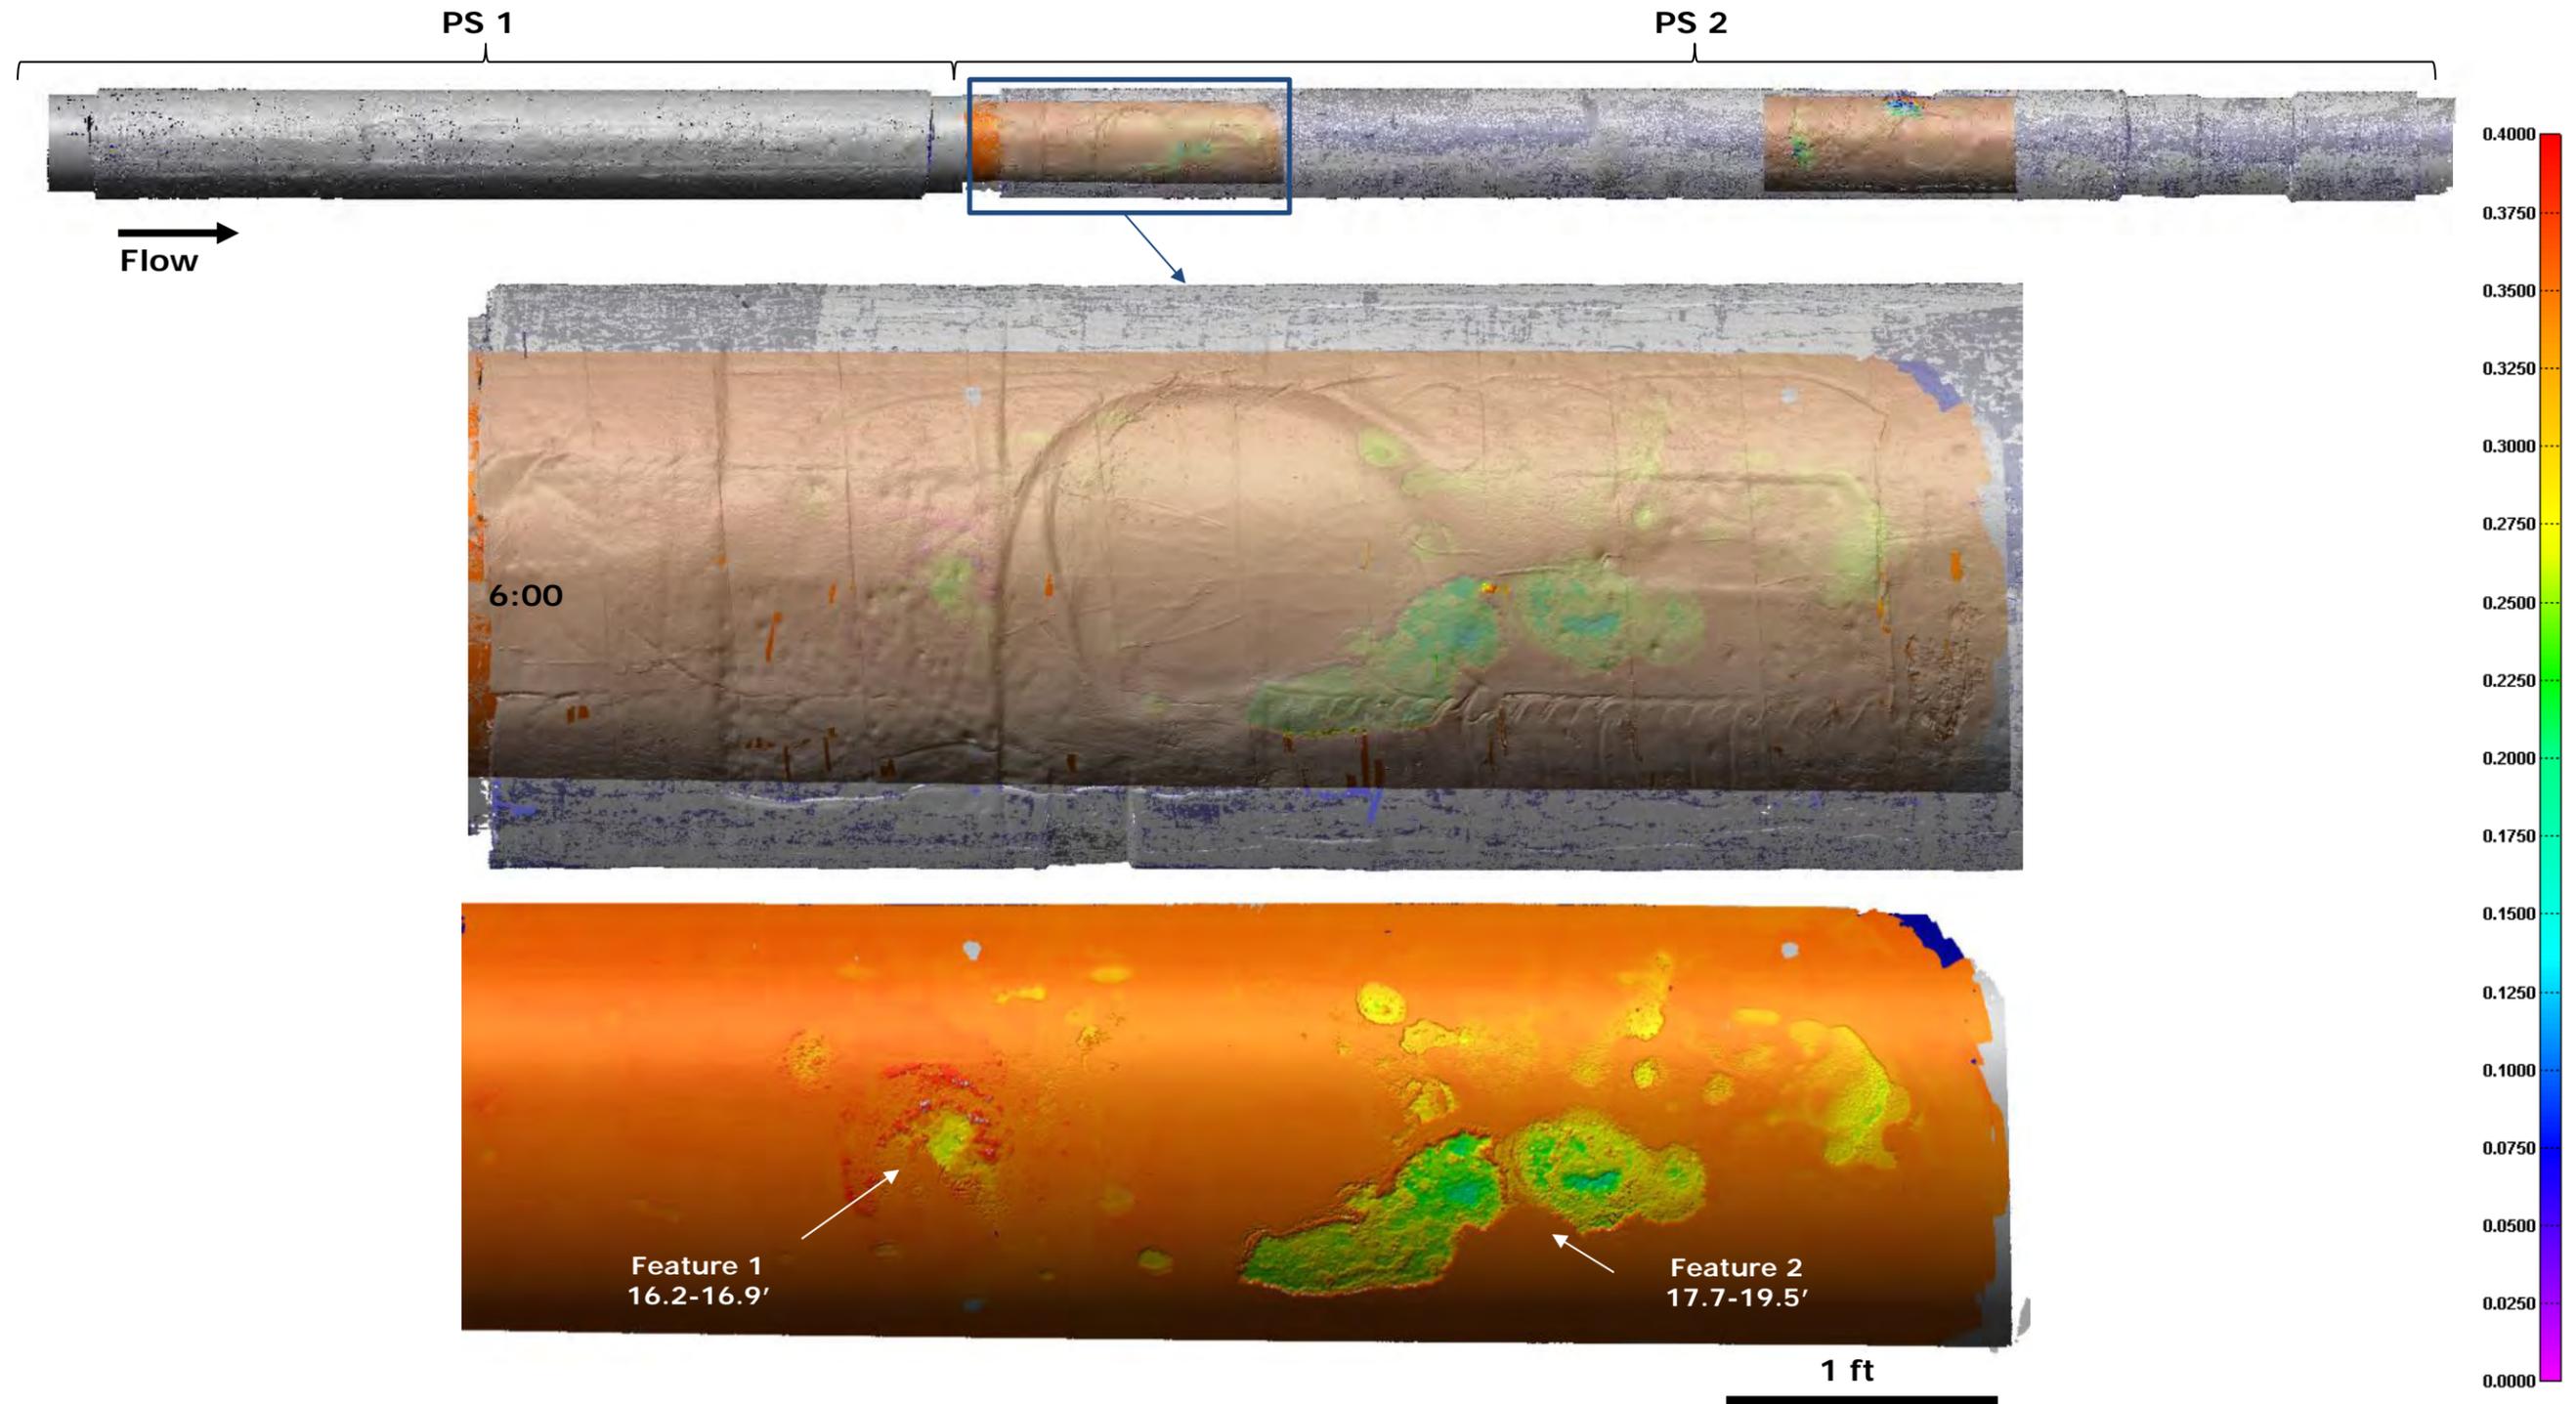
Figure 29. Renderings of PS 1 and PS 2 (viewed from the OD surface) from laser scanning data showing Feature 1 and Feature 2; Coupon 2. The transparency of the insulation was changed to show a correlation between the features observed on the insulation with corrosion features observed on the pipe. The scale on the right is from 0.000 to 0.400 inches.

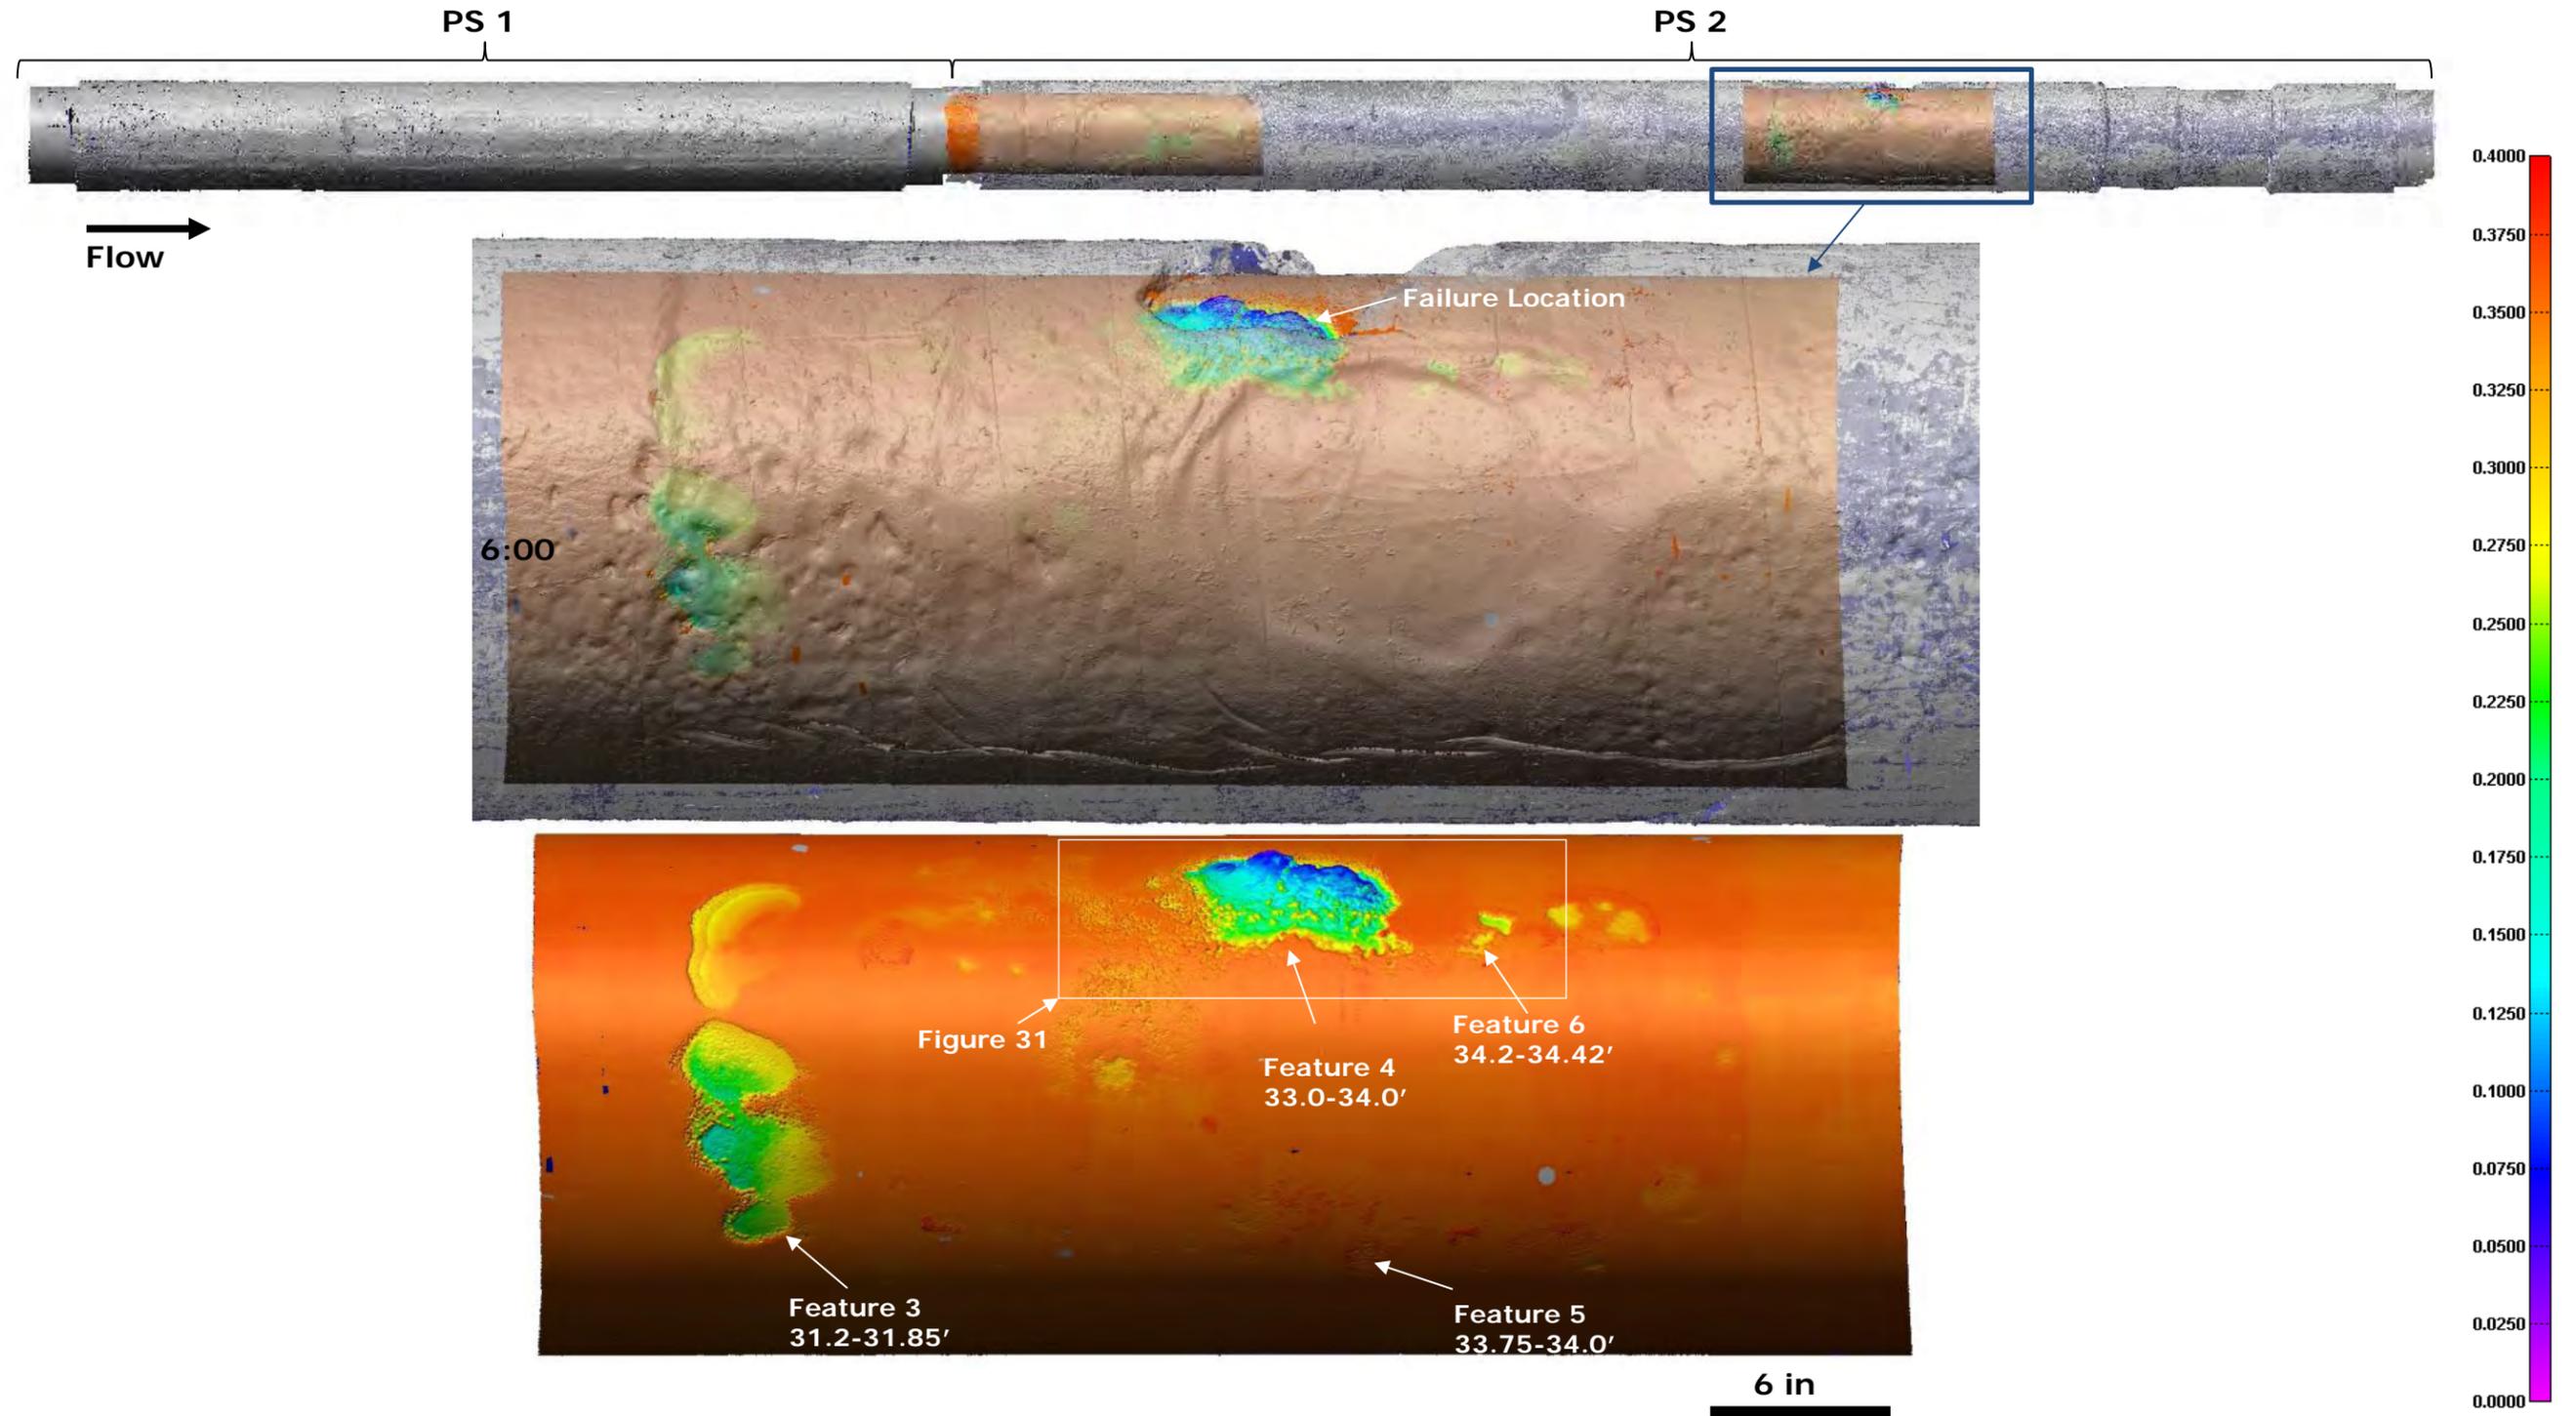
Figure 30. Renderings of PS 1 and PS 2 (viewed from the OD surface) from laser scanning data showing the failure location (Feature 4) and Feature 3, 5, and 6; Coupon 1. The transparency of the insulation was changed to show a correlation between the features observed on the insulation with corrosion features observed on the pipe. The scale on the right is from 0.000 to 0.400 inches.

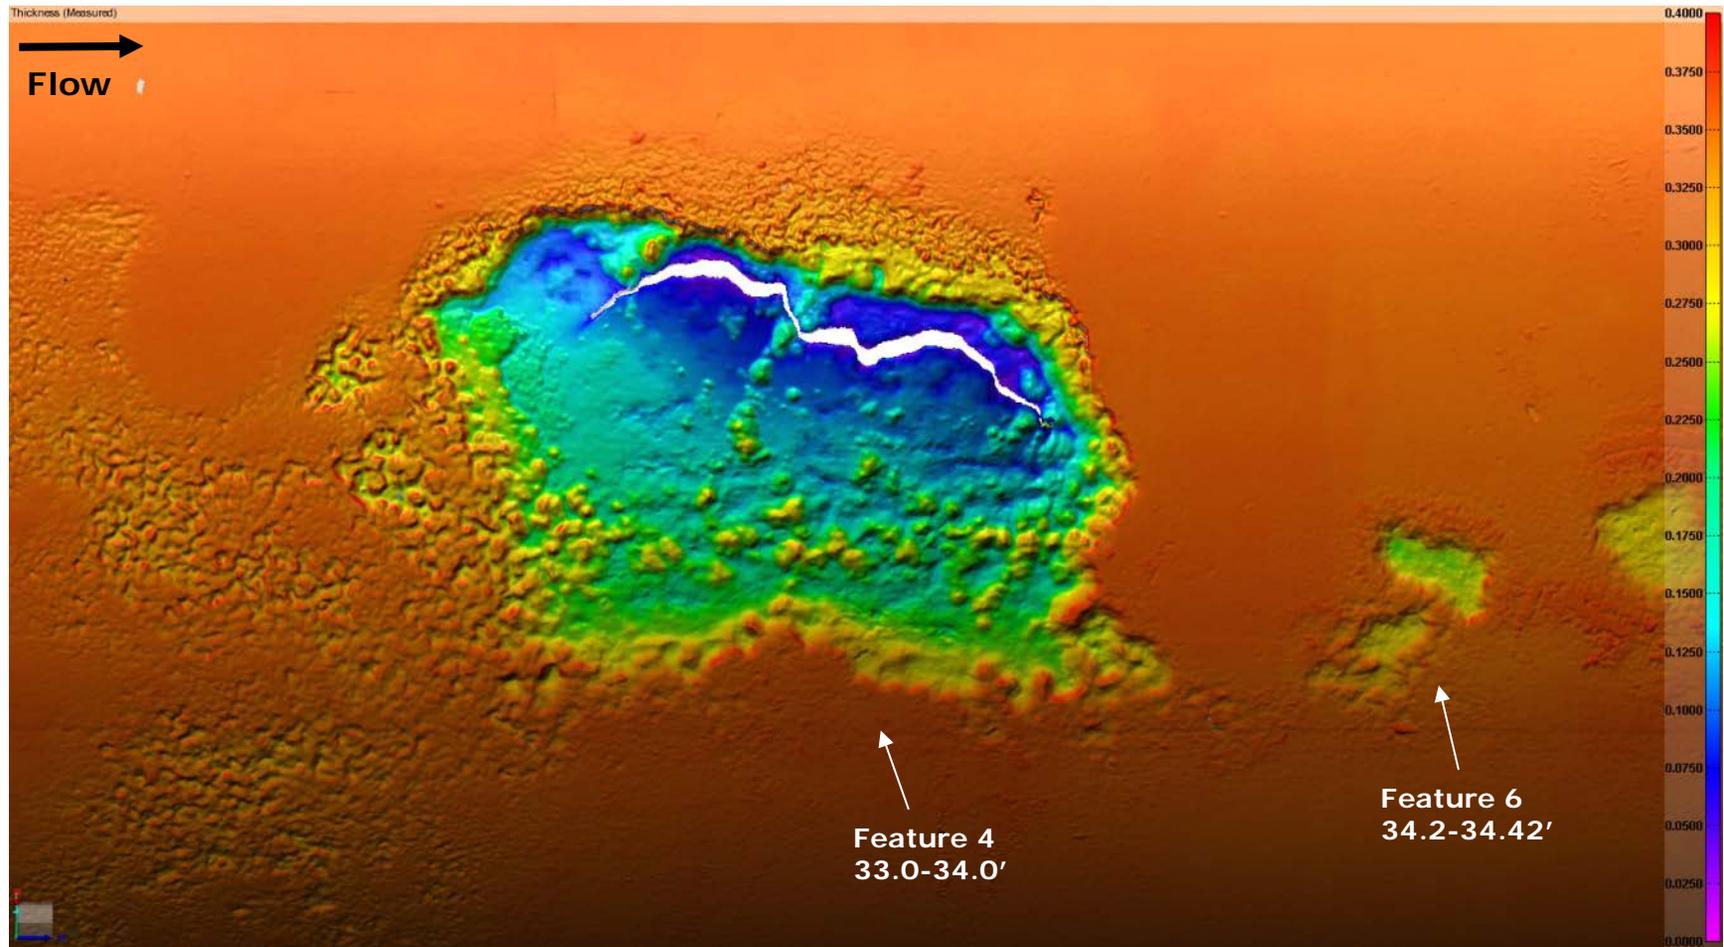
Figure 31. Rendering of the failure location (viewed from the OD surface) from laser scanning data showing the remaining wall thickness along the fracture surface. The scale on the right is from 0.000 to 0.400 inches. Location indicated in Figure 30.

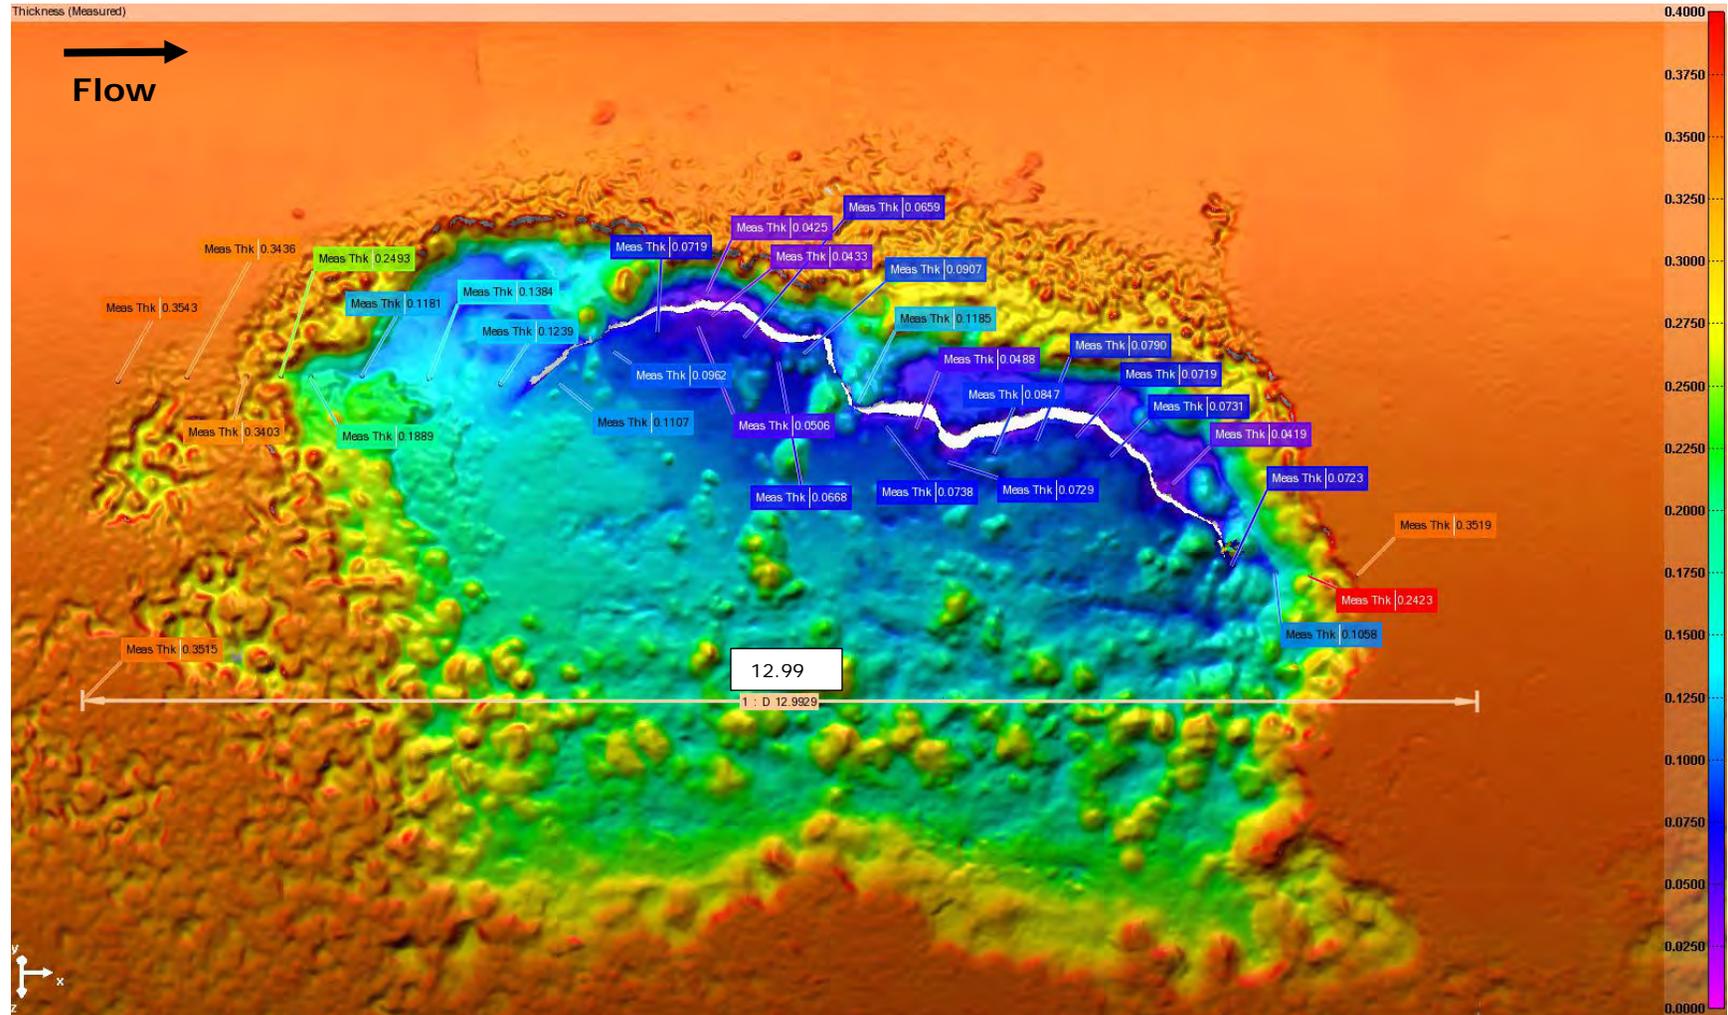
Figure 32. Rendering of the failure location showing various thickness measurements made along the corrosion feature and failure opening. The scale on the right is from 0.000 to 0.400 inches. Measurements are tabulated in Table 4.

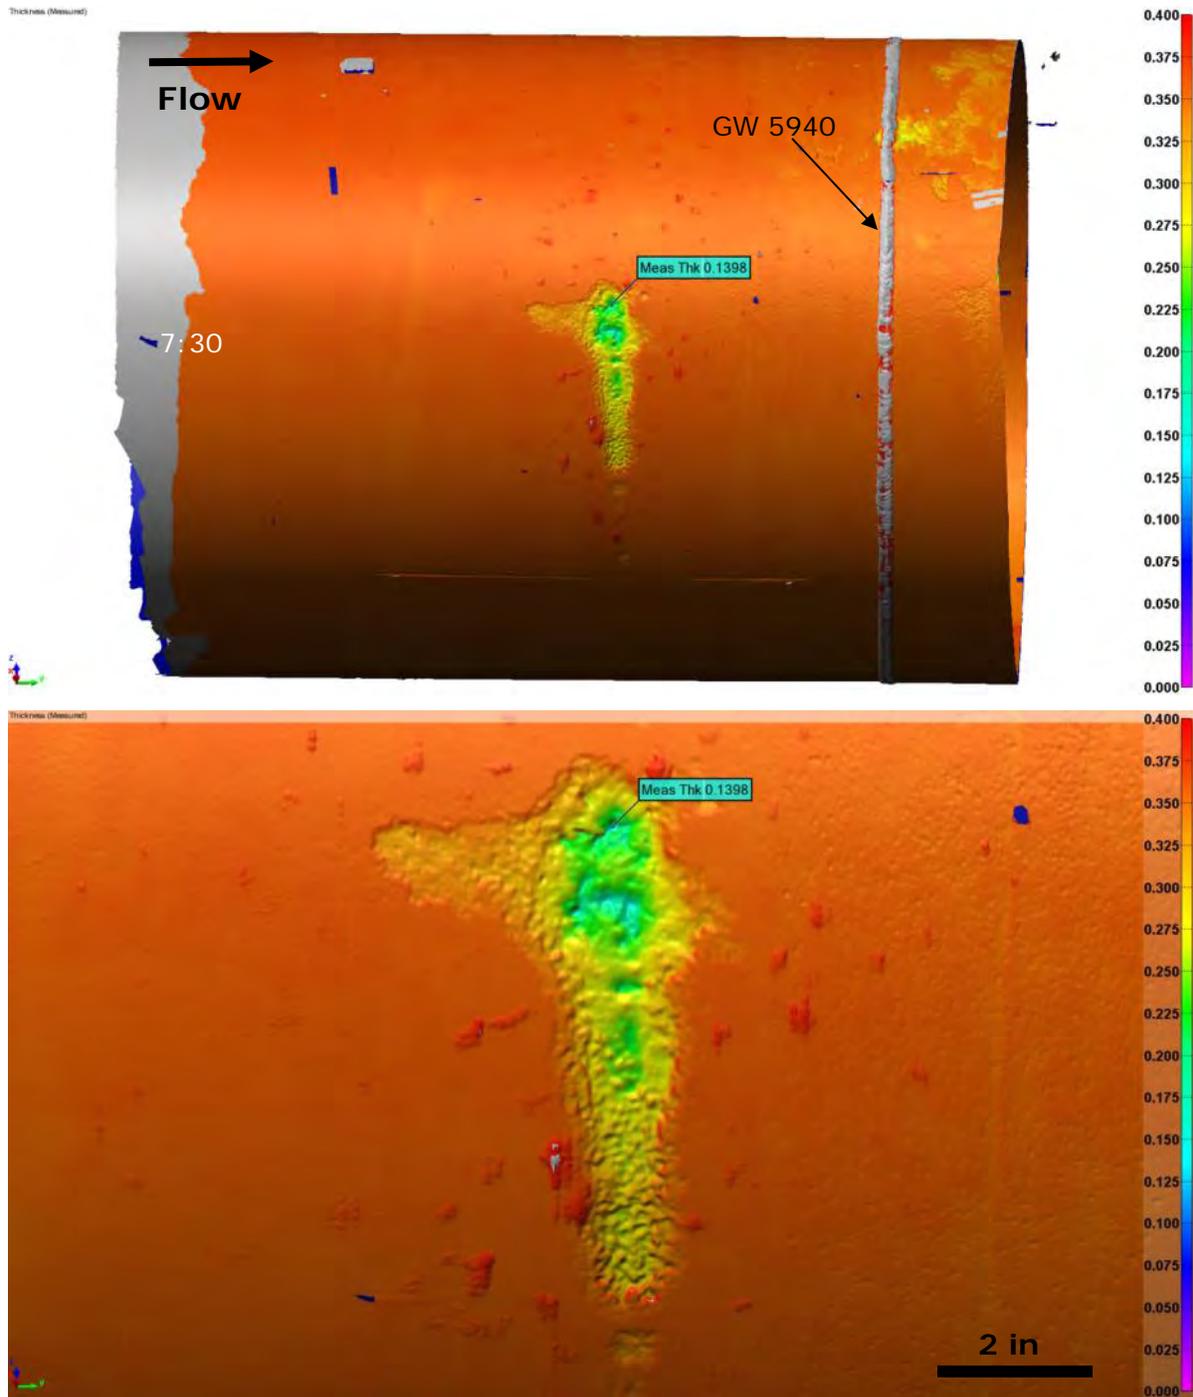
Figure 33. Renderings of the area under the composite repair sleeve showing the thickness profile for the feature repaired on May 13, 2013. The scale on the right is from 0.000 to 0.400 inches.
