**U.S. Department
of Transportation**

**Pipeline and
Hazardous Materials
Safety Administration**

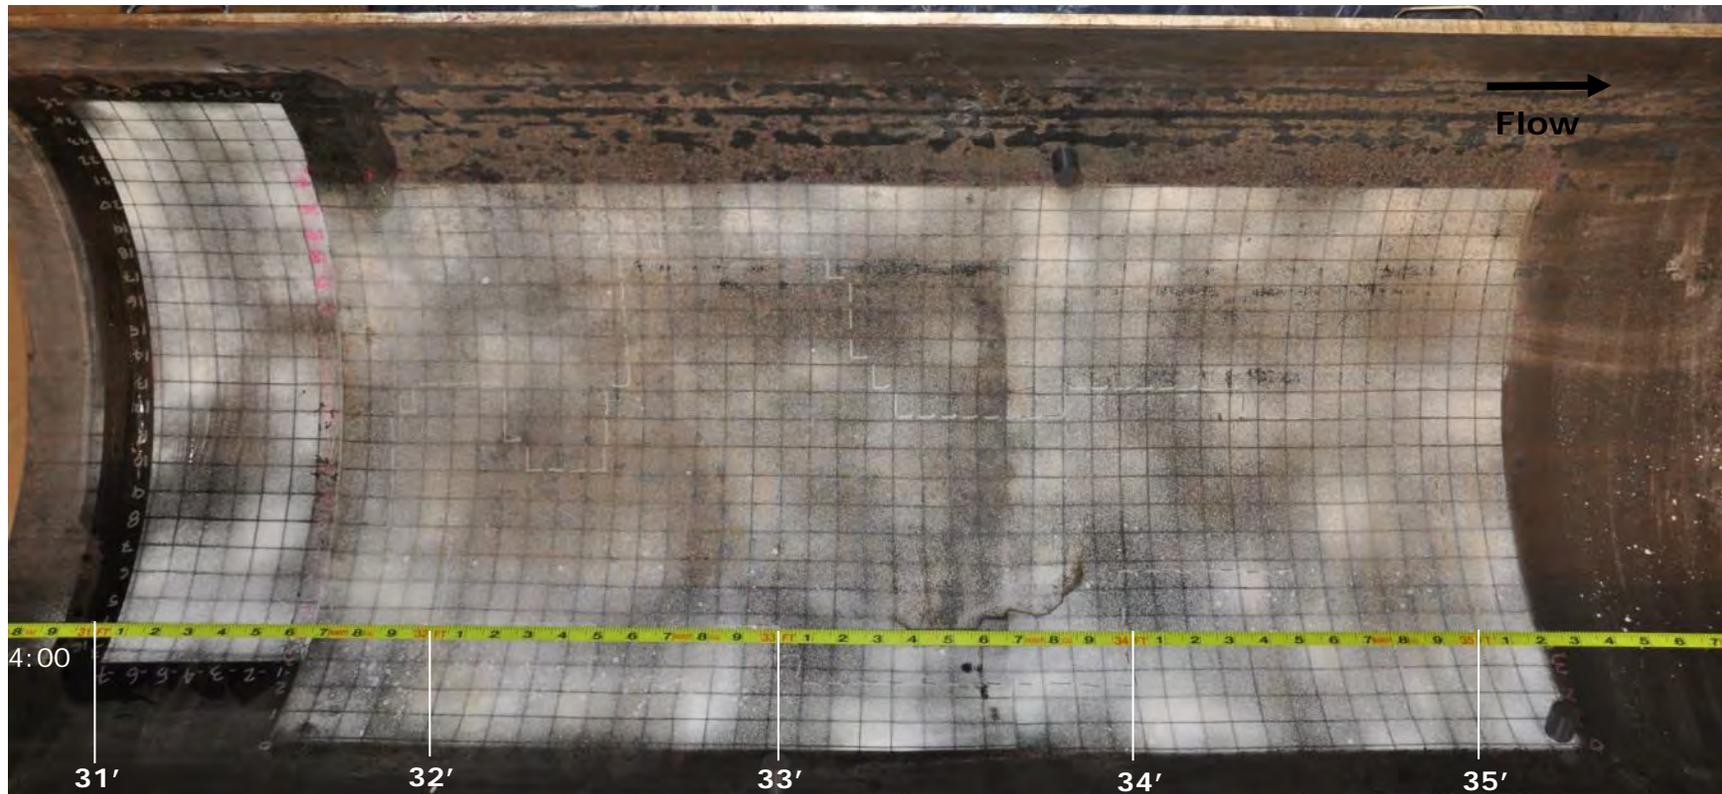
Figure 34. Photograph showing the internal surface of the pipe section at the failure location with the 1 × 1 inch grid painted on the surface. Tape measure indicates distance to U/S GW.

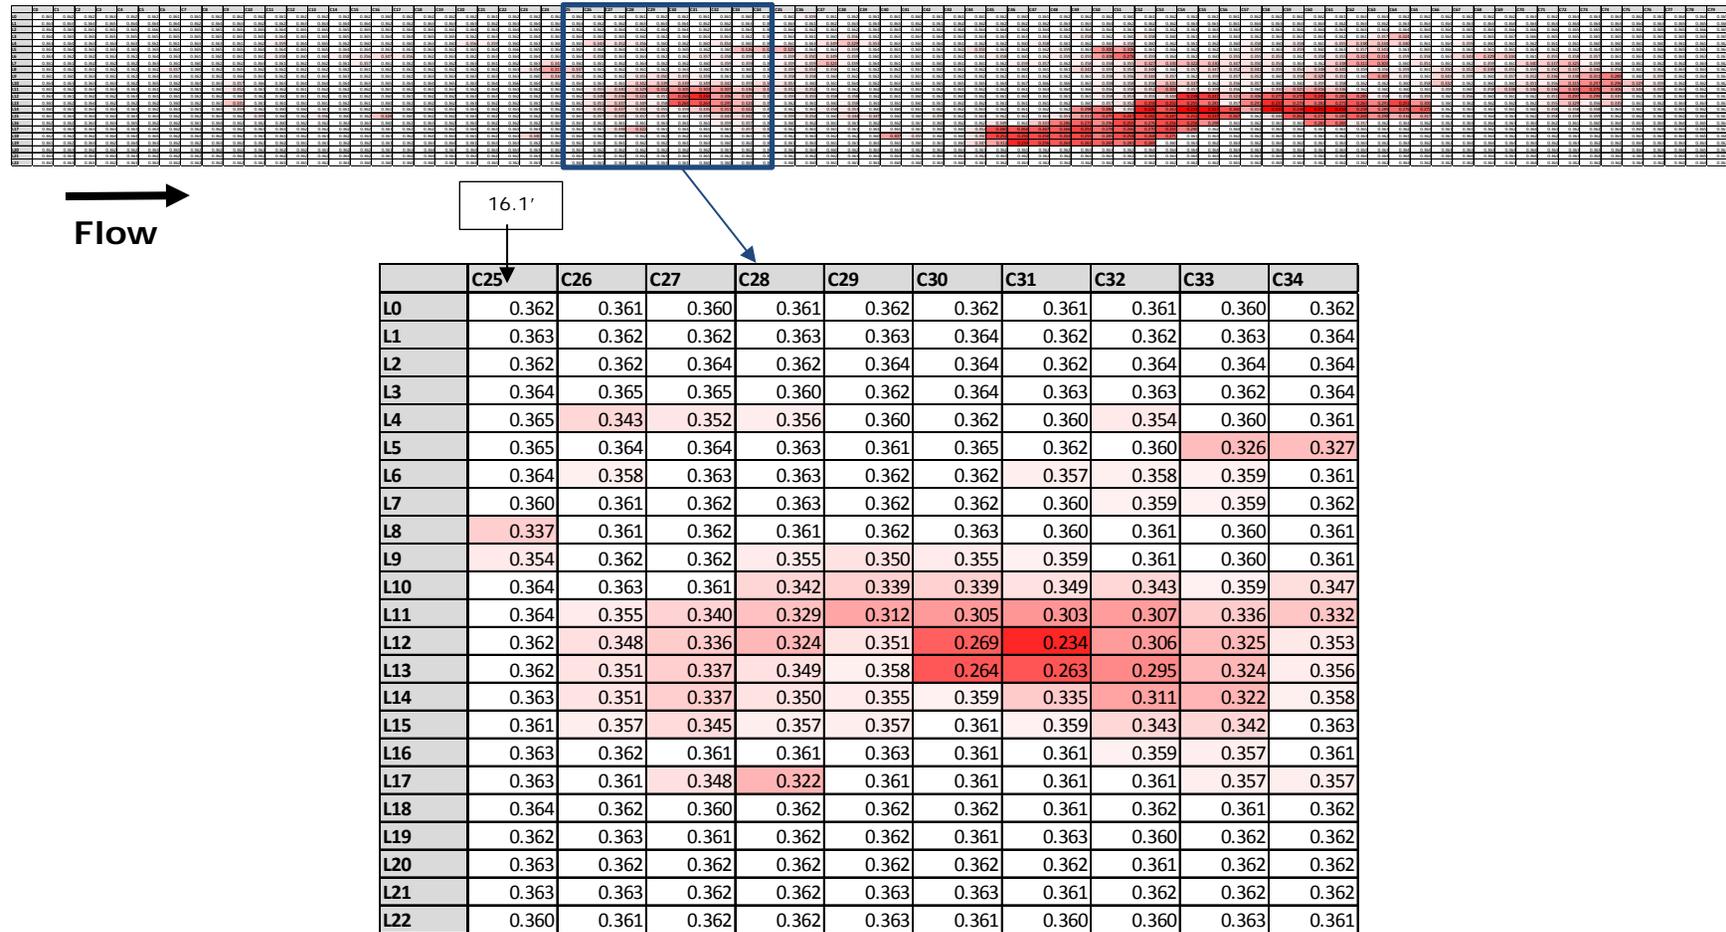
Figure 36. Results of the UT measurements performed on 1" x 1" grid near Feature 1 (Coupon 2).

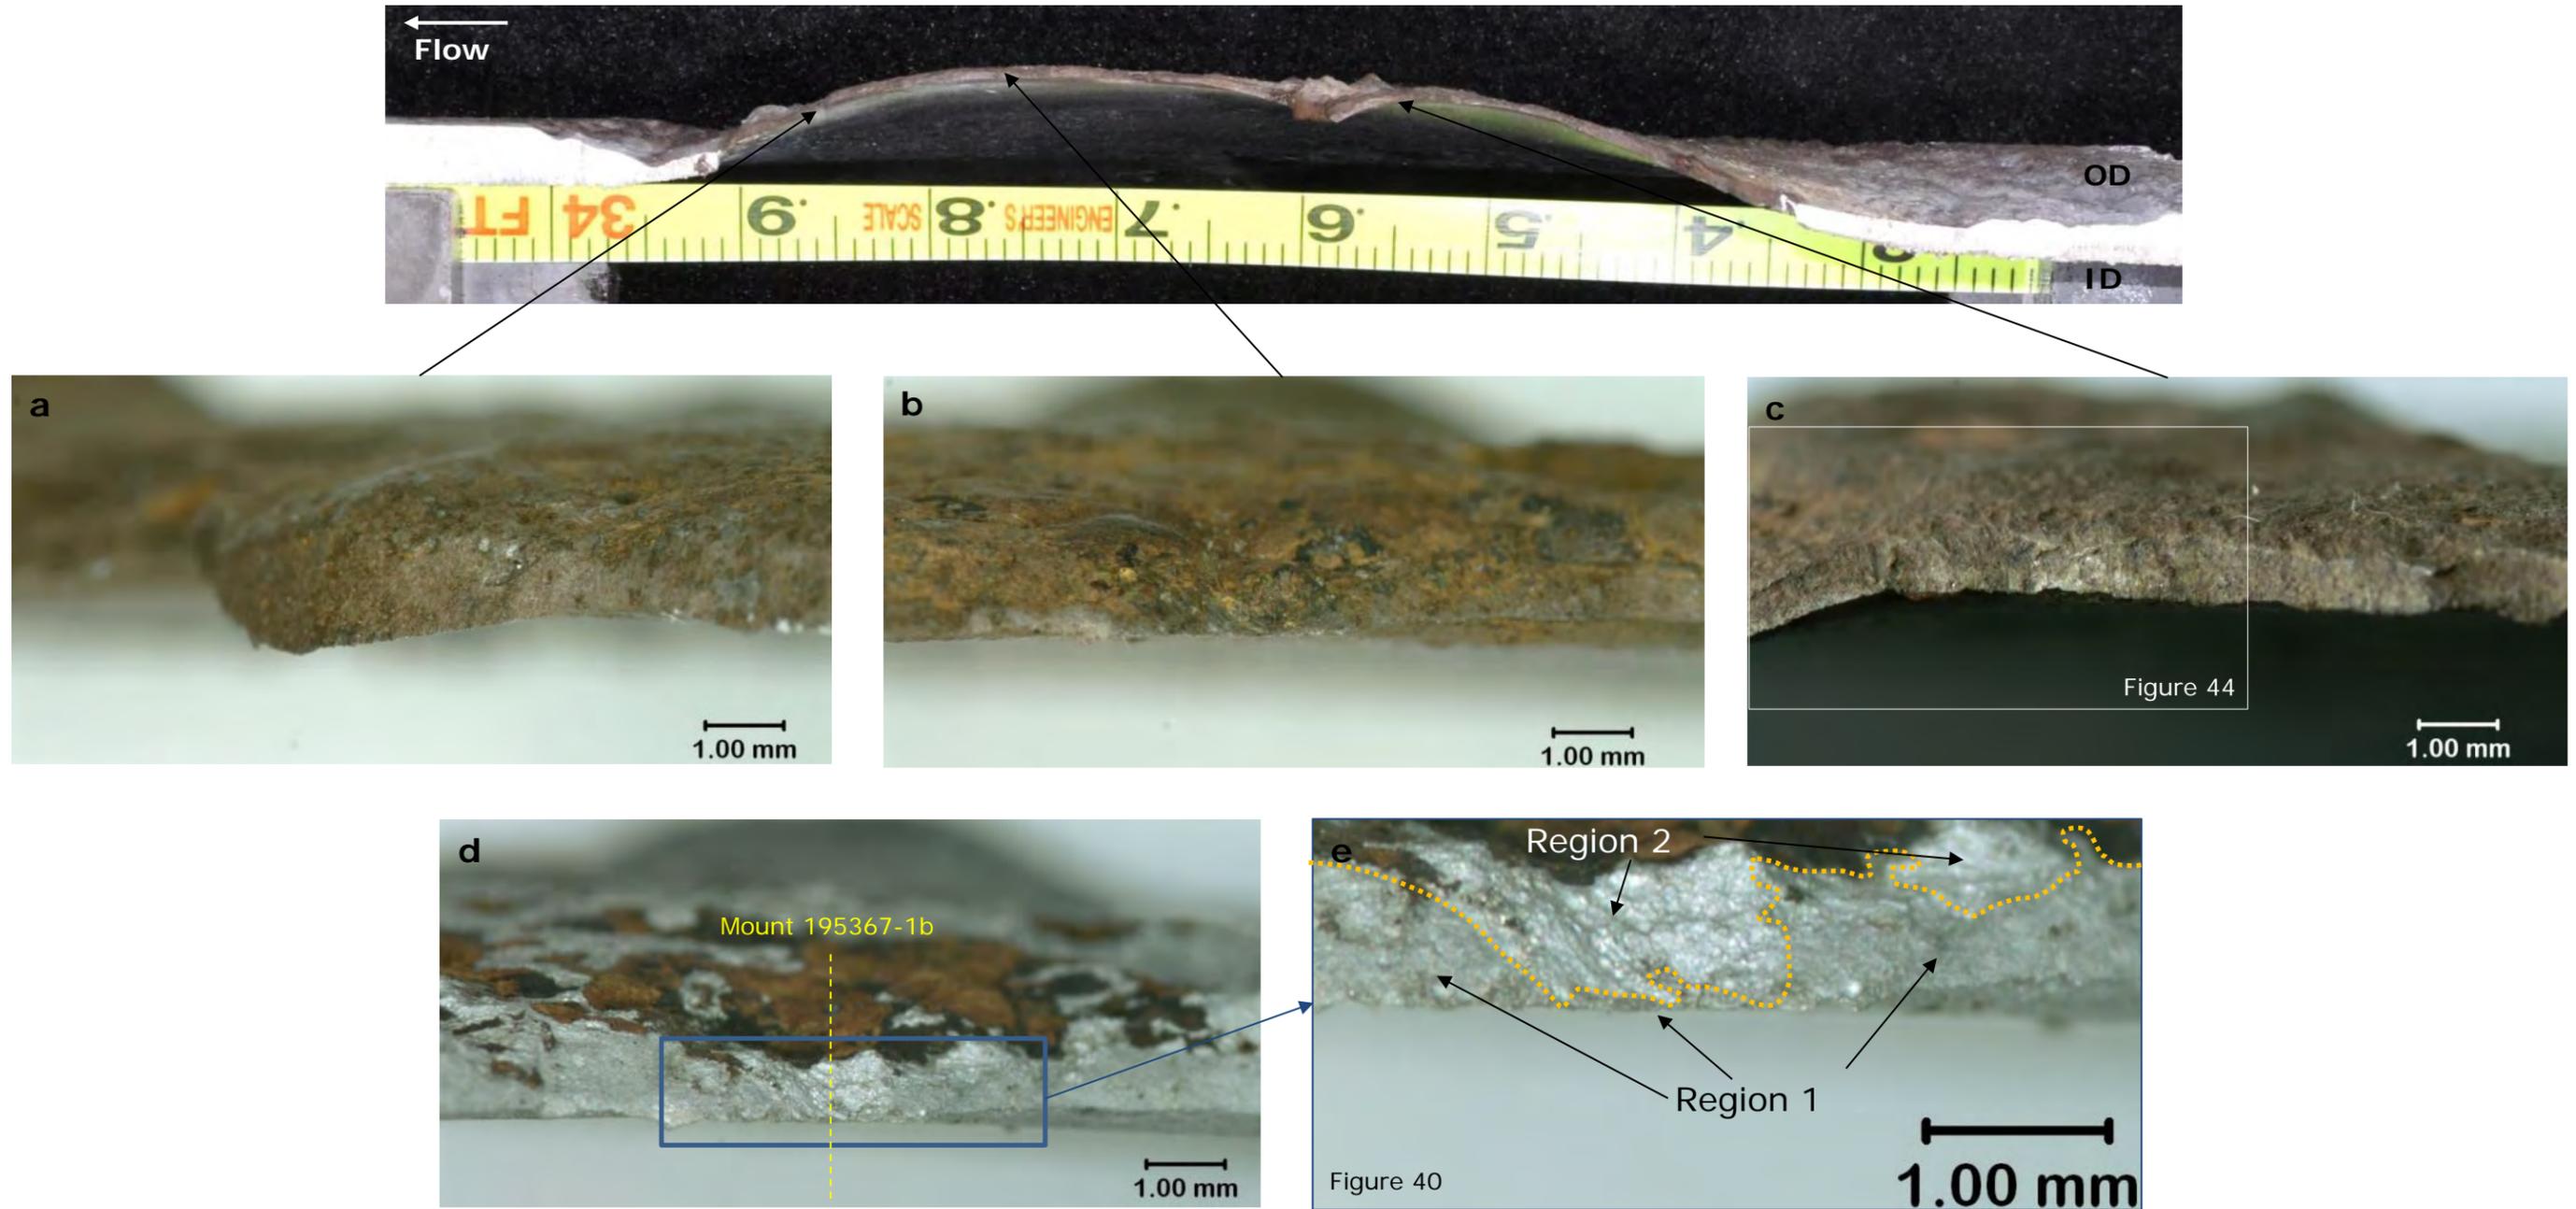
Figure 39. Stereo light photomicrographs of representative locations along the clockwise fracture surface following cleaning with a), b), c) a degreaser and acetone and/or methanol and d), e) an inhibited HCl acid and ENPREP®. Photomicrographs b) and d) are from the same location. Tape measure indicates distance to U/S GW.

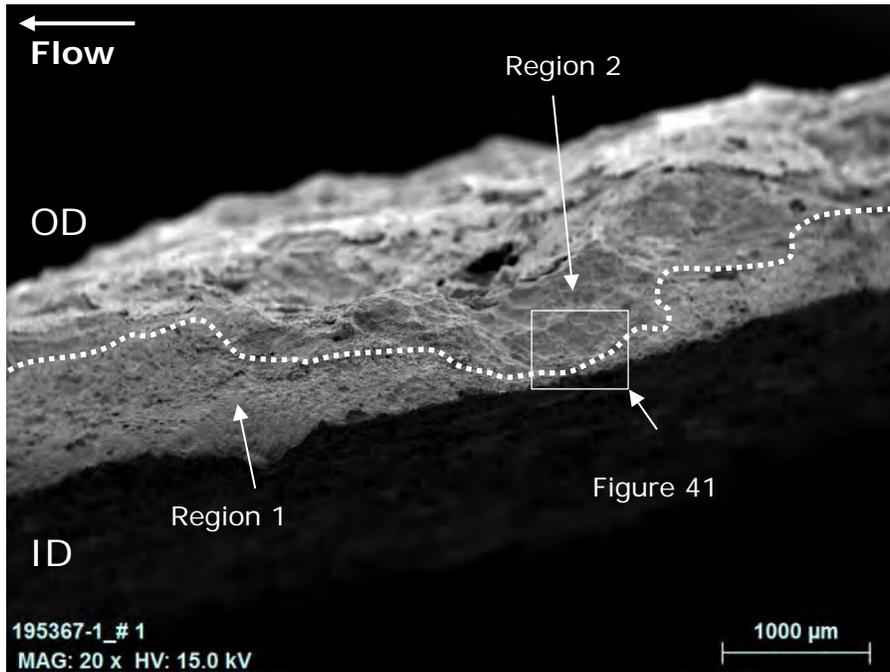
Figure 40. SEM image showing the fracture surface at the location identified in Figure 39e.

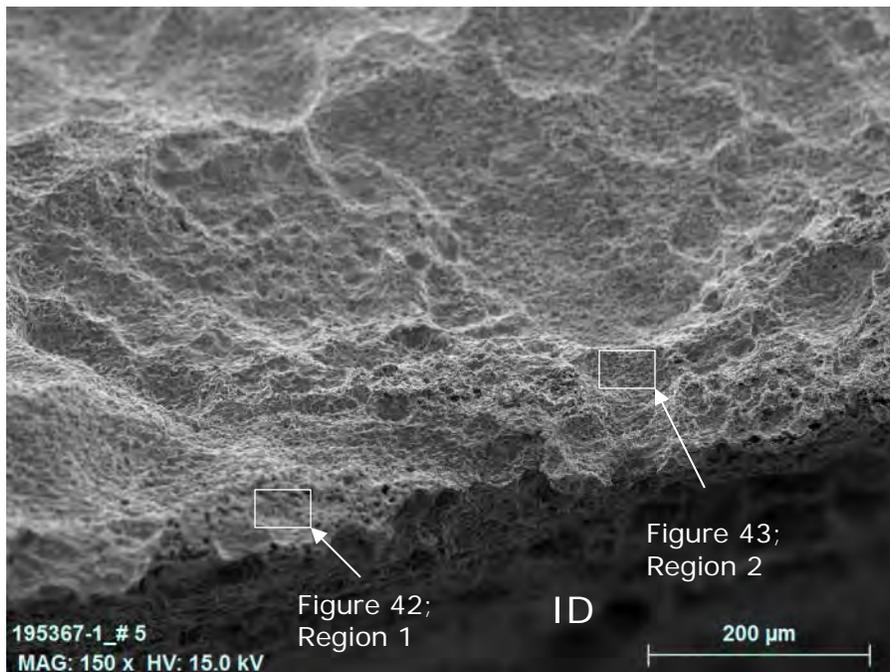
Figure 41. SEM image showing the transition between Region 1 and Region 2. Area indicated in Figure 40.

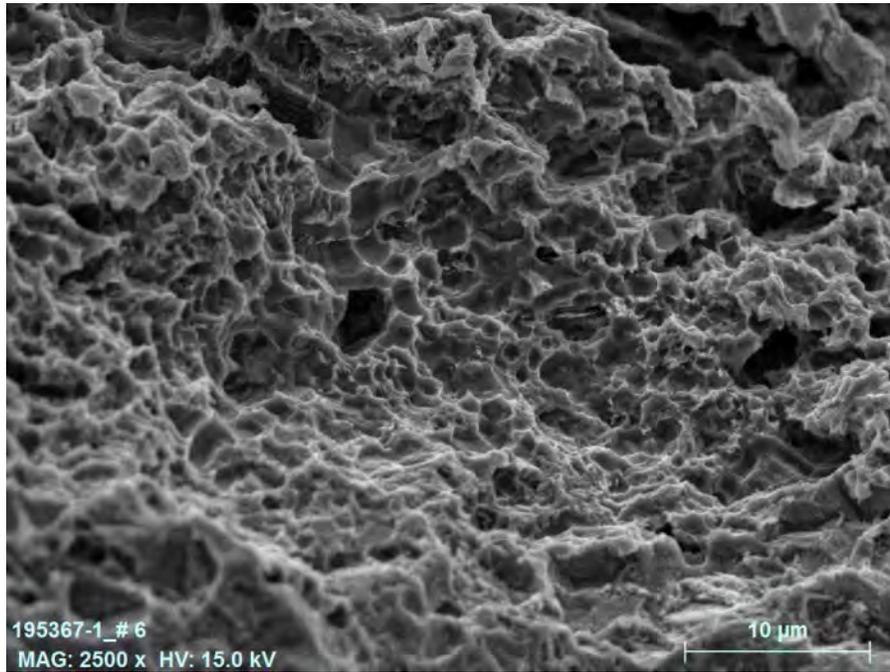
Figure 42. SEM image showing the ductile fracture morphology of Region 1. Area indicated in Figure 41

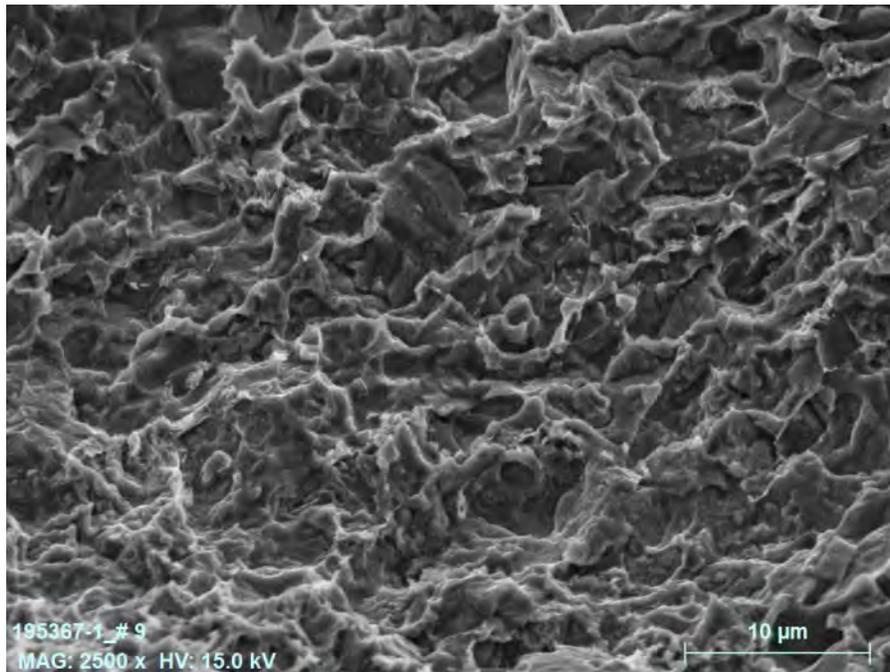
Figure 43. SEM image showing a nondescript/corroded morphology of Region 2. Area indicated in Figure 41

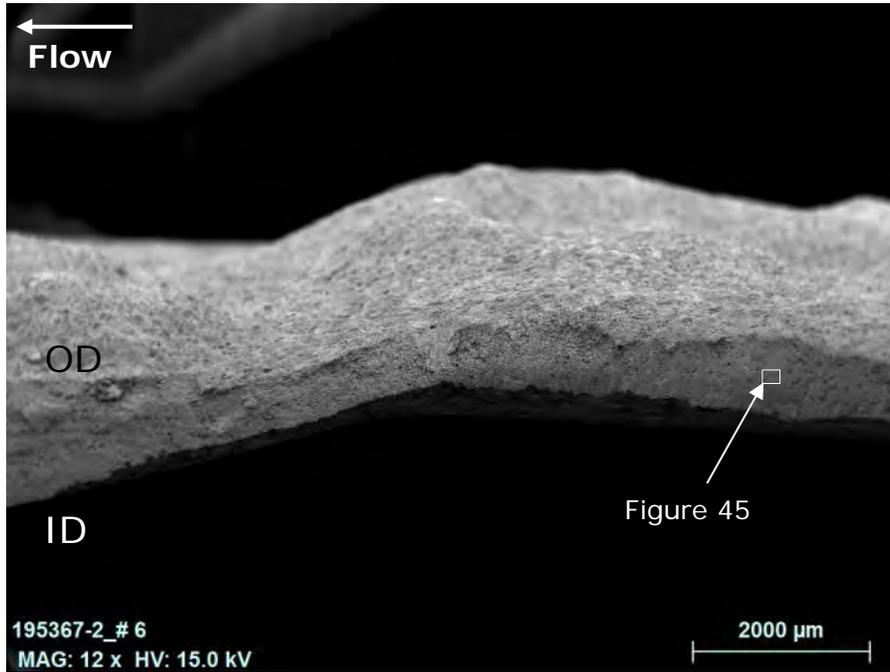
Figure 44. SEM image showing the fracture surface at the location identified in Figure 39c.

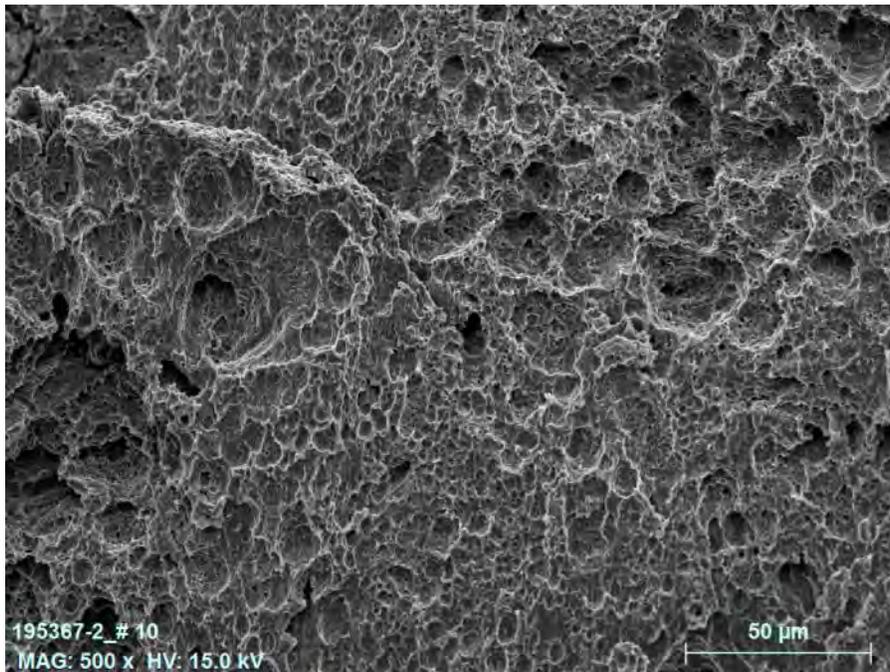
Figure 45. SEM image showing a representative ductile fracture morphology for Region 1. Area indicated in Figure 44.

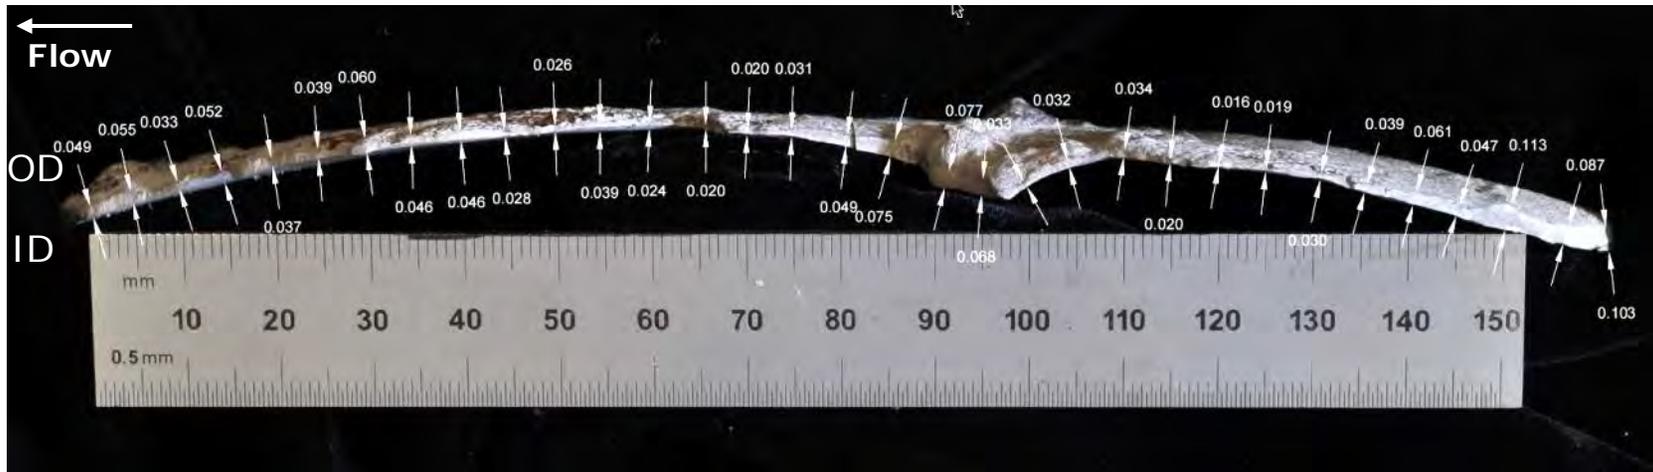
Figure 46. Photograph of the clockwise fracture surface showing thickness measurements of the Region 1 along the fracture surface at 5 mm intervals. Scale in mm.

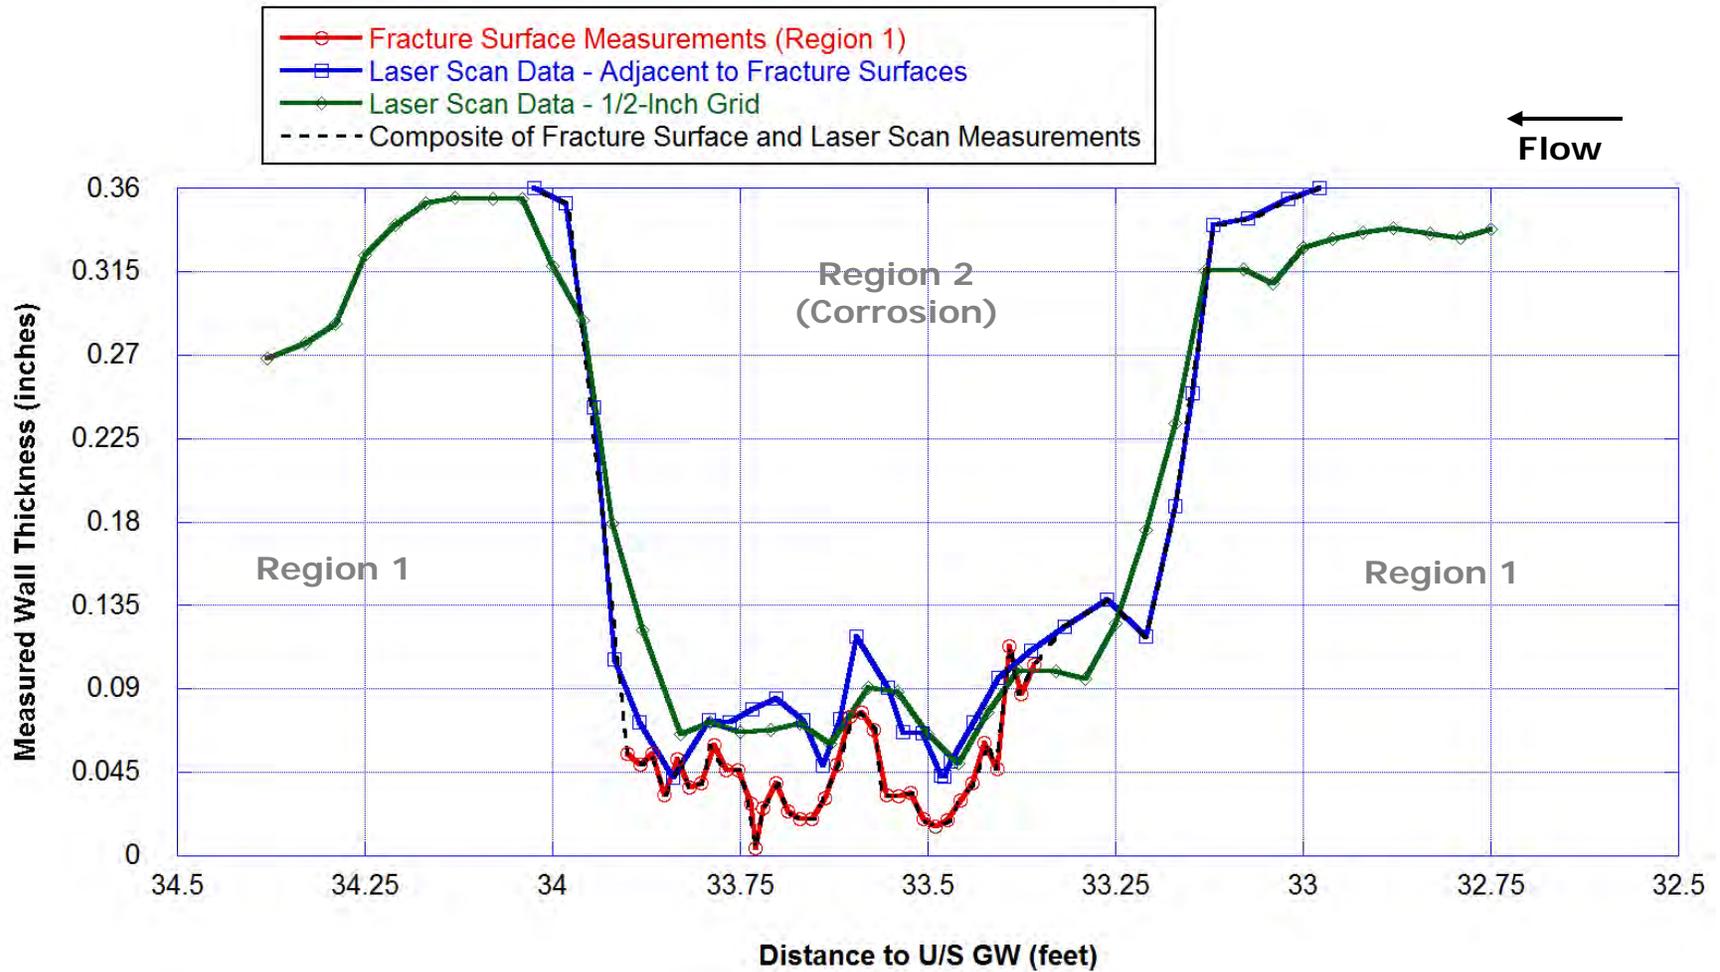
Figure 47. Fracture/Corrosion profile based on three measurement techniques.

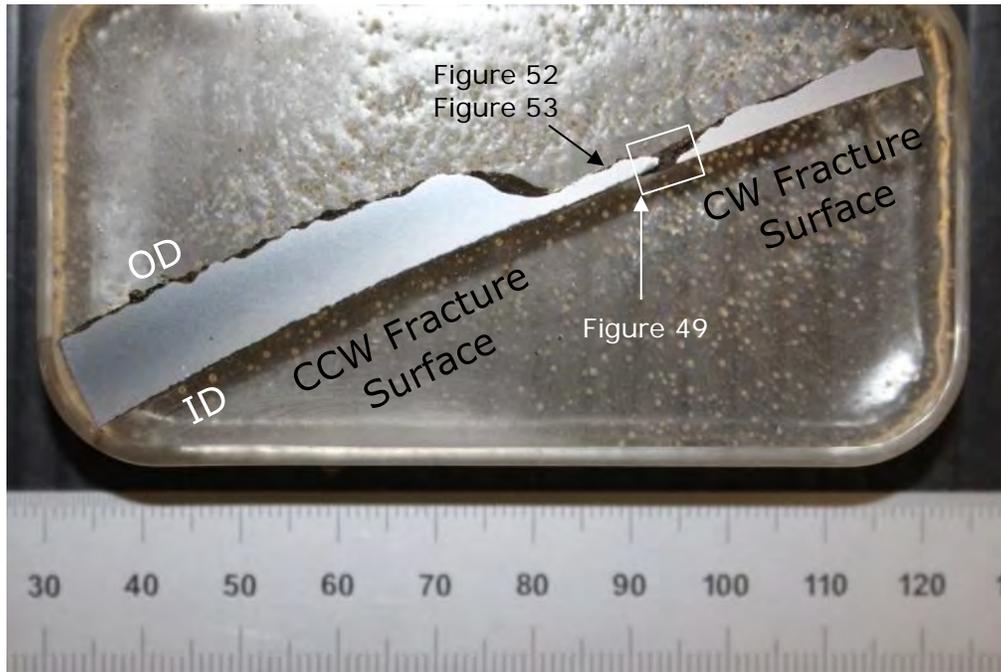
Figure 48. Photograph of the mounted transverse cross-section, Mount 195367-1b removed from the suspected failure origin; Feature 4. Mount location indicated in Figure 39.

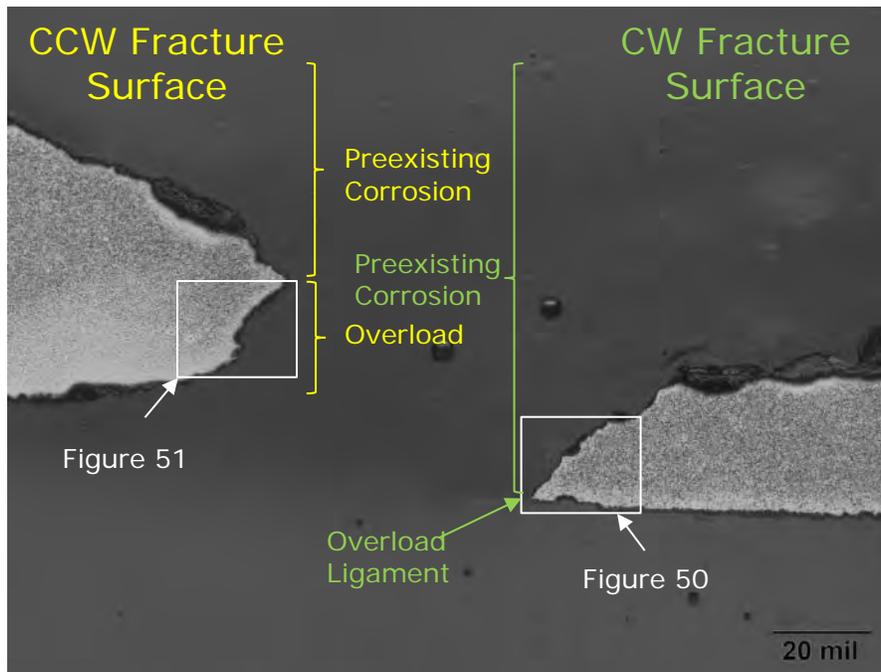
Figure 49. Photomicrograph showing the suspected failure origin in cross-section; Feature 4. Area indicated in Figure 48. (Mount 195367-1b; 4% Nital Etch)

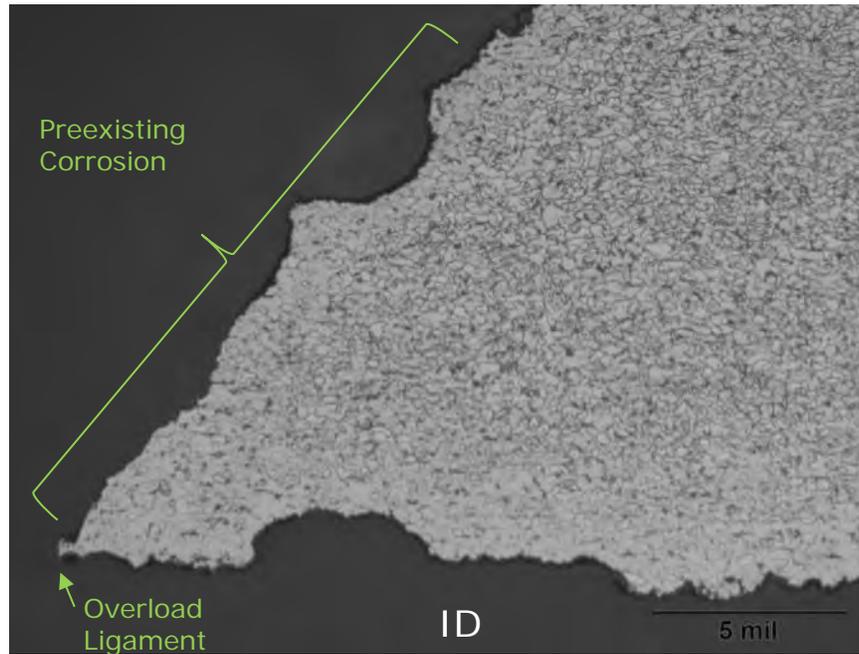
Figure 50. Photomicrograph showing the negligible grain elongation and plasticity along the CW fracture surface. Area indicated in Figure 49. (Mount 195367-1b; 4% Nital Etch)

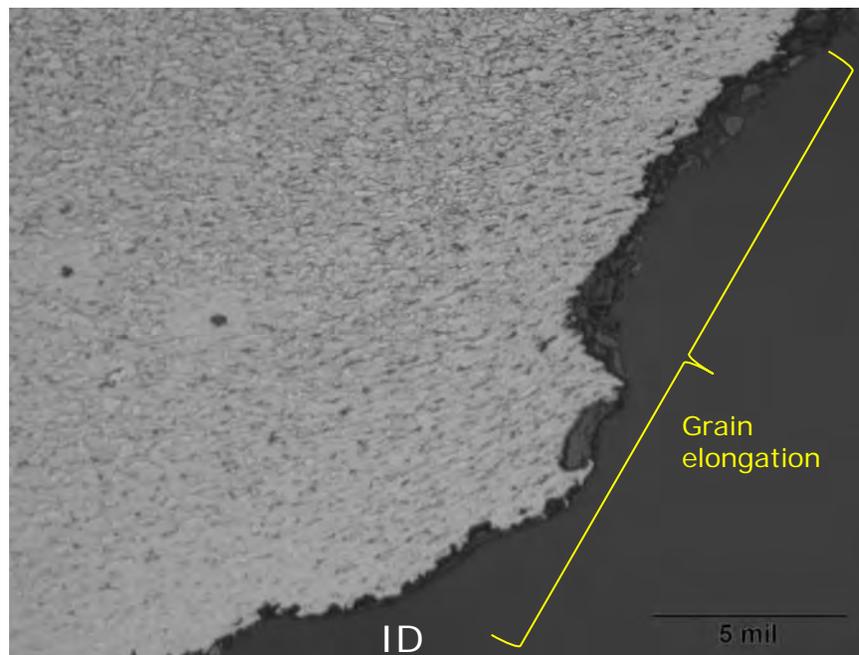
Figure 51. Photomicrograph showing the grain elongation and plasticity along the CCW fracture surface. Area indicated in Figure 49. (Mount 195367-1b; 4% Nital Etch)

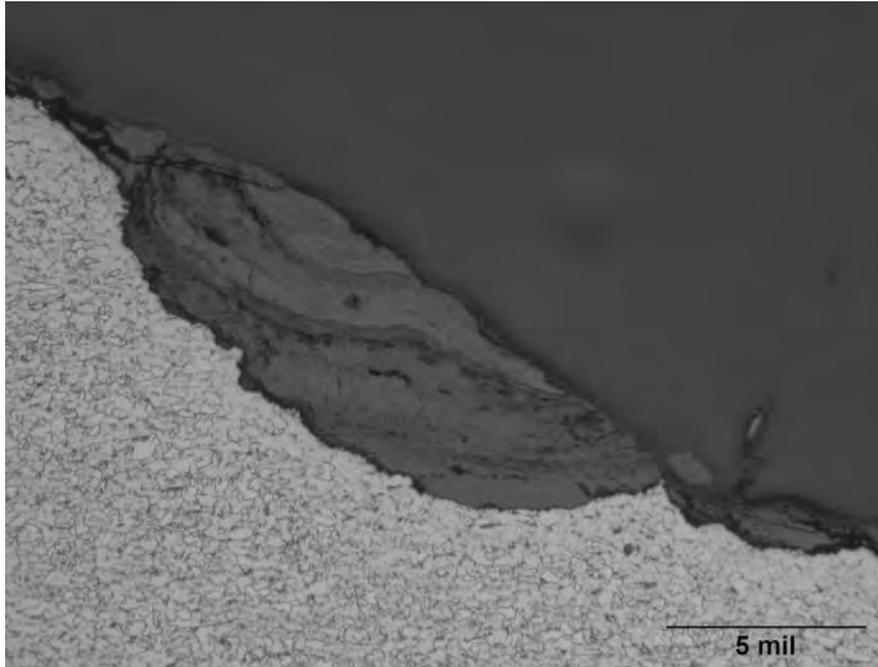
Figure 52. Photomicrograph showing corrosion products near the CCW fracture surface. Area indicated in Figure 48. (Mount 195367-1b; 4% Nital Etch)

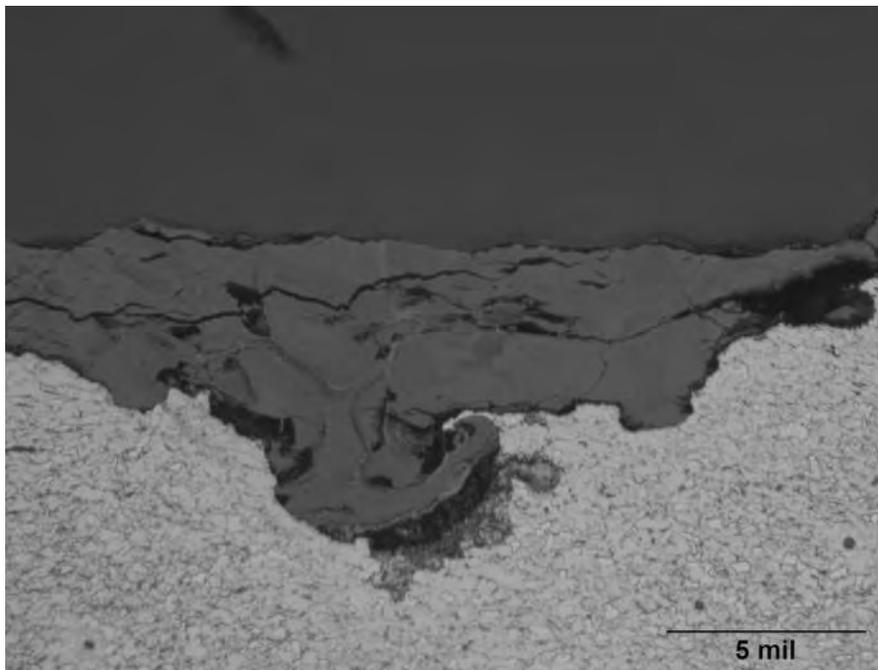
Figure 53. Photomicrograph showing corrosion products with some undercutting near the CCW fracture surface. Area indicated in Figure 49. (Mount 195367-1b; 4% Nital Etch)

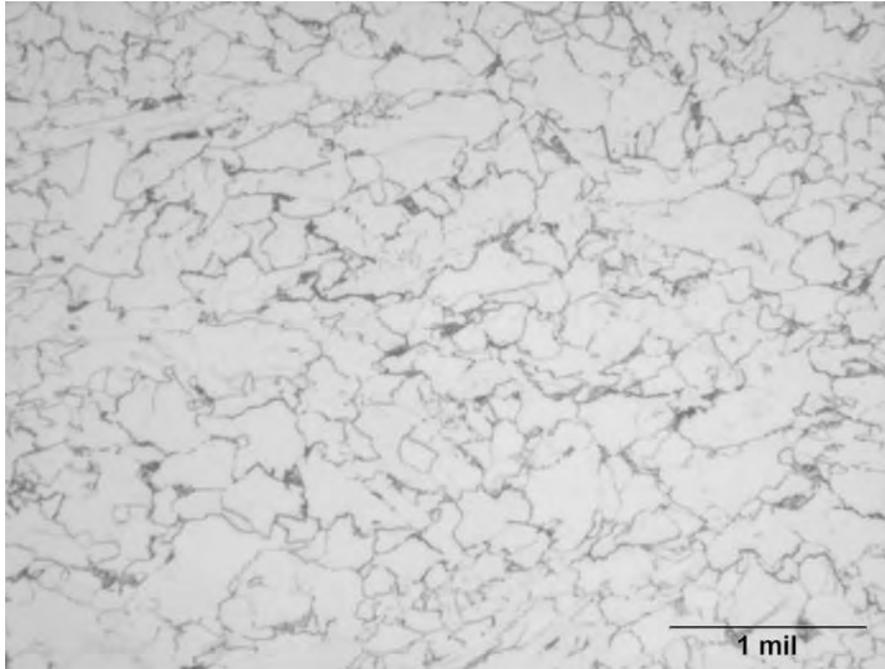
Figure 54. Photomicrograph showing base metal microstructure of Mount 195367-1b; 4% Nital Etch)

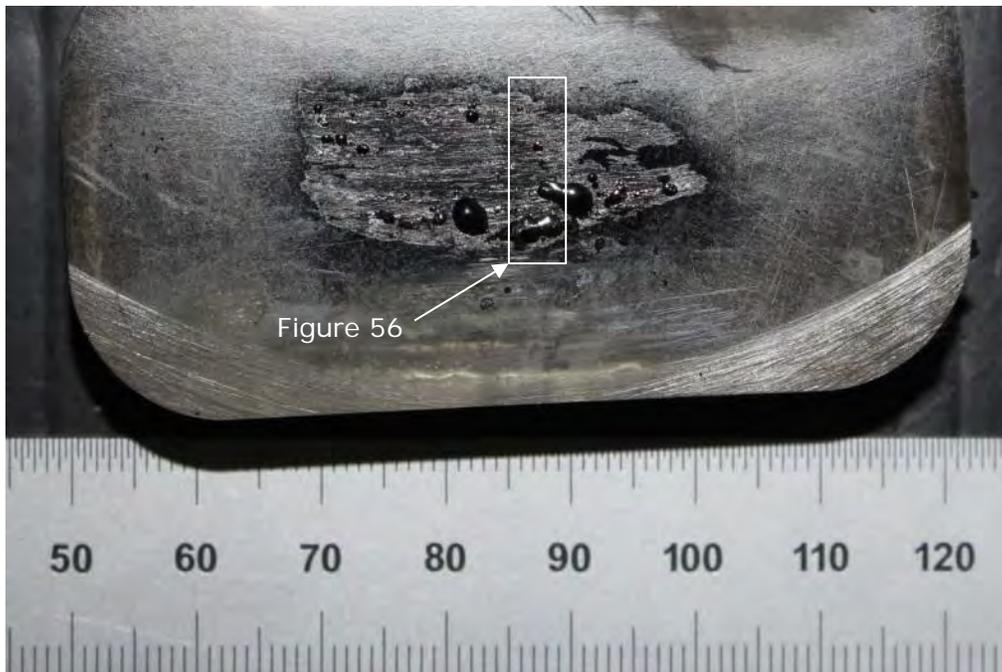
Figure 55. Photograph of the mounted cross-section of corrosion products, Mount 195331-1 removed from Feature 4.

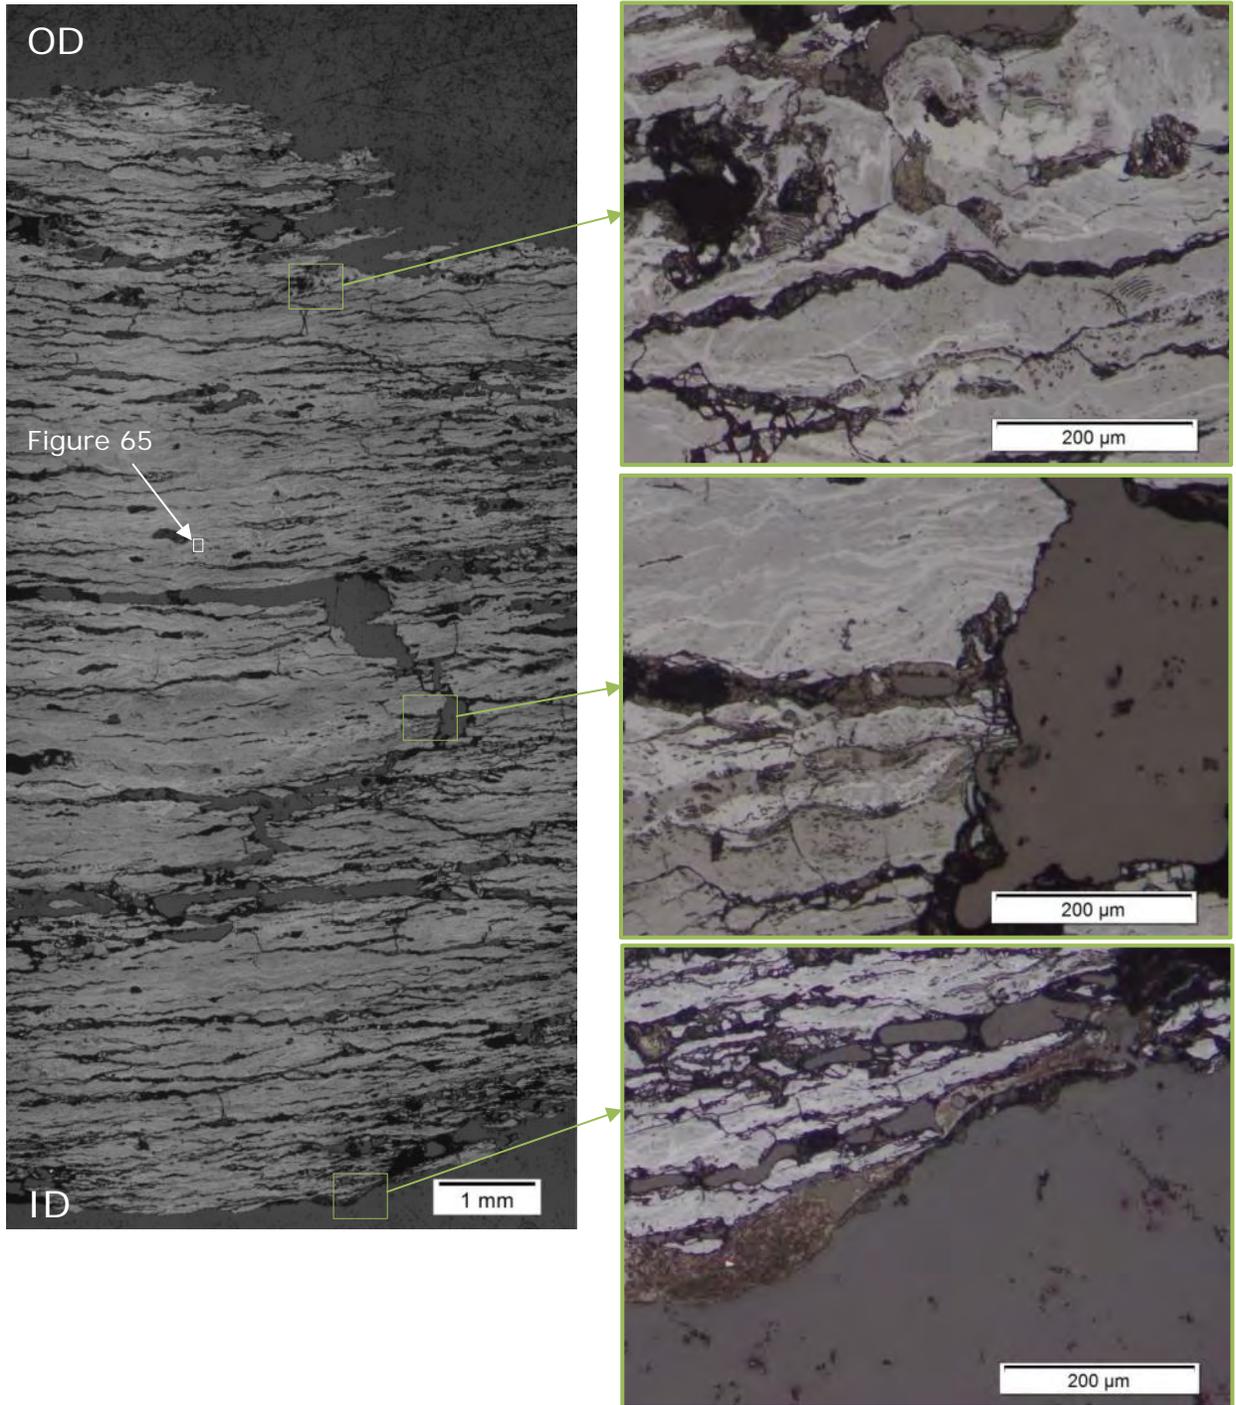
Figure 56. Photomicrographs of the mounted cross-section, Mount 195331-1, from corrosion products removed from Feature 4; location identified in Figure 55.

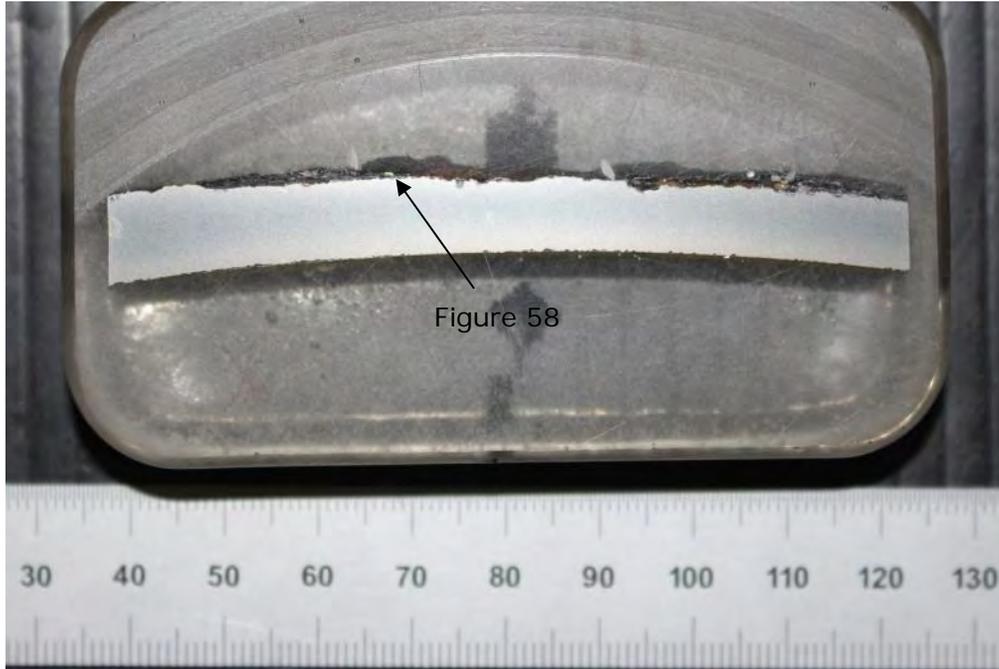
Figure 57. Photograph of the transverse mounted cross-section, Mount 195370-1 removed from Feature 1. Mount location indicated in Figure 22.

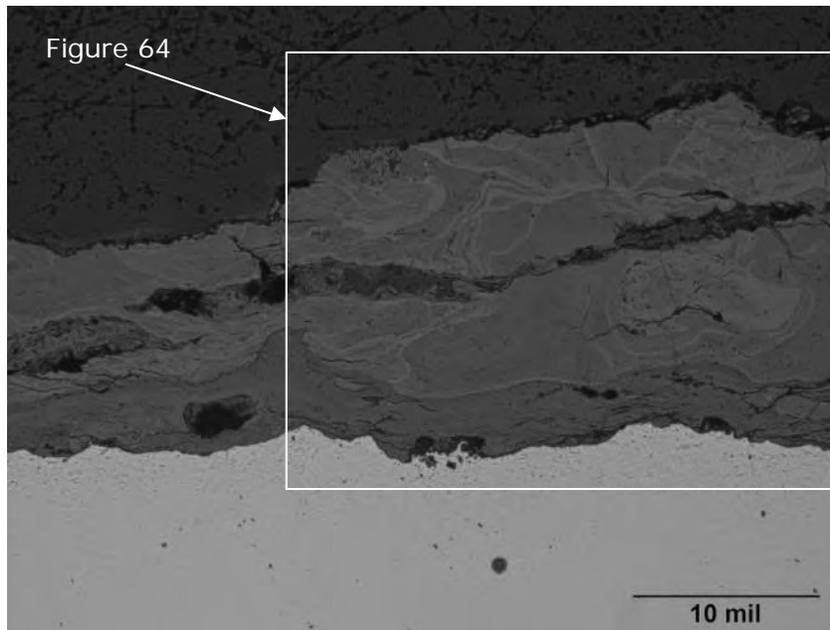
Figure 58. Photomicrograph of the mounted cross-section, Mount 195370-1 removed from Feature 1 showing the corrosion morphology at the external surface; mirror image of location indicated in Figure 57.

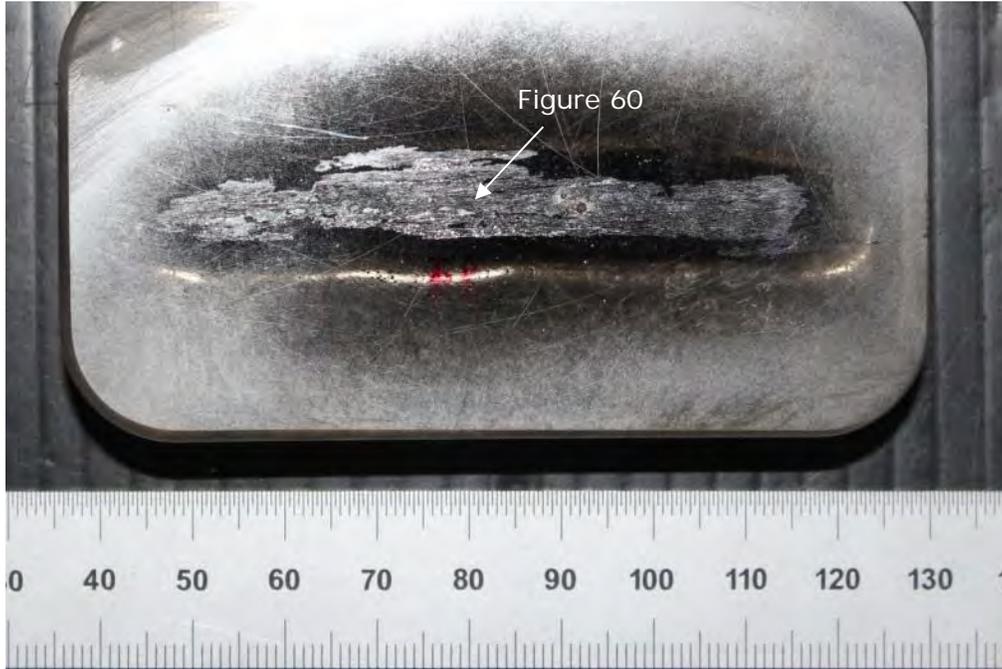
Figure 59. Photograph of the mounted cross-section of corrosion products, Mount 195322-1, removed from Feature 1.

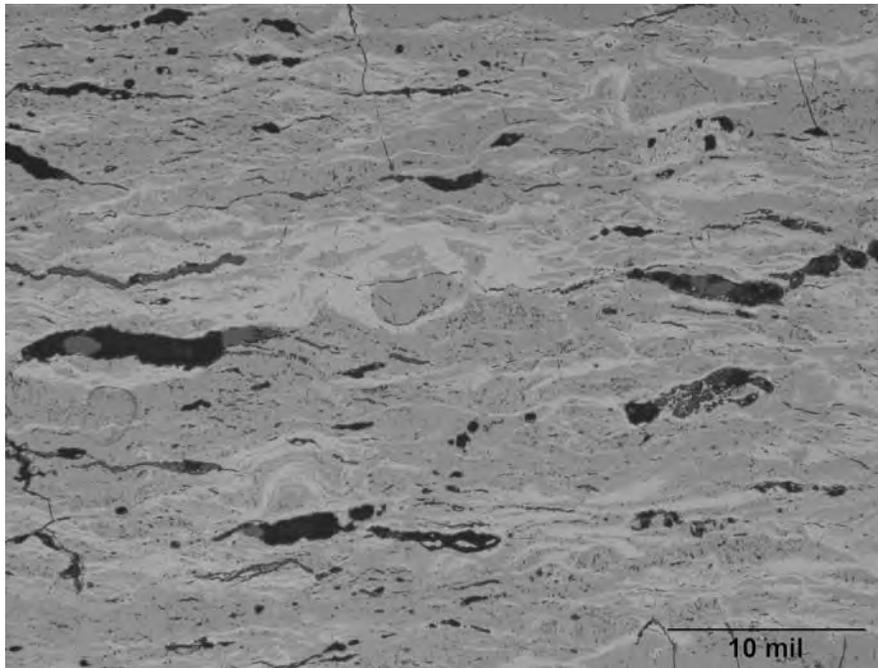
Figure 60. Photomicrographs of the mounted cross-section, Mount 195322-1, from the corrosion product removed from Feature 1; location indicated in Figure 59.
