**U.S. Department
of Transportation**

**Pipeline and
Hazardous Materials
Safety Administration**

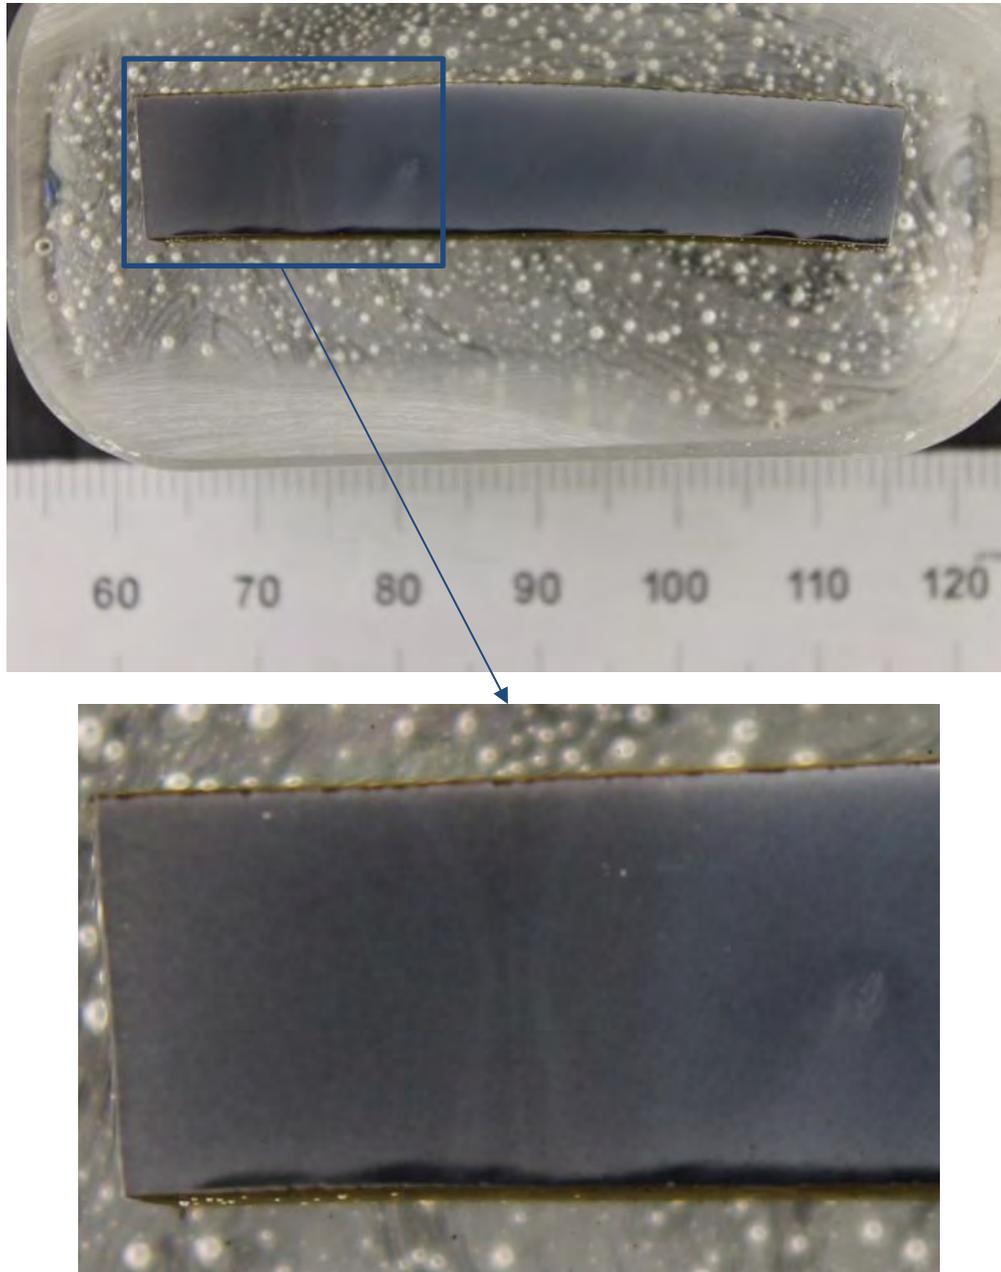
Figure 61. Photograph of the mounted cross-section, Mount 195365-1, removed from across the longitudinal seam weld. Location indicated in Figure 4.

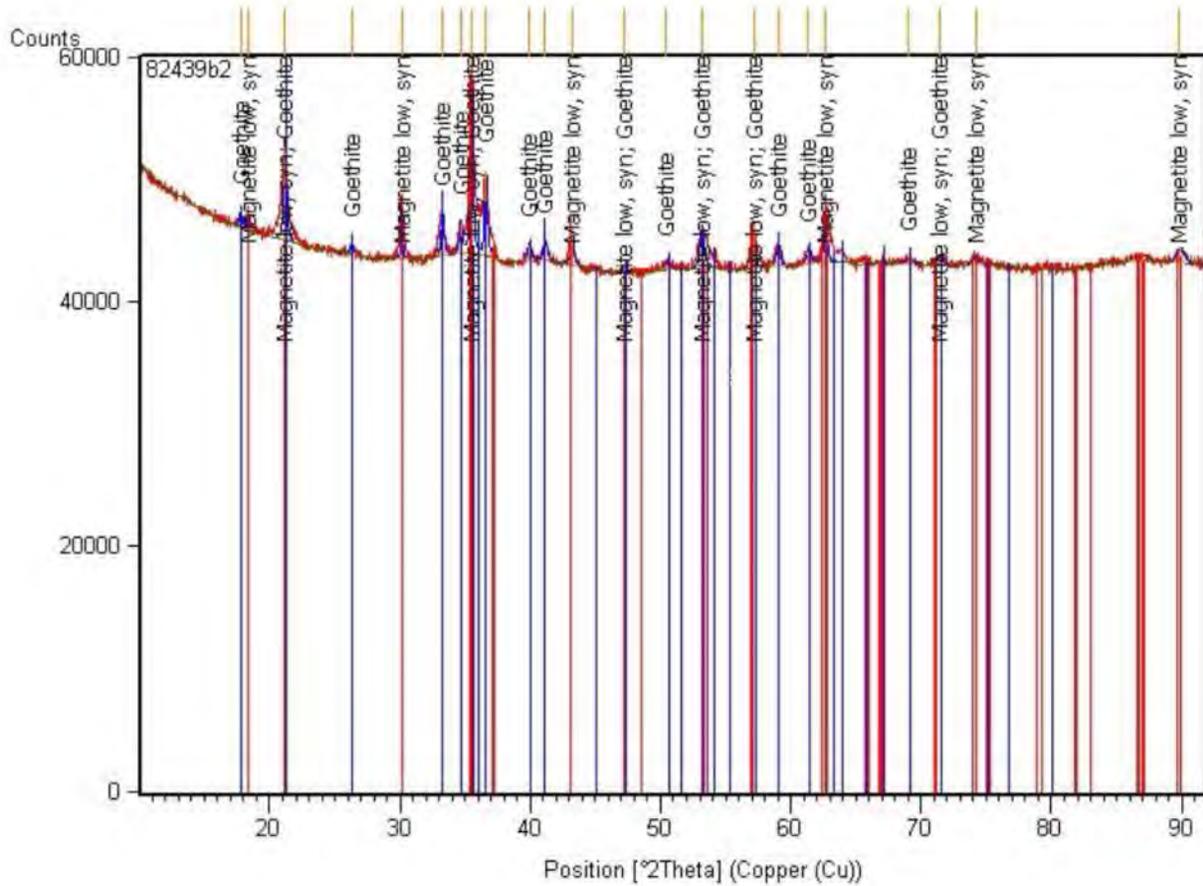
Figure 62. XRD spectrum acquired from the corrosion products collected from Feature 1, identifying Goethite and Magnetite as the compounds.

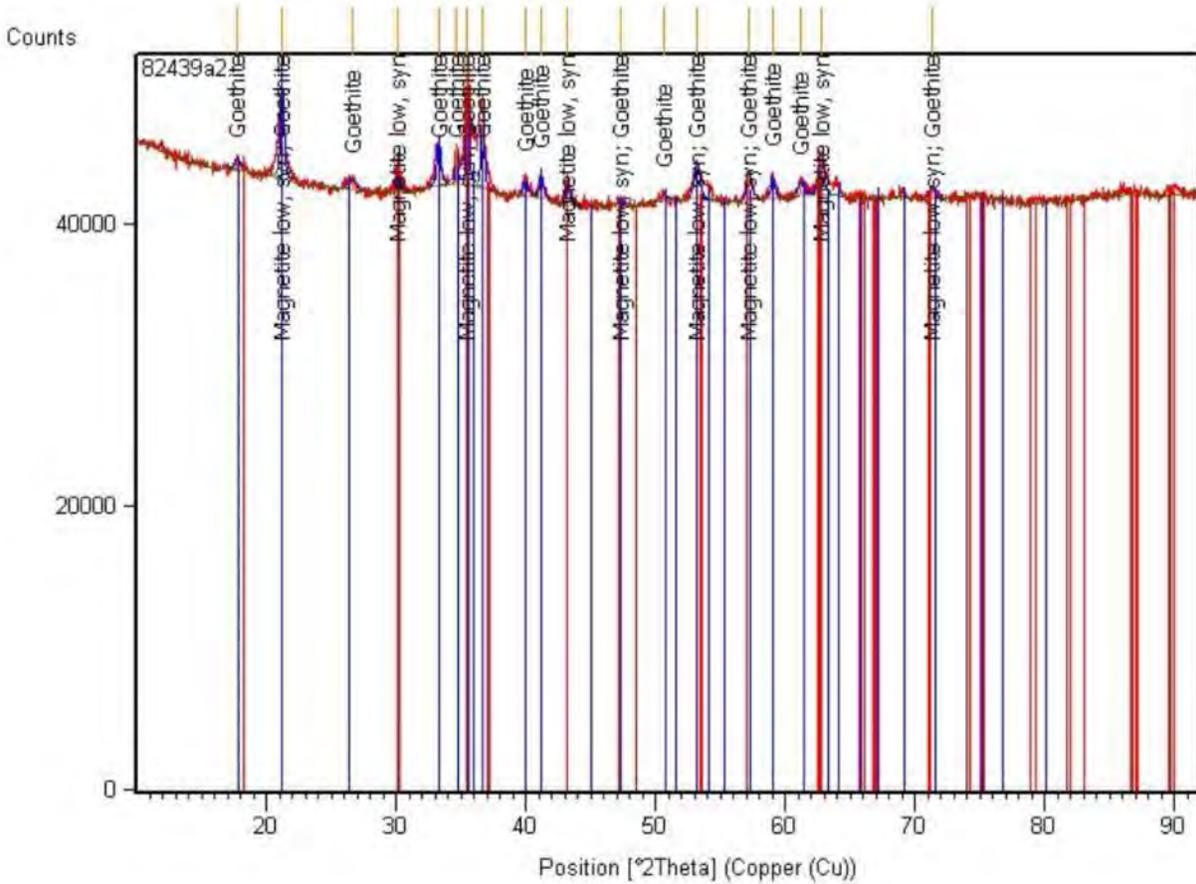
Figure 63. XRD spectrum acquired from the corrosion products collected from Feature 2, identifying Goethite and Magnetite as the compounds.

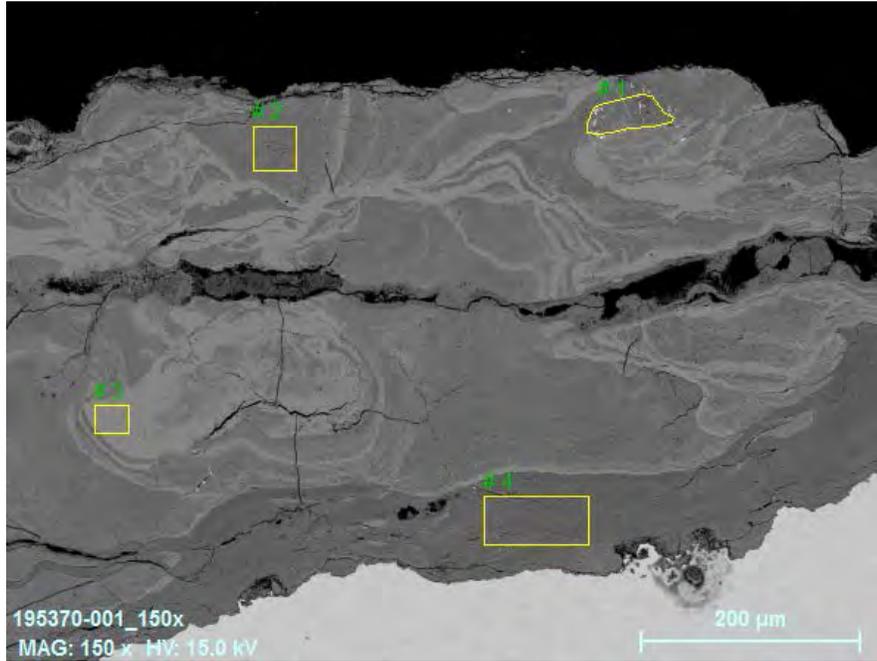
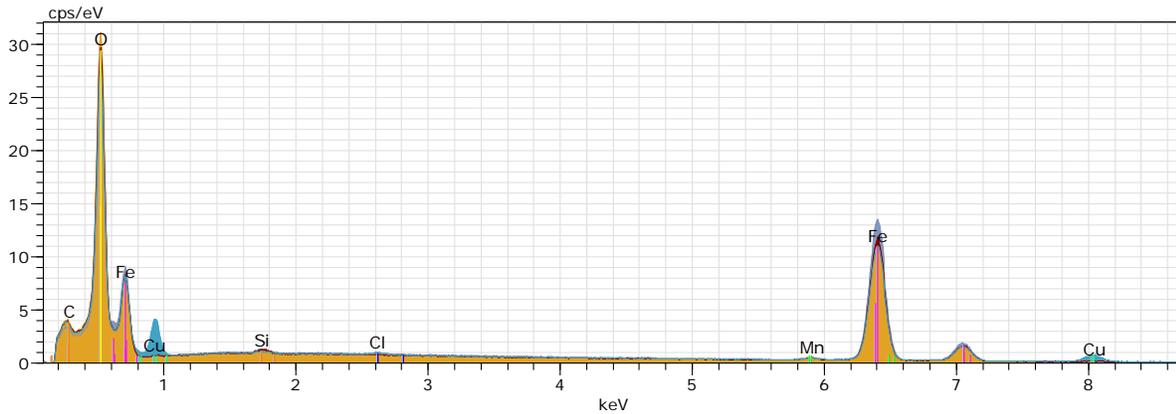
Norm. mass percent (%)

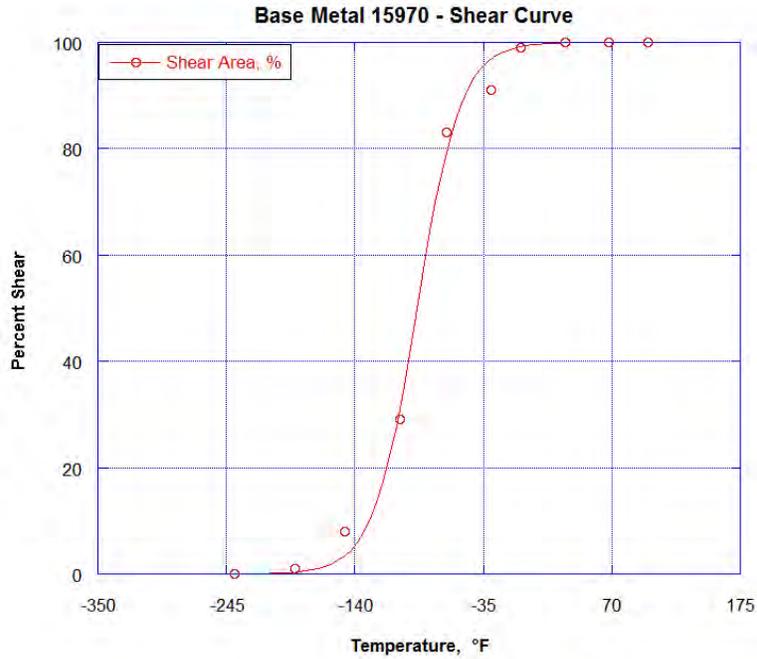
Figure 68. Percent shear from Charpy V-notch tests as a function of temperature for transverse base metal specimens removed from the failure joint (Joint 5930).

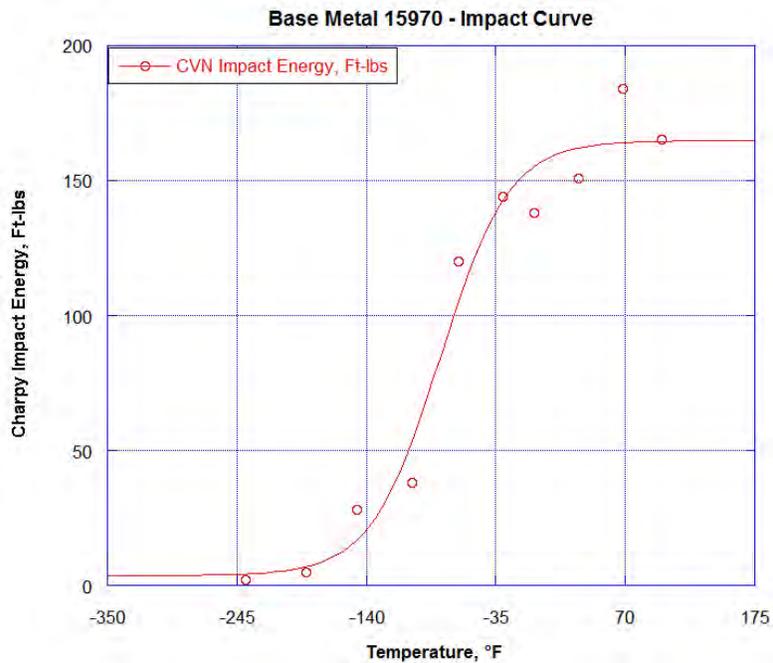
Figure 69. Charpy V-notch impact energy as a function of temperature for transverse base metal specimens removed from the failure joint (Joint 5930).

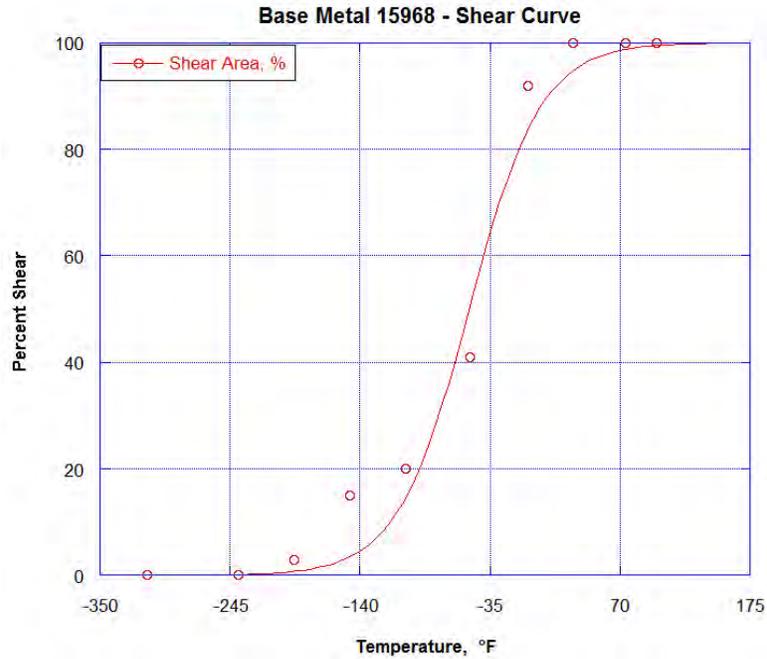
Figure 70. Percent shear from Charpy V-notch tests as a function of temperature for transverse base metal specimens removed from U/S joint (Joint 5920).

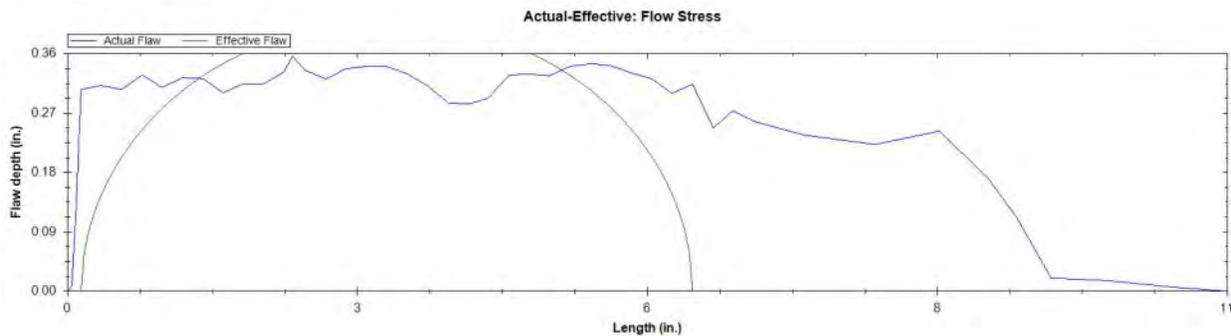
Case 2: Laser Scan Data - Offset from Fracture Surface

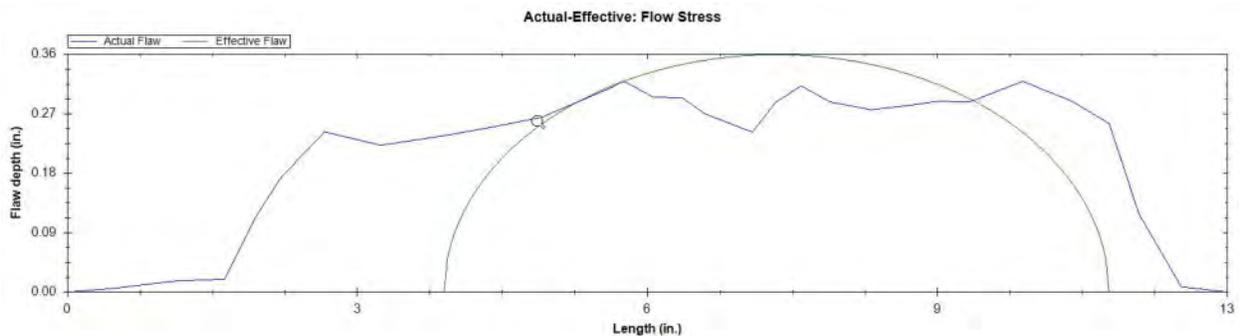
Case 3: Laser Scan Data - 1/2-Inch Grid (Average)

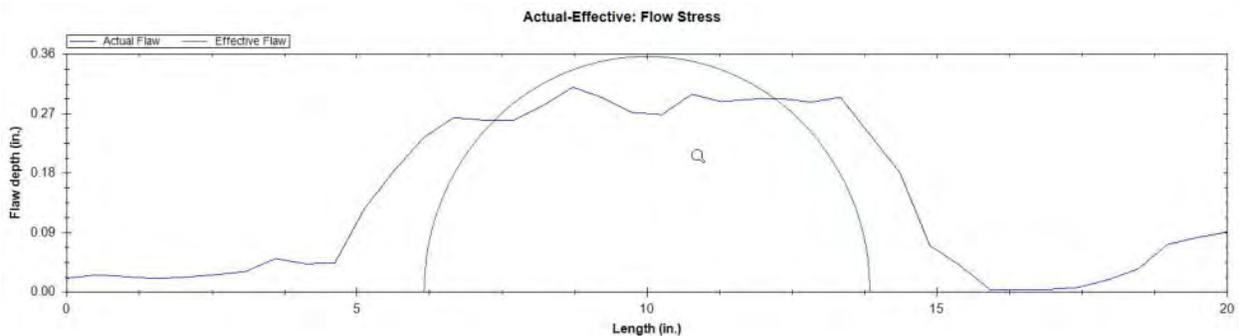
Plains Line 901	Semi-Elliptical Flaw Profile	
	API X65 - Joint 5930	
	Maximum Operating Pressure (psig)	1341
	UTS (psi)	84000
	YS (psi)	64800
	FS (psi)	74800
	E (ksi)	29500
	nexp	0.098
	Jc (lb/in)	12097
	Thin-wall (OD) formula for hoop stress	
	Tmat	208.9
	OD (in.)	24
	Wall Thickness (in.)	0.359
Summary of Results for Effective Area Method		
	Flaw: Start (in.)	6
	Length (in.)	7.5
	Area (in.^2)	2.095
	Depth (in.) Maximum	0.309
	Equivalent Flaw	0.356
	For Design Factor	0.72
	Design Pressure (psig)	1395.79
	Failure Stress (psi)	25516
	Failure Pressure (psig)	763.35
	For Design Factor	0.72
	Maximum Safe Pressure (psig)	549.61
Summary of Results for 0.85dL Eff. Area Method		
	Failure Stress (psi)	23715
	Failure Pressure (psig)	709.46
	For Design Factor	0.72
	Maximum Safe Pressure (psig)	510.81

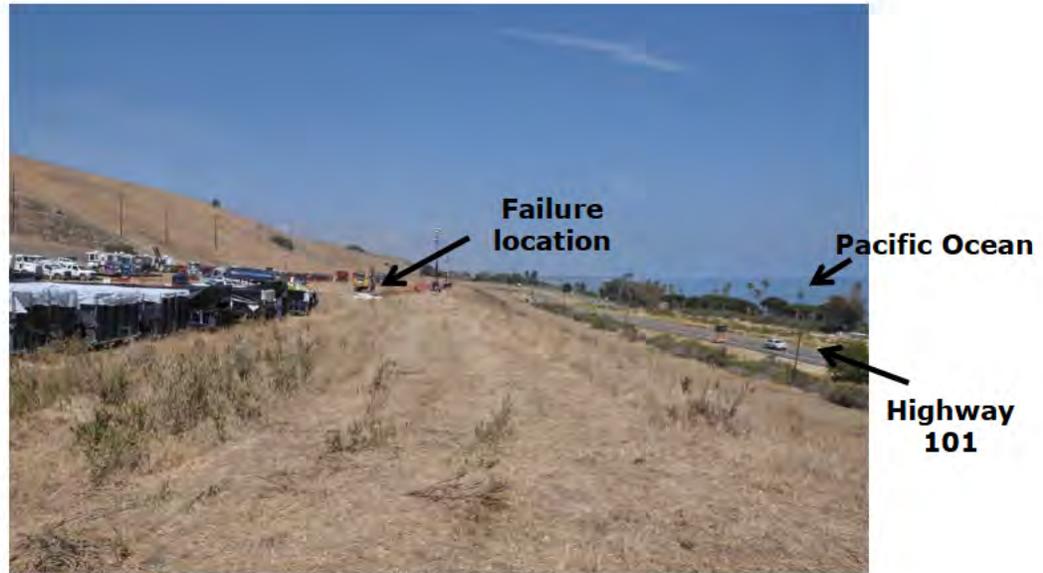
(a) View parallel to pipeline showing slope of hill near failure location

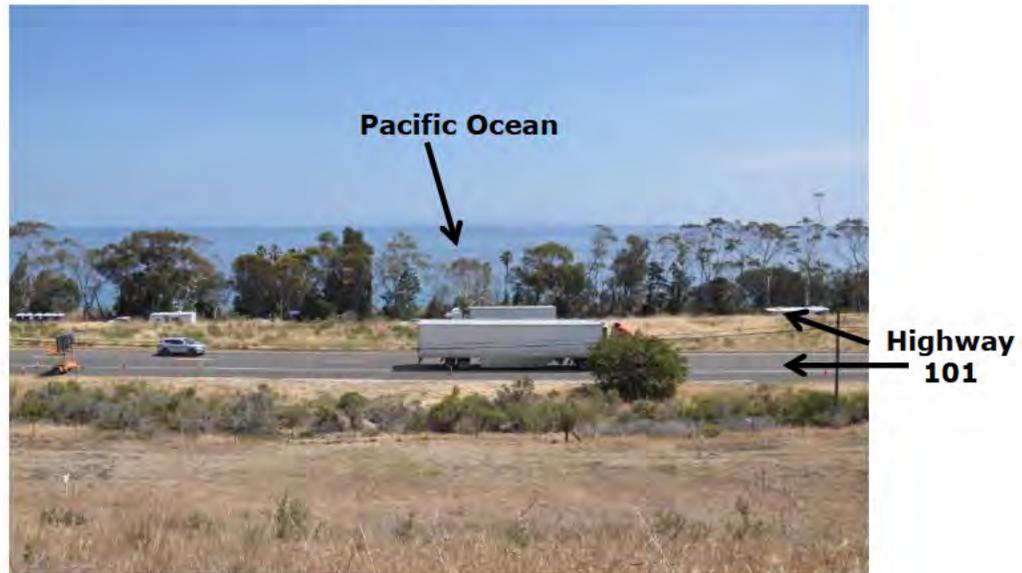
a) View perpendicular to pipeline showing slope of hill near failure location

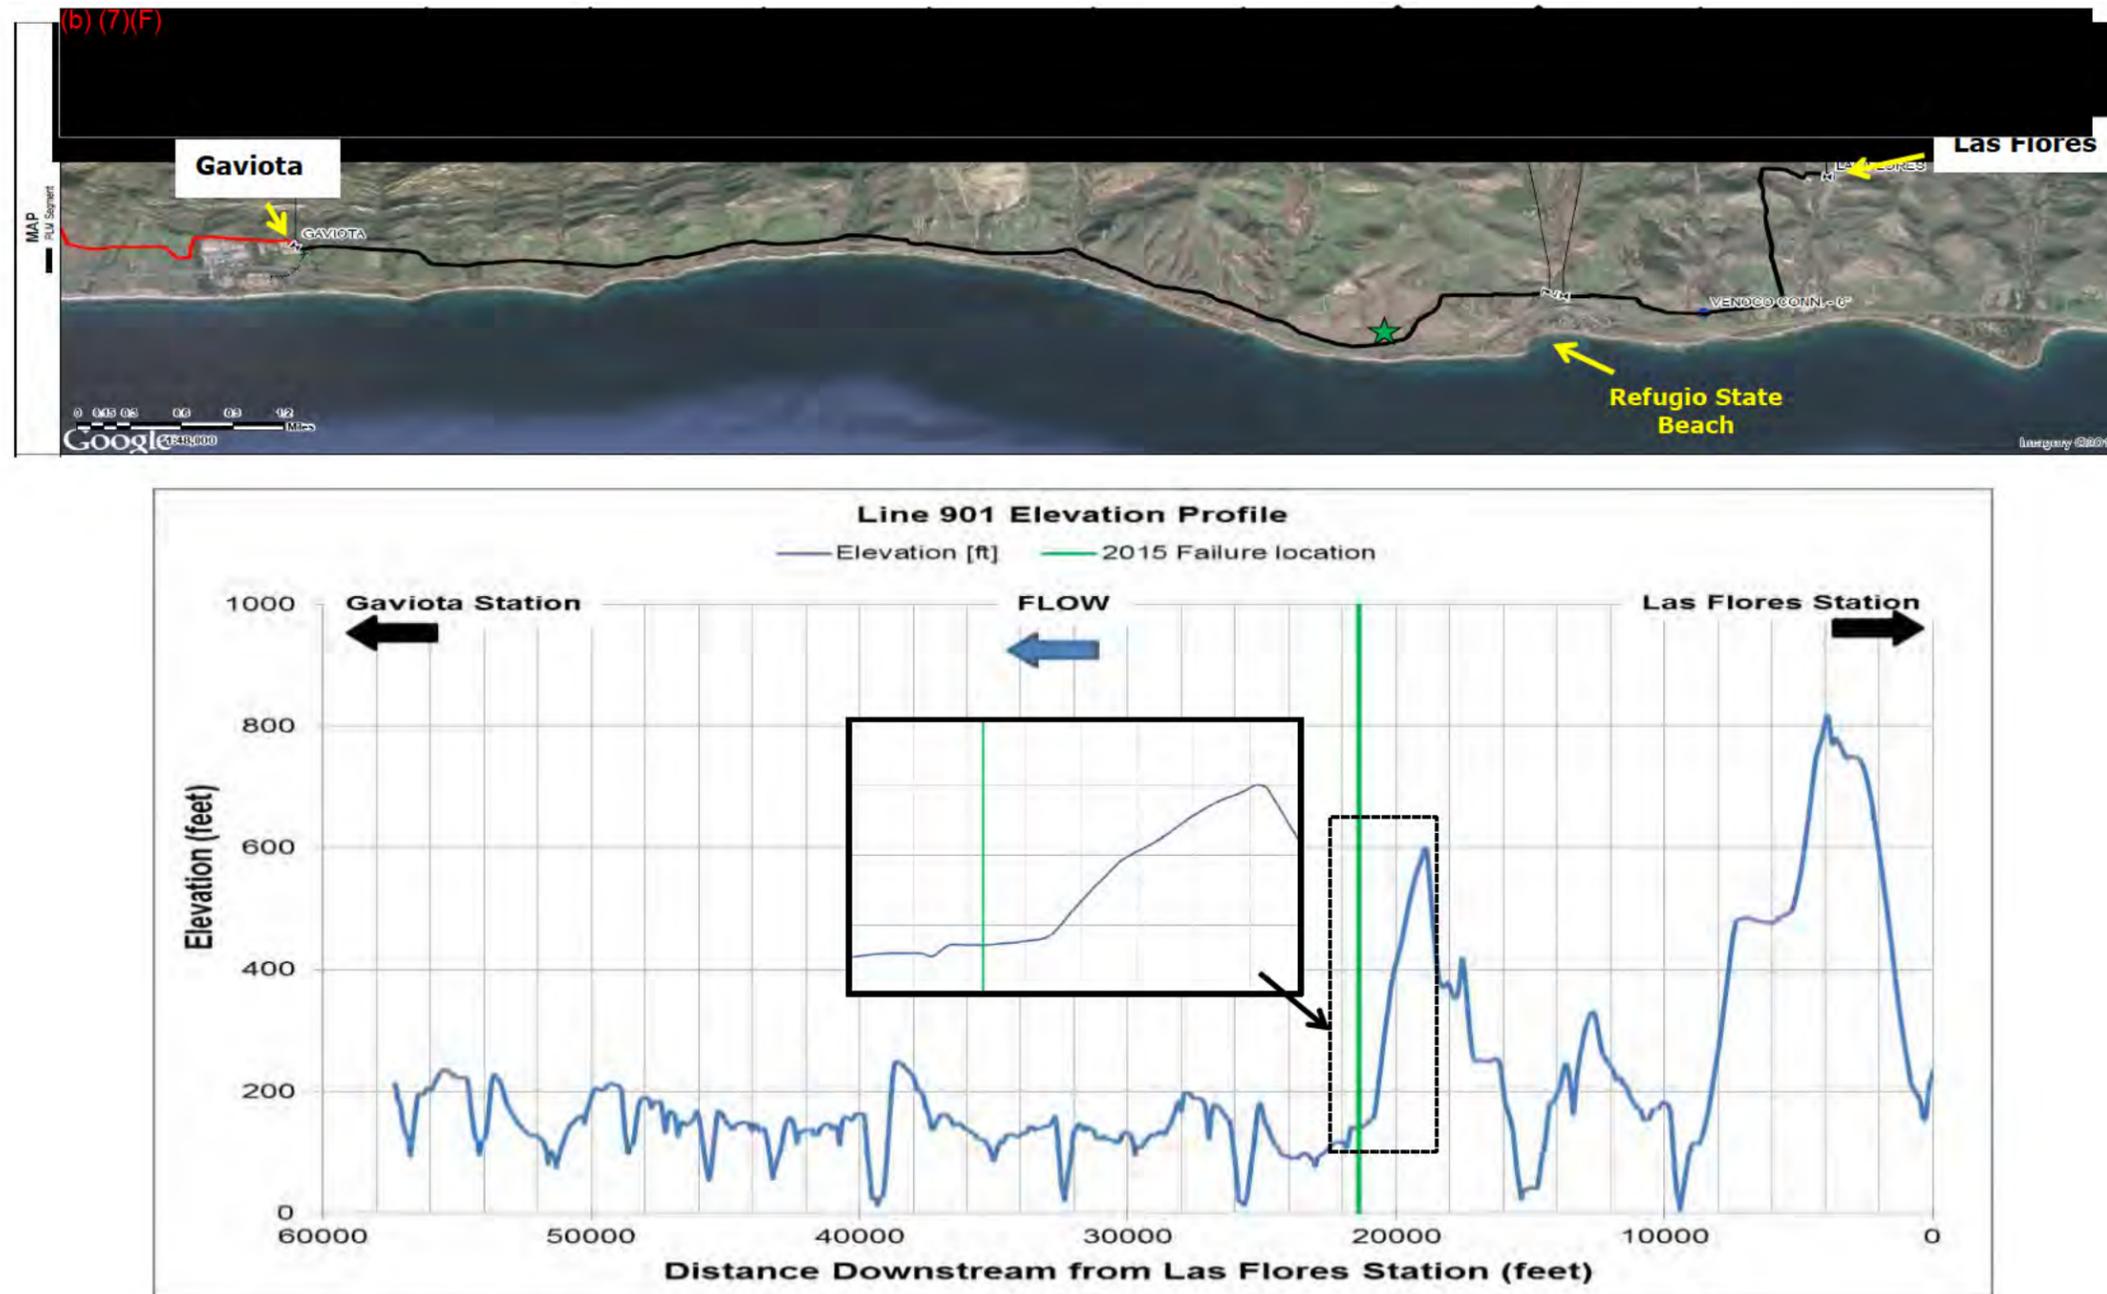
Figure 2. Topographical map and plot showing the elevation profile for Line 901. The white triangles on the map correspond to mile post markers. The green star on the map and the green line on the plot identify the location of the May 19, 2015 failure.

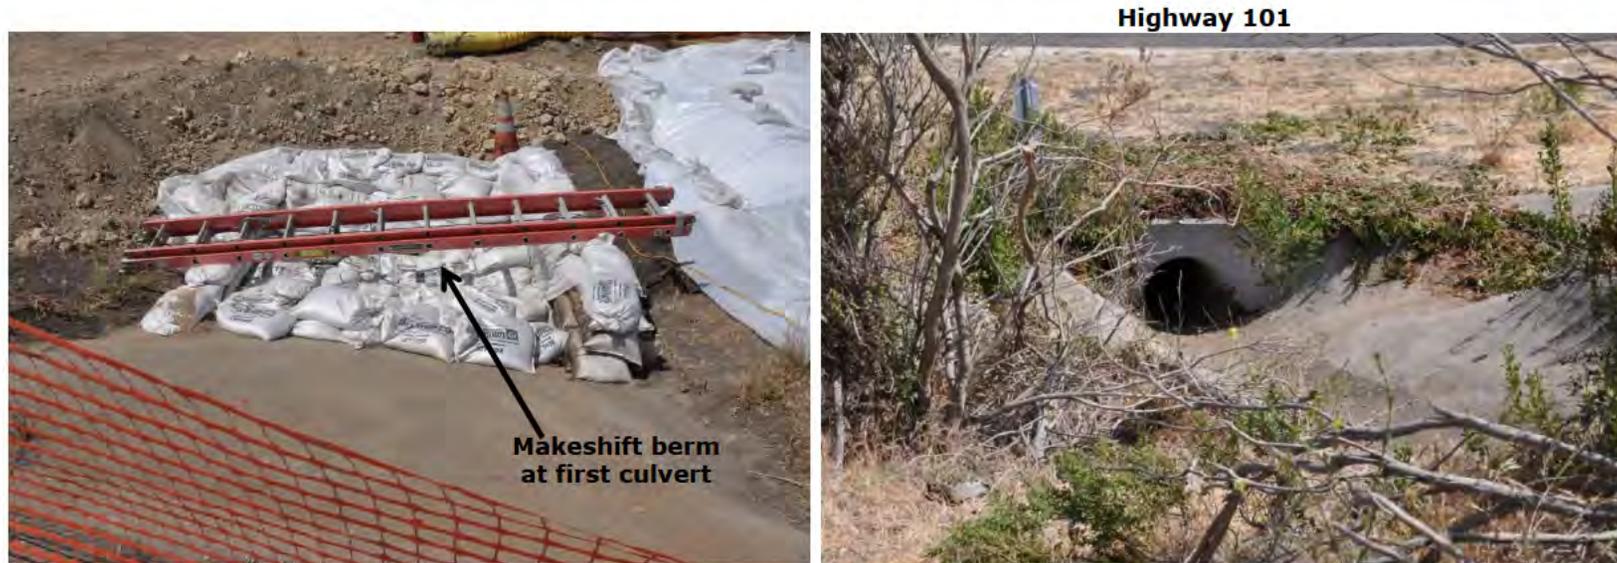
(a) First culvert through which product flowed.

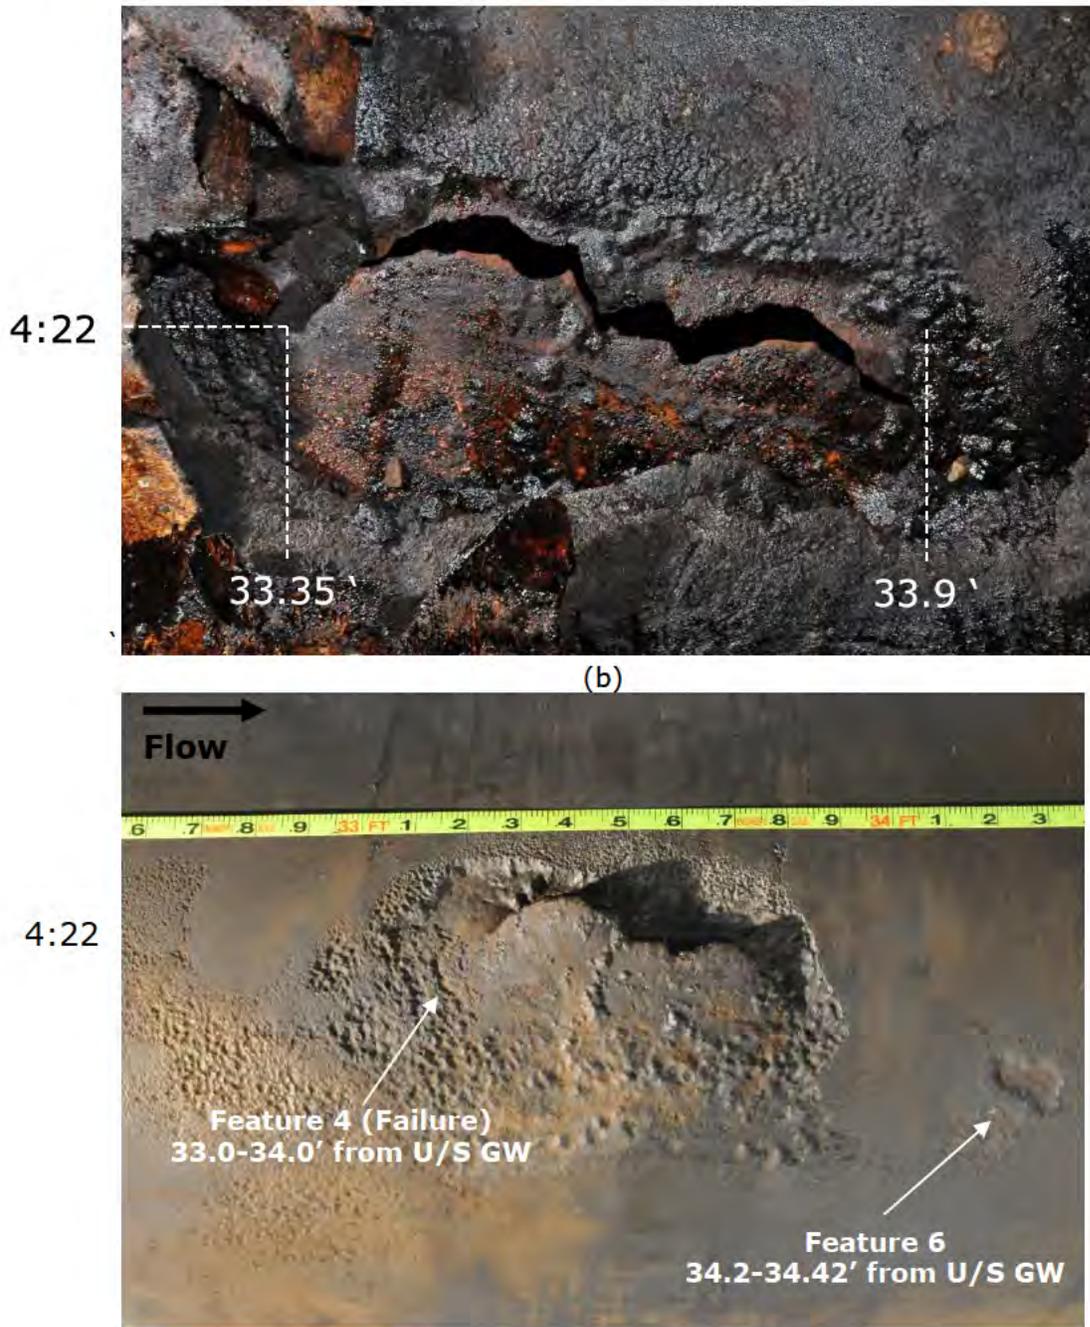
Figure 15. Photograph showing the failure location before (Top) and after (Bottom) cleaning. Tape measure indicates distance to U/S GW (Note: tape slipped 0.1' to the right).

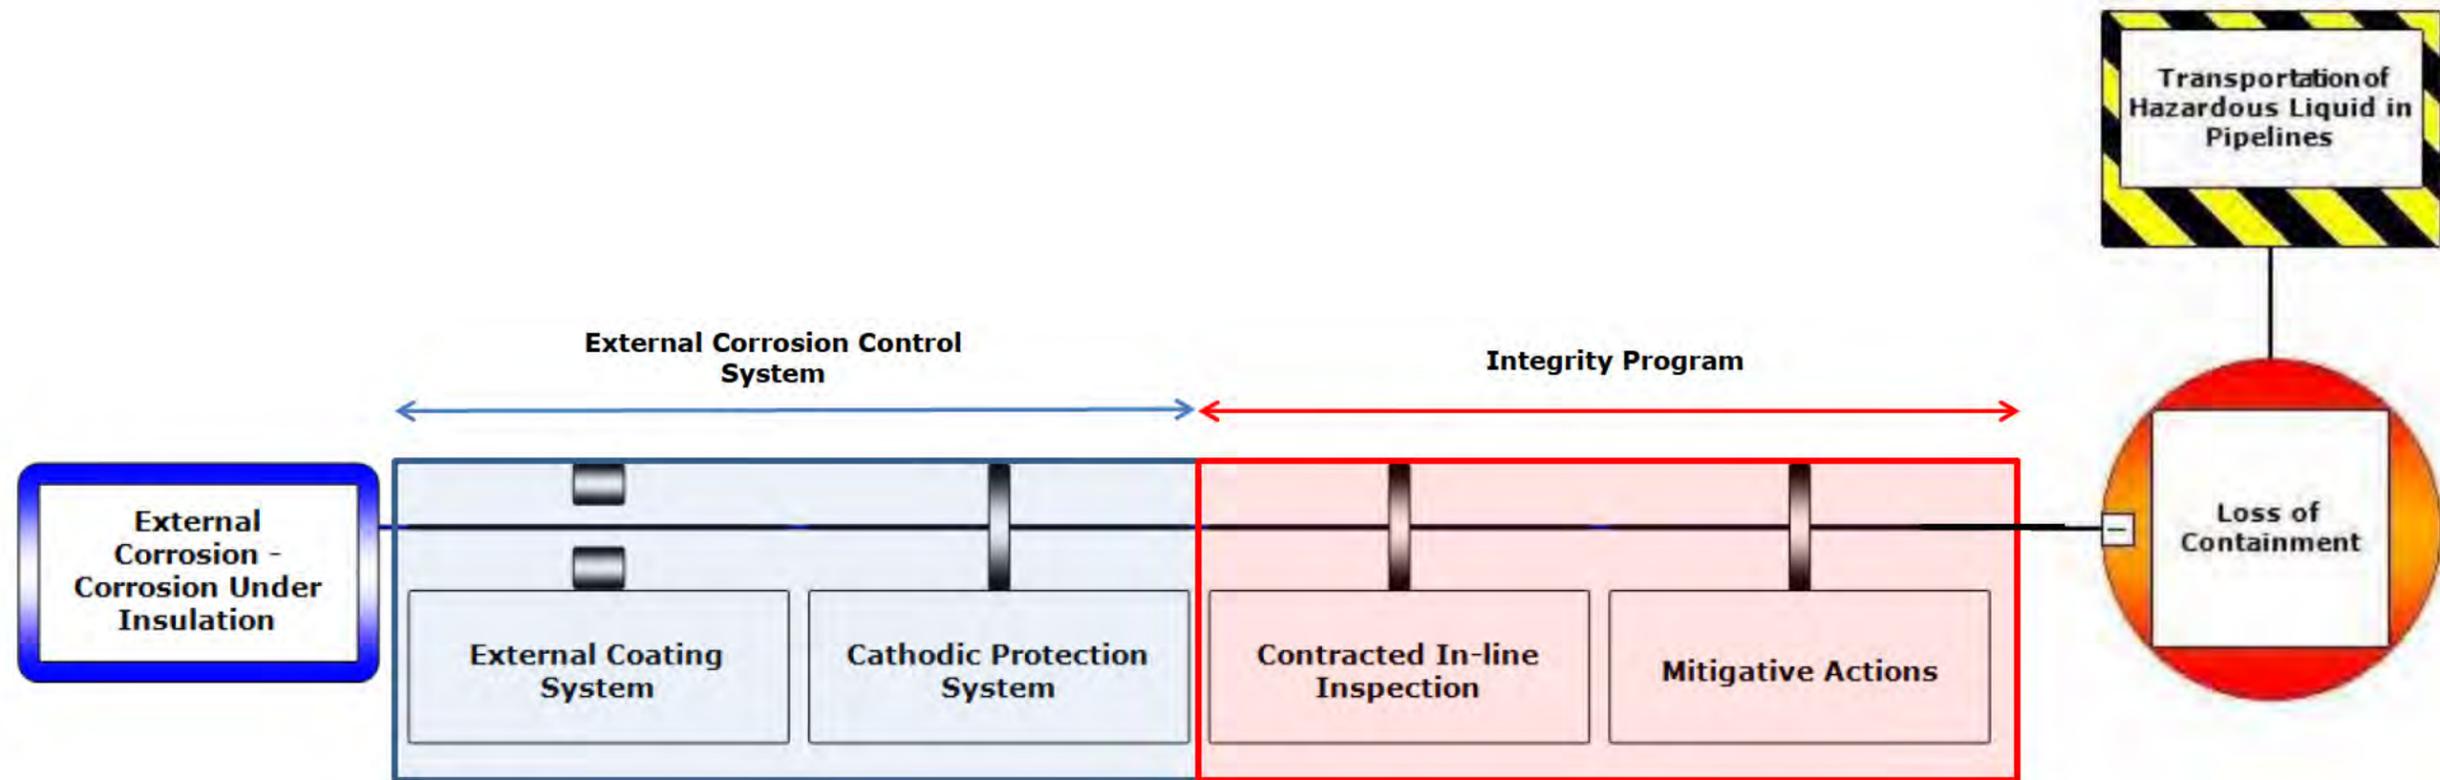
Figure 16. BowTie diagram, generated using the BSCA T™ methodology, summarizing the preventative barriers in place for the Line 901 Release. The barriers shown as two rectangles on either side of the horizontal line correspond to failed barriers, while the thin rectangles that span the horizontal line correspond to ineffective barriers.

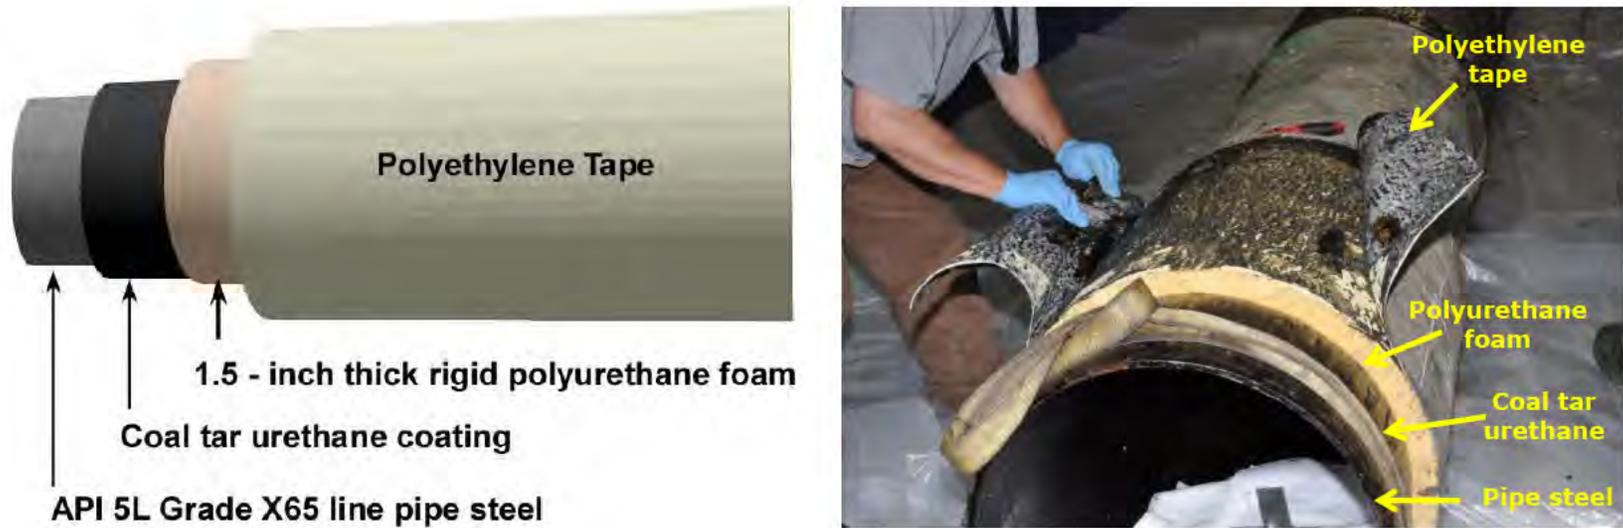
Figure 17. Schematic and photograph showing the protective external coating and the PU foam and PE tape layers present on the Line 901 pipeline.

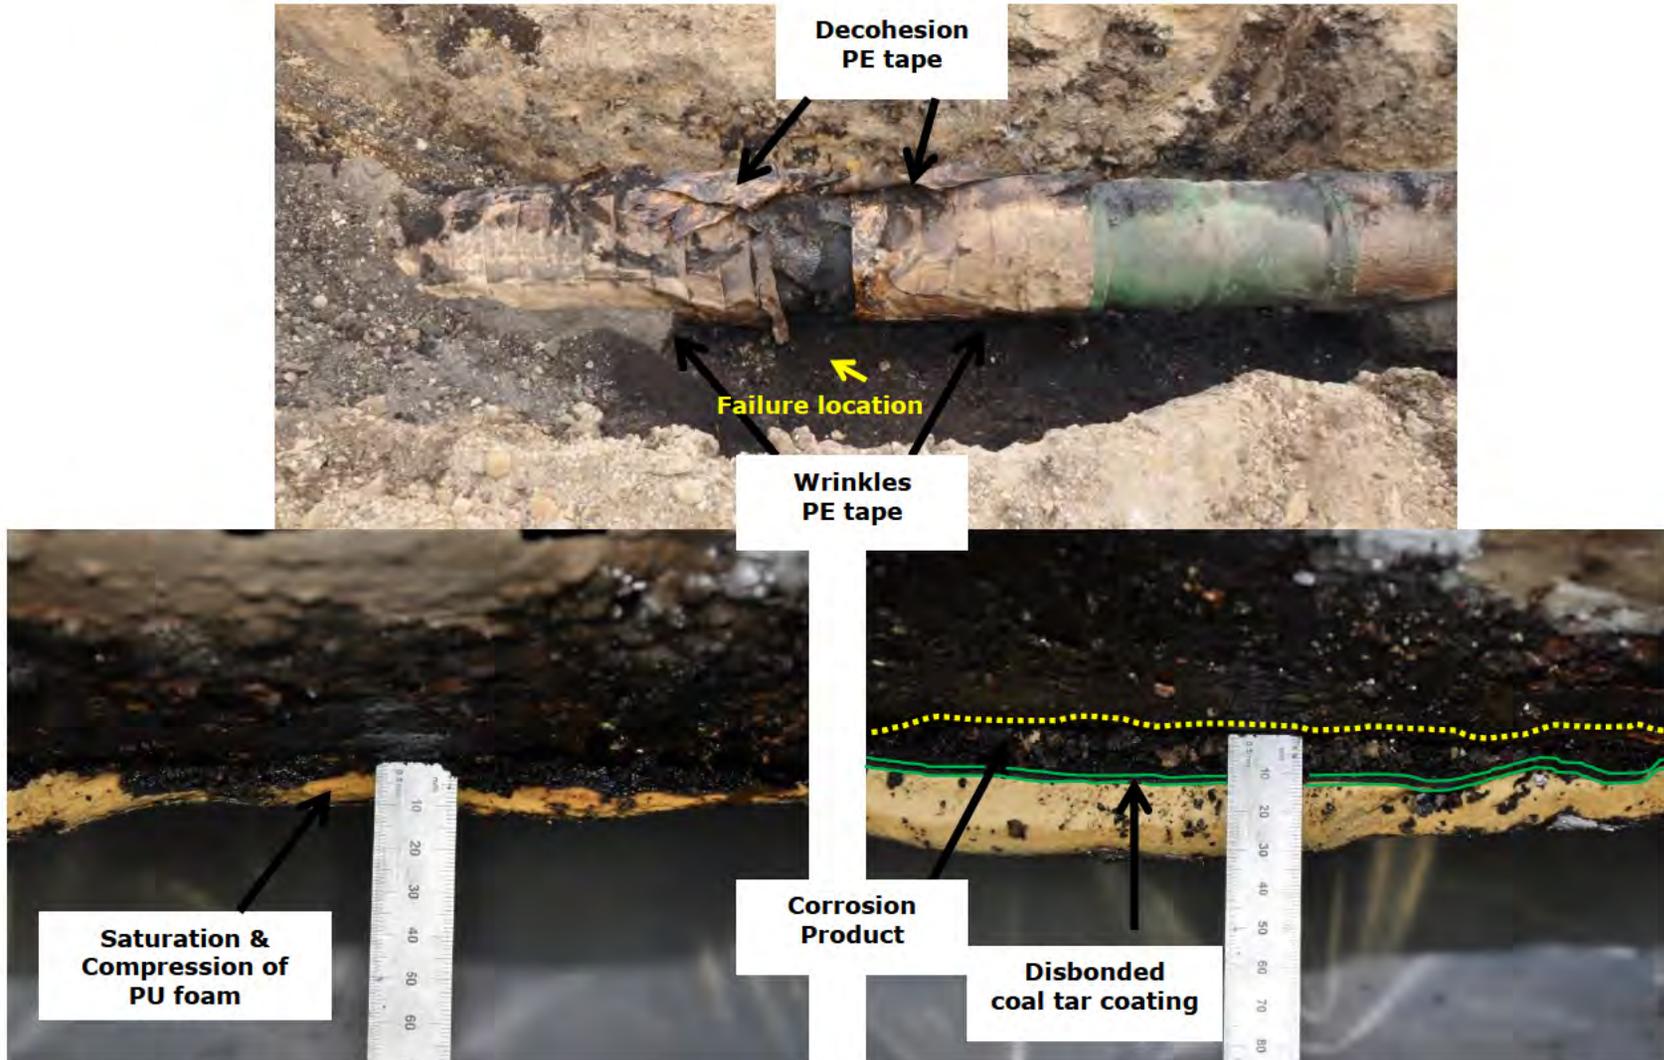
Figure 18. Photographs showing compromised protective coating and PU foam/PE tape layers at the failure location.

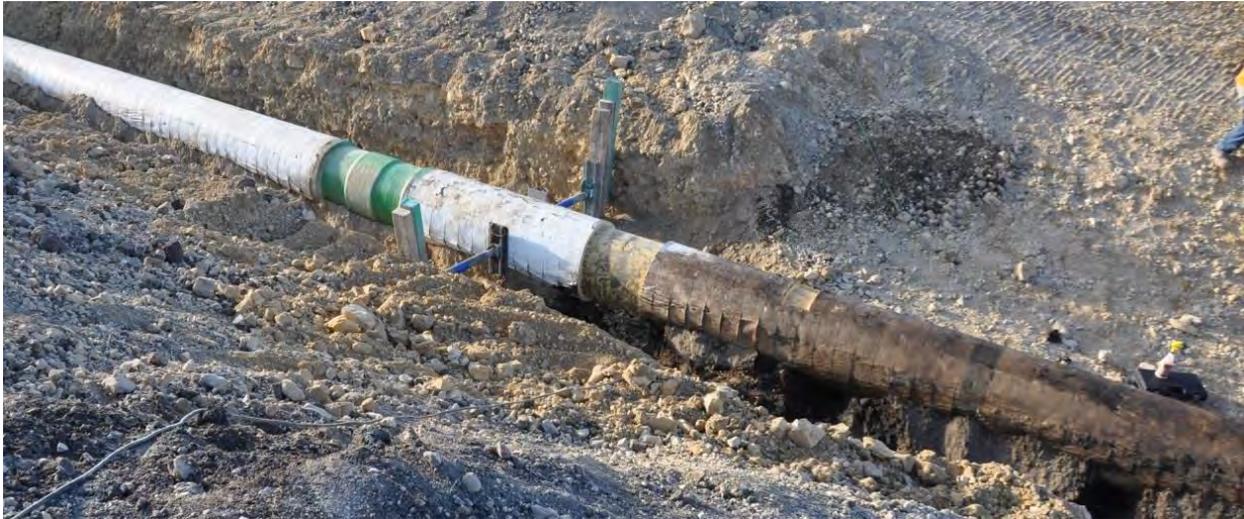
Figure 19. Photograph of wrinkles in the PE tape, located away from the failure location.

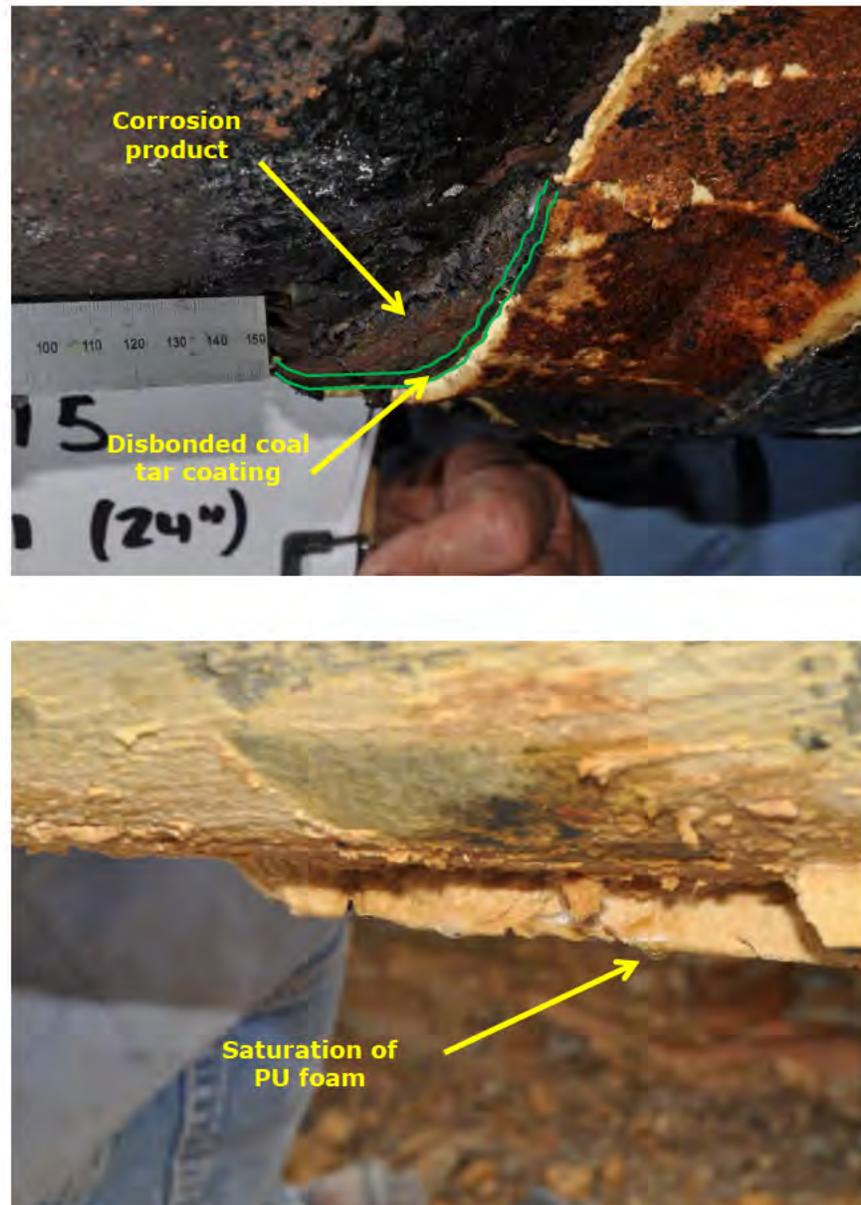
Figure 20. Photographs showing compromised coating and PU foam away from the failure location.

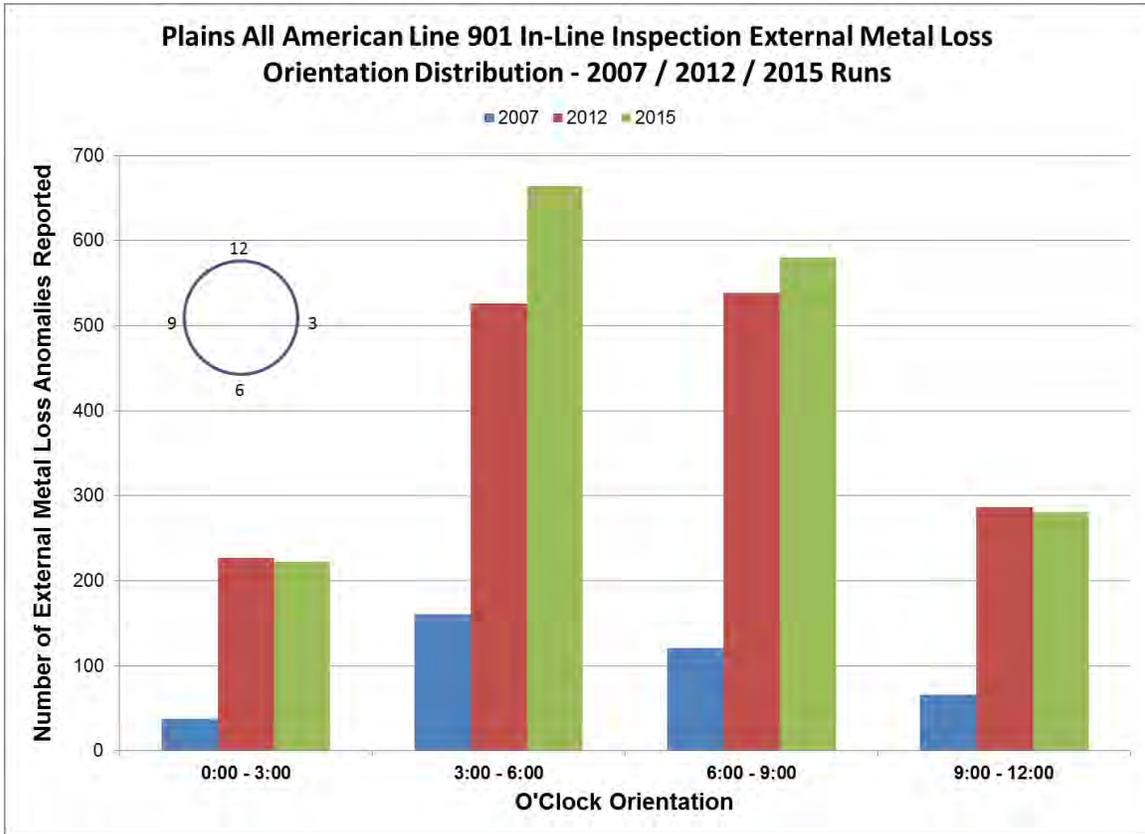
Figure 21. Plot showing the distribution of external metal loss features vs. o'clock orientation identified for Line 901 during the 2007, 2012, and 2015 ILI runs.

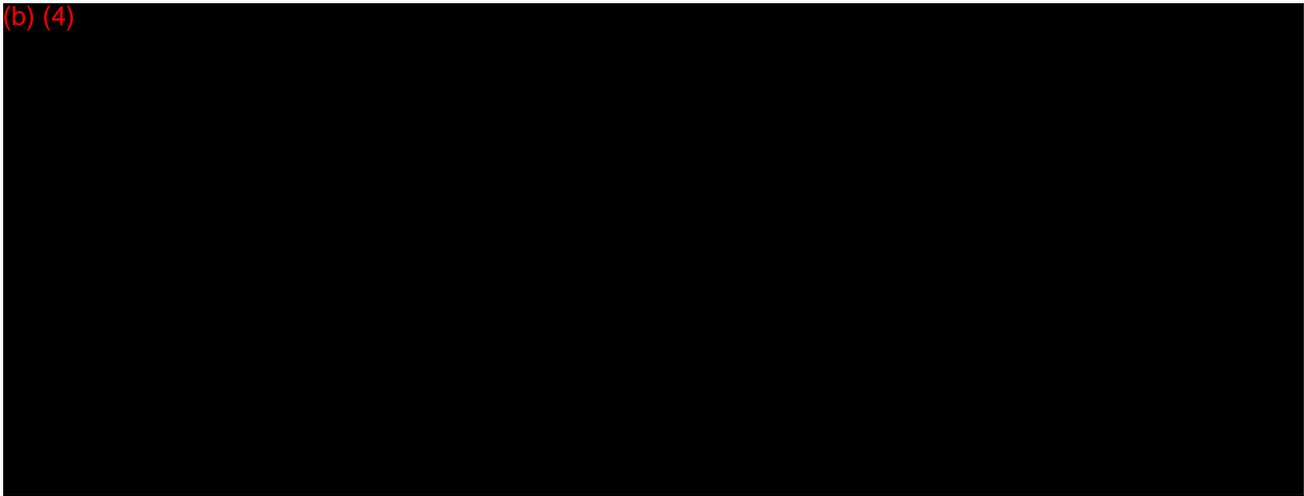
Figure 34. Excerpt from IMP Fig 9-2 illustrating process to estimate corrosion growth rates [Ref 22].
