**U.S. Department
of Transportation**

**Pipeline and
Hazardous Materials
Safety Administration**

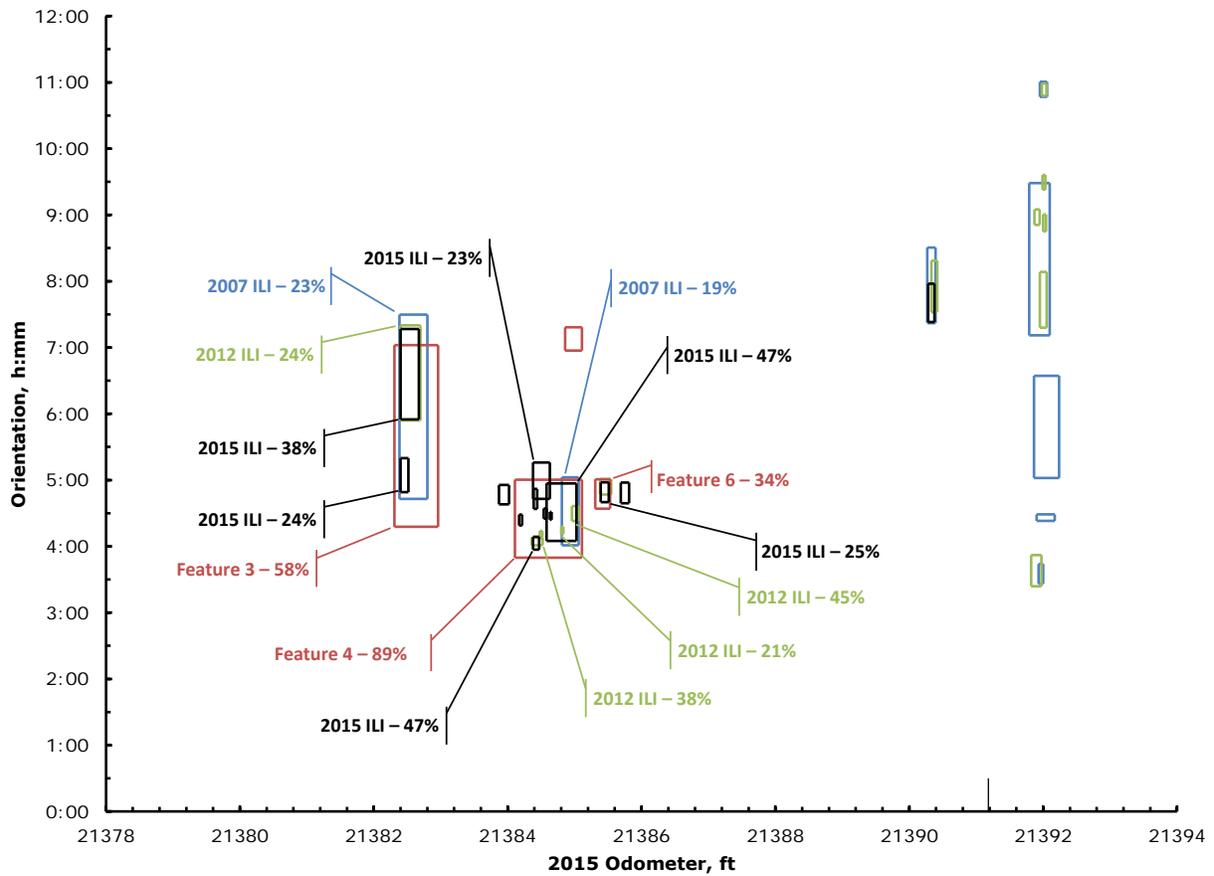
Figure 35. Representation of reported metal loss features on Joint 5930

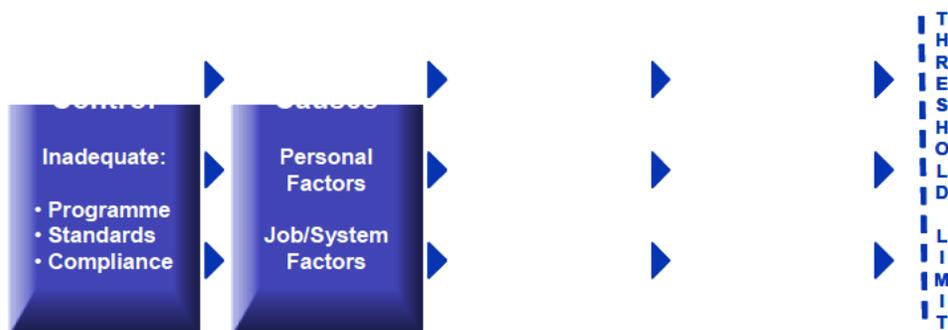
Figure A-1. Schematic showing loss causation model.

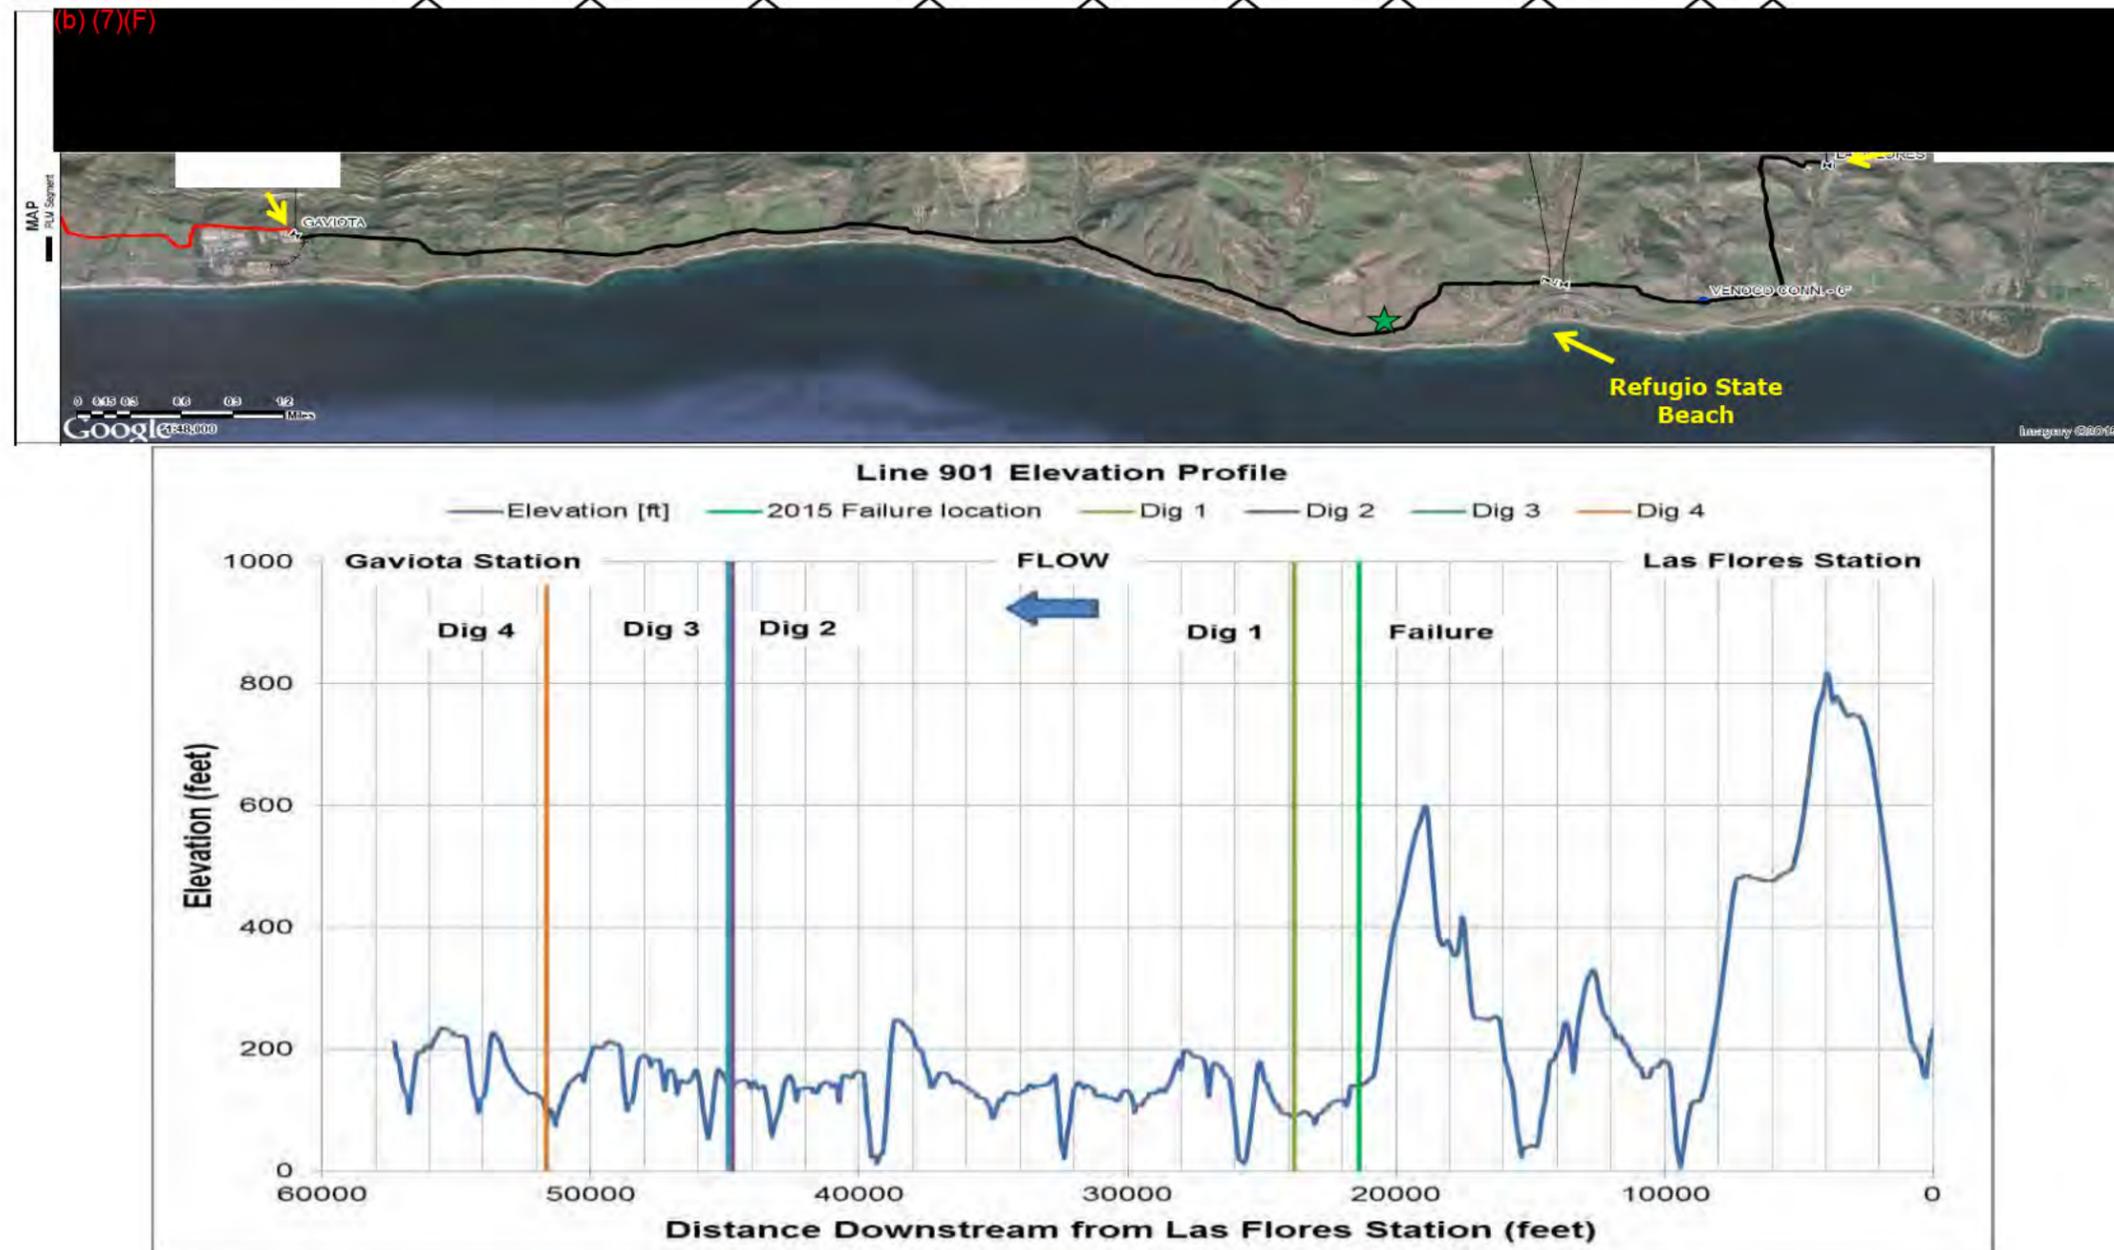
Figure C-1. Topographical map and elevation plot showing the locations of Priority Digs 1 – 4 relative to the failure location. The white triangles on the map correspond to mile post markers. The green star on the map and the green line on the plot identify the location of the May 19, 2015 failure.

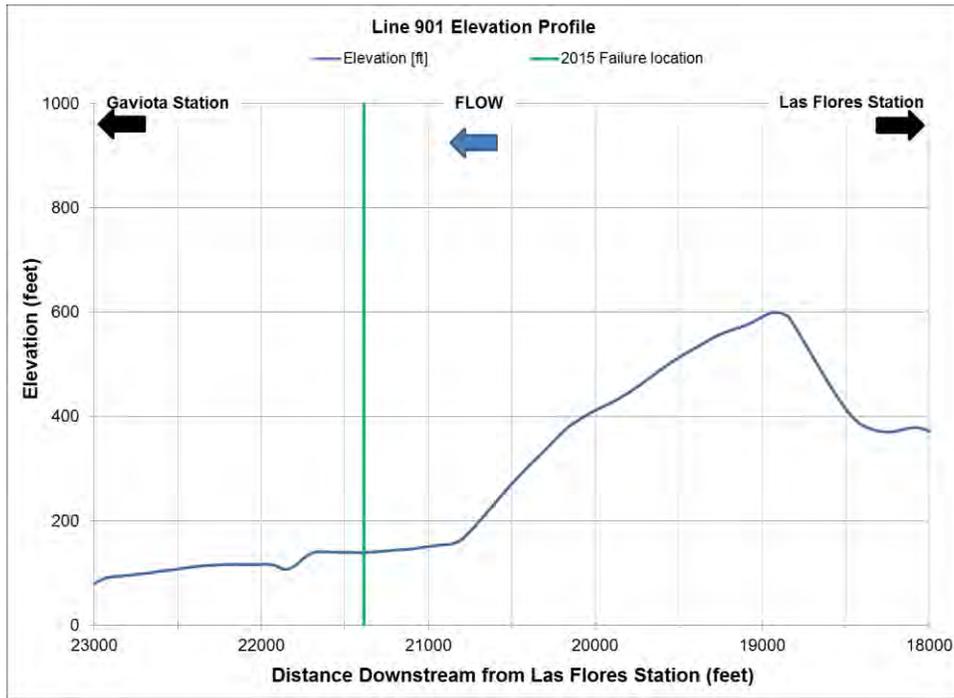
(a) Failure Location

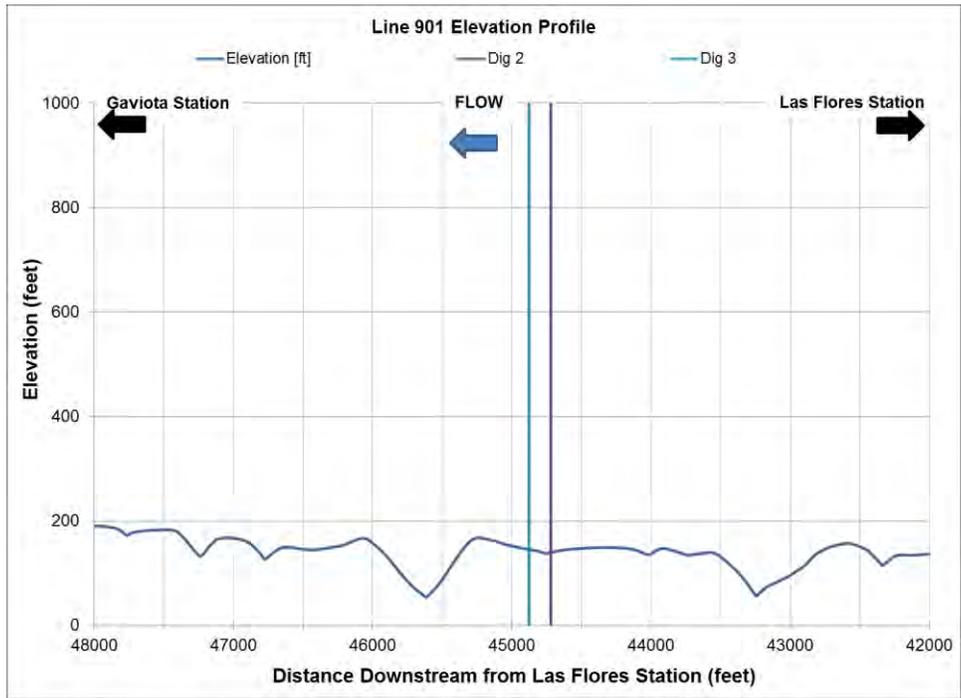
(a) Dig 2 and 3 Locations

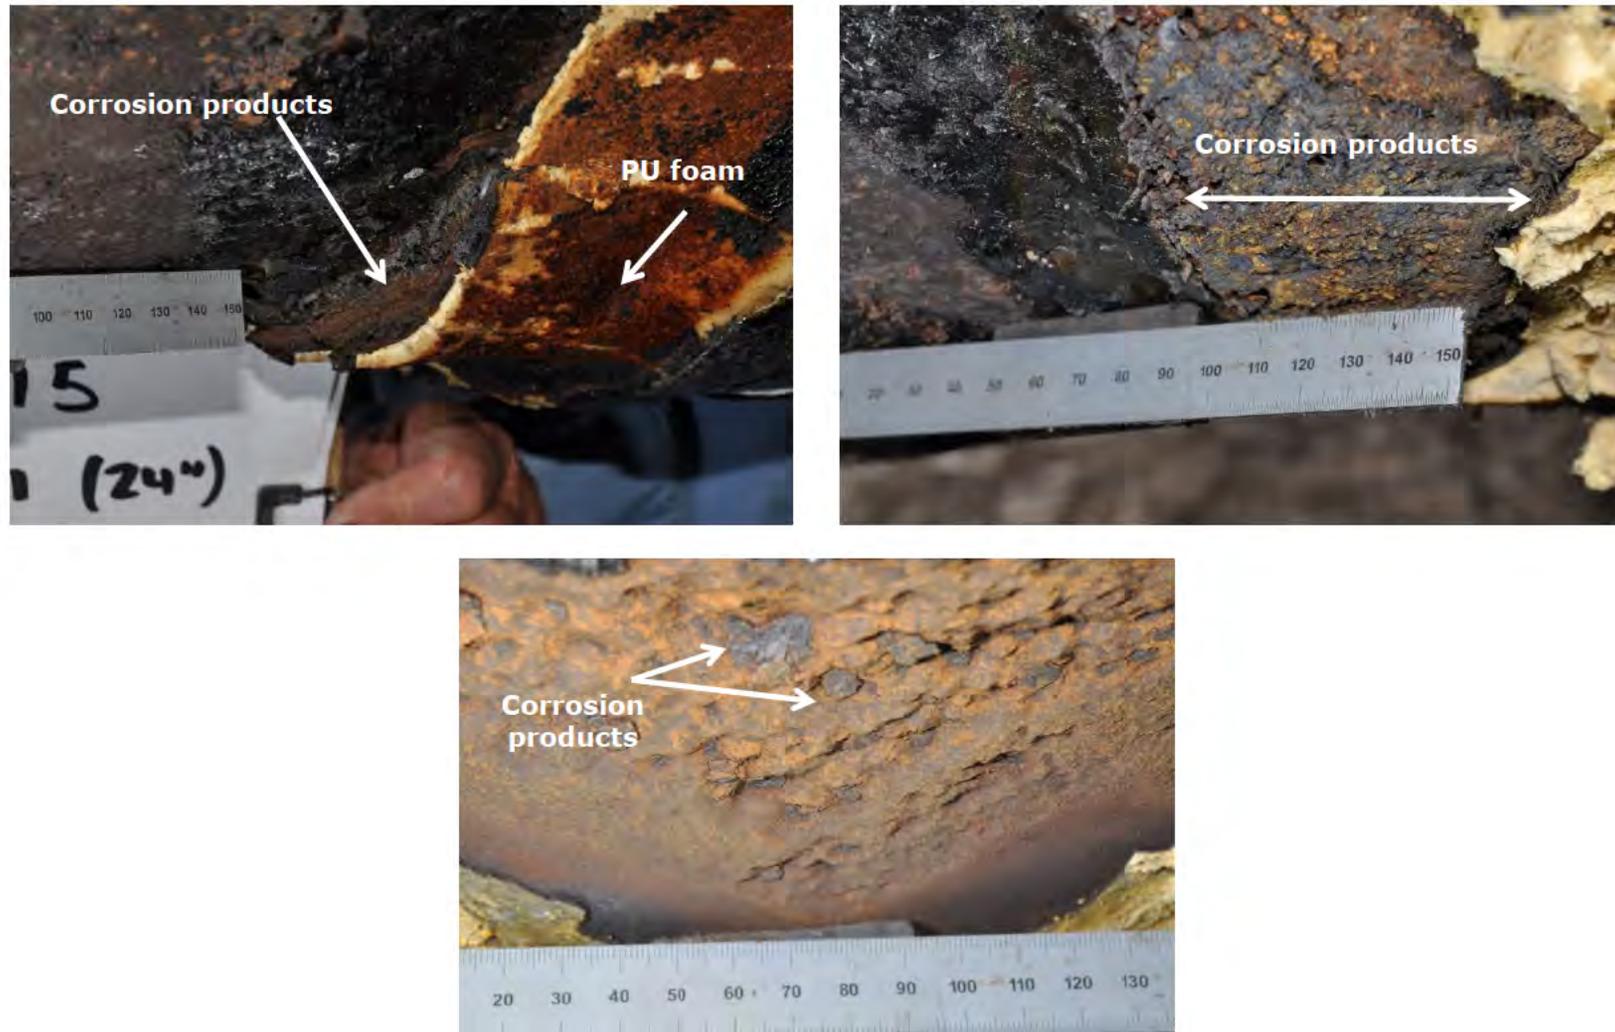
Figure C-4. Field photographs showing the corrosion products associated with the external metal loss feature from Dig 1.

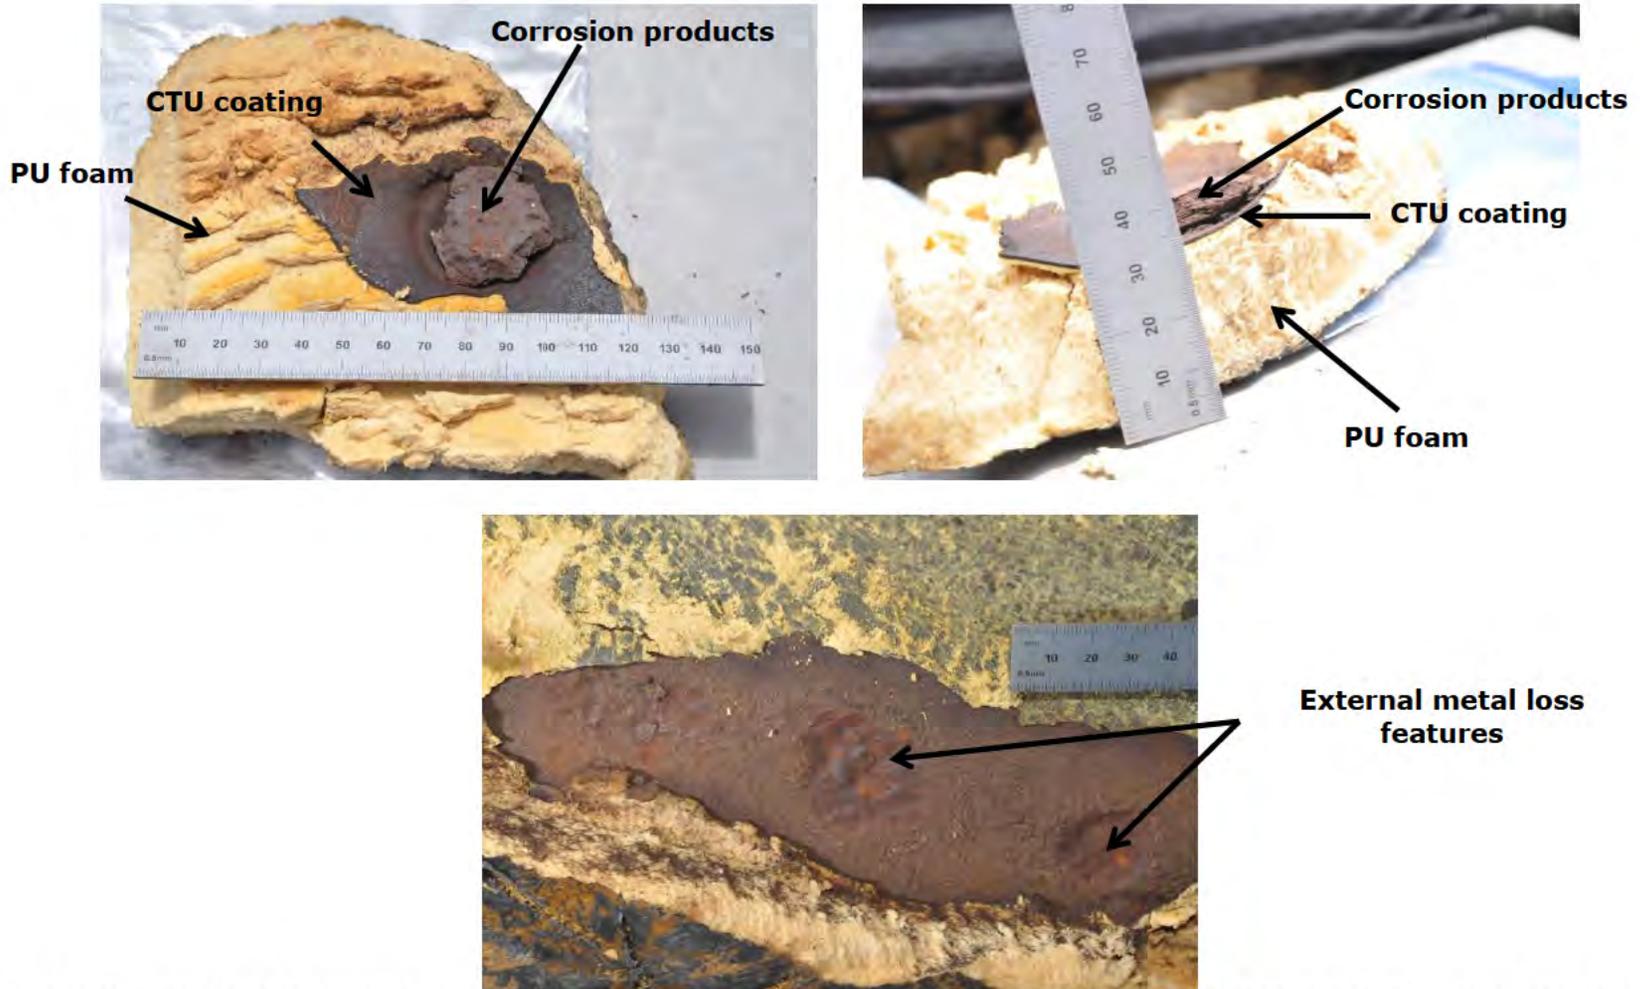
Figure C-5. Field photographs showing representative corrosion products associated with the external metal loss features from Dig 2.

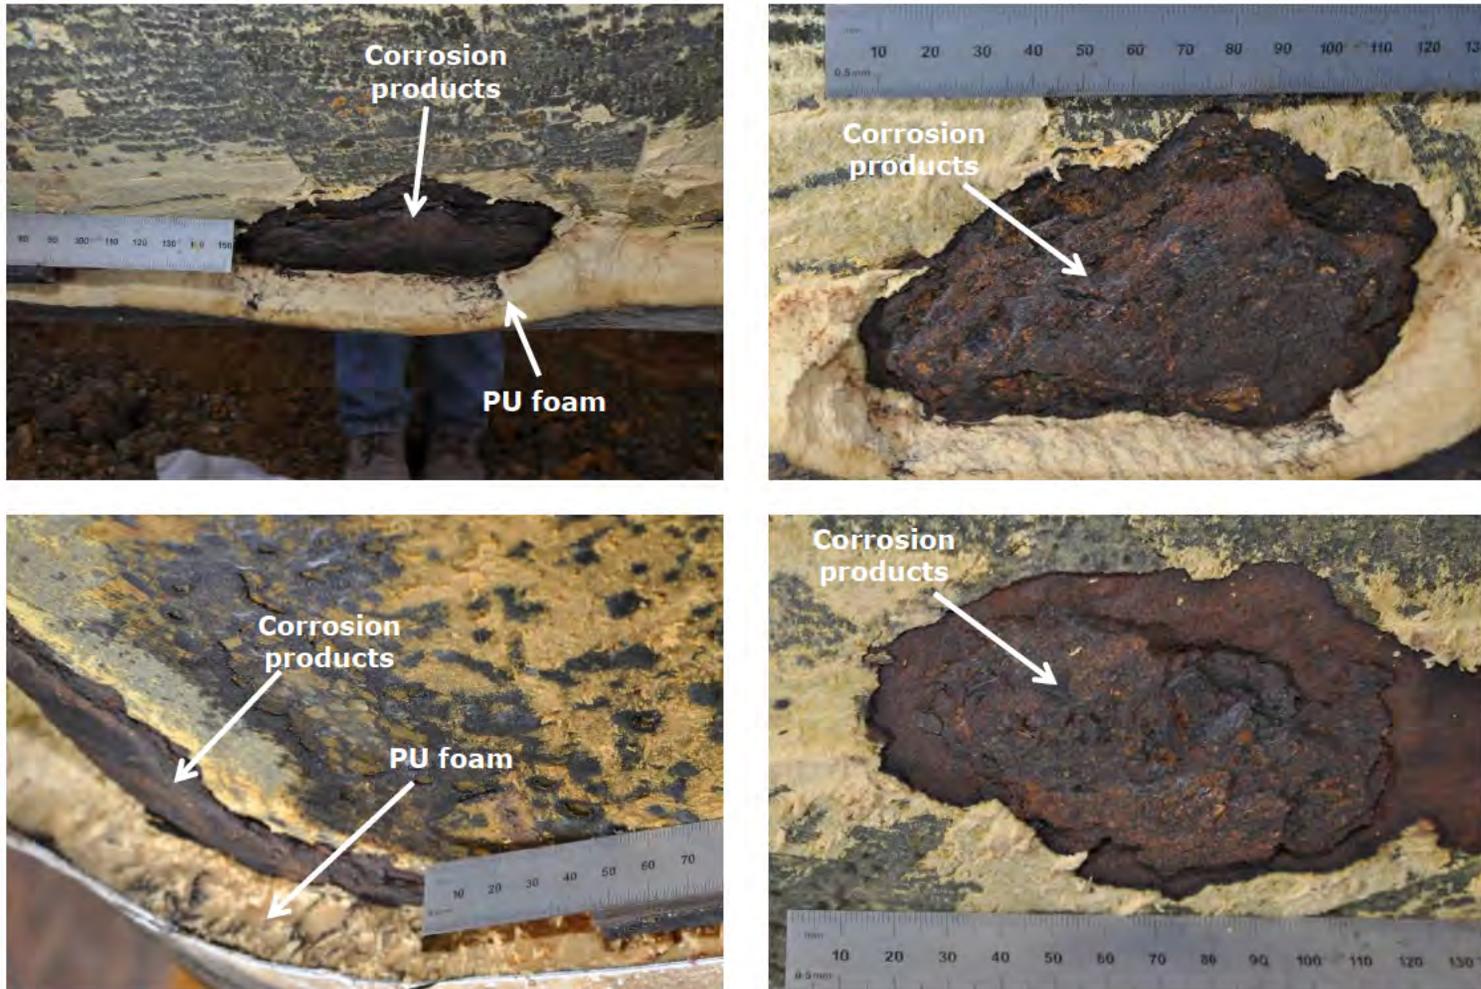
Figure C-6. Field photographs showing representative corrosion products associated with the external metal loss features from Dig 3.

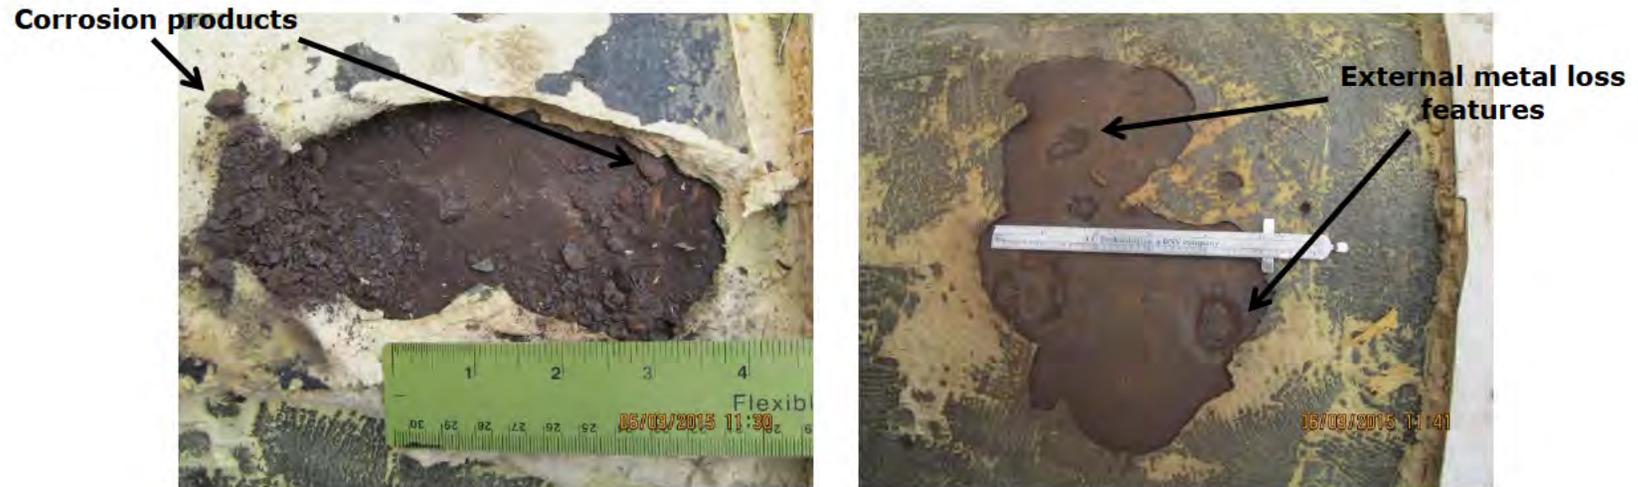
Figure C-7. Field photographs showing representative corrosion products associated with the external metal loss features from Dig 4.

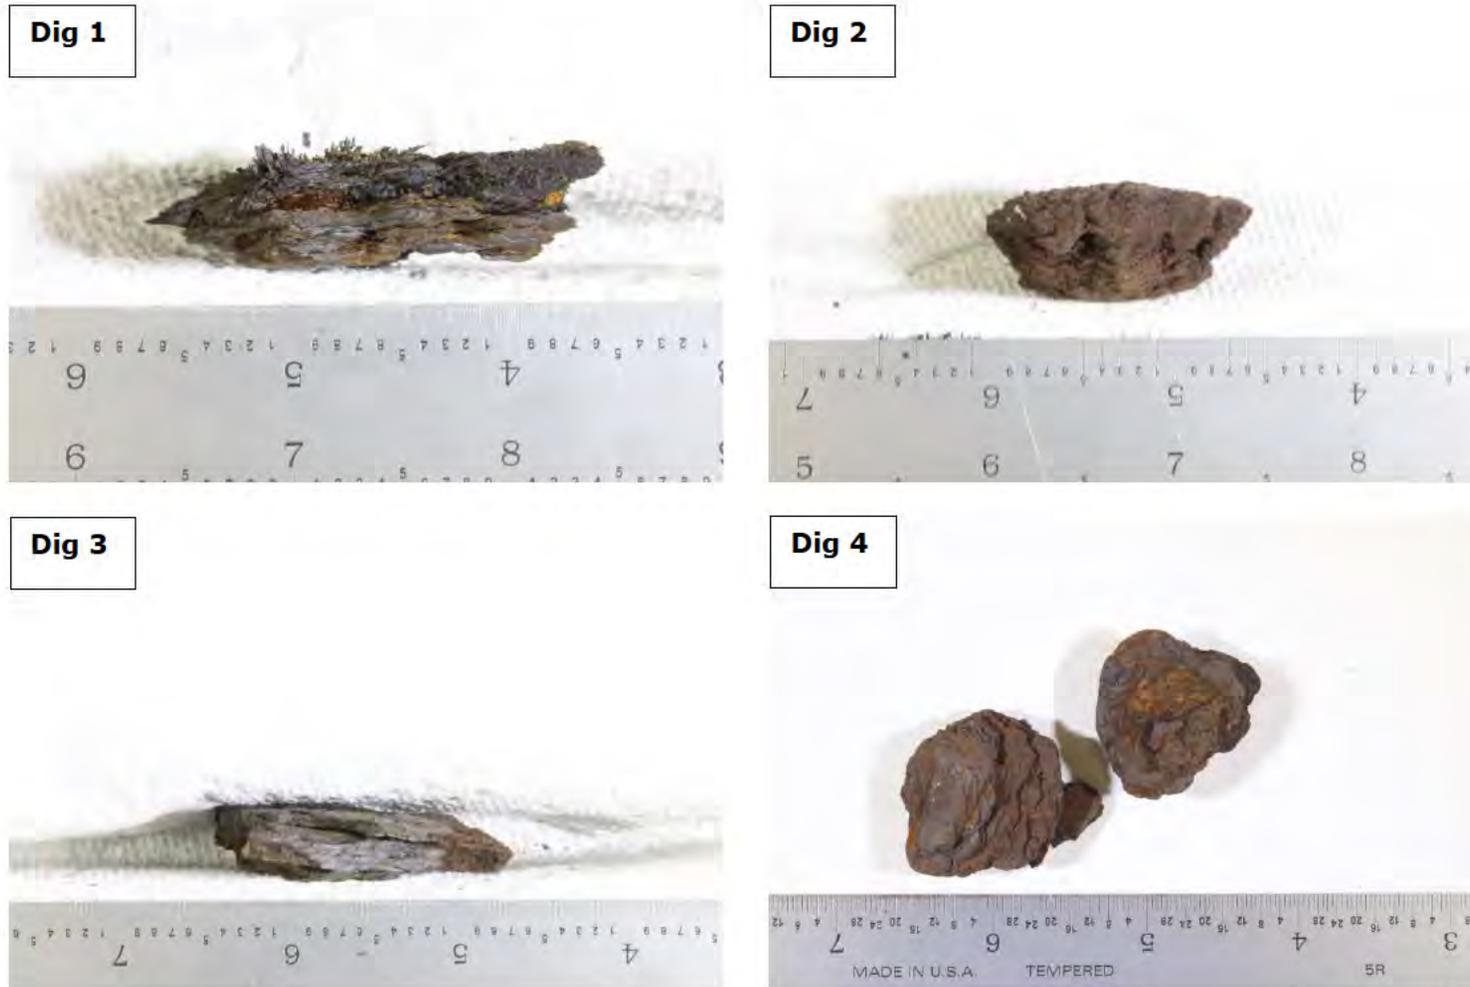
Figure C-8. Photographs showing the layered morphology of representative corrosion products associated with the external metal loss features from Digs 1 – 4.

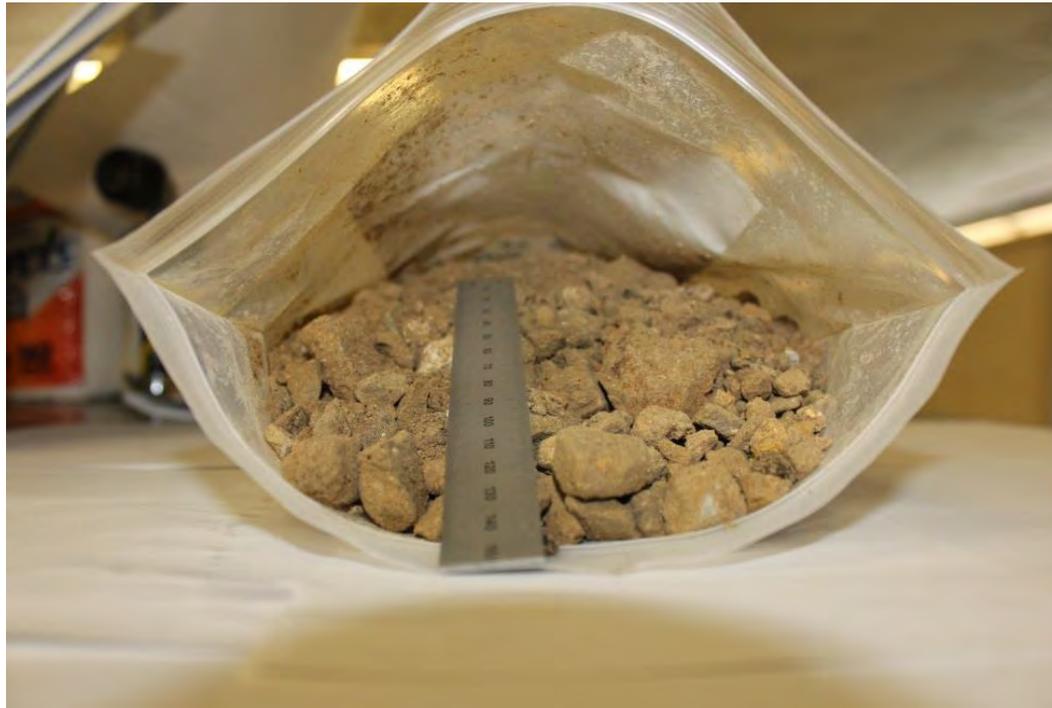
Figure C-9. Photograph of Soil 10000151761, as-received, that was removed near the failure location. The scale pictured is in mm.

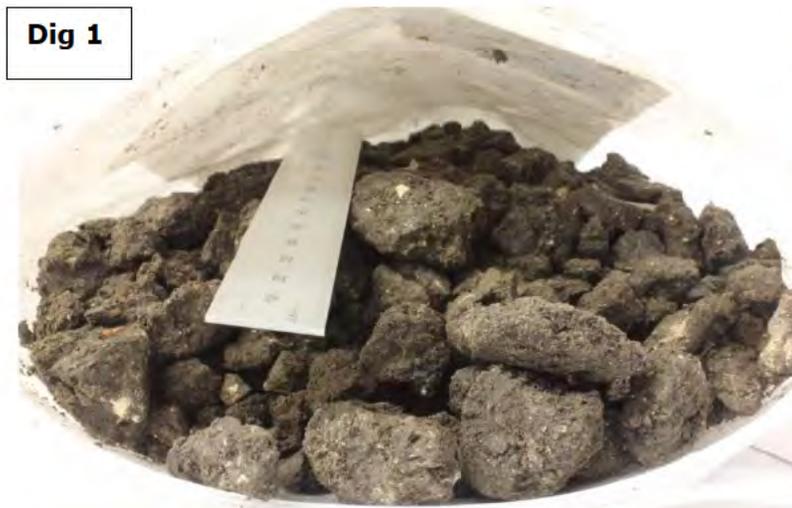
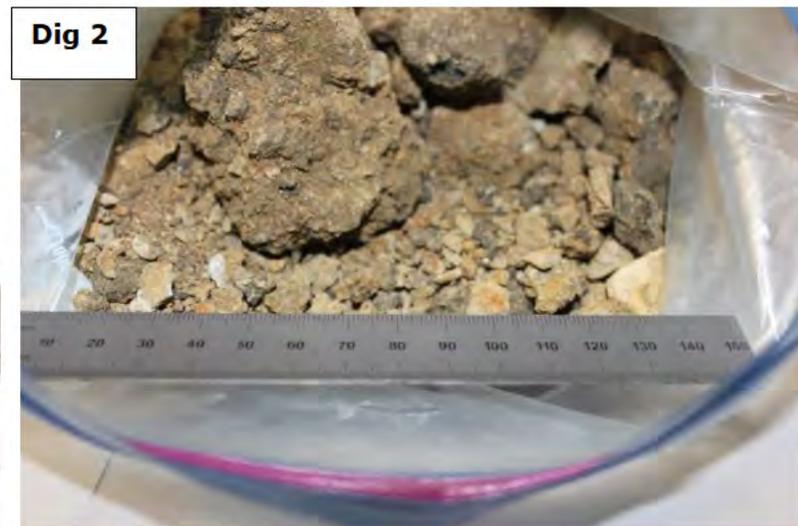
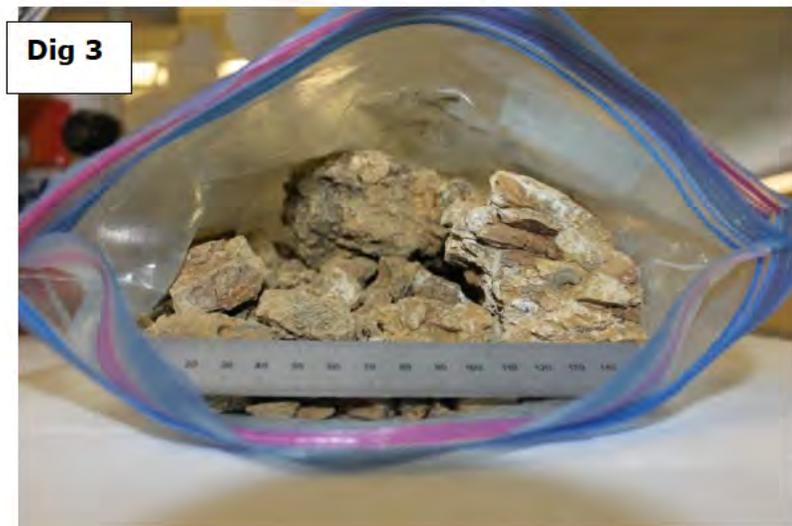
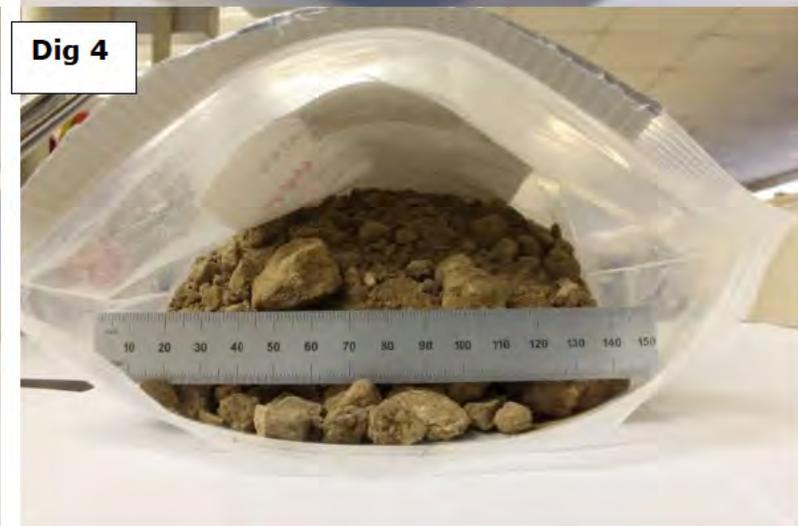
Figure C-10. Photograph of as-received soil for Priority Digs 1 - 4. The scales pictured are in mm.

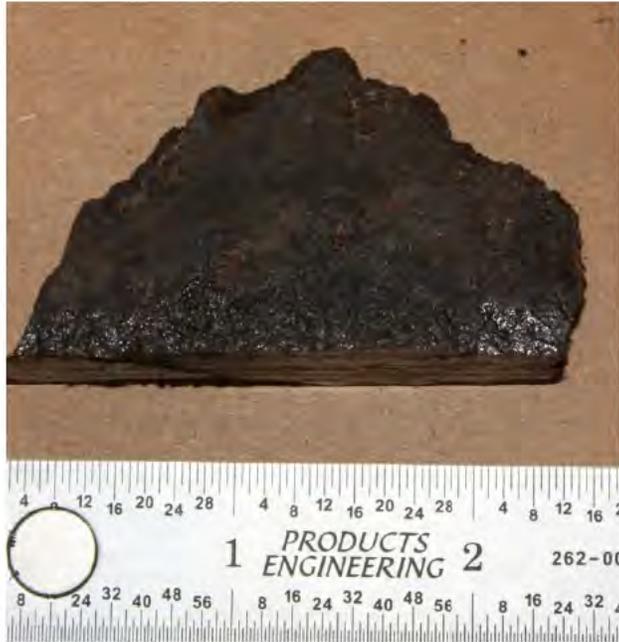
Figure D-1. Photograph showing the portion of Corrosion Product 10000195318 that was used for the density testing. Scale is in inches

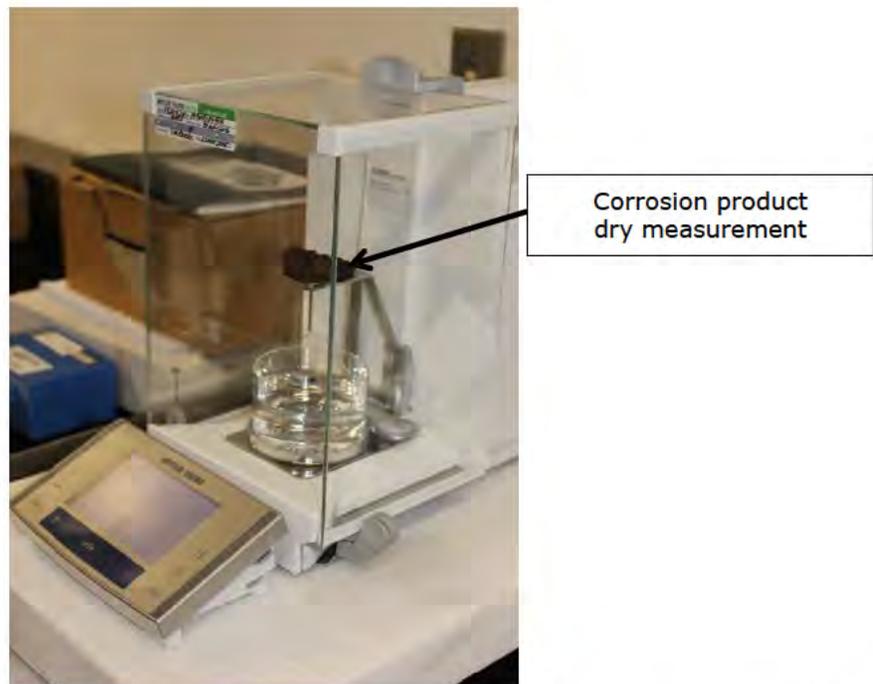
Figure D-2. Photograph showing the test setup used to measure the dry weight of the corrosion product.

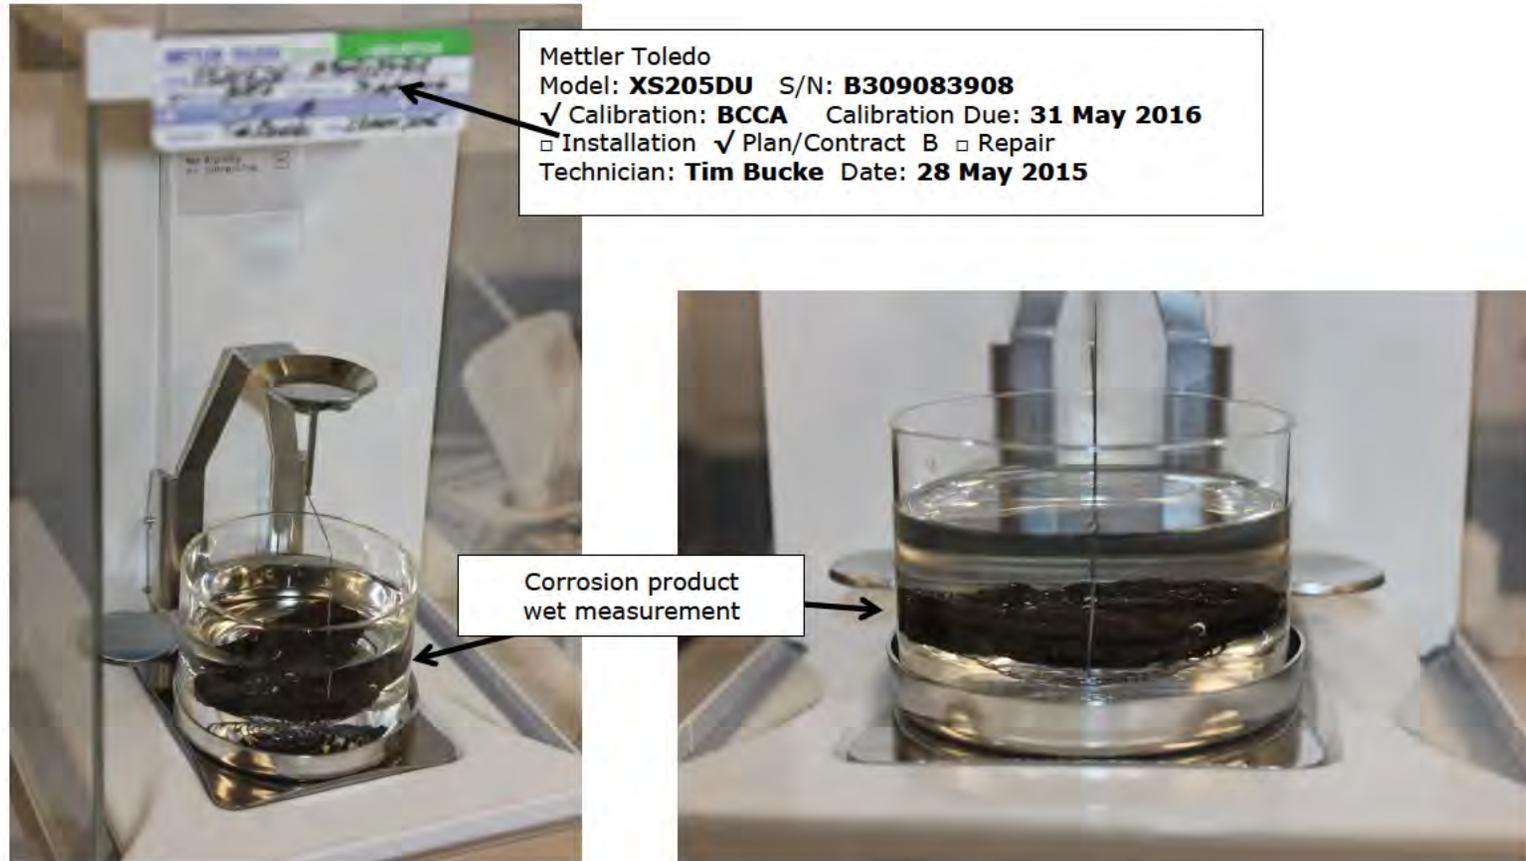
Figure D-3. Photographs showing the test setup (Left) and close-up of the sample (Right) during the submerged testing.

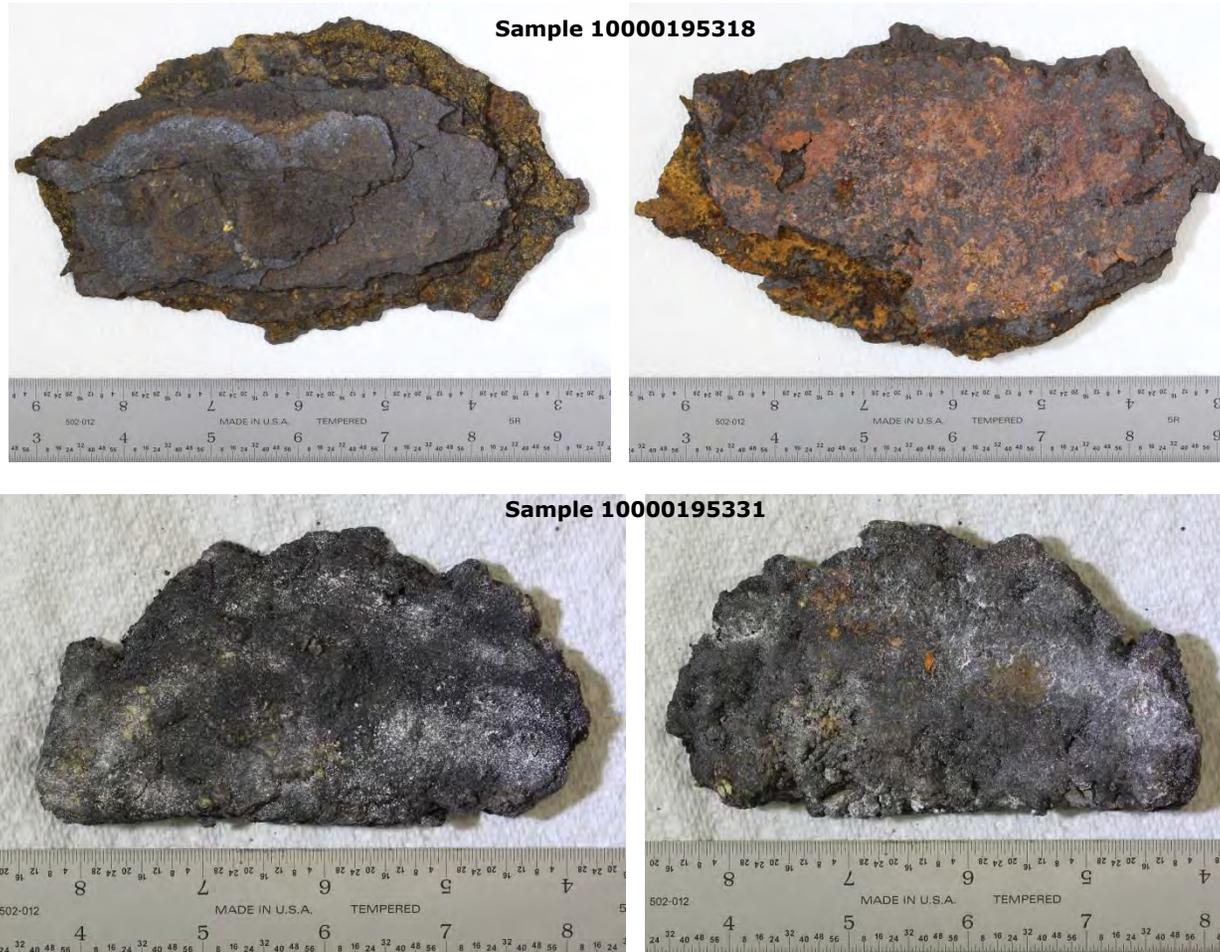
Figure E-1. Photographs of Corrosion Product Sample 10000195318 (Top) and Corrosion Product Sample 10000195331 (Bottom), which were used for the magnetic permeability testing: Surface that was in contact with the pipe surface (Left) and Surface that was in contact with the coating (Right). Top images are flipped about the horizontal axis and bottom images are flipped about the vertical axis.

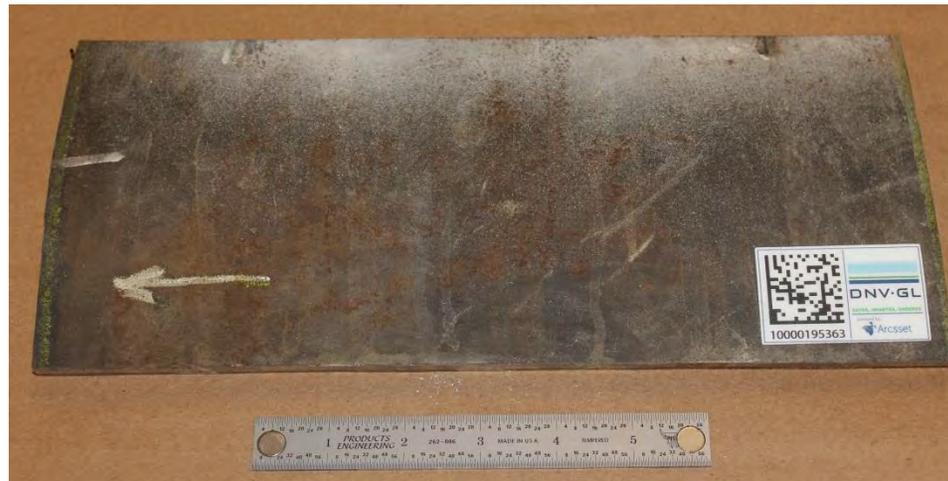
Figure E-2. Photograph of Steel Plate Sample 10000195363, which was used for the magnetic permeability testing

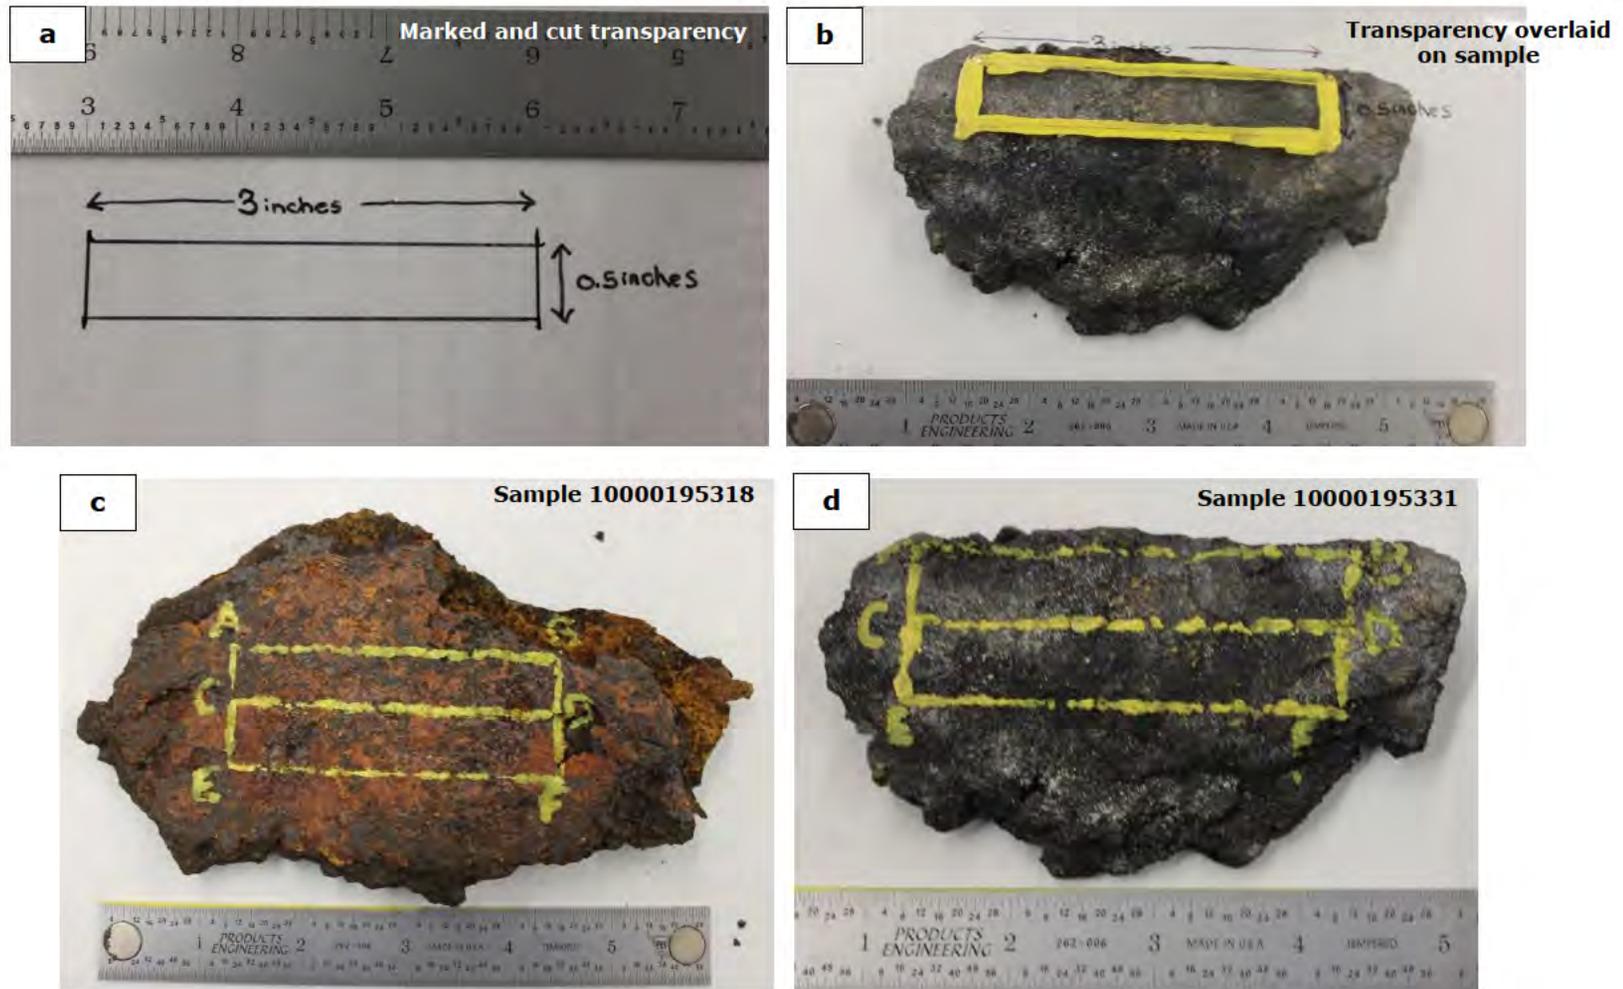
Figure E-5. Photographs showing the labeling process for the corrosion product samples: (a) transparency template, (b) transparency overlaid on Sample 10000195331 for marking, (c) labeled Sample 10000195318, and (d) labeled Sample 10000195331.

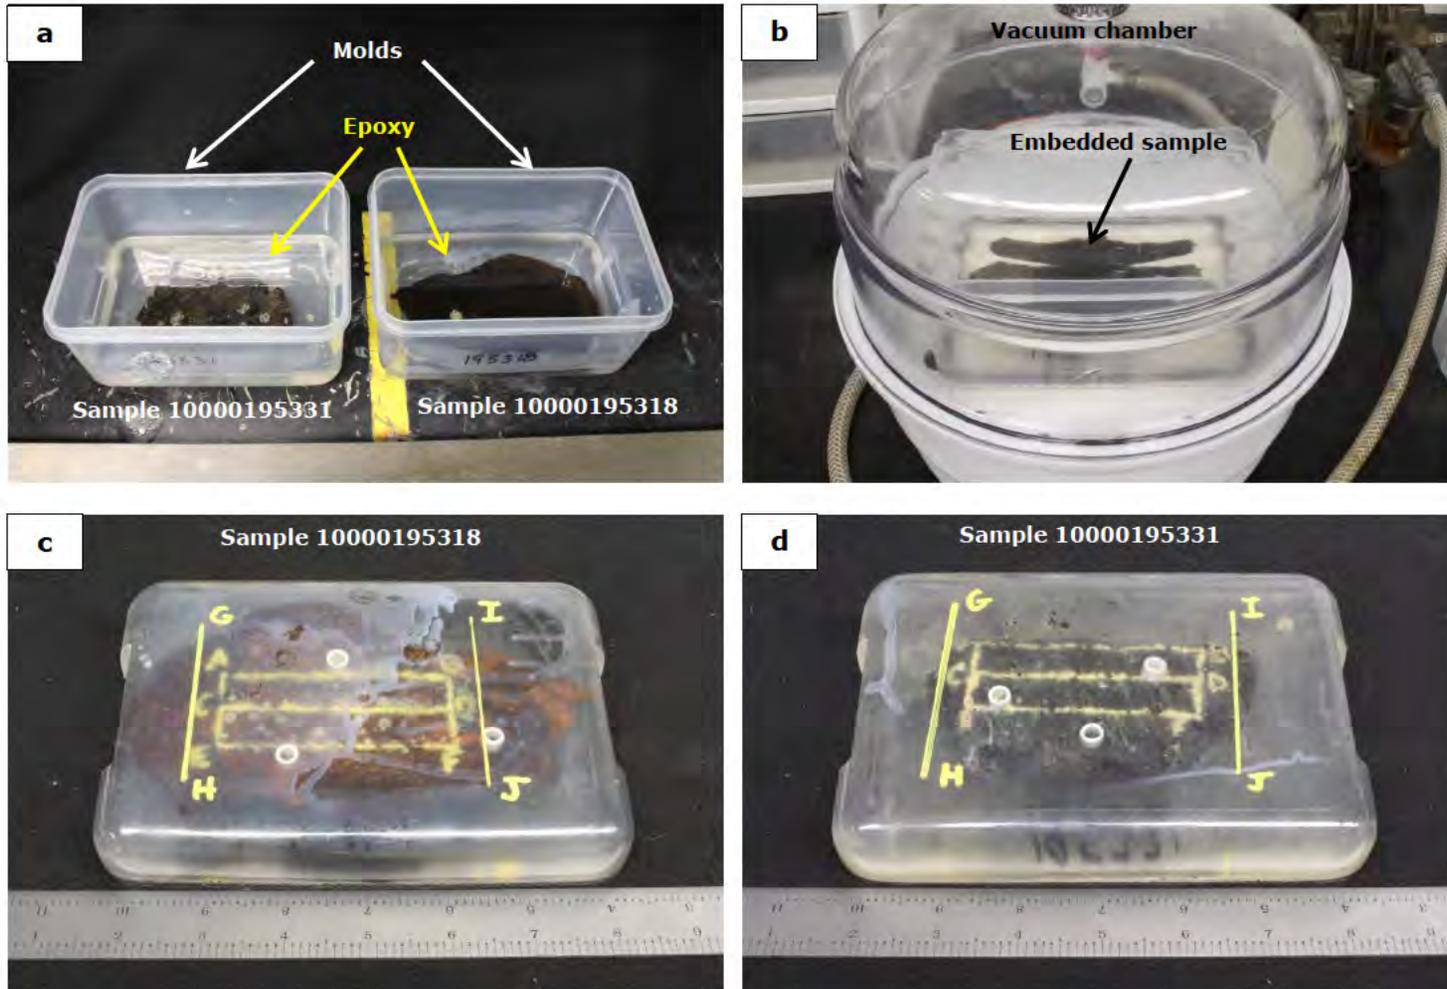
Figure E-7. Photographs showing the embedment process for the corrosion product samples: (a) embedment molds after samples were covered with epoxy, (b) mold samples in vacuum chamber to remove bubbles, (c) embedded Sample 10000195318, and (d) embedded Sample 10000195331.
