**U.S. Department
of Transportation**

**Pipeline and
Hazardous Materials
Safety Administration**

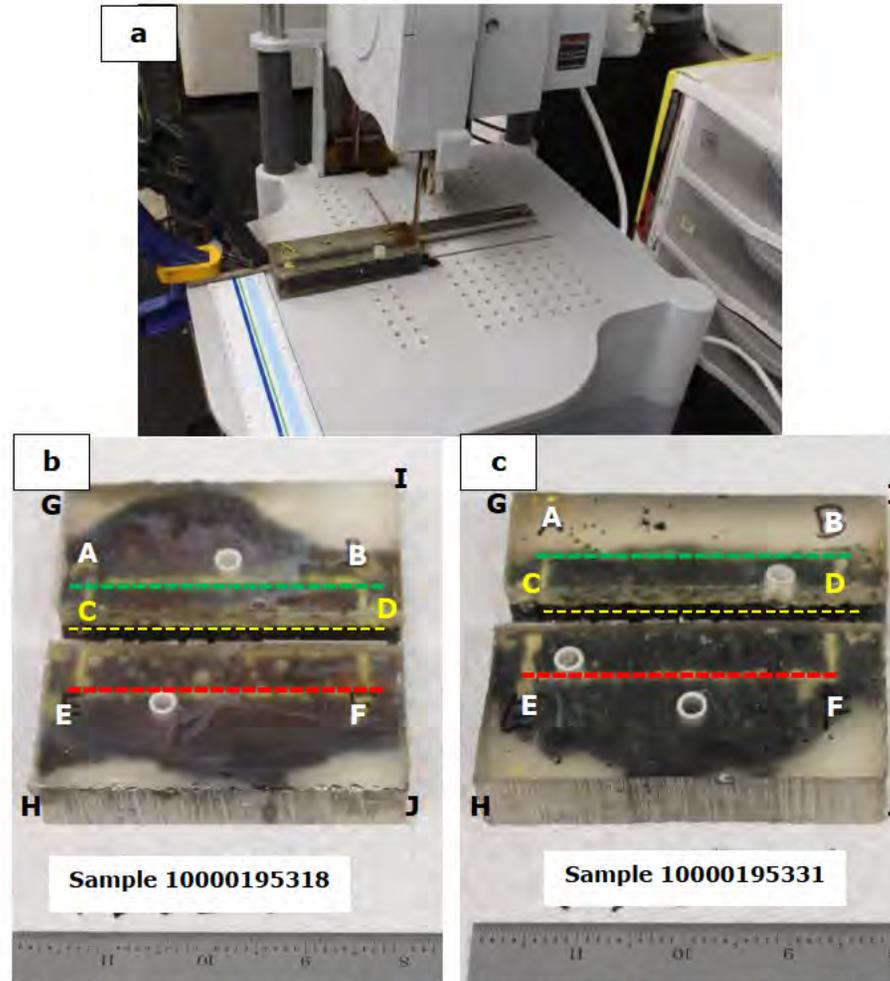
Figure E-8. Photographs showing the cutting process for the corrosion product samples: (a) sample cutting on diamond saw, (b) Sample 10000195318 after cuts were made along Lines G-H, I-J, and C-D and (d) Sample 10000195331 after cuts were made along Lines G-H, I-J, C-D (yellow dashed line), A-B (green dashed line), and E-F (red dashed line). Refer to Figure E-7 for the line identifications.

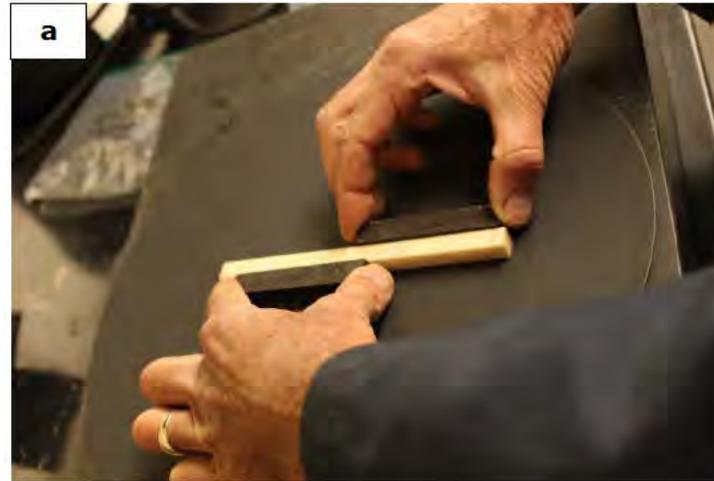
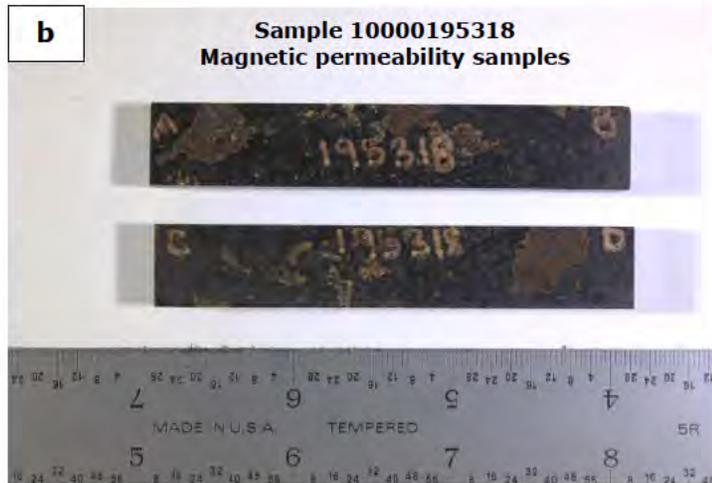
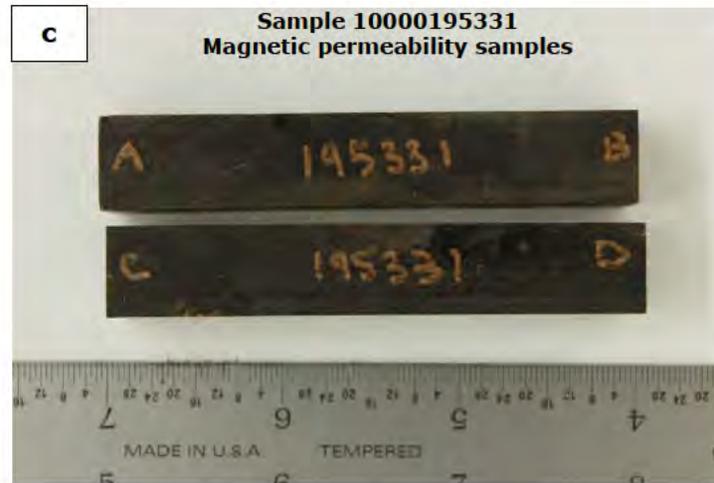
Figure E-9. Photographs showing the finishing process for the corrosion product samples: (a) sample finishing with SiC paper, (b) Sample 10000195318 magnetic permeability samples, and (c) Sample 10000195331 magnetic permeability samples.

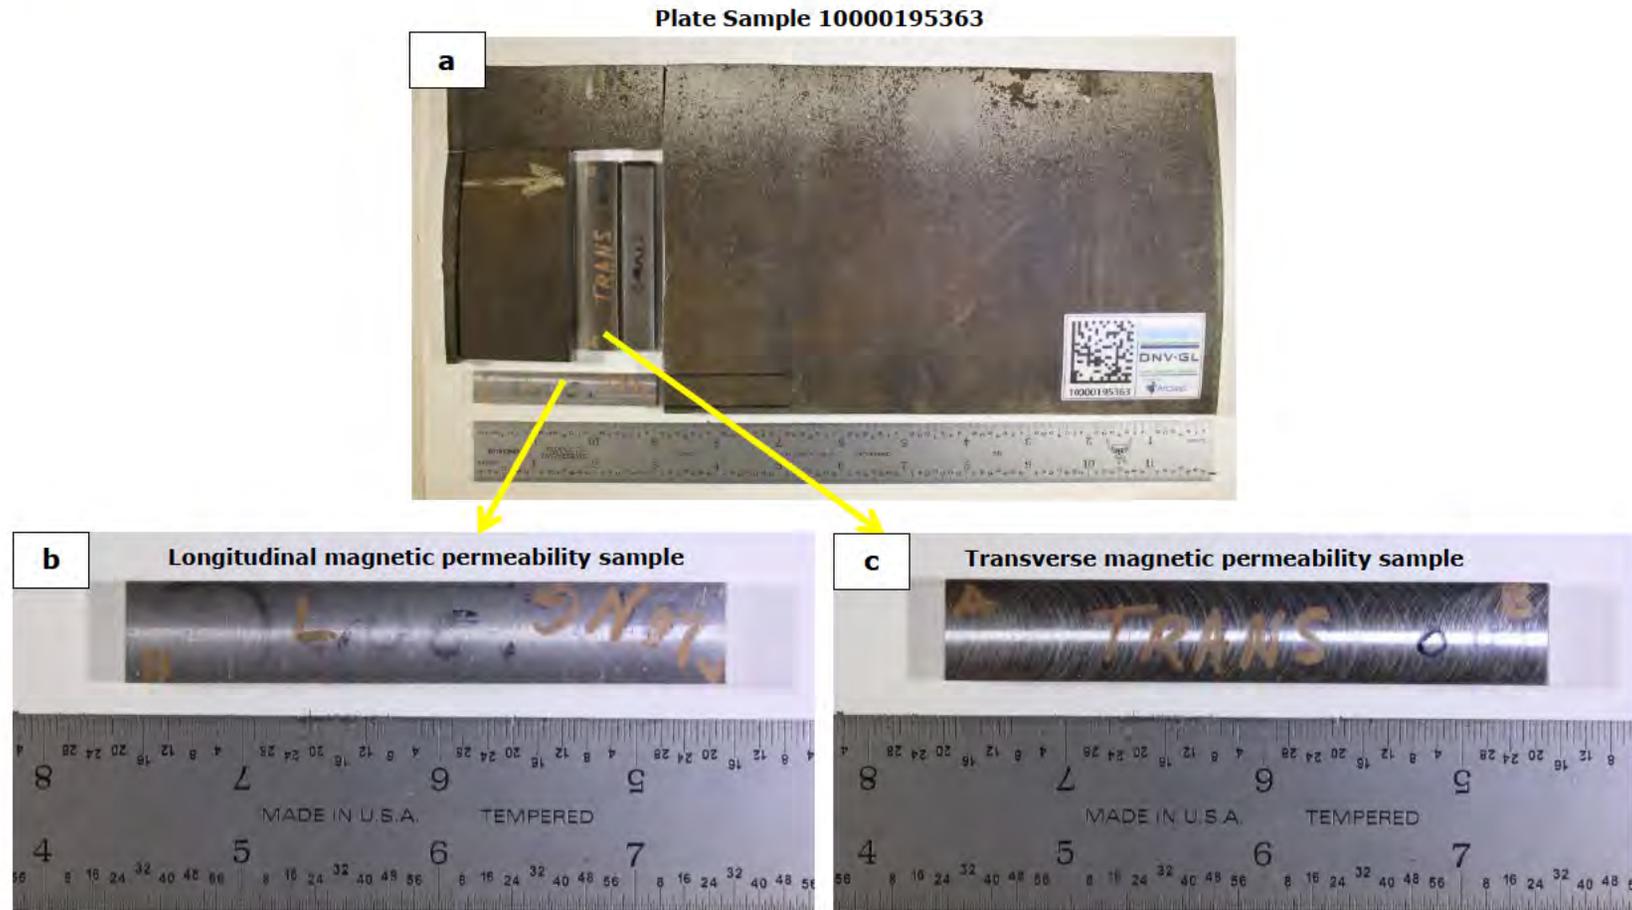
Figure E-10. Photographs showing the plate samples used for the magnetic permeability testing: (a) Plate Sample 1000095363 showing location where samples were removed, (b) Longitudinal magnetic permeability sample, and (c) Transverse magnetic permeability sample.

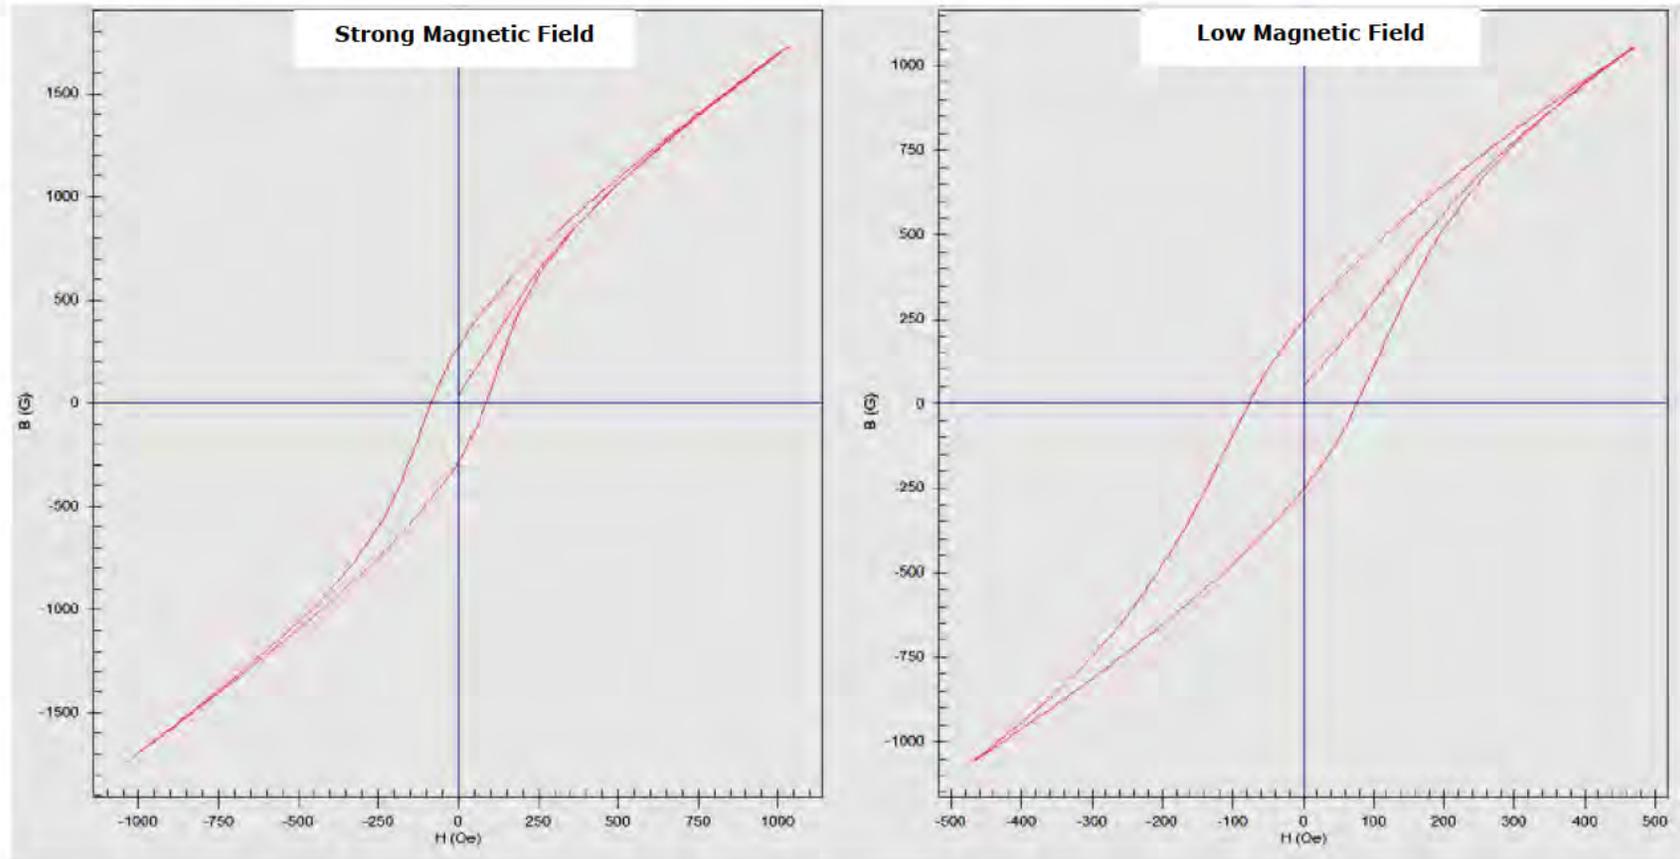
Figure E-13. Plots of magnetic induction (B, magnetic flux density) vs. magnetic field strength (H) for Corrosion Product Specimen 195318 – 3A: Strong magnetic field of 1000 Oe (Left) and Low magnetic field of 460 Oe (Right).

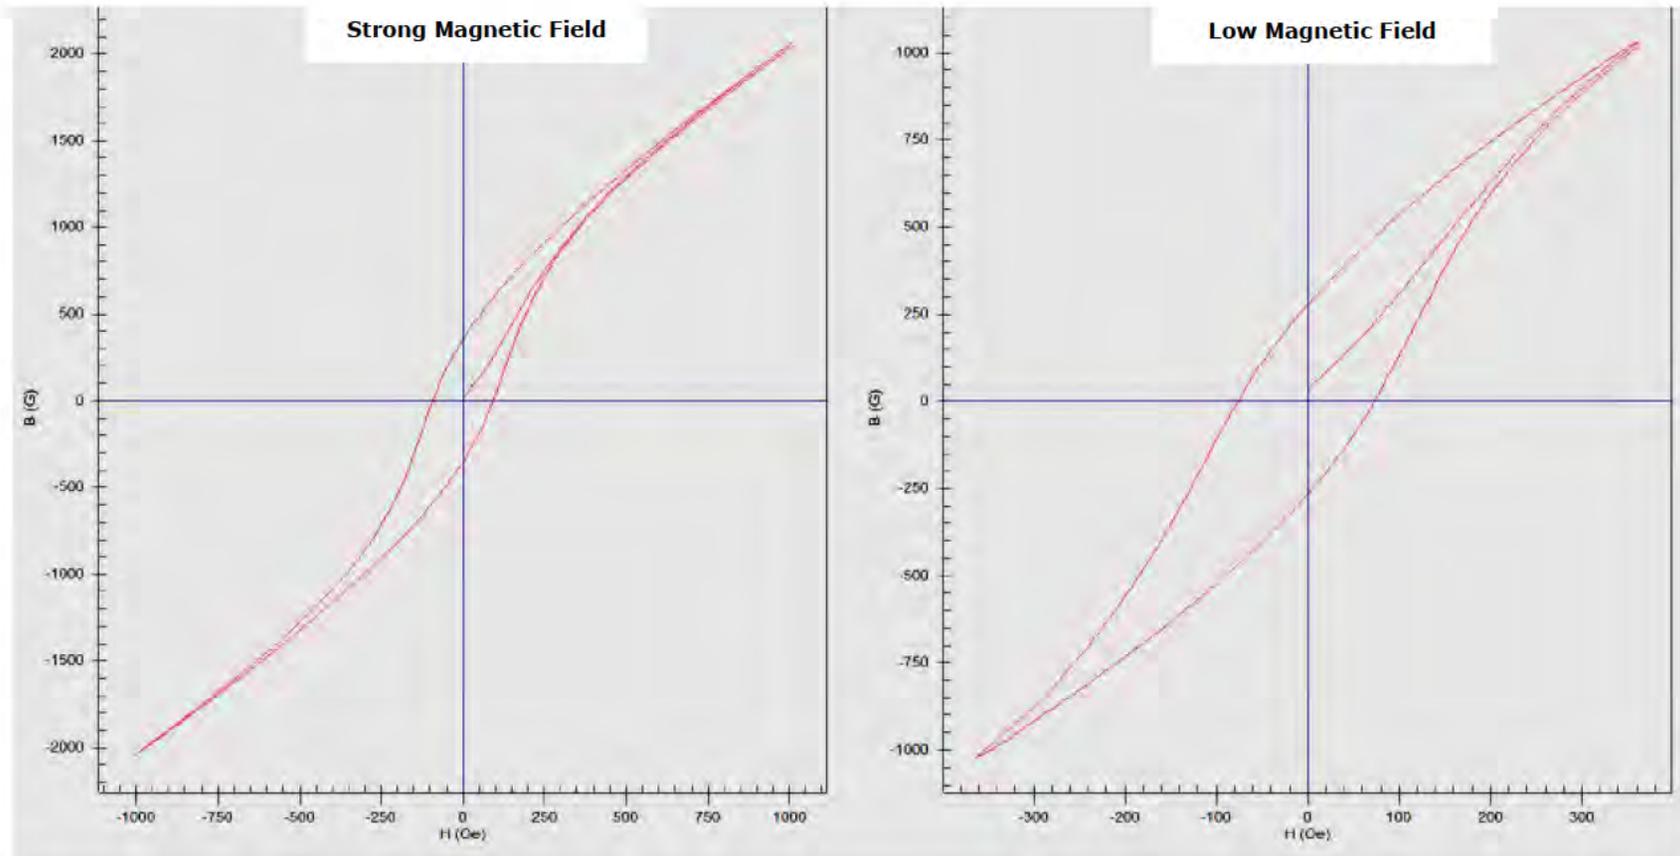
Figure E-14. Plots of magnetic induction (B, magnetic flux density) vs. magnetic field strength (H) for Corrosion Product Specimen 195318 – 3B: Strong magnetic field of 1000 Oe (Left) and Low magnetic field of 360 Oe (Right).

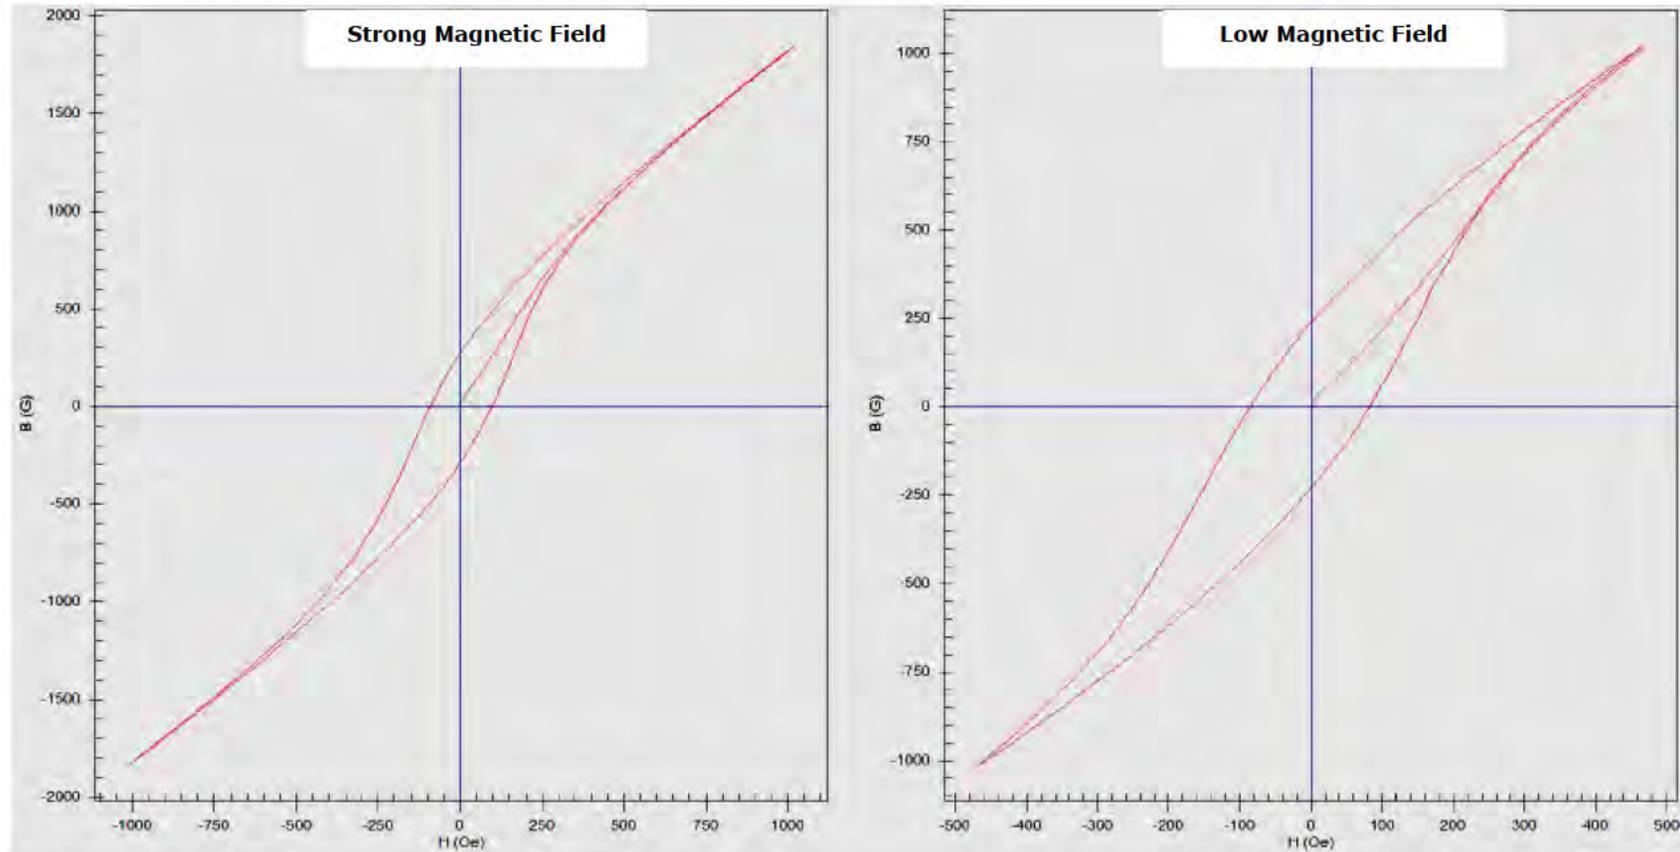
Figure E-15. Plots of magnetic induction (B, magnetic flux density) vs. magnetic field strength (H) for Corrosion Product Specimen 195331 - 2A: Strong magnetic field of 1000 Oe (Left) and Low magnetic field of 460 Oe (Right).

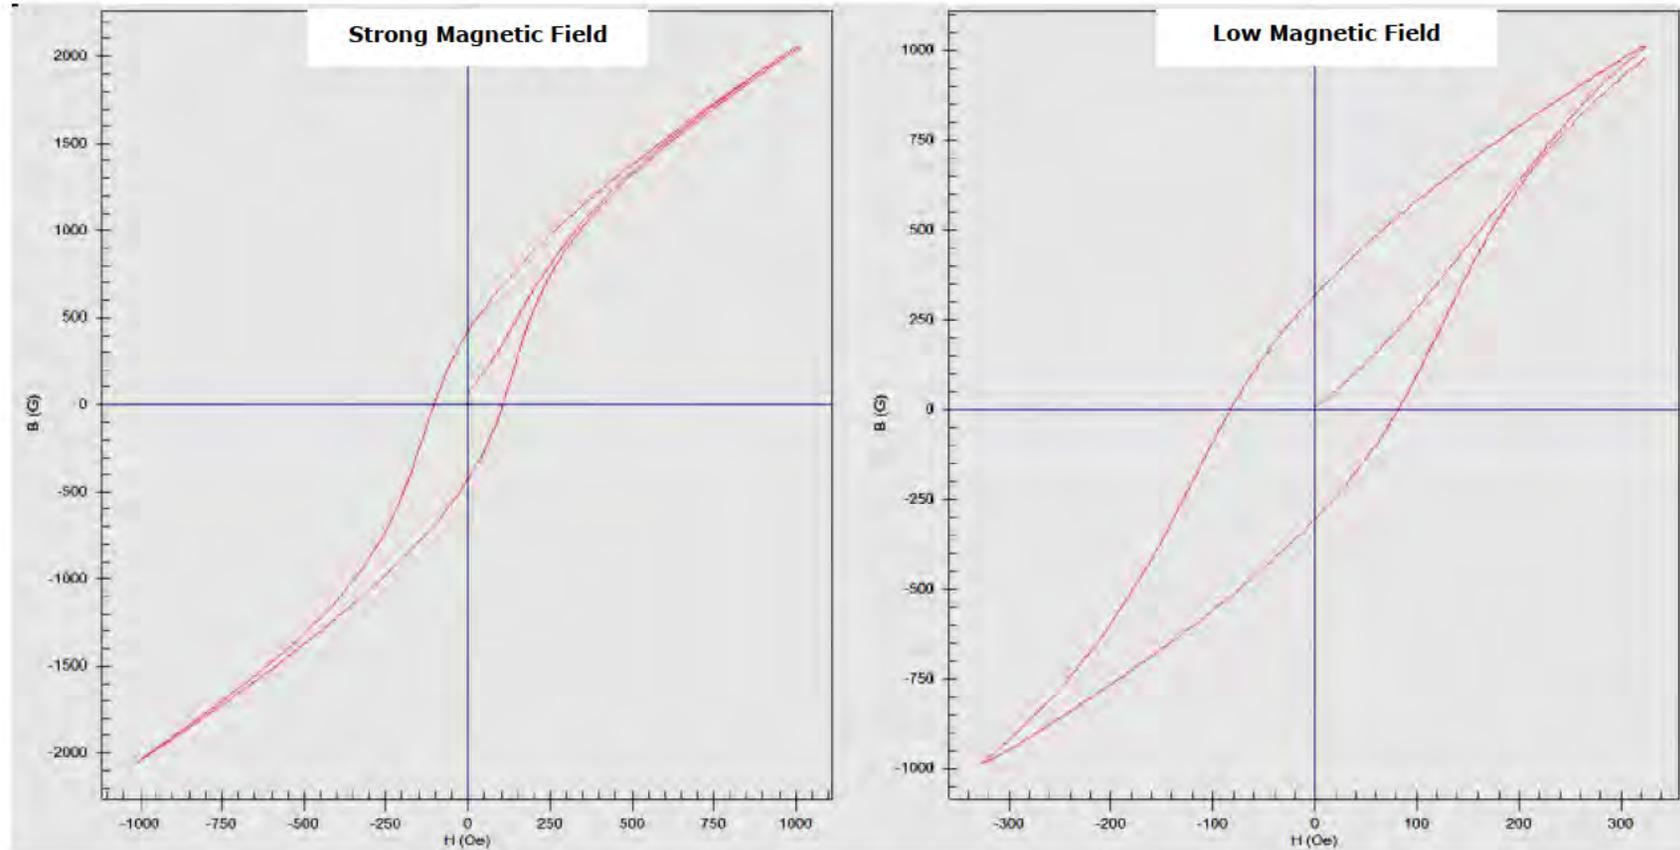
Figure E-16. Plots of magnetic induction (B, magnetic flux density) vs. magnetic field strength (H) for Corrosion Product Specimen 195331 - 2B: Strong magnetic field of 1000 Oe (Left) and Low magnetic field of 320 Oe (Right).

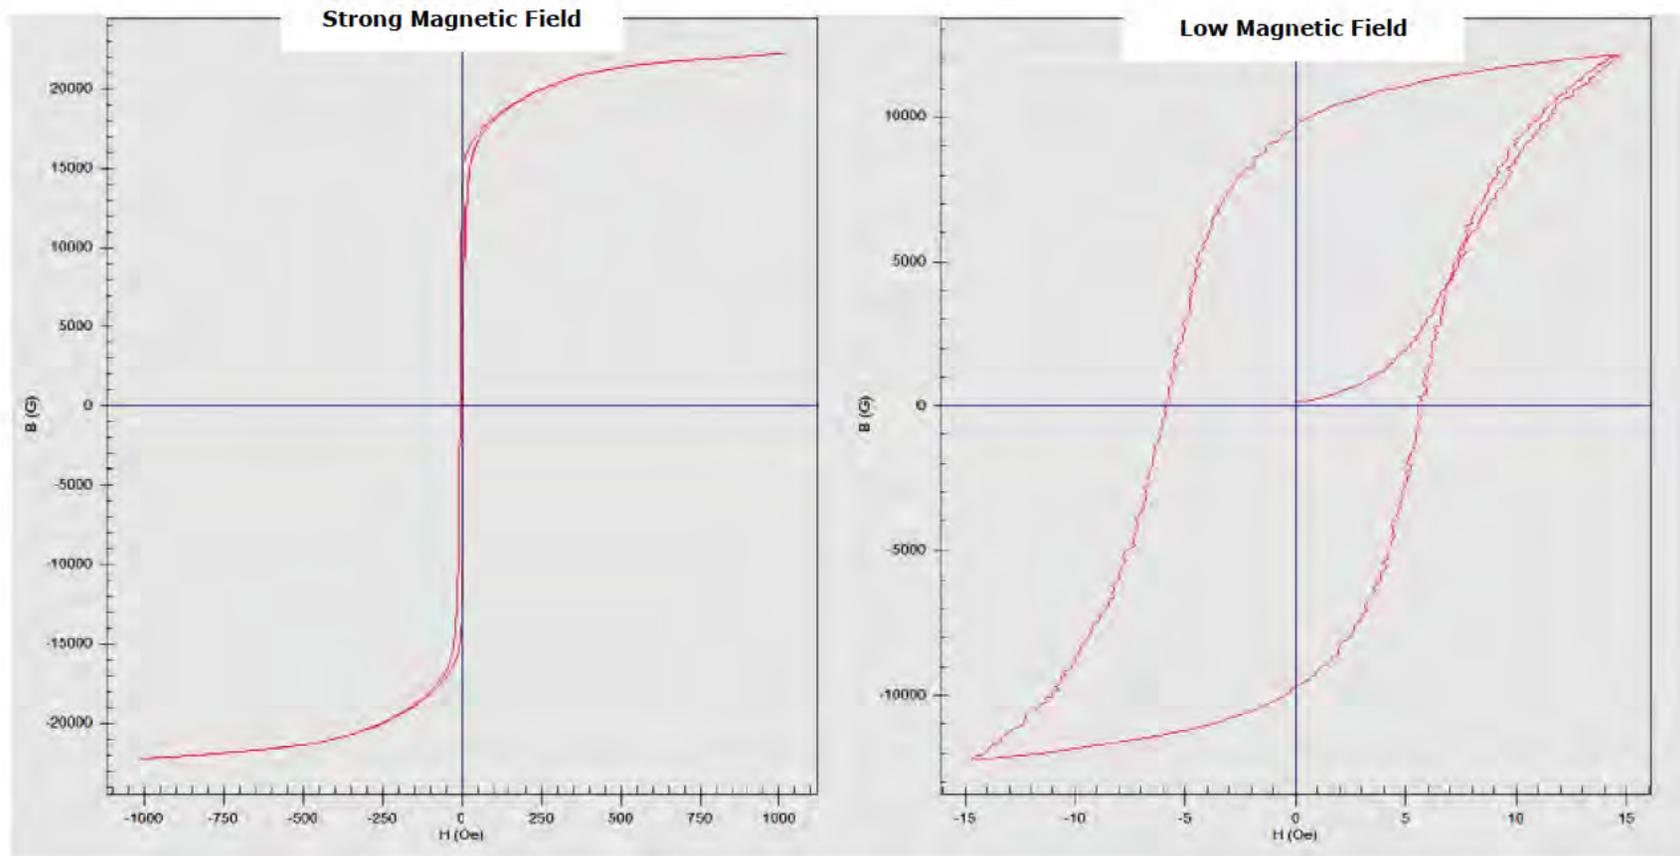
Figure E-17. Plots of magnetic induction (B , magnetic flux density) vs. magnetic field strength (H) for Steel Specimen 195363-2 (Longitudinal): Strong magnetic field of 1000 Oe (Left) and Low magnetic field of 15 Oe (Right).

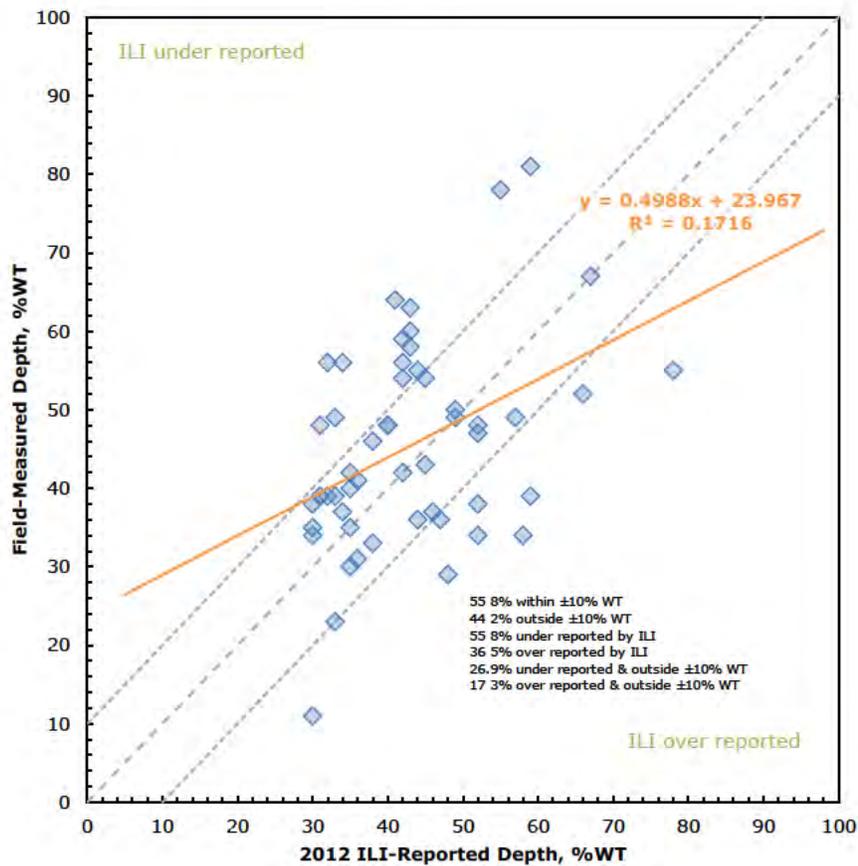
Figure F-4. Comparison of Field-Measured (following 2012 ILI) to 2012 ILI-Reported Depths.

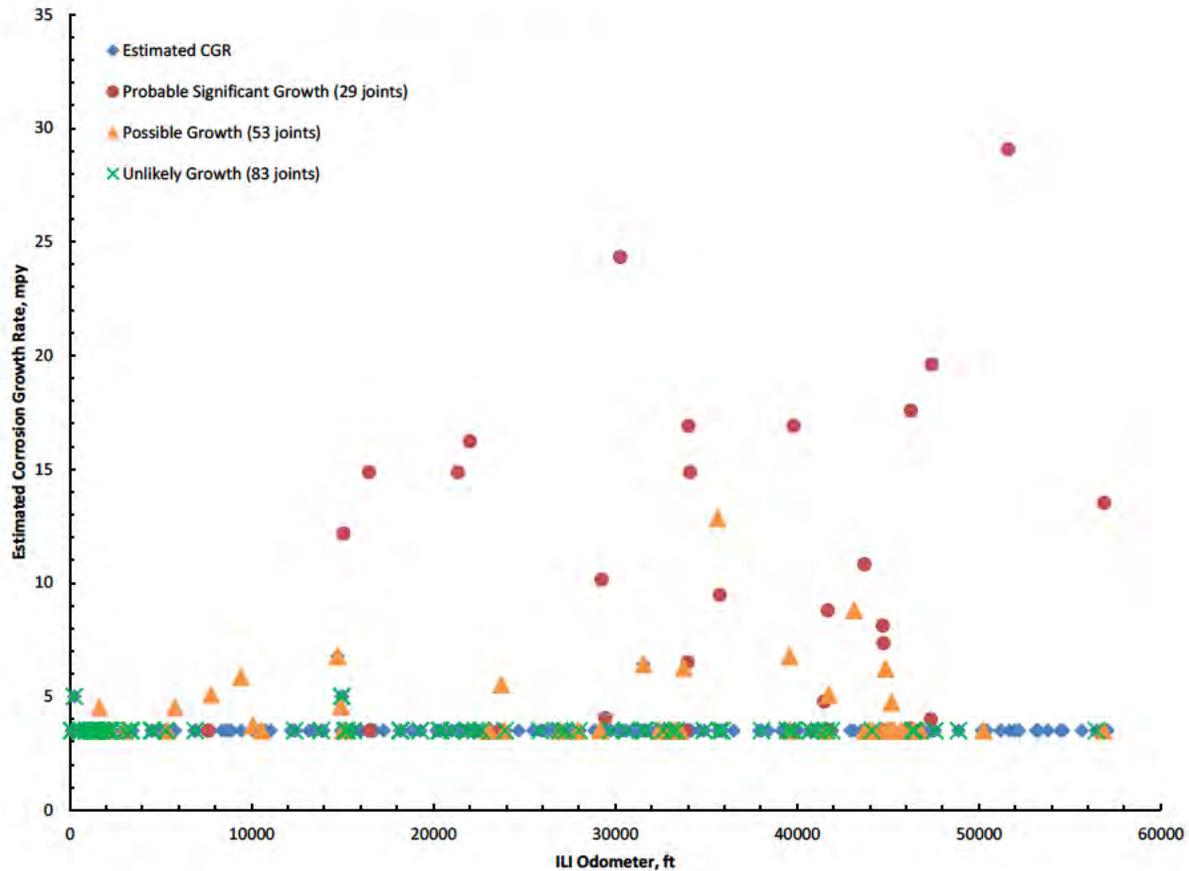
Figure F-5. Estimated Corrosion Growth Rate per Joint after Manual Review.

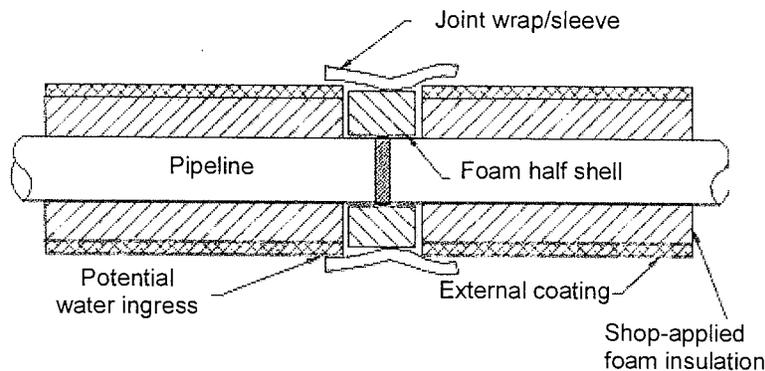
FIGURE 1a: Typical Joint with Damaged Wrap or Sleeve

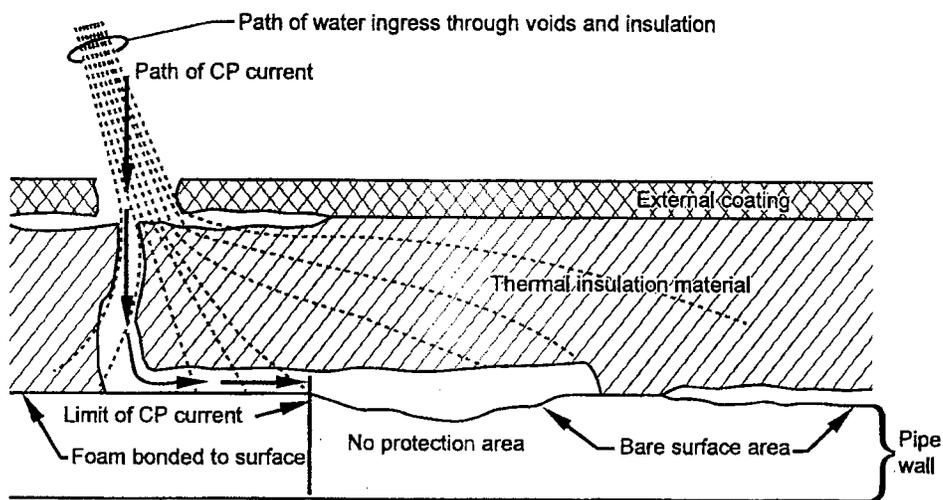
FIGURE 1b: Insulation Material Not Continuously Bonded to Metal

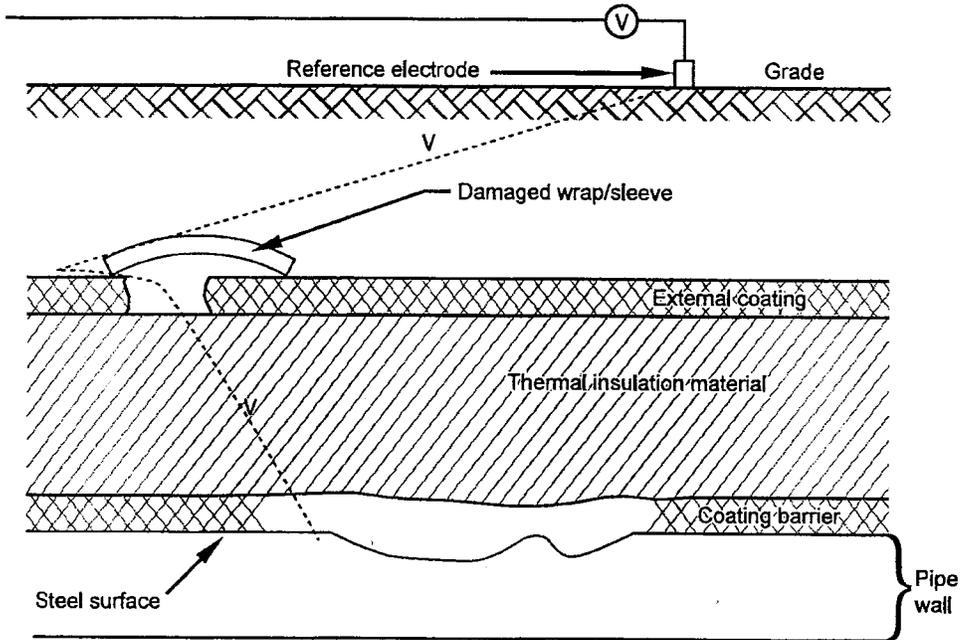
FIGURE 2: Representative Circuit of Potential Measurement
