# Pipeline Failure Investigation Report

**Pipeline System:** Houstonia 200 Line                      **Operator:** Panhandle Eastern Pipeline Company, LP  
**Location:** Mile Post 21.6                                      **Date of Occurrence:** 8/25/2008  
**Medium Released:** Natural gas                              **Quantity:** 13,518,578 CF

# Metallurgical Analysis of 24-Inch Houstonia 200 Service Failure at MP 21.6 (8/25/08)

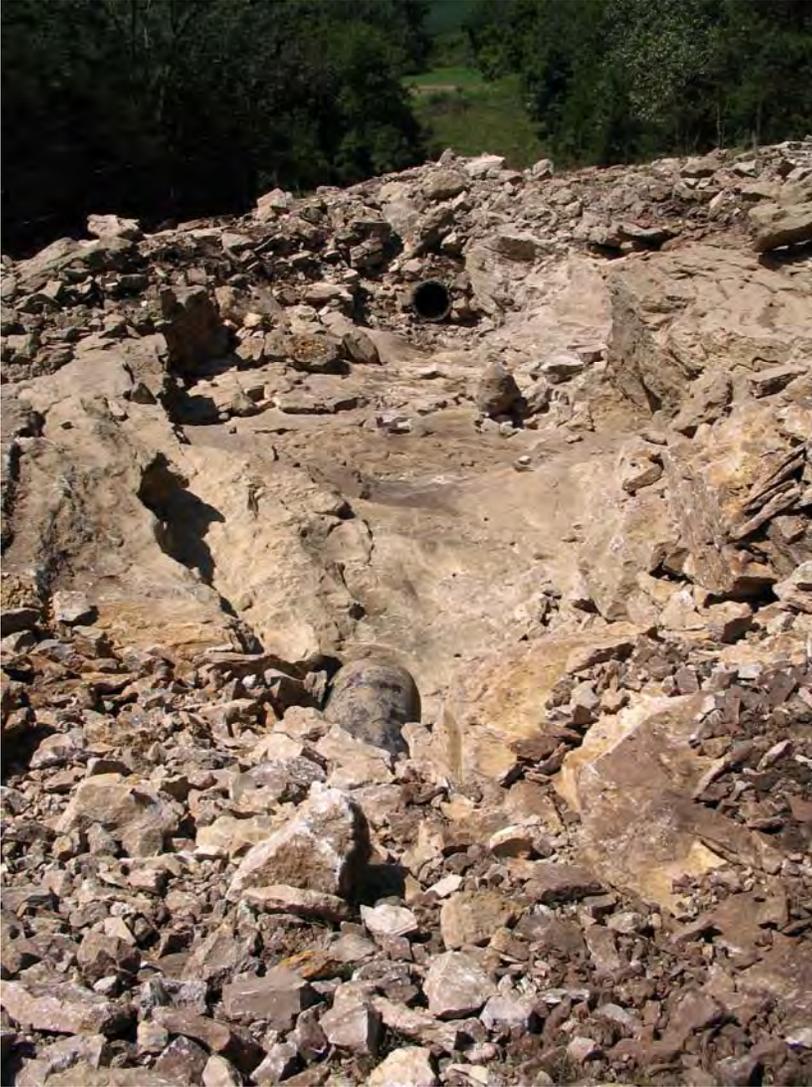
The pipeline experienced a longitudinal rupture in the pipe body. The rupture created a 50 feet by 33 ft by 7 feet deep crater in the ground. Two pipeline segments totalling 28 feet in length and a coupling were ejected from the crater a distance up to 300 feet from the rupture site. The failure origin was a 16 inch long area of reduced wall thickness located at the 6:00 orientation.

8/25/08 – #1- views looking West at the crater caused by the Houstonia 200 failure.

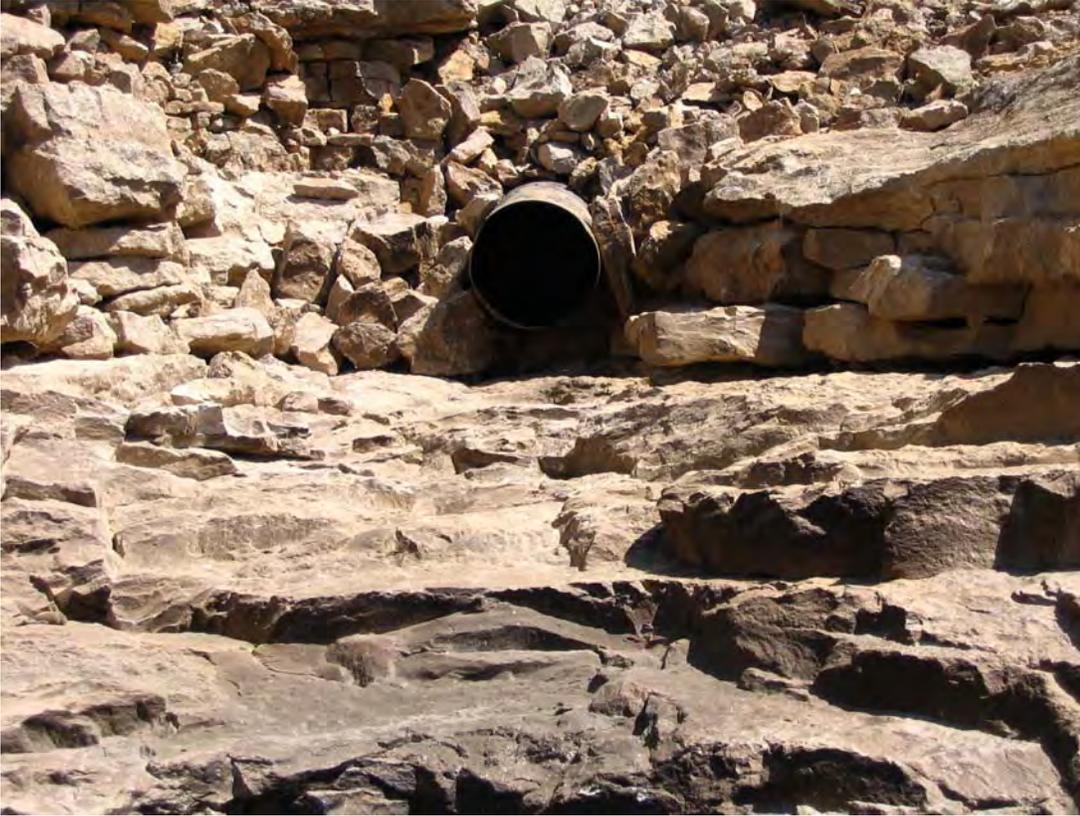
8/25/08 #2 - East view of the exposed pipe.

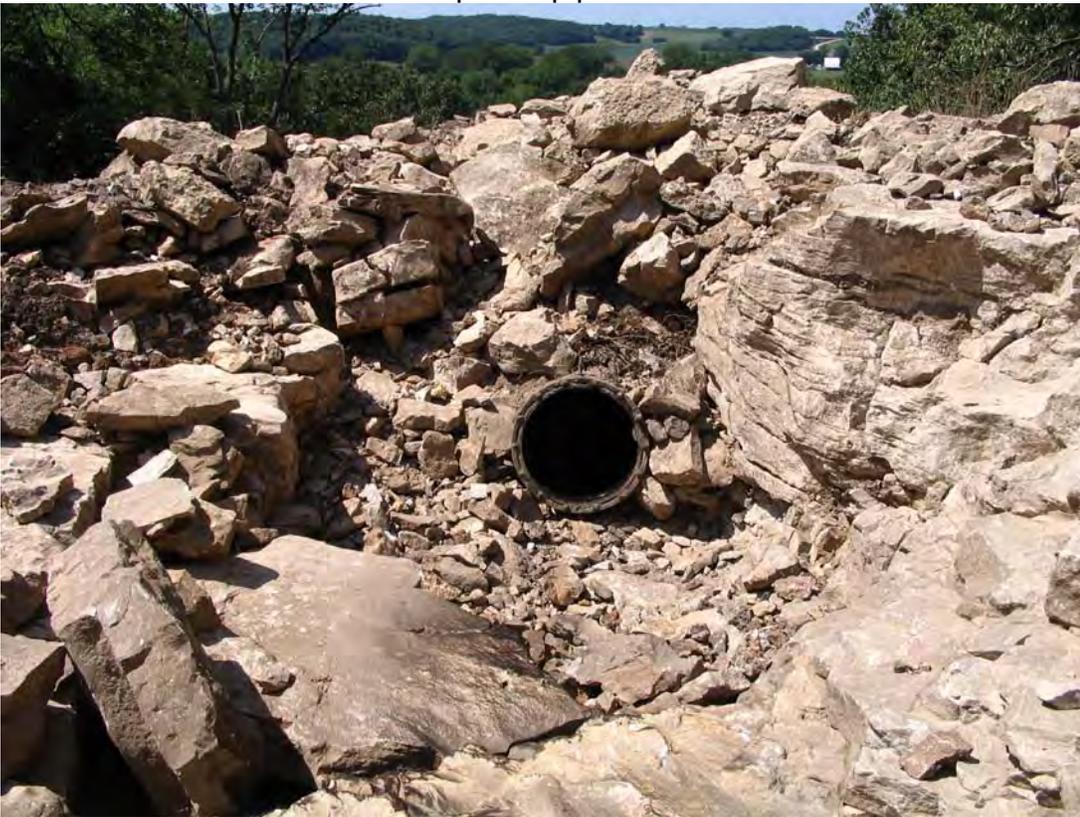
8/25/08 #3 - West close up.

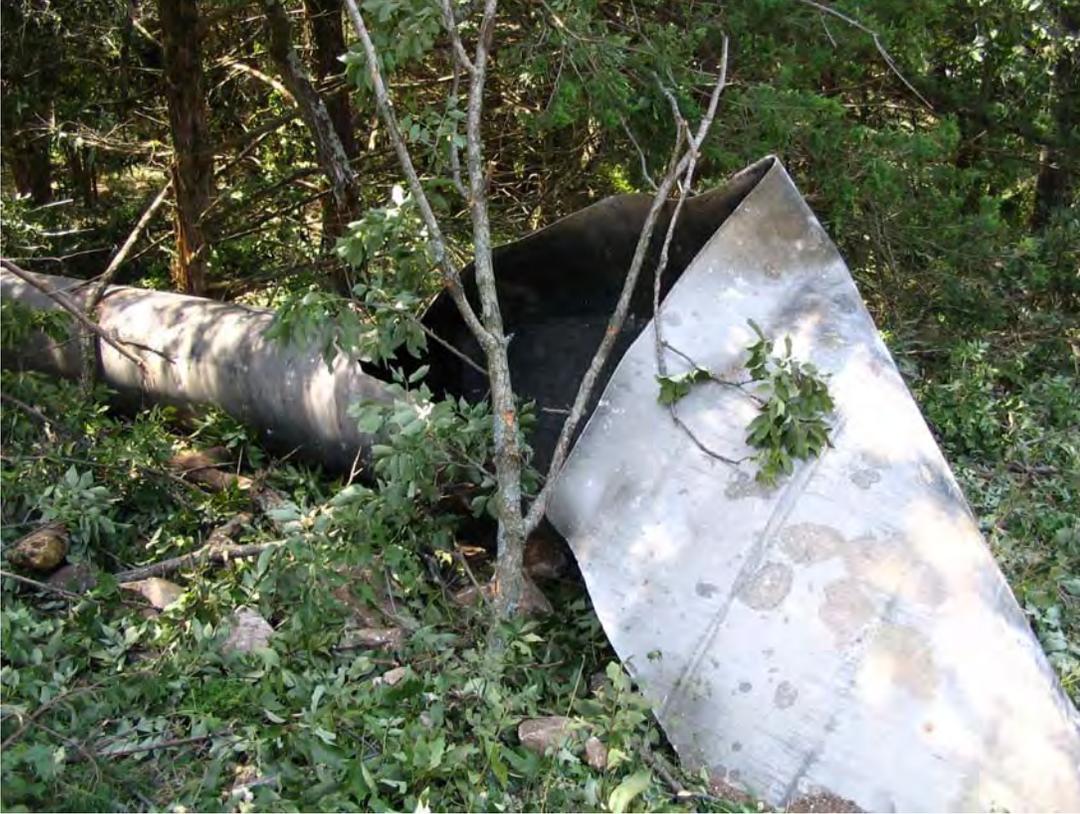
8/25/08 #4 - One of two pipe sections ejected – the longer one – about 30 feet.

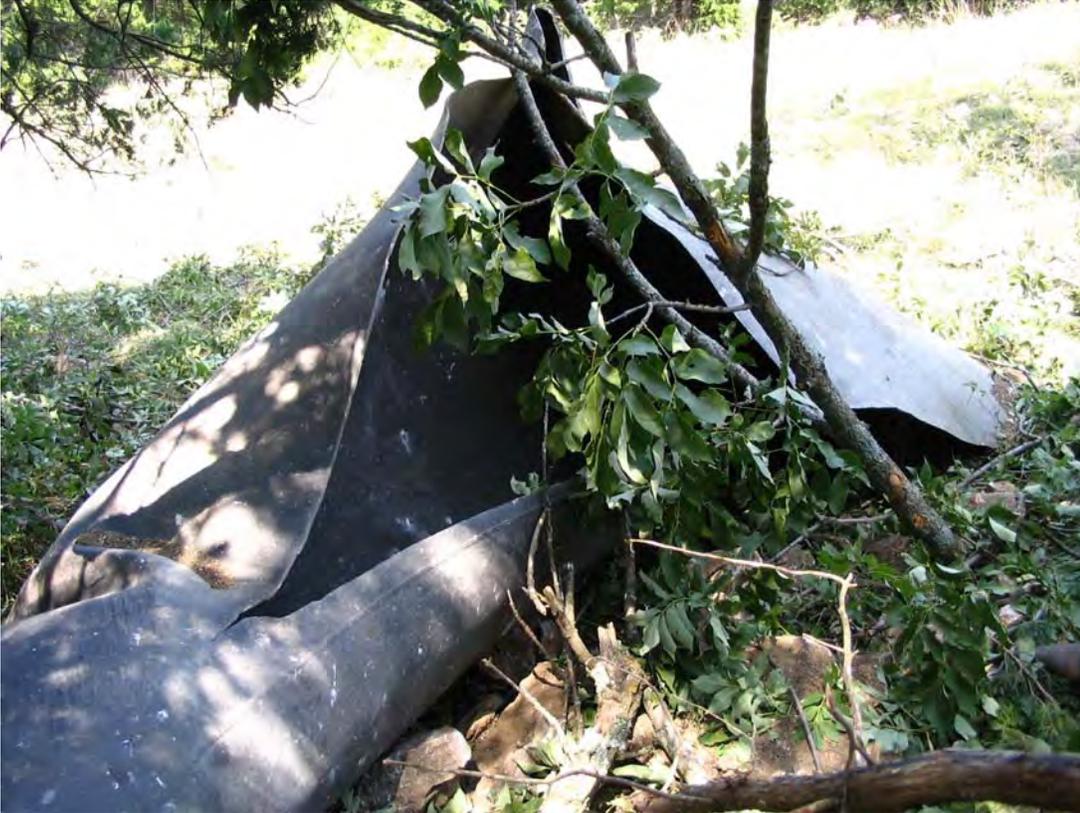
8/25/08 #5 -Closer view of the longer ejected section.

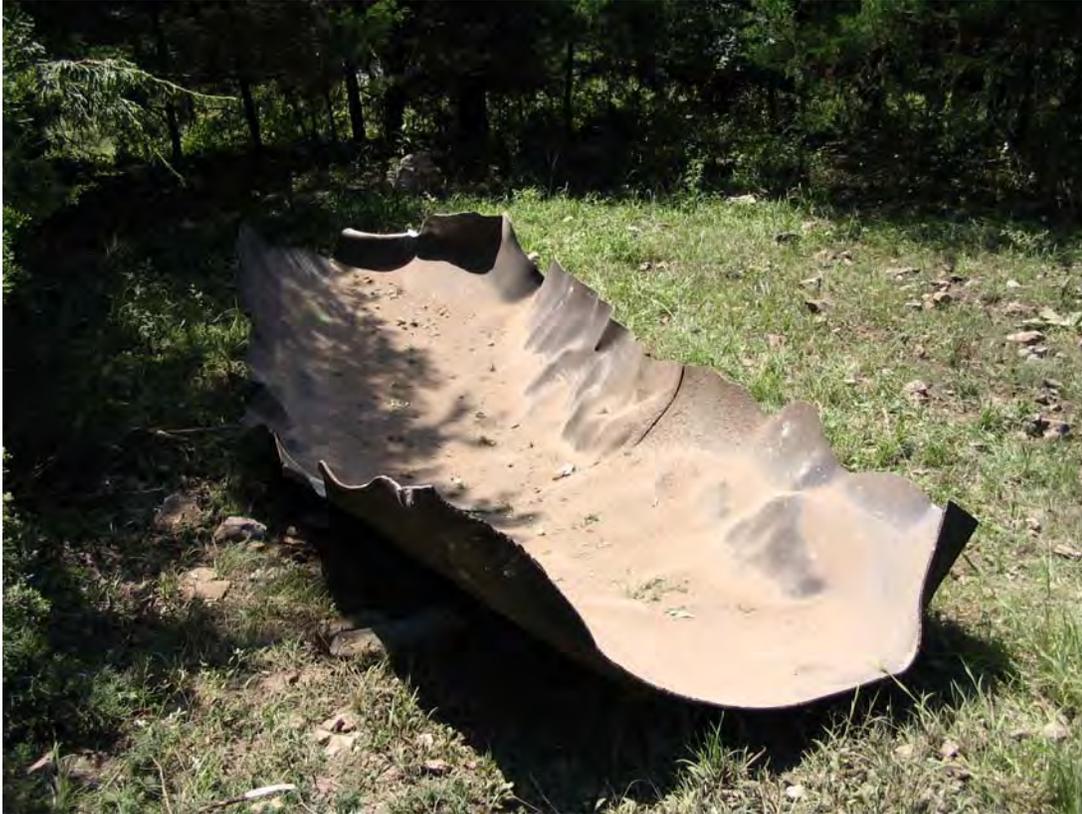
8/25/08 #6 -View of the shorter section ejected – about 23 feet – ruptured full length.

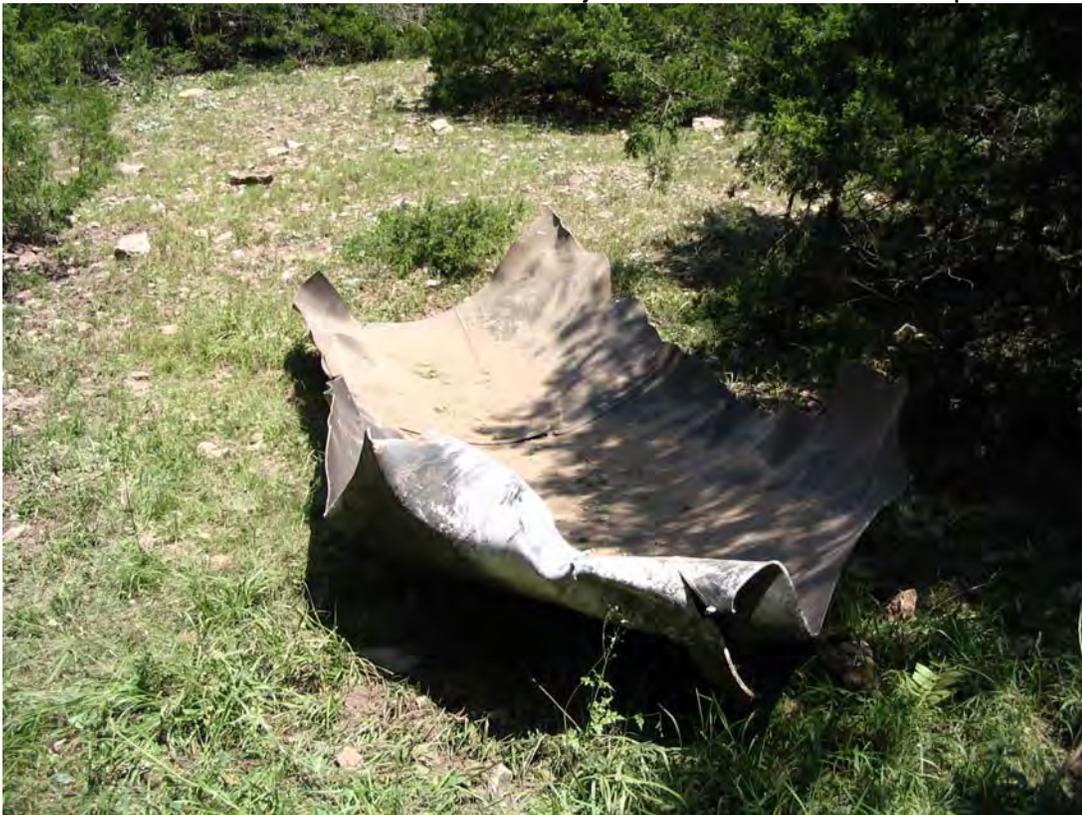
8/25/08 #7 -Another view of same looking north.

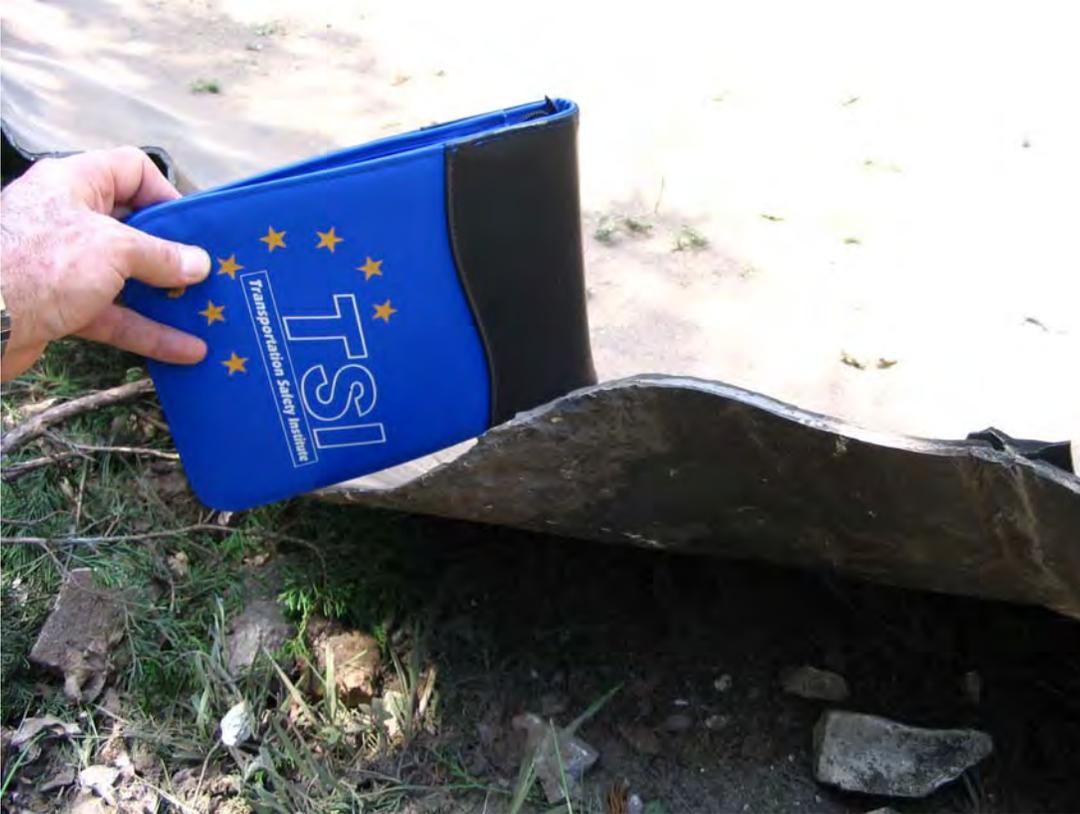
- 1) The failure occurred due to tensile overload at a region of wall thinning caused by external corrosion.
- 2) The maximum wall loss measured at the rupture surface was 0.21 inches depth (75% of wall thickness).

#8 - Areas with external corrosion and reduced wall thickness – possible failure origin.

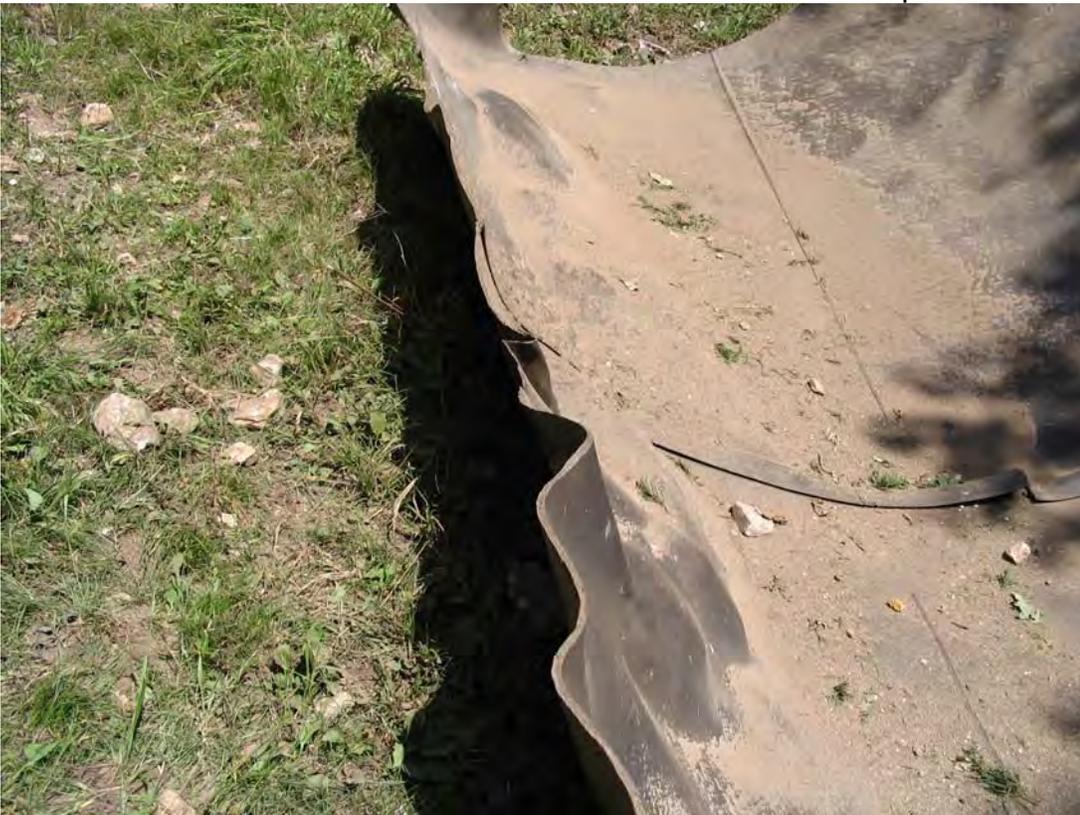
8/25/08 #9 -Side view of the failure origin site with reduced wall thickness.

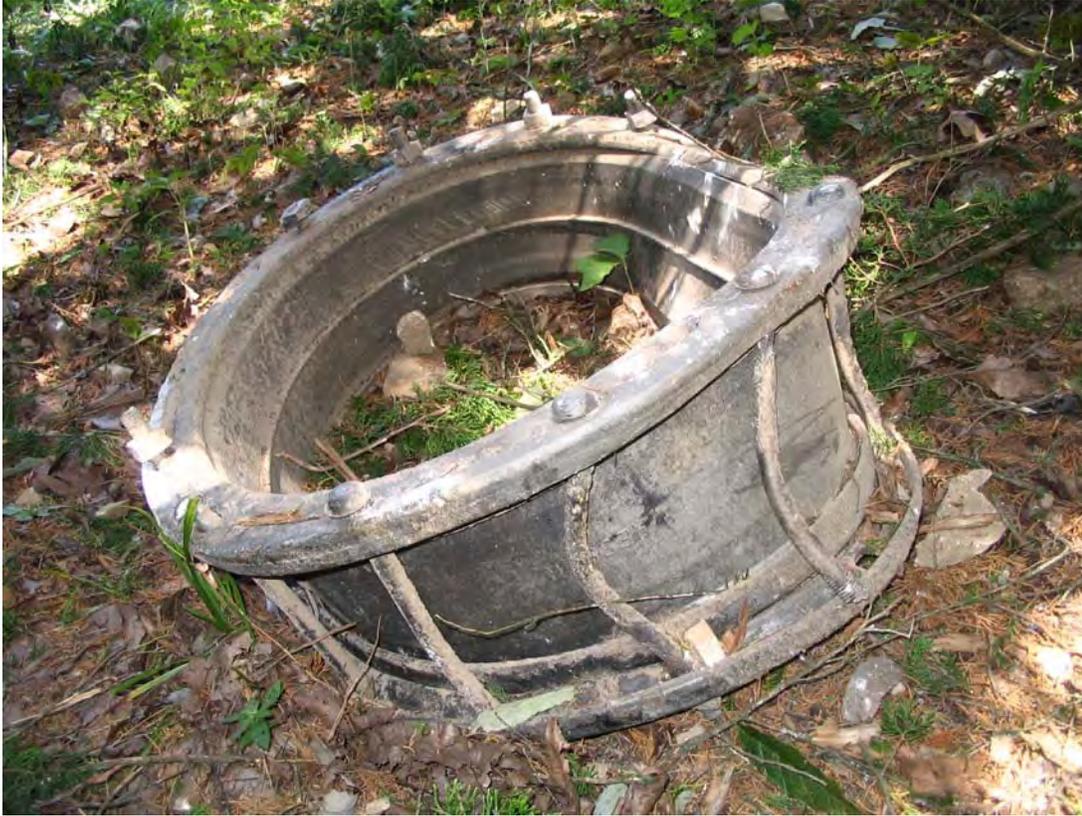
8/25/08 #10 -View of coupling ejected from pipeline.

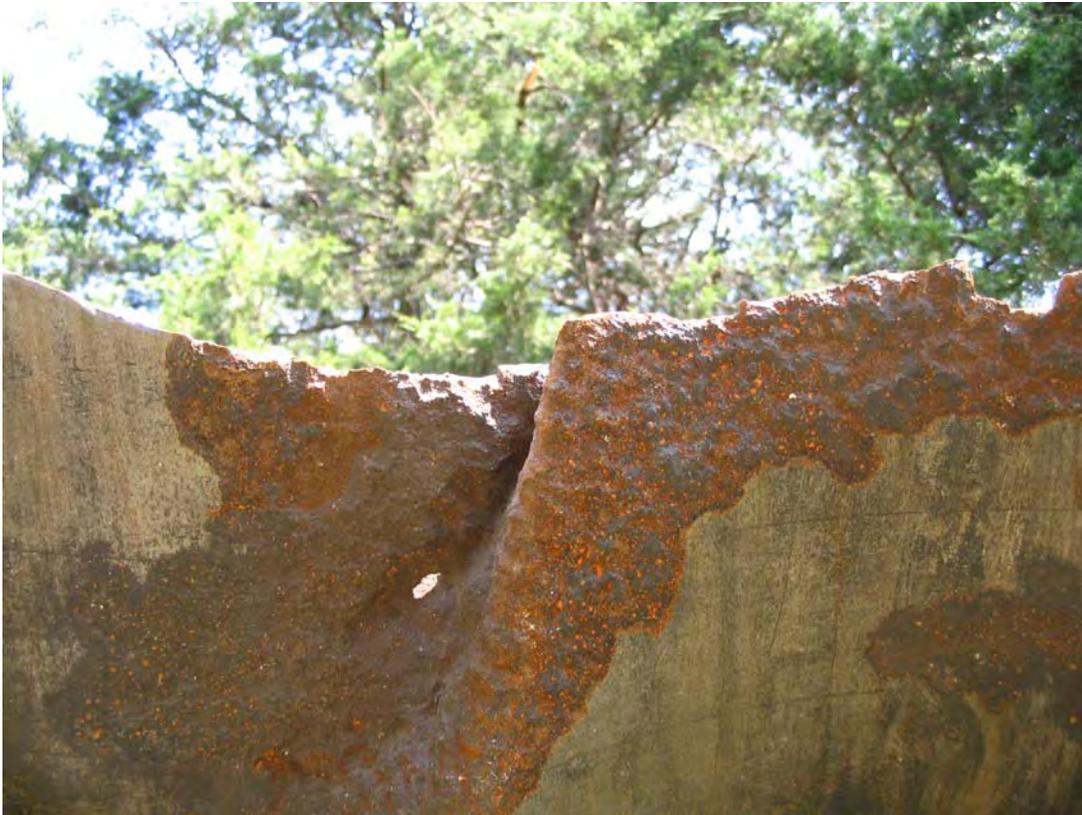
8/25/08 #11 -Close up of external corrosion on the possible origin site.

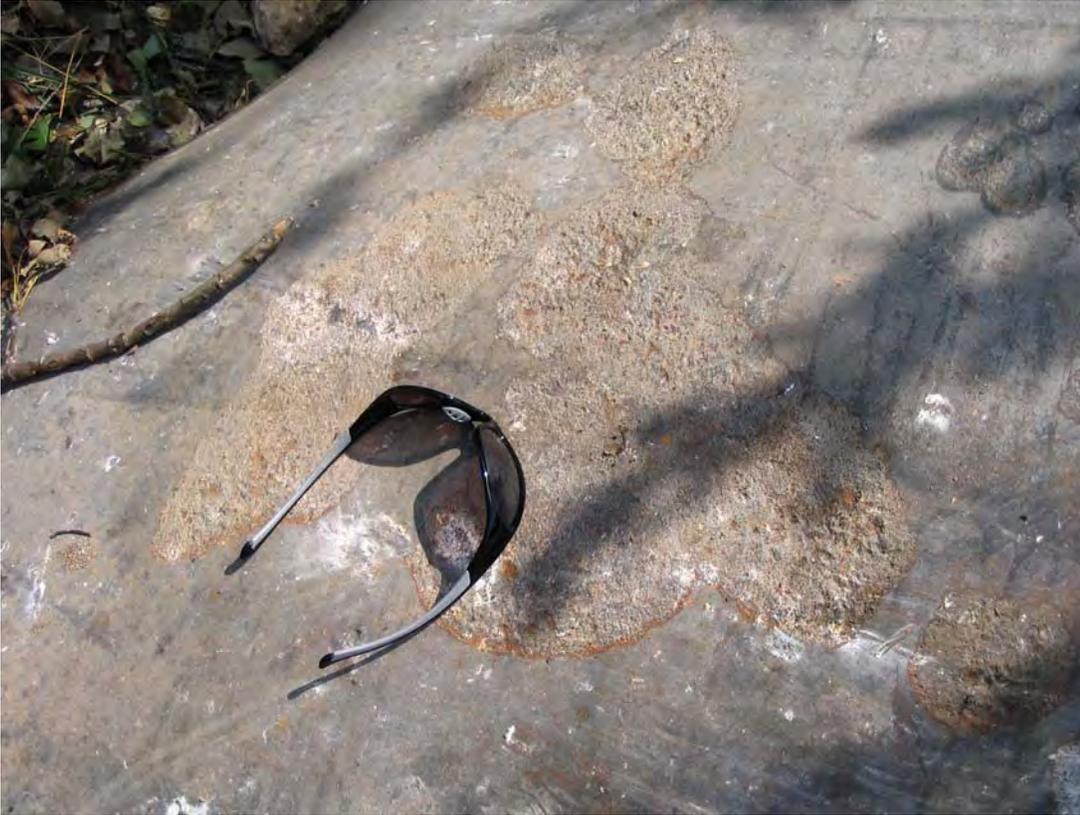
8/25/08 #12 - Another area of external corrosion on the shorter section near the possible failure.

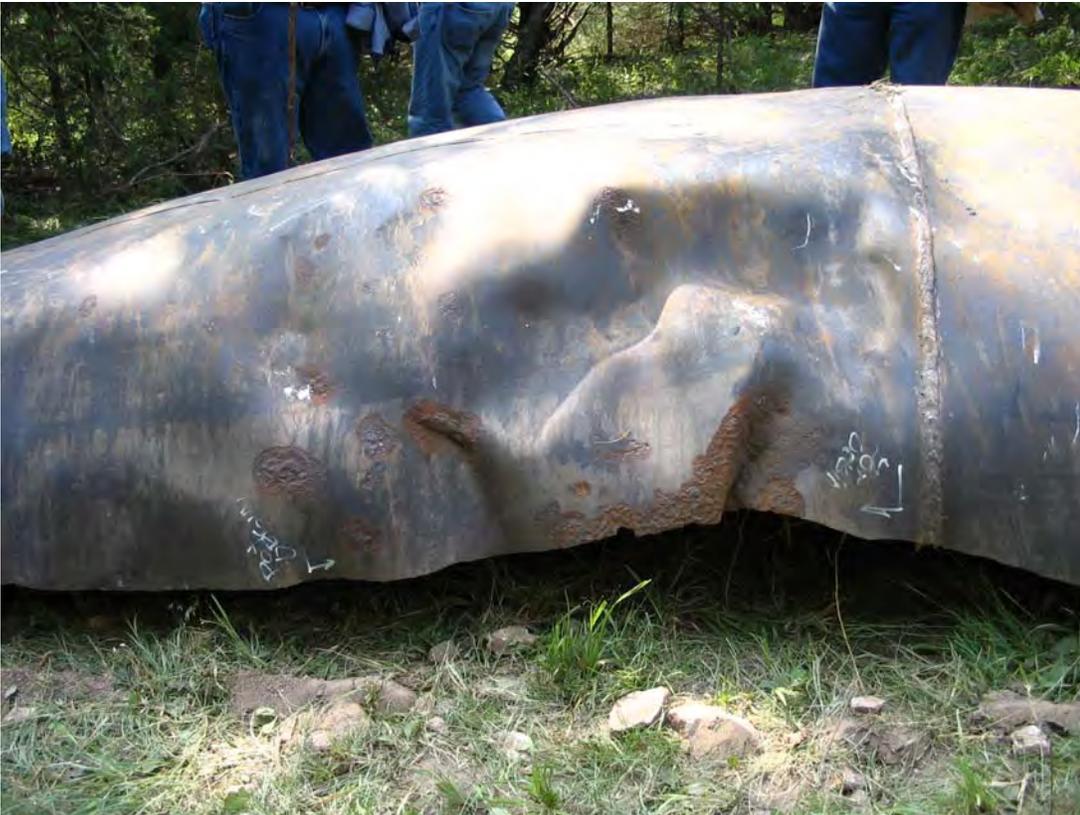
8/26/08 #13 - Different view of the possible failure origin after the pipe was turned over.

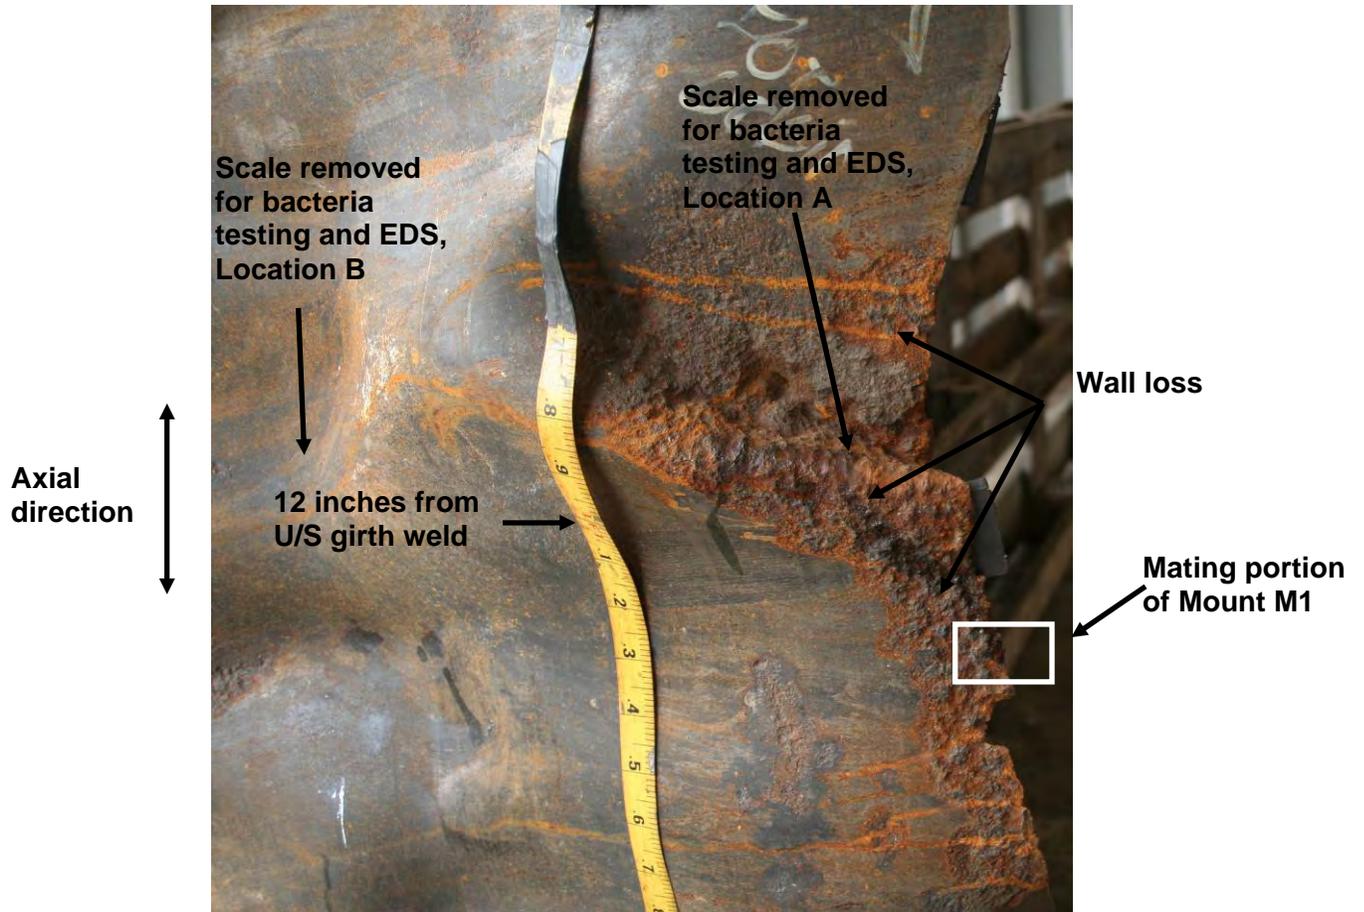
Figure 5. Photograph of the external surface of Pipe Segment A2 on the clockwise side of rupture.

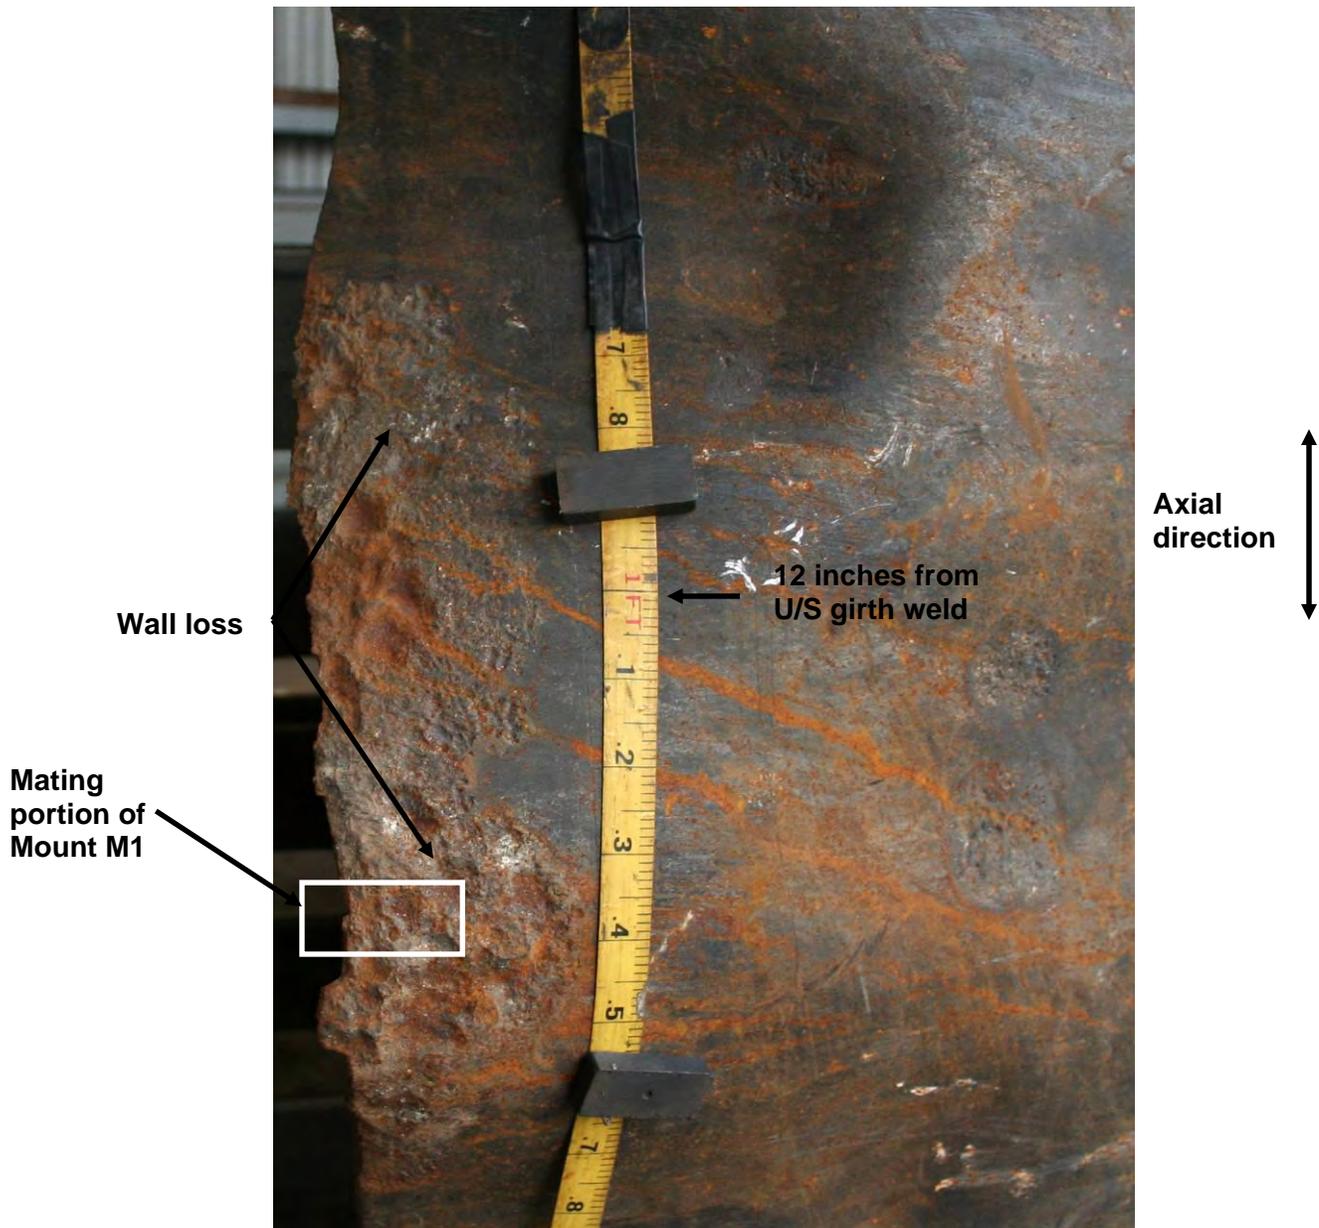
Figure 6. Photograph of the external surface of Pipe Segment A2 on the counter-clockwise side of rupture.

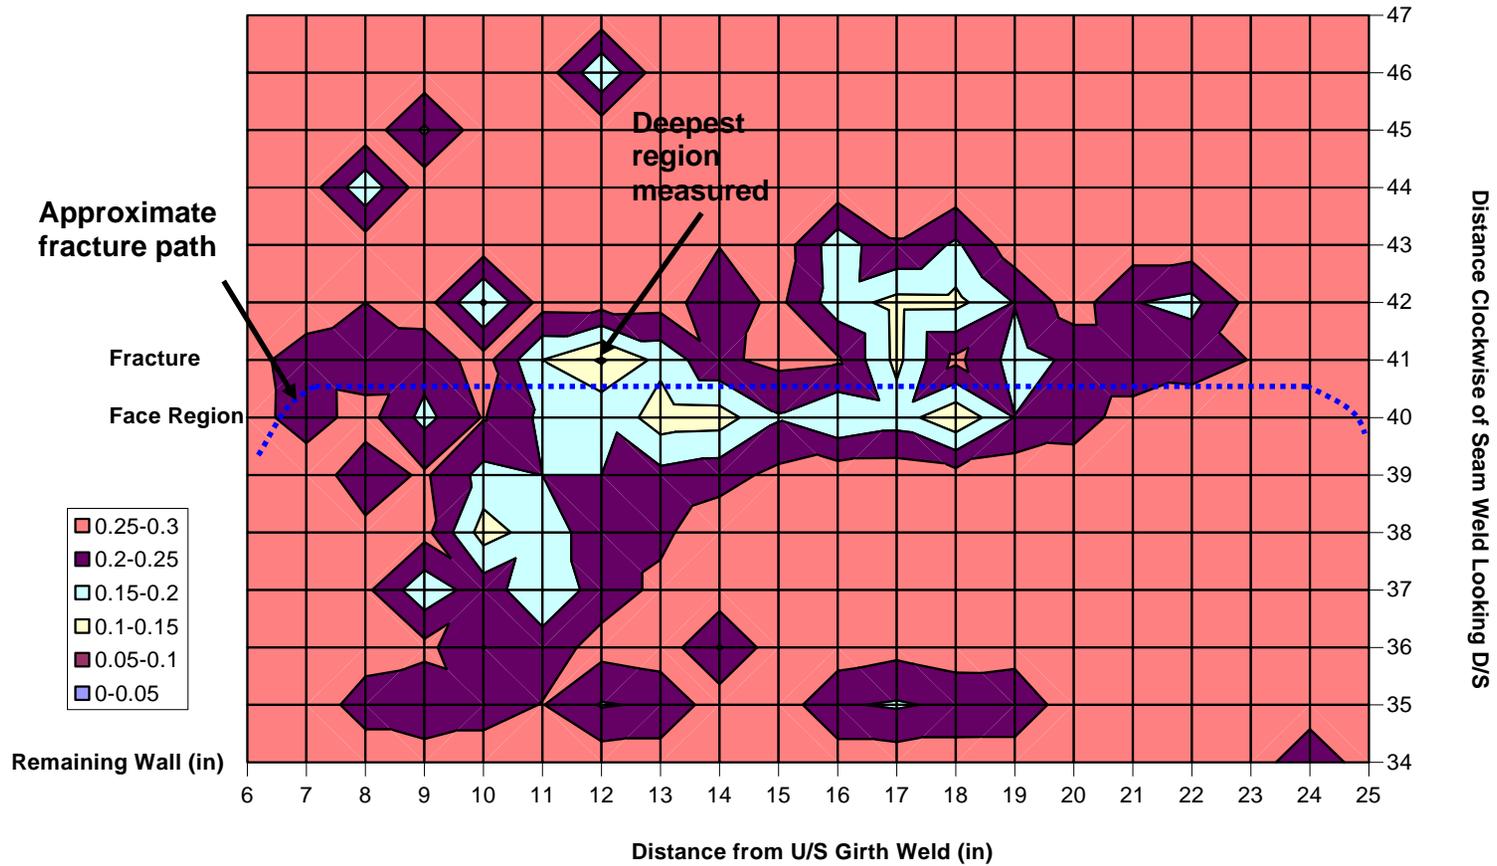
Figure 7. Remaining wall in the region of the probable failure origin.

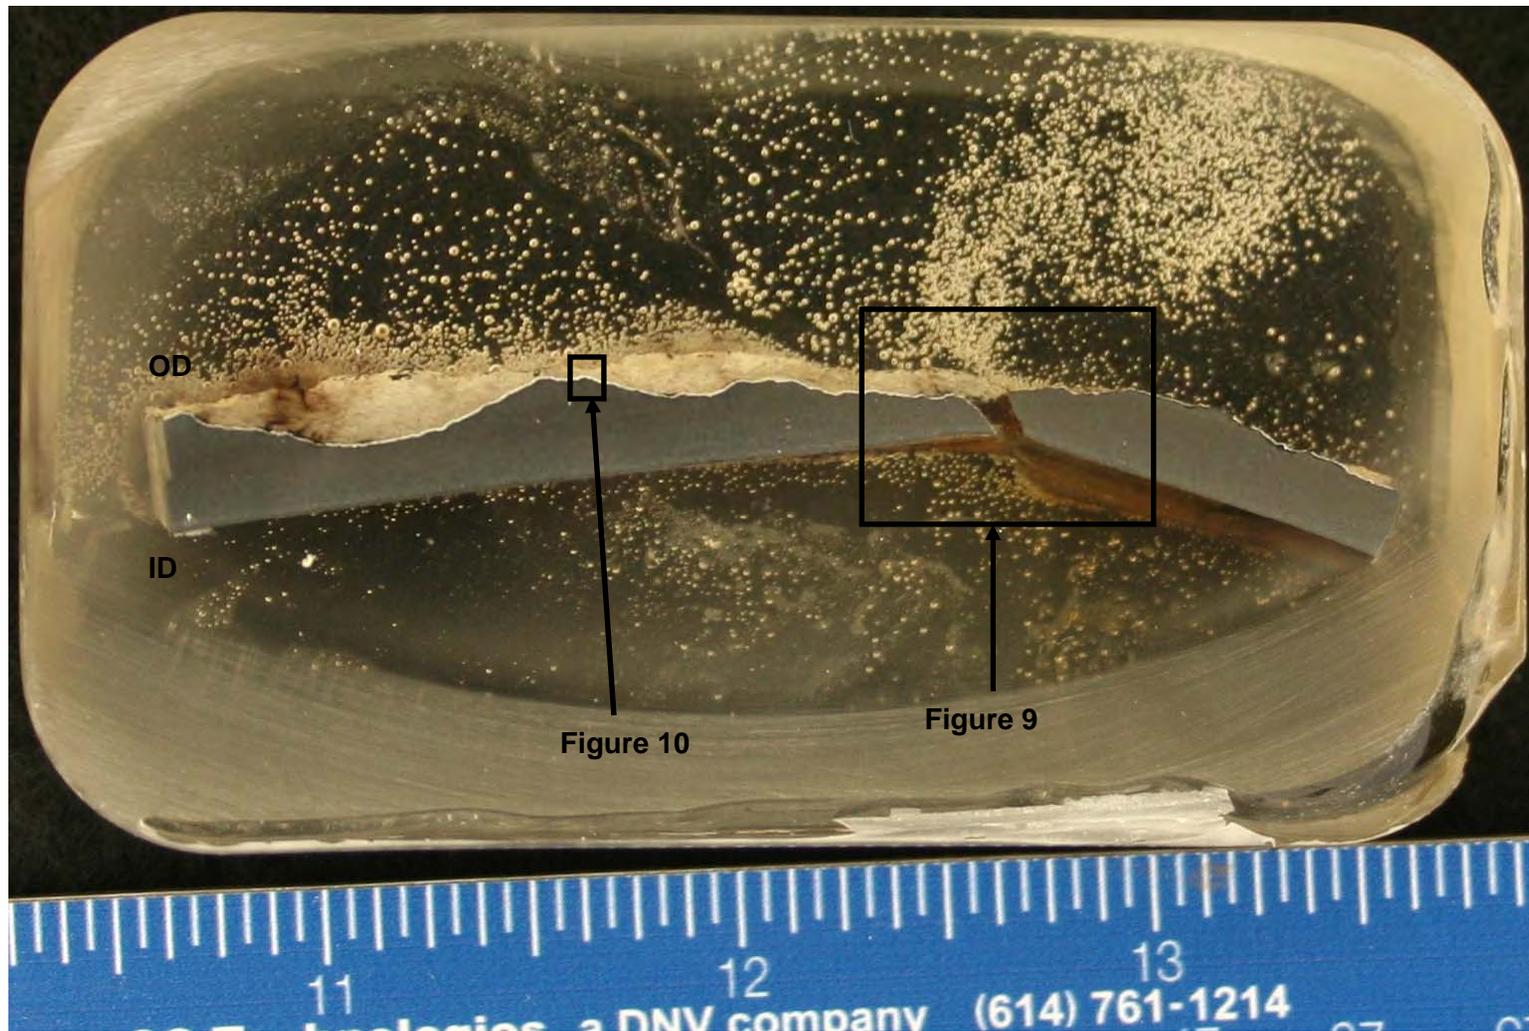
Figure 8. Stereo light photomicrograph of a transverse cross-section removed from the rupture near the failure origin (Mount M1, 4% Nital Etchant).

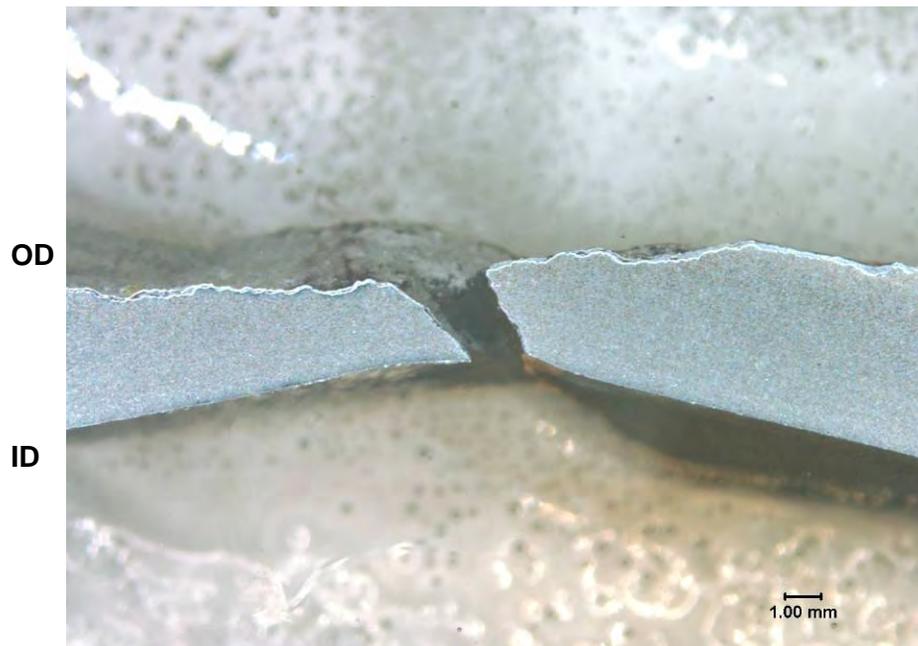
Figure 9. Stereo light photomicrograph of the rupture area indicated in Figure 8 (Mount M1, 4% Nital Etchant).

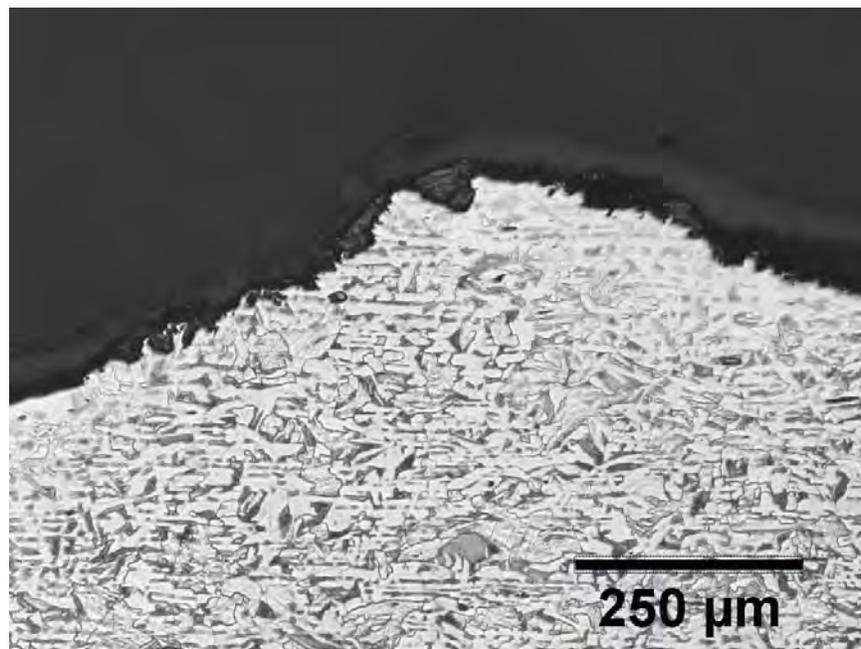
Figure 10. Light photomicrograph of the external surface of the pipe in Mount M1 (4% Nital Etchant, area indicated in Figure 8).

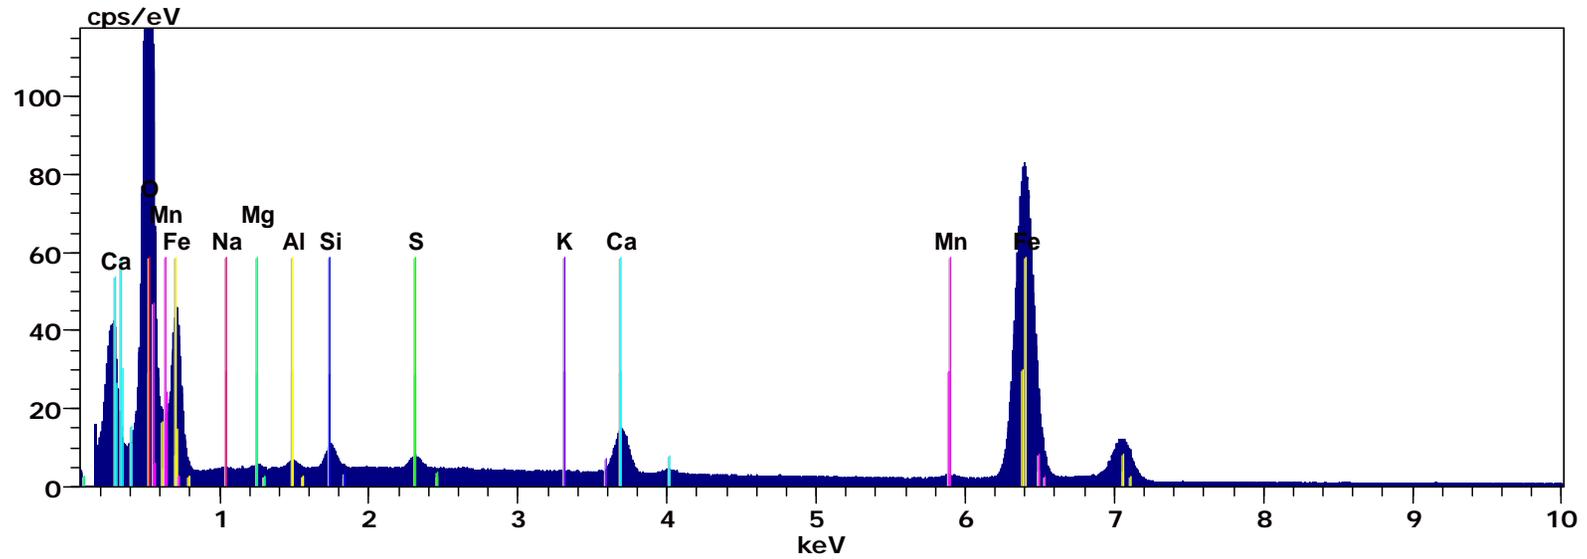
The Fe and O were likely in the form of an iron oxide and other elements are commonly found in soils.

Figure 13. EDS spectrum of scale that was removed from the external surface.

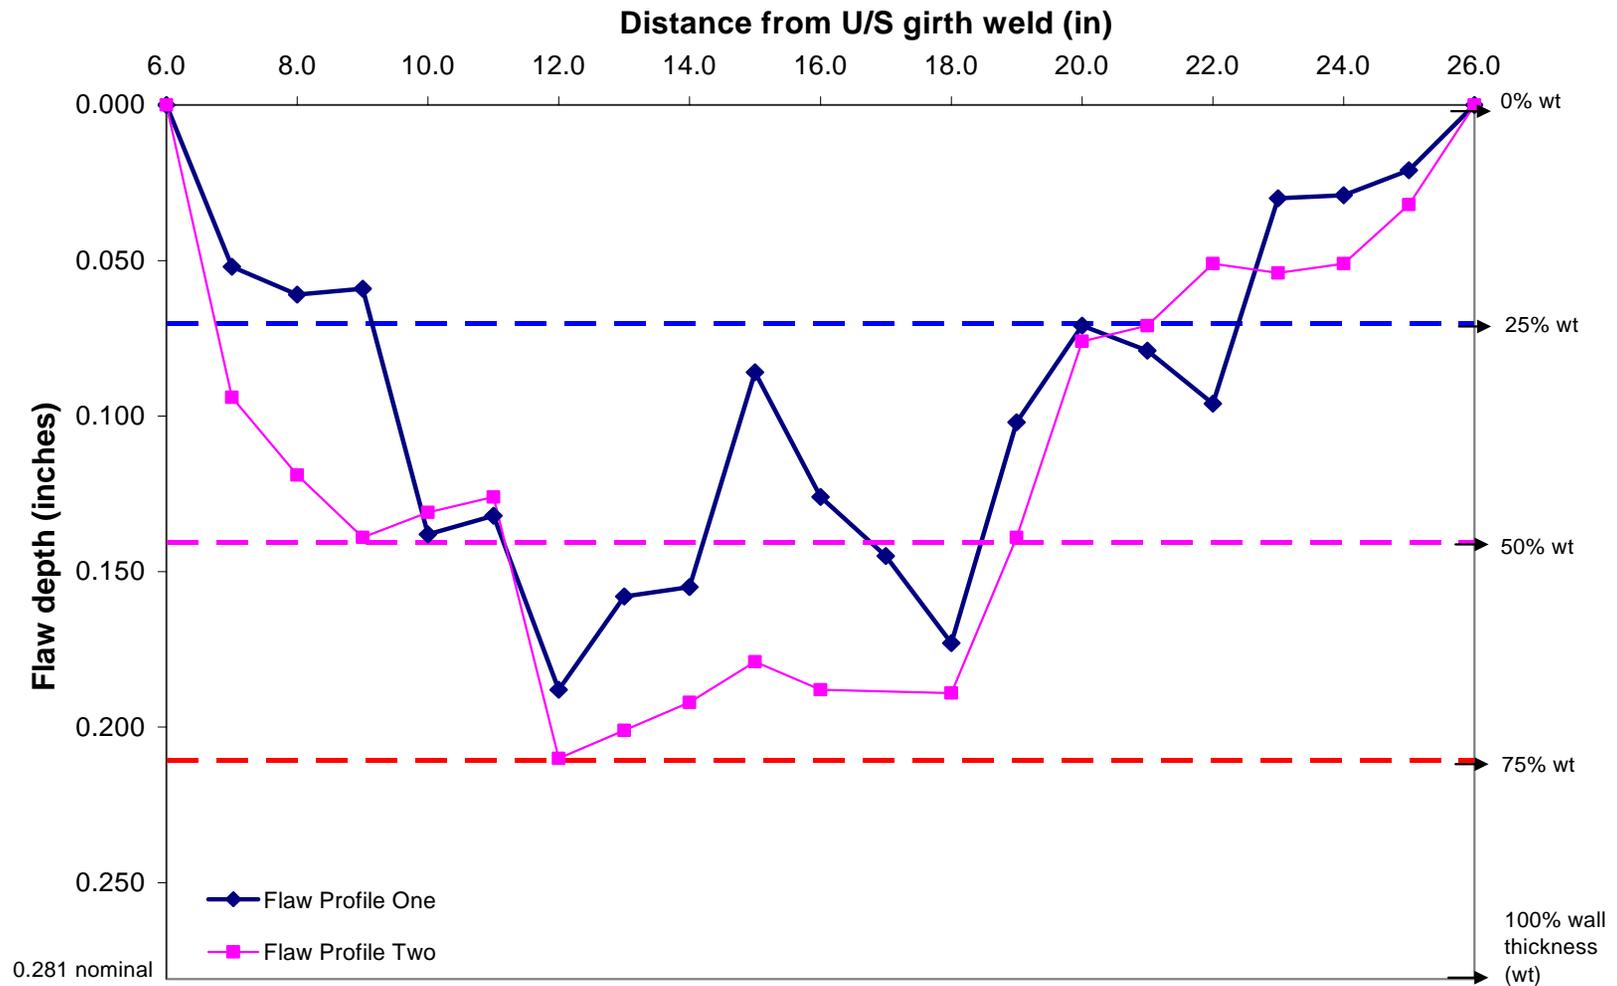
The predicted burst pressure for the region of wall loss that contained the rupture was calculated using the RSTRENG effective area method embodied in CorLAS™. Two flaw profiles were obtained. The first flaw profile (profile 1) was obtained by using a modified river bottom method. A second flaw profile (profile 2) was constructed by measuring the wall thicknesses at the edge of the counter-clockwise fracture surface. A flow strength of the measured yield stress (MYS)+10 ksi was used for the calculation.

Figure 16. Flaw depth vs. length profile of the measured flaws.
