DOT US Department of Transportation
PHMSA Pipelines and Hazardous Materials Safety Administration
OPS Office of Pipeline Safety
Western Region

Principal Investigator Doug Allen, CA SFM
Senior Accident Investigator Peter Katchmar
Region Director Chris Hoidal
Date of Report 11/9/2010
Subject Failure Investigation Report – SFPP LP Bleed Fitting Corrosion

Failure Investigation Report – SFPP Bleed Fitting Failure

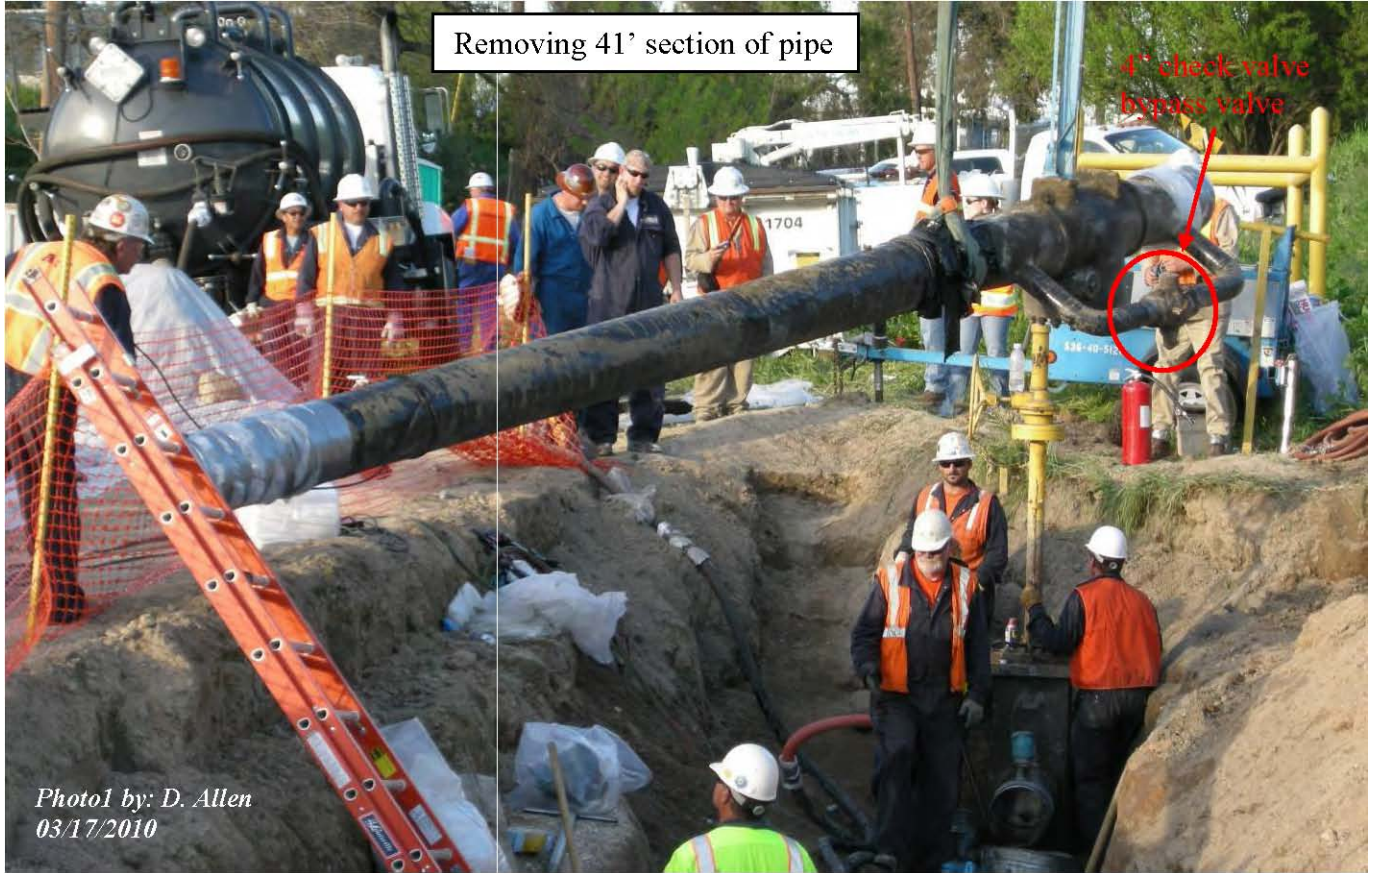
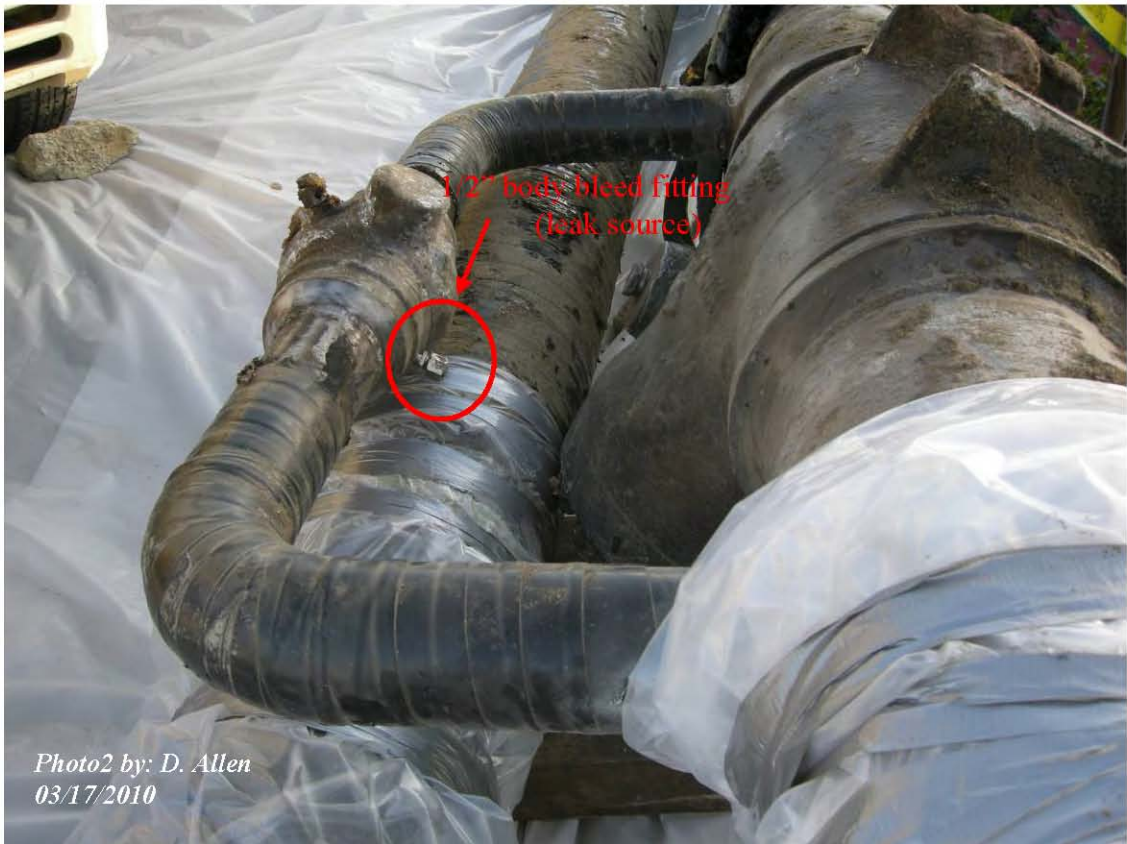
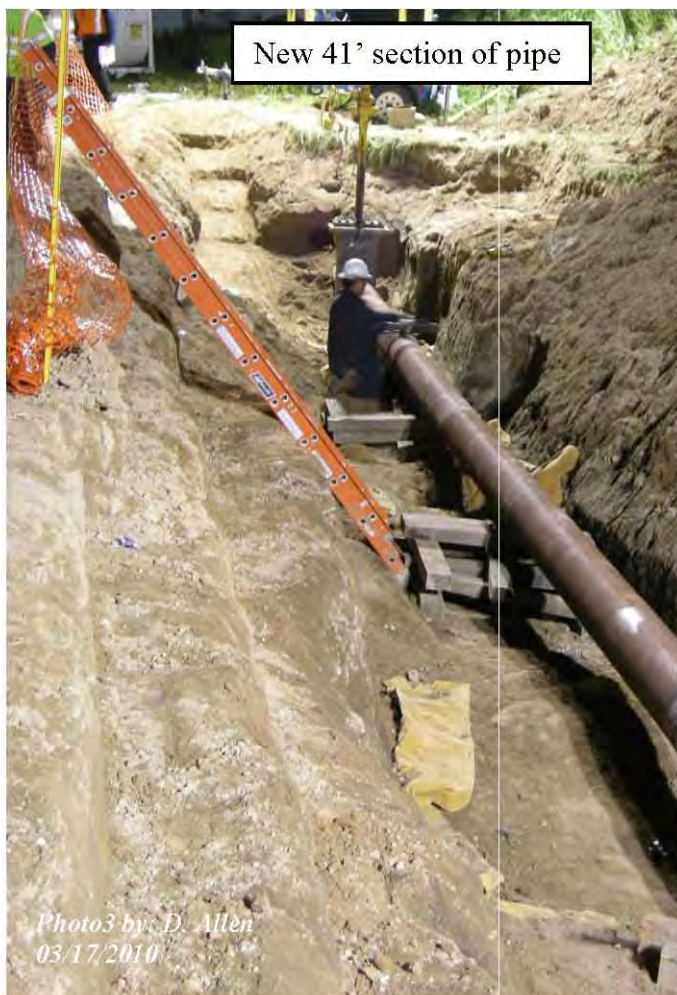
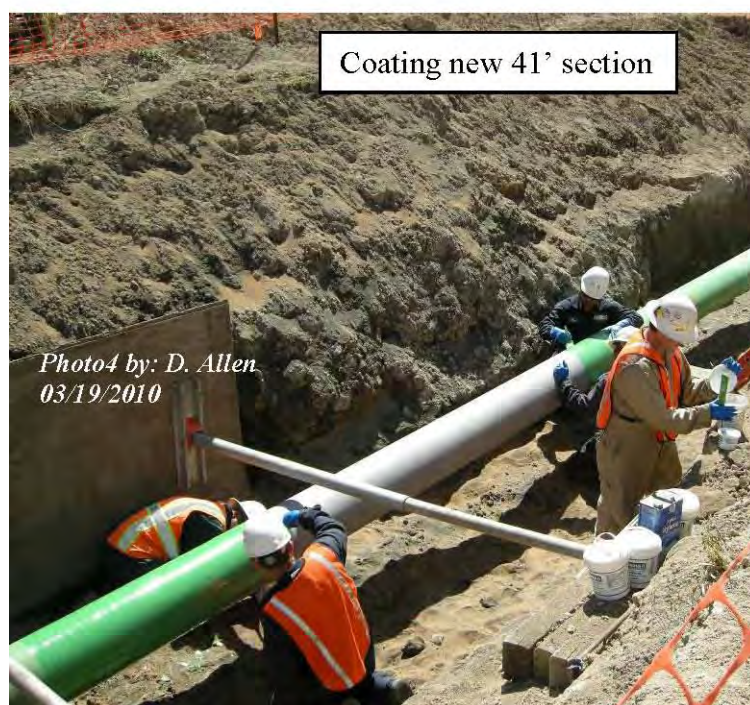
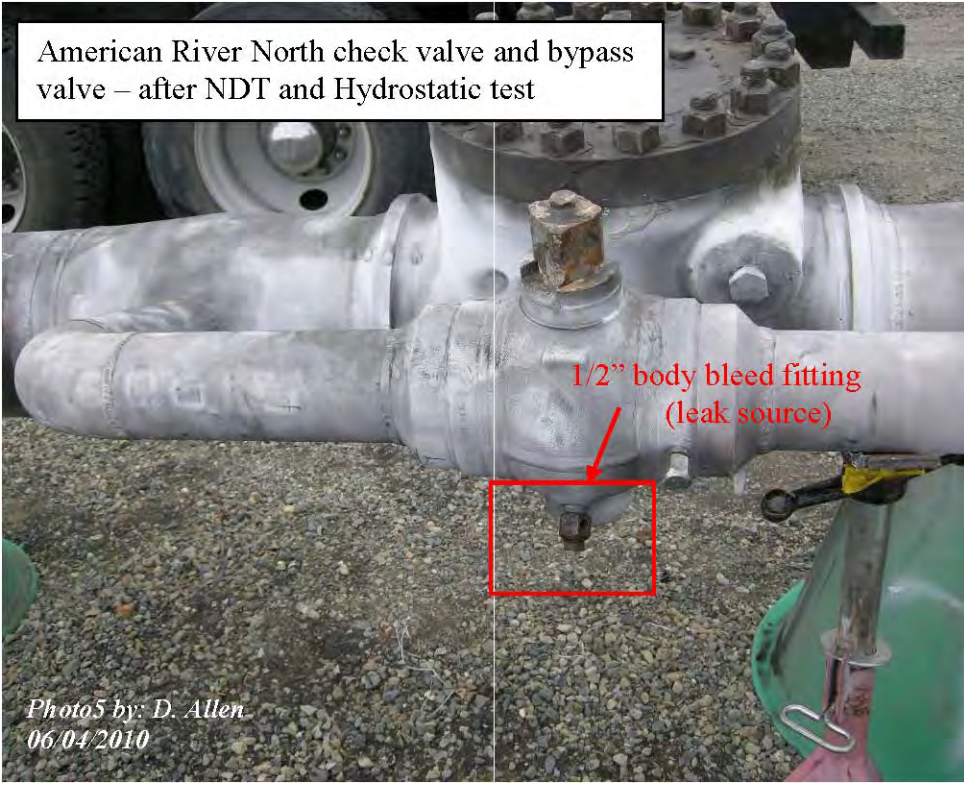
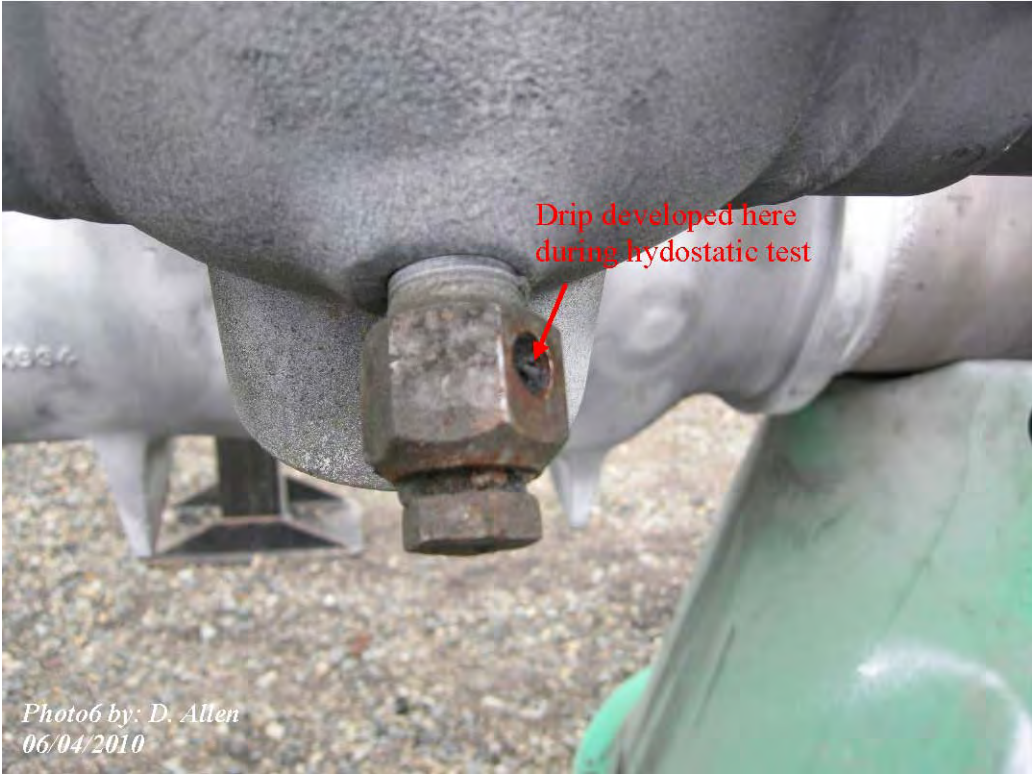
Photographs

The March 16, 2010 release on the LS20 pipeline originated from a ½-inch body bleed fitting on a 4-inch check valve bypass valve. The release was caused by corrosion in the body bleed fitting. Residual water may have been trapped in the fitting assembly initiating the corrosion. Kinder Morgan was unable to determine the source of the water.
