Principal Investigator Roger Sneegas
Region Director David Barrett
Date of Report 1/11/2012
Subject Failure Investigation Report – Southern Star Butt Weld Failure in KS

Date of Failure 3/2/2010
Commodity Released Natural Gas
City/County & State Abbyville/Reno, Kansas
OpID & Operator Name 31711 Southern Star Central Gas Pipeline Co. Inc.
Unit # & Unit Name 853 Lyons
SMART Activity # 129328
Milepost / Location Station 140 – 260+06, milepost 161, About 10 miles downstream of Stafford Station.
Type of Failure Butt weld separated due to crack in weld and external forces
Fatalities 0
Injuries 0
Description of area impacted Class 1 rural pasture land – wetland near a river
Property Damage \$953,905

Failure Investigation Report – Southern Star Butt Weld Failure in KS

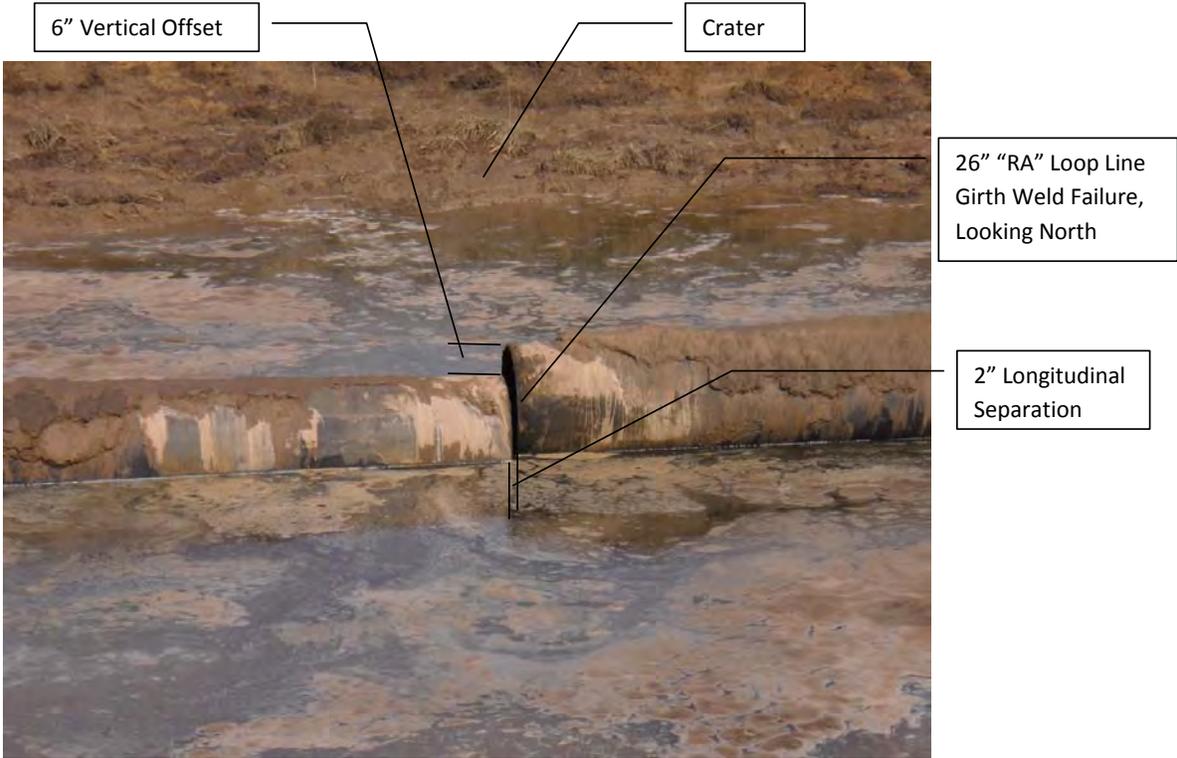
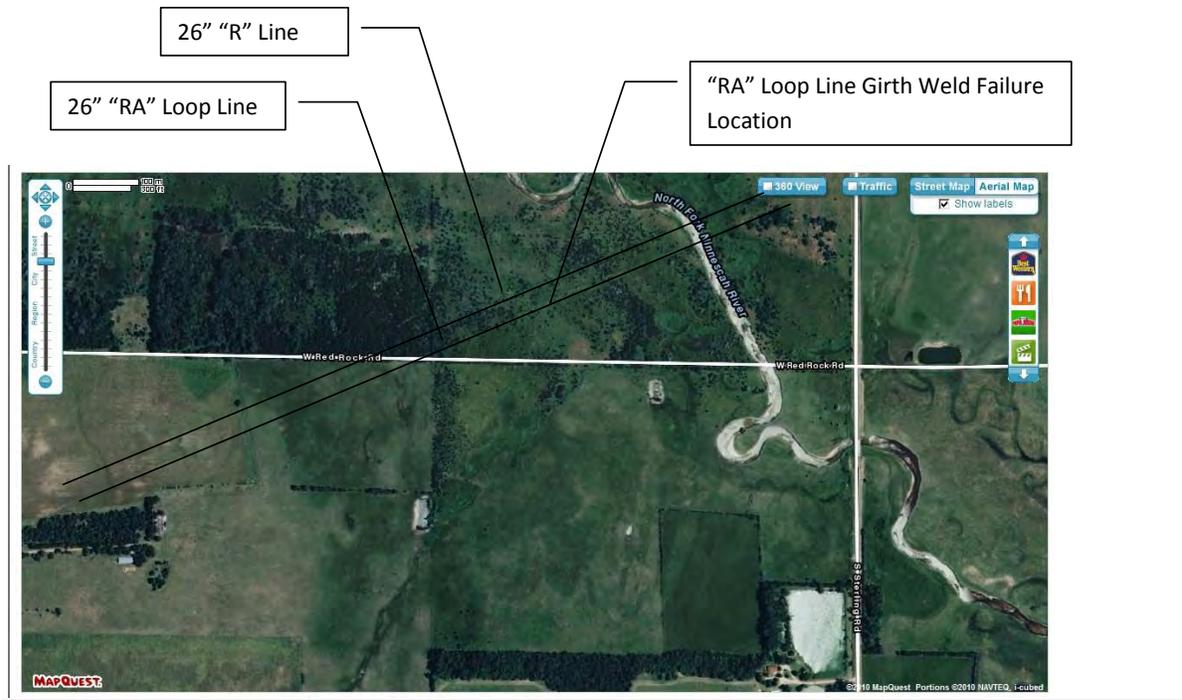
Photo number 1 of failure and site map March 4, 2010

On March 3, 2010, PHMSA Central Region inspectors conducted an on-site investigation of the incident. In situ visual inspection of the damaged pipe joint revealed a circumferential separation of a girth weld. The pipe ends were horizontally separated by about 2 inches and vertically offset about 6 inches. The pipeline longitudinal seams were located between 12:00 and 3:00. See pictures in Appendix A.
