Memorandum

U. S. Department
of Transportation
**Pipeline and Hazardous Materials
Safety Administration**

Subject: Accident Report - Southern Natural Gas Pipeline Rupture of January 23, 2007, Elmore, Alabama, NRC Report # 824407

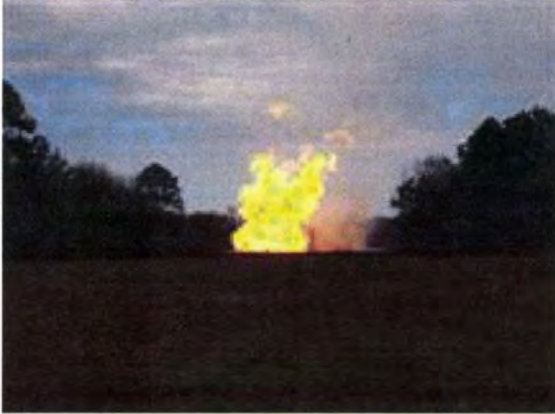
16-in South Main Pipeline after rupture and ignition

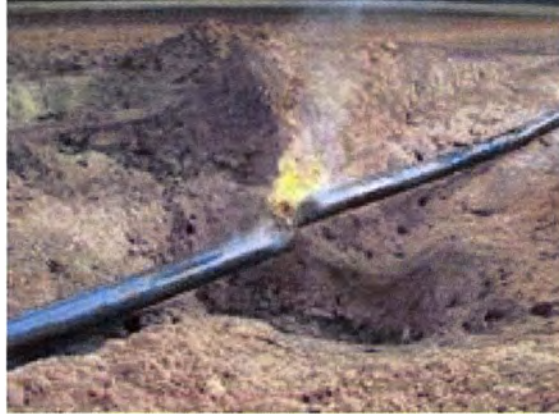
16-in South Main Pipeline after shut-in. Cover completely displaced by high natural gas pressure

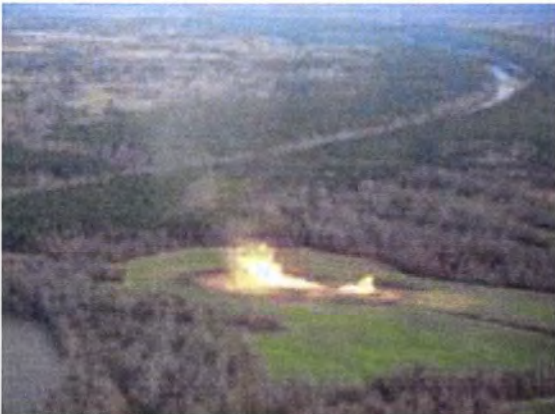
Aerial view of raging fire.

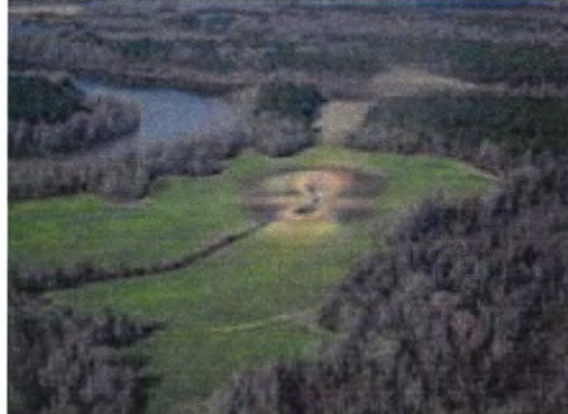
Aerial view of incident site after shut-in

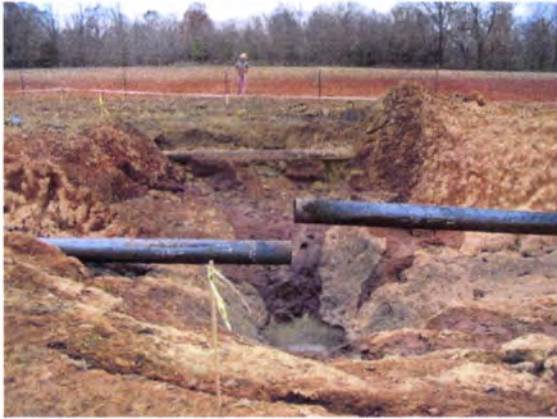
Failed 16-in South Main Line. Abandoned 12-in Montgomery to Columbus pipeline in background (partially exposed)

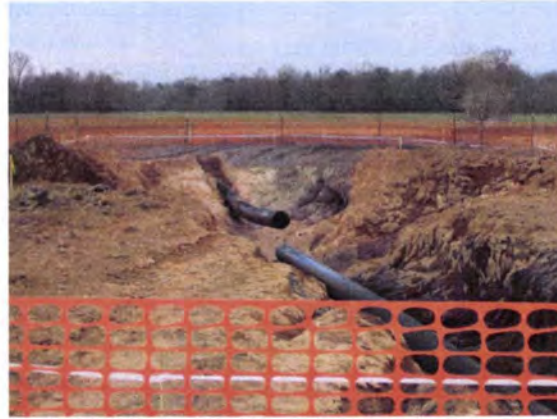
Failed 16-in South Main Line looking downstream

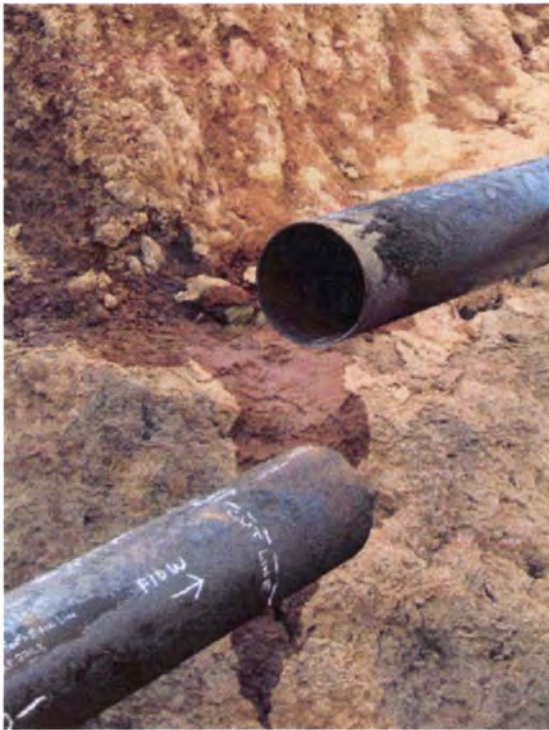
1) The girth weld failed due to excessive axial tensile loading on the pipeline. The source of the load(s) could not be identified.

The metallurgical analysis indicated the sample welds would not have been acceptable according to the workmanship criteria in the 19th Edition of API 1104 as the failed weld contained two burn-throughs and indications of slag and porosity. The 19th Edition of API 1104 was the current API welding standard in use at the time of the incident.

Close-up of clean break

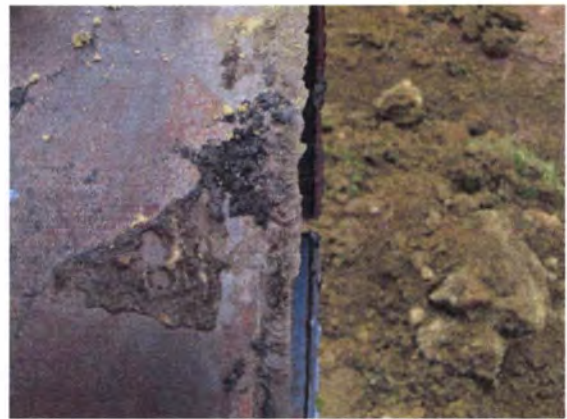
Weldcap intact on failed pipe.
