DOT U.S. Department of Transportation
PHMSA Pipeline and Hazardous Materials Safety Administration
OPS Office of Pipeline Safety
Southwest Region

Investigator David York
Region Director R.M. Seeley
Date of Report 10/5/2016
Subject Failure Investigation Report—Tennessee Gas Pipeline Company, LLC,
in-service stress corrosion cracking (SCC) failure

Failure Investigation Report—TGP In-Service SCC Failure

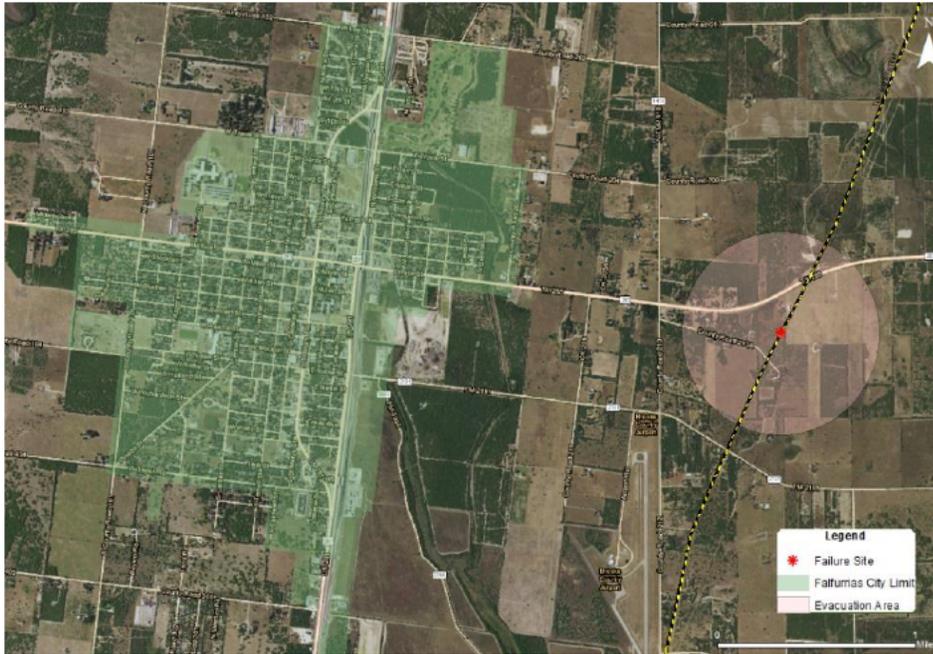
Figure 2: Map of Incident Location

The TGP dispatched personnel to the failure site and to mainline valves located upstream and downstream of the incident location. Responding TGP personnel arrived at the failure site around 8:45 p.m., and took the upstream Agua Dulce Compressor Station offline at approximately 8:46 p.m. The TGP depressurized and isolated an 11.16-mile section of pipe containing the failure segment and mainline valves. The Falfurrias Fire Department temporarily closed a five-mile section of Highway 285 and evacuated homes in a half-mile radius (shown in Figure 2), allowing residents to return just after midnight.

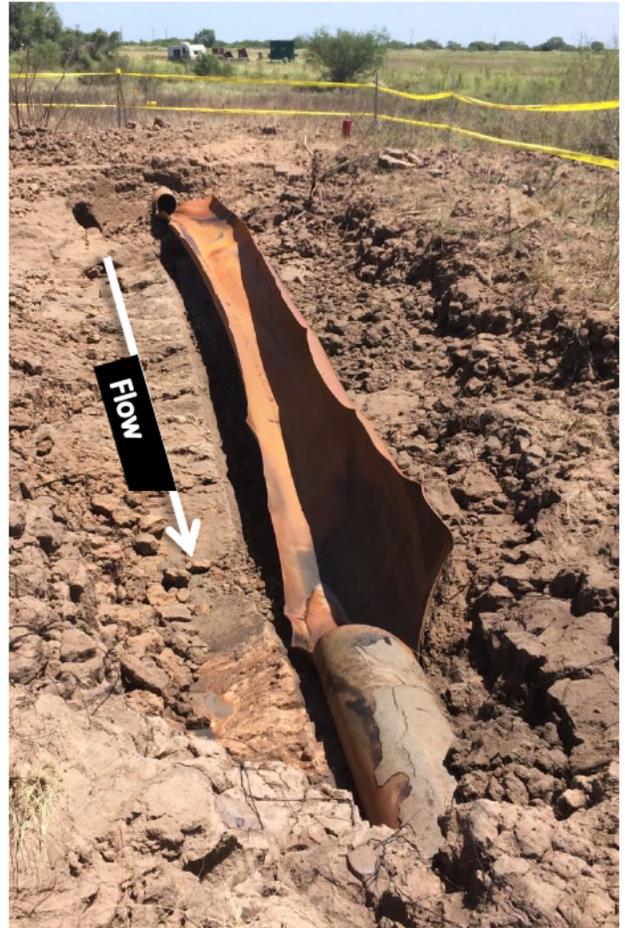
Figure 1 : Photo looking North at failure site

OPS conducted a site evaluation on August 4, 2015; however, due to safety concerns immediately following the incident, initial observation was conducted at a distance from the pipe. The rupture appeared to have stemmed from the long seam and travelled along approximately 55 feet of pipe, with the crack stopping at the adjacent pipe sections. The rupture did not eject the pipe from the ditch, but expelled the ground cover a distance from the

crater, which measured roughly 70 feet long by 30 feet wide. The external coating was found to be damaged during the incident, with large sections no longer bonded to the pipe surface. There were no visible signs of mechanical damage to the pipe or evidence of external/internal corrosion.

The damaged portion of pipe was replaced with 16-inch outer diameter, 0.312-inch wall, grade API-5L X65 pipe with fusion-bonded epoxy external coating which was manufactured by the Stupp Corporation. Approximately 97 feet of this pipe was hydrostatically tested to 2,368 psig on August 6, 2015. The TGP installed 62.8 feet August 7, 2015, completing the repair of the pipeline damaged during the incident.
