DOT US Department of Transportation
PHMSA Pipeline and Hazardous Materials Safety Administration
OPS Office of Pipeline Safety
Southwest Region

Principal Investigators Gene Roberson; Victor Lopez
Region Director R. M. Seeley
Date of Report 10/17/2011
Subject Failure Investigation Report – Tennessee Gas Pipeline Co. – Wrinkle Bend Failure

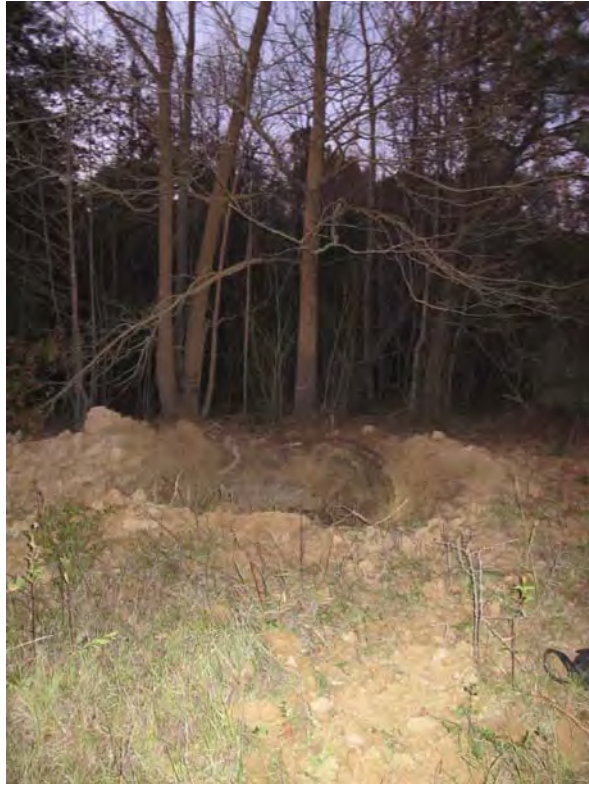
Figure C1 - Failure Site

The MAOP of the pipeline is 750 psig and the operating pressure when the incident occurred was 671 psig. The incident was a sudden failure, leaving a 15' hole around the pipeline. No personal injuries or fire was associated with the incident and all damage was within the limits of the ROW. The PHMSA investigators were able to view the site with the operator. The origin of the release was from a circumferential crack within a wrinkle bend established during construction of the pipeline in 1948. No cause for failure was apparent from visual examination. Photos of the failed section can be seen in Appendix C.

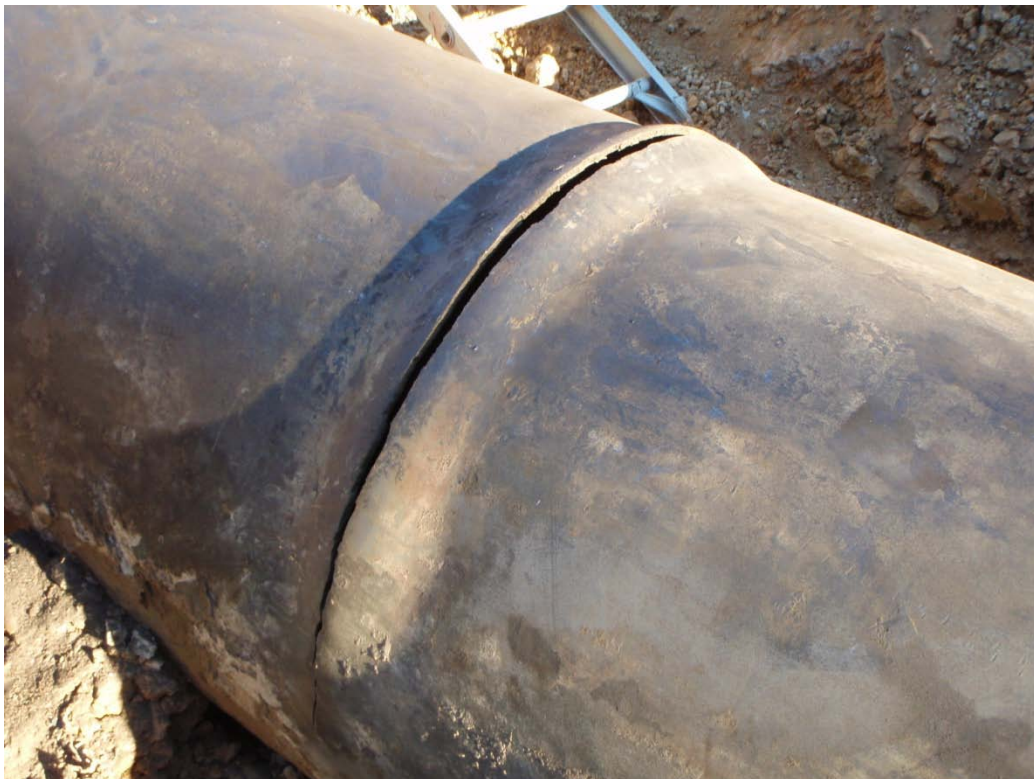
Figure C2 - Failed Wrinkle Bend

The pipeline MAOP is 750 psig and was operating normally at approximately 671 psig when the failure occurred. A 50 inch long, straight circumferential crack had occurred in a wrinkle bend on the 30 inch OD pipeline. Wrinkle bends were common in construction when the pipeline was installed in 1948.

- The failure consisted of a 50.5" long circumferential, tensile overload fracture along the apex of the most downstream convolution of a three wrinkle, under bend that resulted from the cumulative effects of stresses acting on the line. The stresses concentrated in the wrinkle bend were from:
 - a. External stresses from probable shifting of the surrounding soil endured by the line,
 - b. The tri-axial state of stresses inherent to the configuration of in-service wrinkle bends (geometric stress concentrations),
 - c. Internal line pressure from normal pipeline operations.
- Visual, stereomicroscopic, metallographic, and SEM analyses confirmed the failure originated near the 12 o'clock position in a tensile overload manner.
- No Stress Corrosion Cracking (SCC) or other time dependant crack-like indications were

The failure initiated with a circumferential crack within a wrinkle bend on the top half of TGP's 30", 100-2 system approximately 1.5 miles downstream of Station 40.

Following the emergency response, TGP isolated Line 100-2 from MLV 40-2 to MLV 41-2. Site evaluation was performed of the failure and a plan for repair, pending environmental evaluation, was developed. TGP then cut out the failed section and installed approximately 30 feet of pretested pipe, pre bent to match the existing sag bend.

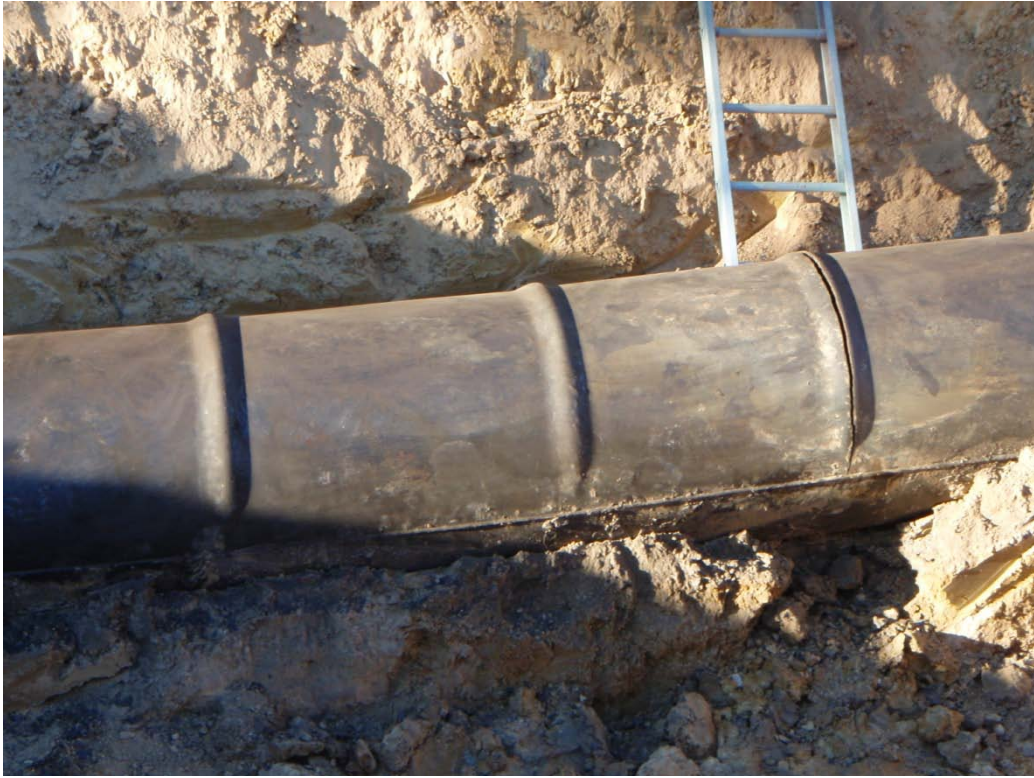
Figure C3 - Exposed Bend

The operator removed the section of pipe containing the failed wrinkle bend and 2 additional wrinkle bends used to establish the sag bend on the pipeline. The section of pipe was sent to a metallurgical lab for testing.

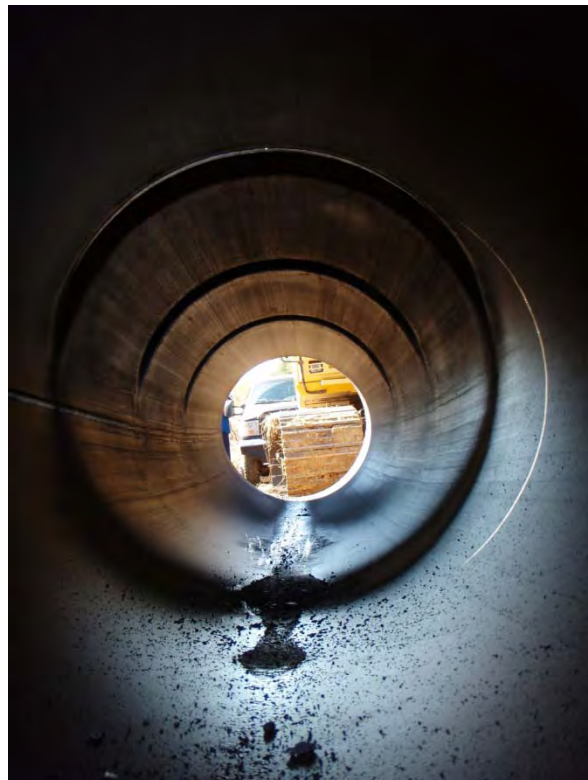
Figure C4 - Pipe Internal

- No measurable external and/or internal corrosion was observed on the pipe segment.
- The chemical composition and mechanical properties of the pipe base metal near the origin, but outside of any wrinkled areas, met typical requirements for line pipe steels of the era.

There were no indications of external or internal corrosion to contribute to the crack. Also, there was no evidence of mechanical damage to the pipe to contribute to the failure.
