Principal Investigator Michael Yazemboski
Senior Accident Investigator Michael Yazemboski
Region Director Byron E. Coy
Date of Report 10/29/2012
Subject Failure Investigation Report – Texas Eastern Transmission (SPECTRA)
Marietta Station Incident

Failure Investigation Report
Texas Eastern Transmission (SPECTRA) - Marietta Station Incident
[Failure Date 04/13/2012]

TEXAS EASTERN TRANSMISSION
MARIETTA COMPRESSOR STATION INCIDENT
APRIL 13, 2012
PHMSA ER INVESTIGATION DATES: APRIL 16-17,
2012

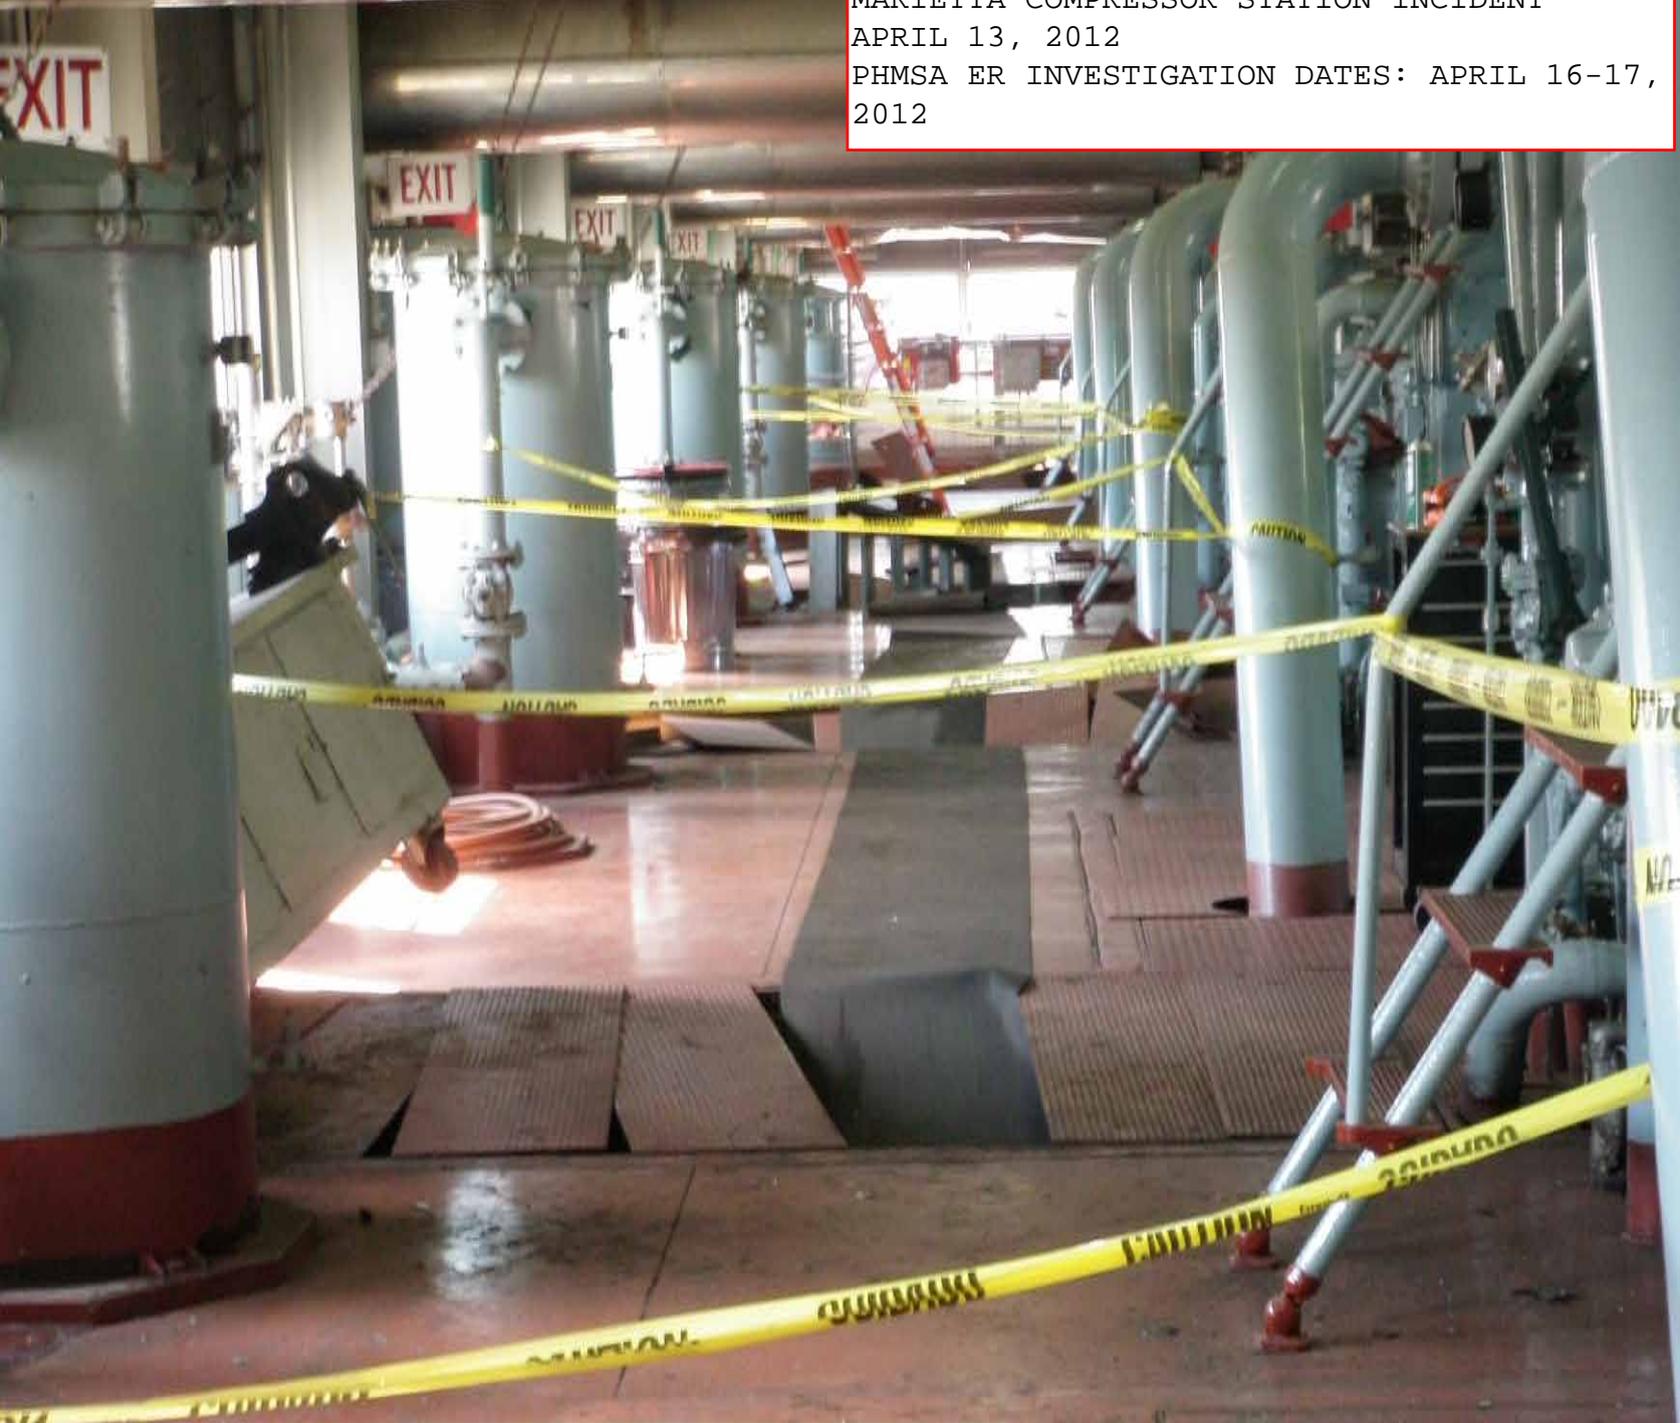
This photo shows the condition inside the Marietta Compressor Station following the incident that occurred April 13, 2012. Note the floor panels that were dislodged by the explosion throughout the length of the building. Air piping running under the floor was ruptured in many locations throughout the length of the building.

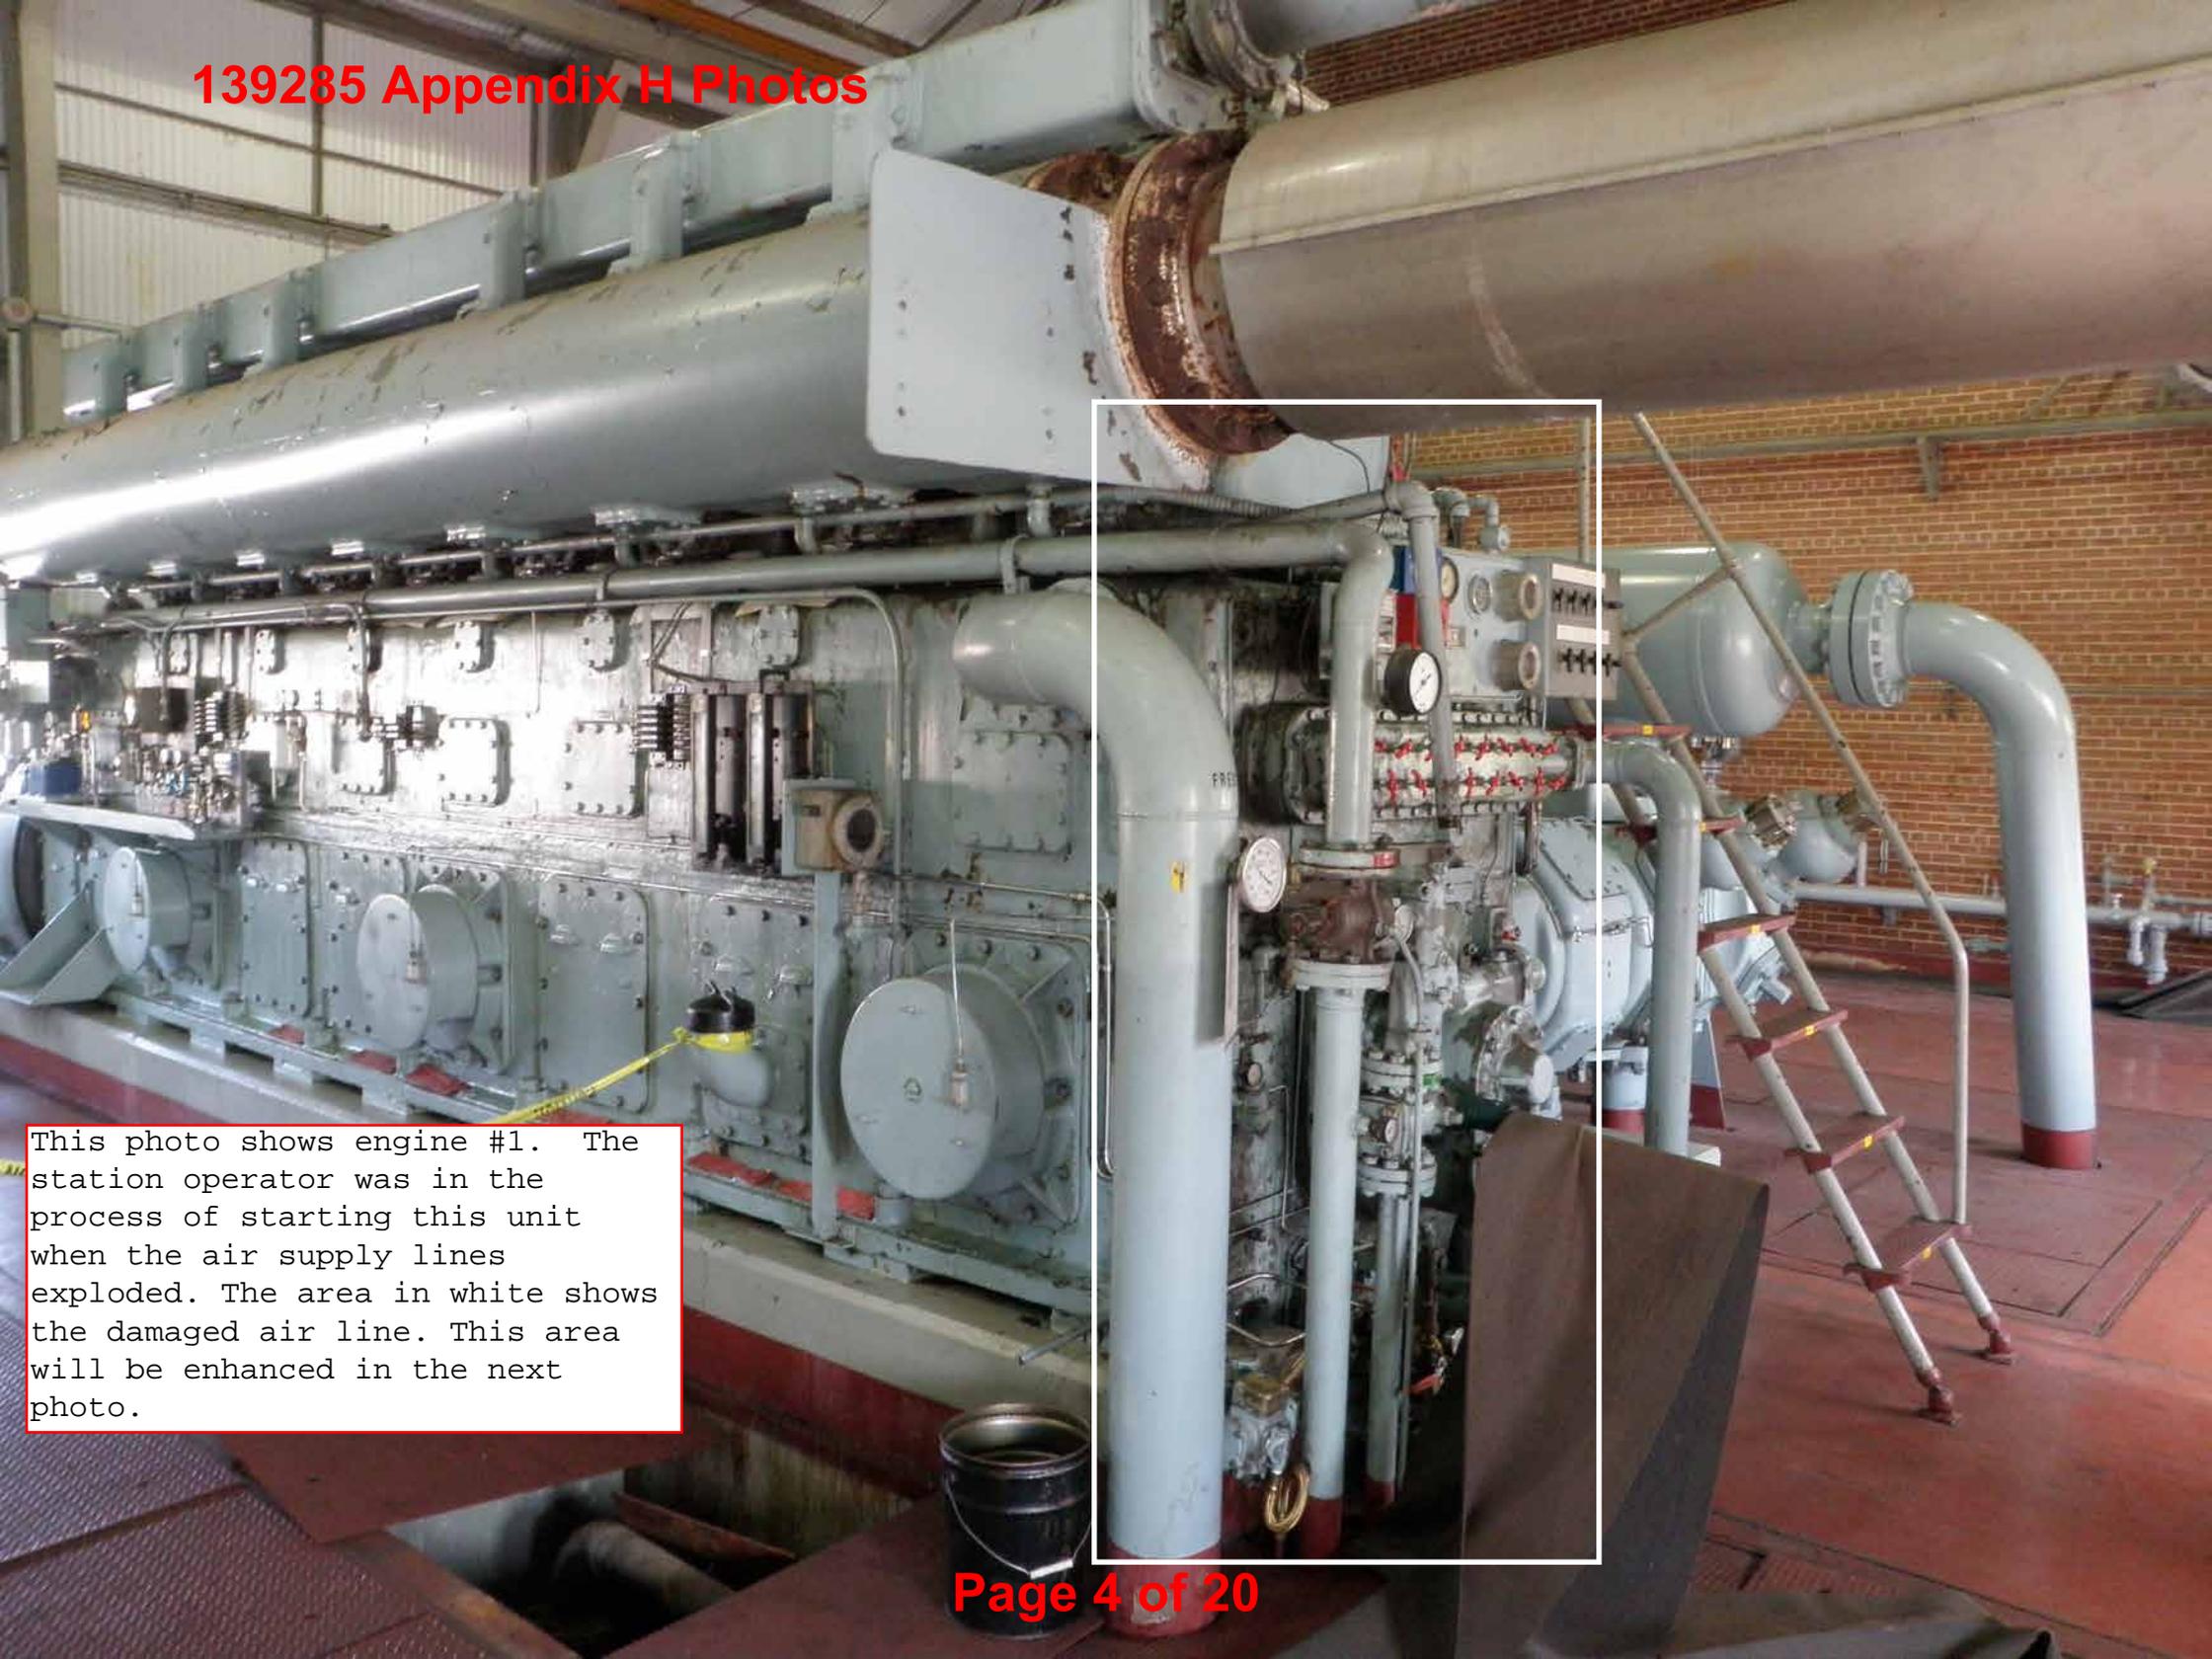
This photo shows engine #1. The station operator was in the process of starting this unit when the air supply lines exploded. The area in white shows the damaged air line. This area will be enhanced in the next photo.

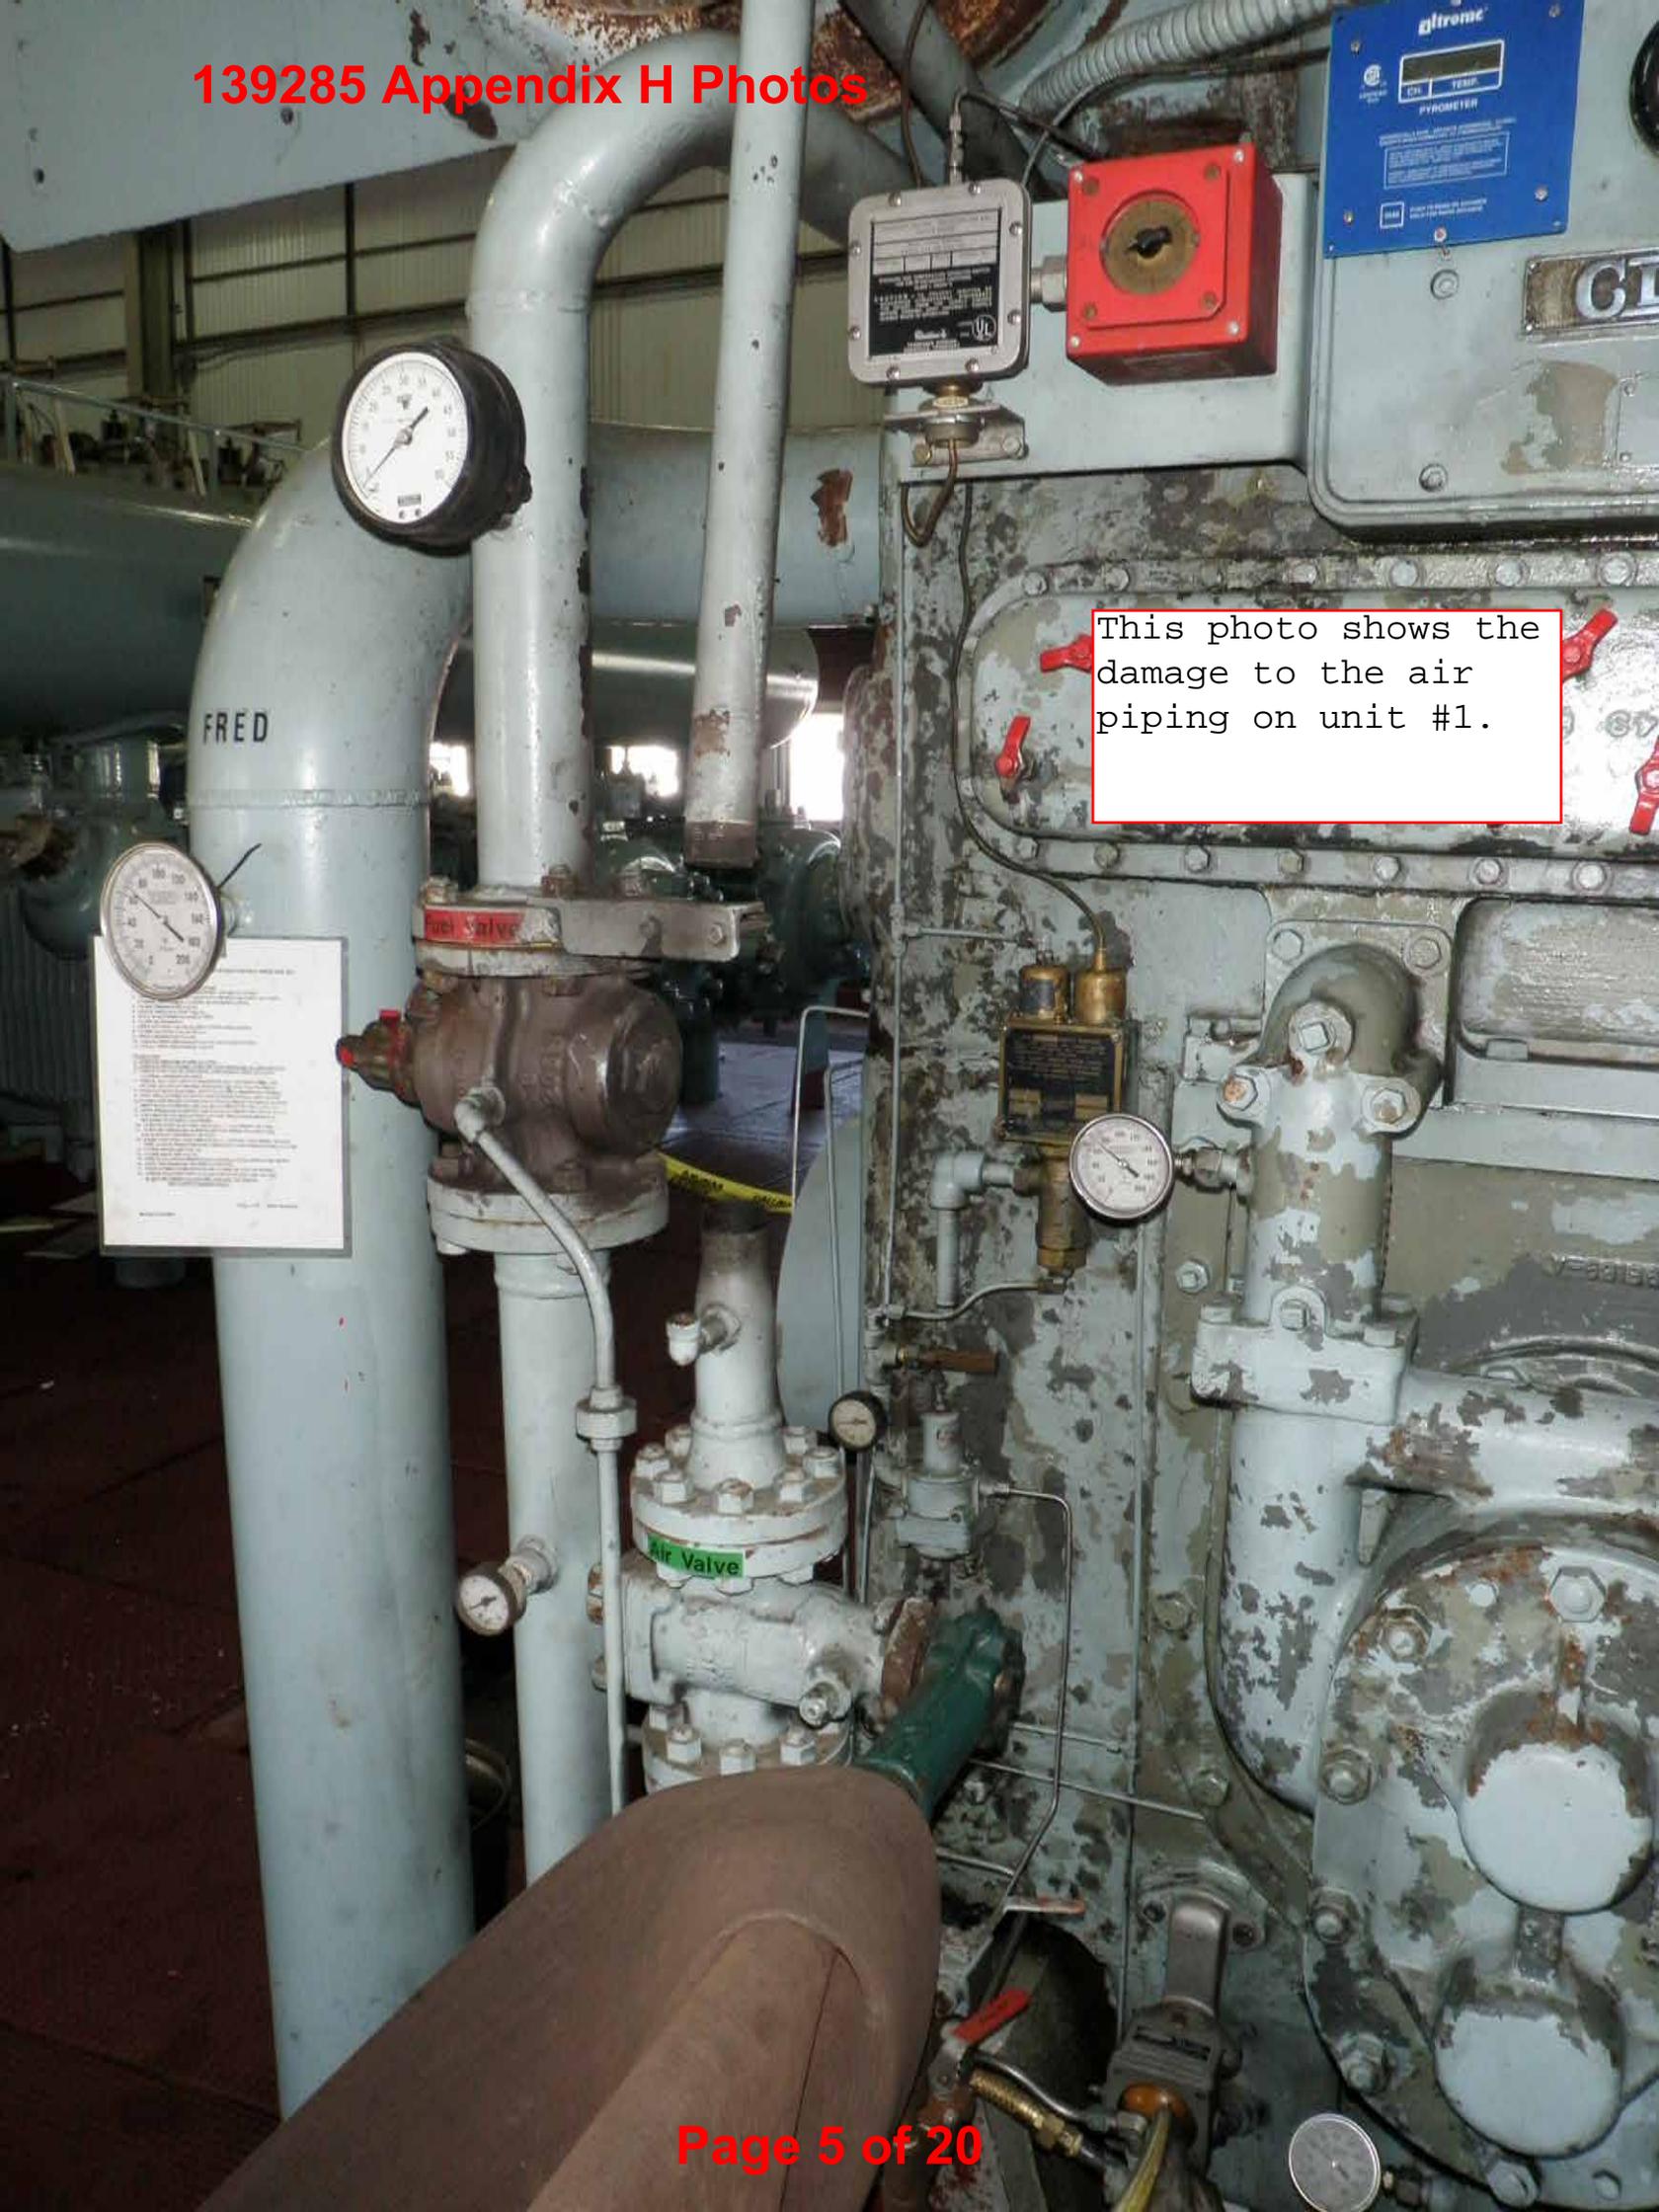
This photo shows the damage to the air piping on unit #1.

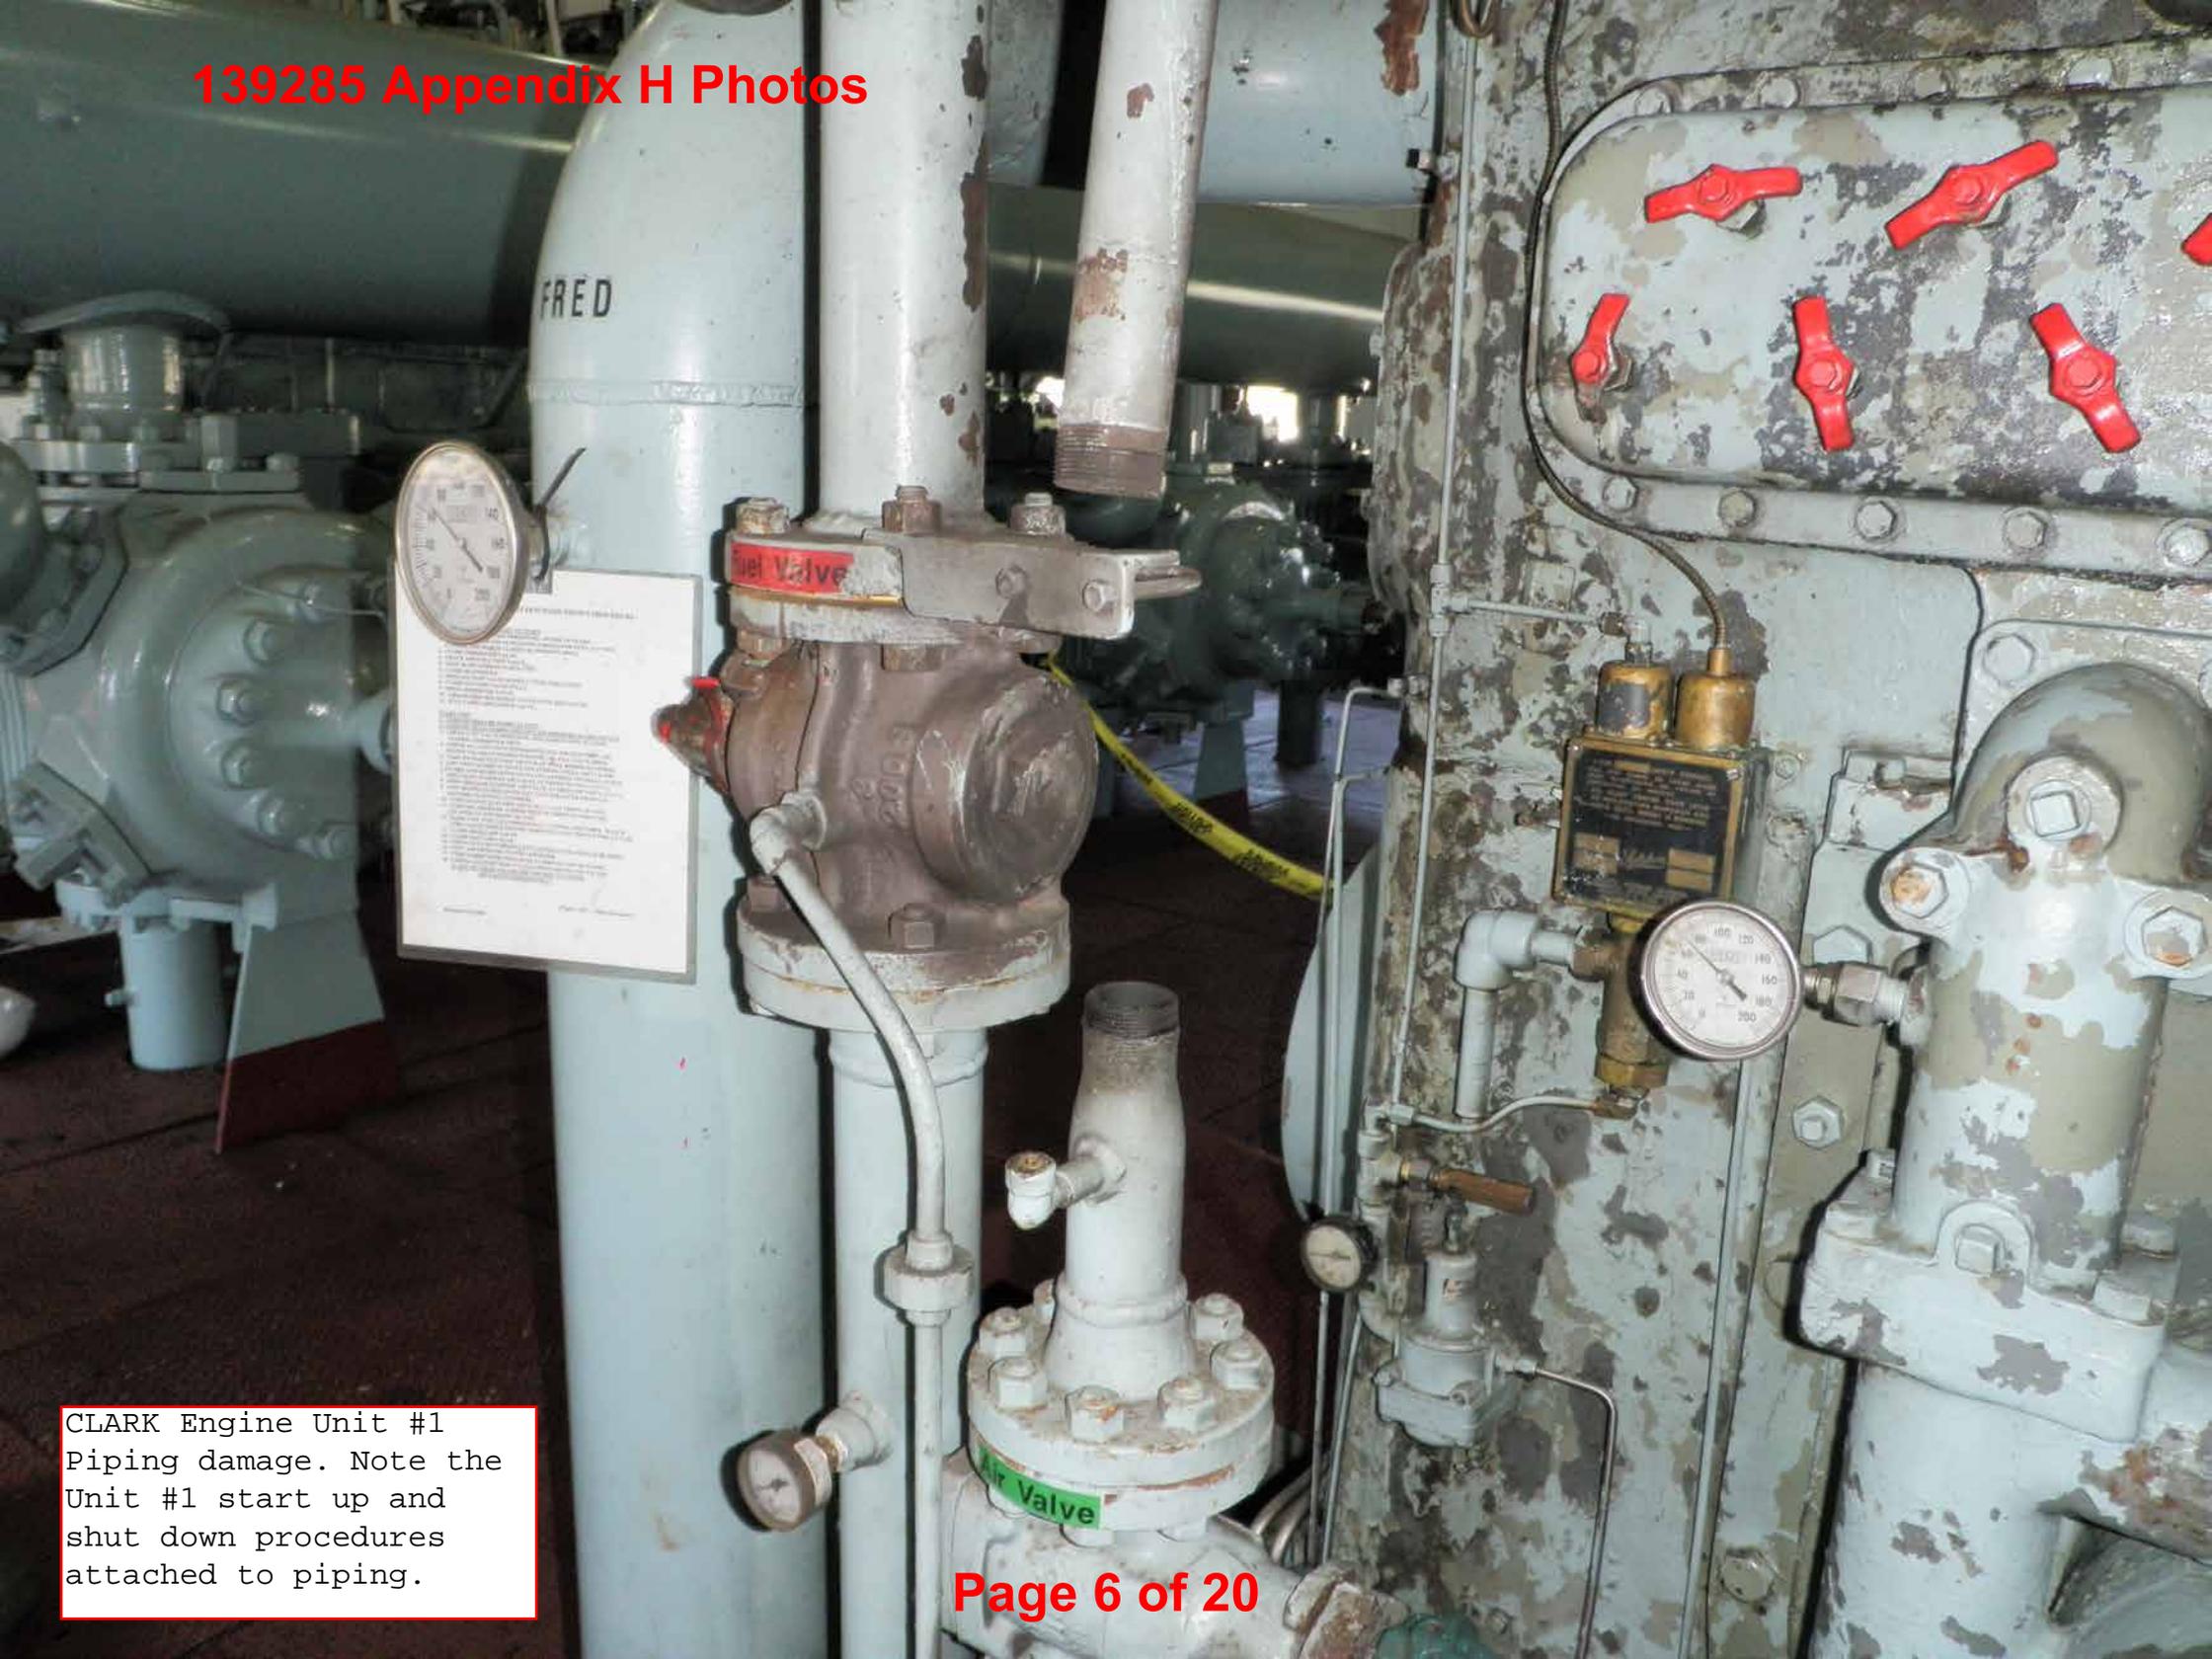
CLARK Engine Unit #1
Piping damage. Note the
Unit #1 start up and
shut down procedures
attached to piping.

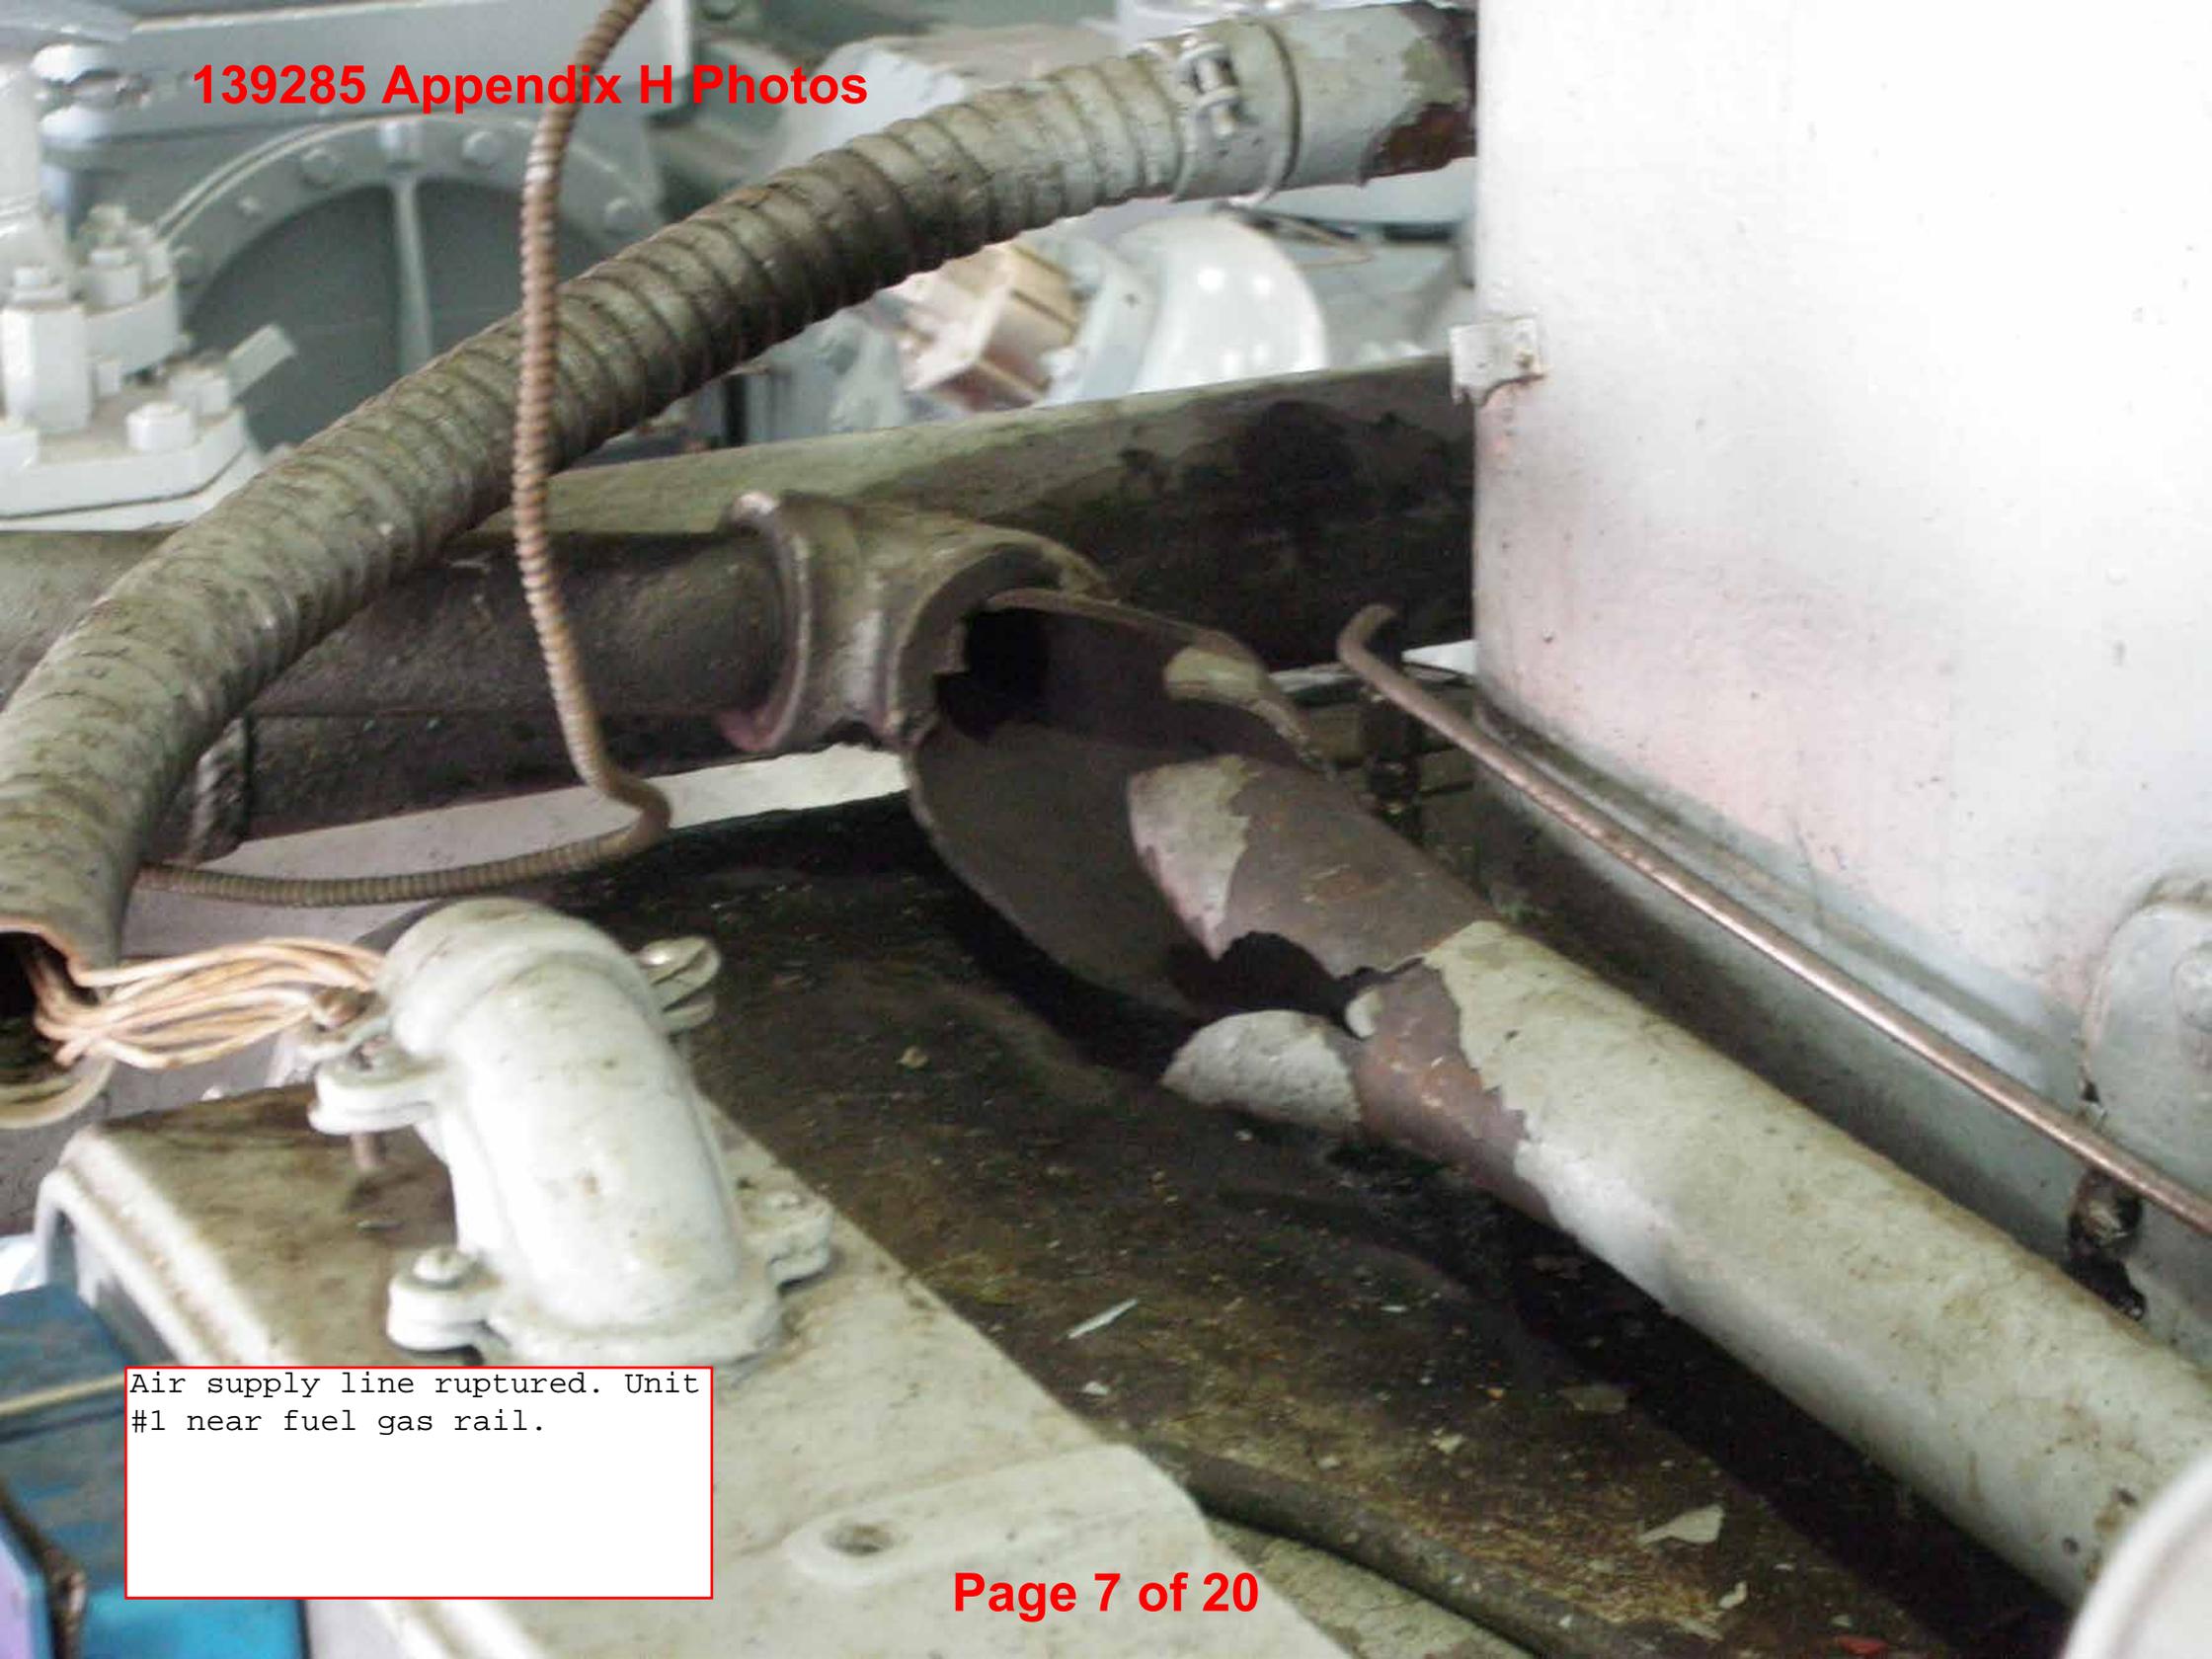
Air supply line ruptured. Unit #1 near fuel gas rail.

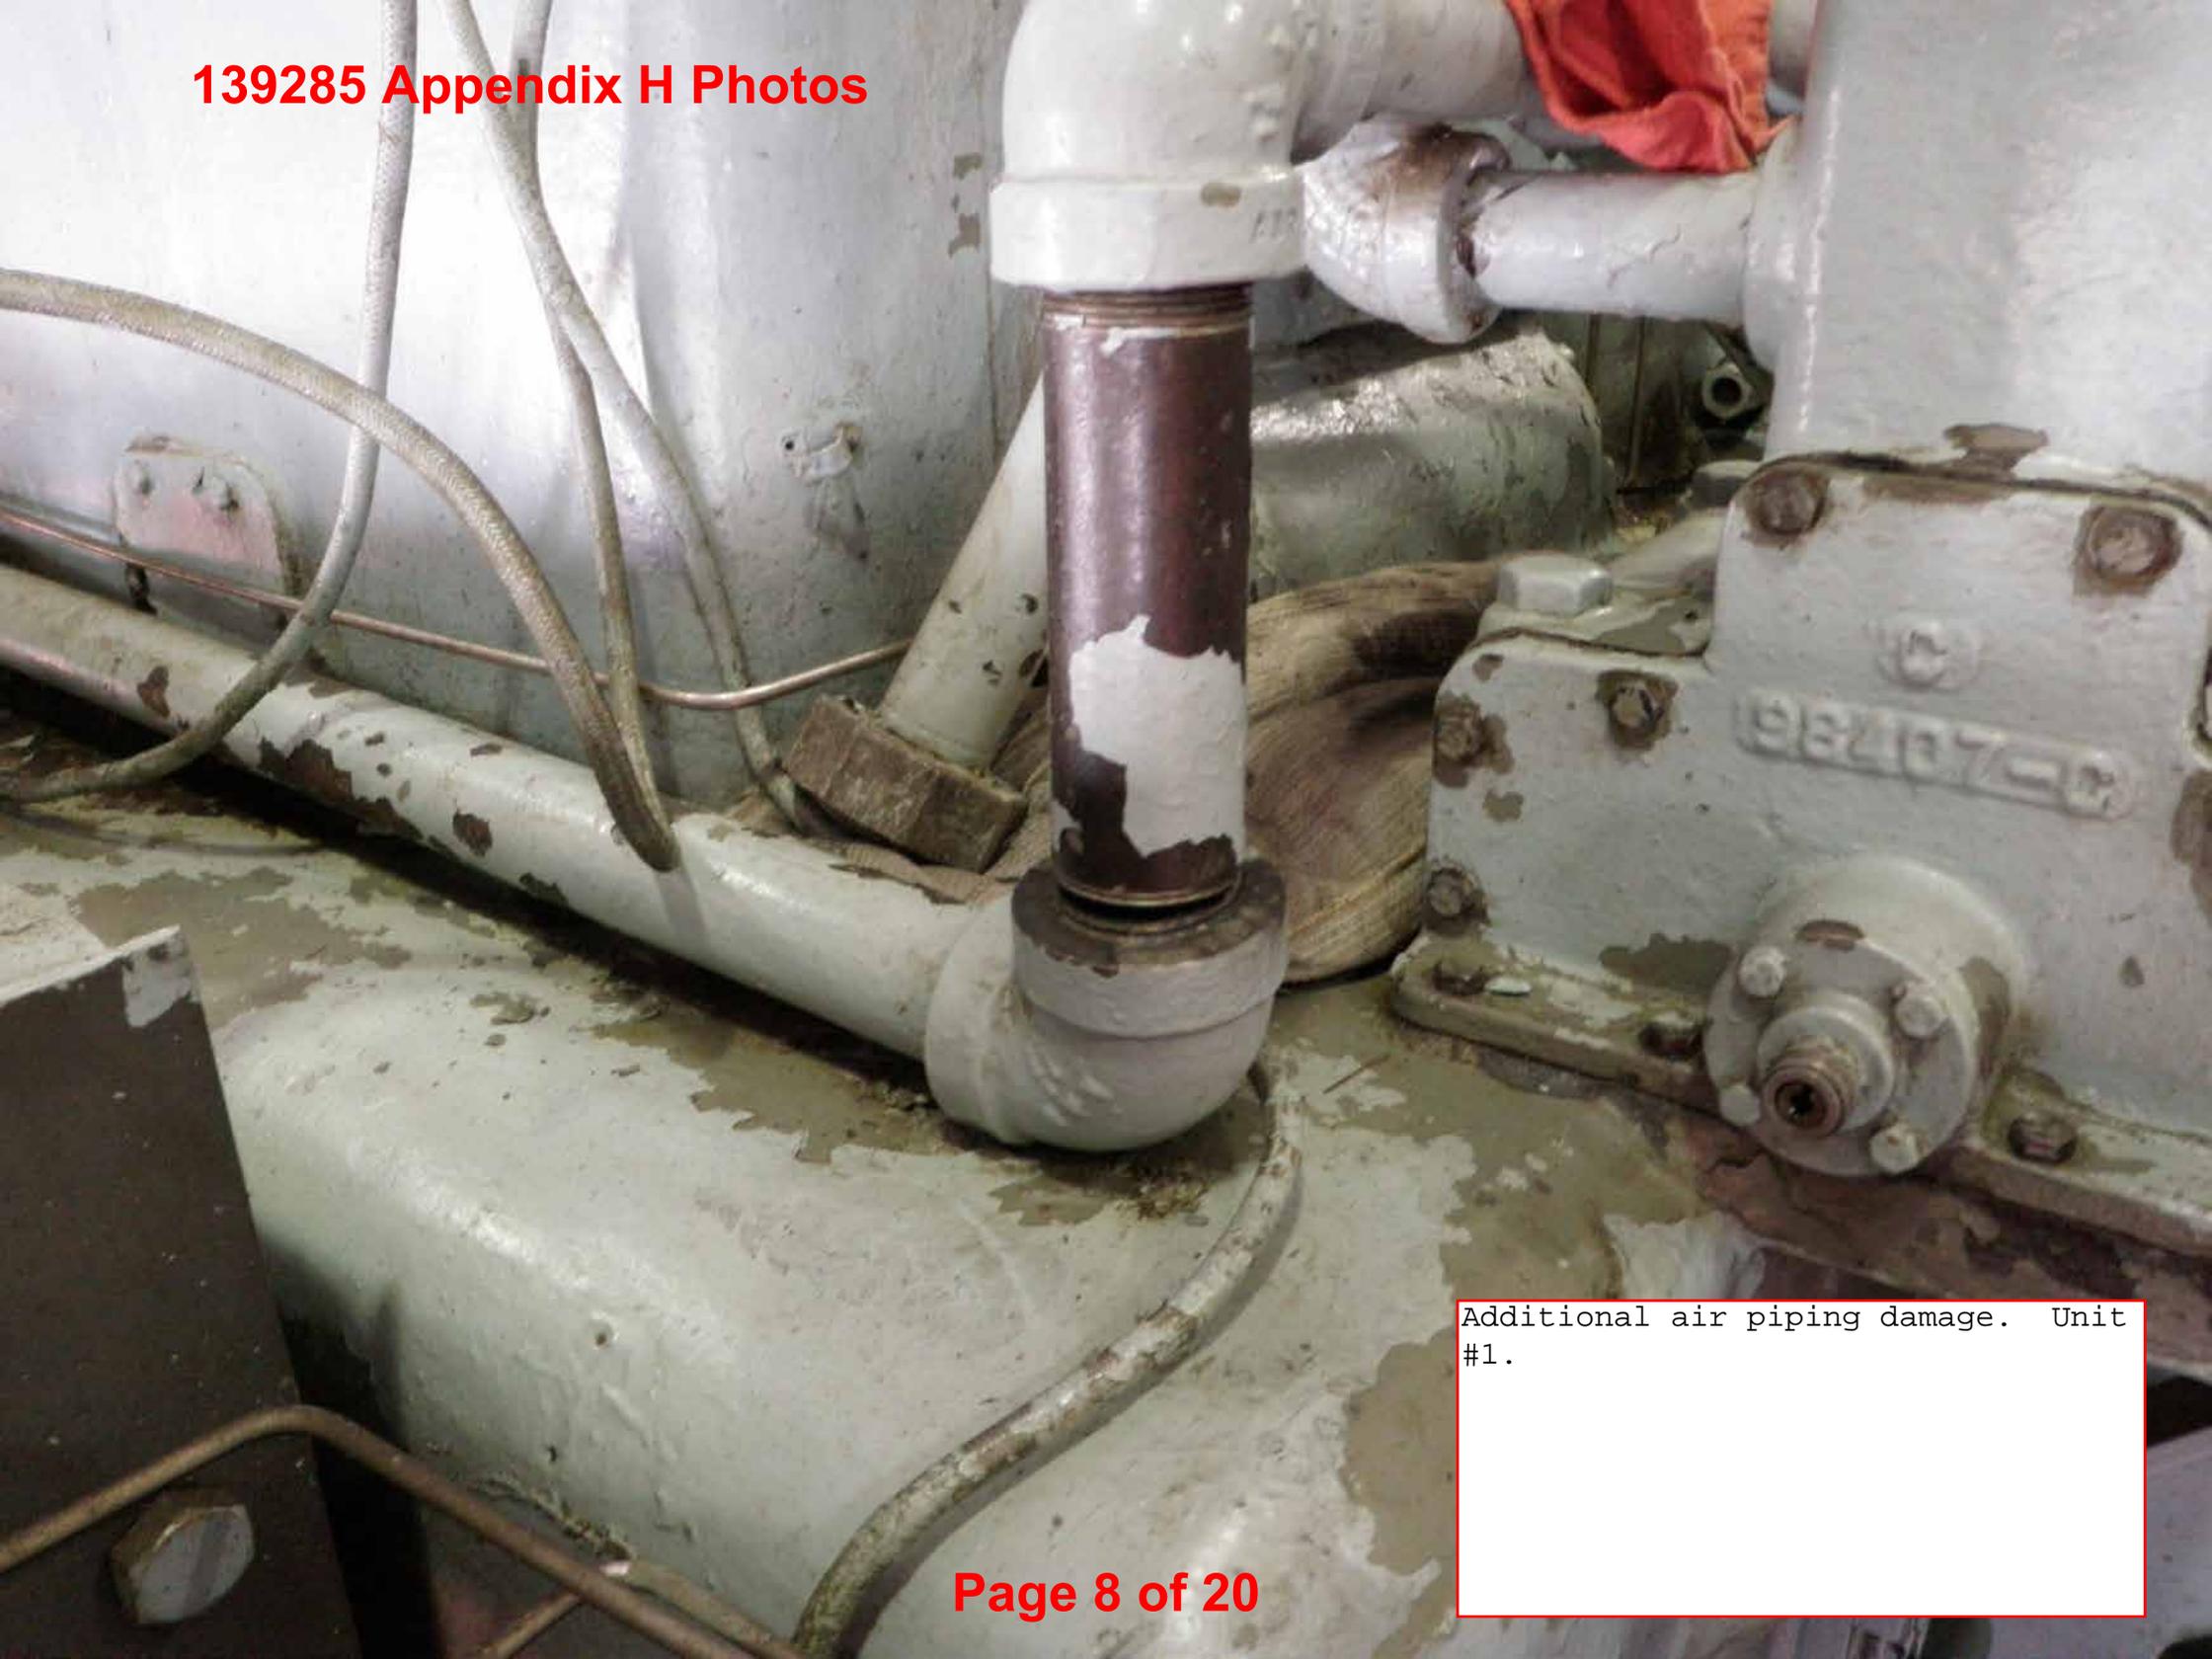
Additional air piping damage. Unit #1.
