Principal Investigator Michael Yazemboski
Senior Accident Investigator Michael Yazemboski
Region Director Byron E. Coy
Date of Report 10/29/2012
Subject Failure Investigation Report – Texas Eastern Transmission (SPECTRA)
Marietta Station Incident

Failure Investigation Report
Texas Eastern Transmission (SPECTRA) - Marietta Station Incident
[Failure Date 04/13/2012]

TEXAS EASTERN TRANSMISSION
MARIETTA COMPRESSOR STATION INCIDENT
APRIL 13, 2012
PHMSA ER INVESTIGATION DATES: APRIL 16-17,
2012

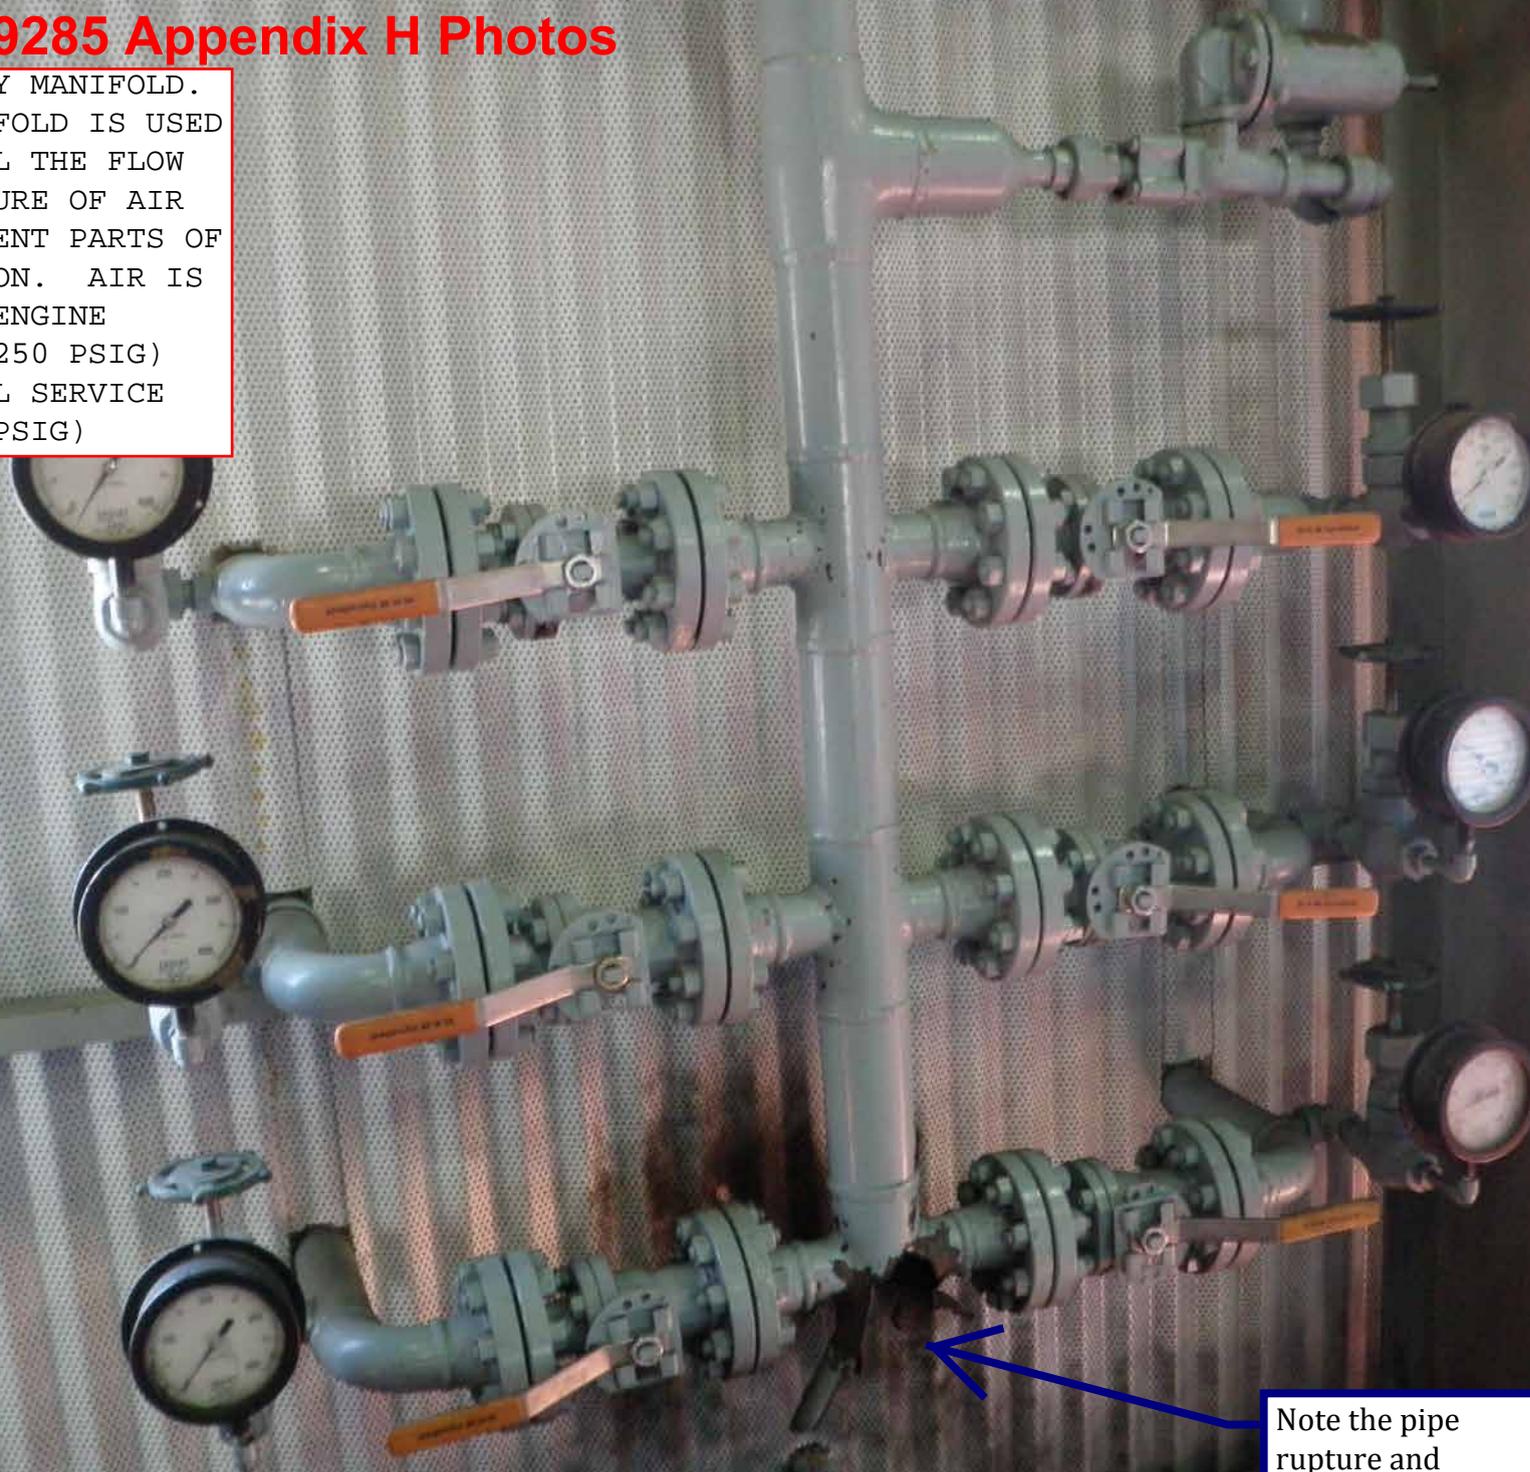
Note the pipe
rupture and
charring on the
wall panels.
