Principal Investigator Jeremy Kemak - NYSDPS
Senior Accident Investigator Michael Yazemboski - PHMSA ER
Region Director Byron E. Coy
Date of Report 10/29/2012
Subject Failure Investigation Report – Columbia Gas Transmission Millennium Pipeline Leak Owego, NY

Failure Investigation Report - Columbia Gas Transmission, Millennium Pipeline Weld Anomaly
Failure Date 01/11/2011

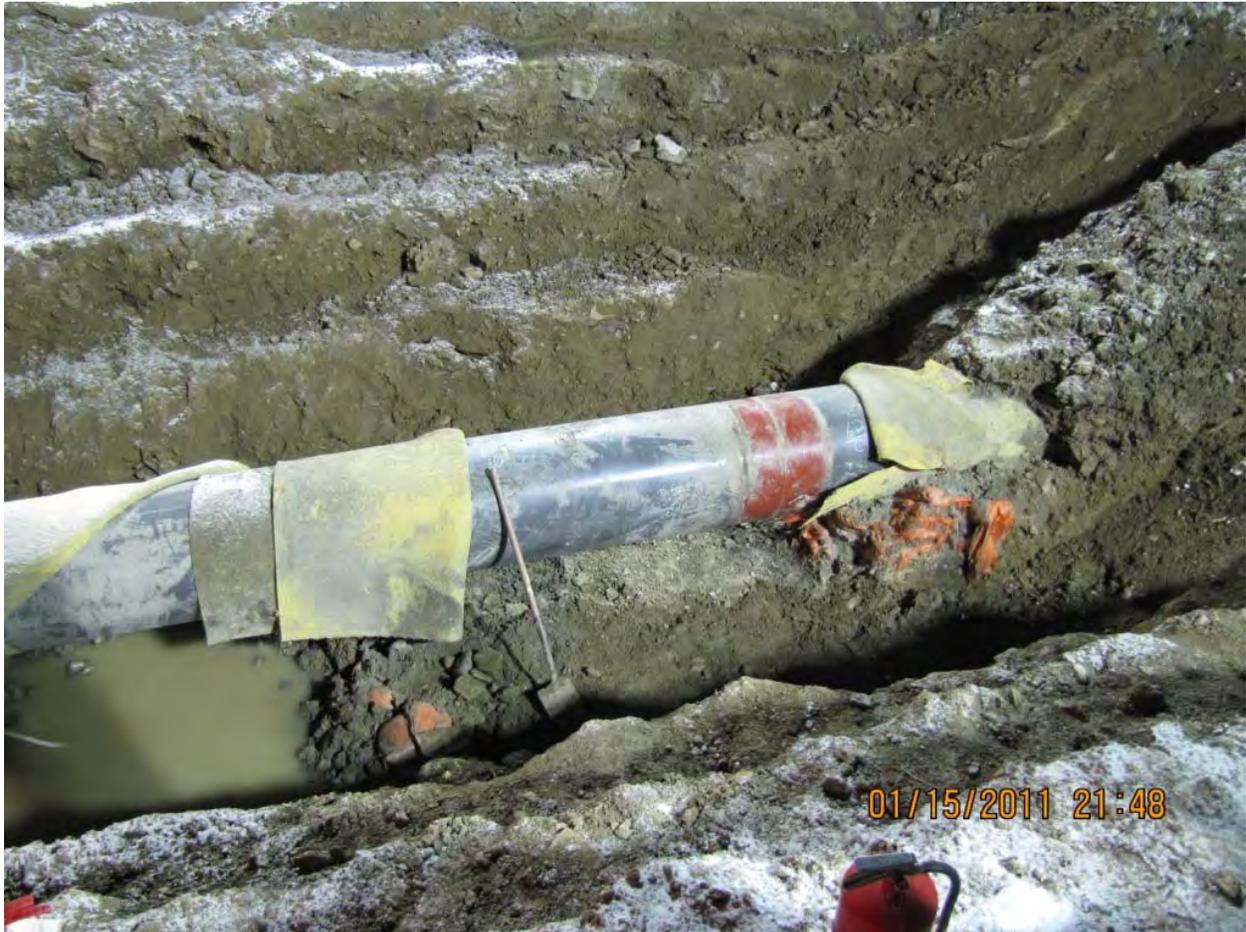
On January 15, 2011, the pipeline pressure was reduced to 200 psig, and excavation of the leak site began. At 17:30, an anomaly was exposed on a circumferential double joint weld. Following the blow down of the pipeline section, the mechanical weld that leaked was radiographed. It was concluded that

Exposed section containing double joint anomaly

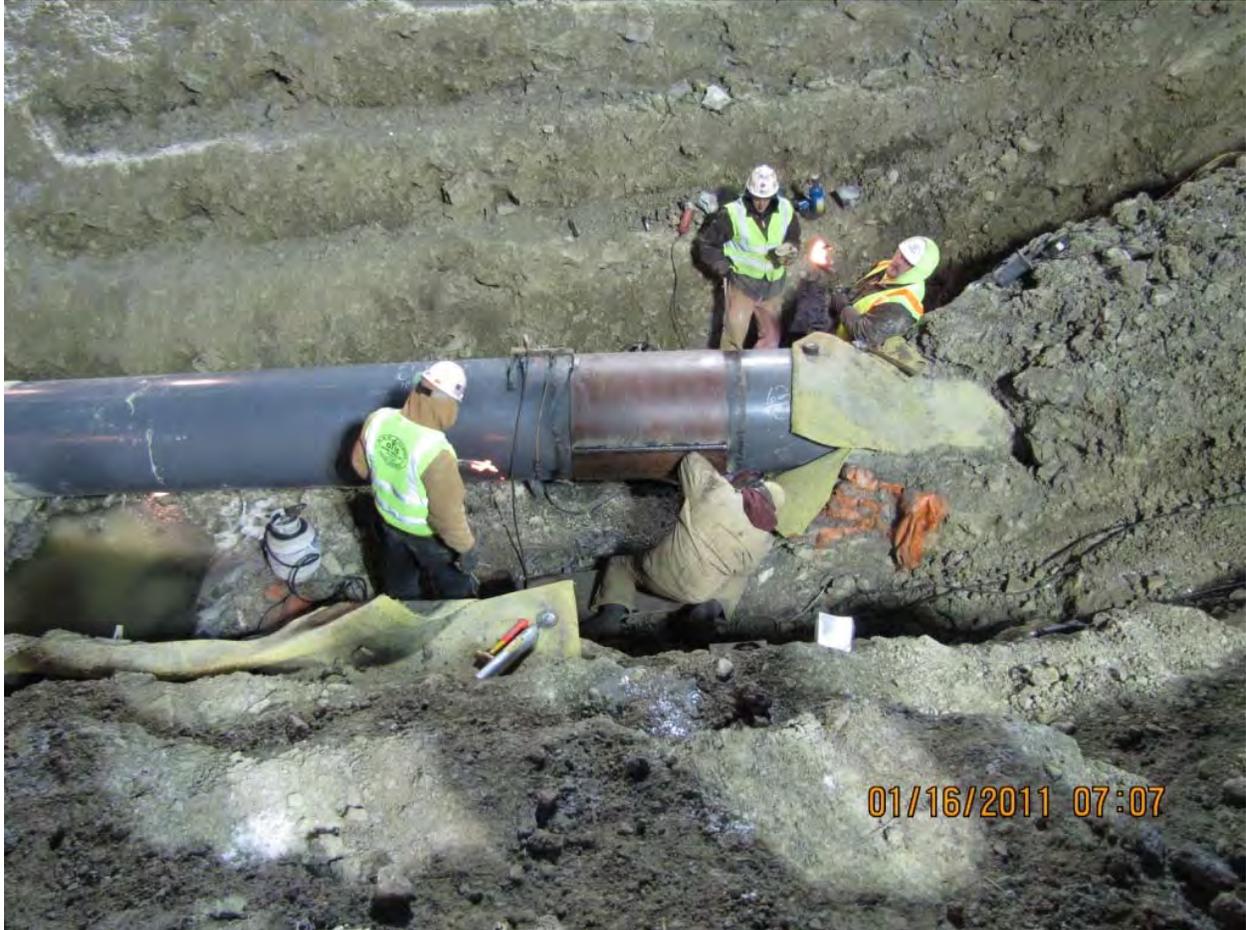
Repair sleeve being installed

In order to permanently repair the leak, excess material was removed from anomaly area, the weld was manually re-welded, and a 3/8 inch thick Dresser Style 115 welded repair sleeve was installed (Appendix B). The repair sleeve was non-destructively evaluated through magnetic particle inspection, and the repair of the leak was completed at 11:30 on January 16, 2011. Once coating was complete, proper backfill was reestablished, and the pipeline was returned to its normal operating pressure at 17:15 on January 16, 2011.

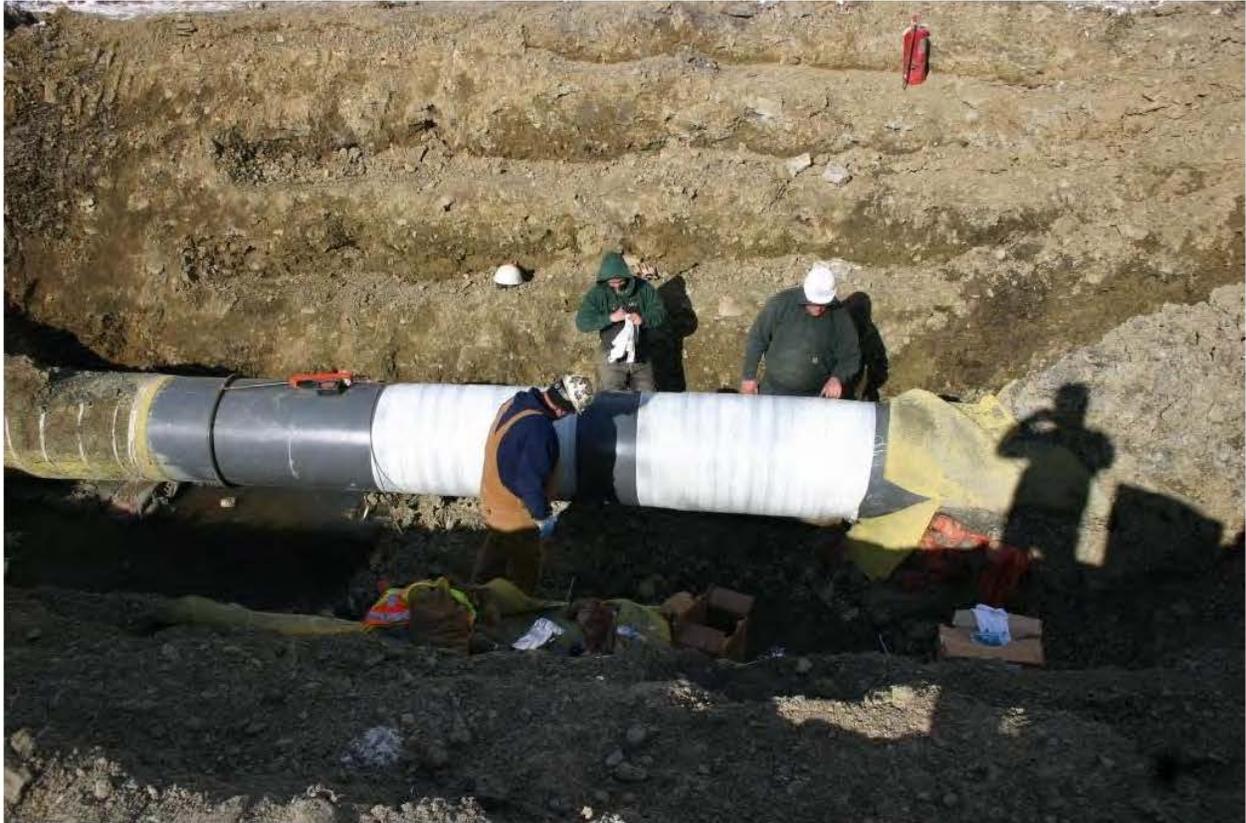
Tape wrap of repair sleeve

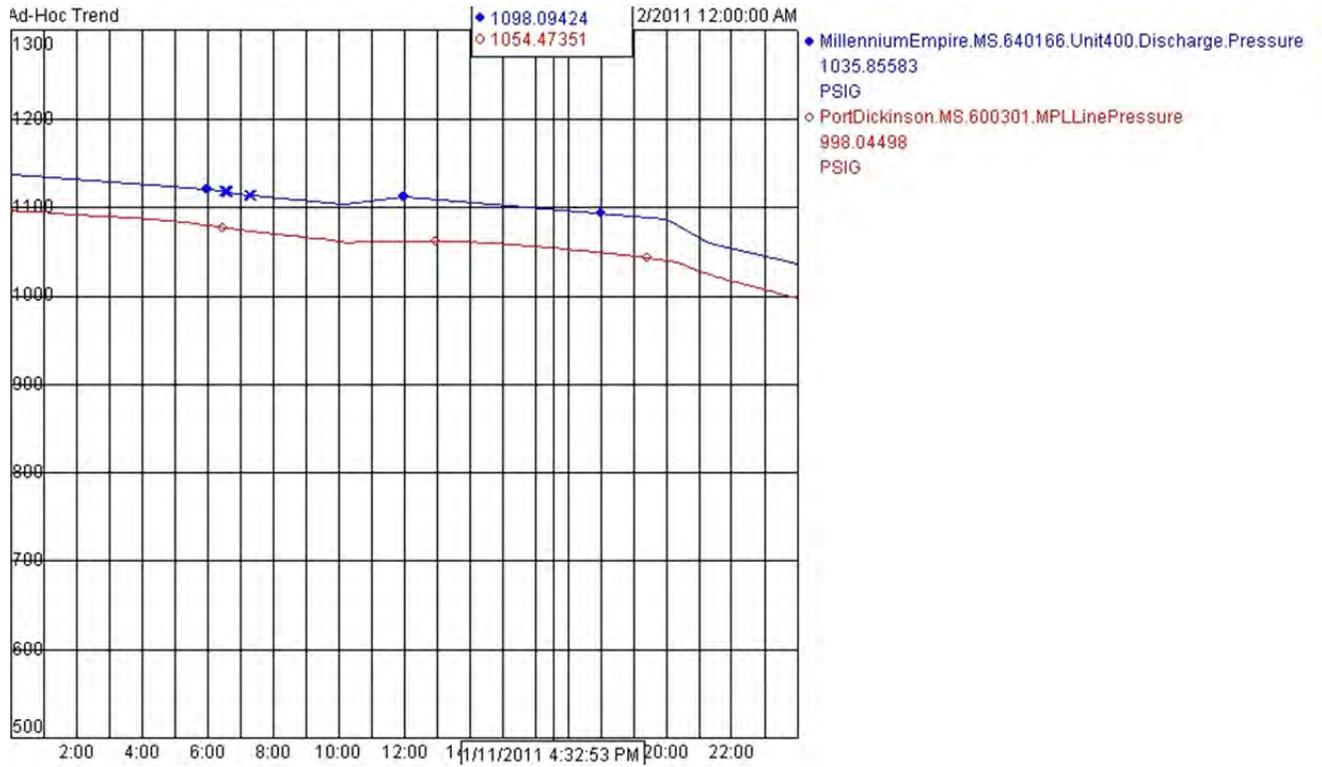
- c. Prior to the leak, the pipeline pressure at the leak location was 1070 psig, which is below the MAOP of 1200 psig for the system.
 - d. The pipeline was excavated at the leak location. Visual inspection indicated that the pipe burial depth was 72 inches, the pipe external coating was in good condition, and there were no signs of external corrosion.

Pressure at time of failure
