DOT US Department of Transportation
PHMSA Pipeline and Hazardous Materials Safety Administration
OPS Office of Pipeline Safety
Southern Region

Principal Investigator Chris Taylor
Region Director Wayne T. Lemoi
Date of Report October 12, 2012
Subject Failure Investigation Report – Central Florida Pipeline 10-inch Jet Fuel Pipeline Failure

Failure Investigation Report – Central Florida Pipeline 10-inch Jet Fuel Pipeline Failure

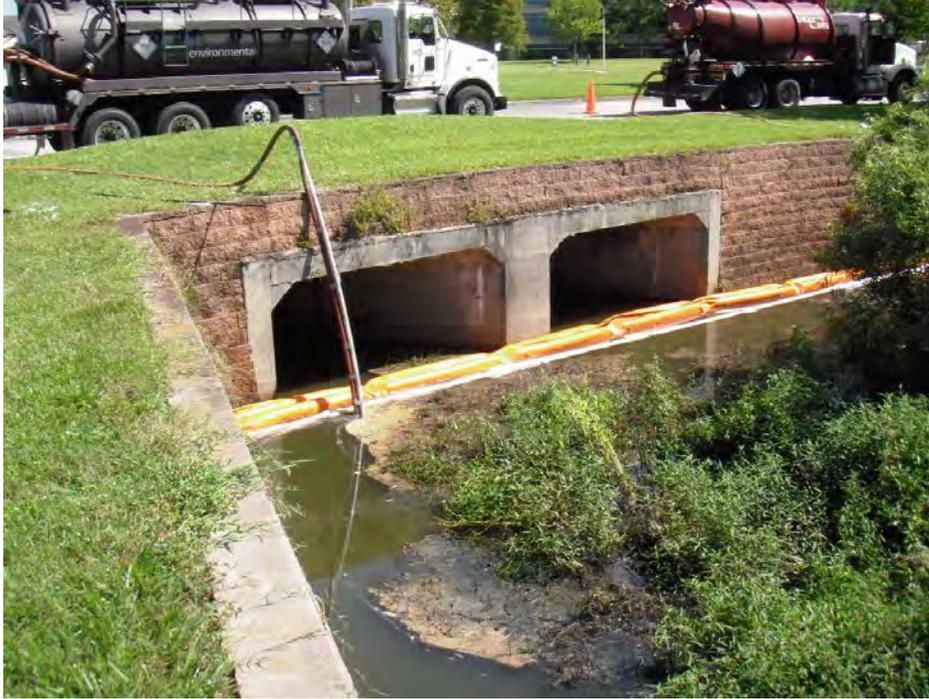
One of several boomed fuel collection points along the Mango Creek, the affected water body

CFPL's environmental response and remediation were supplemented by the response and actions of the state and federal environmental agencies. One key goal of the response was to prevent jet fuel from migrating to and contaminating the Tampa Bypass Canal.¹⁴ The overall response included, but was not limited to: monitoring the air for lower explosive limit (LEL) at the leak site and northward along Mango Creek; deploying hard and soft booms to abate the flow of jet fuel through the creek to the Tampa Bypass Canal; using vacuum trucks to suck product and sludge off the water; and, using underflow dams to allow water flow while capturing the floating jet fuel and sludge (Appendix A).

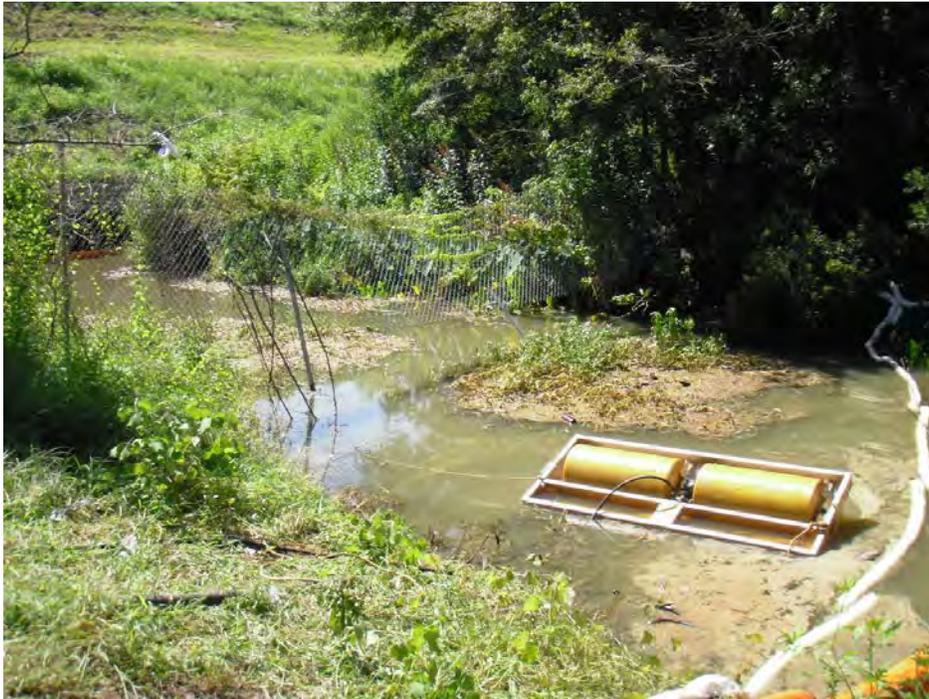
Skimmers and soft booms employed during the clean-up (Division 2)

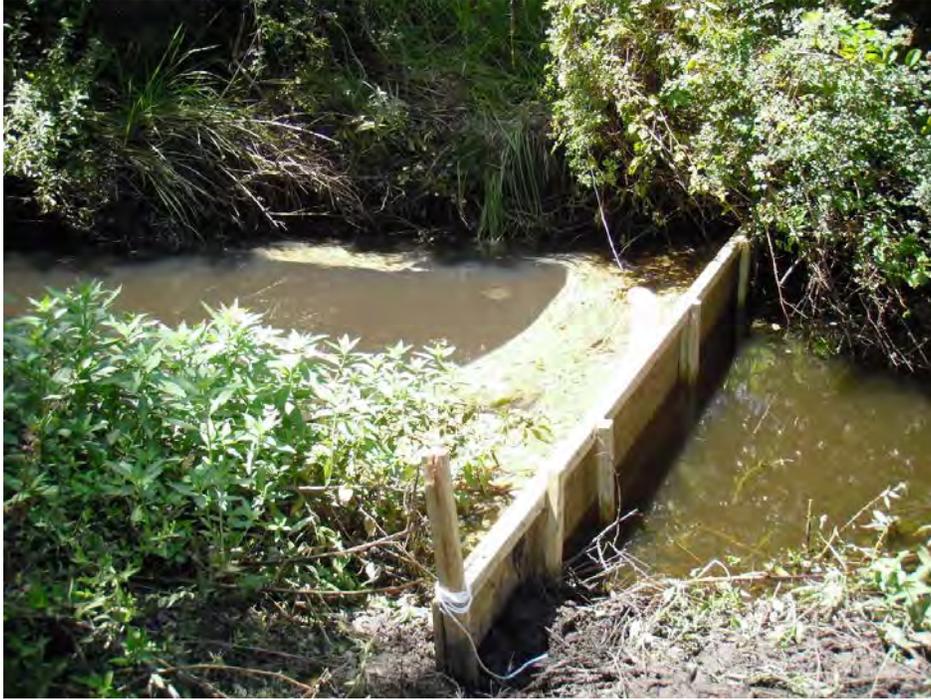
Under-flow dam constructed to prevent jet fuel progression into the Tampa Bypass Canal (Division 4)

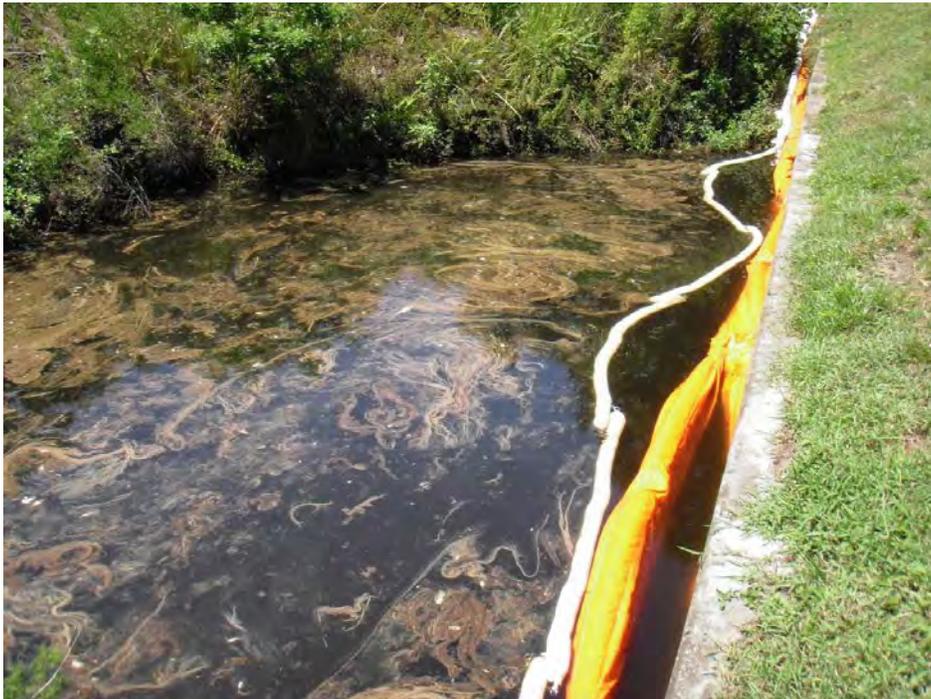
Hard and soft Booms at the final collection point before outflow to the TBC (Division 5)

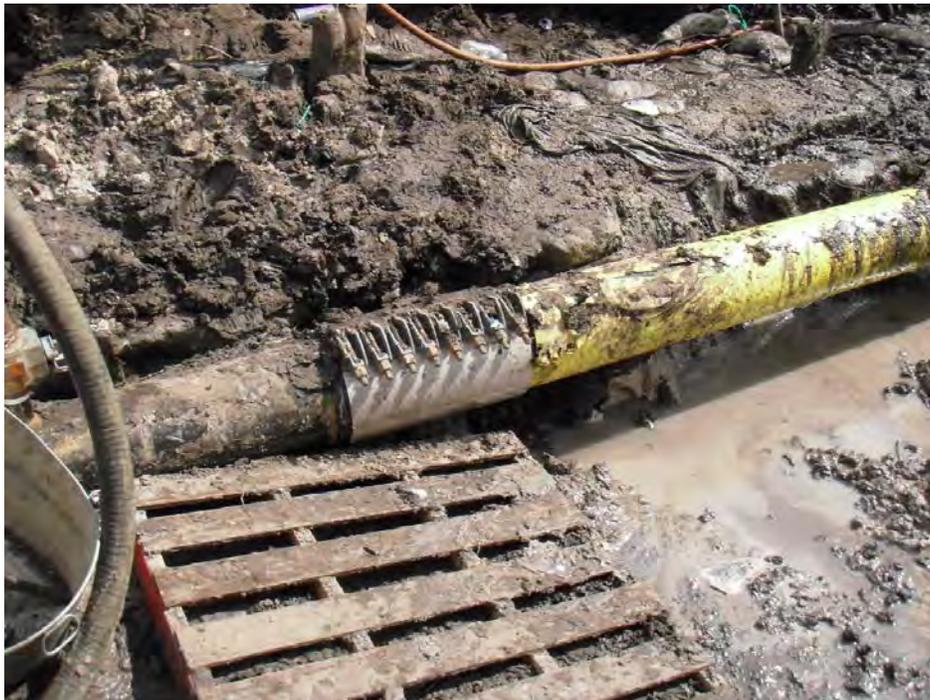
On July 24, 2011, CFPL's pipe repair contractor tapped the 10-inch pipe to begin drain-up of the isolated section. Concurrently, they stripped soil back from the upstream and downstream sides of the temporary leak clamp, to examine the pipe coating for additional evidence of mechanical damage. The PHMSA inspector and CFPL personnel observed additional coating damage approximately 4 feet downstream of the leak clamp. (Appendix A).

Leak clamp installed to stop leak and to facilitate the environmental cleanup.
Jet fuel flow was from right to left. Coating damage observed upstream of leak clamp.

After verifying the pipe leak, the contractor installed a temporary leak clamp to stop the leak and to allow for a more effective environmental cleanup. The stoppage of the leak also allowed for the removal of additional pipe coating to:

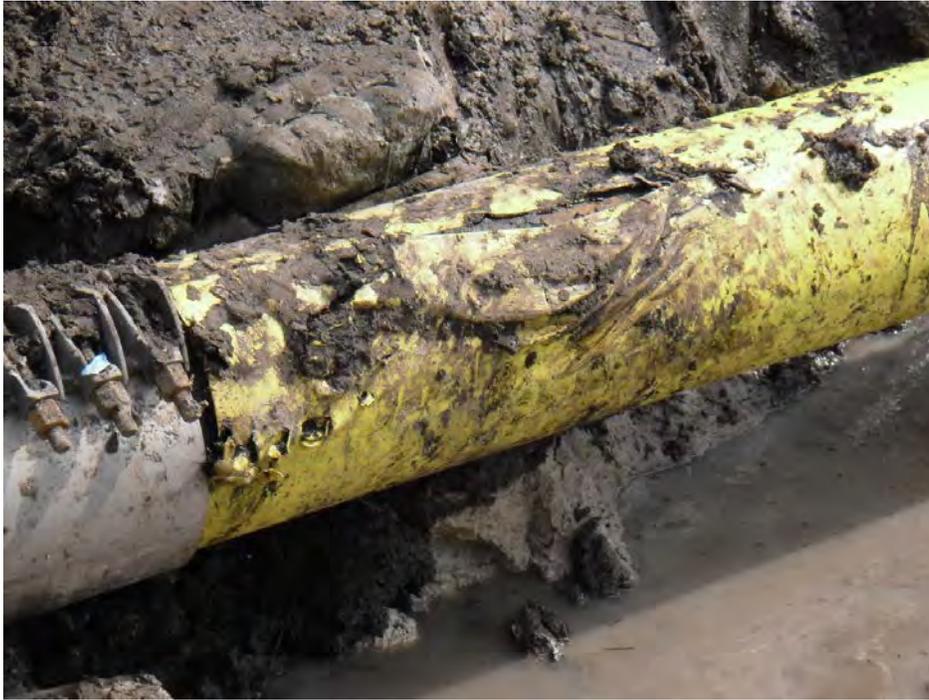
Closer view of coating damage

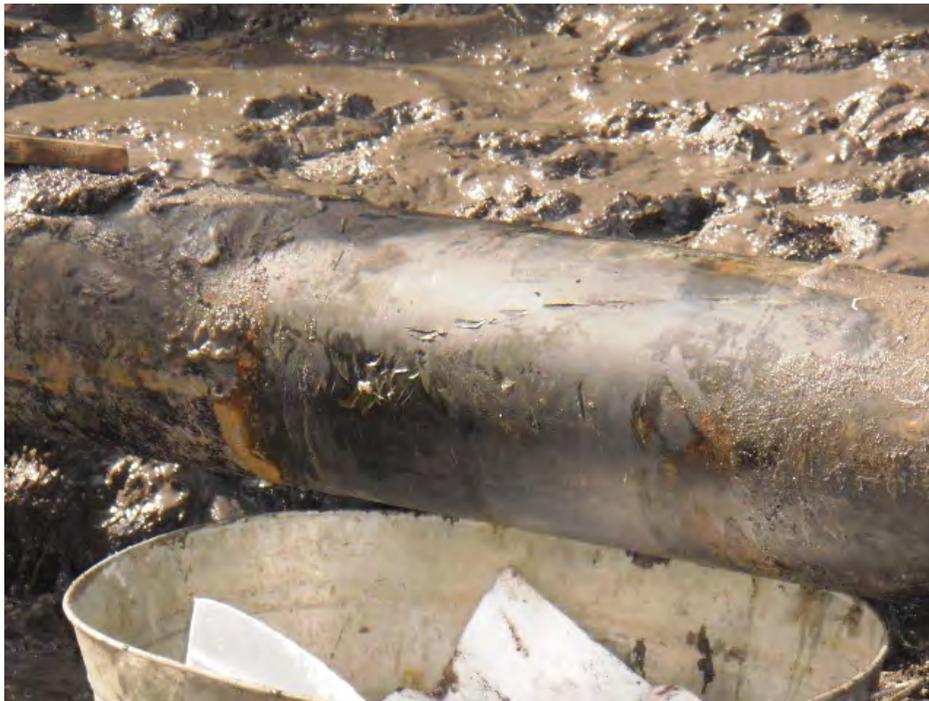
It is suspected, either upon being trapped in or being towed out of the muddy area, the trackhoe made contact with the 10-inch pipe resulting in the mechanical damage that led to the pipe failure.

As discussed in the *EMERGENCY RESPONSE* section of this report, PHMSA, CFPL personnel, and its contractors observed fuel leaking from one of several gouges on the 10-inch pipe. With that discovery, PHMSA focused its pipeline failure investigation on mechanical damage - first, second or third party. PHMSA and CFPL did not eliminate other possible causes of failure from consideration.

The mechanical damage was evident after leak clamp removal. The pipe leaked from one of the gouges shown in the photograph.

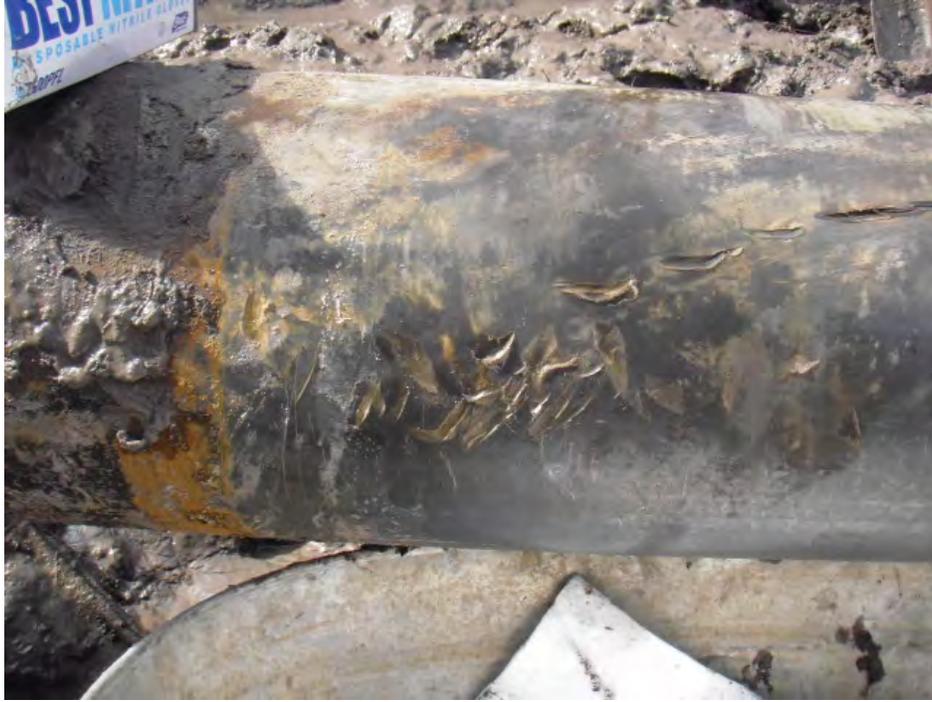
*"...the metallurgical cause of the release was a series of nearly collinear through-wall cracks measuring 3.75 inches...and located within a region of external mechanical damage...The examined pipe segment is otherwise free of any other wall thinning as the result of external or internal corrosion, is not ovalized, and its dimensions and chemical and mechanical properties are consistent with the requirements of API 5L Grade X60 pipe."*¹⁹

*"The mechanical damage on the pipe would have required digging equipment capable of applying both upward and horizontal force <between> 8,000-12,000 lbf."*²⁰

"The fracture surface morphologies of the through-wall cracks found within the gouging are consistent with a ductile tearing mechanism, which suggests that they were largely formed during the high-loading impact event that caused the external gouging. Exponent did not find evidence of fatigue crack growth or other time-dependent growth mechanisms..."

The pipe was damaged in the longitudinal and circumferential direction

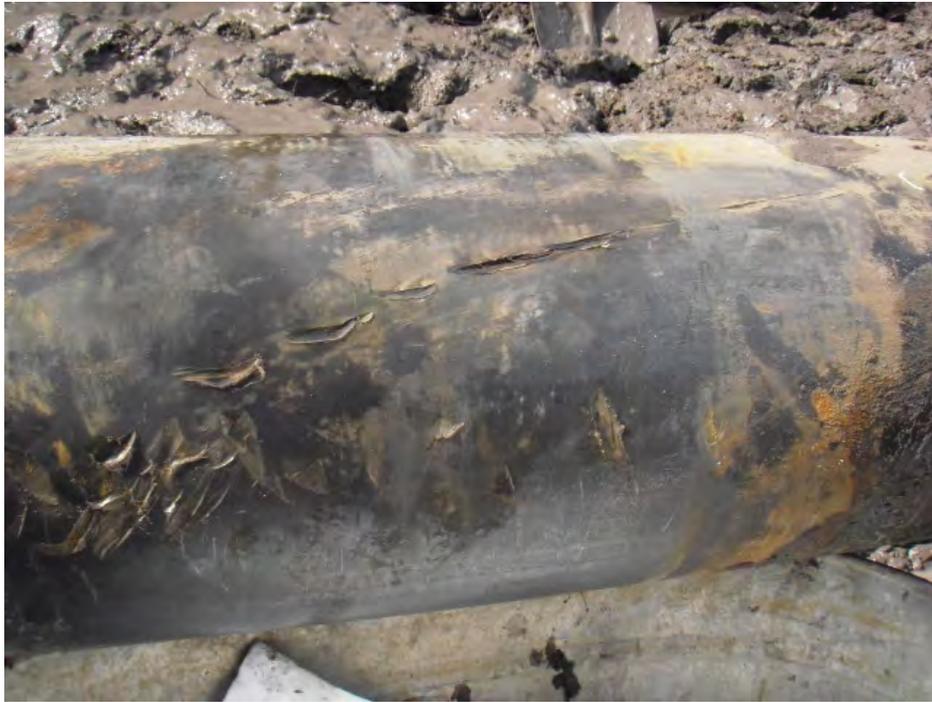
Additional photo showing mechanical damage

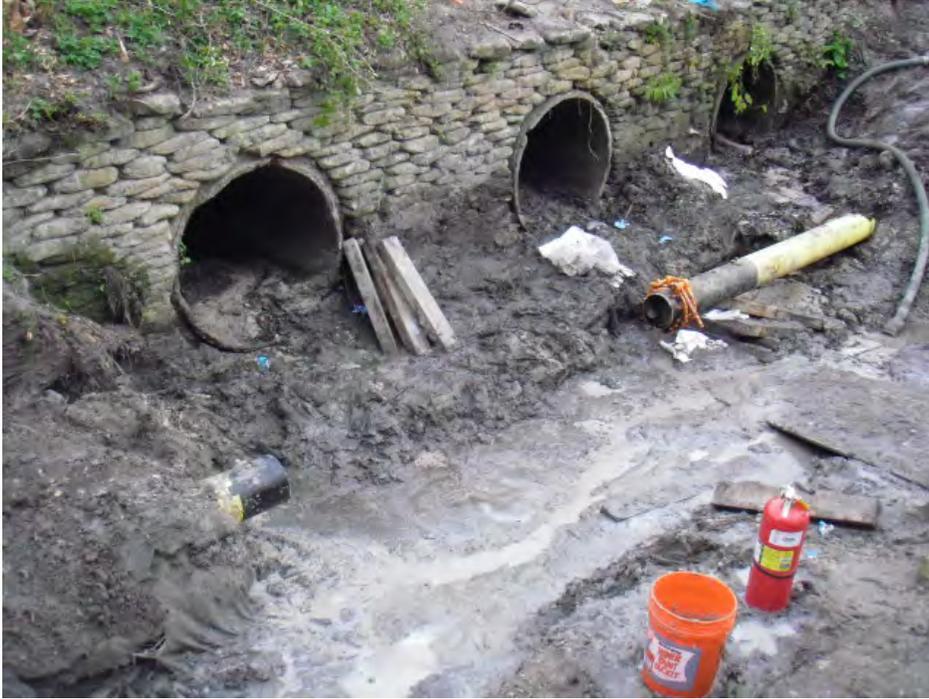
CFPL cut out 13-feet of the jet fuel pipeline that included the damaged section and sent it to Exponent Failure Analysis Associates for metallurgical and mechanical testing.

The CFPL contractor cut-out approximately 13 feet of the 10-inch pipe and replaced it with pretested pipe having the specifications listed below. The cut-out was sent to Exponent Failure Analysis Associates for metallurgical and mechanical analysis.
