Final Report

Technical Root Cause Analysis of Delmont Line 27 Failure – April 29, 2016

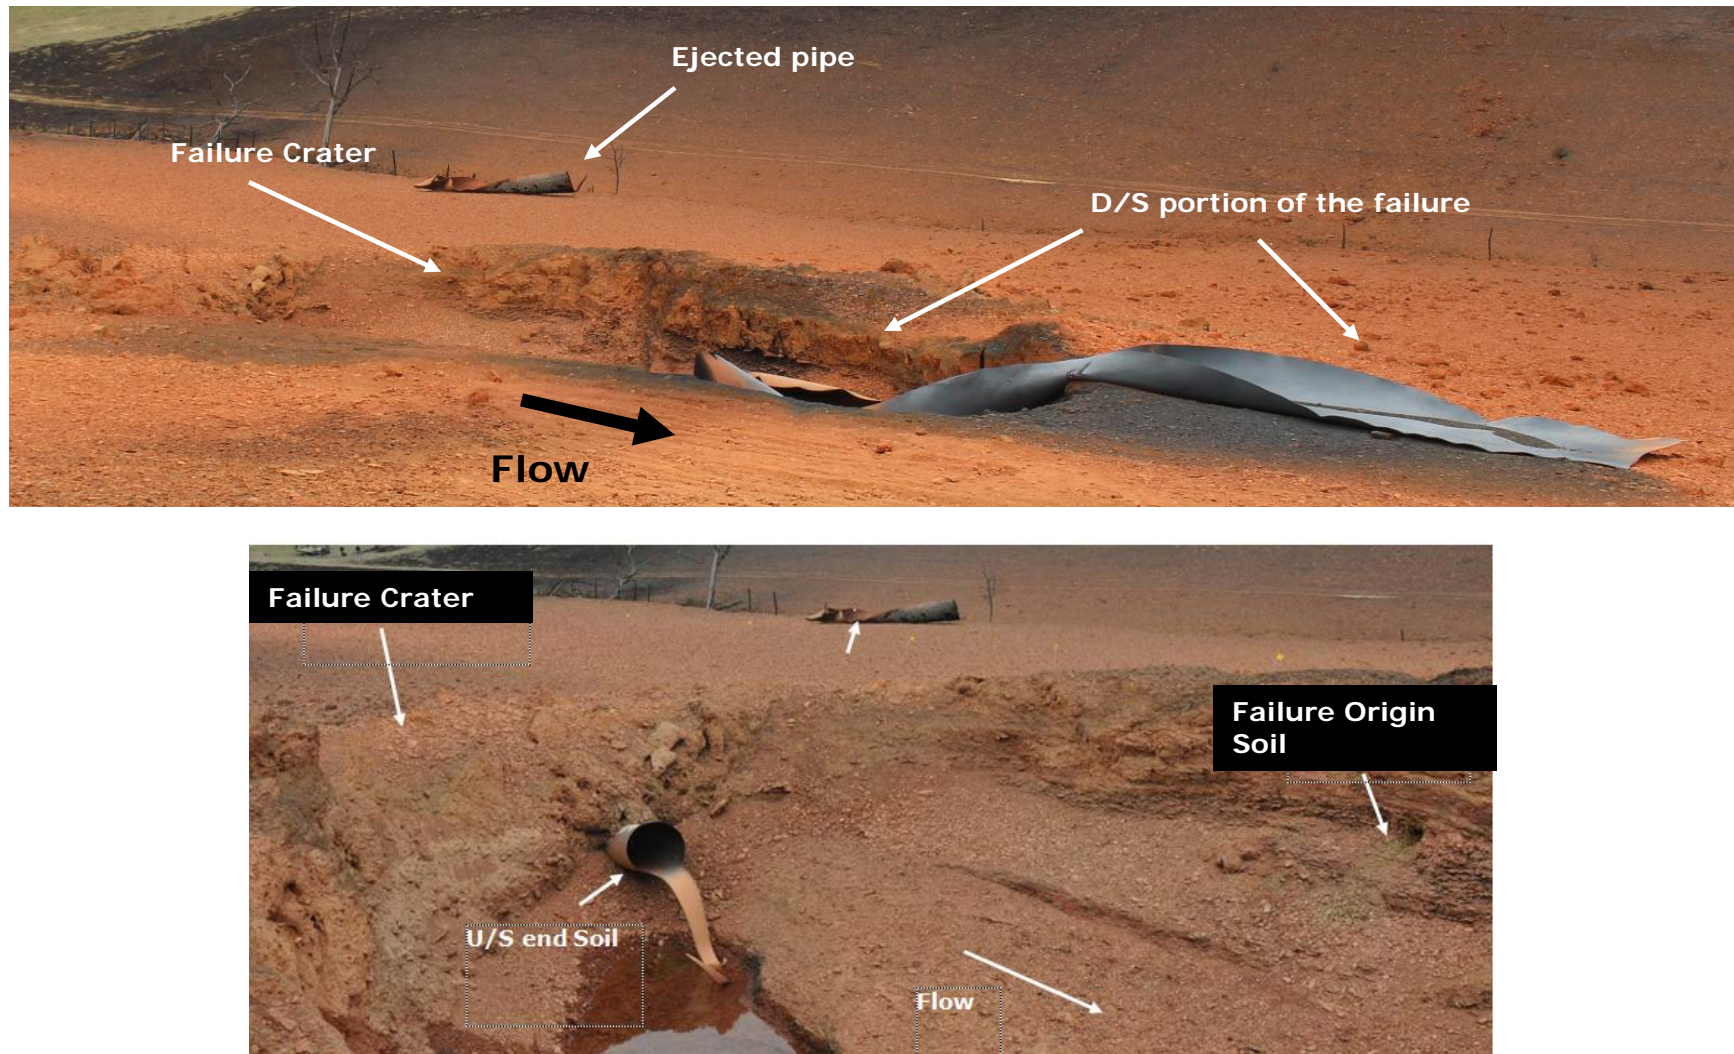
Figure 1. Photographs of the Failure Site showing the failure crater, the ejected pipe section, the U/S and D/S termini of the failure, and the locations where soil samples were collected.

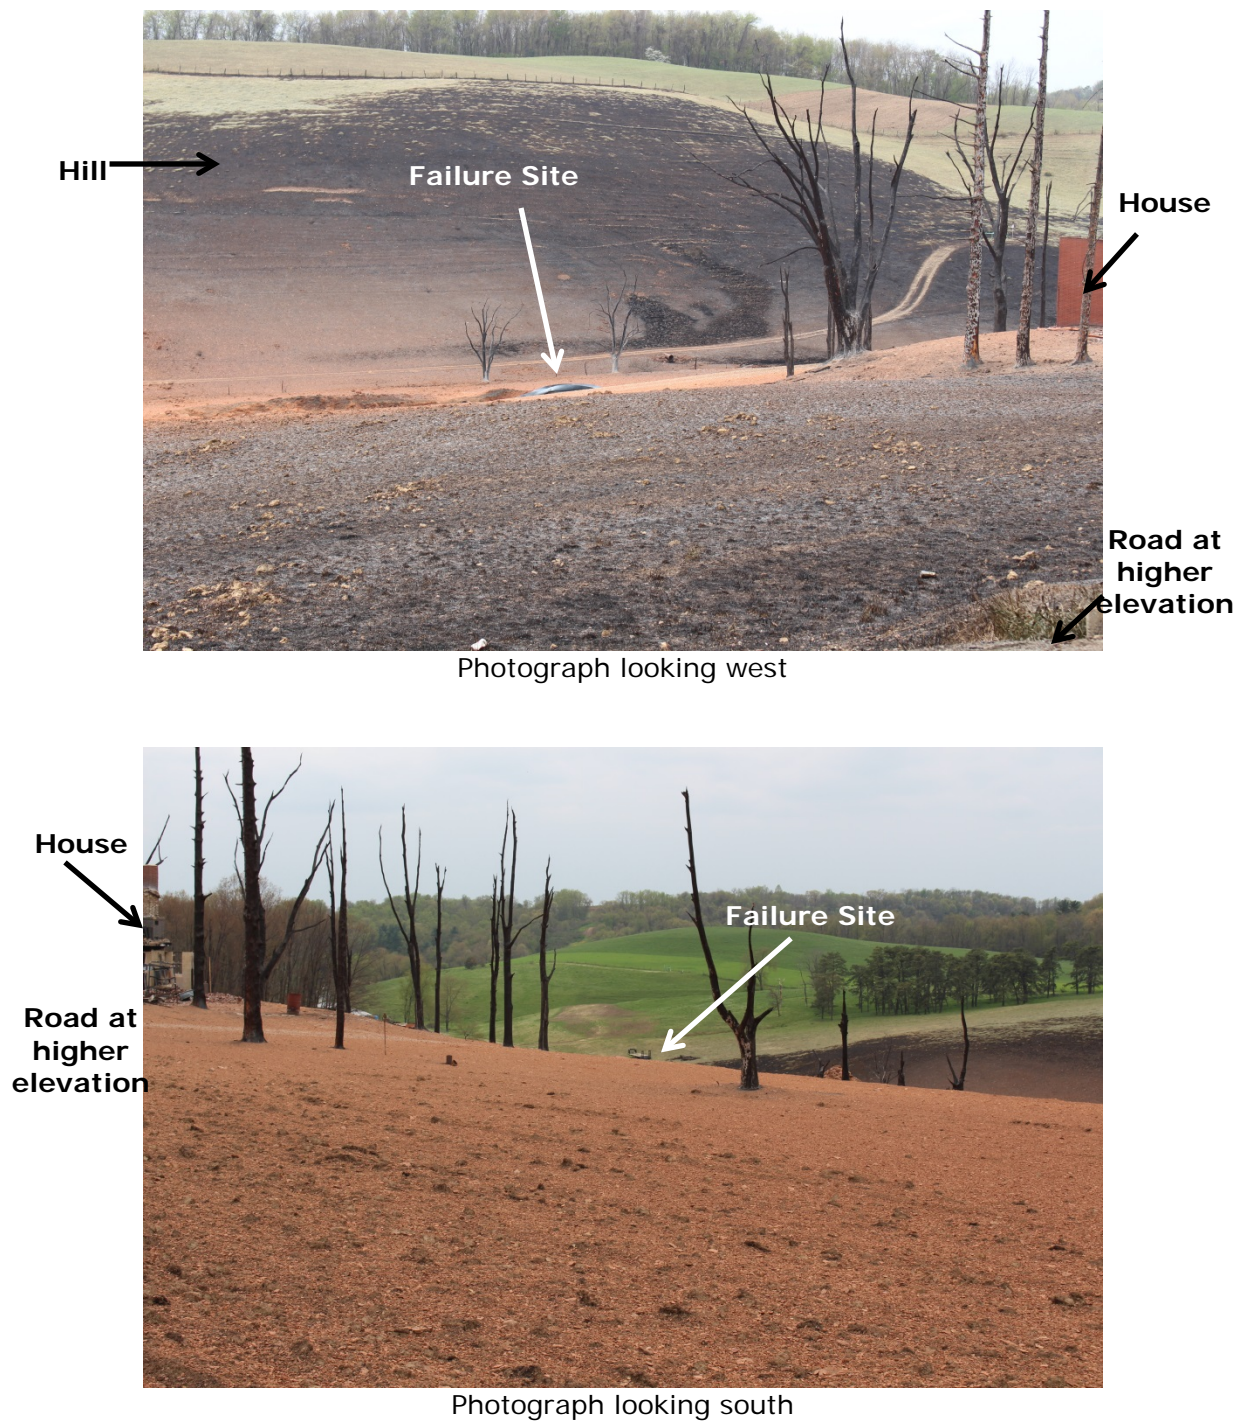
Figure 2. Field photographs showing the topography in the vicinity of the Failure Site.

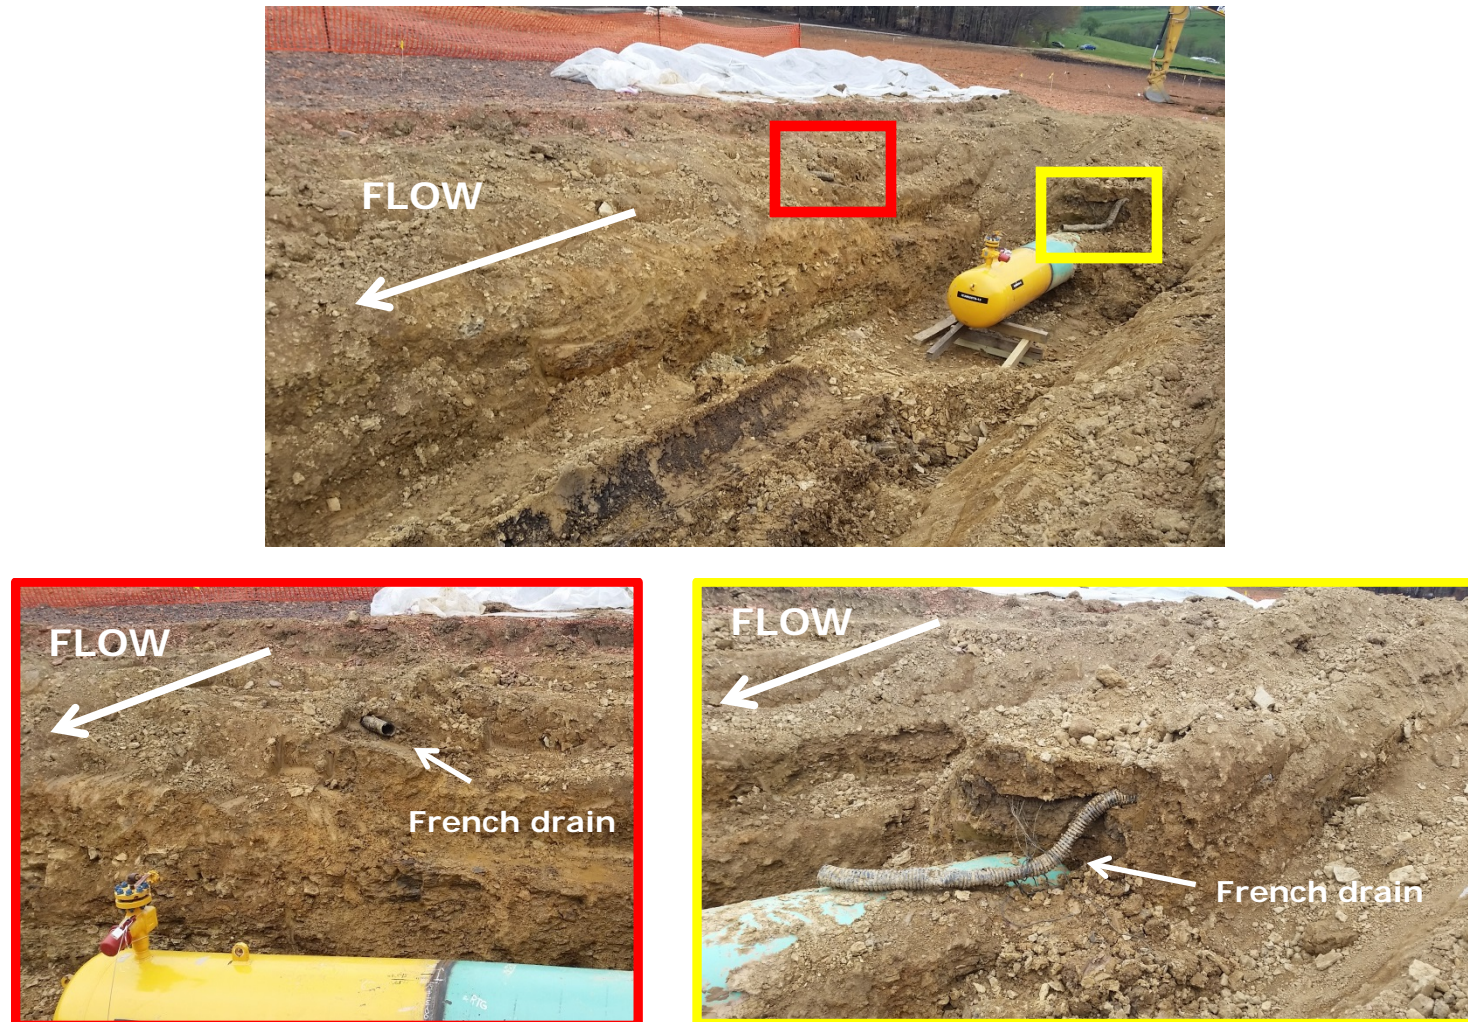
Figure 3. Photographs showing the ends of a French drain within the excavation site near the Failure.

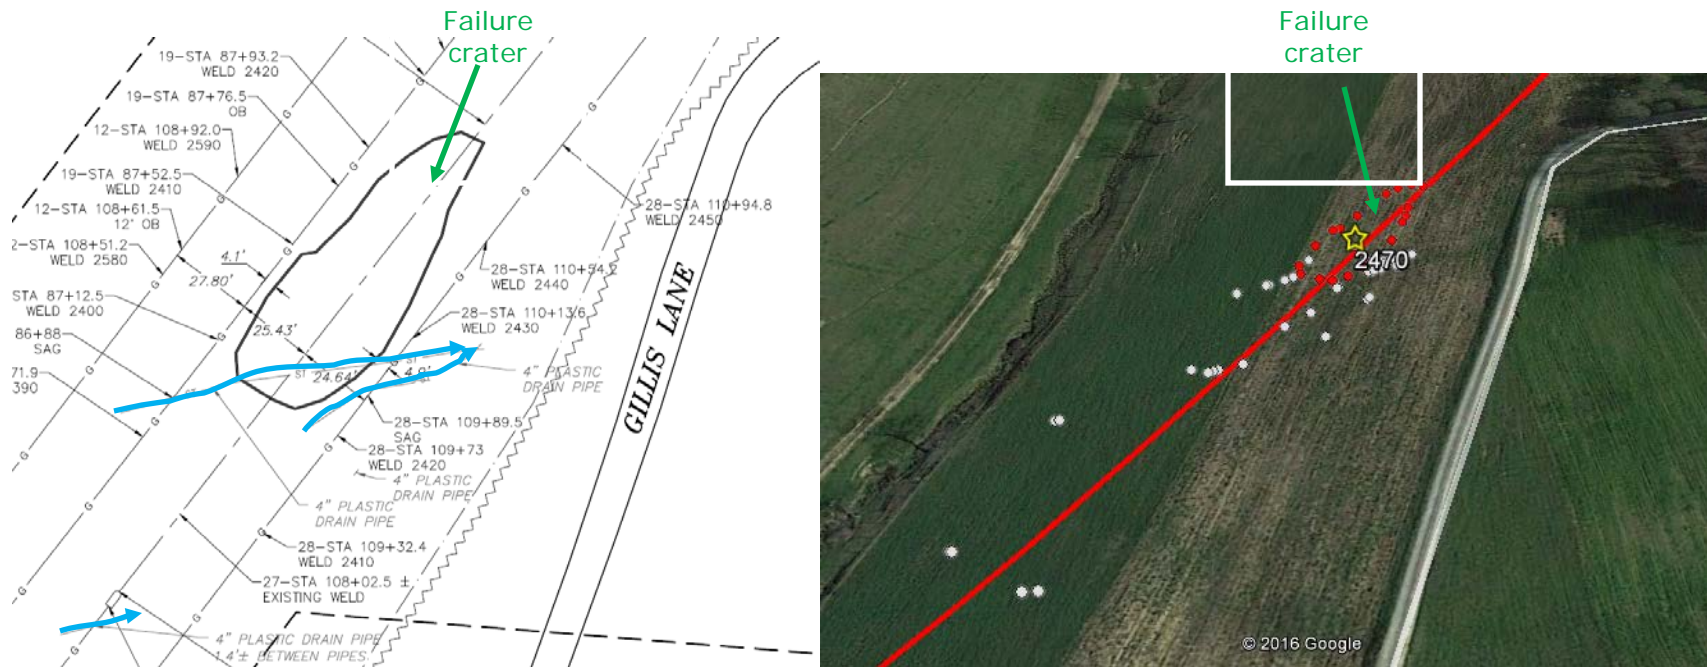
Figure 4. Drawing (Left) and satellite imagery (Right) showing locations of French drains relative to the Failure Site. The blue lines on the drawing (Left) correspond to locations of French drains. The white and red dots identified in the satellite imagery (Right) correspond to GPS coordinates obtained for French drains and the failure crater, respectively. The red line corresponds to the location of Line 27 and the yellow star corresponds to the failure origin in the satellite imagery.

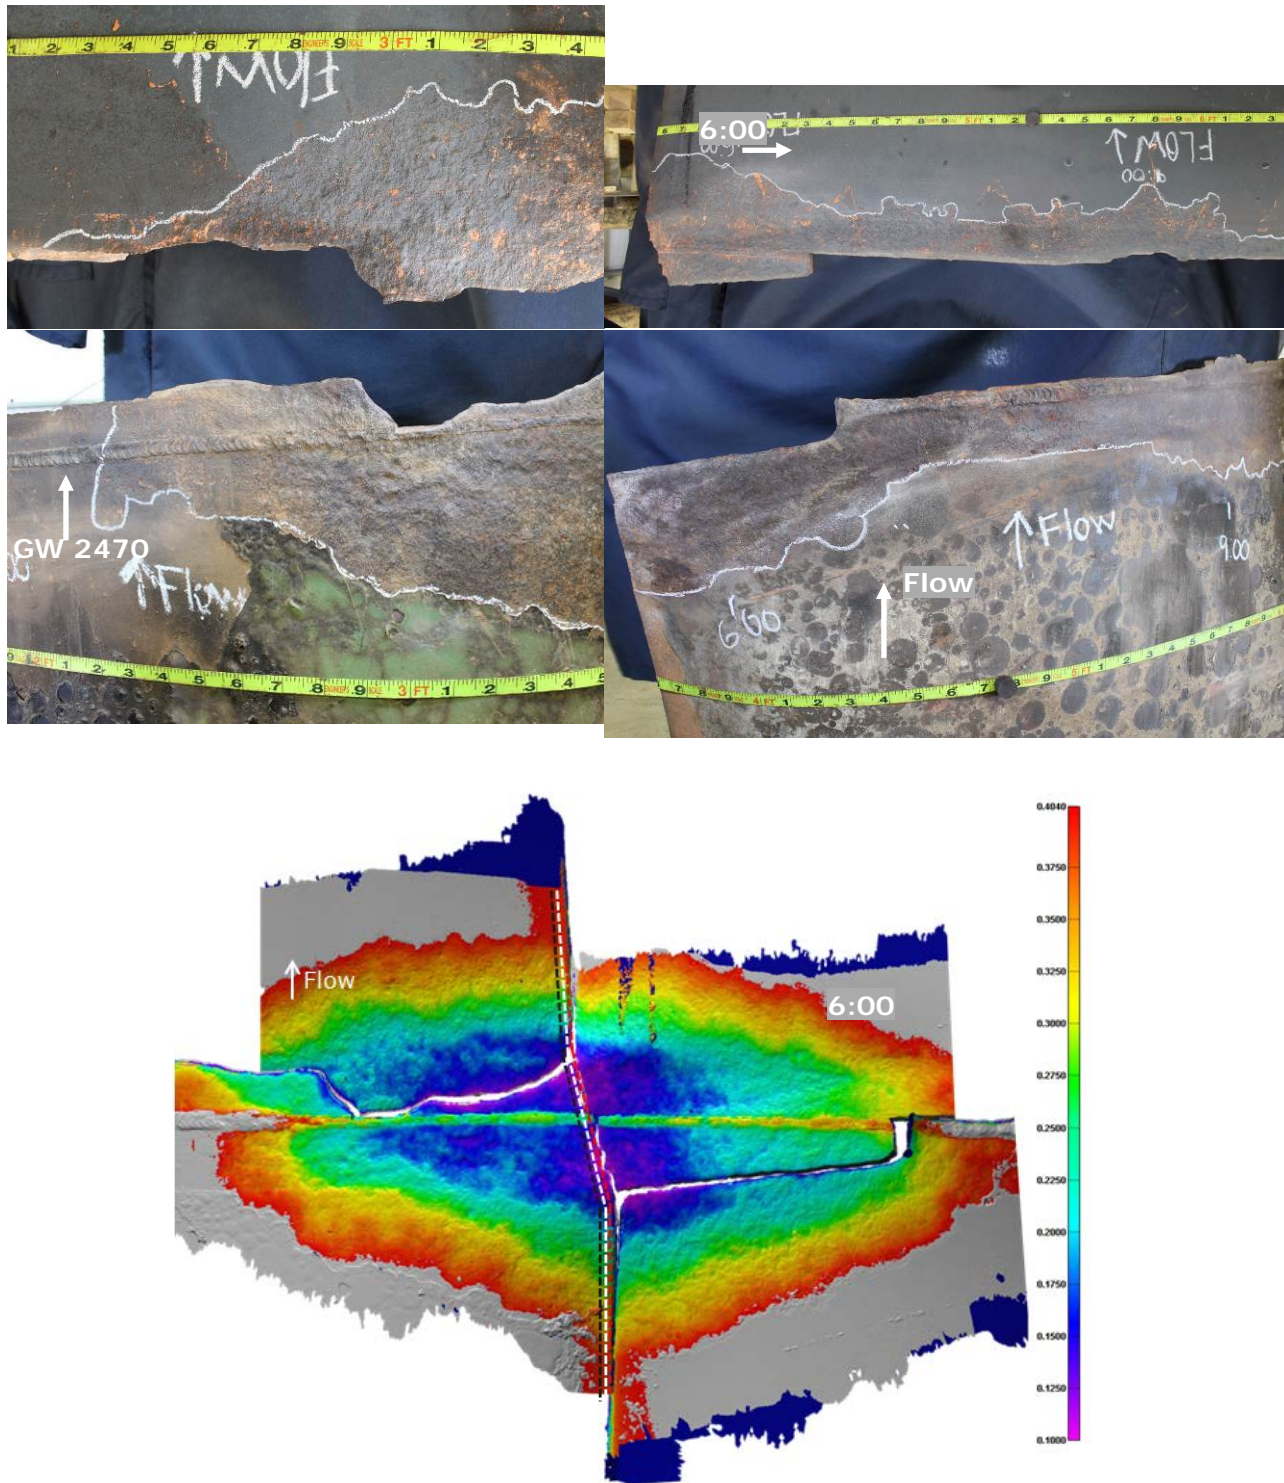
Figure 5. Photographs (top) and color map from laser scanning (bottom) showing region of external wall loss at the failure origin following cleaning the pipe with a solvent. The tape measure indicates distance CW from the 12:00 o'clock orientation at GW 2470.

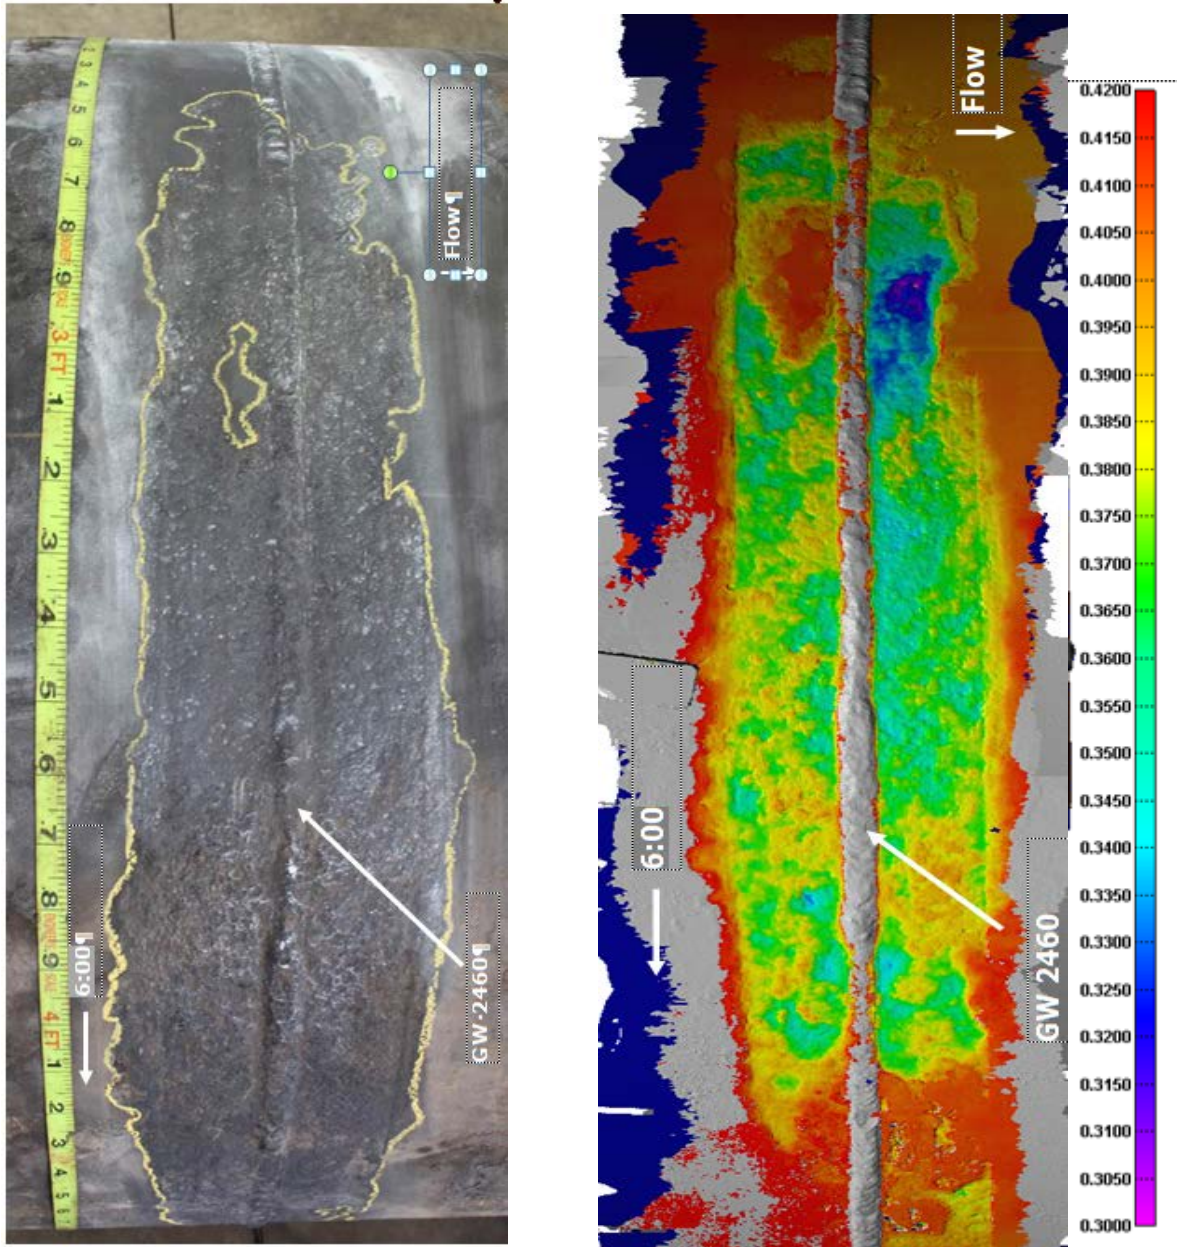
Figure 6. Photograph showing the region of external wall loss at GW 2460 (Left) and color map showing the remaining wall thickness (viewed from the OD surface) from laser scan data (Right). The tape measure indicates distance CW from the 12:00 o'clock orientation at GW 2460.

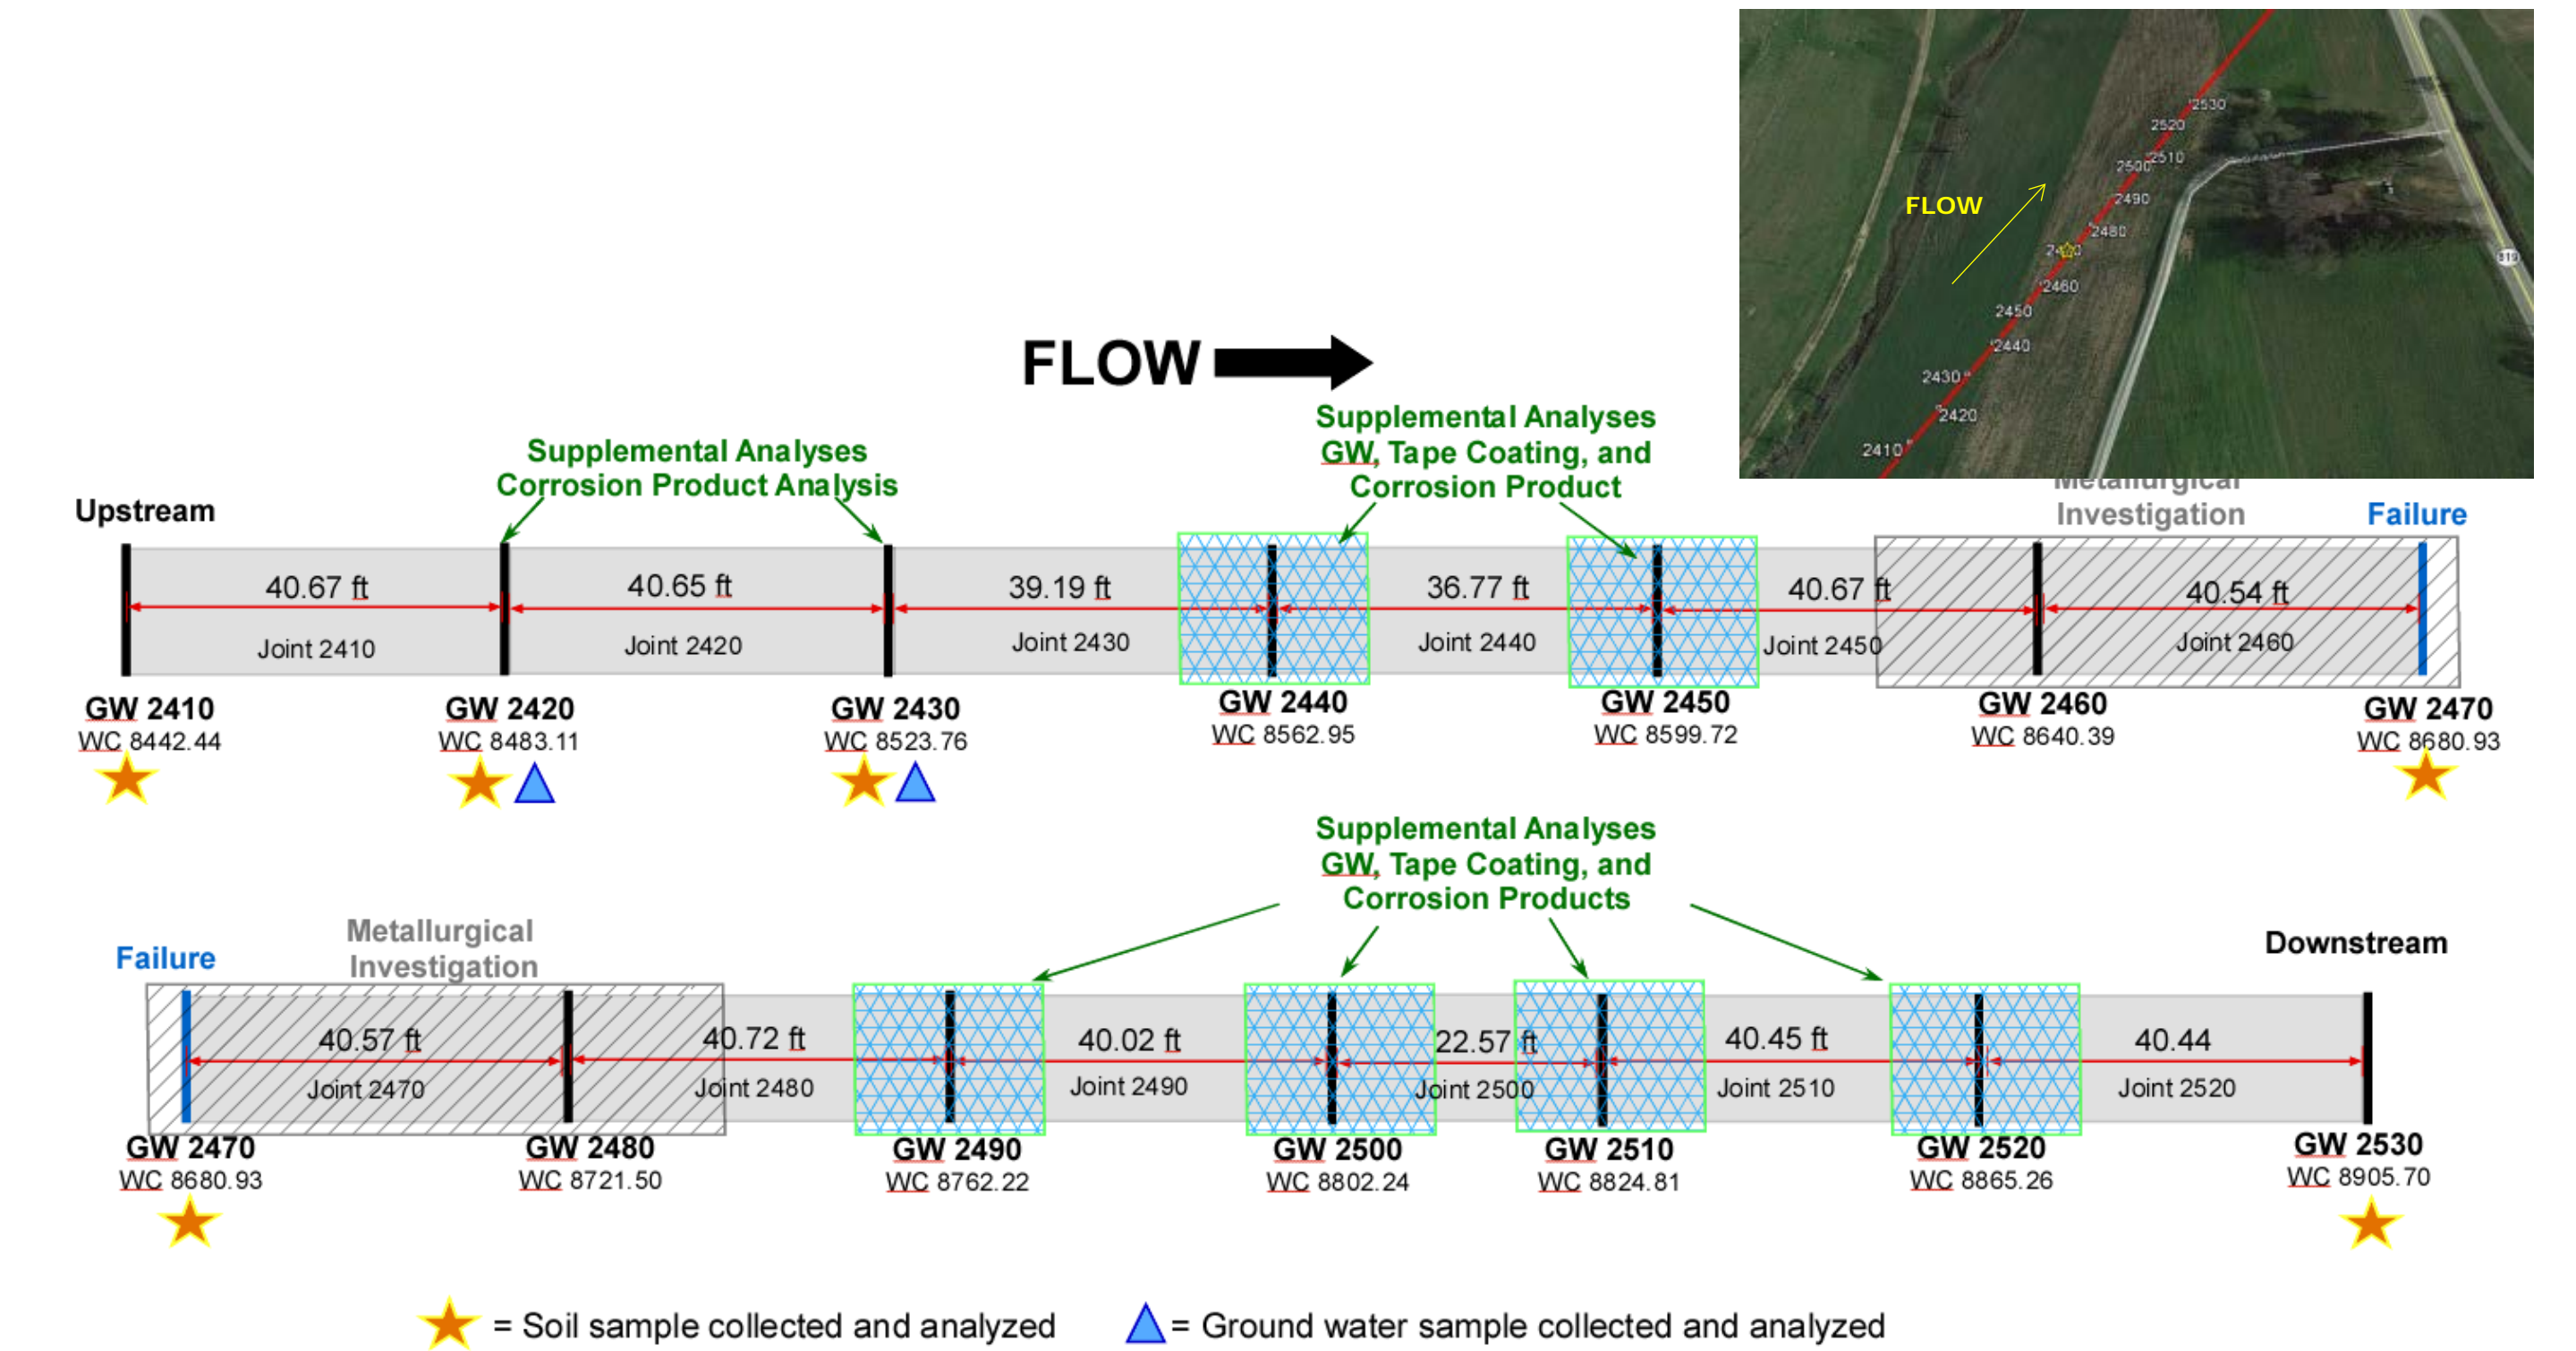
Figure 8. Schematic and a google map image showing girth welds on Line 27 in the vicinity of the failure. The locations where metallurgical, tape coating, corrosion deposit, soil, and ground water samples were taken for various analyses are identified on the schematic.

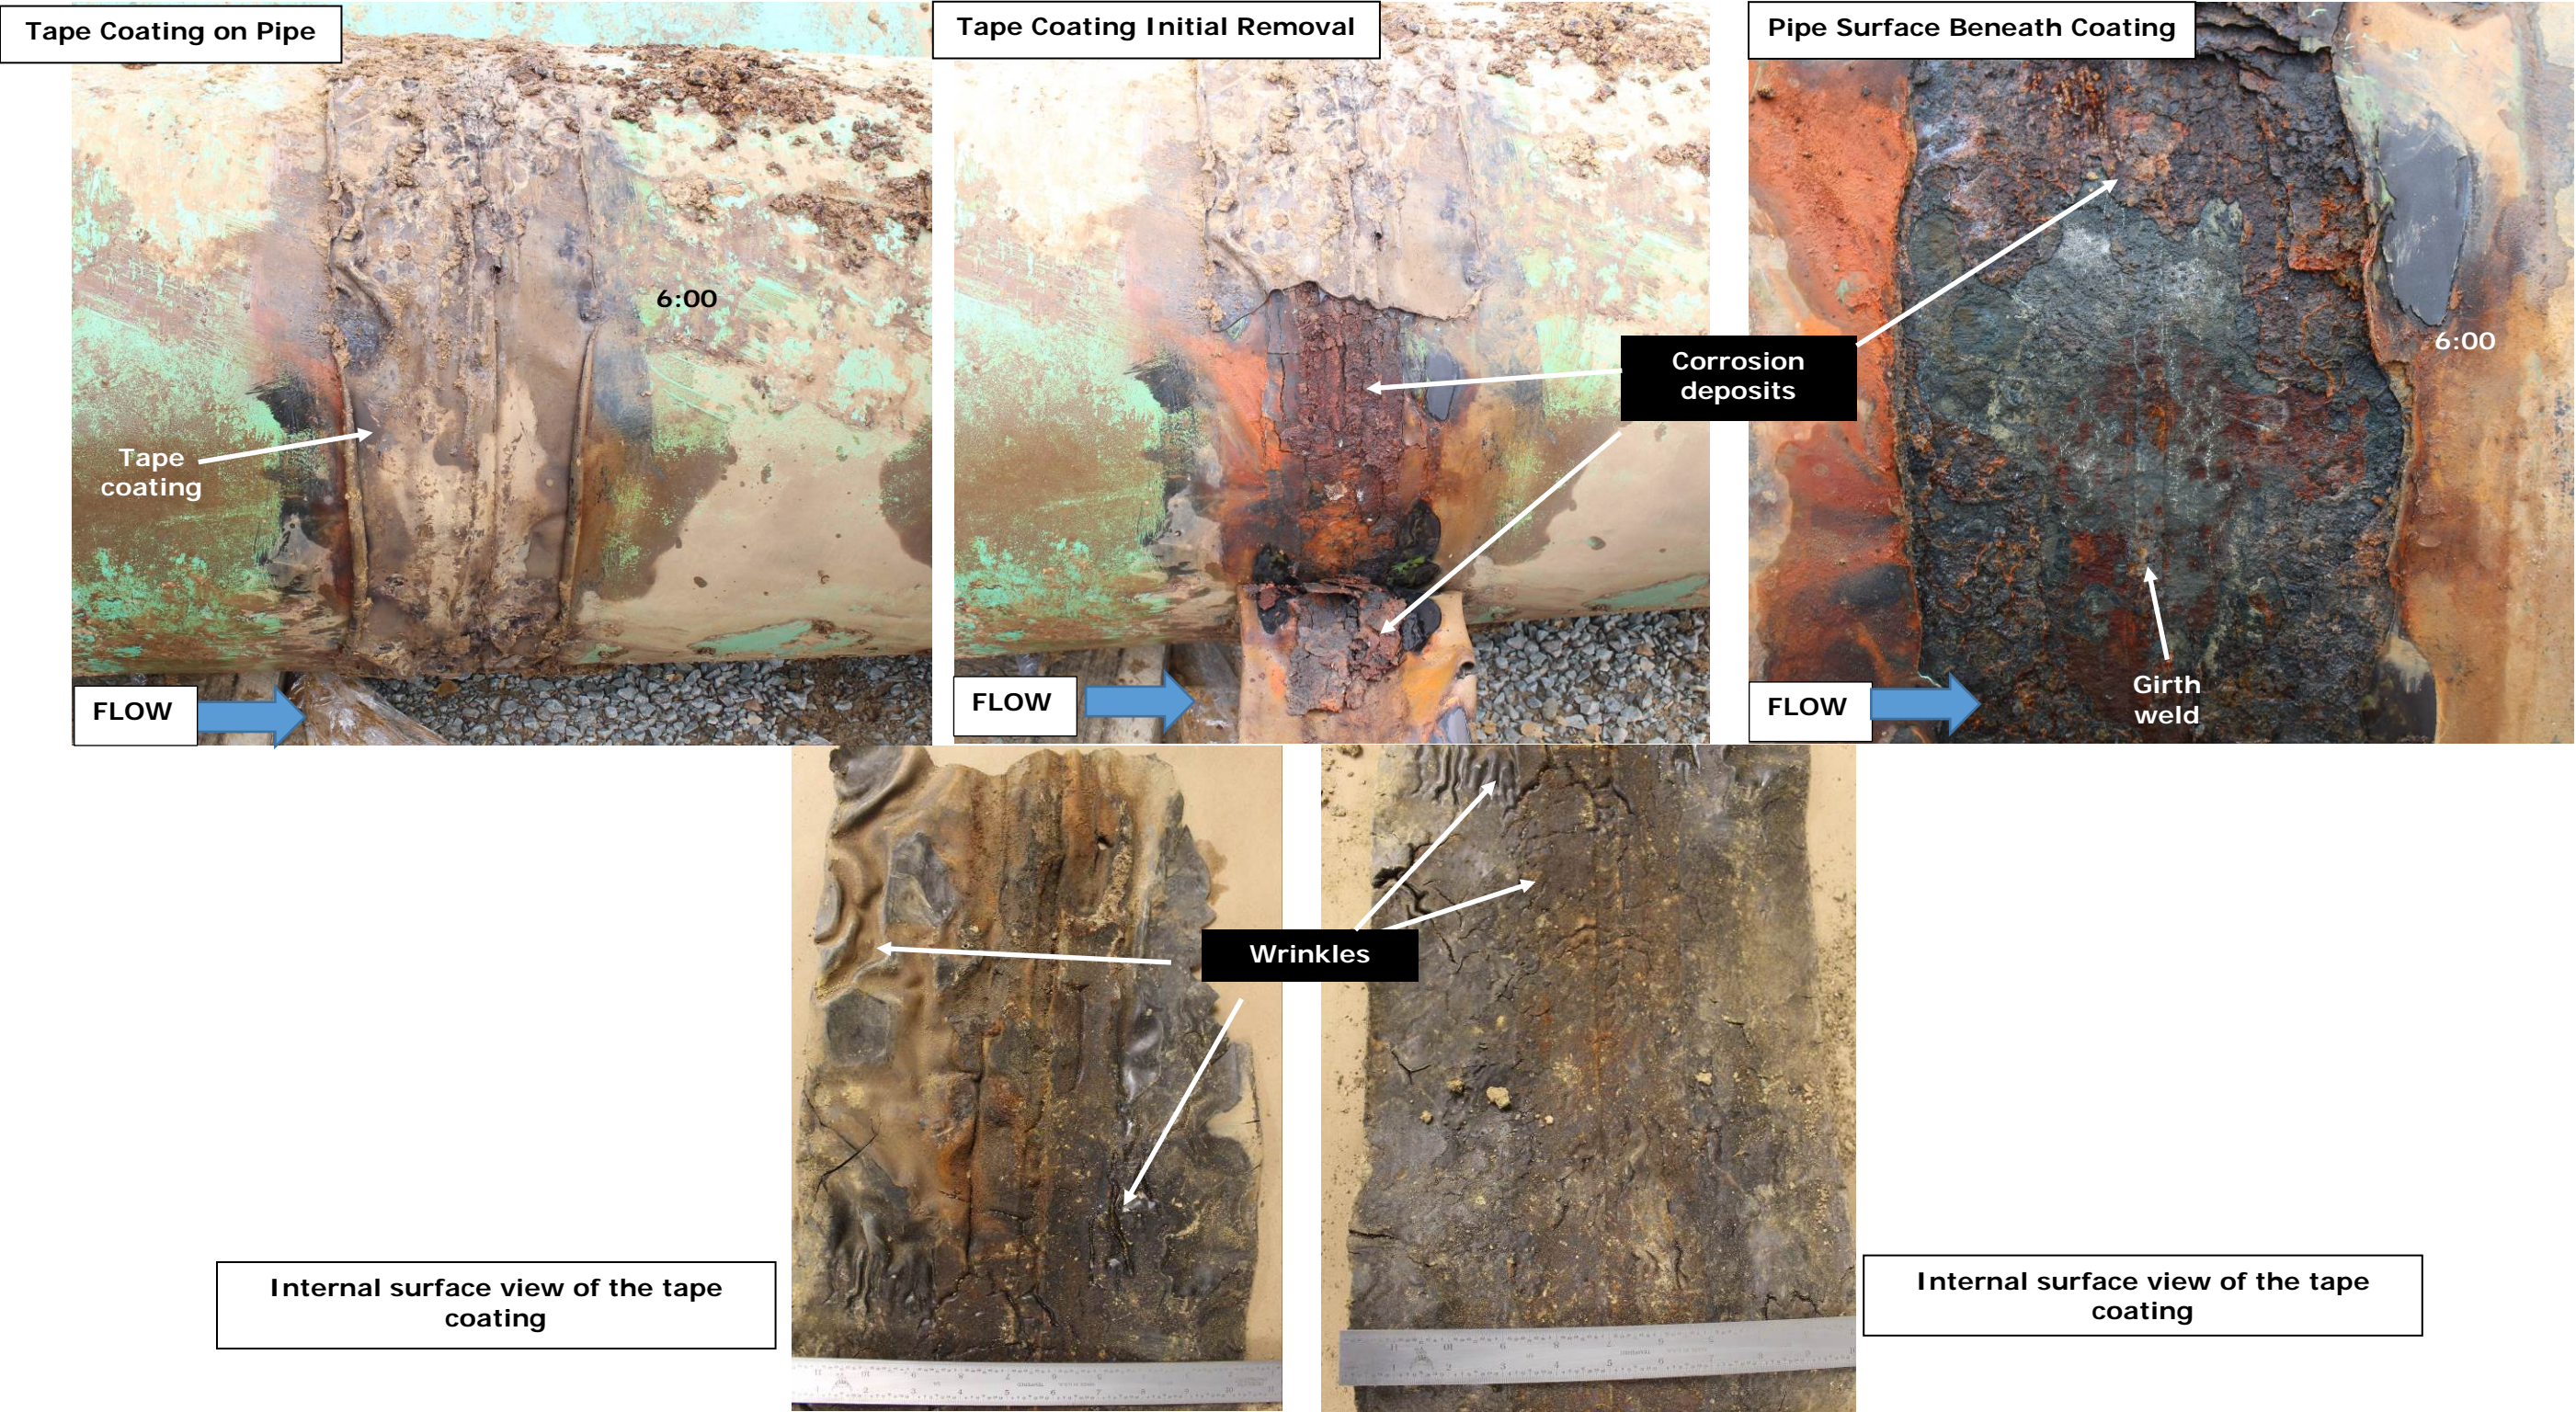
Figure 9. Photographs showing the tape coating and the pipe surface at GW 2450 before and after removal of the tape from the pipe.

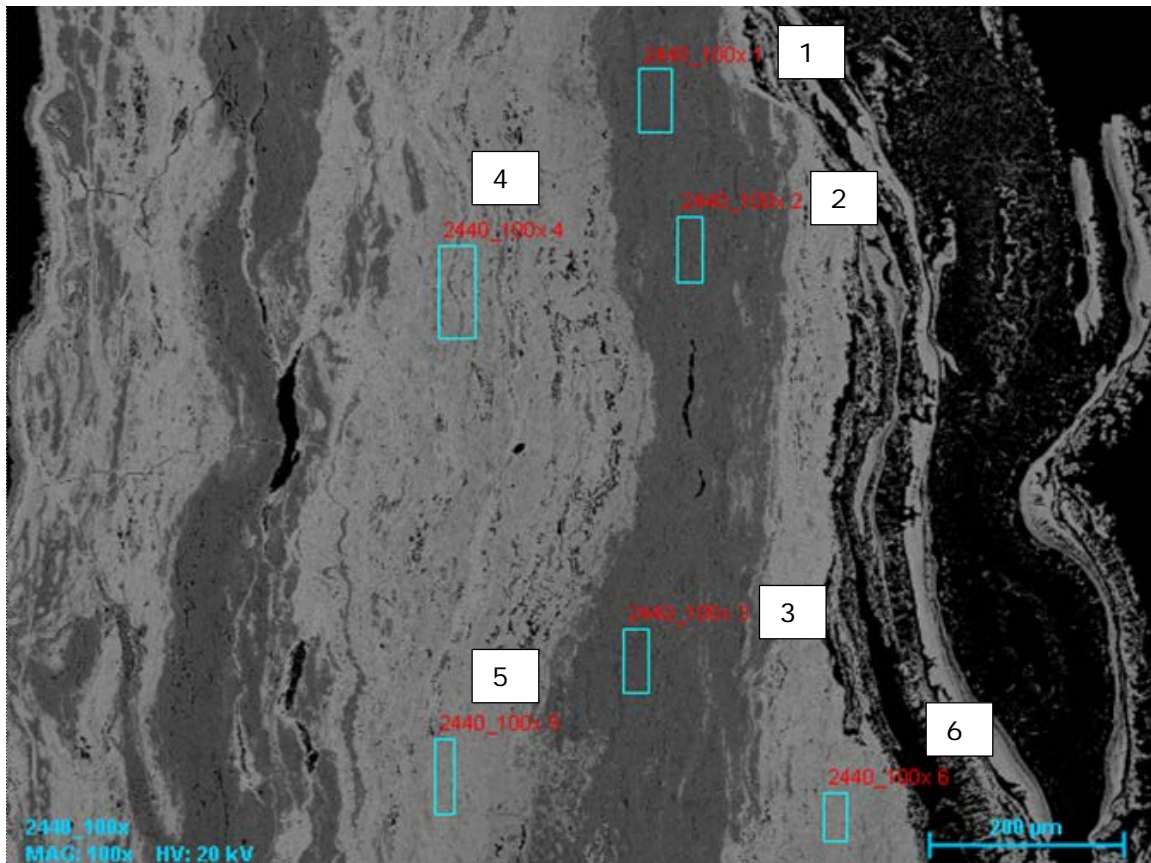
Spectrum	O	Si	S	Cl	V	Cr	Mn	Fe	Ni
2440_100x 1	30.4	0.2	0.3	–	0.1	0.1	0.8	68.1	0.1
2440_100x 2	32.8	0.1	0.3	0.1	–	–	0.5	66.3	–
2440_100x 3	31.1	0.2	0.3	–	0.1	0.1	0.8	67.4	–
2440_100x 4	24.8	0.3	0.1	–	–	0.1	0.4	74.3	–
2440_100x 5	25.1	0.2	0.1	–	–	0.1	0.3	74.1	–
2440_100x 6	24.5	0.2	0.1	–	–	0.0	0.1	75.0	–

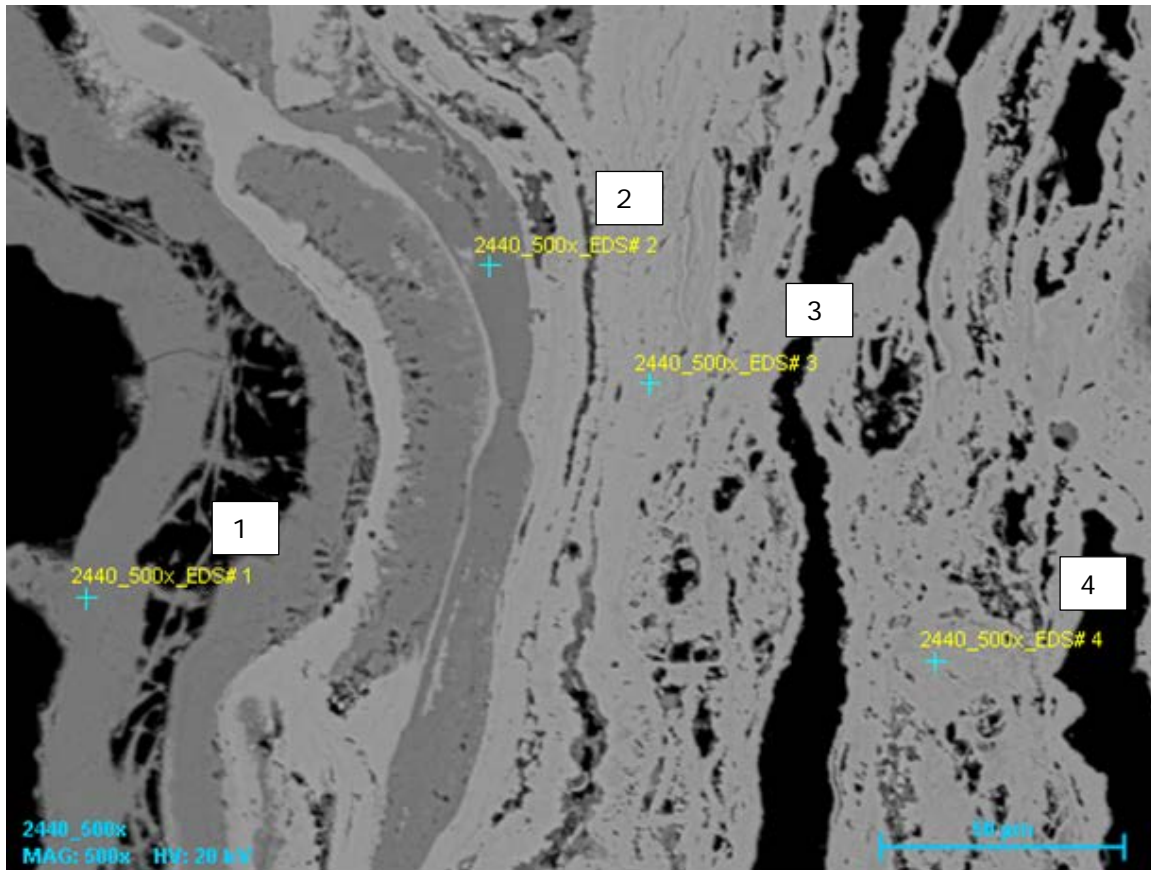
Spectrum	O	Si	S	Mn	Fe
2440_500x_EDS# 1	31.9	0.2	0.1	2.6	65.2
2440_500x_EDS# 2	33.9	0.2	0.0	0.6	65.3
2440_500x_EDS# 3	28.8	0.2	–	0.1	70.9
2440_500x_EDS# 4	29.2	0.4	–	0.1	70.3

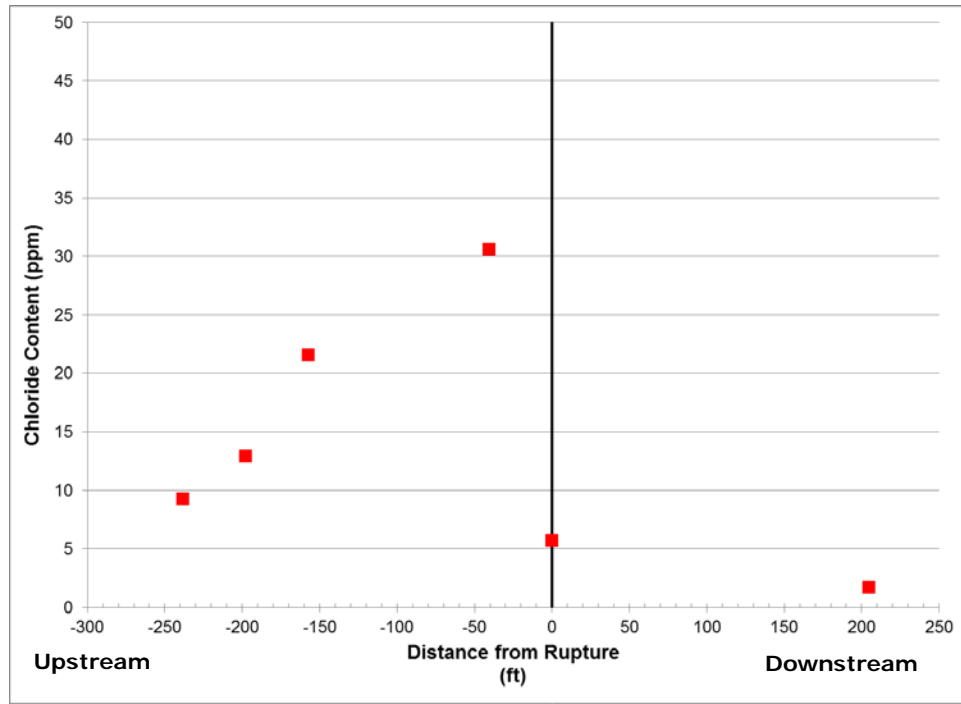
Figure 15. Plot showing chloride content (ppm) identified in soil samples collected along the Isolated Segment in the vicinity of the Failure.
