Final Report

Technical Root Cause Analysis of Delmont Line 27 Failure – April 29, 2016

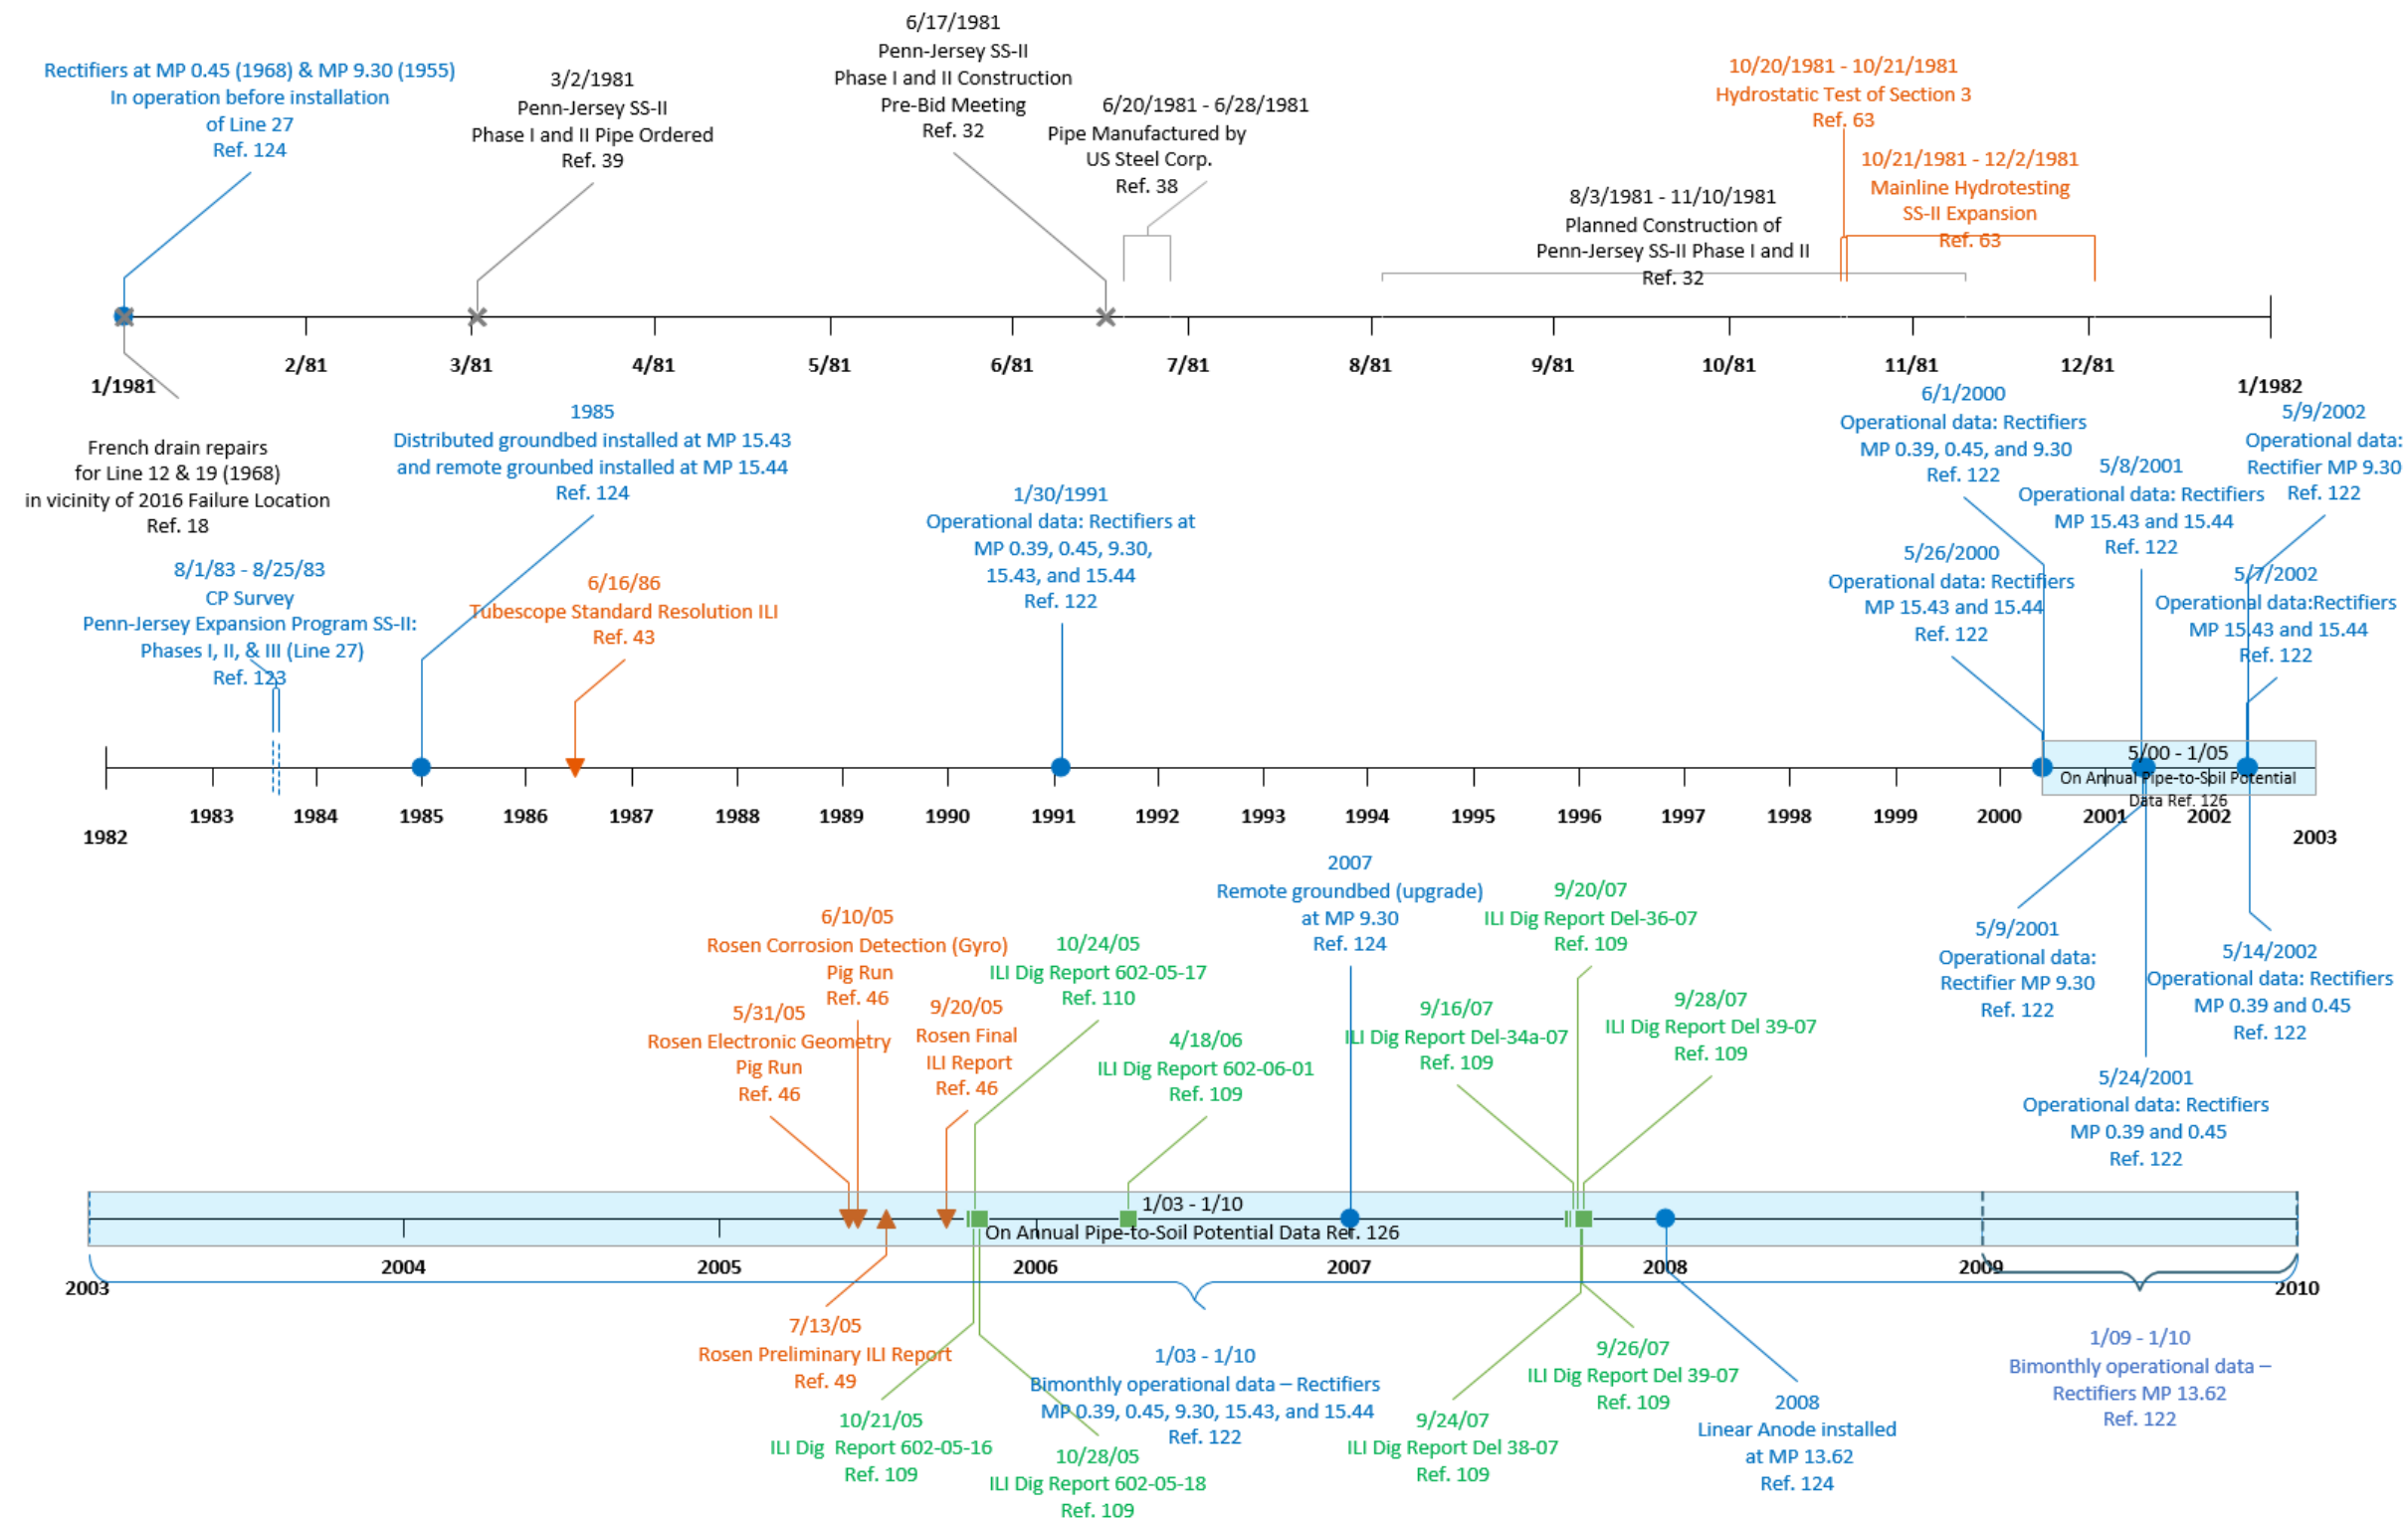
Figure 16. Timeline showing key events for Line 27 (Isolated Segment only) from the time of construction January 1, 2010. The timeline includes dates for (1) construction (Black x and brackets), (2) CP related activities (blue circles, brackets, and blocks), (3) integrity related assessments (orange triangles and brackets), and (4) ILI related digs (Green squares).

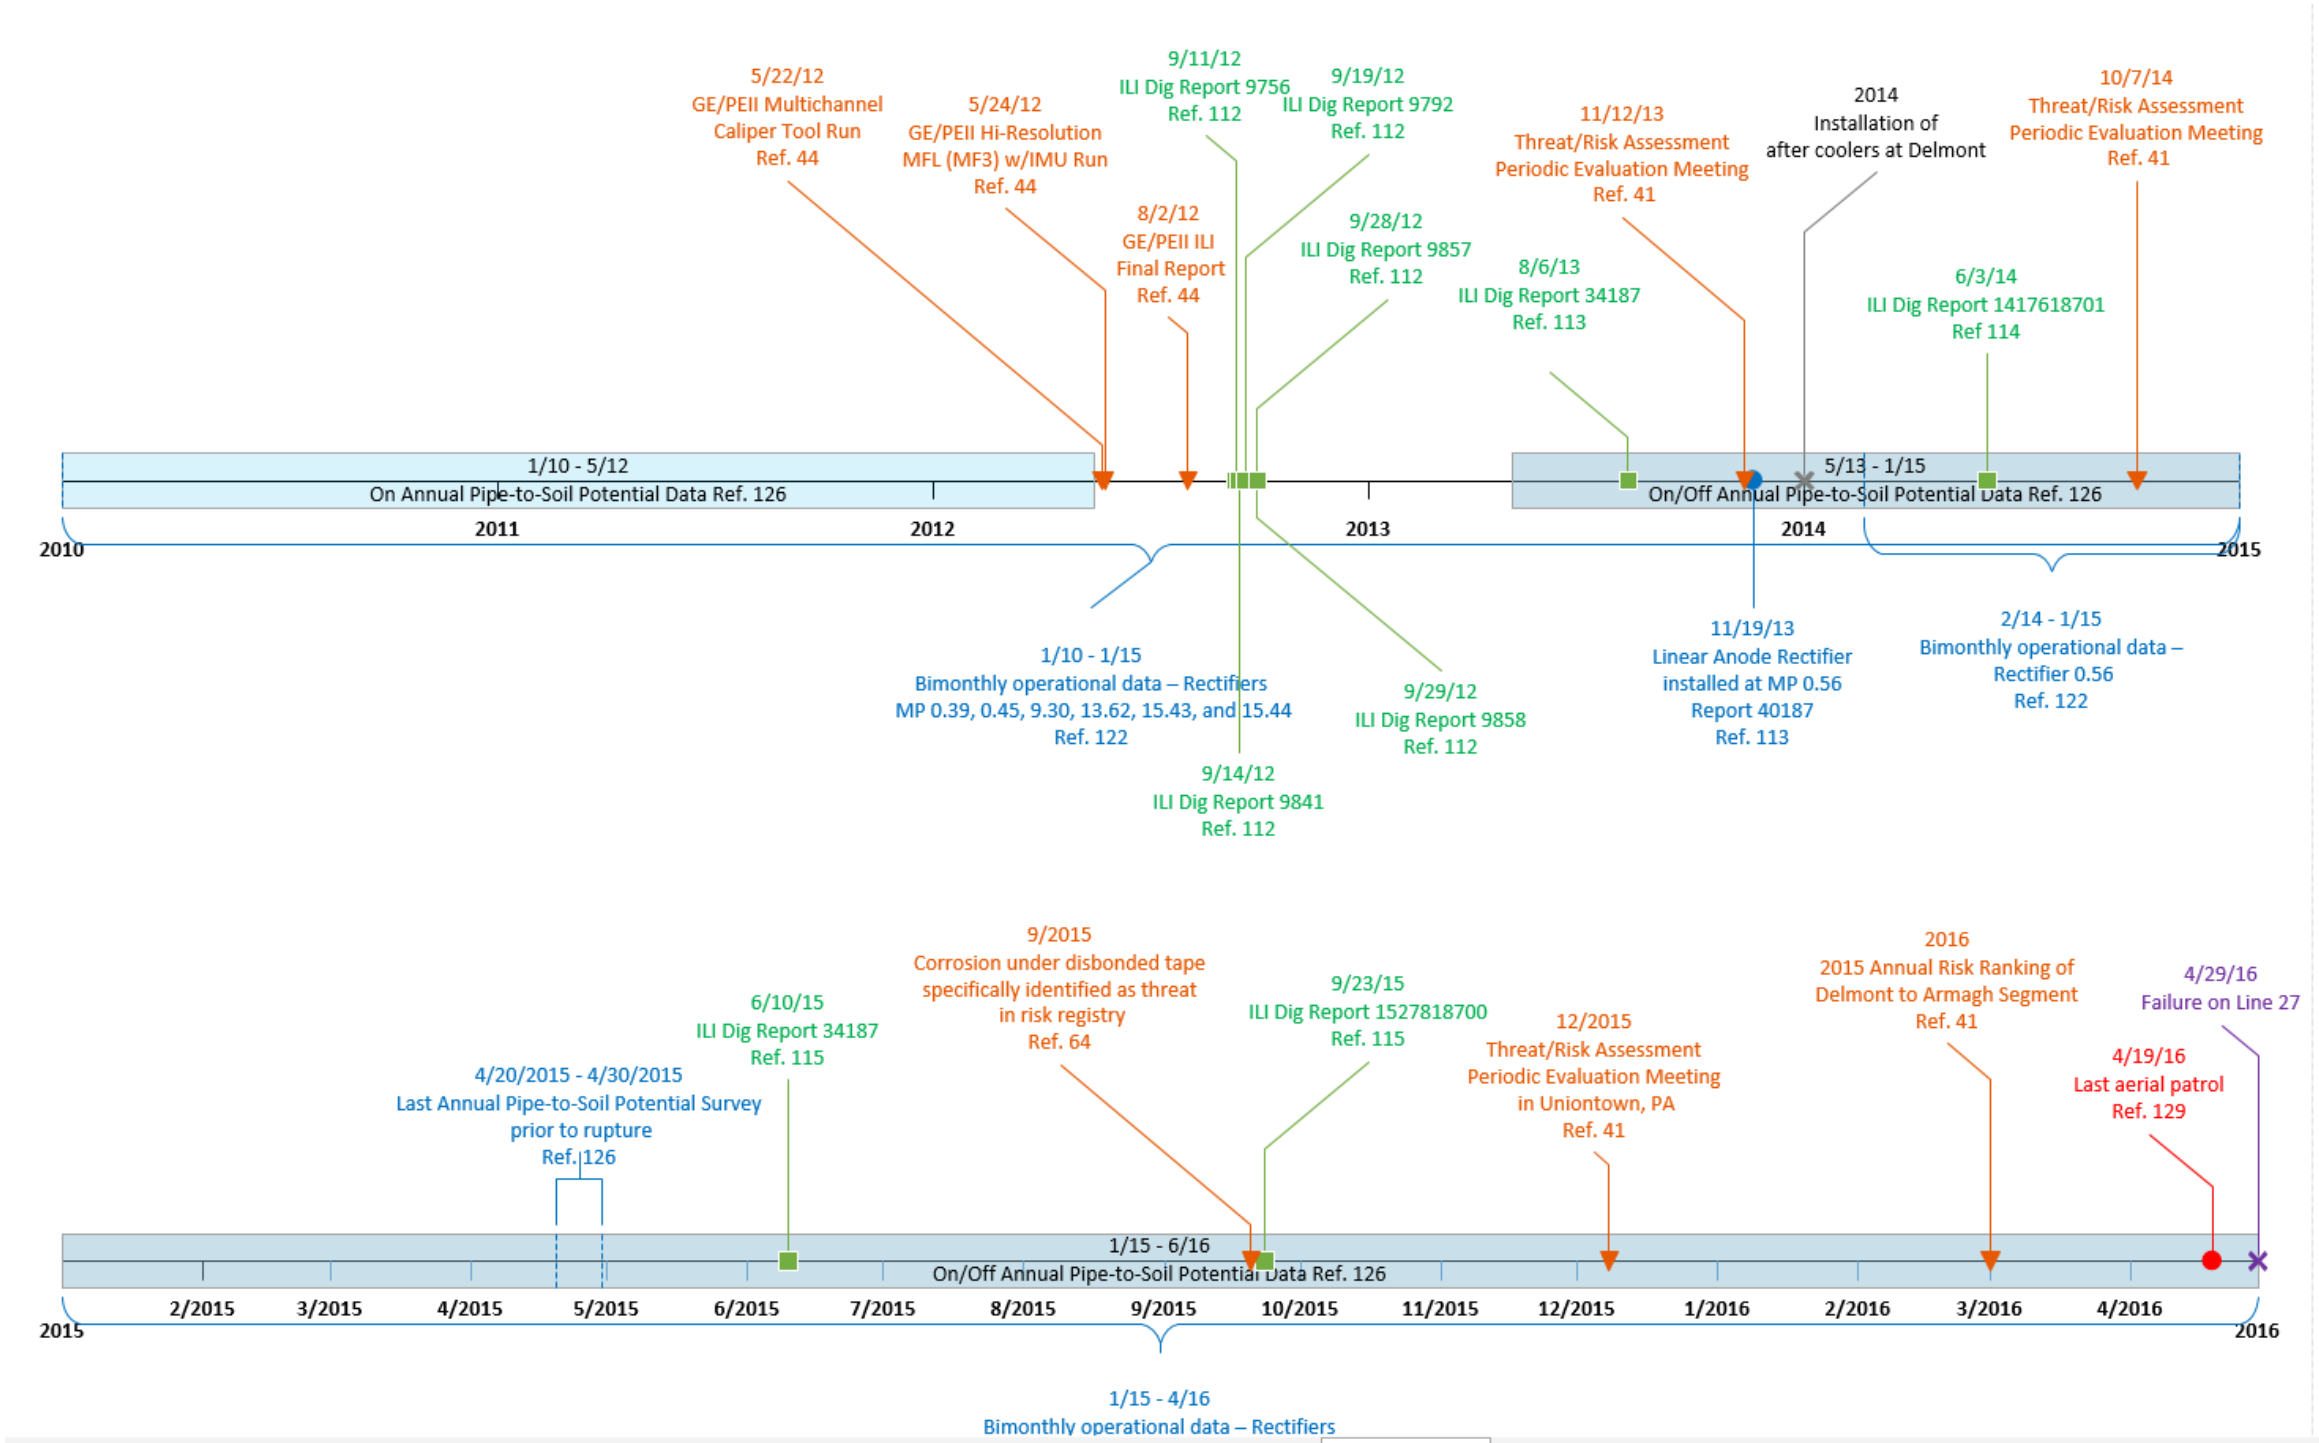
Figure 17. Timeline showing key events for Line 27 (Isolated Segment only) from January 1, 2010 until the failure on April 29, 2016. The timeline includes dates for (1) construction (Black x), (2) CP related activities (blue circles, brackets, and blocks), (3) integrity related assessments (orange triangles), (4) ILI related digs (Green squares), (5) aerial patrol (red circles), and (6) the April 29, 2016 failure (purple X).

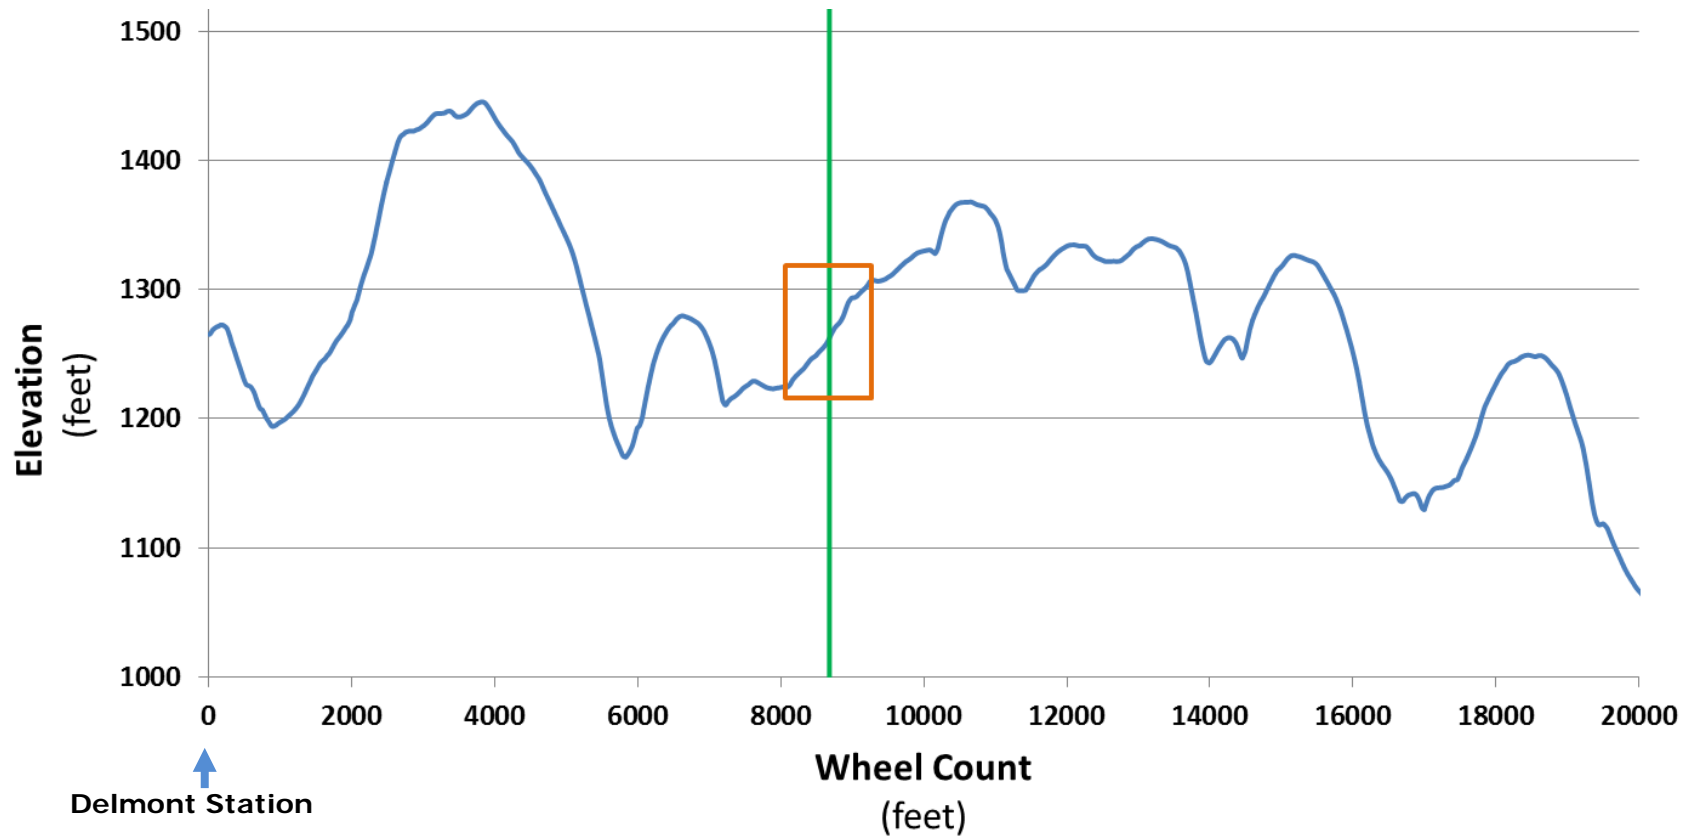
Figure 19. Plot showing the elevation profile for Line 27 in the vicinity of the Failure. The vertical green line on the plot identifies the location of the April 29, 2016 failure.

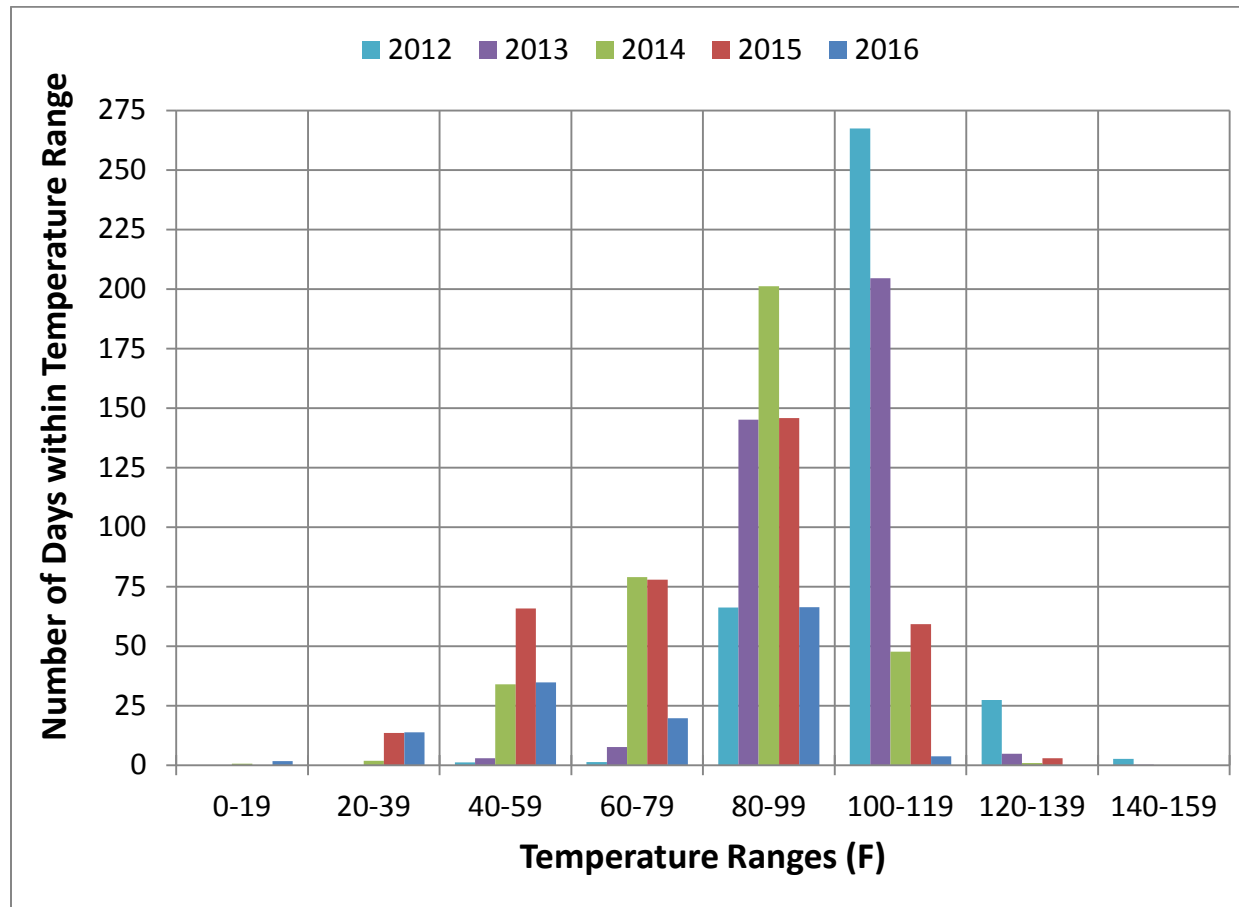
Figure 20. Plot showing Delmont discharge temperatures between 2012 and 2016.

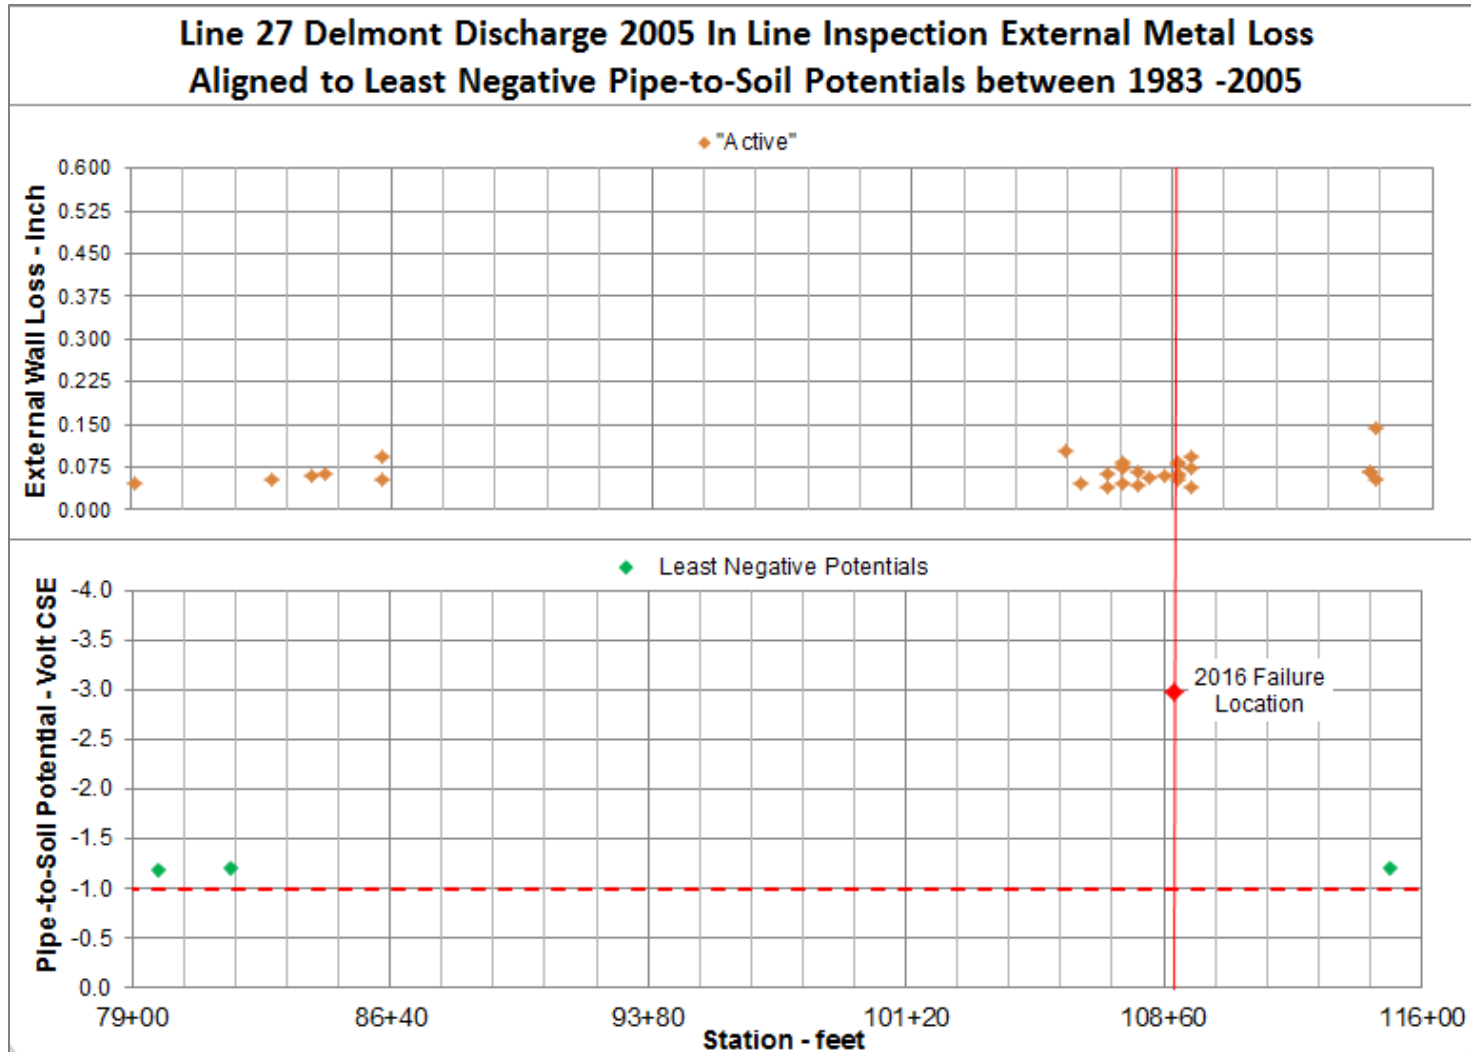
Figure 21. Line 27 Delmont discharge in the vicinity of the failure: External metal loss depths reported in 2005 In-Line inspection report aligned to least negative pipe-to-soil potentials between 1983 and 2005.

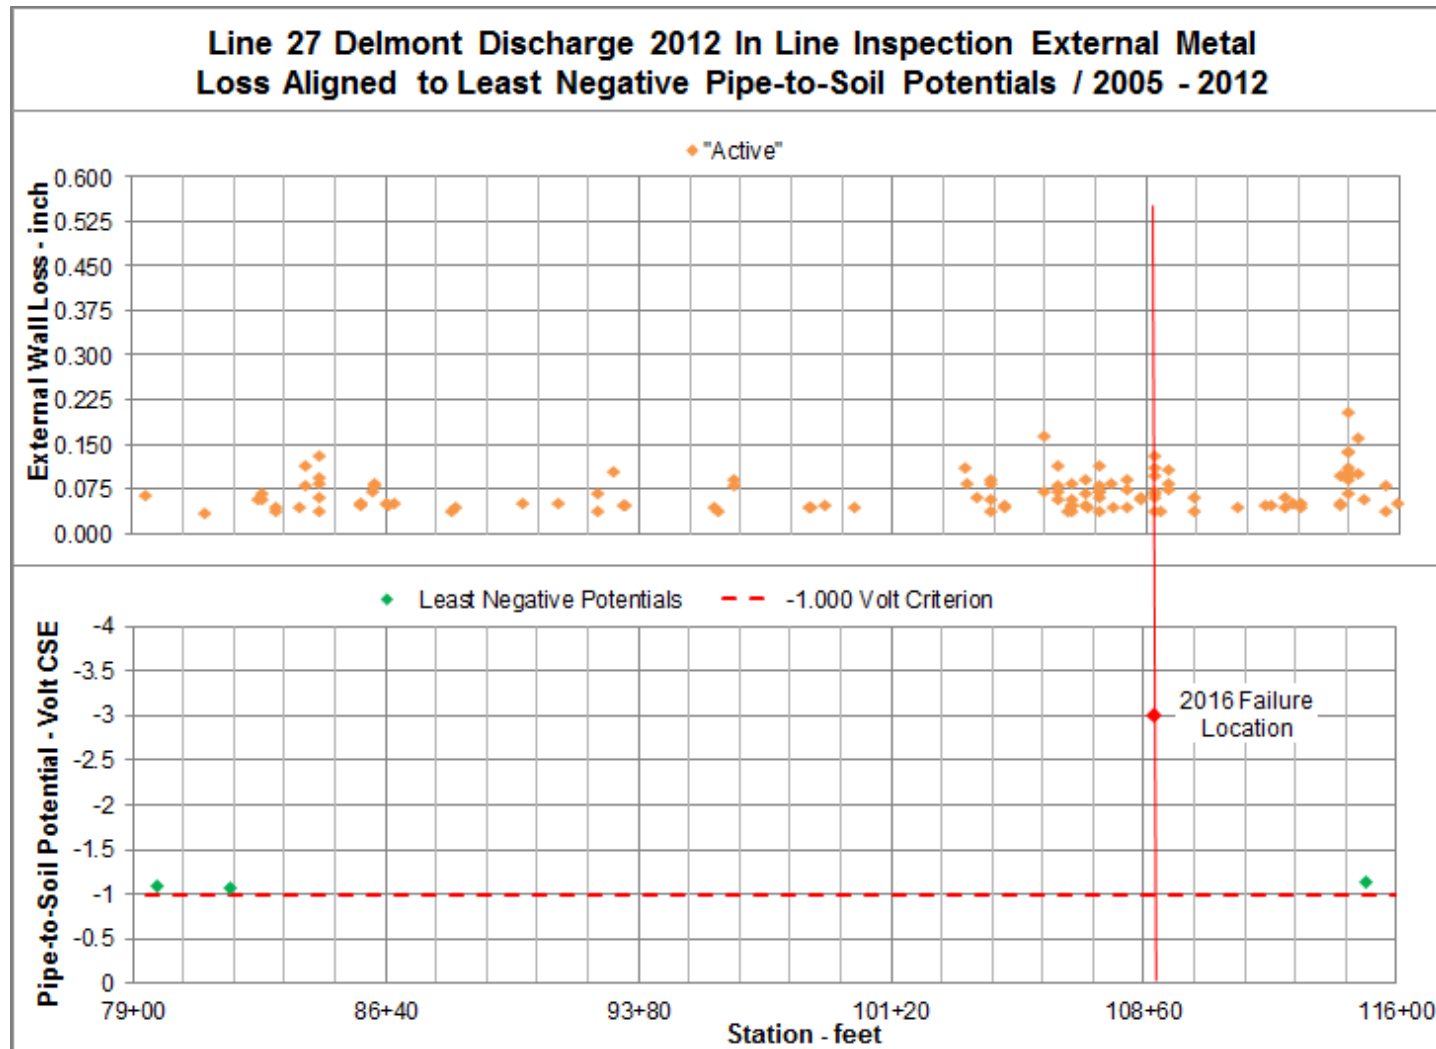
Figure 22. Line 27 Delmont discharge in the vicinity of the failure: External metal loss depths reported in 2012 In-Line inspection report aligned to least negative pipe-to-soil potentials between 2005 and 2012.

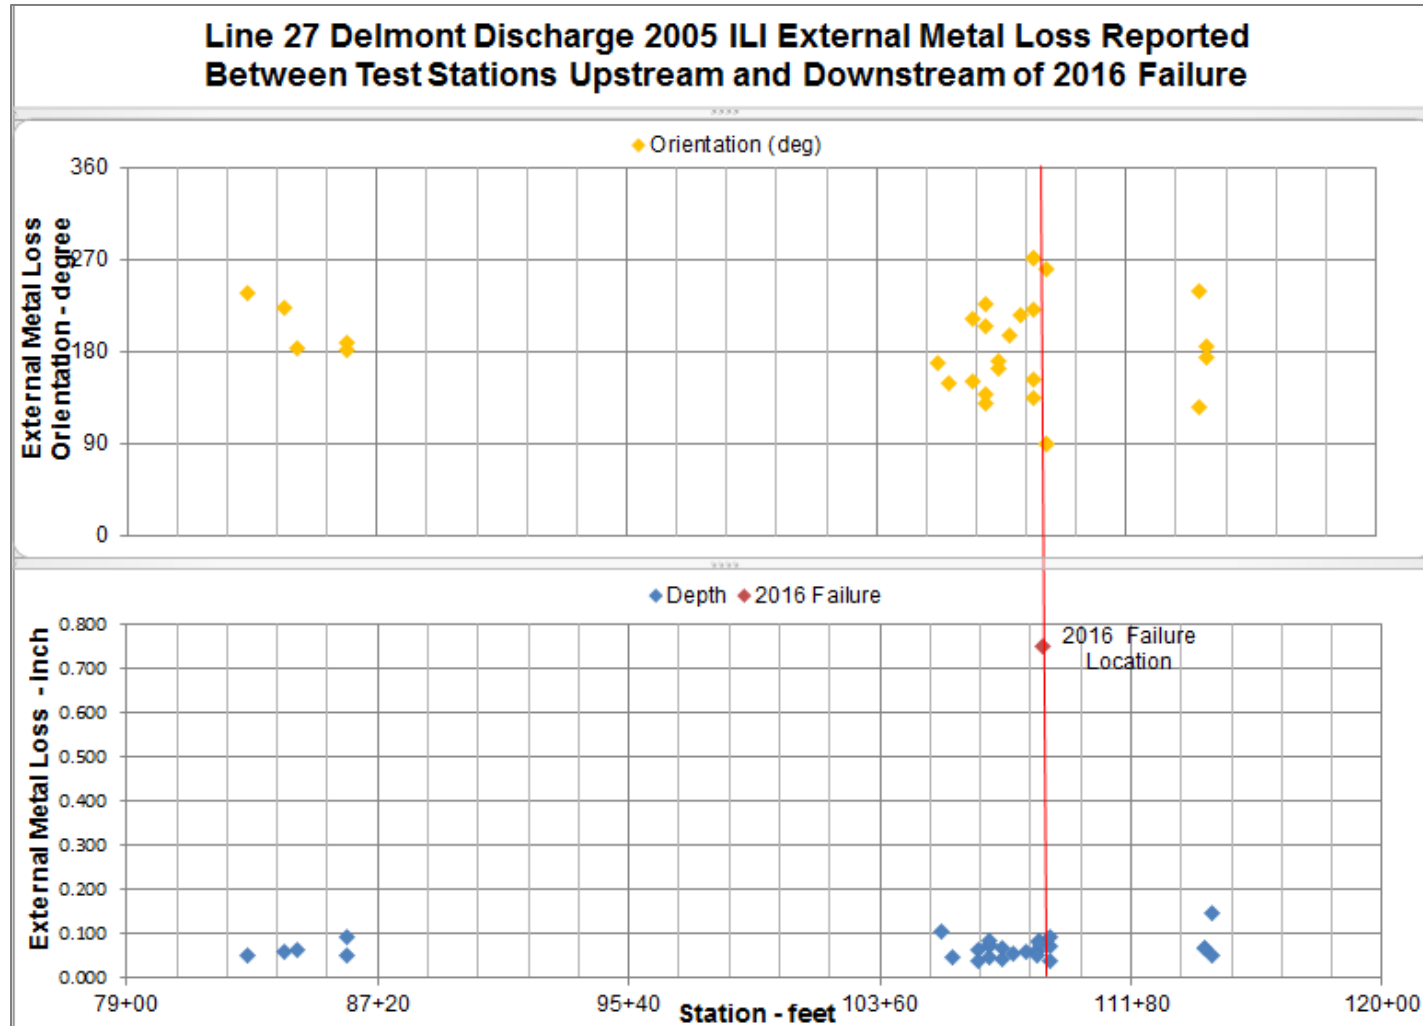
Figure 23. Line 27 Delmont discharge in the vicinity of the failure: External metal loss (orientations and depths) reported in 2005 In-Line inspection report between test stations located upstream and downstream of the 2016 failure. (Figure 7)

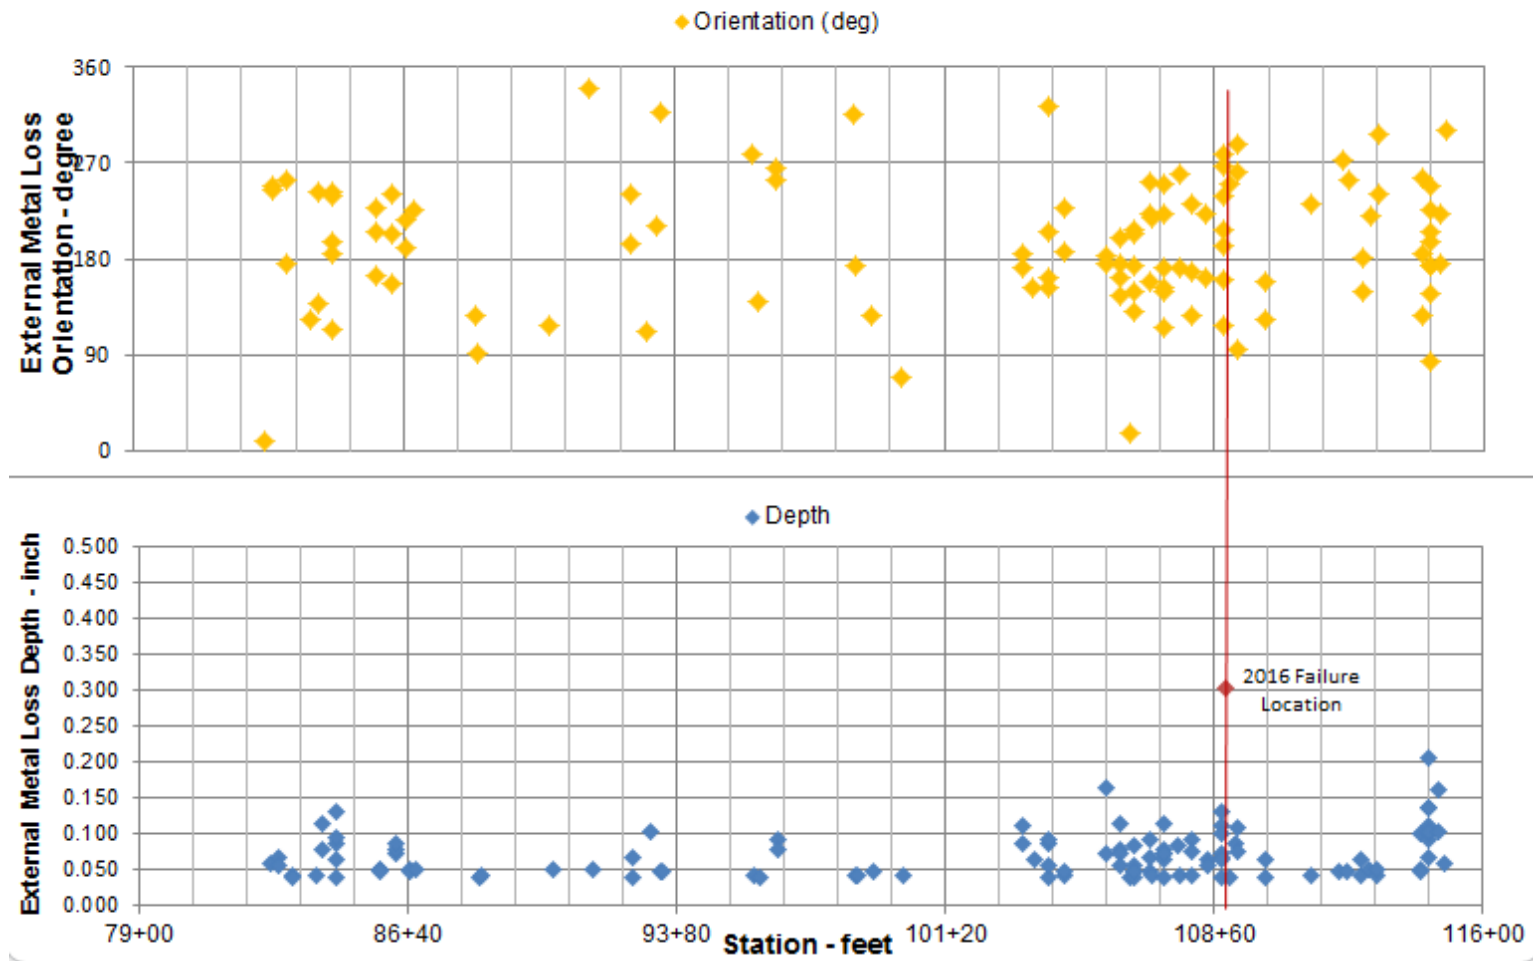
Figure 24. Line 27 Delmont discharge in the vicinity of the failure: External metal loss (orientations and depths) reported in 2012 In-Line inspection report between test stations located upstream and downstream of the 2016 failure.

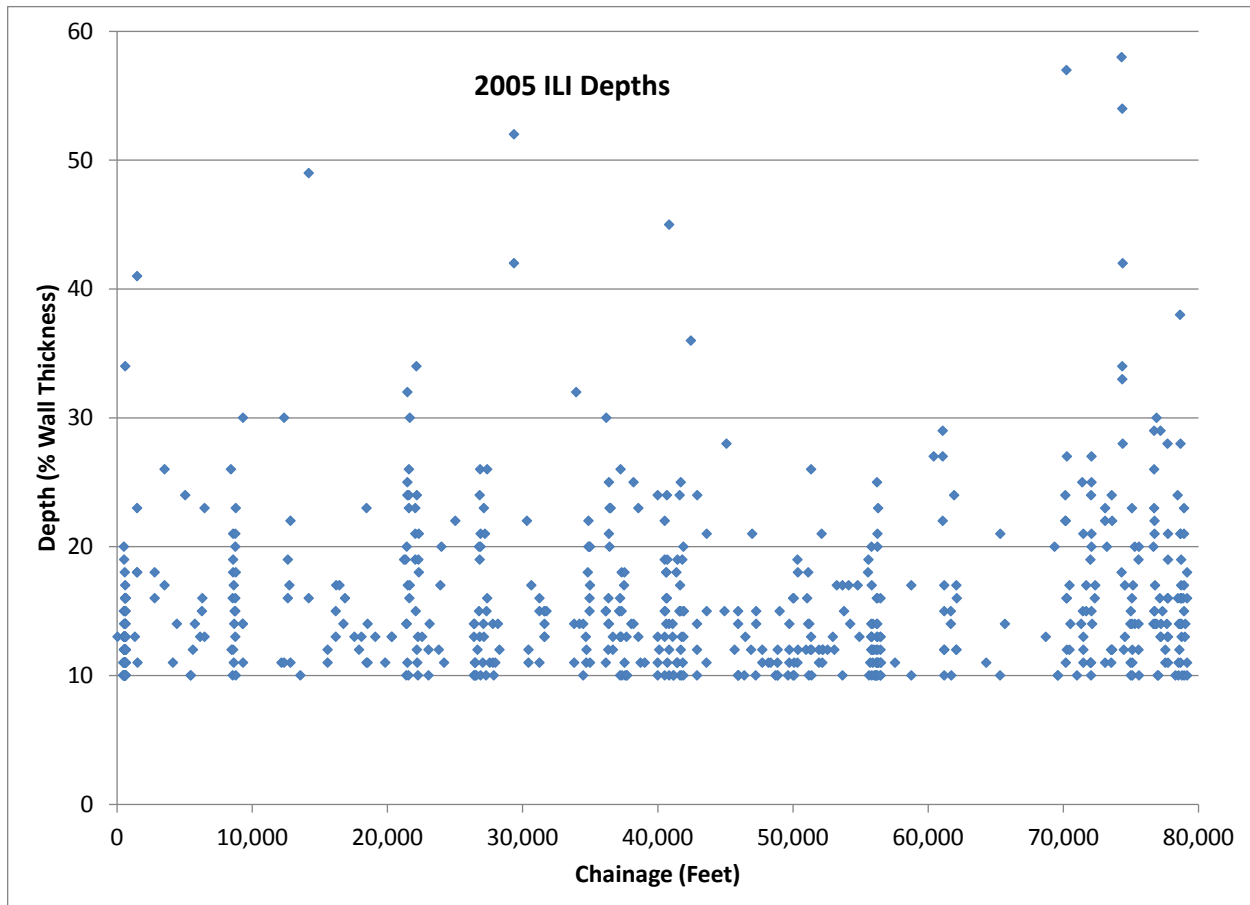
Figure 25. 2005 ILI results (depths) versus distance downstream of Delmont Compressor Station.

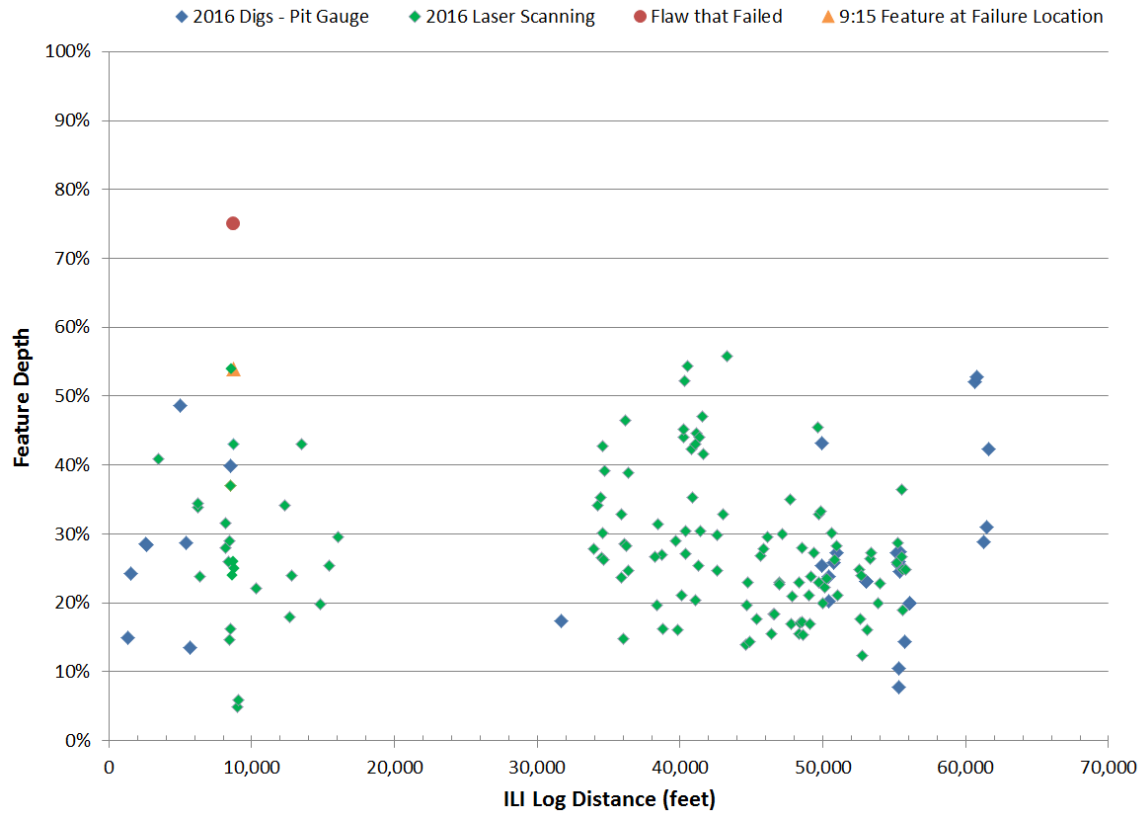
Figure 30. Distribution of feature depths determined from 2016 digs performed between May 17, 2016 and August 20, 2016 on the Isolated Segment and the depths determined for features near GWs at and near the failure location vs. ILI log distance.

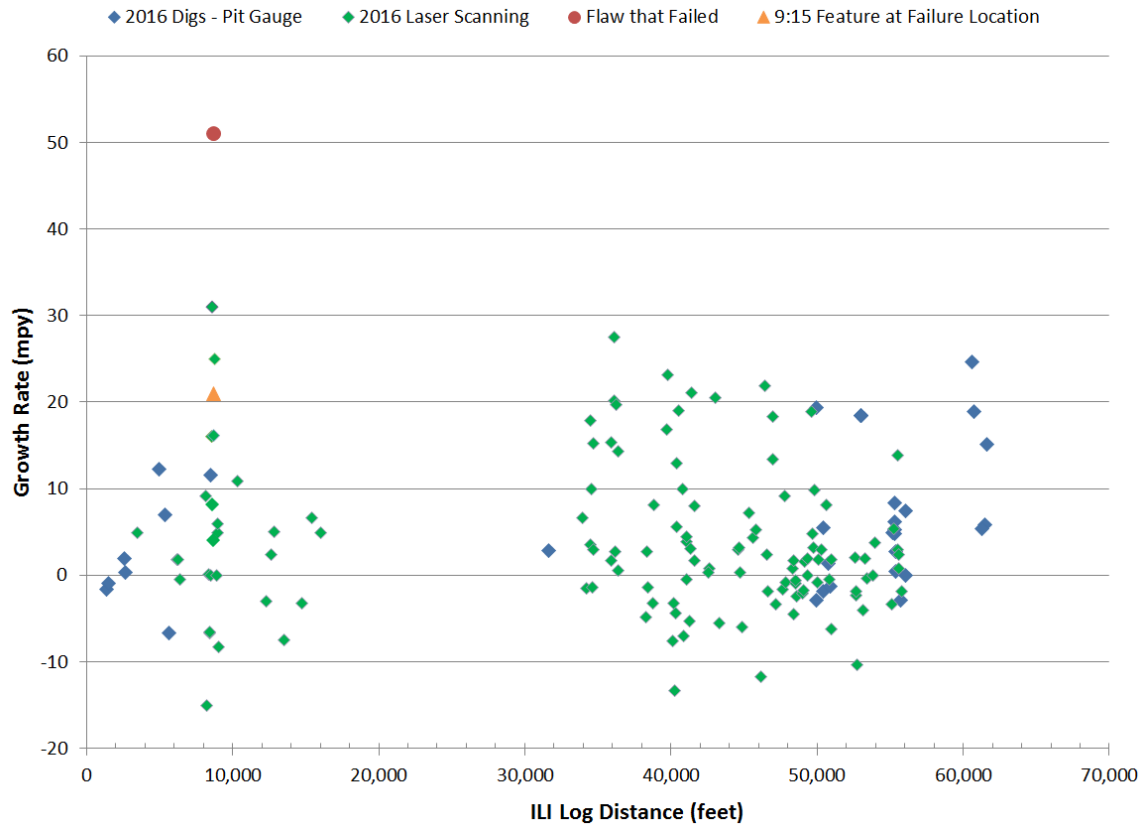
Figure 31. Distribution of corrosion rates determined from 2016 digs performed between May 17, 2016 and August 20, 2016 on the Isolated Segment and the corrosion rates determined for features on GWs at and near the failure location vs. ILI log distance. Corrosion rates determined based on comparison to 2012 ILI results.

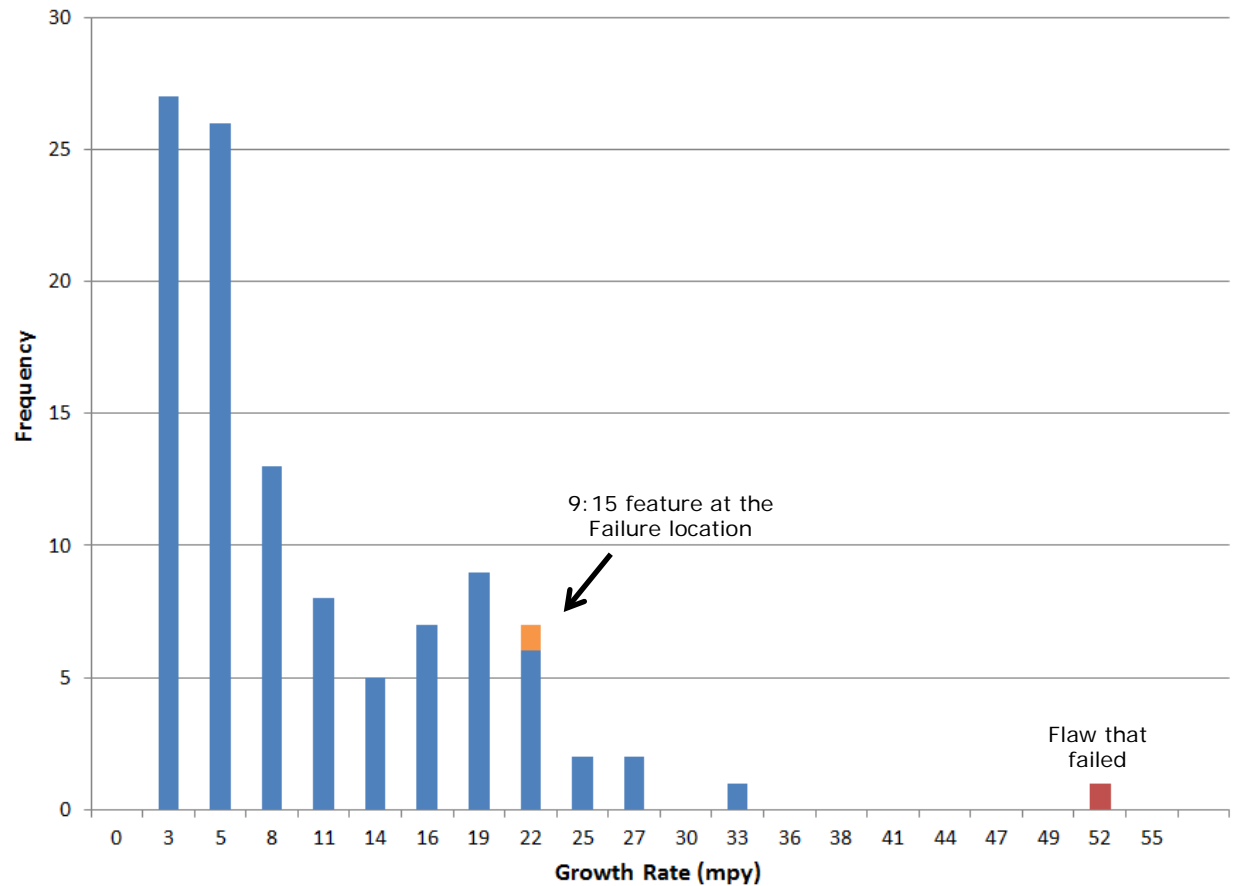
Figure 32. Histogram showing the distribution of corrosion rates determined from 2016 digs performed between May 17, 2016 and August 20, 2016 on the Isolated Segment and the corrosion rates determined for features on GWs at and near the failure location. Corrosion rates determined based on comparison to 2012 ILI results.

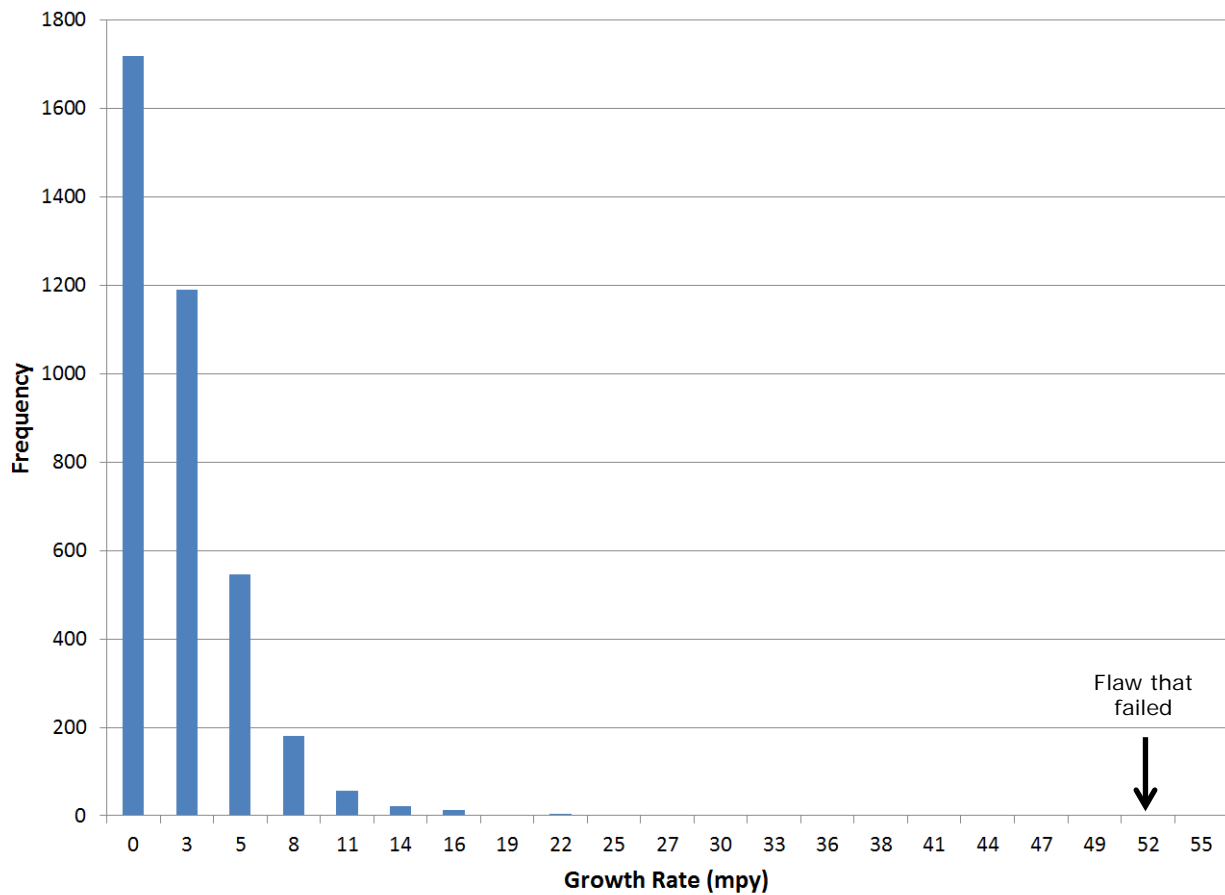
Figure 33. Histogram showing the distribution of corrosion rates determined from the ILI-ILI Master dataset. Corrosion rates determined based on comparison of the 2005 ILI data to the 2012 ILI data.

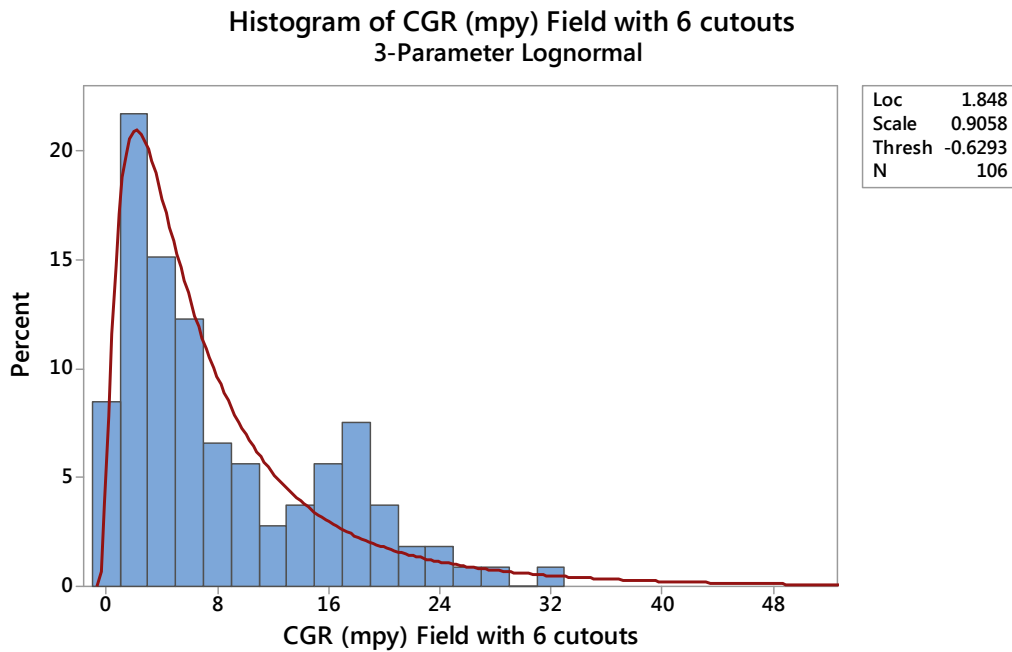
Figure 34. Distribution fit of a 3-Parameter Lognormal to the corrosion growth rates determined from the comparison of the 2016 Field measurements and 2012 ILI data.

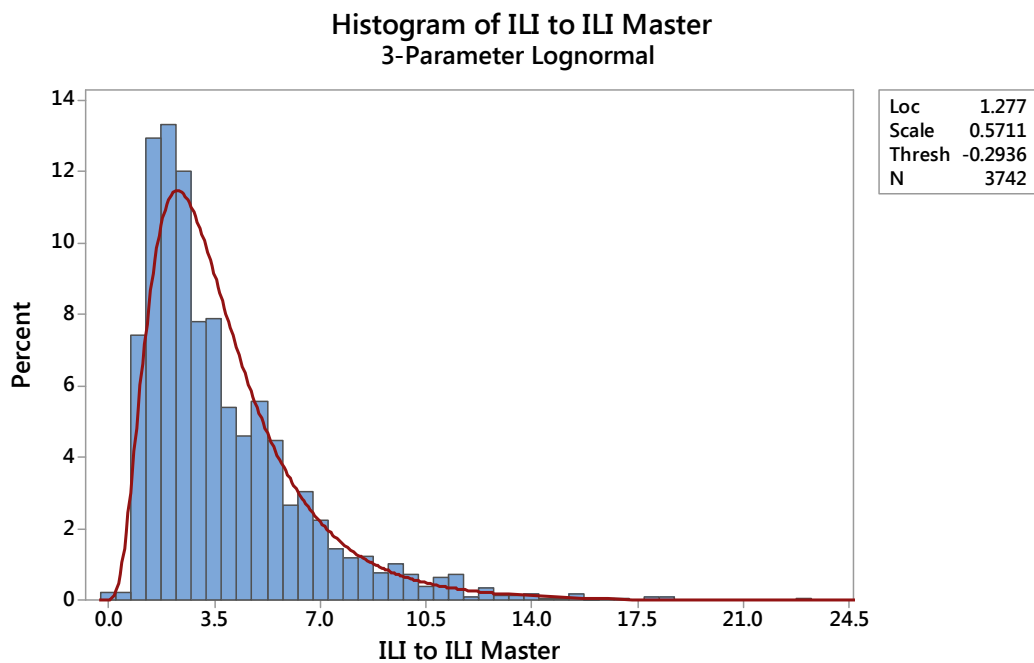
Figure 35. Distribution fit of a 3-Parameter Lognormal to the corrosion growth rates determined from the comparison of the 2005 and 2012 ILI data.
