Final Report

Technical Root Cause Analysis of Delmont Line 27 Failure – April 29, 2016

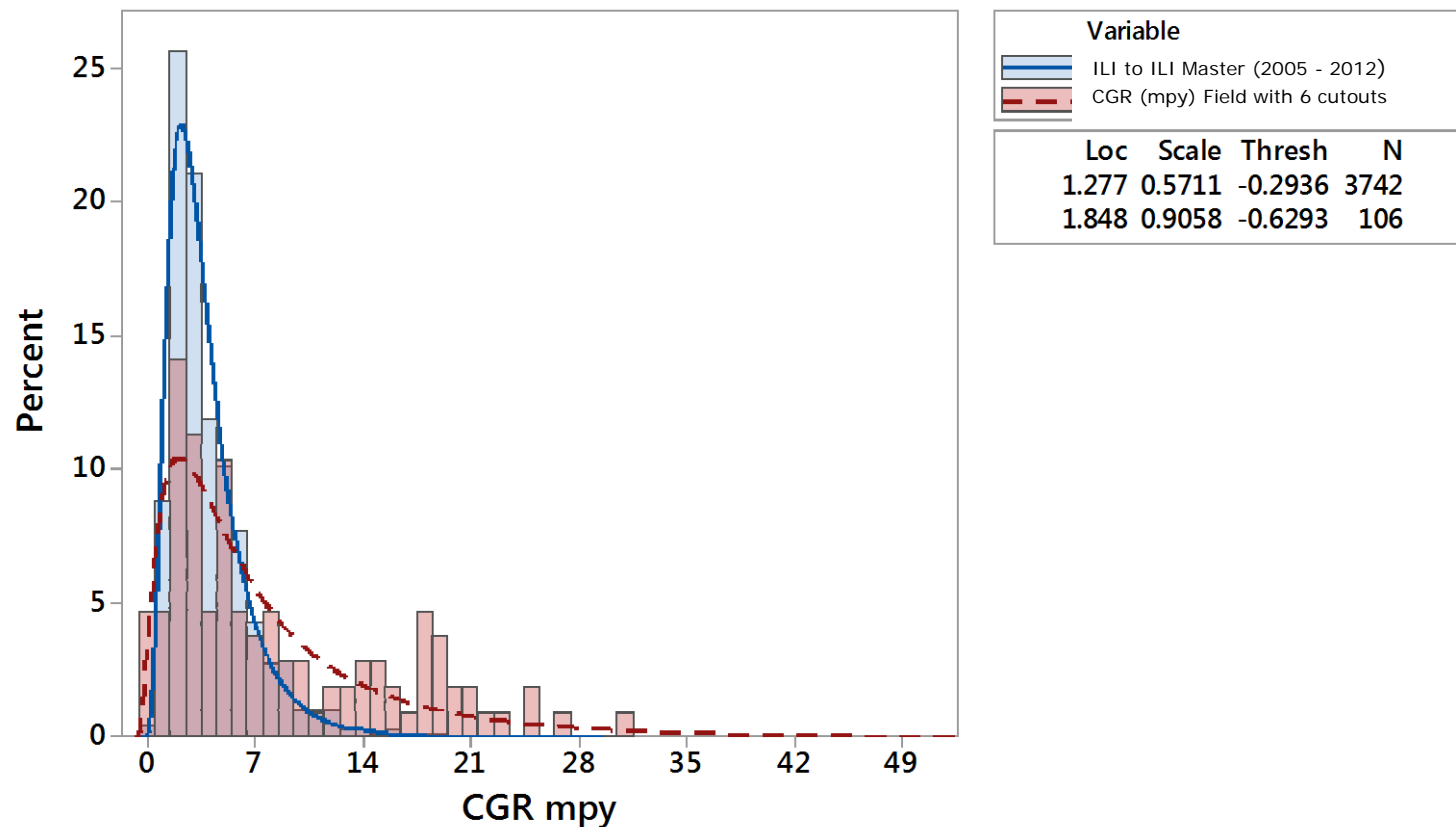
Figure 36. Combined histogram showing the previous two figures overlaid onto each other (i.e. 2005 - 2012 ILI data distribution overlaid with 2012 ILI data – 2016 Field measurement distribution).

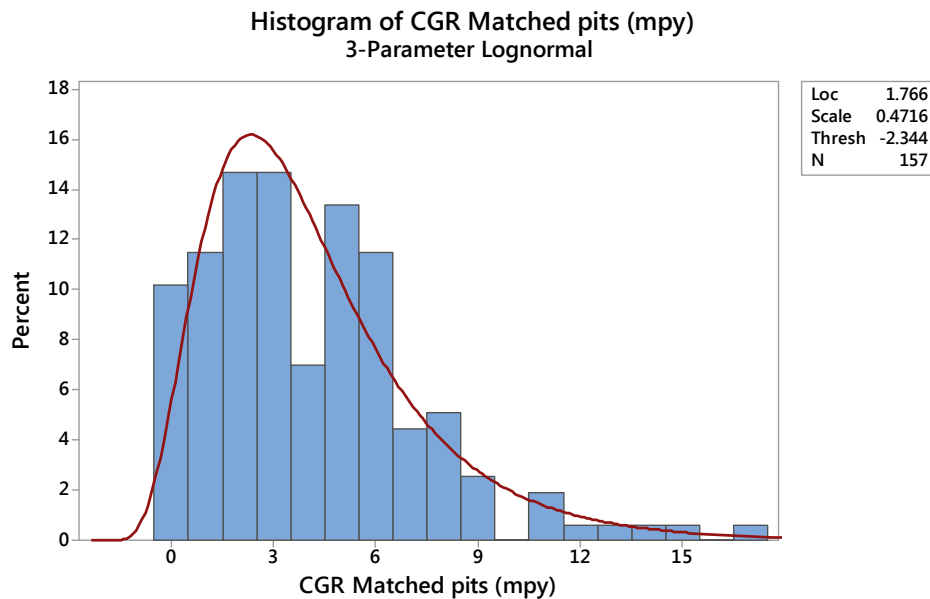
Figure C1. Distribution fit of a 3-Parameter Lognormal to the corrosion growth rates determined from the comparison of the 2005 to 2012 ILI data for matched features.

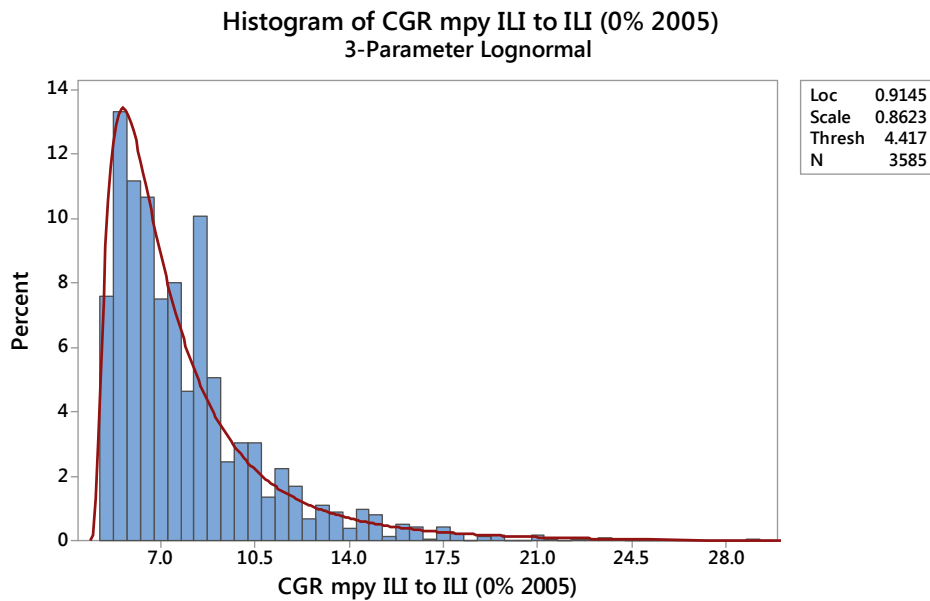
Figure C2. Distribution fit of a 3-Parameter Lognormal to the corrosion growth rates determined from the comparison of the 2005 and 2012 ILI data for unmatched features; assuming depth of 0% in 2005.

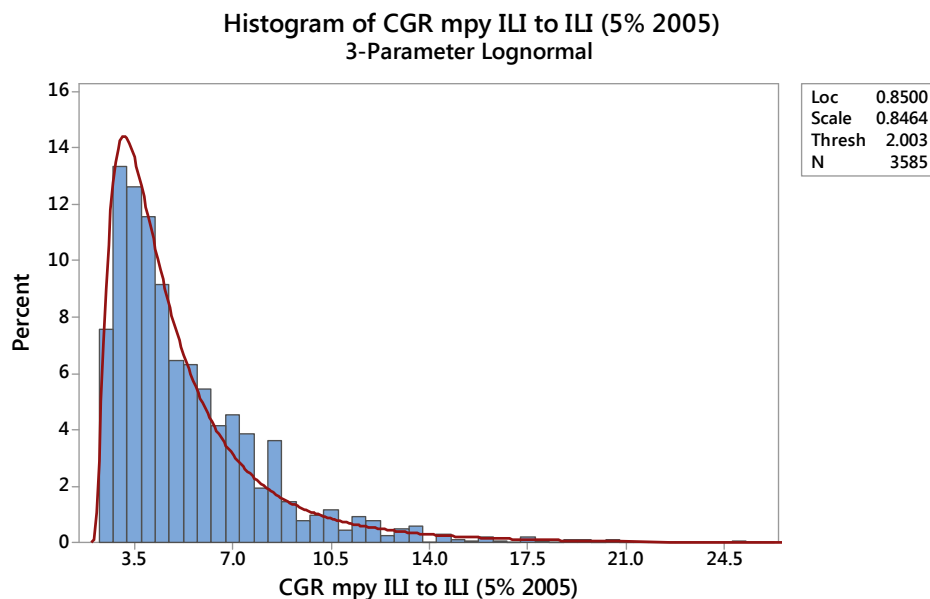
Figure C3. Distribution fit of a 3-Parameter Lognormal to the corrosion growth rates determined from the comparison of the 2005 and 2012 ILI data for unmatched features; assuming depth of 5% in 2005.

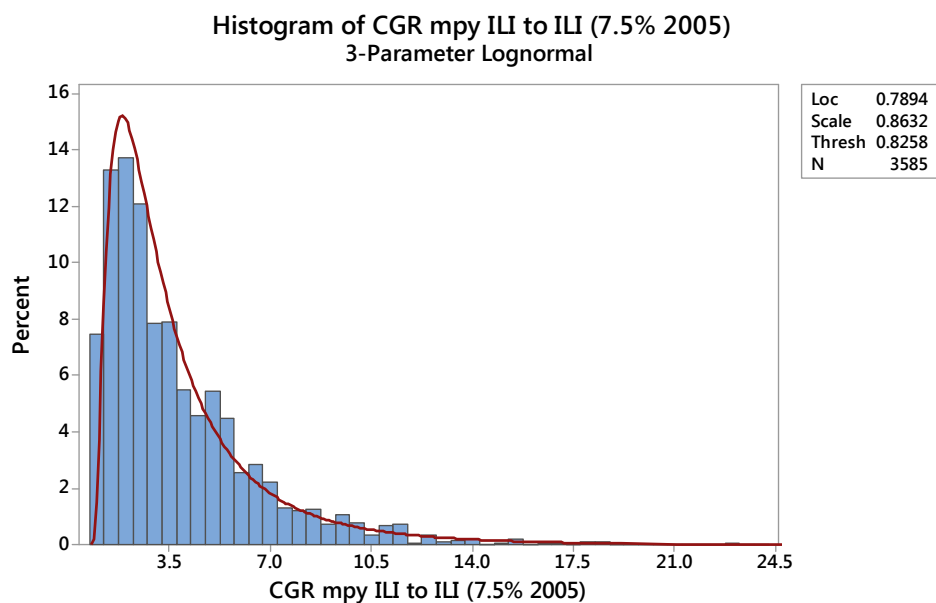
Figure C4. Distribution fit of a 3-Parameter Lognormal to the corrosion growth rates determined from the comparison of the 2005 and 2012 ILI data for unmatched features; assuming depth of 7.5% in 2005.

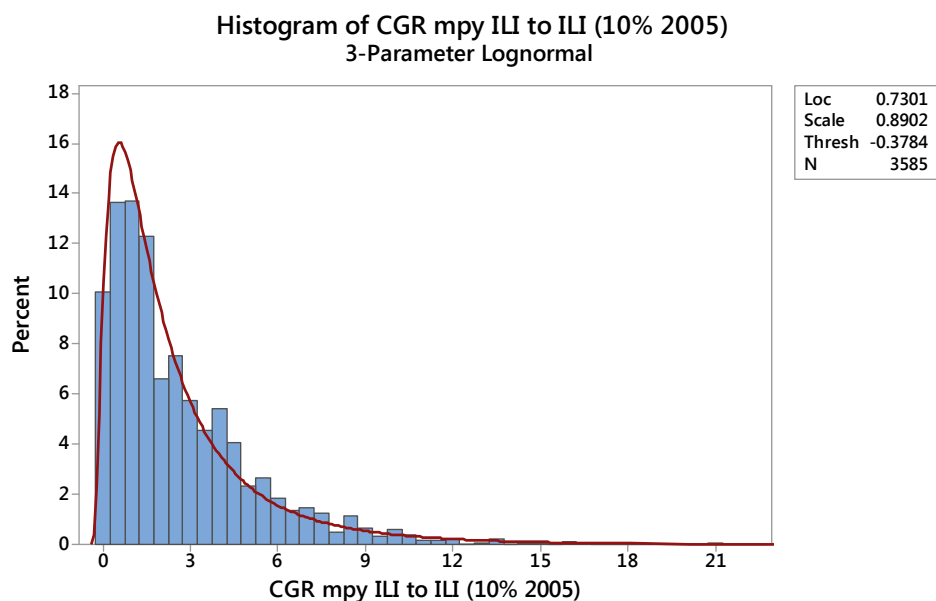
Figure C5. Distribution fit of a 3-Parameter Lognormal to the corrosion growth rates determined from the comparison of the 2005 and 2012 ILI data for unmatched features; assuming depth of 10% in 2005.

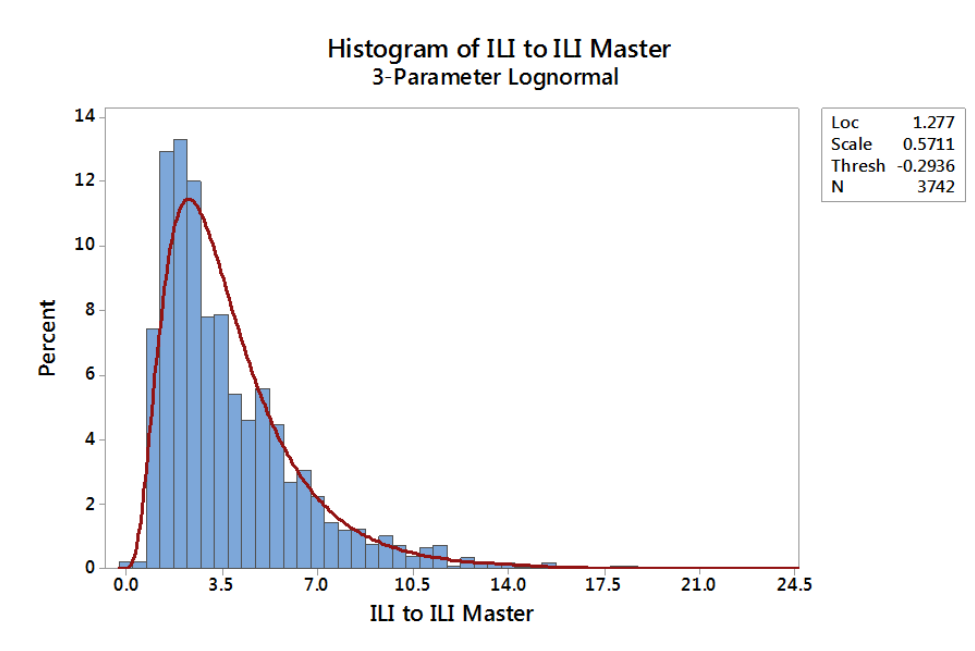
Figure C6. Distribution fit of a 3-Parameter Lognormal to the corrosion growth rates determined from consolidated 2005 to 2012 matched features and 2005 and 2012 ILI data for unmatched features with an assuming depth of 7.5% in 2005.
