Principal Investigator Michael Yazemboski
Senior Accident Investigator Michael Yazemboski
Region Director Byron E. Coy
Date of Report 2/24/2016
Subject Failure Investigation Report—Enterprise Products Operating, LLC:
ATEX Ethane Pipeline Failure, Follansbee, West Virginia

Failure Investigation Report—Enterprise Products Operating, LLC
ATEX Ethane Pipeline Failure
Follansbee, Brook County, West Virginia
[Failure Date 1/26/2015]

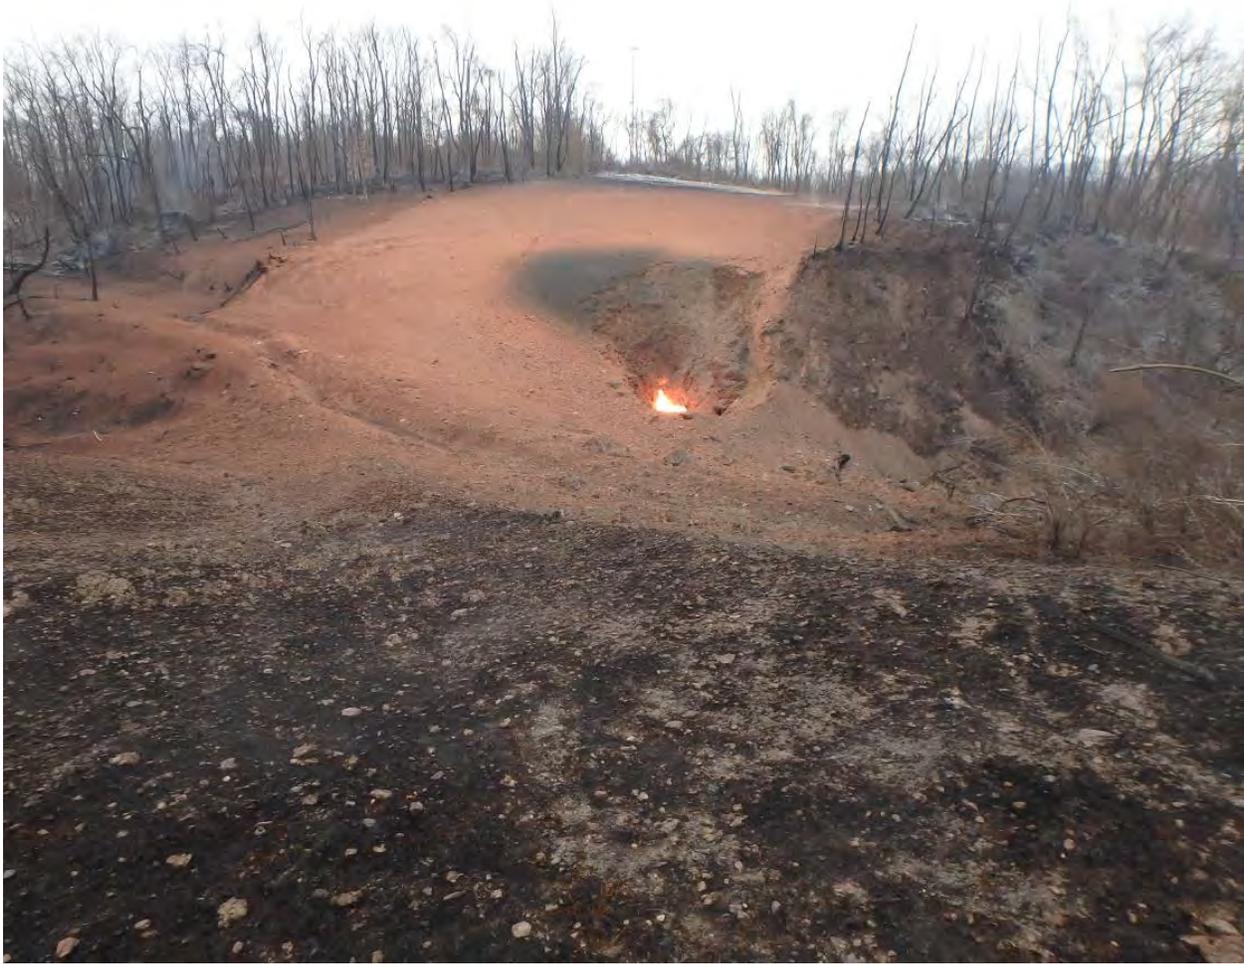
Photo 1 : (Jan 26, 2015)

8. The explosion and fire that resulted from the pipeline rupture burned approximately 5 acres of woodlands. However, there was no impact to waterways due to the rapid vaporization of the liquid ethane, and the area is not considered an HCA.

The explosion and fire that resulted from the pipeline rupture burned approximately 5 acres of woodlands. There was no impact to waterways due to the rapid vaporization of the liquid ethane.

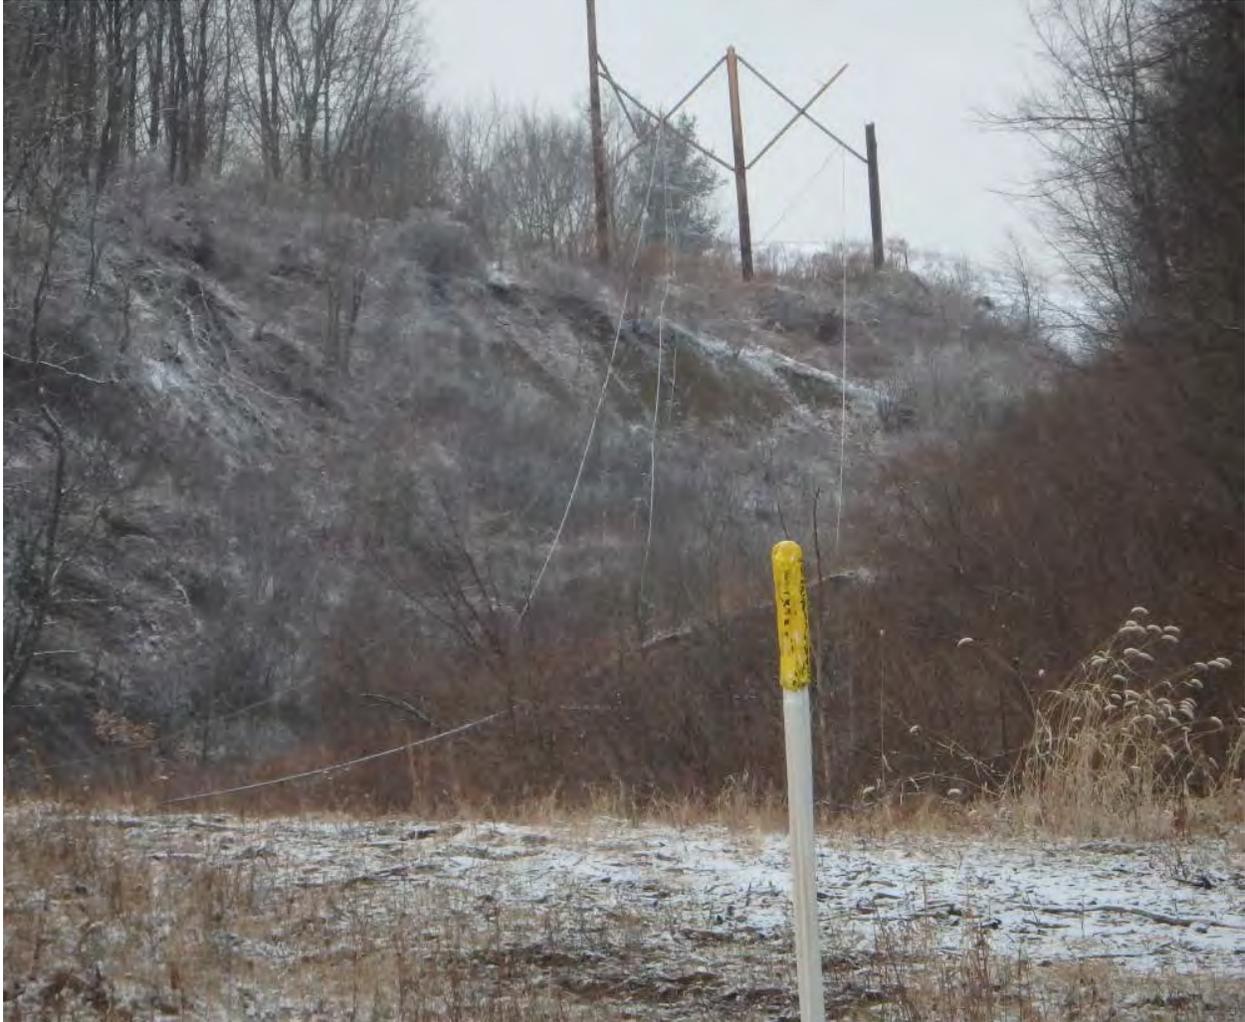
Photo 2 – (Jan 26, 2015)

18. The explosion and fire that resulted from the pipeline rupture burned approximately 5 acres of woodlands and damaged high tension power lines near the failure site (Appendix A, photo 2).

Power lines were damaged in the right-of-way that crosses the Atex-1 pipeline.

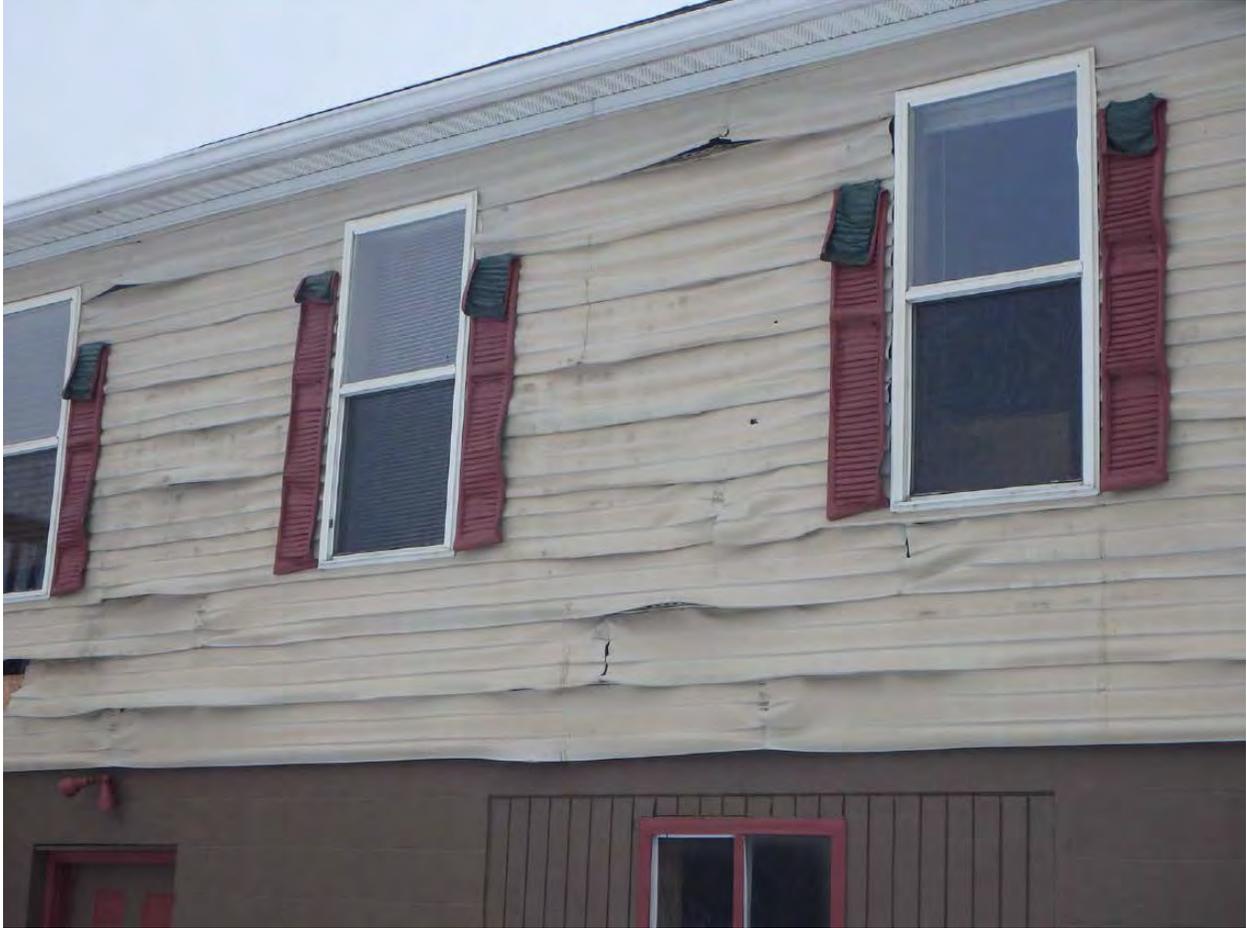
Photo 3 – (Jan 26, 2015)

Siding damaged from residual heat. This home is located approximately 2000 feet from the rupture site.

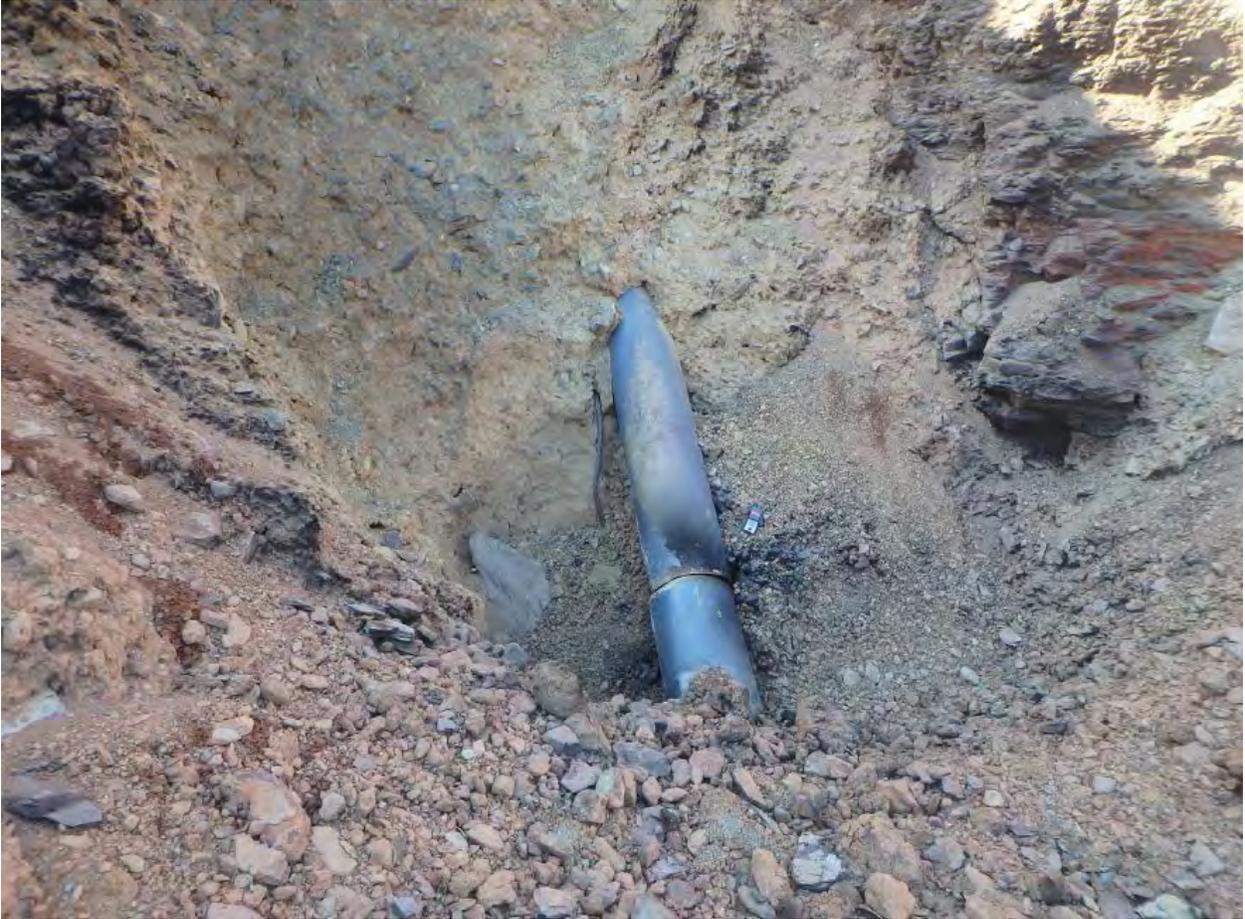
Photo 4 – (Jan 27, 2015)

Rupture site.

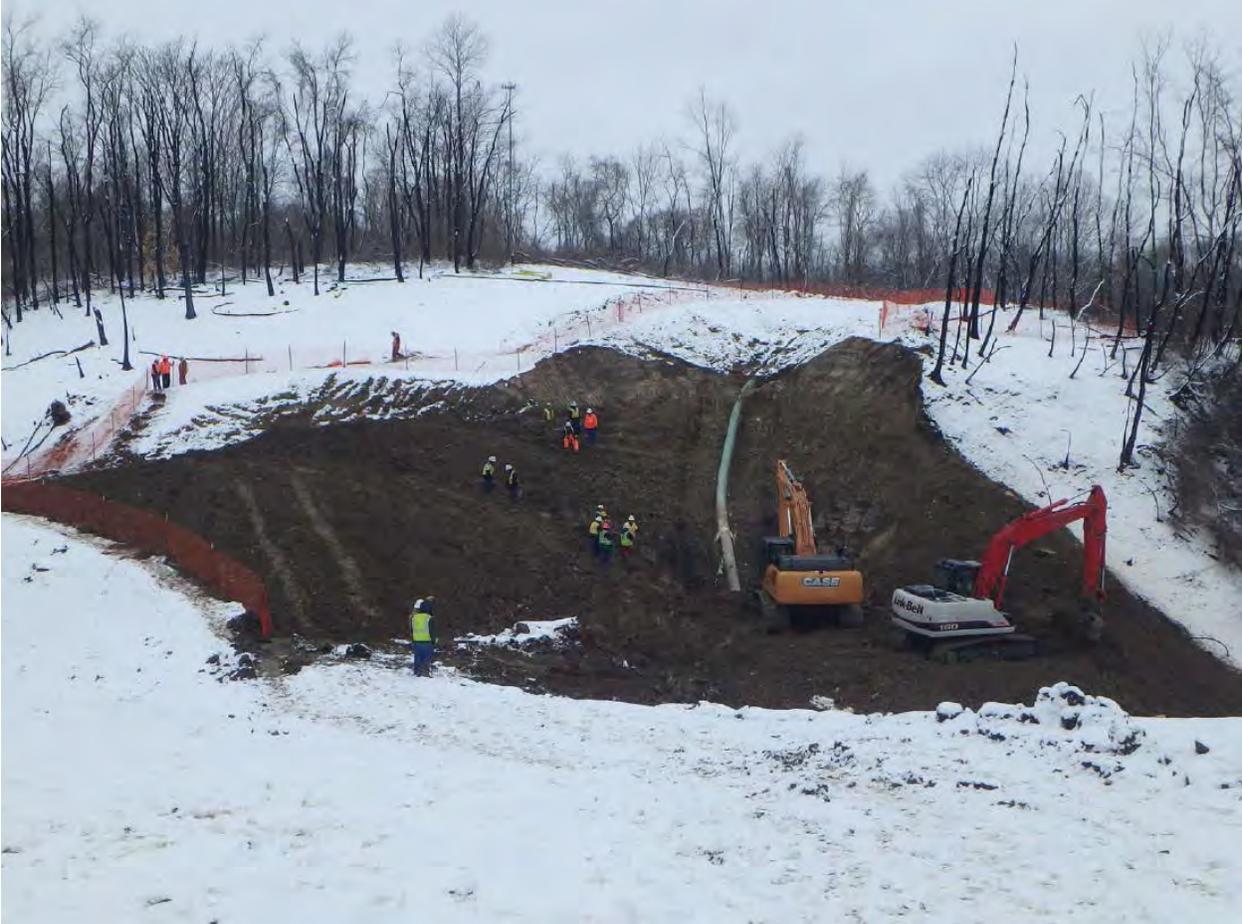
Photo 6 – (Feb 1, 2015)

Excavating the pipe.

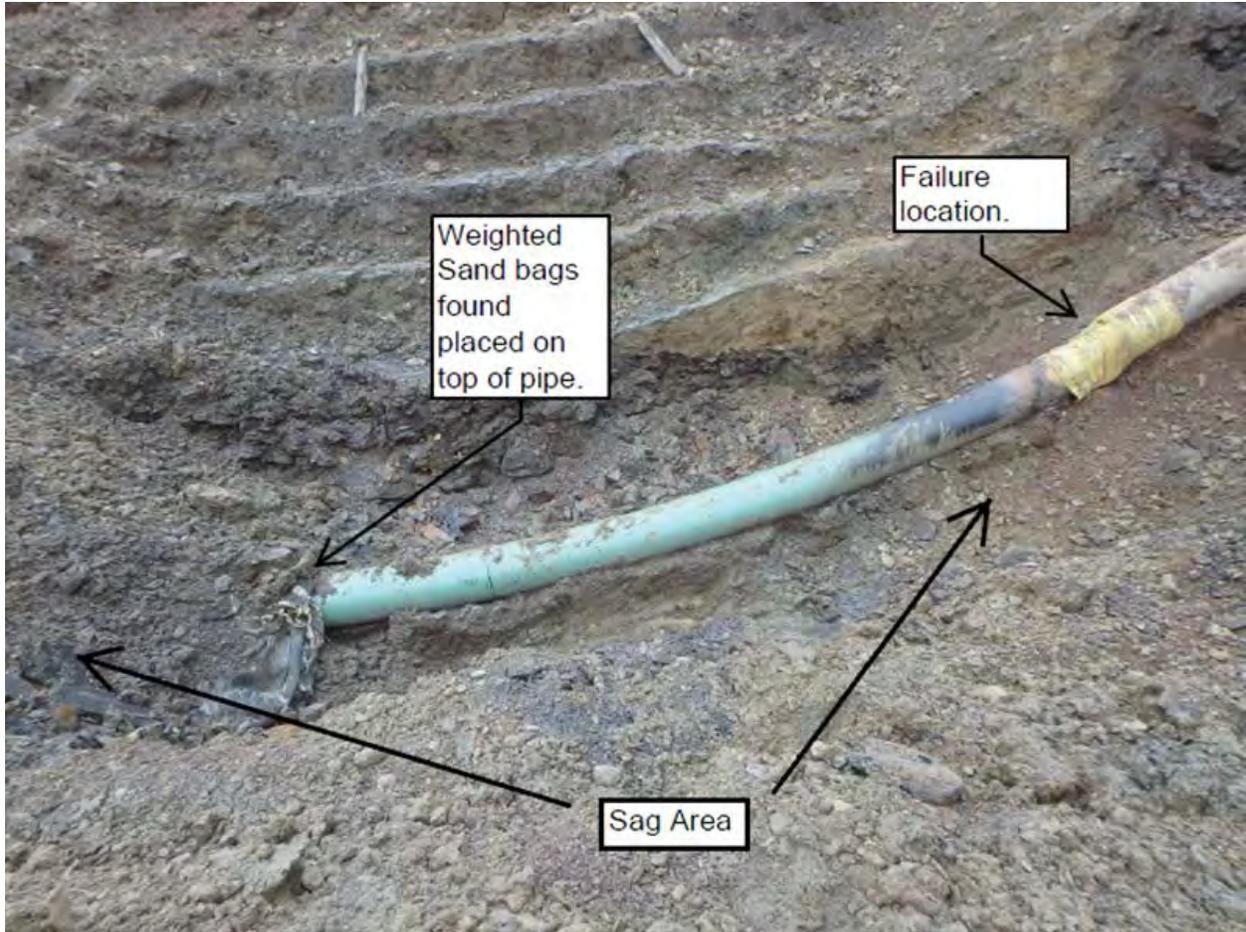
Photo 7 – (Feb 2, 2015)

15. Depth of cover at the failure site was approximately 12 feet.
16. There were multiple complex bends near the failure location.
17. Buoyancy control weights were installed in the vicinity of the failure site during the original construction of the pipeline (Appendix A, photo 7).

Previous mining activities were a contributing factor to the failure. The pipeline settlement in the failure location was likely caused by the consolidation of existing surface mine spoils during construction, added cover, and the placement of buoyancy control measures on the pipe.

Photo shows failure location wrapped with rock shield to protect the pipe ends during excavation. Weighted buoyancy control bags are shown on the pipe.

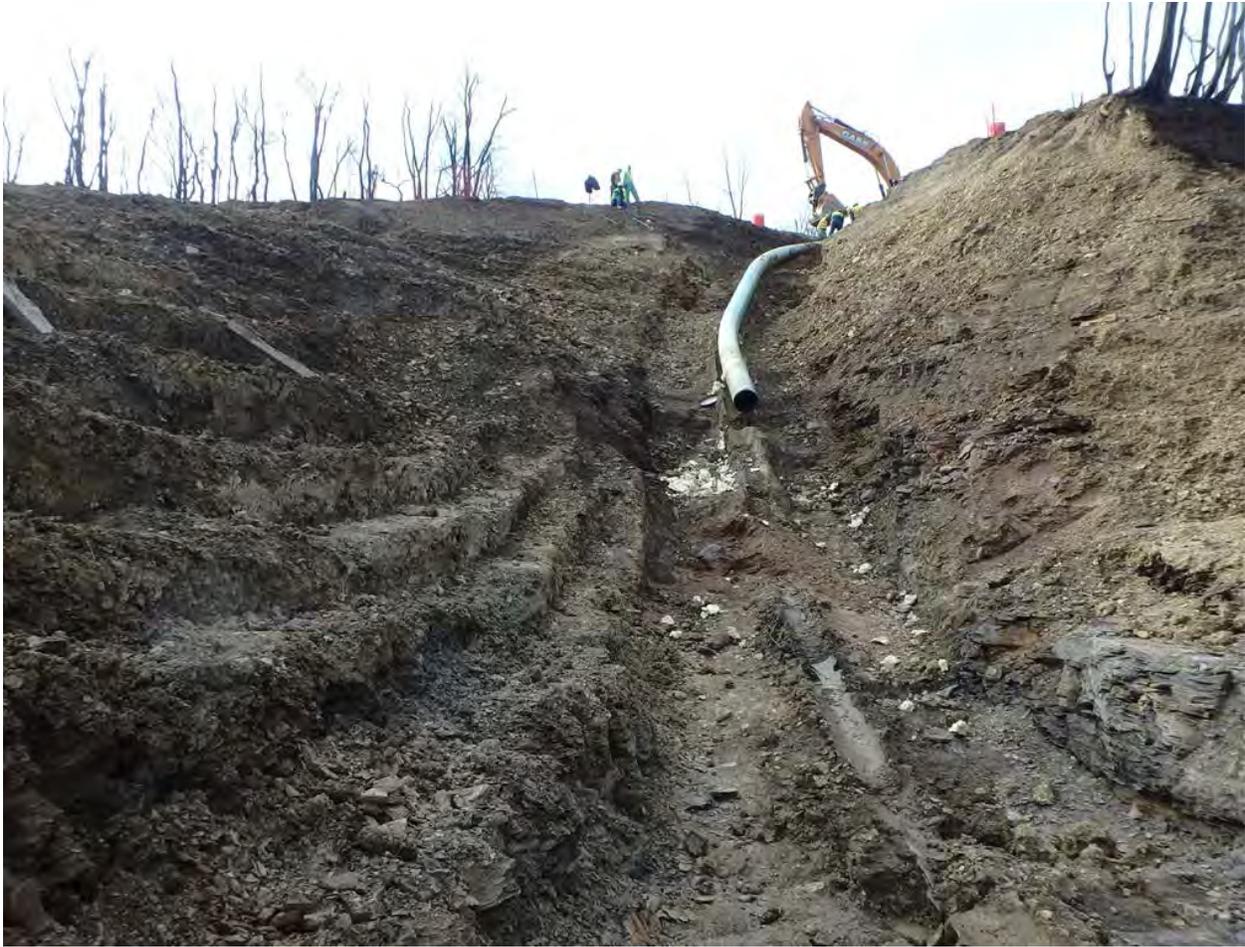
Photo 8 –(Feb 3, 2015)

Removal of ruptured pipe.

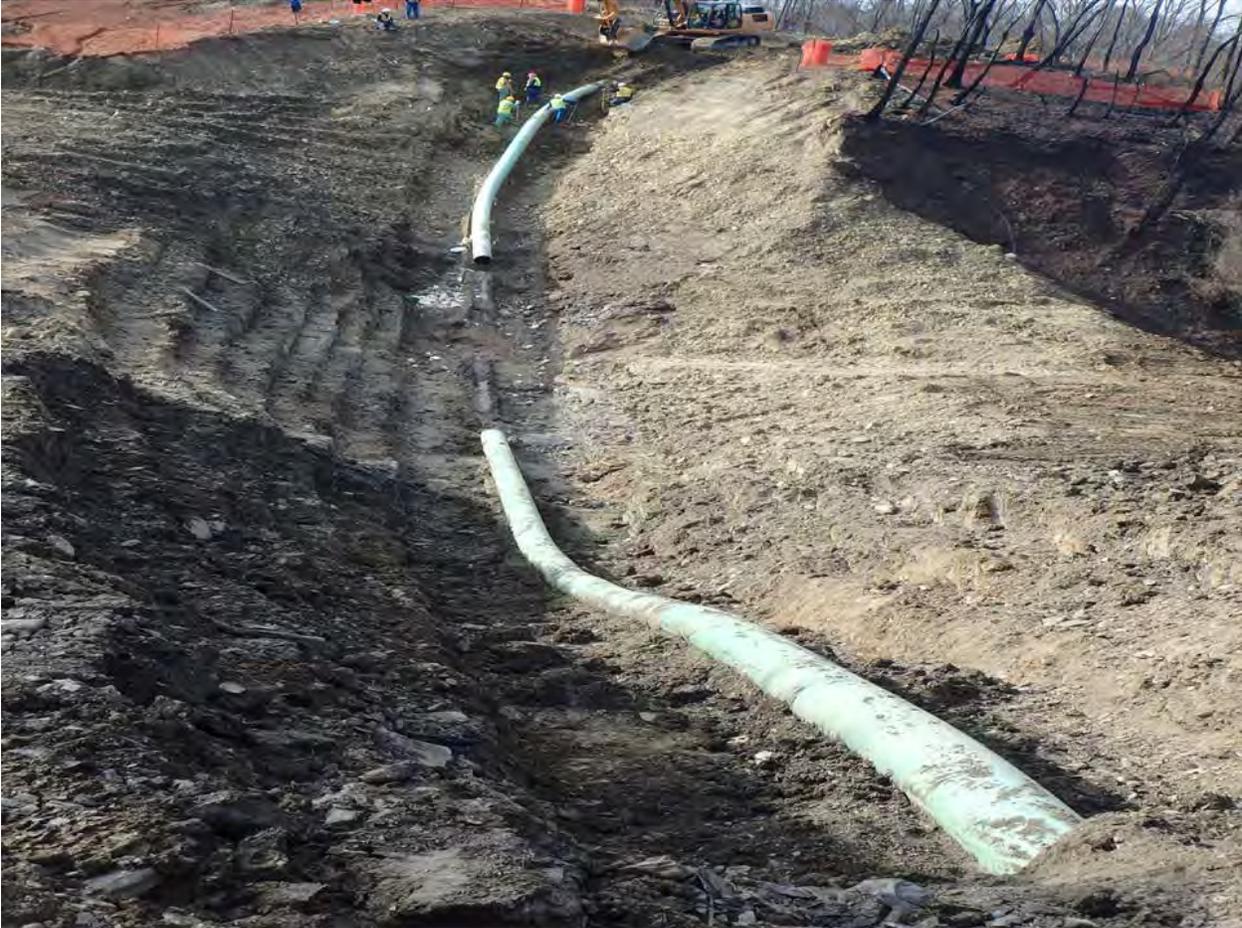
Photo 9 – (Feb 3, 2015)

Metallurgical testing of the failed pipe section was conducted by Kiefner and Associates, and showed that the accident was caused by a girth weld failure due to a ductile tensile overload from stresses resulting from loads imposed by the surrounding soil. The data also indicated that the intact upstream and downstream girth welds met the quality requirements and mechanical properties of API 1104. The mechanical properties of the pipe joints immediately adjacent to the rupture location, as well as the next pipe joints upstream and downstream, also met the chemical and mechanical properties for Grade X70 pipe (Appendix D).

Ruptured pipe section removed including upstream and downstream welds. Pipe and welds sent for metallurgical testing.
