Principal Investigator Gene Roberson
Region Director R.M. Seeley
Date of Report 11/3/2016
Subject Failure Investigation Report—Gulf South Pipeline Company, LP
Sub-sea Fitting Failure—Eugene Island Block 95

Gulf South Pipeline Company, LP—Sub-sea Connection Failure

Failure Date: 8/26/2015

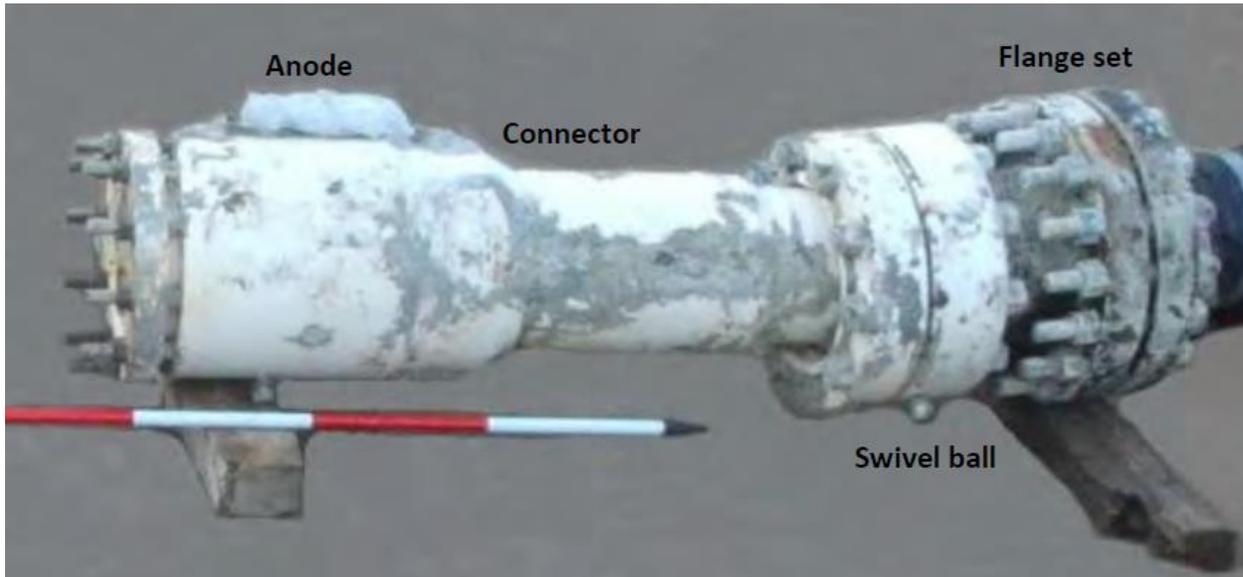
Figure 2: Sub-sea Fitting

The connector was installed in 2006 as an approved repair to damage from Hurricanes Katrina and Rita in 2005.

The sub-sea connector was sent to a Houston, Texas, metallurgical lab for analysis, where it was determined that the connector performed as designed and that all damage observed to the connector slips, seals, and pipe occurred during the incident.

Stress Engineering's conclusion was: "the connector fitting likely failed due to a combination of external forces from the pipe being exposed and the lack of support from the damaged stand off found while exposing the pipe." PHMSA concurs with this finding, since this incident occurred sub-sea and site evaluation was limited.
