Principal Investigator	Gery Bauman/Karen Butler
Region Director	David Barrett
Date of Report	3/28/2015
Editorial Revision Date	11/8/2016
Subject	Failure Investigation Report—Magellan Pipeline Company, LP— External Corrosion, Crevice and Atmospheric

Date of Failure	11/25/2012
Commodity Released	Refined Product—Jet Fuel
City/County & State	Kansas City/Wyandotte, Kansas
OpiD & Operator Name	22610 Magellan Pipeline Company, LP
Unit # & Unit Name	3933 (WPL) Kansas City Unit
SMART Activity #	147517
Milepost/Location	41+27/Line 6495, Fairfax West KCI pipeline
Type of Failure	Pinhole leak at bridge pipe support; crevice and atmospheric corrosion
Fatalities	0
Injuries	0
Description of area impacted	Missouri River Crossing, High Consequence Area (HCA), urban
Total Costs	\$62,477

Failure Investigation Report
Magellan Pipeline Company, LP, External Corrosion, Atmospheric
Failure Date: 11/25/2012

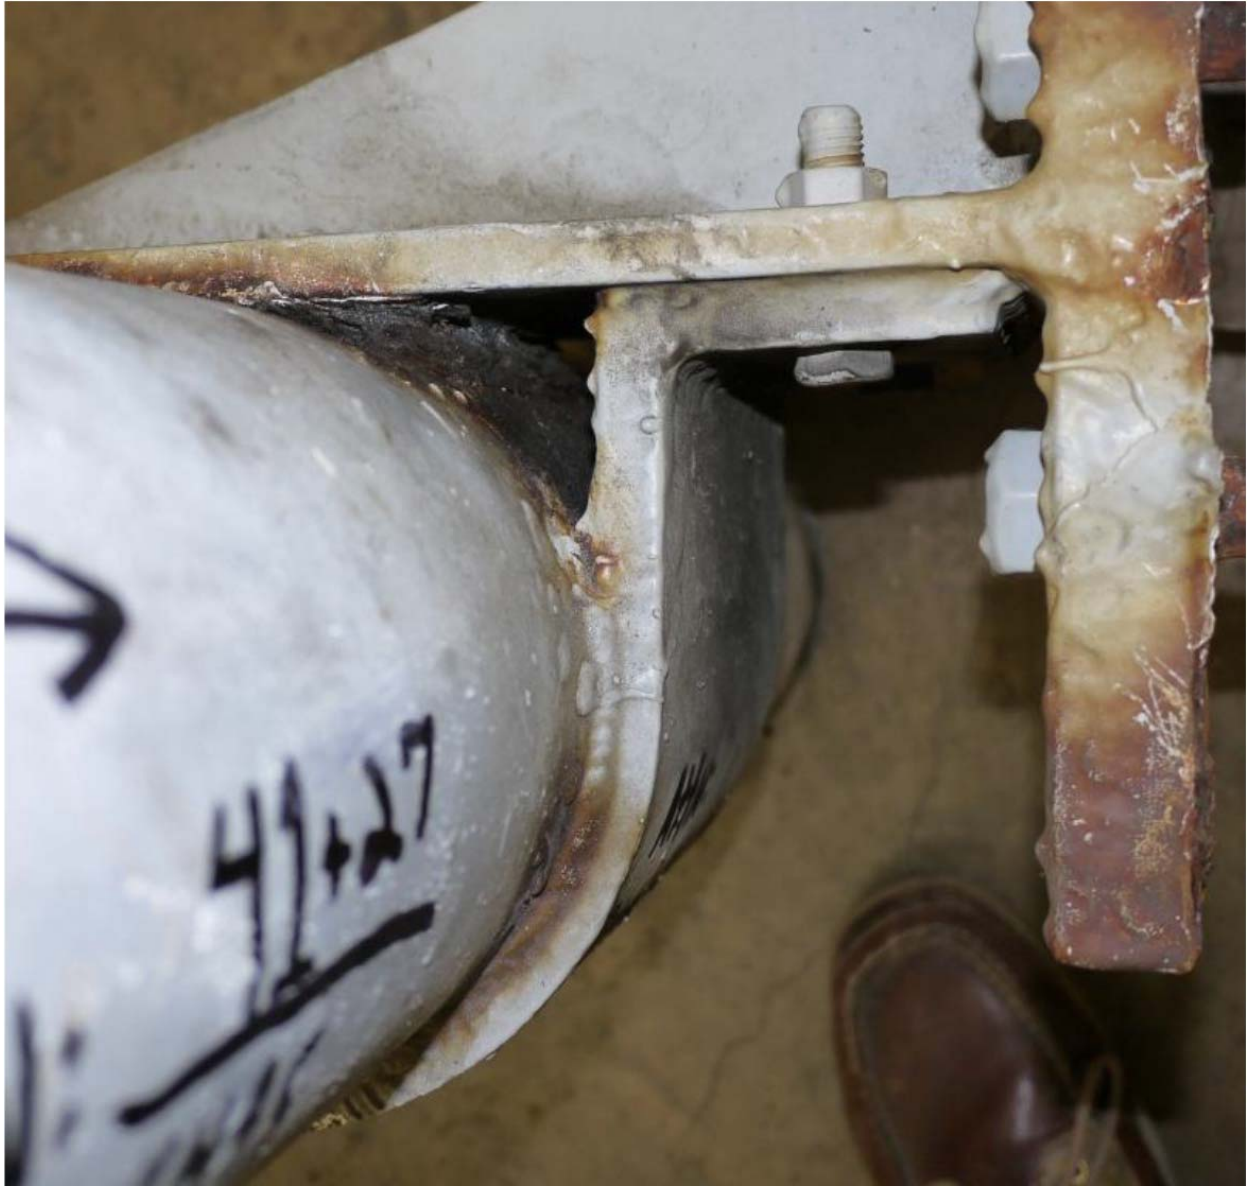
Kiefner and Associates, Inc., conducted the metallurgical analysis and determined that: "external crevice corrosion acted between the pipeline and the pipe support in an area where the support was not welded to the pipeline. This area was exposed to moisture and atmospheric corrosion occurred."³ This report also noted the following significant details:

A pinhole sized leak was oriented at 10:00 o'clock and located under the pipe support.

View of External Corrosion on Pipe/Support Assembly

The pipeline was repaired on Friday, November 30, 2012, by cutting out the pipe support and associated carrier pipe and installing 7.25 feet of pre-tested 6-inch pipe on a supporting nonconductive hanger. The supply of jet fuel to the airport was continually monitored, and one lane of the bridge was closed to traffic under a permit restriction from 8:00 a.m. until 4:30 p.m. After the replacement was completed, the pipeline successfully passed a 90-minute hold test and was returned to service at 4:13 p.m. on Friday, November 30, 2012.

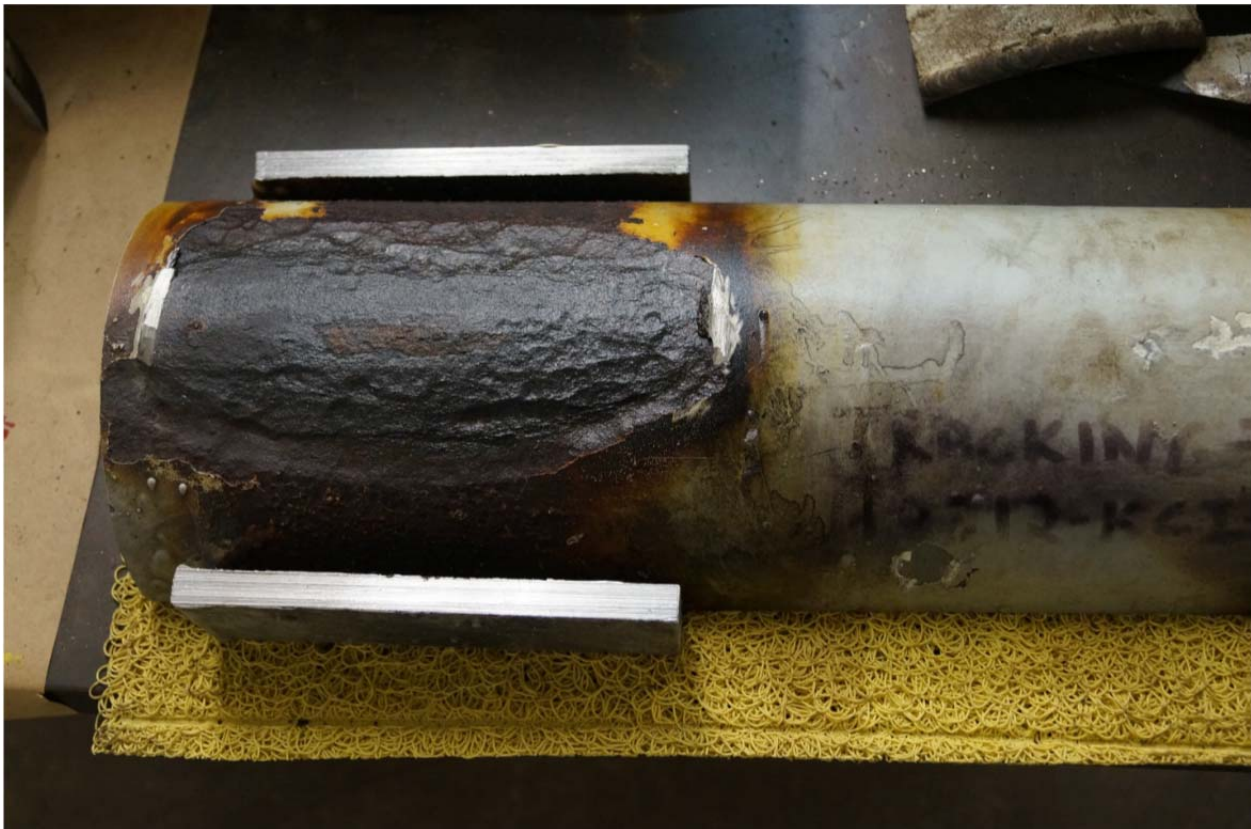
The corrosion products found on the pipe were a layered, dark magnetic oxide product. The presence of magnetic oxides in the corrosion areas has been shown to interfere with the accurate correlation of depths using magnetic-flux-leakage tools. The magnetic oxide normally causes the inspection tool to predict the corrosion depth to be less than the depth that is measured upon excavation. Magnetite commonly forms under anaerobic conditions such as within crevices or under insulation where oxygen is not readily refreshed. Moisture trapped between the bridge support and the pipeline formed corrosion products that built up and reduced the availability of oxygen.

Atmospheric Corrosion - After Cutting Assembly Apart

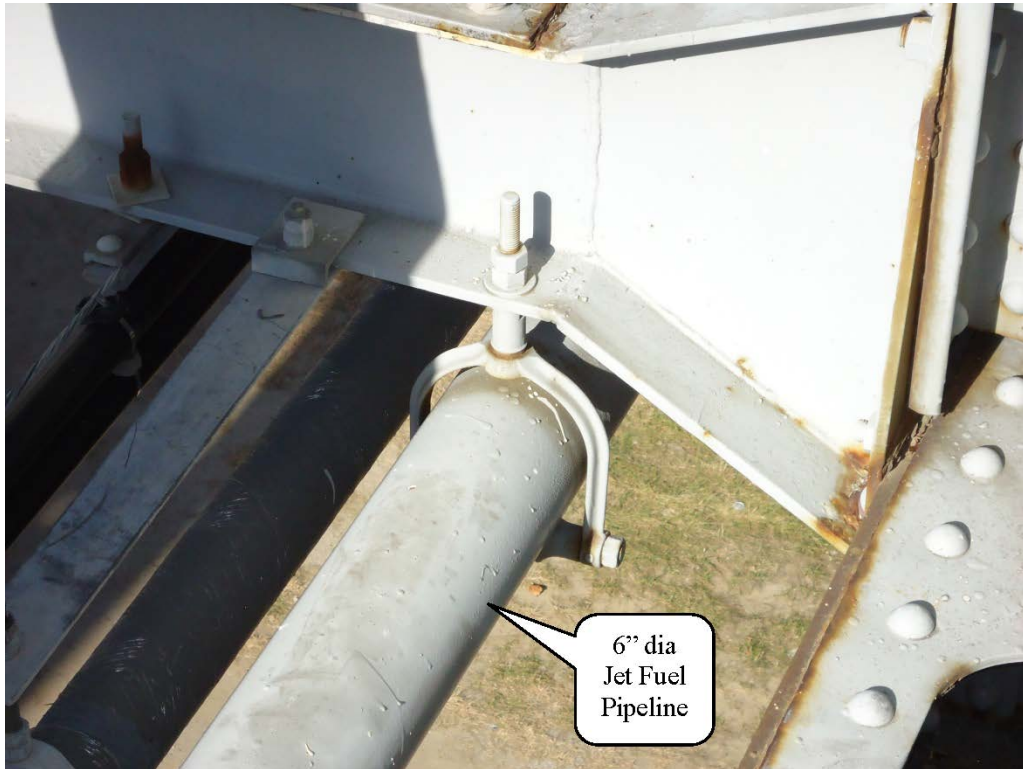
Typical Pipe Roller Hanger Support with cast iron roller. Note surface rust. (Operator-provided photo)

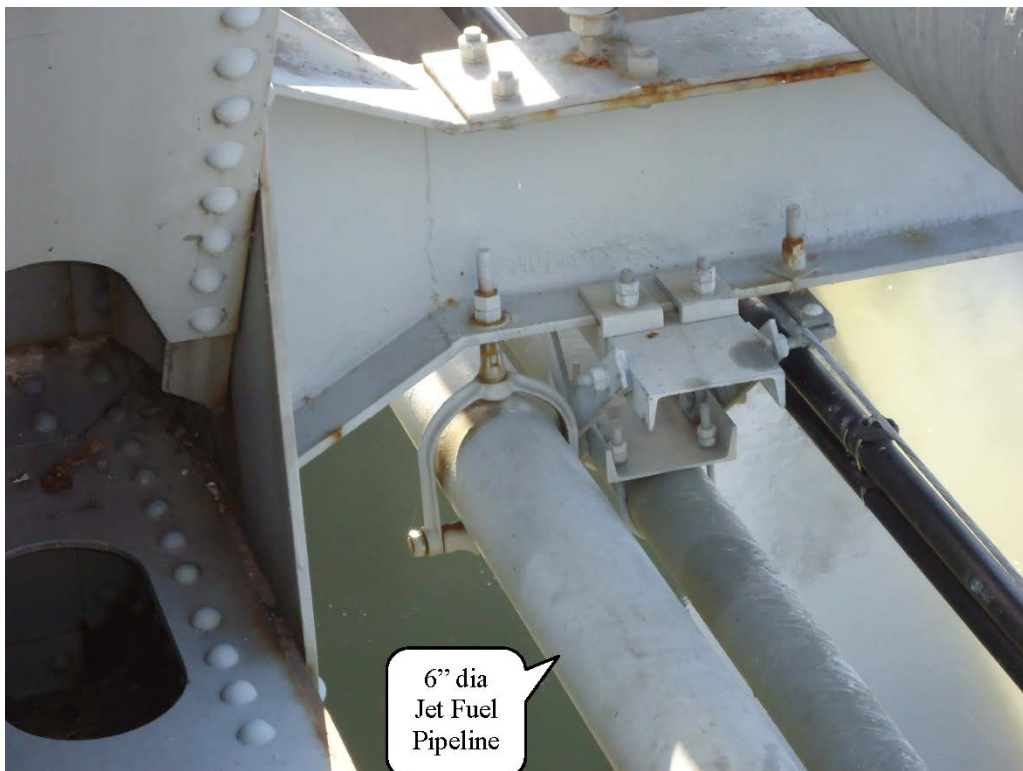
Same as above. Note surface rust. (Operator-provided photo)

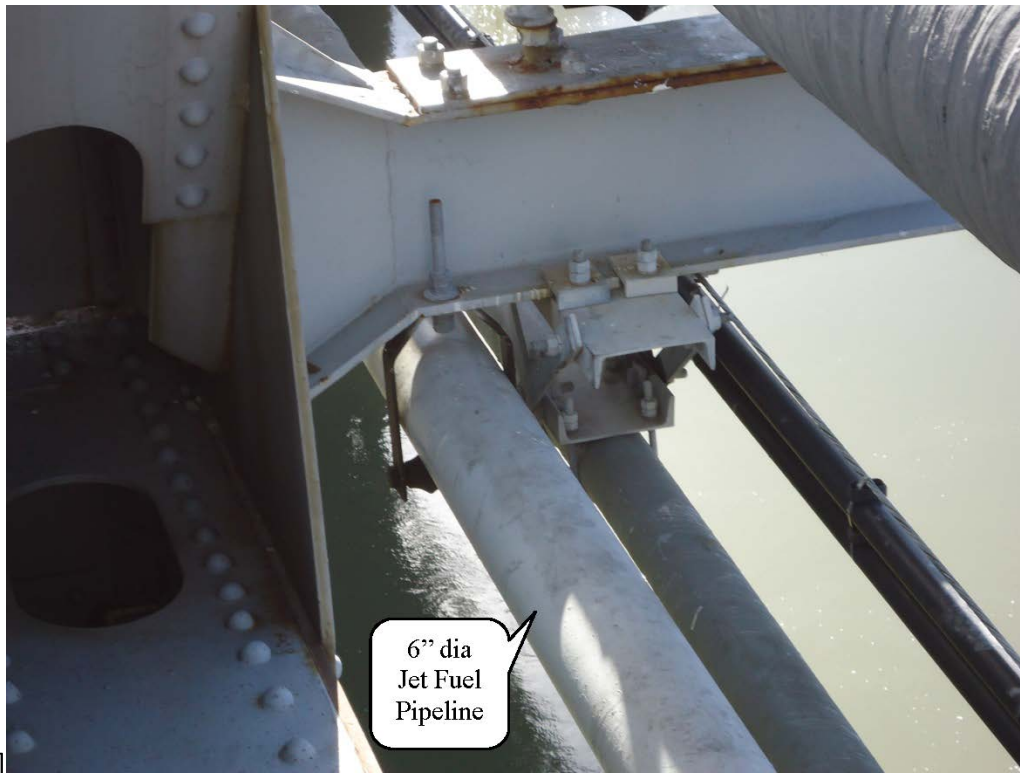
Pipe Roller Hanger Support with a non-conductive roller. (Operator-provided photo)

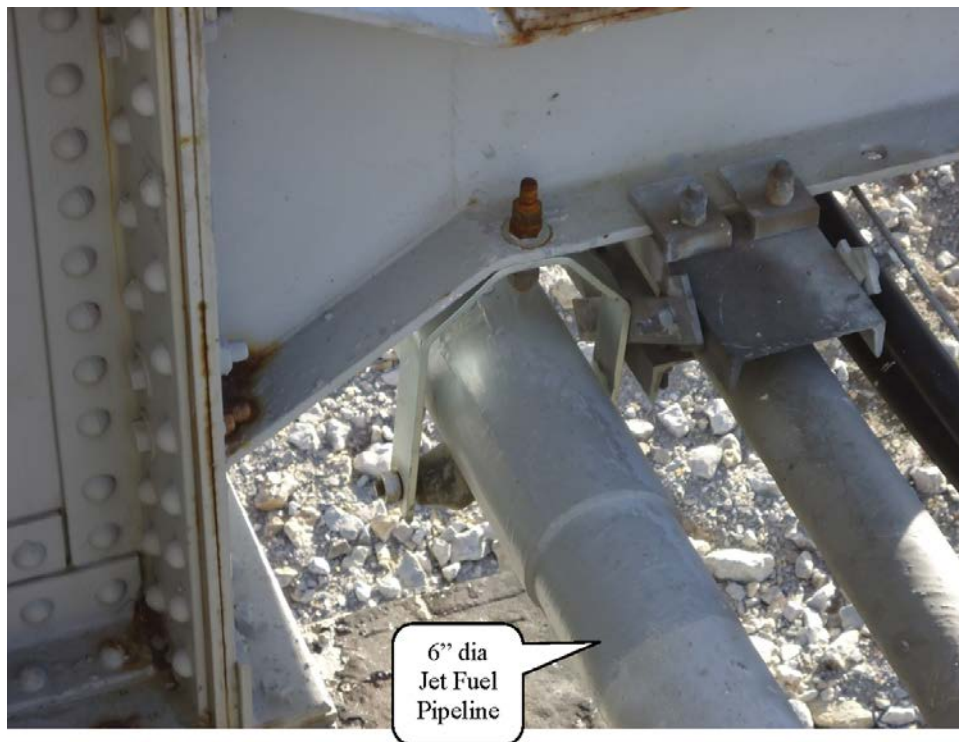
Pipe Roller Hanger Support at welded sleeve with a non-conductive roller. (Operator-provided photo)

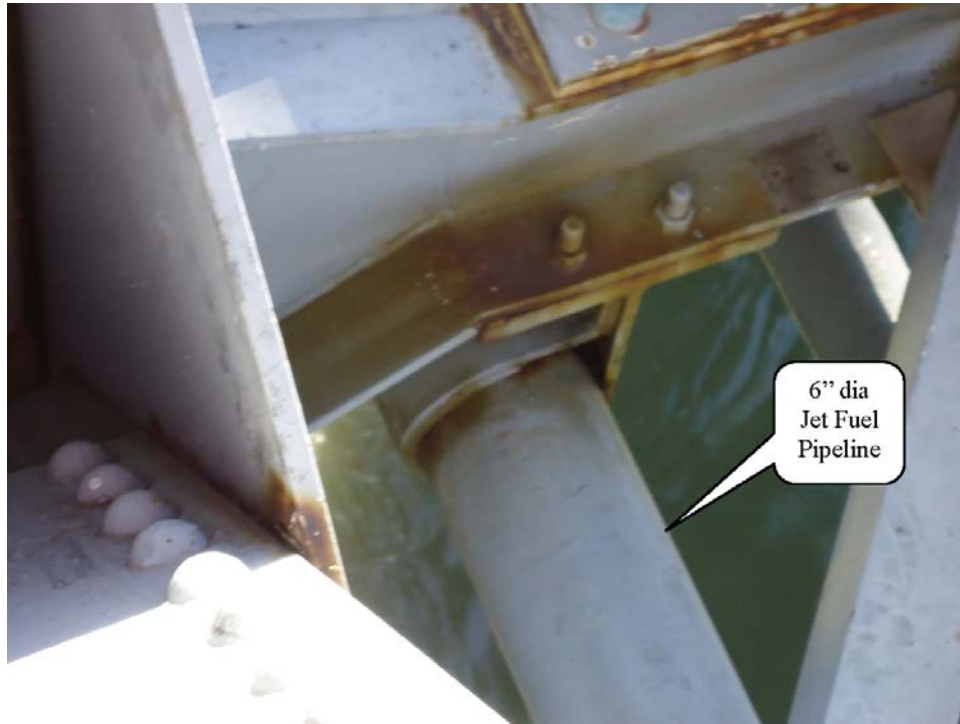
Welded Pipe Support Hanger near center of Bridge – Span 9 Truss Panel Point L16.
Short section of pipe along with hanger was removed due to leak at this location.
(Operator-provided photo)
