Principal Investigator James Bunn/Karen Butler
Region Director Ivan Huntoon (Prior RD)
Date of Report 1/14/2015
Subject Failure Investigation Report – Marathon Pipe Line LLC – Material Failure, Rupture

Failure Investigation Report – Marathon Pipe Line LLC – Material Failure, Rupture

Failure Date 09/03/2008

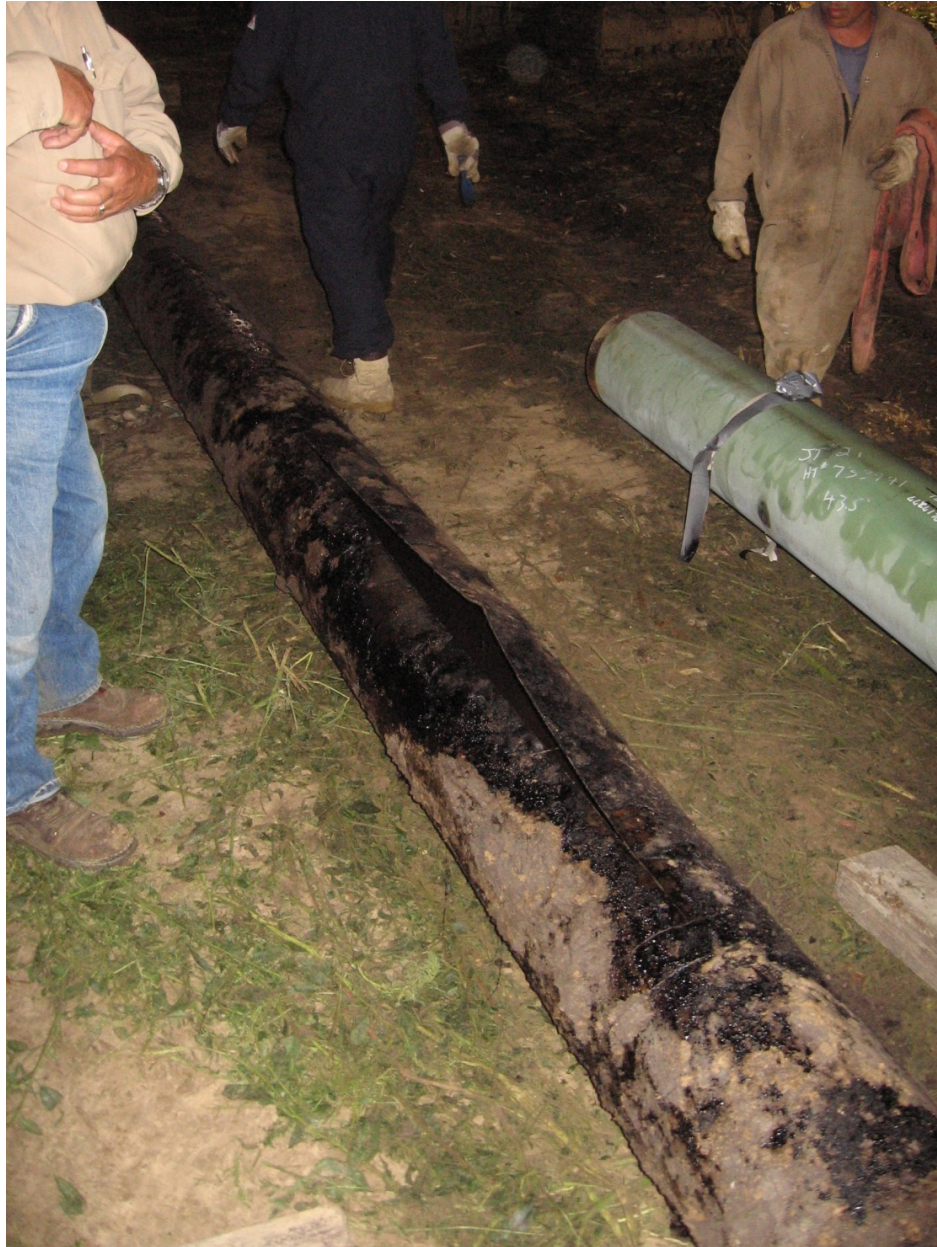
Failed Pipeline Joint

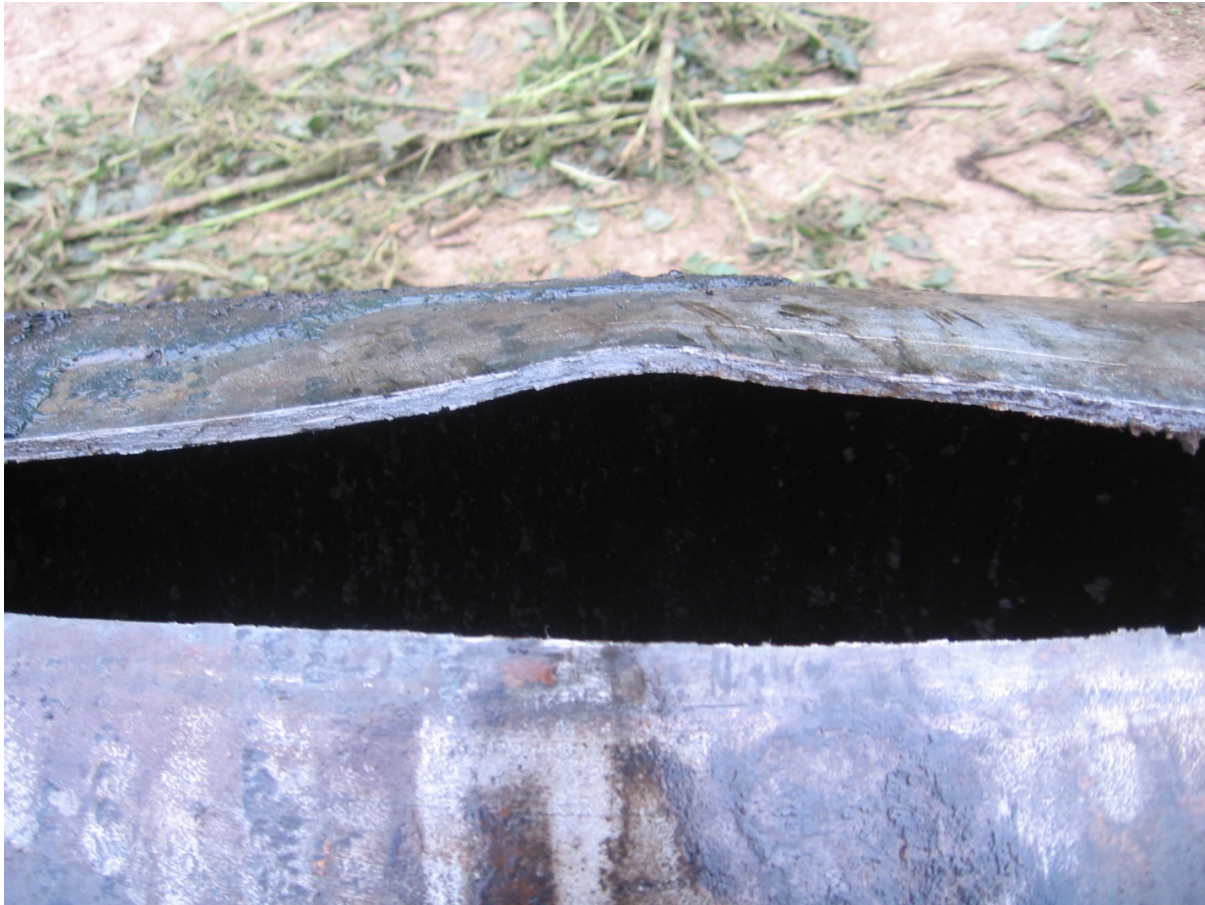
The rupture was reported as 70 inches long with an opening approximately 3.0 inches in width at the 5:30 circumferential position. The deformation measured approximately 0.150 inches deep (1.2 percent of pipe OD at the deepest location). Coating damage and approximately 5 percent through-wall external corrosion was present at the center of the deformation. No indications of internal corrosion, stress corrosion cracking, or other outside force damage were identified during metallurgical analysis. Residual stresses when the pipeline was cut were reported to be negligible.

Close-up photo showing rupture site

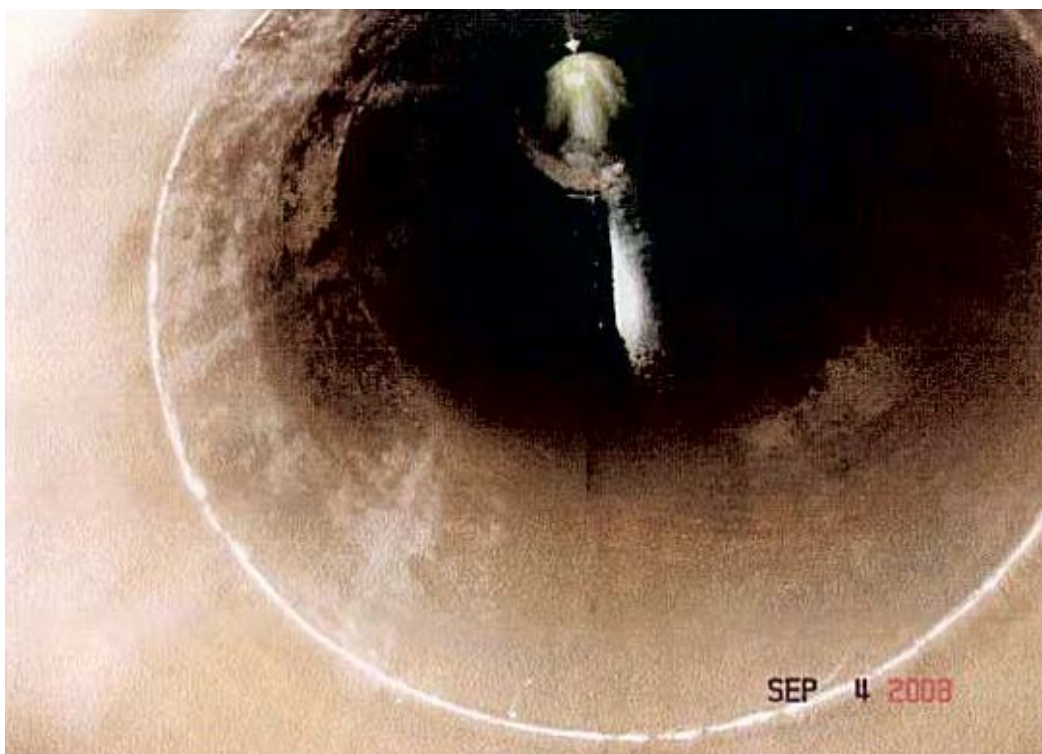
Internal view of removed pipe (provided by operator)

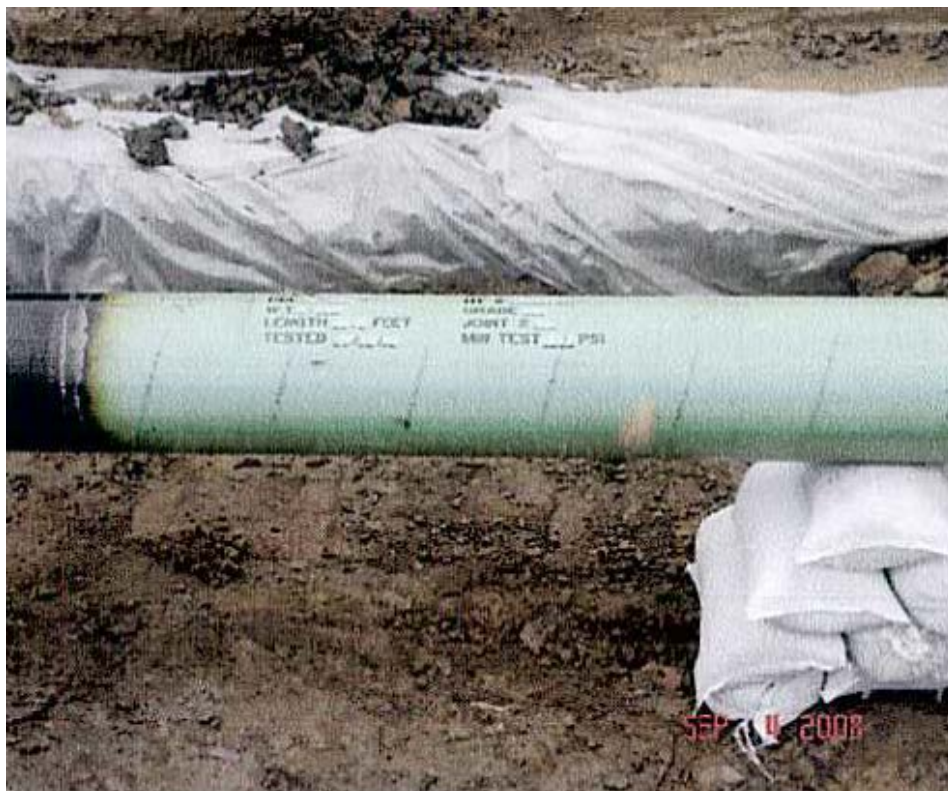
Image of tie-in (provided by operator)
