**Principal Investigator** Molly Atkins  
**Region Director** R.M. Seeley  
**Date of Report** 6/10/2016  
**Subject** Failure Investigation Report – Texas Gas Transmission, LLC, Gas Pipeline Rupture in Farmerville, LA

## **Failure Investigation Report – Texas Gas Transmission, LLC**

September 9, 2015 | Farmerville, LA

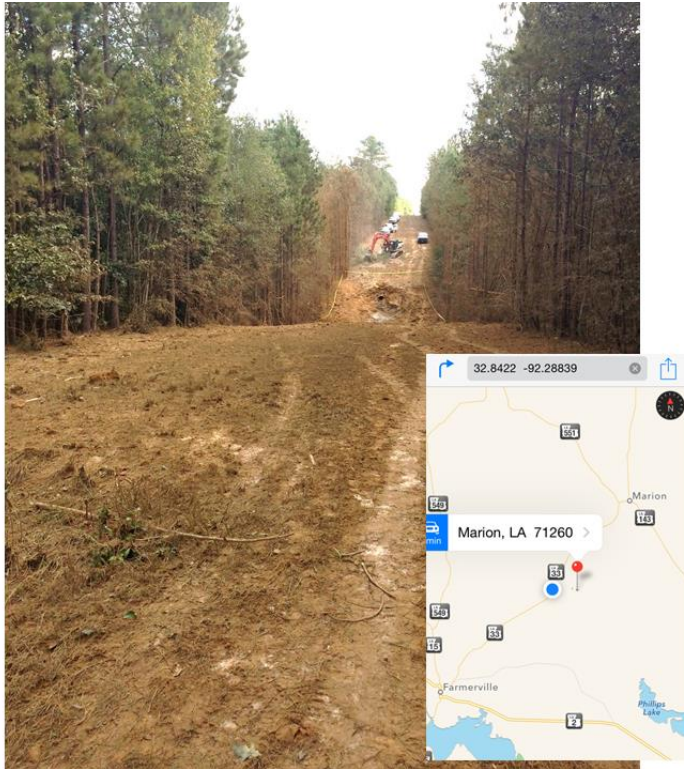
Figure 2 - Incident Vicinity Map and ROW Looking to the East

The incident occurred on the TGT's MLS 26-1 at approximately MP 28.8. Figure 2 is a post-incident view of the general vicinity and the ROW, which is in Union Parish in rural north-central Louisiana. Additional photographs of the vicinity may be found in the metallurgical failure analysis in Appendix A.

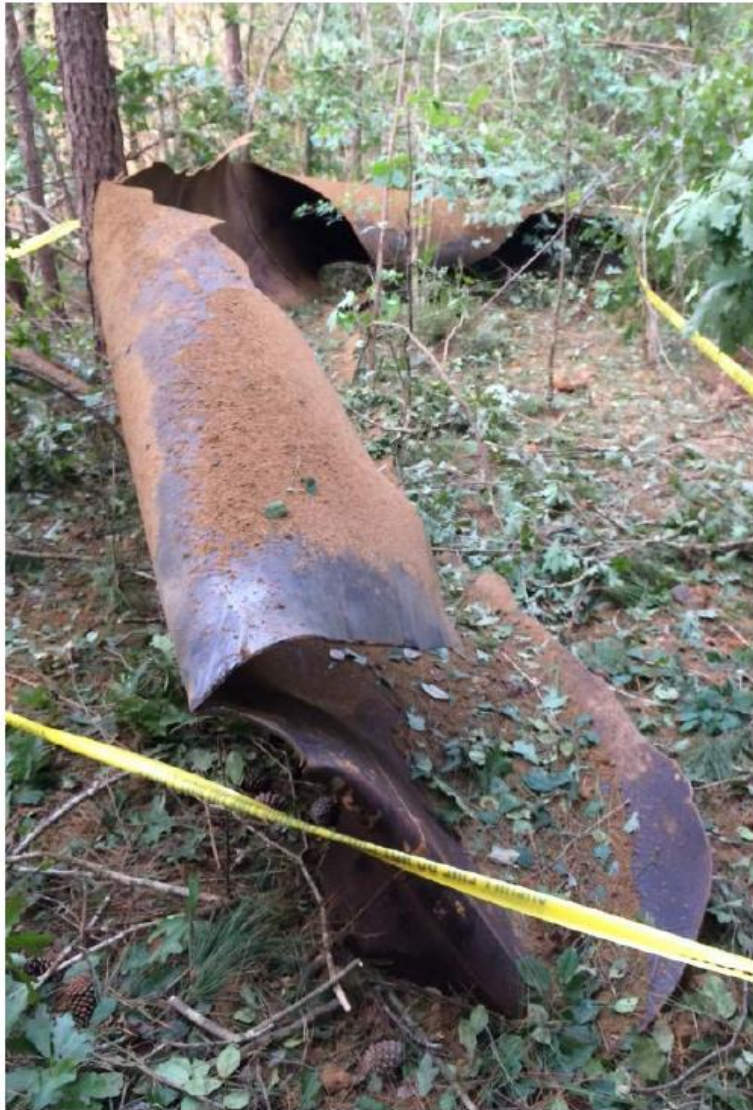
Figure 3 - Failure Origin Location Sketch by PHMSA

The origin of failure was identified on the bottom quarter of the segment of pipe that was ejected from the ditch, as depicted in a diagram sketched by PHMSA and shown in Figure 3:

Pipe ejected from the ditch and rotated 180 degrees such that the east end of the pipe as found in the woods was the failure surface that matched the west end of the rupture site. The approximate total length of the ejected pipe segment was 45 feet, 10 inches.

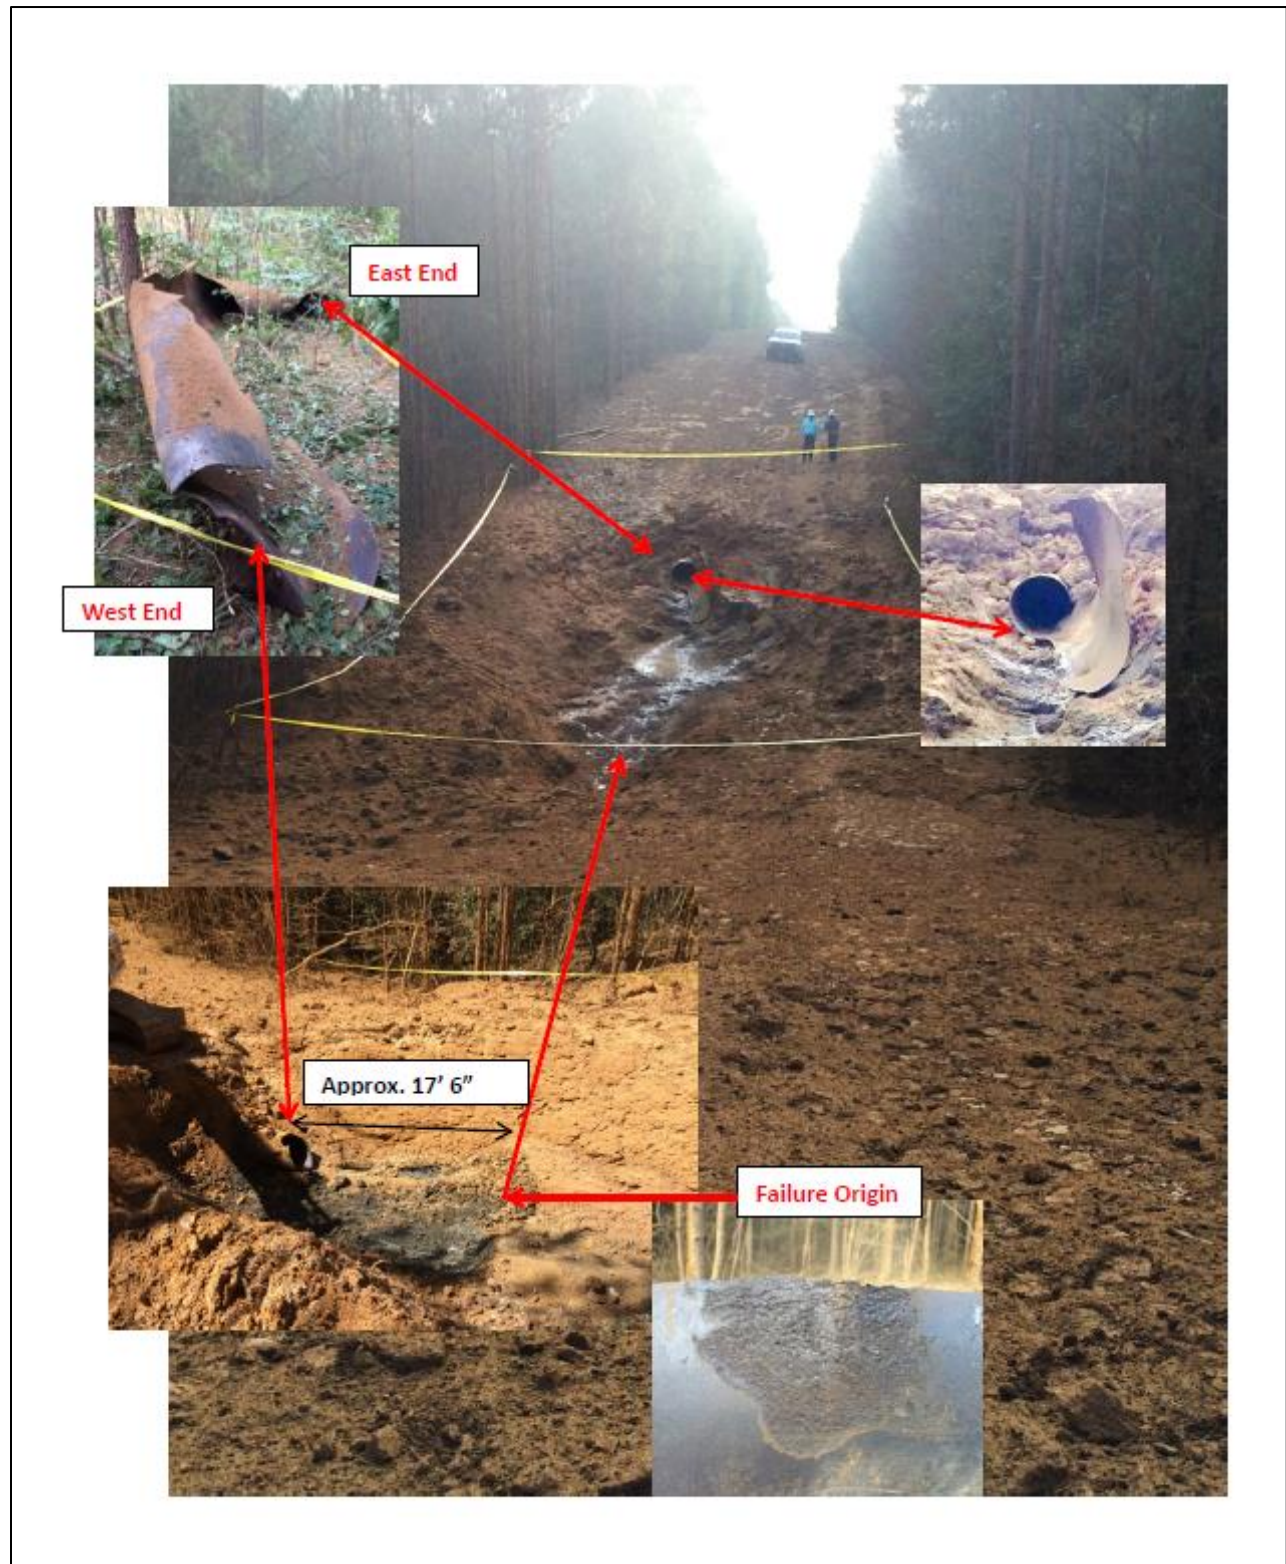
Figure 4 - Correlation of Ejected Pipe Segment with the Ditch and In Situ Pipe

Measurements were taken after the origin of failure was located. The photographs in Figure 4 depict the correlation of the ejected pipe with the in-situ pipe and ditch location:
