DOT U.S. Department of Transportation
PHMSA Pipeline and Hazardous Materials Safety Administration
OPS Office of Pipeline Safety's Accident Investigation Division

Principal Investigator Brian E. Pierzina
AID Director Peter Katchmar
Date of Report November 28, 2018
Subject Failure Investigation Report: Material Failure – Mechanical Damage from Original Construction – TC Oil Pipeline Operations, Inc.

**Failure Investigation Report – TC Oil Pipeline Operations (TransCanada)
Rupture – Material Failure – Damage from Original Construction
Failure Date 11/16/2017**

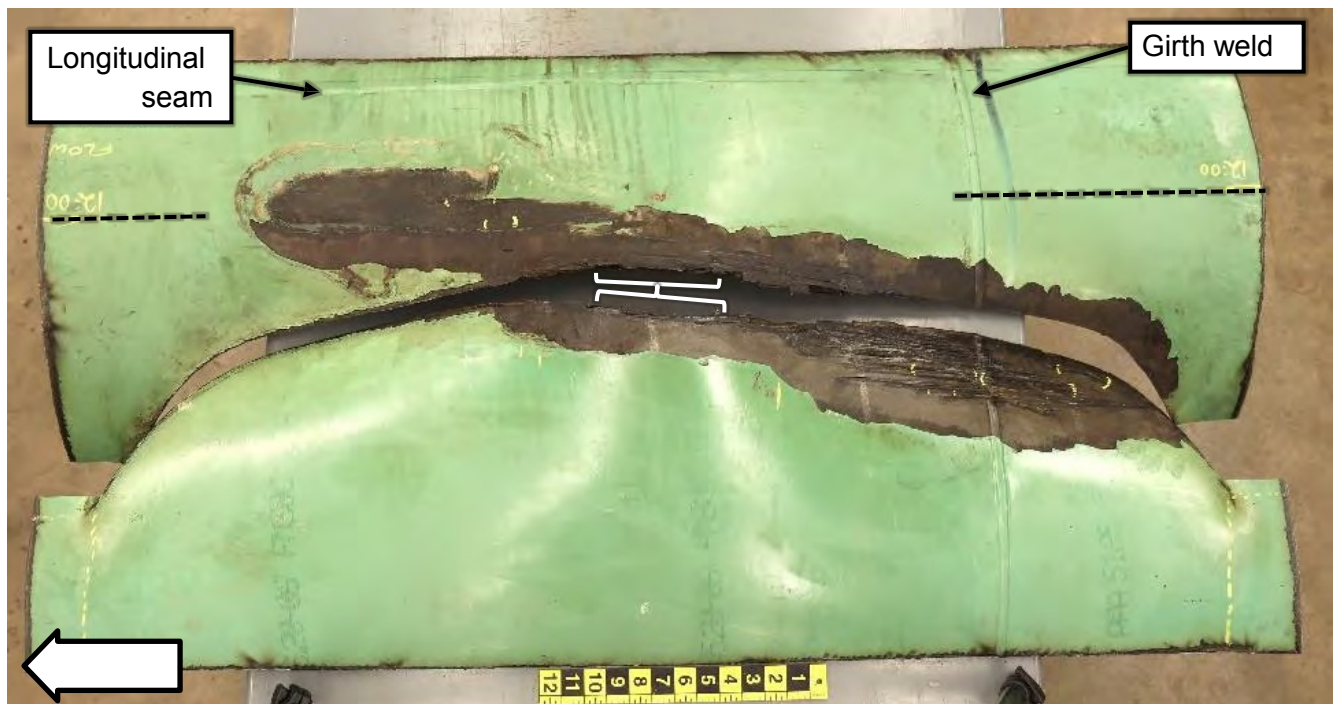
Copied from the NTSB Metallurgical report: Figure 13. Overall view of the exterior surface after sectioning with the two sides of the fracture placed in close proximity. Dashed lines indicate the 12 o'clock position, and unlabeled brackets indicate the fatigue crack region.

There were indications of mostly axial and parallel gouges similar to sliding contact marks on both sides of the rupture opening. Some of these gouges were up to 30-inches long. Within the rupture origin fatigue region, the near-surface depth associated with the initial damage was 0.098 inches. The fracture surface exhibited eight somewhat distinct crack arrest and re-initiation lines at depths of 0.166-inches, 0.189 inches, 0.222 inches, 0.246-inches, 0.257-inches, 0.267-inches, 0.300-inches, and 0.340-inches. These features typically are associated with large pressure cycles, such as the post-construction hydrostatic test, or operational shutdowns.

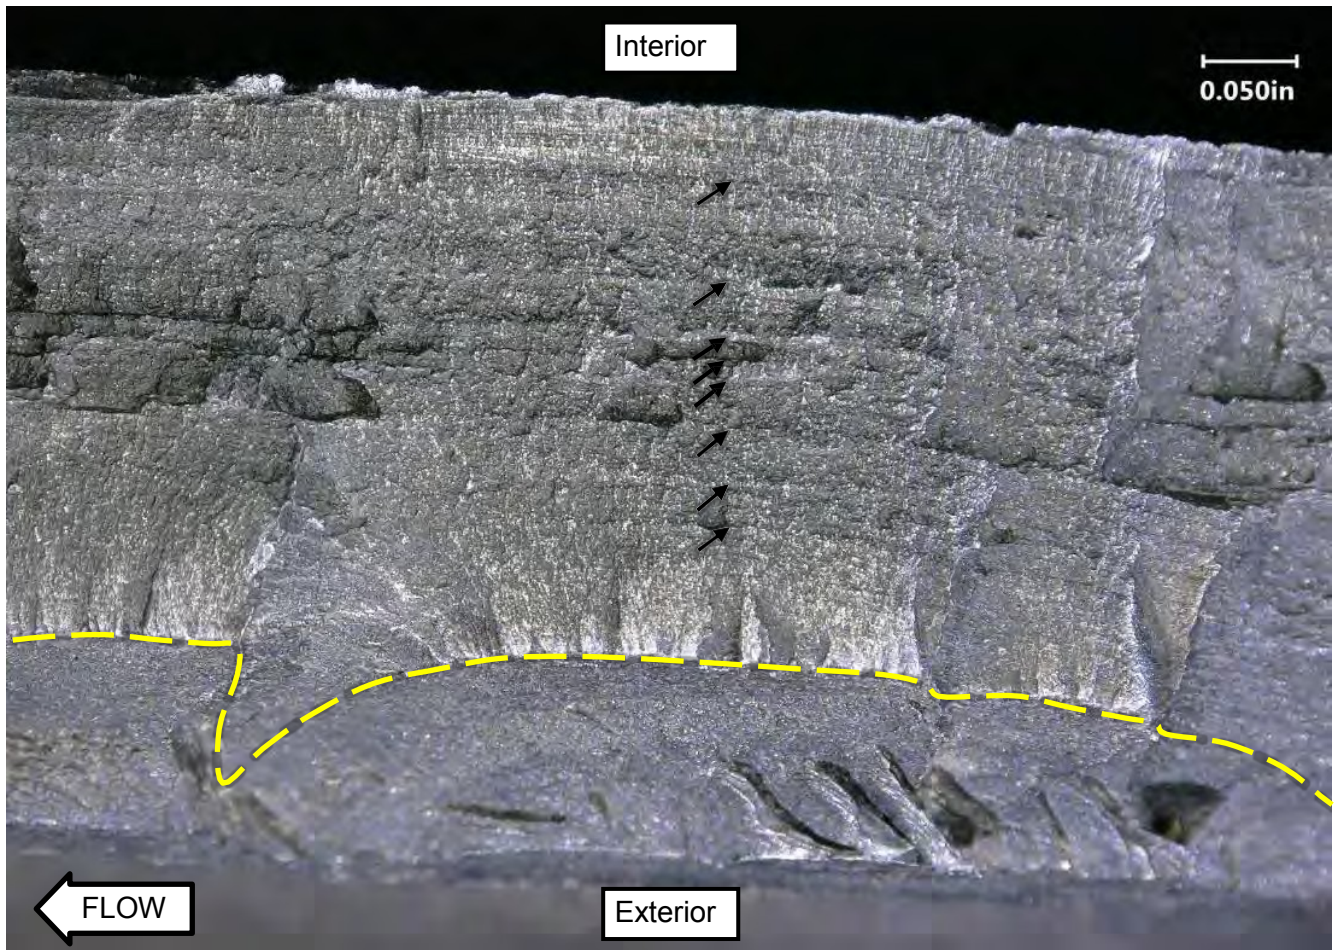
Copied from the NTSB Metallurgical report: Figure 23. Optical image of the fatigue region at origin area A (see figure 21). Fatigue features emanated from near-surface cracks shown bounded by a yellow dashed line. Unlabeled arrows indicate relatively prominent crack arrest lines where emerging radial marks consistent with crack reinitiation were associated with the arrest line.

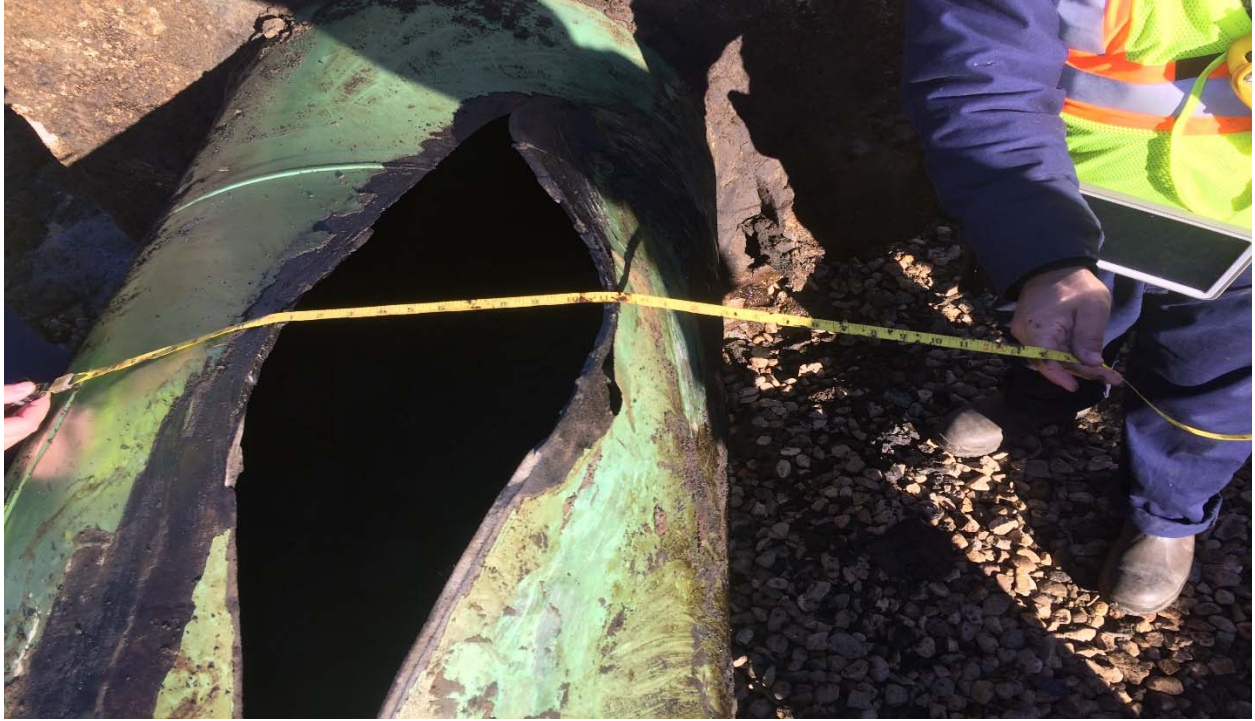
In-Situ Ruptured Pipe Examination

Initial observations of the failed pipe in the field were indicative of mechanical damage that had been inflicted to the pipe body. The damage was separate and apart from the longitudinal weld seam. The rupture origin did not involve a girth weld, but the rupture opening did pass through the adjacent girth weld. There was a set-on concrete weight in close proximity to, but not associated with, the rupture opening. The fracture surfaces were protected, and the failed pipe section was removed. The failed piping was prepared for shipment to the NTSB laboratory in Washington, DC.

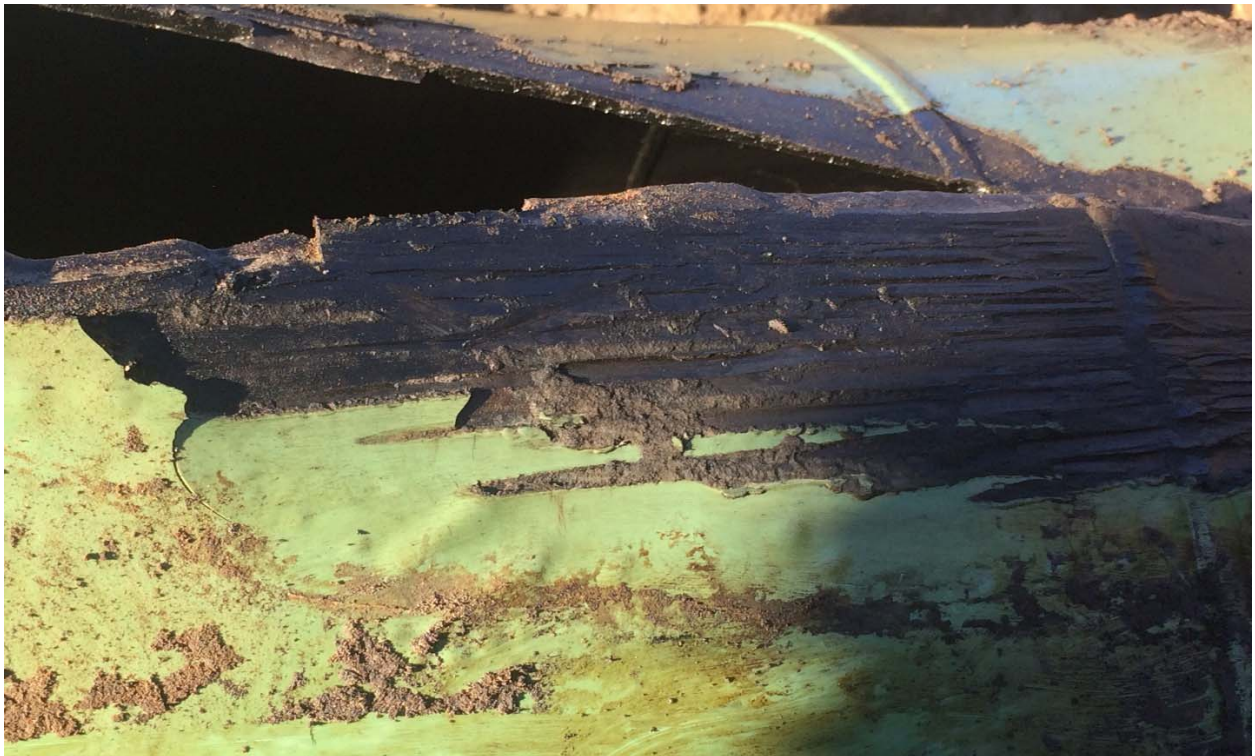
Additional Gouges Adjacent to Rupture Opening

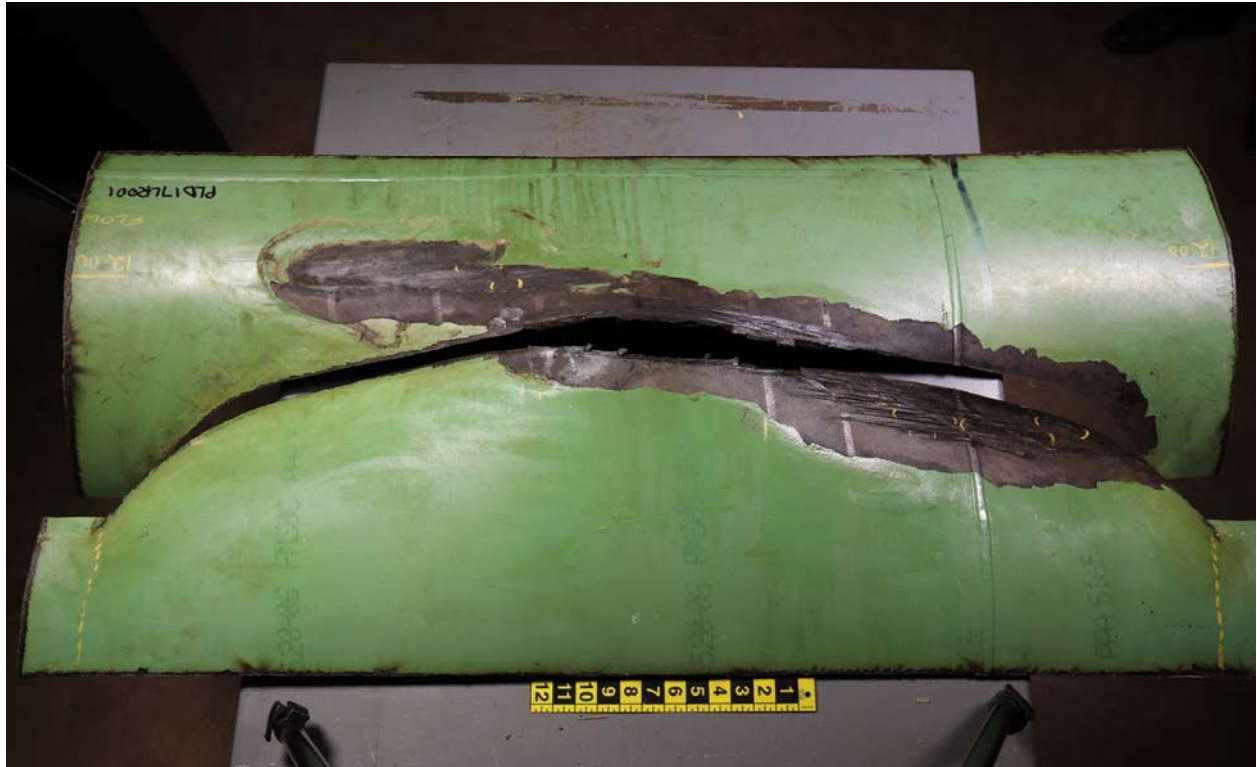
Examination of the failed piping at the NTSB laboratory indicated the rupture was oriented in the axial direction, and extended to a length of 4 feet 4 inches. The rupture opening was just over 11-inches wide at its widest point. The rupture origin was approximately 5.5-inches long, perpendicular to the pipe wall, and exhibited characteristics consistent with fatigue growth.

NTSB Photo – Rupture Opening – Opposing Fracture Surfaces

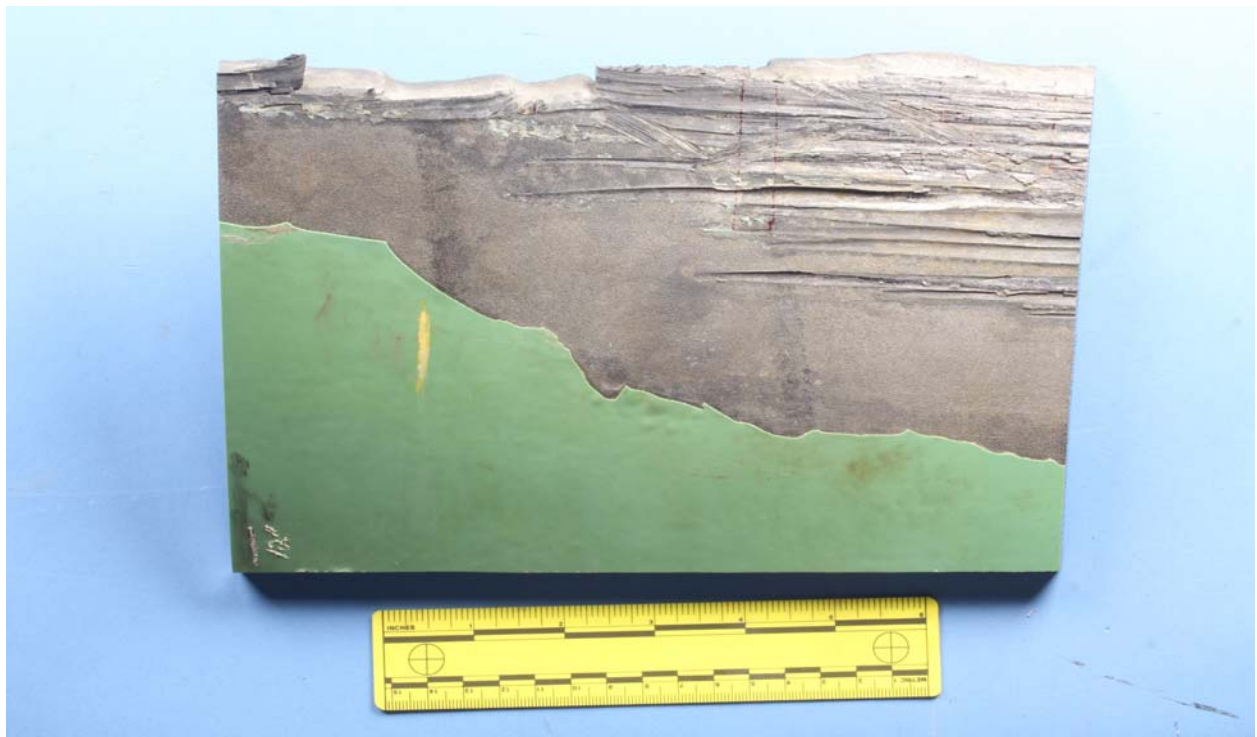
NTSB Photo – Additional Gouges Adjacent to Rupture Opening

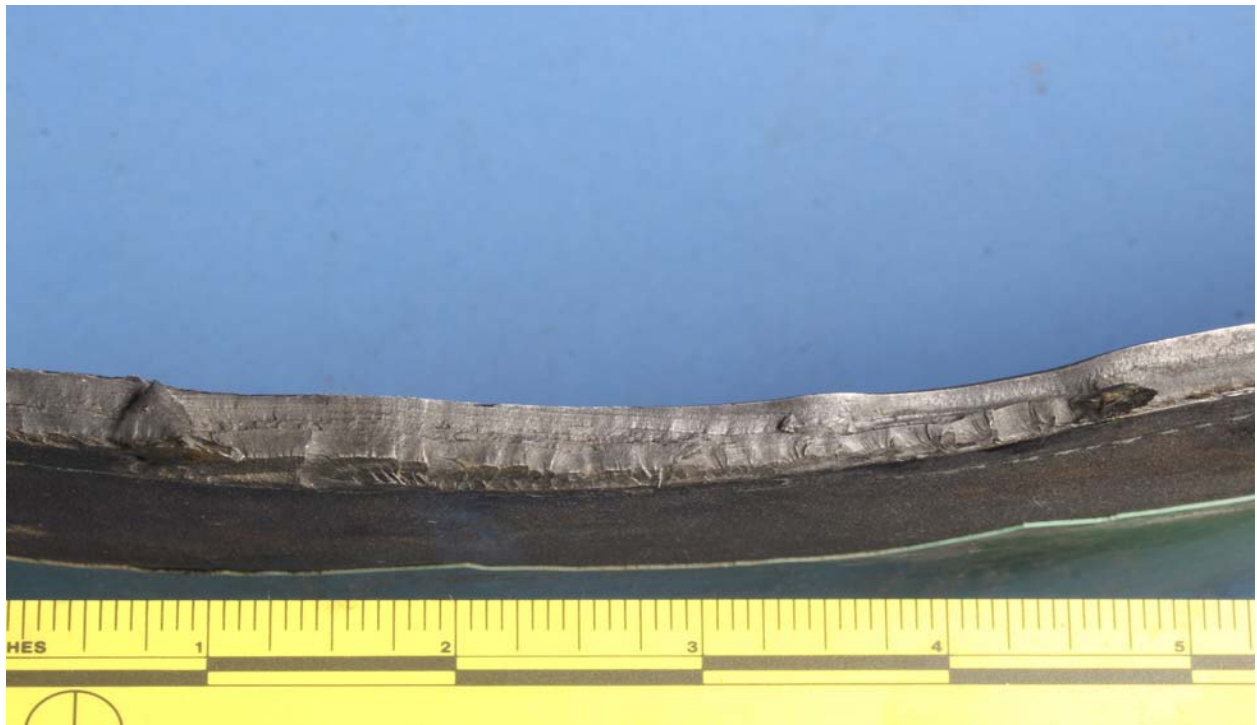
NTSB Photos - Rupture Origin – Fracture Surface

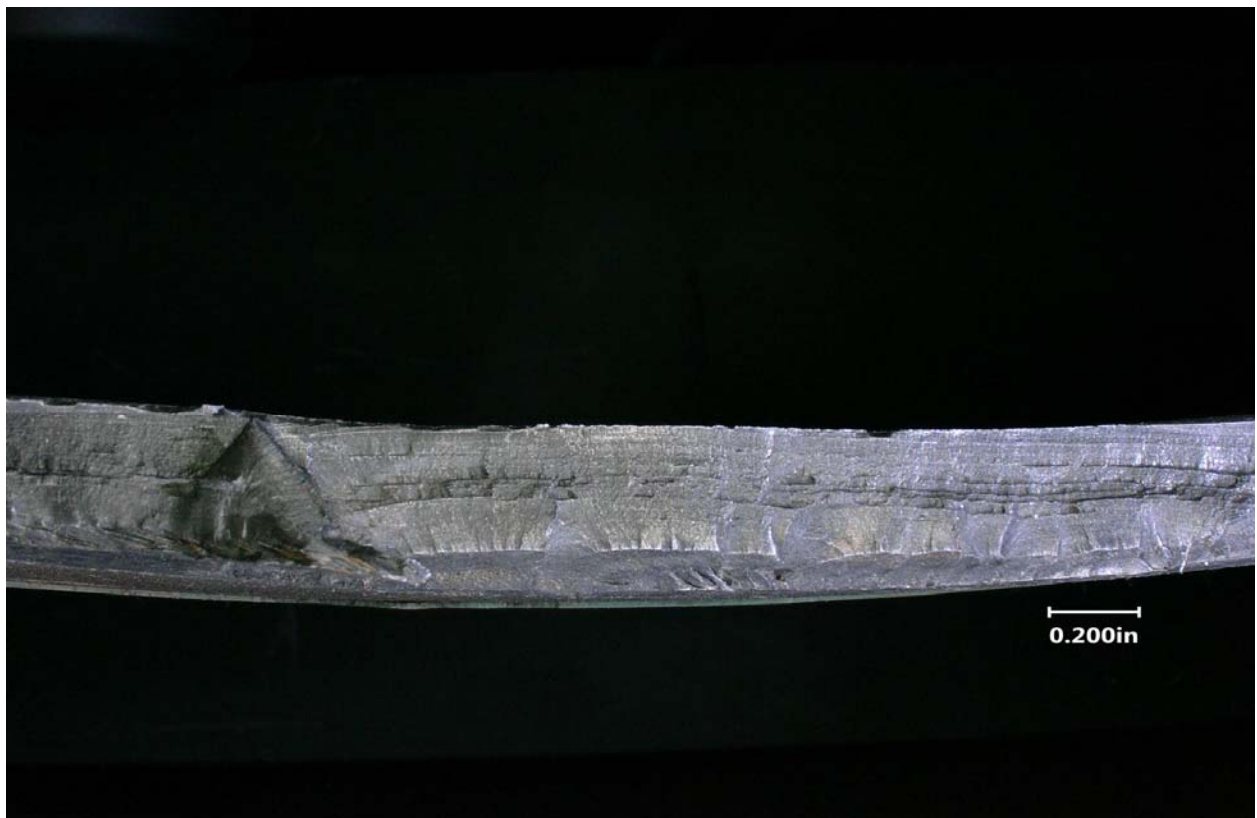
NTSB Photo – Rupture Origin – Dark Contrast
