Principal Investigator Molly Atkins
Region Director R.M. Seeley
Date of Report 2/24/2014
Subject Failure Investigation Report – Enbridge Pipelines, LLC, Tank 3013 24-inch Fill Line failure in Cushing, OK

Failure Investigation Report – Enbridge Cushing Tank Farm

May 17-18, 2013

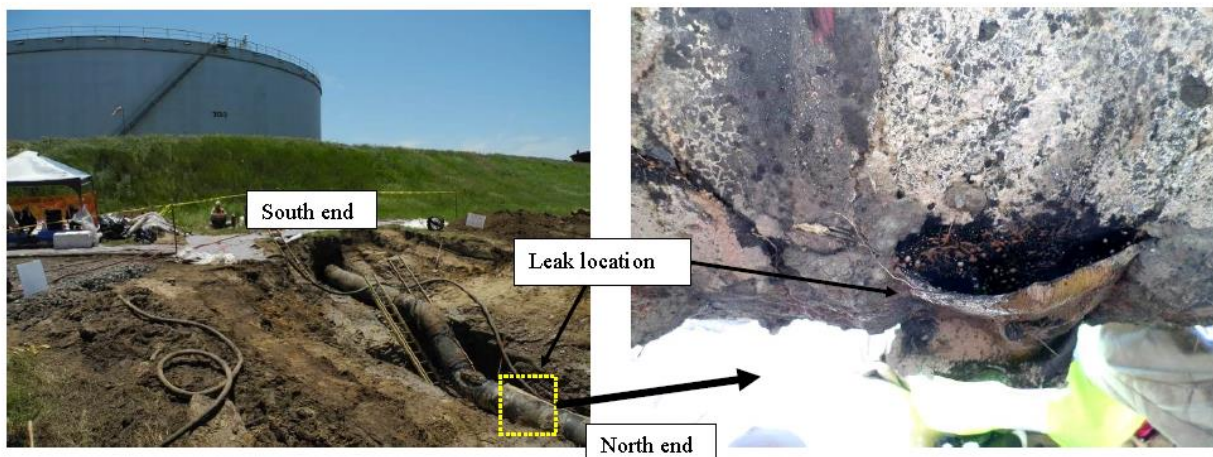
DNVGL's report indicated that the leak in the 24-inch pipe originated from a hole 1.4 inches long and 0.8 inches wide (circumference) that was located beneath black deposits in an area of discrete internal corrosion on the bottom of the pipe. In total, there were four corrosion pits found in the pipe. The leak hole was 100 percent through the pipe wall, while the remaining three pits were between 35 percent and 53 percent through the pipe wall. There was no evidence of general

High to very high concentrations of aerobic, anaerobic, acid-producing, sulfate-reducing, and iron-related bacteria were detected on the inside surface of the pipe at the leak site. Additionally, low to moderate concentrations of all five bacteria types were detected in deposits removed from the leak location in an area with no significant corrosion. The presence of microorganisms on the pipe surfaces, combined with higher levels of bacteria present at the leak site, indicates that microbiologically induced corrosion (MIC) is likely the primary corrosion mechanism.

DNVGL's analysis determined that the leak occurred as a result of internal corrosion that propagated through the pipe wall at the 6:17 o'clock position. The internal corrosion was likely exacerbated due to the accumulation of deposits/sediments caused by non-flowing conditions. There was no indication that the failure involved a mechanical (i.e. strength-related) component.

Figure 1. Field photographs showing the pipe section that leaked, prior to removal: overall site view (Left) and close-up (Right).

The procedures related to the prevention of internal corrosion within terminal piping were expanded to incorporate the lessons learned from this accident. Additionally, the replacement tank fill line piping was installed with an internal coating in order to minimize the likelihood of interior corrosion.
