**Pipeline and Hazardous
Materials Safety
Administration**

March 20, 2023

Reference No. 22-0058

This letter is in response to your June 23, 2022, letter requesting clarification of the Hazardous Materials Regulations (HMR; 49 CFR Parts 171-180) applicable to the repair of an intermediate bulk container (IBC). In your letter, you describe two methods to repair a cracked threaded “nipple” used to attach service equipment to an IBC. The first method would involve removing all but one-half inch of the existing threaded “nipple” and welding a 90-degree threaded elbow pipe in its place. The second method would differ only in that the original threaded “nipple” would be removed entirely. You ask whether either proposed method would be considered a repair or constitute a “different IBC design type” as defined in § 178.801(c)(7) of the HMR.

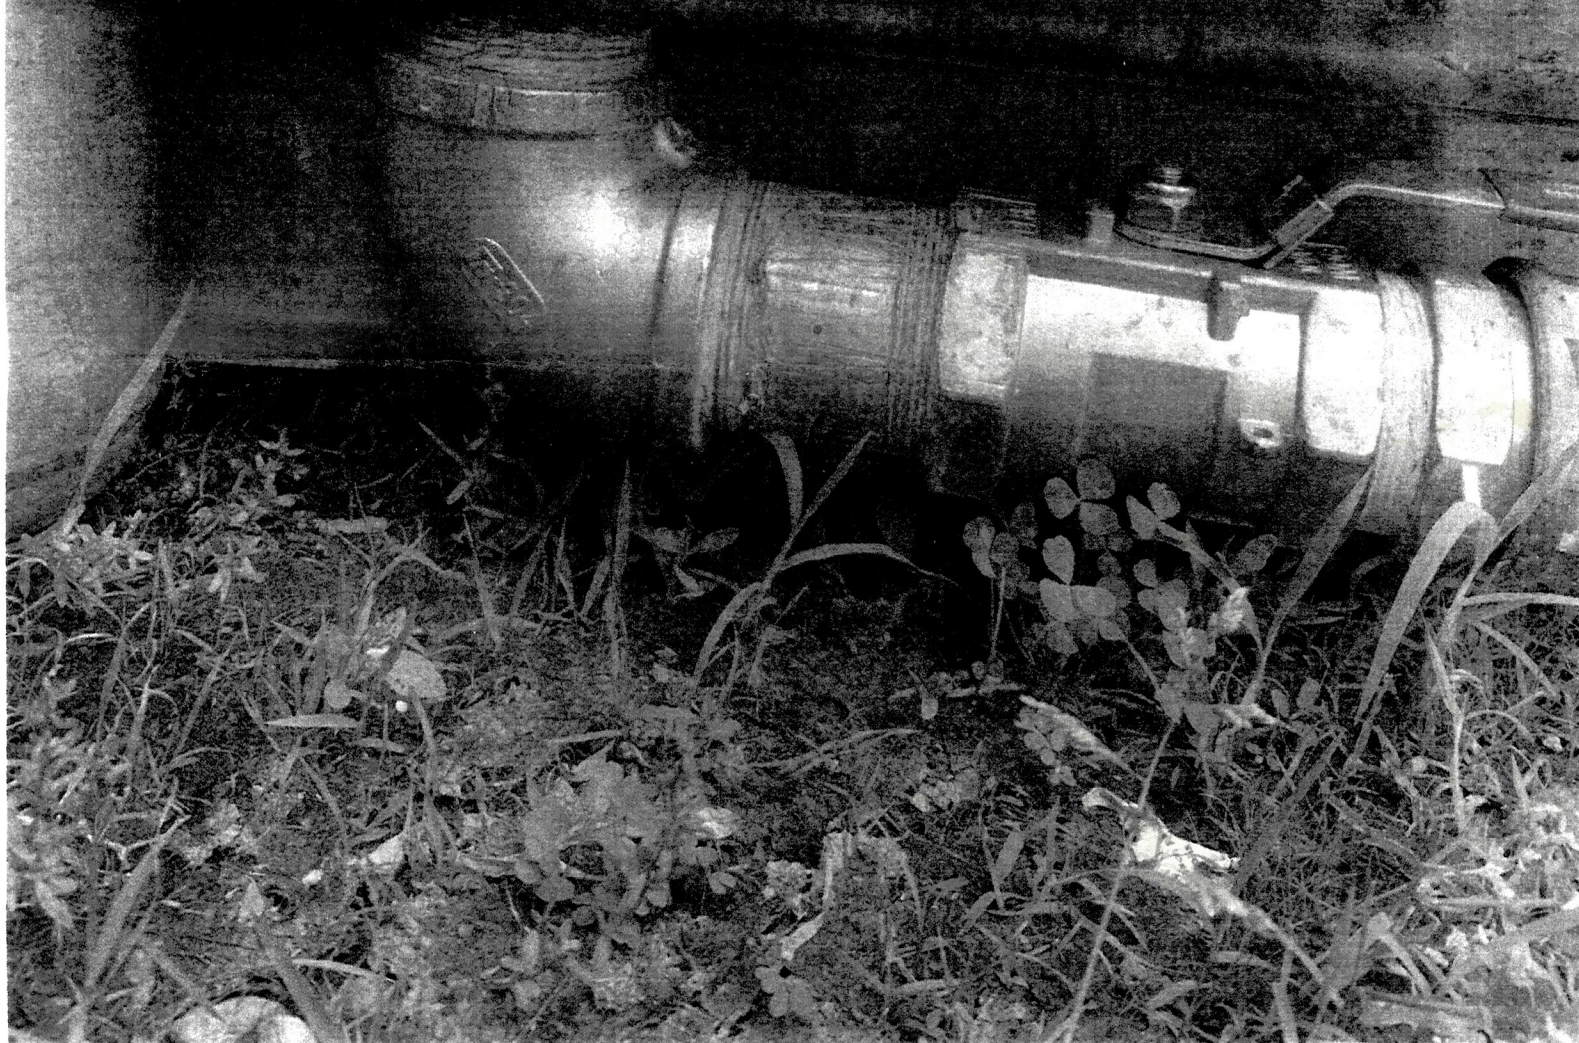
current style

Proposed method option

Based on the information and pictures provided in your letter, it is the opinion of this Office that both of your proposed repair methods would constitute a “different IBC design type” and furthermore, the IBC would be required to be retested in accordance with Part 178, Subpart O (Testing of IBCs). Section §178.801(c)(7)(iv) authorizes the replacement of service equipment without it qualifying as a design change. Because the welding of the 90-degree threaded elbow makes a once-removable fitting a permanent part of the packaging, the repair is considered a different IBC design type in accordance with 178.801(c)(7).

-First method would be to cut the nipple leaving $\frac{1}{2}$ " and attaching a weld on 90deg fitting as you can see in the picture that says "proposed method option". The picture shown though would not be the actual repair type as the picture shows the weld on 90deg elbow welded directly to the tote bottom. We would weld on only the leftover threading going into the barrel.

-Second method would be to remove the threaded nipple all together and weld on the 90deg elbow as shown in the picture that says "proposed method option", and it would reflect the same as the picture shows, welded directly to the bottom of the barrel.
