## **Valve Integrated Pressure Regulator Examination (DOT DUNS #079807449)**

Report Number:  
**R-WHA-15113-0-A-EX1**

**Mark Toughiry  
Pipeline and Hazardous Materials Safety Administration  
1200 New Jersey Avenue, SE  
East Building, 2nd Floor, Room E21-338  
Washington, DC 20590**

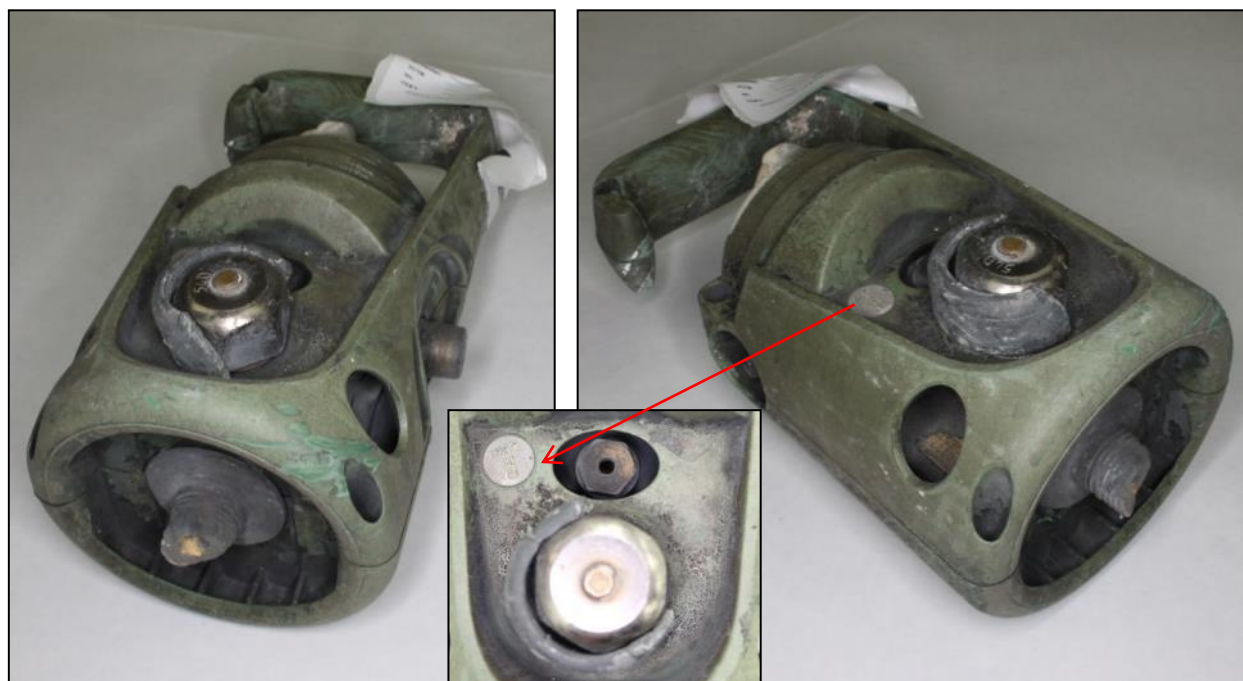
**Figure 1 – Incident VIPR and Shroud (As-Received)**

WHA initially received and inspected the evidence on August 27, 2015 and documented the as-received condition of the incident VIPR, as shown in **Figure 1** and **Figure 2**. These figures depict the condition of the VIPR and shroud, an O-ring consistent with the VIPR-to-cylinder seal and a metallic segment consistent with a portion of the fragmented cylinder. The VIPR and O-ring shown in these photographs was the subject of the WHA investigation. The cylinder

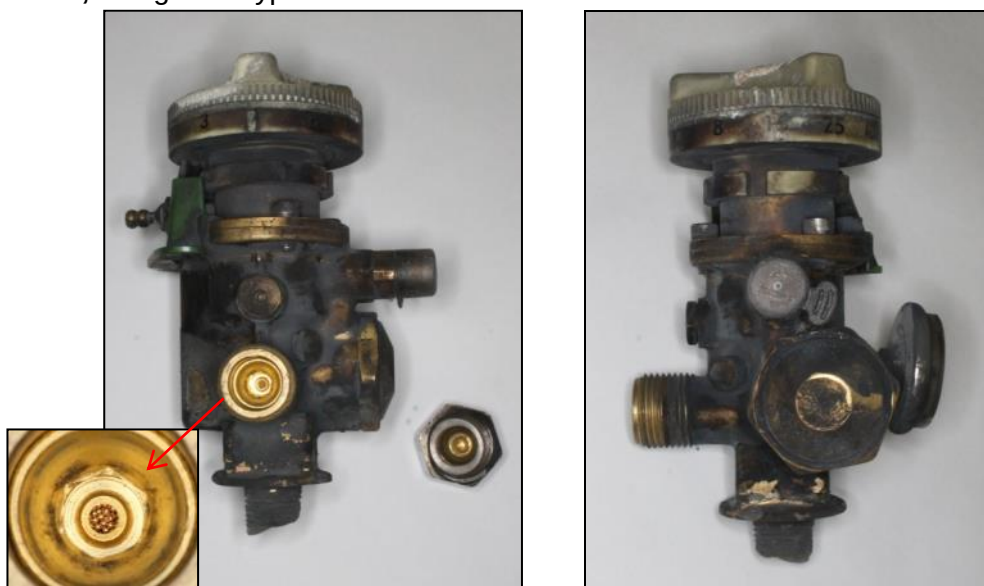
**Figure 5 – Views of VIPR (Rotated Clockwise)**

**Figure 5** and **Figure 6** provide various views of the incident VIPR from four different sides. Figure 5a (top-left) shows an external view of the VIPR with the fill-port cap removed to expose the fill port assembly and filter. This port, like other ports, was visually undamaged, relatively clean, and intact. The fill-port filter was visually undamaged. Other views in this figure also show the external condition of the VIPR from various sides. The VIPR externally was covered with combustion residue, largely consistent with greyish aluminum-oxide (visually) but did not exhibit inside-to-outside evidence of burn-through. It was noteworthy, however, that the pressure gauge was bent consistent with an impact loading. It was also noteworthy that the flange on the VIPR, at the cylinder-to-VIPR interface, was bent on one side, consistent with an impact or bending moment applied to the body of the VIPR (**Figure 6**). The bend and deformation of the flange was approximately opposite the side of the VIPR threads that exhibited the heaviest melt/consumption of brass.

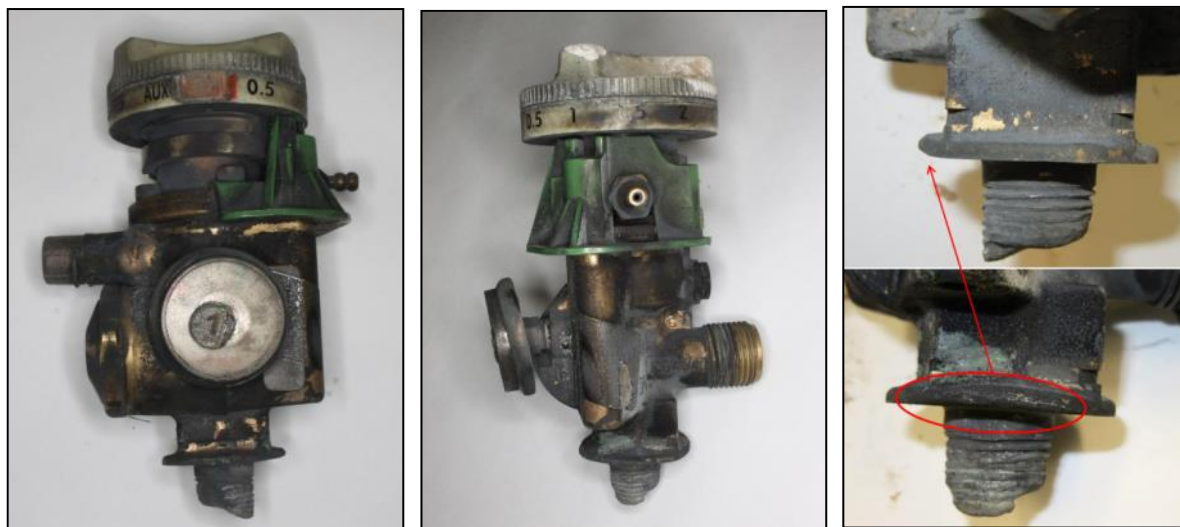
**Figure 6** – Views of VIPR (Rotated Clockwise) and Flange Close-up

The VIPR exhibited combustion and slag deposits on the majority of its external components and external surfaces. However, external fire damage to the VIPR was generally limited to the cylinder-to-VIPR thread connection. Fire damage to the thread connection was also heaviest on the lower 12 o'clock region of the threads away from the flange and flange O-ring seal. VIPR damage to the cylinder thread post is shown in **Figure 20**. Noteworthy bending, consistent with impact, was also observed on the flange and the pressure gauge at 6 o'clock (**Figure 6**).

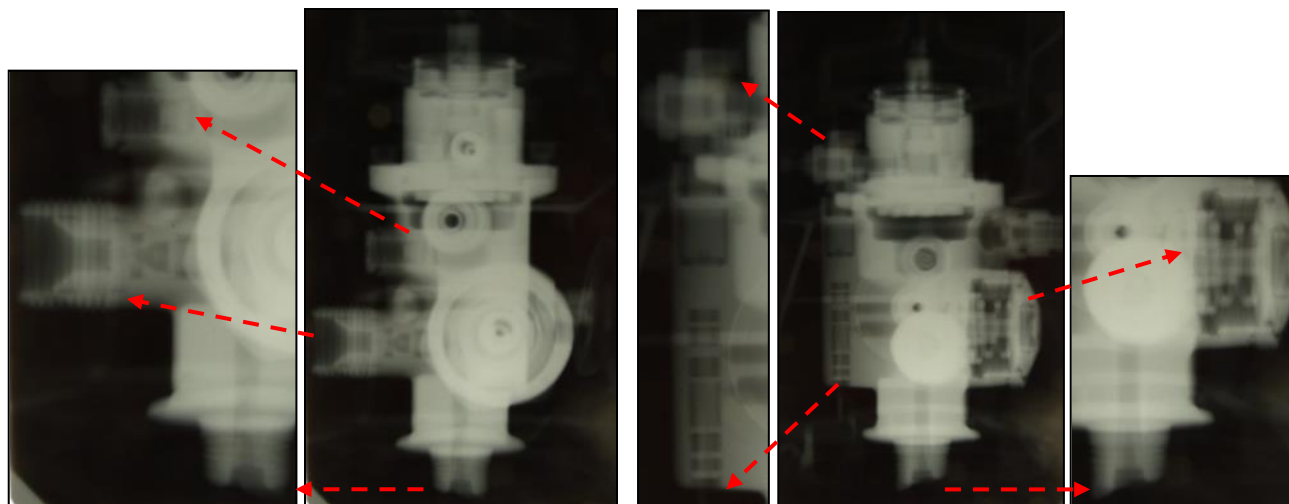
**Figure 7** – X-ray Radiographic Views of VIPR (Noting Various Features of Design)

**Figure 7** depicts several x-ray radiographic images of the VIPR showing views of the internal components. The x-ray images revealed that the internal components were intact and did not exhibit internal burning or combustion, to the extent that could be discriminated from the images. The fill valve, regulator, flow valve, relief valve, burst disc, and flow head could be observed and did not exhibit indications of damage or internal combustion from the images obtained. The melt/consumption patterns on the cylinder-to-VIPR threads were clear and indicated involvement only of the threads externally without internal propagation being evident in these images. The cylinder-to-VIPR filter was also evident in the x-ray images and appeared visually intact having the expected conical geometry. Further views of this filter using a boroscope confirmed the intact nature of this filter and are hyperlinked in **Appendix A**.

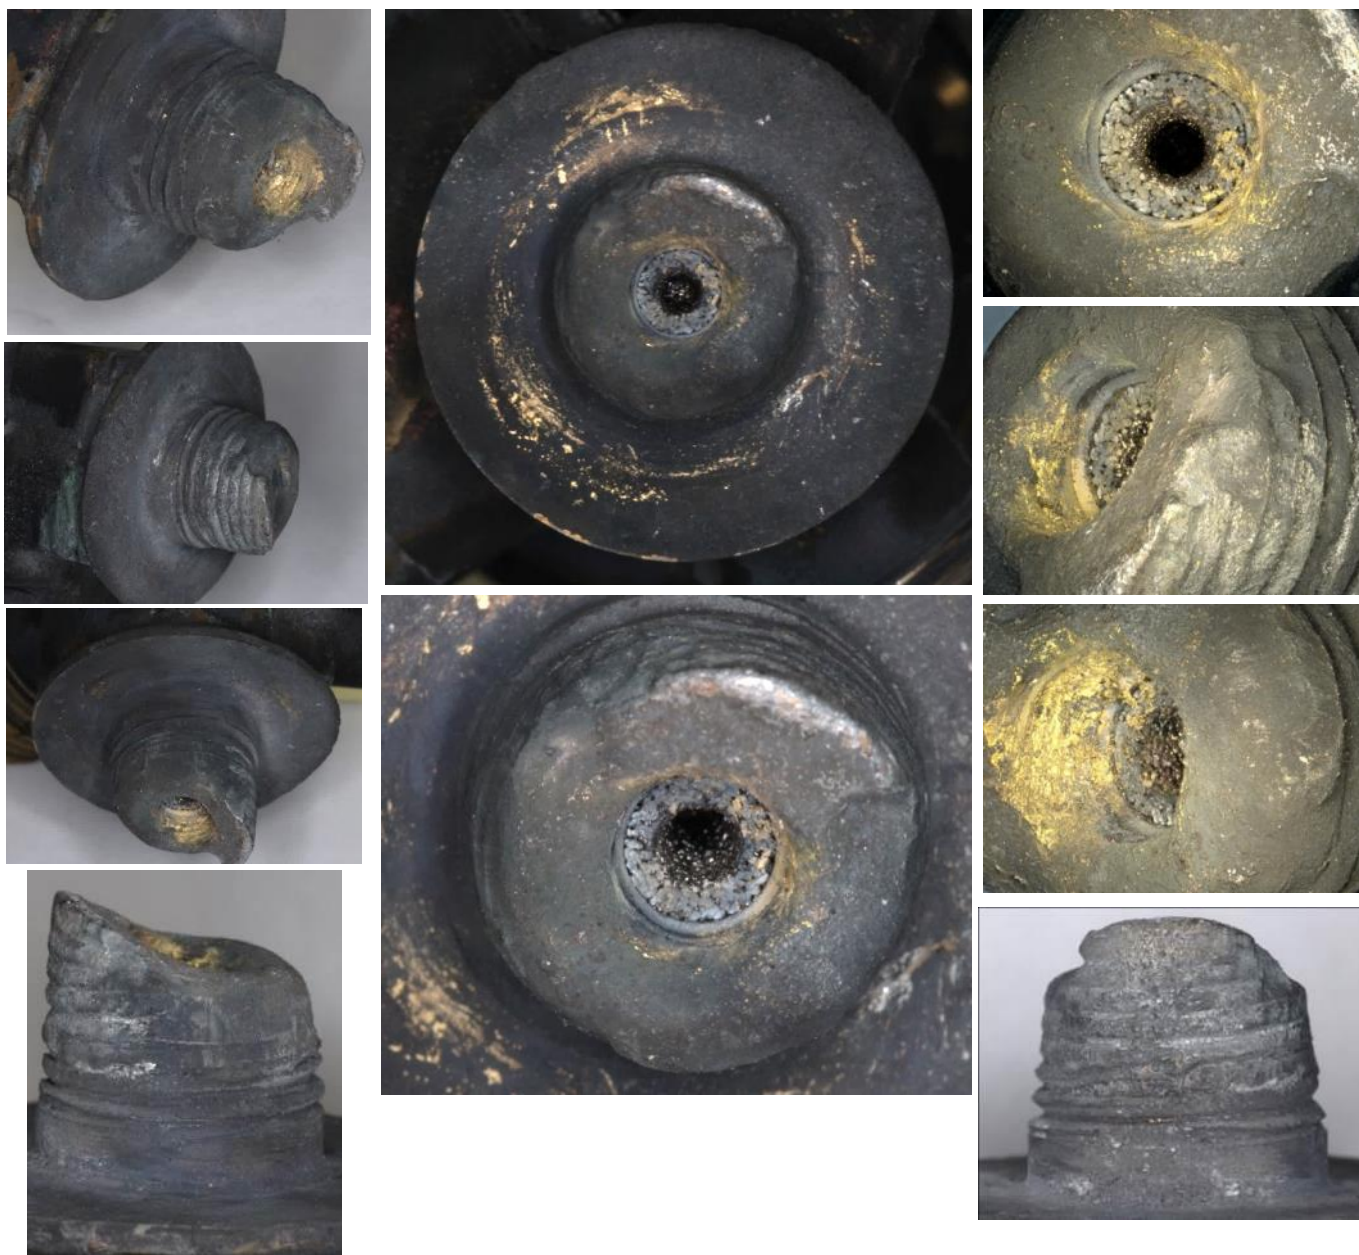
**Figure 8 – Magnified Images of the VIPR Thread Damage**

**Figure 8** depicts magnified images of the flange of the VIPR and the fire-damaged threads. **Figure 9** provides more detailed images of the VIPR thread damage. These images show that the surfaces proximate to the VIPR threads were covered with combustion residue and were primarily comprised of aluminum combustion products (see also EDS summary in **Appendix D**, discussed later). The threads also exhibited melting and/or consumption with a geometric preference for material loss on one side of the threads. The filter was covered with combustion residue but was intact and did not exhibit evidence of compromise or burn-through. The filter's threaded retainer element was missing.

**Figure 8** and **Figure 9** depict various views of the VIPR threads, VIPR flange region proximate to what would have been the cylinder and cylinder O-ring gland. These figures depict the very heavy melting and melt-flow associated with the lower segments of the VIPR threads. The SEM/EDS analysis was consistent with evidence of heavy aluminum combustion products deposited on the VIPR threads and suggested that aluminum combustion had developed initially in the lower segment of the threads proximate to the 12 o'clock region<sup>8</sup>.

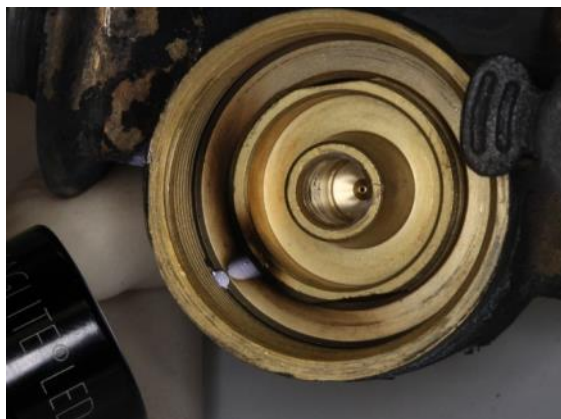
**Figure 10** – Regulator Atmospheric Vent Port Illuminated from Exterior

The components listed above were inspected and documented by all parties present during the WHA joint inspection. During disassembly, WHA observed combustion product deposits inside some component housings. However, analysis revealed the residue was not associated with internal combustion. Several components have ports drilled into them that allow communication with the external environment, such as the regulator atmospheric sensing port (**Figure 10**). The combustion deposits were consistent with the external fire depositing combustion products on these components through the external ports onto surfaces within the VIPR housing. However, the VIPR did not exhibit internal fire-damage, melt-flow patterns, or propagation patterns that were consistent with fire originating inside or within the VIPR.

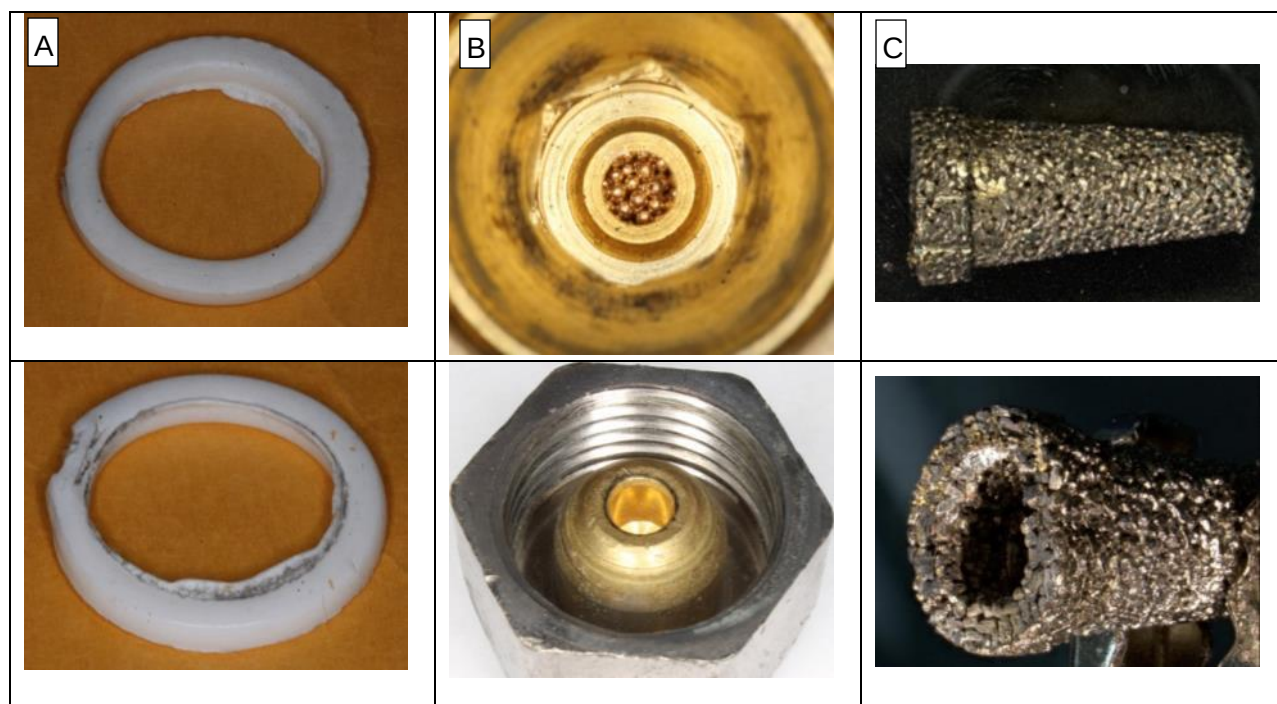
**Figure 12** – Photographs of the Cylinder O-ring seal (A), Inlet Fill Port Filter and Cap (B), and Cylinder-to-VIPR Filter (C)

**Figure 12** depicts the condition of what was provided to WHA as the cylinder O-ring (determined by FTIR to be PTFE) and two of the VIPR filters. The inlet fill port filter and protective cap are also shown in this figure. These components were visually clean but solvent rinses of the filter indicated detectable levels of a hydrocarbon contaminant. The cylinder-to-VIPR filter is also depicted and after careful removal from the VIPR threads, was observed to exhibit an intact and largely clean appearance. However, detectable levels of hydrocarbon were also observed on this filter for both careful solvent rinsing of the interior conical bore and solvent rinsing of the external conical structure. During these solvent rinses the filter was positioned so that careful solvent rinses would drain from the filter in such a manner that the interior and exterior would not be cross-exposed.

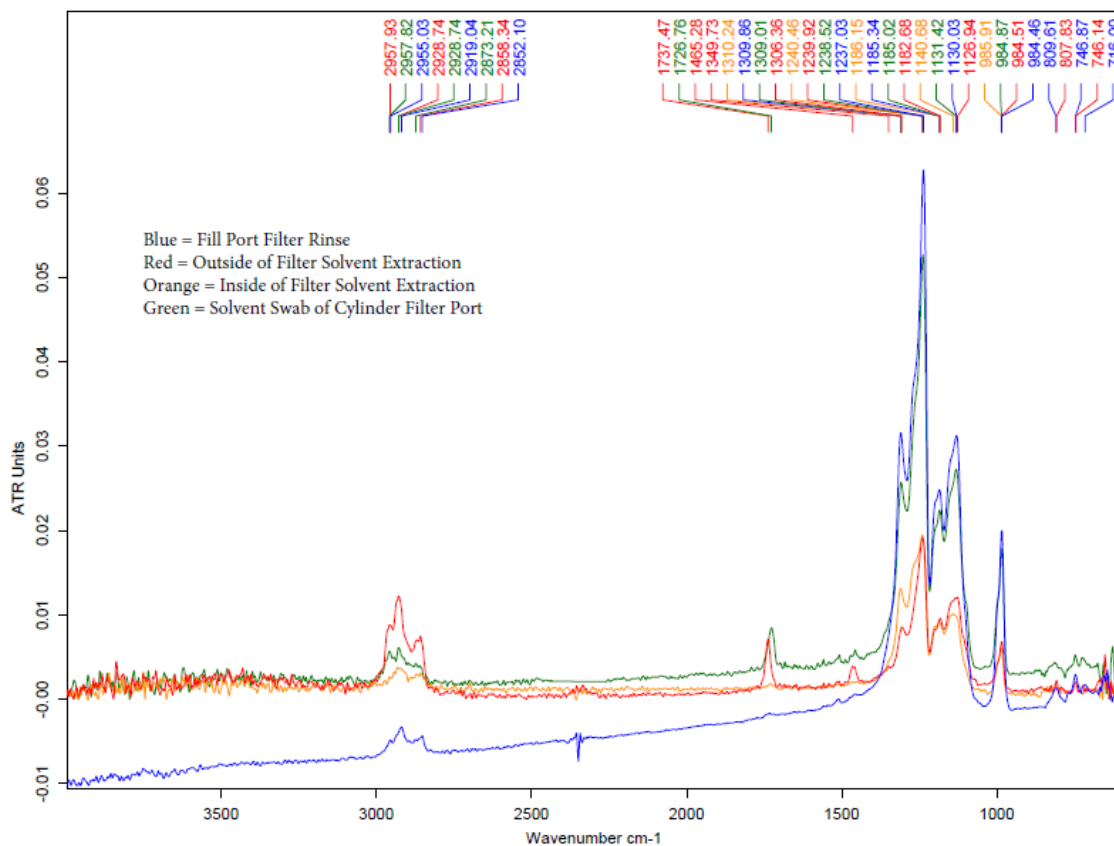
**Figure 13 – FTIR Comparisons of VIPR Fill Port and Cylinder-to-VIPR Filter**

**Figure 13** depicts the results of the FTIR sampling, comparing the fill port filter and the cylinder filter (interior and exterior). Each sample taken from these filters exhibited aliphatic hydrocarbon functionality (~2800 to 3000 wavenumbers) consistent with contamination. **Figure 14** depicts the FTIR sampling of the cylinder-to-VIPR filter, which also exhibited predominant hydrocarbon contamination and weaker functionality for Dioctyl Sebecate (discussed later). These samples also exhibited functionality consistent with a perfluoropolyether grease (**Figure 14**, Krytox or equivalent, ~900 to 1300 wavenumbers), which was a common finding with many samples, considered a result of the lubrication of the VIPR assemblies with an oxygen-compatible grease during assembly.

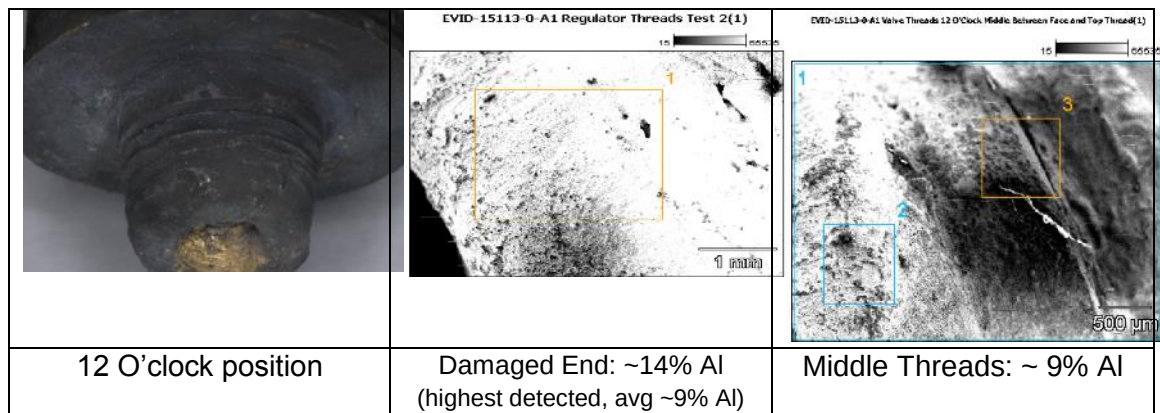
**Figure 18 – 12 O'clock Position SEM Images**

- 12 o'clock position: Al content (~10%) generally consistent throughout thread position from damaged end to flange. This was the approximate position observed to exhibit the heaviest brass consumption and/or melt/flow and exhibited the heaviest thread distortion.

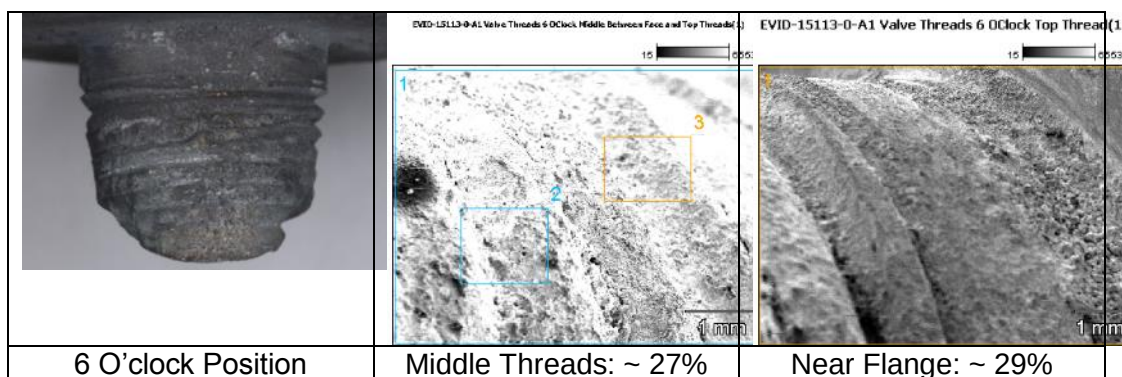
**Figure 19** – 6 O'clock Position SEM Images

- 3 o'clock position: Al content generally higher on damaged end (~12%) than flanged end (~6%)
- 9 o'clock position: Al content (~12%) consistent throughout thread region from damaged end to flange, highest amount of Al (~18%) on thread in one location near the flange; however, overall, the Al concentration was reasonably consistent along this position.
- 6 o'clock position: Al content generally increasing from damaged end (~18%) to flanged end (~30%). This position exhibited heavy aluminum and aluminum combustion products clinging to the threads, probably having been less effected by aluminum combustion before the VIPR was ejected from the cylinder.
