**Hydraulic Pressure Cycling and Performance Evaluation of five DOT-3AL 2015
Cylinders**

FINAL REPORT

Packer Project # 501856

**Prepared for
Mark Toughiry
Office of Hazardous Materials Technology
Pipeline and Hazardous
Materials Safety Administration
U.S. Department of Transportation**

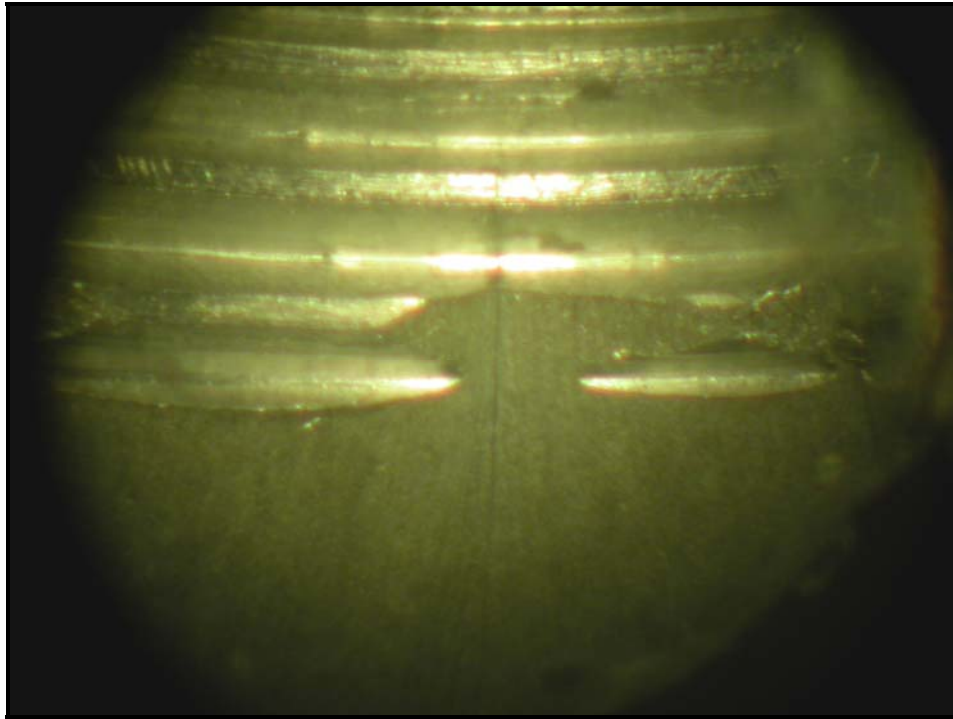
- Internal observation of the cylinder showed cracks in the shoulder area showed by Figures 11 to 13. The location of cracks is identified in Figures 14 and 15. The cylinder showed no major signs of corrosion on the inside.

Figure 11: Shows borescope image of the crack in the shoulder area of DOT-3AL cylinder # AR0119582 at 0° location identified in Figure 15.

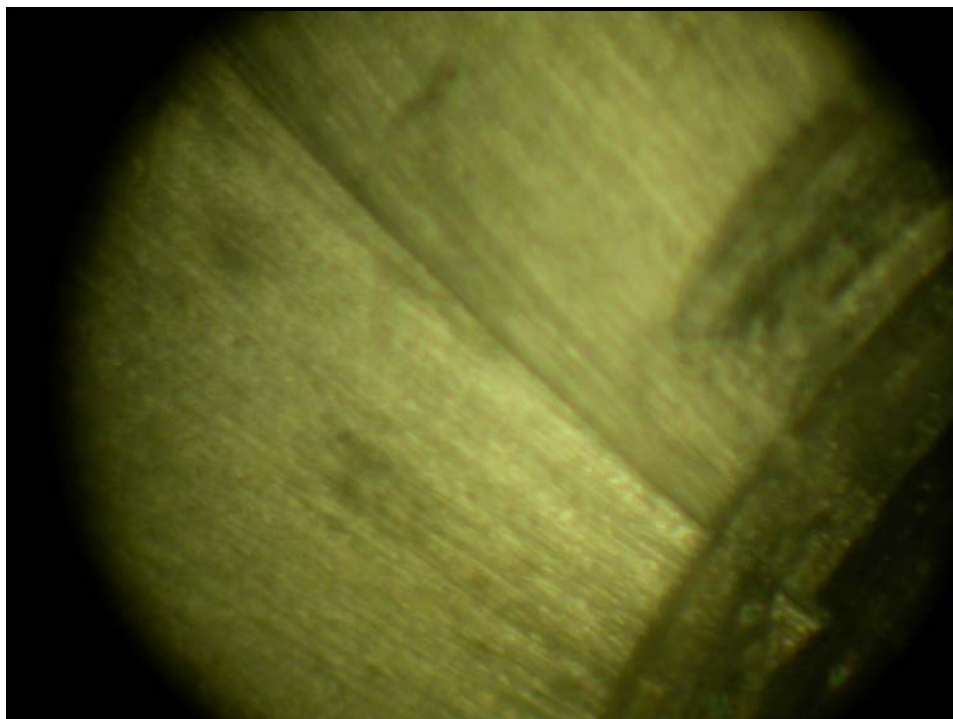
Figure 12: Shows borescope image of the crack in the shoulder area of DOT-3AL cylinder # AR0119582 at 100° location identified in Figure 15.

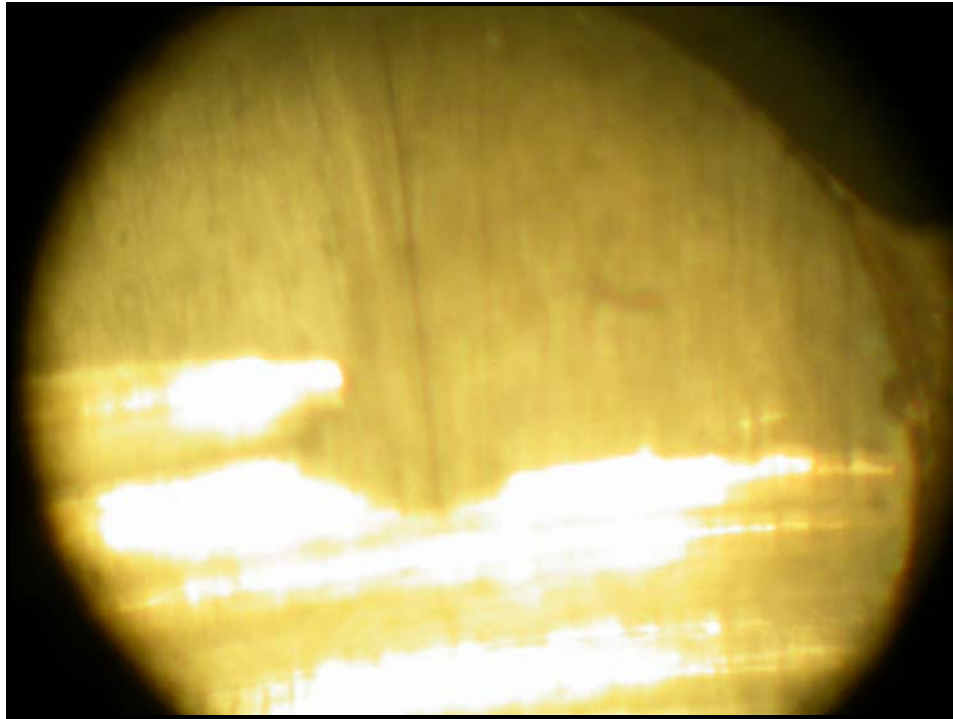
Figure 13: Shows borescope image of the crack in the shoulder area of DOT-3AL cylinder # AR0119582 at 110° location identified in Figure 15.

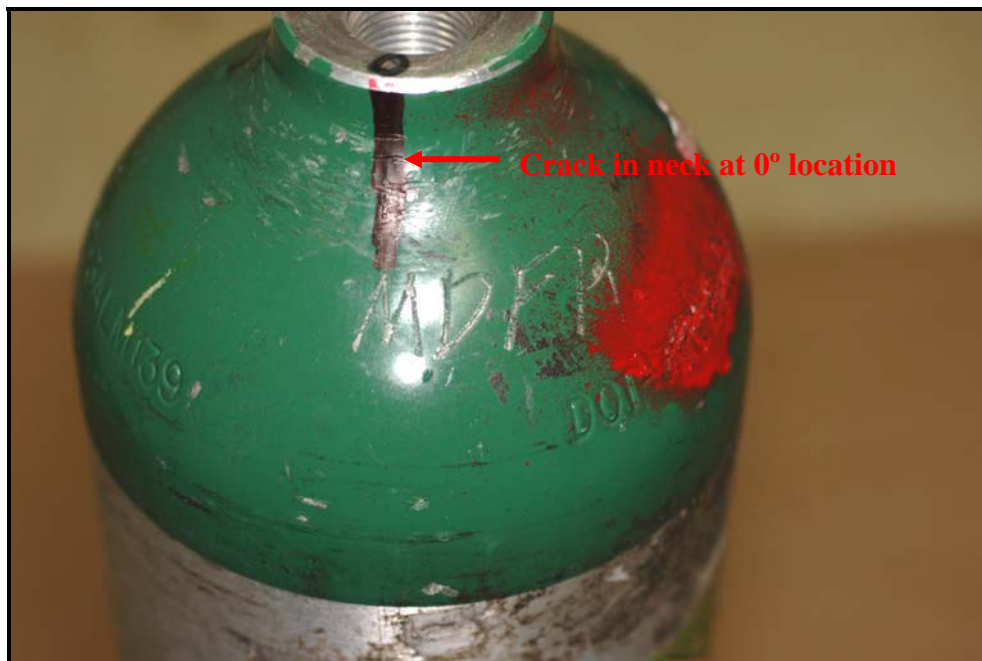
Figure 14: Shows the orientation of the crack in the shoulder area of DOT-3AL cylinder # AR0119582 at 0° location with respect to the indented markings.

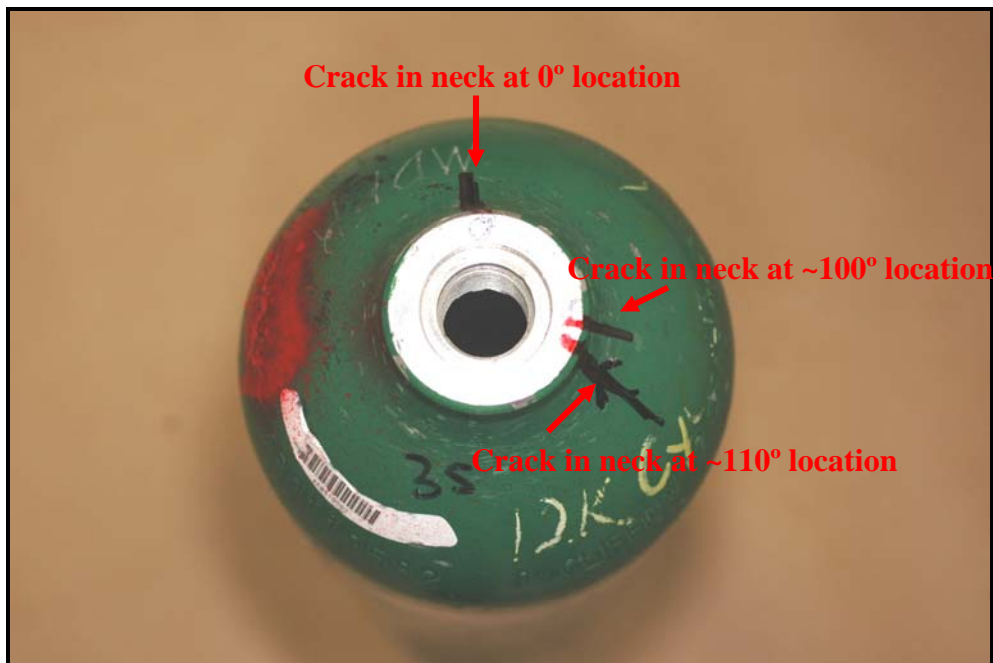
Figure 15: Shows the orientation of the cracks in the shoulder area of DOT-3AL cylinder # AR0119582 with respect to the 0° crack location.

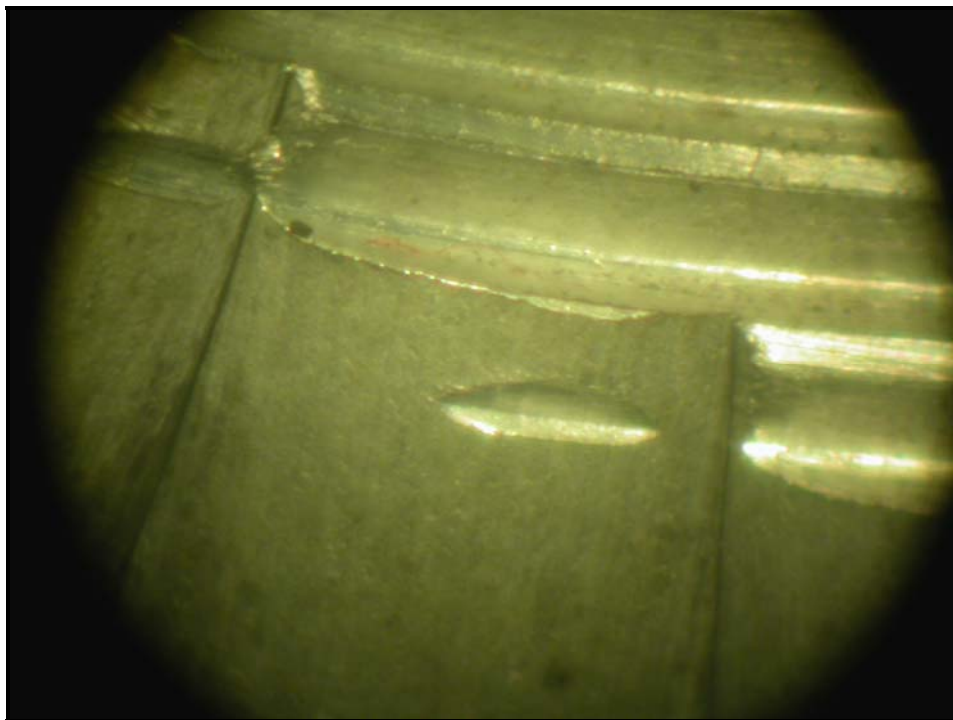
Figure 28: Shows borescope image of the crack in the shoulder area of DOT-3AL cylinder # AR0118046 at 0° location identified in Figure 32.

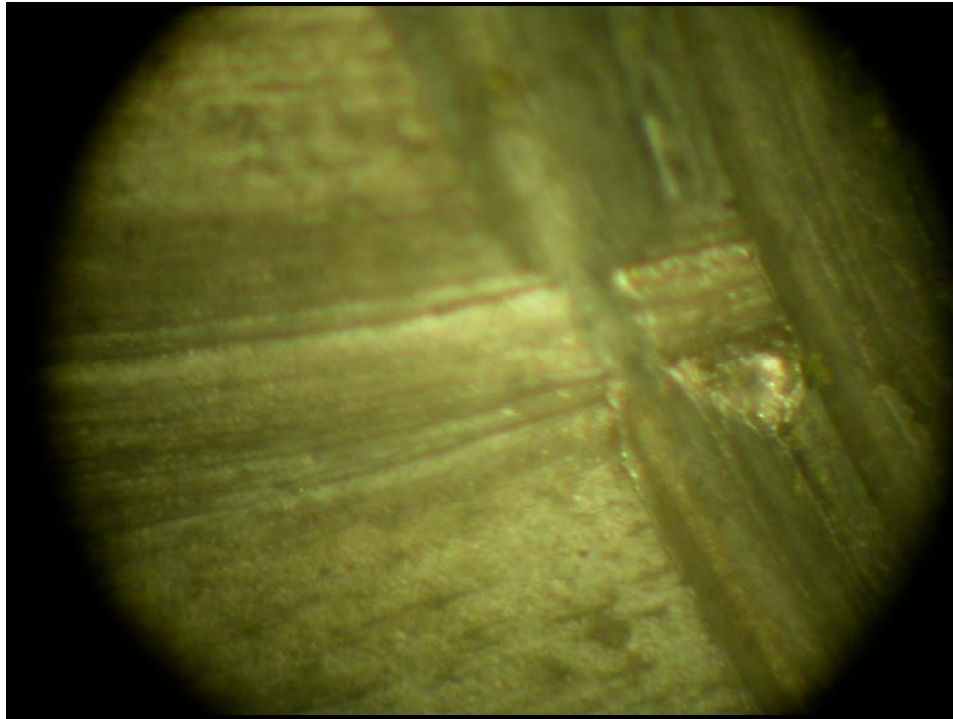
Figure 29: Shows borescope image of the crack in the shoulder area of DOT-3AL cylinder # AR0118046 at 90° location identified in Figure 32.

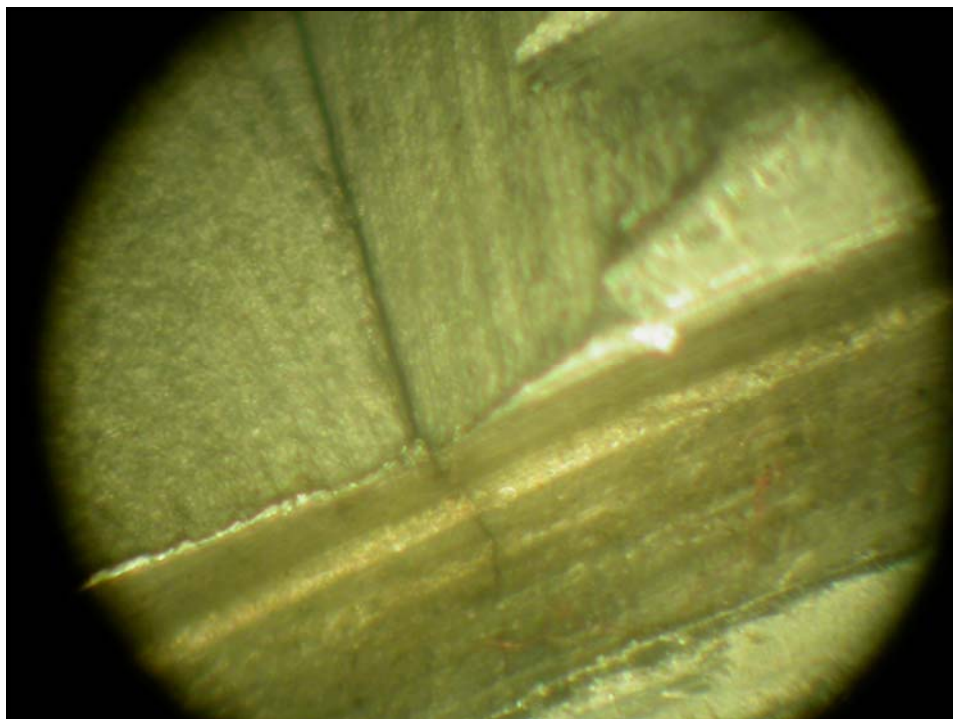
Figure 30: Shows borescope image of the crack in the shoulder area of DOT-3AL cylinder # AR0118046 at 175° location identified in Figure 32.

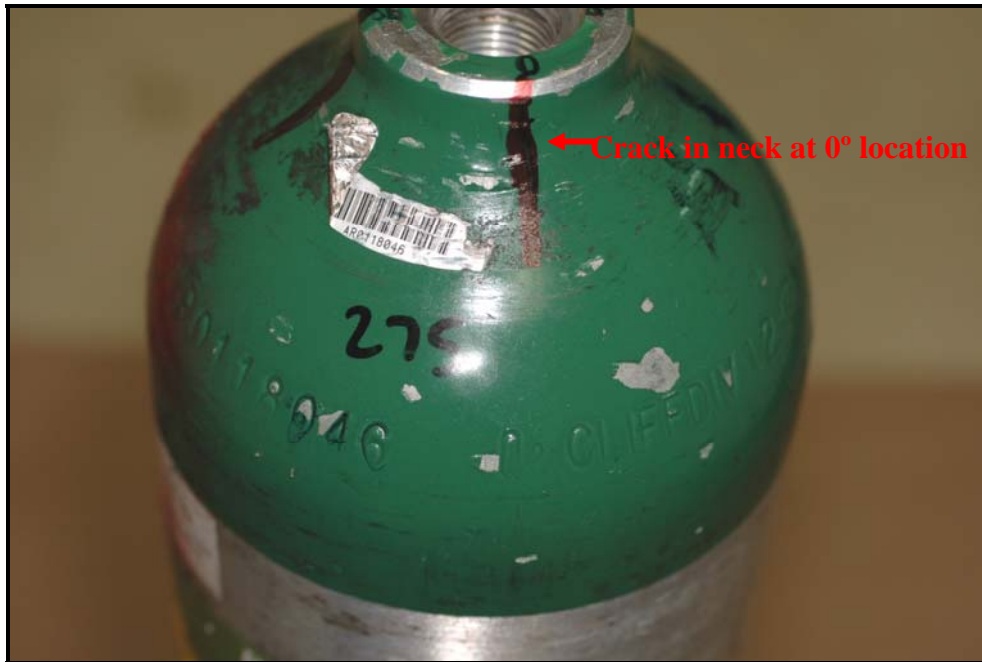
Figure 31: Shows the orientation of the crack in the shoulder area of DOT-3AL cylinder # AR0118046 at 0° location with respect to the indented markings.

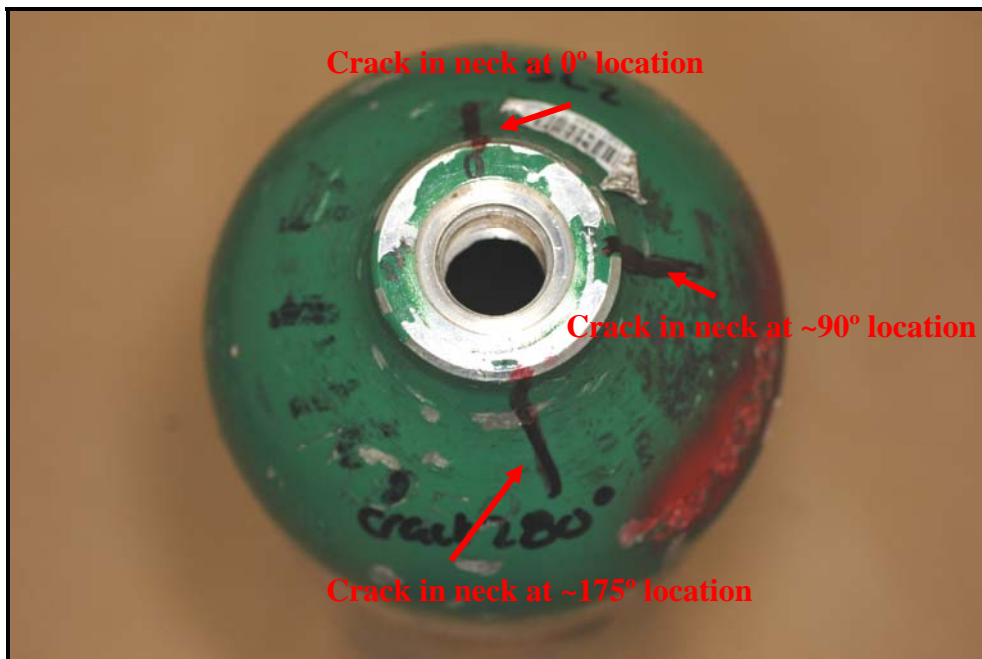
Figure 32: Shows the orientation of the cracks in the shoulder area of DOT-3AL cylinder # AR0118046 with respect to the 0° crack location.

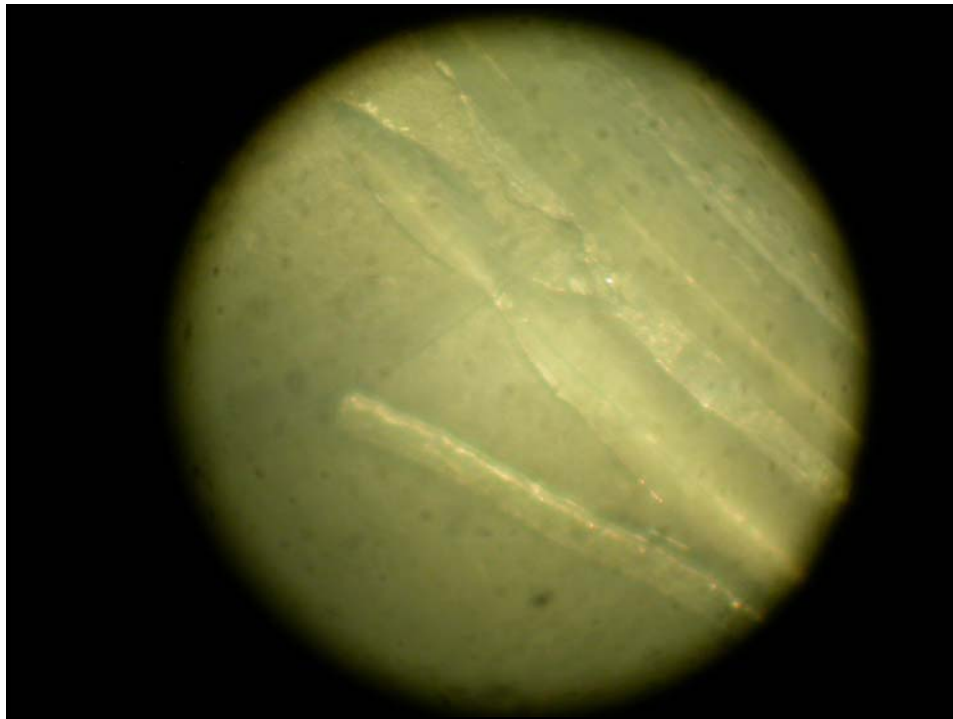
Figure 44: Shows borescope image of the crack in the shoulder area of DOT-3AL cylinder # AR0116501 at 0° location identified in Figure 48.

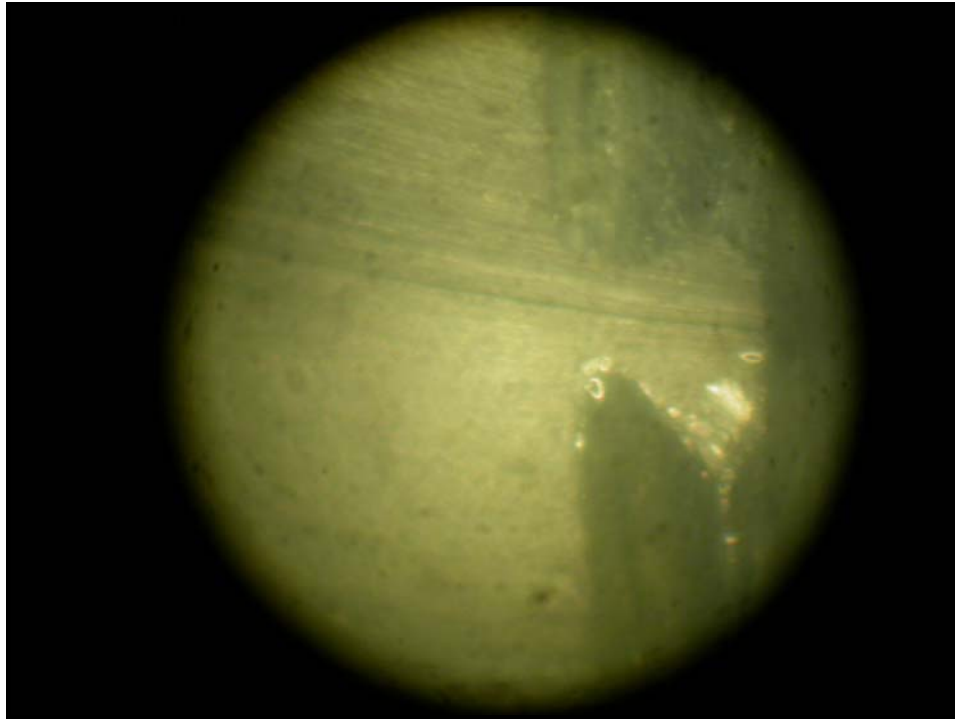
Figure 45: Shows borescope image of the crack in the shoulder area of DOT-3AL cylinder # AR0116501 at 90° location identified in Figure 48.

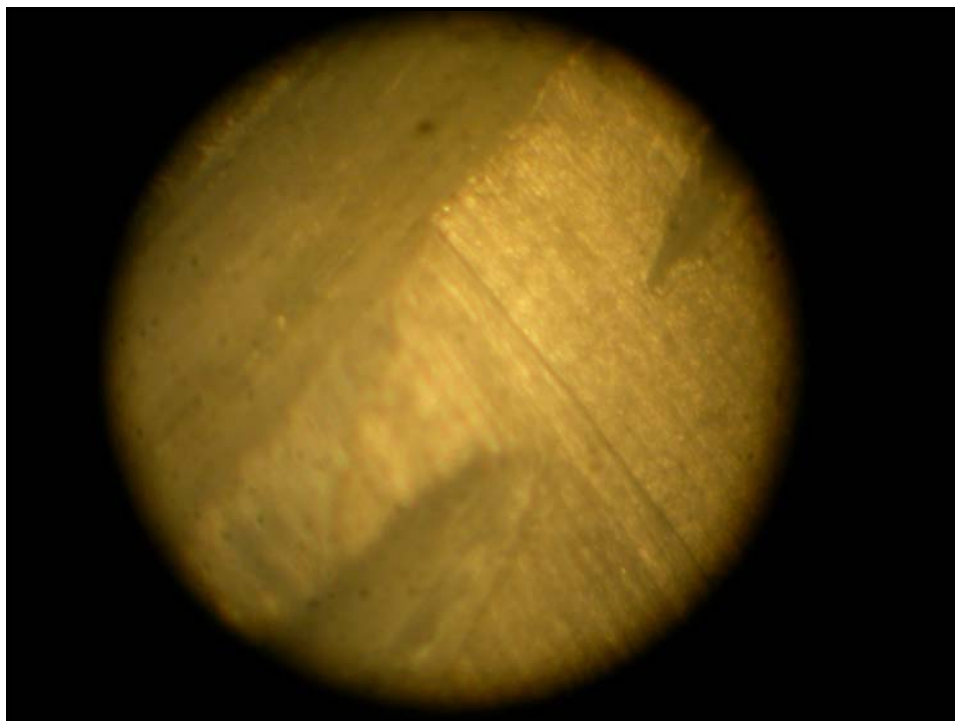
Figure 46: Shows borescope image of the crack in the shoulder area of DOT-3AL cylinder # AR0116501 at 180° location identified in Figure 48.

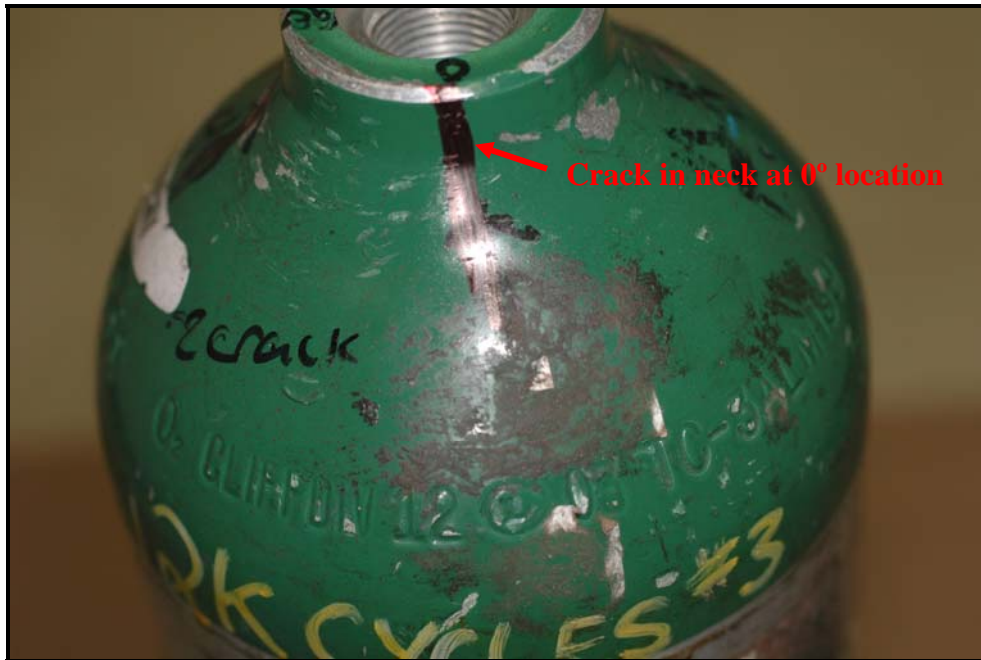
Figure 47: Shows the orientation of the crack in the shoulder area of DOT-3AL cylinder # AR0116501 at 0° location with respect to the indented markings.

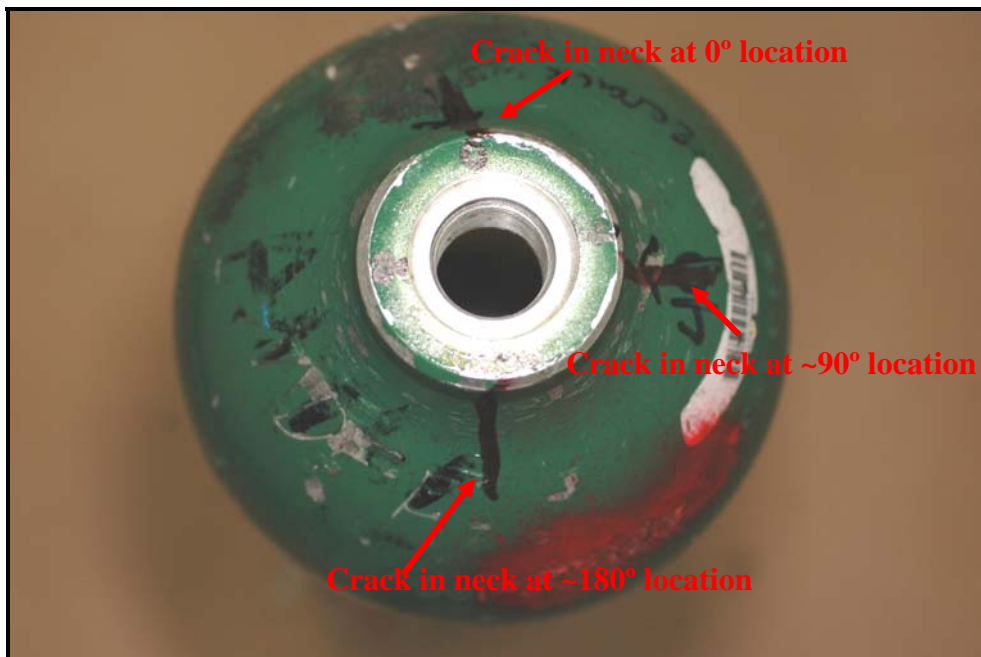
Figure 48: Shows the orientation of the cracks in the shoulder area of DOT-3AL cylinder # AR0116501 with respect to the 0° crack location.

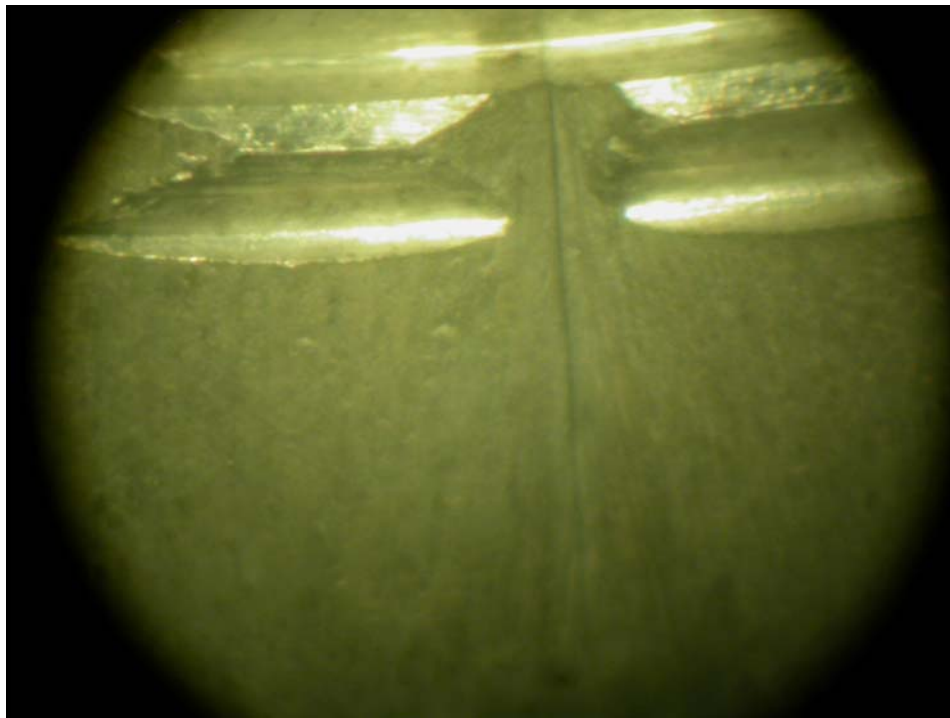
Figure 60: Shows borescope image of the crack in the shoulder area of DOT-3AL cylinder # AR0118110 at 0° location identified in Figure 64.

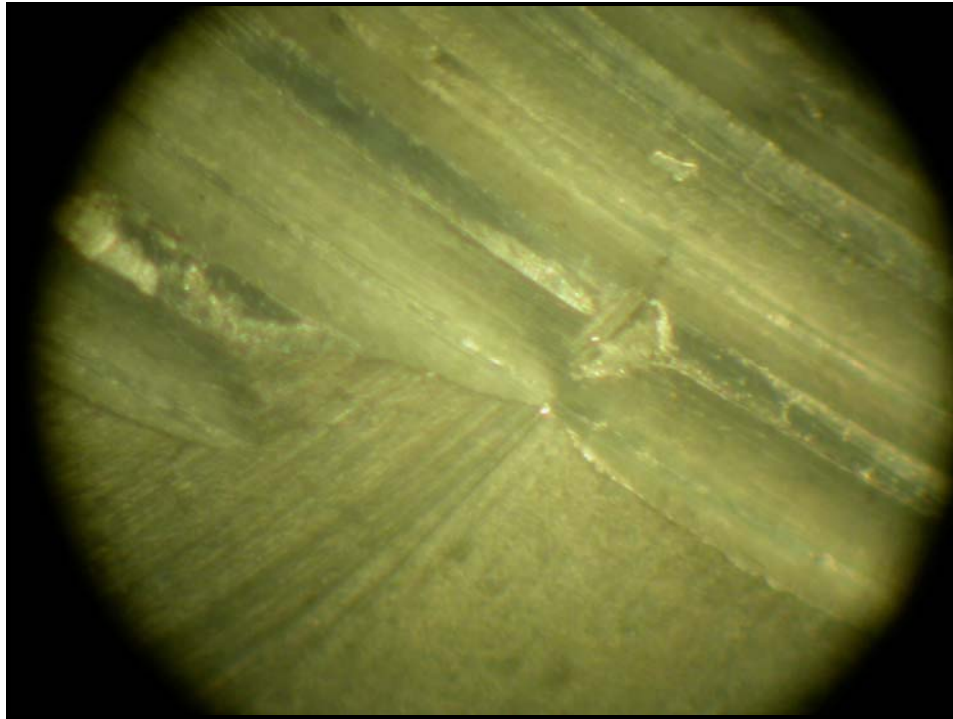
Figure 61: Shows borescope image of the crack in the shoulder area of DOT-3AL cylinder # AR0118110 at 45° location identified in Figure 64.

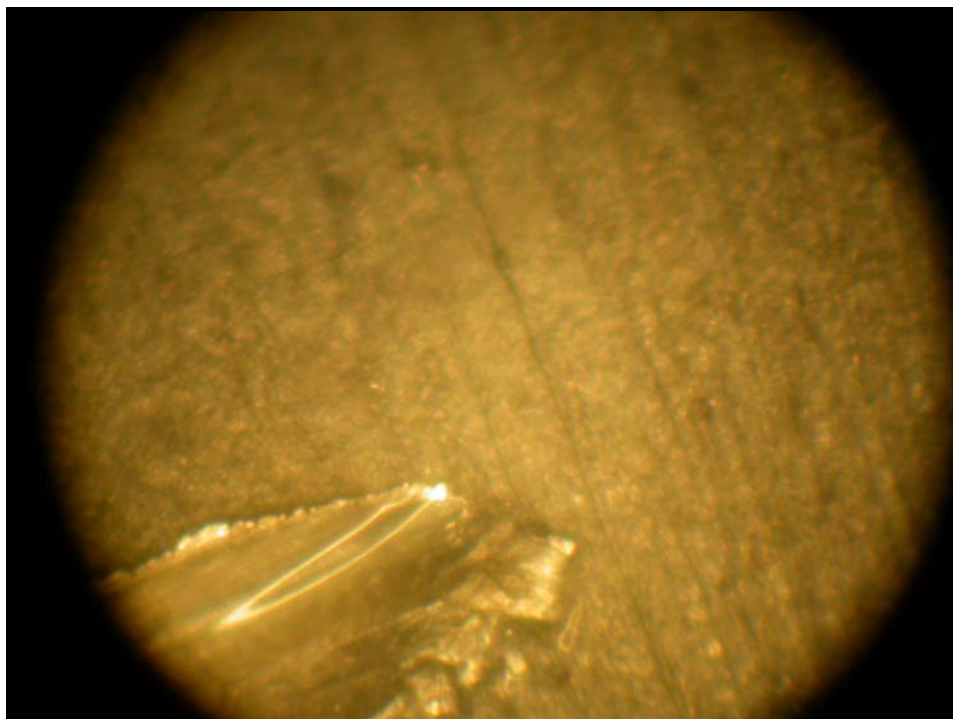
Figure 62: Shows borescope image of the crack in the shoulder area of DOT-3AL cylinder # AR0118110 at 165° location identified in Figure 64.

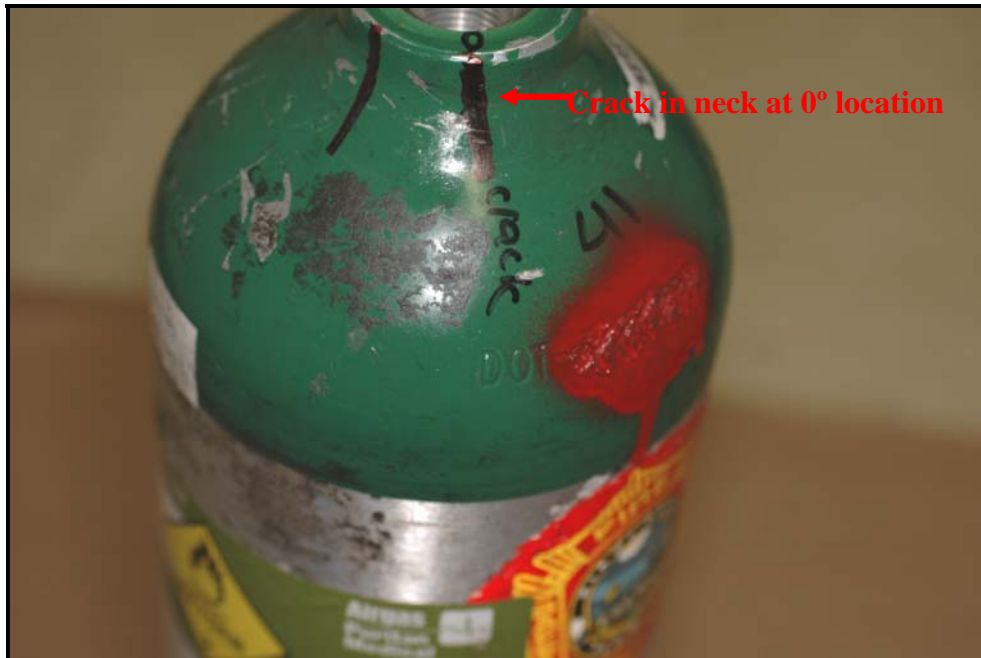
Figure 63: Shows the orientation of the crack in the shoulder area of DOT-3AL cylinder # AR0118110 at 0° location with respect to the indented markings.

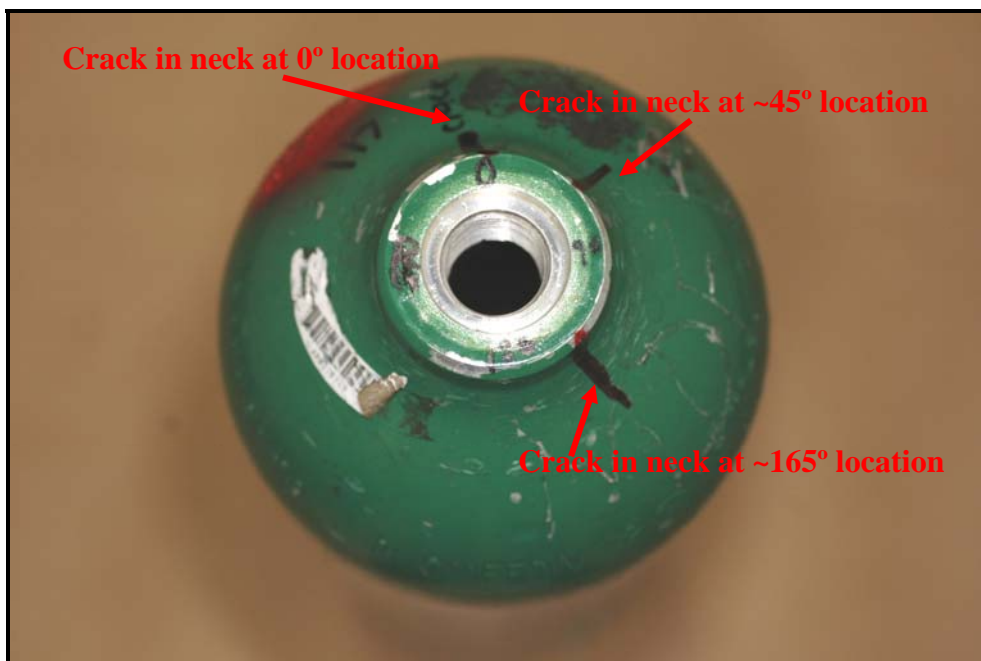
Figure 64: Shows the orientation of the cracks in the shoulder area of DOT-3AL cylinder # AR0118110 with respect to the 0° crack location.

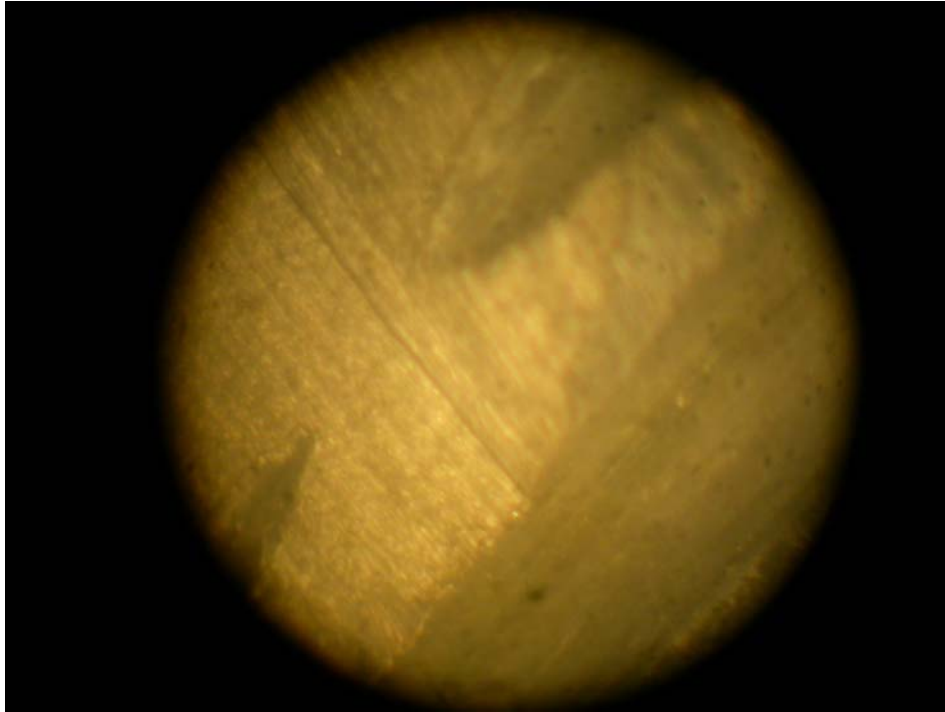
Figure 77: Shows borescope image of the crack in the shoulder area of DOT-3AL cylinder # AR0119572 at 90° location identified in Figure 81.

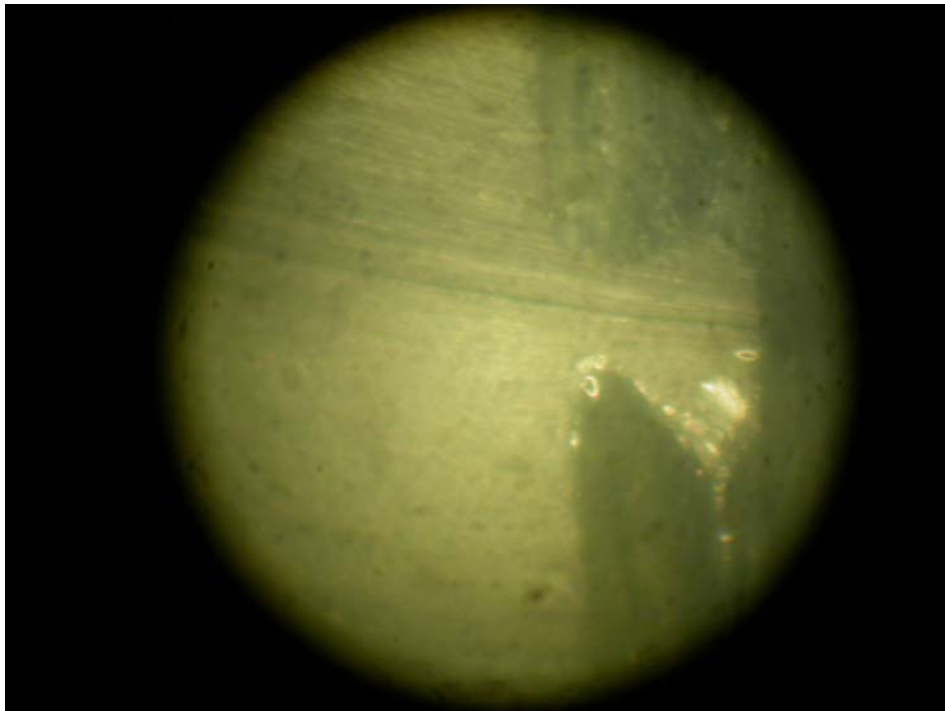
Figure 78: Shows borescope image of the crack in the shoulder area of DOT-3AL cylinder # AR0119572 at 180° location identified in Figure 81.

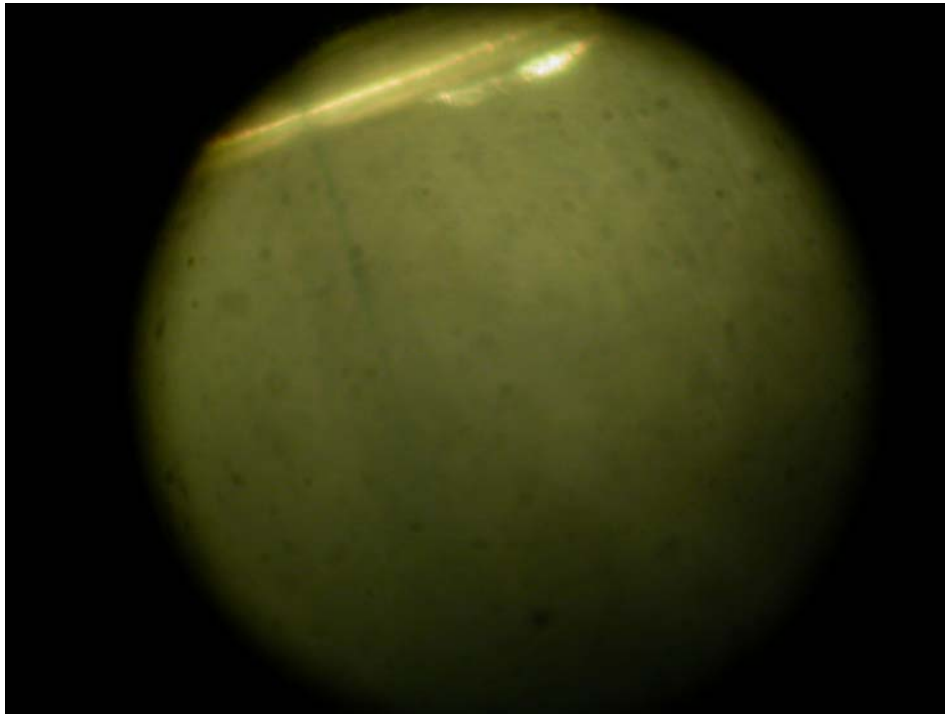
Figure 79: Shows borescope image of the crack in the shoulder area of DOT-3AL cylinder # AR0119572 at 280° location identified in Figure 81.

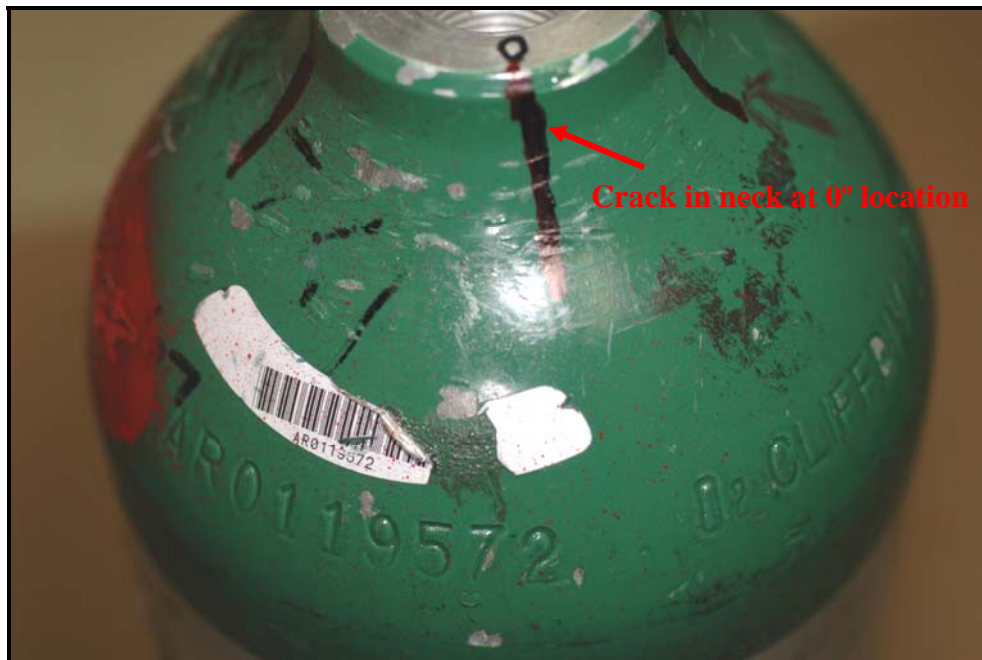
Figure 80: Shows the orientation of the crack in the shoulder area of DOT-3AL cylinder # AR0119572 at 0° location with respect to the indented markings.

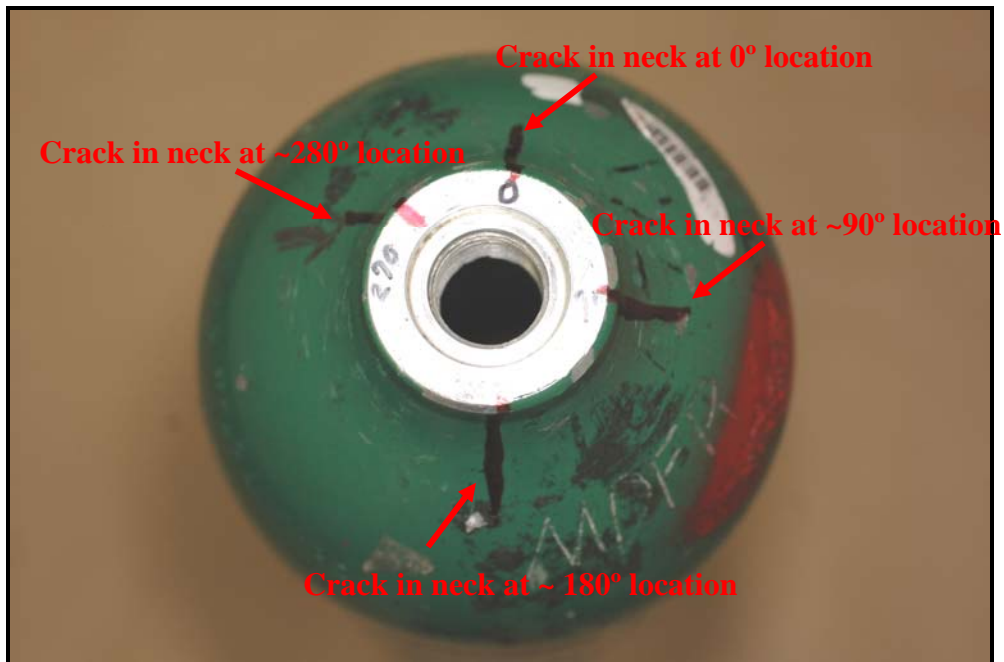
Figure 81: Shows the orientation of the cracks in the shoulder area of DOT-3AL cylinder AR0119572 with respect to the 0° crack location.

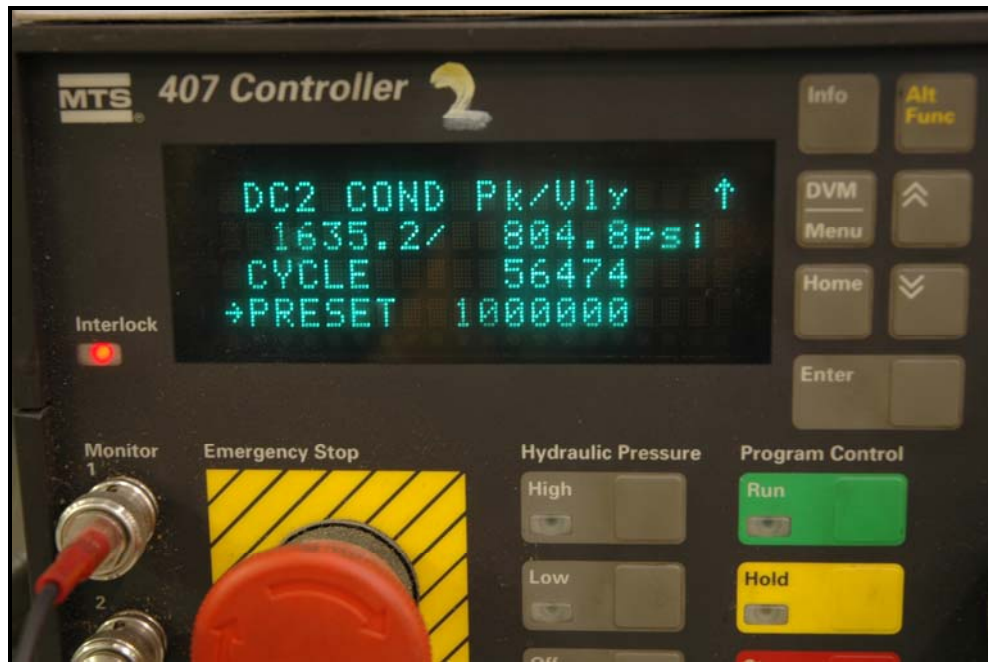
The cylinders AR0119572 and AR0118110 were pressure cycled until failure occurred. The cylinder AR0119572 failed after 56,474 cycles as shown in Figure 89. The failure occurred at the bottom of the cylinder as seen in Figures 90 and 91. The cylinder AR0118110 failed after 53,507 cycles as shown in Figure 92. The failure occurred on the wall of the cylinder near the bottom as shown in Figures 93 and 94.

Figure 89: Shows the maximum/minimum pressure and the number of cycles until the failure of the DOT – 3AA cylinder # AR0119572. The cylinder leaked after 56,474 cycles.

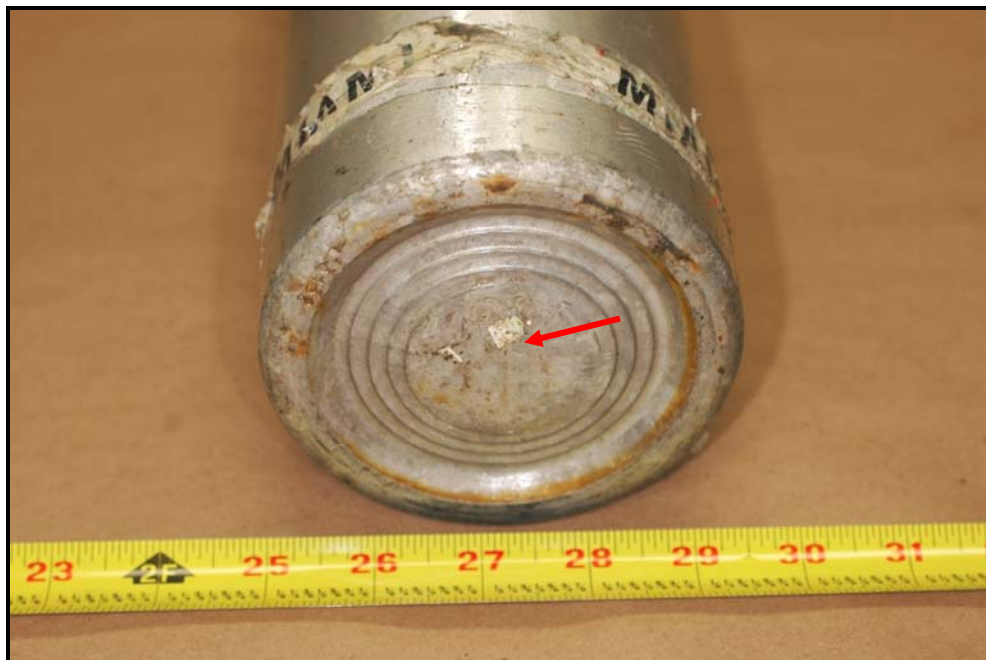
The cylinder AR0119572 leaked at the bottom after 56,474 cycles. The cylinder AR0118110 failed on the wall of the cylinder near the bottom after 53,507 cycles.

Figure 90: Shows the location where the leak occurred as indicated by the arrow. The cylinder # AR0119572 leaked at the base of the cylinder.

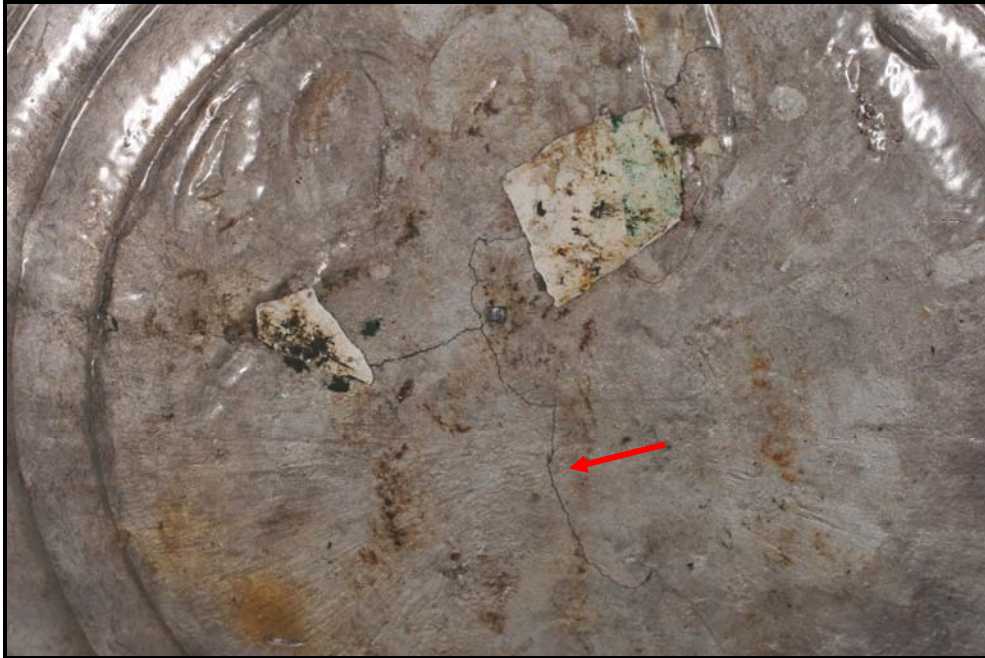
Figure 91: Shows the leak at the base of the cylinder # AR0119572

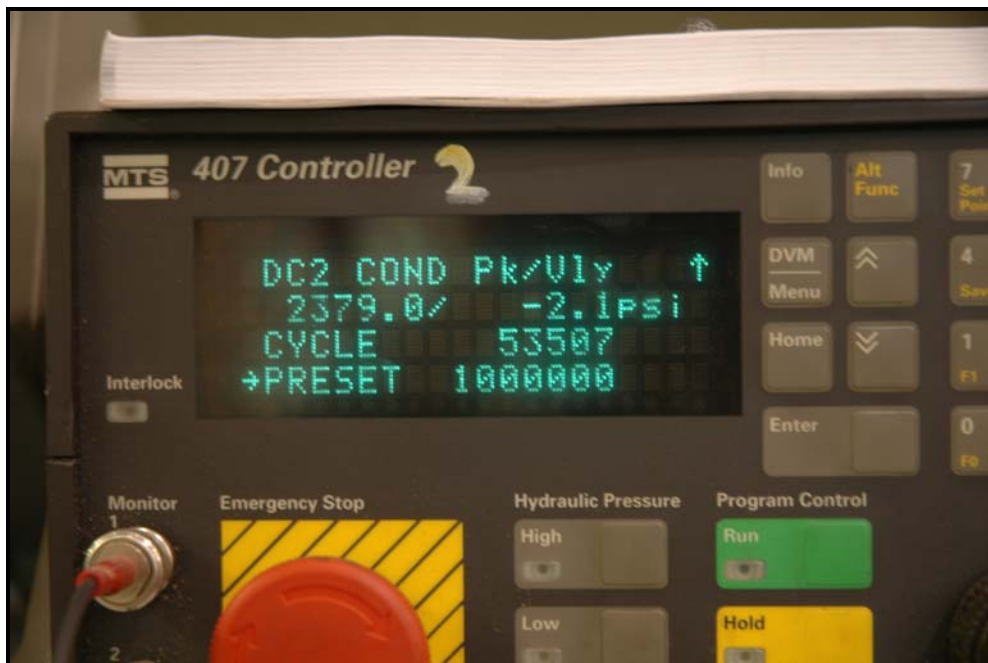
Figure 92: Shows the maximum/minimum pressure and the number of cycles until the failure of the DOT – 3AA cylinder # AR0118110. The cylinder leaked after 53,507 cycles.

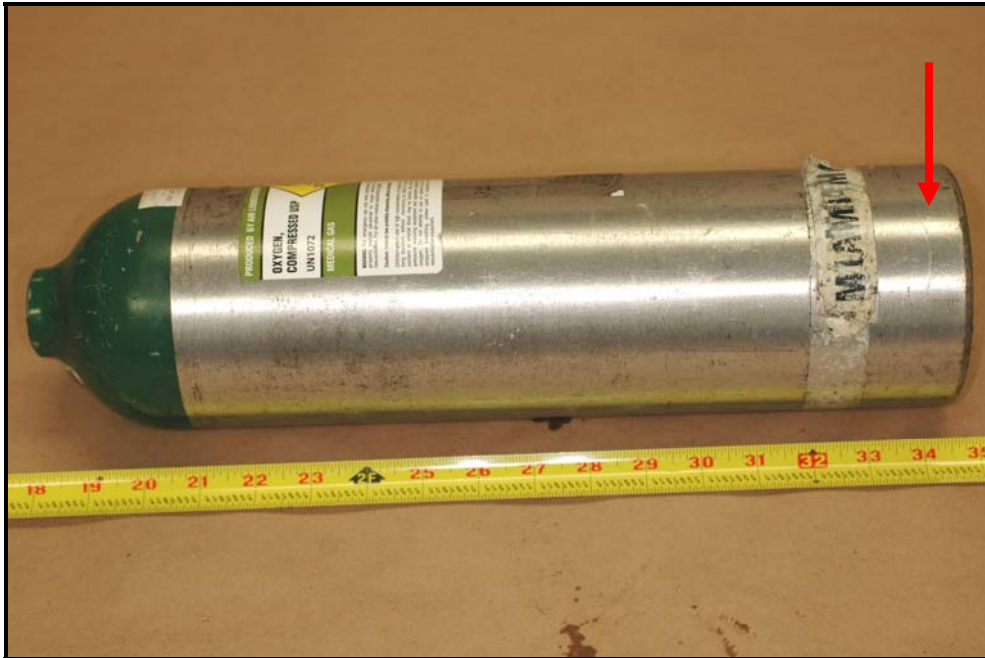
Figure 93: Shows the location where the leak occurred as indicated by the arrow. The cylinder # AR0118110 leaked on the wall of the cylinder near the bottom of the cylinder.

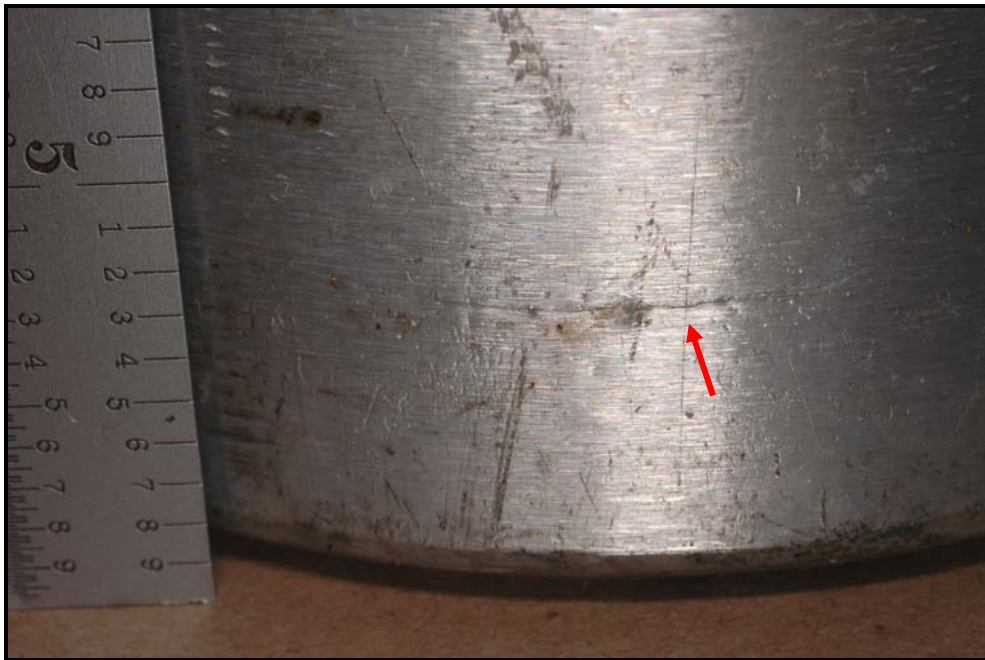
Figure 94: Shows the leak on the wall of the cylinder near the bottom of the cylinder # AR0118110

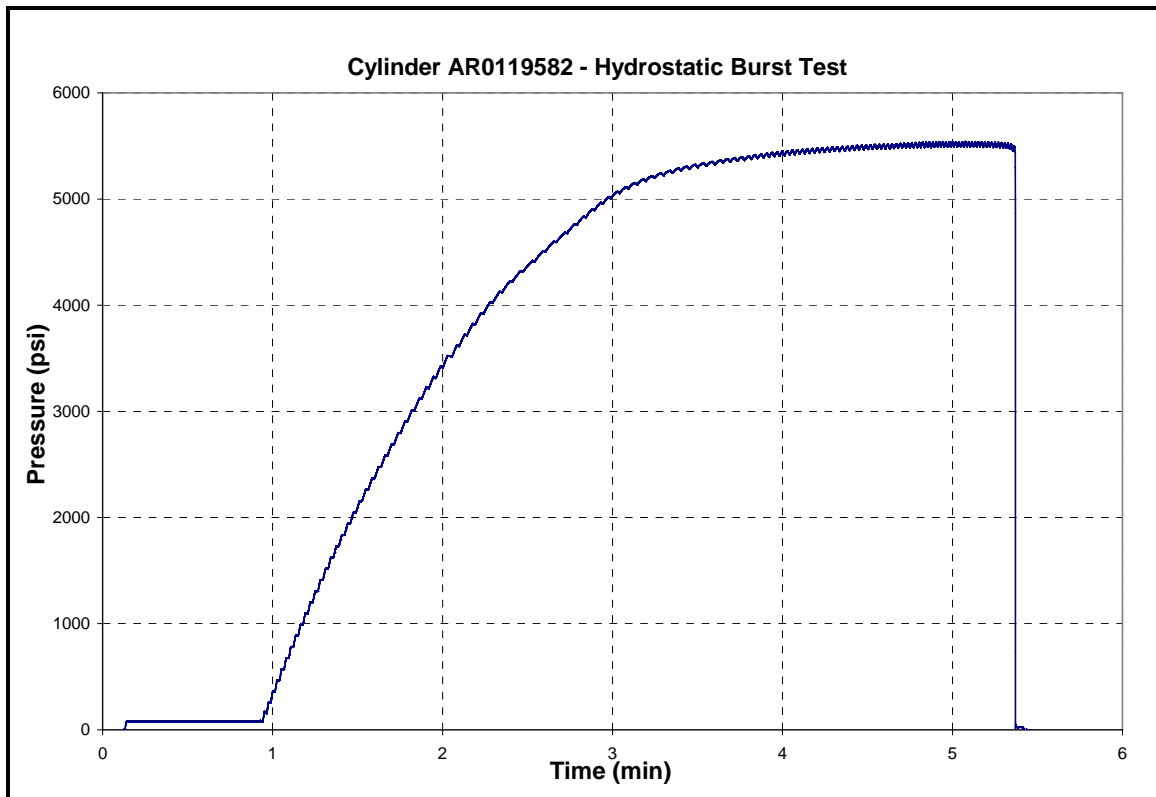
During the hydraulic burst test the cylinder AR0119582 reached a maximum pressure of 5,534 psi in about 5.23 min (5 min 13 sec) and failed after 5.52 min (5 min and 31 sec). The cylinder burst along the length of the cylinder.

Figure 97: Pressure v Time data for Hydraulic burst test of cylinder # AR0119582.
