**Hydraulic Pressure Cycling and Performance Evaluation of five DOT-3AL 2015
Cylinders**

FINAL REPORT

Packer Project # 501856

**Prepared for
Mark Toughiry
Office of Hazardous Materials Technology
Pipeline and Hazardous
Materials Safety Administration
U.S. Department of Transportation**

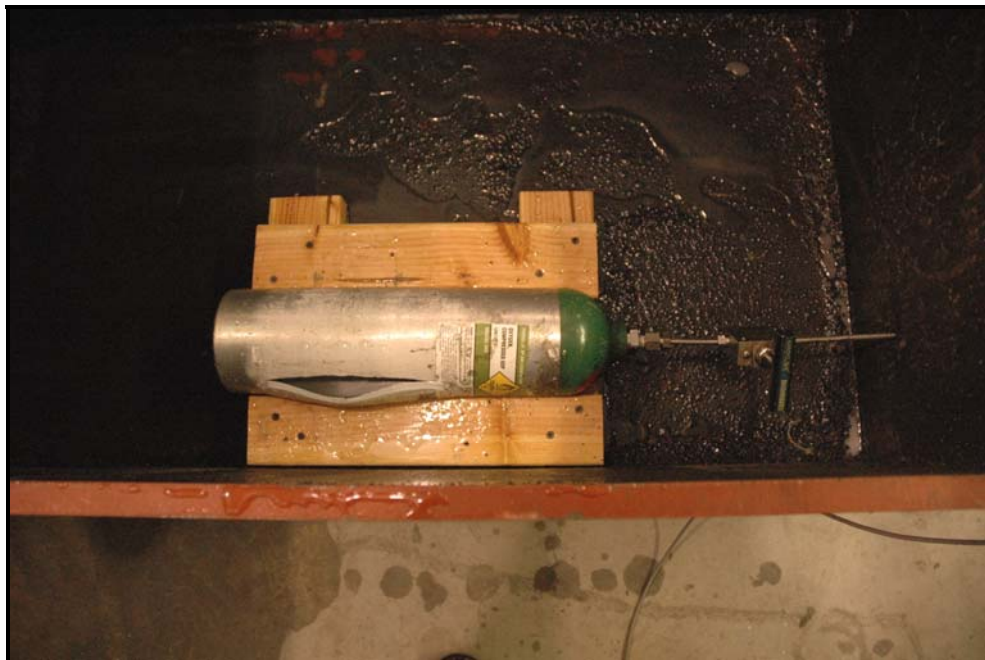
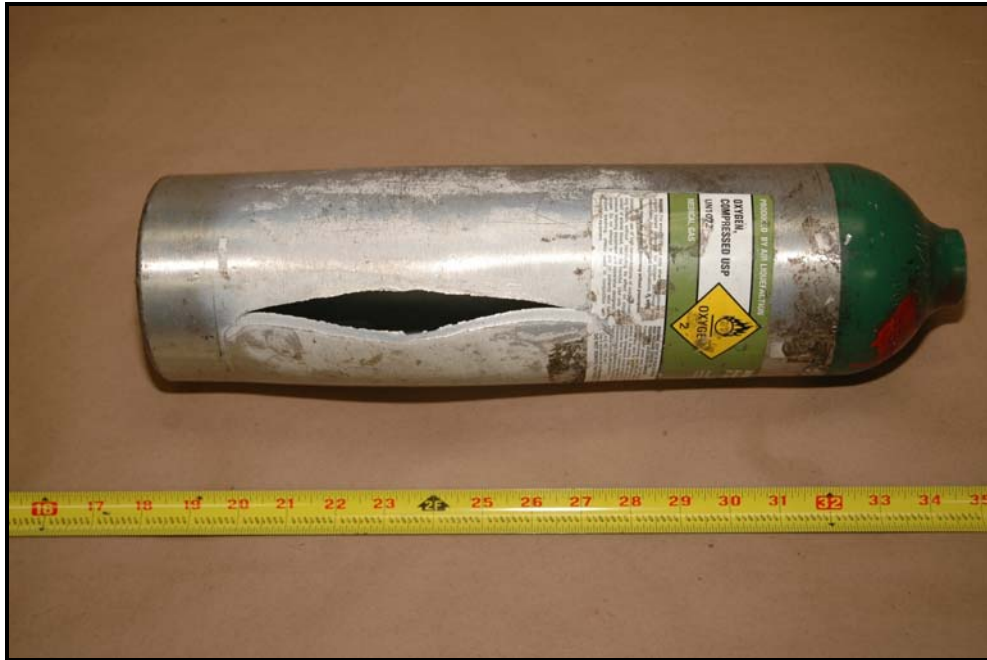
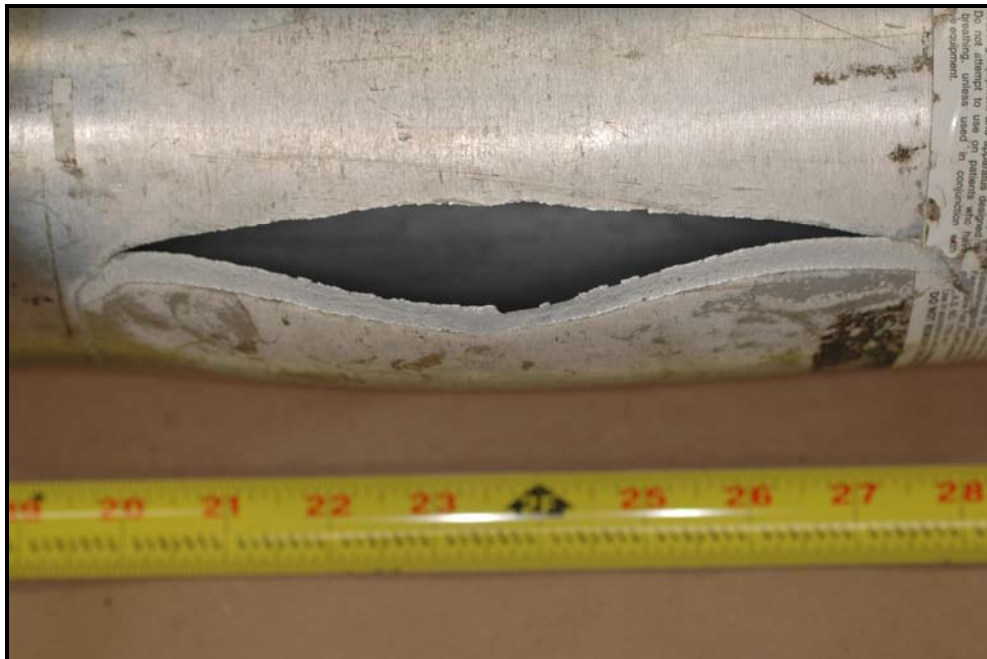
After completing 12,000 cycles of pressure cycling test, the cylinder AR0115982 was filled with water and hydrostatically tested to failure. The hydrostatic burst test was performed using a SC Hydraulic Engineering Model 10-60005402 air-powered fluid pump. The pressure was measured using an Omegadyne PX35 pressure transducer (0-30,000 psi) and recorded with an IOTech Wavebook 516E at a rate of 100 samples per second. Care was taken to avoid air entrapment in the circuit. The test setup is as shown in Figures 95 to 96. The pressure data is shown in Figure 97. The cylinder reached a maximum pressure of 5,534 psi in about 5.23 min (5 min 13 sec) and failed after 5.52 min (5 min and 31 sec). The cylinder burst along the length of the cylinder. The failure location is as shown in Figures 98 to 100.

Figure 98: Ruptured cylinder #AR0119582 after hydraulic burst testing

Figure 99: Ruptured cylinder #AR0119582 after hydraulic burst testing

Figure 100: Ruptured cylinder #AR0119582 after hydraulic burst testing
