Valve Integrated Pressure Regulator Examination (DOT DUNS #079807449)

Report Number:
R-WHA-15113-0-A-EX1

WHA International Inc., (WHA) was requested by the Pipeline and Hazardous Materials Safety Administration (PHMSA) to document and evaluate the valve portion of a ruptured DOT 3AL cylinder that had been involved in a fire during high-pressure oxygen service, and to determine the following:

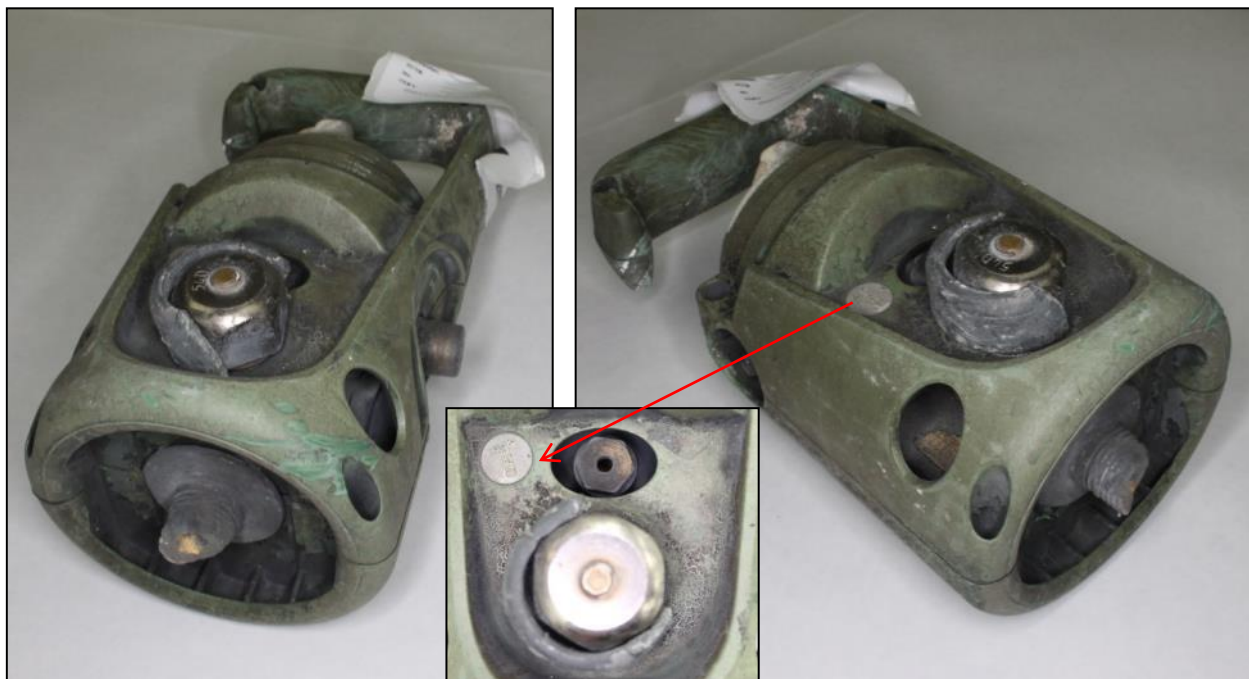
Figure 1 – Incident VIPR and Shroud (As-Received)

WHA initially received and inspected the evidence on August 27, 2015 and documented the as-received condition of the incident VIPR, as shown in **Figure 1** and **Figure 2**. These figures depict the condition of the VIPR and shroud, an O-ring consistent with the VIPR-to-cylinder seal and a metallic segment consistent with a portion of the fragmented cylinder. The VIPR and O-ring shown in these photographs was the subject of the WHA investigation. The cylinder

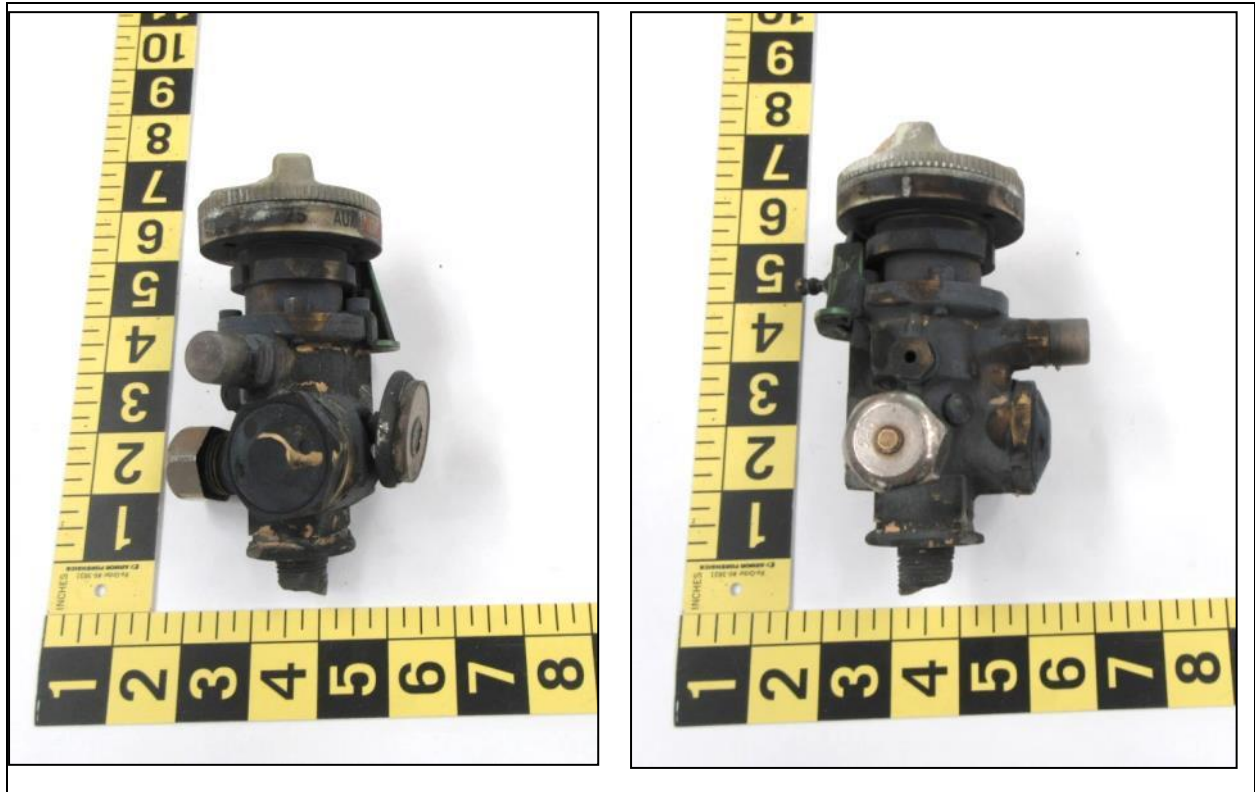
Figure 3 – Incident VIPR (Shroud Removed)

Figure 3 and **Figure 4** depict the condition of the VIPR in its as-received condition after removal of the external plastic shroud. The VIPR was heavily covered with soot and combustion products but was generally intact without any inside-to-outside combustion evident in the external examination¹. The predominant area of melt-flow and thermal involvement was observed on the threads of the VIPR, associated with the interface to the cylinder. This region of the VIPR exhibited very heavy involvement and had burned/melted where the original threaded interface to the cylinder had been. The VIPR included the following markings:

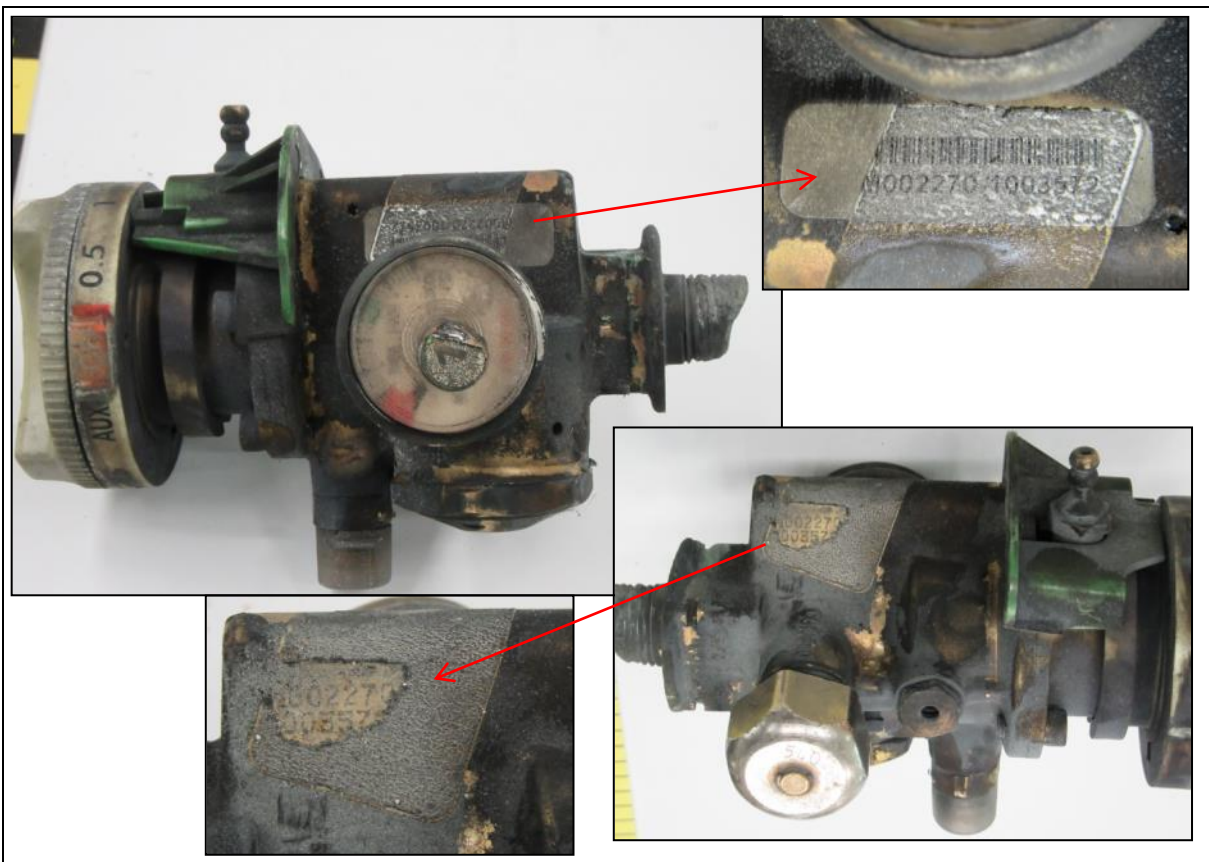
Figure 4 – Grab 'n Go Markings

- Praxair Grab 'n Go Vantage VIPR (based on flow range, 0.5 to 25 lpm)
- Post-recall modified based on "T" decal affixed to the plastic shroud
- Valve Markings
 - Serial Number M002270-1003572
 - "CGA 540" marking on fill valve port and cap
 - Burst disc cap marked "32" and "3360" (consistent with 3360 psig nominal rupture pressure)
 - Body marking above threads/flange: ¾-16, UNF-2A

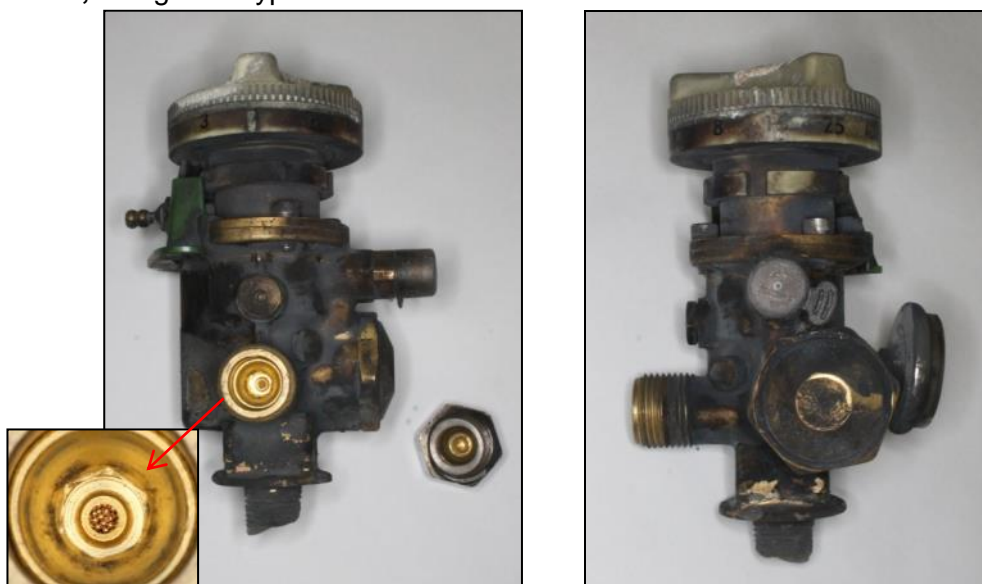
Figure 5 – Views of VIPR (Rotated Clockwise)

Figure 5 and **Figure 6** provide various views of the incident VIPR from four different sides. Figure 5a (top-left) shows an external view of the VIPR with the fill-port cap removed to expose the fill port assembly and filter. This port, like other ports, was visually undamaged, relatively clean, and intact. The fill-port filter was visually undamaged. Other views in this figure also show the external condition of the VIPR from various sides. The VIPR externally was covered with combustion residue, largely consistent with greyish aluminum-oxide (visually) but did not exhibit inside-to-outside evidence of burn-through. It was noteworthy, however, that the pressure gauge was bent consistent with an impact loading. It was also noteworthy that the flange on the VIPR, at the cylinder-to-VIPR interface, was bent on one side, consistent with an impact or bending moment applied to the body of the VIPR (**Figure 6**). The bend and deformation of the flange was approximately opposite the side of the VIPR threads that exhibited the heaviest melt/consumption of brass.

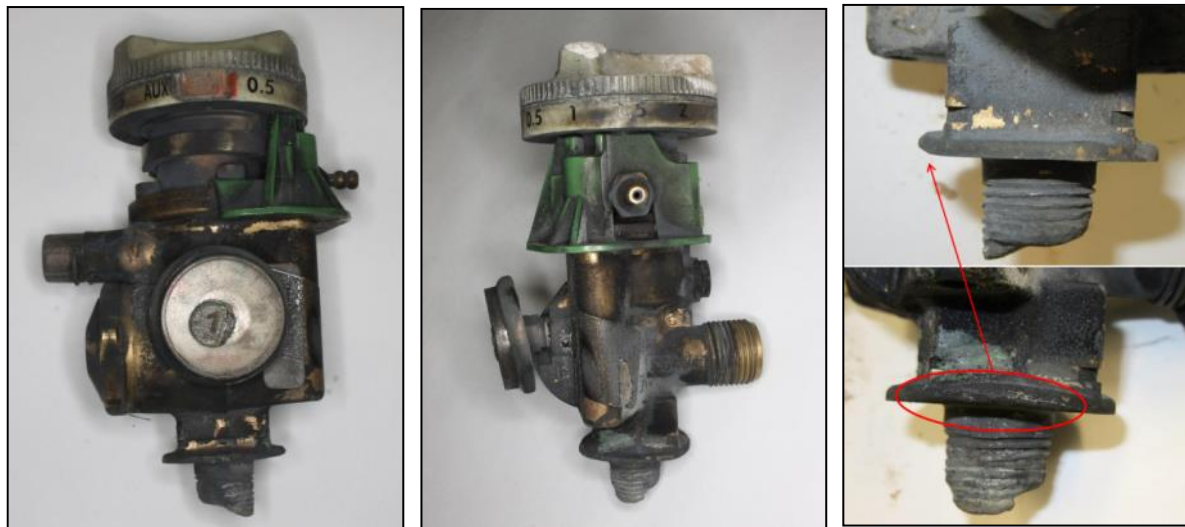
Figure 6 – Views of VIPR (Rotated Clockwise) and Flange Close-up

The VIPR exhibited combustion and slag deposits on the majority of its external components and external surfaces. However, external fire damage to the VIPR was generally limited to the cylinder-to-VIPR thread connection. Fire damage to the thread connection was also heaviest on the lower 12 o'clock region of the threads away from the flange and flange O-ring seal. VIPR damage to the cylinder thread post is shown in **Figure 20**. Noteworthy bending, consistent with impact, was also observed on the flange and the pressure gauge at 6 o'clock (**Figure 6**).

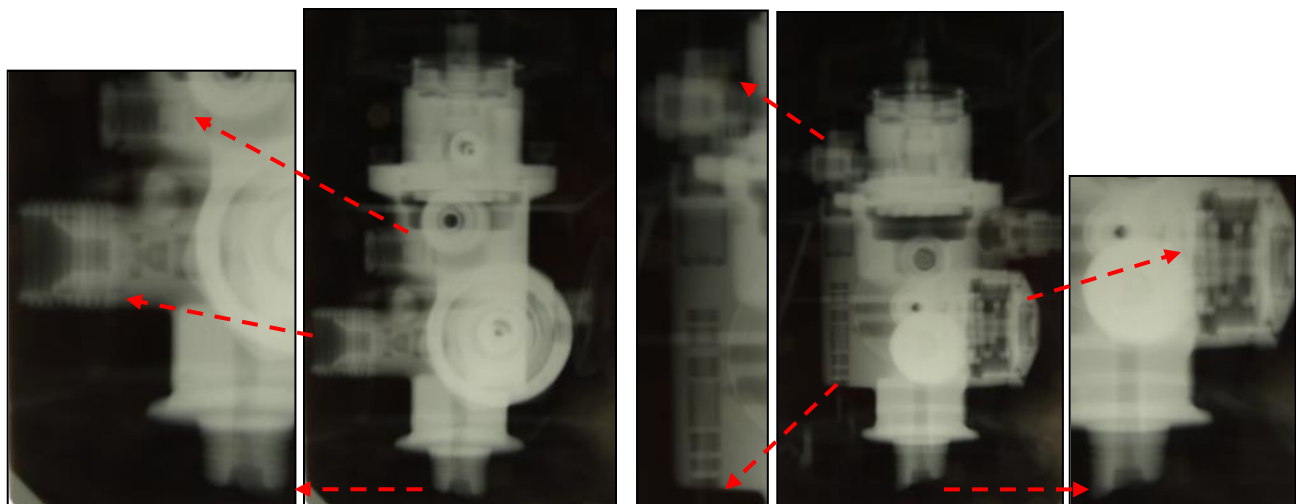
Figure 7 – X-ray Radiographic Views of VIPR (Noting Various Features of Design)

Figure 7 depicts several x-ray radiographic images of the VIPR showing views of the internal components. The x-ray images revealed that the internal components were intact and did not exhibit internal burning or combustion, to the extent that could be discriminated from the images. The fill valve, regulator, flow valve, relief valve, burst disc, and flow head could be observed and did not exhibit indications of damage or internal combustion from the images obtained. The melt/consumption patterns on the cylinder-to-VIPR threads were clear and indicated involvement only of the threads externally without internal propagation being evident in these images. The cylinder-to-VIPR filter was also evident in the x-ray images and appeared visually intact having the expected conical geometry. Further views of this filter using a boroscope confirmed the intact nature of this filter and are hyperlinked in **Appendix A**.

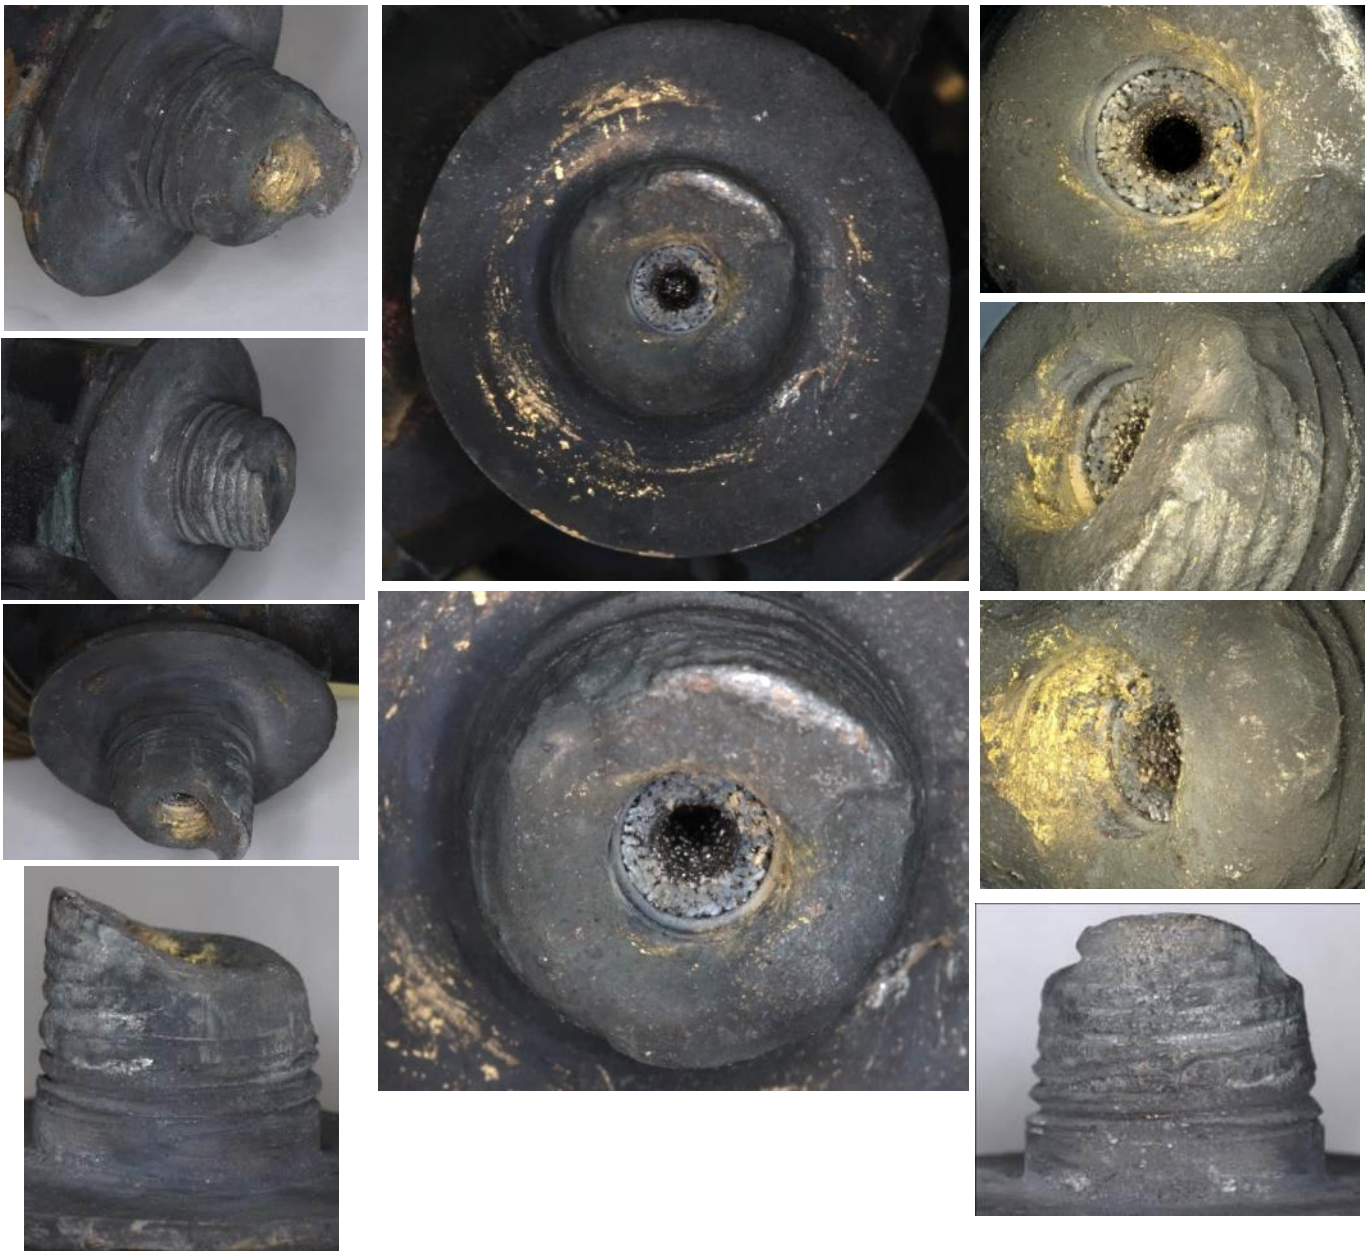
Figure 8 – Magnified Images of the VIPR Thread Damage

Figure 8 depicts magnified images of the flange of the VIPR and the fire-damaged threads. **Figure 9** provides more detailed images of the VIPR thread damage. These images show that the surfaces proximate to the VIPR threads were covered with combustion residue and were primarily comprised of aluminum combustion products (see also EDS summary in **Appendix D**, discussed later). The threads also exhibited melting and/or consumption with a geometric preference for material loss on one side of the threads. The filter was covered with combustion residue but was intact and did not exhibit evidence of compromise or burn-through. The filter's threaded retainer element was missing.

Figure 8 and **Figure 9** depict various views of the VIPR threads, VIPR flange region proximate to what would have been the cylinder and cylinder O-ring gland. These figures depict the very heavy melting and melt-flow associated with the lower segments of the VIPR threads. The SEM/EDS analysis was consistent with evidence of heavy aluminum combustion products deposited on the VIPR threads and suggested that aluminum combustion had developed initially in the lower segment of the threads proximate to the 12 o'clock region⁸.

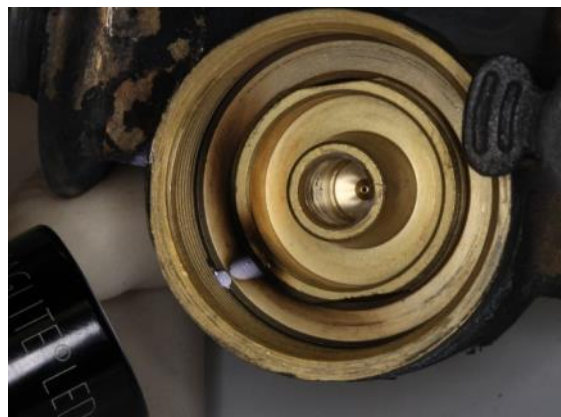
Figure 10 – Regulator Atmospheric Vent Port Illuminated from Exterior

The components listed above were inspected and documented by all parties present during the WHA joint inspection. During disassembly, WHA observed combustion product deposits inside some component housings. However, analysis revealed the residue was not associated with internal combustion. Several components have ports drilled into them that allow communication with the external environment, such as the regulator atmospheric sensing port (**Figure 10**). The combustion deposits were consistent with the external fire depositing combustion products on these components through the external ports onto surfaces within the VIPR housing. However, the VIPR did not exhibit internal fire-damage, melt-flow patterns, or propagation patterns that were consistent with fire originating inside or within the VIPR.

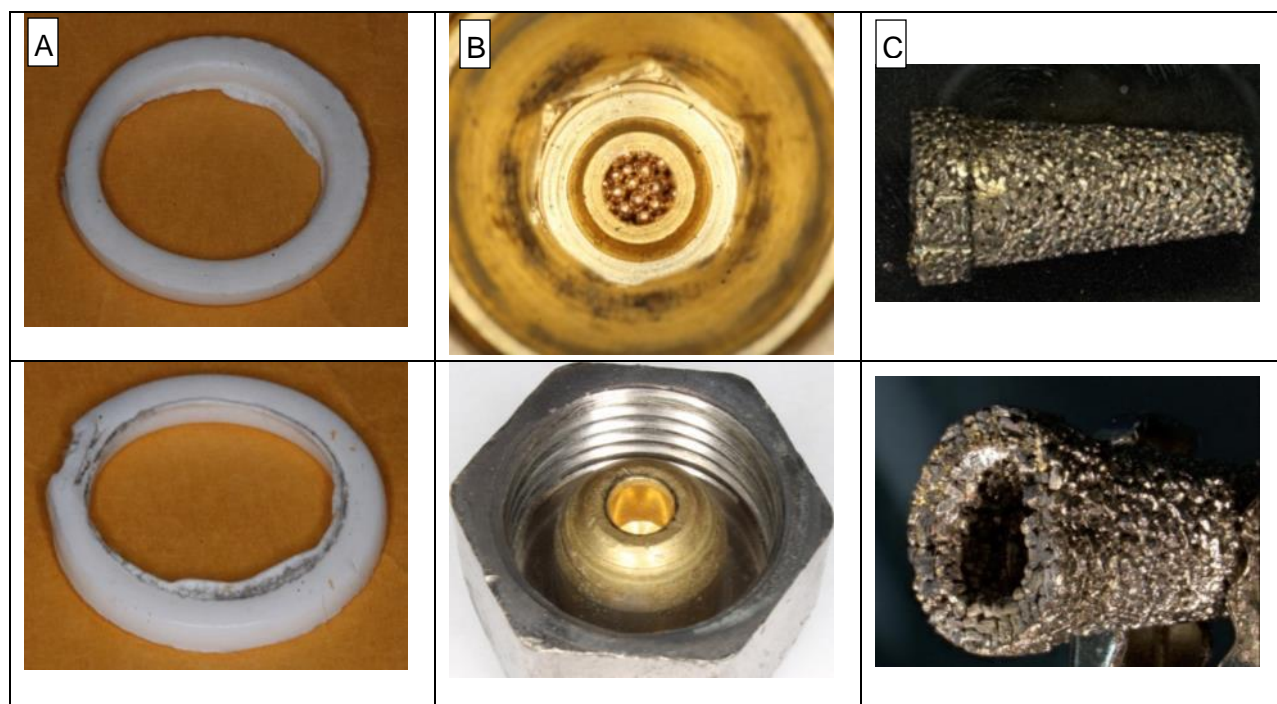
Figure 12 – Photographs of the Cylinder O-ring seal (A), Inlet Fill Port Filter and Cap (B), and Cylinder-to-VIPR Filter (C)

Figure 12 depicts the condition of what was provided to WHA as the cylinder O-ring (determined by FTIR to be PTFE) and two of the VIPR filters. The inlet fill port filter and protective cap are also shown in this figure. These components were visually clean but solvent rinses of the filter indicated detectable levels of a hydrocarbon contaminant. The cylinder-to-VIPR filter is also depicted and after careful removal from the VIPR threads, was observed to exhibit an intact and largely clean appearance. However, detectable levels of hydrocarbon were also observed on this filter for both careful solvent rinsing of the interior conical bore and solvent rinsing of the external conical structure. During these solvent rinses the filter was positioned so that careful solvent rinses would drain from the filter in such a manner that the interior and exterior would not be cross-exposed.

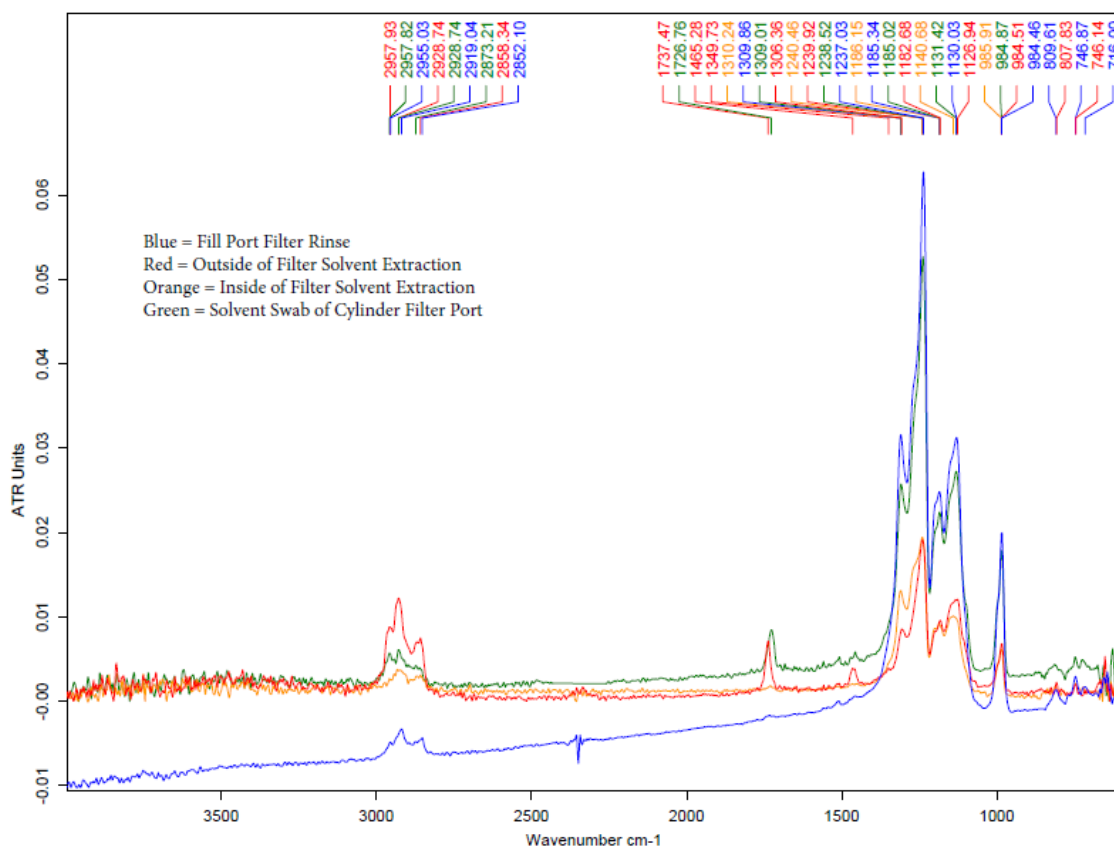
Figure 13 – FTIR Comparisons of VIPR Fill Port and Cylinder-to-VIPR Filter

Figure 13 depicts the results of the FTIR sampling, comparing the fill port filter and the cylinder filter (interior and exterior). Each sample taken from these filters exhibited aliphatic hydrocarbon functionality (~2800 to 3000 wavenumbers) consistent with contamination. **Figure 14** depicts the FTIR sampling of the cylinder-to-VIPR filter, which also exhibited predominant hydrocarbon contamination and weaker functionality for Dioctyl Sebecate (discussed later). These samples also exhibited functionality consistent with a perfluoropolyether grease (**Figure 14**, Krytox or equivalent, ~900 to 1300 wavenumbers), which was a common finding with many samples, considered a result of the lubrication of the VIPR assemblies with an oxygen-compatible grease during assembly.

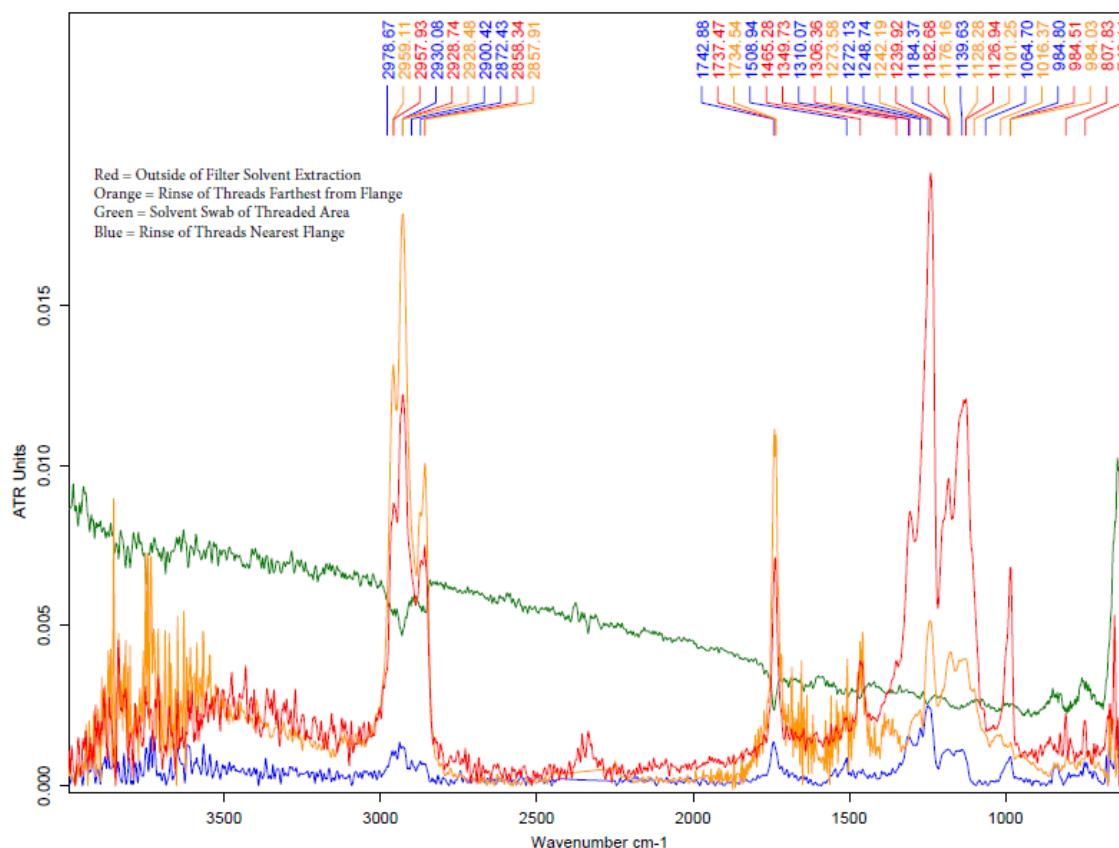
Figure 15 – FTIR Comparisons of Solvent Rinses of VIPR Threads

Figure 15 depicts a comparison of several solvent rinses on the VIPR threads compared to the solvent rinse of the exterior of the cylinder-to-VIPR filter. These comparisons show that measurable levels of predominantly hydrocarbon and Krytox-like grease could still be detected on the threads after the fire, especially in the areas most damaged away from the flange region (orange compared to blue lines). The FTIR analysis indicated that the VIPR exhibited hydrocarbon contamination extending from the fill port inlet through to the cylinder filter and into the VIPR/cylinder threads.

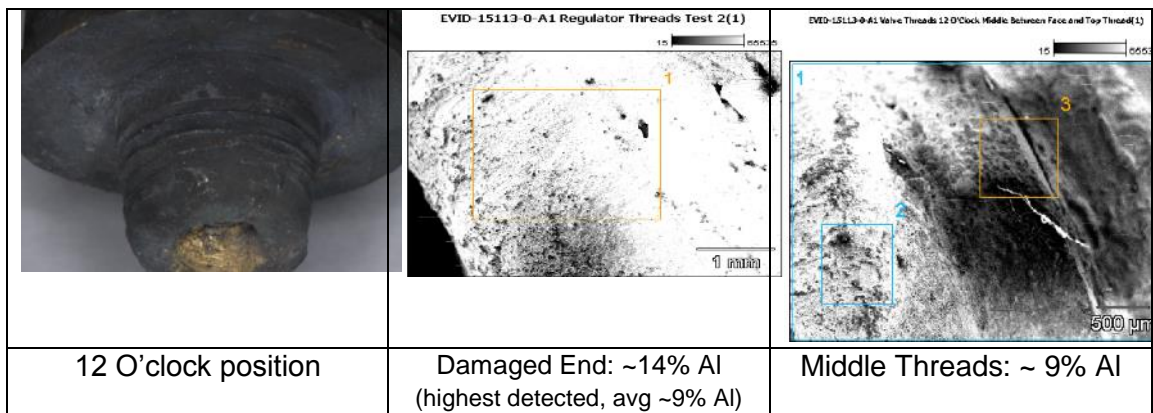
Figure 18 – 12 O'clock Position SEM Images

- 12 o'clock position: Al content (~10%) generally consistent throughout thread position from damaged end to flange. This was the approximate position observed to exhibit the heaviest brass consumption and/or melt/flow and exhibited the heaviest thread distortion.

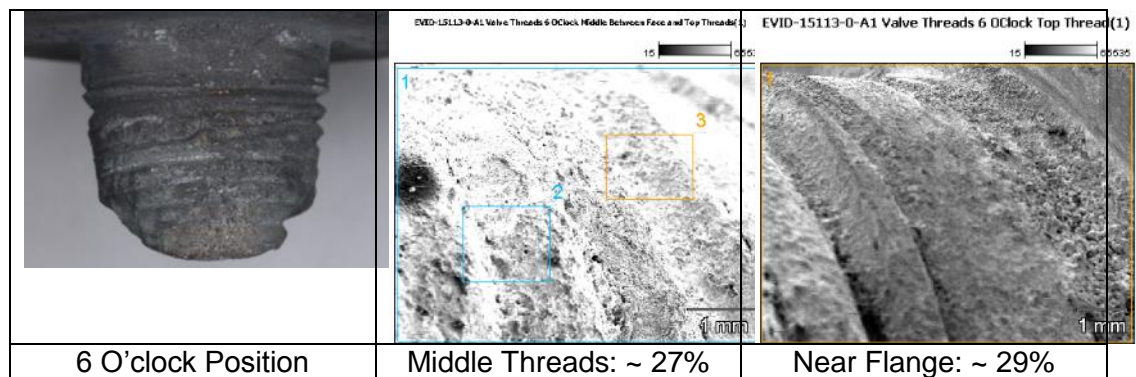
Figure 19 – 6 O'clock Position SEM Images

- 3 o'clock position: Al content generally higher on damaged end (~12%) than flanged end (~6%)
- 9 o'clock position: Al content (~12%) consistent throughout thread region from damaged end to flange, highest amount of Al (~18%) on thread in one location near the flange; however, overall, the Al concentration was reasonably consistent along this position.
- 6 o'clock position: Al content generally increasing from damaged end (~18%) to flanged end (~30%). This position exhibited heavy aluminum and aluminum combustion products clinging to the threads, probably having been less effected by aluminum combustion before the VIPR was ejected from the cylinder.
