**Assessment of Pipeline Integrity  
of Kinder-Morgan Conversion  
Of the Rancho Pipeline**

**City of Austin Texas**

**June, 2004**

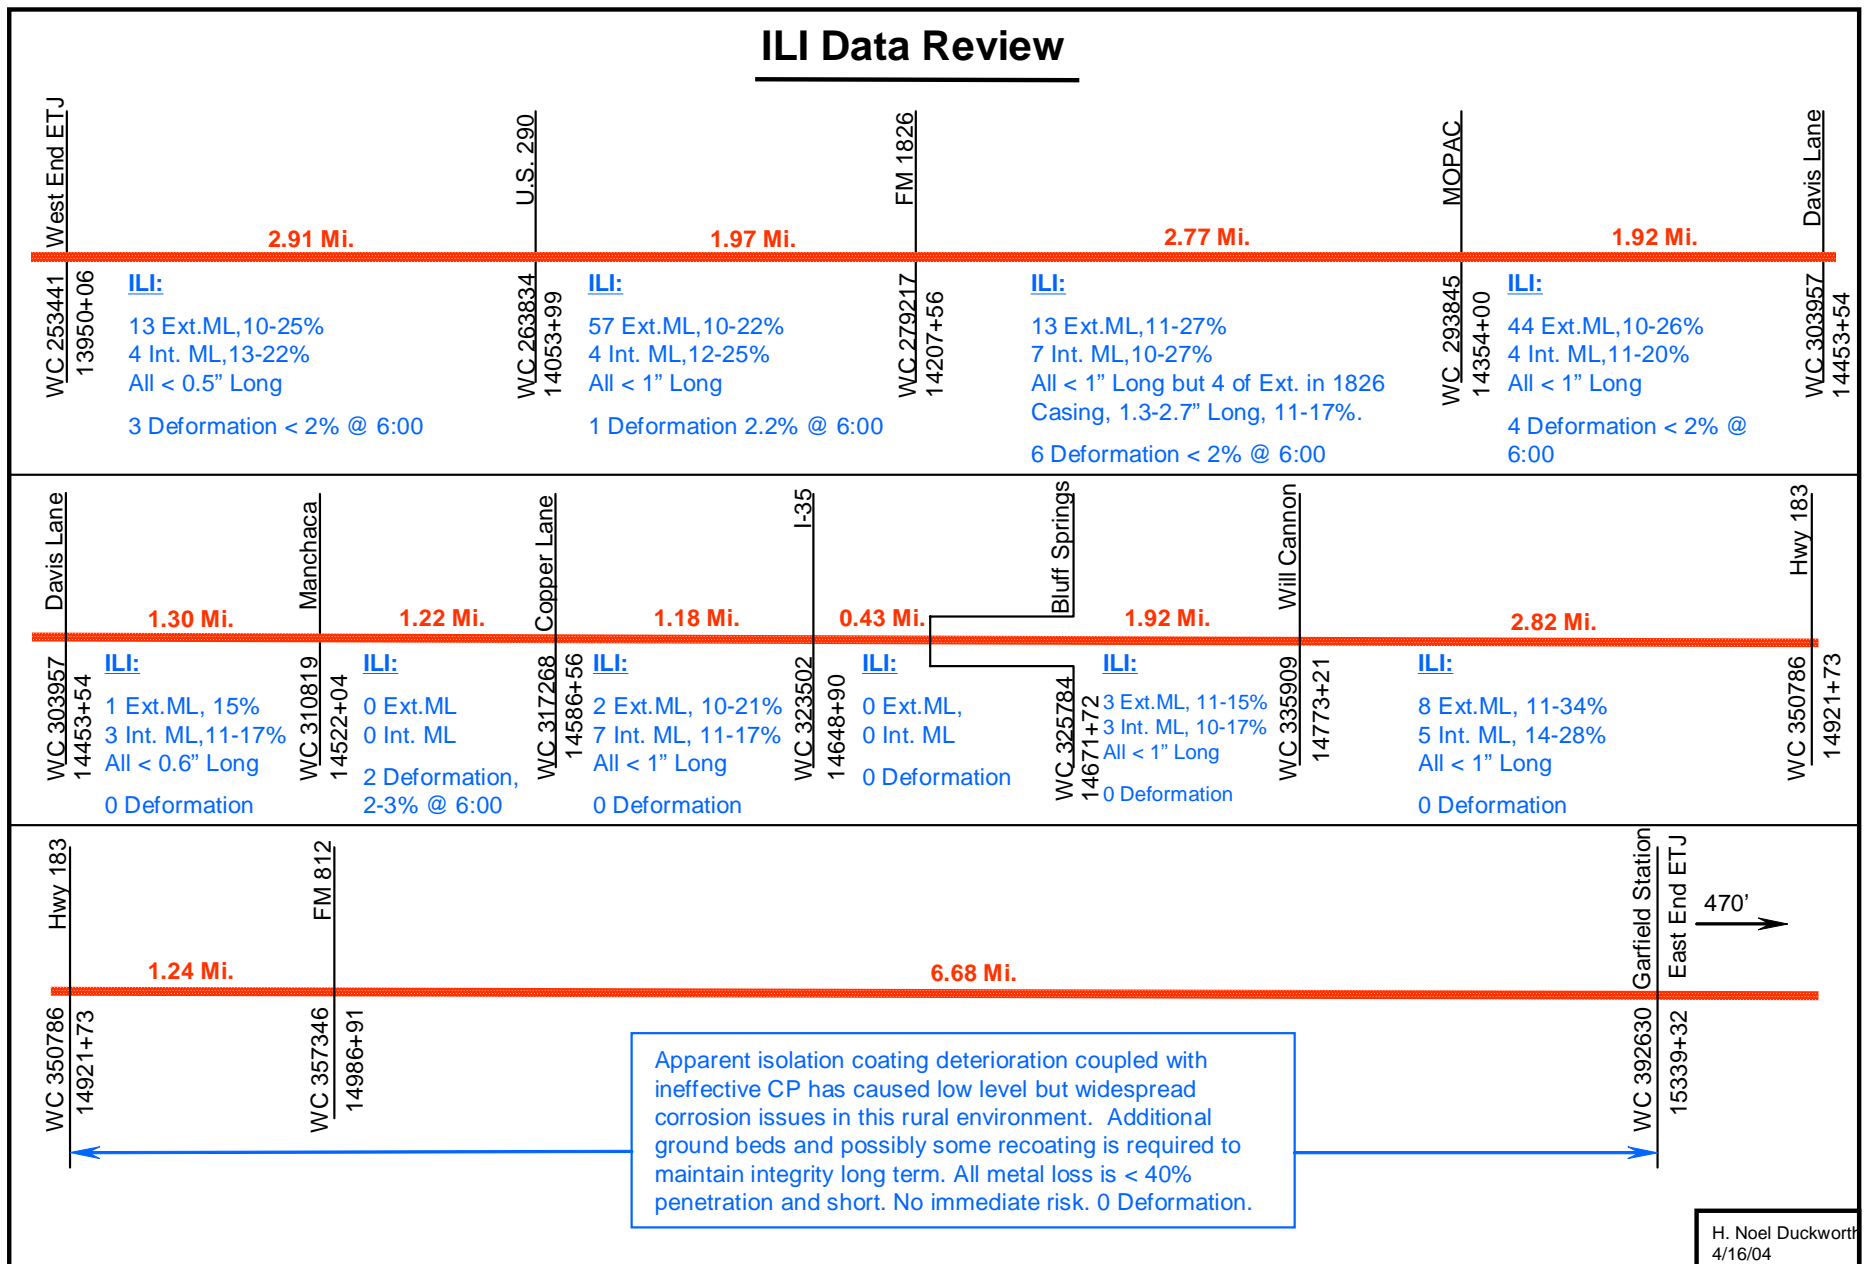
Figure 2. ILI Data Review.

All of the 2003 ILI data was evaluated from both the High Resolution Magnetic Flux (HRMFL) as provided by GE-PII and the Deformation survey data provided by Enduro and the data was found to be of high quality and therefore should identify the anomalies detectable with the tools employed (see Table 4) in the pipeline. The results of this evaluation can be seen graphically in Figure 2.

Figure 2 shows that most of the corrosion from the Western boundary of the ETJ to Highway 183 East of I-35 is very isolated, shallow, and short along the longitudinal axis. It is obvious that these locations are not injurious in their present state and they appear to be under control from a cathodic protection point of view. Between Highway 183 and the Eastern ETJ boundary, there is a much higher density of external coating problems with apparent ineffective cathodic protection which has, over the course of many years, caused low level but widespread corrosion issues in this mostly farmland environment.

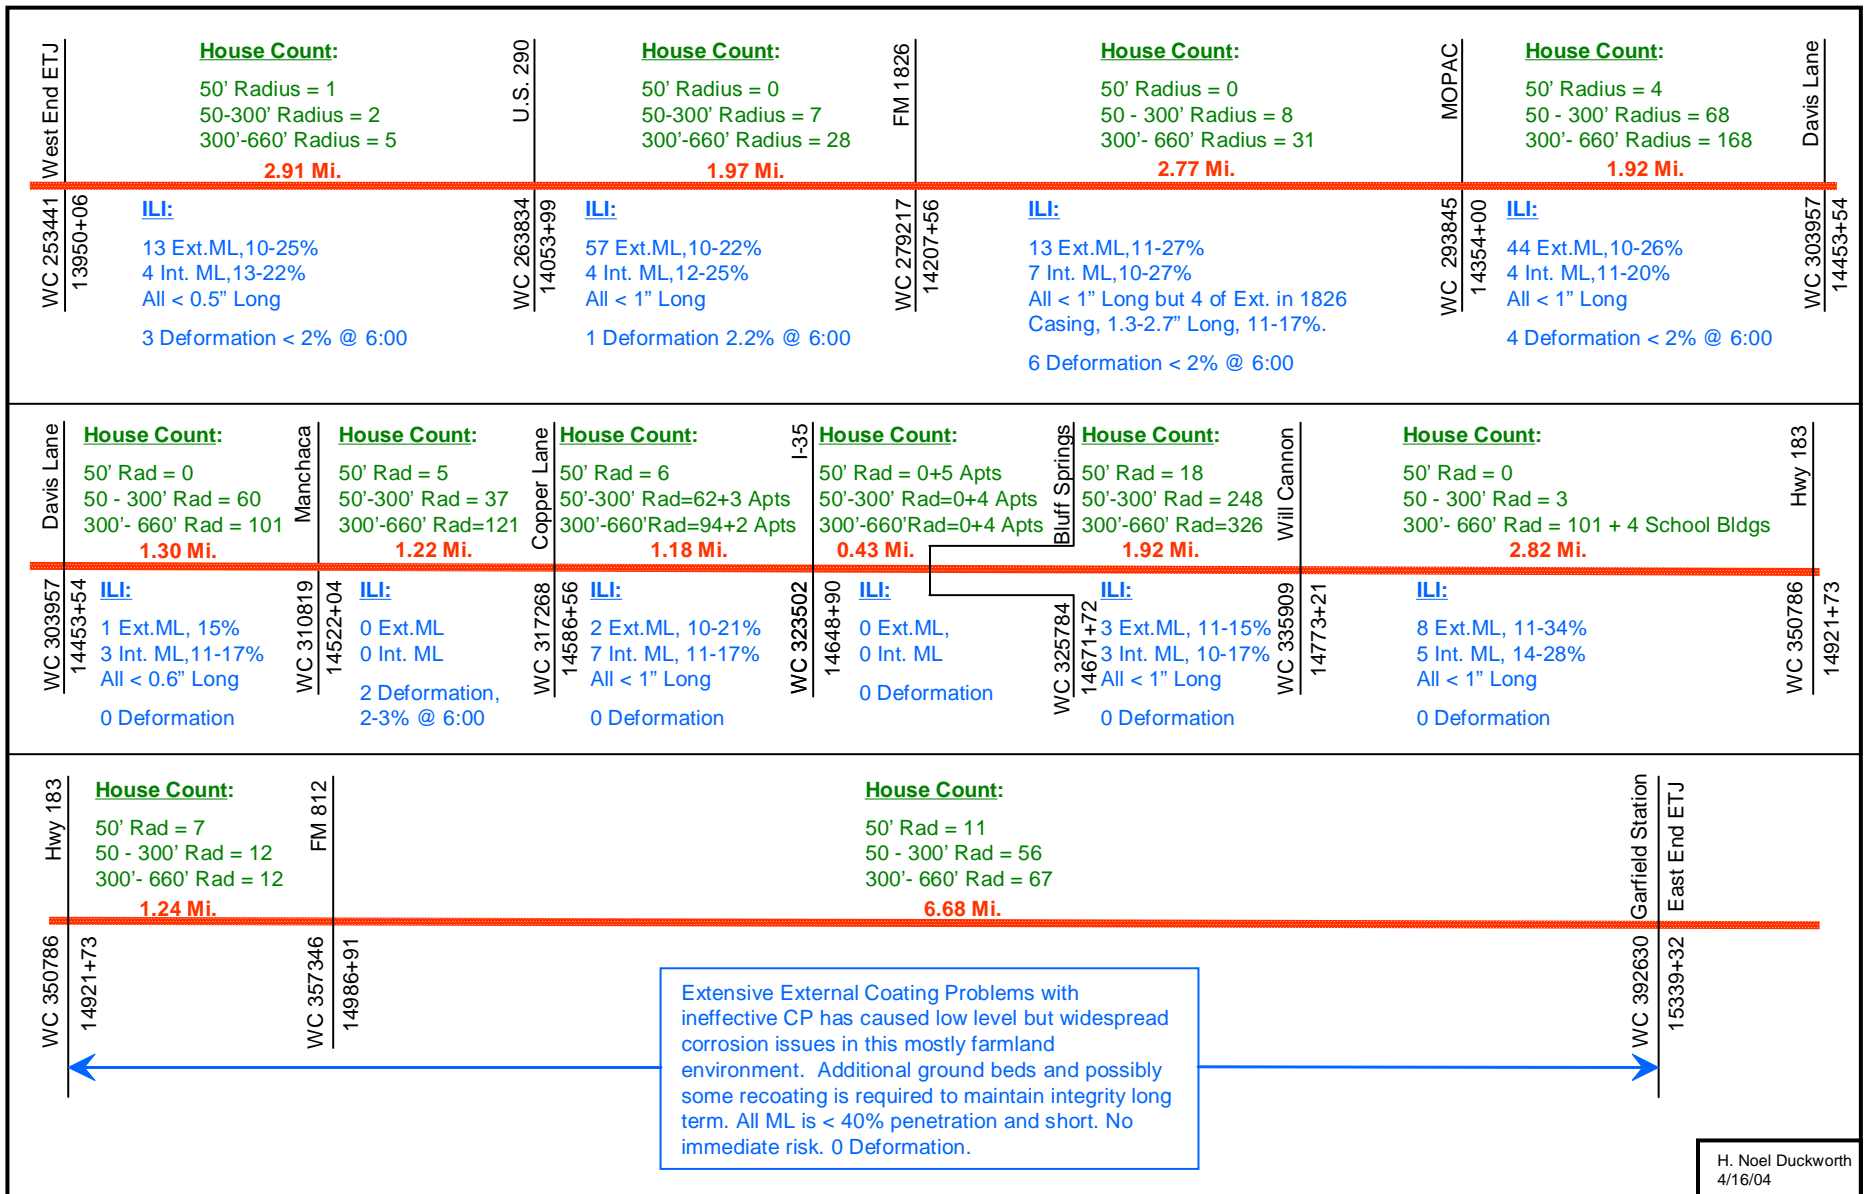
Figure 3. Population Density and ILI Data Review.

review. The result of our evaluation reasonably corresponds with that of Kinder-Morgan and is shown graphically in Figure 3 along with the data from Figure 2 for correlation purposes.

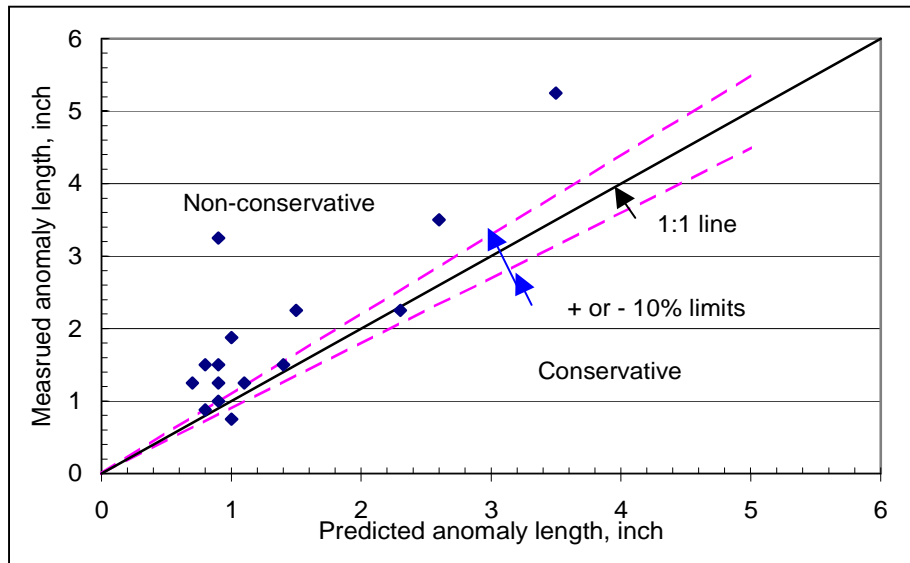
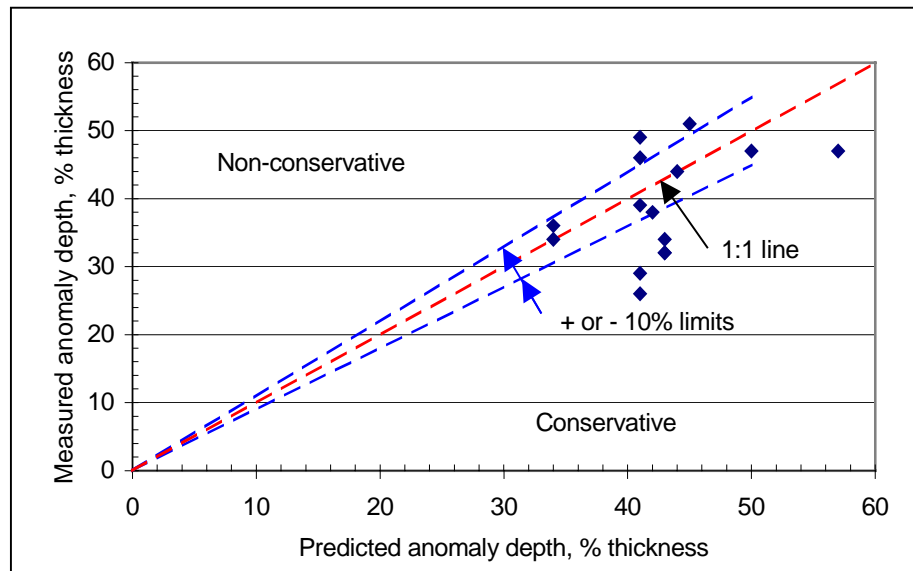
One of the issues in an ILI inspection is: “How accurately do the tools predict the metal loss lengths and depths that are necessary to calculate failure pressures/severity of anomalies detected”? This issue was examined by comparing the predicted versus measured lengths and depths of anomalies detected with the HRMFL tool in Figures 4 and 5. The depth predictions are generally within the + or - 10% claimed accuracy of the HRMFL tool by the Vendors. The length predictions are not as good since 60% of them in this instance were in the non-conservative region where the measured lengths are longer than the predicted lengths. The problem with the length prediction inaccuracy is that it limits the ability to calculate failure pressures accurately. This makes it difficult to determine which anomalies need to be dug and field inspected. Adjacent pitting can interact structurally with each other such that they behave as one larger pit. There are several concepts relating to evaluating this “interaction” and Kinder-Morgan has chosen a conservative method that was developed as an element of the “RSTRENG” method of determining the strength of corroded pipe. In fact, Kinder-Morgan uses the RSTRENG model for all of their strength evaluations. In order for “RSTRENG” to be an accurate method of predicting pipe strength, the dimensions need to be precisely measured by hand and utilization of ILI data does not provide the finite detail required. It can be used, however, as a method to estimate strength and can be very effective in establishing priorities when there are many locations of corrosion. The errors described by the ILI data for defect length is caused by the application of the interaction rules and, while it is a greater error than normally found, it is offset by choosing such a low level depth removal criteria (40%).

Kinder-Morgan has elected to remove all anomalies that are 40% or more of the wall thickness in depth regardless of the length. This is a fairly reasonable approach for this line operating at 50% SMYS. What was found is that anomalies that were less than 2 inches in length have such high failure pressures that the length inaccuracy is not a problem. However, there were 4 anomalies that had measured lengths greater than 2 inches and the worst of these, from a failure prediction viewpoint, had a predicted failure pressure that decreased from 92 to 77% SMYS based on the measured depth and length, a reduction of 25%. The other reductions for anomalies greater than 2 inches ranged from 8 to 16%. Since this line was to be pressure tested from 100 to 110% SMYS it is important to make sure that all of the injurious anomalies that were detected with MFL were removed to reduce the probability of test failures. It was possible that the length inaccuracy would affect the effective removal of anomalies that could fail in the pressure test. Since there were no corrosion related failures during the high level pressure testing, this length prediction deficiency has been proven to not be an issue.

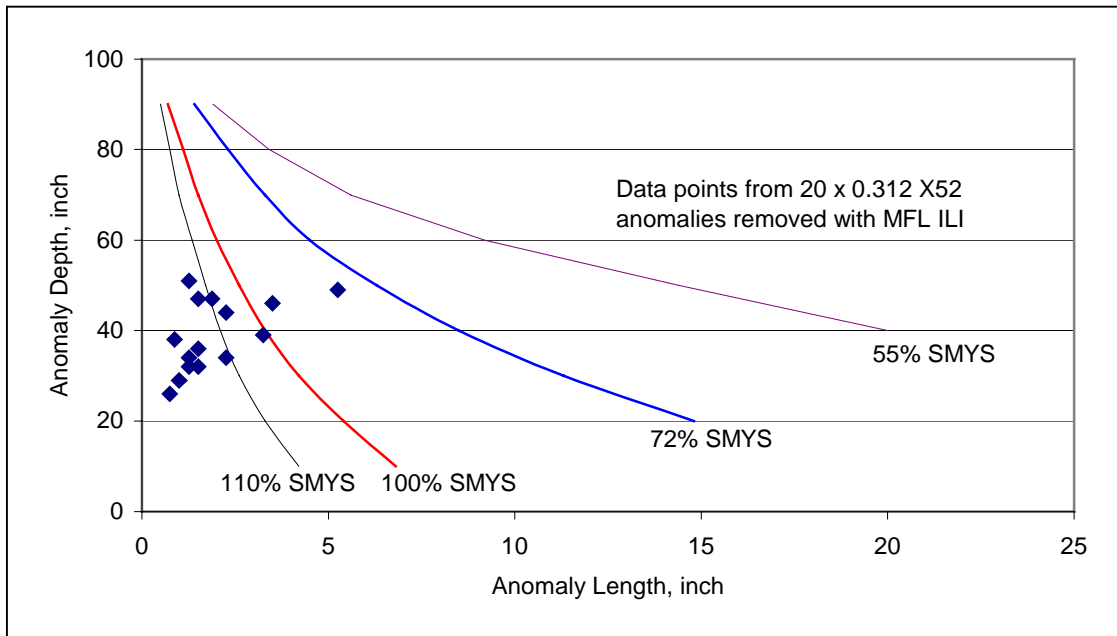
**Figure 6. Calculated Failure Pressures of Anomalies Removed From 24" x 0.312" X52 Rancho Pipe**

Kinder-Morgan has removed all pipe containing metal loss defects that exceed 40% wall thickness penetration regardless of length. As shown in Figure 6, all of the defects removed are significantly below and to the left of the 55% of SMYS curve. Thus, this action, a requirement of the K-M Company operating procedures, exceeds those mitigation actions required by Federal and State codes and further, it exceeds common Industry Standards.

Figure 6 presents the lengths and depths of the anomalies removed from the Rancho Pipeline. These are compared to calculated curves of failure stress levels for various length rectangular flaws in the Rancho pipe. All but two of the data points have calculated failure pressures above 100% SMYS. The two data points below 100% SMYS have calculated failure pressures of 77 and 93 % SMYS. These two would have failed in the planned hydrotest. The three data points between 100 and 110% SMYS may also have failed in the hydrotest depending on the elevation of the pipe at their locations. The remaining 10 data points have failure pressures that are too high to reach in a hydrotest illustrating the benefit of using ILI in place of hydrotesting for metal loss anomaly removal. Thus, while there is a length accuracy issue with the HRMFL data, the HRMFL is still capable of detecting anomalies that are much smaller than could be detected with a pressure test.

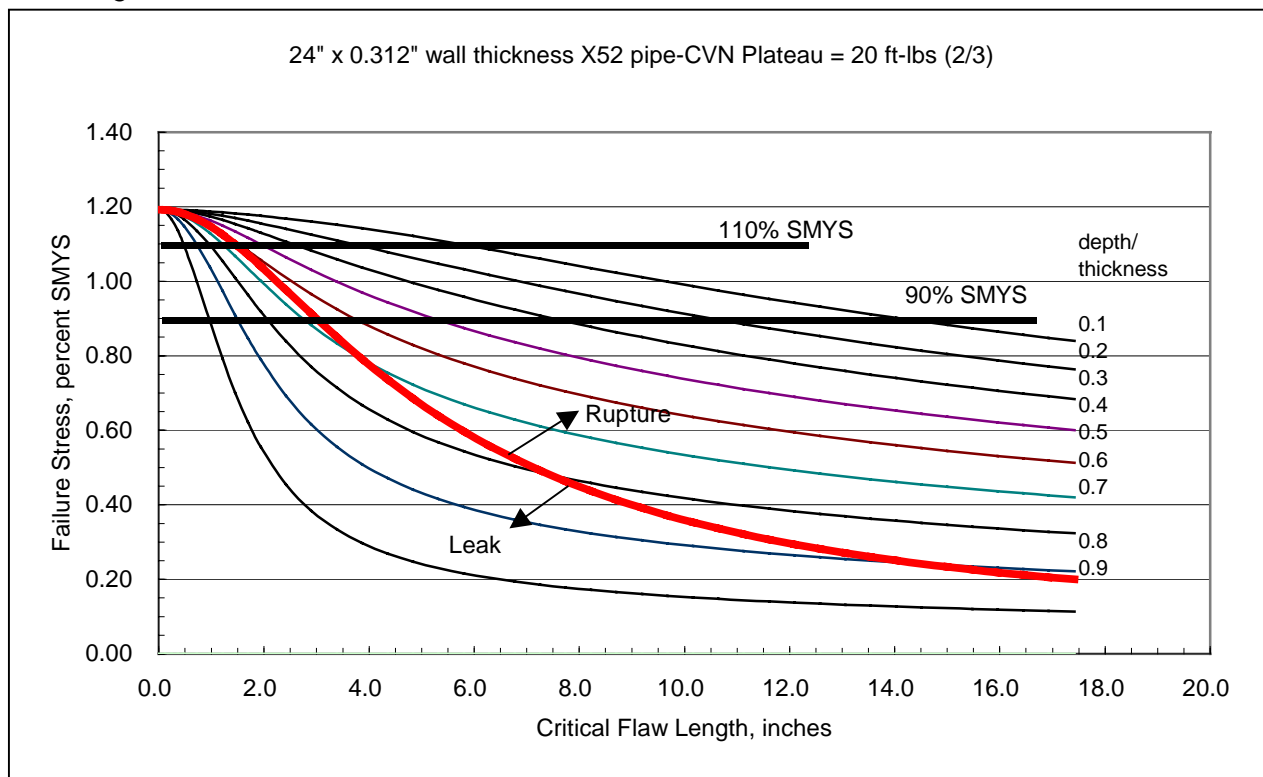
**Figure 7. Critical Flaw Depths and Lengths in 24 x 0.312 inch X52 Pipe**

To assess the significance of the test stress level a calculated curve of flaw depths and lengths is presented in Figure 7. Figure 7 shows a calculated<sup>15</sup> plot of flaw sizes that are on the verge of failure at the stress levels shown for the 24 by 0.312 inch wall thickness X52 pipe with a pipe toughness (Charpy V-notch impact plateau energy) of 20 ft-lbs based on a 2/3 width specimen. (A similar plot exists for the 24 x 0.344 inch wall thickness X52 pipe except that the flaws are slightly larger at the same stress level.) A series of curves are shown along with a heavier curve that crosses the other curves. The series of curves are labeled with d/t values from 0.1 to 0.9, which indicates the depth, d of the flaw to the thickness, t of the pipe. Horizontally, the effect of total flaw length is shown, indicating that the longer a flaw, the lower the failure stress. Similarly the deeper a flaw, the lower the failure stress. The flaws represented by the curve are flaws of uniform depth or rectangular flaws. (This provides a conservative estimate of the failure stress as most flaws are parabolic and will have a higher failure stress.)

The heavy line curve that crosses many of the other curves separates leaks and breaks. When a flaw fails in the region above the heavy curve, it will fail as a rupture and below it the failure will be a leak.

Figure 7 indicates that at a 90% SMYS minimum stress level proposed for the pressure test, flaws that range from 1.2 inches long by 90% deep to 16.7 inches long by 10% deep would be on the verge of failure in the test. In the 24 x 0.344 inch X52 pipe, the stress levels are even lower, i.e., the minimum is 81.6% SMYS and the maximum is 92.6% SMYS in Kinder-Morgan's proposed hydrostatic pressure test plan. At a stress of 81.6% SMYS the surviving flaw sizes in

the 24 x 0.344 inch X52 pipe are 1.5 inches long by 90% deep up to 22 inches long by 10 % deep. These are fairly large flaws, which is fortunate in that they demonstrate that pipelines can tolerate large flaws without failure. However, by testing to a higher-pressure level the remaining flaws would be smaller.

Third, the authors believe that the test pressure should be increased to 110% SMYS if it is possible. Accomplishing this will assure the public that the pipe has been demonstrated to have a high integrity when placed in service. This pipeline has had excellent service with very few service incidents (mainly corrosion and mechanical damage) and these will probably be the continuing integrity concerns as has been discussed previously. One of the benefits of testing the pipeline to a high stress level at this time is that it will allow the line to remain in operation for a longer period after the test without reinspection since the starting anomalies will be smaller allowing more time for their growth until they reach a critical size and thus extending the time between inspections.
