NAPSR

Distribution New Construction

St. Louis, Missouri April 20, 2010

Inspection findings related to Plastic Materials

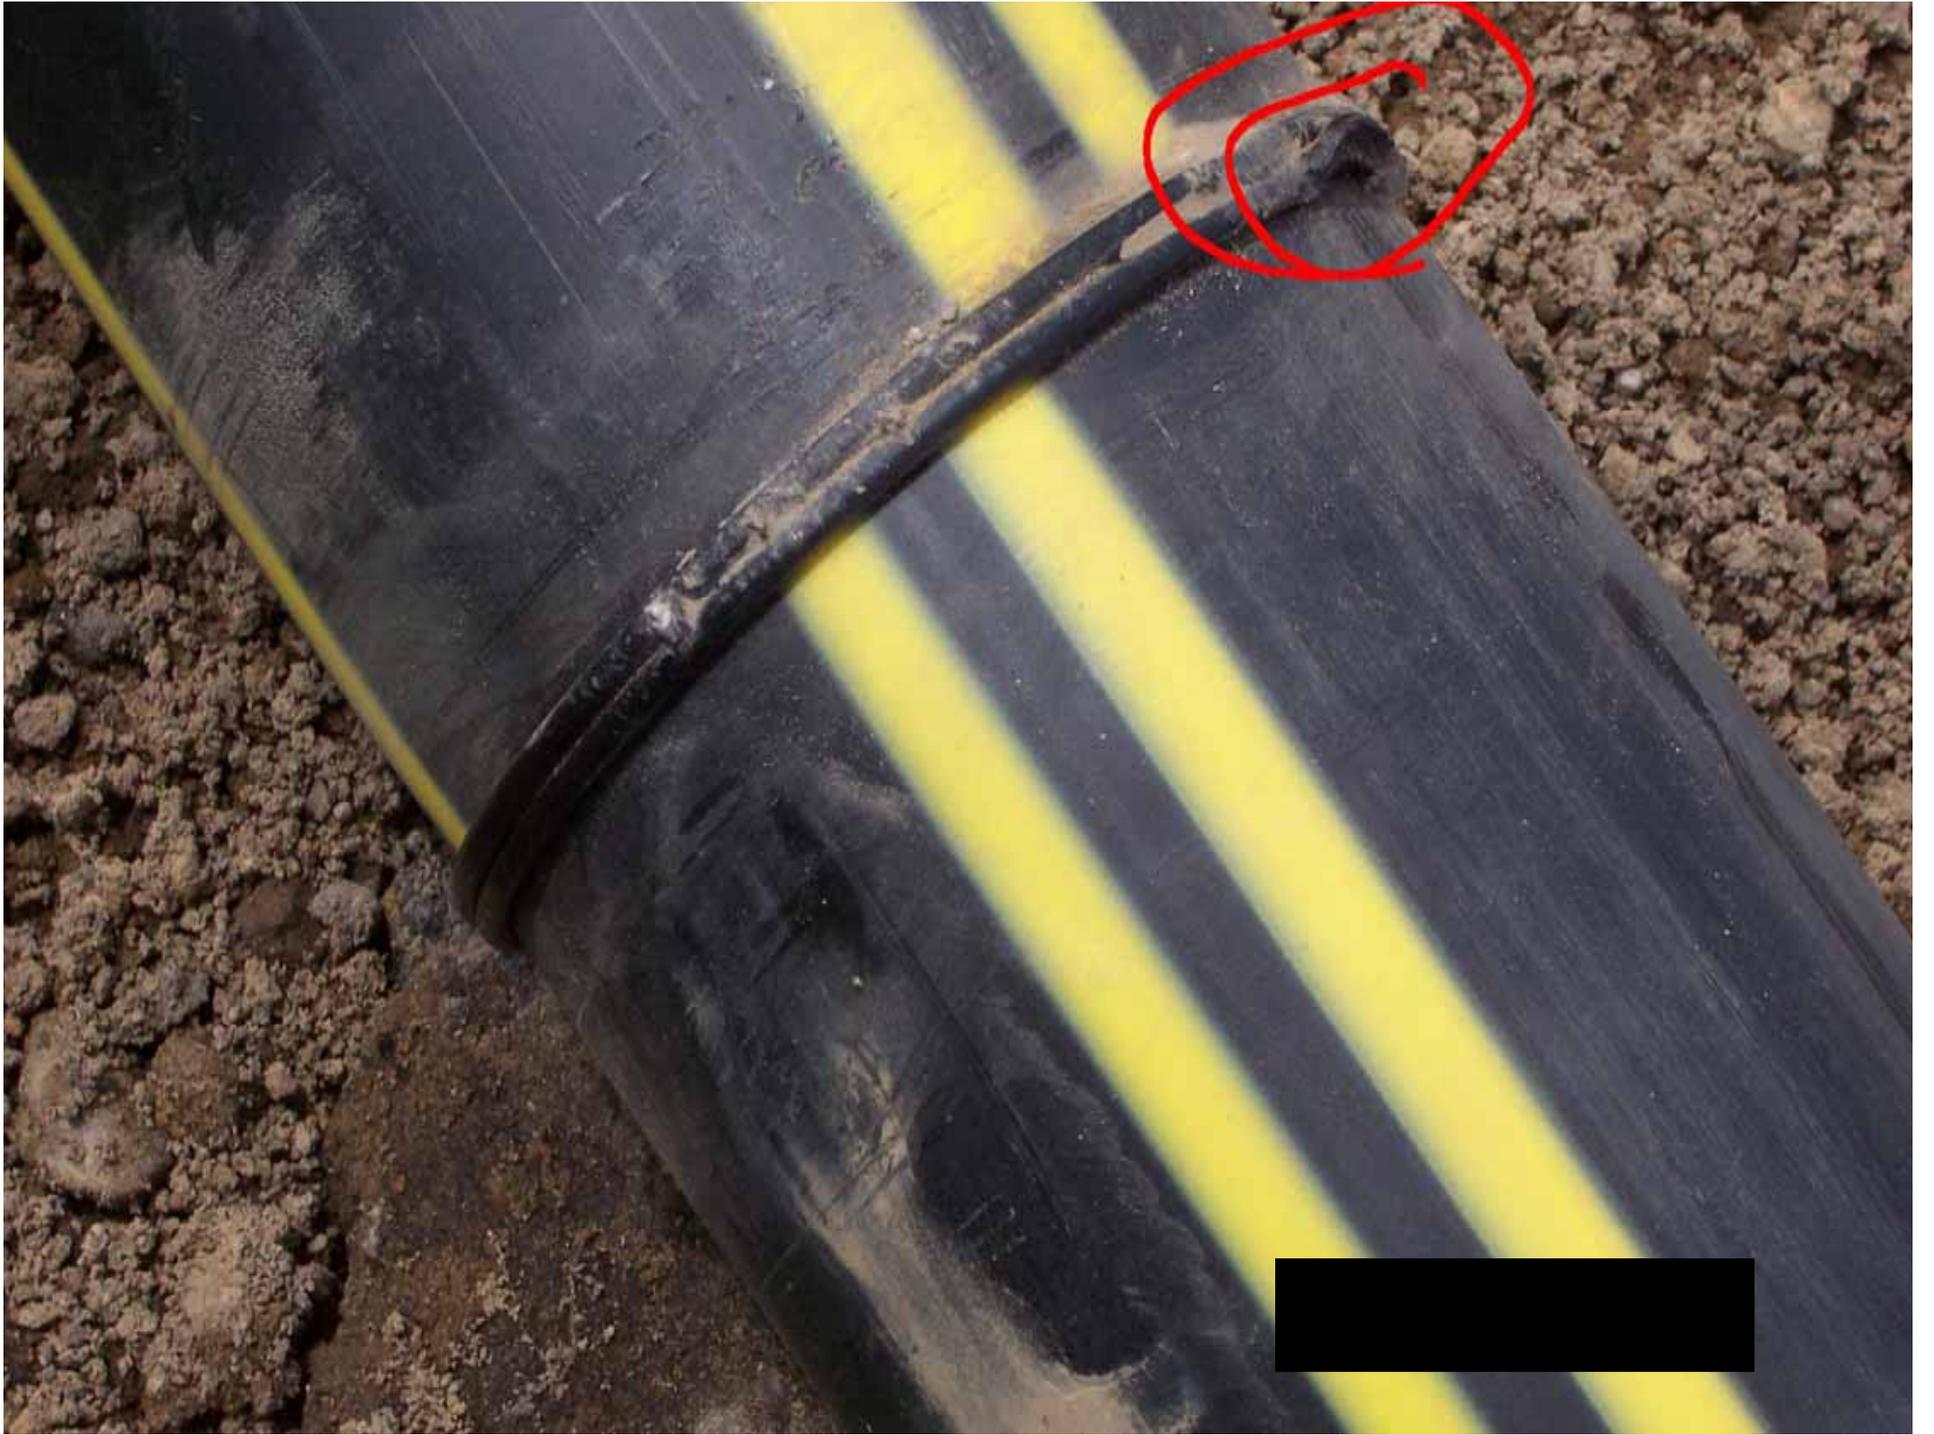
Right in the area to be joined...

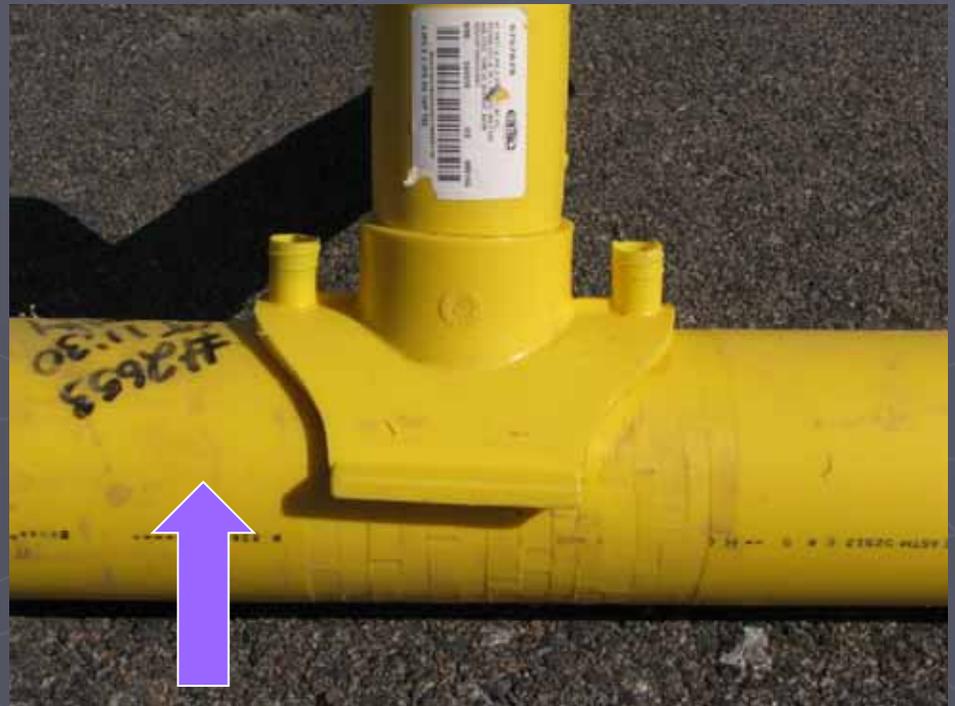
- ▶ The tapping tee failed during tapping operations by the contractor. The Operator initiated a Failure Investigation and concluded that the tee failed due to improper preparation and clamping. The manufacturer is redesigning the clamping tool used during the electrofusion process.

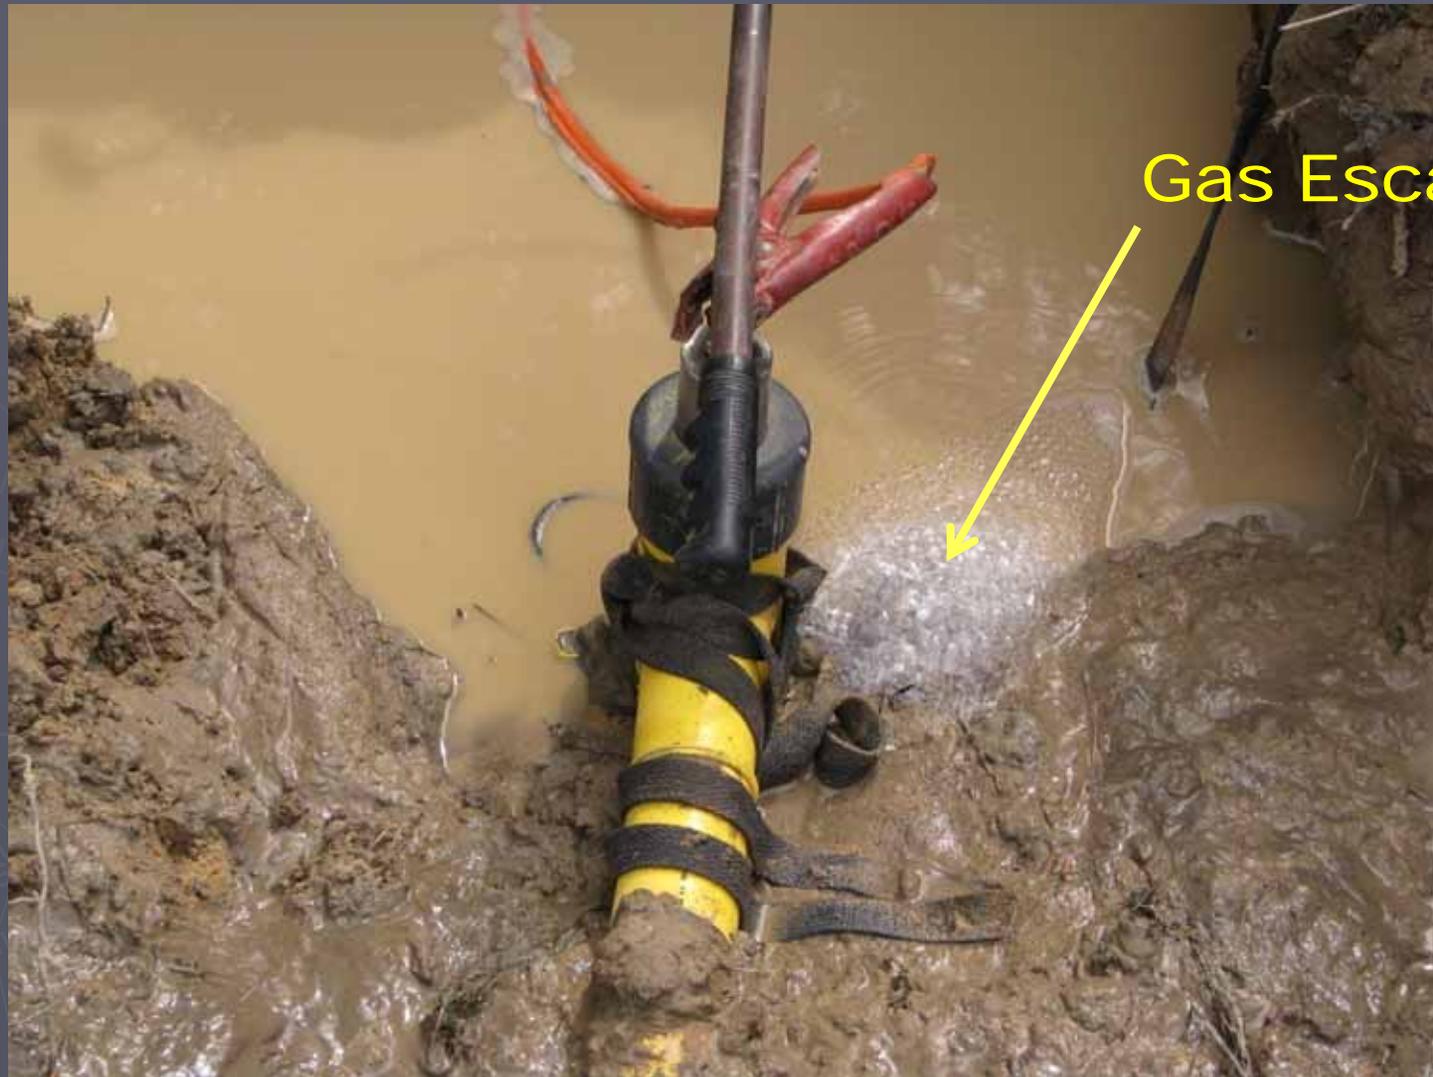
Newly installed high volume tapping tee.

Gas Escaping

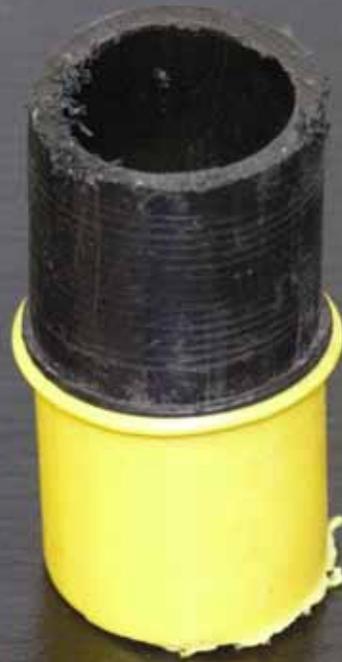
The Operator did not follow procedures.

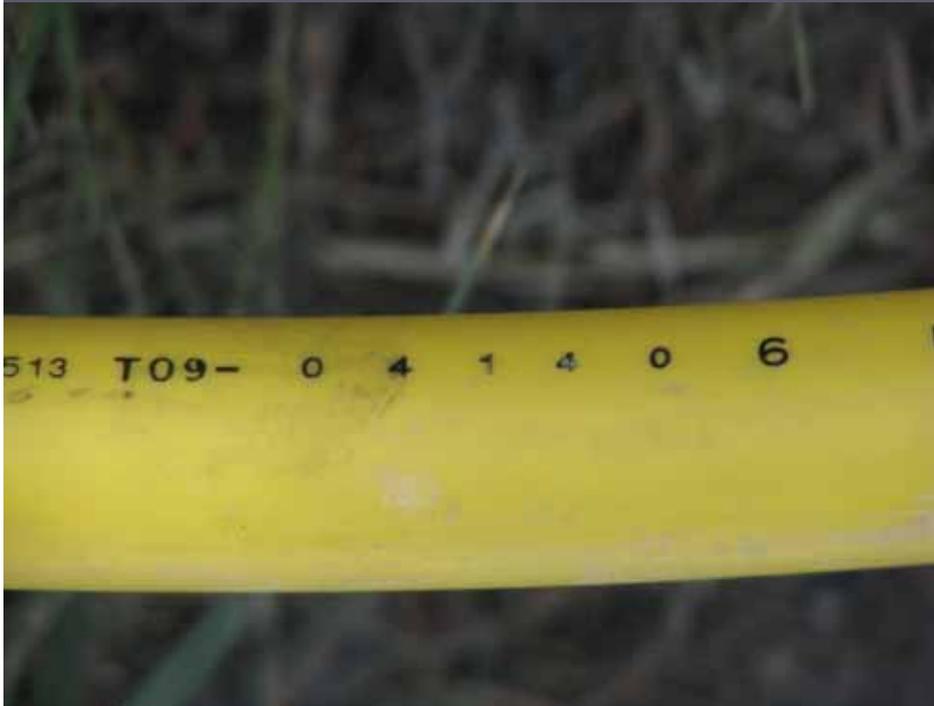
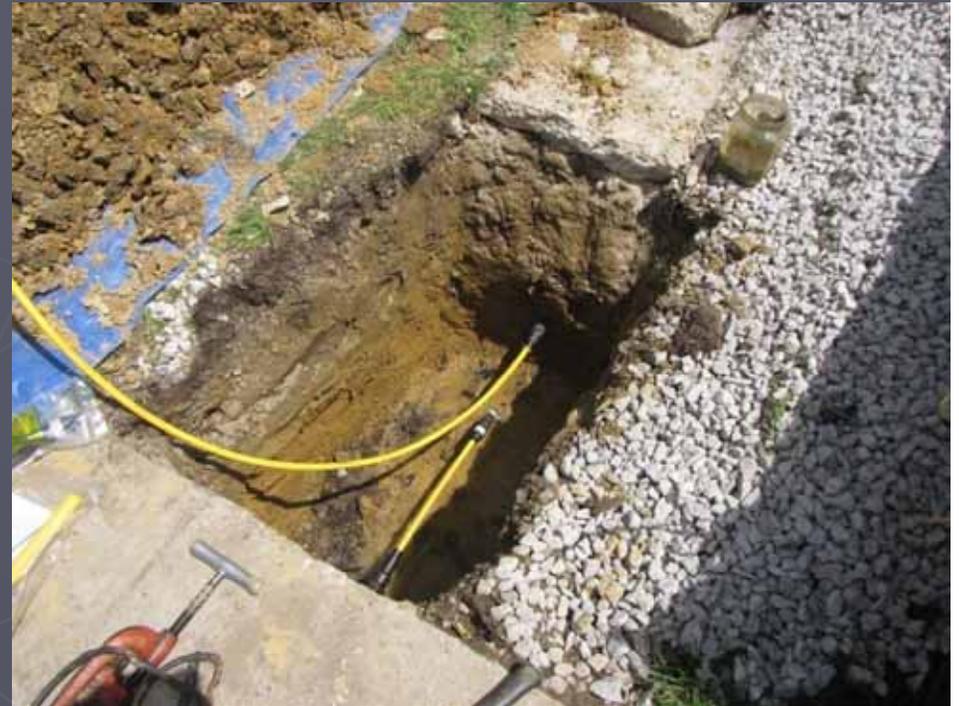
§192.605(a) - Failure to follow written procedures.

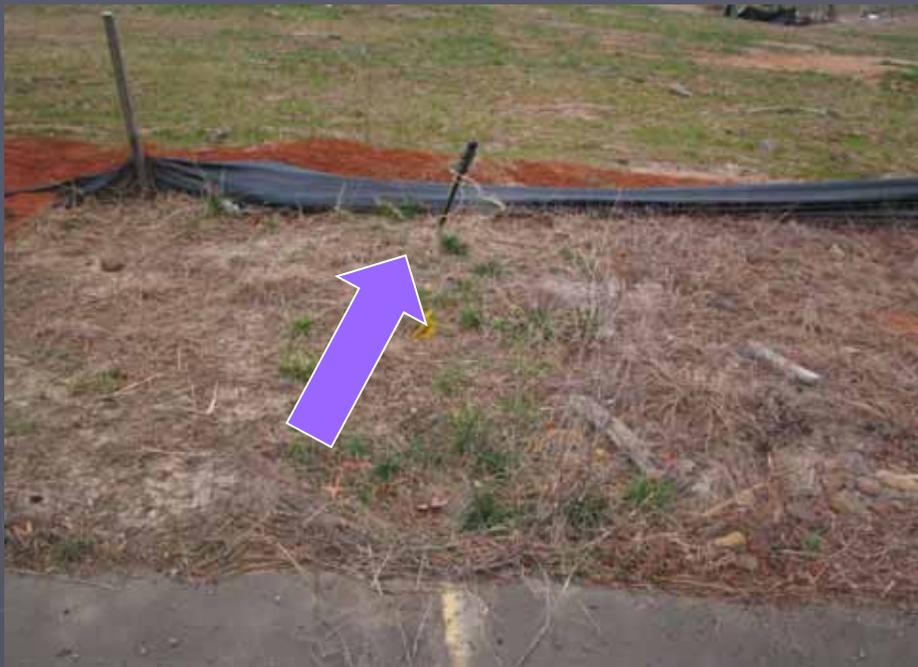
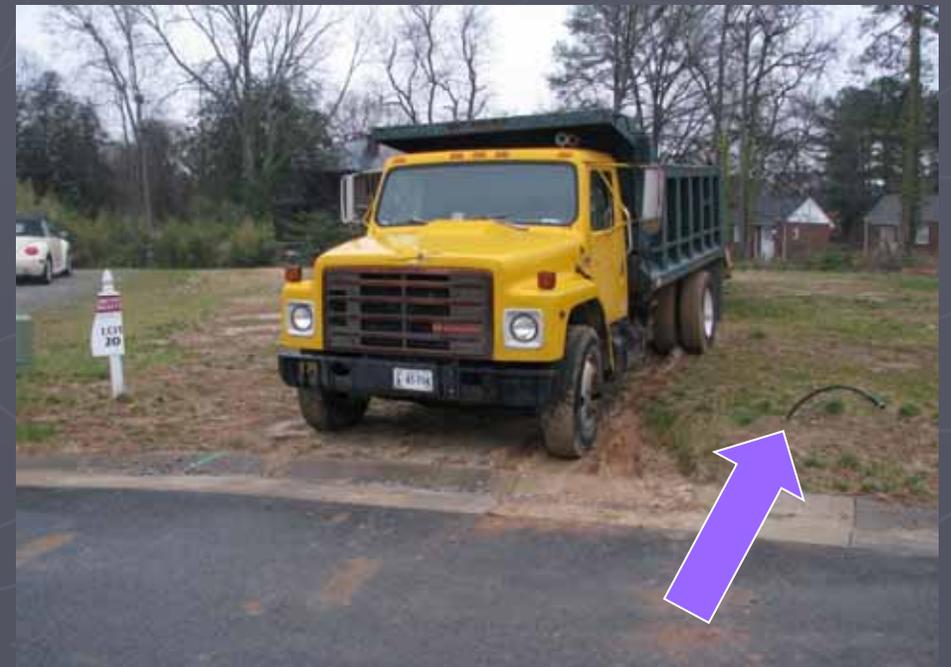
- ▶ The Operator's contractor installed service stubs above ground that were left above the ground for several years.

§192.375(a)(i) - Failure to install a service line in a manner to protect the above ground level part of a plastic service from deterioration and external damage.

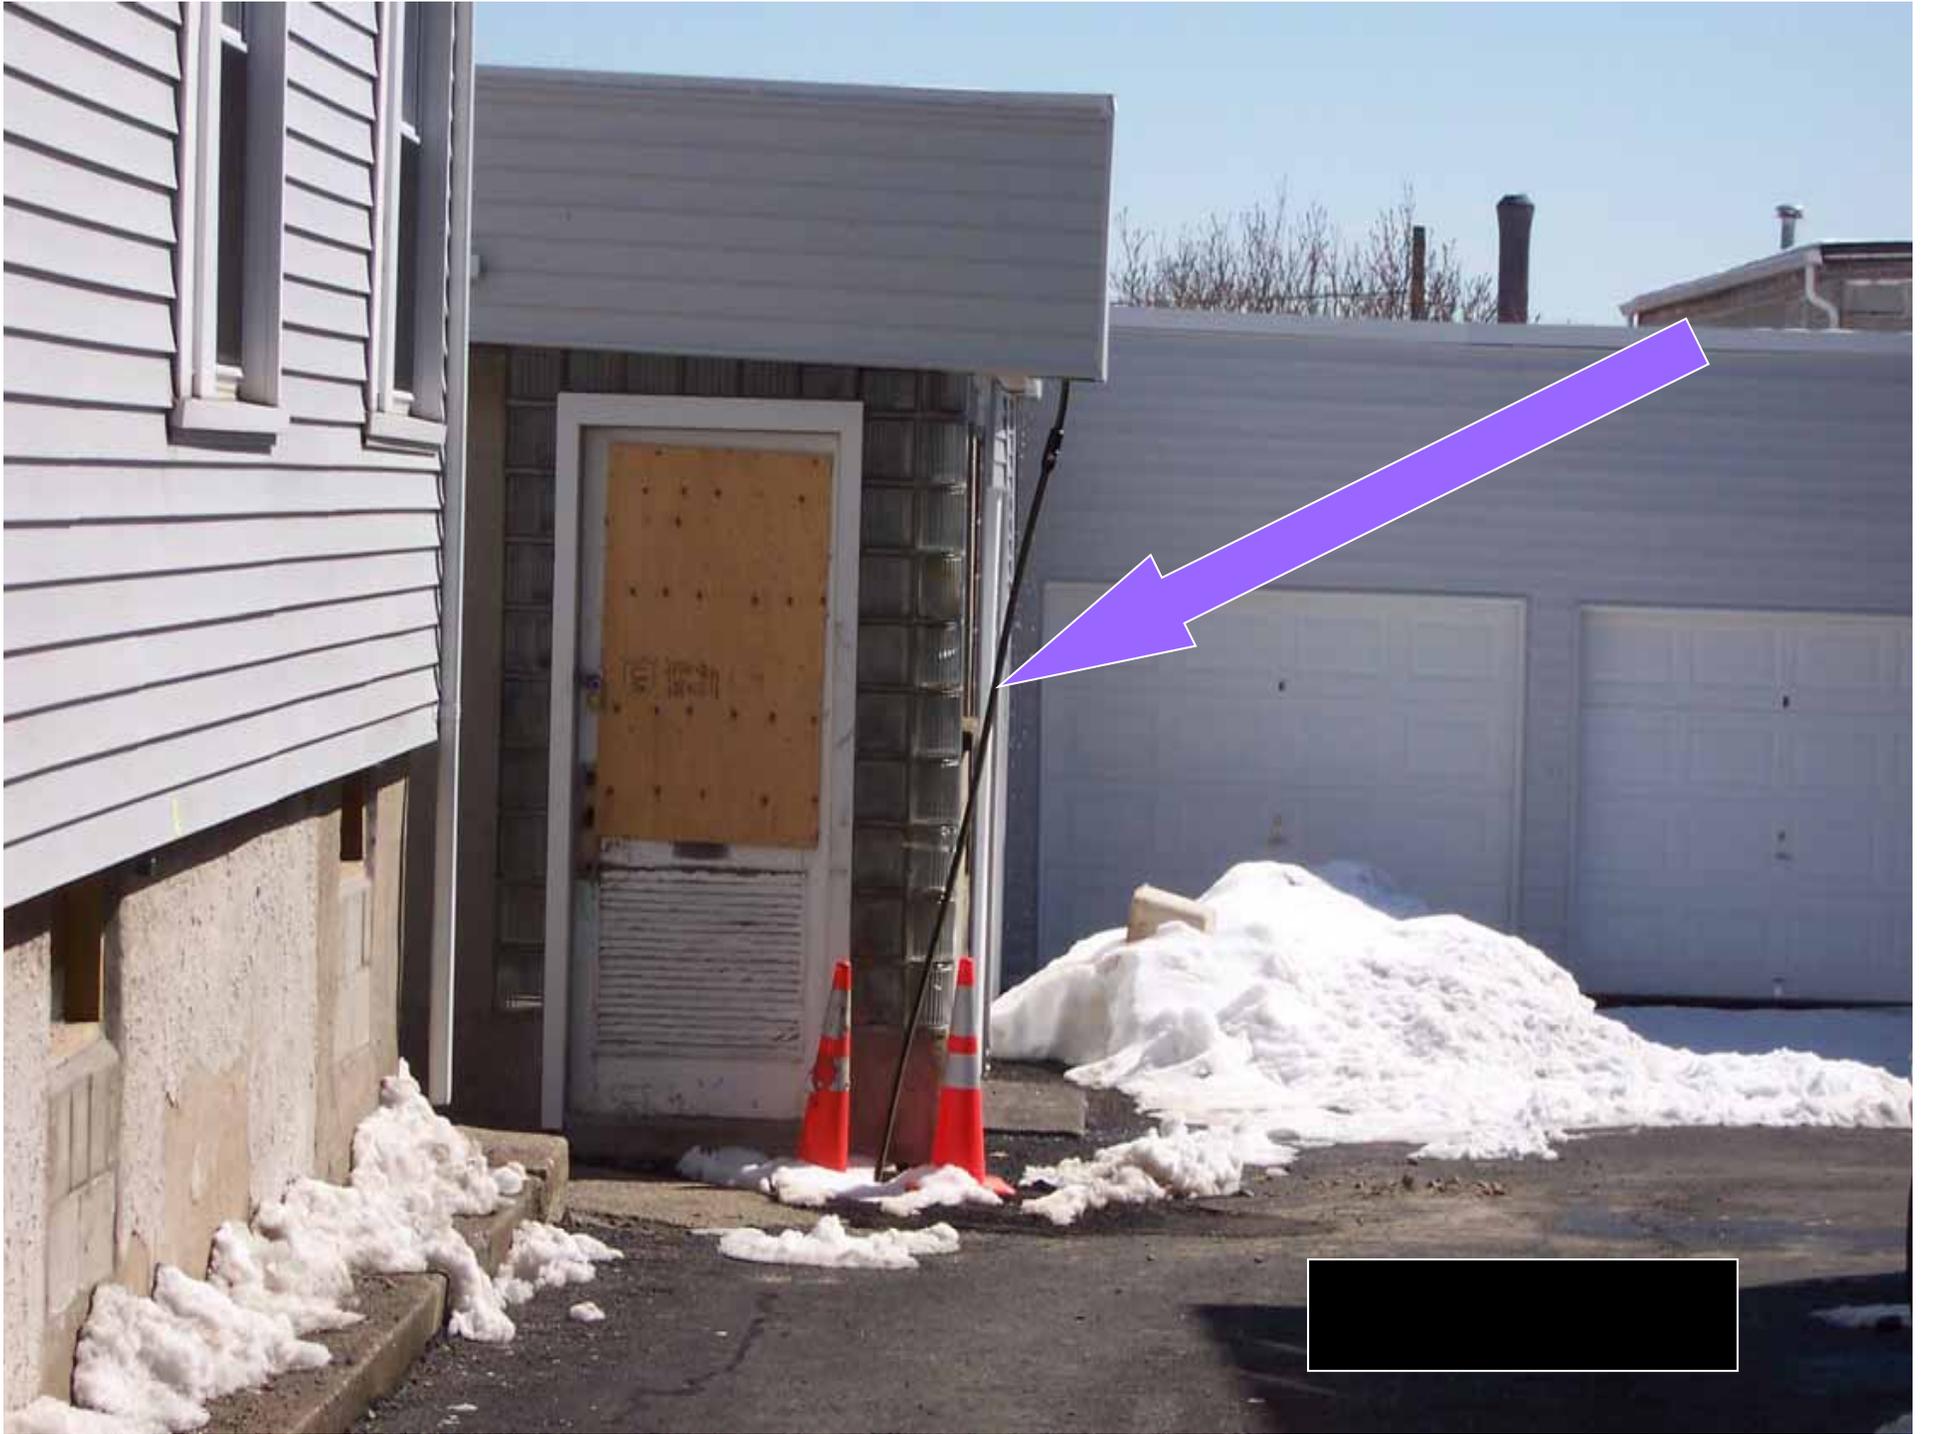
- ▶ The Operator installed a temporary gas service above ground over a garage.

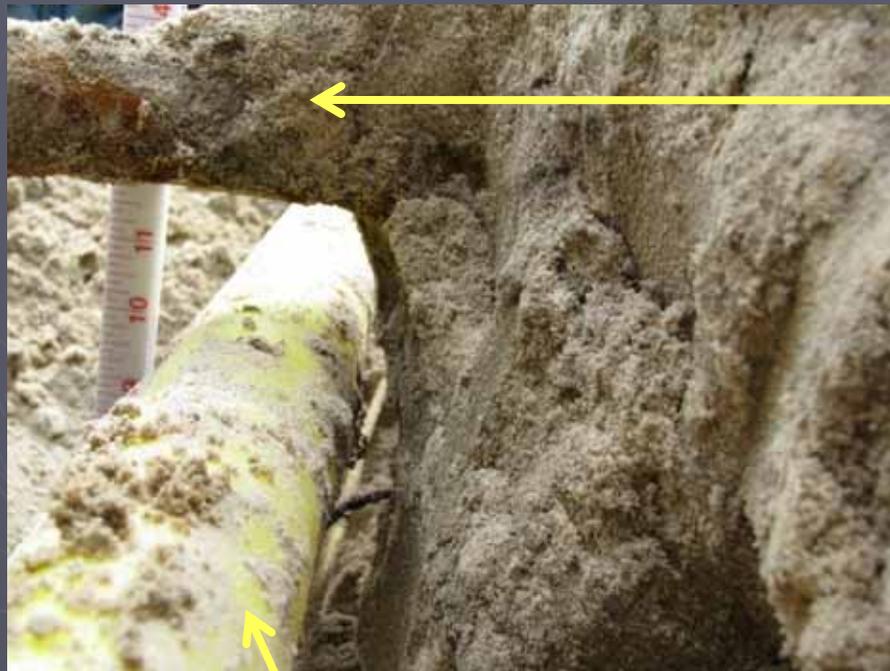
§192.325(b) - Failure to install a main with enough clearance from any other underground structure to allow for proper maintenance

Electric Line

Sewer Line

2" Plastic Gas Main

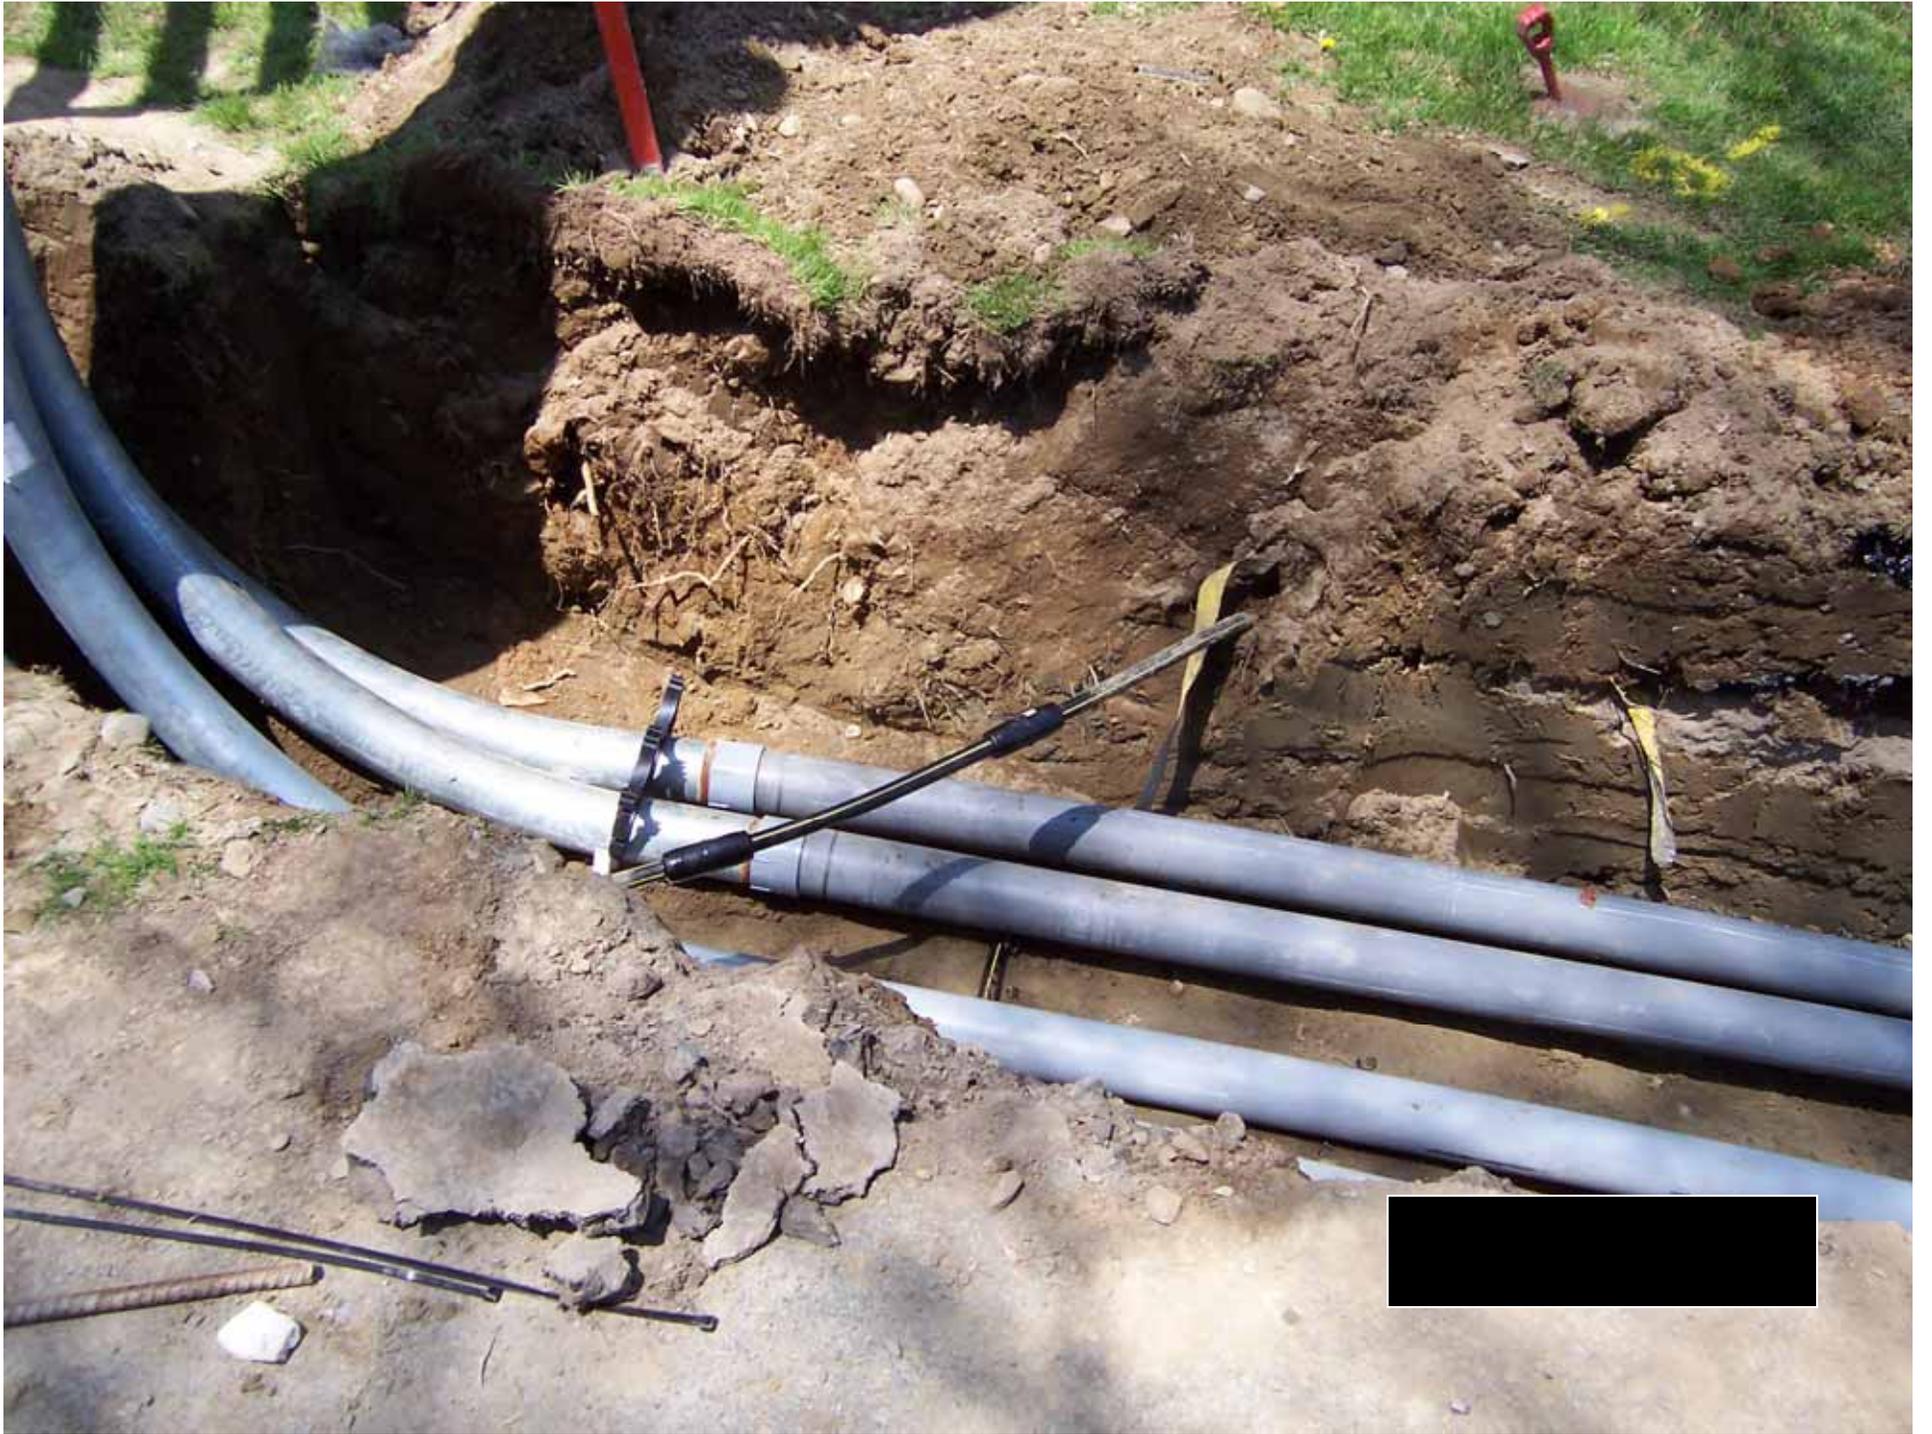
Grounding rod right next to the service

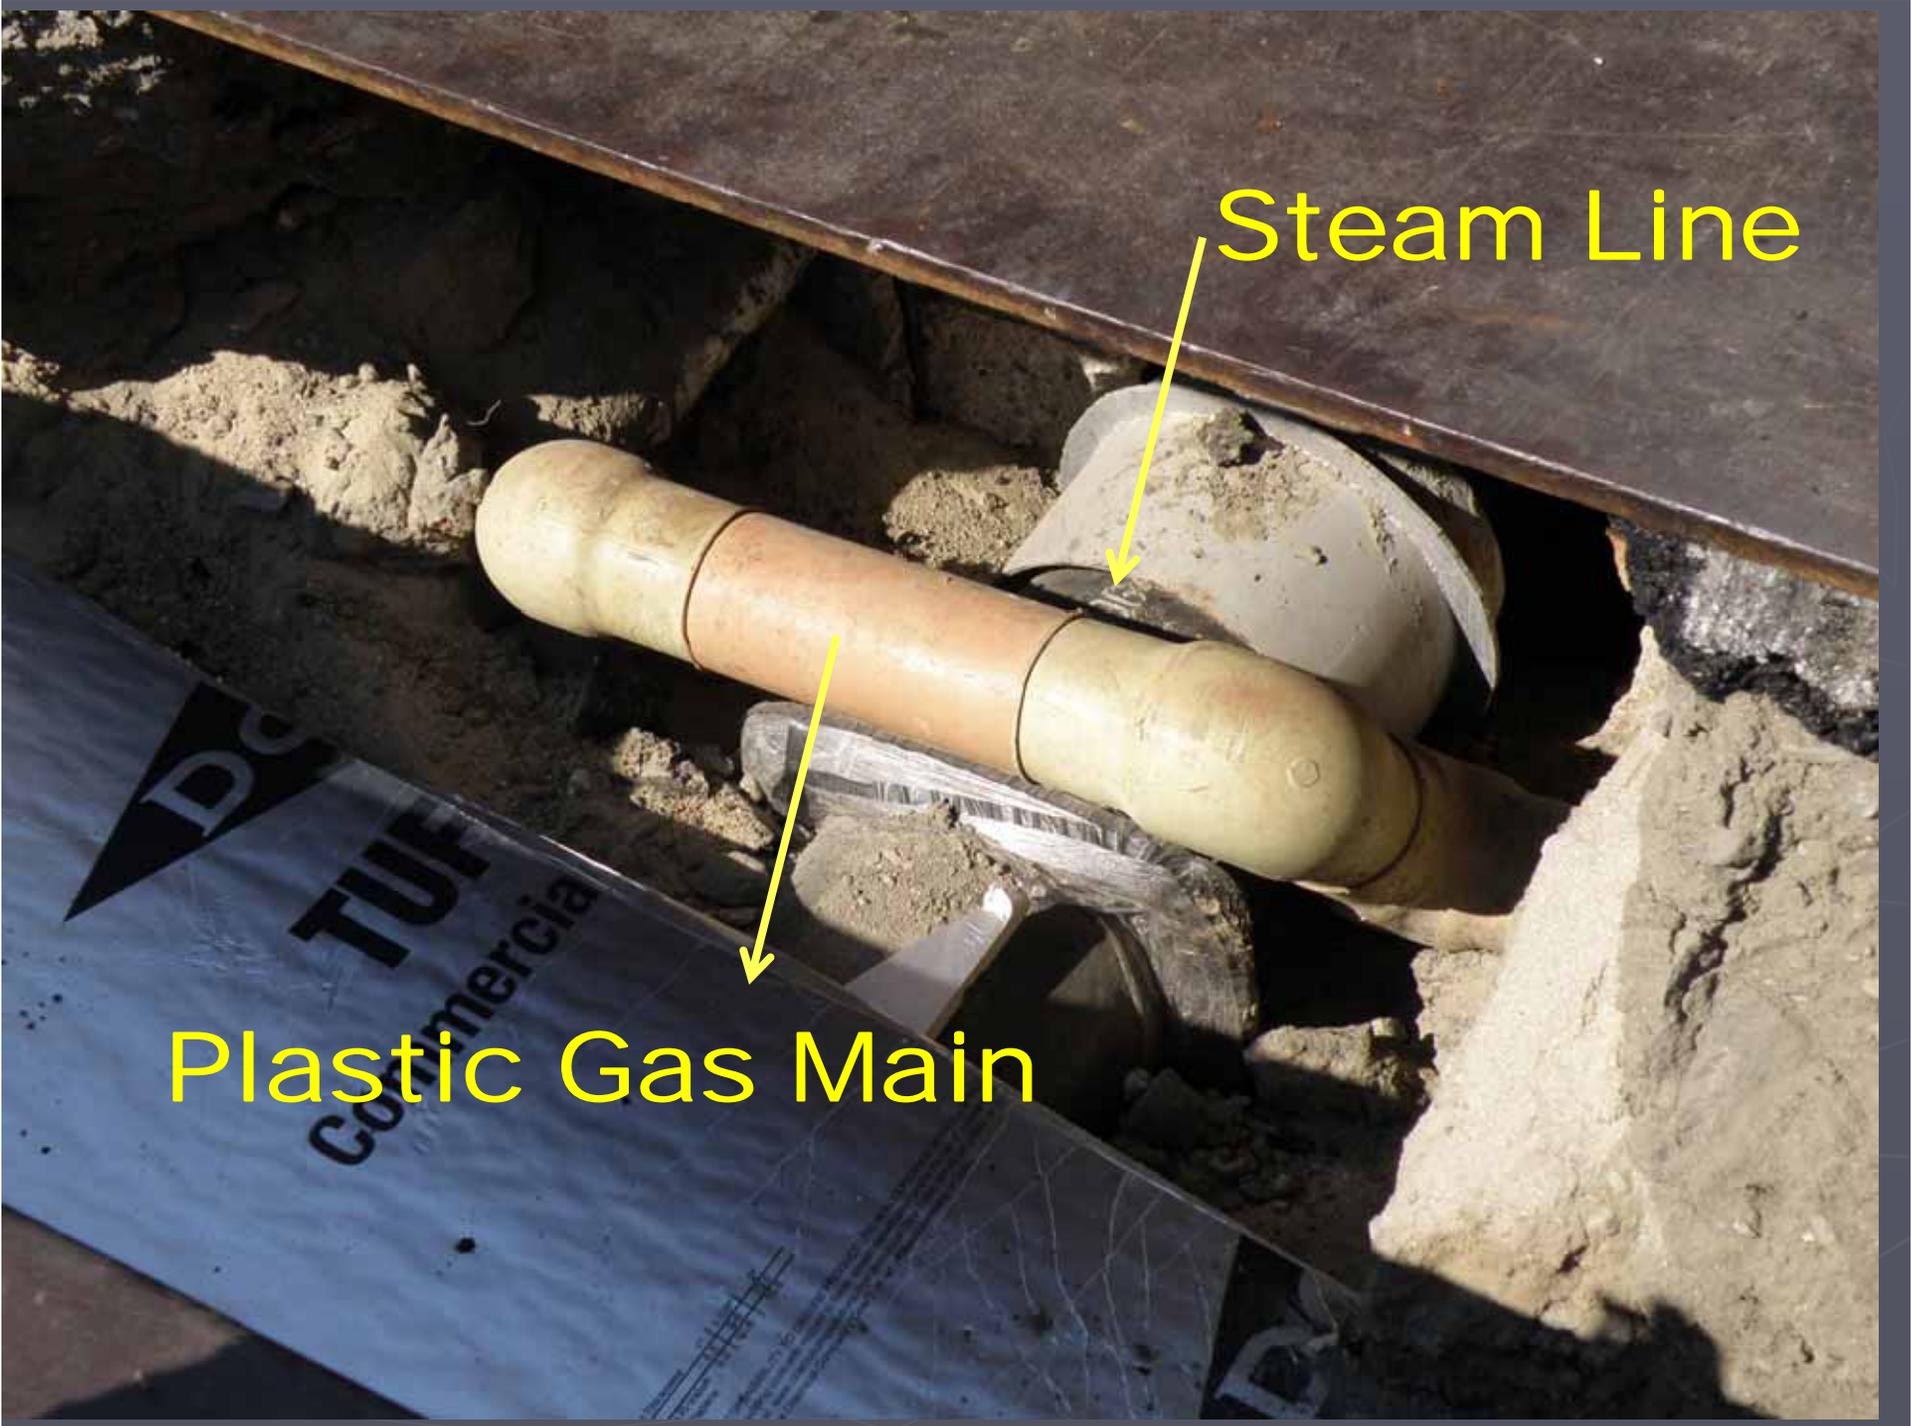
Each main must be installed with enough clearance ... to protect against damage that might result from proximity to other structures.

Steam Line

Plastic Gas Main

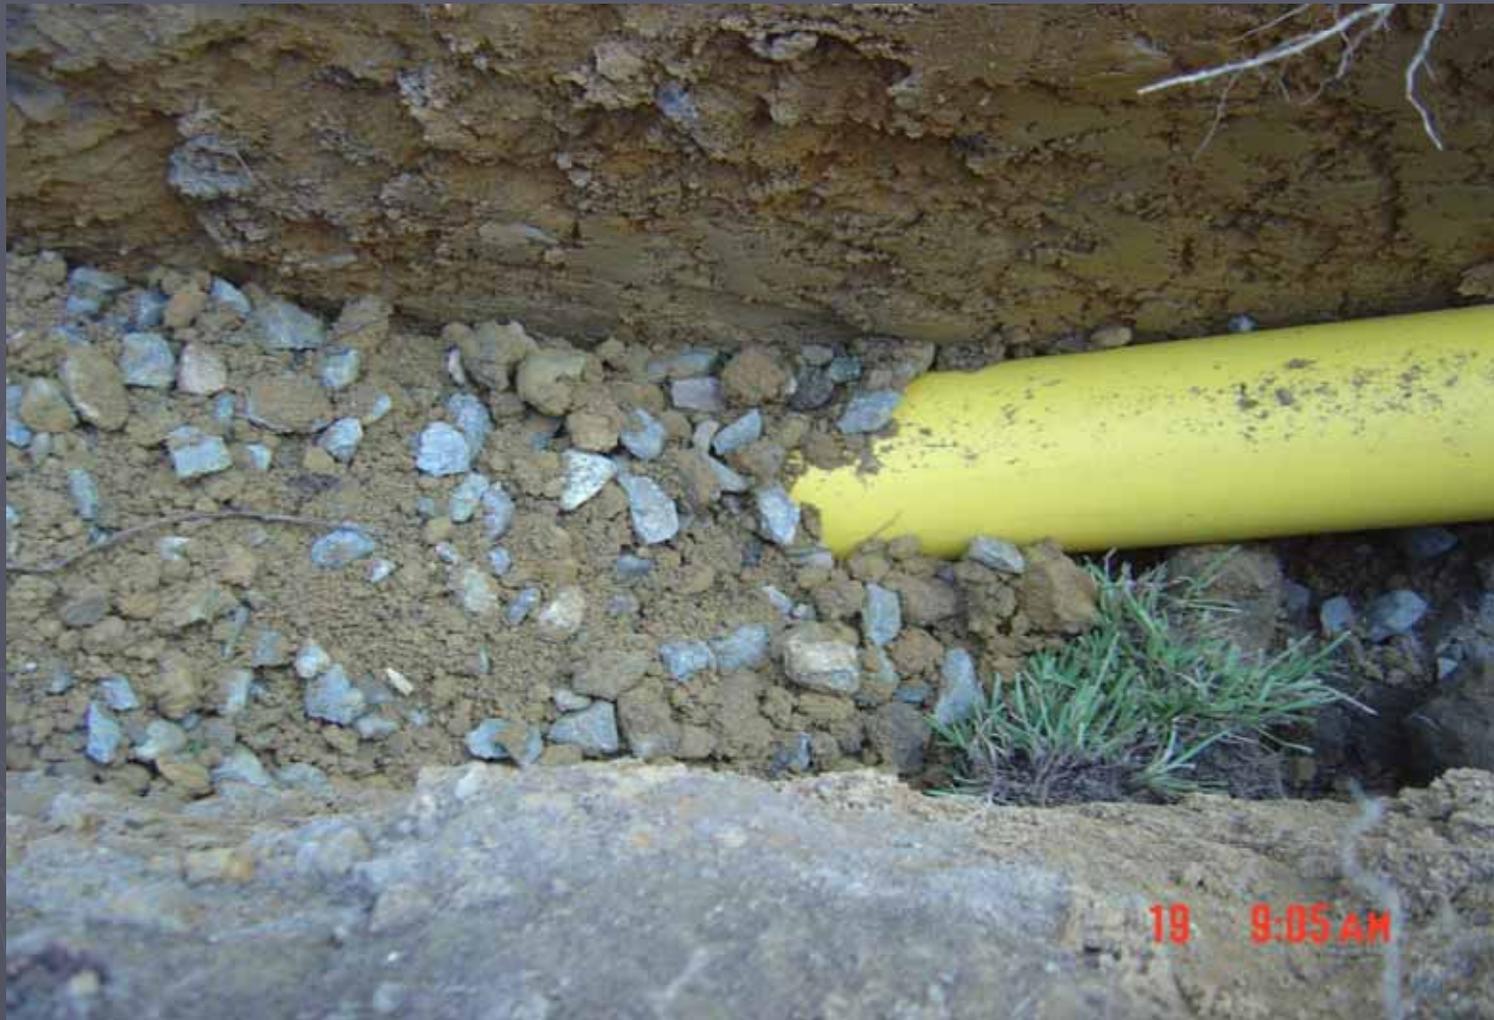
§192.319(b)(2) - Backfill in a manner that prevents damage to the pipe from the backfill material.

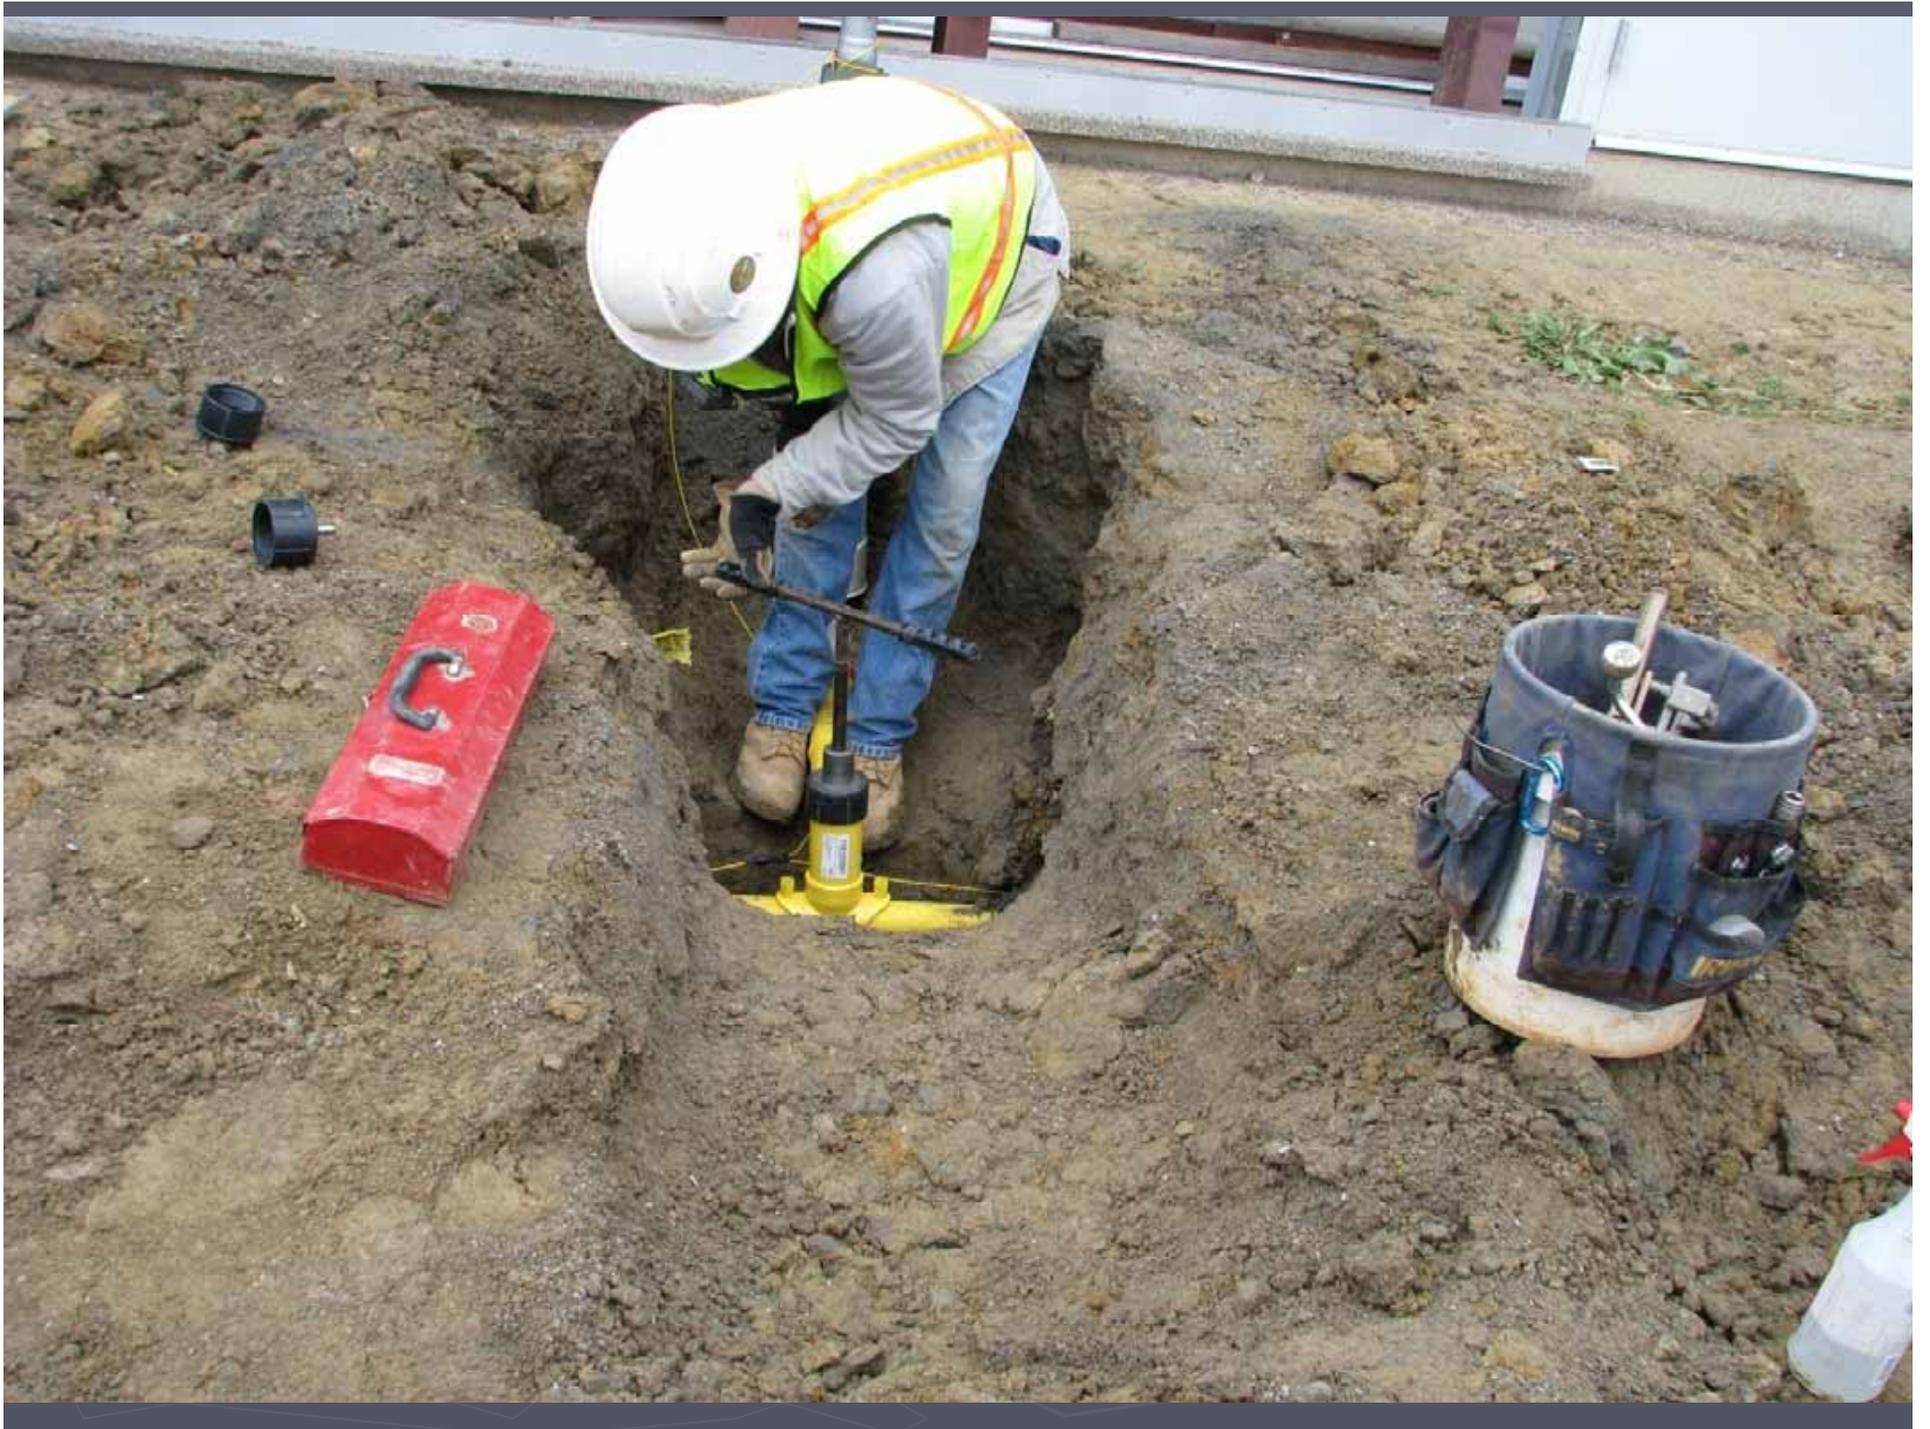
- ▶ The Operator was performing a tapping process without properly grounding the cutting tool. A failure of the operator to follow procedures.

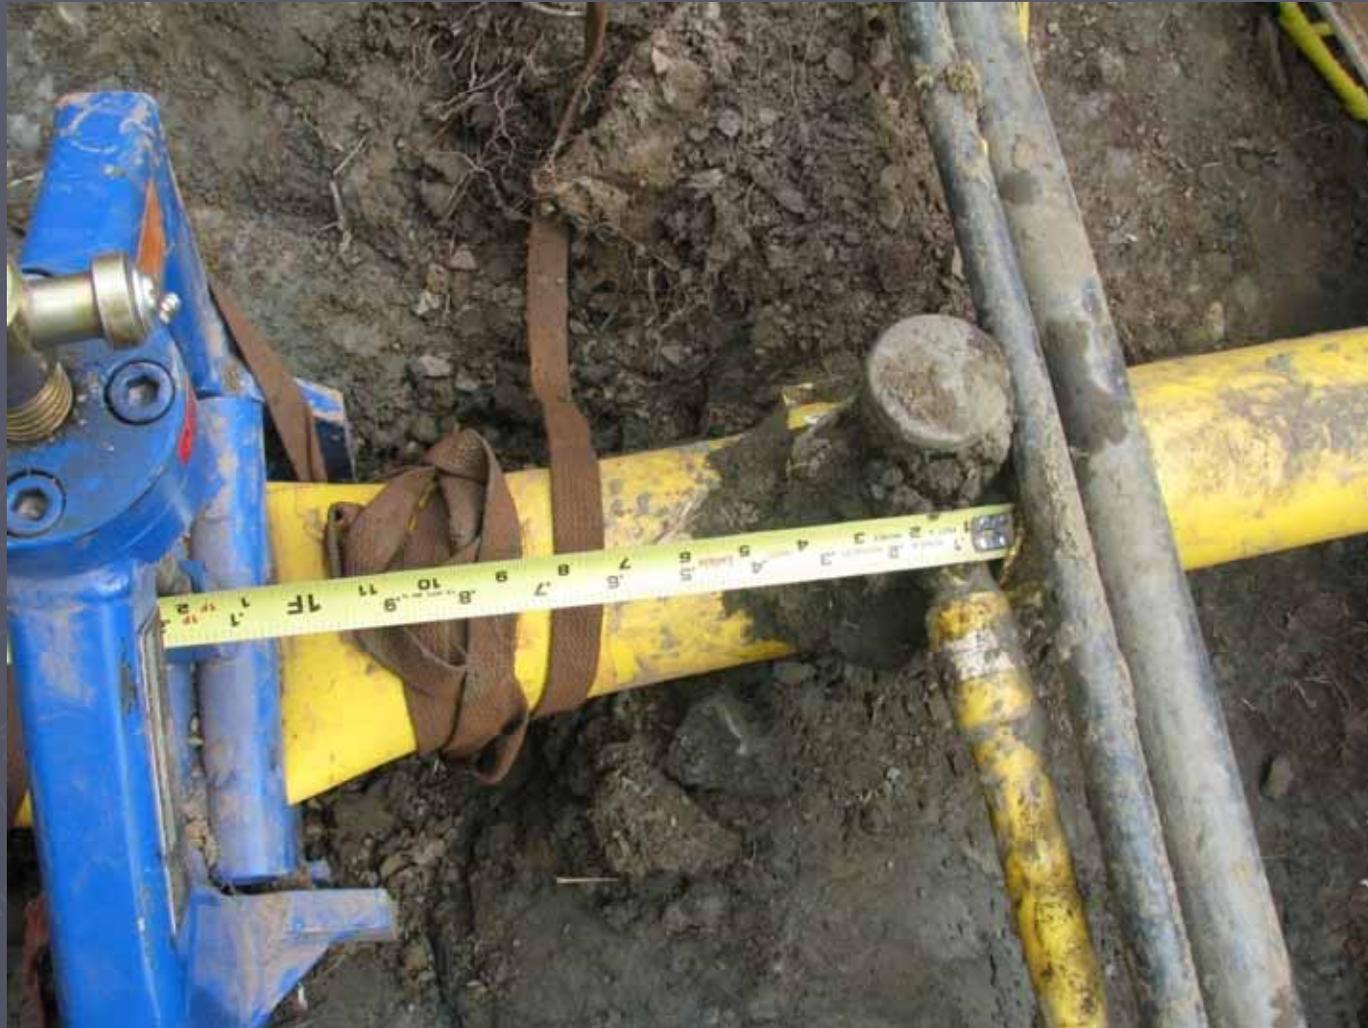
§192.605(b) - Failure to have adequate procedures for squeezing off a pipeline.

- ▶ The squeeze off tool must be at least 3 pipe diameters, or 12 inches, whichever is greater, away from any butt fusion, or any socket, saddle, or mechanical fitting.
