NAPSR

Distribution New Construction

St. Louis, Missouri April 20, 2010

Inspection findings related to Plastic Materials

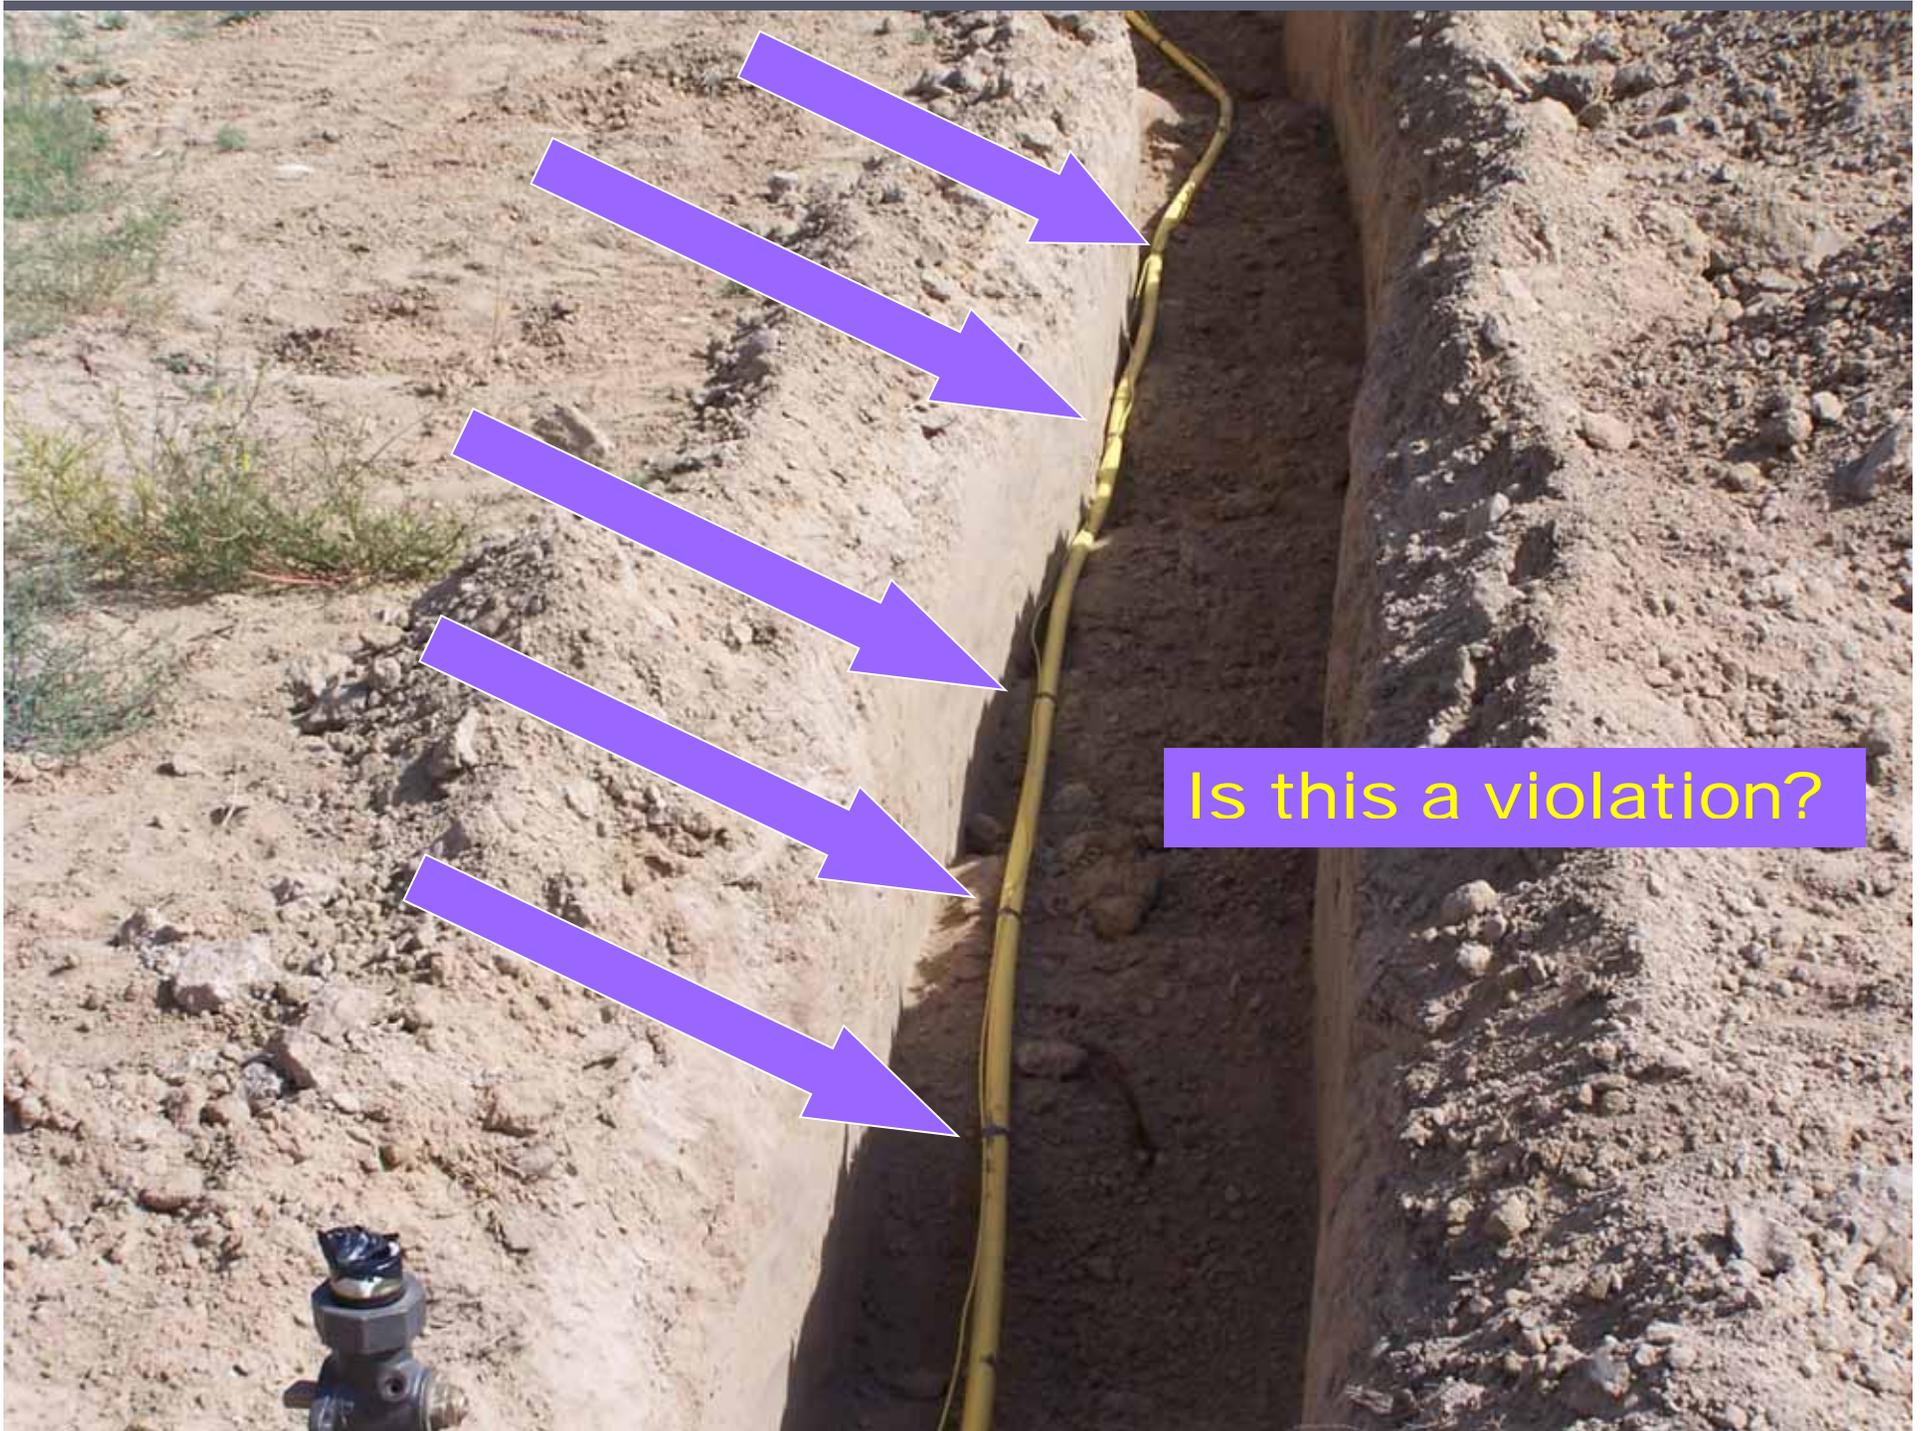
Tracer wire may not be wrapped around the pipe and contact must be minimized, but is not prohibited.

Is this a violation?

How is this line going to be marked?

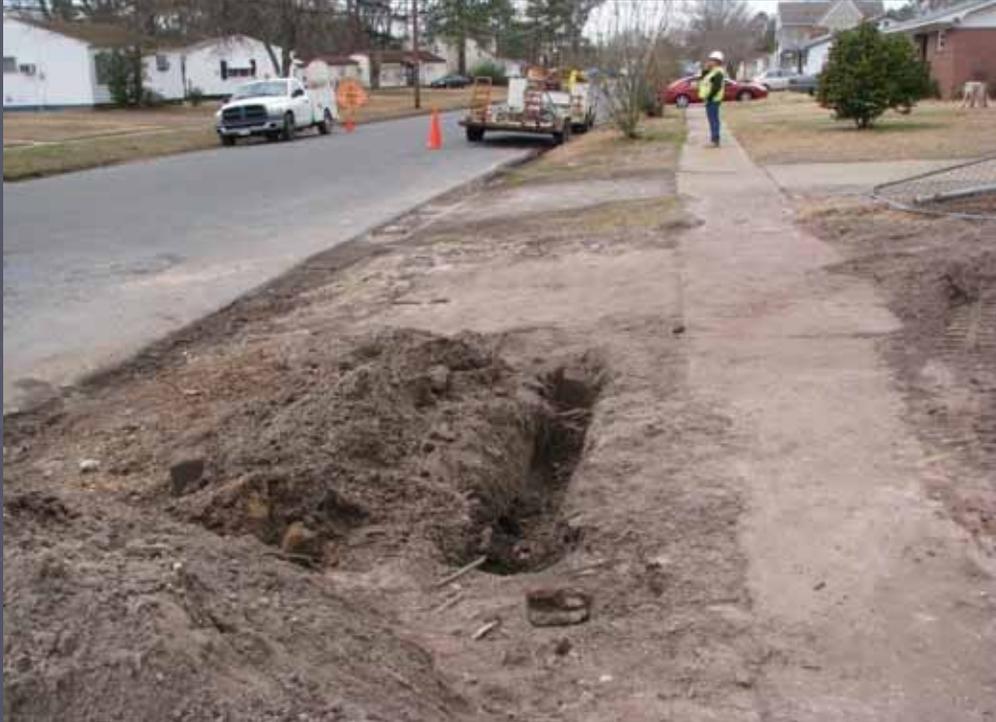
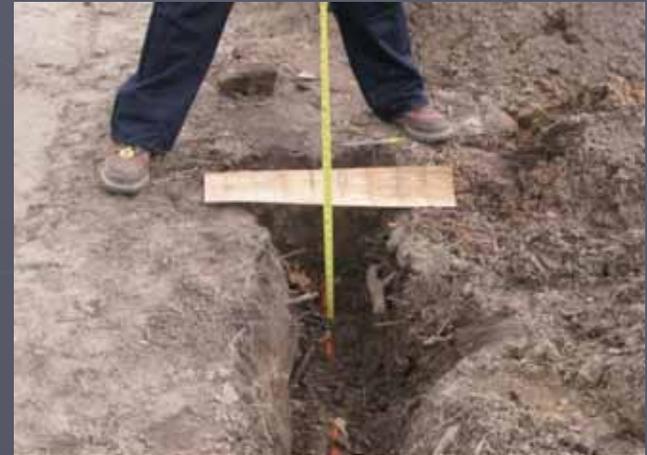
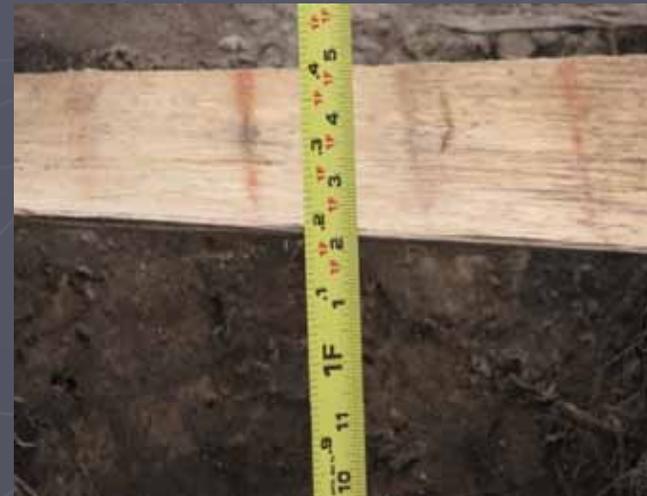
§192.327(b) - Failure to install a main with at least 24 inches of cover.

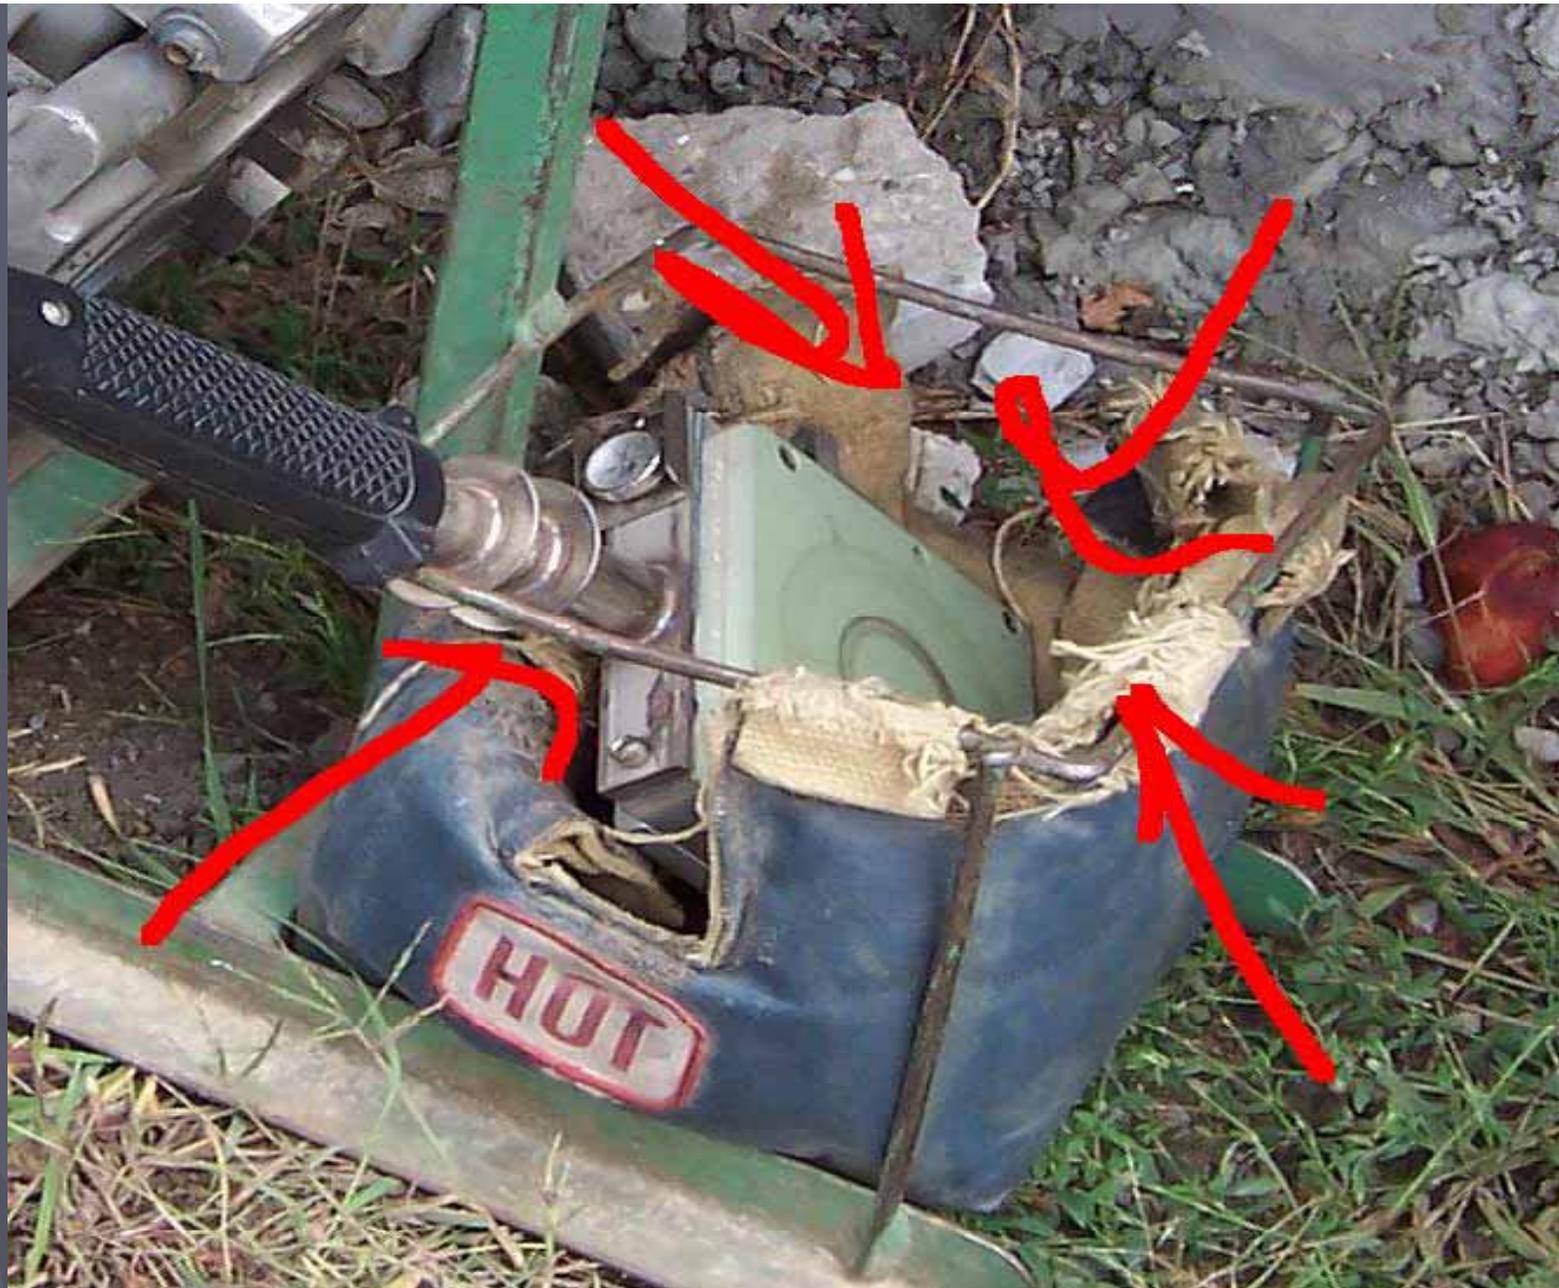
Ripped heater bag and dirty heat plate.

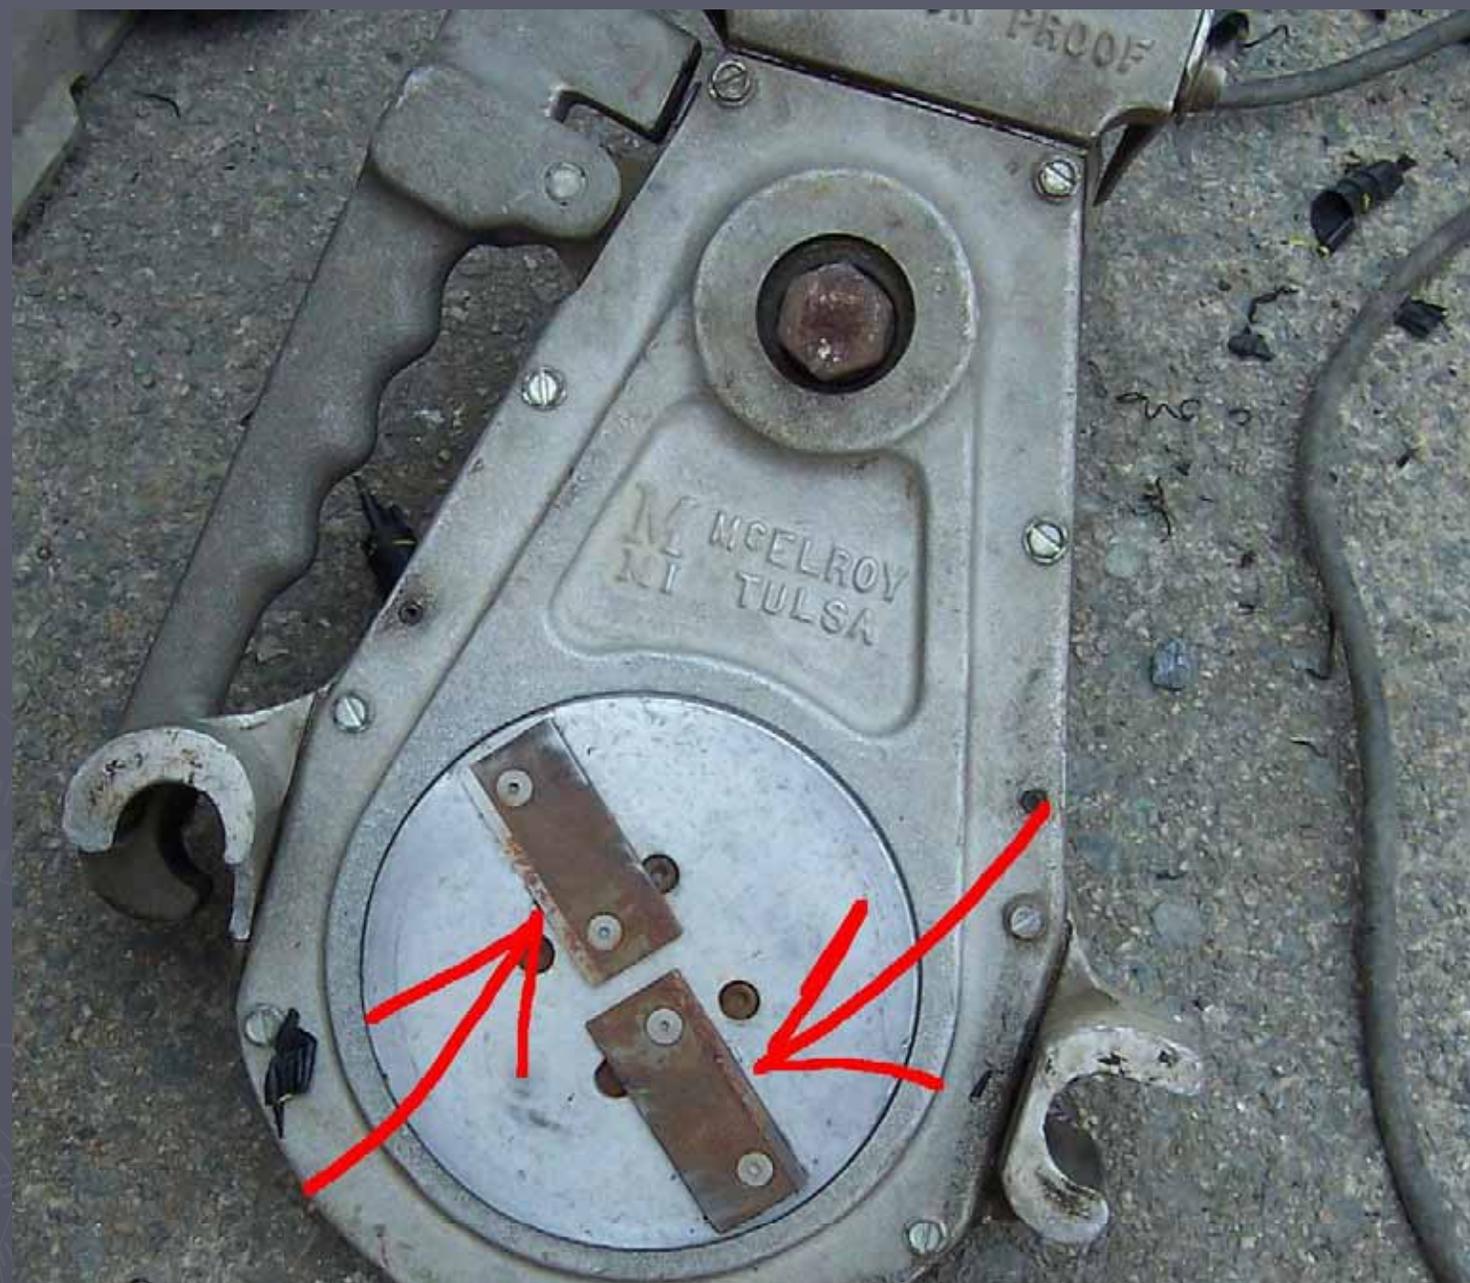
Rusty facing blades, your prone to failure.
