U.S. Department of Transportation
Pipeline and Hazardous Materials
Safety Administration

Construction Issues

Gery Bauman

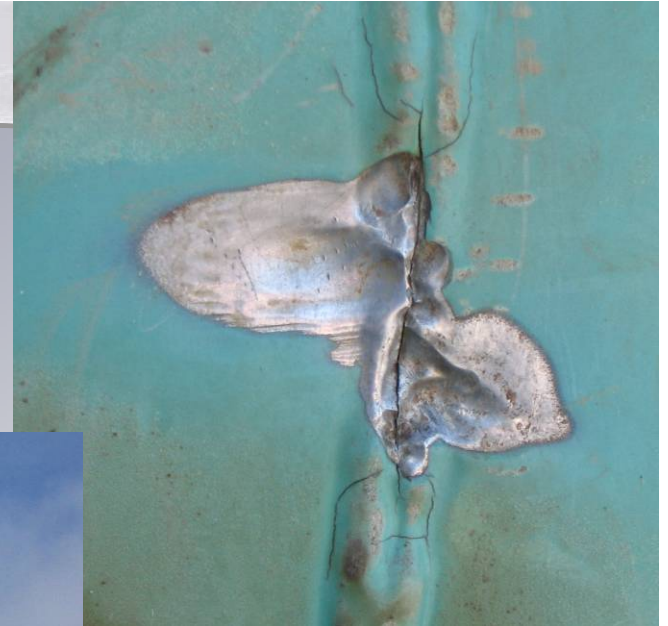
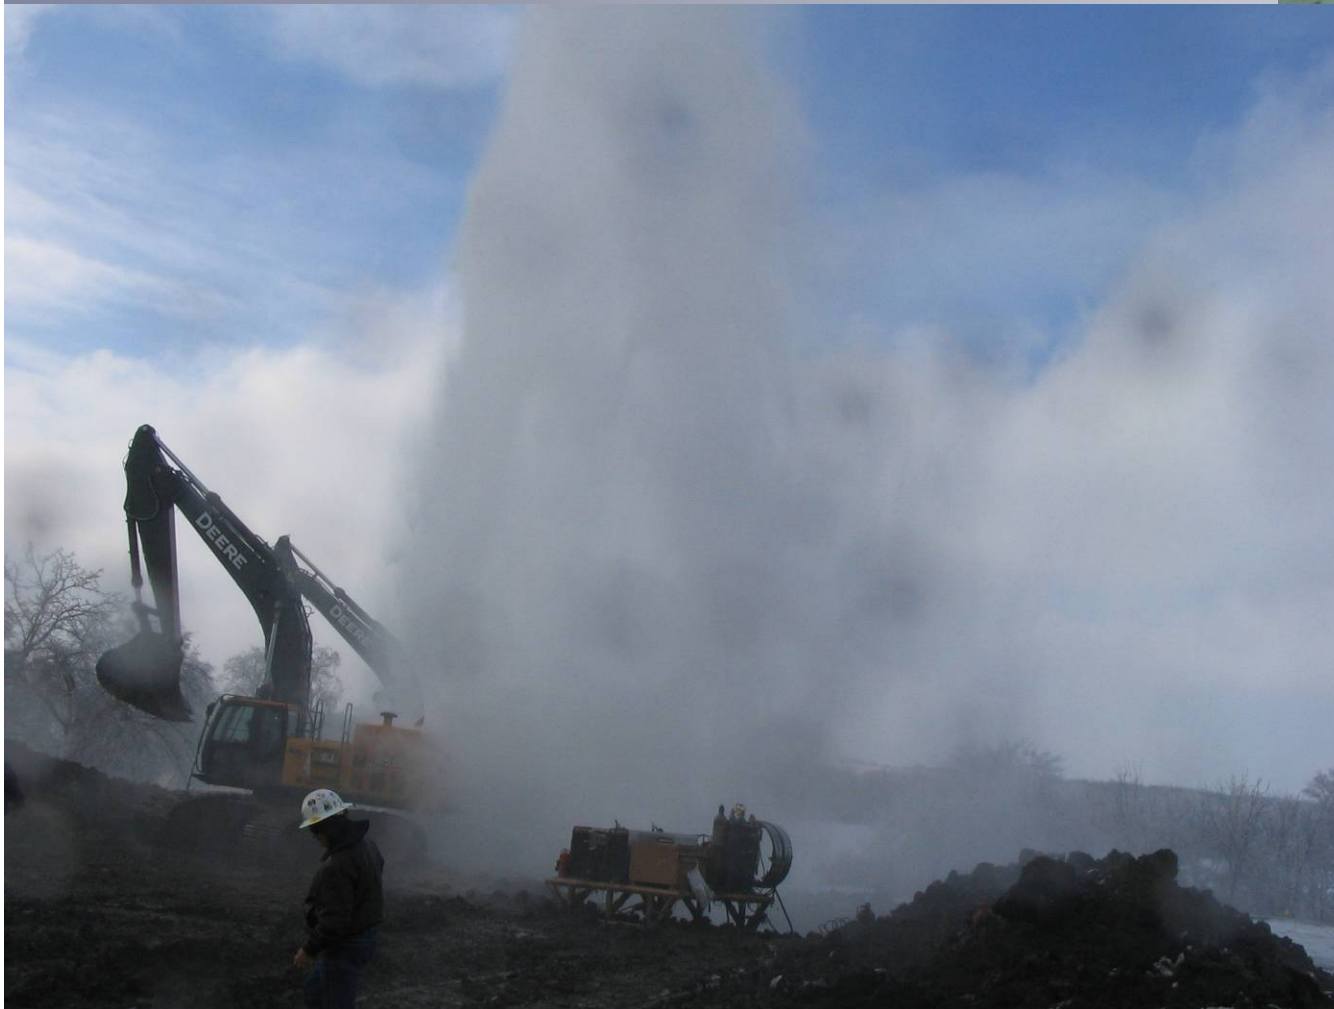
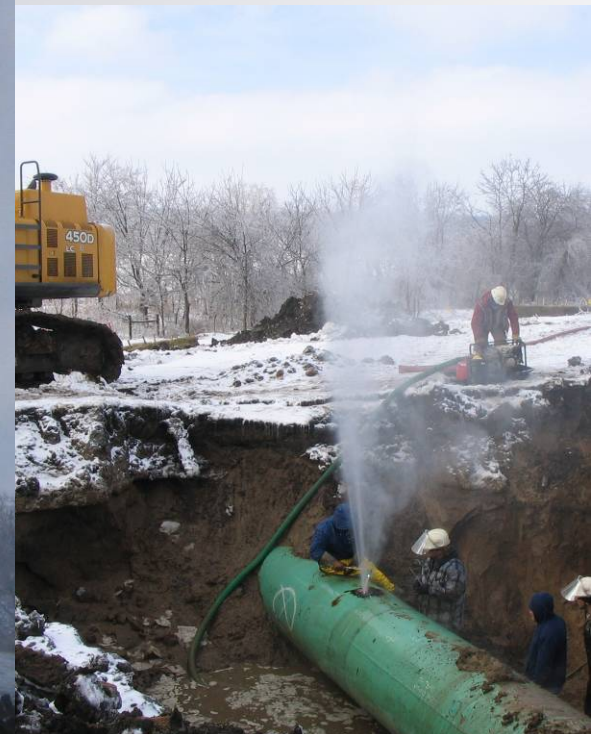
"Houston We Have A Problem"

- Recently there have been occurrences of through wall cracked welds discovered during the hydrotest phase of pipeline construction.
- These discoveries are extremely troubling as typically cracked welds are found and repaired or removed during the non destructive testing and repair phase of pipeline construction.
- Concerns
 - Are there partially cracked welds that remain?
 - Long term viability of the pipeline? Fatigue? External loading?
 - Ramifications of a failure of a pipeline operating at 72% or 80% SMYS?

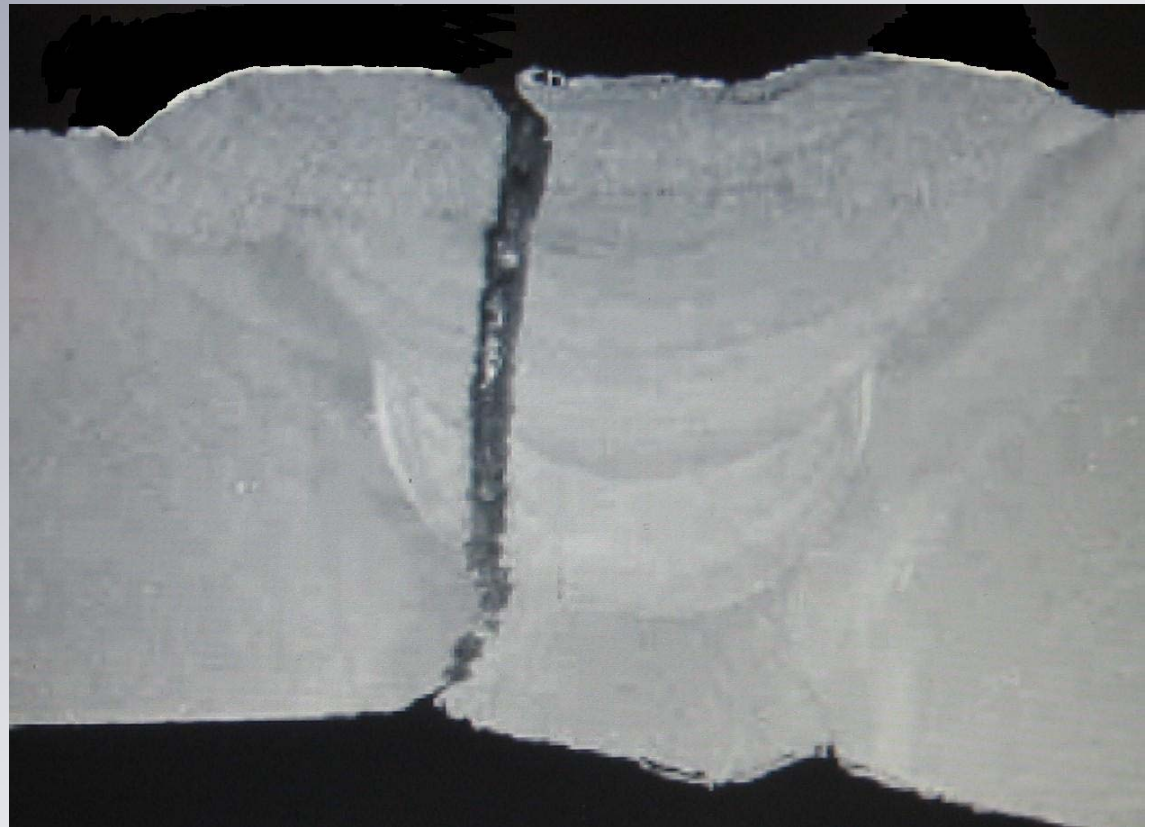
Cross section of a HAC Pipeline Weld

- In all cases (except of hinging) metallurgical investigations concluded hydrogen assisted cracking (HAC) was the failure mechanism
- Construction records associated with the leaks and additional investigations were reviewed and most of the time either ultrasonic inspection or radiography were completed the same day as the weld; no Non Destructive Testing (NDT) reports indicate cracks - this helps confirm Delayed HAC. In some cases the NDT was completed on the following day, here again no NDT reports indicate cracks. UT was used on the mechanized projects and radiography was used on the manual welding projects.
- Construction records indicate some cracked welds were found during construction and removed.
- Ambient temperature ranged from below 0 to 60° F

- To have HAC there must be three things present in the weld; a source of hydrogen, a micro-structure susceptible to the effects of hydrogen, and stresses in the weld.
 - Hydrogen is present in the coating of all E XX10 electrodes.
 - There are always stresses present in the weld due to heating and cooling; and the restraint geometry inherent in a pipeline weld. Higher stress levels can be present in repair welds, tie-in welds, transition welds, and welds with poor joint alignment.

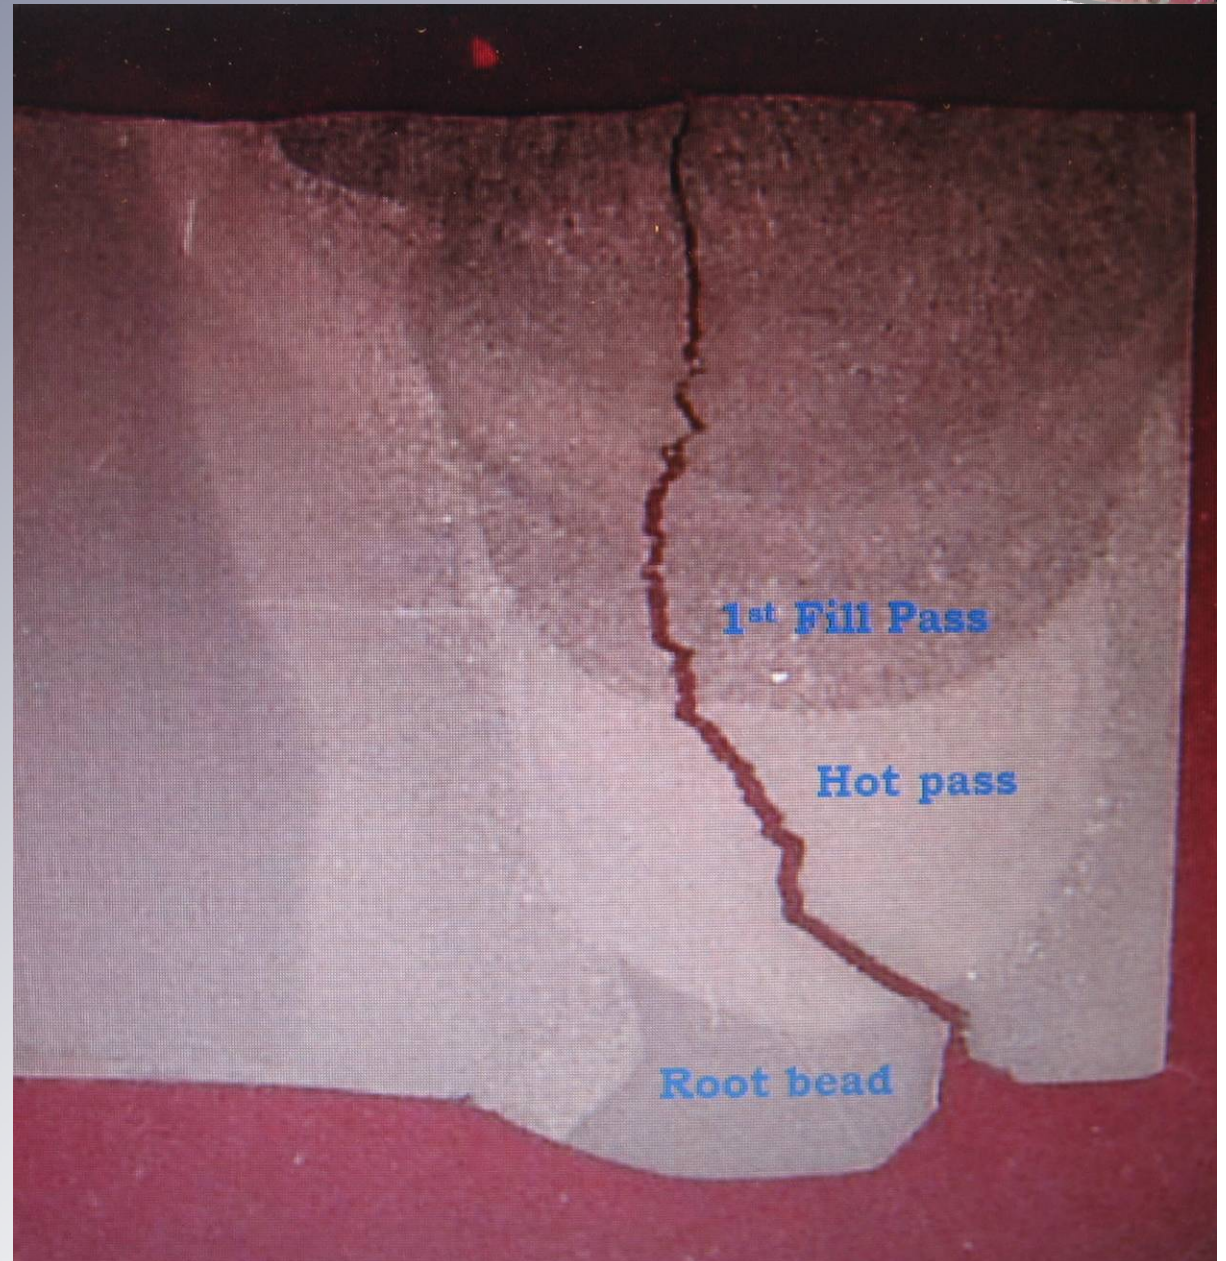
Cross section of a HAC Pipeline Repair Weld

- In all of the mechanized weld repair failures cellulosic electrodes were used for the root and hot pass. Fill and cap passes varied from cellulosic, low hydrogen, or Flux Cored Arc Welding (FCAW).
- In all of the failed manual welds cellulosic electrodes were used.
- In all procedures preheat was specified and ranged from “if ambient temperature below 50° F use 150° F preheat” to a blanket statement requiring “250° F minimum preheat”
- Statements about “Time Between Passes” were varied as well as “Time Between All Other Passes”

Repair Weld Cracking Issues

- Develop dedicated repair welding procedures
- Minimize the use of cellulosic electrodes or manage risk
- Develop specific through wall repair procedures
- Develop specific partial wall repair procedures
- Consider repair welder's skills
- Possibly higher preheat temperatures and a minimum interpass temperatures
- Cold weather considerations
- Avoid accelerated weld cooling

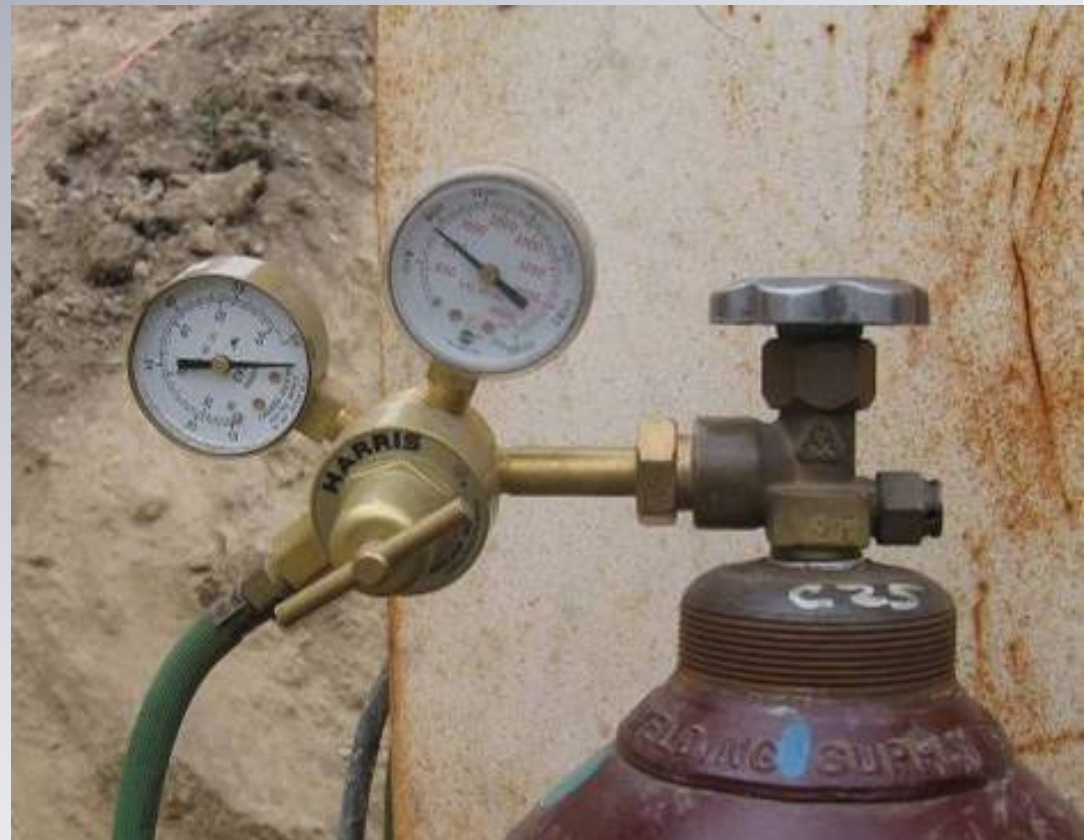
Porosity

- Welders were not experienced with the gas-shielded FCAW process
- Welders had history of repairs due to porosity defects
- Welders thought more gas would prevent porosity
- High gas flow rates cause turbulent flow from nozzle contaminating the shielding gas
- Welders must follow the welding procedure

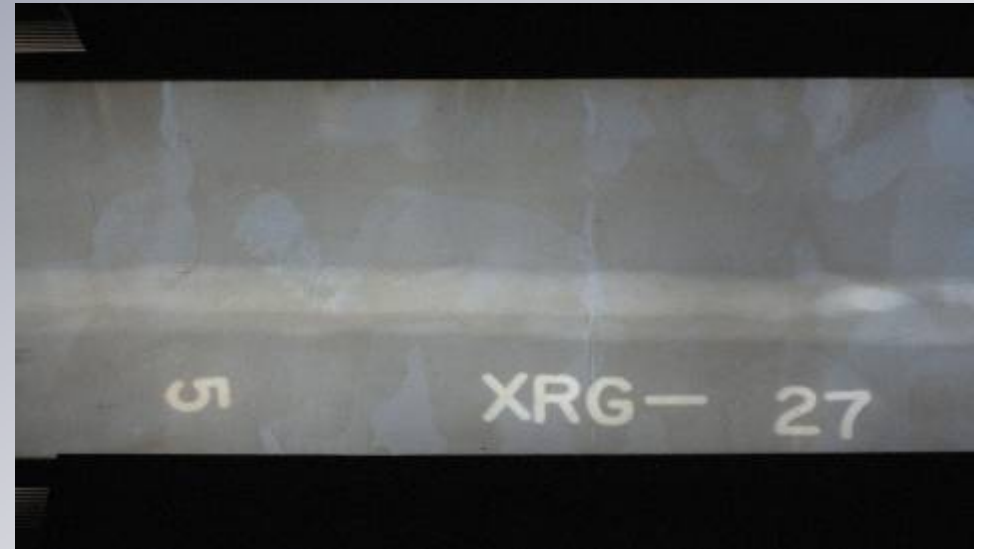
- Notice chemical stains and brown hue API 11.1.1 a – free from fog and other processing irregularities that could mask defects

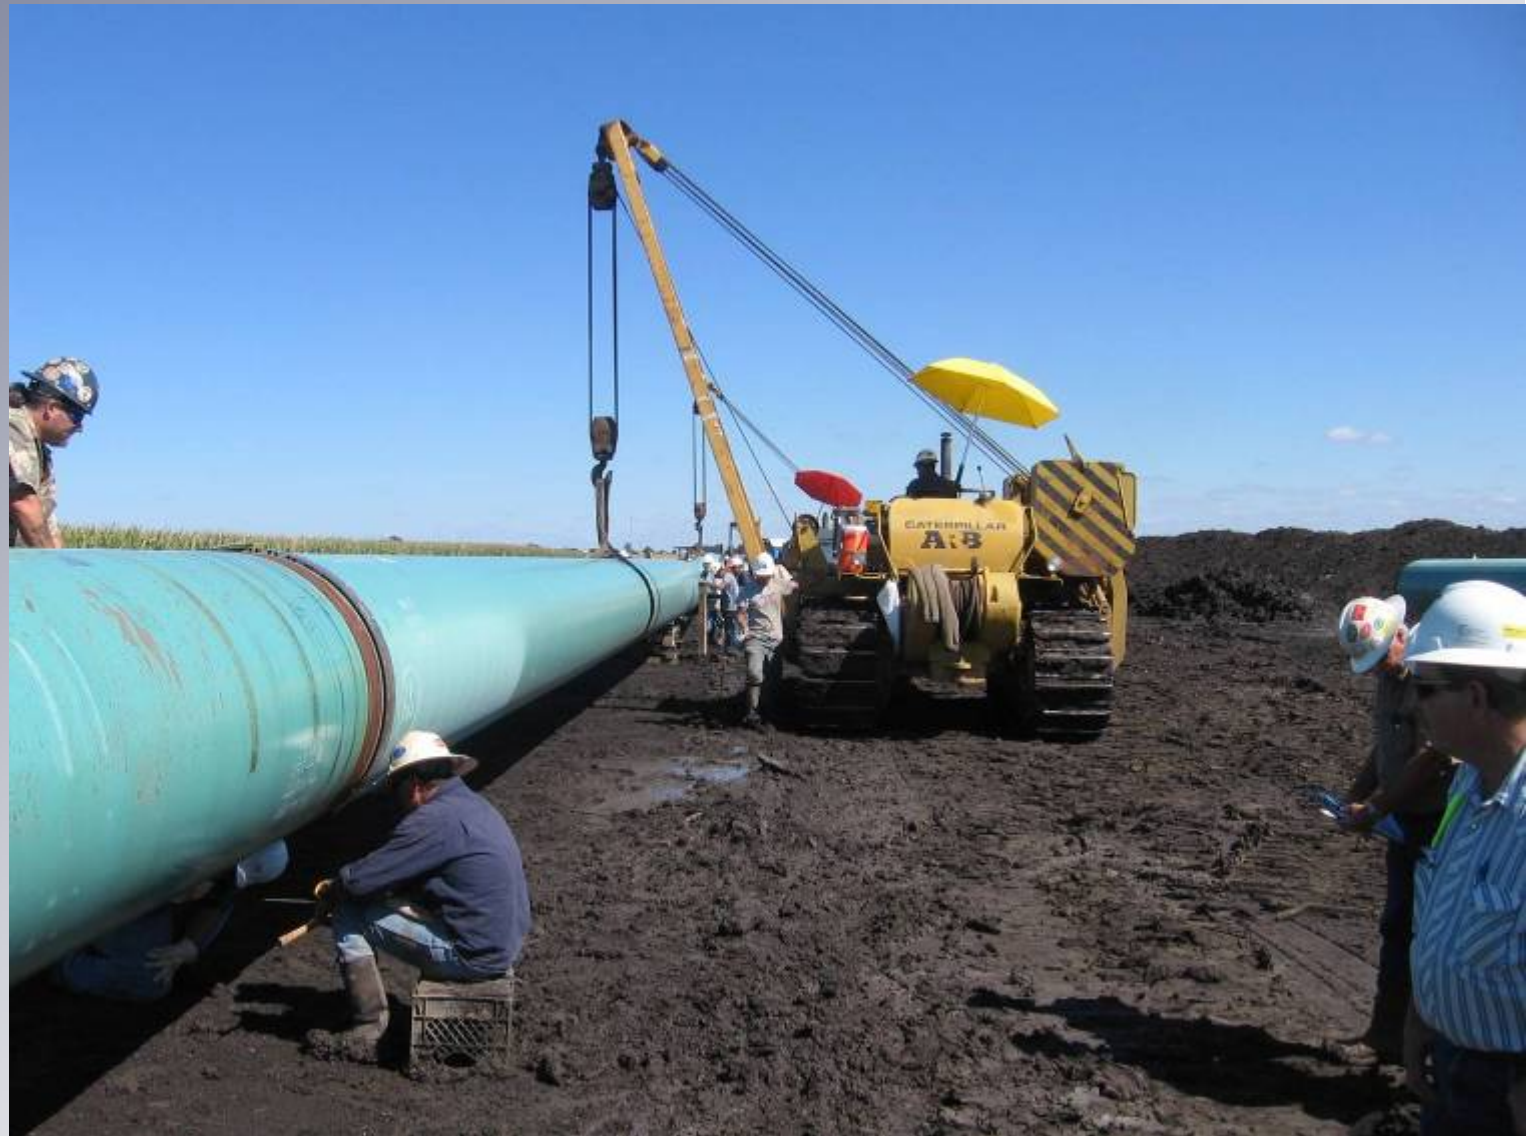
- Movement during root bead welding can overstress deposited weld metal and cause cracking.
- Hydrotest failure attributed to “hinging”

Is the pipe moving as the root bead is welded?

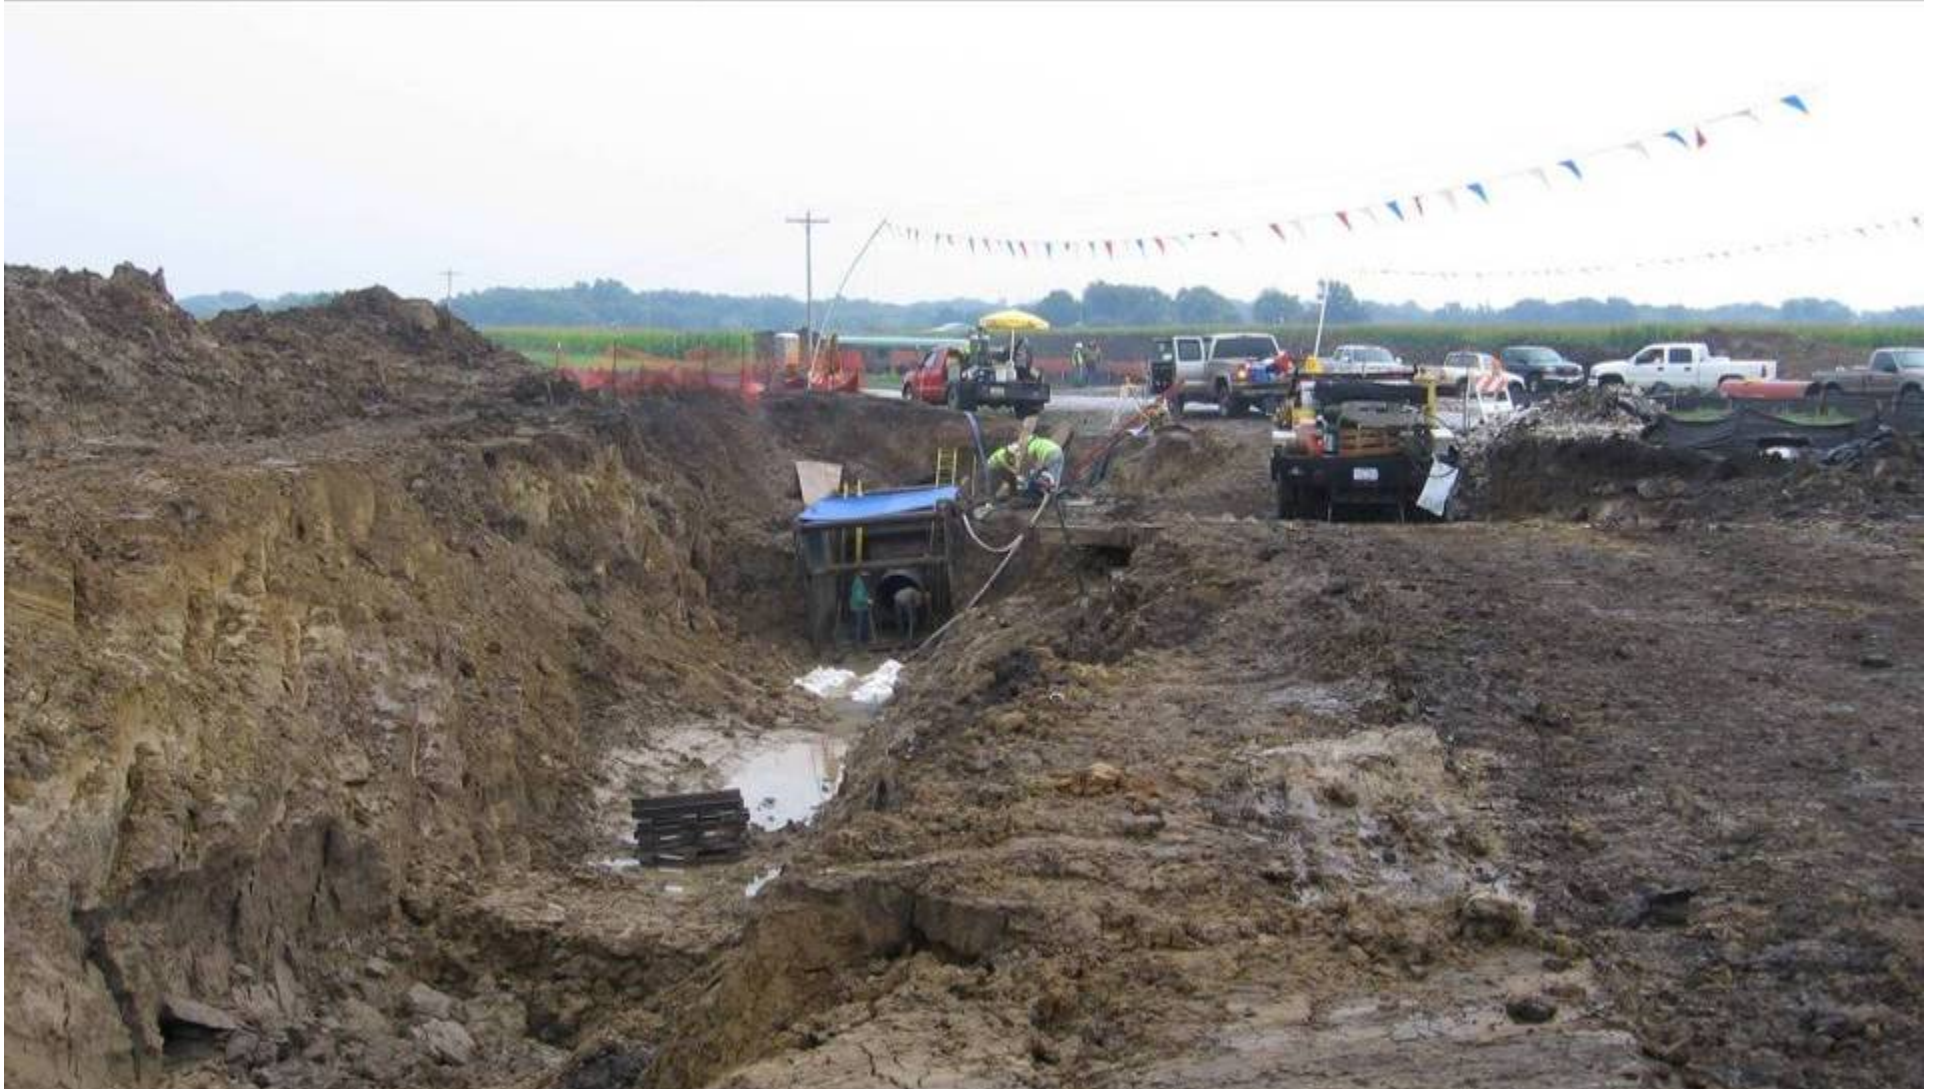
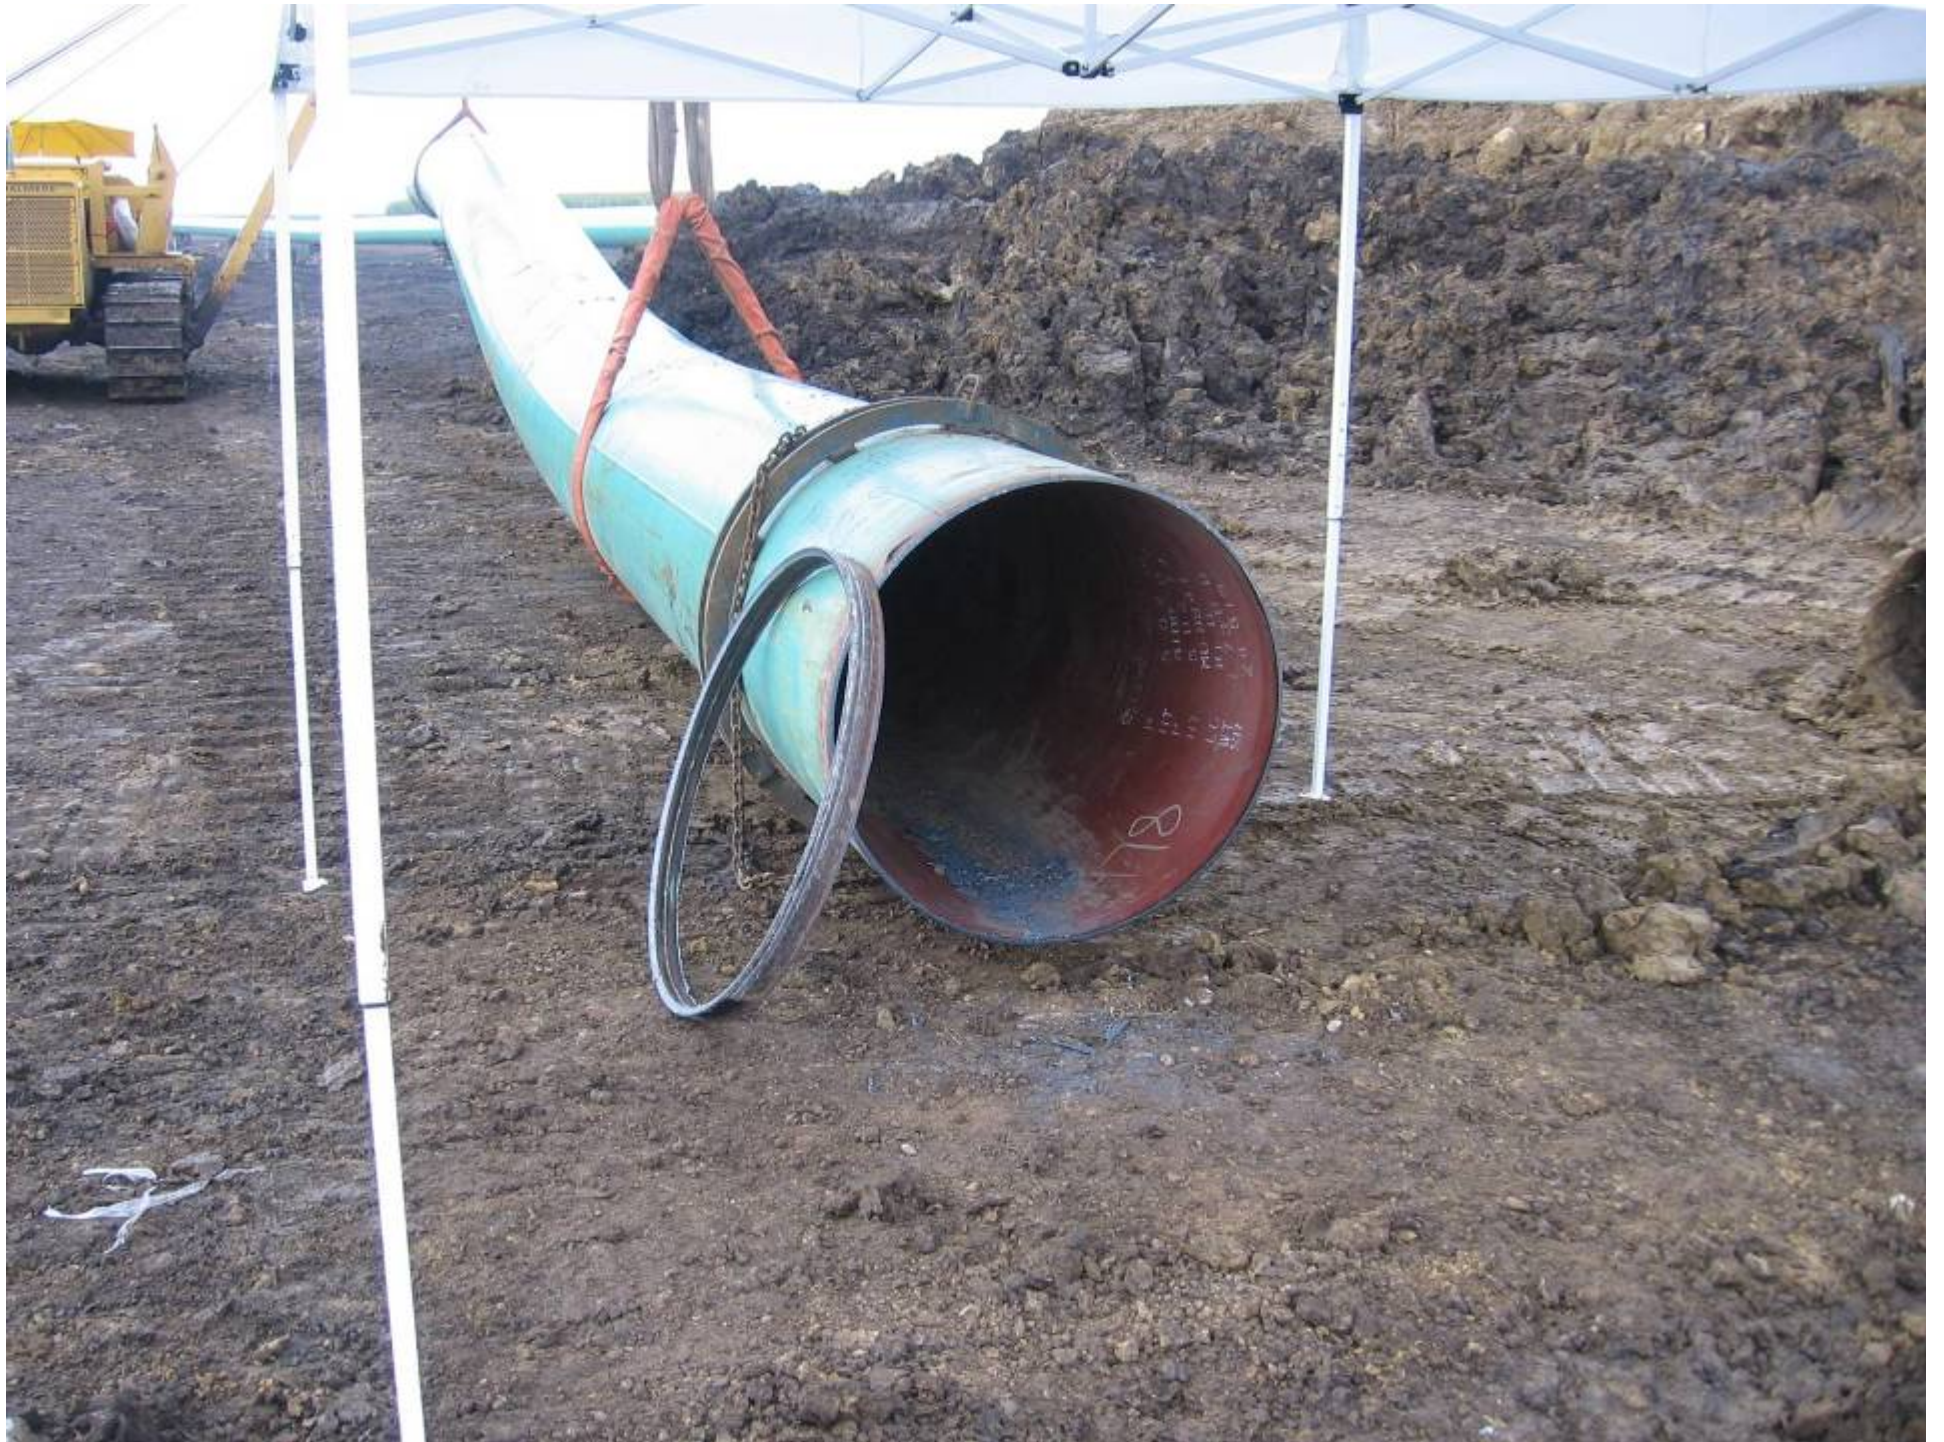
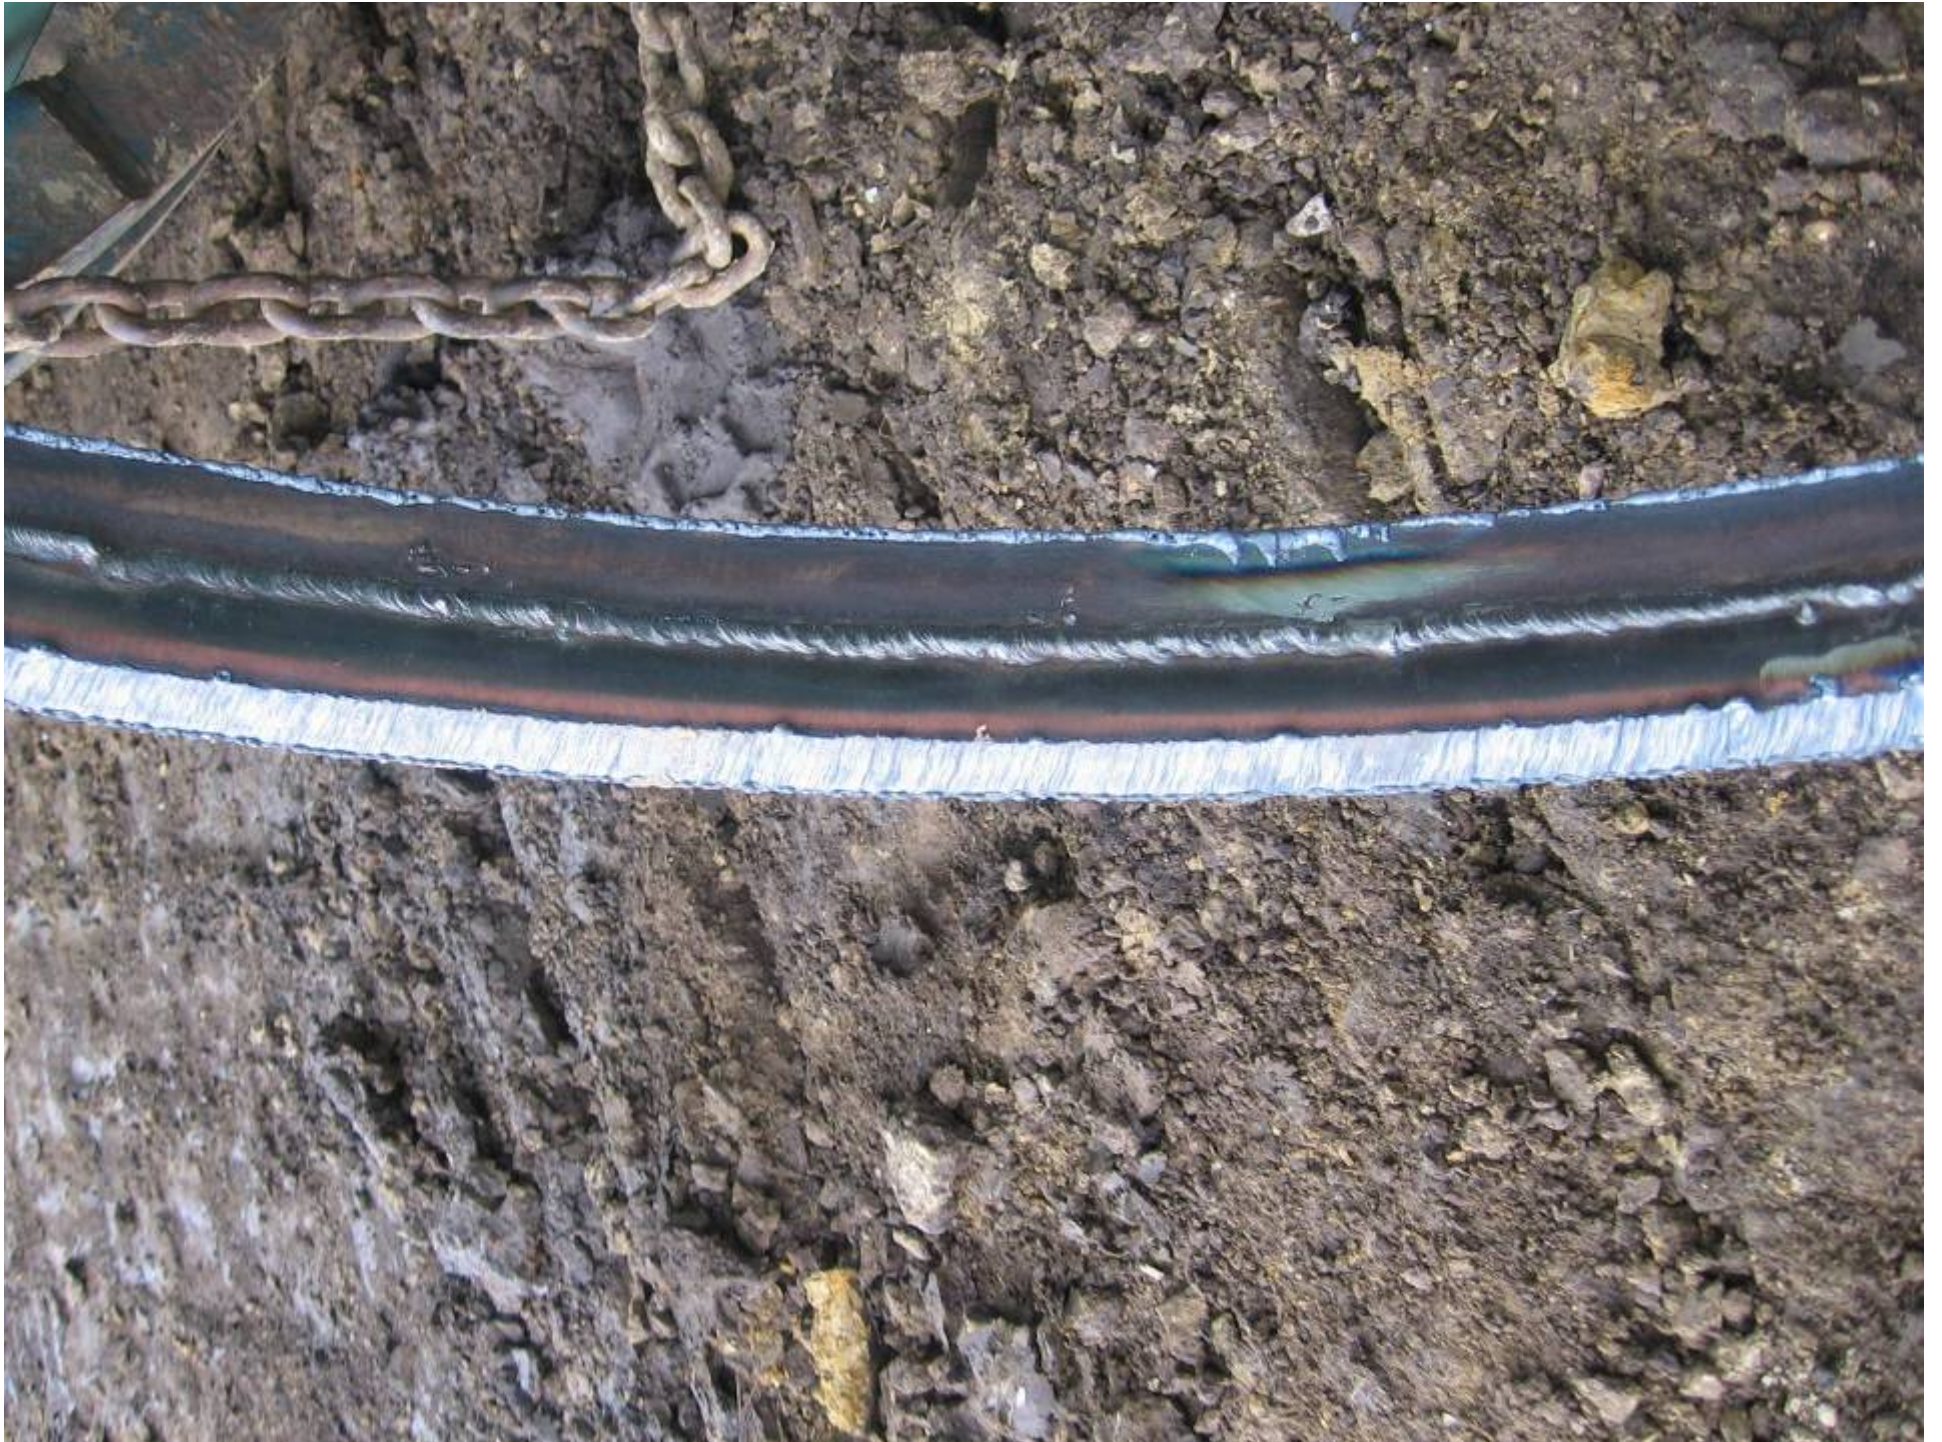
- Arc burns are not acceptable on high pressure gas pipelines and liquid pipelines.
- The following slides show that arc burns can happen during internal back welding.
