**Pipeline and Hazardous
Materials Safety
Administration**

Ref. No.: 12-0121

Safety Recommendation

In reply refer to: H-12-2 through -6

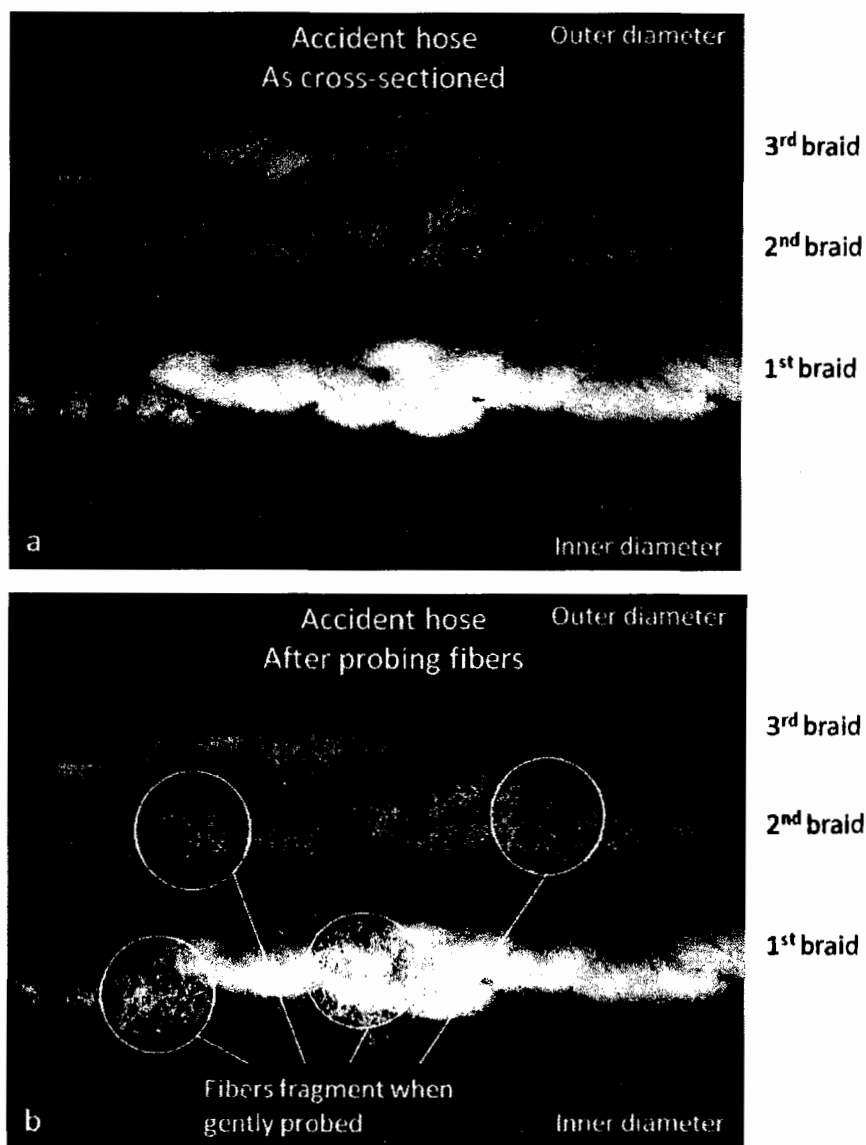
The reinforcing fibers in the two innermost PET braid layers of the hose assembly appeared to be severely damaged on both halves of the fracture surface along the entire length of the ruptured area. In some parts of the ruptured area, the fibers were clumped together and appeared to be encased in salt-like particles. Laboratory analysis of the hose assembly revealed that the fibers in the two innermost PET braid layers were degraded to the point that they were brittle and friable when strained or mechanically flexed. (See figure 2.)

Figure 2. Cross-section of accident hose showing brittleness of fibers in two innermost PET braid layers.

The PET used for the yarn braids is not chemically resistant to anhydrous ammonia or ammonium hydroxide. As documented in several studies,⁹ exposure to anhydrous ammonia or ammonia-related compounds results in a chemical reaction (ammonolysis) that can cause PET fibers to degrade and lose strength.

Testing completed by both the NTSB's Materials Laboratory and an independent laboratory¹⁰ confirms that the PET fibers in the accident hose had sustained chemical degradation that dramatically reduced the strength of the PET fiber. The NTSB concluded that the accident hose failed because it was not chemically compatible with the anhydrous ammonia in the cargo tank and that caused the chemical degradation, loss of mechanical strength, and ultimate failure of the cargo hose.

Require cargo tank motor vehicle carriers and transfer facilities to verify (1) that cargo transfer hose assemblies, whether carried on the vehicle or provided by the facility, are chemically compatible with the hazardous material to be transferred and (2) that drivers verify hoses are marked as compatible with the material to be transferred before either loading or unloading operations begin. (H-12-3)
