U.S. Department of Transportation

Office of Pipeline Safety – Accident Investigation Division

# Failure Investigation Report Marathon Pipe Line, LLC.

Natural Gasoline Release – Girth Weld Failure

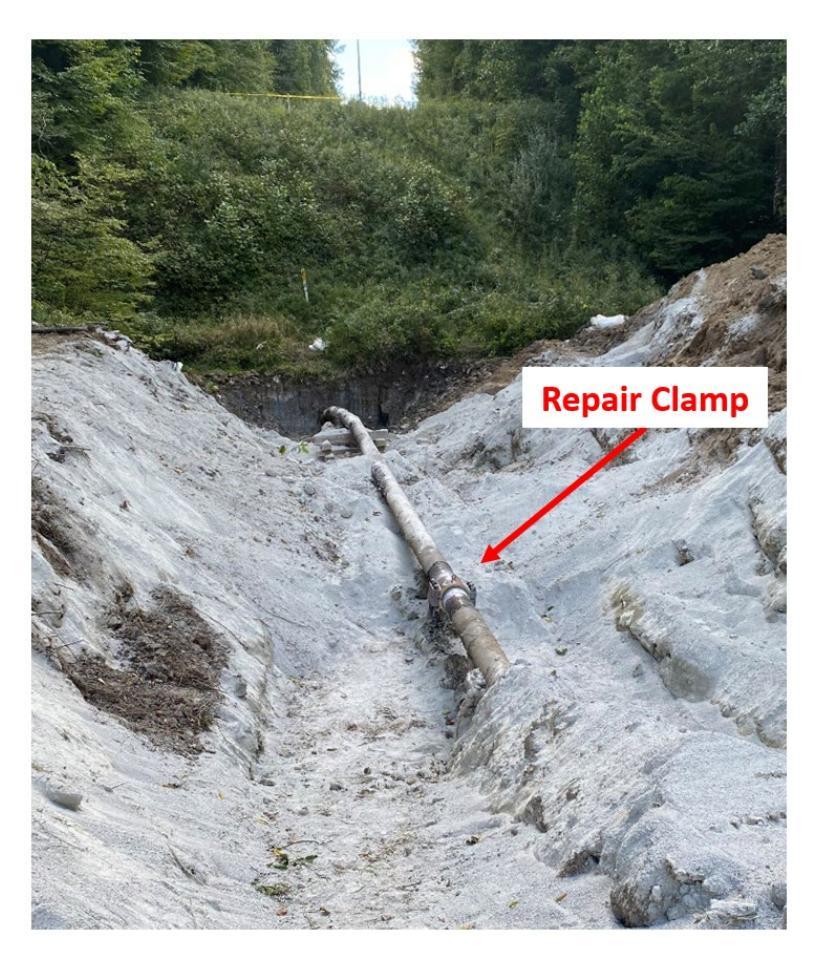
The failure location was approximately 80 feet upstream of Dyer Creek. The failure defect was in a girth weld at the 5:45 position. An estimated 458.2 bbls of the natural gasoline reached the creek, where most of the product evaporated. Prior to AID's arrival, Marathon placed a wood plug in the pinhole, covered it with duct tape, and installed a 10-inch PLIDCO clamp over the wood plug to stop the leak (**Figure 1**). Ultrasonic Testing (UT) wall thicknesses measurements of 0.250 inches minimum and 0.282 inches maximum were obtained near the 10-inch repair clamp, in the 0.277-inch wall pipe.

Figure 1. 10-inch PLIDCO Clamp Repair Over the Failure Defect (Looking West) – AID Photograph.

Marathon replaced the 10-inch PLIDCO clamp with a 24-inch PLIDCO clamp as a temporary repair to return the pipeline to service. AID observed that the surface was properly prepared, and the clamp was installed in accordance with the manufacturer's recommendations.

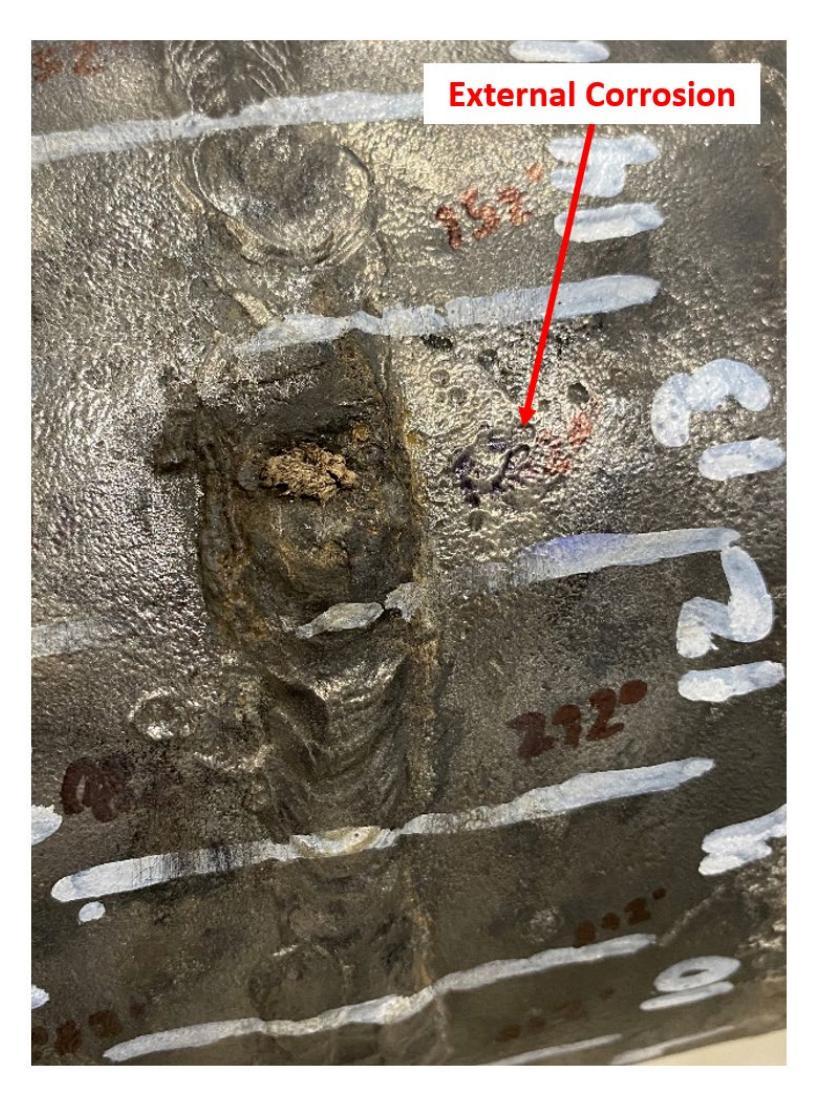
On November 8, 2022, AID witnessed the metallurgical analysis. The 24-inch PLIDCO repair clamp was removed to allow visual examination of the leak source. Visual examination of the failed girth weld revealed evidence of a pinhole, arc burns, weld repairs, and external corrosion a few inches upstream from the pinhole (**Figure 2**). The external corrosion appeared to be historic because the coating was intact before removal. There was no visual evidence of calcareous deposits, surface porosity, or undercut associated with the failed girth weld.

Figure 2. External Corrosion at 5:45 Position – AID Photograph.

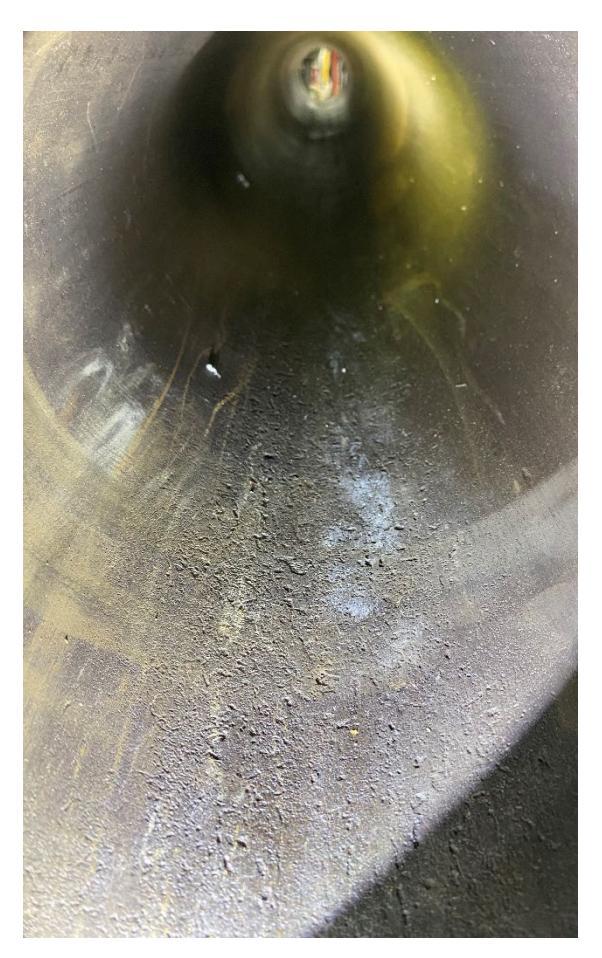
There was shallow internal corrosion found at the 6:00 position both upstream and downstream of the failed girth weld (**Figure 3**).

Figure 3. Shallow Internal Corrosion at 6:00 Position, Looking Upstream Toward the Failed Girth Weld – AID Photograph.

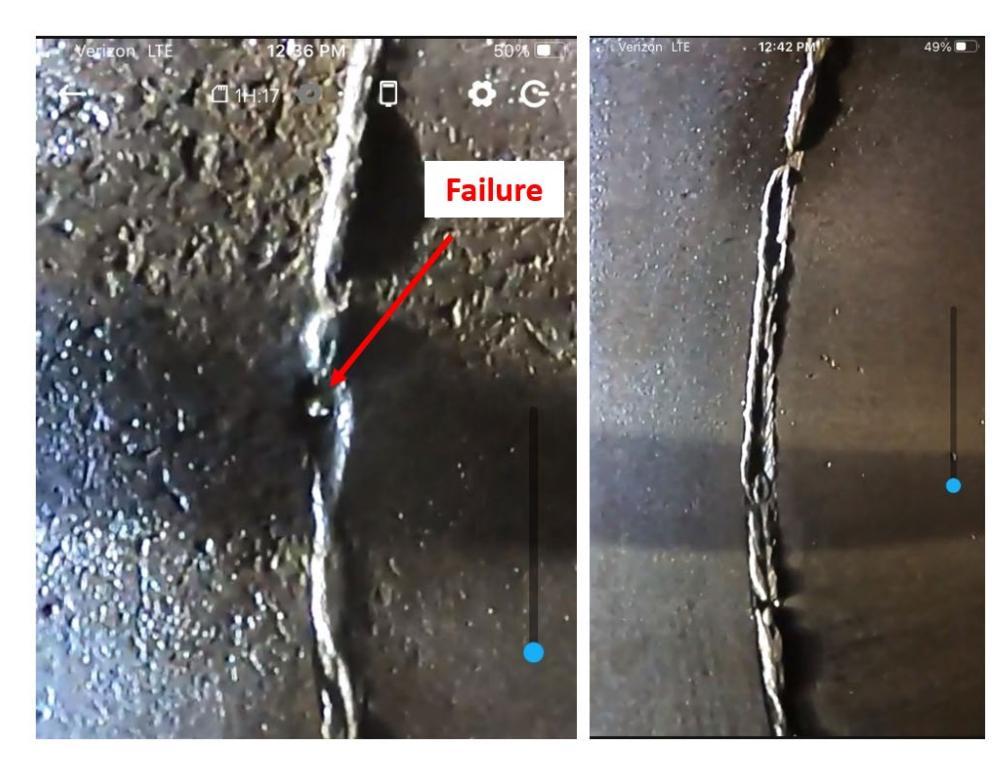
Marathon provided photographs of the inside of the pipe near the failure location at 5:45 position (Figure 4, on left) and at the smallest wall thickness at the 3:30 position (Figure 4, on right). Shallow internal corrosion was visible both upstream and downstream of the failure location and areas of inadequate penetration were also visible in the root pass of the girth weld.

**Figure 4.** On the Left Photo, at the 5:45 Position There is Root Pass Burn-Through. The Failure Arrow Points Directly at the Wood Plug Still in The Girth Weld Pinhole. On The Right Photo, at the 3:00 Position, There is Incomplete Penetration of the Root Pass – ADV Integrity Photograph.

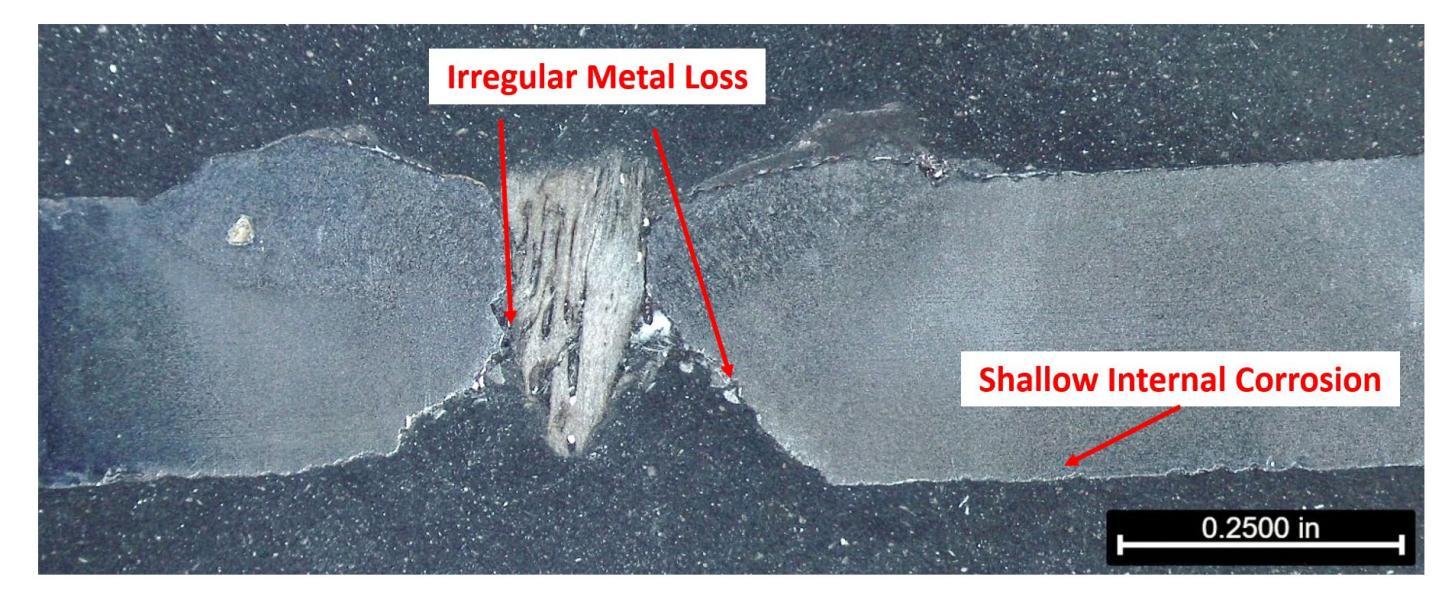
ADV Integrity's metallurgical analysis (Appendix D) indicated that the leak was identified at a start-stop of the weld cap pass. The internal pipe surface contained a region of minor internal corrosion along the bottom of the pipe, from approximately the 5:00 to 7:00 position. A metallurgical cross section through the identified leak (**Figure 5**) showed the wood plug centered within the weld. The leak's cross section contained areas of irregular metal loss, resembling internal corrosion. It appeared that the leak

is associated with a burn-through of the root pass in conjunction with poor welding practices that occurred in the 1945 construction of the pipeline.

Figure 5. Cross Section Showing Internal Lack of Weld Deposit in the Root, a Concave Weld Cap, and the 1/8-inch Wood Plug – ADV Integrity Photograph.

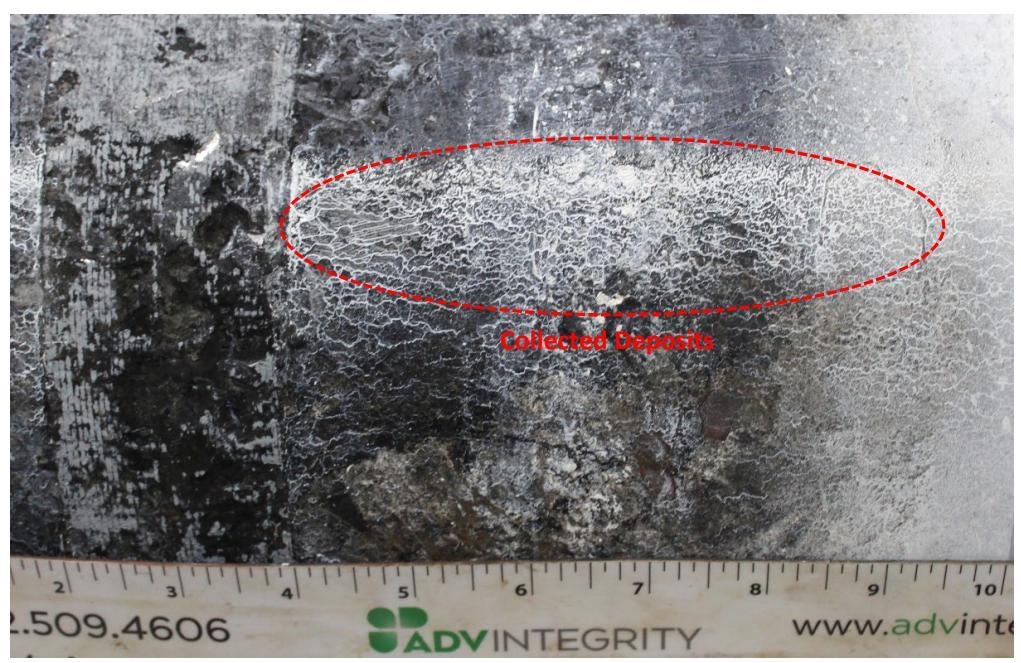
Figure 2-8: Photograph of deposits present along the external pipe surface. Numbered scale divisions are inches.

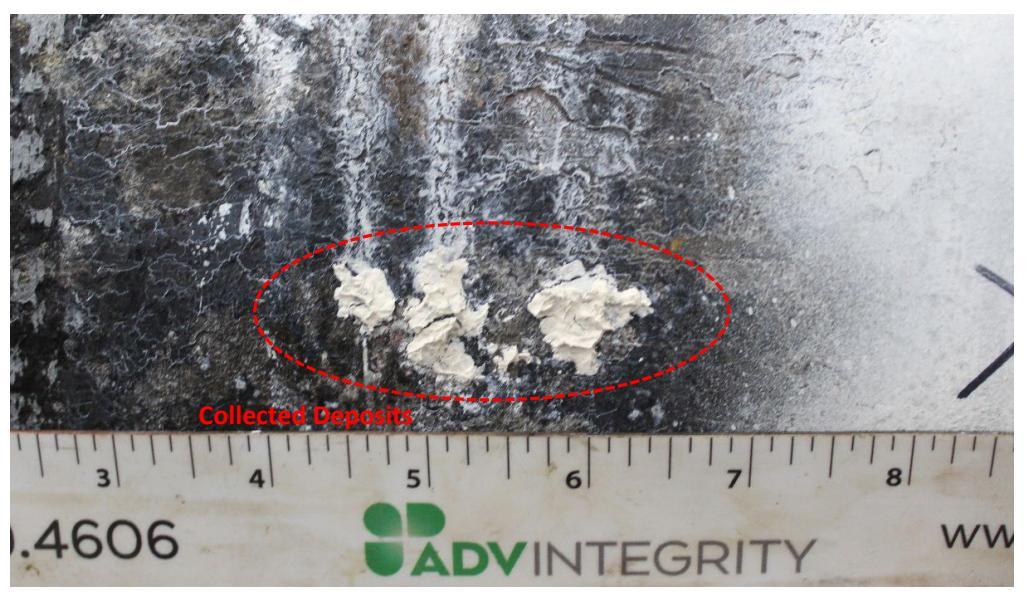
Figure 2-9: Photograph of deposits present along the external pipe surface. Numbered scale divisions are inches.

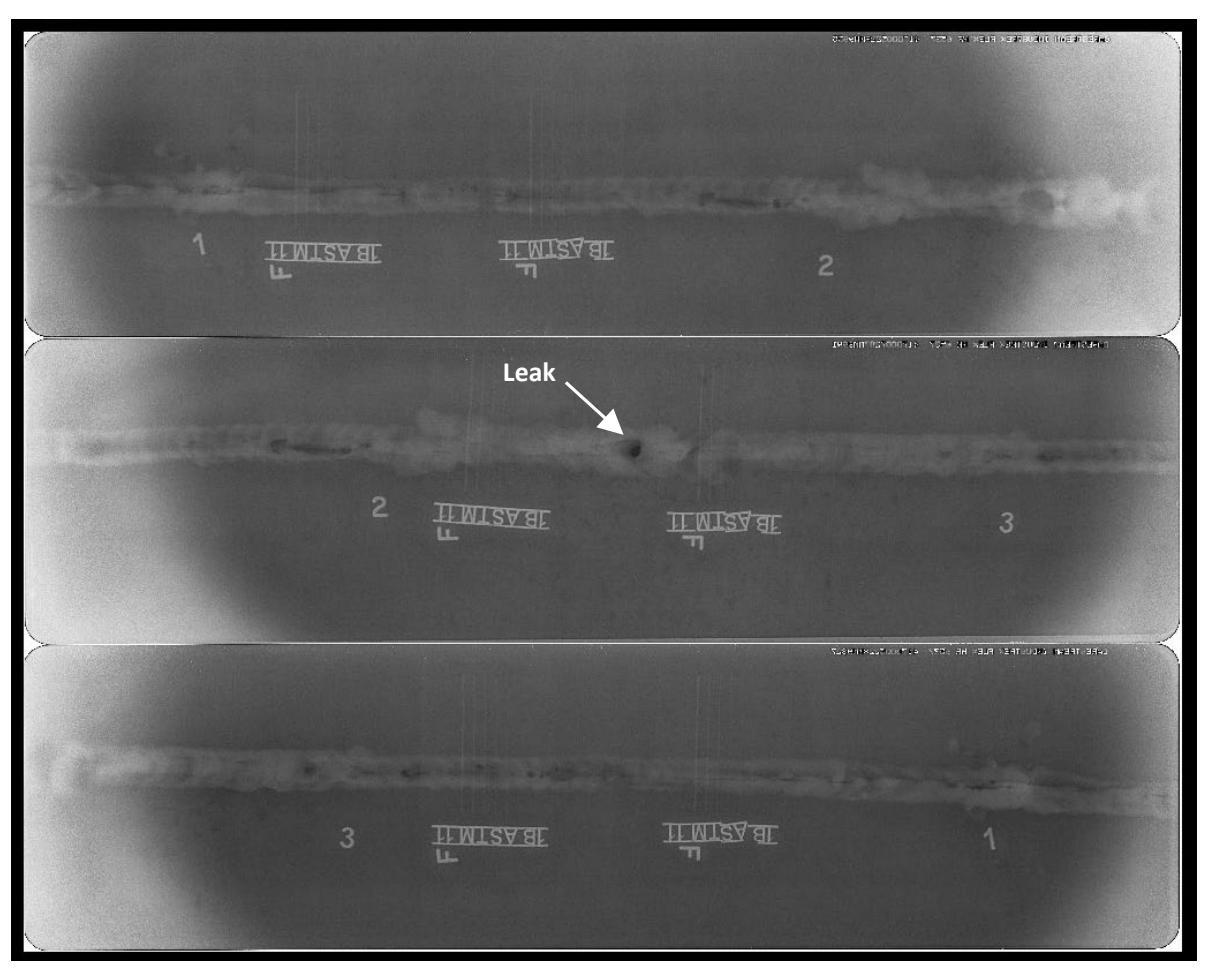
ADV contracted Acuren Inspection, Inc. to perform RT of the girth weld to API 1104. Areas of incomplete fusion, incomplete penetration, underfill, and porosity were identified. These features were outside acceptable workmanship limits within current editions of API 1104, however, construction codes at the time of construction did not require inspection. Images of the RT film are shown in Figure 3-1. The leak was identified in the middle film (view 2-3). The full reader sheet is attached in Appendix A.

Figure 3-1: RT Images.

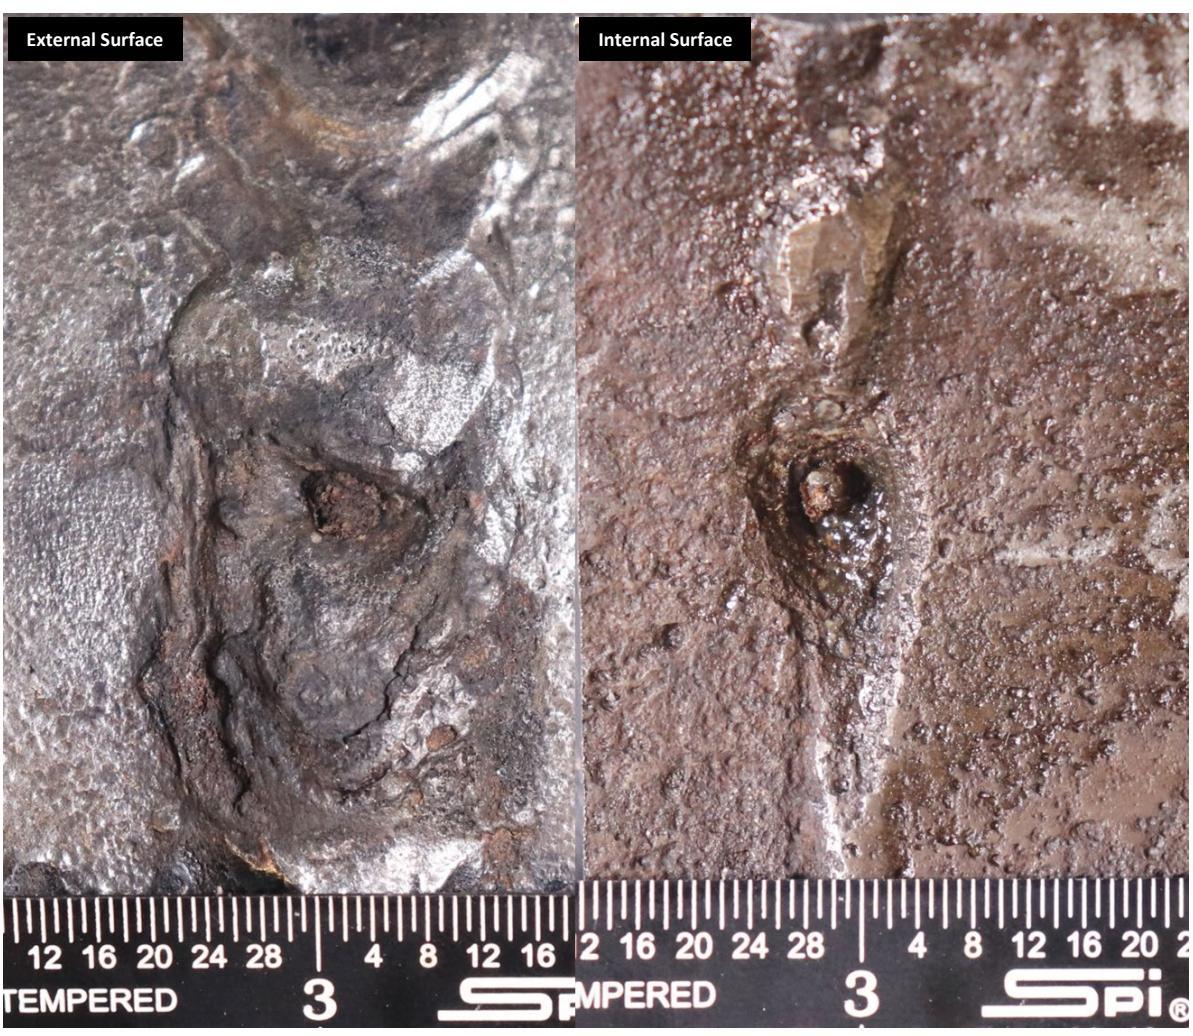
The leak was identified just adjacent to the external cap tie in between the passes on either side of the pipe. The internal pipe surface contained a region of minor internal corrosion along the bottom of the pipe, approximately 5:00 o'clock to 7:00 o'clock (inch mark 11-17), shown in Figure 4-7. No deposits were collected from the internal pipe surface as there was insufficient present for examination. The external and internal pipe surface around the leak is shown in Figure 4-8. The internal surface contained a teardrop-like area of wall loss at the identified leak.

Figure 4-8: Photograph of external (left) and internal (right) weld surface at the leak. Major numbered scale divisions are inches.

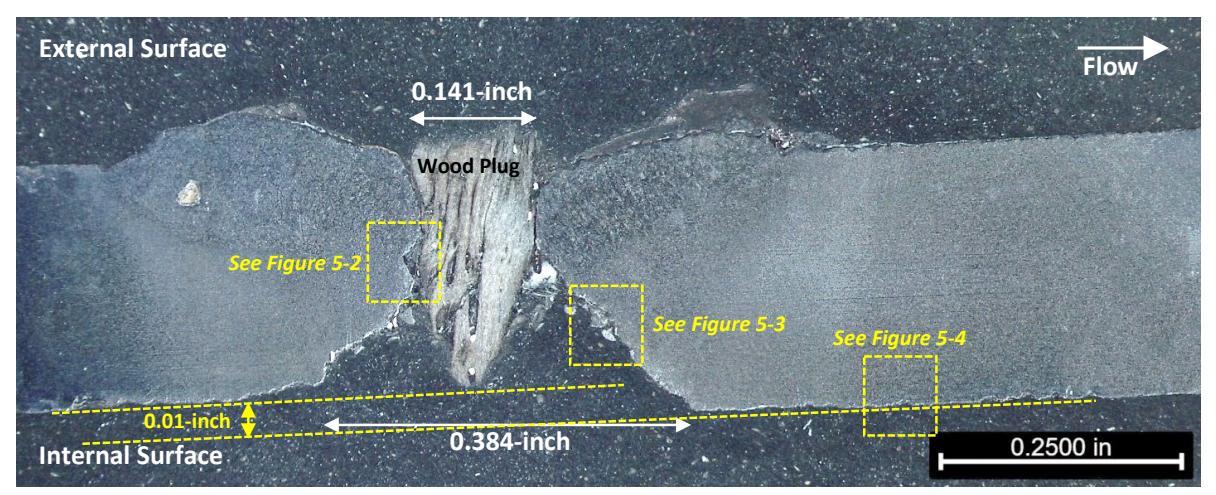
Figure 5-1: Photomicrograph across leak. Etchant is 2% Nital; original magnification is 0.6x.

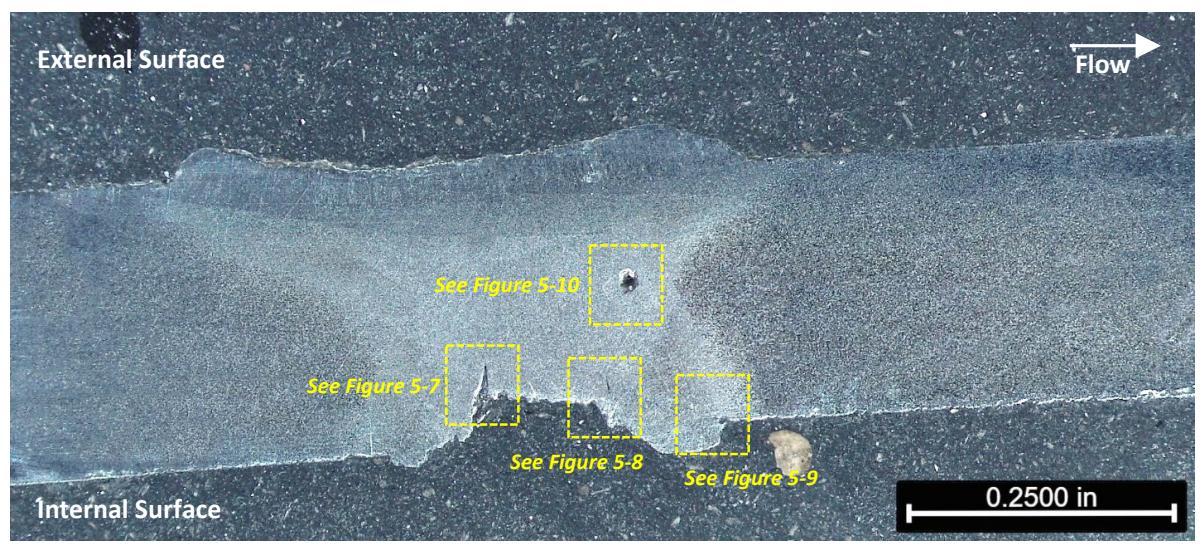
ADV prepared a metallurgical cross section through the 8-inch mark, approximately the 3:00 o'clock orientation, shown in Figure 5-6. The cross section appeared consistent with the visually identified region of suckback. Weld features were identified connecting to the internal pipe surface centered along the root and along the weld toe on one side of the weld, appearing consistent with lack of penetration. These features are shown in Figure 5-7 through Figure 5-9. Minor wall loss along the internal surface was identified, appearing consistent with internal corrosion. A volumetric feature, appearing consistent with porosity, was identified within the weld metal, shown in Figure 5-10.

Figure 5-6: Photomicrograph across 8-inch mark. Etchant is 2% Nital; original magnification is 0.6x.

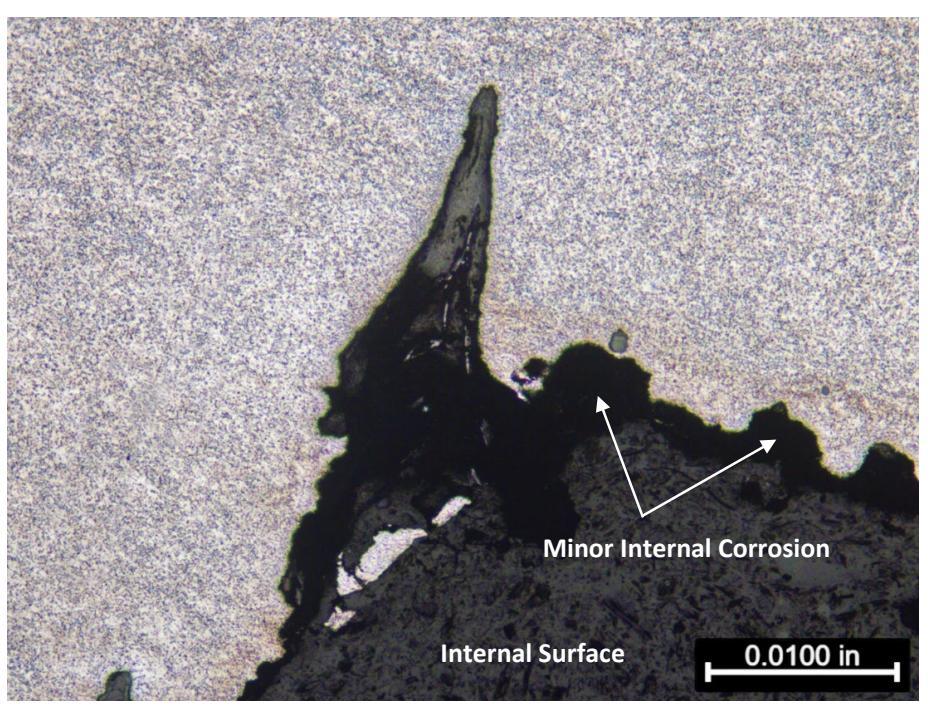
Figure 5-7: Photomicrograph of internal surface connected weld feature. Etchant is 2% Nital; original magnification is 100x.

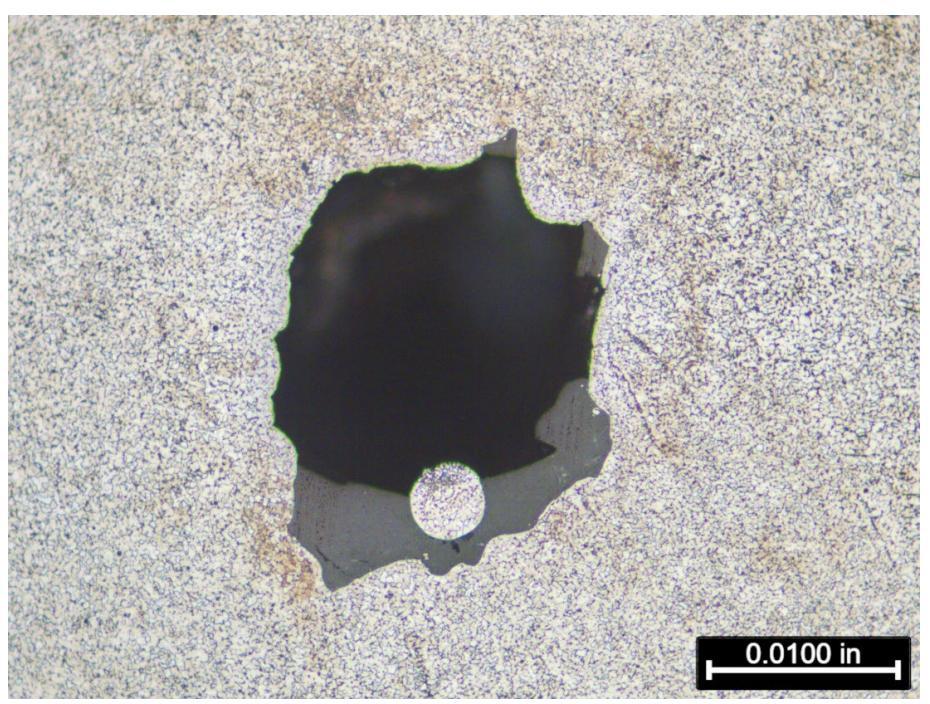
Figure 5-10: Photomicrograph of volumetric feature present within weld metal. Etchant is 2% Nital; original magnification is 100x.

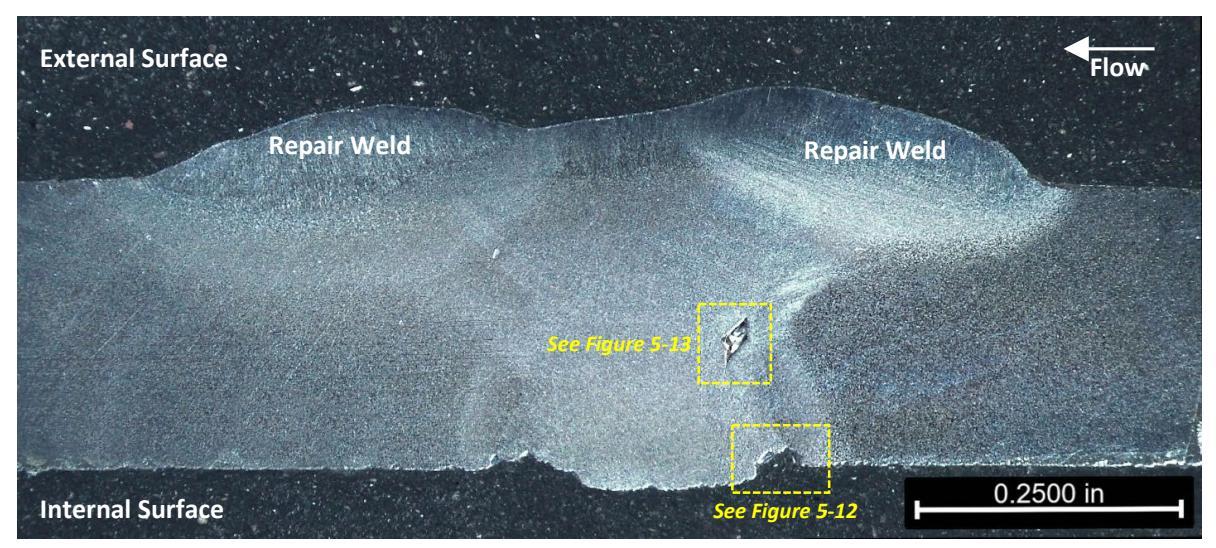
ADV prepared a metallurgical cross section through the 10-inch mark, approximately the 4:30 o'clock orientation, shown in Figure 5-11. The cross section appeared consistent with external surface weld repairs along the cap pass toes. An irregular, rounded internally connected feature was identified along the original root's toe, shown in Figure 5-12. This feature appears consistent with internal undercut, potentially altered via minor internal corrosion. A volumetric feature, appearing consistent with porosity, was identified within the original weld metal, shown in Figure 5-13.

Figure 5-11: Photomicrograph across 10-inch mark. Etchant is 2% Nital; original magnification is 0.6x.

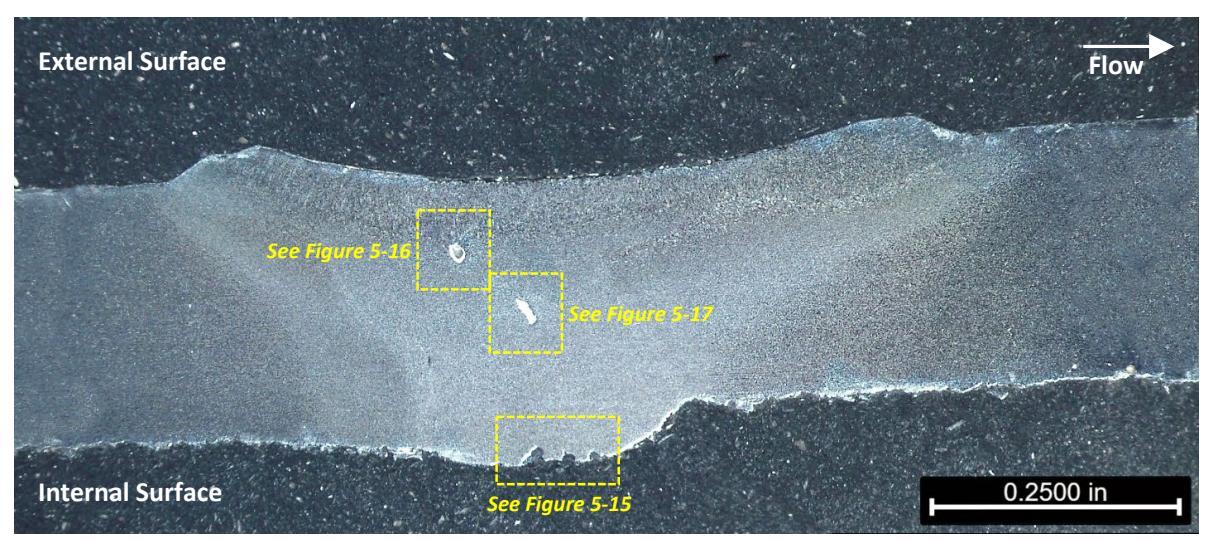
ADV prepared a metallurgical cross section through the 14-inch mark, approximately the 6:15 o'clock orientation, shown in Figure 5-14. The cross section appeared consistent with a concave cap pass. Several irregular, rounded internally connected features were identified along the weld, shown in Figure 5-15. These features appeared consistent with internal corrosion. Two volumetric features was identified within the weld metal, shown in Figure 5-16 and Figure 5-17.

Figure 5-14: Photomicrograph across 14-inch mark. Etchant is 2% Nital; original magnification is 0.6x.

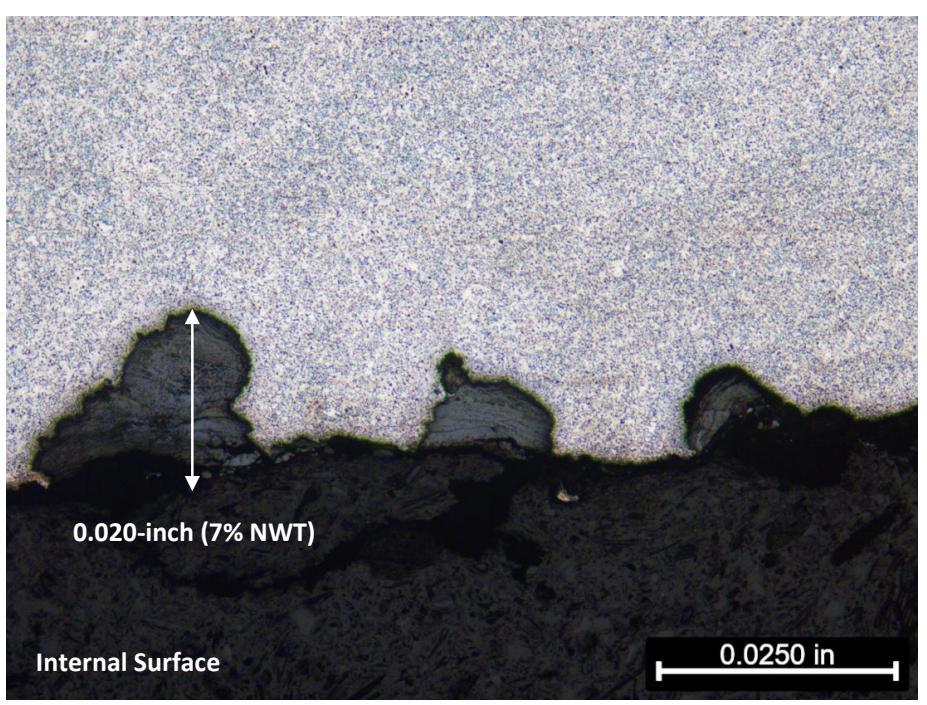
Figure 5-15: Photomicrograph of wall loss present along the internal surface of the weld. Etchant is 2% Nital; original magnification is 50x.

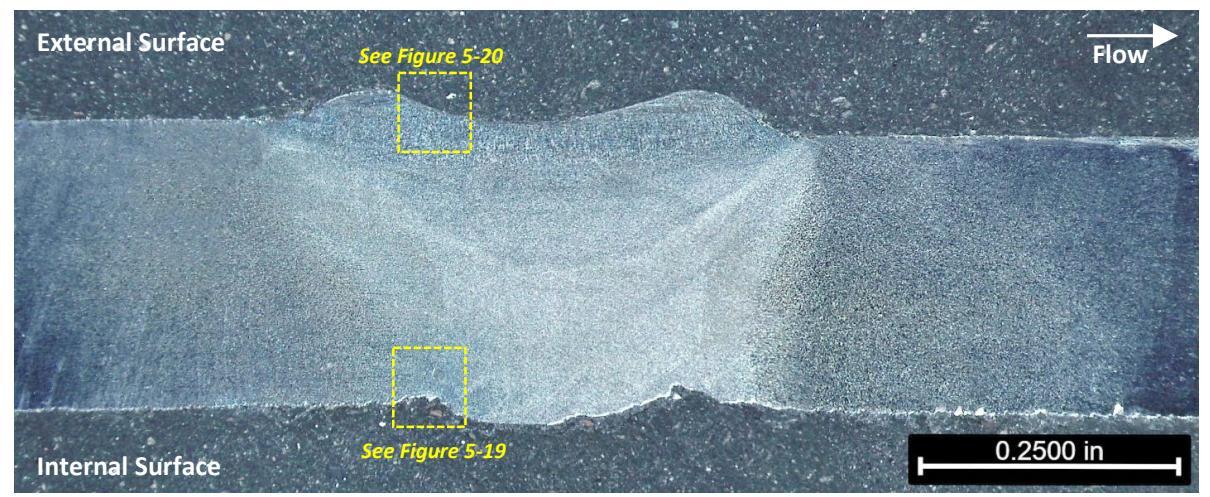
ADV prepared a metallurgical cross section through the 23-inch mark, approximately the 10:15 o'clock orientation, shown in Figure 5-18. An irregular, rounded internally connected feature was identified along the root's toe, shown in Figure 5-19. This feature appears consistent with internal undercut, potentially altered via minor internal corrosion. Weld solidification cracks were identified along the external weld pass, shown in Figure 5-20.

Figure 5-18: Photomicrograph across 23-inch mark. Etchant is 2% Nital; original magnification is 0.6x.

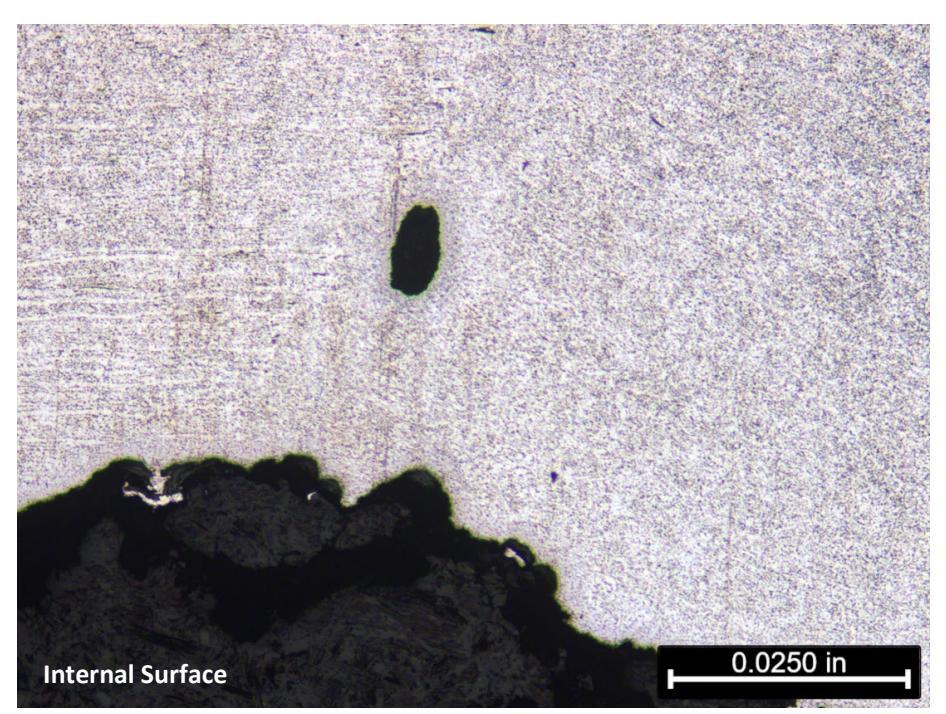
Figure 5-19: Photomicrograph of internal surface connected weld feature. Etchant is 2% Nital; original magnification is 50x.

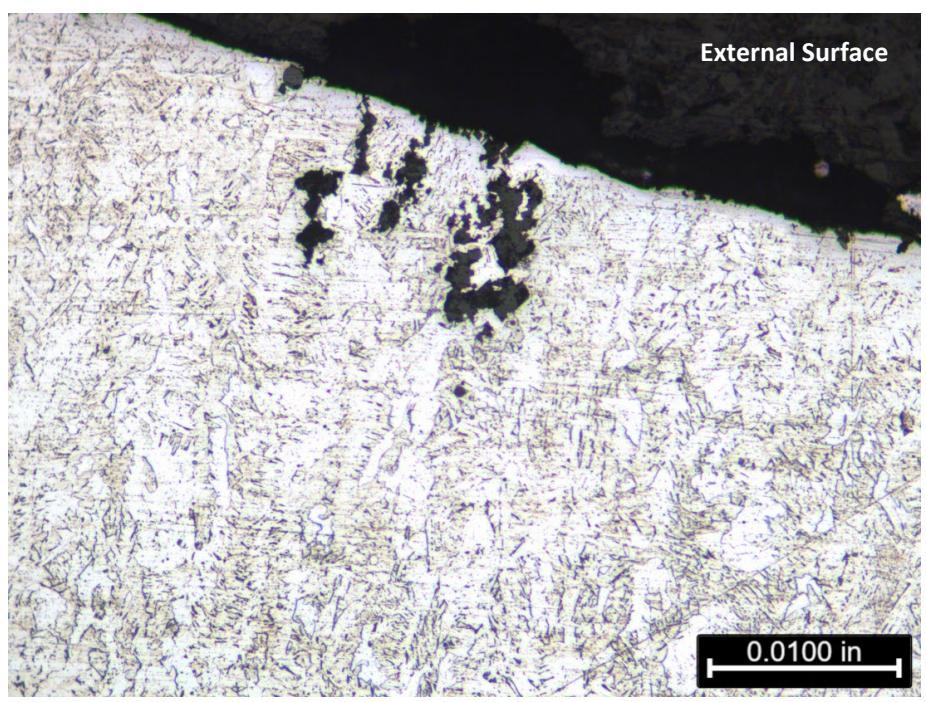
Figure 5-20: Photomicrograph of external surface connected weld feature. Etchant is 2% Nital; original magnification is 100x.

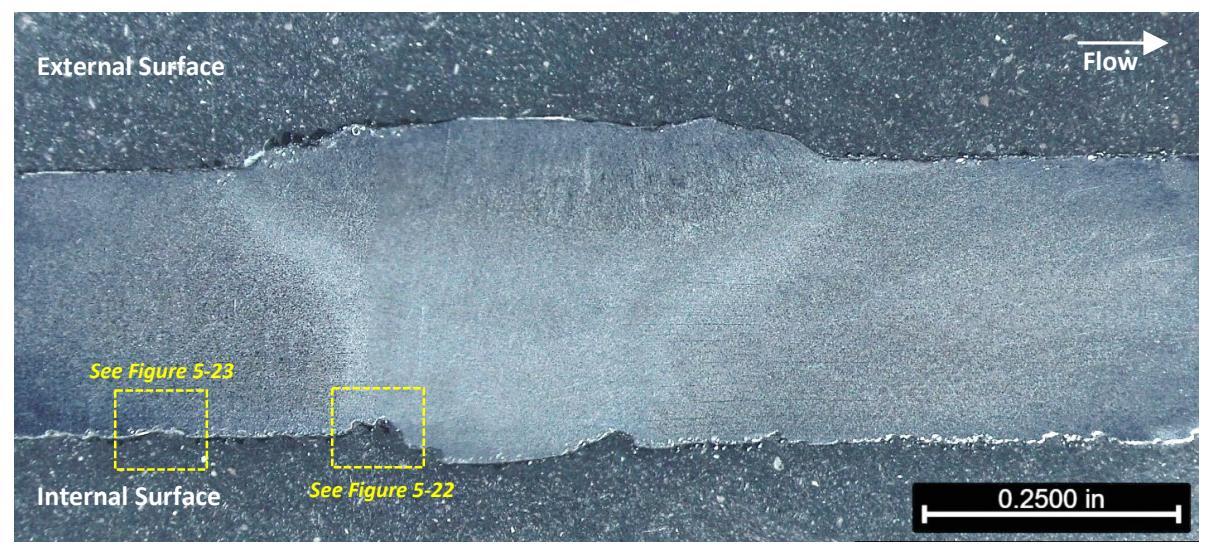
ADV prepared a metallurgical cross section through an intact portion of the girth weld, shown in Figure 5-21. Two irregular, rounded internally connected feature were identified along the root's toe, with the most significant shown in Figure 5-22. This feature appears consistent with internal undercut, potentially altered via minor internal corrosion. Several irregular, rounded internally connected features were identified along the base pipe adjacent to the girth weld, shown in Figure 5-23. These features appeared consistent with internal corrosion.

Figure 5-21: Photomicrograph across weld adjacent to leak. Etchant is 2% Nital; original magnification is 0.6x.

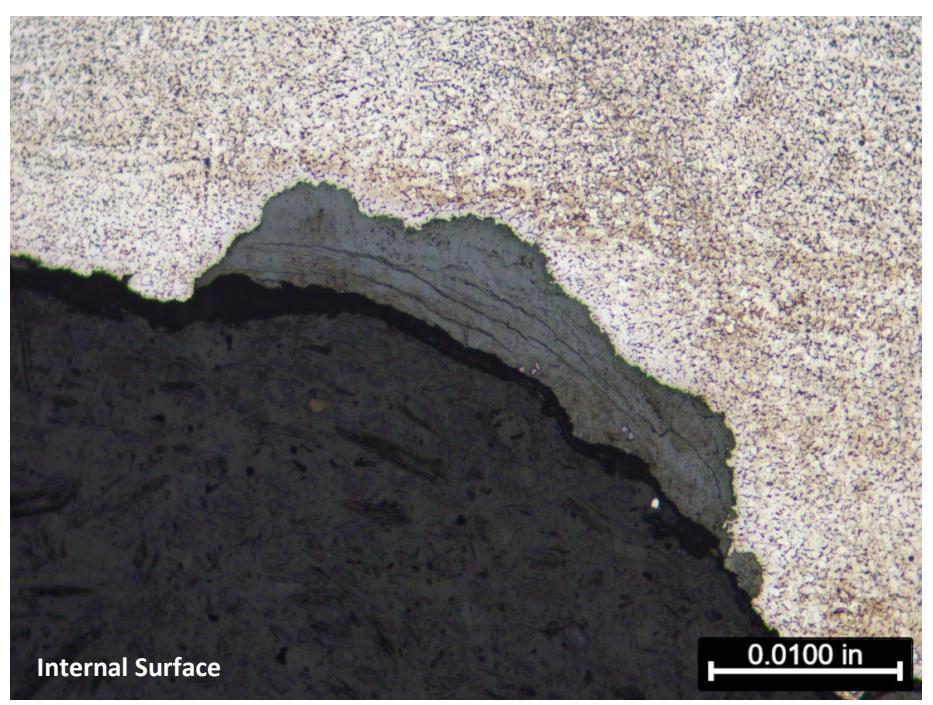
Figure 5-22: Photomicrograph of wall loss present along the internal surface of the weld. Etchant is 2% Nital; original magnification is 100x.

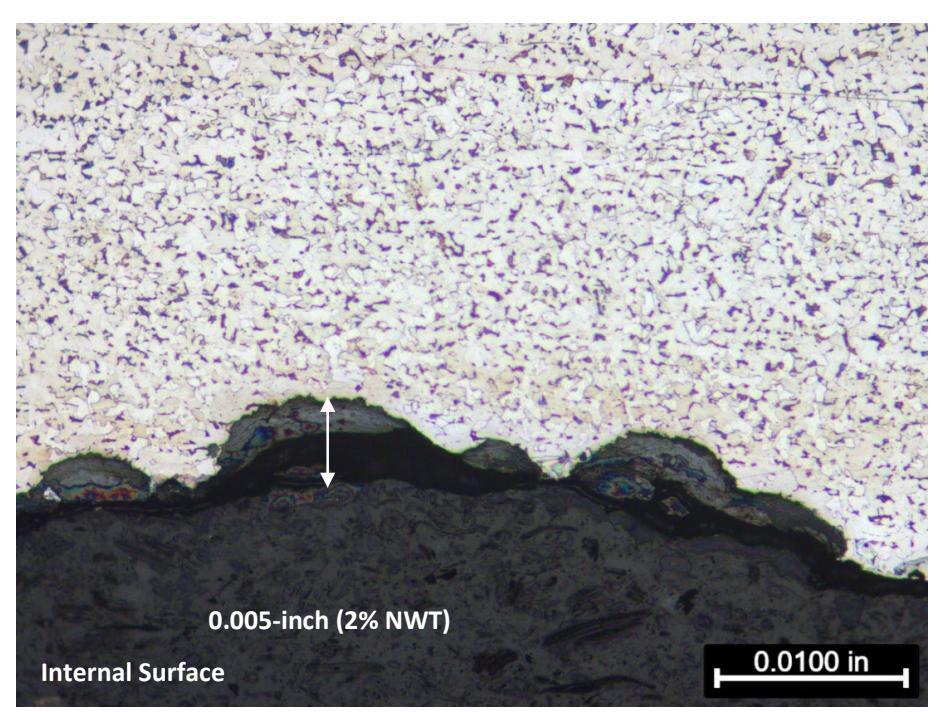
Figure 5-23: Photomicrograph of wall loss present along the internal surface adjacent to the weld. Etchant is 2% Nital; original magnification is 100x.
