**Digital Wave Corporation** 13760 East Arapahoe Road Centennial, CO 80112

Use of Modal Acoustic Emission (MAE) for life extension of civilian self-contained breathing apparatus (SCBA) DOT-CFFC cylinders

# FINAL REPORT

Contract DTPH56-13-P-000029

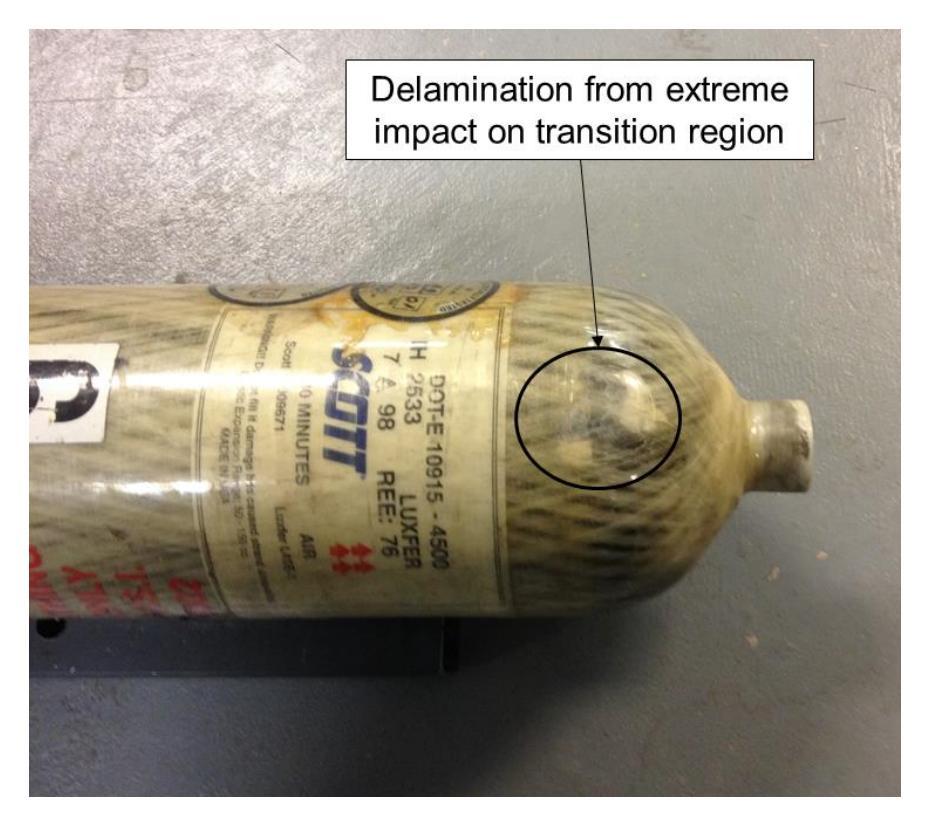
Figure 5.7 - Typical impact damage observed in the transition region of the SCBA cylinder as a result of the DOT/DWC extreme impact simulation.

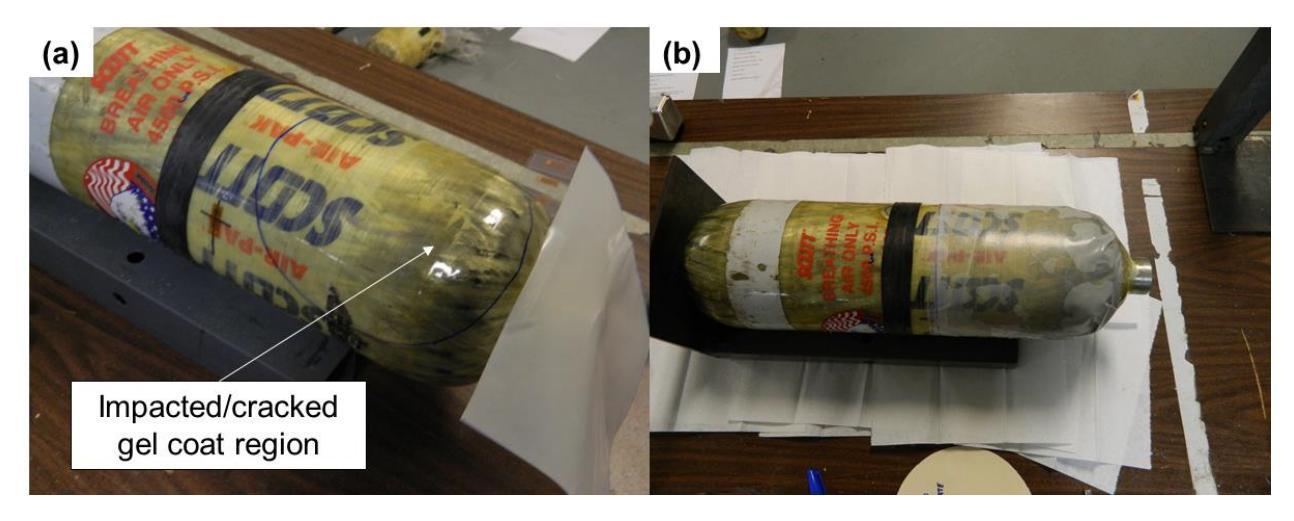
Figure 5.9 – (a) cracked region of the gel coat due to fifteen foot impact and 1,000 cycles with the 6" diameter sulfuric acid patch highlighted in blue, and (b) the protective polymer film used to cover sulfuric acid patch to prevent outgassing and corrosion of the high pressure system.

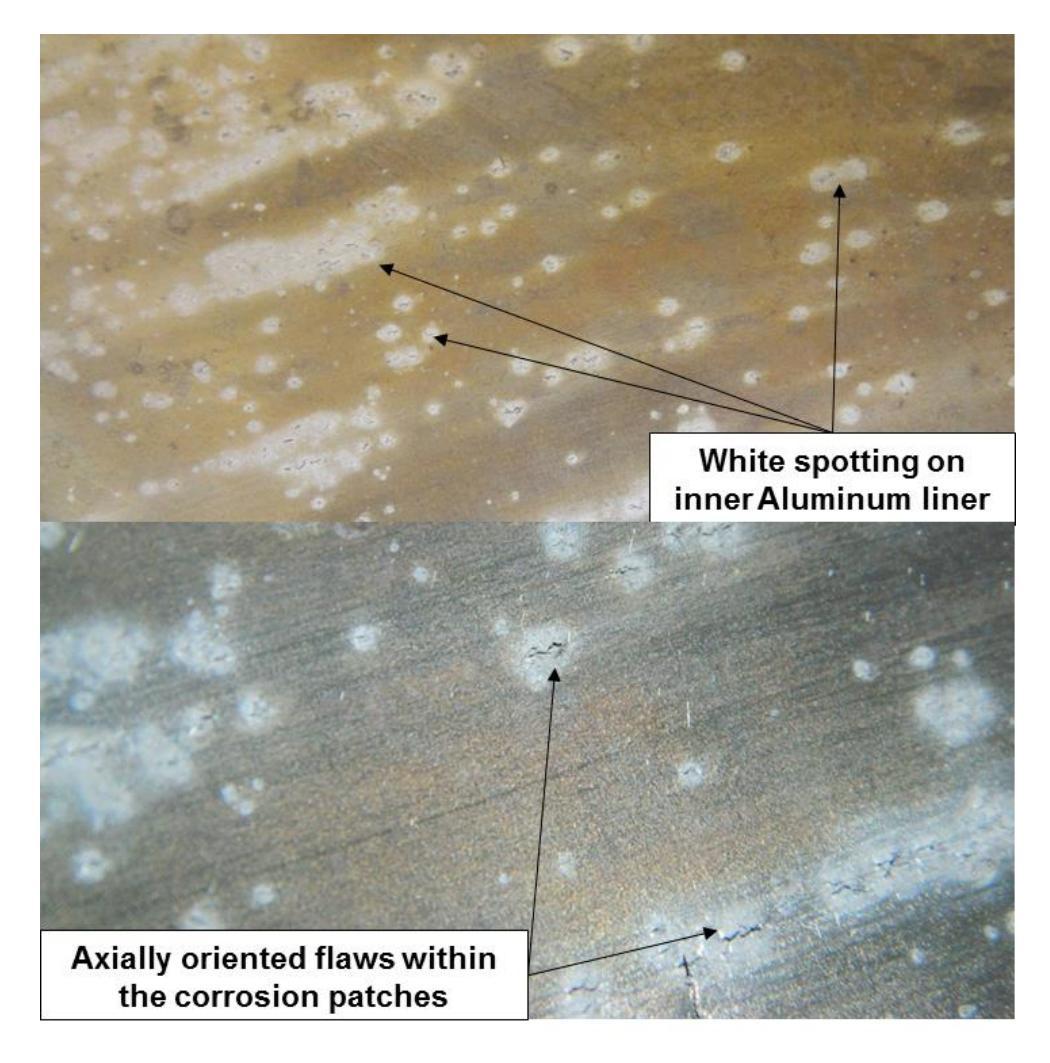
As was pointed out in Section 4.0, a large percentage (62.0%) of the civilian SCBA cylinders which were donated to the present study exhibited indications of corrosion of the aluminum liner. Most of the corrosion indications were in the form of white spotting on the internal wall of the aluminum liner (Figure 5.10a); this spotting is believed to be due to mineral deposits, resulting from prolonged exposure to hard water. However, the true significance of this type of corrosion was found from a piece of an aluminum liner after an EOL burst test, as shown in Figure 5.10b. From Figure 5.10b, a large number of minute flaws (having a preferential axial orientation) were discovered in the centers of the white spotting after the EOL burst test. The opened flaws were far more visible after the EOL burst test due to the fact that the aluminum liner was plastically deformed to such an extent as to open up the crack mouths. While these corrosion induced flaws do not reduce the ultimate burst pressure of the CFFC pressure cylinders, it will be shown in the following results sections and theoretically confirmed in Section 9.0 that cylinder leakage due to crack growth through the Aluminum liner during cyclic hydrostatic fatigue did occur due to these types of flaws acting as crack initiation sites.

Figure 5.10 – (a) common white spotting corrosion on the internal aluminum observed during the internal visual inspection, and (b) opened crack mouths (by means of an EOL burst test) found inside of the corrosion spots.

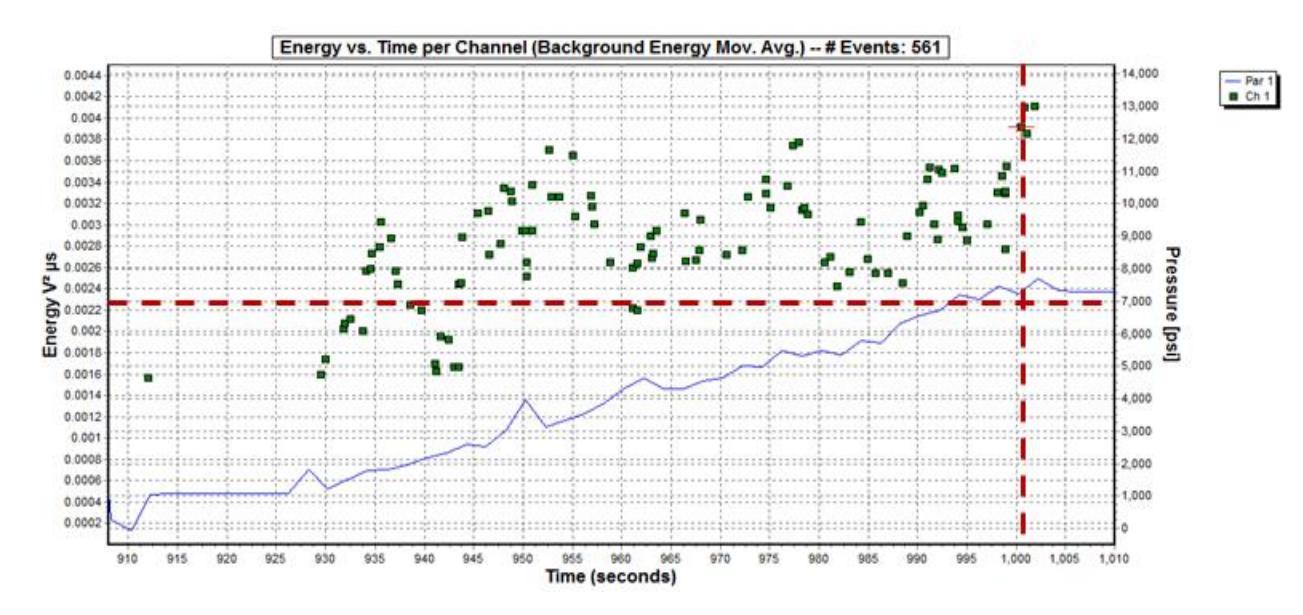
Figure 6.6 - BEO on the second test pressure cycle for ALT604 – 3742. Such an oscillation in the background energy caused the cylinder to fail the MAE life extension requirement.

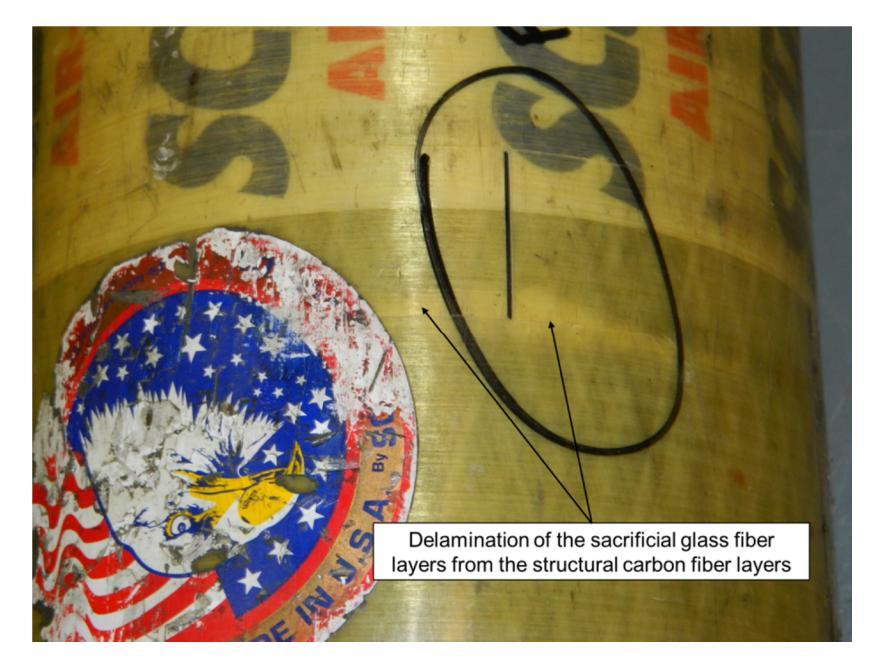
Figure 6.21 – Delamination of the sacrificial glass fiber layers from the structural carbon fiber layers as a result of cyclic fatigue.

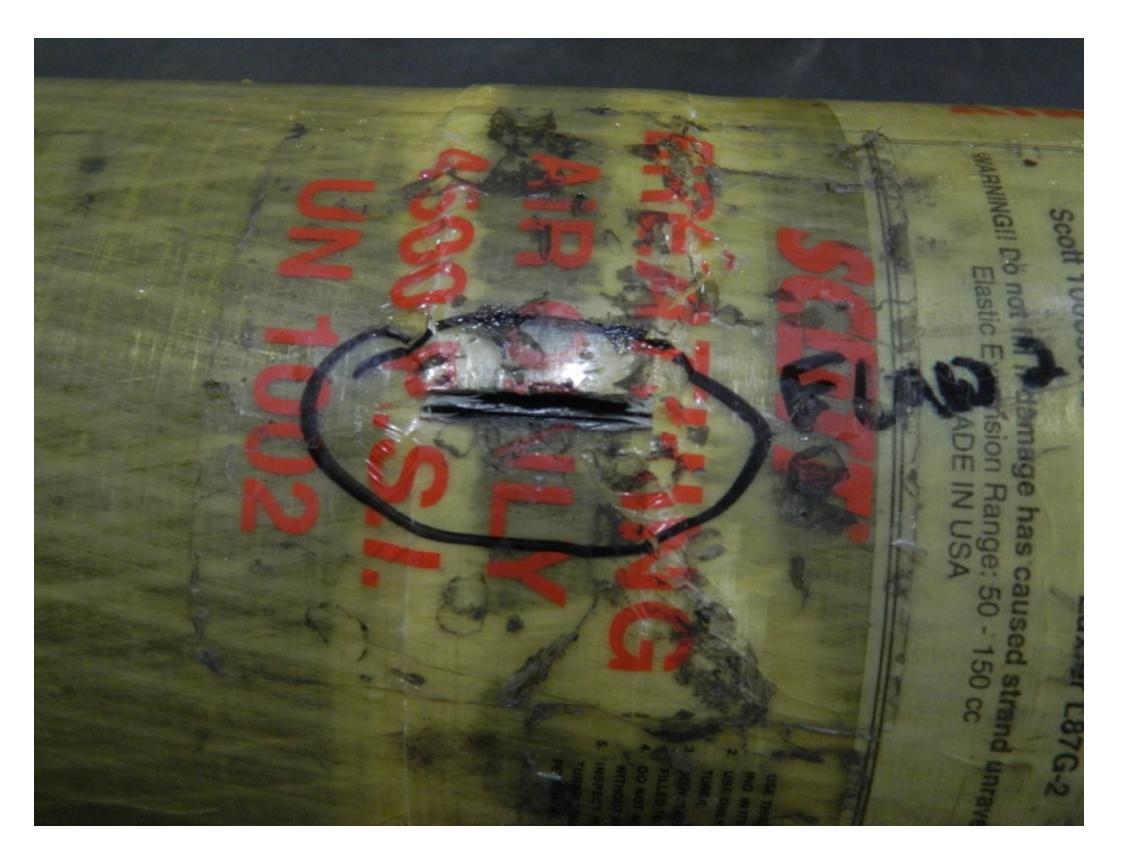
Figure 6.23 – Extreme amount of delamination originating from the axially oriented notch on a cylinder that was pressurized to 95% of its' burst pressure.

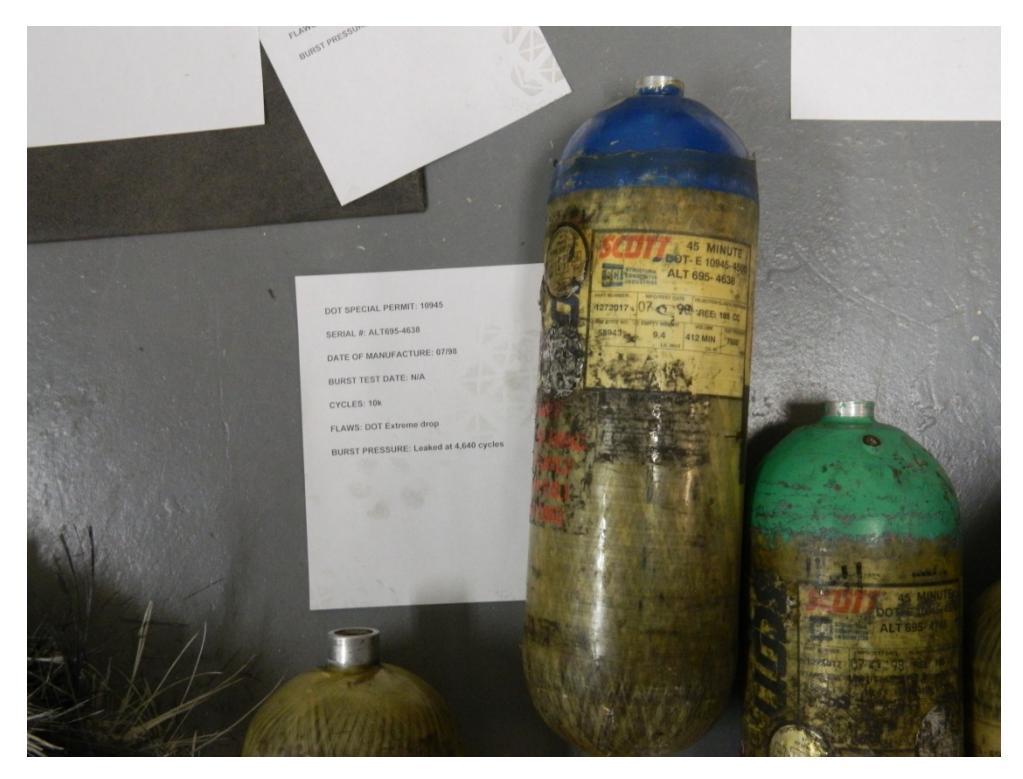
Figure 10.66 – Image of ALT695-4638, leaked after 4640 cycles.

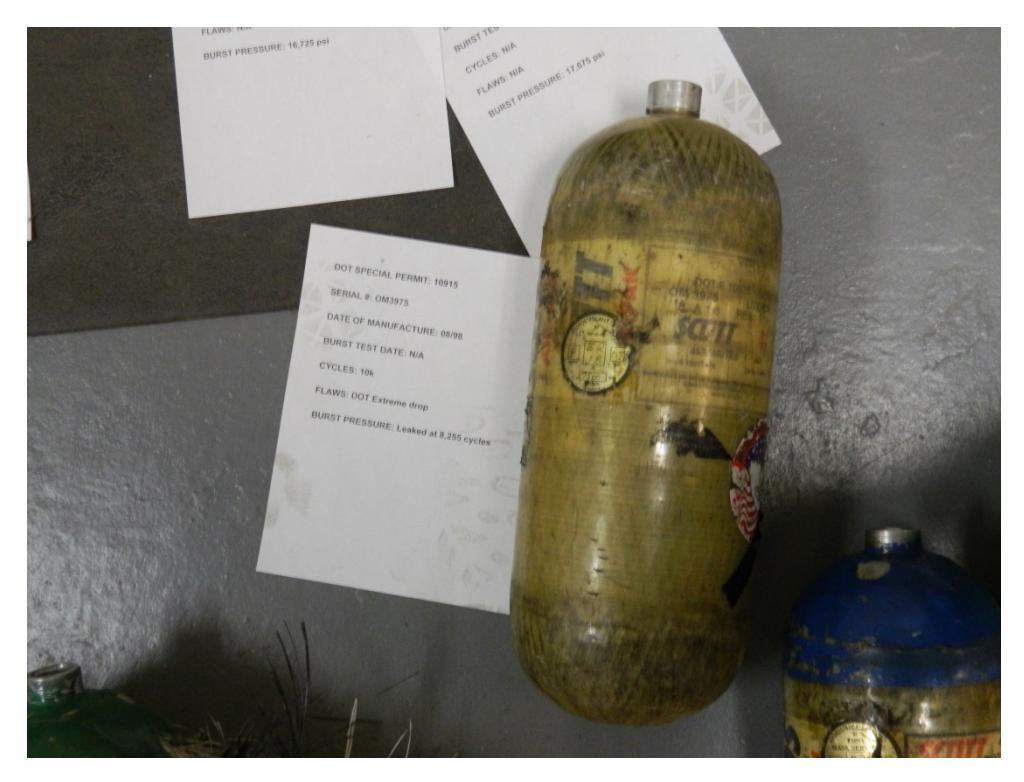
Figure 10.67 – Image of OM3957, leaked after 8,255 cycles.

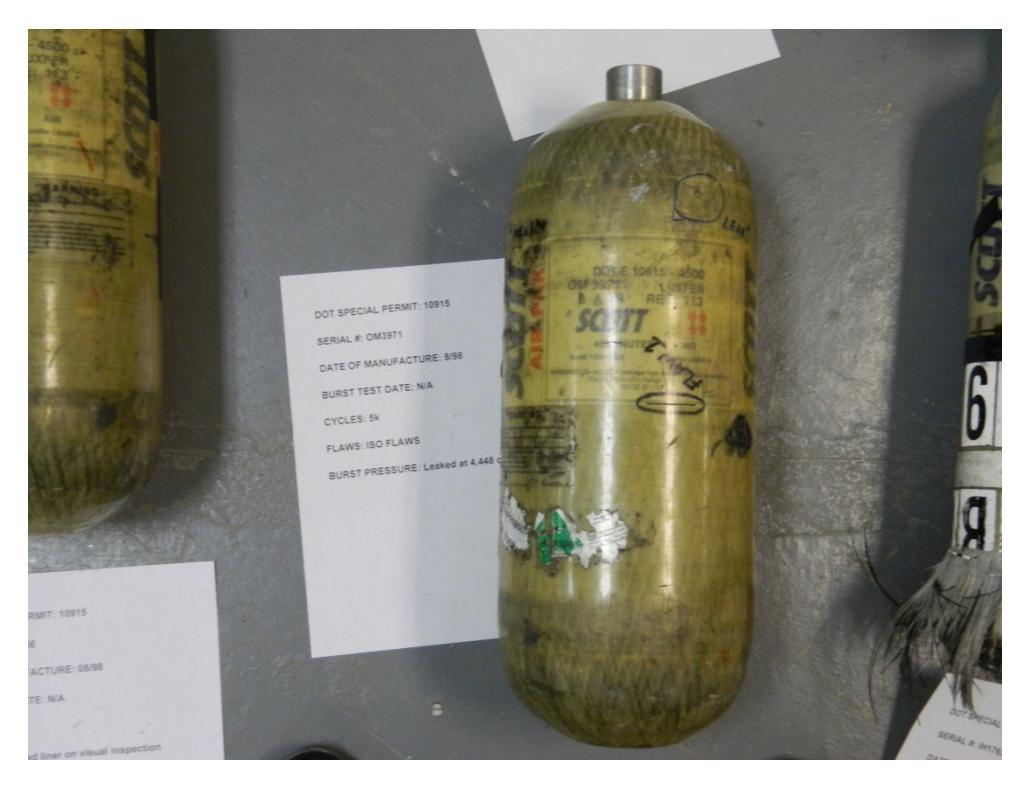
Figure 10.77 – Image of OM3957, leaked after 4,448 cycles.

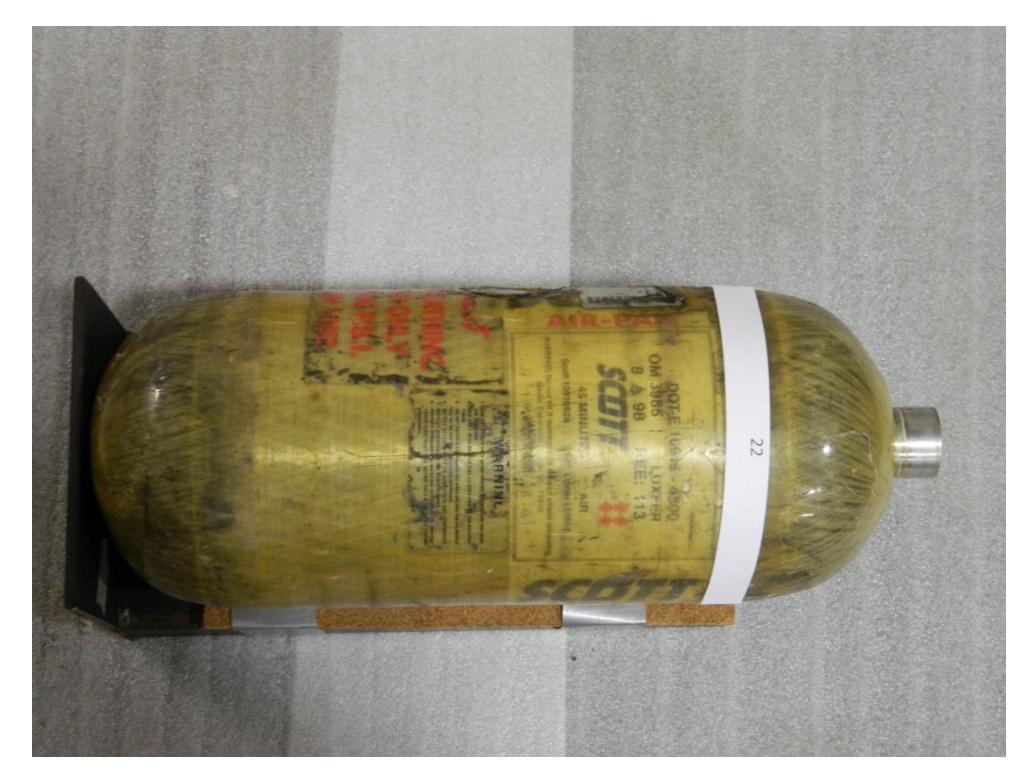
Figure 10.86 – Image of OM3985, leaked after 5,369 cycles.

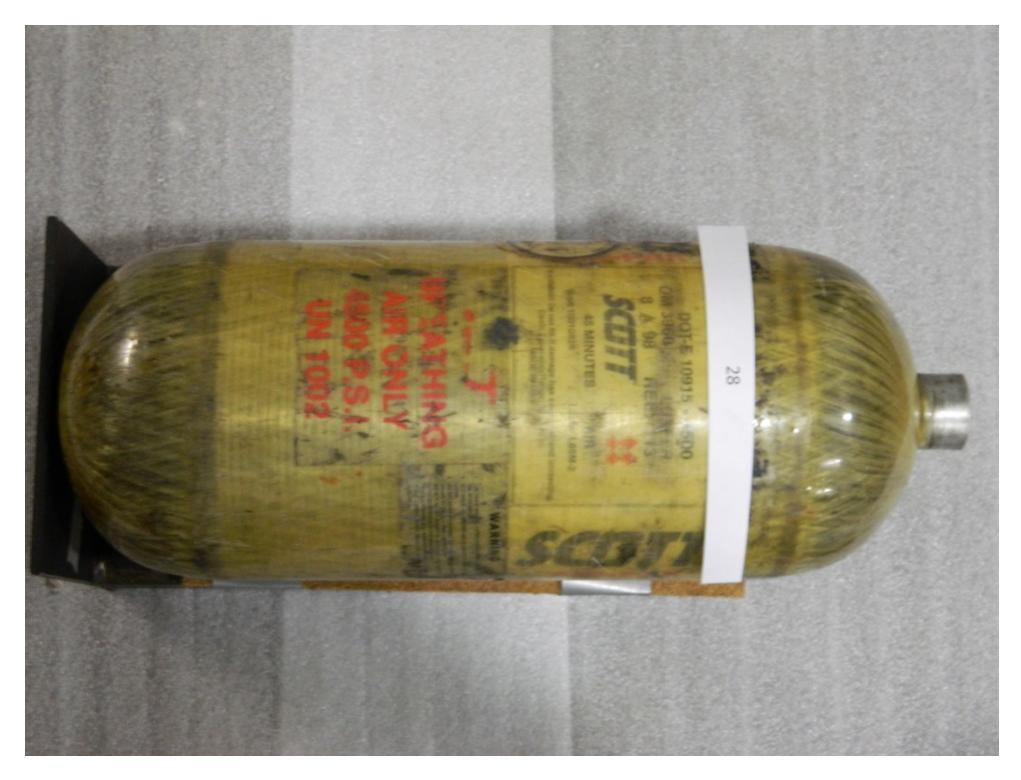
Figure 10.87 – Image of OM3960, leaked after 5,364 cycles.

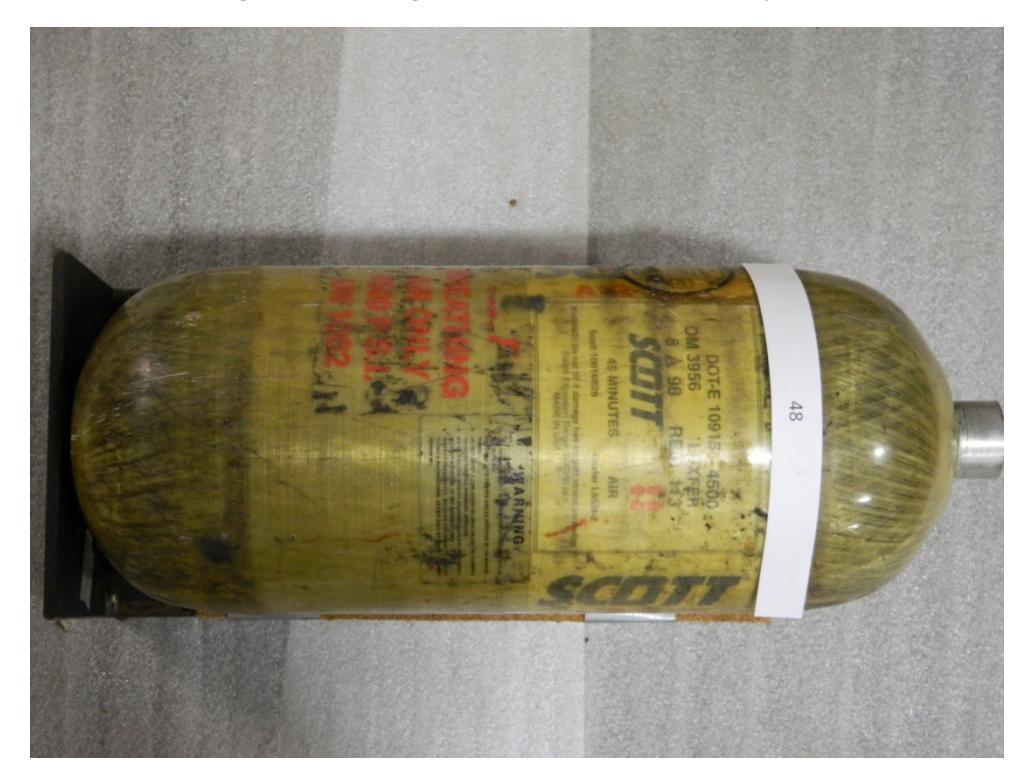
Figure 10.88 – Image of OM3956, leaked after 8,680 cycles.

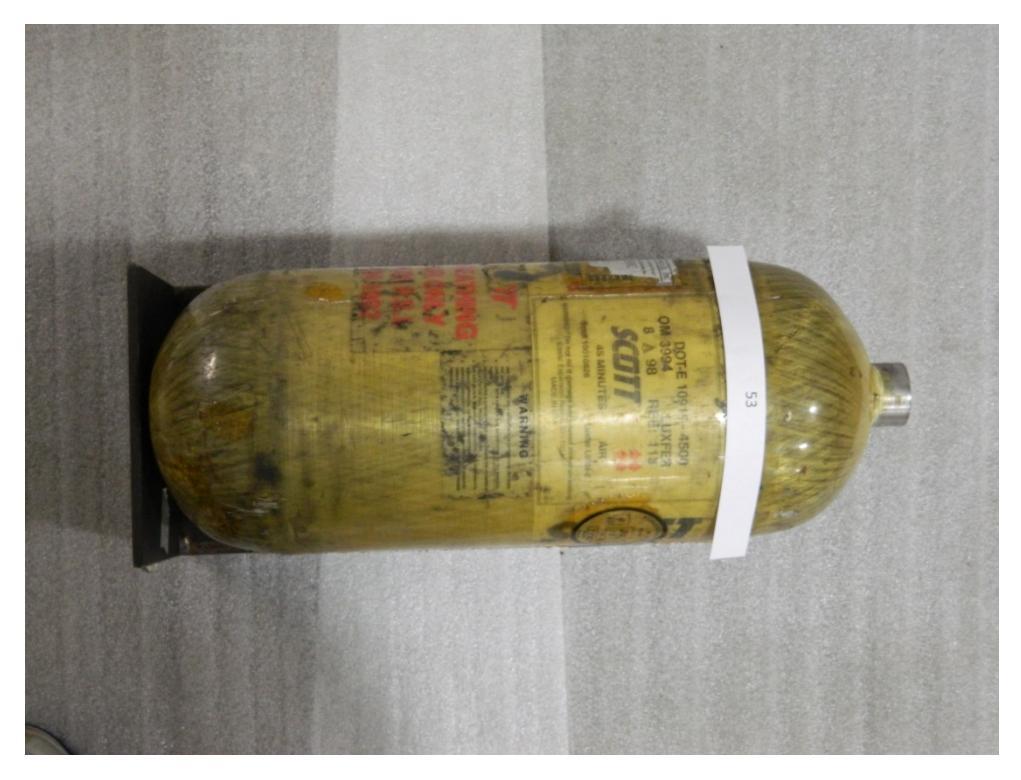
Figure 10.89 – Image of OM3994, leaked after 5,369 cycles.

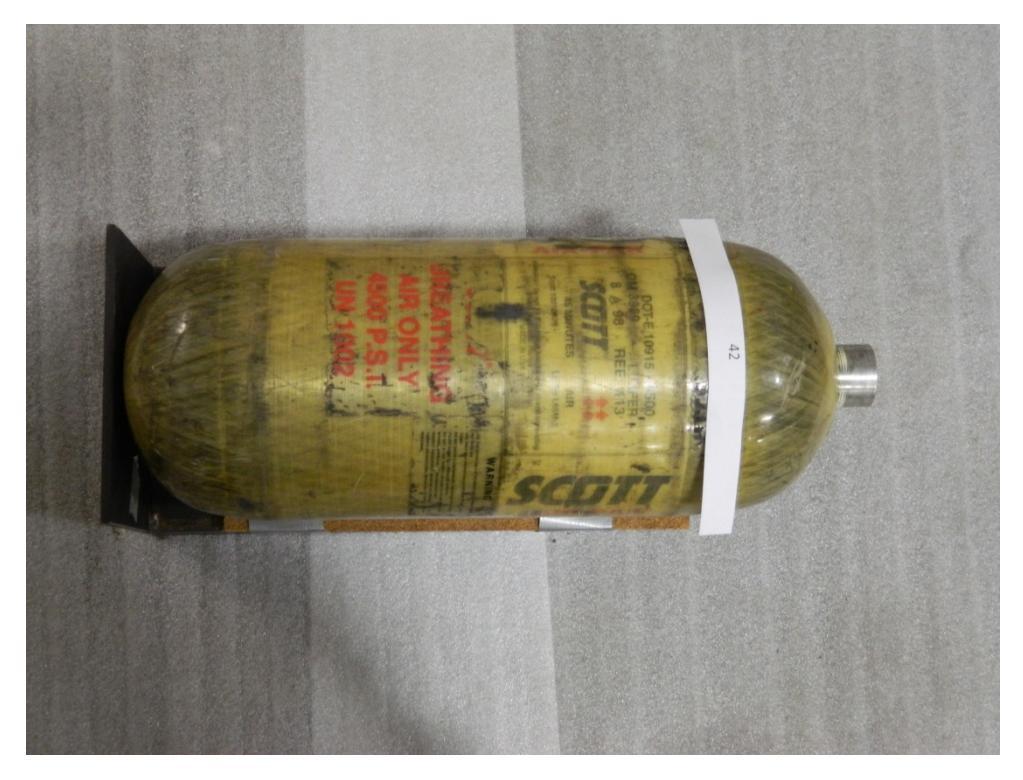
Figure 10.91 – Image of OM3969, leaked after 6,986 cycles.

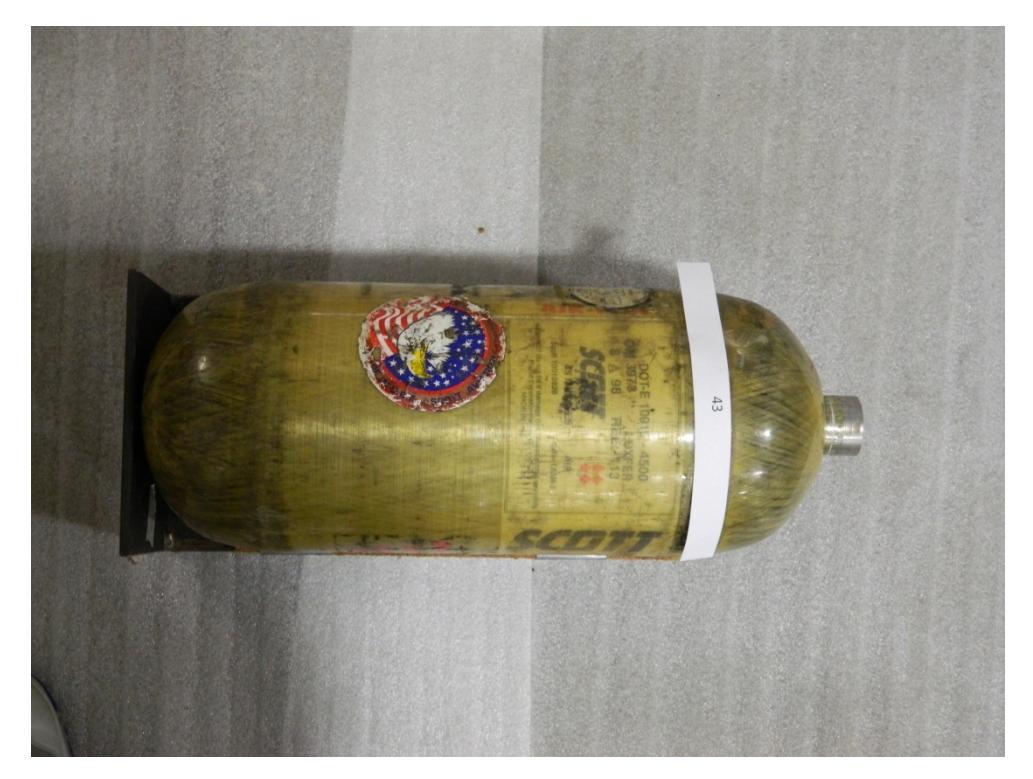
Figure 10.92 – Image of OM3973, leaked after 6,568 cycles.

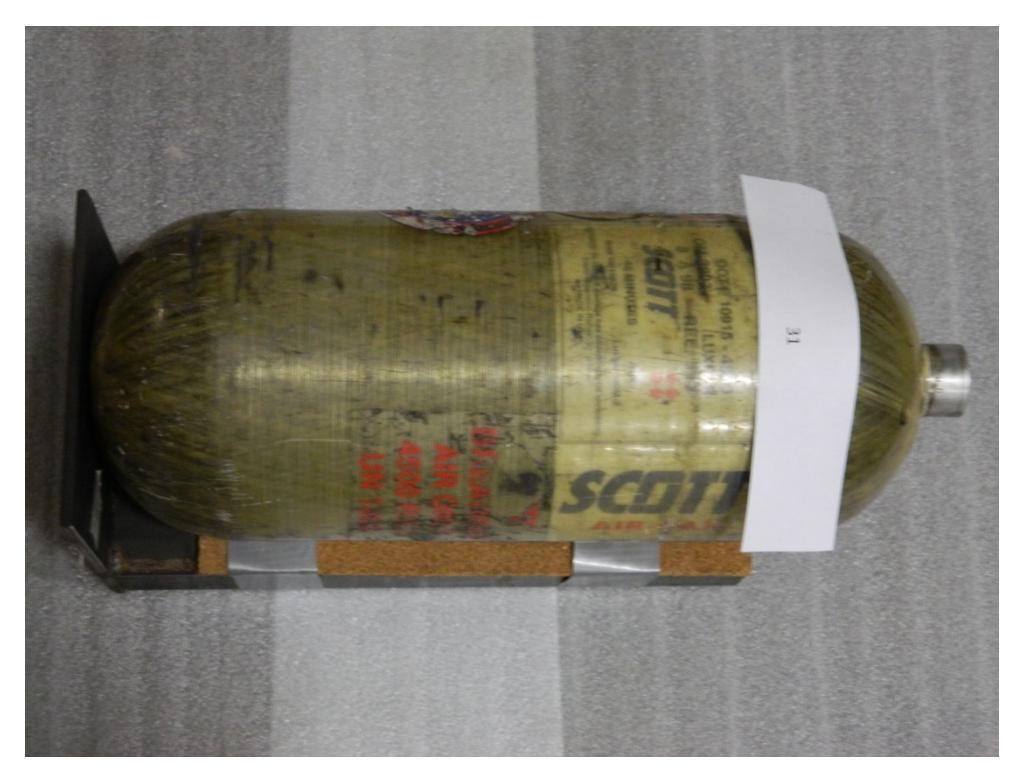
Figure 10.93 – Image of OM3985, leaked after 6,984 cycles.
