DOTUS Department of TransportationPHMSAPipelines and Hazardous Materials Safety AdministrationOPSOffice of Pipeline Safety
Southwest Region

| Principal Investigator | Jocelyn M. Kerl |
|---|--|
| Subject | Failure Investigation Report – Centurion Pipeline L.P. |

| Date of Failure | 08/02/15 |
|---|--|
| Type of Failure | Tank Mixer Failure |

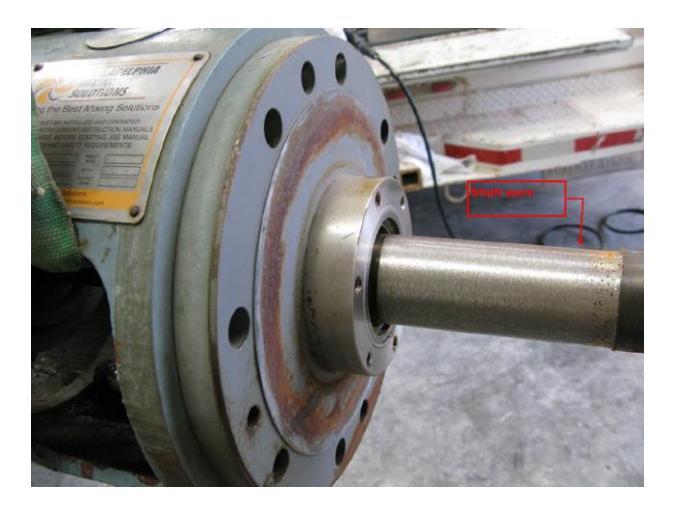
Centurion personnel conducted a failure investigation of the mixer. Centurion disassembled the mixer and found that, there was a failure of the sealed outboard bearing, which lead to the failure of the oil shut-off device. (see Appendix C)

Figure 4. Photograph – Worn Mixer Shaft Source: Failure Analysis of Centurion Pipeline – Wasson Station Tank 6830 Mixer Failure Investigation

The investigation identified that the cause of the accident was the failure of one of the sealed-for-life bearings on the Philadelphia Cutlass mixer. The design of the Philadelphia Cutlass Mixer was not a factor in this accident.

Centurion replaced the Philadelphia Cutlass (F) Fixed-Angle Side Entry Mixer with a Jensen Series Variable Angle Mixer on Monday, August 3, 2015 and Tank 6830 was returned to service. (See Appendix D)

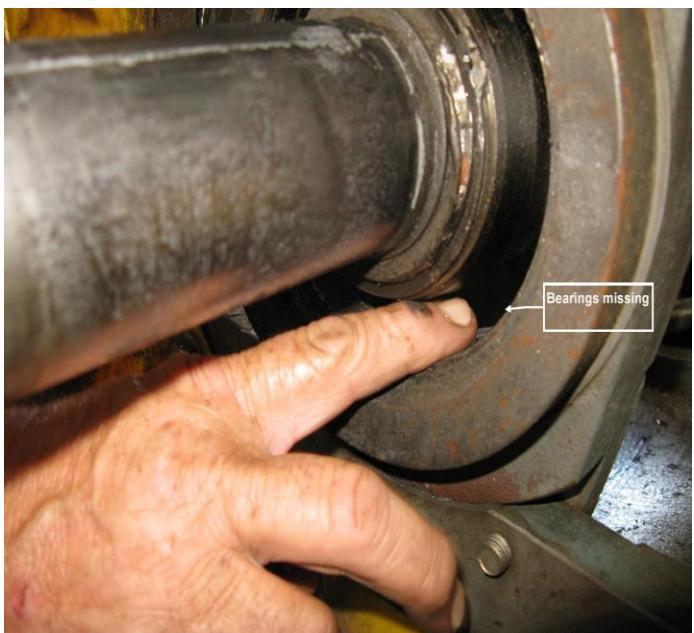
Figure 5. Photograph – Missing bearings on Mixer Source: Failure Analysis of Centurion Pipeline – Wasson Station Tank 6830 Mixer Failure Investigation
