# NATIONAL TRANSPORTATION SAFETY BOARD

MATERIALS LABORATORY FACTUAL REPORT

Place	: Amherst, South Dakota
Date	: November 16, 2017
Vehicle	: TransCanada Keystone pipeline
NTSB No.	: PLD18LR001
Investigator	: Kalu Kelly Emeaba, RPH-20

Section of pipeline and piece of concrete set-on pipeline weight.

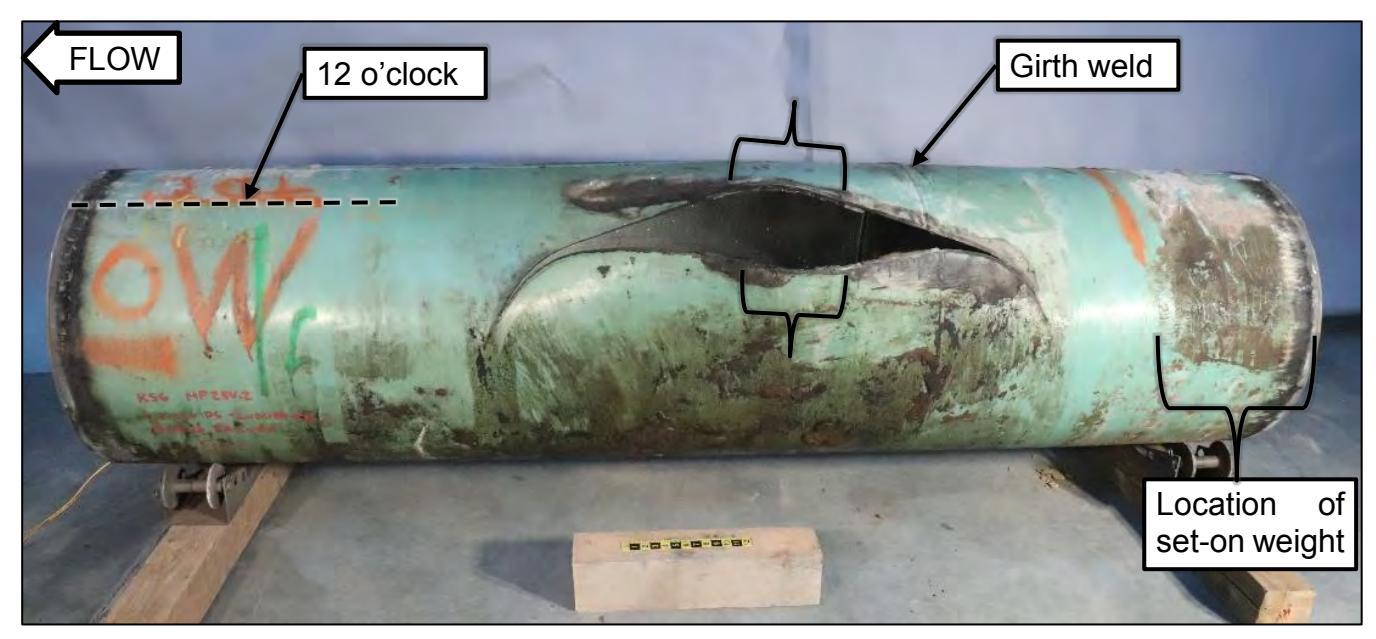
Overall views of the submitted components are shown in figures 1 and 2. The pipe section was approximately 9 feet 10 inches long and contained a rupture extending up to approximately 4 feet 4 inches long in the axial direction. At its widest point, the rupture opening was 11.25 inches wide. Unlabeled brackets in figure 1 indicate a portion of the fracture with flat fracture features perpendicular to the wall and curving crack-front arrest lines, features consistent with fatigue as described in the next subsection of this report.

Figure 1. Overall view of the pipe piece. Unlabeled brackets indicate the location of fatigue features on the fracture surface.

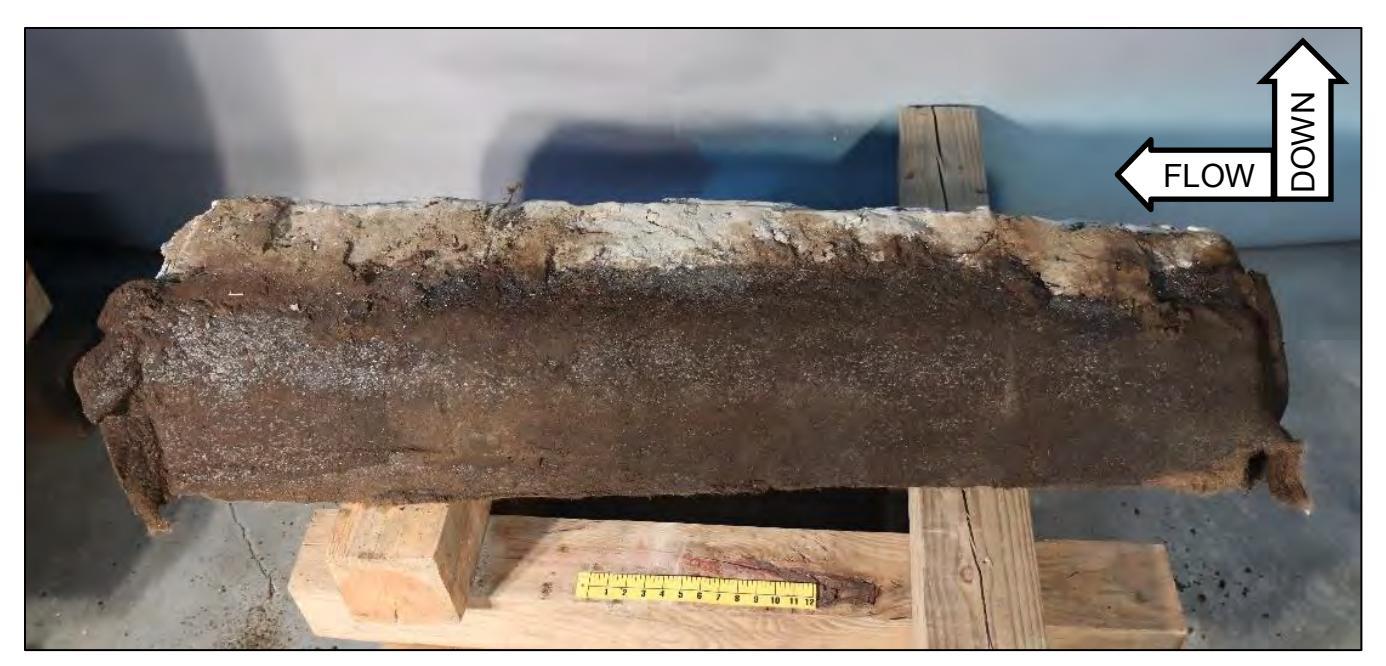
The lower face of the set-on weight piece shown in figure 2 was mostly covered with oily dirt deposits, but a piece of the upstream end corner between the exterior face and the lower face was fractured away and appeared relatively clean consistent with a recent fracture. The set-on weight piece was cleaned using a solution of Alconox and water and acetone as needed with a soft-bristle brush and wood scrapers to remove oil and dirt deposits on the surface, and the resulting cleaned piece is shown in figures 46 and 47. During the cleaning process, chunks of the corner between the exterior face and the lower face were chipped away with a wood brush handle in the area indicated in figure 47.

Figure 2. Lower end of a concrete set-on weight leg submitted for examination with the pipe piece.

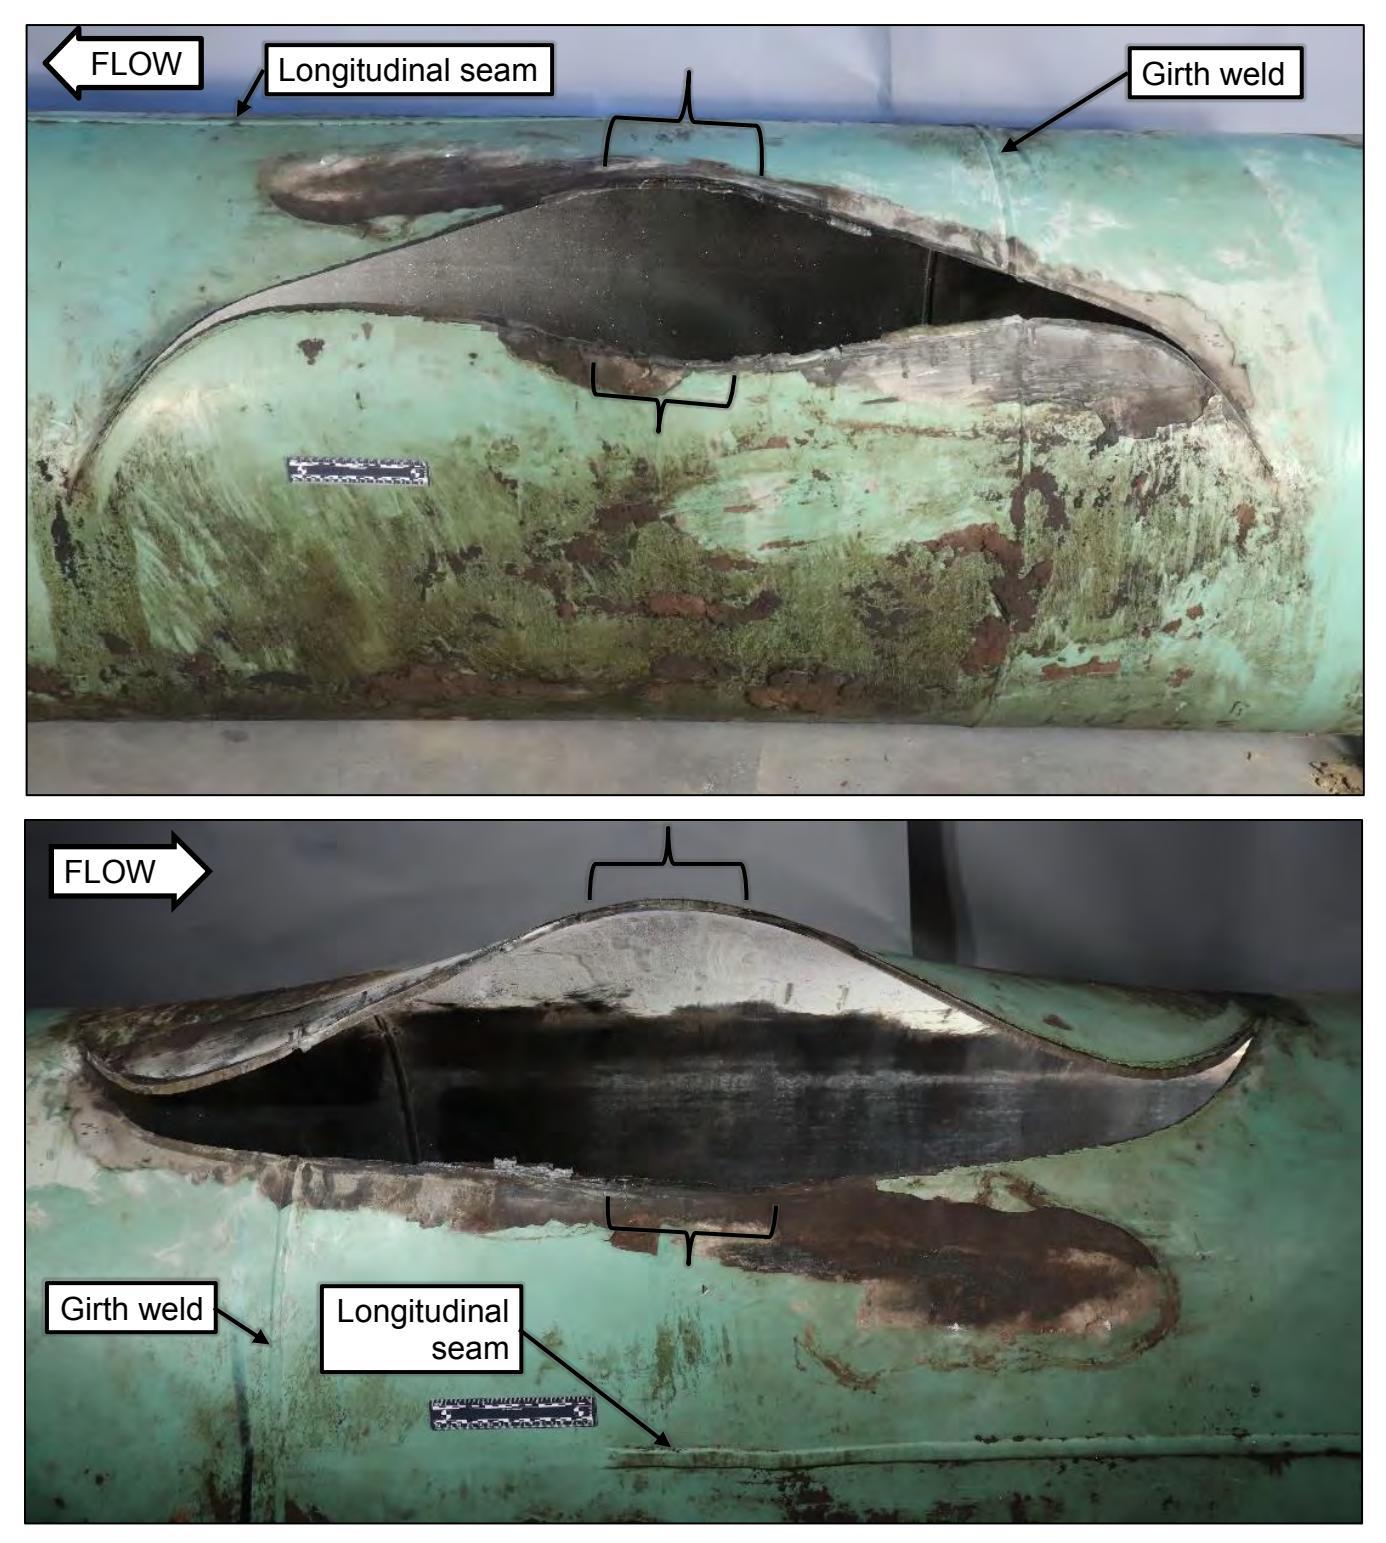
Closer views of the ruptured area of the pipe as received are shown in figure 3, and a view of the fracture surface at the origin area is shown in figure 4. The pipe section

Figure 3. Overall views of the pipe rupture. Unlabeled brackets indicate the location of fatigue features on the fracture surface.

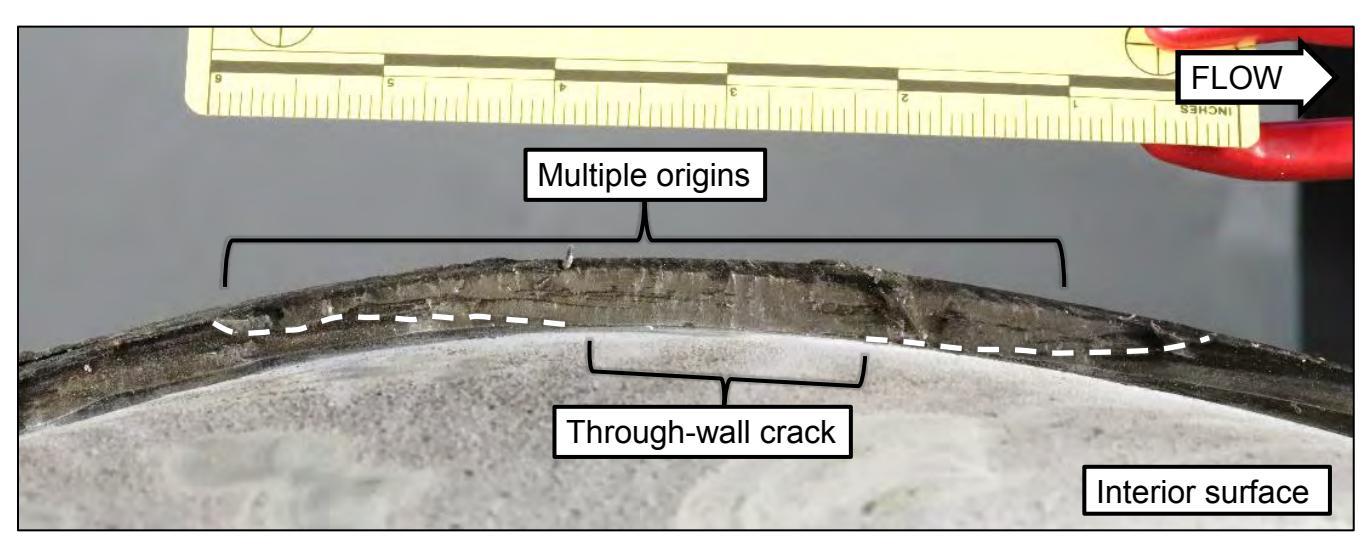
A closer view of the left side<sup>2</sup> of the fracture is shown in figure 4. A region of the fracture surface bounded by the dashed lines in figure 4 was relatively smoother and was perpendicular to the pipe wall, consistent with fatigue crack growth. Ratchet marks<sup>3</sup> were observed on the fracture surface, and curving crack-front arrest lines were consistent with fatigue emanating from multiple origins near the exterior surface as indicated with a bracket in figure 4. Near the middle of the fatigue region, the fatigue region intersected the interior surface along a length of 1.95 inches as indicated in figure 4. The fatigue region measured up to 5.52 inches long, and the depth was up to the full wall thickness of 0.3921 inch as measured with a ball-flat micrometer near the origin area.

Figure 4. Closer view of the left side of the fracture showing the fatigue region.

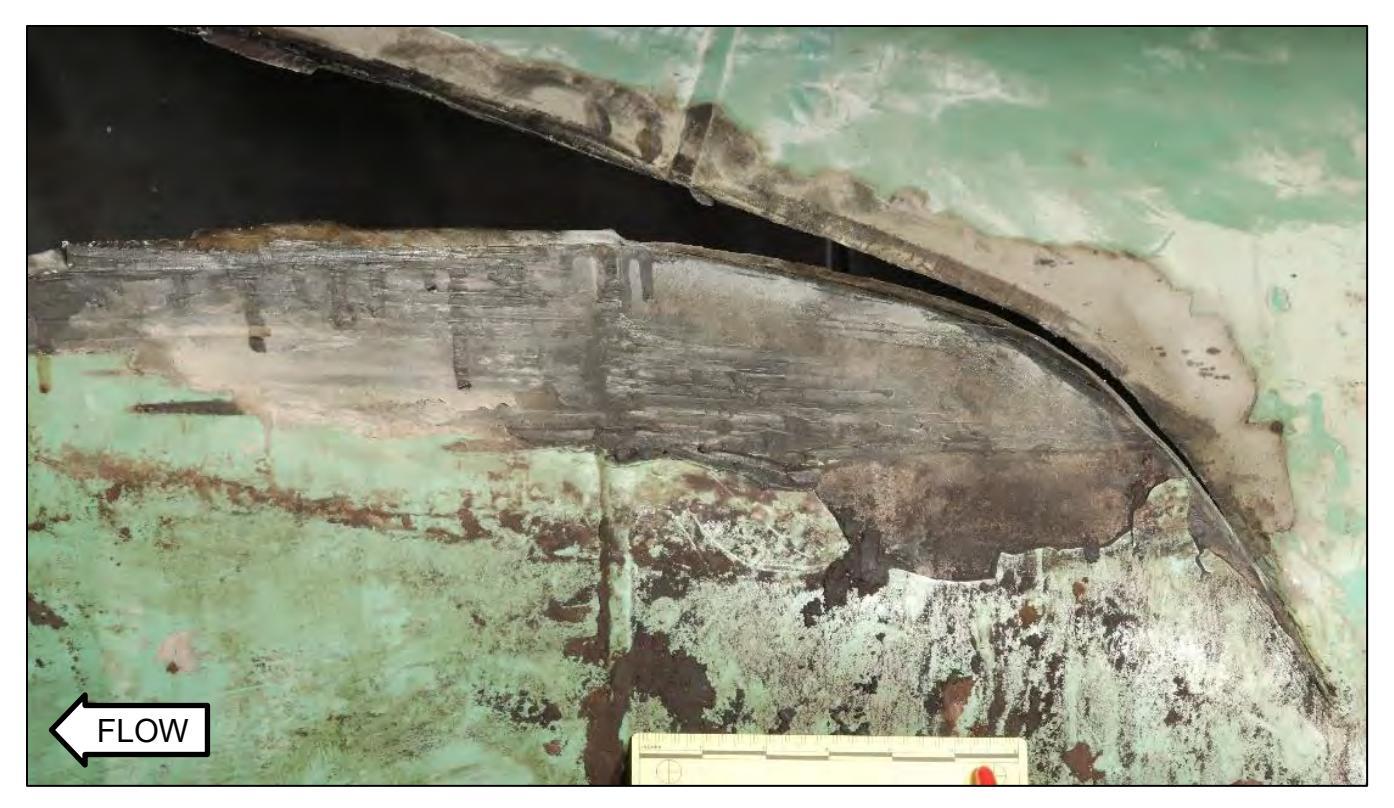
Areas of the exterior surface adjacent to the fracture surface had missing coating, and exposed metal surface areas were disturbed with sliding contact marks. The sliding contact marks were observed on both sides of the fracture as shown in figures 5 through 7 and were mostly aligned nearly parallel to the longitudinal axis of the pipe. On the counterclockwise side of the fracture shown in figure 5, the area of sliding contact marks extended up to 9 inches upstream of the girth weld and up to 21.5 inches downstream of the girth weld, including the surface adjacent to the fatigue region. The circumferential width of the sliding contact area measured up to 3.5 inches wide measuring counterclockwise from the fracture.

Figure 5. Sliding contact marks and missing coating on the surface adjacent to the left side of the fracture viewed as-received before cleaning.

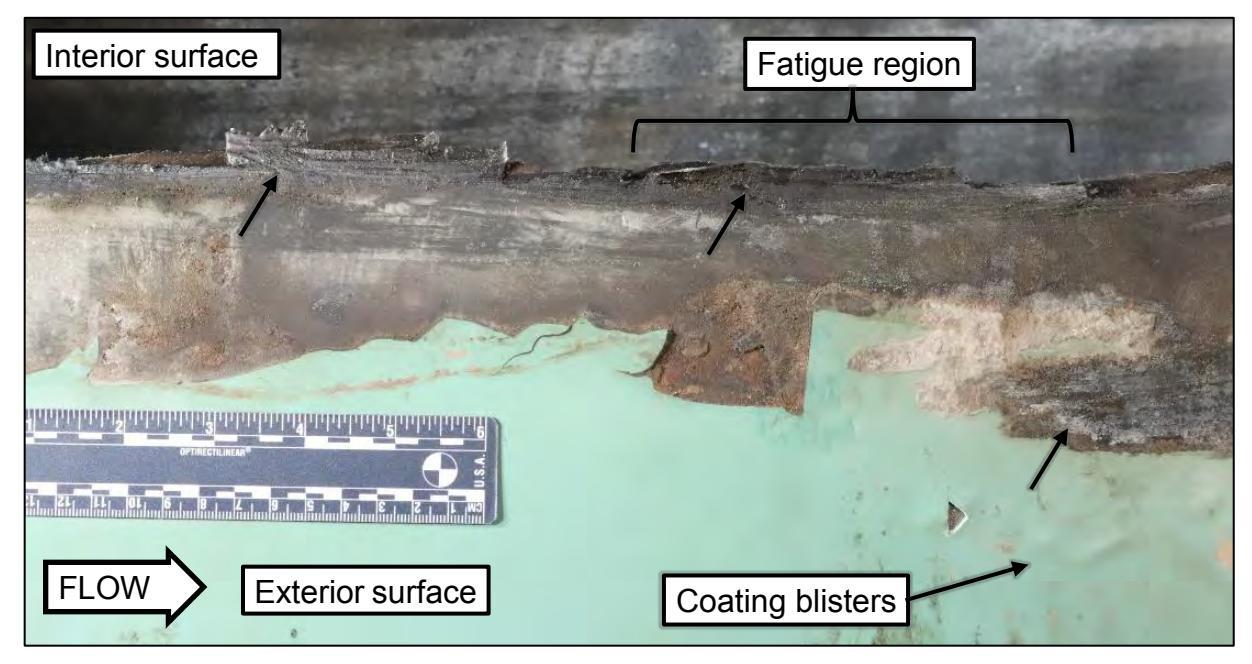
On the clockwise side of the fracture shown in figures 6 and 7, sliding contact marks were present in two separate areas. In the upstream area shown in figure 6, sliding

contact marks were located adjacent to the fracture surface including the fatigue region in an area between 2 inches to 21.75 inches from the girth weld and within 1.5 inches of the fracture surface. In a separate area located further clockwise from the fracture, sliding contact marks were observed between 16.5 inches and 36 inches from the girth weld. The area of contact marks was up to 6.5 inches wide starting 2.75 inches counterclockwise from the longitudinal seam, an area that included the 12 o'clock position. The upstream end of this region is shown in figure 6 adjacent to the coating blisters, and the downstream end is shown in figure 7.

Figure 6. Pipe surface adjacent to the right side of the fracture. Unlabeled arrows indicate sliding contact marks on the surface.

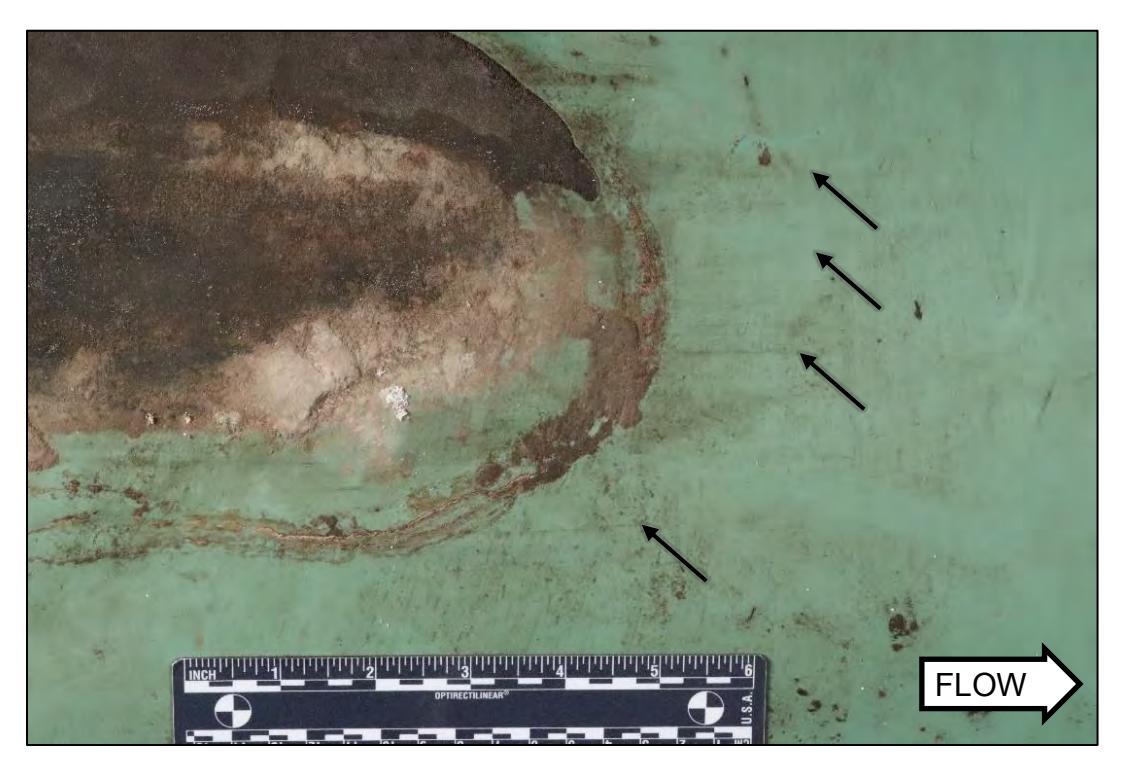
Figure 7. Downstream end of the sliding contact marks located at the top of the pipe. Unlabeled arrows indicate sliding contact marks on the exterior surface of the intact coating.

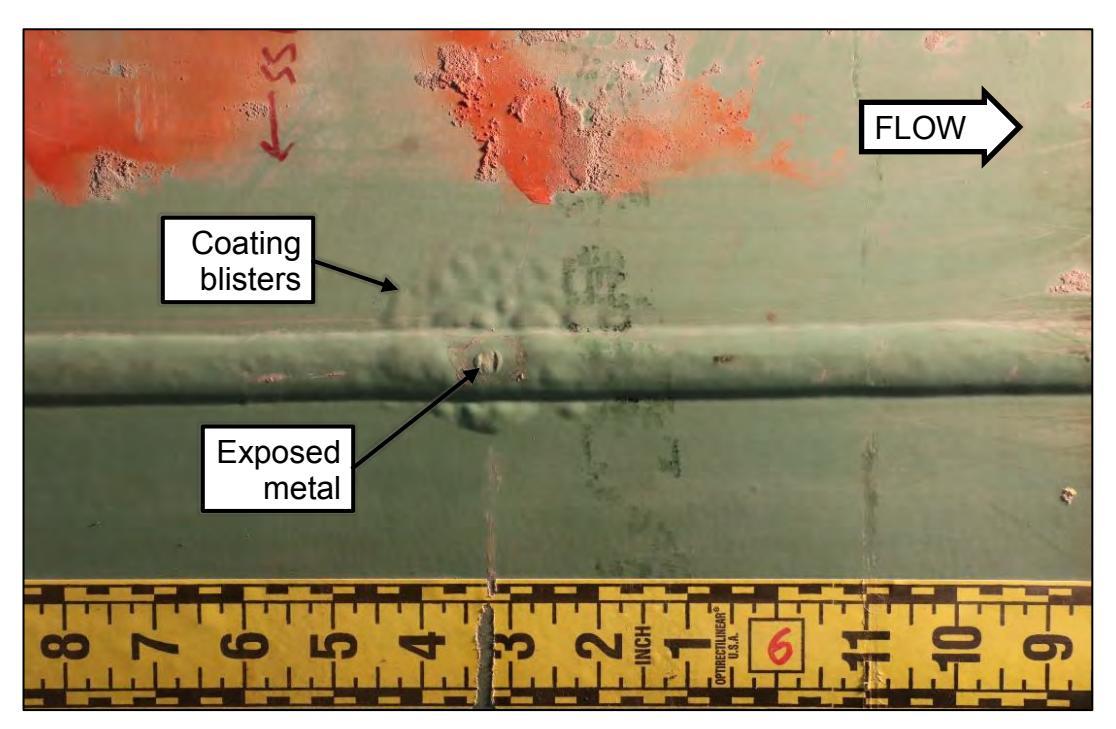
previously noted. One area of exposed metal was found on the longitudinal seam approximately 5 feet 9 inches from the girth weld as shown in figure 8. Blisters in the coating were observed surrounding the area of exposed metal as indicated. The remainder of the coating was smooth and intact with ink manufacturing marks visible on the surface and no evidence of disbondment.

Figure 8. Isolated area of coating damage on the longitudinal seam approximately 69 inches downstream from the girth weld.

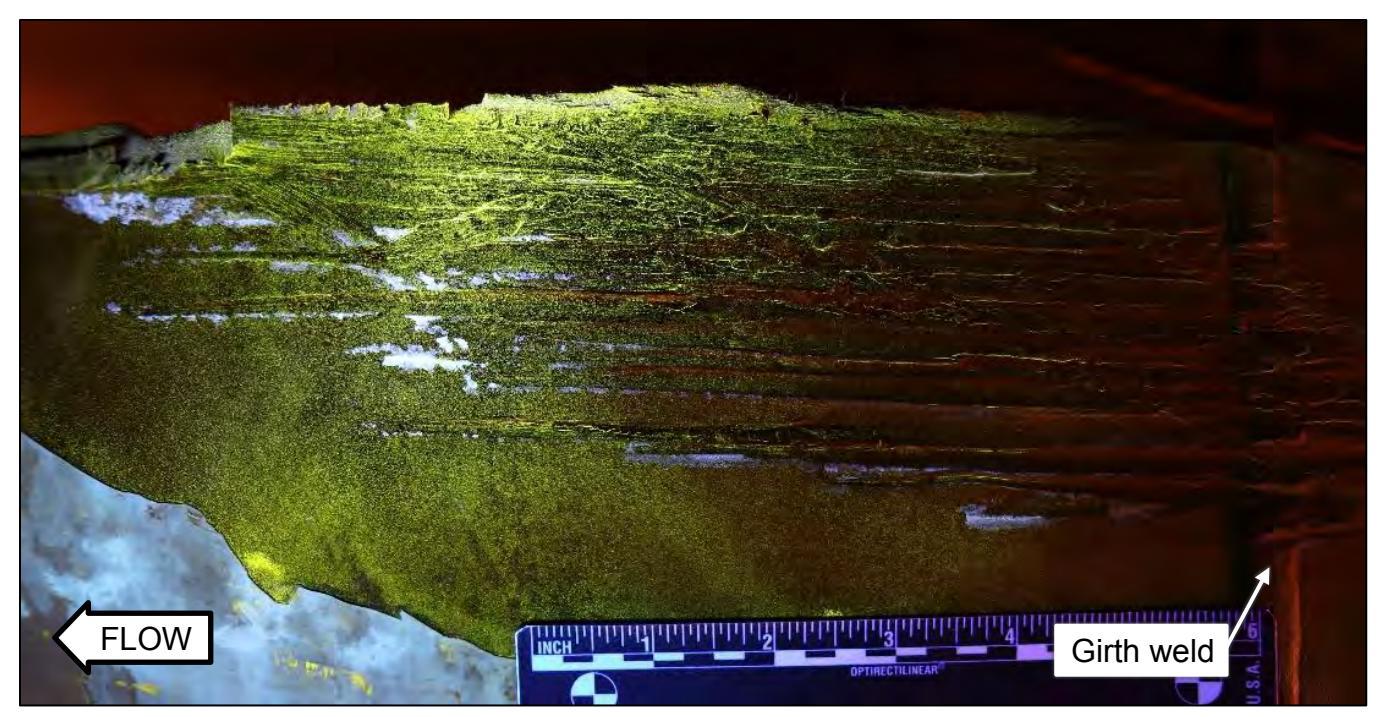
Figure 9. View of crack indications detected using fluorescent MPI in the area of sliding contact damage adjacent to the left side of the fracture.

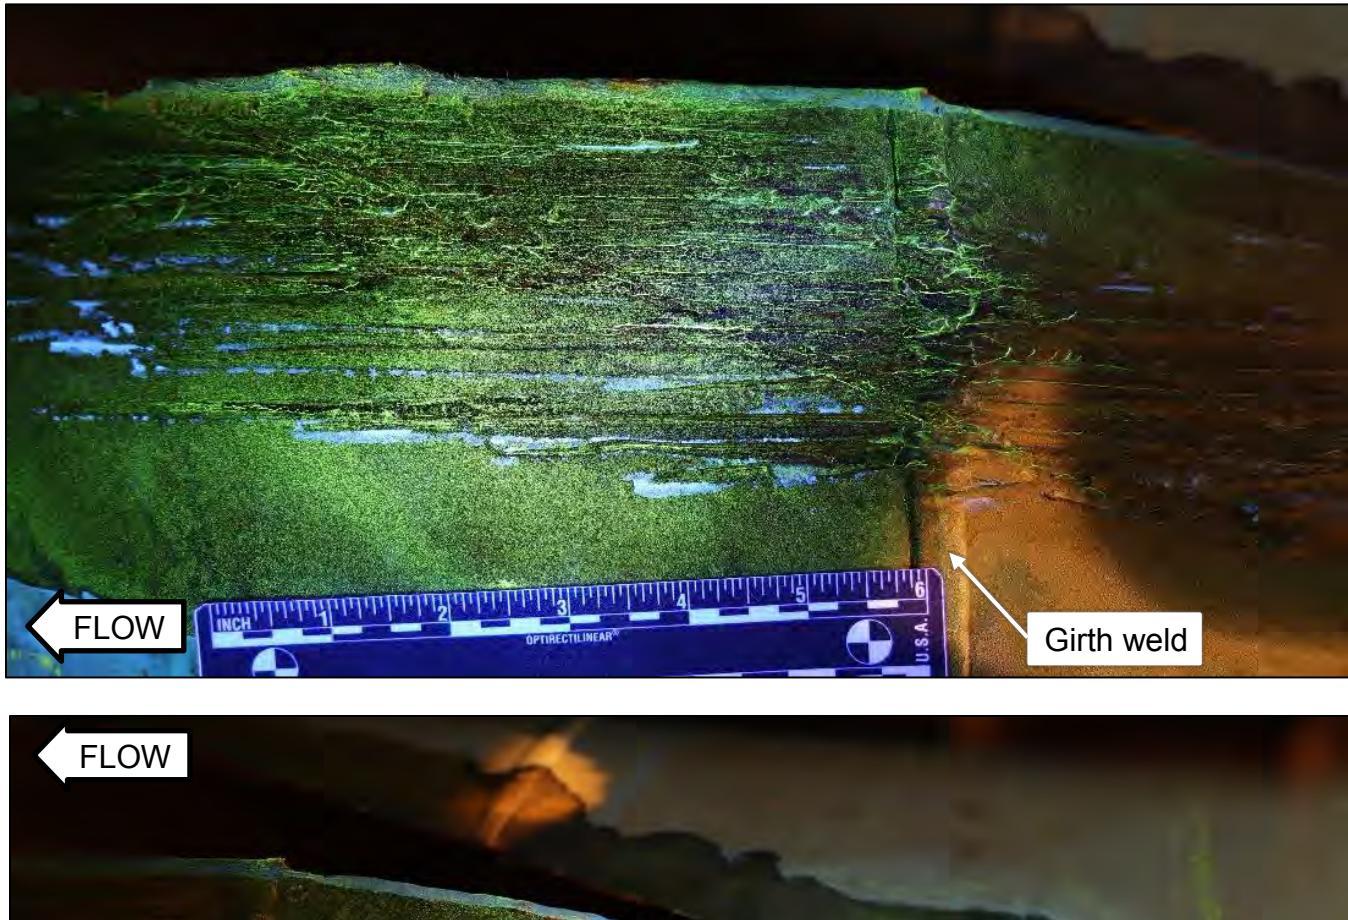
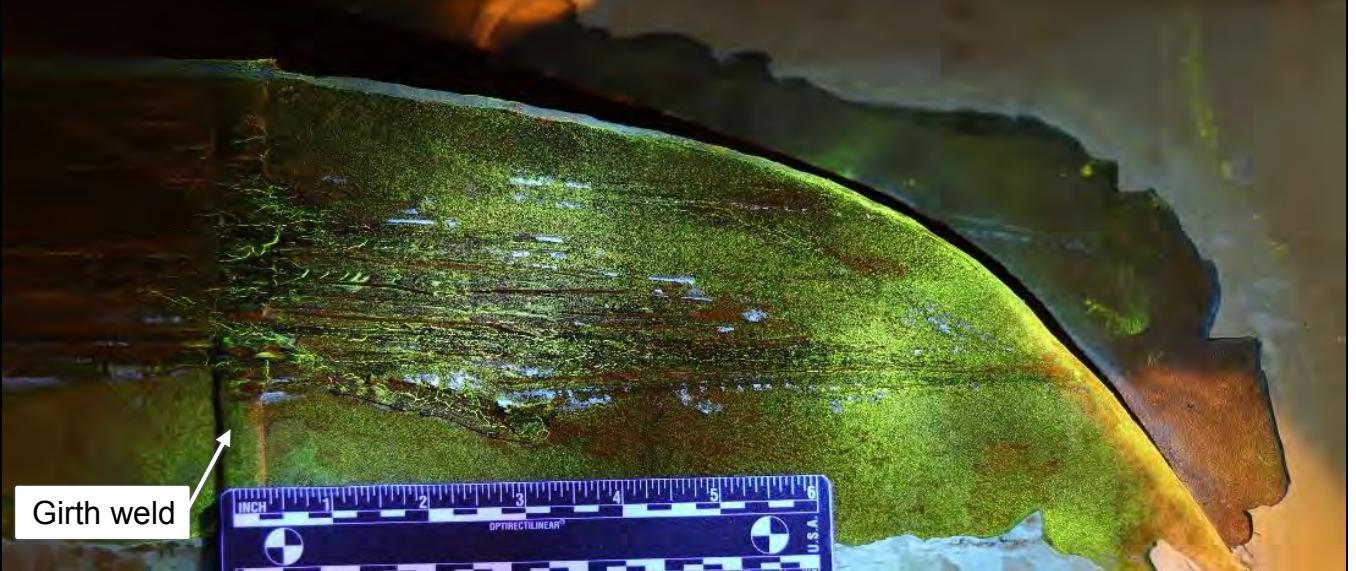
Figure 10. Views of crack indications detected using fluorescent MPI in the area of sliding contact damage adjacent to the left side of the fracture.

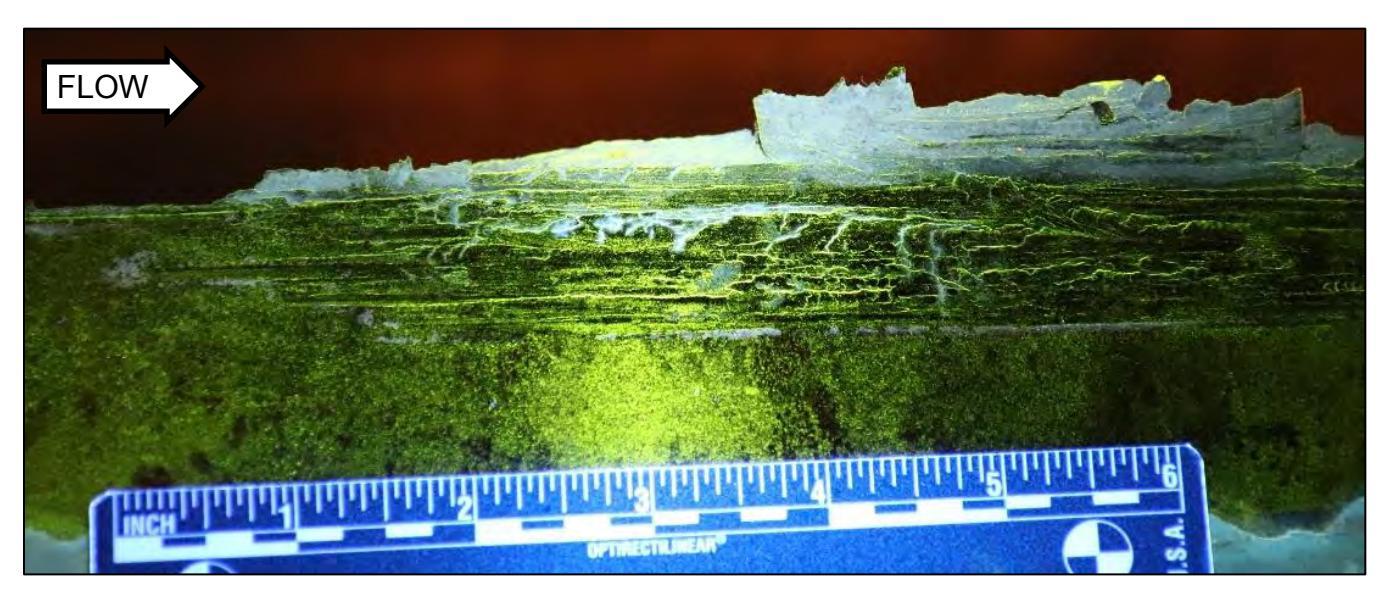
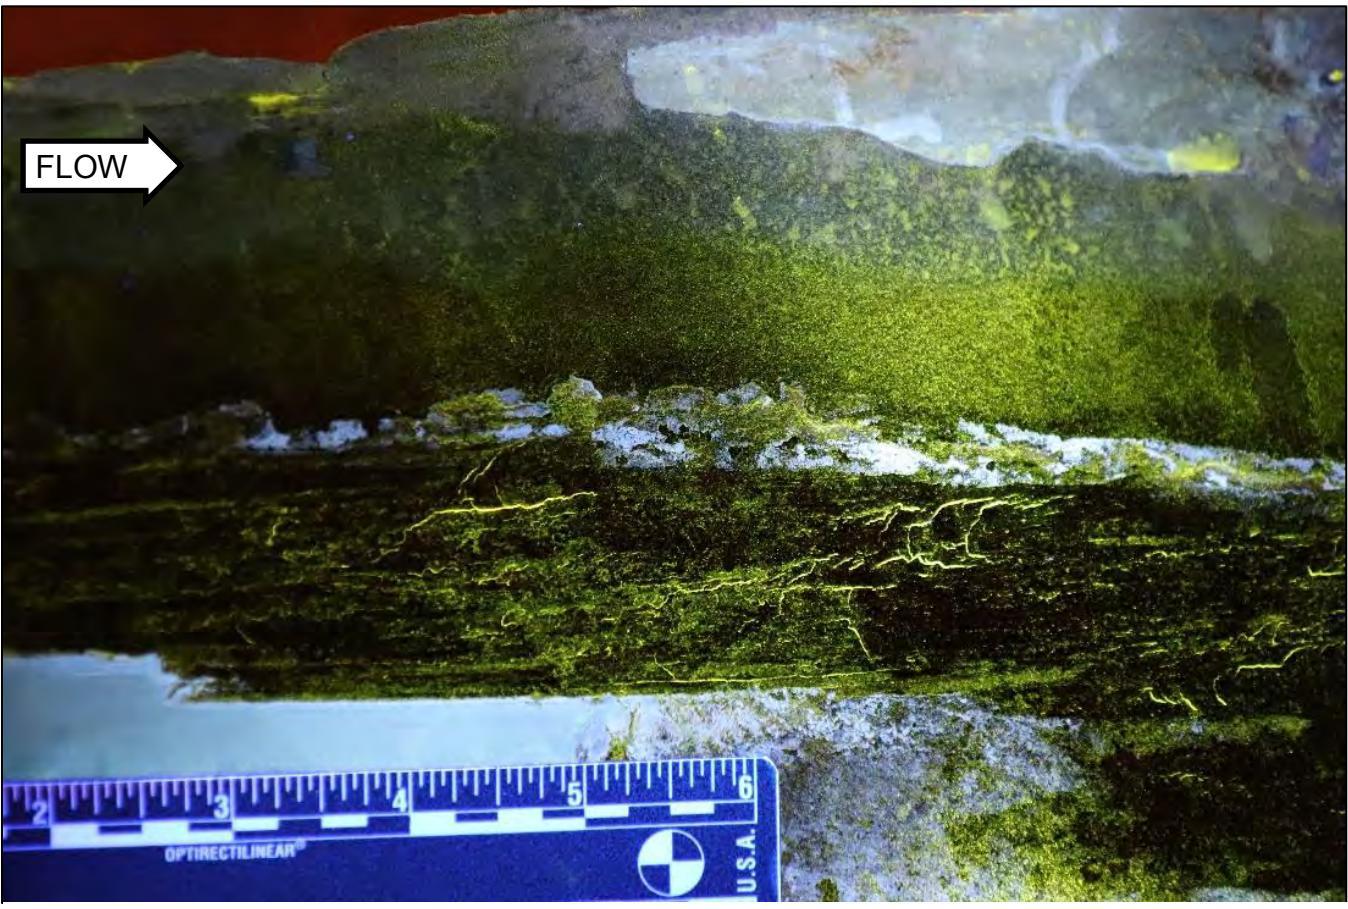
Figure 11. Views of crack indications detected using fluorescent MPI in the area of sliding contact damage adjacent to the right of the fracture approximately 10 inches downstream of the girth weld (upper image) and at the top of the pipe approximately 20 inches downstream of the girth weld (lower image).

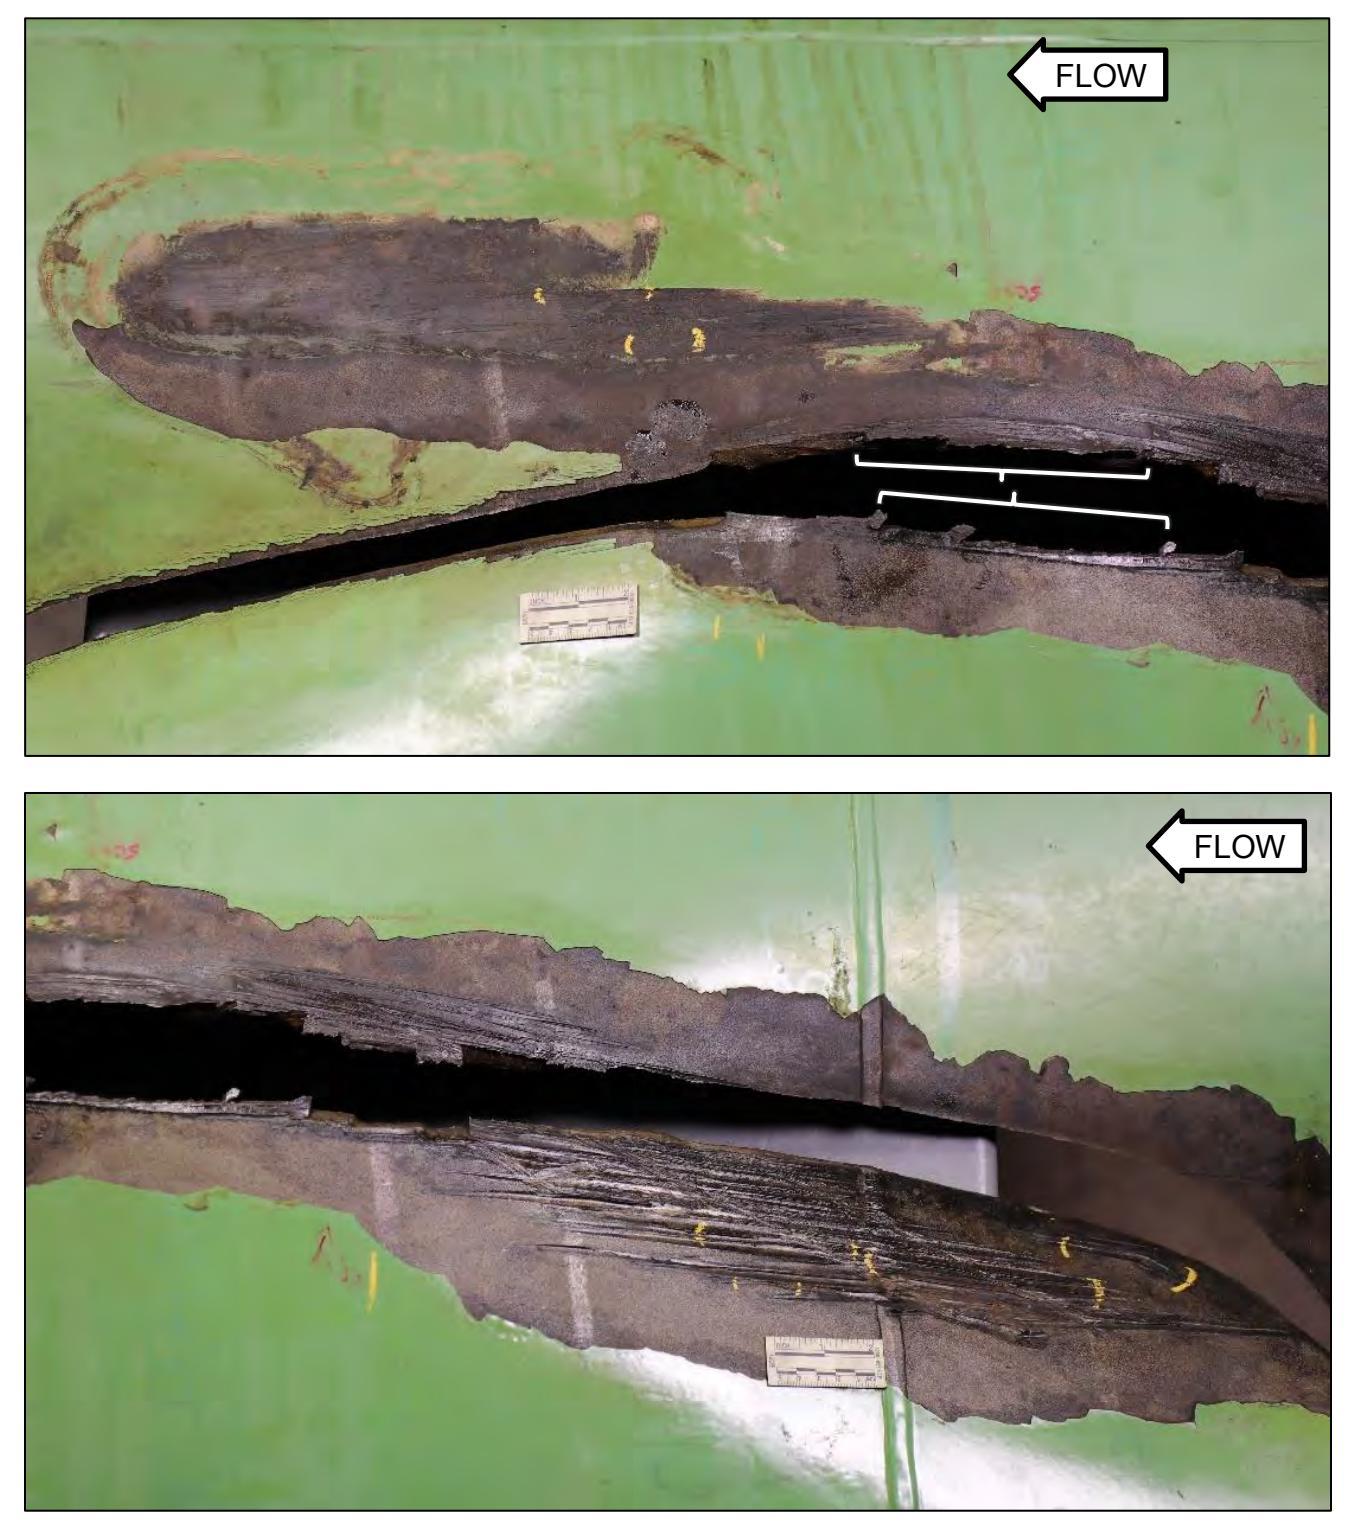
Figure 14. Closer views of sliding contact marks on the pipe surface with the two sides of the fracture placed in close proximity. Brackets in the upper image indicate the fatigue region.

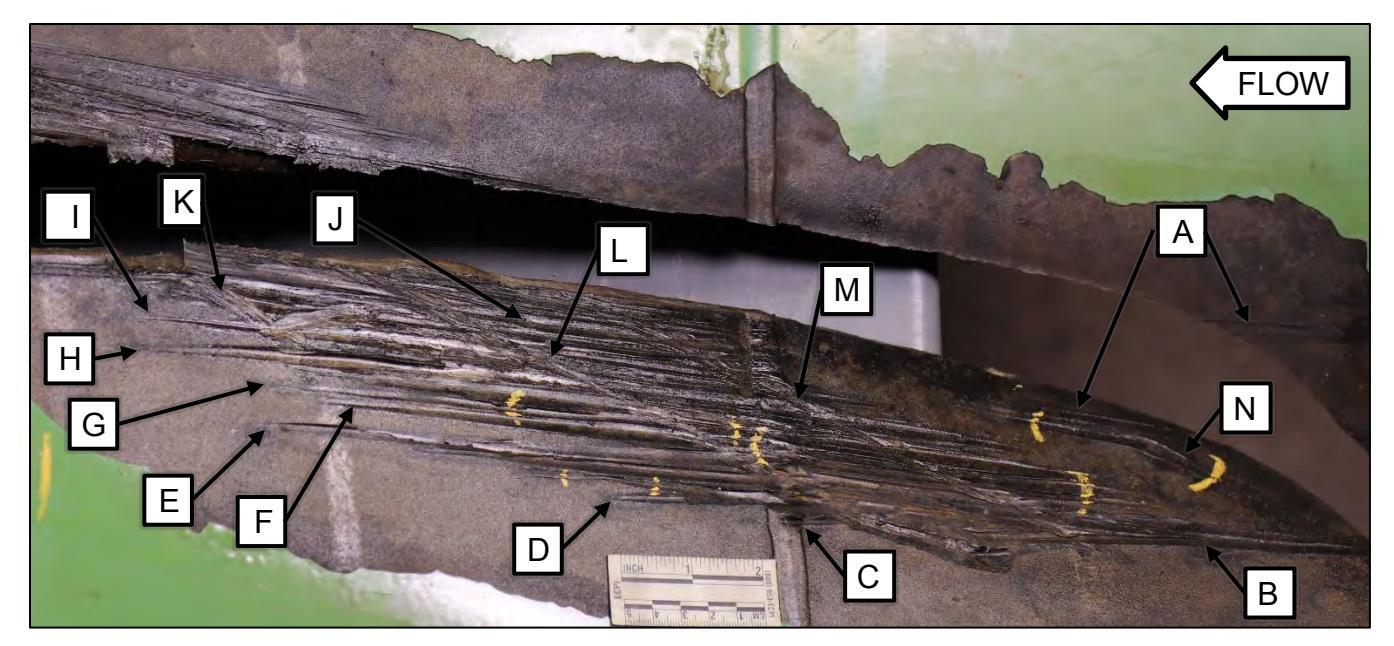
Grooves A and B were oriented approximately parallel to each other and to the longitudinal axis of the pipe and extended the furthest upstream. Grooves A and B extended across the fracture with 2.5 inches of groove A and 0.4 inch of groove B located upstream of the rupture. The grooves were separated approximately 2 inches apart. The axial lengths of grooves A and B were 6.3 inches and 6.7 inches, respectively.

Sliding contact marks K, L, and M were oriented at approximately 45 degrees to the longitudinal axis of the pipe. These marks interrupted the longitudinal grooves consistent with having been made after the other marks. Marks K and L were continuous across the two sides of the fracture and were approximately 1.5 inches apart. Marks L and M were nearly parallel and were approximately 1.25 inches apart where mark M intersected the fracture and were approximately 1.1 inches apart at the upstream end of mark L. Groove N had a change in direction with the downstream portion nearly parallel to the longitudinal axis and the upstream portion nearly parallel to contact mark M. The spacing between mark M and the parallel portion of groove N was 2.25 inches.

Figure 15. Sliding contact marks labeled for reference in the text.

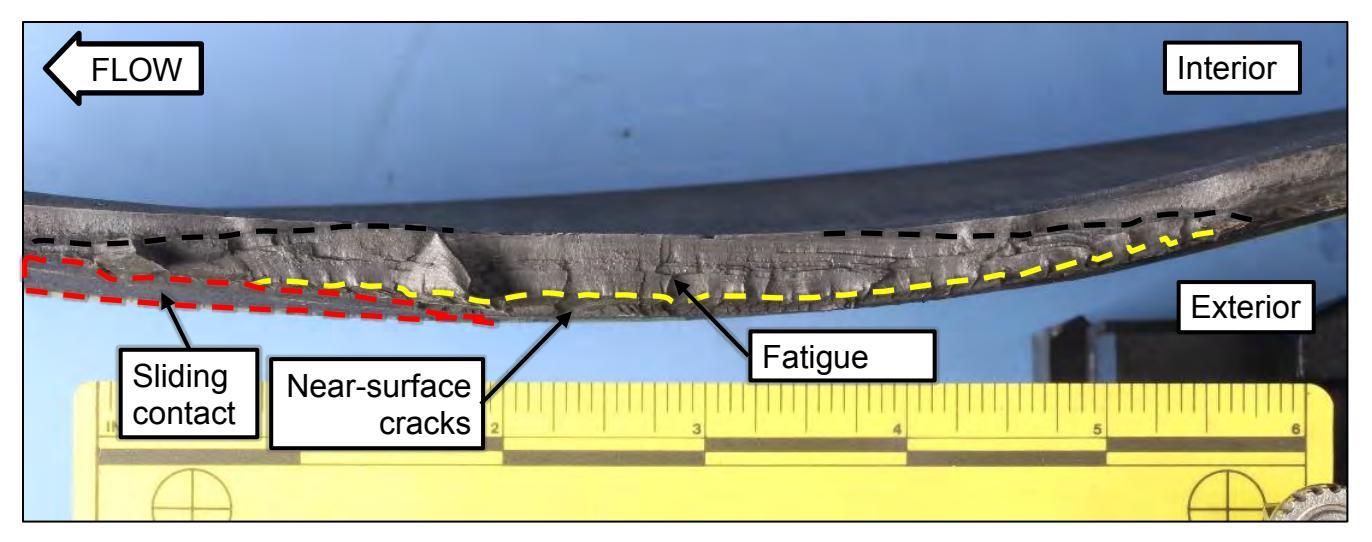
Views of the cleaned fracture surface at the fatigue region are shown in figures 19 and 20. Red dashed lines in figures 19 and 20 indicate areas of the exterior surface adjacent to the fracture where sliding contact marks were observed. (Only a portion of the marks are visible in the view shown in figure 19.) Extending from the surface from multiple locations along the length of the sliding contact mark were a series of near-surface cracks. The near-surface cracks extended from the surface at a shallow angle up to the depth indicated by the yellow dashed line in figure 19. As shown in figure 19, the near-surface crack depth was greatest at the center of the fatigue region where the fatigue region extended to the interior surface. Fatigue features including ratchet marks and curving crack-front arrest marks emanated from the near-surface crack boundary.

Figure 19. Close view of the fatigue region on the left side of the fracture after cleaning. Fatigue features emanated from near-surface cracks and extended to the boundary indicated with a black dashed line. The boundary of the near-surface cracks is indicated with a yellow dashed line. A portion of the area of the sliding contact damage on the exterior surface is also visible in this view, and the visible area is bounded by a red dashed line.

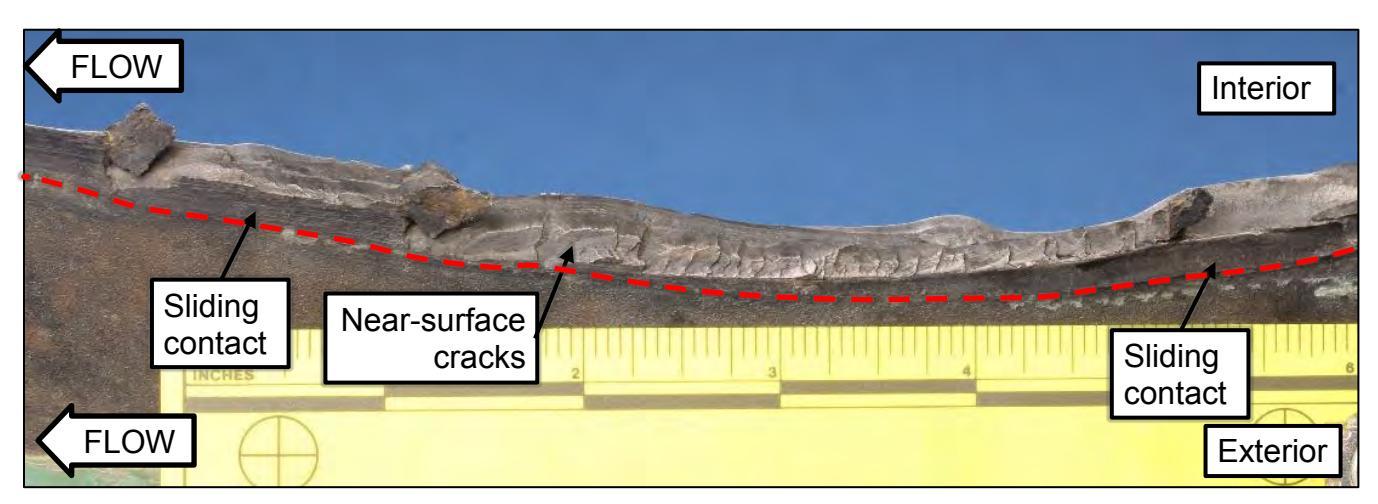
Figure 20. Oblique view of the fatigue region shown in the previous figure. A dashed line indicates the boundary of sliding contact damage observed on the exterior surface adjacent to the fracture.

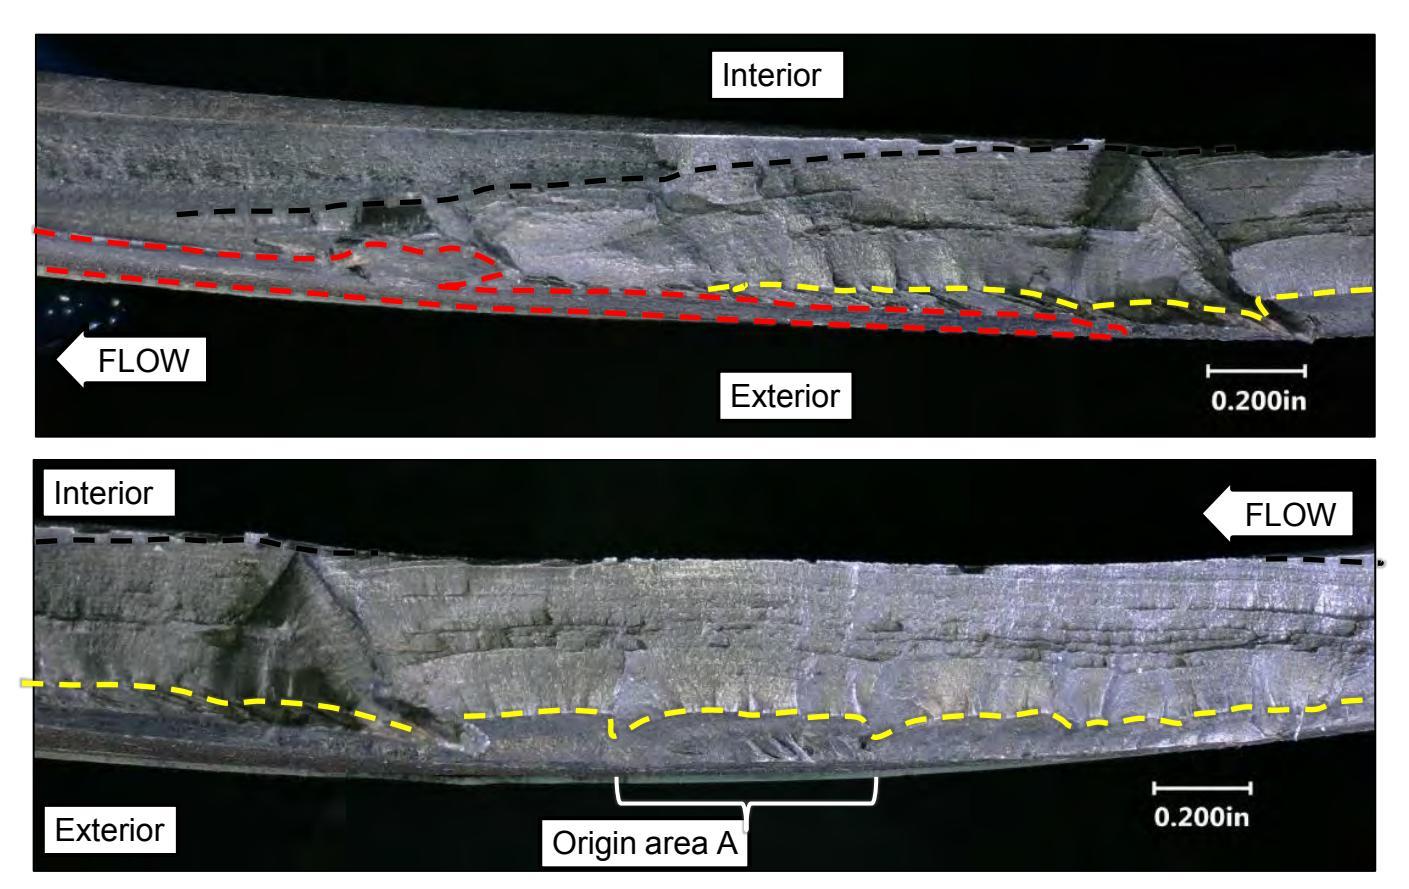
Optical images of the fatigue region at higher magnification are shown in figures 21 and 22. The boundary for the near-surface cracks had discrete curved segments consistent with multiple individual cracks coalescing along most of the length of the fatigue region. Each discrete segment of the curving boundary was associated with multiple fatigue origins.

Figure 21. Optical images at higher magnification showing the downstream end (upper image) and middle portion (lower image) of the fatigue region (bounded by the black dashed lines), near-surface cracks (bounded by the yellow dashed lines), and visible portion of the sliding contact damage on the exterior surface (bounded by the red dashed line).

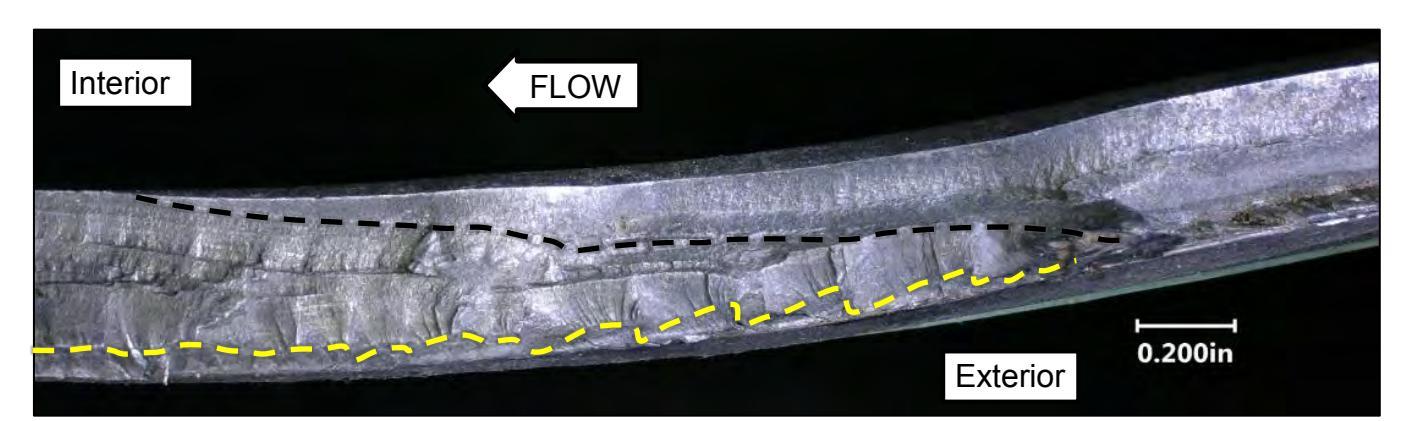
Figure 22. Optical image at higher magnification showing the upstream end of the fatigue region (bounded by the black dashed line) and the near-surface cracks (bounded by the yellow dashed line).
