# NATIONAL TRANSPORTATION SAFETY BOARD

MATERIALS LABORATORY FACTUAL REPORT

Place	: Amherst, South Dakota
Date	: November 16, 2017
Vehicle	: TransCanada Keystone pipeline
NTSB No.	: PLD18LR001
Investigator	: Kalu Kelly Emeaba, RPH-20

Section of pipeline and piece of concrete set-on pipeline weight.

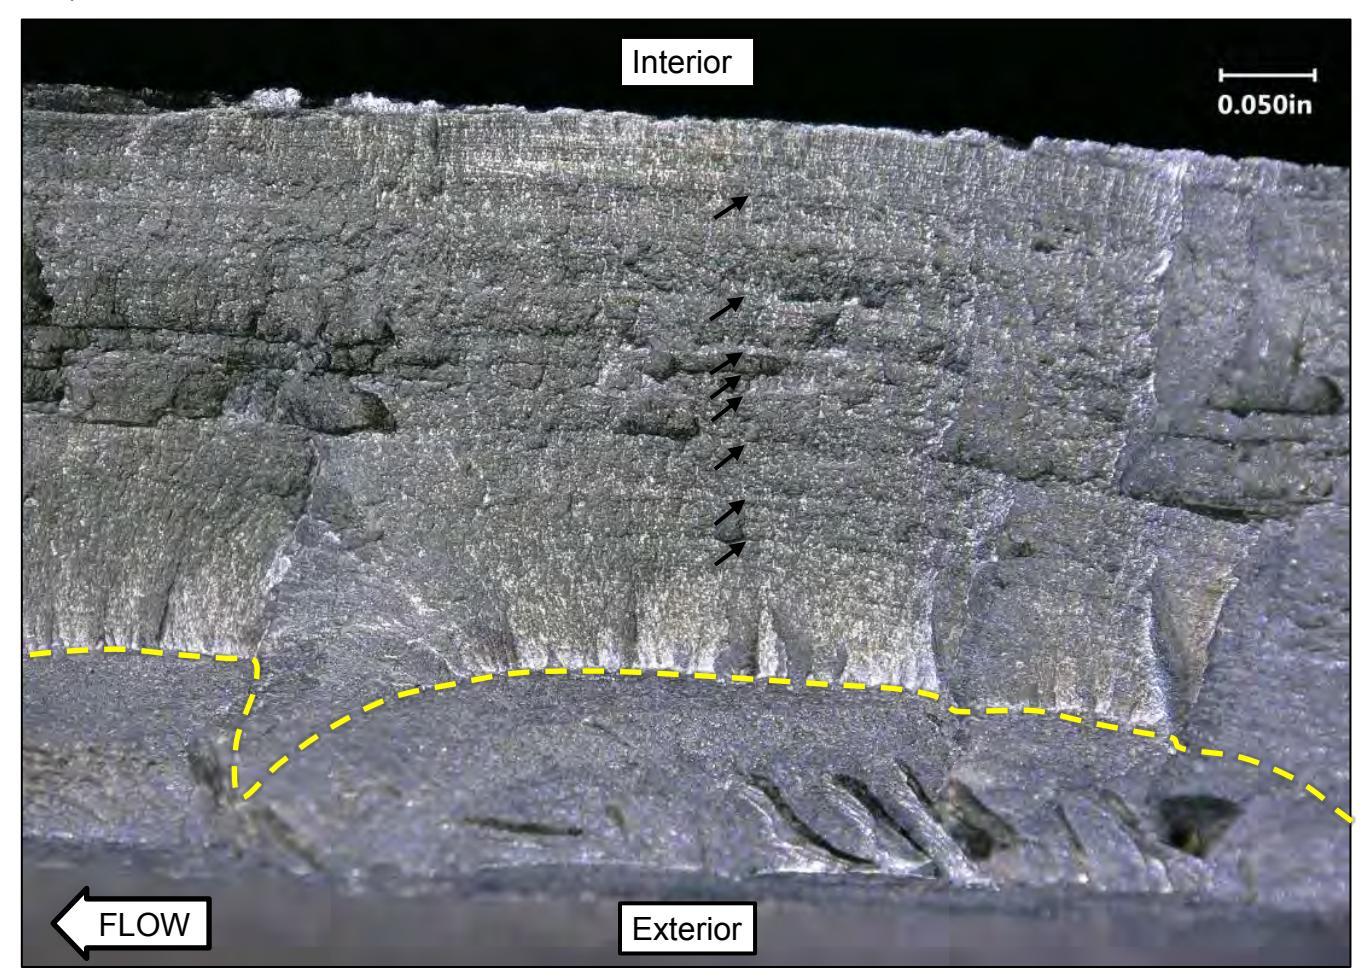
A magnified optical image of the middle portion of the fatigue region where the fatigue region extended to the interior surface of the pipe is shown in figure 23. For reference in this report, this portion of the fatigue region is referenced as origin area A as indicated in figure 21. At this location, the depth of the near-surface crack measured 0.098 inch. Eight relatively prominent crack-front arrest lines were observed as indicated with unlabeled arrows in figure 23. These arrest lines were generally characterized by a relatively large step or undulation at the crack front and crack reinitiation features such as emerging radial marks. The depths associated with the relatively prominent crack-front arrest lines were 0.166 inch, 0.189 inch, 0.222 inch, 0.246 inch, 0.257 inch, 0.267 inch, 0.300 inch, and 0.340 inch.

Figure 23. Optical image of the fatigue region at origin area A (see figure 21). Fatigue features emanated from near-surface cracks shown bounded by a yellow dashed line. Unlabeled arrows indicate relatively prominent crack arrest lines where emerging radial marks consistent with crack reinitiation were associated with the arrest line.

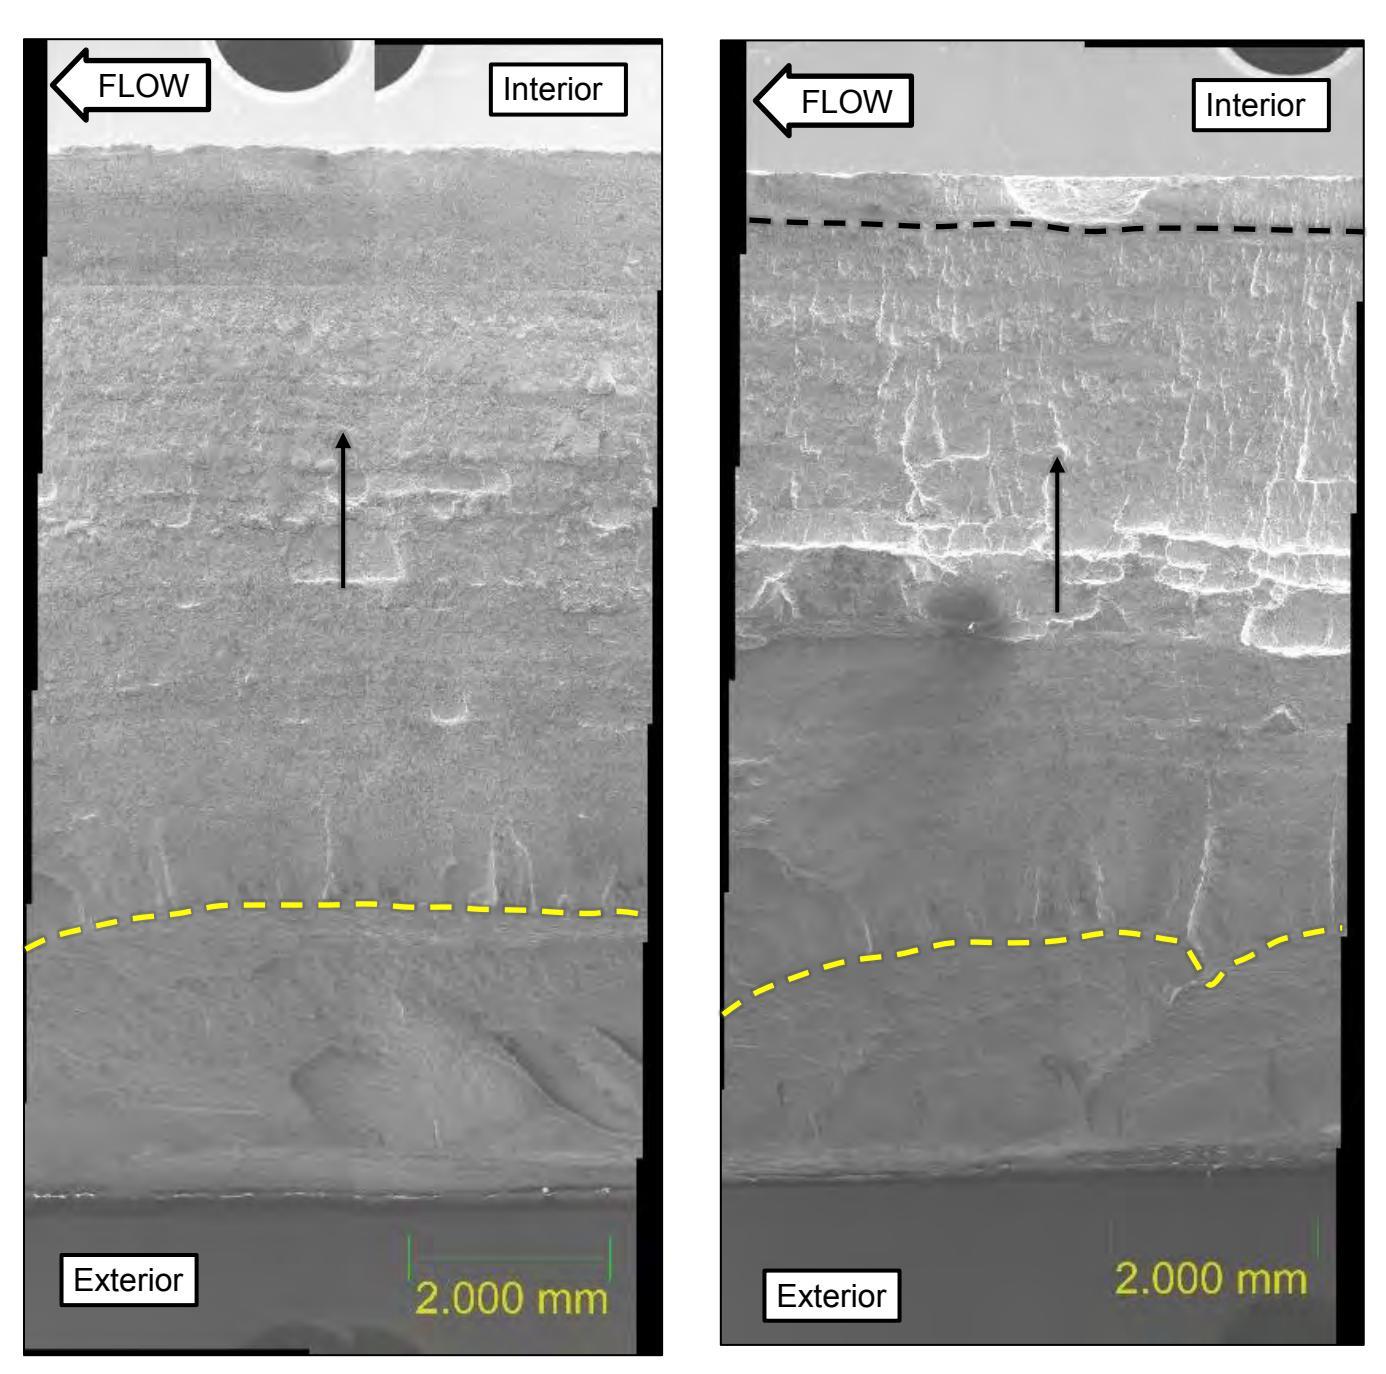
The piece shown in figure 18 was sectioned further to facilitate examination of the fatigue region using a scanning electron microscope (SEM). SEM images of the fracture surface at origin area A and the adjacent origin area upstream from origin area A are shown in figure 24. Each image in figure 24 is a montage of 12 individual SEM image that were stitched together to form an image of the fracture across the pipe wall thickness. The areas associated with the near-surface cracks are bounded with yellow dashed lines, and the extent of the fatigue region in the upstream origin area is indicated with a black

Figure 24. Series of SEM images of the fracture surface stitched together to form a montage image of fracture features at origin area A (left image) and at the adjacent origin area located upstream from origin area A (right image). Yellow dashed lines indicate the depth of the near-surface cracks, and a black dashed line in the right image indicates the extent of the fatigue region. In the left image, the fatigue region extends to the interior surface. Unlabeled arrows indicate the general direction of fatigue crack propagation from the near-surface crack boundary toward the interior surface.

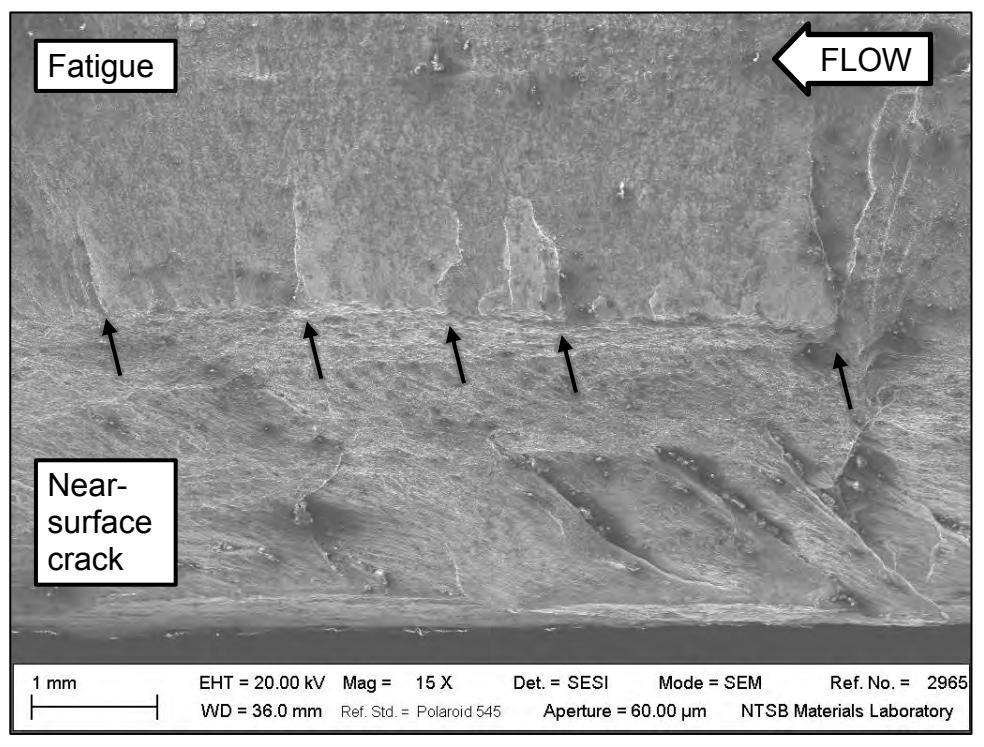
A closer SEM view of fatigue origin area A is shown in figure 25. The near surface crack area had radial features consistent with fracture initiation at the exterior surface and propagation angled radially inward, circumferentially clockwise, and toward the downstream direction. Ratchet marks were present at the end of the near-surface crack between individual fatigue origin areas. Unlabeled arrows in figure 25 indicate several of the ratchet marks associated with origin area A.

Figure 25. SEM image of the primary fatigue origin area emanating from a near-surface crack. Arrows point to ratchet marks located between origin areas.

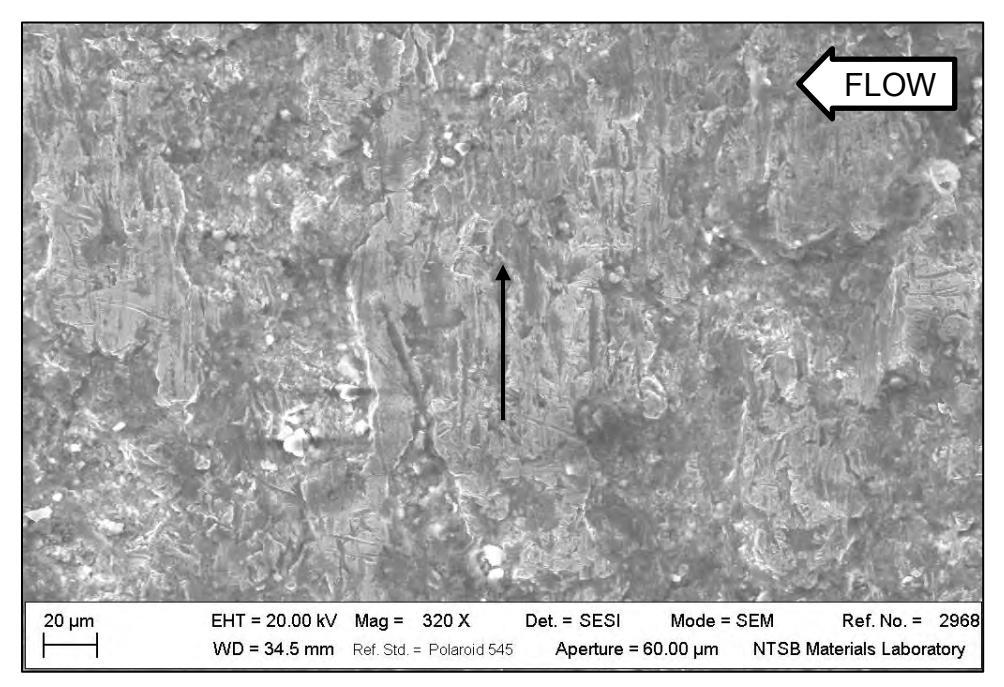
An SEM view of typical features observed at higher magnification in the fatigue region are shown in figure 26. Transgranular fracture features consistent with fatigue were observed, but fine fracture features were mostly obliterated by post-fracture abrasion damage or were obscured by residual carbon-based deposits.

Figure 26. View of typical fracture features in the fatigue region. Fine fracture features were damaged by post-fracture abrasion. An unlabeled arrow indicates the direction of crack propagation.

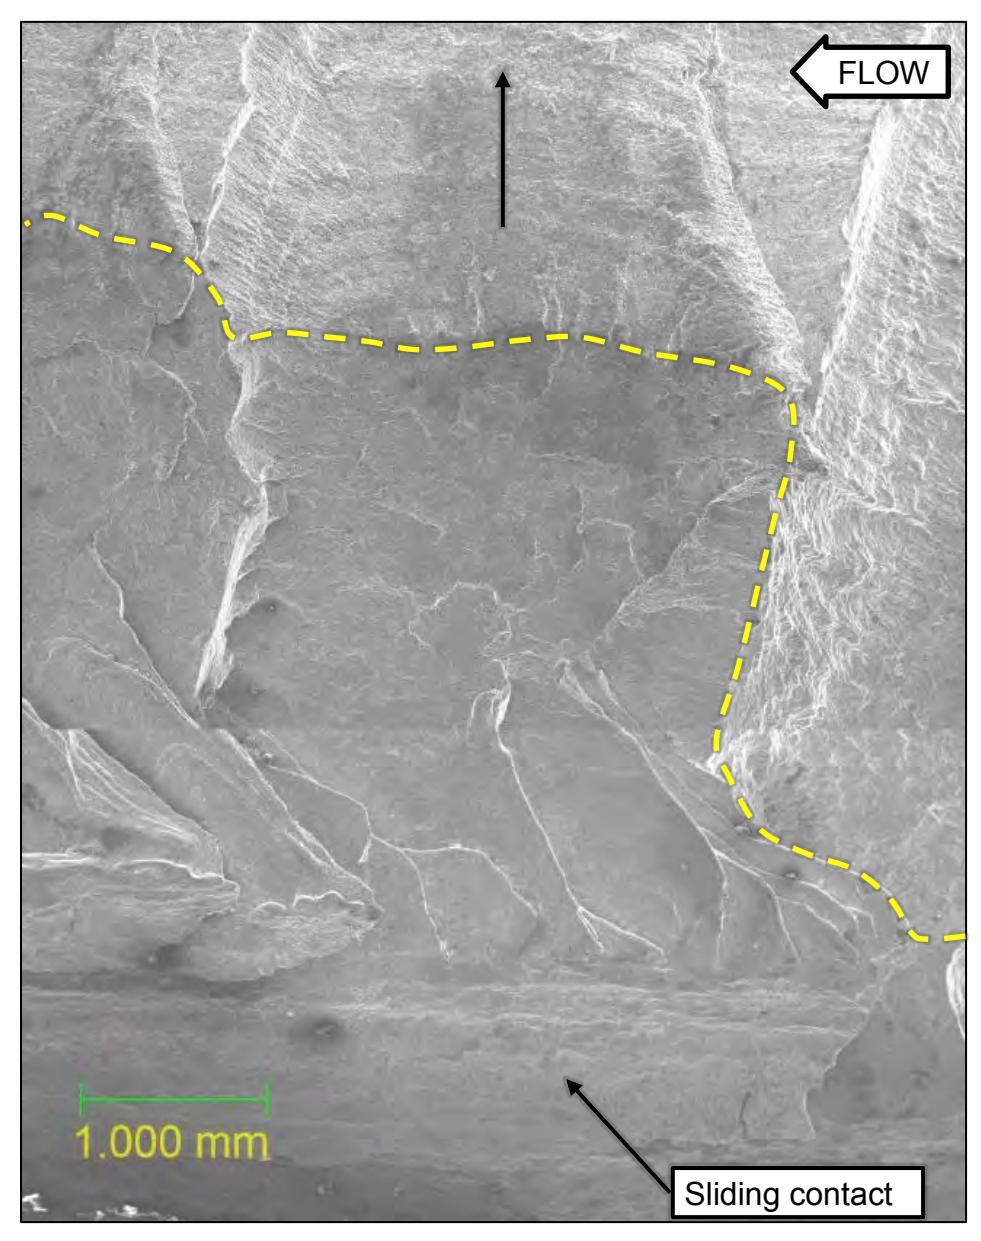
Next, the fracture surface was tilted to examine the fracture features associated with the near-surface cracks as directly viewed with the electron beam oriented approximately perpendicular to the fracture face. A view of one of the near-surface cracks at origin area A is shown in figure 27. The fracture surface had transgranular fracture features with river markings consistent with a cleavage or quasi-cleavage fracture features consistent with overstress fracture.

Figure 27. Two SEM images stitched together to form a montage image of a near-surface crack at origin area A. The fracture surface was tilted so that the electron beam was approximately perpendicular to the near-surface crack fracture plane. A yellow dashed line indicates the extent of the near-surface crack. Sliding contact marks are also visible on the exterior surface as indicated. An unlabeled arrow indicates the direction of fatigue crack propagation emanating from the near-surface crack boundary.

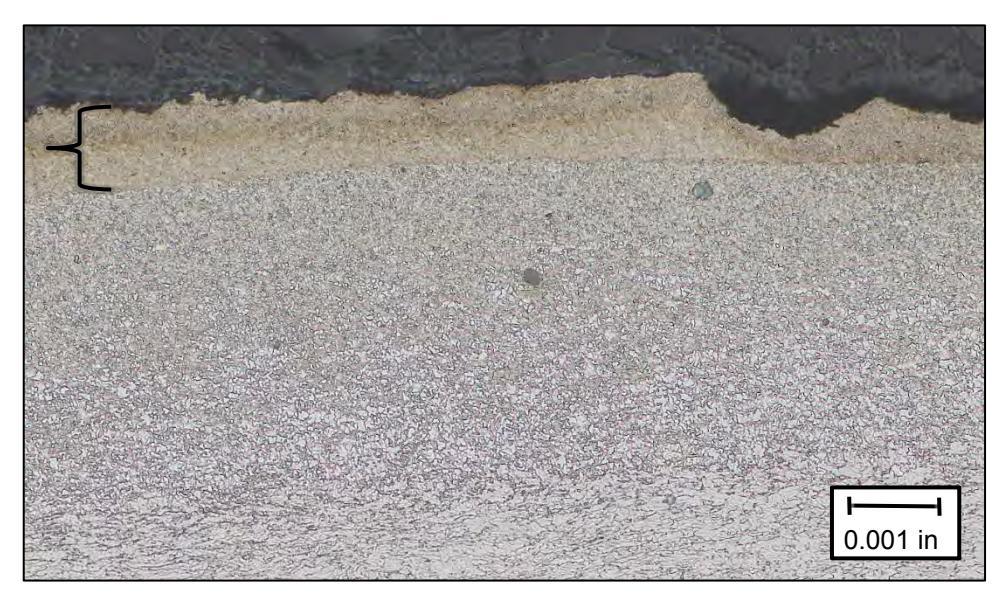
Figure 29 shows the typical microstructure of the pipe material near the middle of the thickness as obtained from sample M3 etched with 4% nital etch (a solution containing 4% nitric acid in methanol commonly used for metallographic examination of steel). Near the surface in areas of sliding contact grooves, the microstructural features showed evidence of distorted grains and changes in microstructure as shown for mount M2 in figure 30. Some areas in all 3 mounts such as the area shown in figure 30 had a surface layer that etched differently from the underlying material and formed a distinct boundary between the surface layer and the underlying material. A bracket in figure 30 indicates the location of the surface layer, measuring up to approximately 0.001 inch thick at the

Figure 30. Micrograph of mount M2 at the exterior surface in an area of sliding contact. Some areas of the sliding contact had material at the surface that etched differently as indicated with an unlabeled bracket in this micrograph (etched with 4% nital).

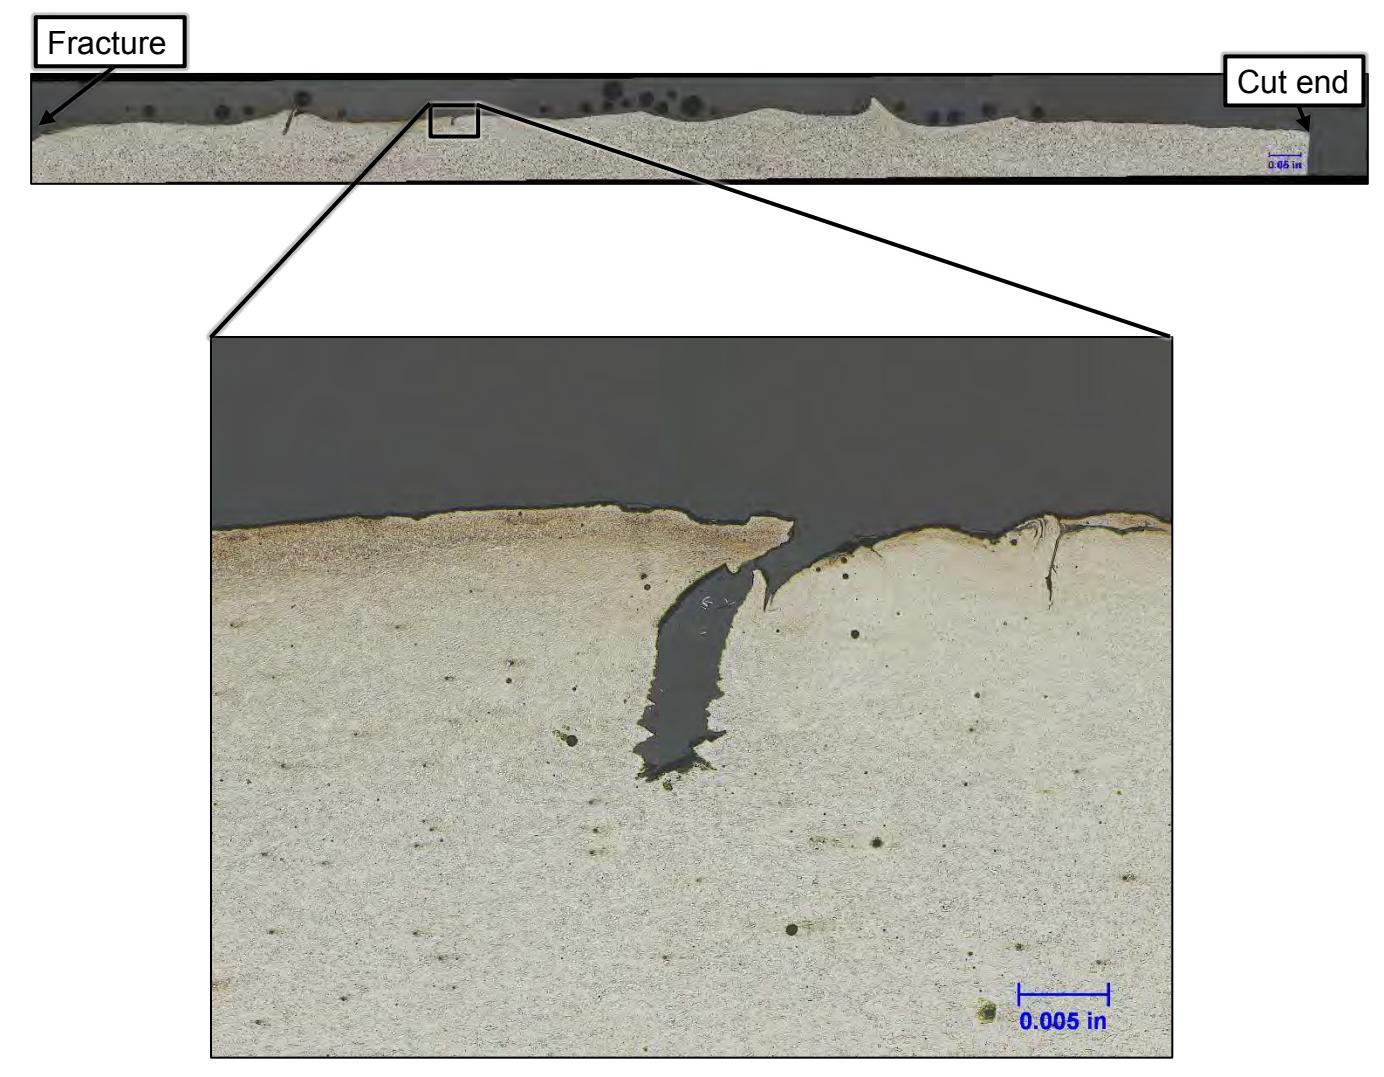
cracks were observed at the surface in the area of sliding contact damage, and a closer view of one of the cracks is shown in figure 36. The crack profile had transgranular fracture features with a jagged crack path and a blunt tip.

Figure 36. Stitched montage of micrographs of mount M1 showing the pipe exterior surface profile (upper image) with a detail image of one of the near-surface crack profiles (lower image).

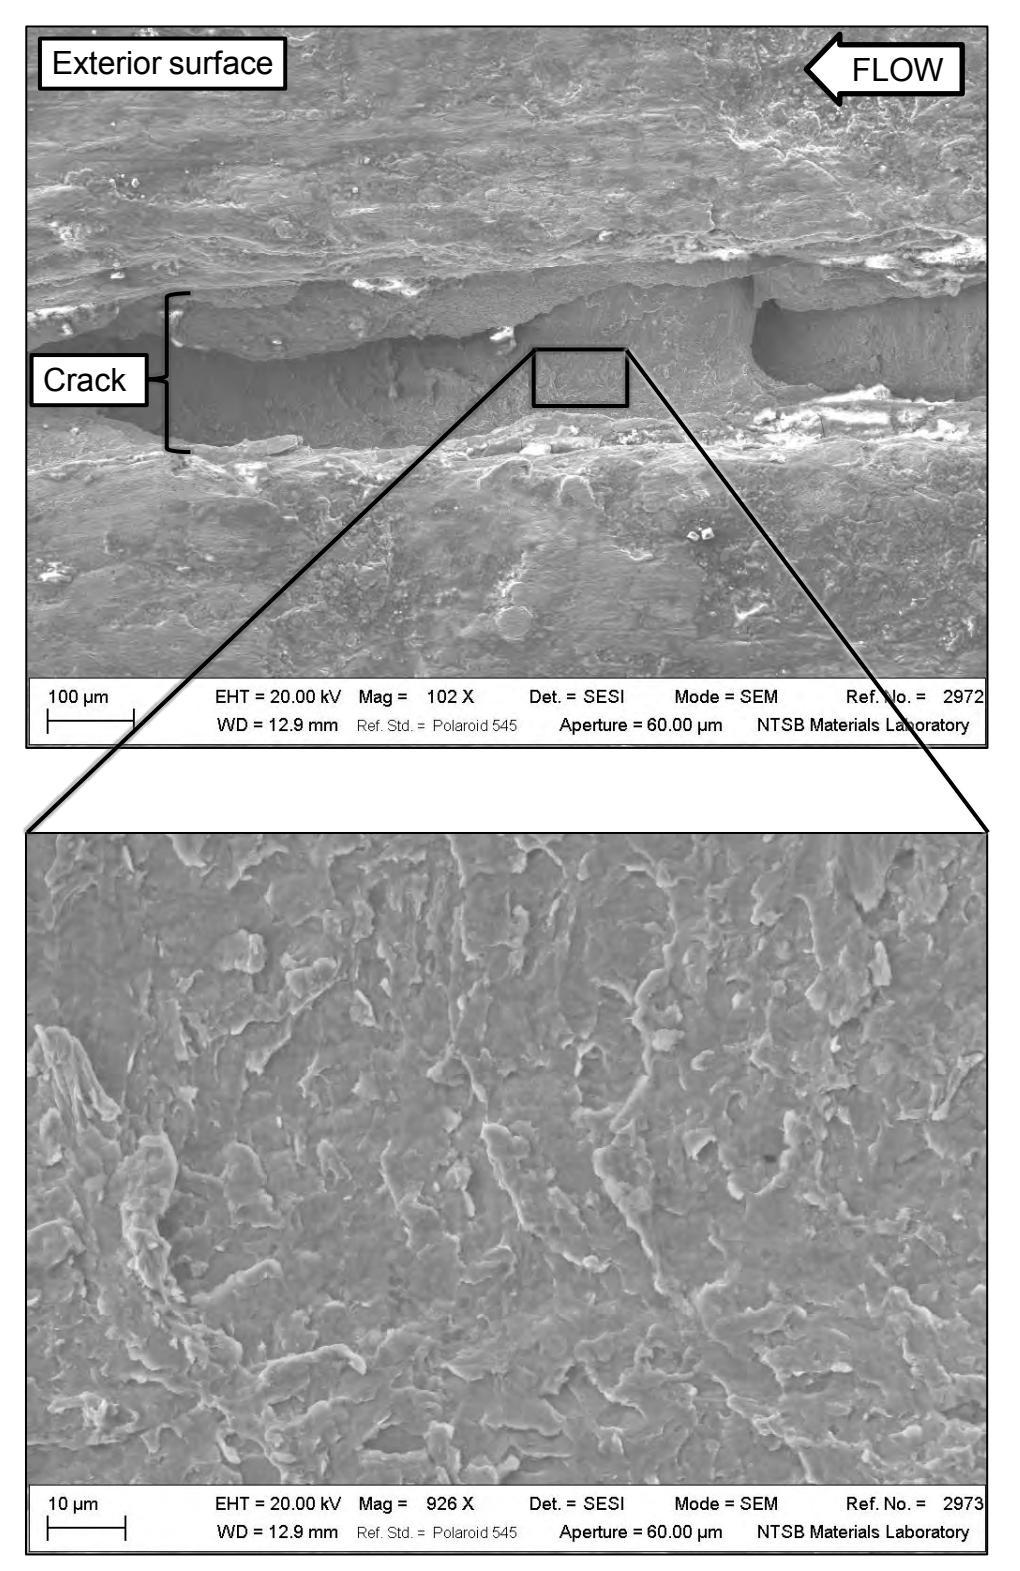
The piece of the pipe wall in the area of sliding contact between mounts M2 and M3 (see figure 28) was examined using the SEM. A crack-like feature was observed on the exterior surface as shown in figure 40. The fracture surface visible inside the crack opening is shown at higher magnification in the lower image in figure 40. Transgranular fracture features were observed with tear ridges, indicative of quasi-cleavage fracture features consistent with overstress fracture.

Figure 40. SEM image of a crack opening in an area of sliding contact on the exterior surface of the piece between mounts M2 and M3 (see figure 28). Fracture features had a transgranular appearance with tear-ridges consistent with quasi-cleavage fracture.

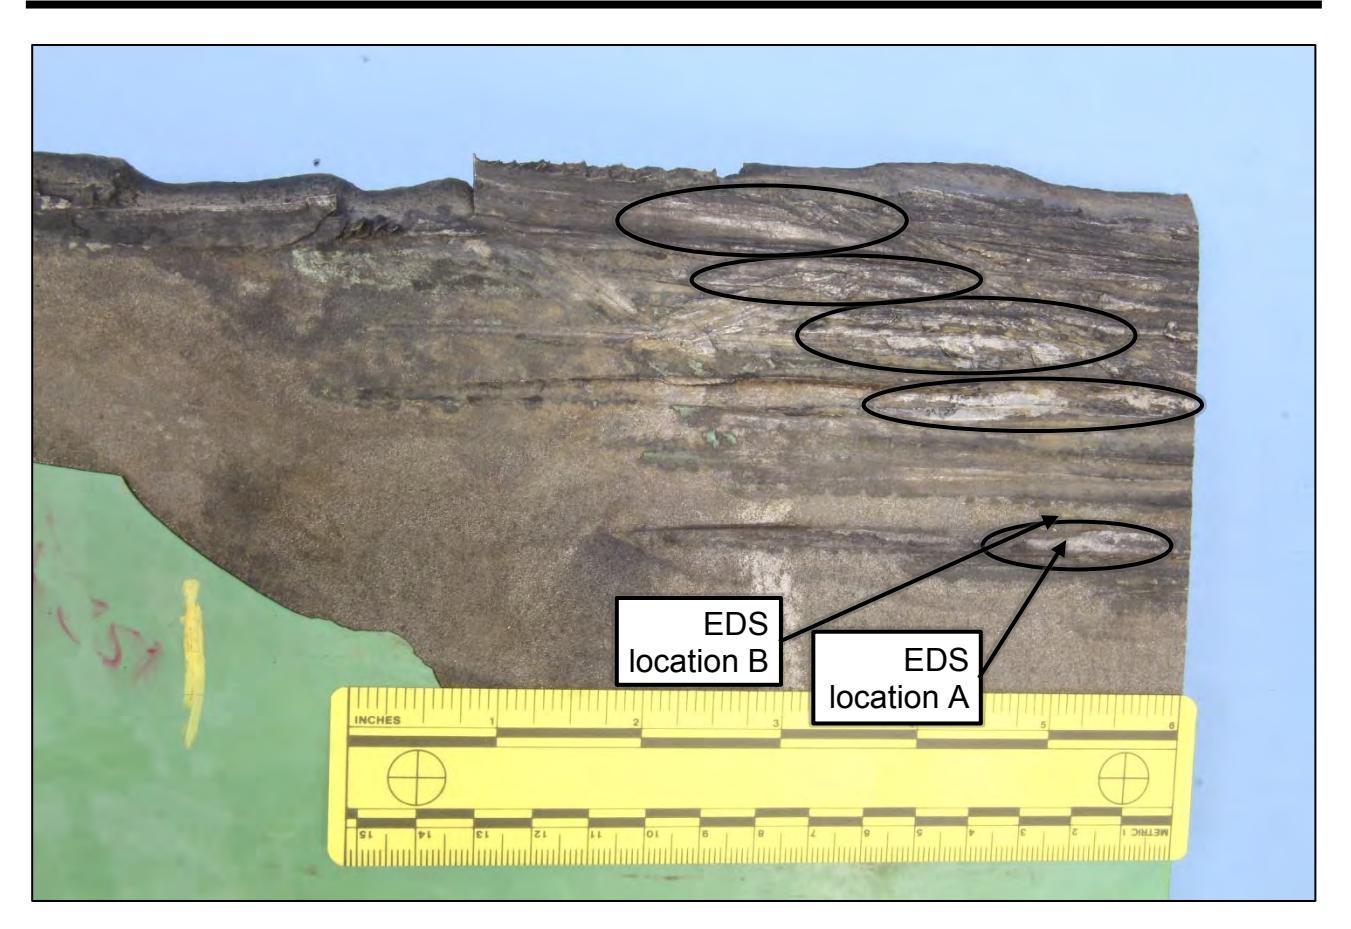
Areas of the exterior surface on the largest piece shown in figure 28 were also examined using the SEM and EDS. As the surface was examined, a difference in the EDS spectra was noted in areas within the sliding contact grooves versus undisturbed areas between the grooves. The examined area of sliding contact damage is shown in figure 41 before samples were taken for metallographic examination. Areas with relatively light gray and more reflective surfaces in the sliding contact marks are shown circled. In figure 42, a typical spectrum from an area with the lighter gray appearance (location A in figure 41) is shown. The EDS spectra in these areas contained a distinct peak of chromium consistent with the deposited steel layer observed in the metallographic mounts. By comparison, the chromium peak was largely absent from the surfaces between the sliding contact marks such as location B noted in figure 41 with the corresponding spectrum shown in figure 42.

Figure 41. Circled areas on the exterior surface appeared lighter gray and more reflective consistent with less corrosion relative to the surrounding areas. These areas were all located within the sliding contact damage. EDS spectra in these areas showed a higher chromium peak than the undisturbed surfaces (see EDS spectra for locations A and B in figure 42).

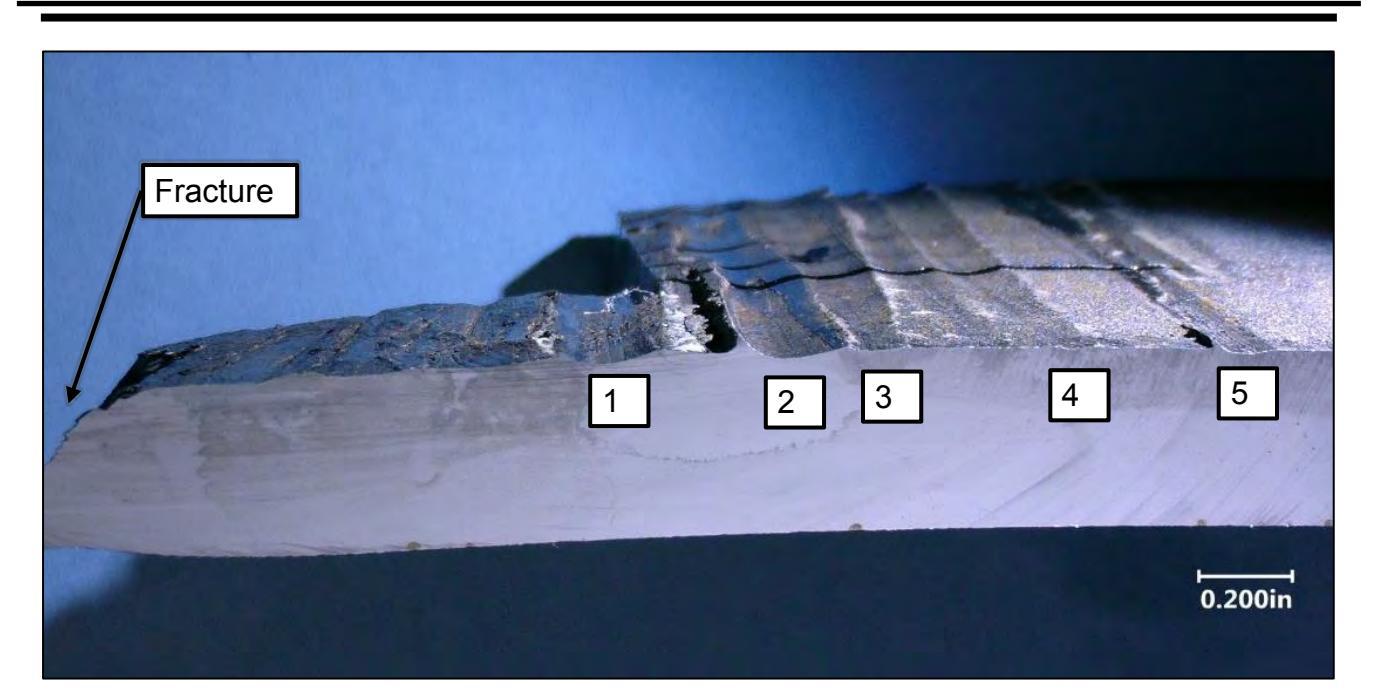
The longitudinally-oriented sliding contact grooves generally had a rounded profile at the bottom of the grooves. The cut face for the piece upstream of mount M1 is shown in figure 43 where the groove profiles are visible. The radii of several of the grooves that were distinctly separate from overlapping damage were measured, and the measured grooves are labeled 1 through 5 in figure 43. An example of the measurement for groove 1 is shown in figure 44 where the radius of curvature measured approximately 0.233 inch. The radius of curvature for grooves 2 through 5 measured 0.116 inch, 0.103 inch, 0.085 inch, and 0.108 inch, respectively.

Figure 43. Optical image of the cut face of the piece adjacent to the upstream side of mount M1. Radius of curvature measurements were conducted at each of the 5 groove locations indicated.
