U.S. Department
of Transportation
**Pipeline and Hazardous
Materials Safety
Administration**

Reference No. 21-0097

Request for Letter of Interpretation re:

Product: Bernzomatic / Worthington
handheld torch cylinders, “non-refillable
tall” containing propane and propylene

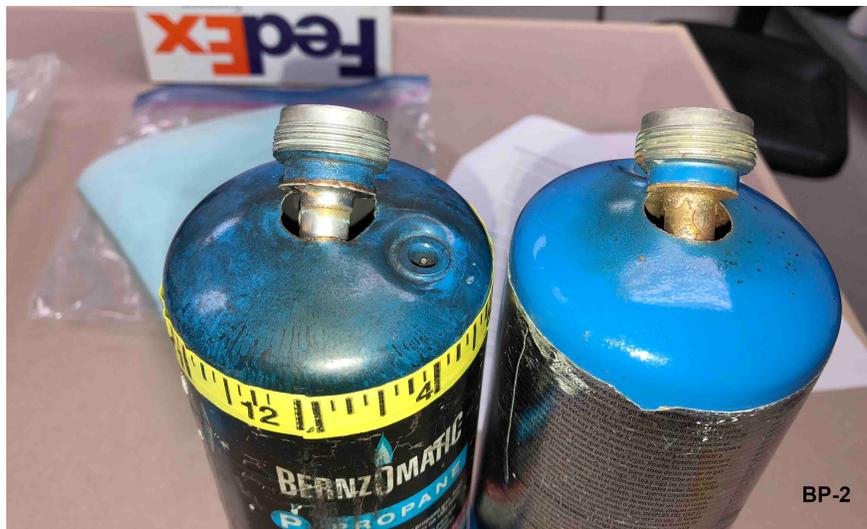
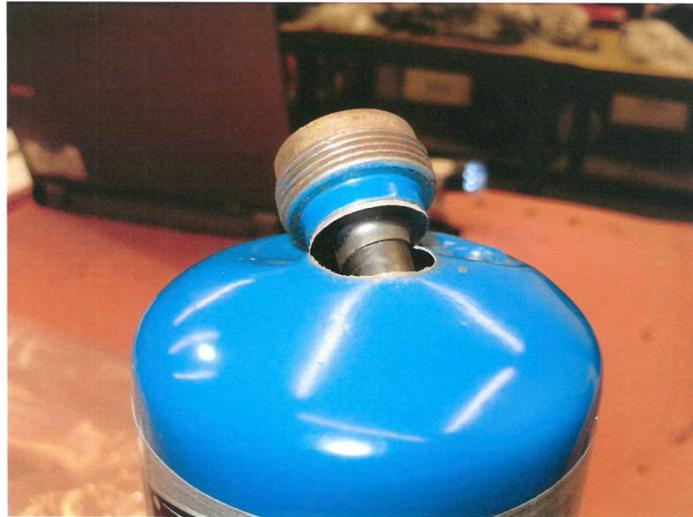
Many of these cylinders have failed, causing severe burn injuries and fatalities. These photos show the area of failure of three of the cylinders:

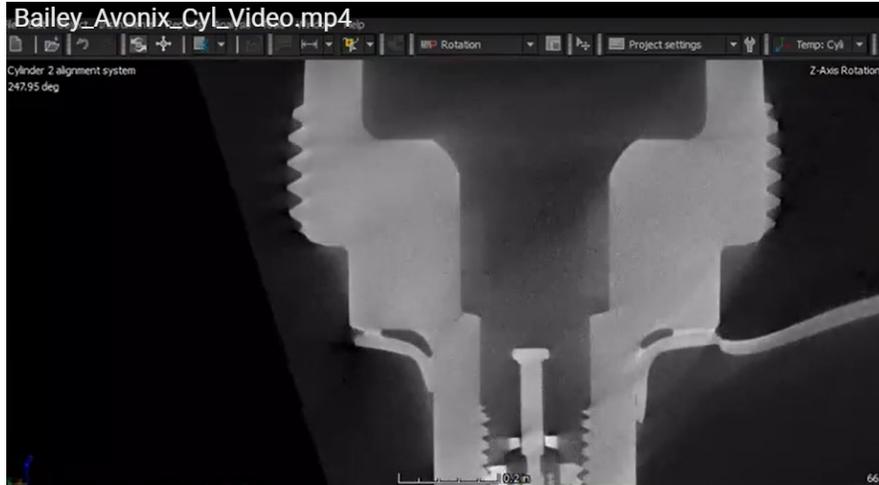
Inquiry Photo 1 - Bailey Cylinder

The manufacturer’s expert, Dr. Pfaendtner, took CT scans and videos which showed that on the two cylinders he tested, there were very large voids in the welding (brazing) compound as shown on these photos:

Do the photographs and videos provided on this request letter, showing the voids in the weld (brazing compound) of the “Bailey” and “Peralta” cylinders (inquiry photos 1 and 2 above), and Pfaendtner cylinder (lower image on p.5), show voids which can be interpreted to be in full compliance with the requirement for complete penetration of the brazing material throughout the joint? Do the voids otherwise fail to satisfy the requirements?

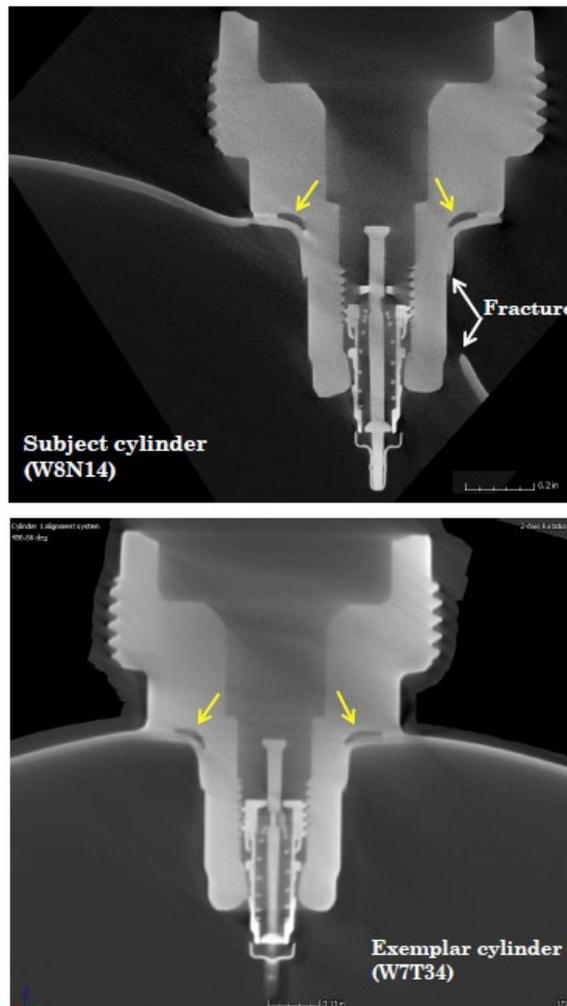
The manufacturer's expert then randomly purchased a cylinder from Lowe's and examined it. He found the same voids as shown on this photo:

Figure 19. Computed Tomography (CT) X-ray images of dome area of subject (top image) and exemplar (bottom image) propane cylinders. Yellow arrows indicate voids in braze joint.

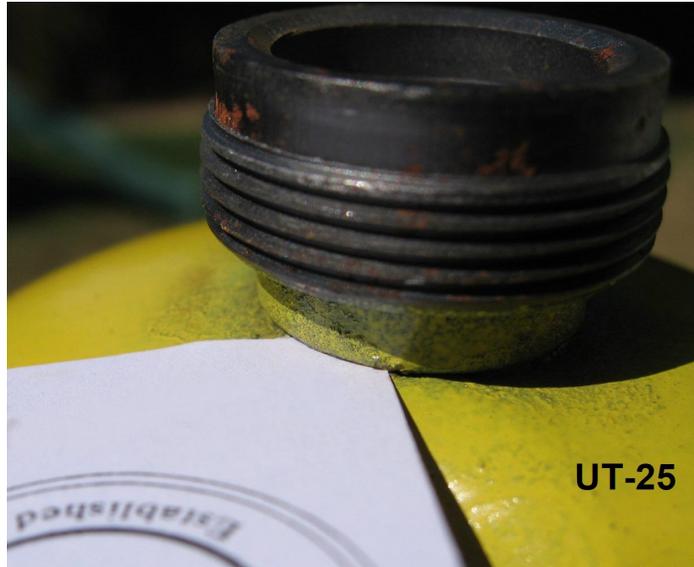
We observed large voids on several of these cylinders and have some in our possession. This is a photo of one of the cylinders containing MAPP fuel:

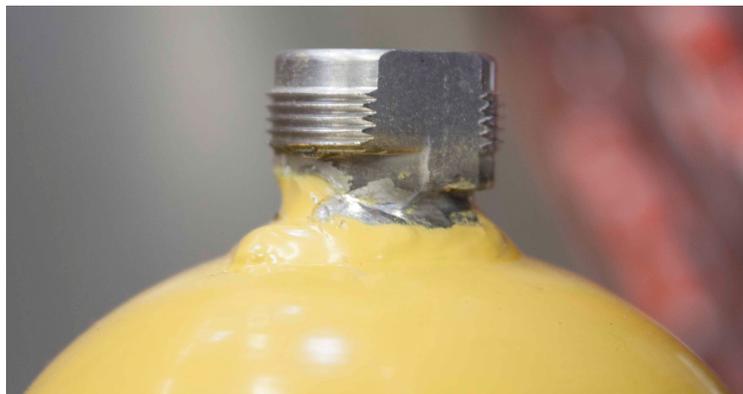
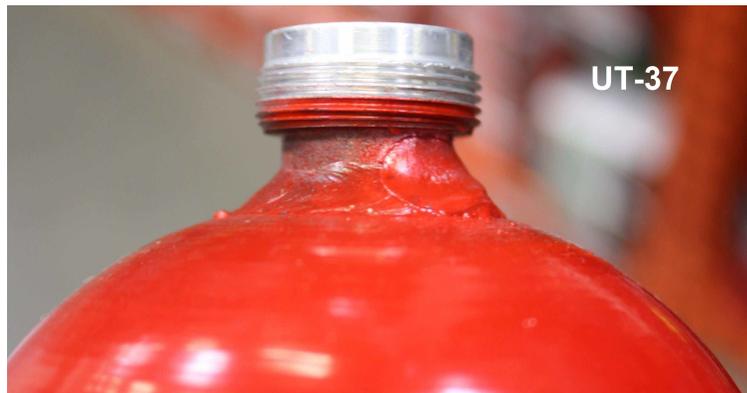
Further, I personally found and photographed these two cylinders at Home Depot in CA:

Worthington Cylinder Corporation advises that it re-works cylinders with inadequate joints. However, it's expert, Dr. Pfaendtner, provided this statement of his findings with regard to the two re-worked cylinders shown above:

“[A]lso, the combining or mixing of brazing and welding processes on a single joint would be inconsistent with proper manufacturing procedures. Anyone with proper knowledge of brazing and welding processes would know that the two processes should not be combined. This would result in an intermixing of the braze alloy with the base metal (copper and steel, respectively in this case), with unpredictable and potentially hazardous consequences with respect to the strength of the joint.”
