PACKER ENGINEERING INC, 1950 North Washington Street, Naperville, IL 60566

Evaluation of Three DOT 3AL 6061-T6 Cylinders to Determine the Neck Cracks Cause and Initiation Site (CIS of Neck Cracks)

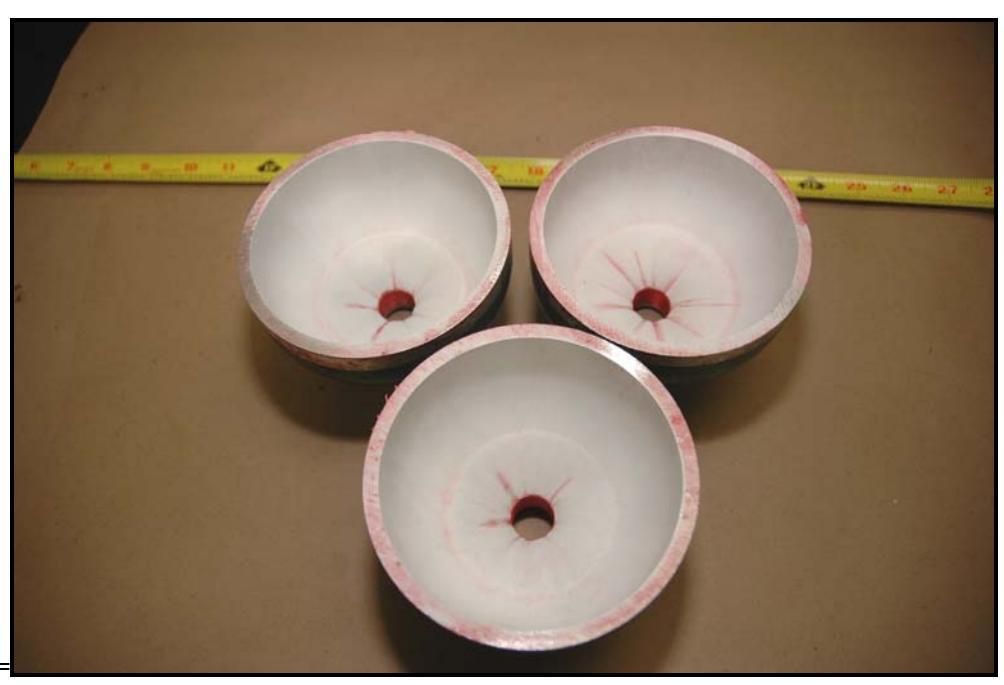
Figure 66: Indications observed on the three cylinder heads after dye penetration test

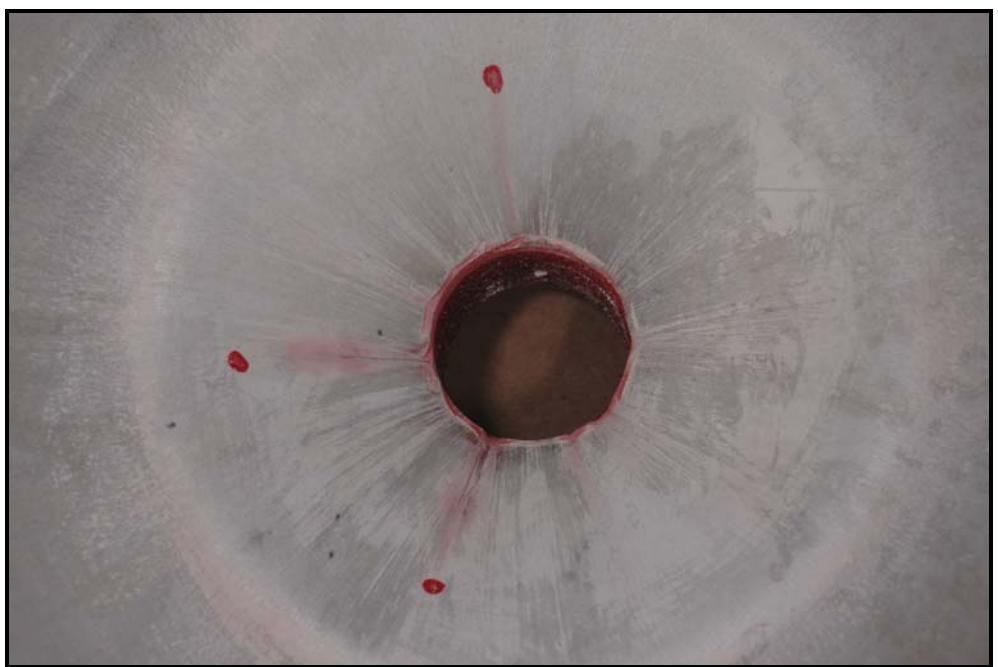
Figure 67: Shows the indications in neck area in the cylinder # AR0119524 exposed after dye penetration test

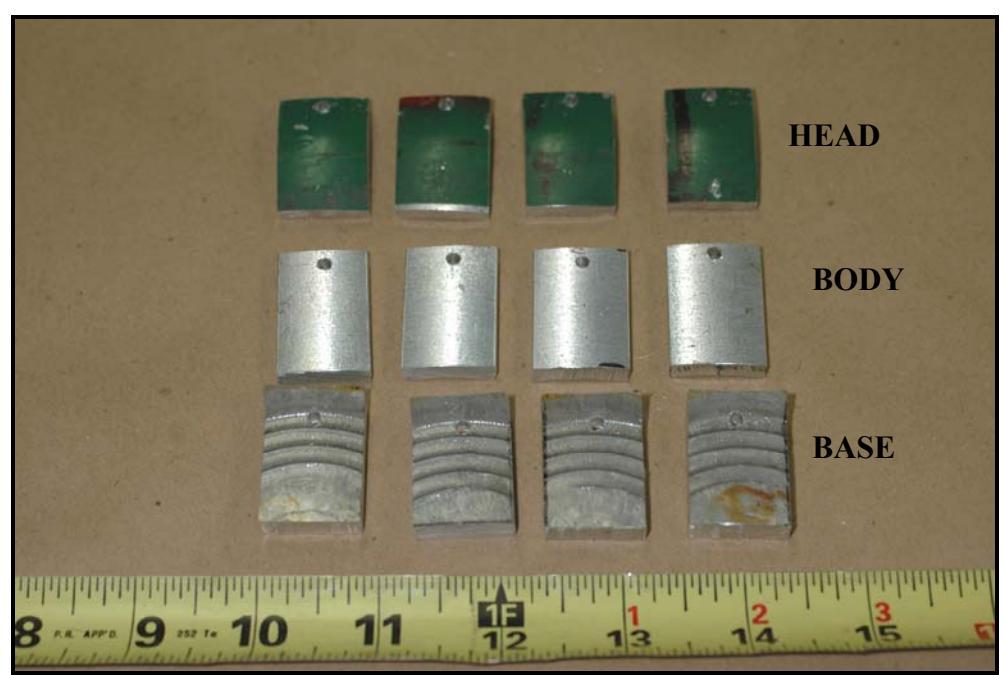
Figure 87: Shows the outer surface of the specimens from the head, body and base machined for assessing inter-crystalline corrosion

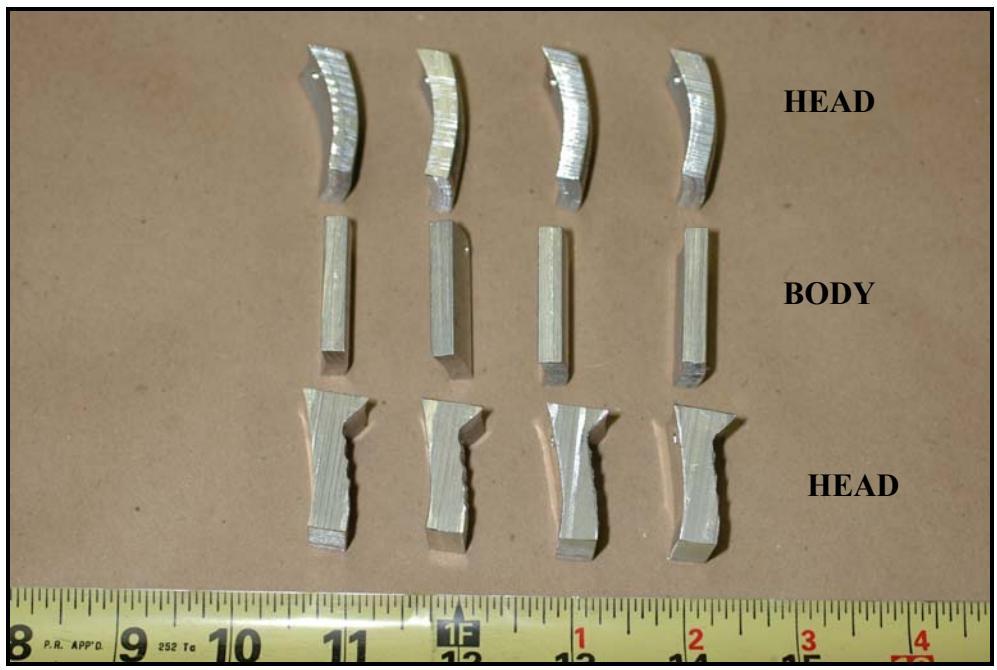
Figure 88: Shows the cross-section of the specimens from the head, body and base machined for assessing inter-crystalline corrosion

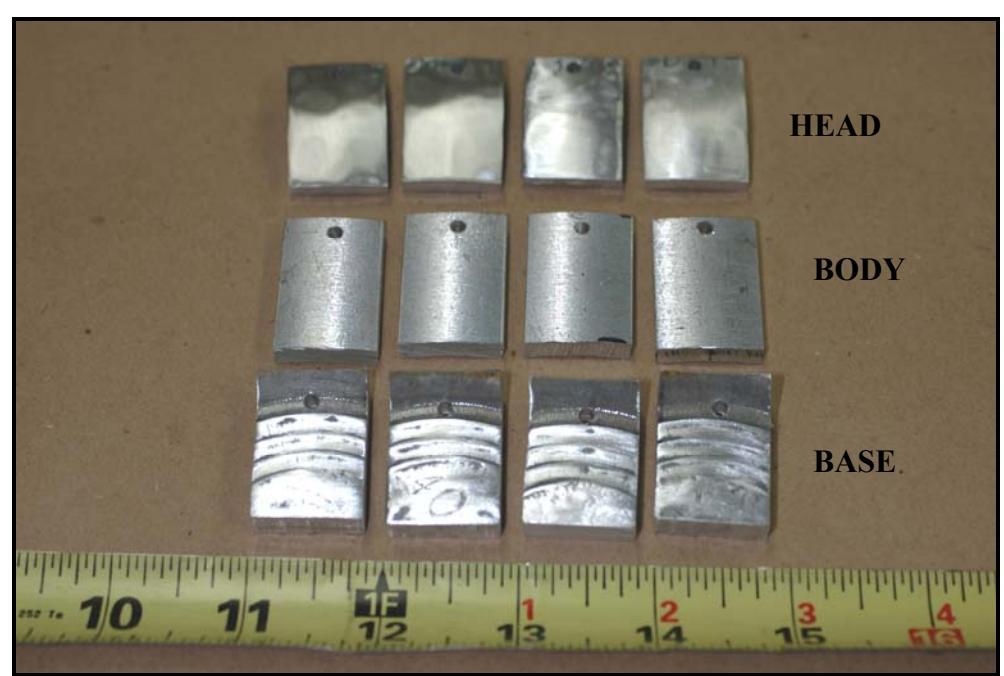
Figure 89: Shows the outer surface of the specimens after removing the paint from the head and coating from the base.

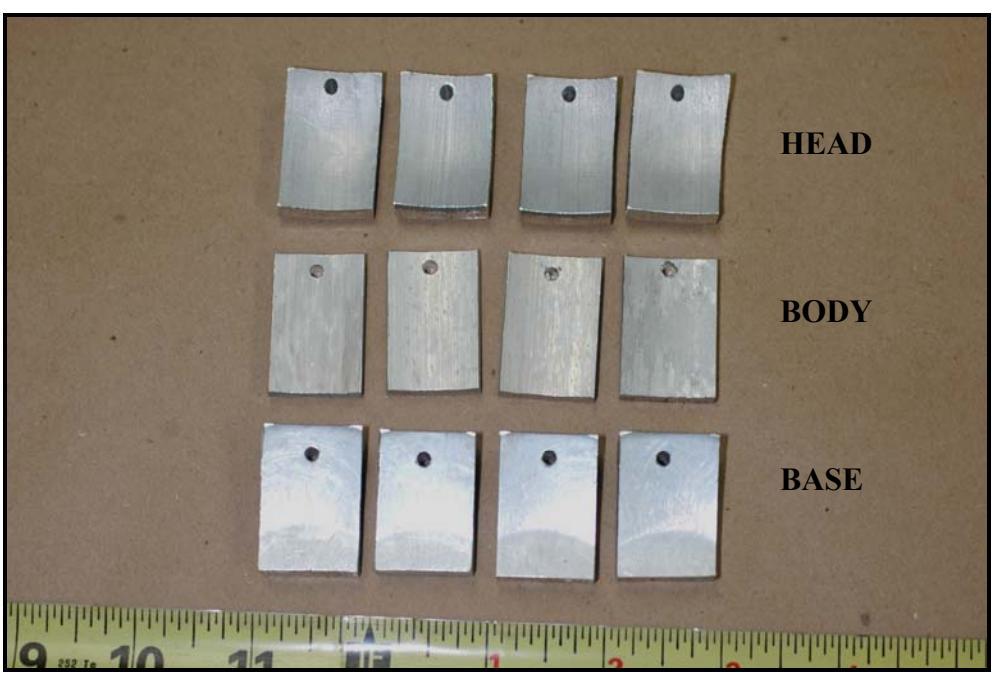
Figure 90: Shows the inside surface of the specimens from the head, body and base machined for assessing inter-crystalline corrosion

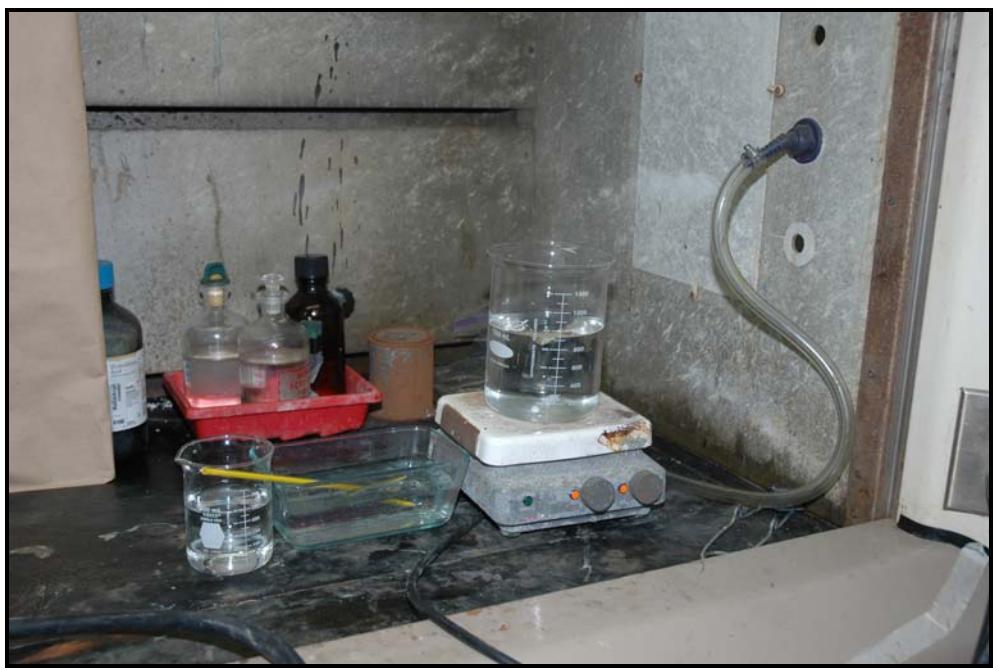
Figure 91: Set up for cleaning the samples before corrosion test.

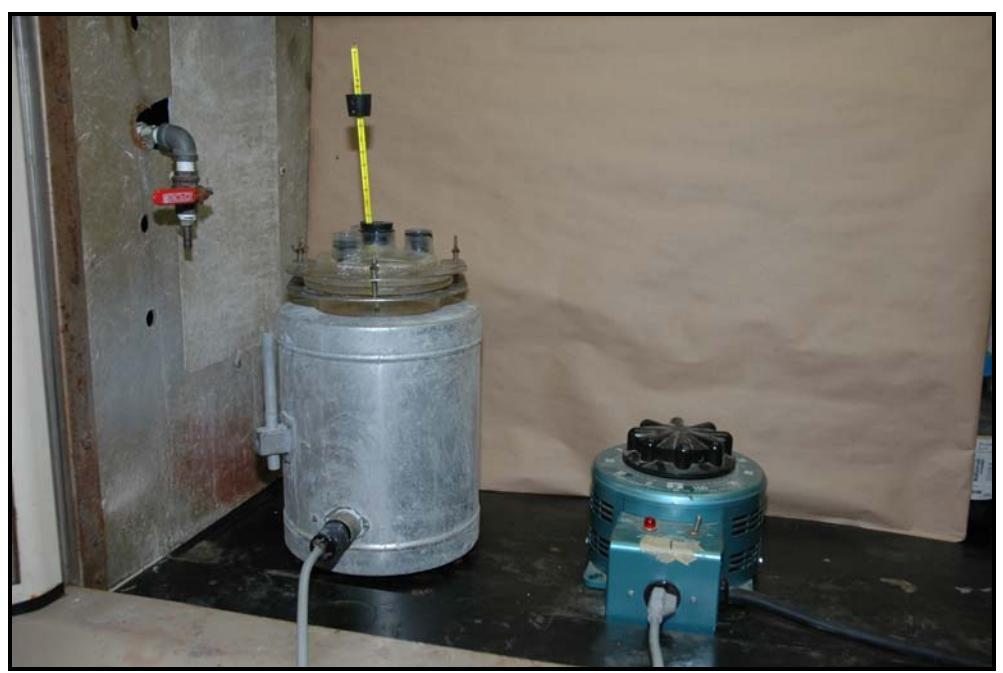
Figure 92: Shows set up for etching the specimens for 6 hours to assess the susceptibility to inter-crystalline corrosion.

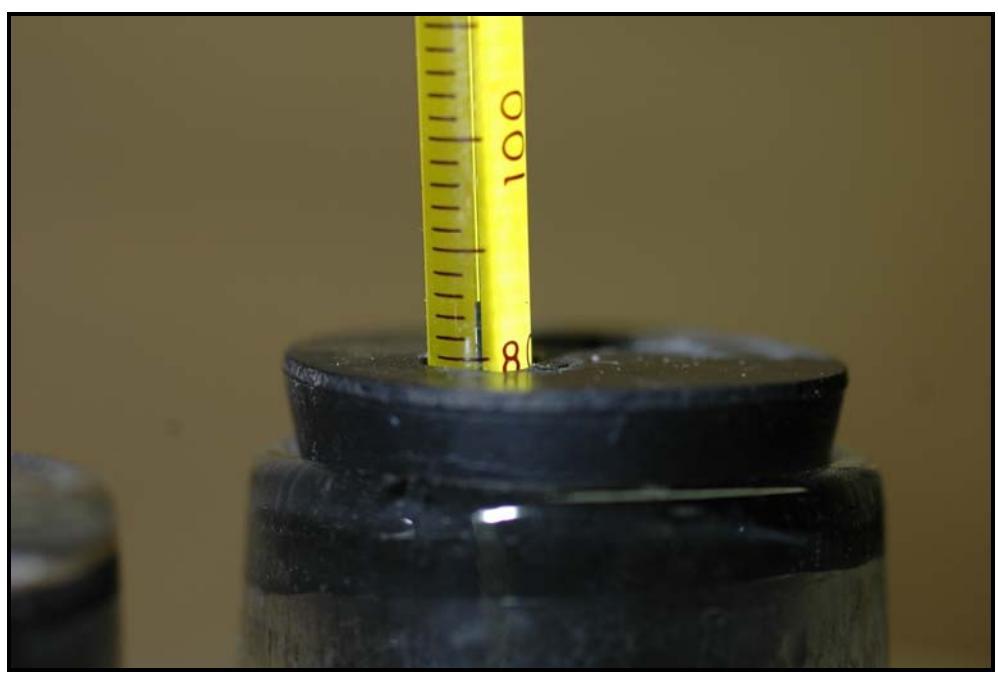
Figure 93: Shows the temperature at which the test was performed.

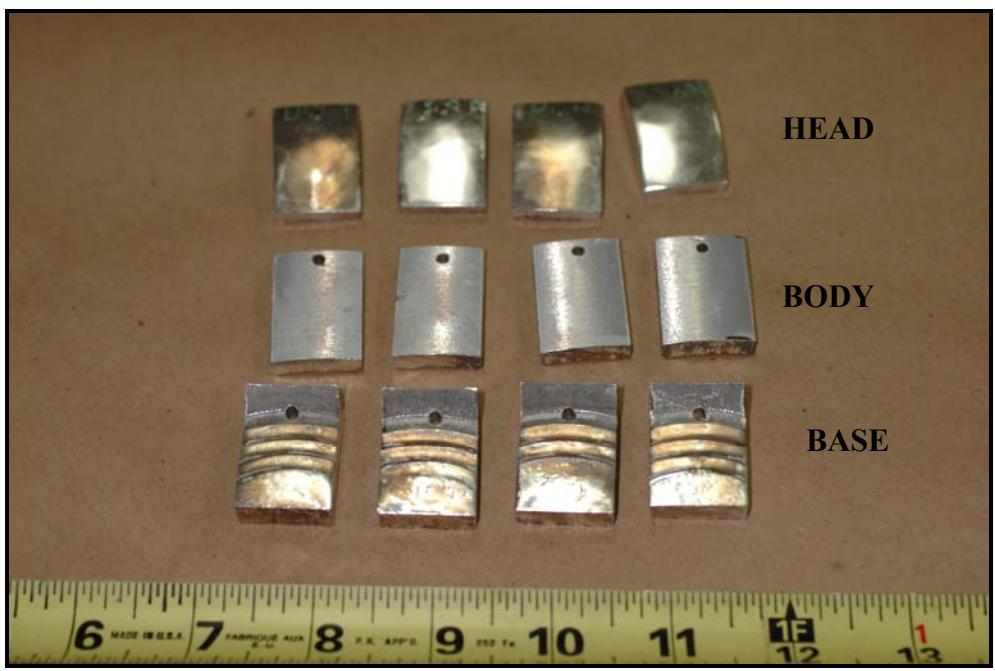
Figure 94: Shows the outer surface of the specimens after the corrosion test.

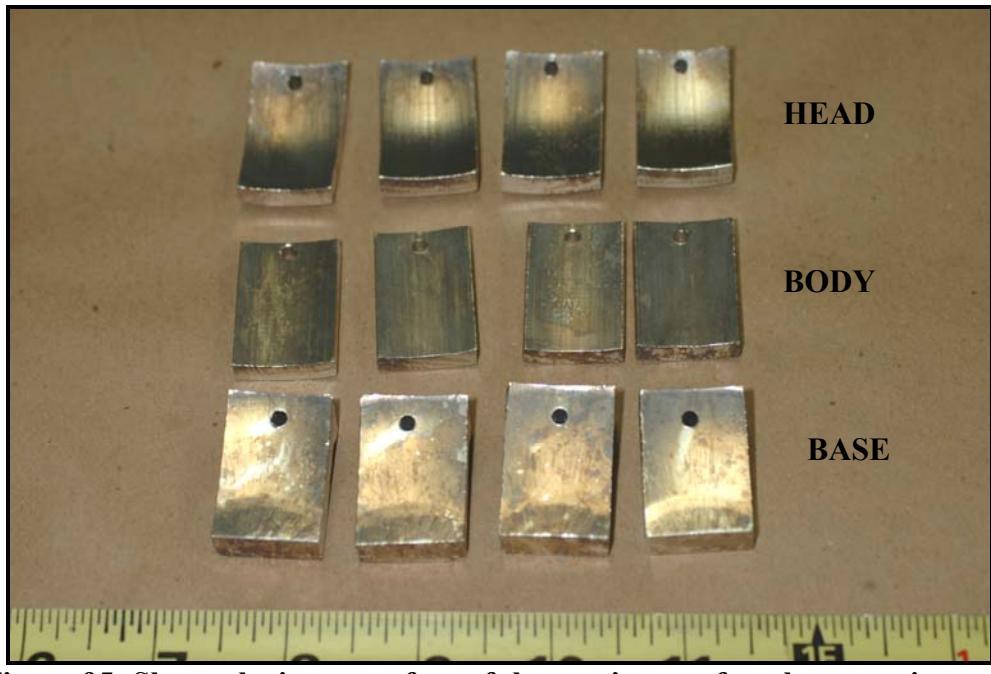
Figure 95: Shows the inner surface of the specimens after the corrosion test.

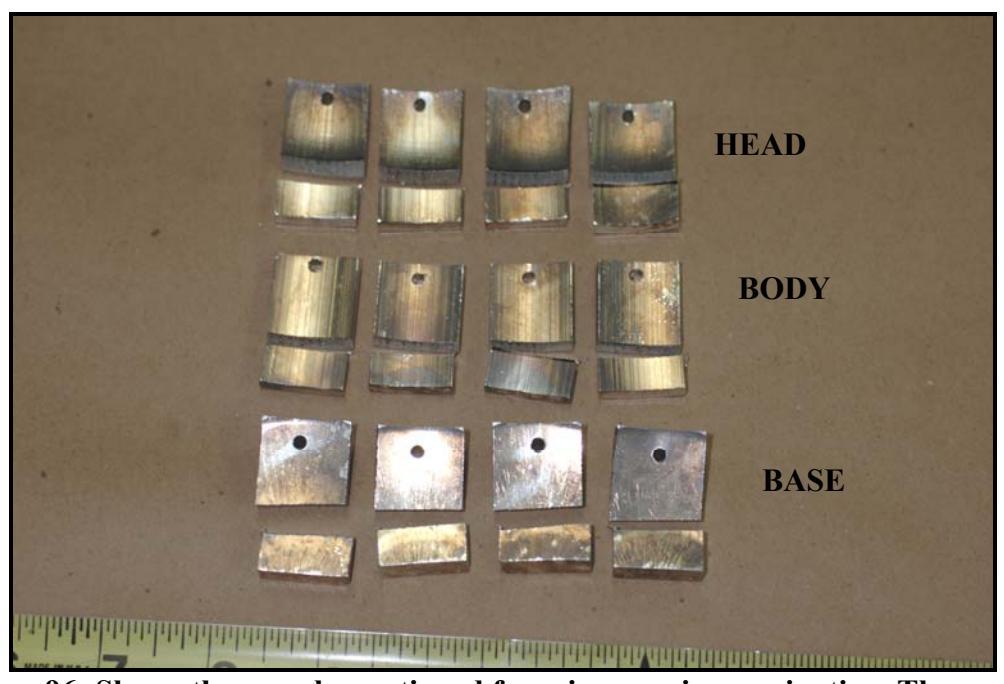
Figure 96: Shows the samples sectioned for microscopic examination. The smaller sections from each sample was mounted in epoxy and mechanically polished.

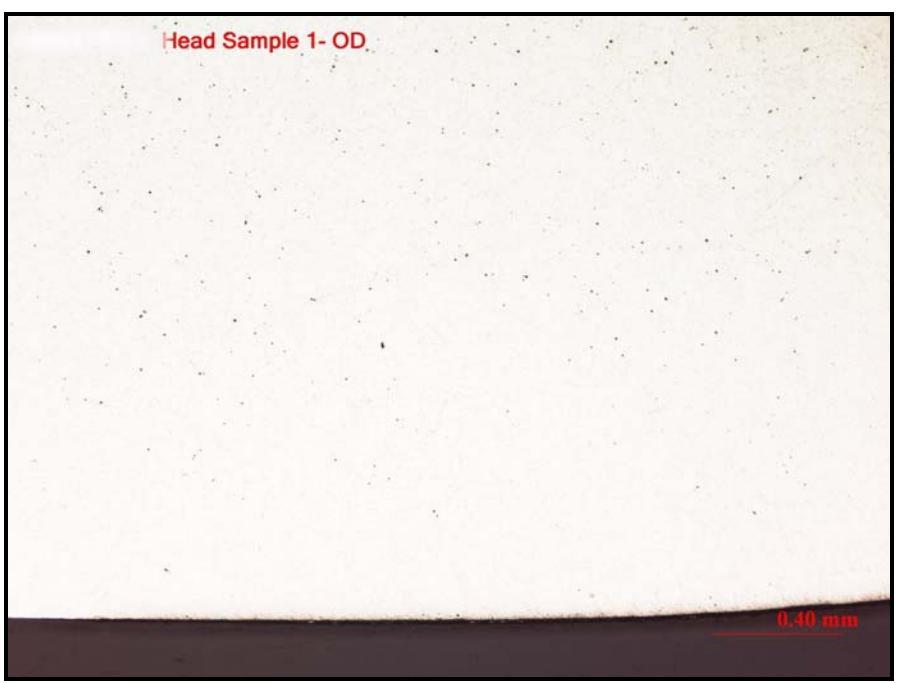
Figure 100: Microscope image shows the unetched OD of the sample 1 from the head of the cylinder # AR0118876. No inter-crystalline attack observed. Magnification: 50X.

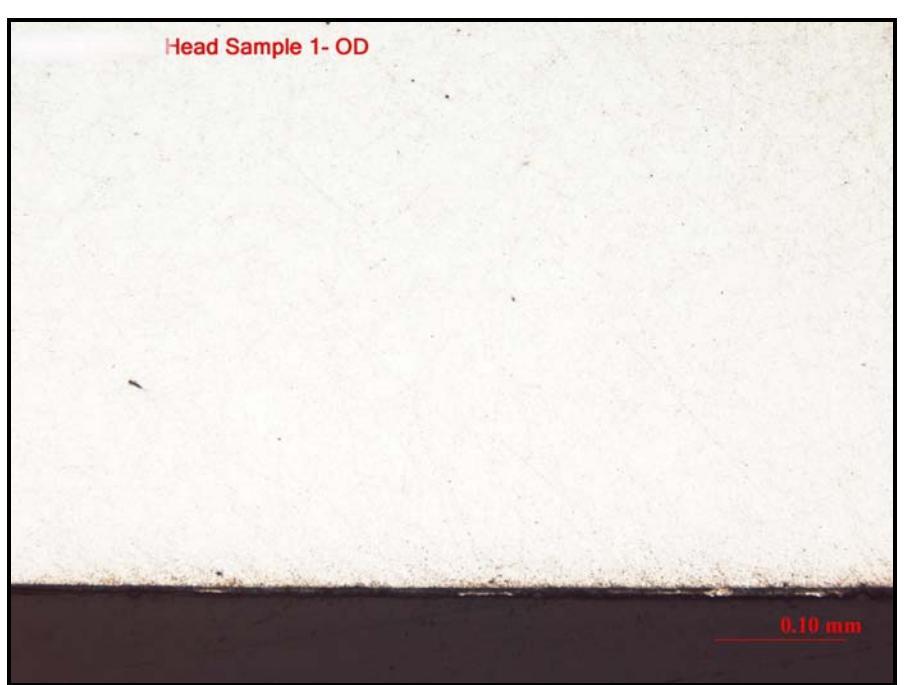
Figure 101: Microscope image shows the unetched OD of the sample 1 from the head of the cylinder # AR0118876. No inter-crystalline attack observed. Magnification: 200X.

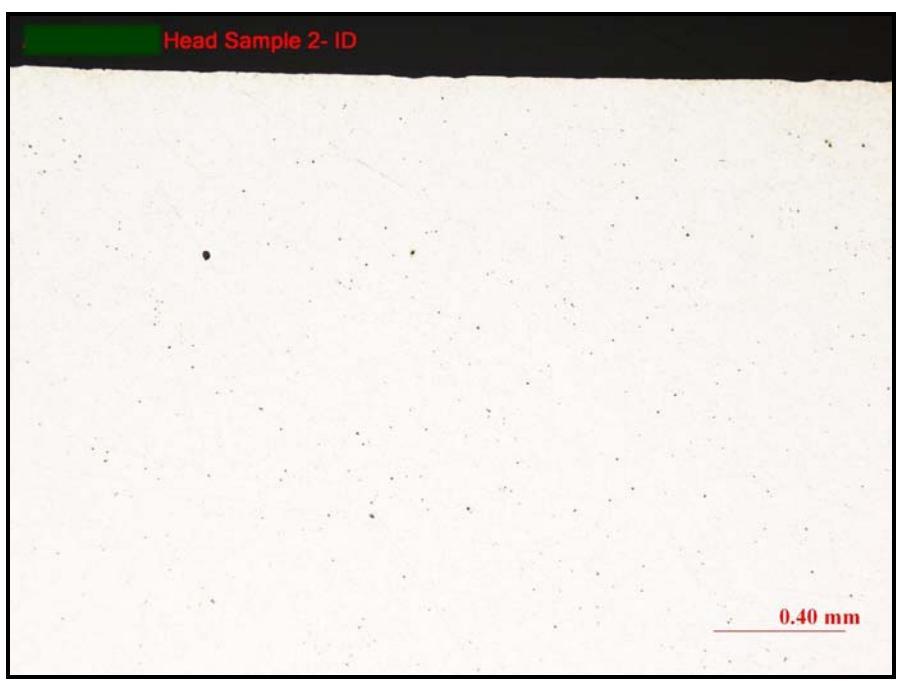
Figure 102: Microscope image shows the unetched ID of the sample 2 from the head of the cylinder # AR0118876. No inter-crystalline attack observed. Magnification 50X.

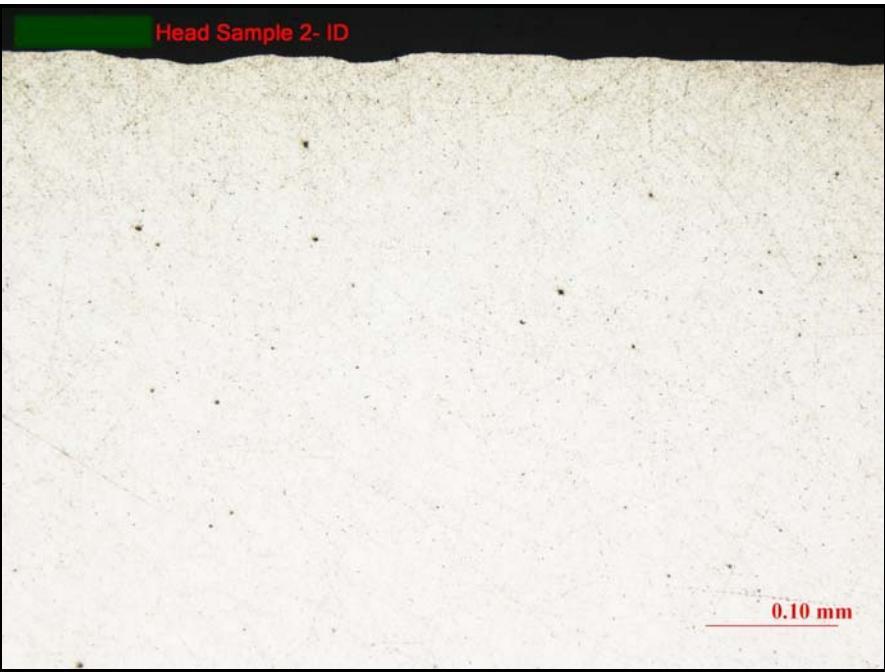
Figure 103: Microscope image shows the unetched ID of the sample 2 from the head of the cylinder # AR0118876. No inter-crystalline attack observed. Magnification: 200X.

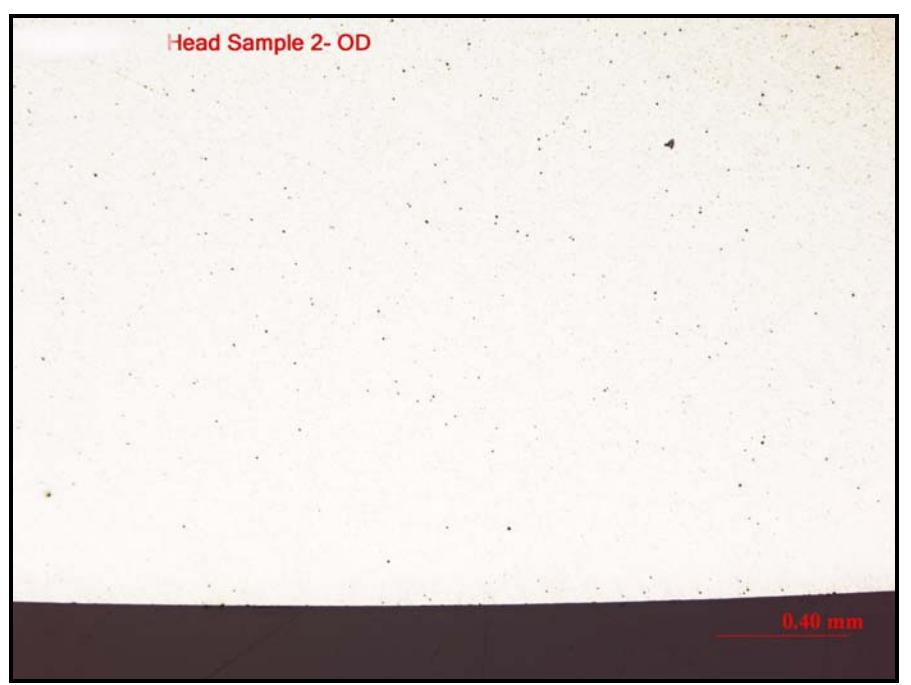
Figure 104: Microscope image shows the unetched OD of the sample 2 from the head of the cylinder # AR0118876. Magnification: 50X.

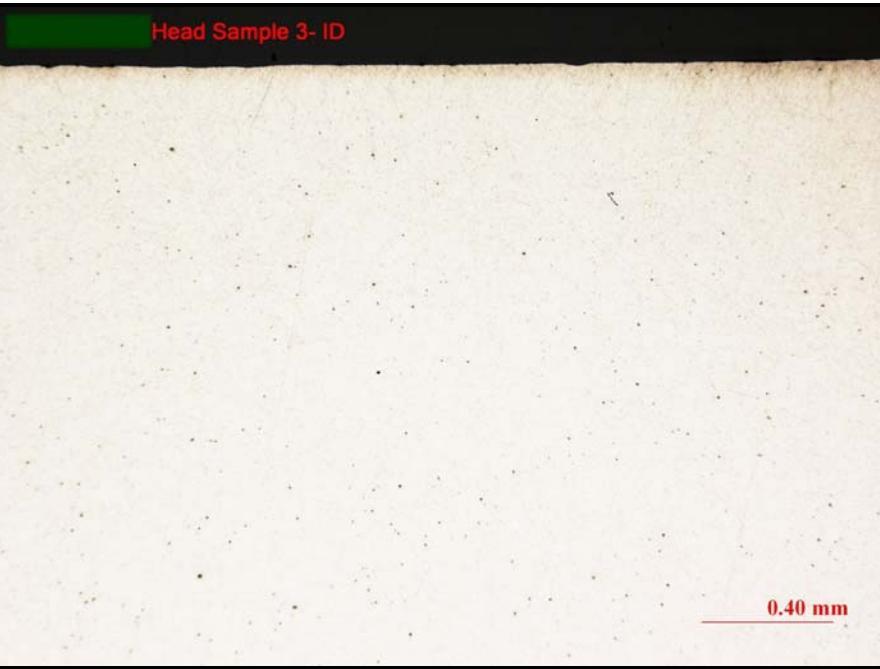
Figure 107: Microscope image shows the unetched ID of the sample 3 from the head of the cylinder # AR0118876. No inter-crystalline attack observed. Magnification: 50X.

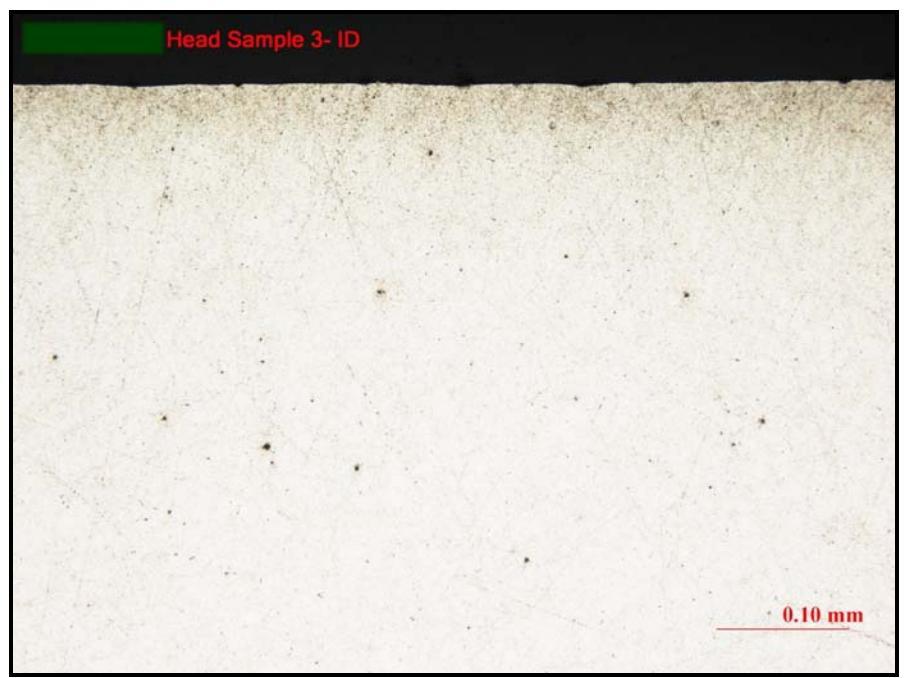
Figure 108: Microscope image shows the unetched ID of the sample 3 from the head of the cylinder # AR0118876. No inter-crystalline attack observed. Magnification: 200X.

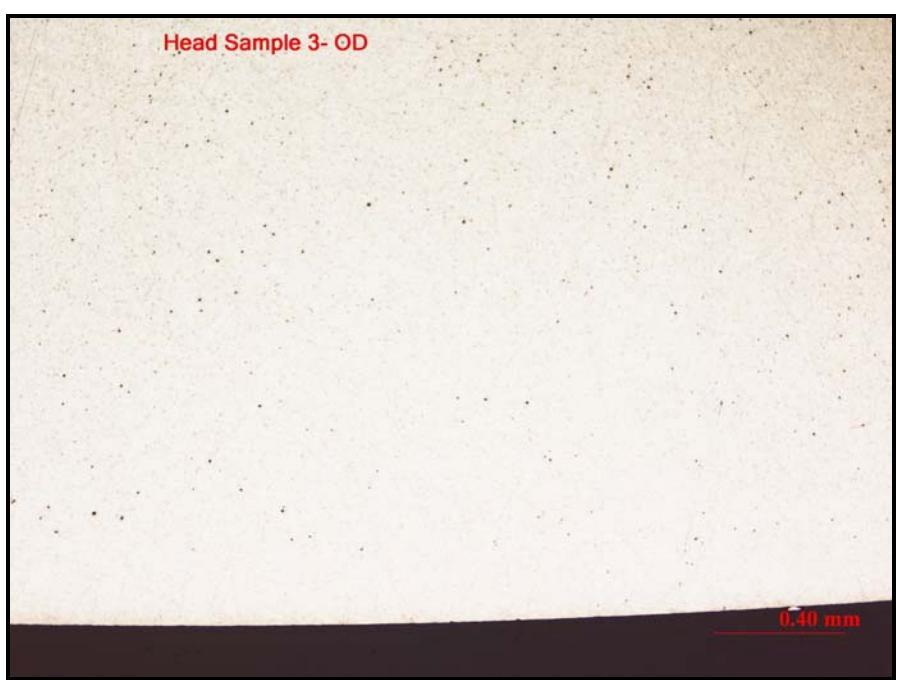
Figure 109: Microscope image shows the unetched OD of the sample 3 from the head of the cylinder # AR0118876. No inter-crystalline attack observed. Magnification: 50X.

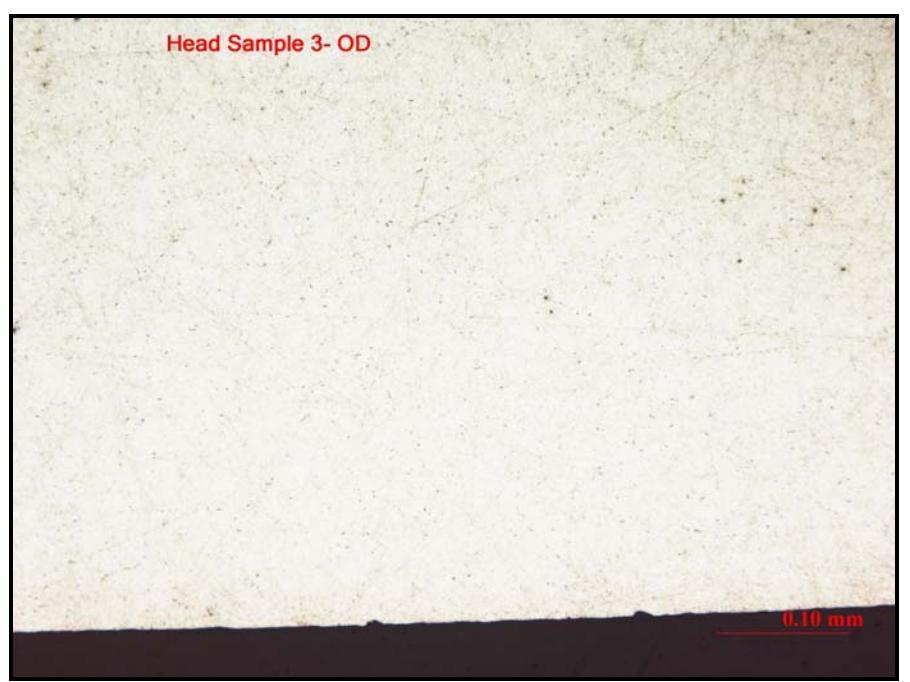
Figure 110: Microscope image shows the unetched OD of the sample 3 from the head of the cylinder # AR0118876. No inter-crystalline attack observed. Magnification: 200X.

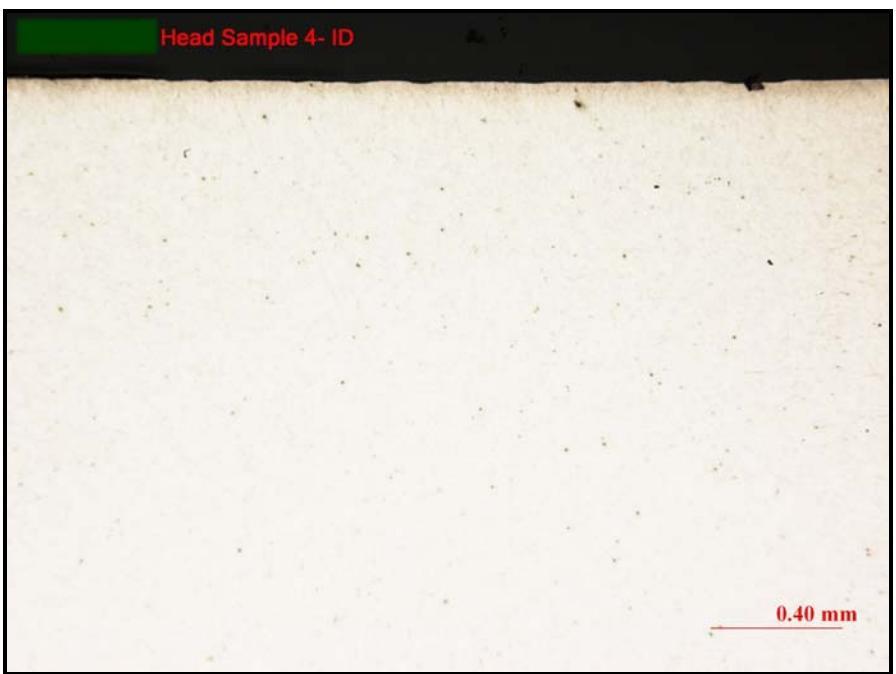
Figure 111: Microscope image shows the unetched ID of the sample 4 from the head of the cylinder # AR0118876. No inter-crystalline attack observed. Magnification: 50X.

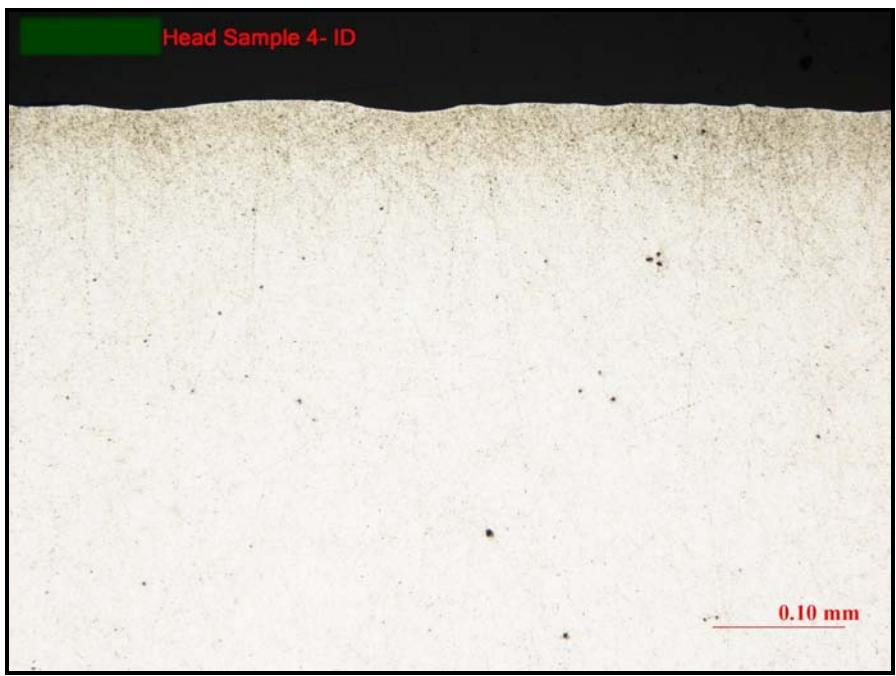
Figure 112: Microscope image shows the unetched ID of the sample 4 from the head of the cylinder # AR0118876. No inter-crystalline attack observed. Magnification: 200X.

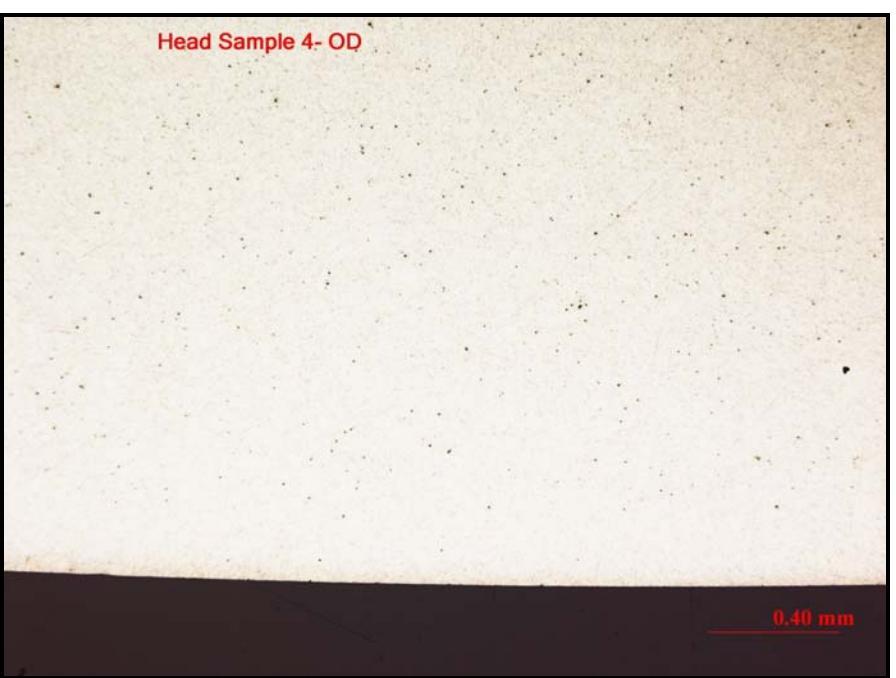
Figure 113: Microscope image shows the unetched OD of the sample 4 from the head of the cylinder # AR0118876. No inter-crystalline attack observed. Magnification: 50X.

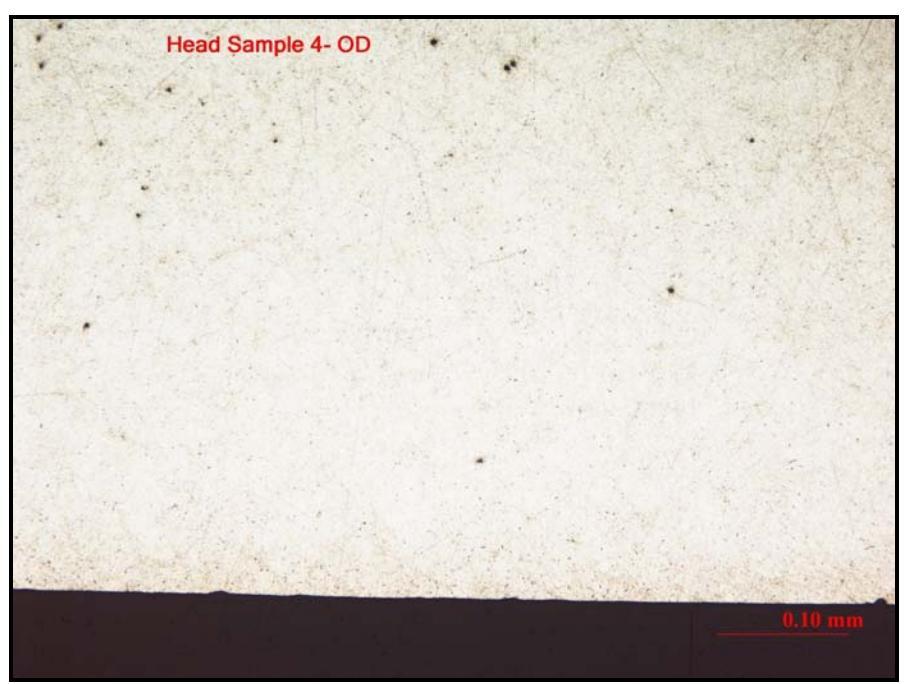
Figure 114: Microscope image shows the unetched OD of the sample4 from the head of the cylinder # AR0118876. No inter-crystalline attack observed. Magnification: 200X.

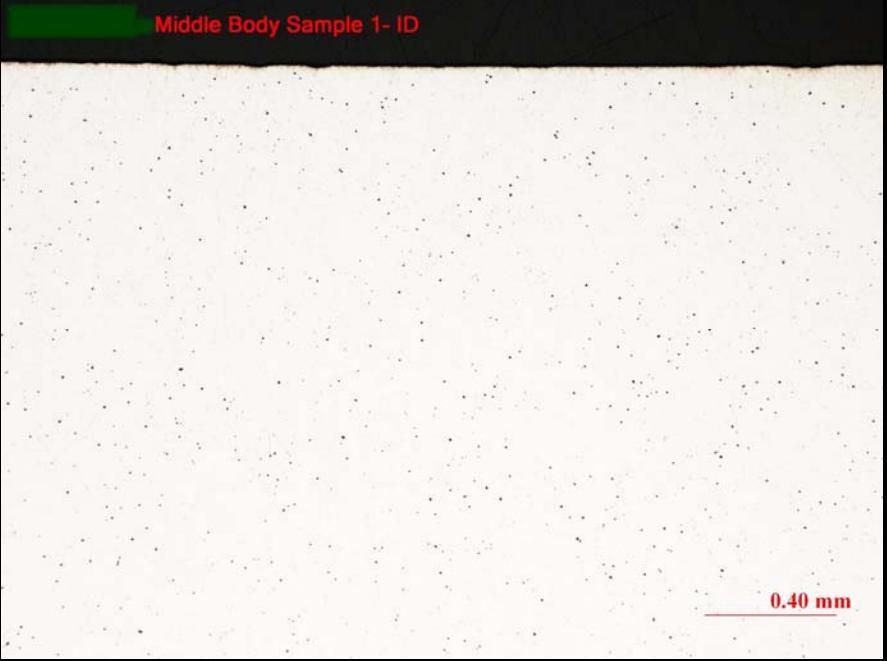
Figure 115: Microscope image shows the unetched ID of the sample 1 from the middle body of the cylinder # AR0118876. No inter-crystalline attack observed. Magnification: 50X.

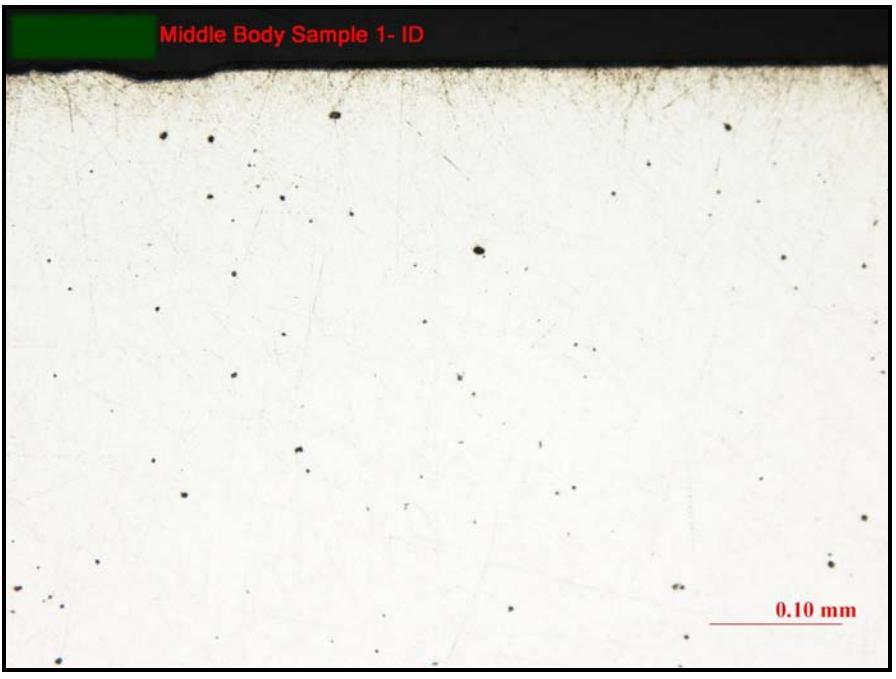
Figure116: Microscope image shows the unetched ID of the sample 1 from the middle body of the cylinder # AR0118876. No inter-crystalline attack observed. Magnification: 200X.

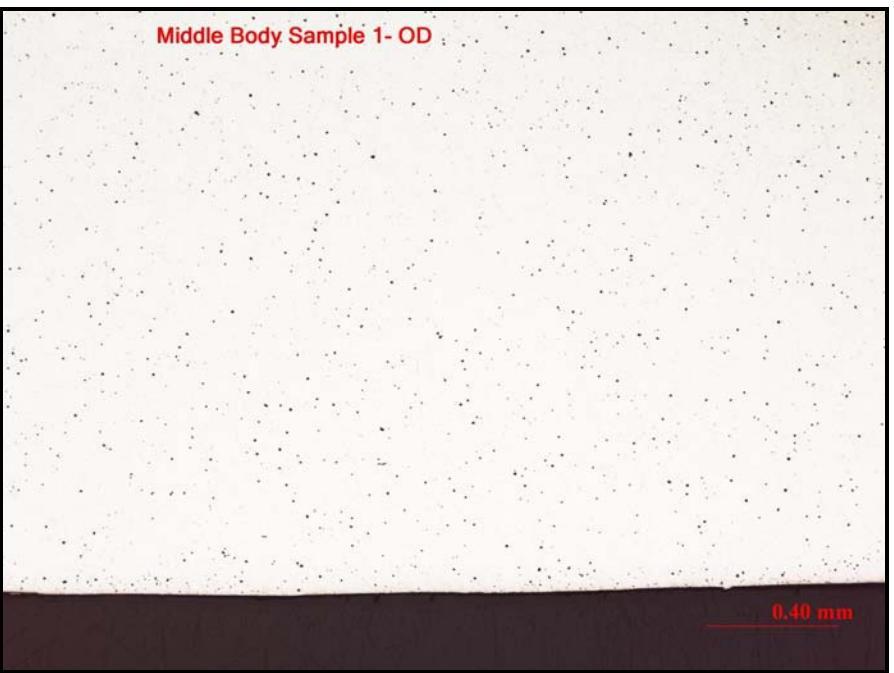
Figure 117: Microscope image shows the unetched OD of the sample 1 from the middle body of the cylinder # AR0118876. No inter-crystalline attack observed. Magnification: 50X.

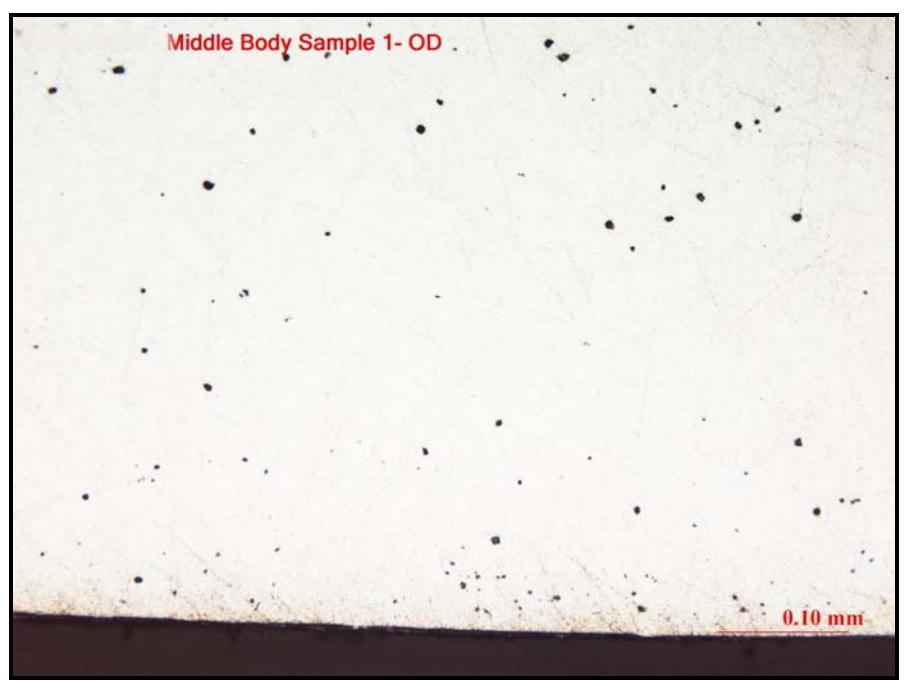
Figure 118: Microscope image shows the unetched OD of the sample 1 from the middle body of the cylinder # AR0118876. No inter-crystalline attack observed. Magnification: 200X.

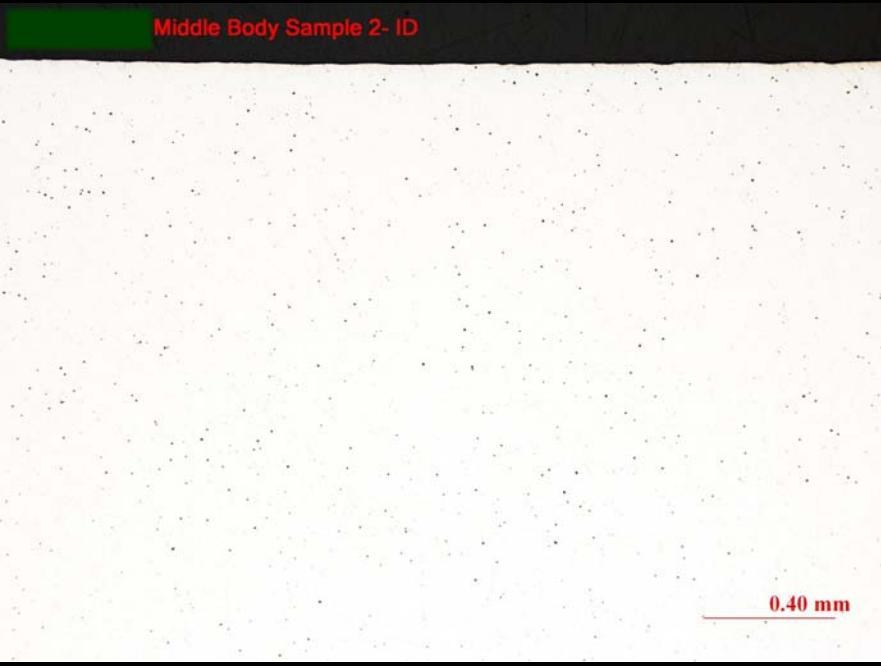
Figure 119: Microscope image shows the unetched ID of the sample 2 from the middle body of the cylinder # AR0118876. No inter-crystalline attack observed. Magnification: 50X.

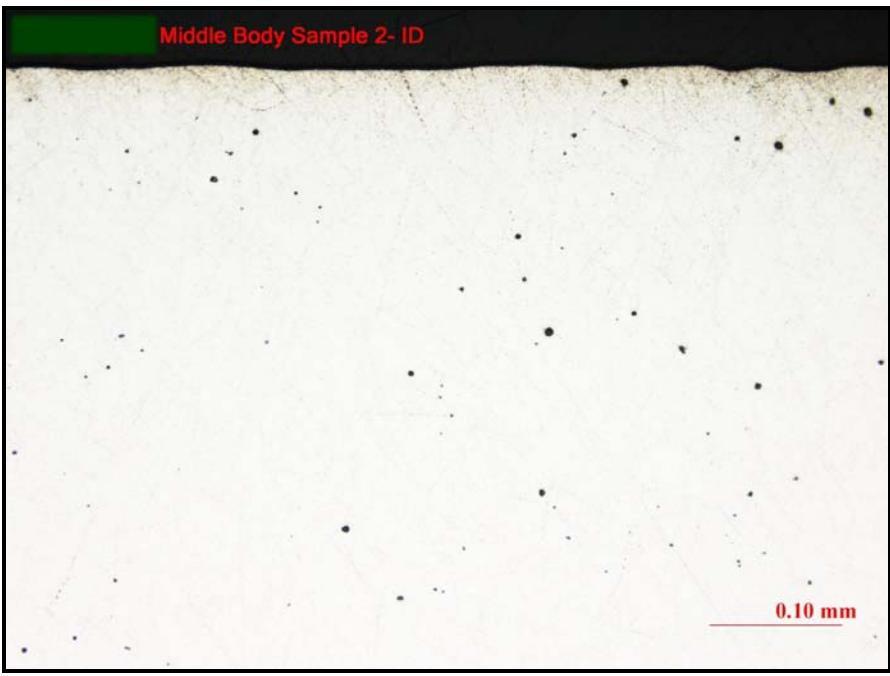
Figure 120: Microscope image shows the unetched ID of the sample 2 from the middle body of the cylinder # AR0118876. No inter-crystalline attack observed. Magnification: 200X.

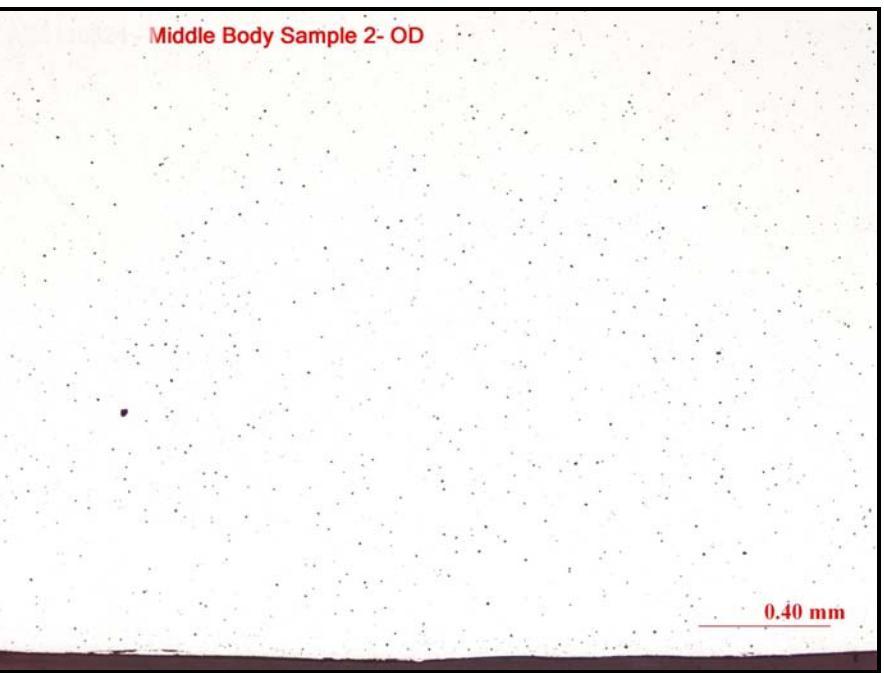
Figure 121: Microscope image shows the unetched OD of the sample 2 from the middle body of the cylinder # AR0118876. No inter-crystalline attack observed. Magnification: 50X.

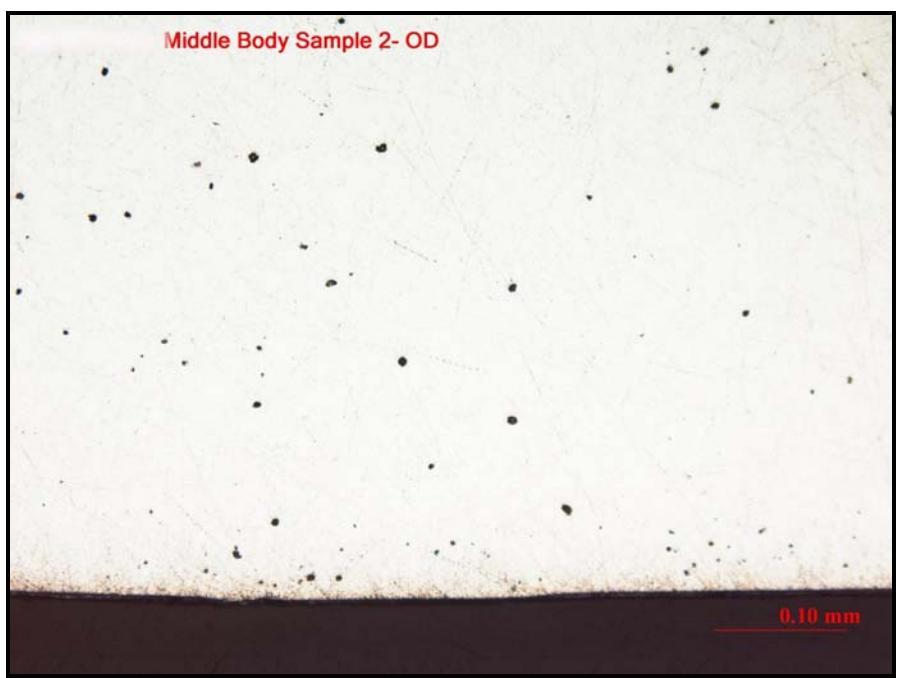
Figure 122: Microscope image shows the unetched OD of the sample 2 from the middle body of the cylinder # AR0118876. No inter-crystalline attack observed. Magnification: 200X.

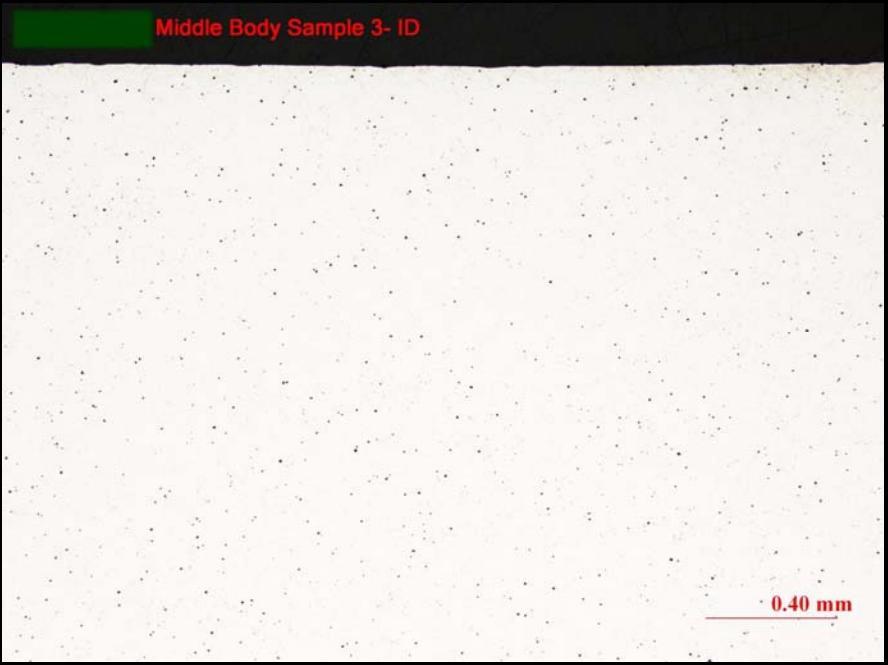
Figure 123: Microscope image shows the unetched ID of the sample 3 from the middle body of the cylinder # AR0118876. No inter-crystalline attack observed. Magnification: 50X.
