PACKER ENGINEERING INC, 1950 North Washington Street, Naperville, IL 60566

Evaluation of Three DOT 3AL 6061-T6 Cylinders to Determine the Neck Cracks Cause and Initiation Site (CIS of Neck Cracks)

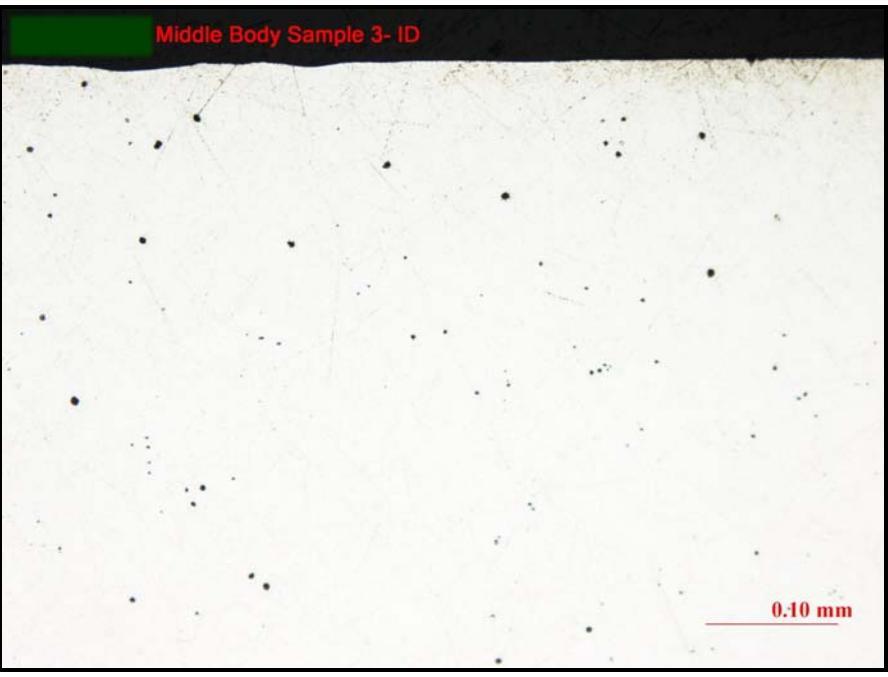
Figure 124: Microscope image shows the unetched ID of the sample 3 from the middle body of the cylinder # AR0118876. No inter-crystalline attack observed. Magnification: 200X.

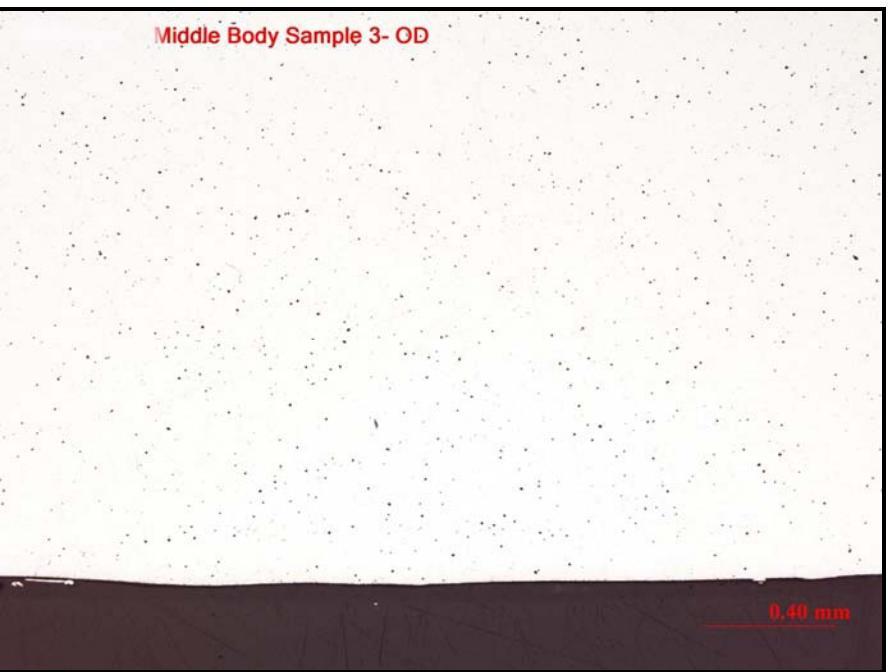
Figure 125: Microscope image shows the unetched OD of the sample 3 from the middle body of the cylinder # AR0118876. No inter-crystalline attack observed. Magnification: 50X.

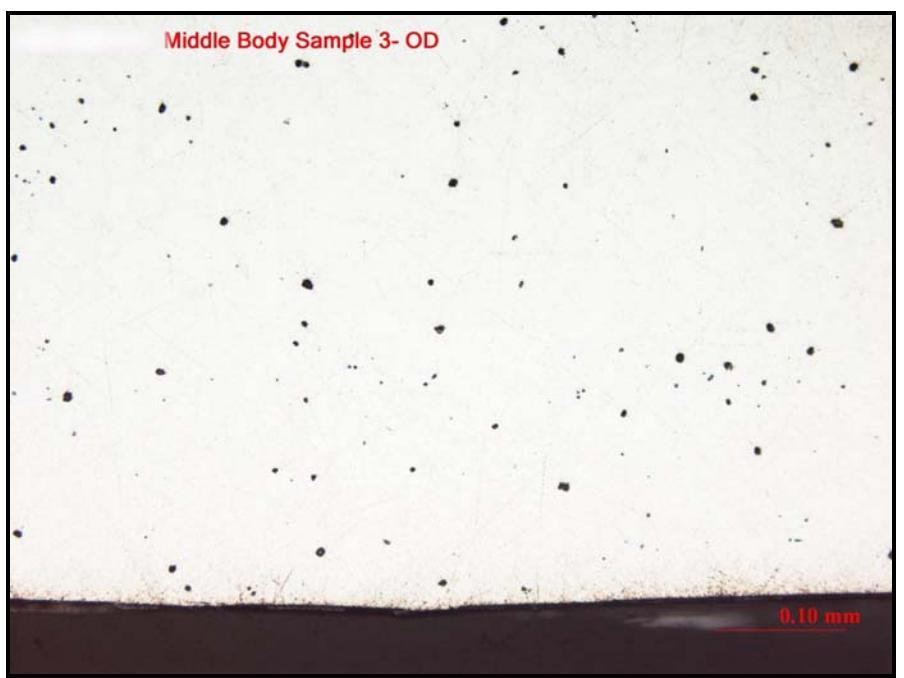
Figure 126: Microscope image shows the unetched OD of the sample 3 from the middle body of the cylinder # AR0118876. No inter-crystalline attack observed. Magnification: 200X.

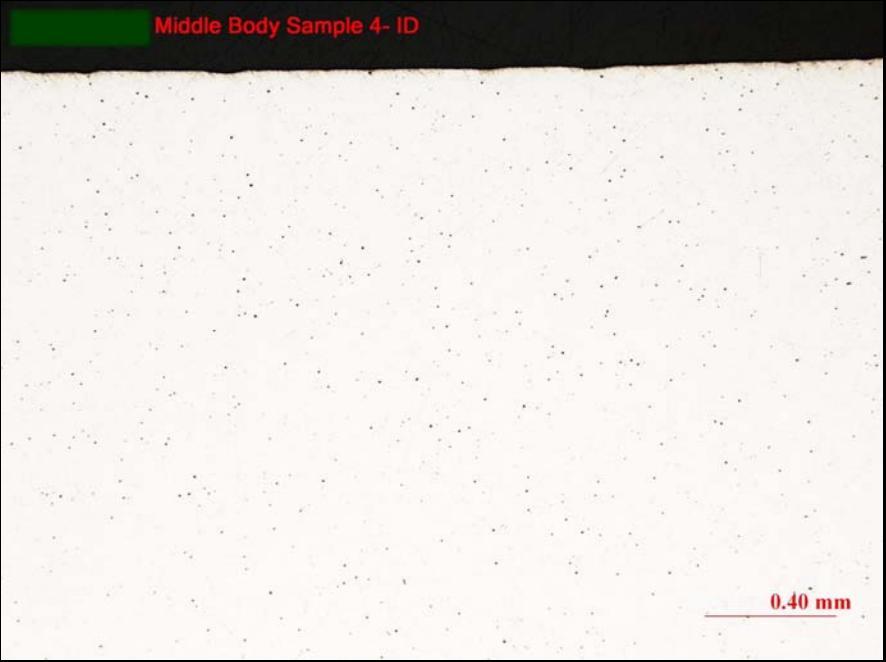
Figure 127: Microscope image shows the unetched ID of the sample 4 from the middle body of the cylinder # AR0118876. No inter-crystalline attack observed. Magnification: 50X.

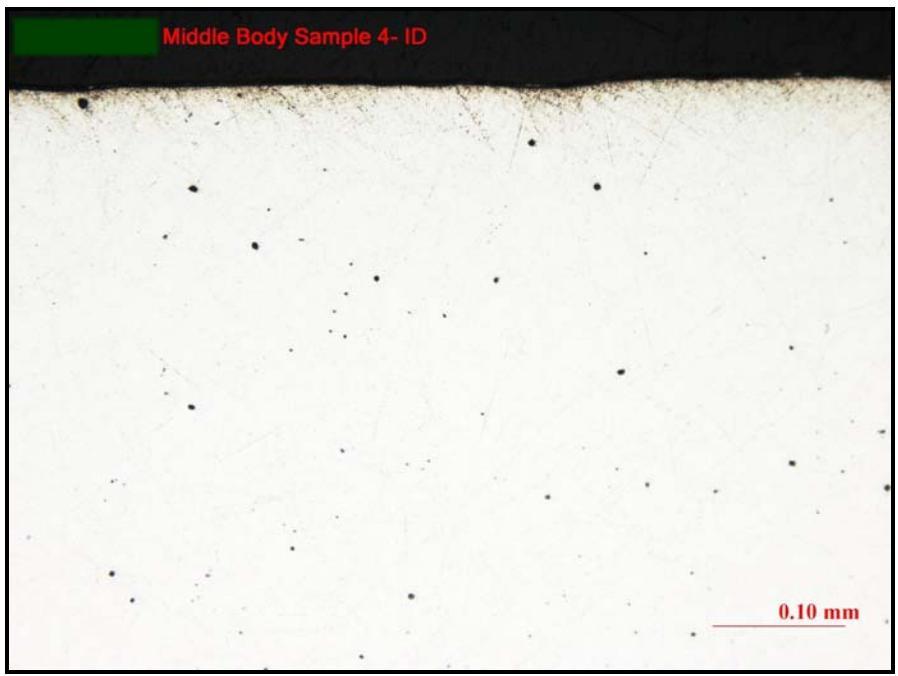
Figure 128: Microscope image shows the unetched ID of the sample 4 from the middle body of the cylinder # AR0118876. No inter-crystalline attack observed. Magnification: 200X.

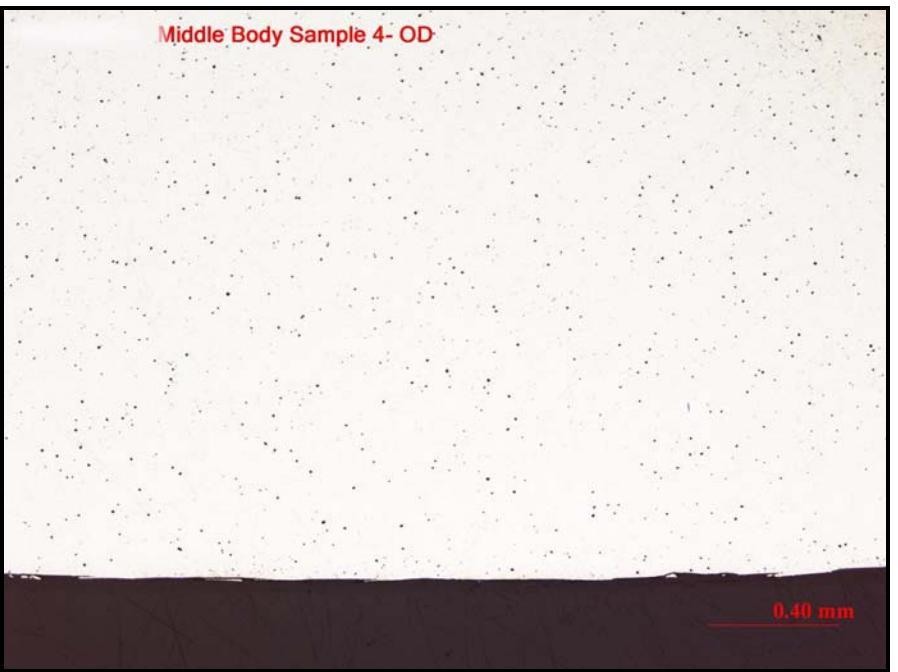
Figure 129: Microscope image shows the unetched OD of the sample 4 from the middle body of the cylinder # AR0118876. No inter-crystalline attack observed. Magnification: 50X.

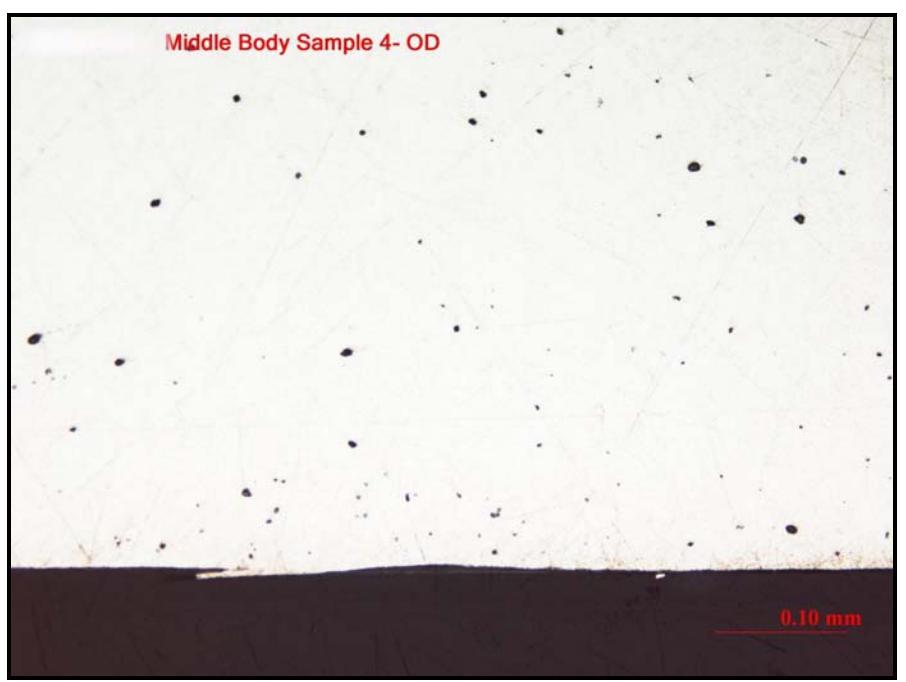
Figure 130: Microscope image shows the unetched OD of the sample 4 from the middle body of the cylinder # AR0118876. No inter-crystalline attack observed. Magnification: 200X.

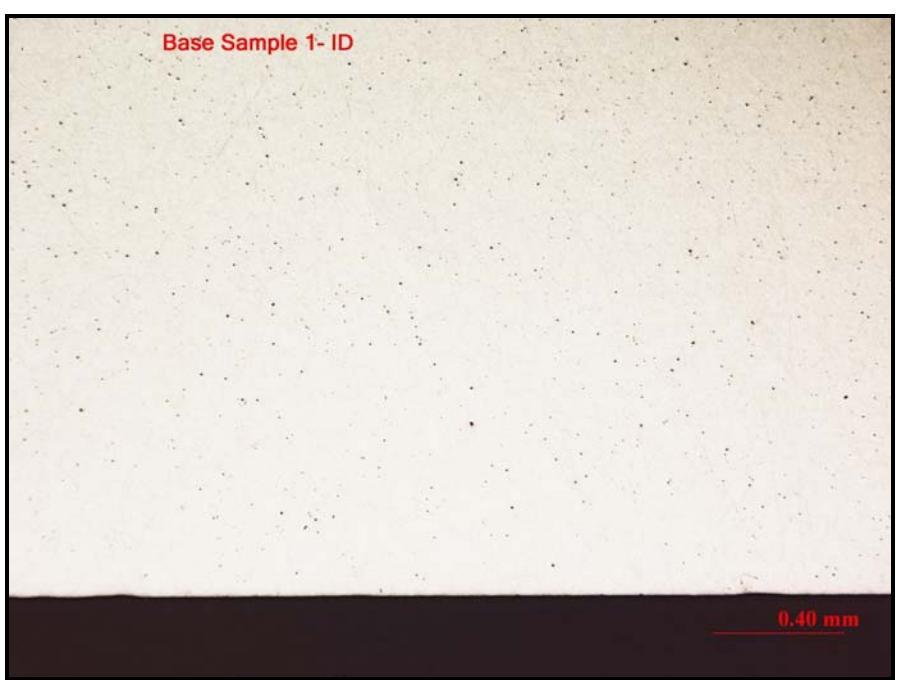
Figure 131: Microscope image shows the unetched ID of the sample 1 from base of the cylinder # AR0118876. No inter-crystalline attack observed. Magnification: 50X.

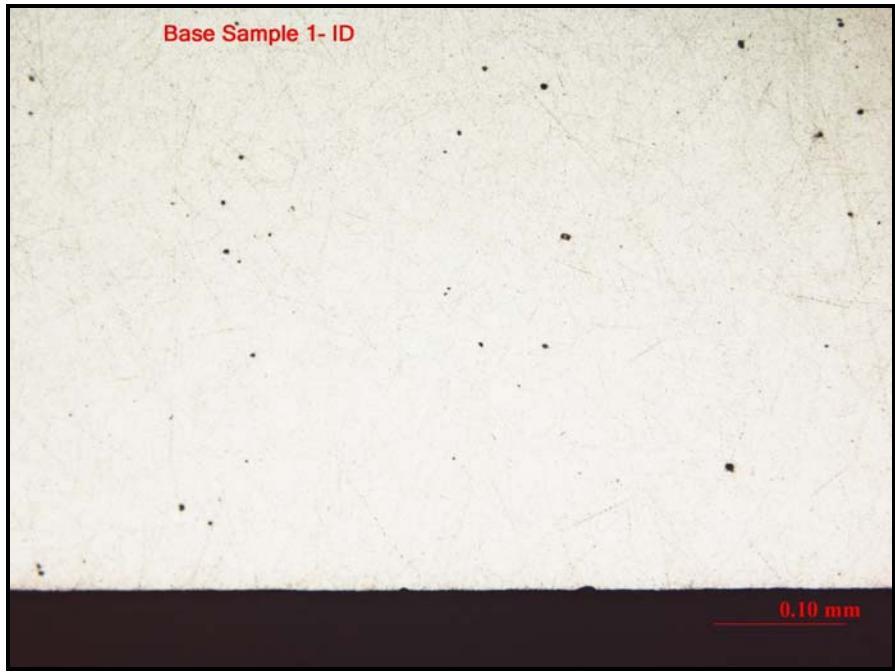
Figure 132: Microscope image shows the unetched ID of the sample 1 from base of the cylinder # AR0118876. No inter-crystalline attack observed. Magnification: 200X.

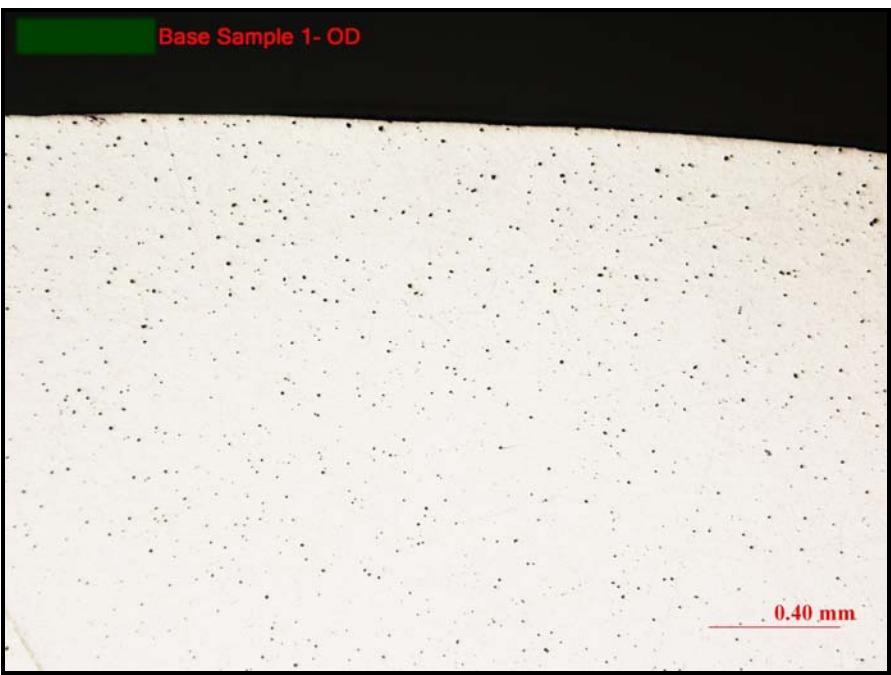
Figure 133: Microscope image shows the unetched OD of the sample 1 from base of the cylinder # AR0118876. Magnification: 50X.

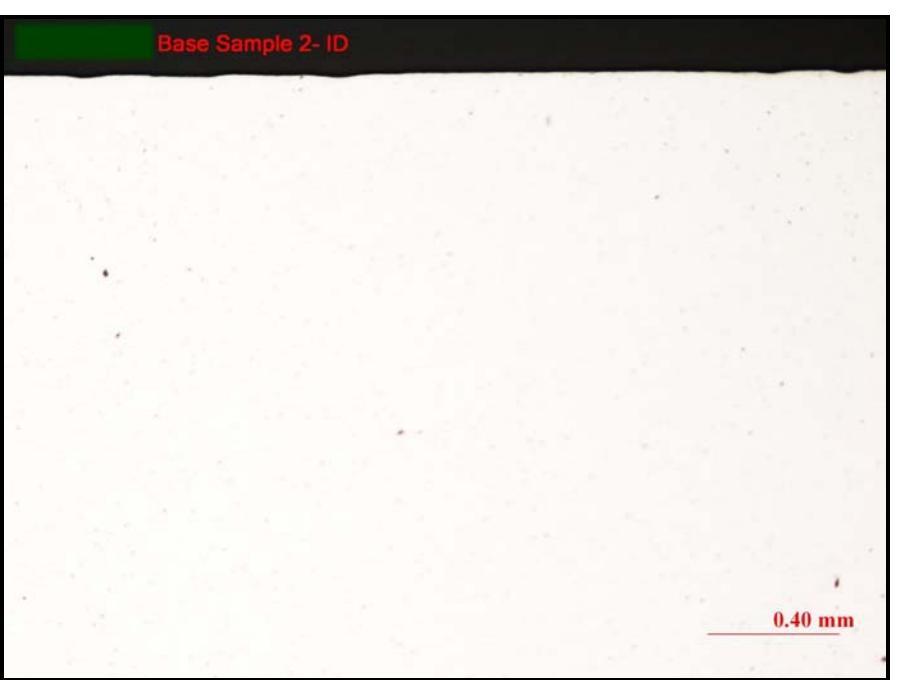
Figure 139: Microscope image shows the unetched ID of the sample 2 from base of the cylinder # AR0118876. No inter-crystalline attack observed. Magnification: 50X.

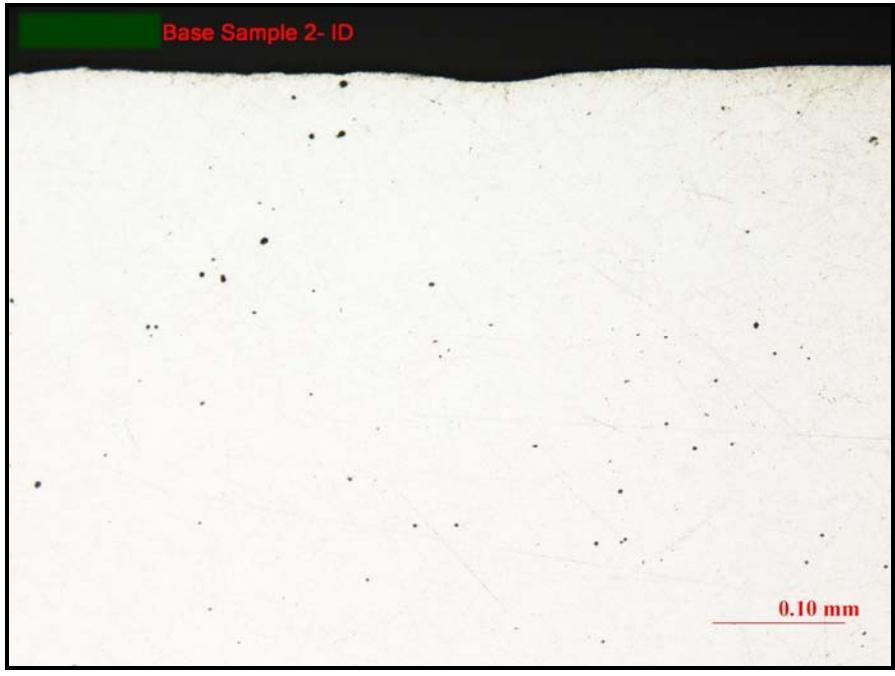
Figure 140: Microscope image shows the unetched ID of the sample 2 from base of the cylinder # AR0118876. No inter-crystalline attack observed. Magnification: 200X.

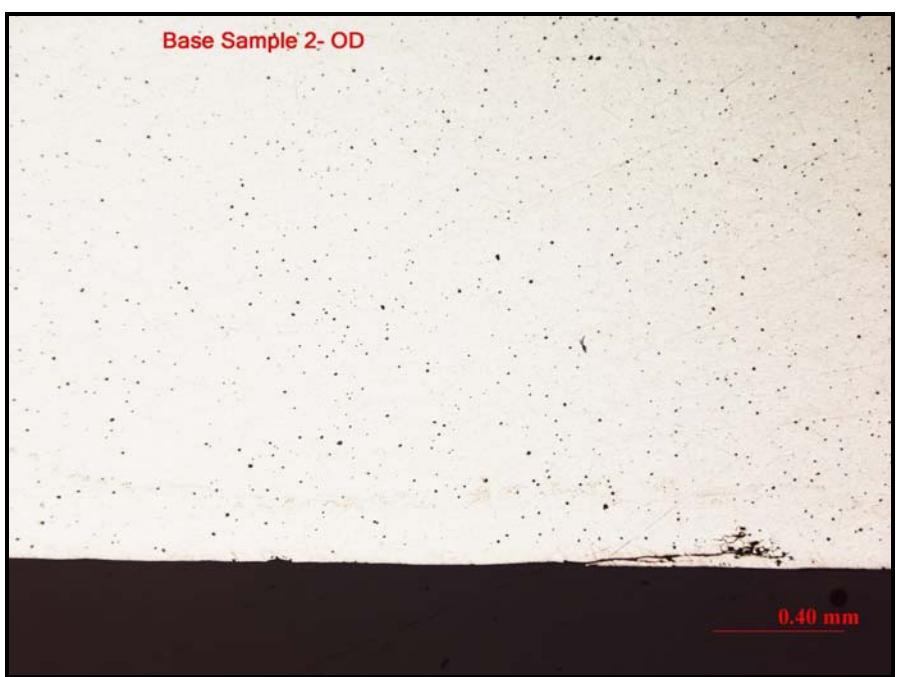
Figure 141: Microscope image shows the unetched OD of the sample 2 from base of the cylinder # AR0118876. No inter-crystalline attack observed. Magnification: 50X.

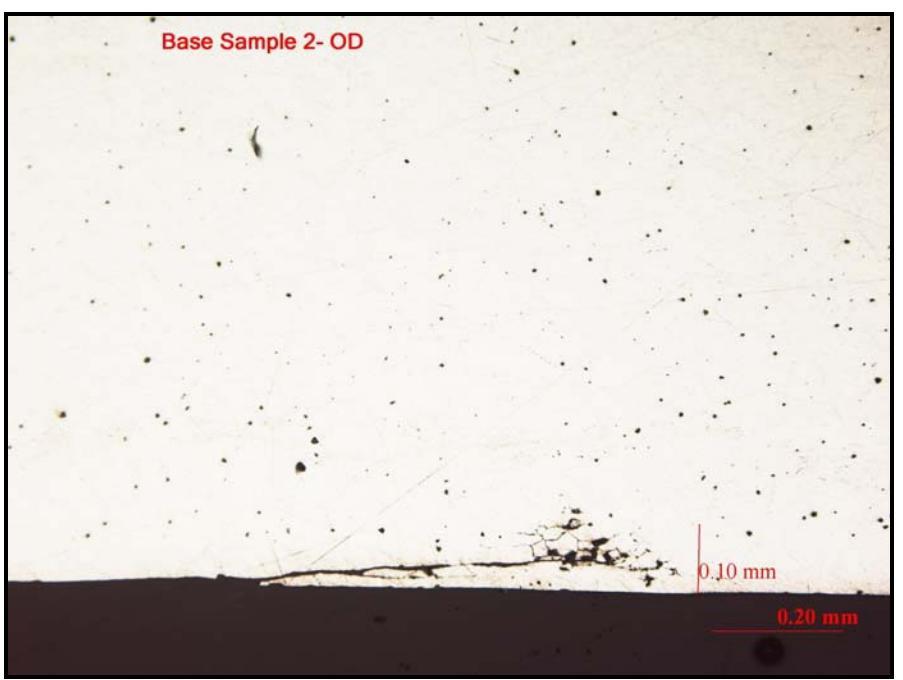
Figure 142: Microscope image shows the unetched OD of the sample 2 from base of the cylinder # AR0118876. Inter-crystalline attack = 0.1 mm. Magnification: 100X.

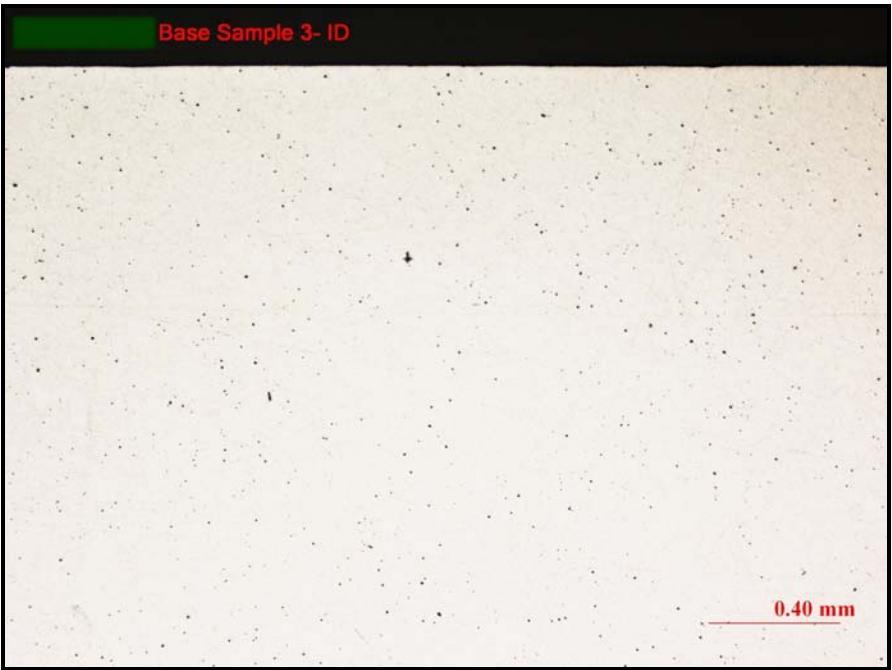
Figure 145: Microscope image shows the unetched ID of the sample 3 from the base of the cylinder # AR0118876. No inter-crystalline attack observed. Magnification: 50X.

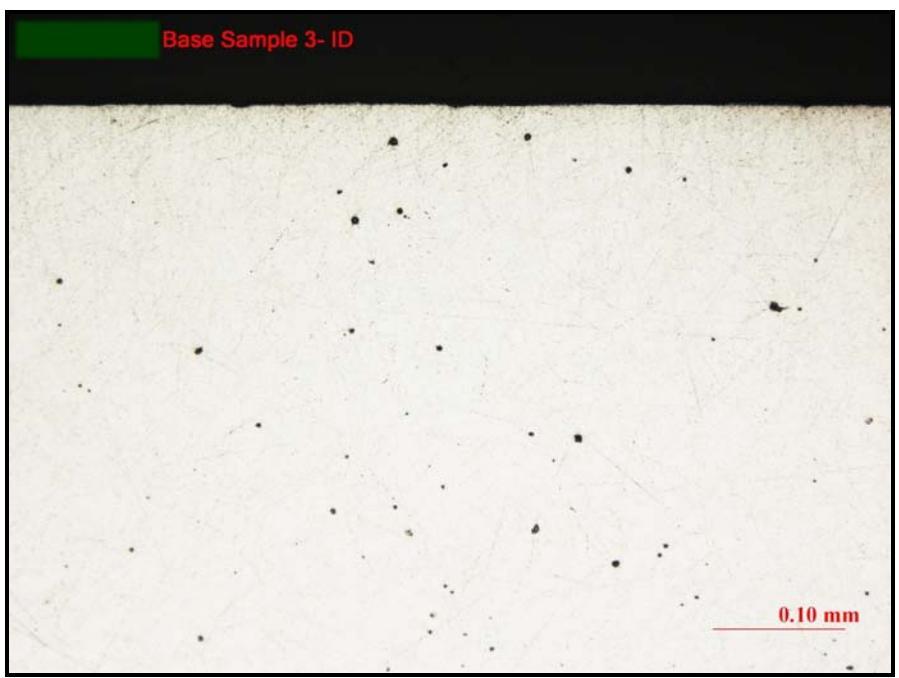
Figure 146: Microscope image shows the unetched ID of the sample 3 from the base of the cylinder # AR0118876. No inter-crystalline attack observed. Magnification: 200X.

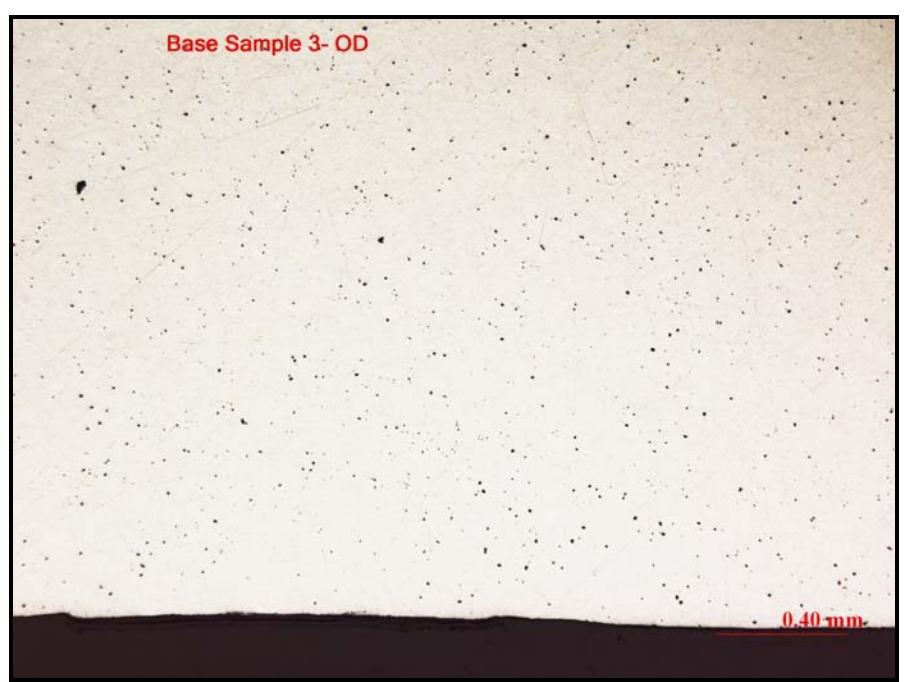
Figure 147: Microscope image shows the unetched OD of the sample 3 from the base of the cylinder # AR0118876. Magnification: 50X.

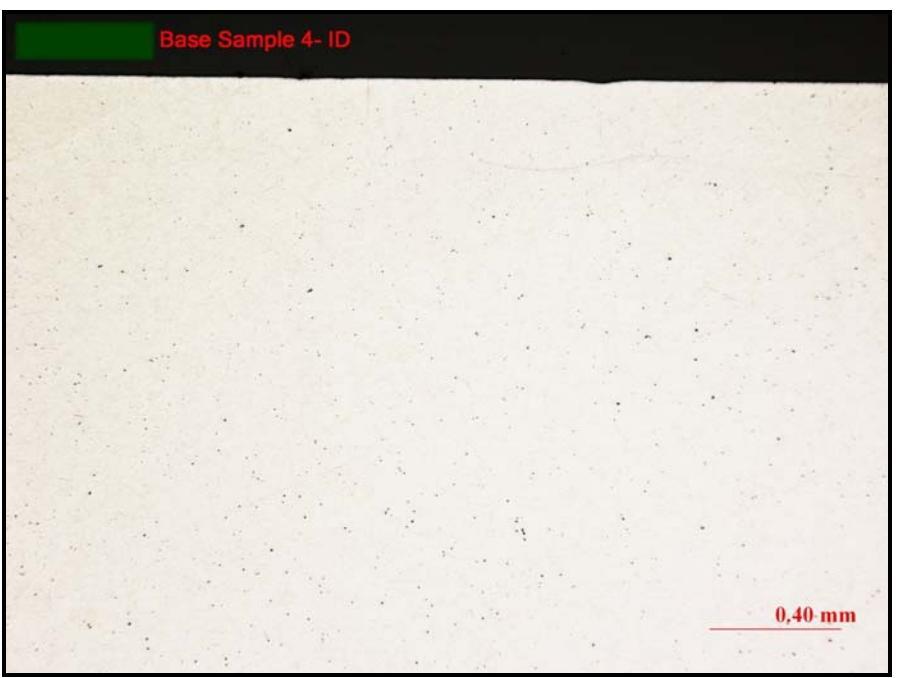
Figure 150: Microscope image shows the unetched ID of the sample 4 from the base of the cylinder # AR0118876. No inter-crystalline attack observed. Magnification: 50X.

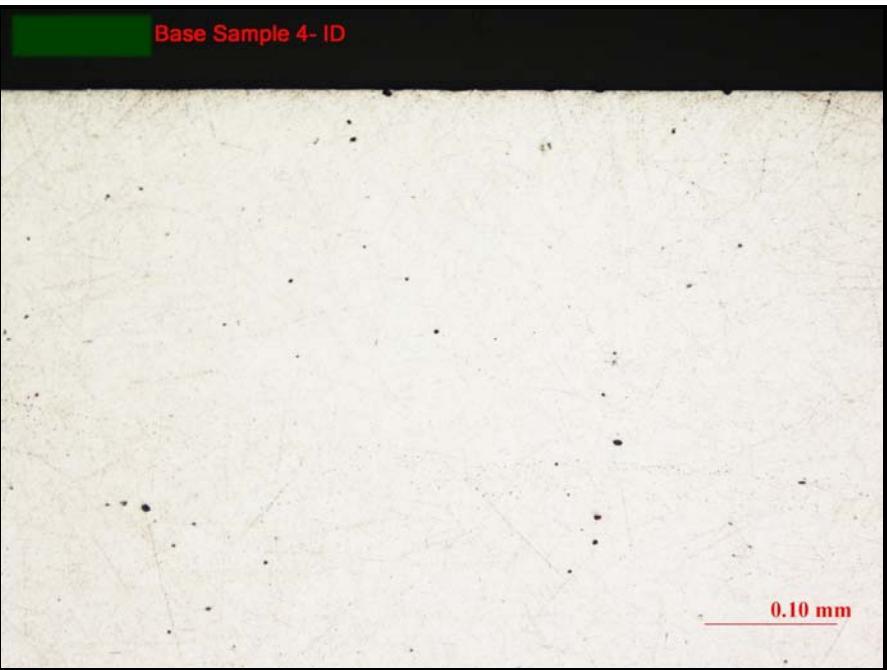
Figure 151: Microscope image shows the unetched ID of the sample 4 from the base of the cylinder # AR0118876. No inter-crystalline attack observed. Magnification: 200X.

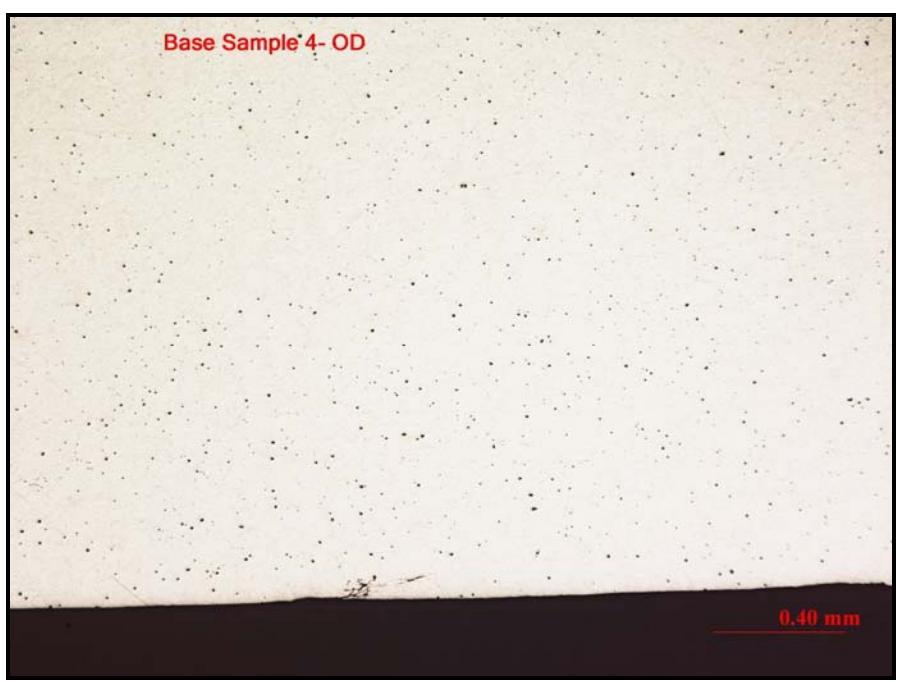
Figure 152: Microscope image shows the unetched OD of the sample 4 from the base of the cylinder # AR0118876. Magnification: 50X.

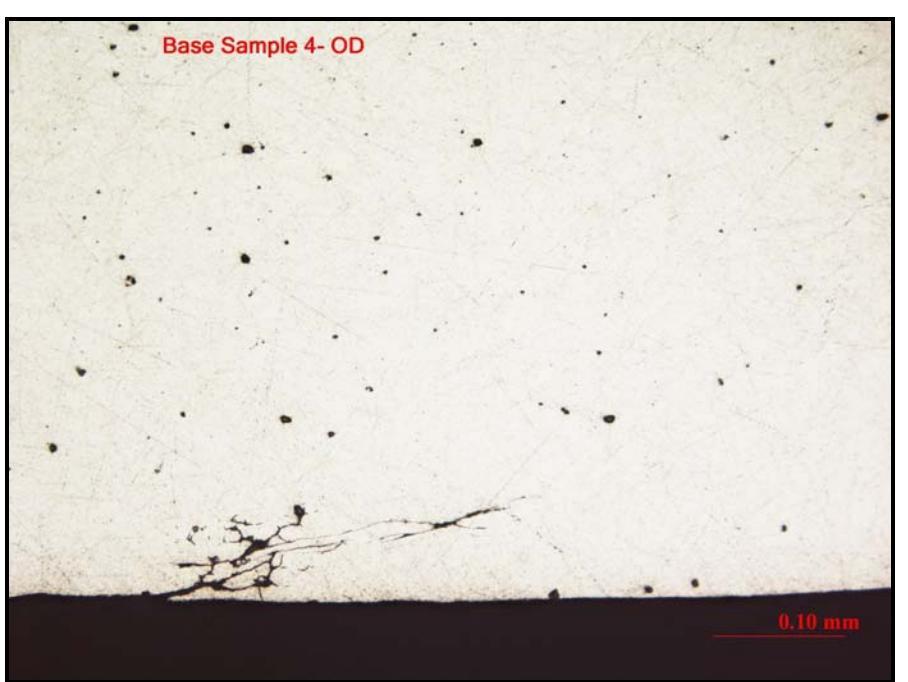
Figure 153: Microscope image shows the unetched OD of the sample 4 from the base of the cylinder # AR0118876. Inter-crystalline attack observed. Magnification: 200X.

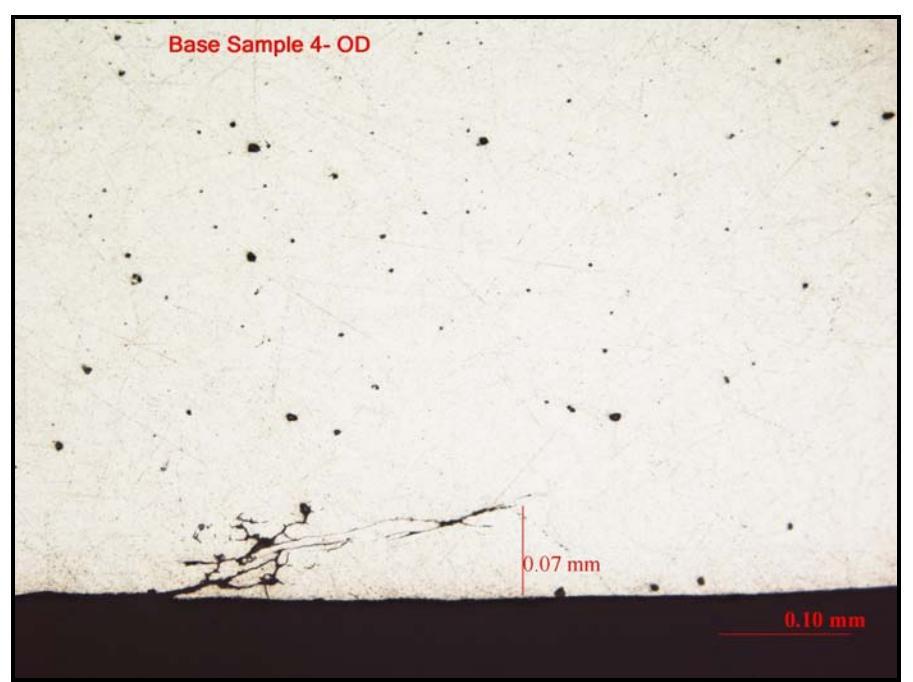
Figure 154: Microscope image shows the unetched OD of the sample 4 from the base of the cylinder # AR0118876. Inter-crystalline attack < 0.1 mm. Magnification: 200X.

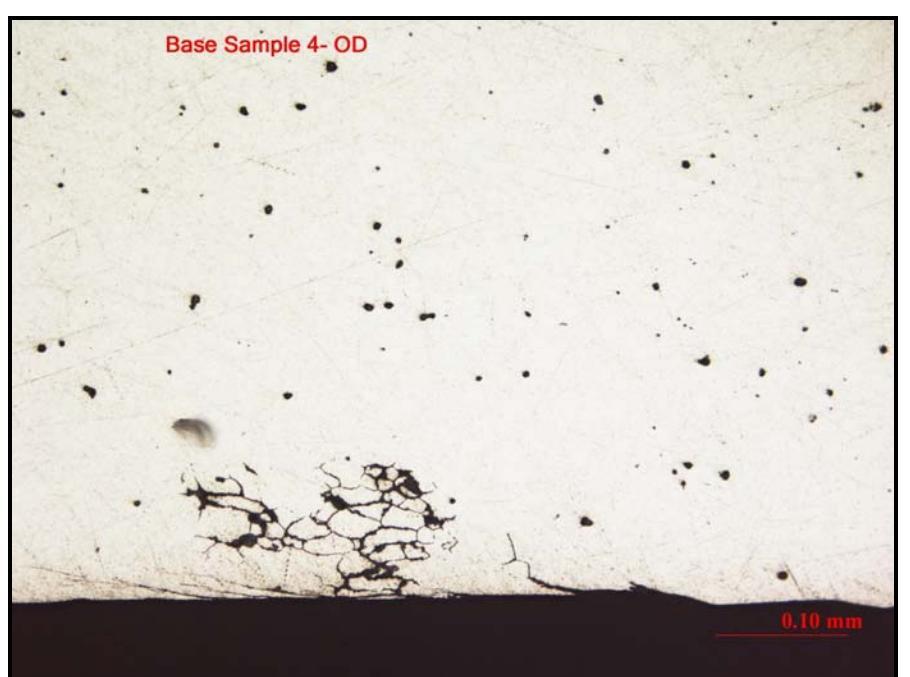
Figure 157: Microscope image shows the unetched OD of the sample 4 from the base of the cylinder # AR0118876. Inter-crystalline attack observed. Magnification: 200X.

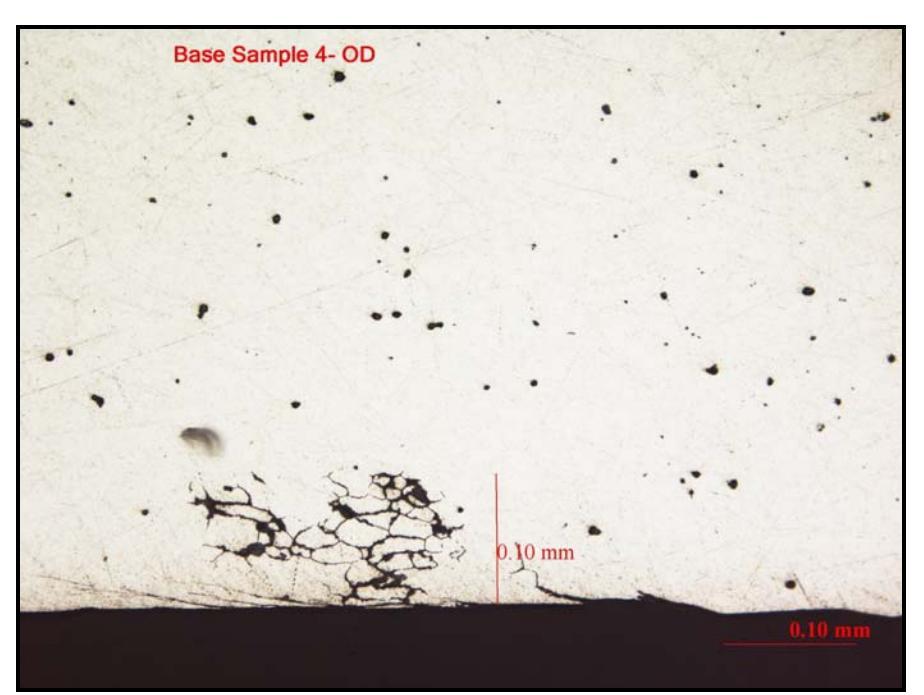
Figure 158: Microscope image shows the unetched ID of the sample 1 from Head of the cylinder # AR0118876. Inter-crystalline attack = 0.1 mm. Magnification: 200X.

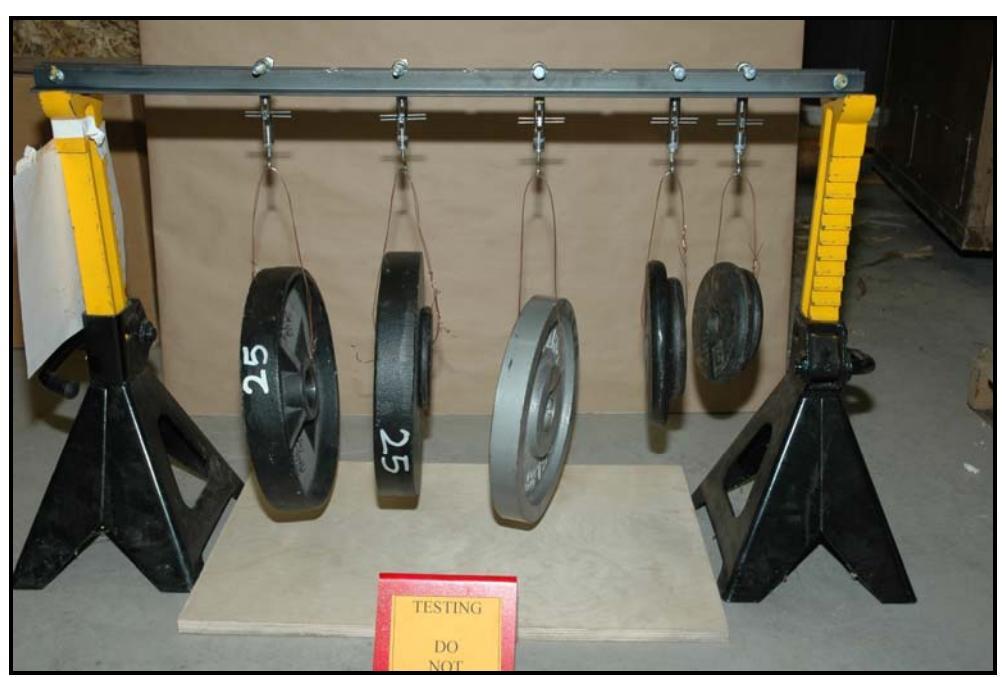
Figure 162: Shows the set up at the beginning of the 90 day sustained load cracking test.

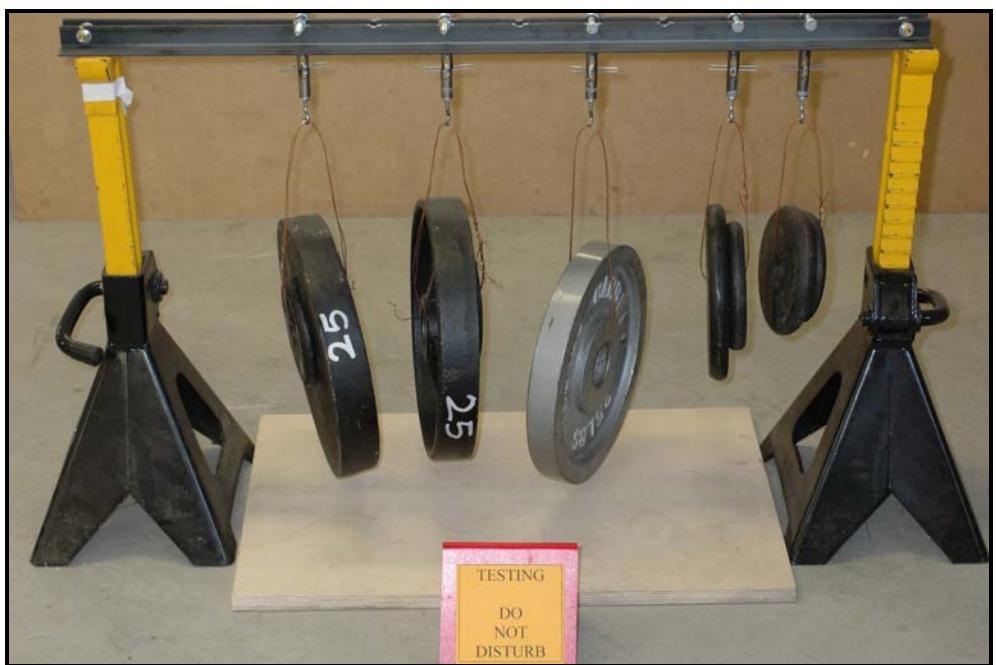
Figure 163: Shows the test set up at the end of the 90 day sustained load cracking test.

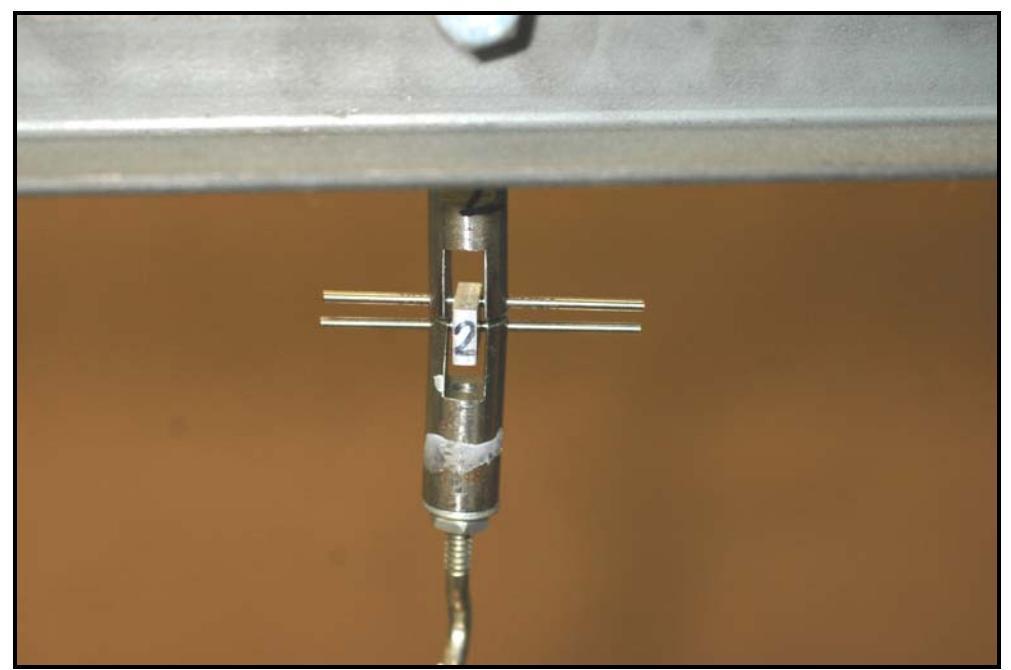
Figure 164: Shows the unloaded compact tension sample 2 at the end of the 90 day test. Note the sample didn't break after the 90 day test.

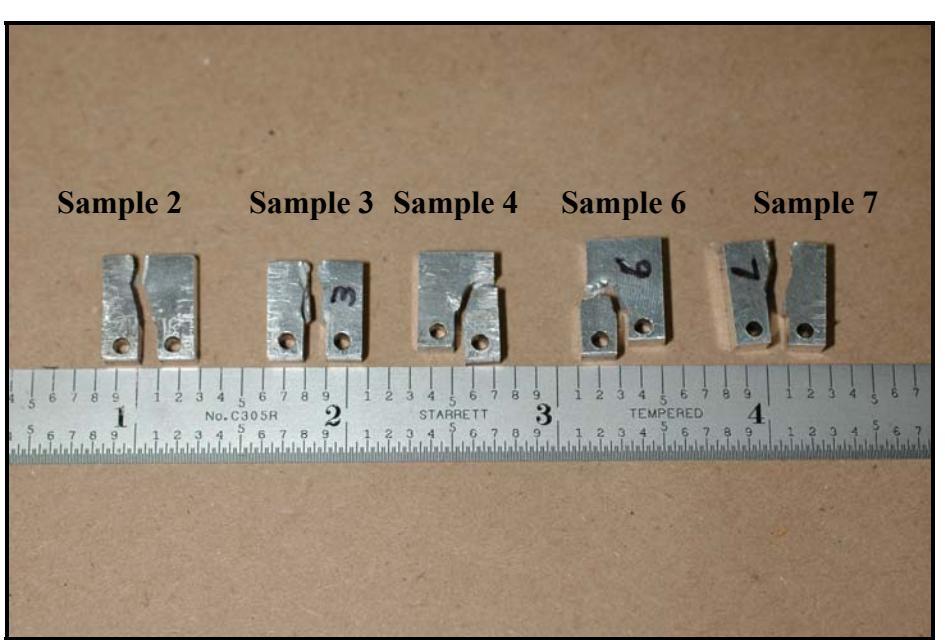
Figure 169: Shows the failed samples after being subjected to post-fatigue and final overload fracture. The fracture surface of each of these specimens was observed using the SEM.

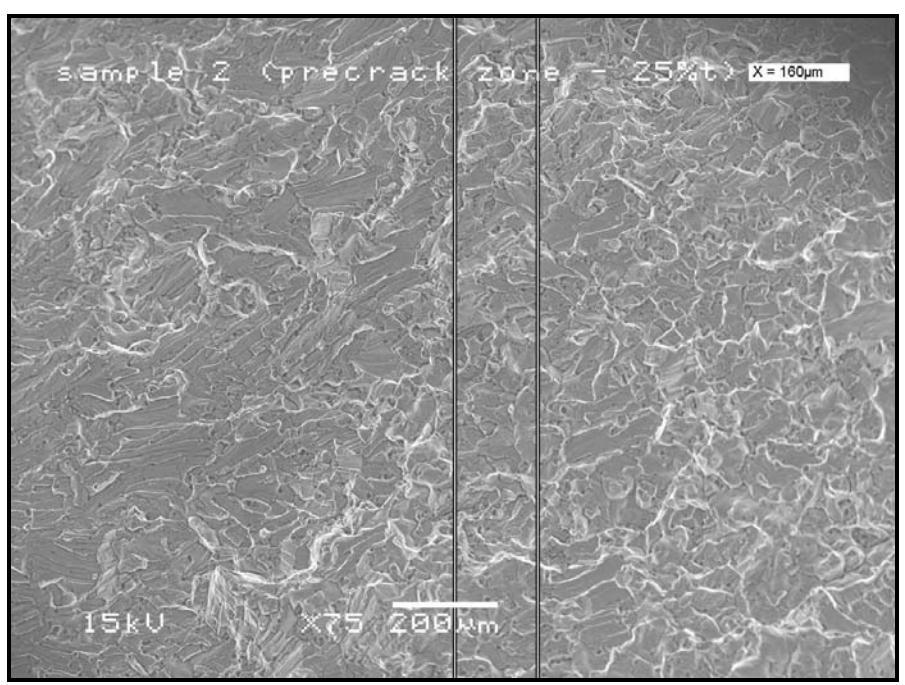
Figure 170: SEM image of sample 2 shows the fracture surface along the 0.16 mm distance from the pre-fatigue crack zone at 25% thickness, 75X. Fatigue was observed throughout the 0.16 mm distance from pre-fatigue crack zone.

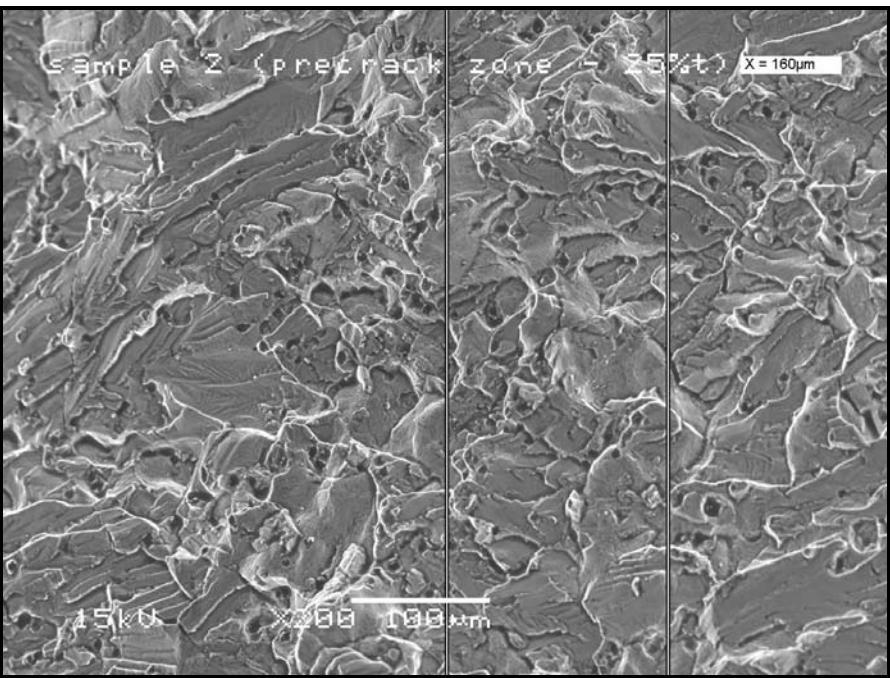
Figure 171: SEM image of sample 2 shows the fracture surface along the 0.16 mm distance from the pre-fatigue crack zone at 25% thickness, 200X. Fatigue was observed throughout the 0.16 mm distance from pre-fatigue crack zone.

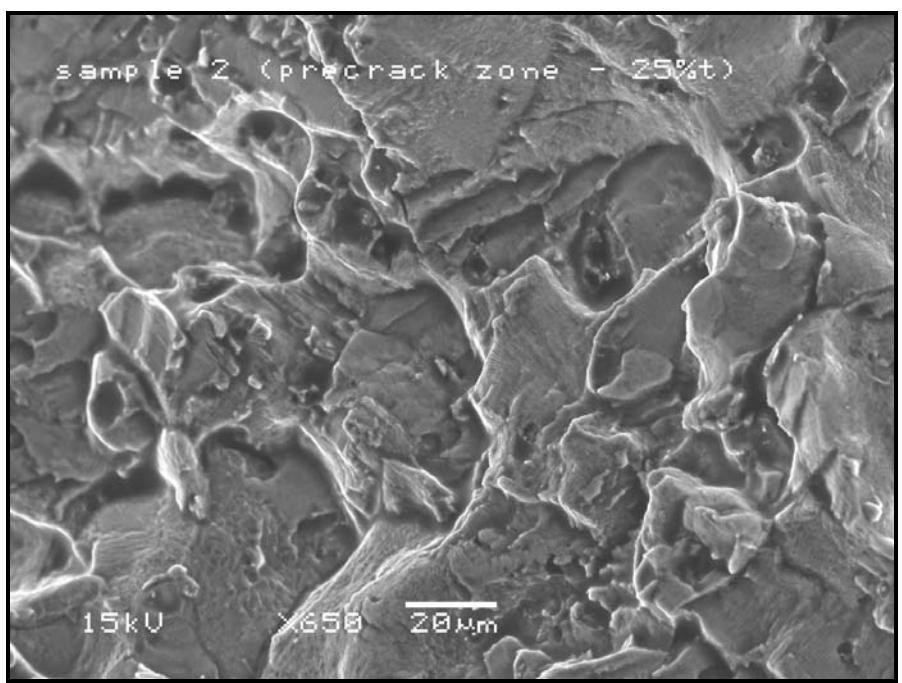
Figure 172: SEM image of sample 2 shows the fracture surface at the pre-fatigue crack zone at 25% thickness, 650X. Fatigue striations were observed throughout the pre-fatigue crack zone.

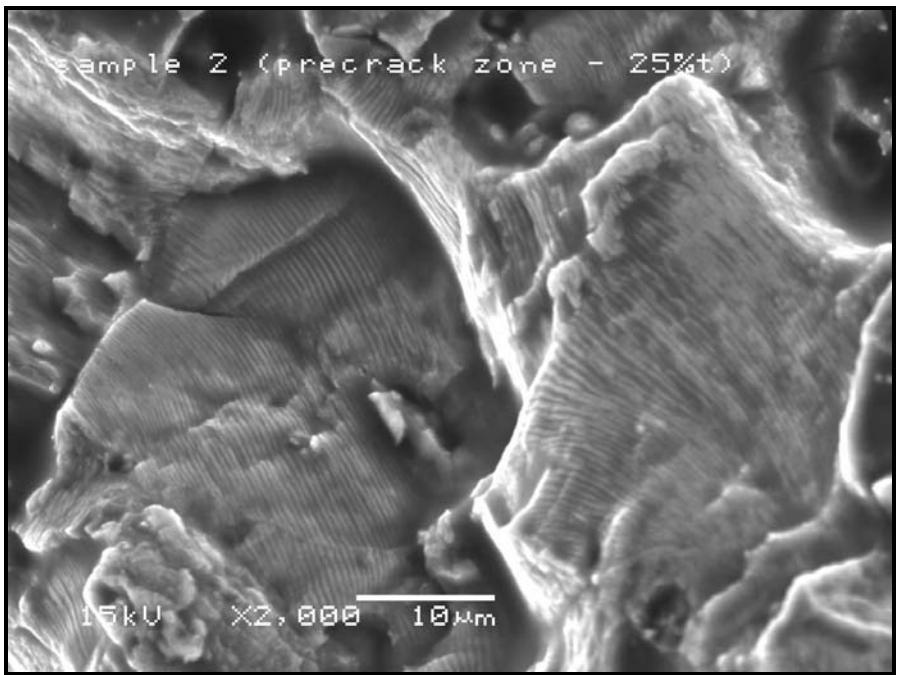
Figure 173: SEM image of sample 2 shows the fracture surface at the pre-fatigue crack zone at 25% thickness, 2000X. Fatigue striations were observed throughout the pre-fatigue crack zone.

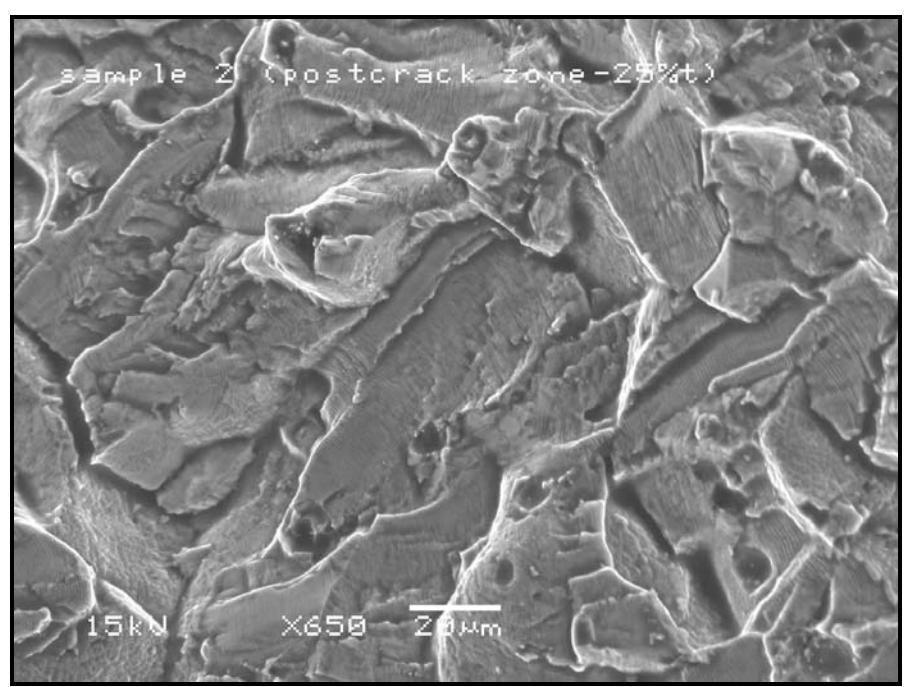
Figure 174: SEM image of sample 2 shows the fracture surface at the post-fatigue crack zone at 25% thickness, 650X. Fatigue striations were observed throughout the post-fatigue crack zone along the 0.16 mm from the pre-fatigue crack zone.

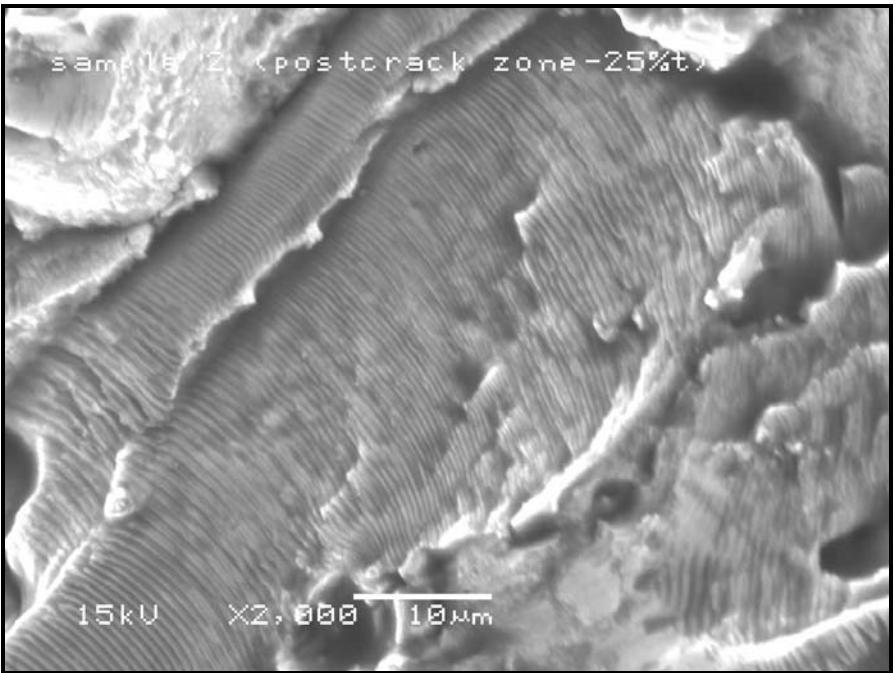
Figure 175: SEM image of sample 2 shows the fracture surface at the post-fatigue crack zone at 25% thickness, 650X. Fatigue striations were observed throughout the post-fatigue crack zone along the 0.16 mm from the pre-fatigue crack zone.

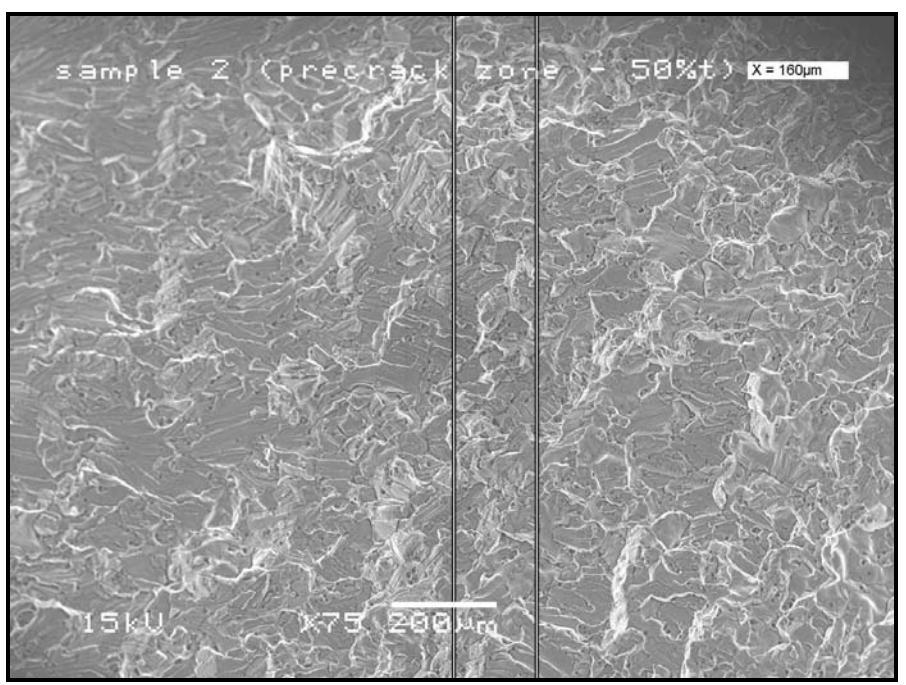
Figure 176: SEM image of sample 2 shows the fracture surface along the 0.16 mm distance from the pre-fatigue crack zone at 50% thickness, 75X. Fatigue was observed throughout the 0.16 mm distance from pre-fatigue crack zone.
