PACKER ENGINEERING INC, 1950 North Washington Street, Naperville, IL 60566

Evaluation of Three DOT 3AL 6061-T6 Cylinders to Determine the Neck Cracks Cause and Initiation Site (CIS of Neck Cracks)

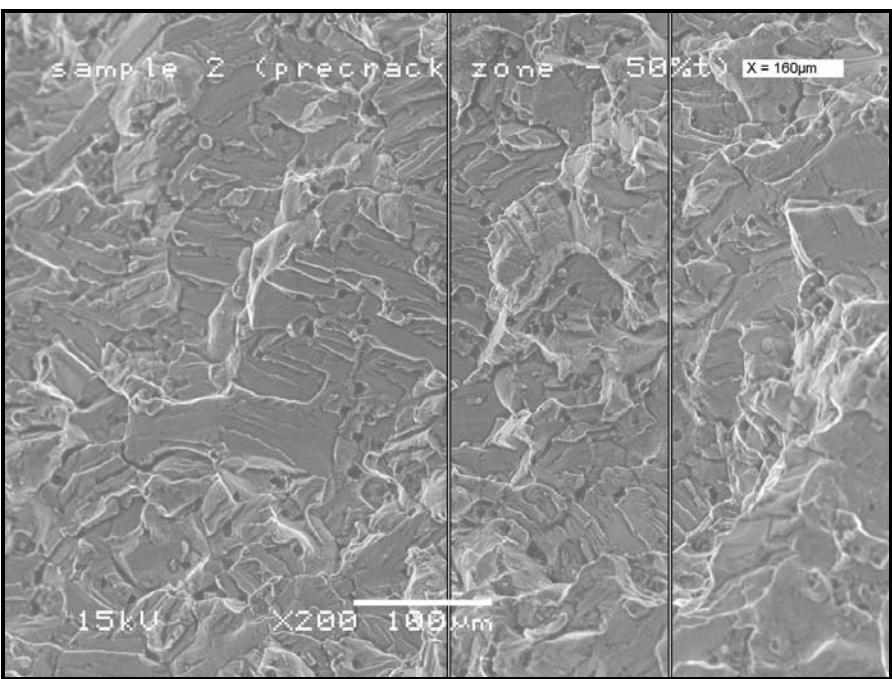
Figure 177: SEM image of sample 2 shows the fracture surface along the 0.16 mm distance from the pre-fatigue crack zone at 50% thickness, 200X. Fatigue was observed throughout the 0.16 mm distance from pre-fatigue crack zone.

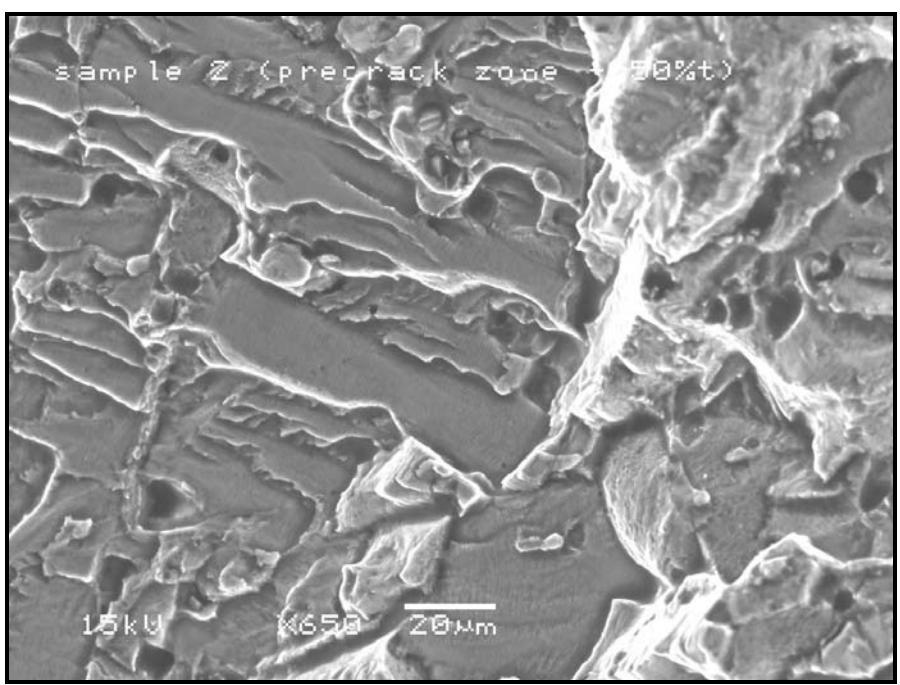
Figure 178: SEM image of sample 2 shows the fracture surface at the pre-fatigue crack zone at 50% thickness, 650X. Fatigue striations were observed throughout the pre-fatigue crack zone.

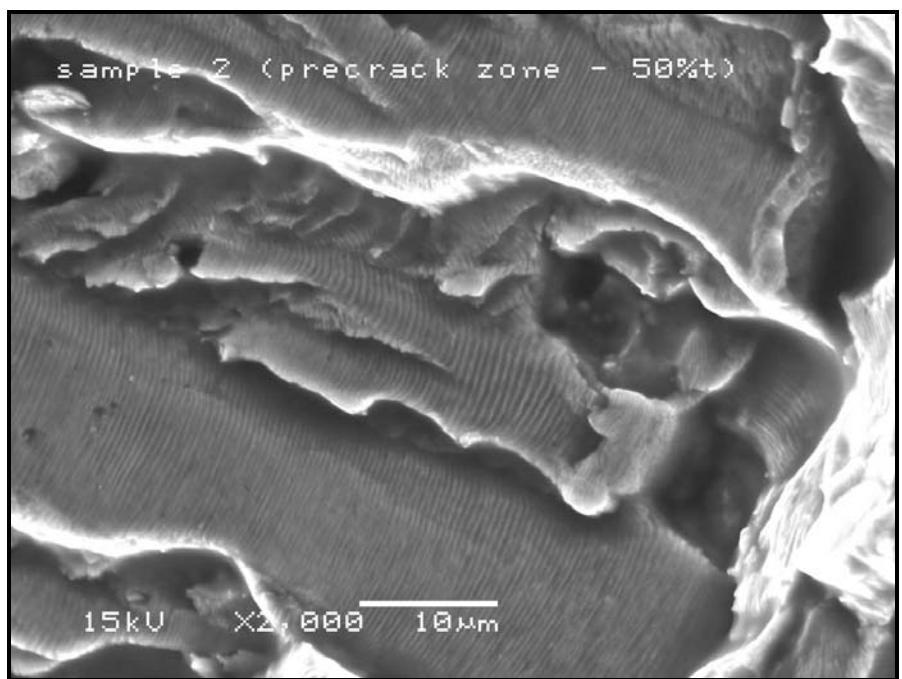
Figure 179: SEM image of sample 2 shows the fracture surface at the pre-fatigue crack zone at 50% thickness, 2000X. Fatigue striations were observed throughout the pre-fatigue crack zone.

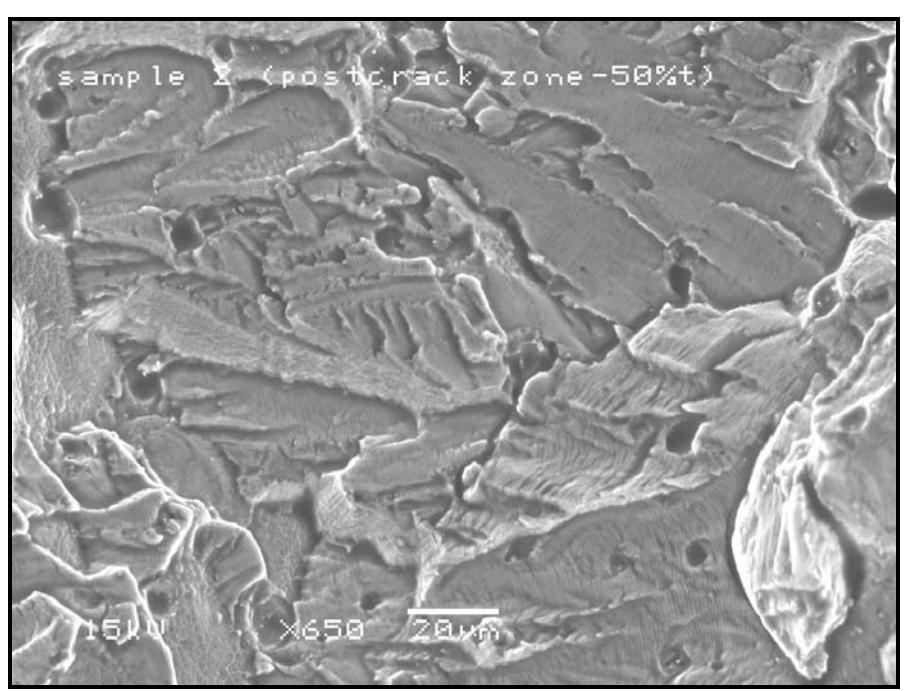
Figure 180: SEM image of sample 2 shows the fracture surface at the post-fatigue crack zone at 50% thickness, 650X. Fatigue striations were observed throughout the post-fatigue crack zone along the 0.16 mm from the pre-fatigue crack zone.

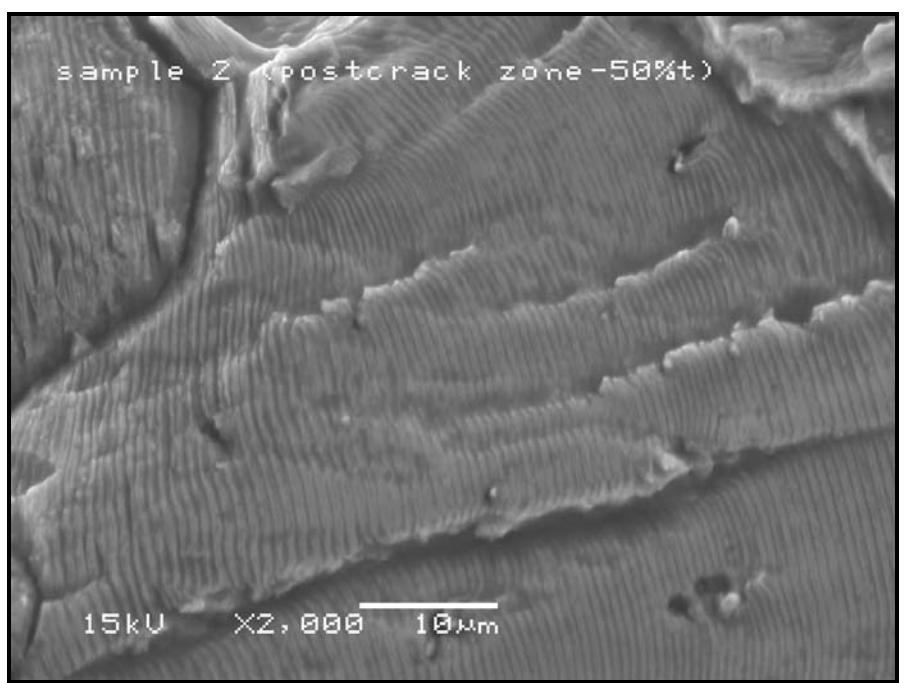
Figure 181: SEM image of sample 2 shows the fracture surface at the post-fatigue crack zone at 50% thickness, 650X. Fatigue striations were observed throughout the post-fatigue crack zone along the 0.16 mm from the pre-fatigue crack zone.

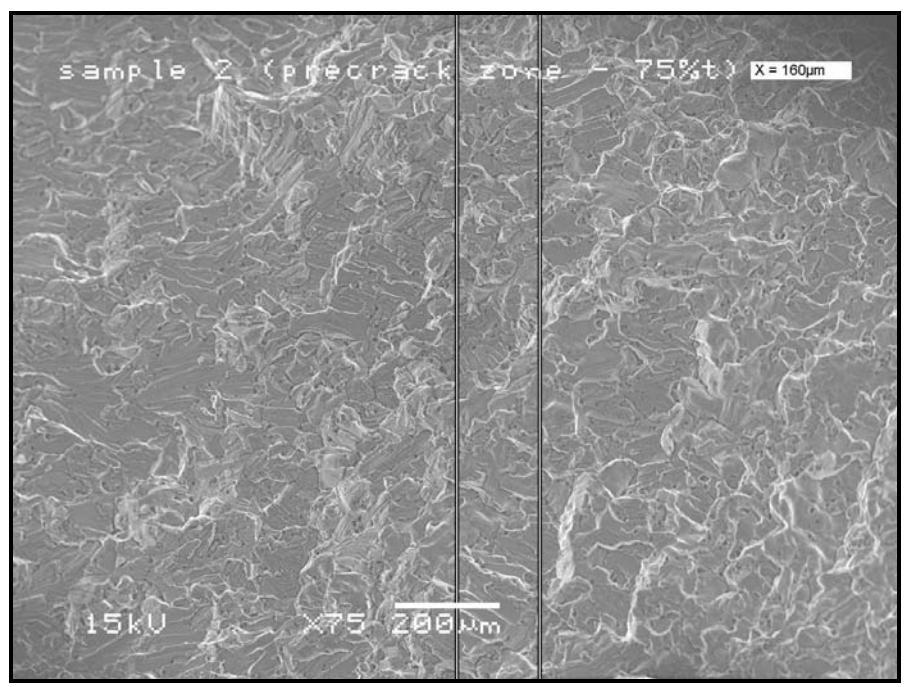
Figure 182: SEM image of sample 2 shows the fracture surface along the 0.16 mm distance from the pre-fatigue crack zone at 75% thickness, 75X. Fatigue was observed throughout the 0.16 mm distance from pre-fatigue crack zone.

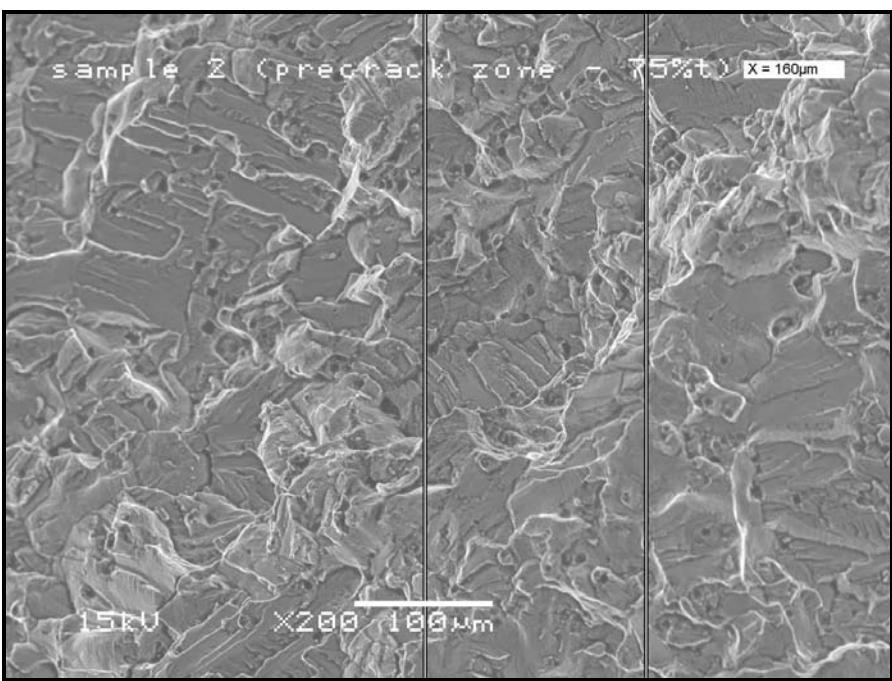
Figure 183: SEM image of sample 2 shows the fracture surface along the 0.16 mm distance from the pre-fatigue crack zone at 75% thickness, 200X. Fatigue was observed throughout the 0.16 mm distance from pre-fatigue crack zone.

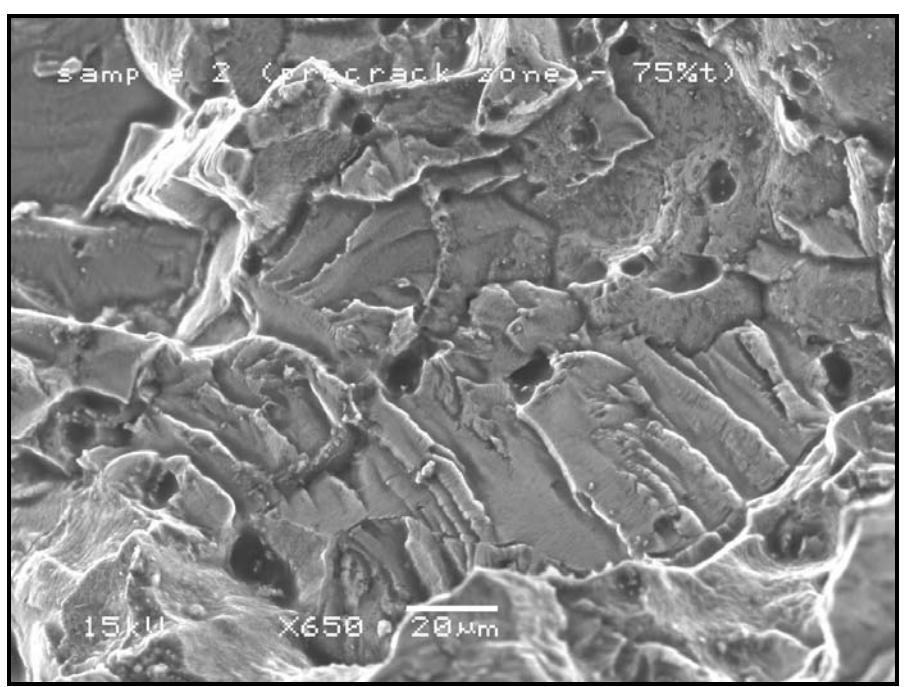
Figure 184: SEM image of sample 2 shows the fracture surface at the pre-fatigue crack zone at 75% thickness, 650X. Fatigue striations were observed throughout the pre-fatigue crack zone.

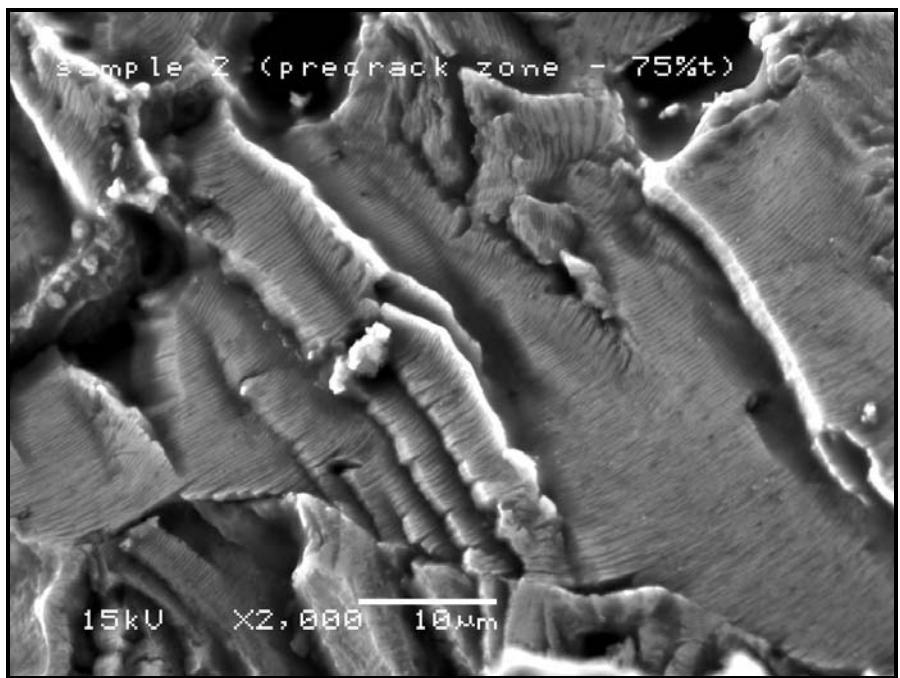
Figure 185: SEM image of sample 2 shows the fracture surface at the pre-fatigue crack zone at 75% thickness, 2000X. Fatigue striations were observed throughout the pre-fatigue crack zone.

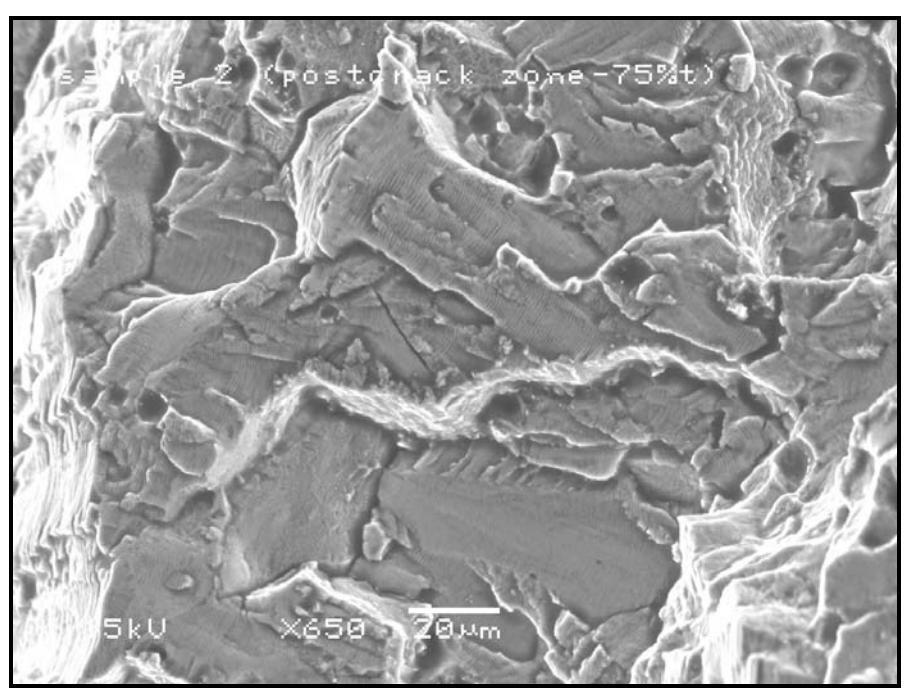
Figure 186: SEM image of sample 2 shows the fracture surface at the post-fatigue crack zone at 75% thickness, 650X. Fatigue striations were observed throughout the post-fatigue crack zone along the 0.16 mm from the pre-fatigue crack zone.

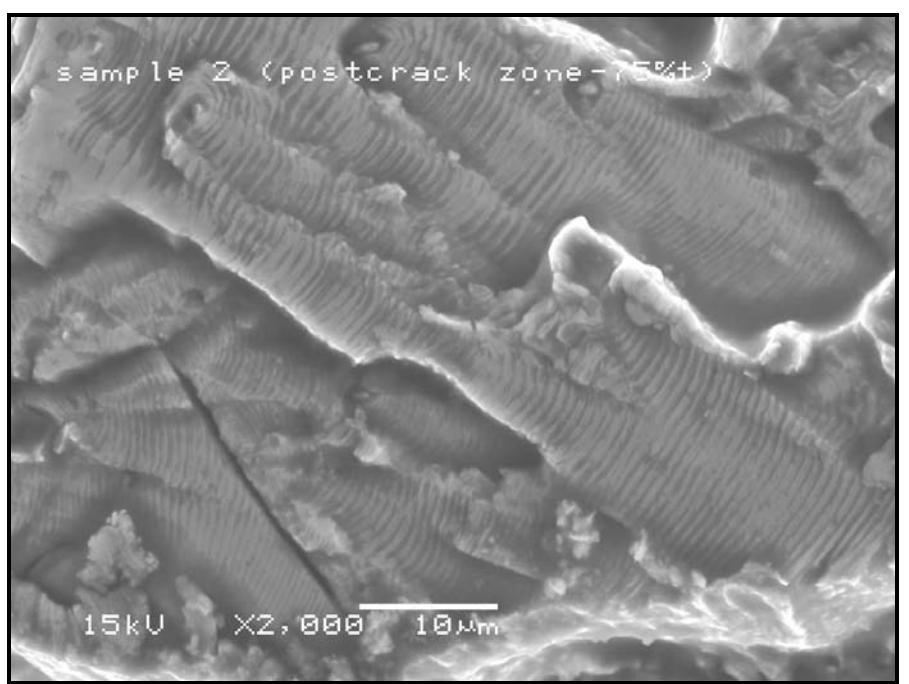
Figure 187: SEM image of sample 2 shows the fracture surface at the post-fatigue crack zone at 75% thickness, 2000X. Fatigue striations were observed throughout the post-fatigue crack zone along the 0.16 mm from the pre-fatigue crack zone.

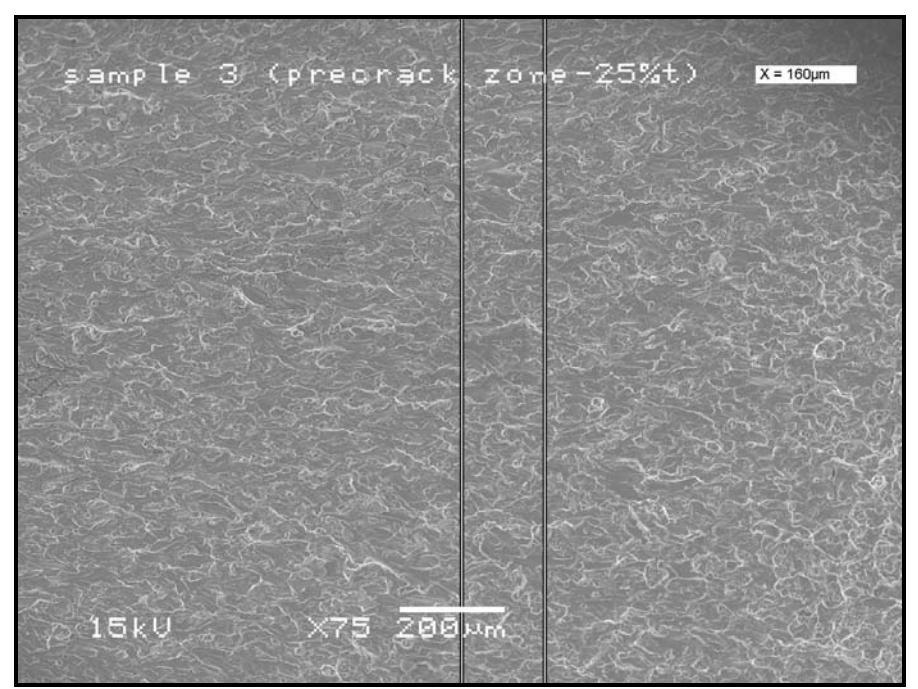
Figure 188: SEM image of sample 3 shows the fracture surface along the 0.16 mm distance from the pre-fatigue crack zone at 25% thickness, 75X. Fatigue was observed throughout the 0.16 mm distance from pre-fatigue crack zone.

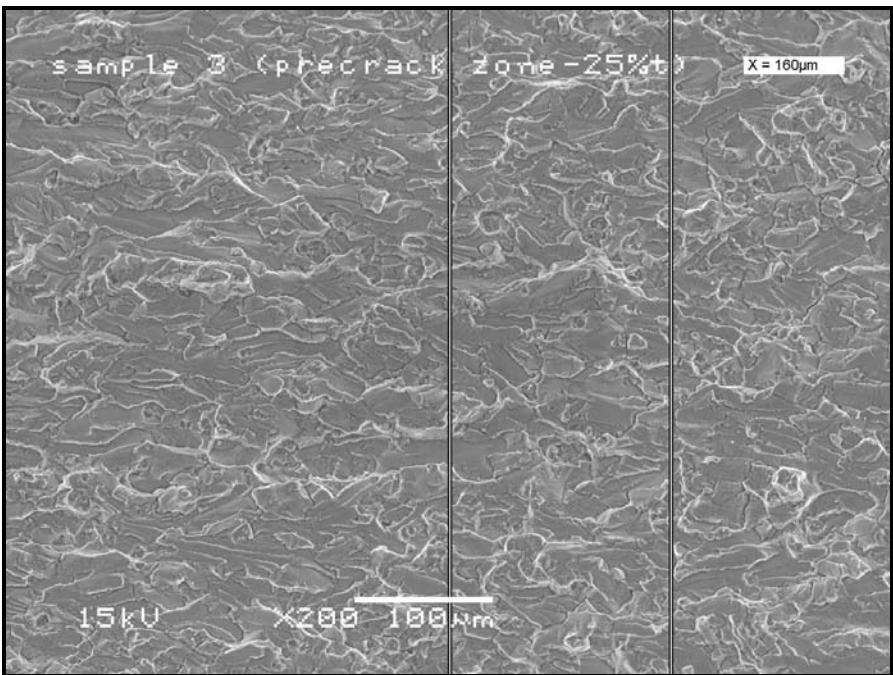
Figure 189: SEM image of sample 3 shows the fracture surface along the 0.16 mm distance from the pre-fatigue crack zone at 25% thickness, 200X. Fatigue was observed throughout the 0.16 mm distance from pre-fatigue crack zone.

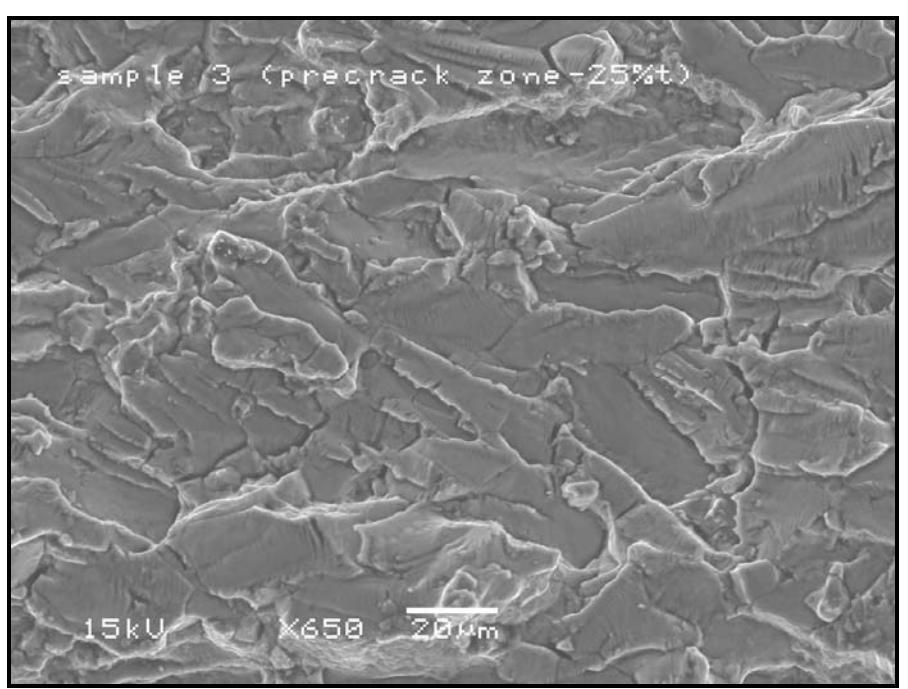
Figure 190: SEM image of sample 3 shows the fracture surface at the pre-fatigue crack zone at 25% thickness, 650X. Fatigue striations were observed throughout the pre-fatigue crack zone.

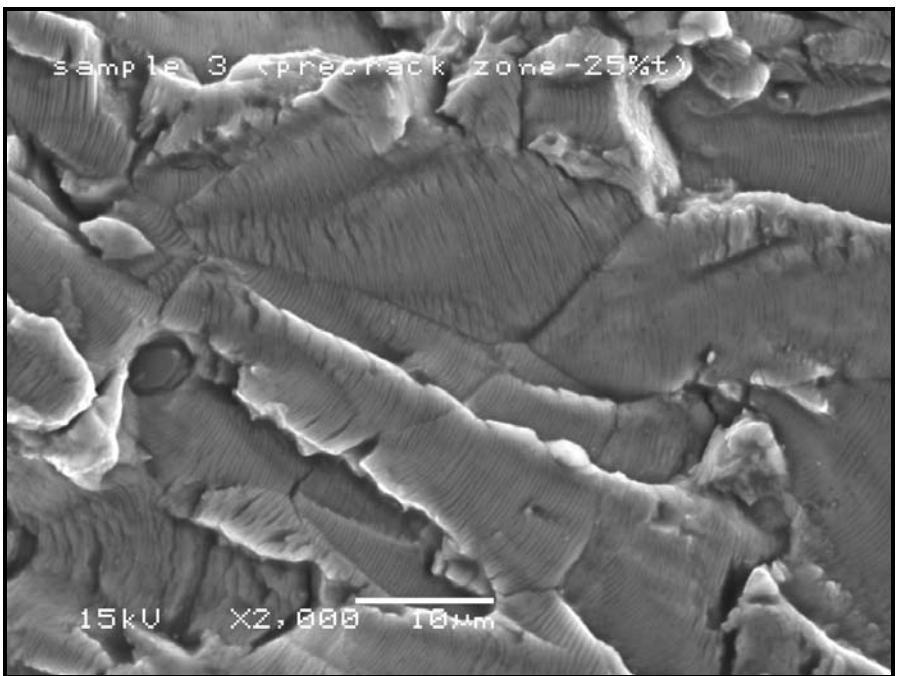
Figure 191: SEM image of sample 3 shows the fracture surface at the pre-fatigue crack zone at 25% thickness, 2000X. Fatigue striations were observed throughout the pre-fatigue crack zone.

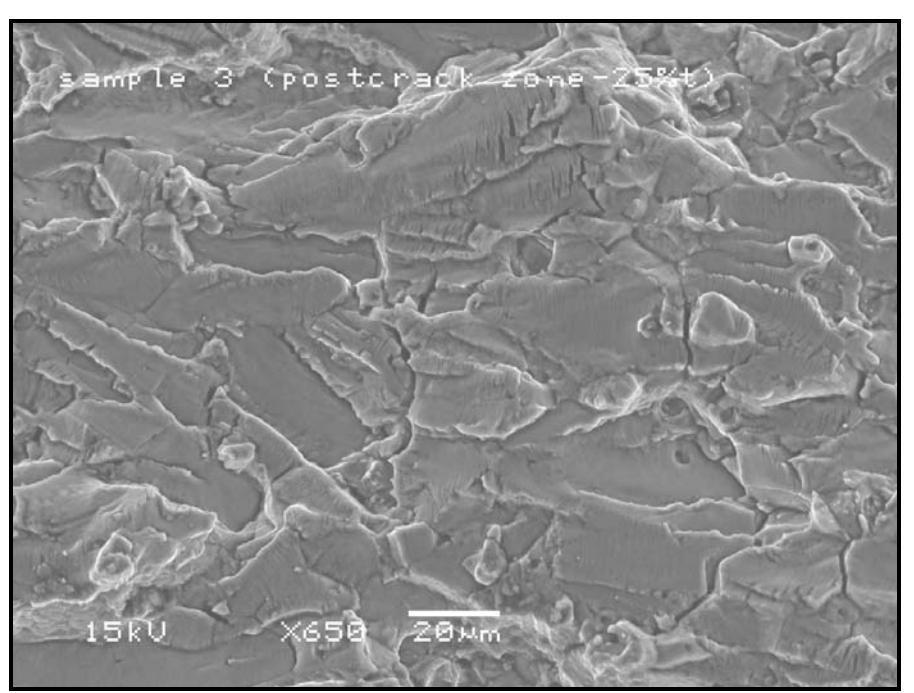
Figure 192: SEM image of sample 3 shows the fracture surface at the post-fatigue crack zone at 25% thickness, 650X. Fatigue striations were observed throughout the post-fatigue crack zone along the 0.16 mm from the pre-fatigue crack zone.

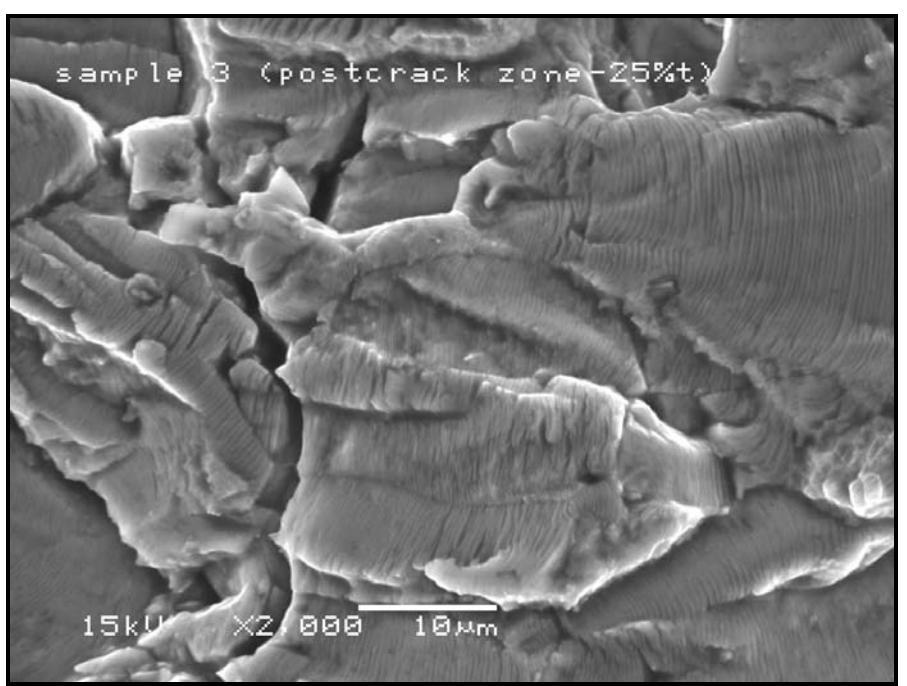
Figure 193: SEM image of sample 3 shows the fracture surface at the post-fatigue crack zone at 25% thickness, 2000X. Fatigue striations were observed throughout the post-fatigue crack zone along the 0.16 mm from the pre-fatigue crack zone.

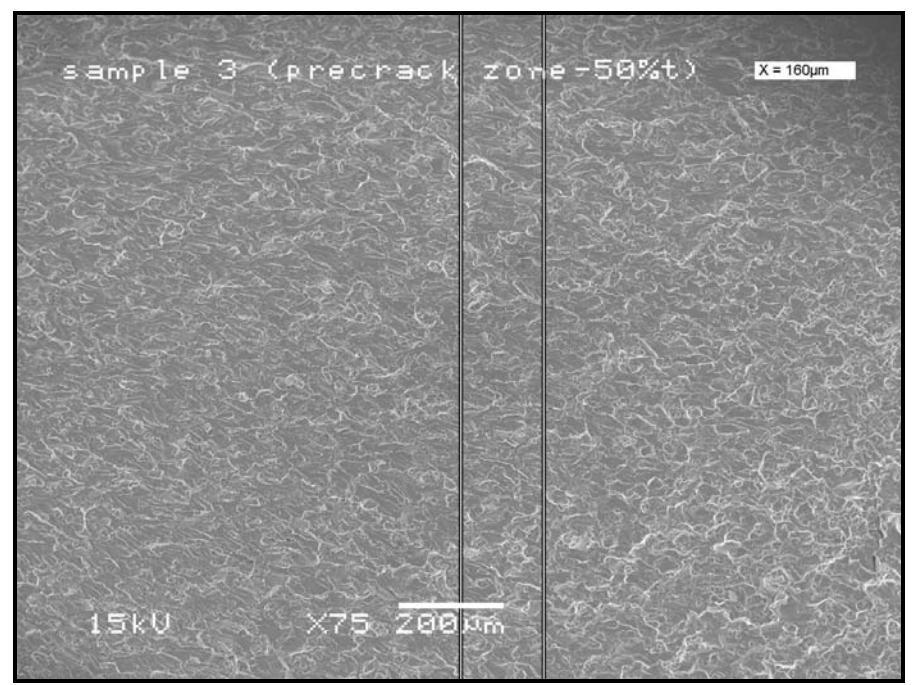
Figure 194: SEM image of sample 3 shows the fracture surface along the 0.16 mm distance from the pre-fatigue crack zone at 50% thickness, 75X. Fatigue was observed throughout the 0.16 mm distance from pre-fatigue crack zone.

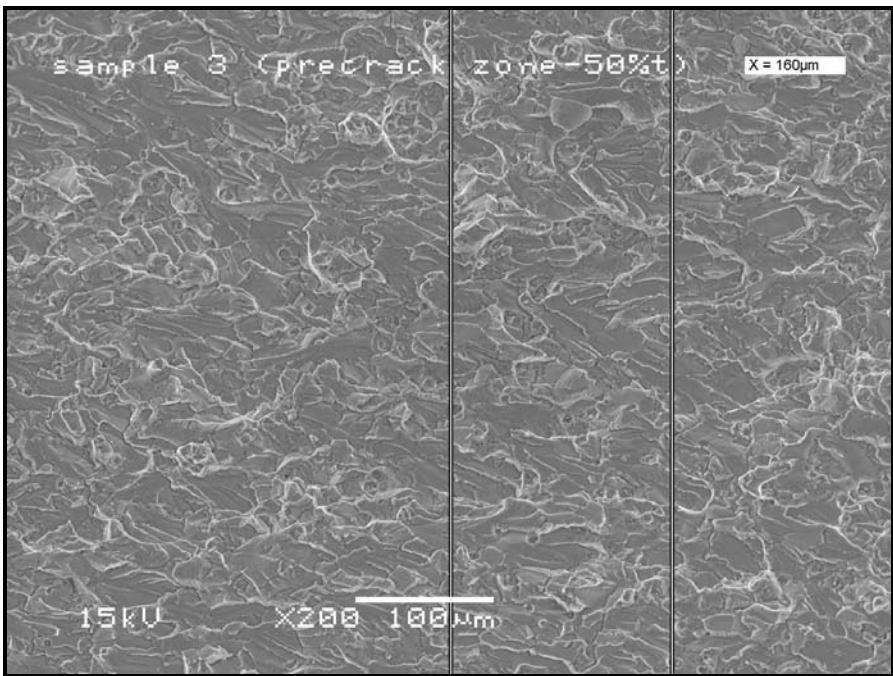
Figure 195: SEM image of sample 3 shows the fracture surface along the 0.16 mm distance from the pre-fatigue crack zone at 50% thickness, 200X. Fatigue was observed throughout the 0.16 mm distance from pre-fatigue crack zone.

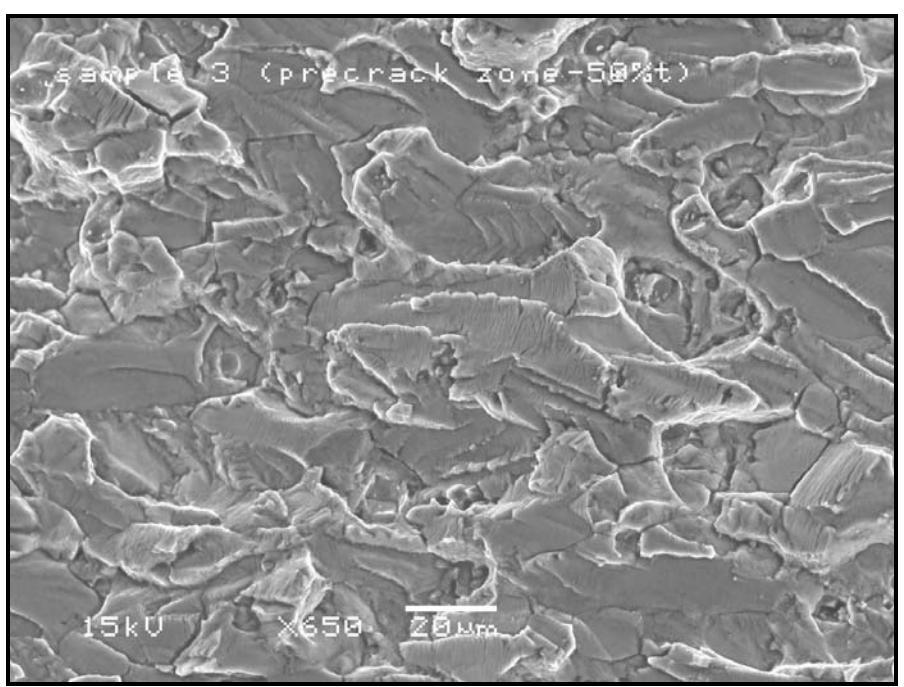
Figure 196: SEM image of sample 3 shows the fracture surface at the pre-fatigue crack zone at 50% thickness, 650X. Fatigue striations were observed throughout the pre-fatigue crack zone.

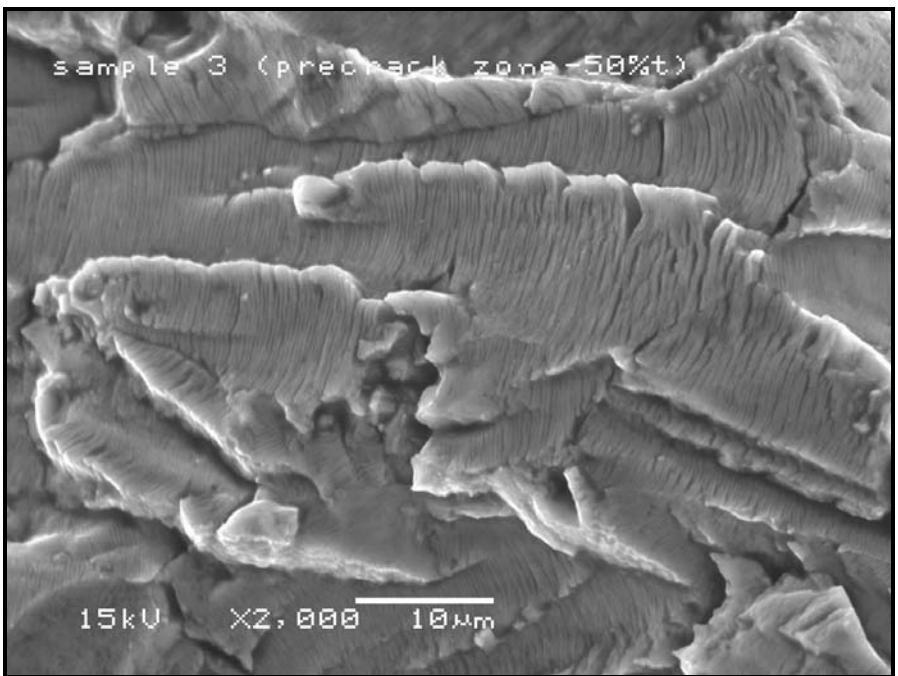
Figure 197: SEM image of sample 3 shows the fracture surface at the pre-fatigue crack zone at 50% thickness, 2000X. Fatigue striations were observed throughout the pre-fatigue crack zone.

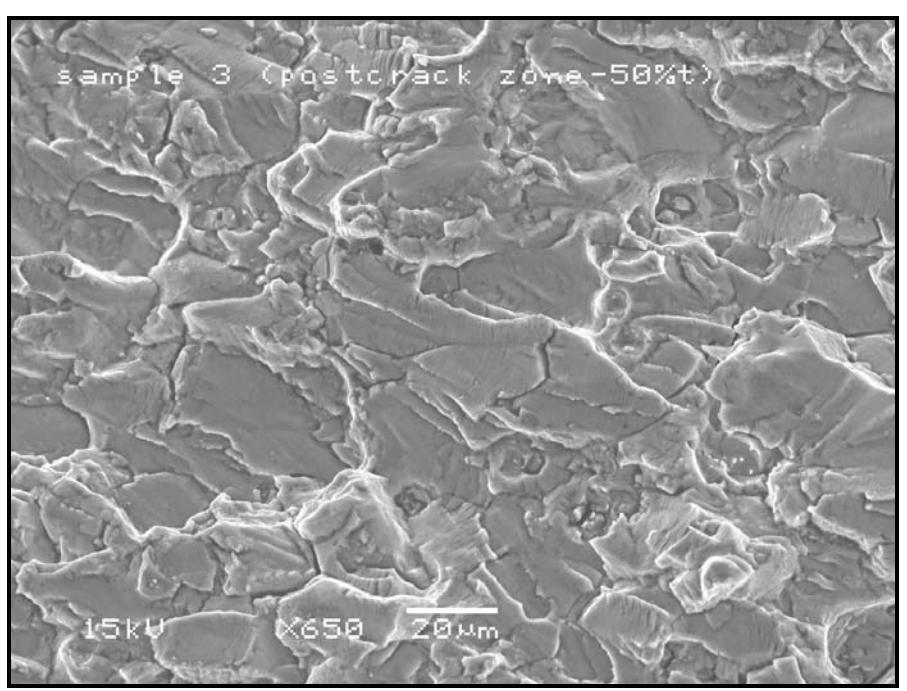
Figure 198: SEM image of sample 3 shows the fracture surface at the post-fatigue crack zone at 50% thickness, 650X. Fatigue striations were observed throughout the post-fatigue crack zone along the 0.16 mm from the pre-fatigue crack zone.

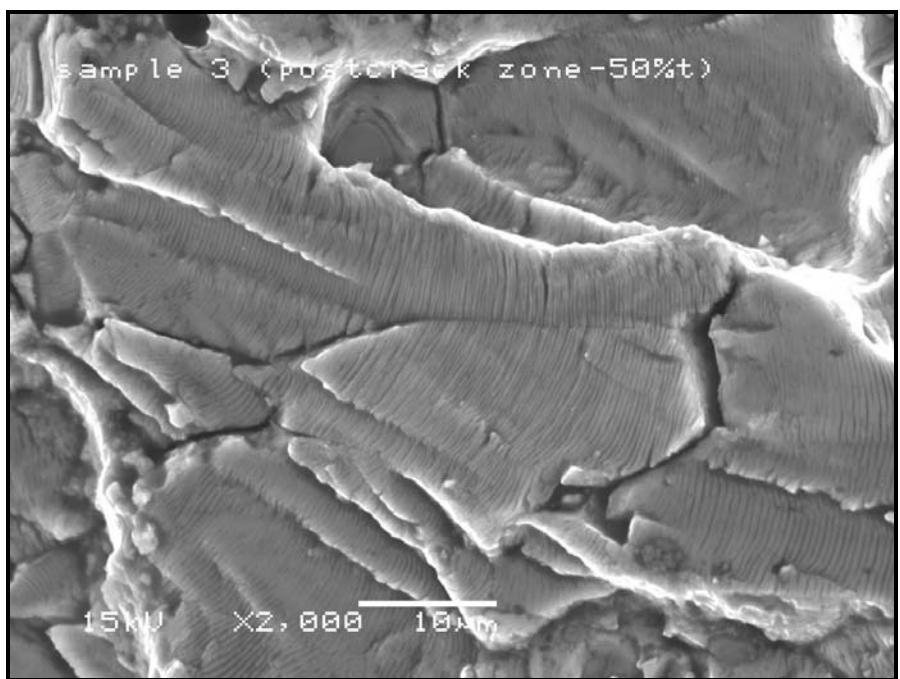
Figure 199: SEM image of sample 3 shows the fracture surface at the post-fatigue crack zone at 50% thickness, 2000X. Fatigue striations were observed throughout the post-fatigue crack zone along the 0.16 mm from the pre-fatigue crack zone.

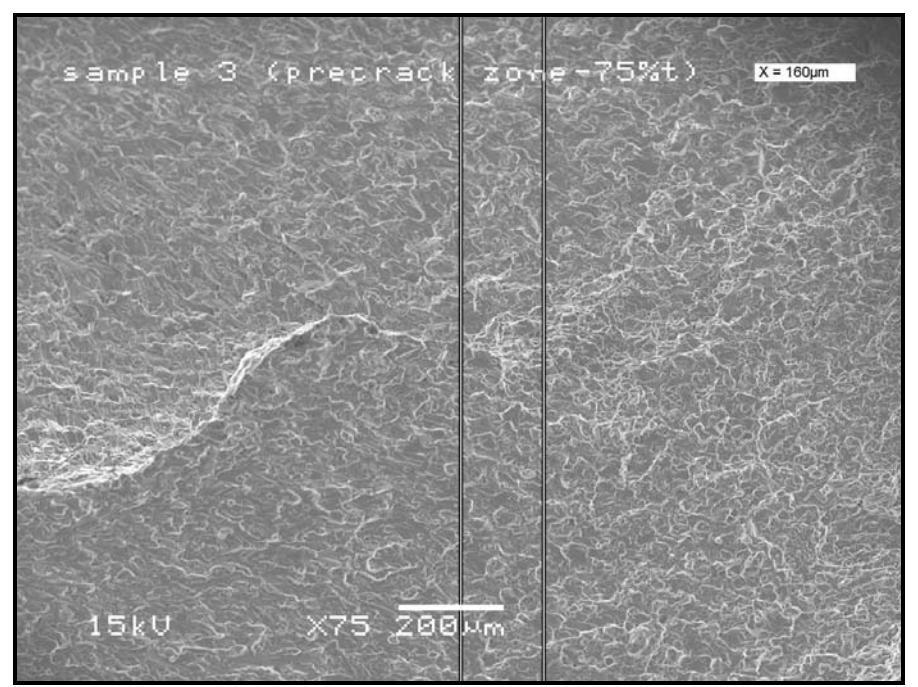
Figure 200: SEM image of sample 3 shows the fracture surface along the 0.16 mm distance from the pre-fatigue crack zone at 75% thickness, 75X. Fatigue was observed throughout the 0.16 mm distance from pre-fatigue crack zone.

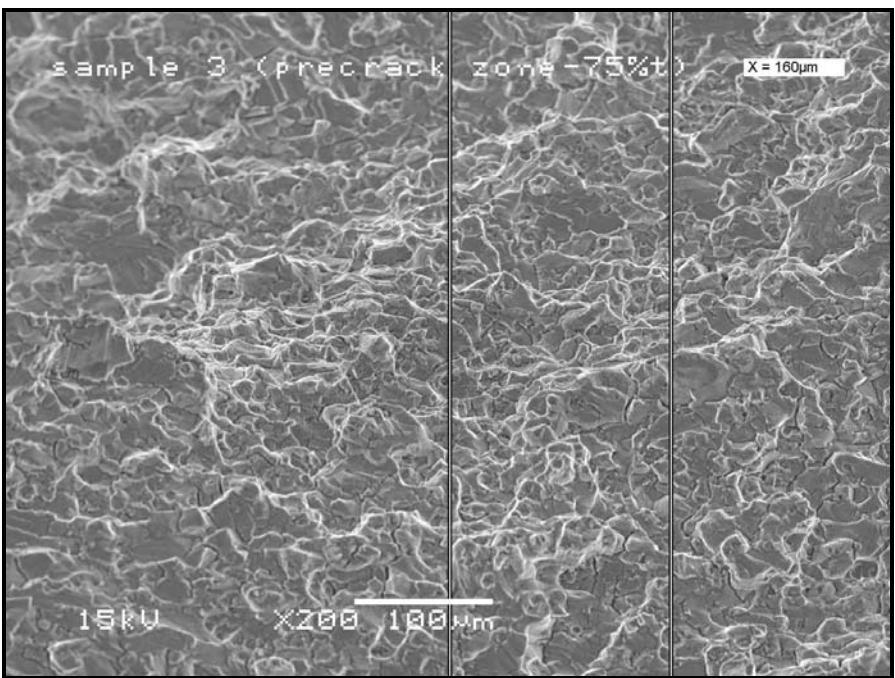
Figure 201: SEM image of sample 3 shows the fracture surface along the 0.16 mm distance from the pre-fatigue crack zone at 75% thickness, 200X. Fatigue was observed throughout the 0.16 mm distance from pre-fatigue crack zone.

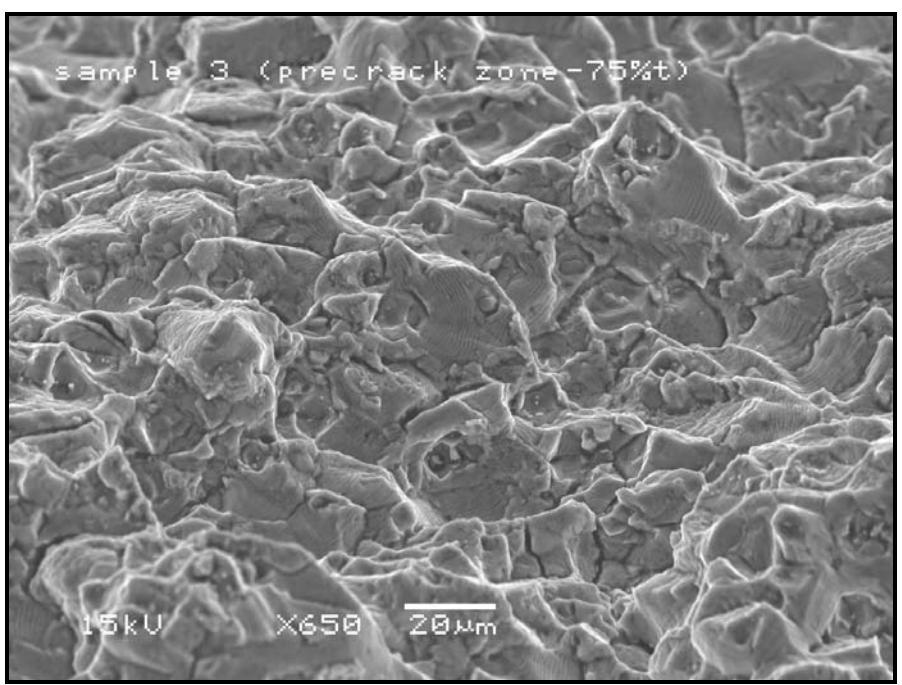
Figure 202: SEM image of sample 3 shows the fracture surface at the pre-fatigue crack zone at 75% thickness, 650X. Fatigue striations were observed throughout the pre-fatigue crack zone.

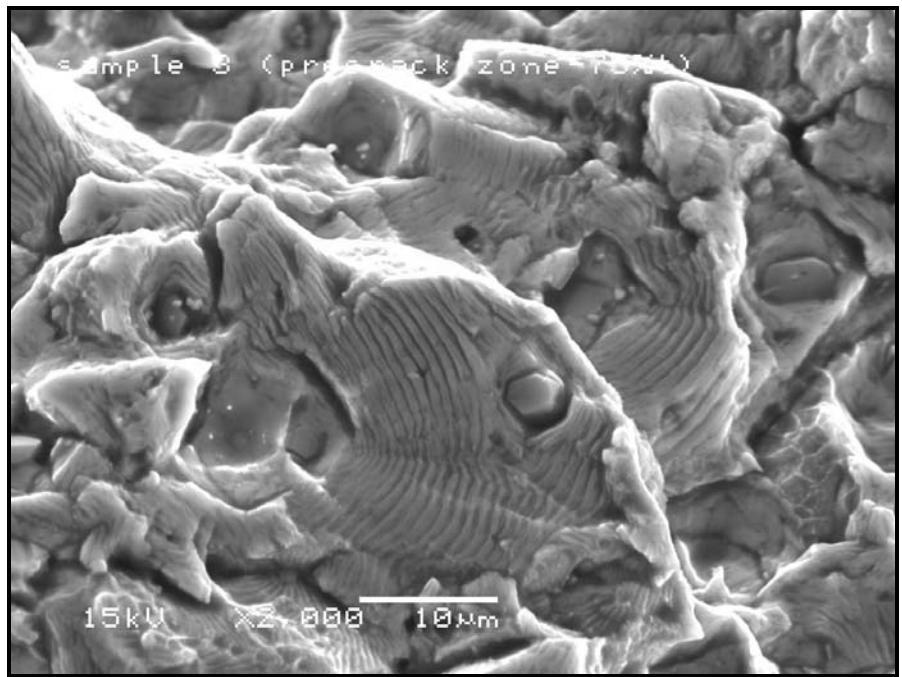
Figure 203: SEM image of sample 3 shows the fracture surface at the pre-fatigue crack zone at 75% thickness, 2000X. Fatigue striations were observed throughout the pre-fatigue crack zone.

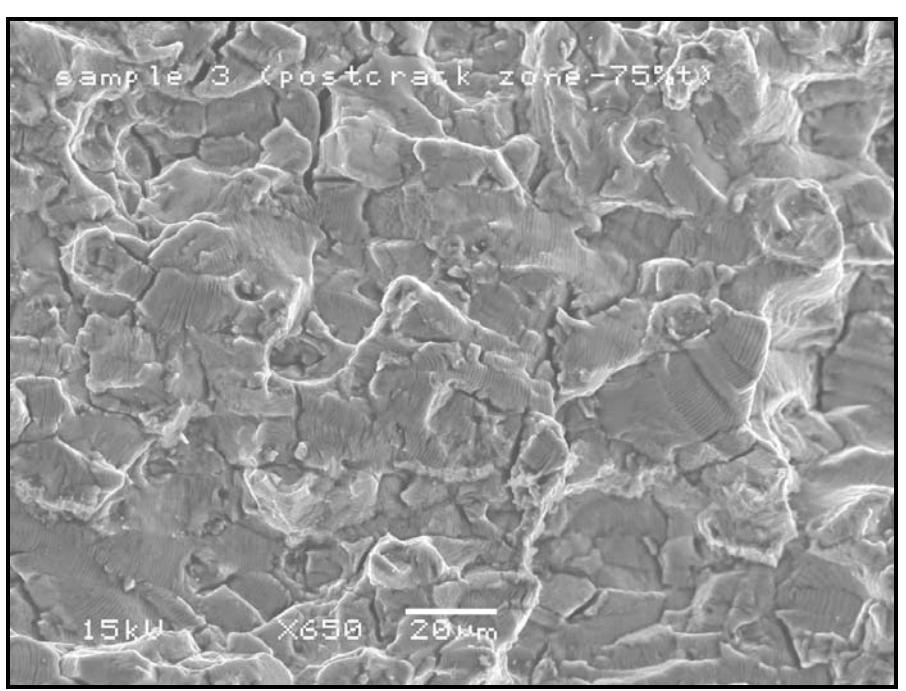
Figure 204: SEM image of sample 3 shows the fracture surface at the post-fatigue crack zone at 75% thickness, 650X. Fatigue striations were observed throughout the post-fatigue crack zone along the 0.16 mm from the pre-fatigue crack zone.

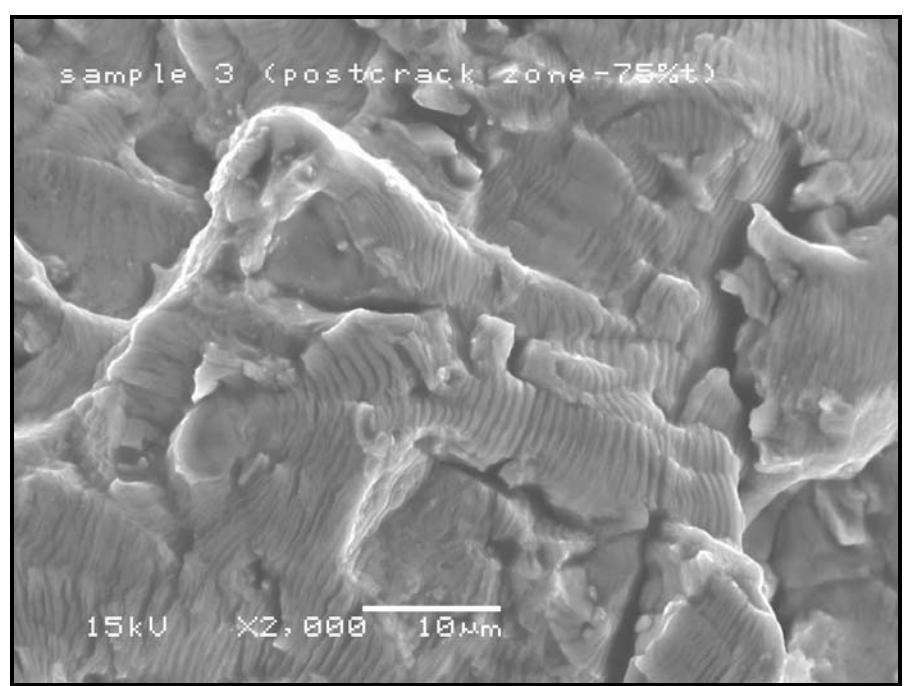
Figure 205: SEM image of sample 3 shows the fracture surface at the post-fatigue crack zone at 75% thickness, 2000X. Fatigue striations were observed throughout the post-fatigue crack zone along the 0.16 mm from the pre-fatigue crack zone.

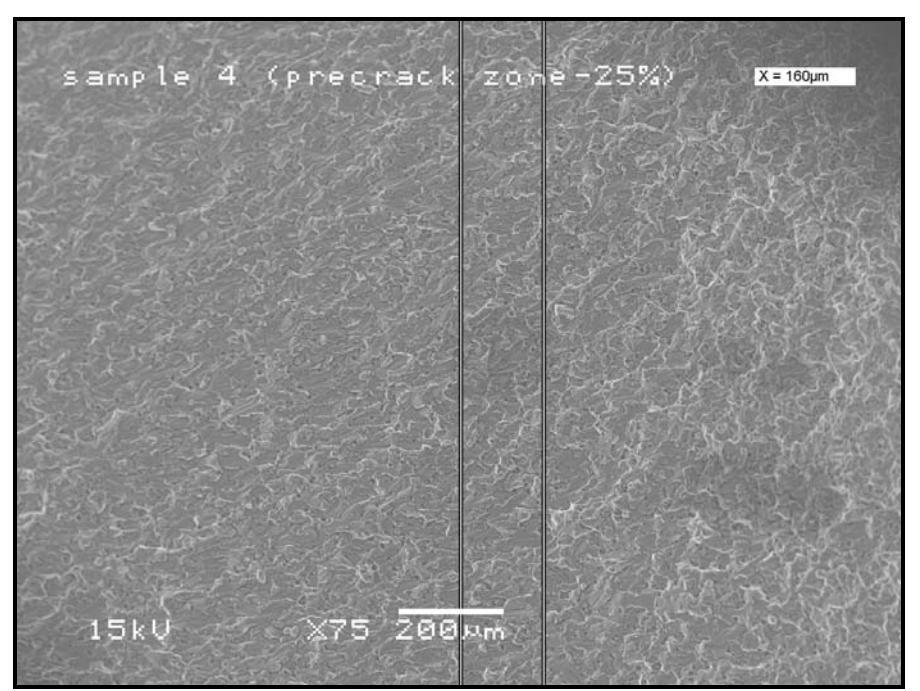
Figure 206: SEM image of sample 4 shows the fracture surface along the 0.16 mm distance from the pre-fatigue crack zone at 25% thickness, 75X. Fatigue was observed throughout the 0.16 mm distance from pre-fatigue crack zone.

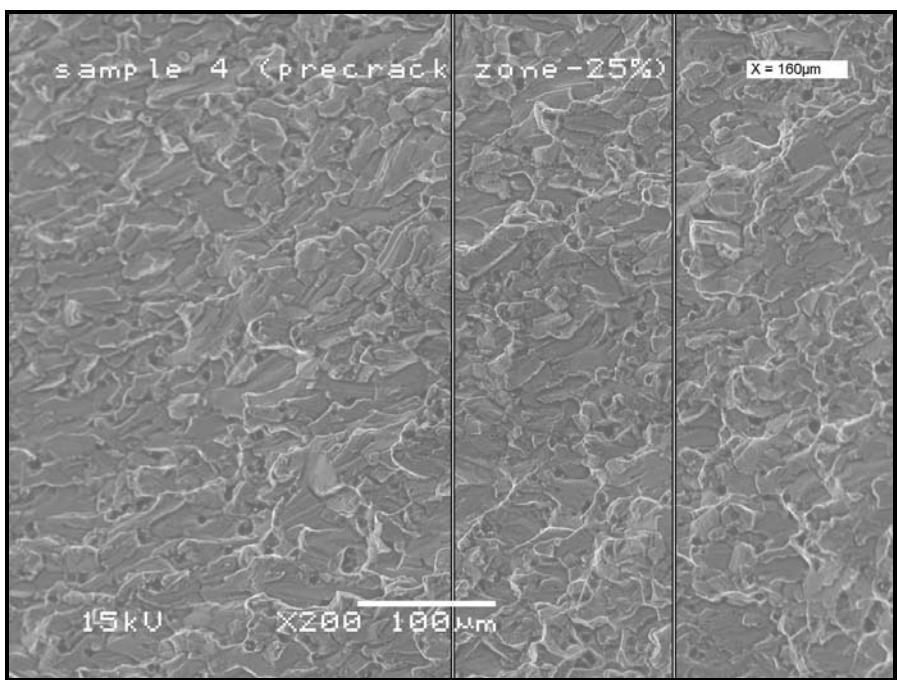
Figure 207: SEM image of sample 4 shows the fracture surface along the 0.16 mm distance from the pre-fatigue crack zone at 25% thickness, 200X. Fatigue was observed throughout the 0.16 mm distance from pre-fatigue crack zone.

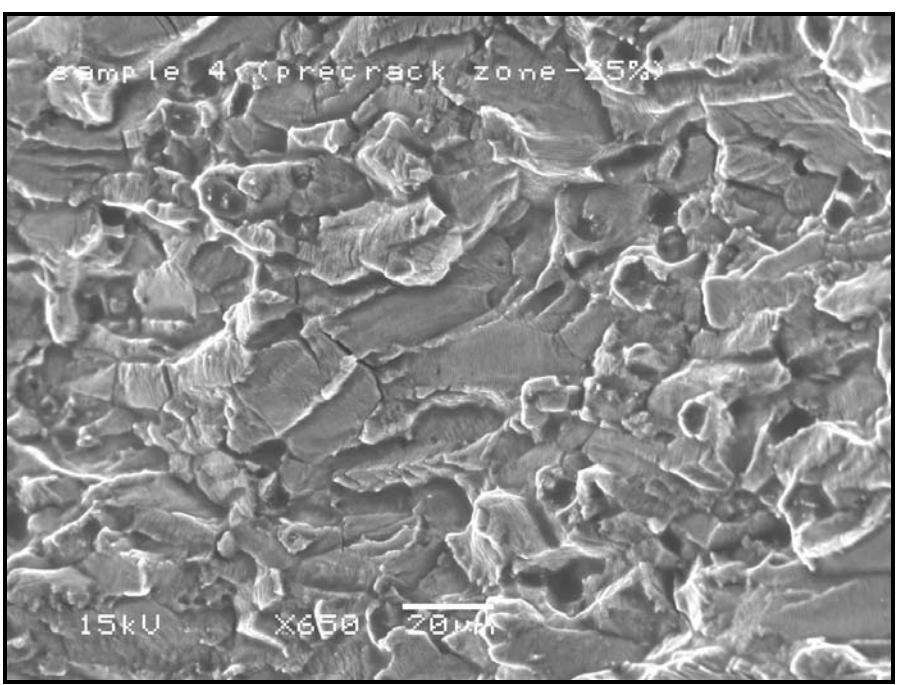
Figure 208: SEM image of sample 4 shows the fracture surface at the pre-fatigue crack zone at 25% thickness, 650X. Fatigue striations were observed throughout the pre-fatigue crack zone.

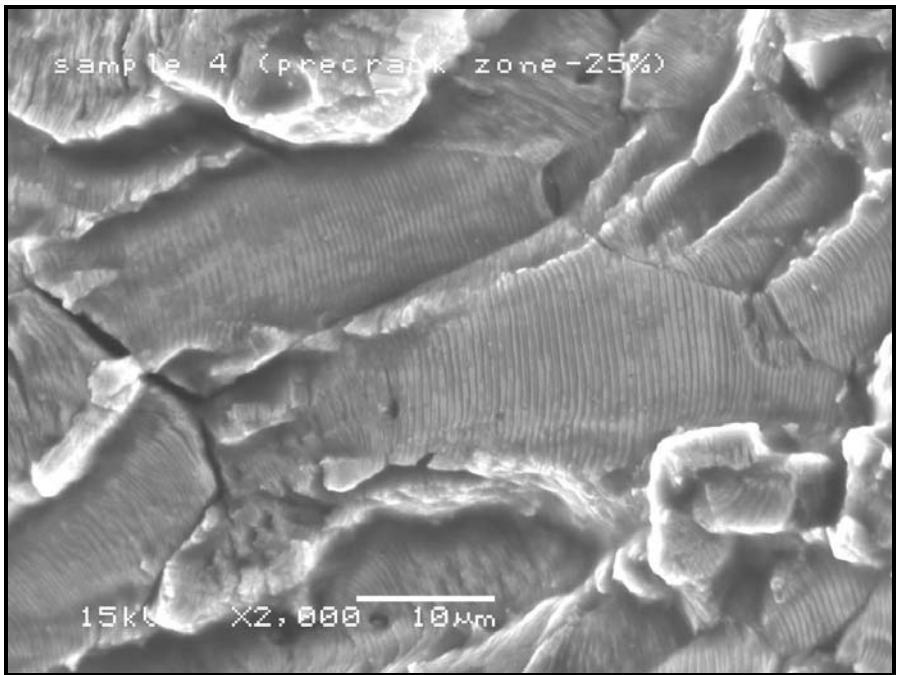
Figure 209: SEM image of sample 4 shows the fracture surface at the pre-fatigue crack zone at 25% thickness, 2000X. Fatigue striations were observed throughout the pre-fatigue crack zone.

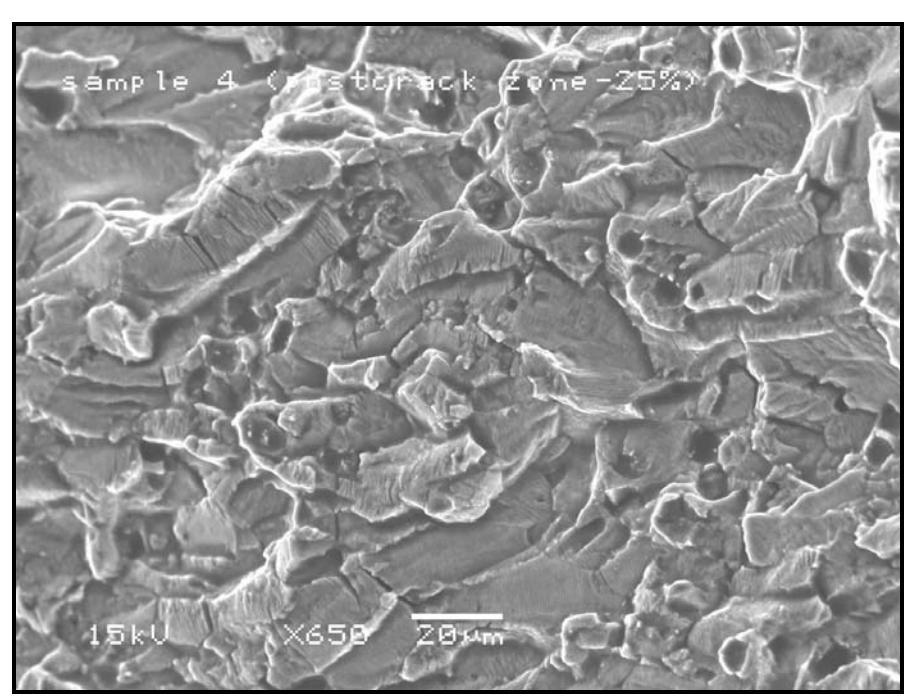
Figure 210: SEM image of sample 4 shows the fracture surface at the post-fatigue crack zone at 25% thickness, 650X. Fatigue striations were observed throughout the post-fatigue crack zone along the 0.16 mm from the pre-fatigue crack zone.
