PACKER ENGINEERING INC, 1950 North Washington Street, Naperville, IL 60566

Evaluation of Three DOT 3AL 6061-T6 Cylinders to Determine the Neck Cracks Cause and Initiation Site (CIS of Neck Cracks)

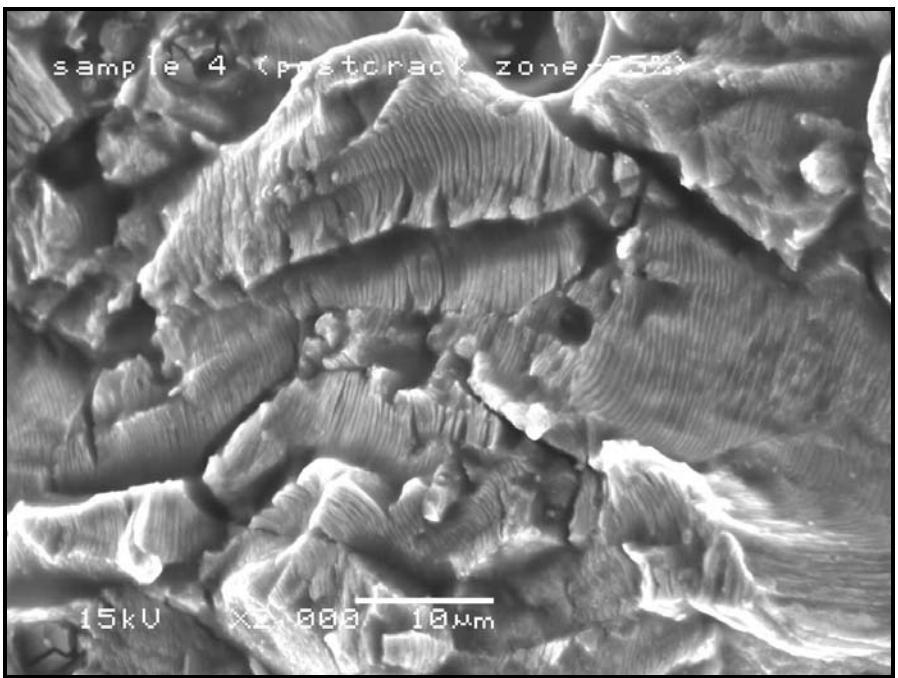
Figure 211: SEM image of sample 4 shows the fracture surface at the post-fatigue crack zone at 25% thickness, 2000X. Fatigue striations were observed throughout the post-fatigue crack zone along the 0.16 mm from the pre-fatigue crack zone.

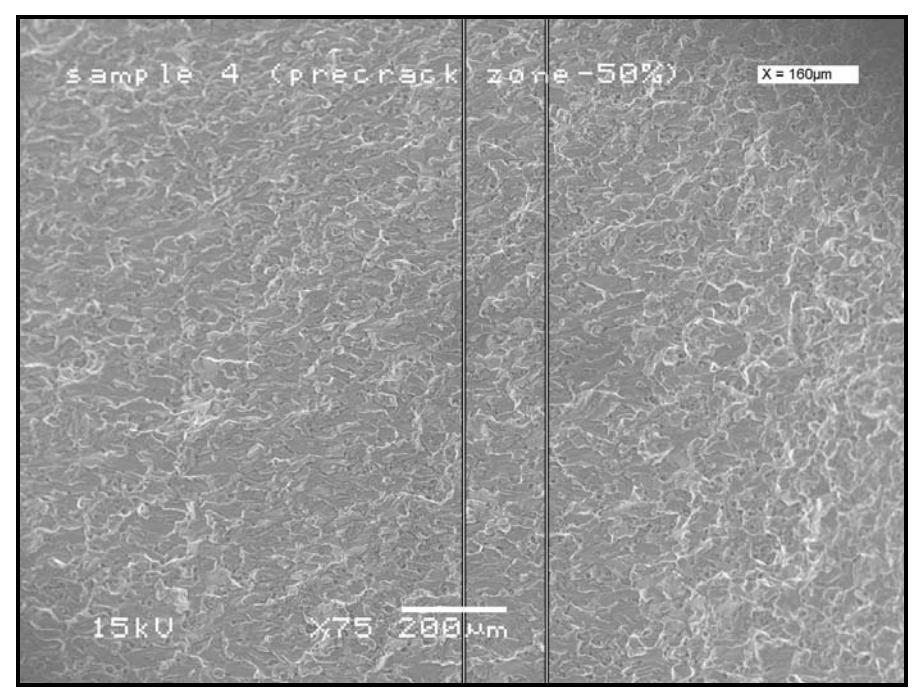
Figure 212: SEM image of sample 4 shows the fracture surface along the 0.16 mm distance from the pre-fatigue crack zone at 50% thickness, 75X. Fatigue was observed throughout the 0.16 mm distance from pre-fatigue crack zone.

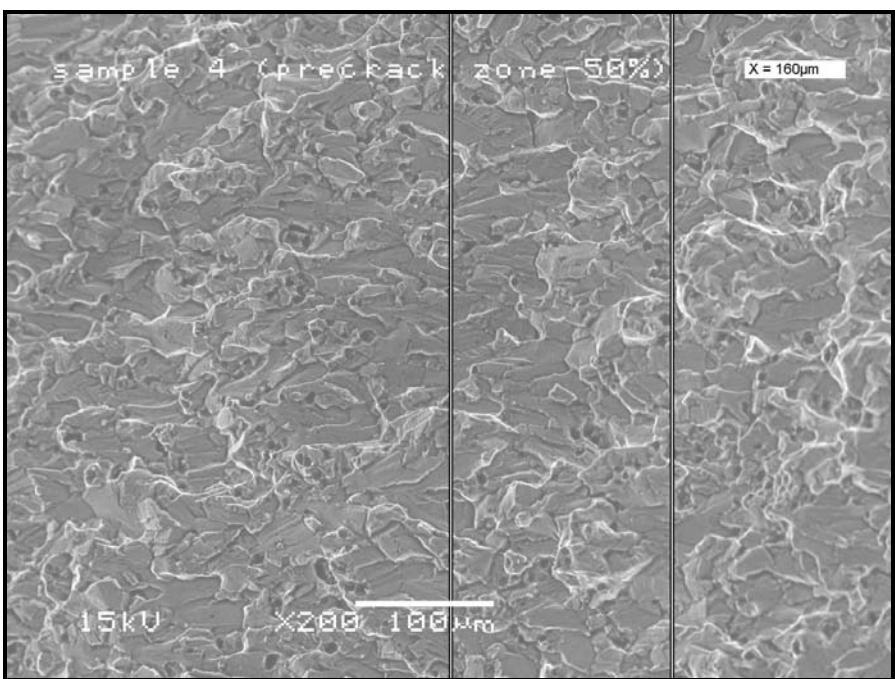
Figure 213: SEM image of sample 4 shows the fracture surface along the 0.16 mm distance from the pre-fatigue crack zone at 50% thickness, 200X. Fatigue was observed throughout the 0.16 mm distance from pre-fatigue crack zone.

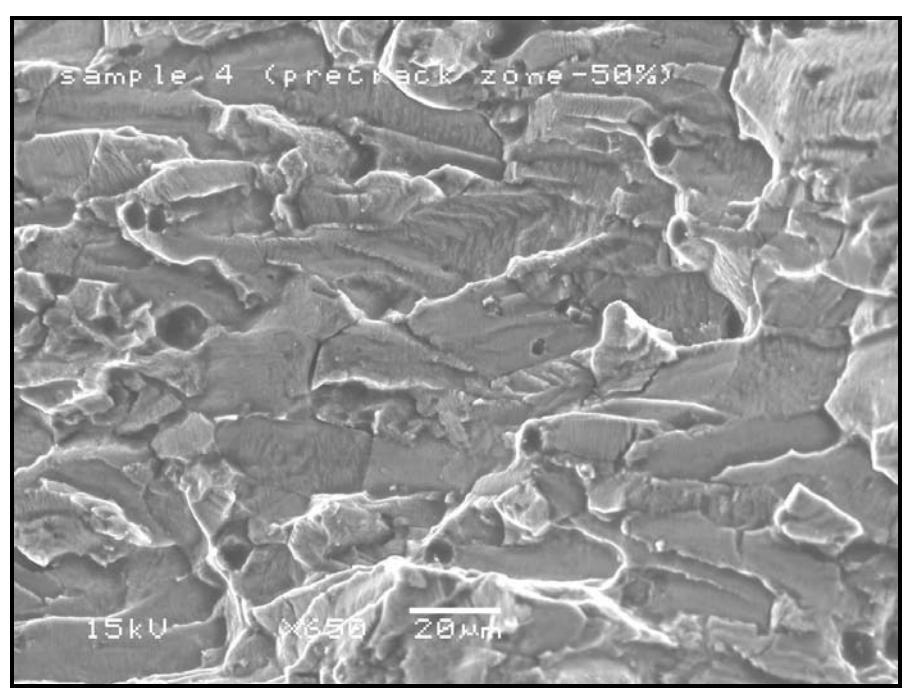
Figure 214: SEM image of sample 4 shows the fracture surface at the pre-fatigue crack zone at 50% thickness, 650X. Fatigue striations were observed throughout the pre-fatigue crack zone.

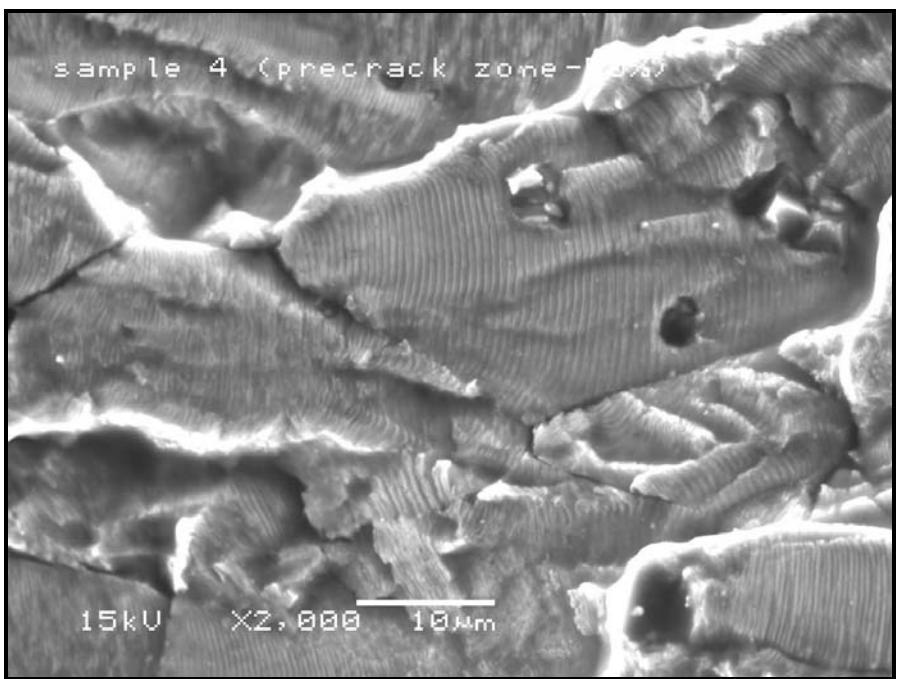
Figure 215: SEM image of sample 4 shows the fracture surface at the pre-fatigue crack zone at 50% thickness, 2000X. Fatigue striations were observed throughout the pre-fatigue crack zone.

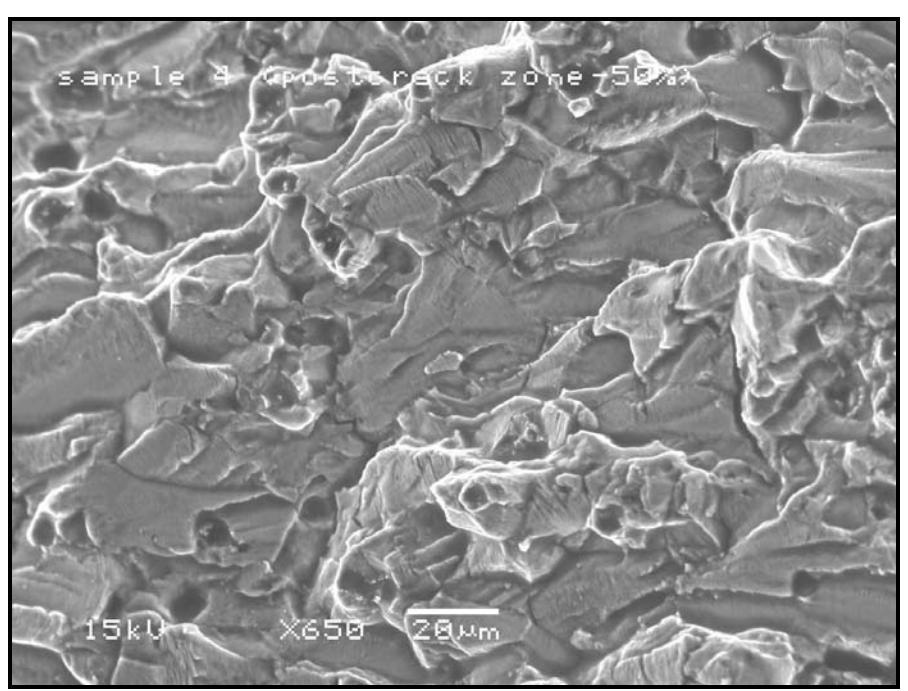
Figure 216: SEM image of sample 4 shows the fracture surface at the post-fatigue crack zone at 50% thickness, 650X. Fatigue striations were observed throughout the post-fatigue crack zone along the 0.16 mm from the pre-fatigue crack zone.

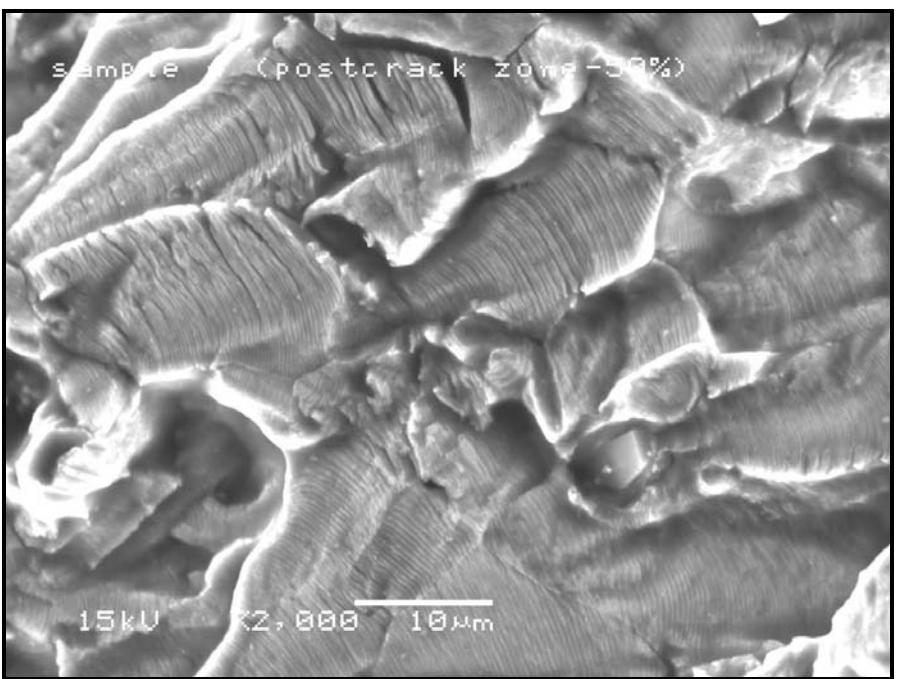
Figure 217: SEM image of sample 4 shows the fracture surface at the post-fatigue crack zone at 50% thickness, 2000X. Fatigue striations were observed throughout the post-fatigue crack zone along the 0.16 mm from the pre-fatigue crack zone.

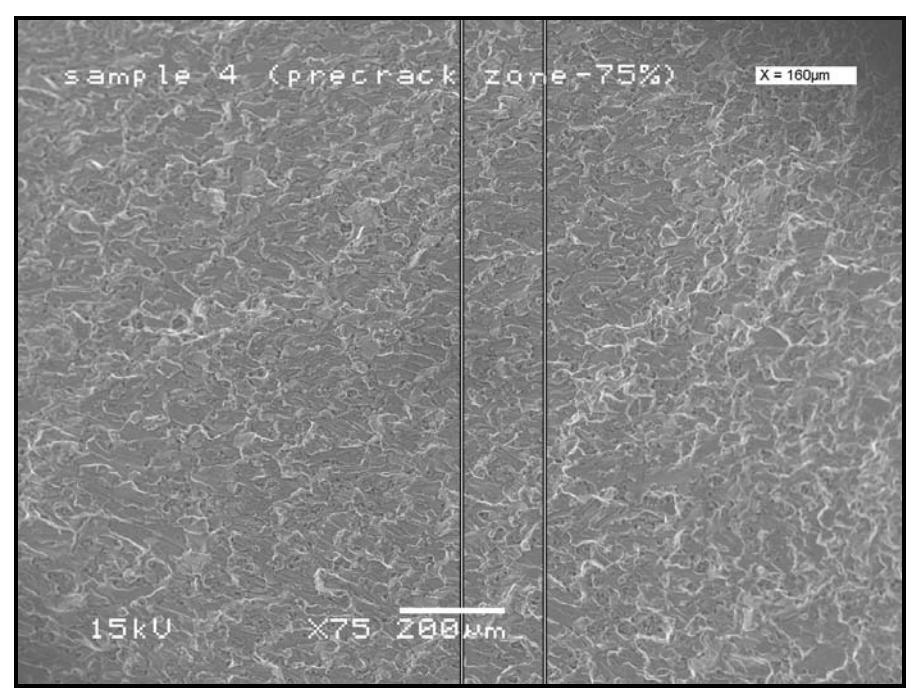
Figure 218: SEM image of sample 4 shows the fracture surface along the 0.16 mm distance from the pre-fatigue crack zone at 75% thickness, 75X. Fatigue was observed throughout the 0.16 mm distance from pre-fatigue crack zone.

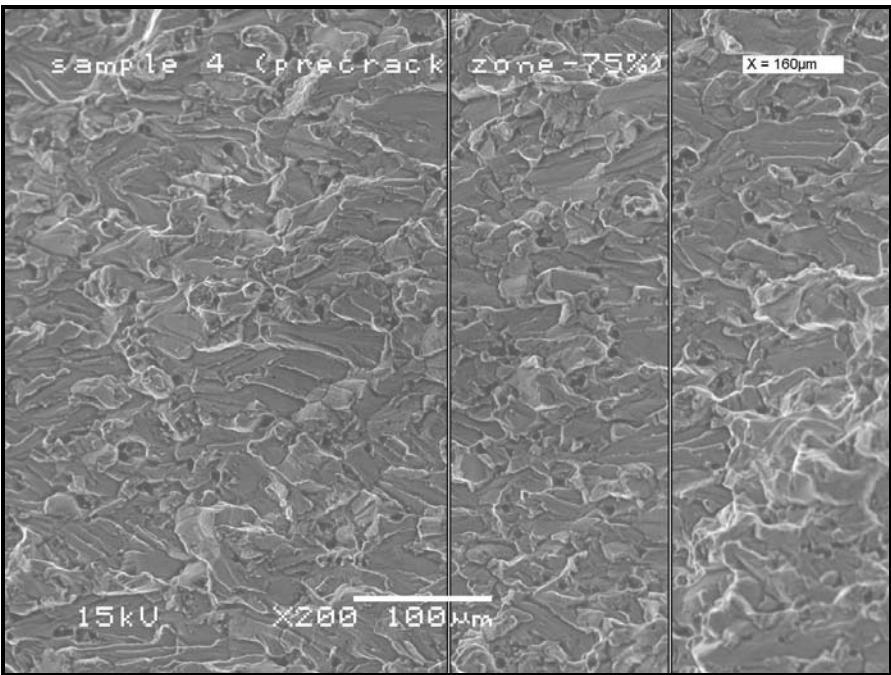
Figure 219: SEM image of sample 4 shows the fracture surface along the 0.16 mm distance from the pre-fatigue crack zone at 75% thickness, 200X. Fatigue was observed throughout the 0.16 mm distance from pre-fatigue crack zone.

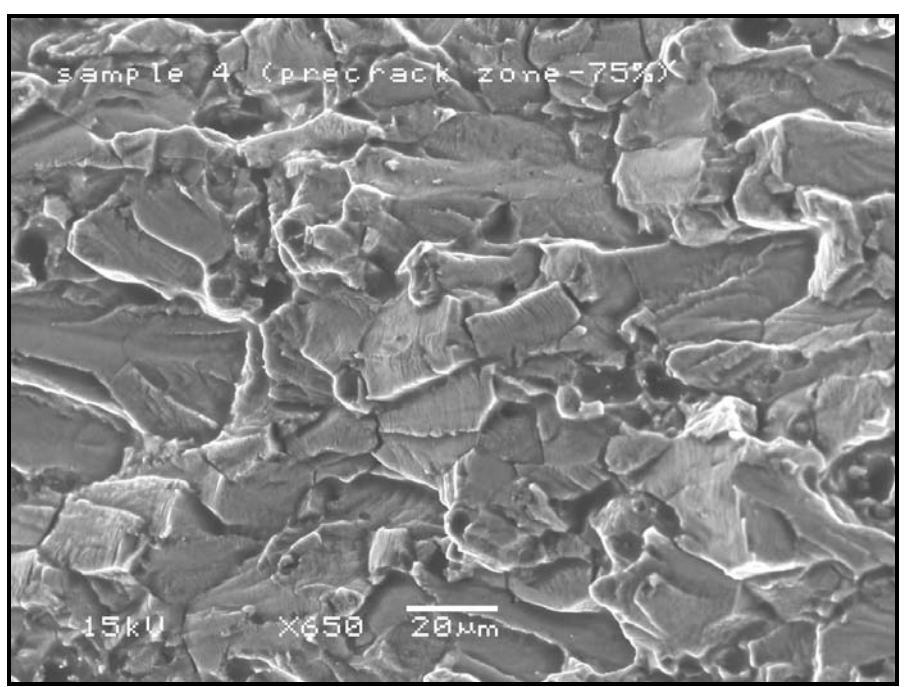
Figure 220: SEM image of sample 4 shows the fracture surface at the pre-fatigue crack zone at 75% thickness, 650X. Fatigue striations were observed throughout the pre-fatigue crack zone.

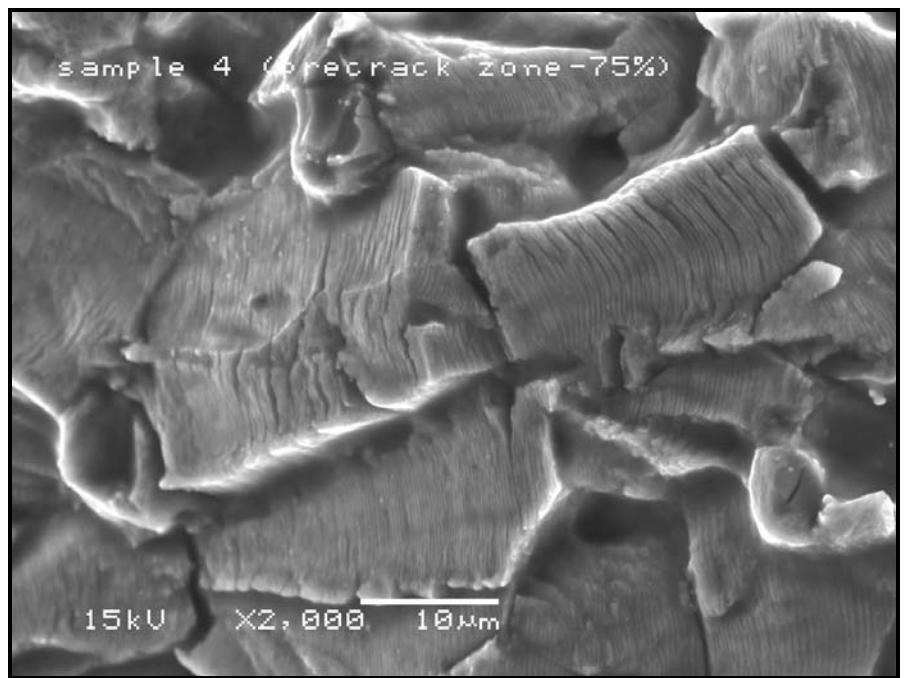
Figure 221: SEM image of sample 4 shows the fracture surface at the pre-fatigue crack zone at 75% thickness, 2000X. Fatigue striations were observed throughout the pre-fatigue crack zone.

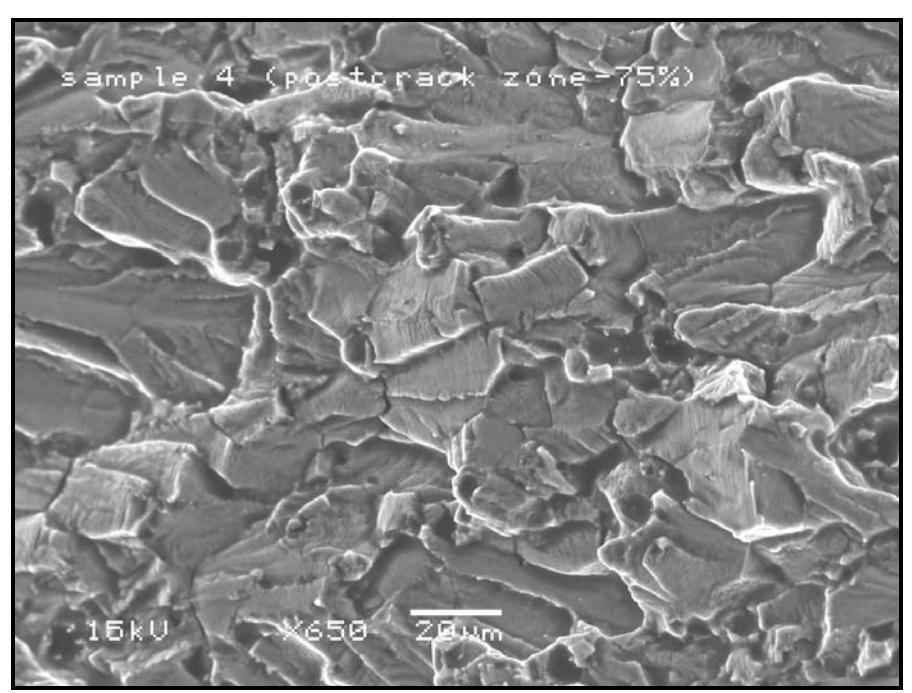
Figure 222: SEM image of sample 4 shows the fracture surface at the post-fatigue crack zone at 75% thickness, 650X. Fatigue striations were observed throughout the post-fatigue crack zone along the 0.16 mm from the pre-fatigue crack zone.

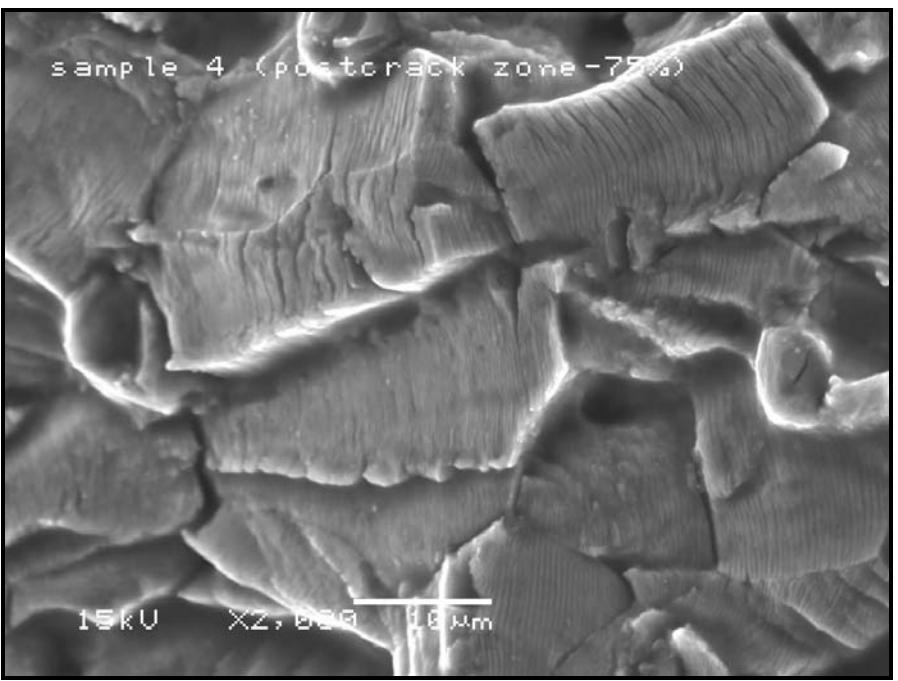
Figure 223: SEM image of sample 4 shows the fracture surface at the post-fatigue crack zone at 75% thickness, 2000X. Fatigue striations were observed throughout the post-fatigue crack zone along the 0.16 mm from the pre-fatigue crack zone.

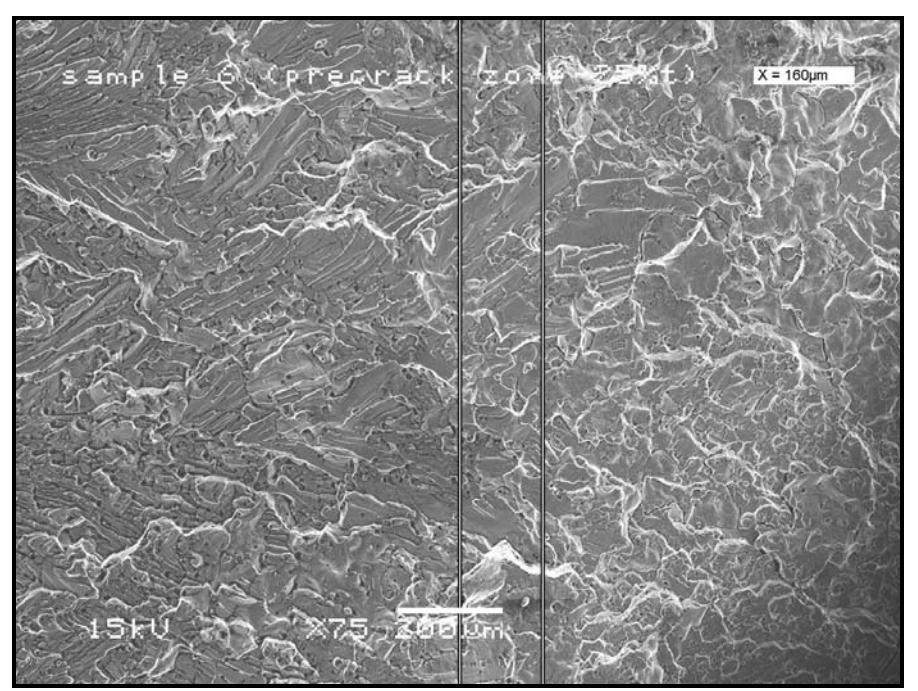
Figure 224: SEM image of sample 6 shows the fracture surface along the 0.16 mm distance from the pre-fatigue crack zone at 25% thickness, 75X. Fatigue was observed throughout the 0.16 mm distance from pre-fatigue crack zone.

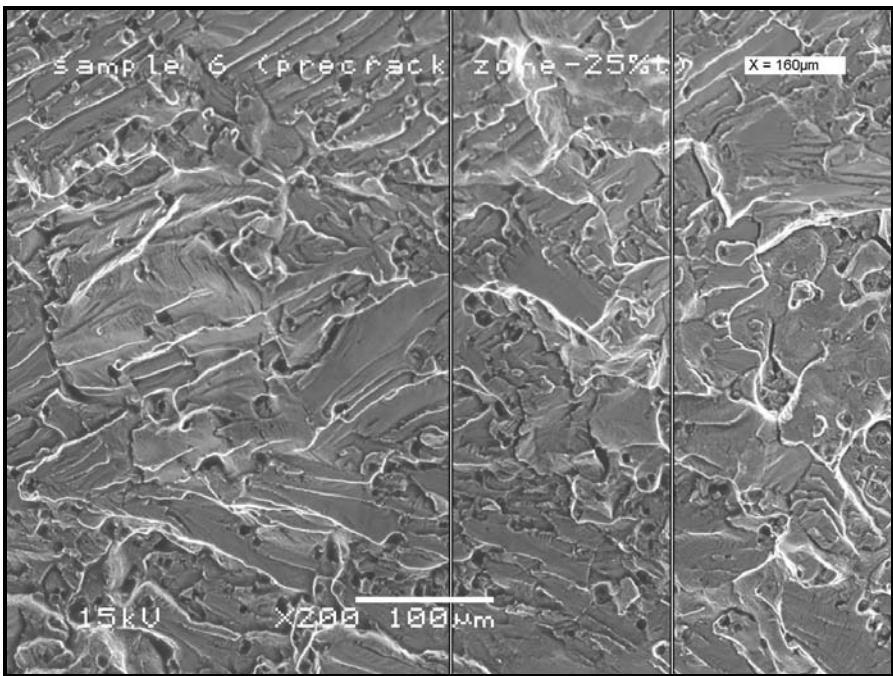
Figure 225: SEM image of sample 6 shows the fracture surface along the 0.16 mm distance from the pre-fatigue crack zone at 25% thickness, 200X. Fatigue was observed throughout the 0.16 mm distance from pre-fatigue crack zone.

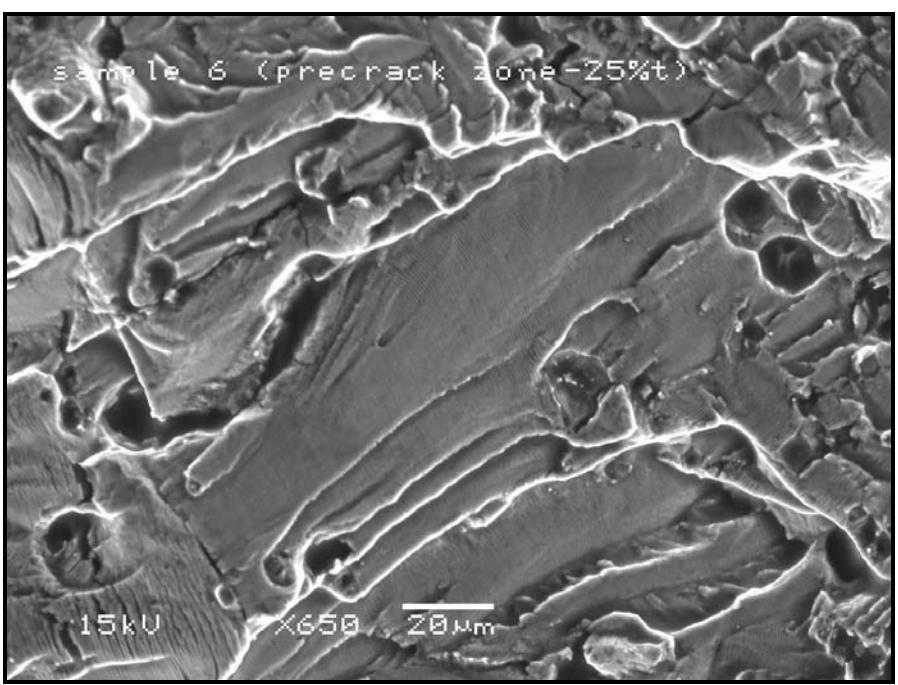
Figure 226: SEM image of sample 6 shows the fracture surface at the pre-fatigue crack zone at 25% thickness, 650X. Fatigue striations were observed throughout the pre-fatigue crack zone.

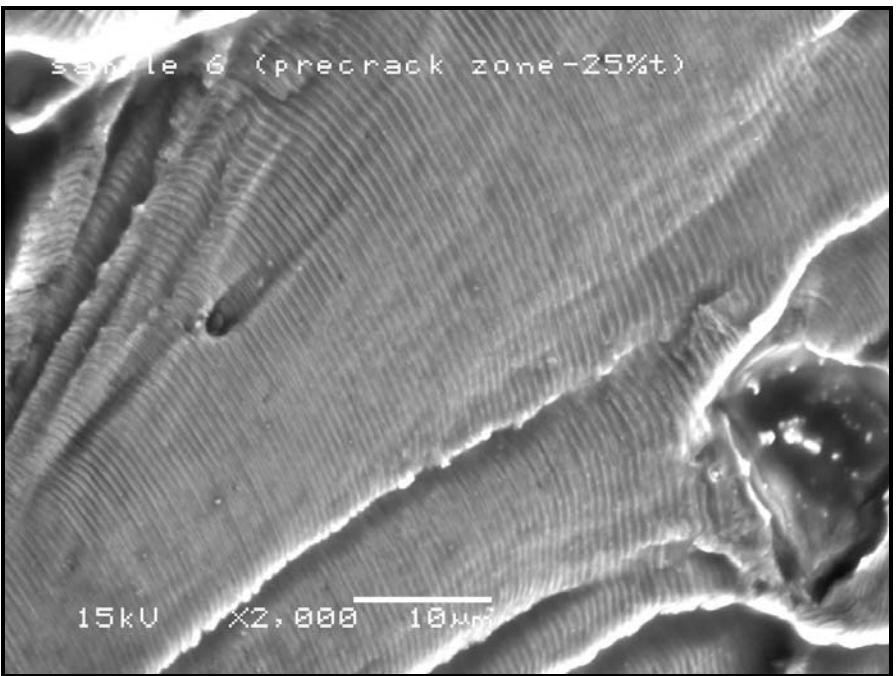
Figure 227: SEM image of sample 6 shows the fracture surface at the pre-fatigue crack zone at 25% thickness, 2000X. Fatigue striations were observed throughout the pre-fatigue crack zone.

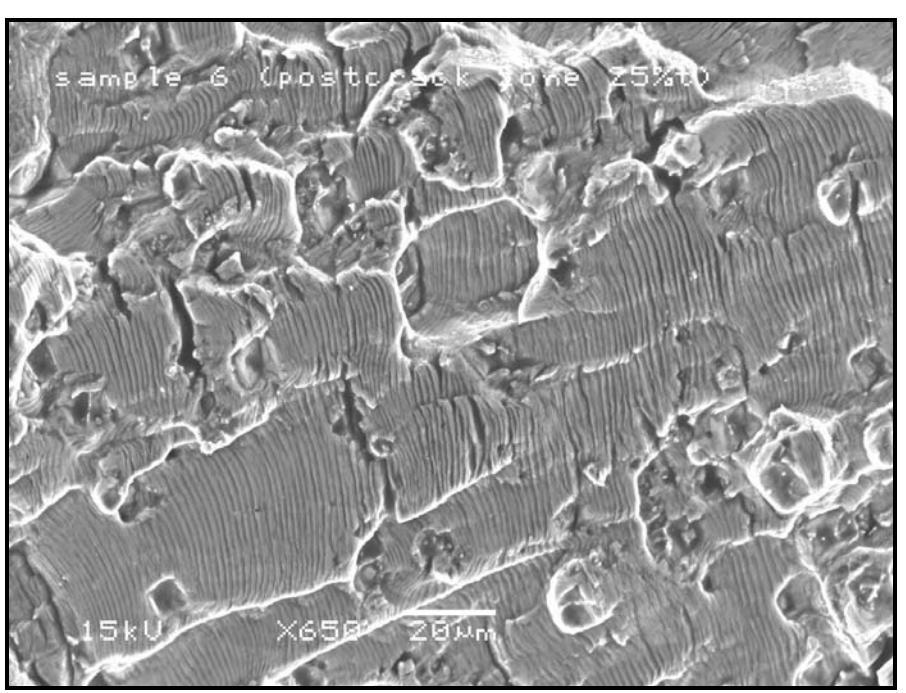
Figure 228: SEM image of sample 6 shows the fracture surface at the post-fatigue crack zone at 25% thickness, 650X. Fatigue striations were observed throughout the post-fatigue crack zone along the 0.16 mm from the pre-fatigue crack zone.

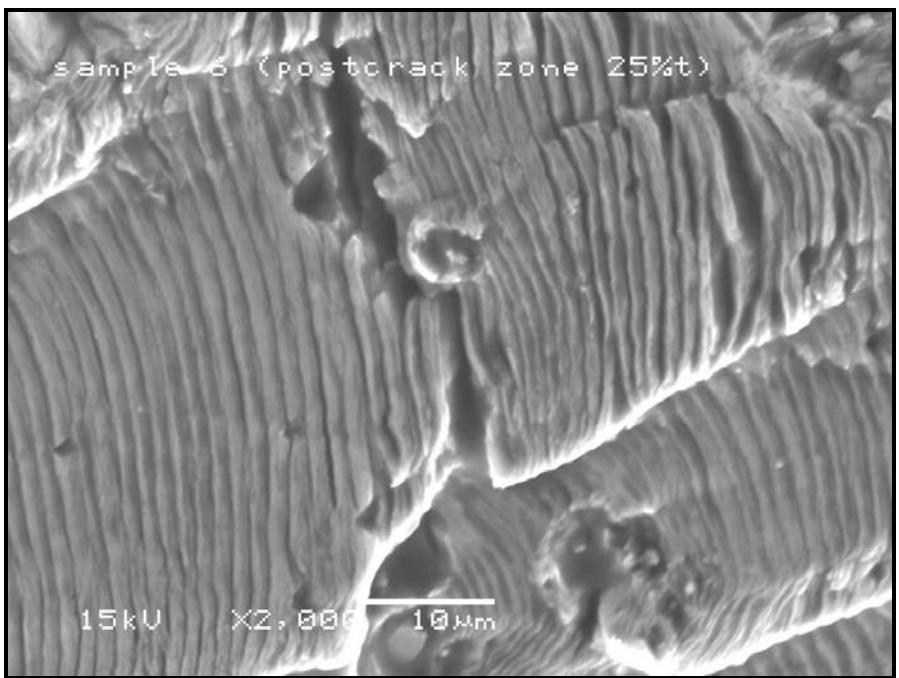
Figure 229: SEM image of sample 6 shows the fracture surface at the post-fatigue crack zone at 25% thickness, 650X. Fatigue striations were observed throughout the post-fatigue crack zone along the 0.16 mm from the pre-fatigue crack zone.

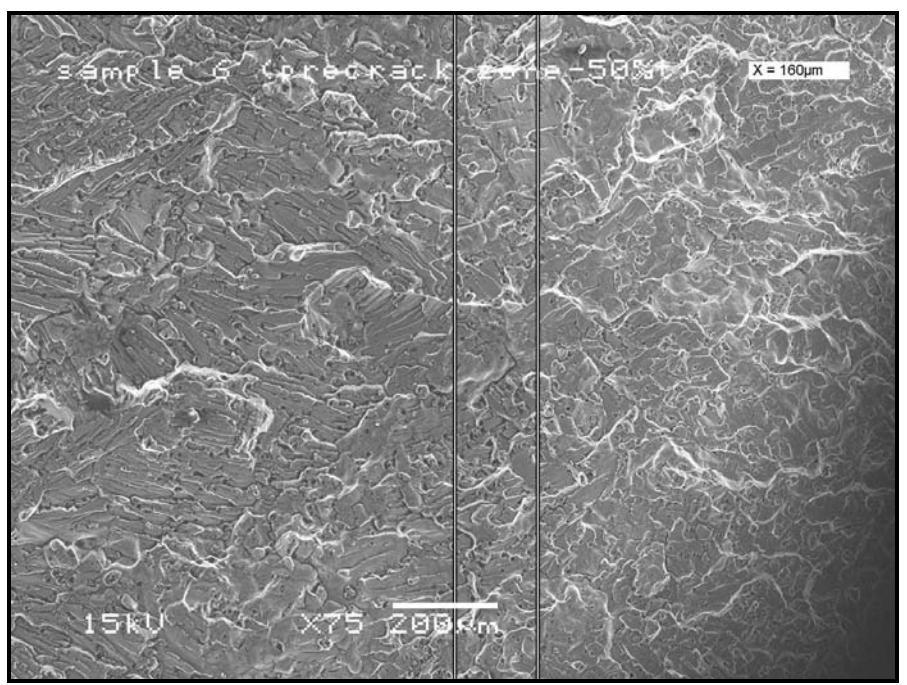
Figure 230: SEM image of sample 6 shows the fracture surface along the 0.16 mm distance from the pre-fatigue crack zone at 50% thickness, 75X. Fatigue was observed throughout the 0.16 mm distance from pre-fatigue crack zone.

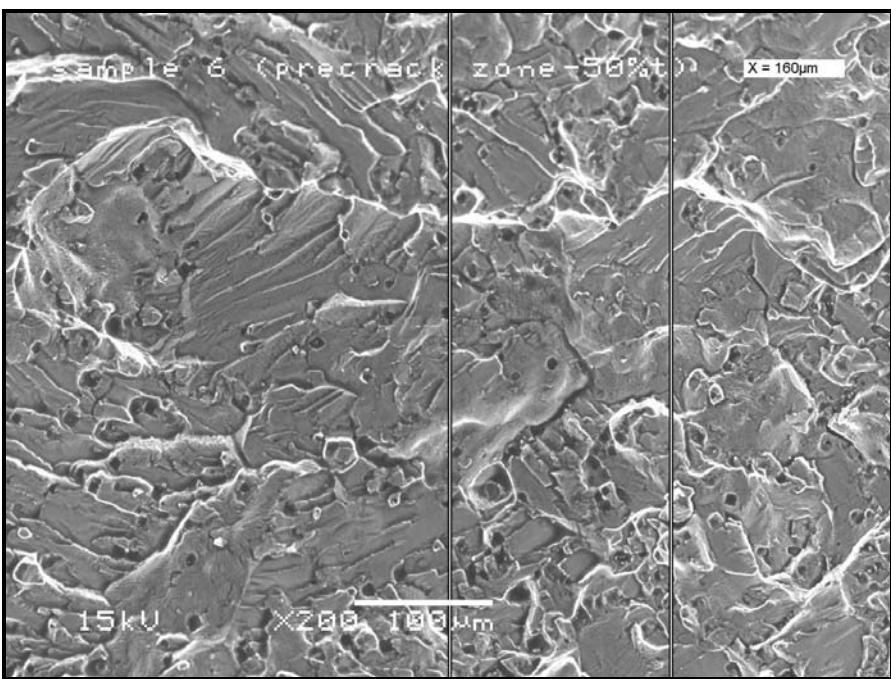
Figure 231: SEM image of sample 6 shows the fracture surface along the 0.16 mm distance from the pre-fatigue crack zone at 50% thickness, 200X. Fatigue was observed throughout the 0.16 mm distance from pre-fatigue crack zone.

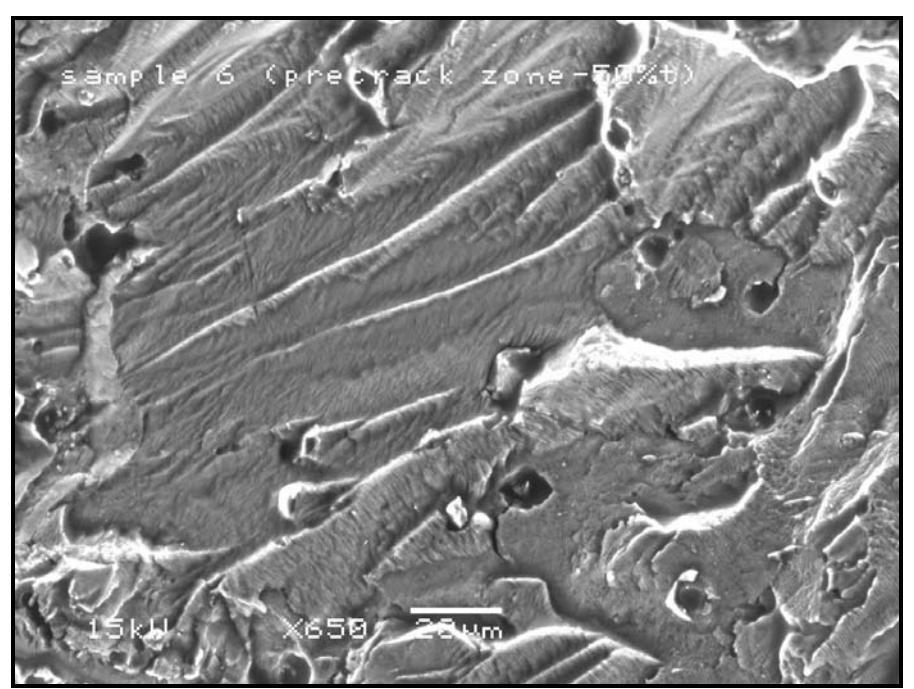
Figure 232: SEM image of sample 6 shows the fracture surface at the pre-fatigue crack zone at 50% thickness, 650X. Fatigue striations were observed throughout the pre-fatigue crack zone.

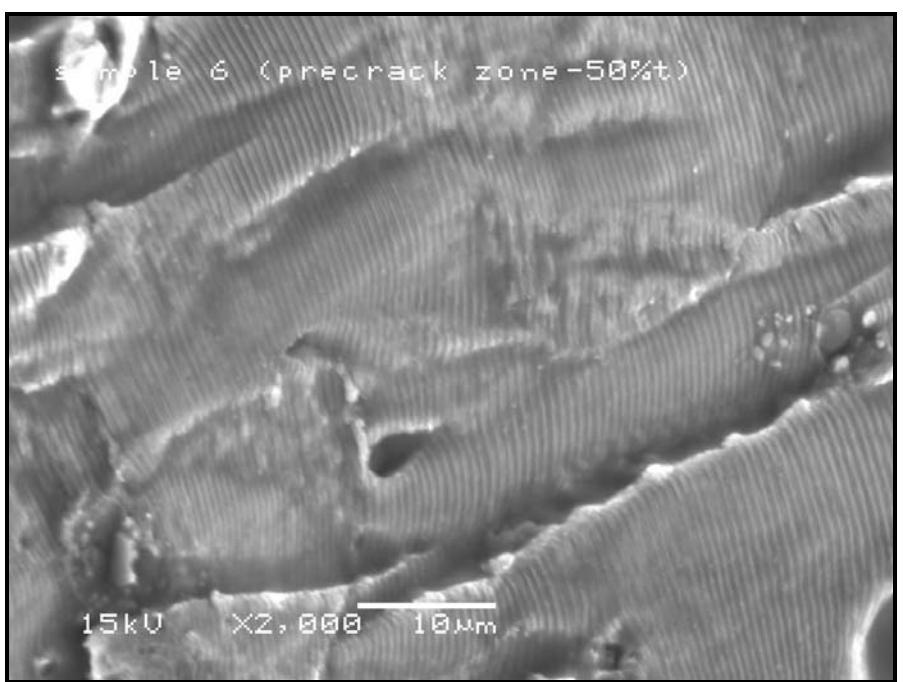
Figure 233: SEM image of sample 6 shows the fracture surface at the pre-fatigue crack zone at 50% thickness, 2000X. Fatigue striations were observed throughout the pre-fatigue crack zone.

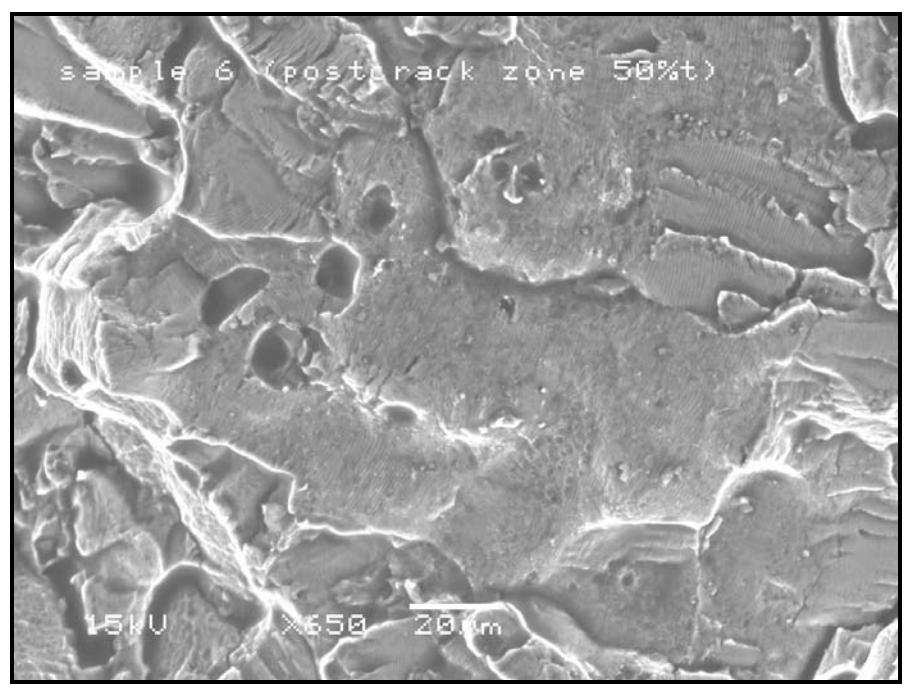
Figure 234: SEM image of sample 6 shows the fracture surface at the post-fatigue crack zone at 50% thickness, 650X. Fatigue striations were observed throughout the post-fatigue crack zone along the 0.16 mm from the pre-fatigue crack zone.

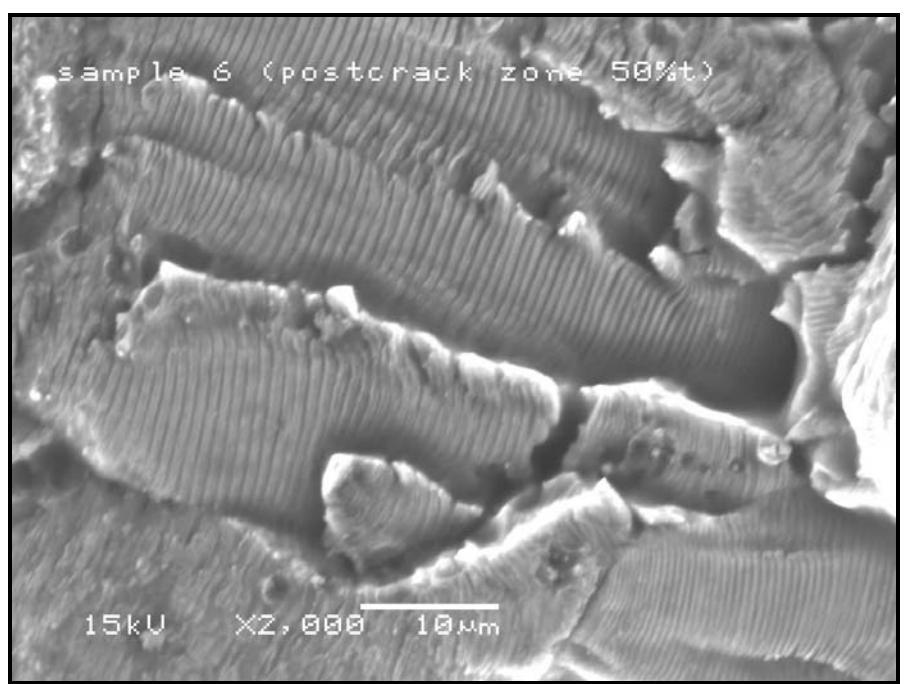
Figure 235: SEM image of sample 6 shows the fracture surface at the post-fatigue crack zone at 50% thickness, 650X. Fatigue striations were observed throughout the post-fatigue crack zone along the 0.16 mm from the pre-fatigue crack zone.

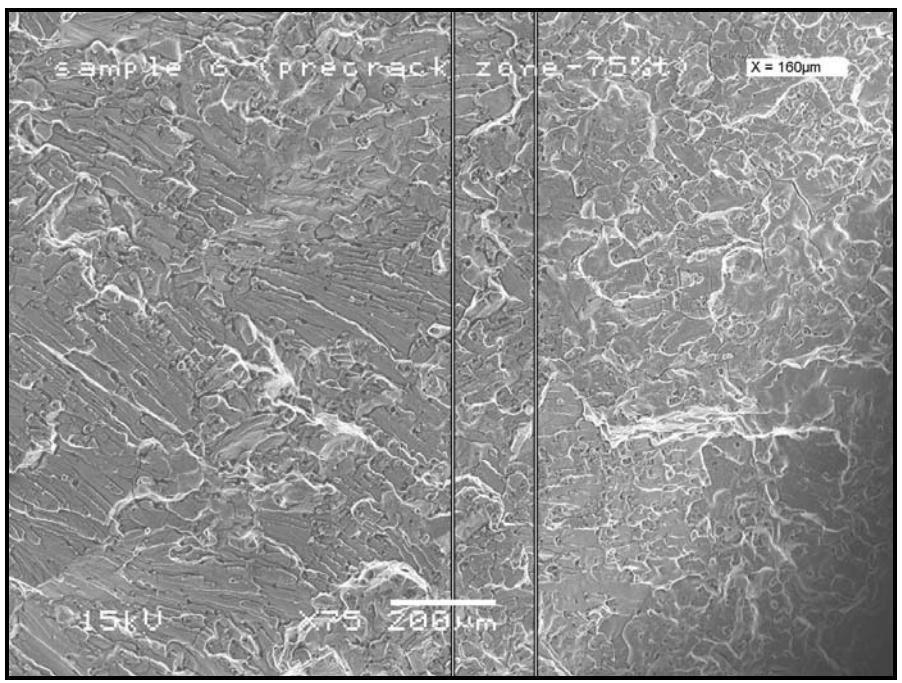
Figure 236: SEM image of sample 6 shows the fracture surface along the 0.16 mm distance from the pre-fatigue crack zone at 75% thickness, 75X. Fatigue was observed throughout the 0.16 mm distance from pre-fatigue crack zone.

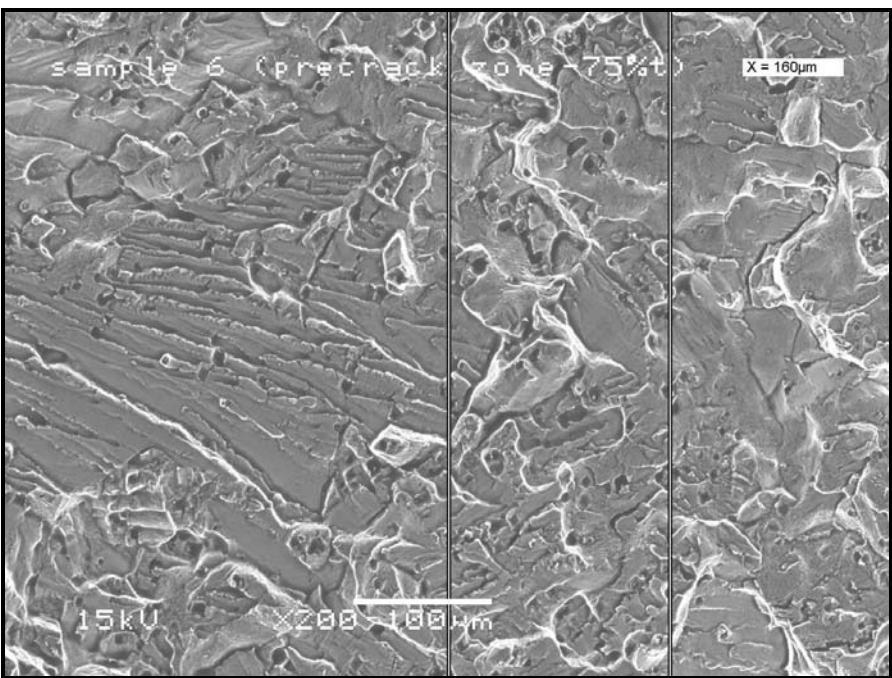
Figure 237: SEM image of sample 6 shows the fracture surface along the 0.16 mm distance from the pre-fatigue crack zone at 75% thickness, 200X. Fatigue was observed throughout the 0.16 mm distance from pre-fatigue crack zone.

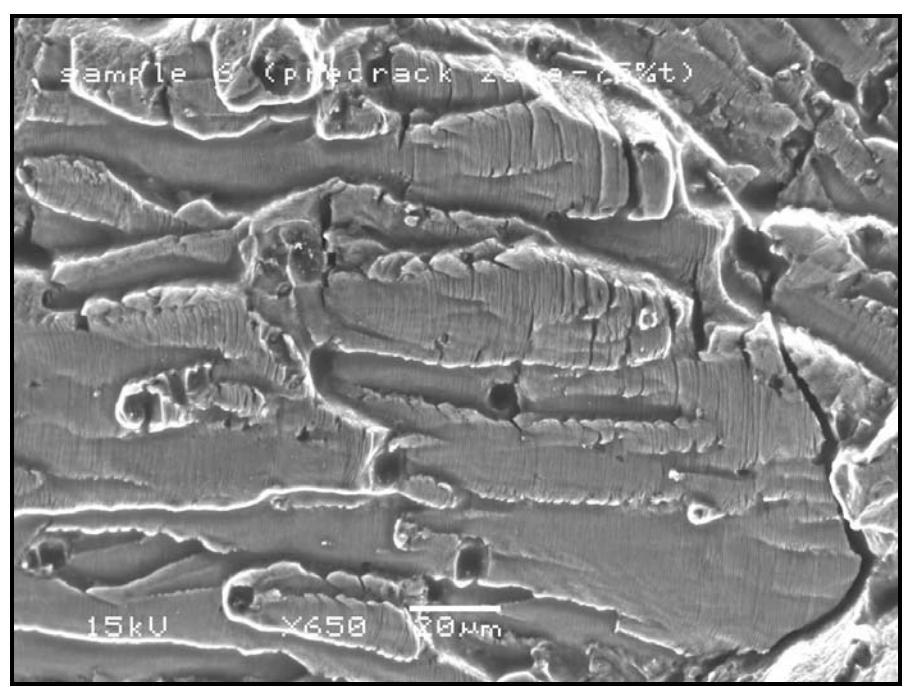
Figure 238: SEM image of sample 6 shows the fracture surface at the pre-fatigue crack zone at 75% thickness, 650X. Fatigue striations were observed throughout the pre-fatigue crack zone.

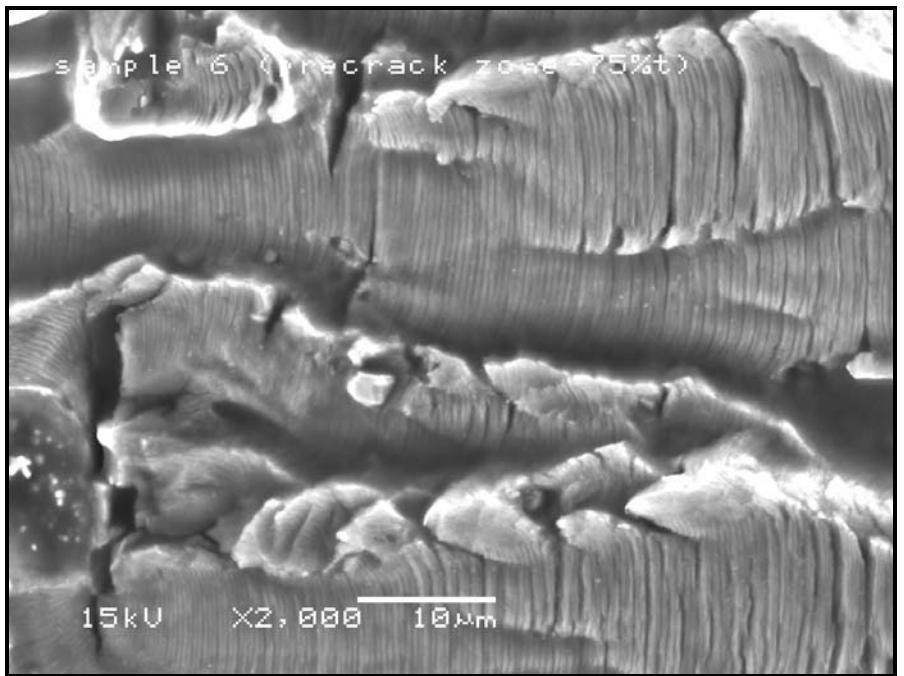
Figure 239: SEM image of sample 6 shows the fracture surface at the pre-fatigue crack zone at 75% thickness, 2000X. Fatigue striations were observed throughout the pre-fatigue crack zone.

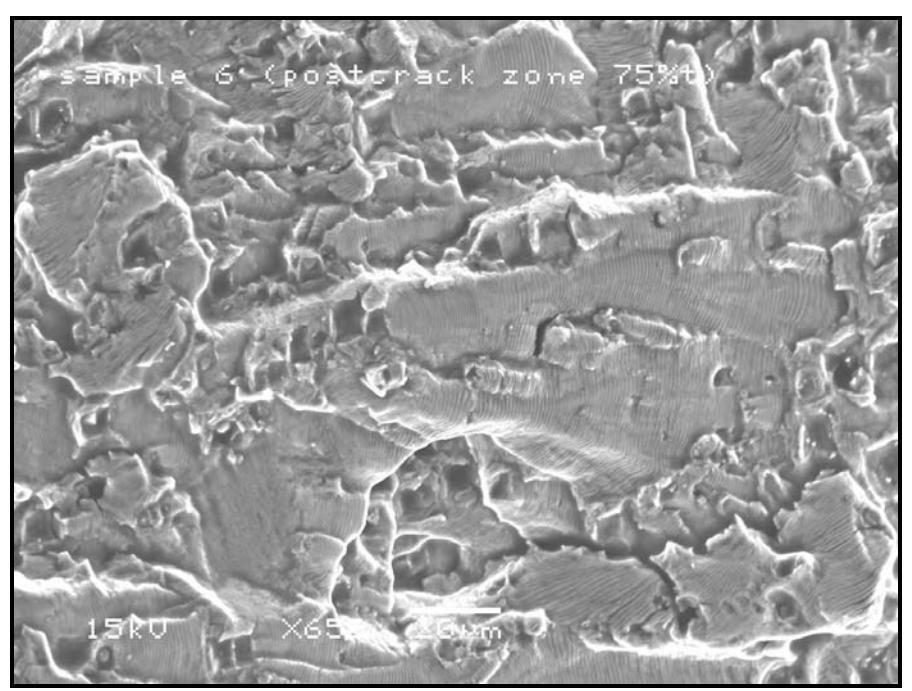
Figure 240: SEM image of sample 6 shows the fracture surface at the post-fatigue crack zone at 75% thickness, 650X. Fatigue striations were observed throughout the post-fatigue crack zone along the 0.16 mm from the pre-fatigue crack zone.

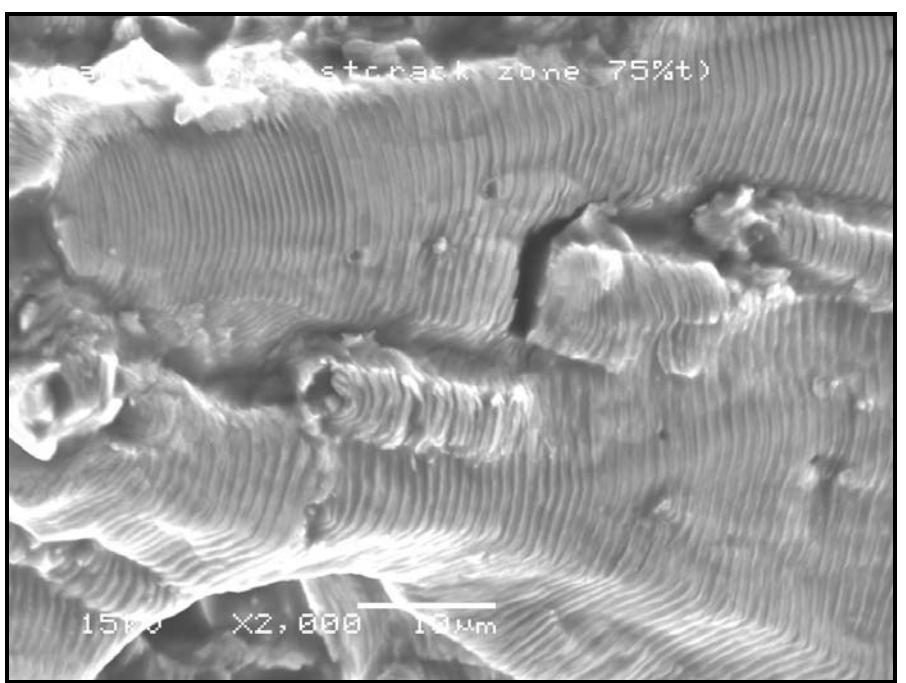
Figure 241: SEM image of sample 6 shows the fracture surface at the post-fatigue crack zone at 75% thickness, 2000X. Fatigue striations were observed throughout the post-fatigue crack zone along the 0.16 mm from the pre-fatigue crack zone.

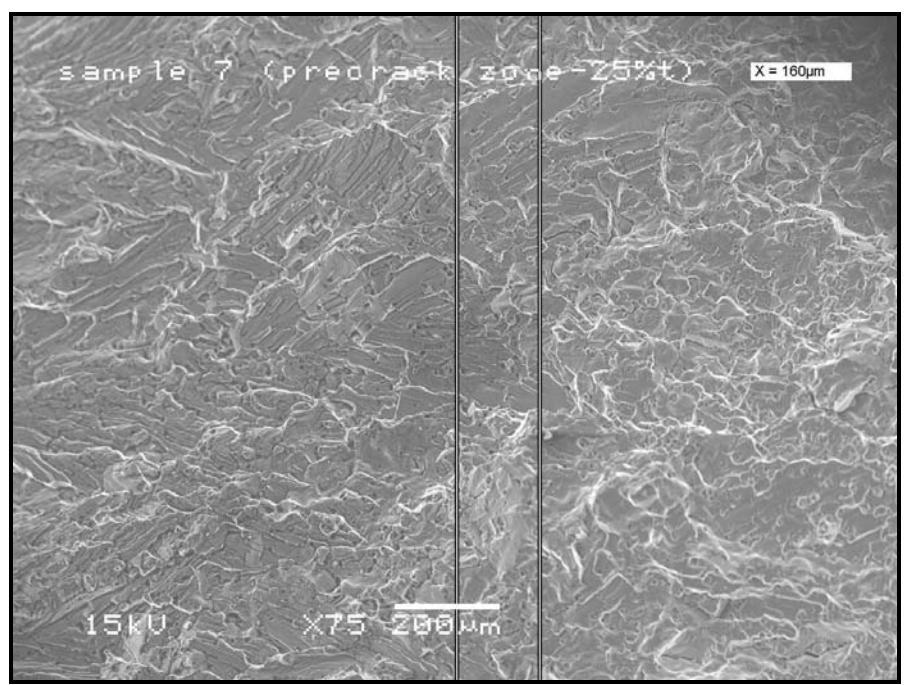
Figure 242: SEM image of sample 7 shows the fracture surface along the 0.16 mm distance from the pre-fatigue crack zone at 25% thickness, 75X. Fatigue was observed throughout the 0.16 mm distance from pre-fatigue crack zone.

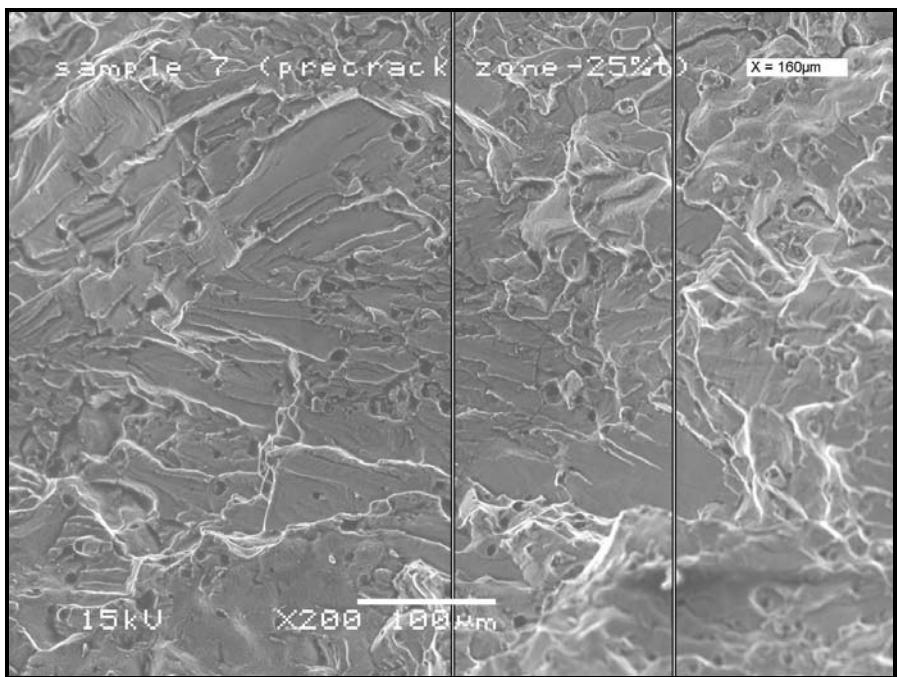
Figure 243: SEM image of sample 7 shows the fracture surface along the 0.16 mm distance from the pre-fatigue crack zone at 25% thickness, 200X. Fatigue was observed throughout the 0.16 mm distance from pre-fatigue crack zone.

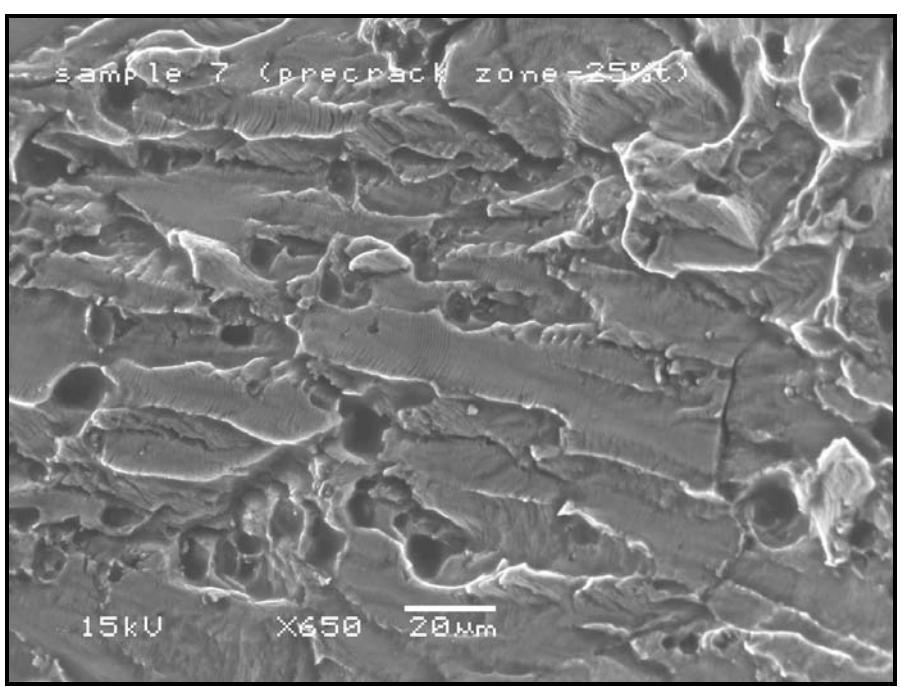
Figure 244: SEM image of sample 7 shows the fracture surface at the pre-fatigue crack zone at 25% thickness, 650X. Fatigue striations were observed throughout the pre-fatigue crack zone.
