PACKER ENGINEERING INC, 1950 North Washington Street, Naperville, IL 60566

Evaluation of Three DOT 3AL 6061-T6 Cylinders to Determine the Neck Cracks Cause and Initiation Site (CIS of Neck Cracks)

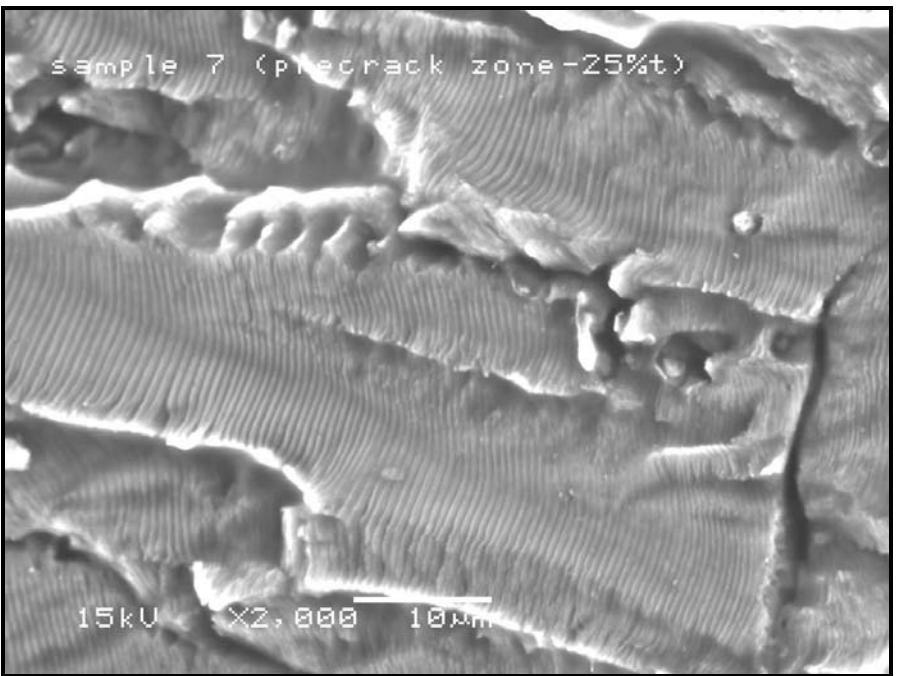
Figure 245: SEM image of sample 7 shows the fracture surface at the pre-fatigue crack zone at 25% thickness, 2000X. Fatigue striations were observed throughout the pre-fatigue crack zone.

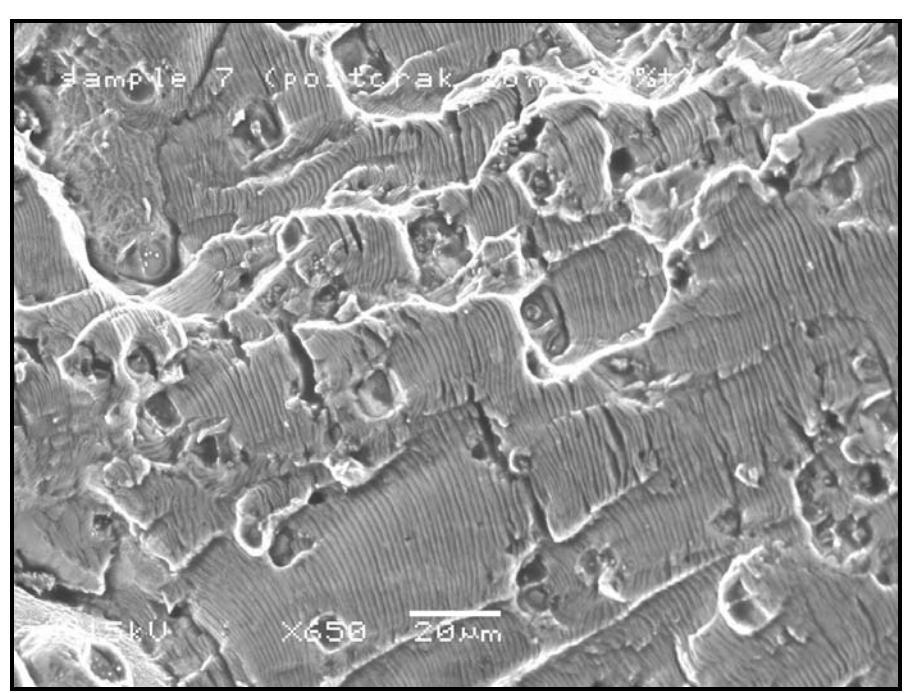
Figure 246: SEM image of sample 7 shows the fracture surface at the post-fatigue crack zone at 25% thickness, 650X. Fatigue striations were observed throughout the post-fatigue crack zone along the 0.16 mm from the pre-fatigue crack zone.

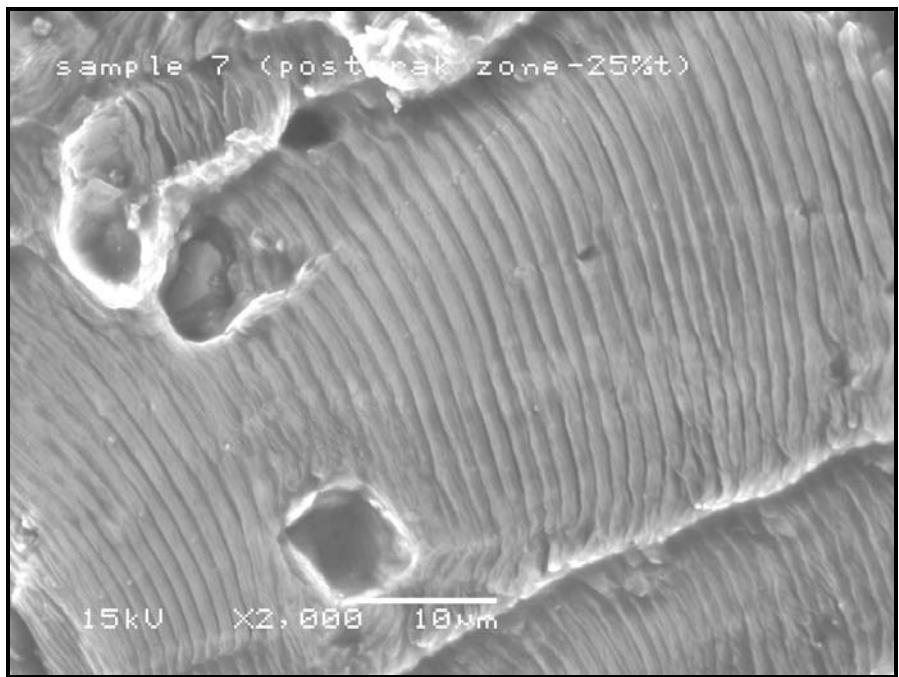
Figure 247: SEM image of sample 7 shows the fracture surface at the post-fatigue crack zone at 25% thickness, 2000X. Fatigue striations were observed throughout the post-fatigue crack zone along the 0.16 mm from the pre-fatigue crack zone.

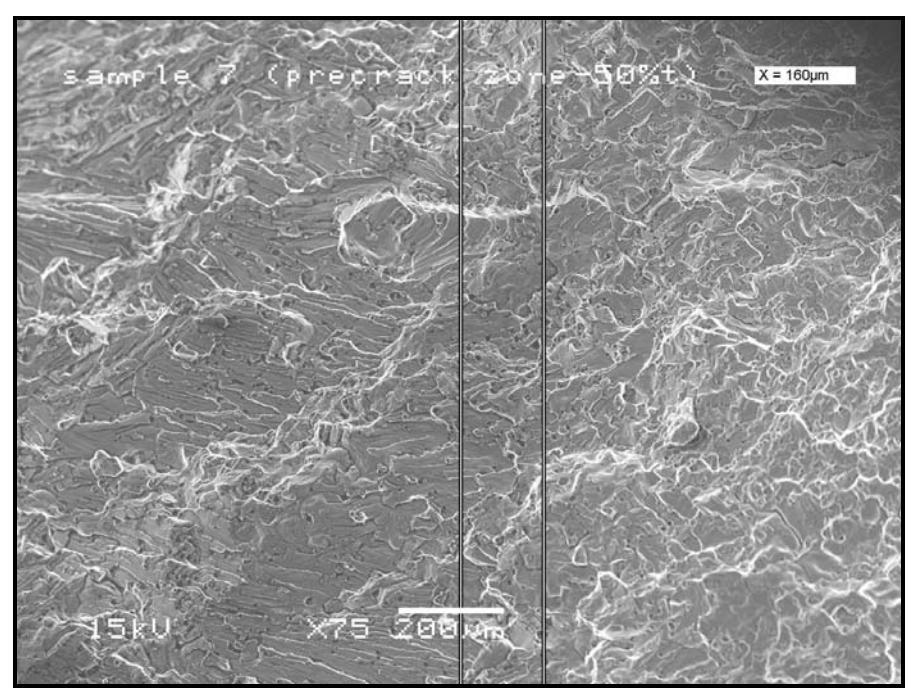
Figure 248: SEM image of sample 7 shows the fracture surface along the 0.16 mm distance from the pre-fatigue crack zone at 50% thickness, 75X. Fatigue was observed throughout the 0.16 mm distance from pre-fatigue crack zone.

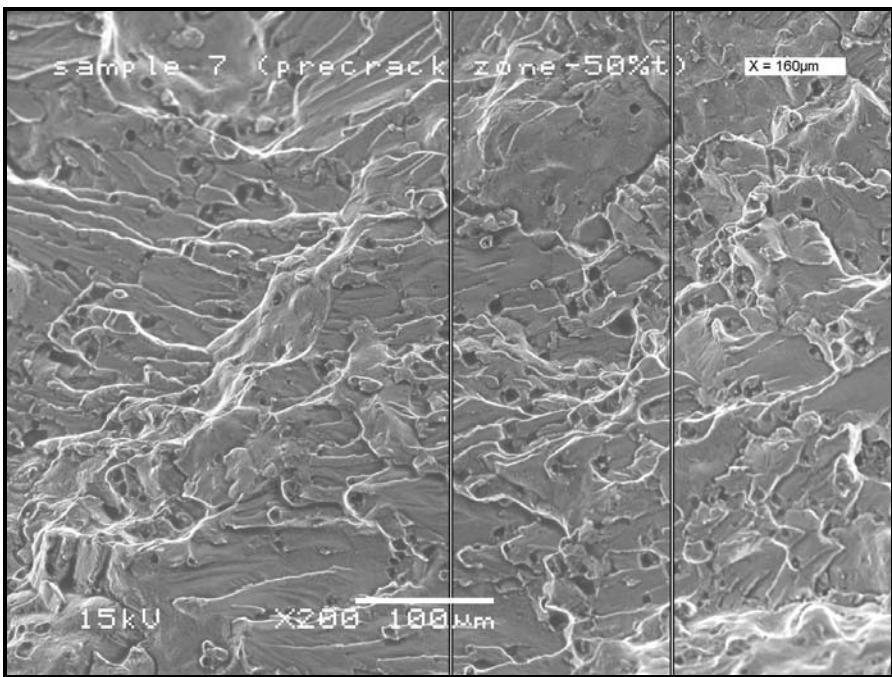
Figure 249: SEM image of sample 7 shows the fracture surface along the 0.16 mm distance from the pre-fatigue crack zone at 50% thickness, 200X. Fatigue was observed throughout the 0.16 mm distance from pre-fatigue crack zone.

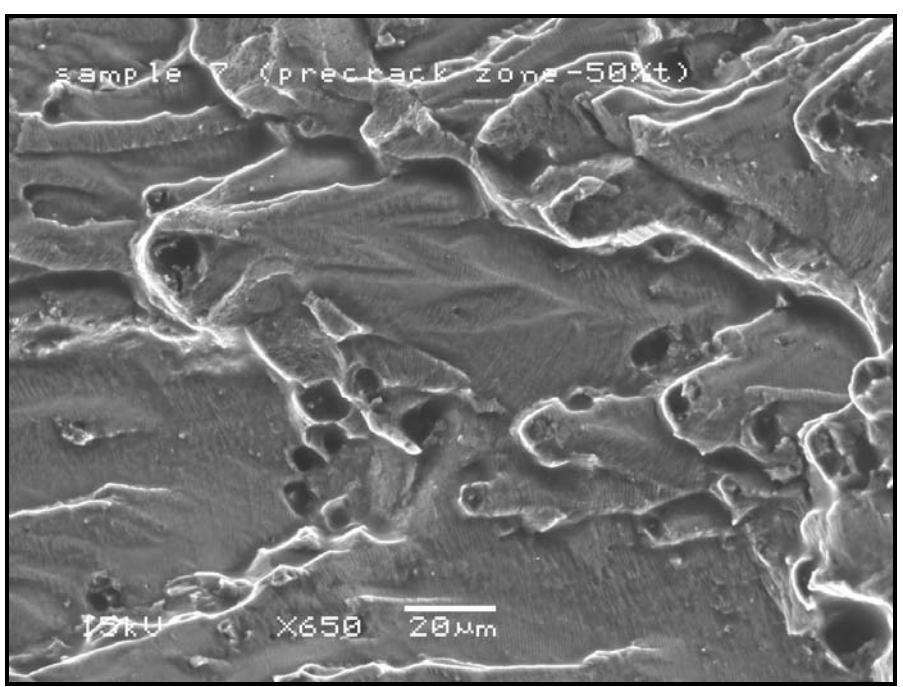
Figure 250: SEM image of sample 7 shows the fracture surface at the pre-fatigue crack zone at 50% thickness, 650X. Fatigue striations were observed throughout the pre-fatigue crack zone.

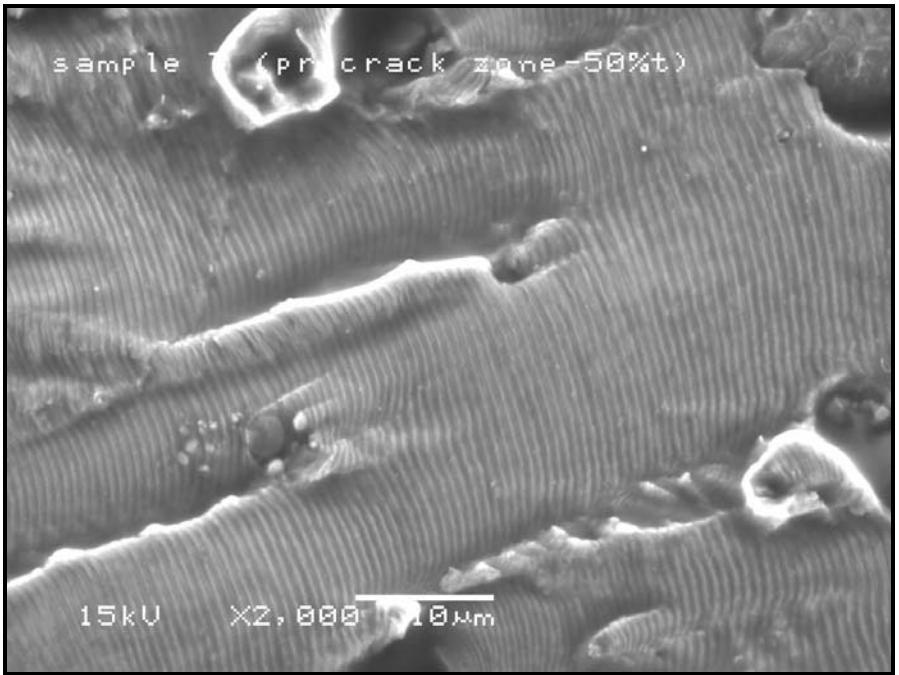
Figure 251: SEM image of sample 7 shows the fracture surface at the pre-fatigue crack zone at 50% thickness, 2000X. Fatigue striations were observed throughout the pre-fatigue crack zone.

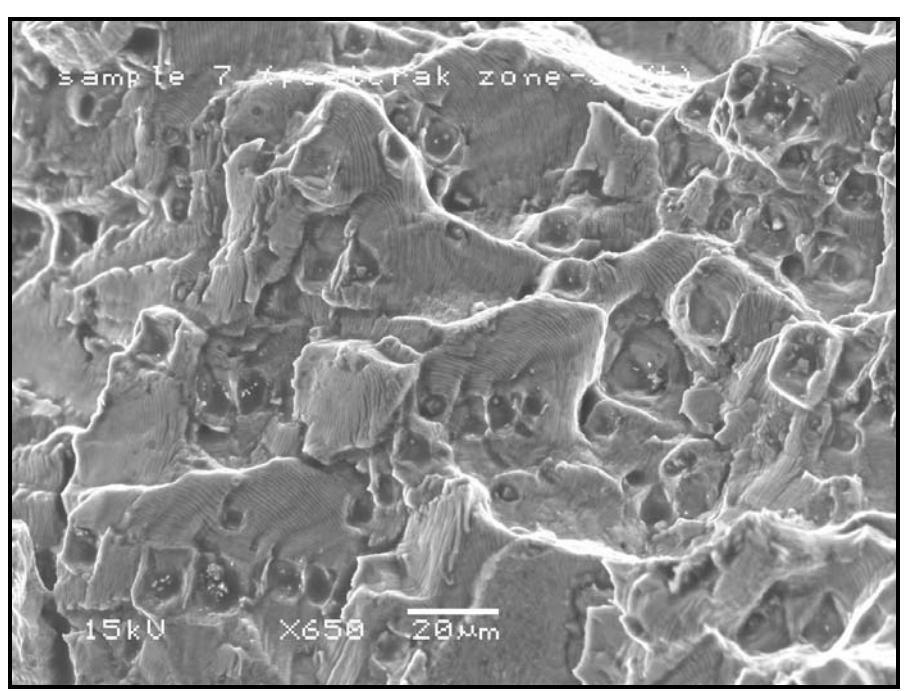
Figure 252: SEM image of sample 7 shows the fracture surface at the post-fatigue crack zone at 50% thickness, 650X. Fatigue striations were observed throughout the post-fatigue crack zone along the 0.16 mm from the pre-fatigue crack zone.

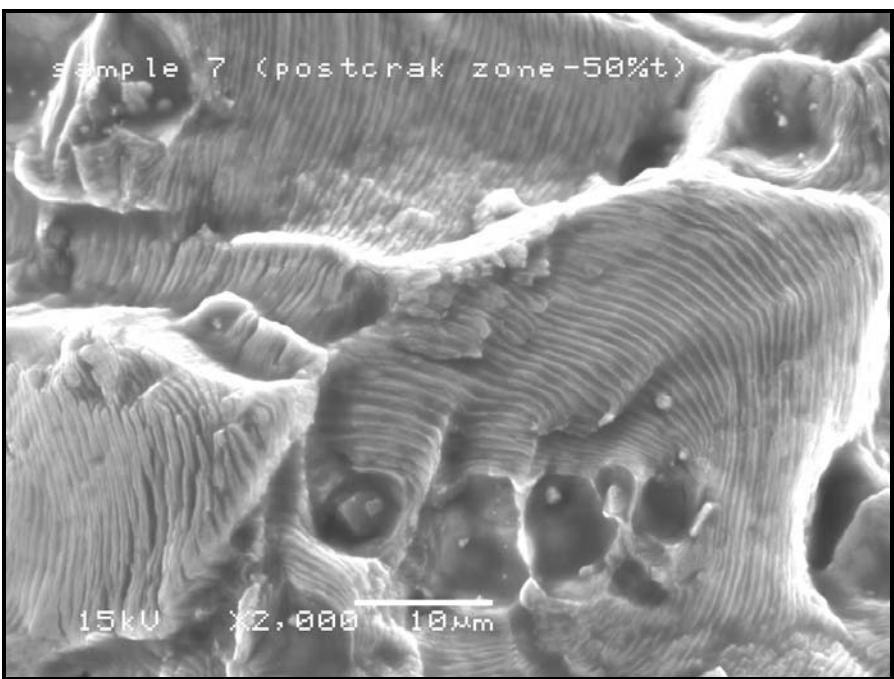
Figure 253: SEM image of sample 7 shows the fracture surface at the post-fatigue crack zone at 50% thickness, 2000X. Fatigue striations were observed throughout the post-fatigue crack zone along the 0.16 mm from the pre-fatigue crack zone.

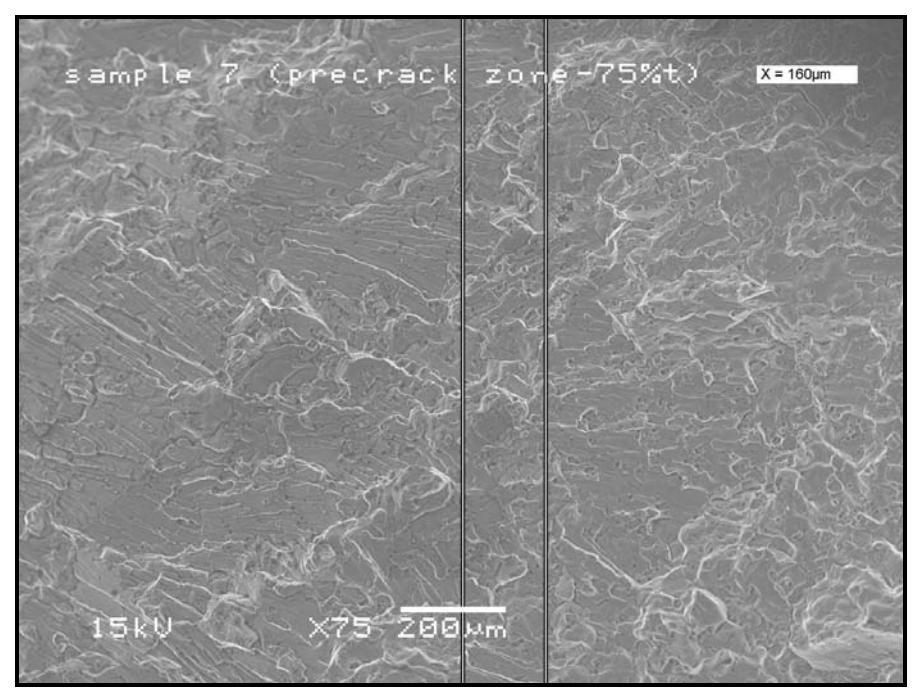
Figure 254: SEM image of sample 7 shows the fracture surface along the 0.16 mm distance from the pre-fatigue crack zone at 75% thickness, 75X. Fatigue was observed throughout the 0.16 mm distance from pre-fatigue crack zone.

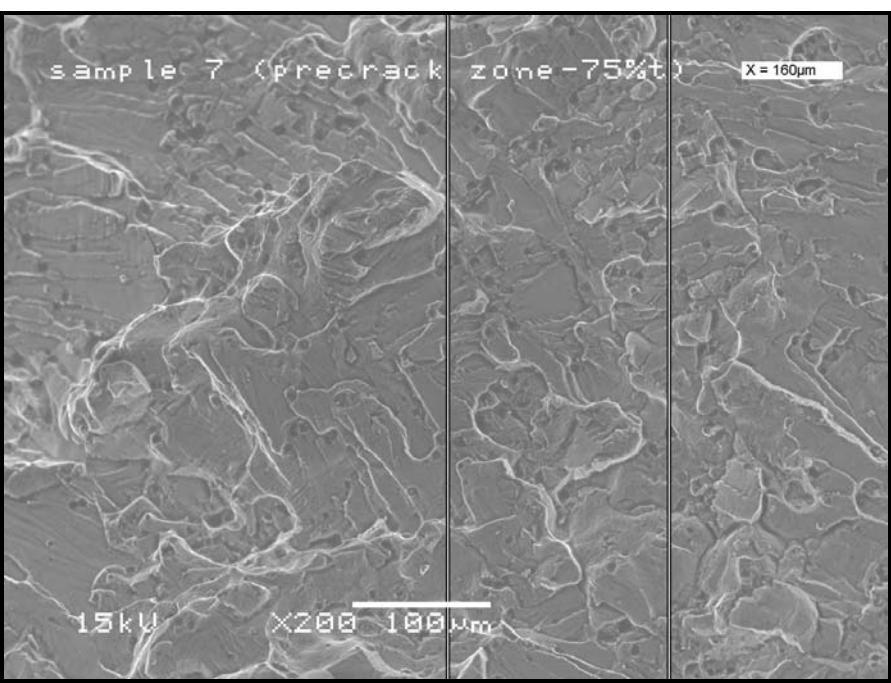
Figure 255: SEM image of sample 7 shows the fracture surface along the 0.16 mm distance from the pre-fatigue crack zone at 75% thickness, 200X. Fatigue was observed throughout the 0.16 mm distance from pre-fatigue crack zone.

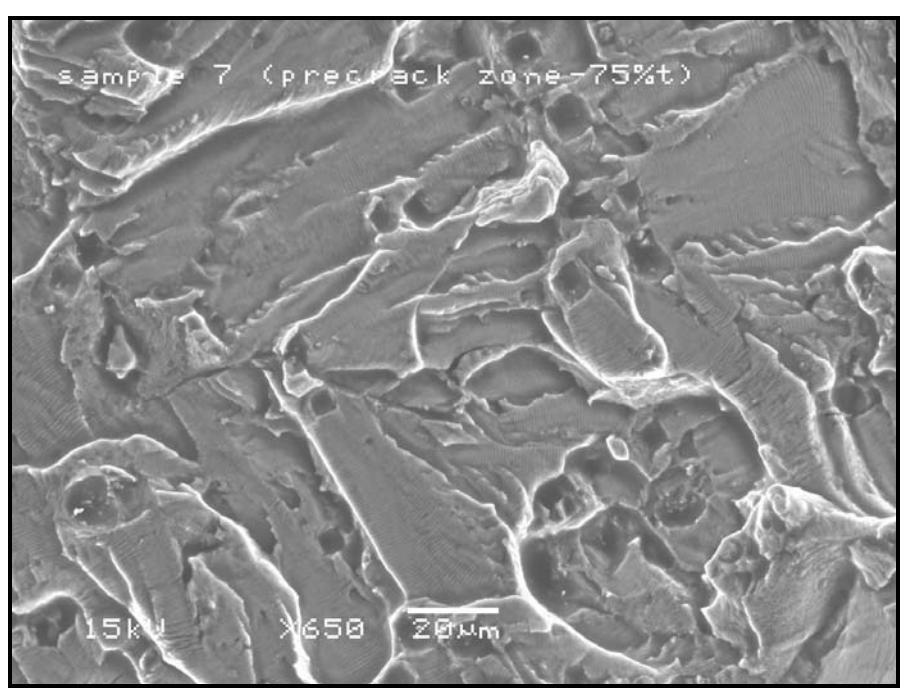
Figure 256: SEM image of sample 7 shows the fracture surface at the pre-fatigue crack zone at 75% thickness, 650X. Fatigue striations were observed throughout the pre-fatigue crack zone.

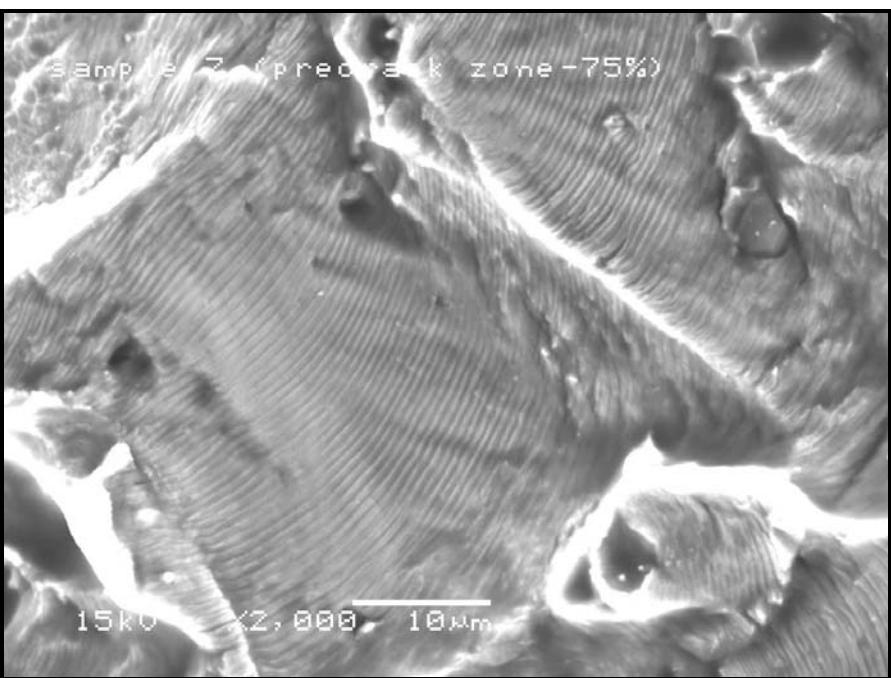
Figure 257: SEM image of sample 7 shows the fracture surface at the pre-fatigue crack zone at 75% thickness, 2000X. Fatigue striations were observed throughout the pre-fatigue crack zone.

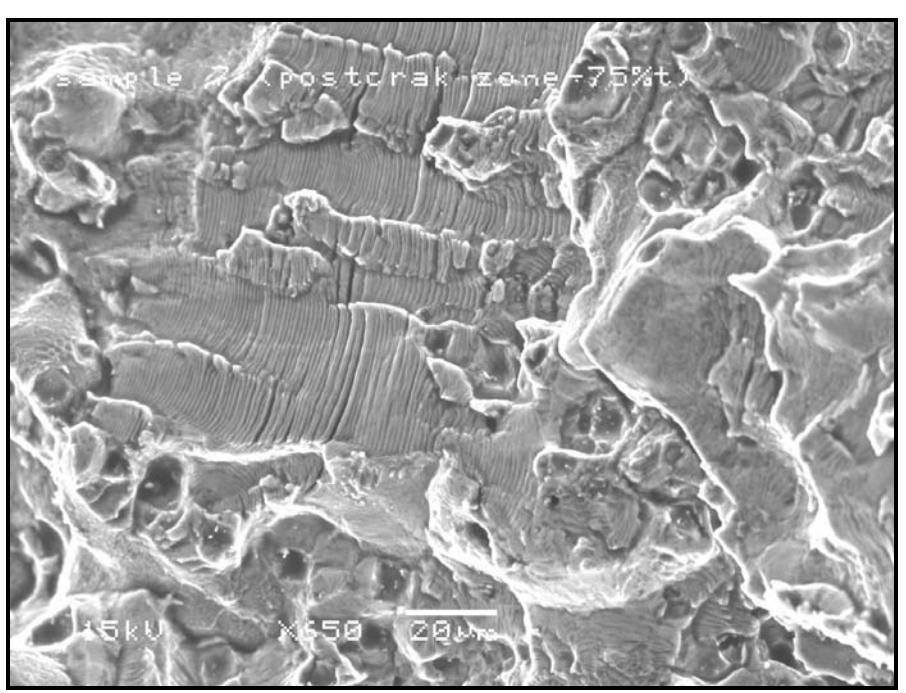
Figure 258: SEM image of sample 7 shows the fracture surface at the post-fatigue crack zone at 75% thickness, 650X. Fatigue striations were observed throughout the post-fatigue crack zone along the 0.16 mm from the pre-fatigue crack zone.

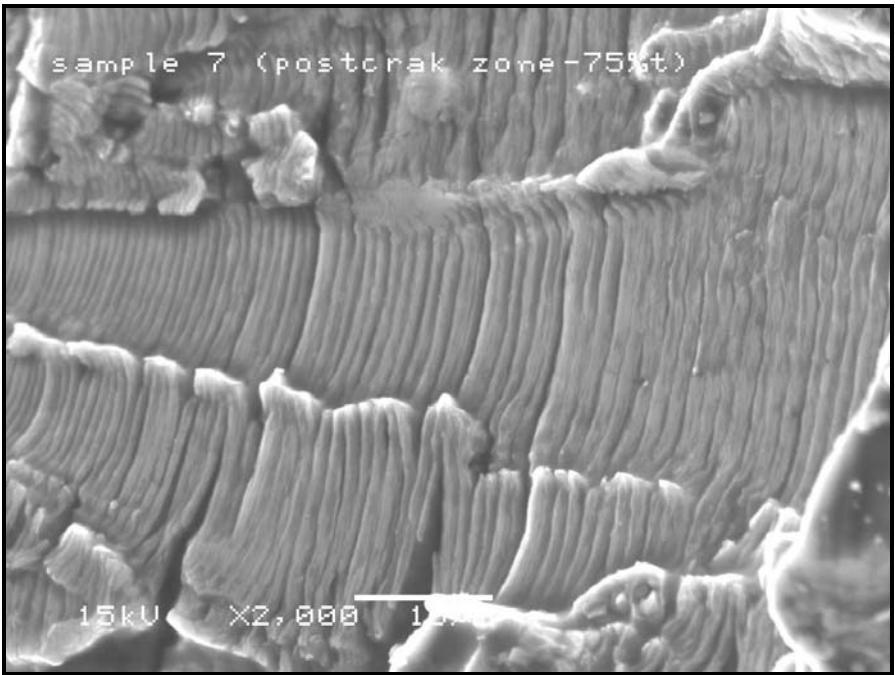
Figure 259: SEM image of sample 7 shows the fracture surface at the post-fatigue crack zone at 75% thickness, 2000X. Fatigue striations were observed throughout the post-fatigue crack zone along the 0.16 mm from the pre-fatigue crack zone.

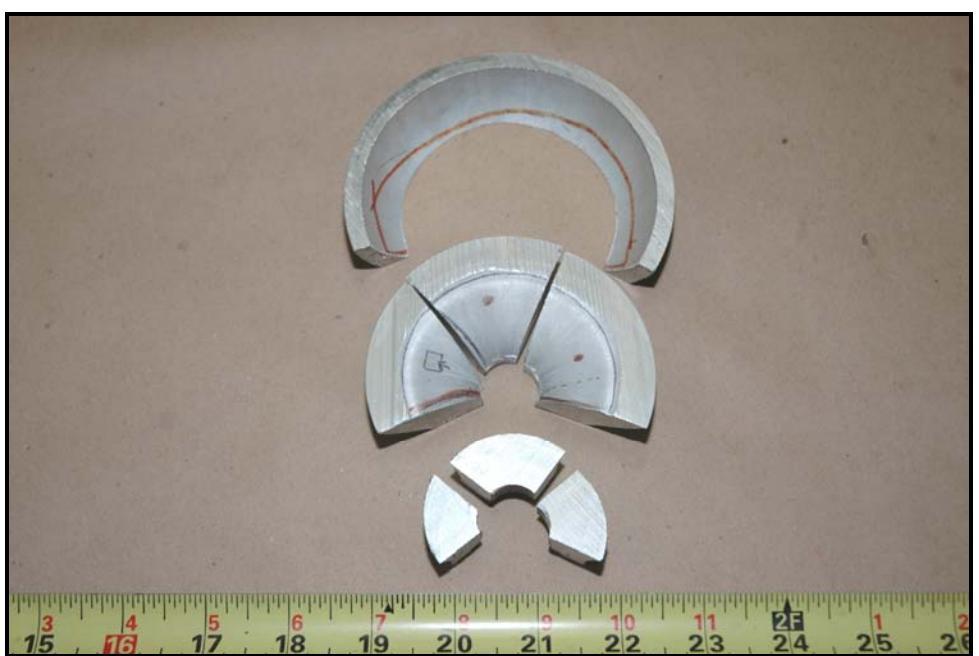
Figure 260: Shows the section of the neck region of cylinder # AR0119524 cut for fractographic analysis.

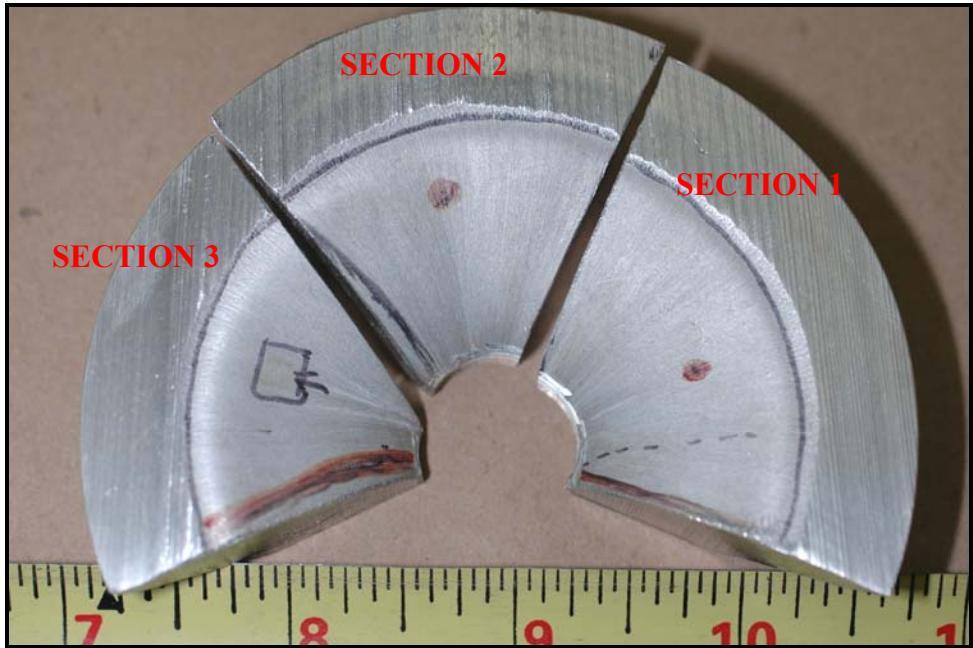
Figure 261: Shows the section of the neck region of cylinder # AR0119524 cut for fractographic analysis. Section 1 was used for SEM observation of fracture surface. Sections 2 and 3 were used for metallographic analysis.

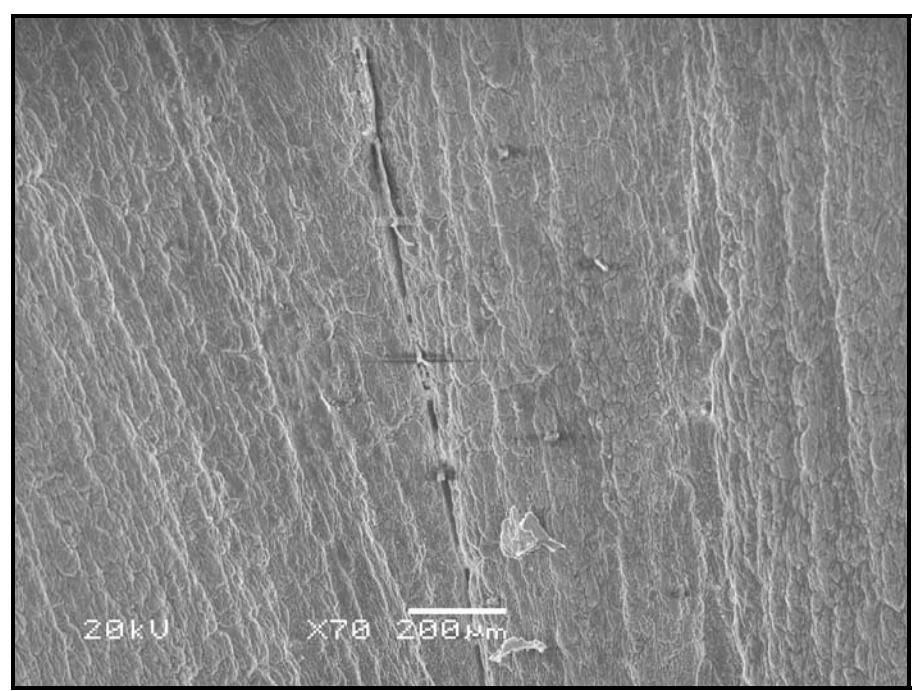
Figure 262: Shows the crack in the neck forming folds of section 1 from cylinder # AR0119524 identified in Figure 261. Magnification: 70X

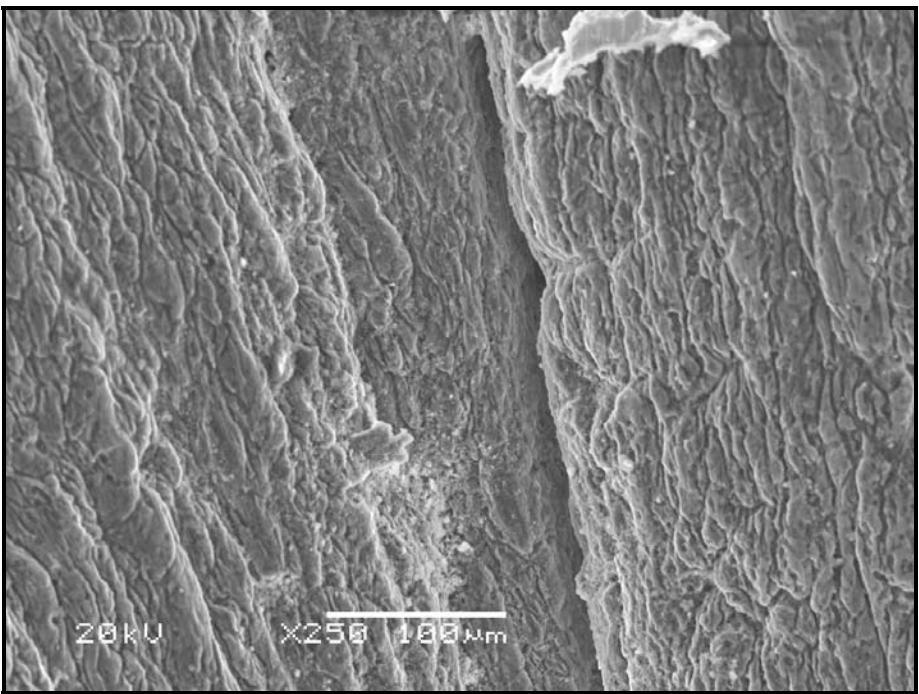
Figure 263: Shows the crack in the neck forming folds of section 1 from cylinder # AR0119524 identified in Figure 261. Magnification: 250X

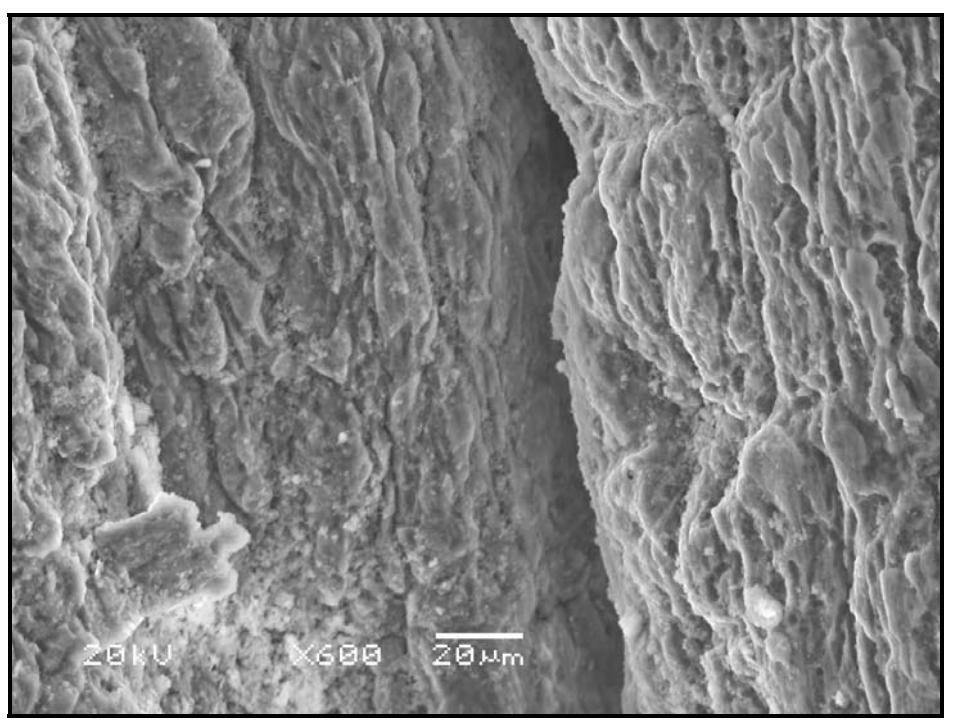
Figure 264: Shows the crack in the neck forming folds of section 1 from cylinder # AR0119524 identified in Figure 261. Magnification: 600X

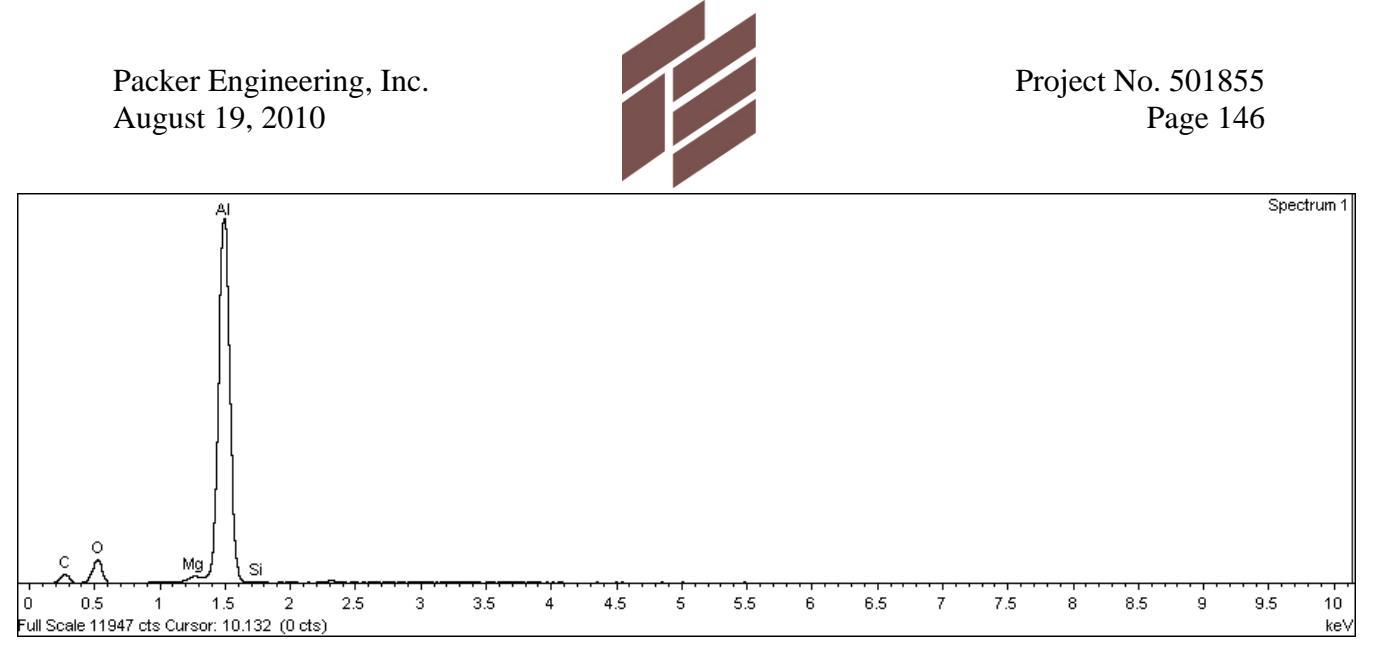
Figure 265: Shows the EDS spectra of the deposit observed on the fracture surface.

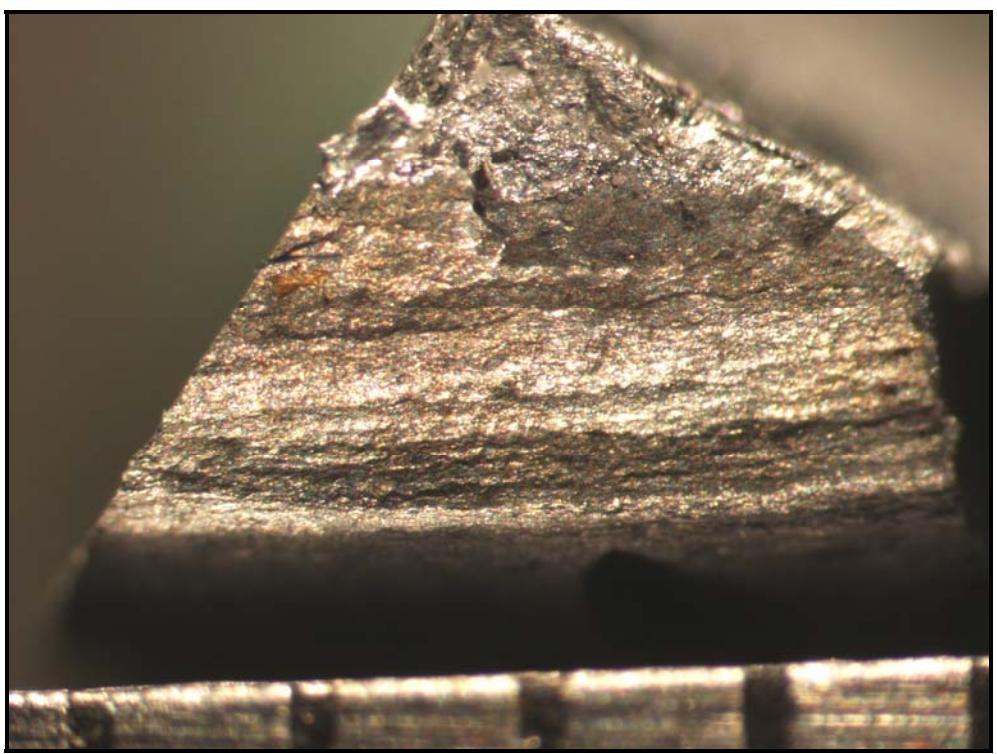
Figure: 266: Stereoscope image of the fracture surface of the after cleaning. Shows the surface is damaged and has rubbing marks.

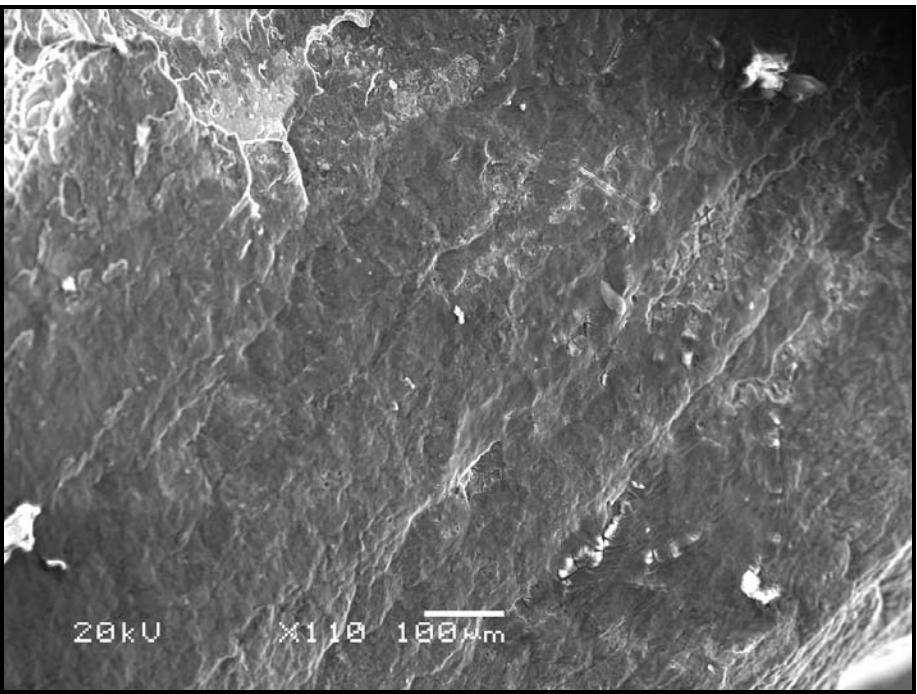
Figure 267: SEM image of the fracture surface after cleaning shows the fracture surface is damaged has rubbing marks and an oxide layer. Magnification: 110X

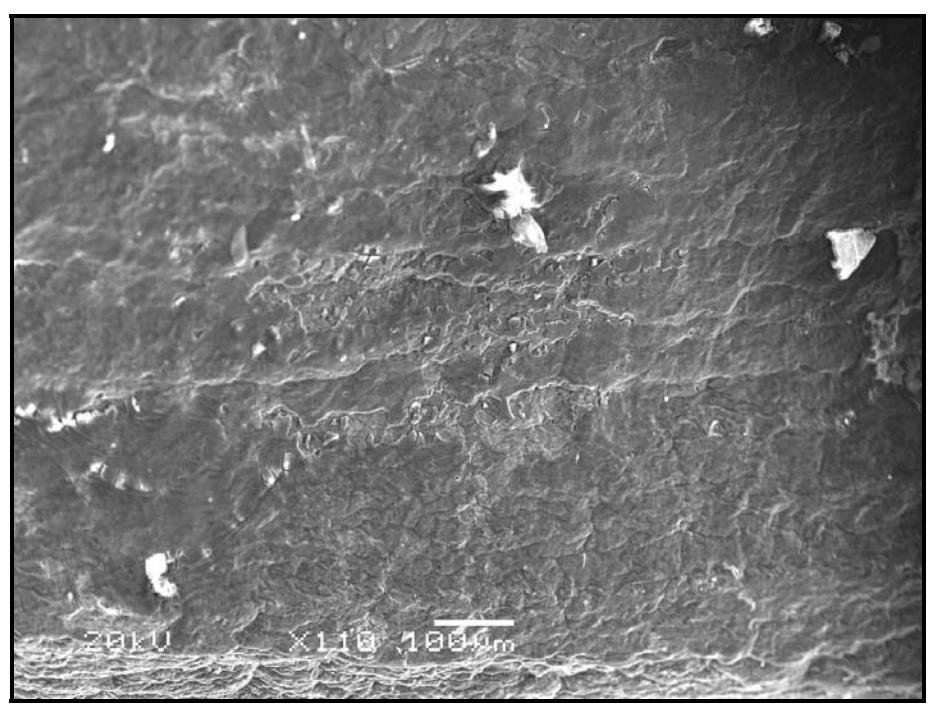
Figure 268: SEM image of the fracture surface after cleaning shows the fracture surface is damaged has rubbing marks and an oxide layer. Magnification: 110X

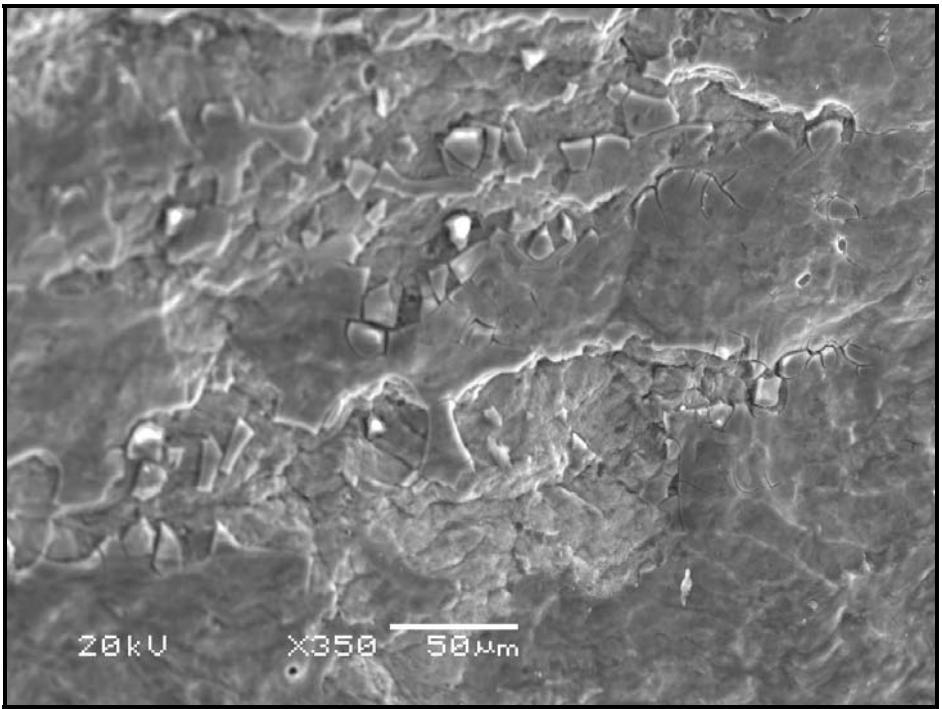
Figure 269: SEM image of the fracture surface after cleaning shows the fracture surface is damaged has rubbing marks and an oxide layer. Magnification: 350X

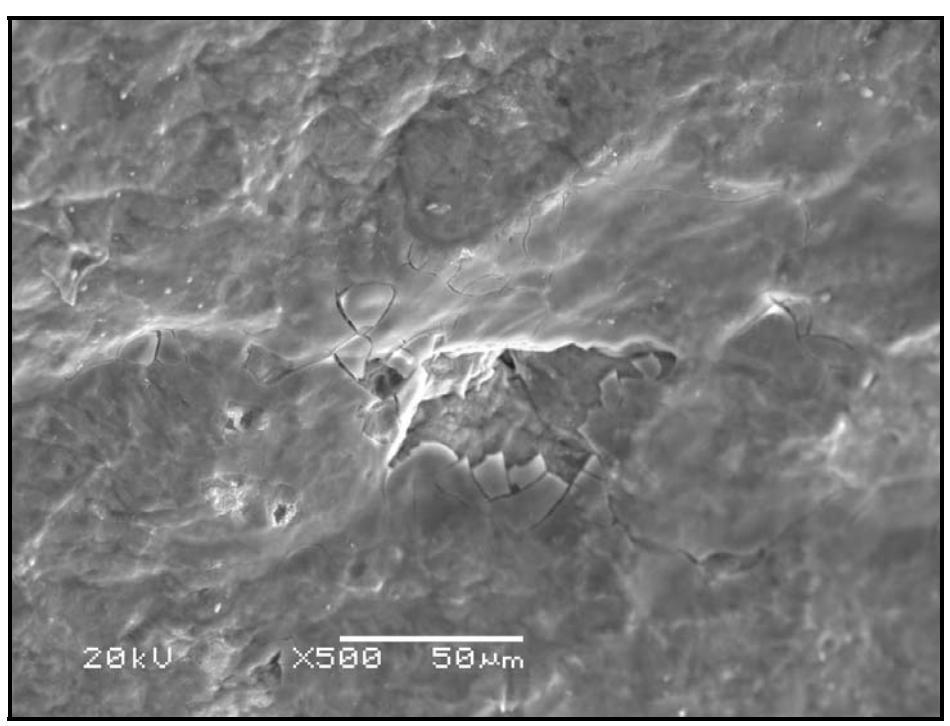
Figure 270: SEM image of the fracture surface after cleaning shows the fracture surface is damaged has rubbing marks and an oxide layer. Magnification: 500X

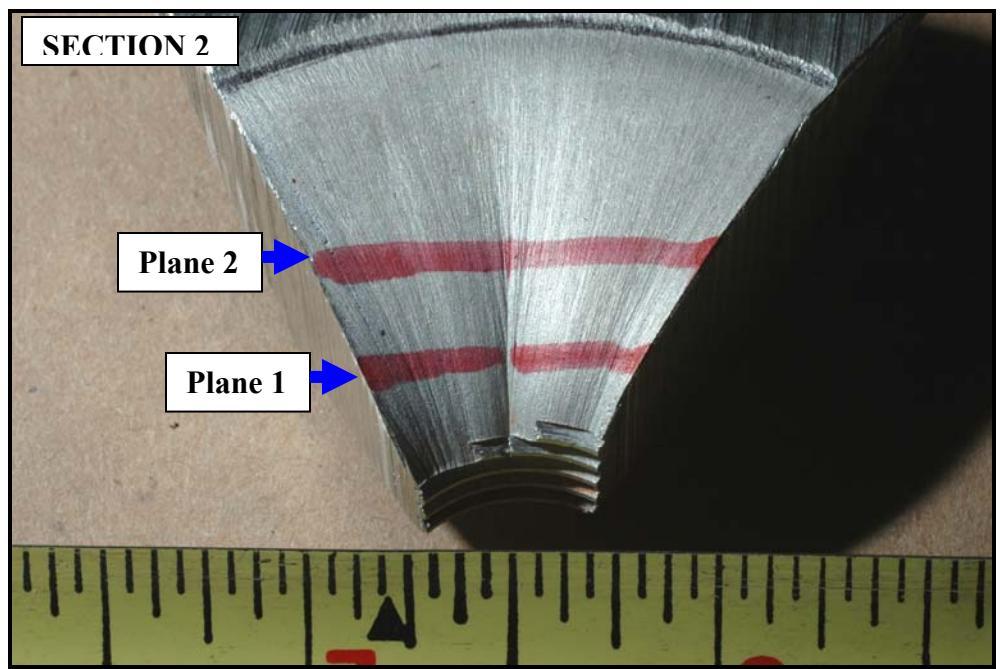
Figure 271: Shows the section 2 from cylinder # AR0119524. This section was cut on plane 1 and plane 2 and mounted for microstructural observation.

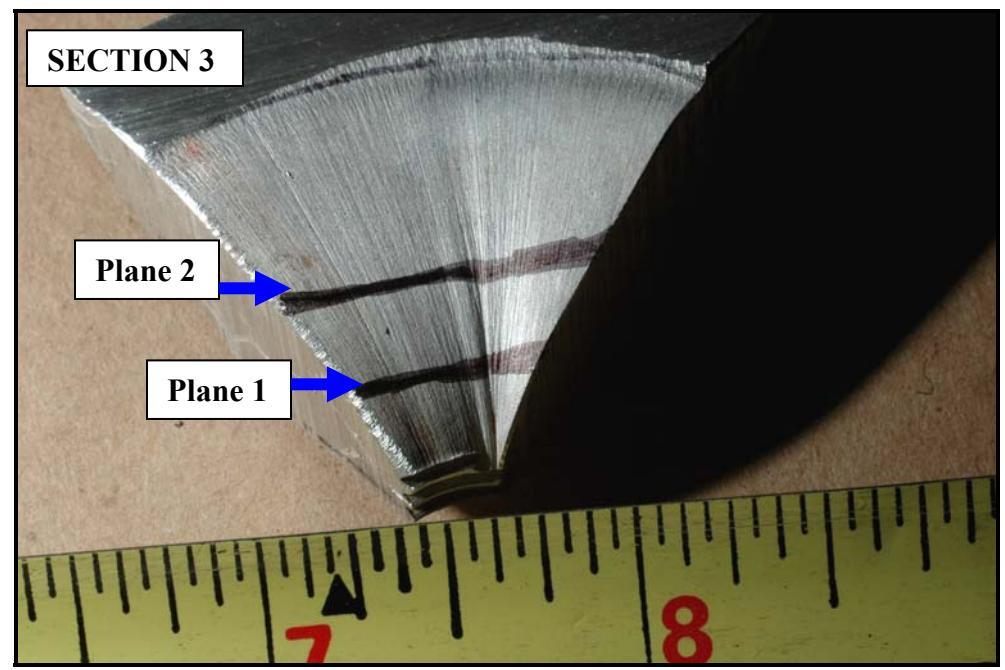
Figure 272: Shows the section 2 from cylinder # AR0119524. This section was cut on plane 1 and plane 2 and mounted for microstructural observation.

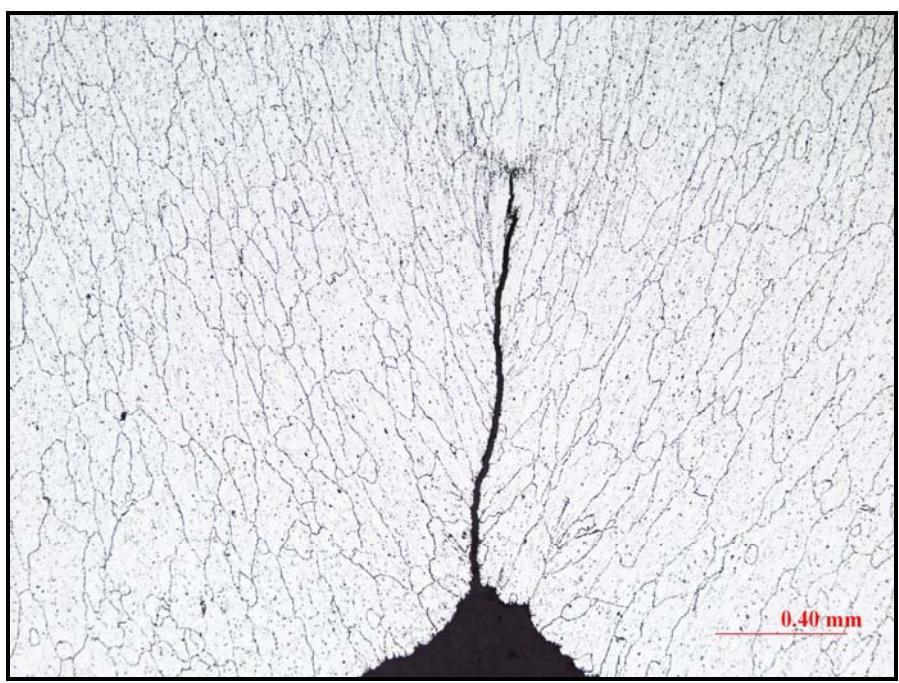
Figure 273: Shows the crack in the neck forming fold propagating from the ID to the OD in plane 1 of section 1. Magnification: 50X Etchant: Keller's Etch

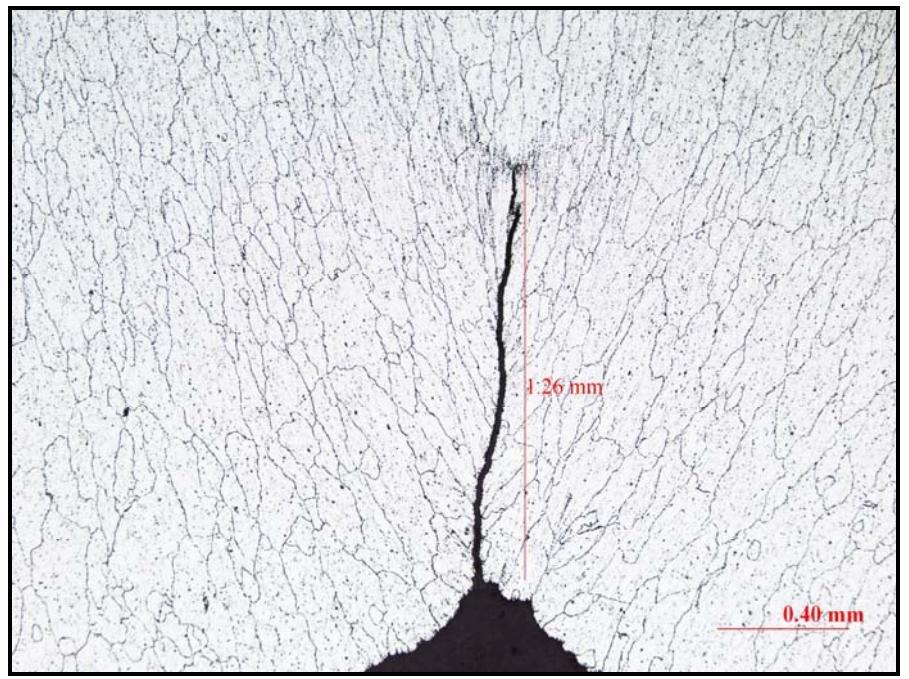
Figure 274: Shows the crack in the neck forming fold propagating from the ID to the OD in plane 1 of section 1. The crack is 1.26 mm deep. Magnification: 50X Etchant: Keller's Etch

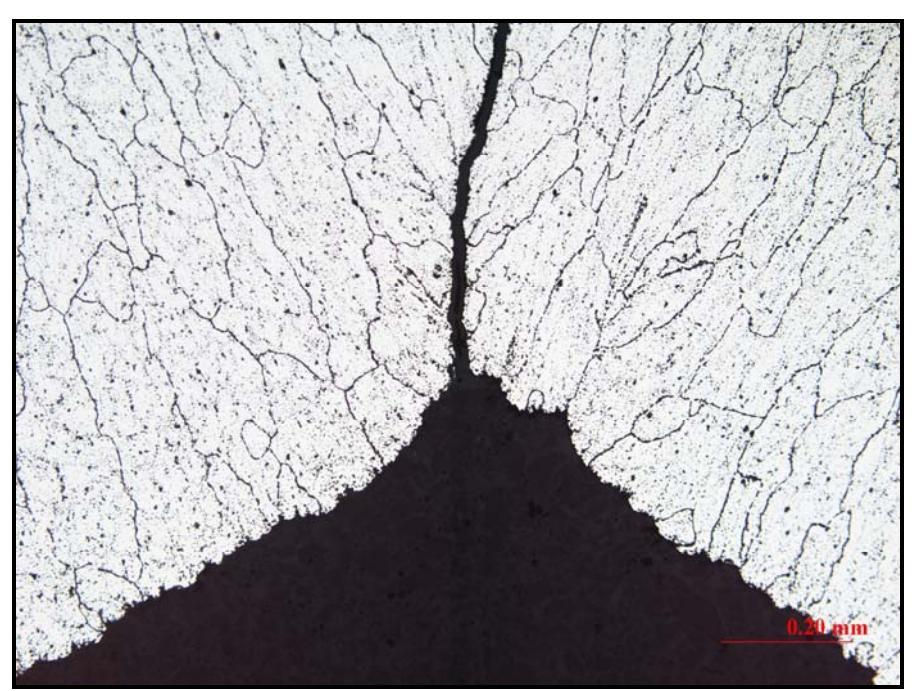
Figure 275: Shows the crack in the neck forming fold propagating from the ID to the OD in plane 1 of section 1. Magnification: 100X Etchant: Keller's Etch

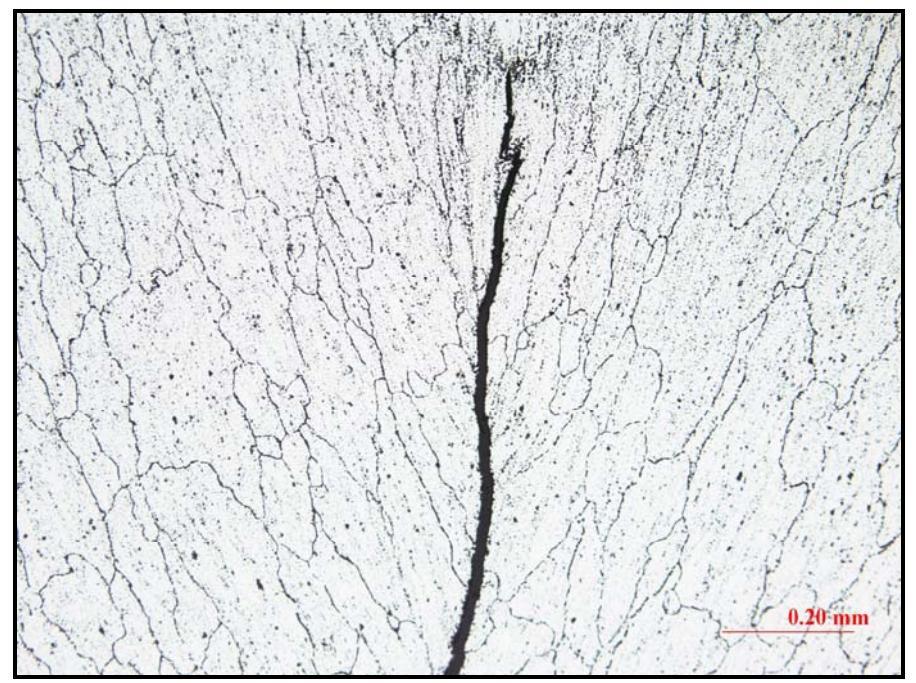
Figure 276: Shows the crack in the neck forming fold propagating from the ID to the OD in plane 1 of section 1. Magnification: 100X Etchant: Keller's Etch

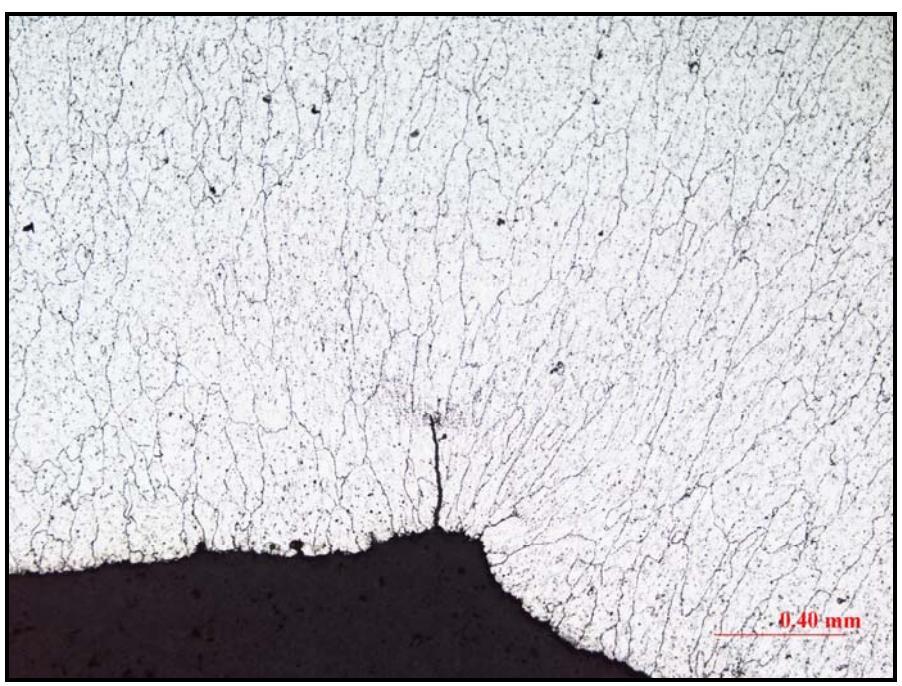
Figure 277: Shows the crack in the neck forming fold propagating from the ID to the OD in plane 2 of section 1. Magnification: 50X Etchant: Keller's Etch
