PACKER ENGINEERING INC, 1950 North Washington Street, Naperville, IL 60566

Evaluation of Three DOT 3AL 6061-T6 Cylinders to Determine the Neck Cracks Cause and Initiation Site (CIS of Neck Cracks)

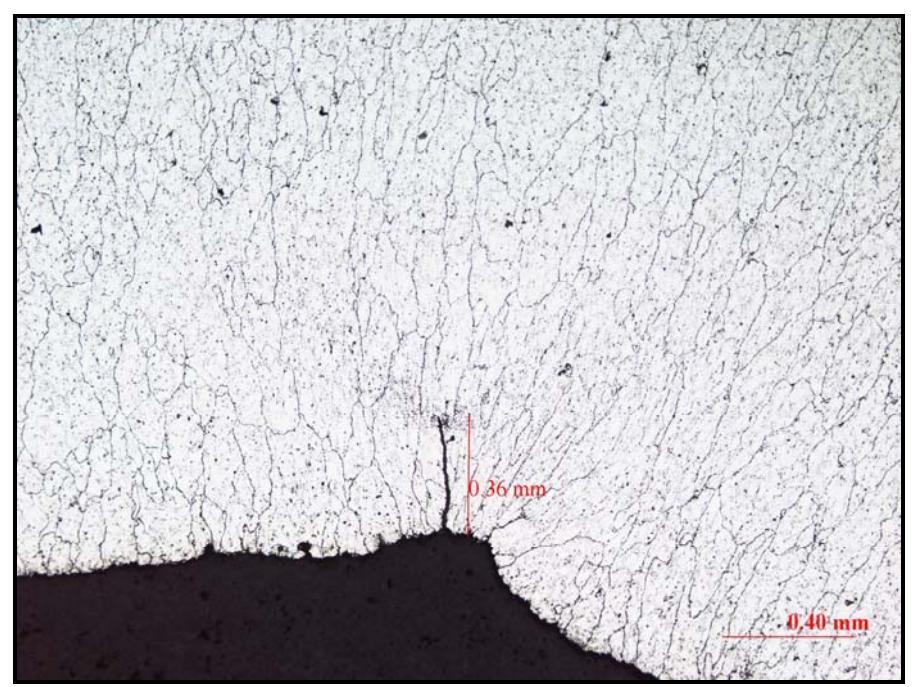
Figure 278: Shows the crack in the neck forming fold propagating from the ID to the OD in plane 2 of section 1. The crack is 0.36 mm deep. Magnification: 50X Etchant: Keller's Etch

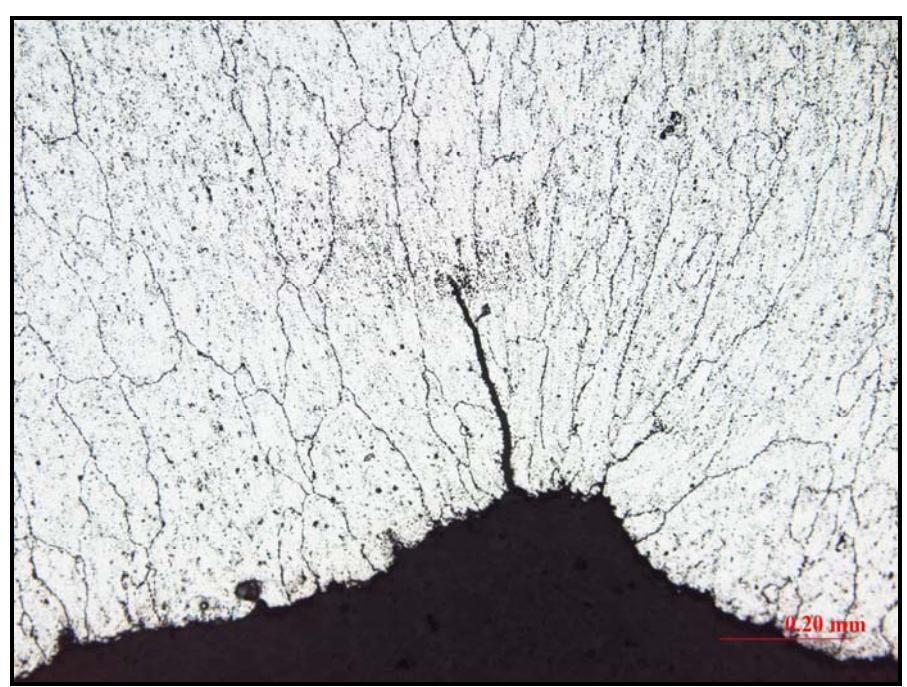
Figure 279: Shows the crack in the neck forming fold propagating from the ID to the OD in plane 2 of section 1. Magnification: 100X Etchant: Keller's Etch

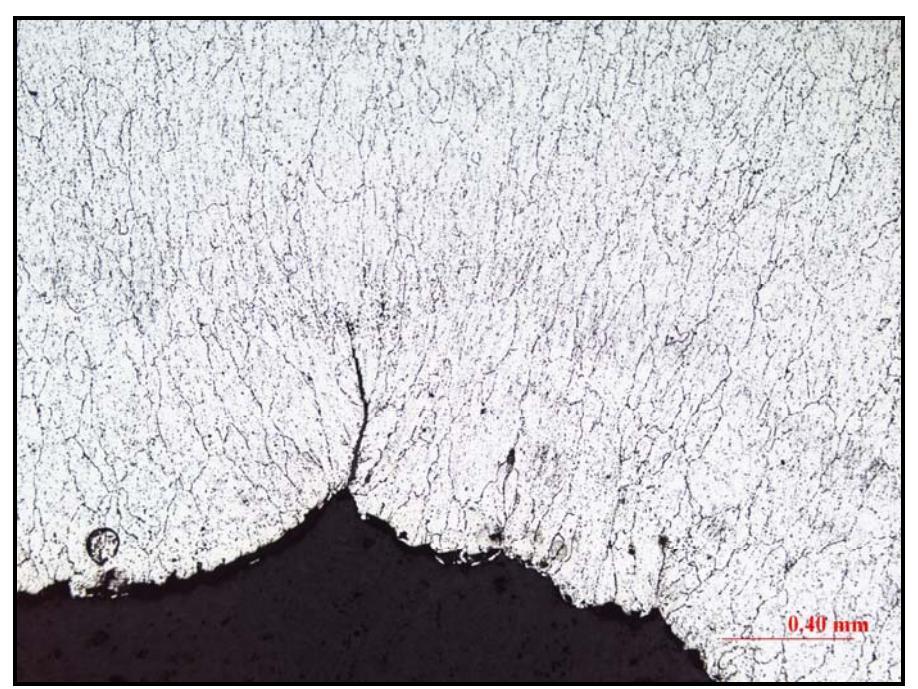
Figure 280: Shows the crack in the neck forming fold propagating from the ID to the OD in plane 1 of section 2. Magnification: 50X Etchant: Keller's Etch

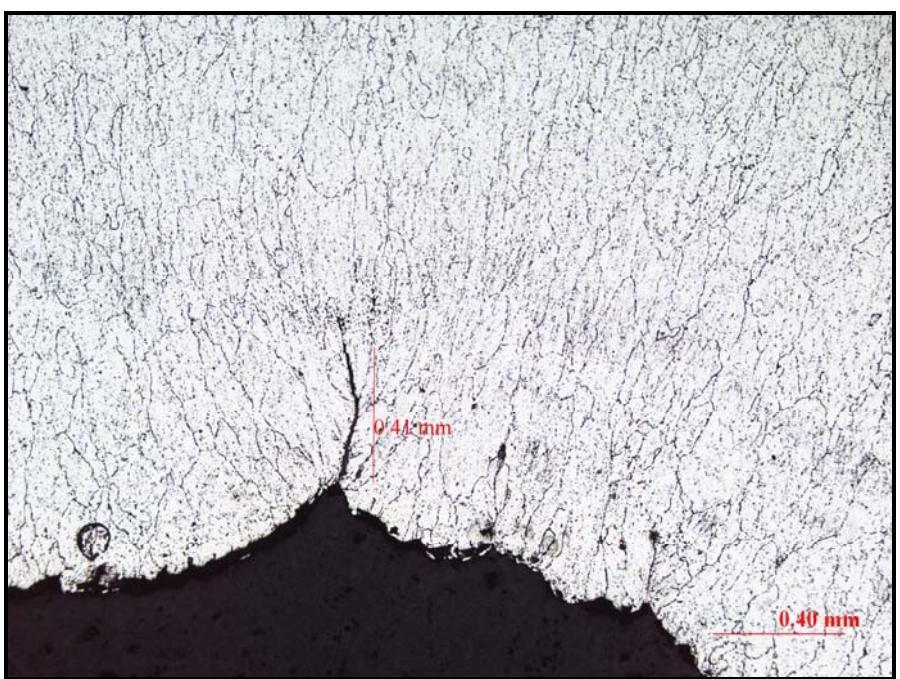
Figure 281: Shows the crack in the neck forming fold propagating from the ID to the OD in plane 1 of section 2. The crack is 0.41 mm deep. Magnification: 50X Etchant: Keller's Etch

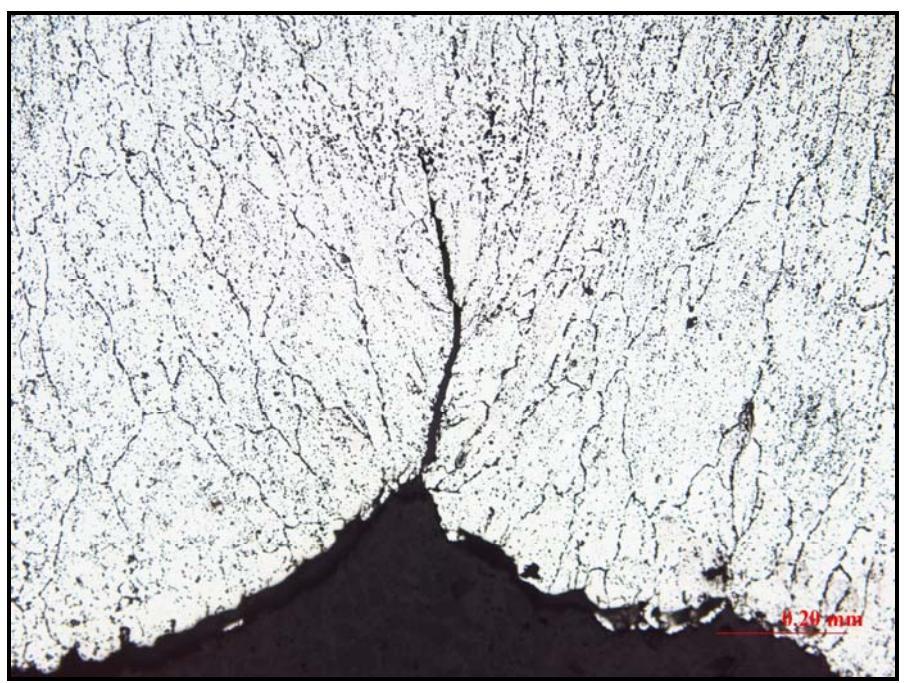
Figure 282: Shows the crack in the neck forming fold propagating from the ID to the OD in plane 1 of section 2. Magnification: 100X Etchant: Keller's Etch

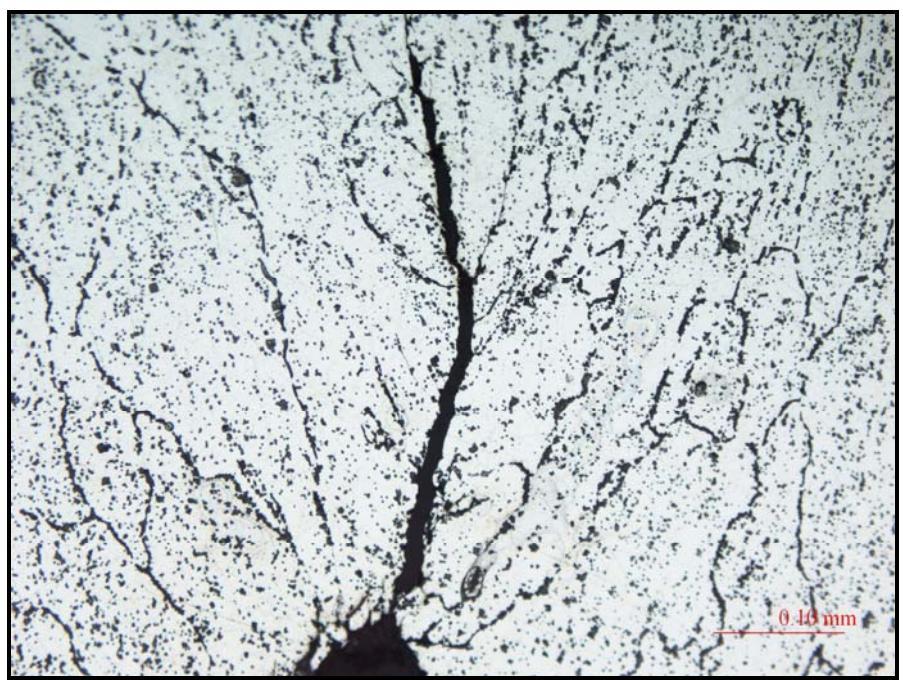
Figure 283: Shows the crack in the neck forming fold propagating from the ID to the OD in plane 1 of section 2. Magnification: 200X Etchant: Keller's Etch

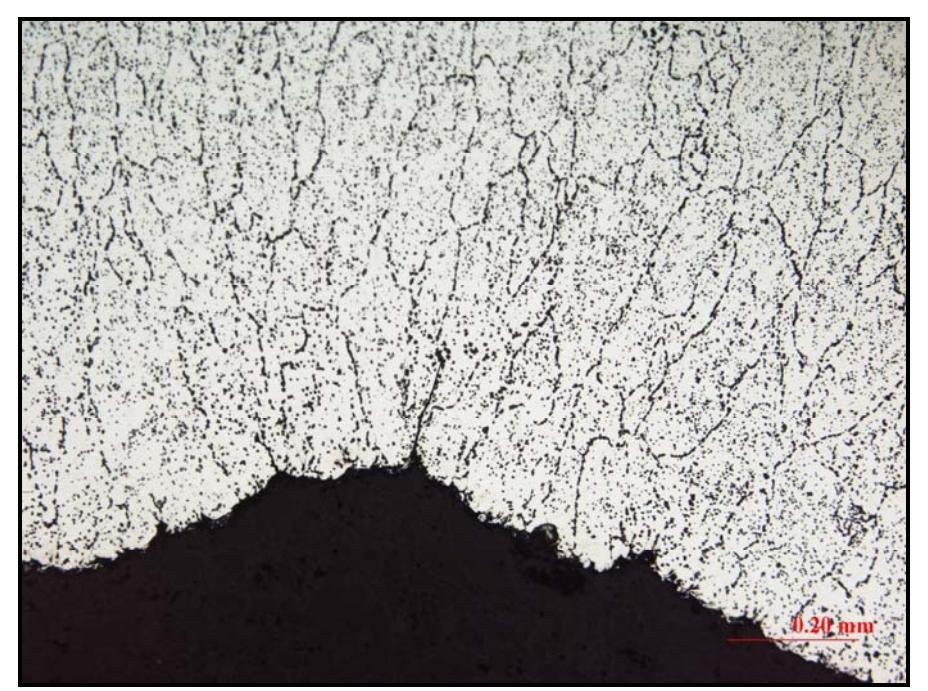
Figure 284: Shows the crack in the neck forming fold propagating from the ID to the OD in plane 2 of section 2. Magnification: 50X Etchant: Keller's Etch

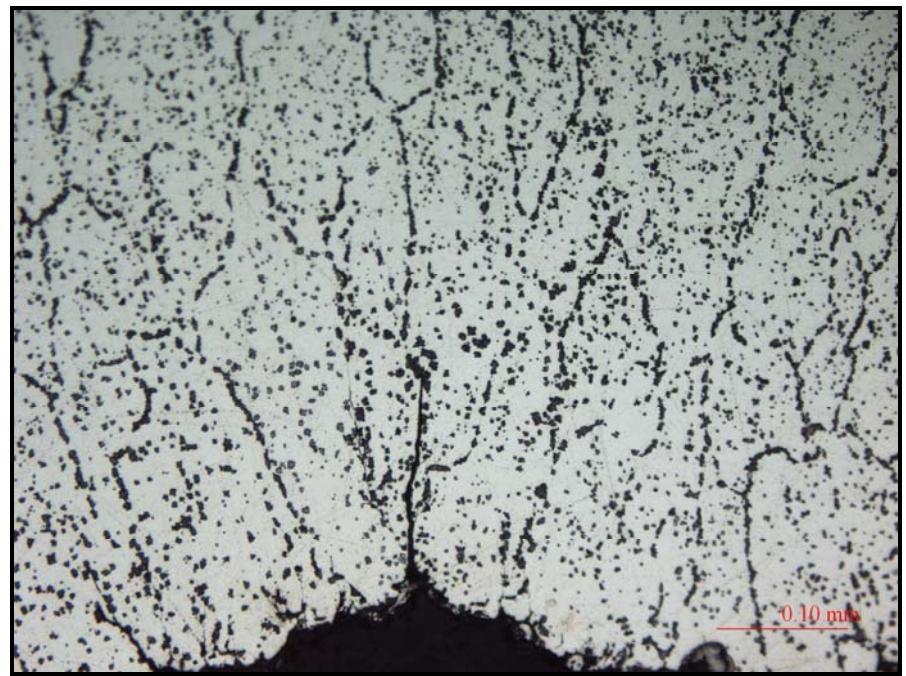
Figure 285: Shows the crack in the neck forming fold propagating from the ID to the OD in plane 2 of section 2. Magnification: 200X Etchant: Keller's Etch

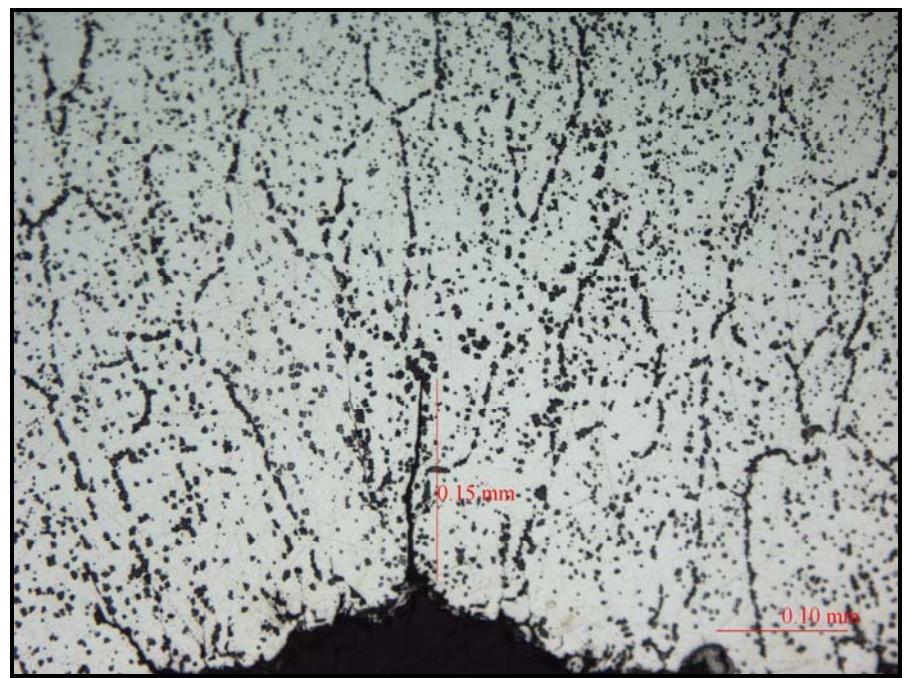
Figure 286: Shows the crack in the neck forming fold propagating from the ID to the OD in plane 2 of section 2. The crack is 0.15 mm deep. Magnification: 200X Etchant: Keller's Etch

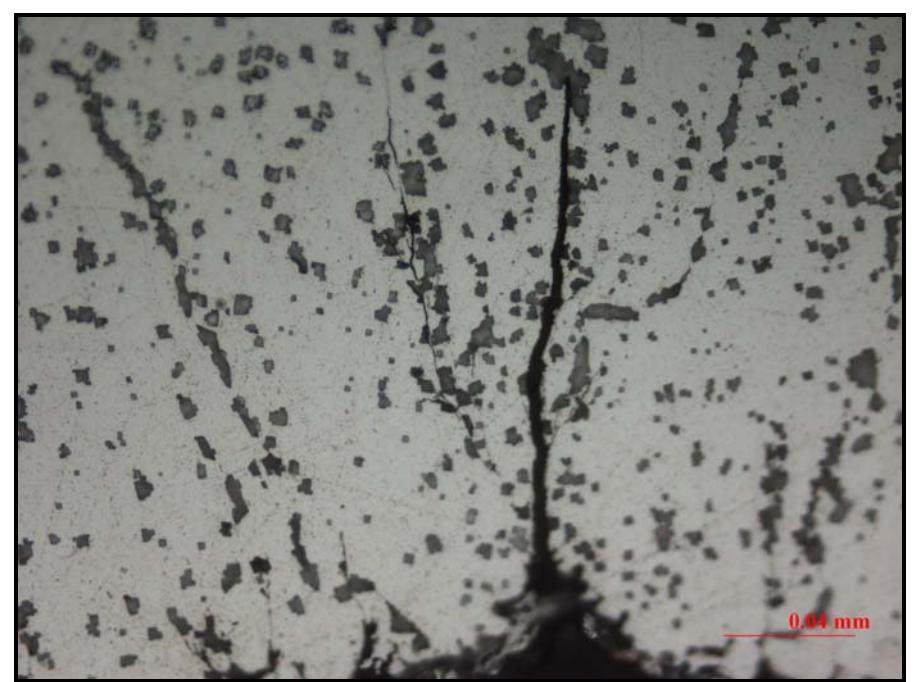
Figure 287: Shows the crack in the neck forming fold propagating from the ID to the OD in plane 2 of section 2. Magnification: 500X Etchant: Keller's Etch
