# Fatigue life improvement of DOT-CFFC composite cylinders

December 2015

Digital Wave Corporation Brian Burks PhD, Steven Ziola PhD, Michael Gorman PhD 13760 East Arapahoe Road Centennial, CO 80121 (303) 790-7559

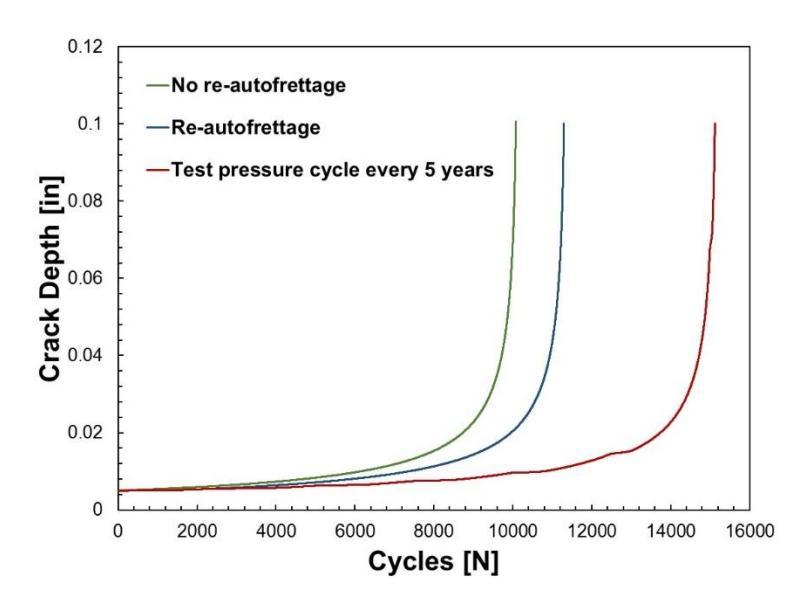
Figure 3.5 provides the crack length as a function of the number of cycles to maximum developed for the representative DOT-CFFC cylinders that were and were not reautofrettaged, as well as a cylinder which was reautofrettaged and then subjected to a test pressure cycle every 2,500 cycles (or 5 years of service life). The Paris law model predicts that the considered initial flaw ( $a_0 = 0.005$ ",  $2c_0 = 0.018$ ") would grow to a depth of 0.076" in 10,000 cycles. A slightly larger flaw (only one to two thousandths of an inch deeper) would grow through the remaining 0.024" before 10,000 cycles, resulting in leakage of the aluminum liner.

The Wheeler model predicts reduced crack growth behavior (as compared to cylinders which did not experience the tensile overload). This reduced crack growth rate behavior is due to all existing cracks being blunted and put into residual compression upon the removal of the tensile overload; such behavior is what enables the enhanced fatigue behavior. Finally, from Figure 3.5 it is apparent that the application of a test pressure cycle every 2,500 cycles predicts even greater fatigue life performance than a cylinder which was only reautofrettaged, and exceptional fatigue life performance as compared to a cylinder which has not experienced any form of a tensile overload once a flaw initiation site was present.

Figure 3.5 – Crack depth as a function of the number of cycles to maximum developed pressure for Aluminum liners that were and were not reautofrettaged, as well as a cylinder which was subjected to a test pressure cycle every 5 years of service life.

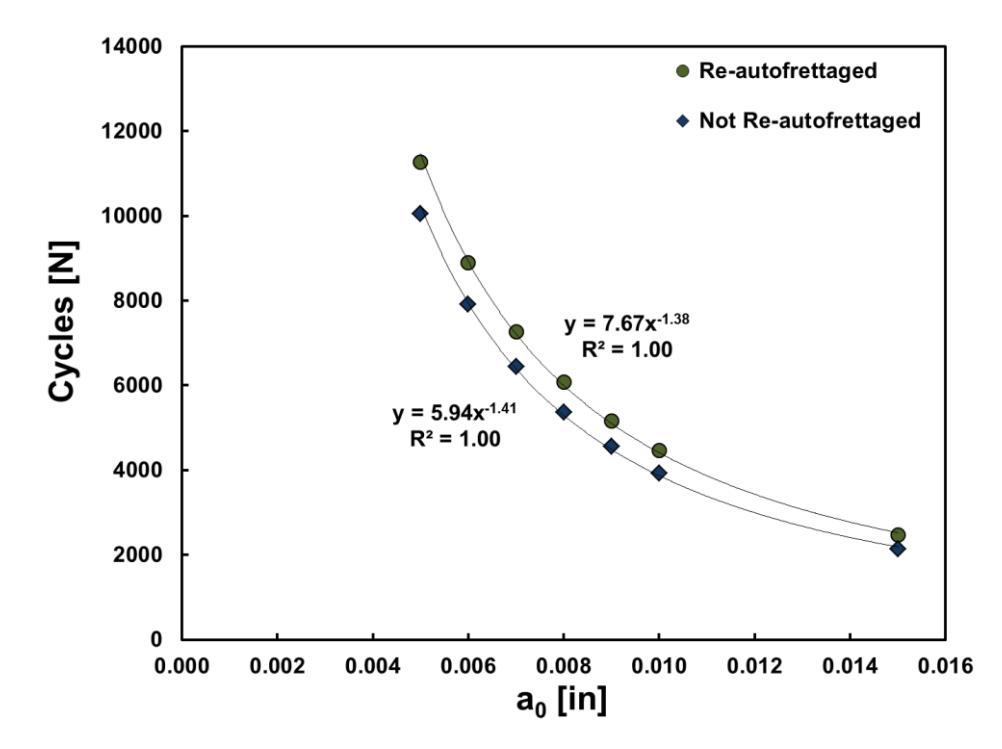
Figure 3.6 – Effect of the initial flaw depth (a<sub>0</sub>) on the total number of obtainable fatigue cycles to maximum developed pressure prior to the flaw growing through the aluminum liner.

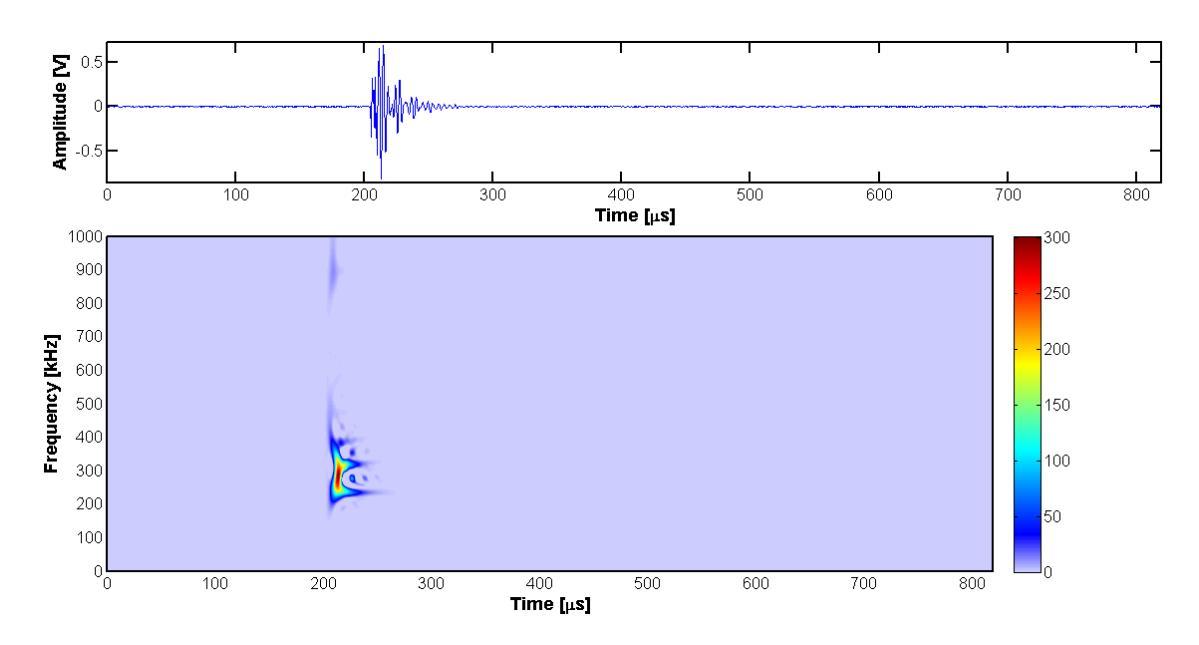
The lone cylinder which was rejected by the MAE acceptance criteria was cylinder ALT695-4944, and the cylinder was rejected due to an event on the second test pressure cycle which exceeded the partial fiber tow fracture energy. Figure 5.6 presents the time domain waveform as well as a time-frequency representation of the detected partial fiber tow fracture event which failed the cylinder. Based upon the location of the transducer (3" below the top cylinder-to-side wall transition) relative to the location of the Level 3 cut on the cylinder side wall (Table 4.1) and a wave ranging analysis, it is confirmed that the Level 3 cut was a significant enough stress concentrator that upon the application of a test pressure cycle, portions of neighboring fiber tows failed. Thus, the MAE acceptance criteria has once again shown to provide an exceptionally conservative examination of DOT-CFFC cylinders that is in good agreement with visual observations of defects within the cylinders.

Figure 5.6 – (top) Time domain waveform, and (bottom) time-frequency representation of the partial fiber tow fracture event that occurred on the second test pressure cycle which failed cylinder ALT695-4944.
