Inspection Report

New Albany Light, Gas, Water 1168 E Bankhead New Albany, MS 38652 ATTN: Chris Camp Project In-Service Pipe Section Analysis Inspection performed at: World Testing, Inc. Mt. Juliet, TN Personnel & Company contacted during inspection Chris Camp and Jackie Cruse Description of Item(s) Inspection Chris Camp and Jackie Cruse Description of Item(s) Inspection There Feet of 6" Gas Pipe Client Authorized modifications/clarifications We region and two longitudinal factory seam welds. We conducted the following: Radiographic, Ultrasonic: Root Bend, Marcian Petroleum Institute Standard 1104 Welding of Pipelines and Related Fausion and Porosity. The longitudinal weld and two failed due to Lack of Fusion and Porosity. The longitudinal weld one passed and weld two failed due to Lack of Fusion and Slag indications. The longitudinal weld one passed and weld two failed due to Lack of Fusion and Slag indications. The longitudinal weld one passed and weld two failed due to Lack of Fusion and Slag indications. The longitudinal weld one passed and weld two failed due to Lack of Fusion and Slag indications. The longitudinal weld one passed and weld two failed due to Lack of Fusion and

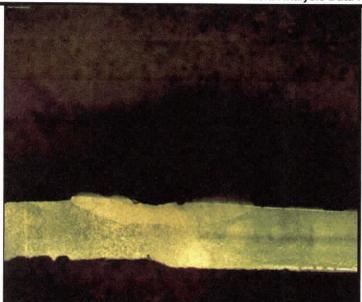
Figure 1: Girth Seam

D.	th complex failed in the world and didn't would be	. Two samples were taken fro	om the	Circumfere	ntial	weld.
Macro-etch Test: One sample was taken from the circumforantial wold and and from the leading to the	ВС	iti samples railed in the weld and didn't meet the minimun	n Ultimate Tensile Strength.				
		Macro-etch Test: One sample was taken from the simulation	orontial wold and are former	L _ 1 _			
Macro-etch Test: One sample was taken from the circumferential weld and one from the longitudinal weld. Both samples exhibited corrosion and lack of fusion.	sa	mples exhibited corrosion and lack of fusion	erential weld and one from t	ne long	itudinal we	eld. B	oth

Description:	Butt Weld
Weld Process:	SMAW
Weld Size:	0.125"
Magnification:	10x
Comments:	Internal Undercut

3. Also, from the two photos of the etched surface of the welds, it appears to **be historic rimmed or capped primary steel** with **centerline carbon segregation**. This type of steel has a core of higher strength, carbon rich microstructure, and the outer and inner walls have a weaker, carbon denuded zone which can be a challenge sometimes to match with weld filler material and the associated desired carbon equivalents (C.E.).
